**Cell 1 Regional Coastal Monitoring Programme
Lynemouth 'Post Storm' Beach Monitoring Survey
Report 2023**

**Northumberland County
Council**

December 2023

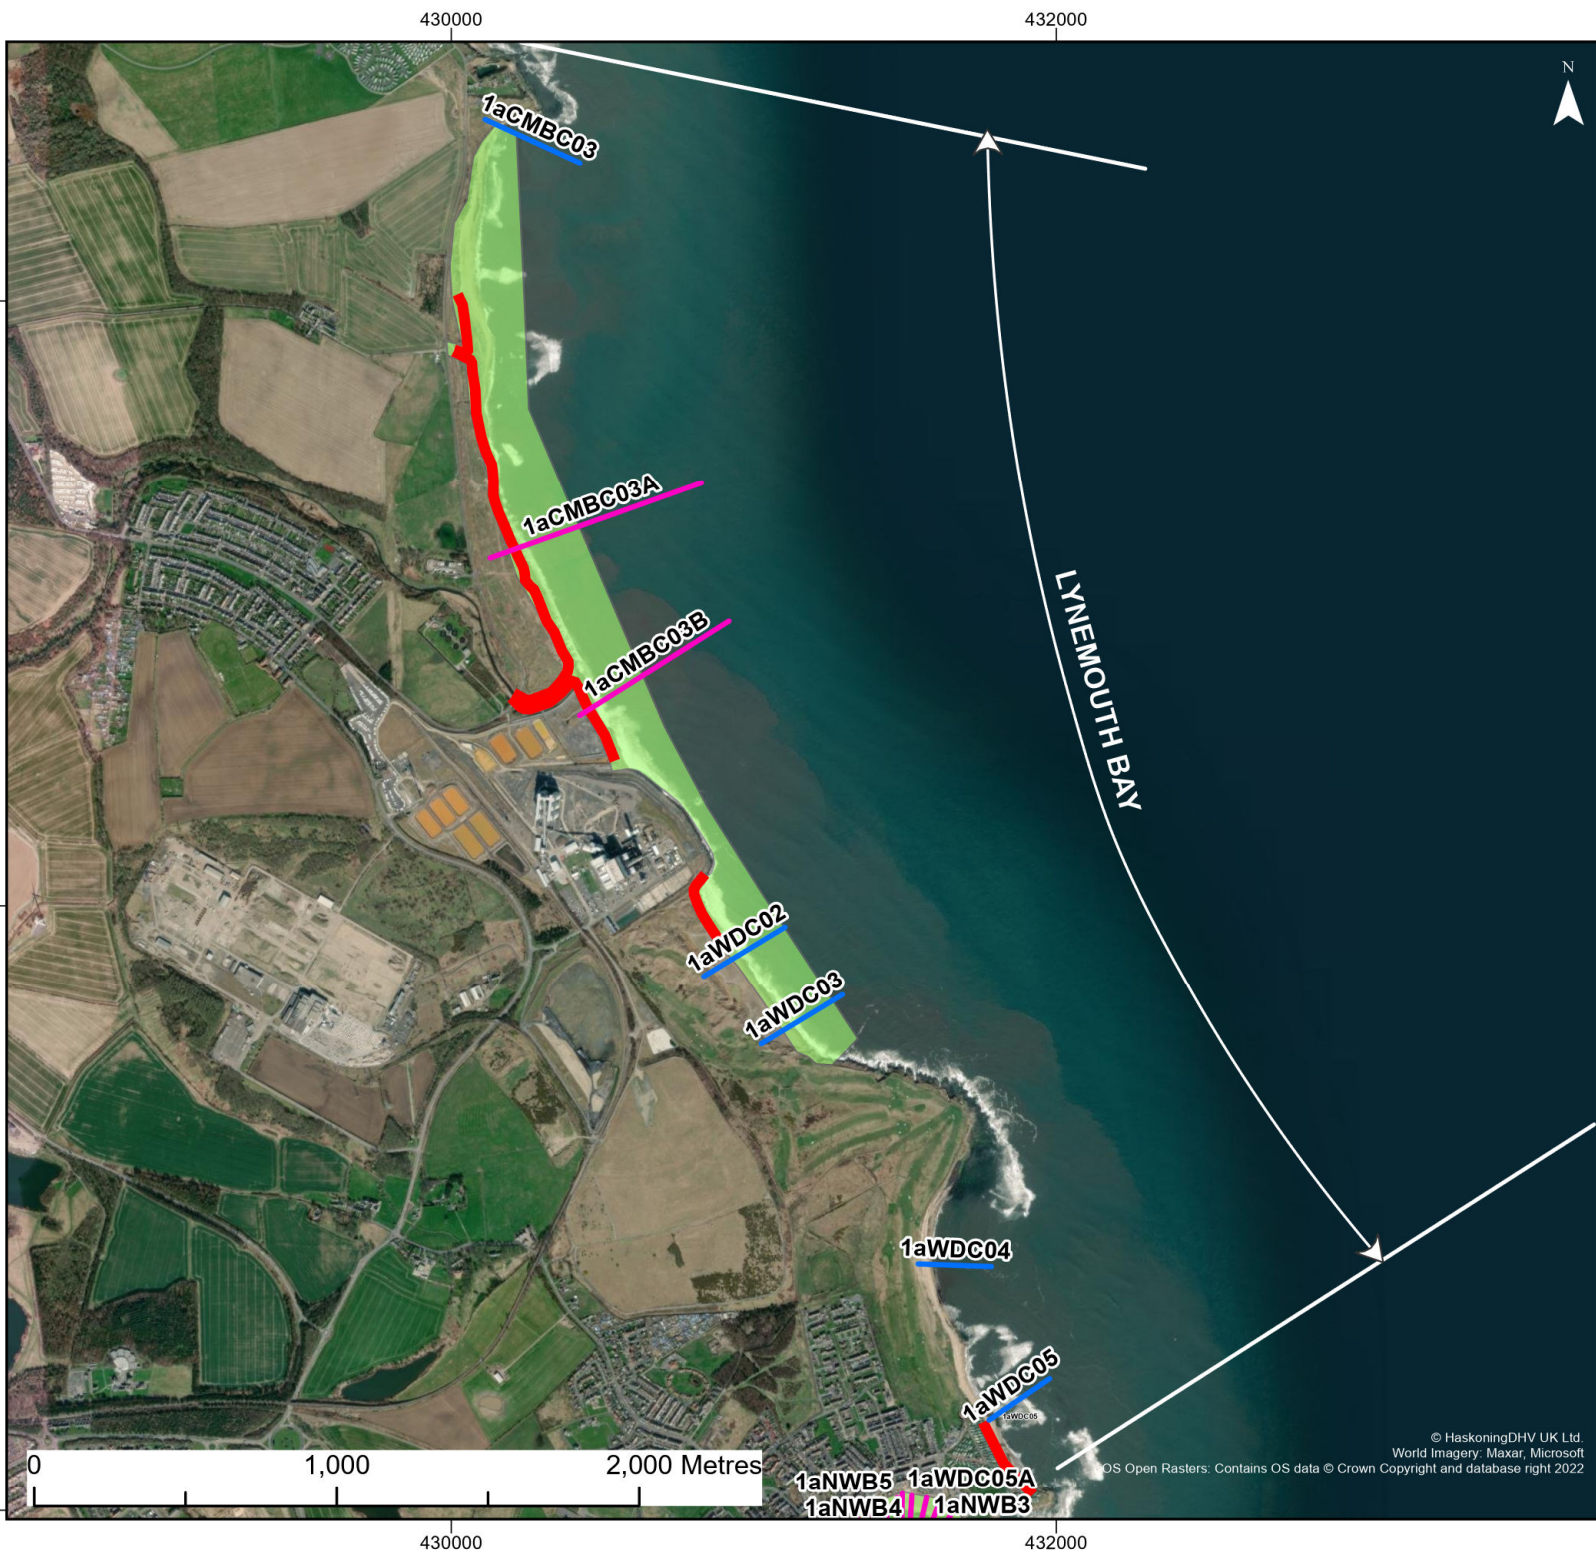
Figure 2 - Map 1

SURVEY LOCATIONS

LYNEMOUTH BAY

The location of these surveys is shown in **Figure 2**. The Post-Storm survey was undertaken along this frontage between 14 – 16th November 2023. During this time, the weather was overcast and raining heavily. The wind was force 4 from the south west. The sea state was rough.

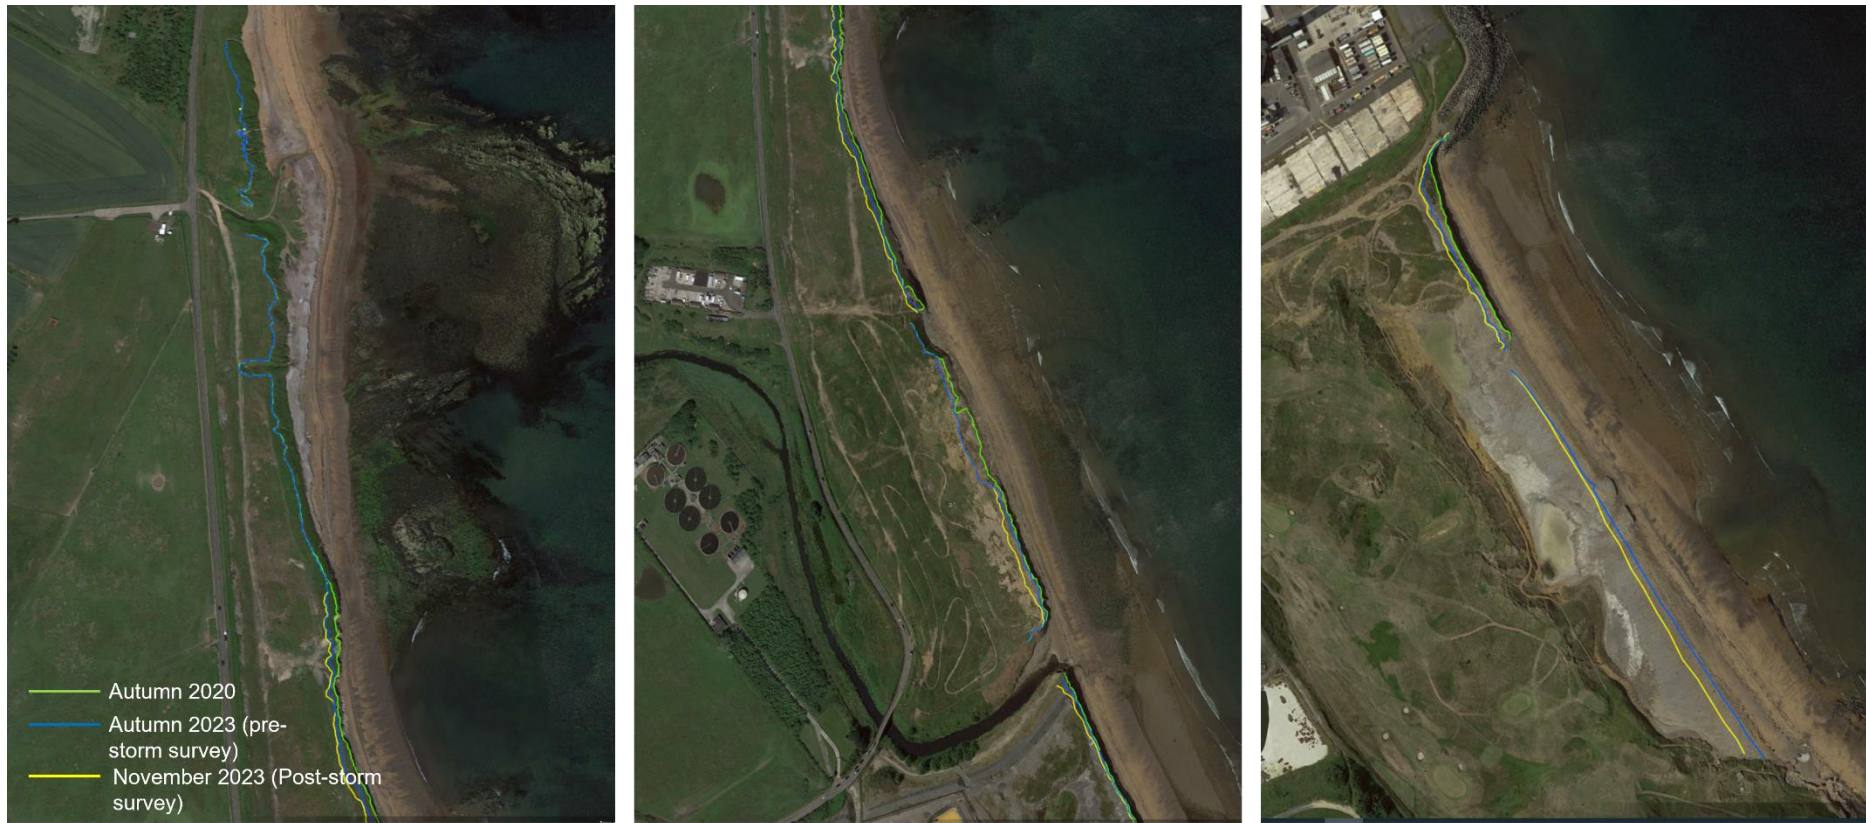
Figure 3 Lynemouth cliff top surveys in Autumn 2020, Autumn 2023 (pre-storm survey) and November 2023 (post-storm survey) (north: left, centre: middle, and south: right)

Survey Date	Description of Changes Since Last Survey	Interpretation
November 2023	<p>Colliery Spoil Edge Survey:</p> <p>Colliery spoil edge survey data was collected for a baseline survey in December 2020. Subsequent surveys have been taken up until autumn 2023, followed by the current post-storm survey in November 2023 (Figure 3).</p> <p>The results from the November 2023 Post Storm survey have been analysed against the August 2023 Full Measures survey to ascertain the impact of the recently named storms. The surveys show the colliery spoil edge has not changed from the northernmost extent of the survey to the cliff in the lee of Headagee since the previous survey.</p> <p>From Headagee to the cliff edge adjacent to the traveller's site, the cliff edge has retreated by up to 7.50m in places, although usually between 2 – 4.5m.</p> <p>The cliff edge between the traveller's site and the River Lyne has remained stable in the northern half, whilst the southern half has retreated by up to 10.0m. The cliff edge between the River Lyne and the Power Station has undergone a lower amount of retreat by up to 5.0m.</p> <p>The cliff edge to the south of the Power Station has retreated by between 1m in the north, increasingly to 11.5m of retreat in the southernmost survey area.</p>	<p>Longer term trends: Since cliff top surveys began in December 2020, cliff movement has been greatest in the centre of the bay (north of the River Lyne - with up to 19.0m of colliery spoil edge retreat) and in the lee of the rock revetment surrounding the power station (up to 18.0m retreat). The northern part of the survey area has shown less movement with smaller sections of retreat up to 3.0m.</p>

The beach profile surveys show a significant retreat of the cliff top has occurred at some profiles, particularly at profile 1aCMBC03A where the cliff has retreated by up to 2.0m. The profiles also show a large retreat of the toe of the colliery spoil berm, by up to 1.4m at profile 1aCMBC03B. This is also evident in Map 2 of Appendix B. The topographic survey plot shows a large landward retreat of the beach extent in general from the last survey.

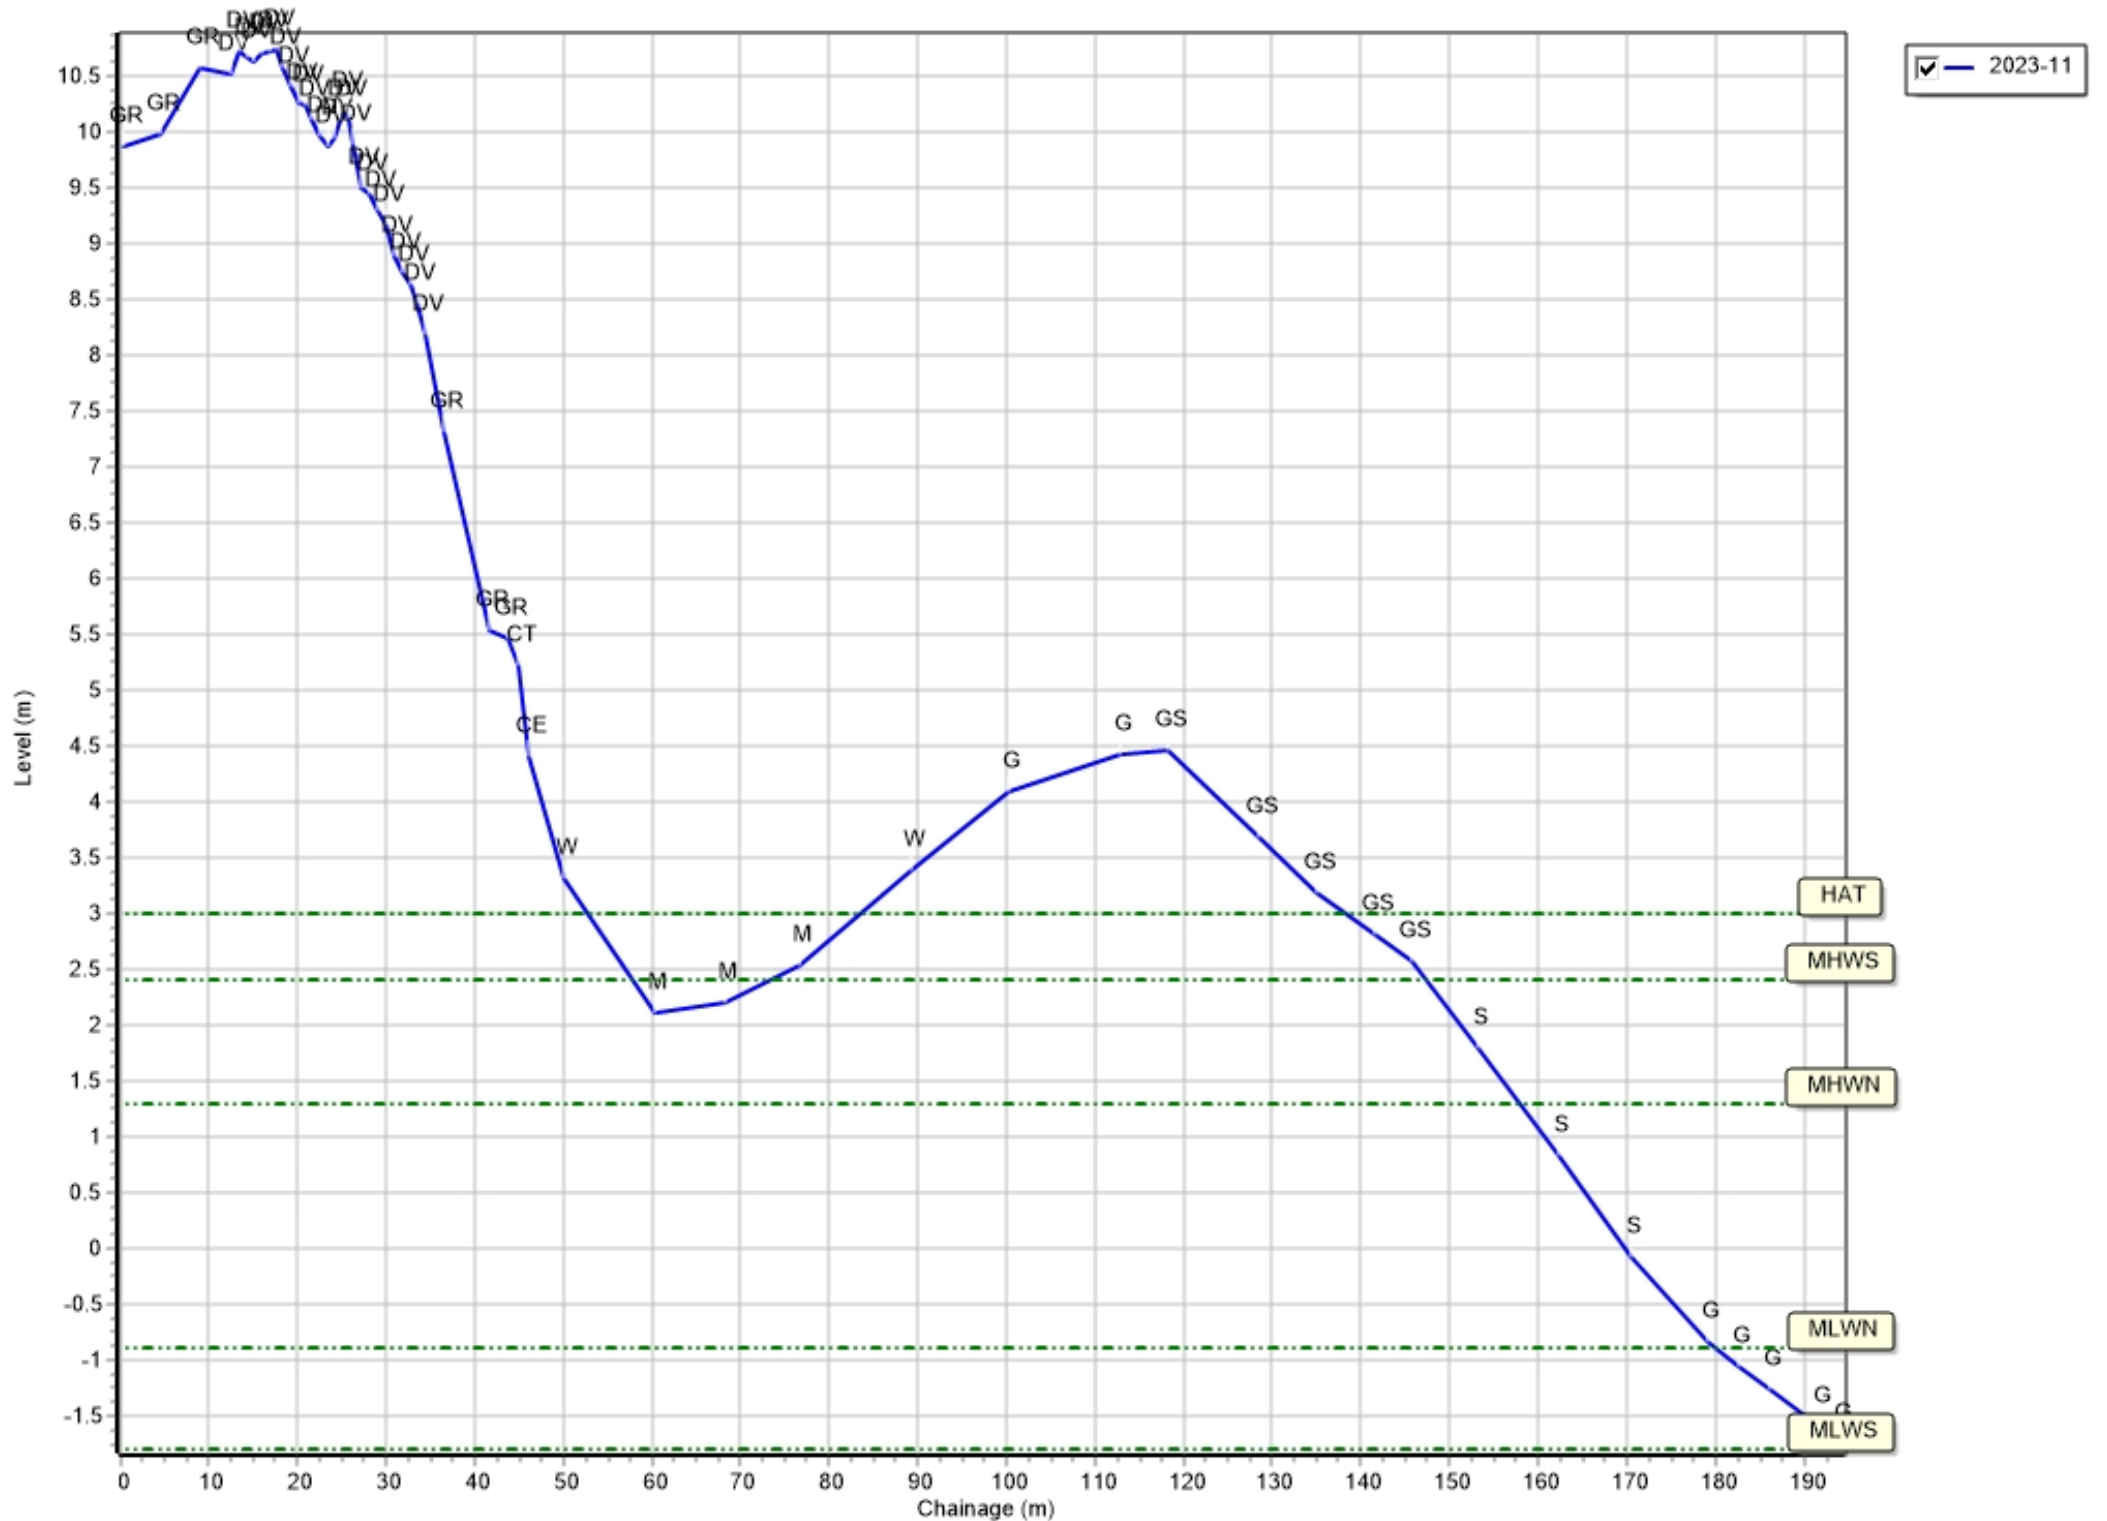
Profiles: 1aWDC02

Until the profiles start to return to an equilibrium following a period of calm, it is unclear how much material was lost out of the system as a result of the storms. Regardless, it is likely that the colliery spoil berm will continue to retreat, accelerating following stormy periods and eventually reaching the backing cliffs. For example, the crest of the colliery spoil berm at Profile WDC02 is within 65m of these natural cliffs in 2023 compared to 120m in 2002.

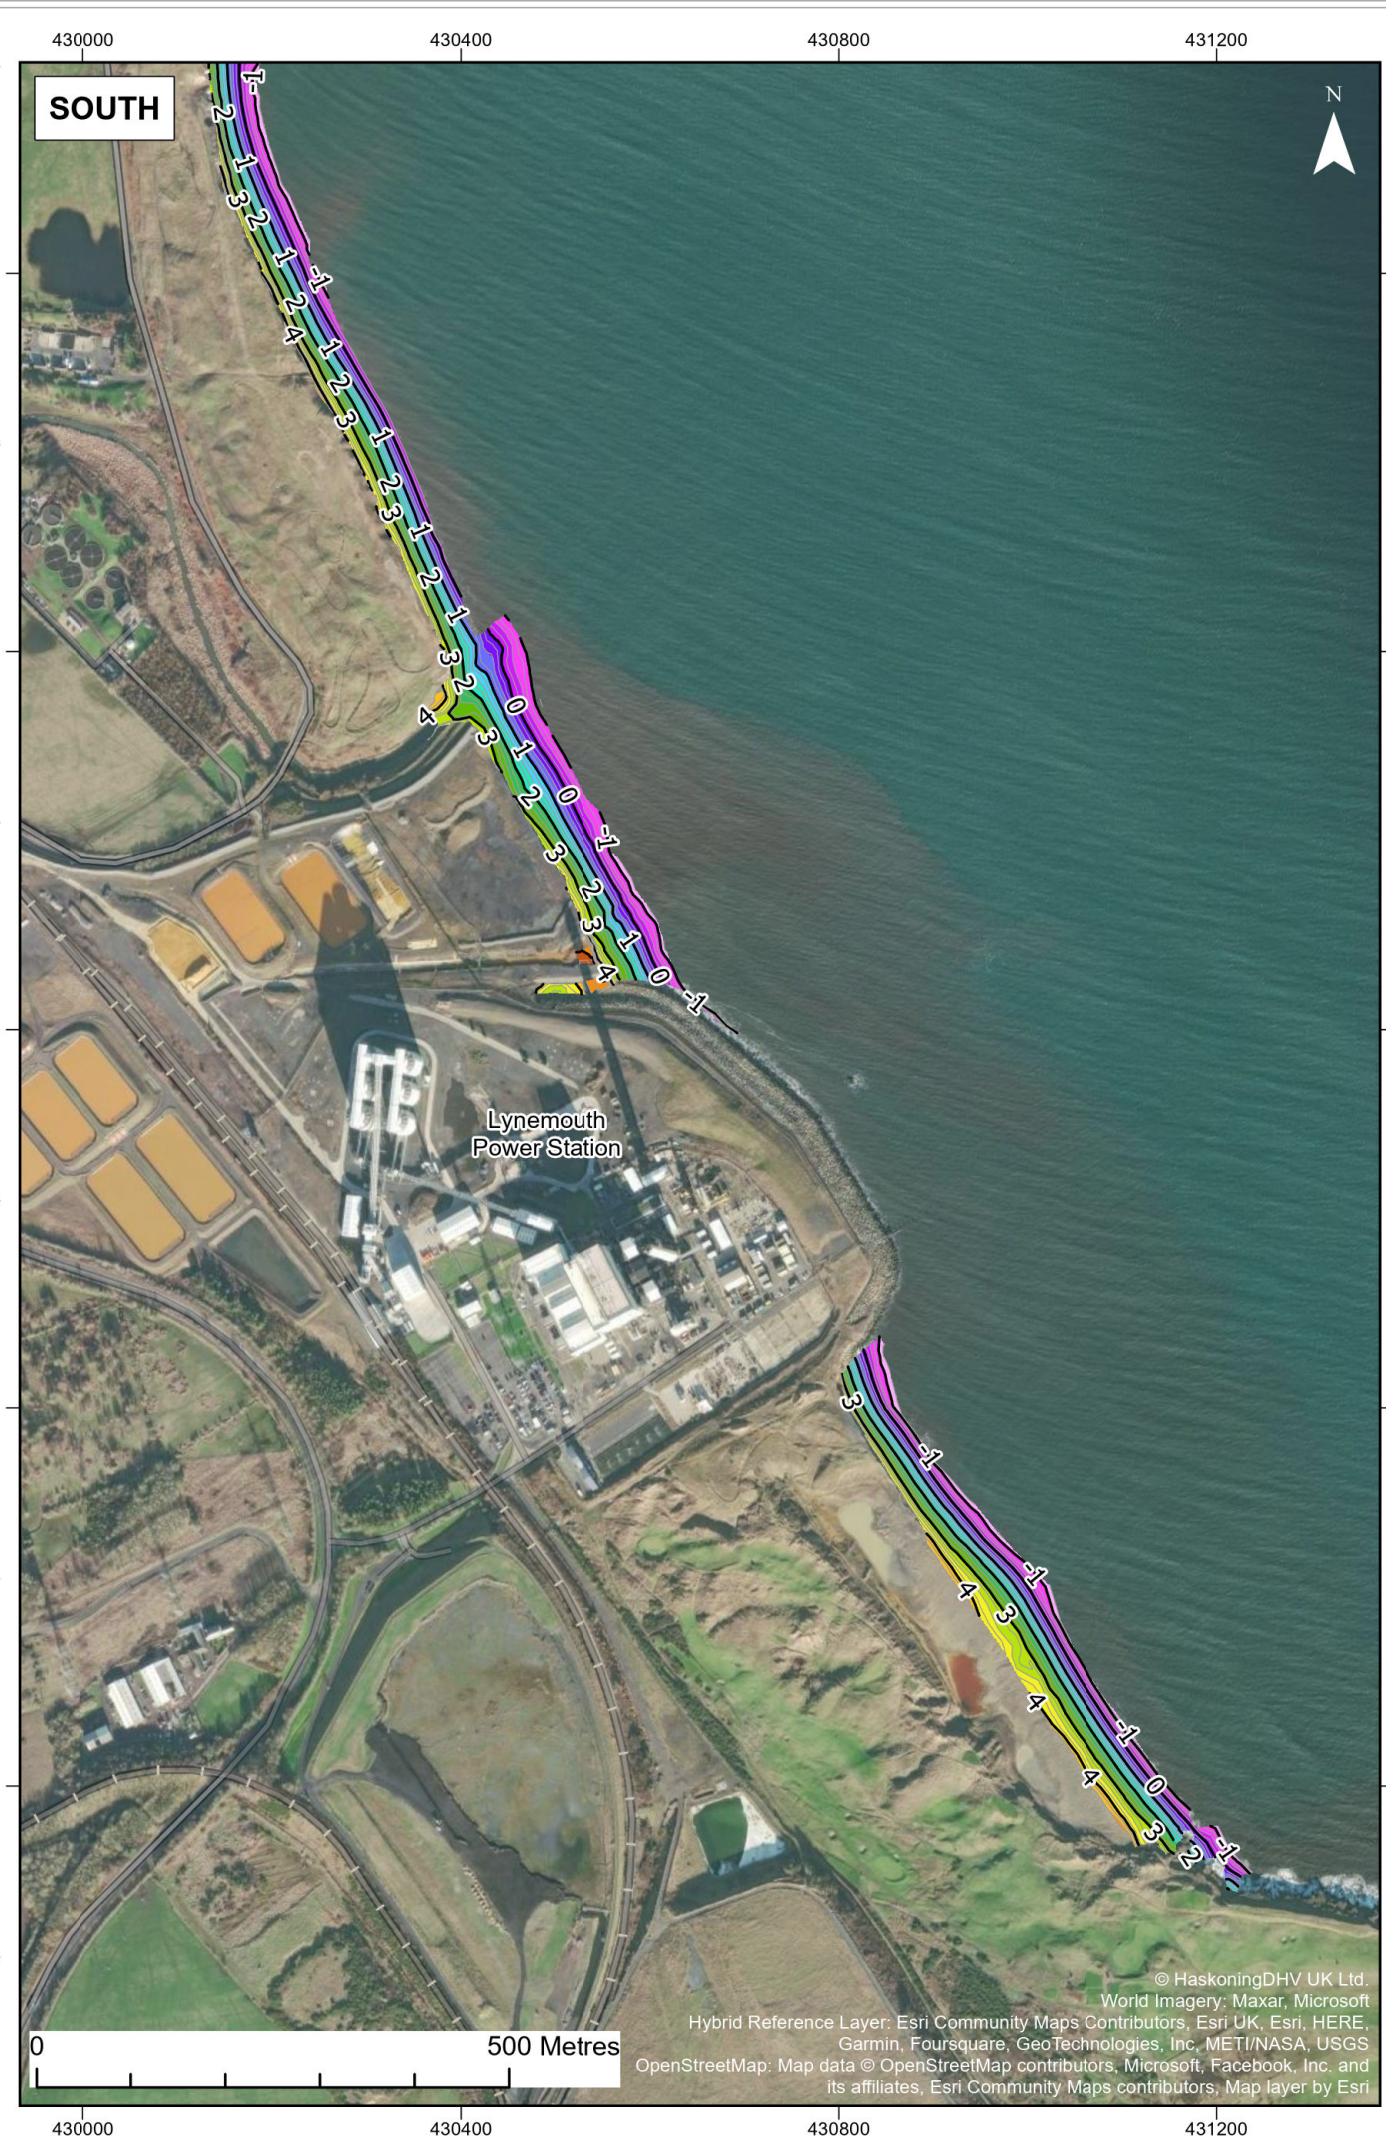
Appendix B - Map 1

TOPOGRAPHIC SURVEY (16th November 2023)

<p>Aug 2023 to Nov 2023</p>	<p>Beach Topographic Survey:</p> <p>Lynemouth Bay is covered by a 6-monthly topographic survey, which was added to the programme in December 2020. This first survey represents a useful pre-scheme baseline against which future beach topographic surveys can be compared to determine locations and rates of change (landward recession or foreshore lowering/accretion). This additional survey was undertaken in November 2023 to assess the impacts of three named storms that occurred in late September and early November 2023.</p> <p>A difference plot has also been produced using the DGM (Appendix B – Map 9) produced from the last topographic survey (Autumn 2023) and the present survey (Post Storm, November 2023).</p> <p>The plot shows the most significant change in the north of the bay is the high magnitude erosion at the toe of the colliery spoil berm (>2m) and in the lee of the rock outcrops at Headagee (up to 1.75m).</p>	<p>The beach topographic survey plot shows a landward retreat of the beach survey extent across the majority of the survey area. High magnitude erosion is concentrated in the lee of Headagee, at the mouth of the River Lyne and the south of the survey extent south of the Power Station.</p> <p>There is a remediation scheme to the north of the Power Station planned to commence in January 2024.</p>

Survey Date	Description of Changes Since Last Survey	Interpretation
	<p>The survey report notes that 'a lot of sand has been removed from the beach compared to the recent full measures survey exposing areas of rubble'. The rest of the beach in the north of the bay is dominated by patches of little change/low level erosion, with some isolated patches of accretion (up to 1.0m). Some of the accretion occurs on top of the colliery spoil berm which could reflect material that has been transported by storm waves / fallen from the cliffs behind. The survey report notes that a 'lot of debris has been washed ashore'. Erosion has occurred at the mouth of the River Lyne (up to 1.75m), and the survey report notes that 'the River Lyne was too deep to survey bed levels'.</p> <p>The plot for the south of the bay is similar to the north, in that it is dominated by erosion and minor change ($\pm 0.1\text{m}$) with isolated patches of accretion just south of the River Lyne and south of Lynemouth Power Station (1.5m). The most significant change in the south of the bay is at the southernmost end of the survey where high levels of erosion occur across the beach profile, reaching up to 1.75-2.0m.</p> <p>The beach extent in August 2023 (mapped as a dotted line) shows a much wider beach front compared to the present post-storm survey, except in the lee of the rock outcrops at Headagee which remains in a similar position.</p>
