**Cell 1 Regional Coastal Monitoring Programme
Newbiggin-by-the-Sea 'Post Storm' Beach
Monitoring Survey Report 2023**

**Northumberland County
Council**

December 2023

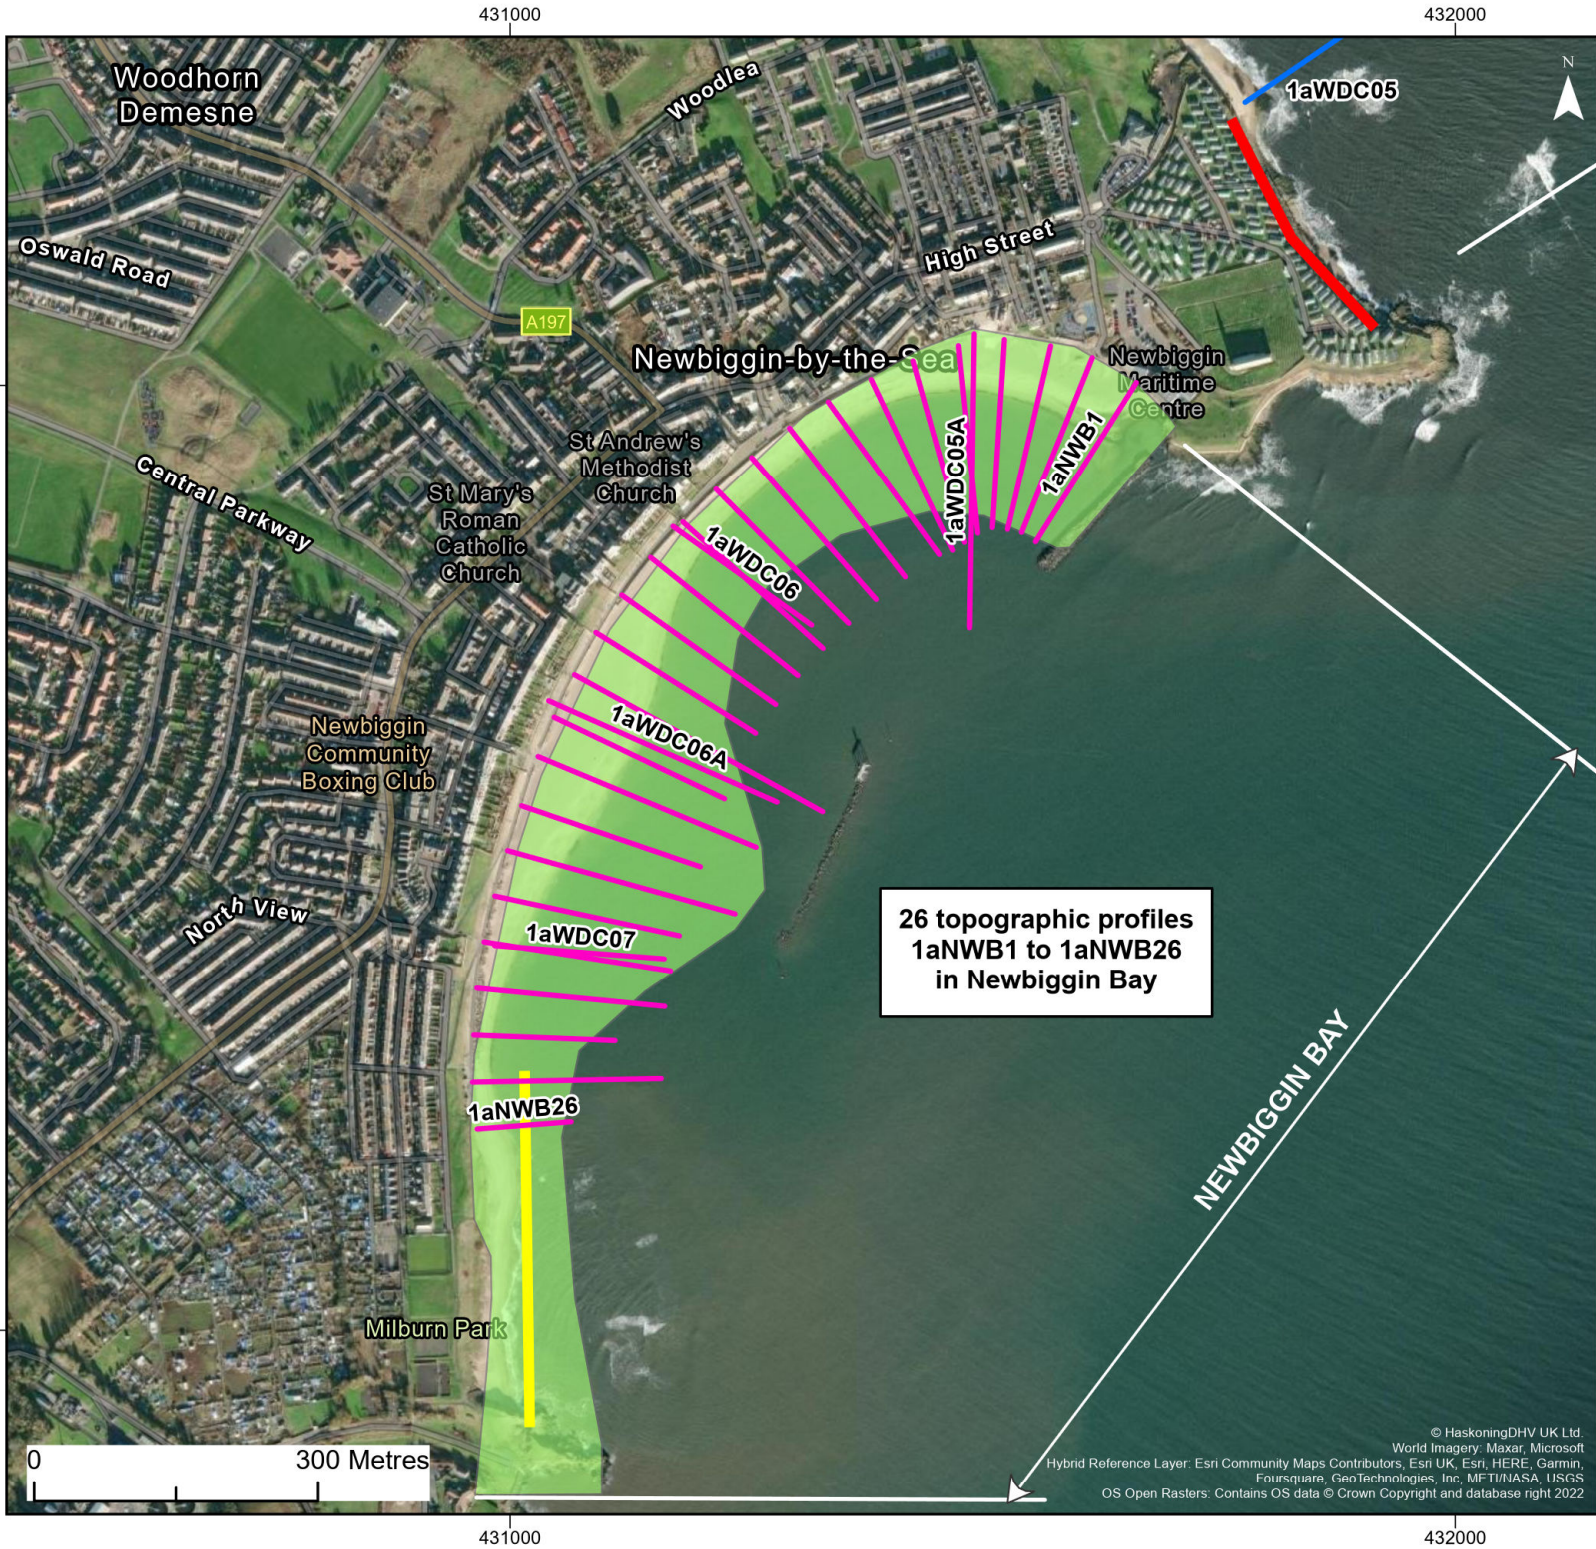
**Figure 2 - Map 1
NEWBIGGIN BAY
Northumberland County Council Frontage**

The location of these surveys is shown in **Figure 2**. The Post-Storm survey was undertaken along this frontage on 13th November 2023. During this time, the weather was overcast and raining heavily. The wind was force 4 from the south west. The sea state was rough.

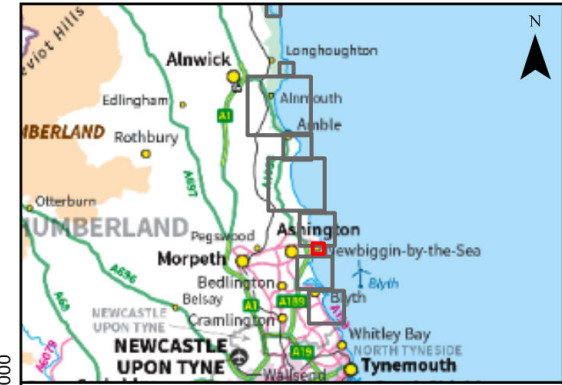
SURVEY LOCATIONS

Topographic Profile

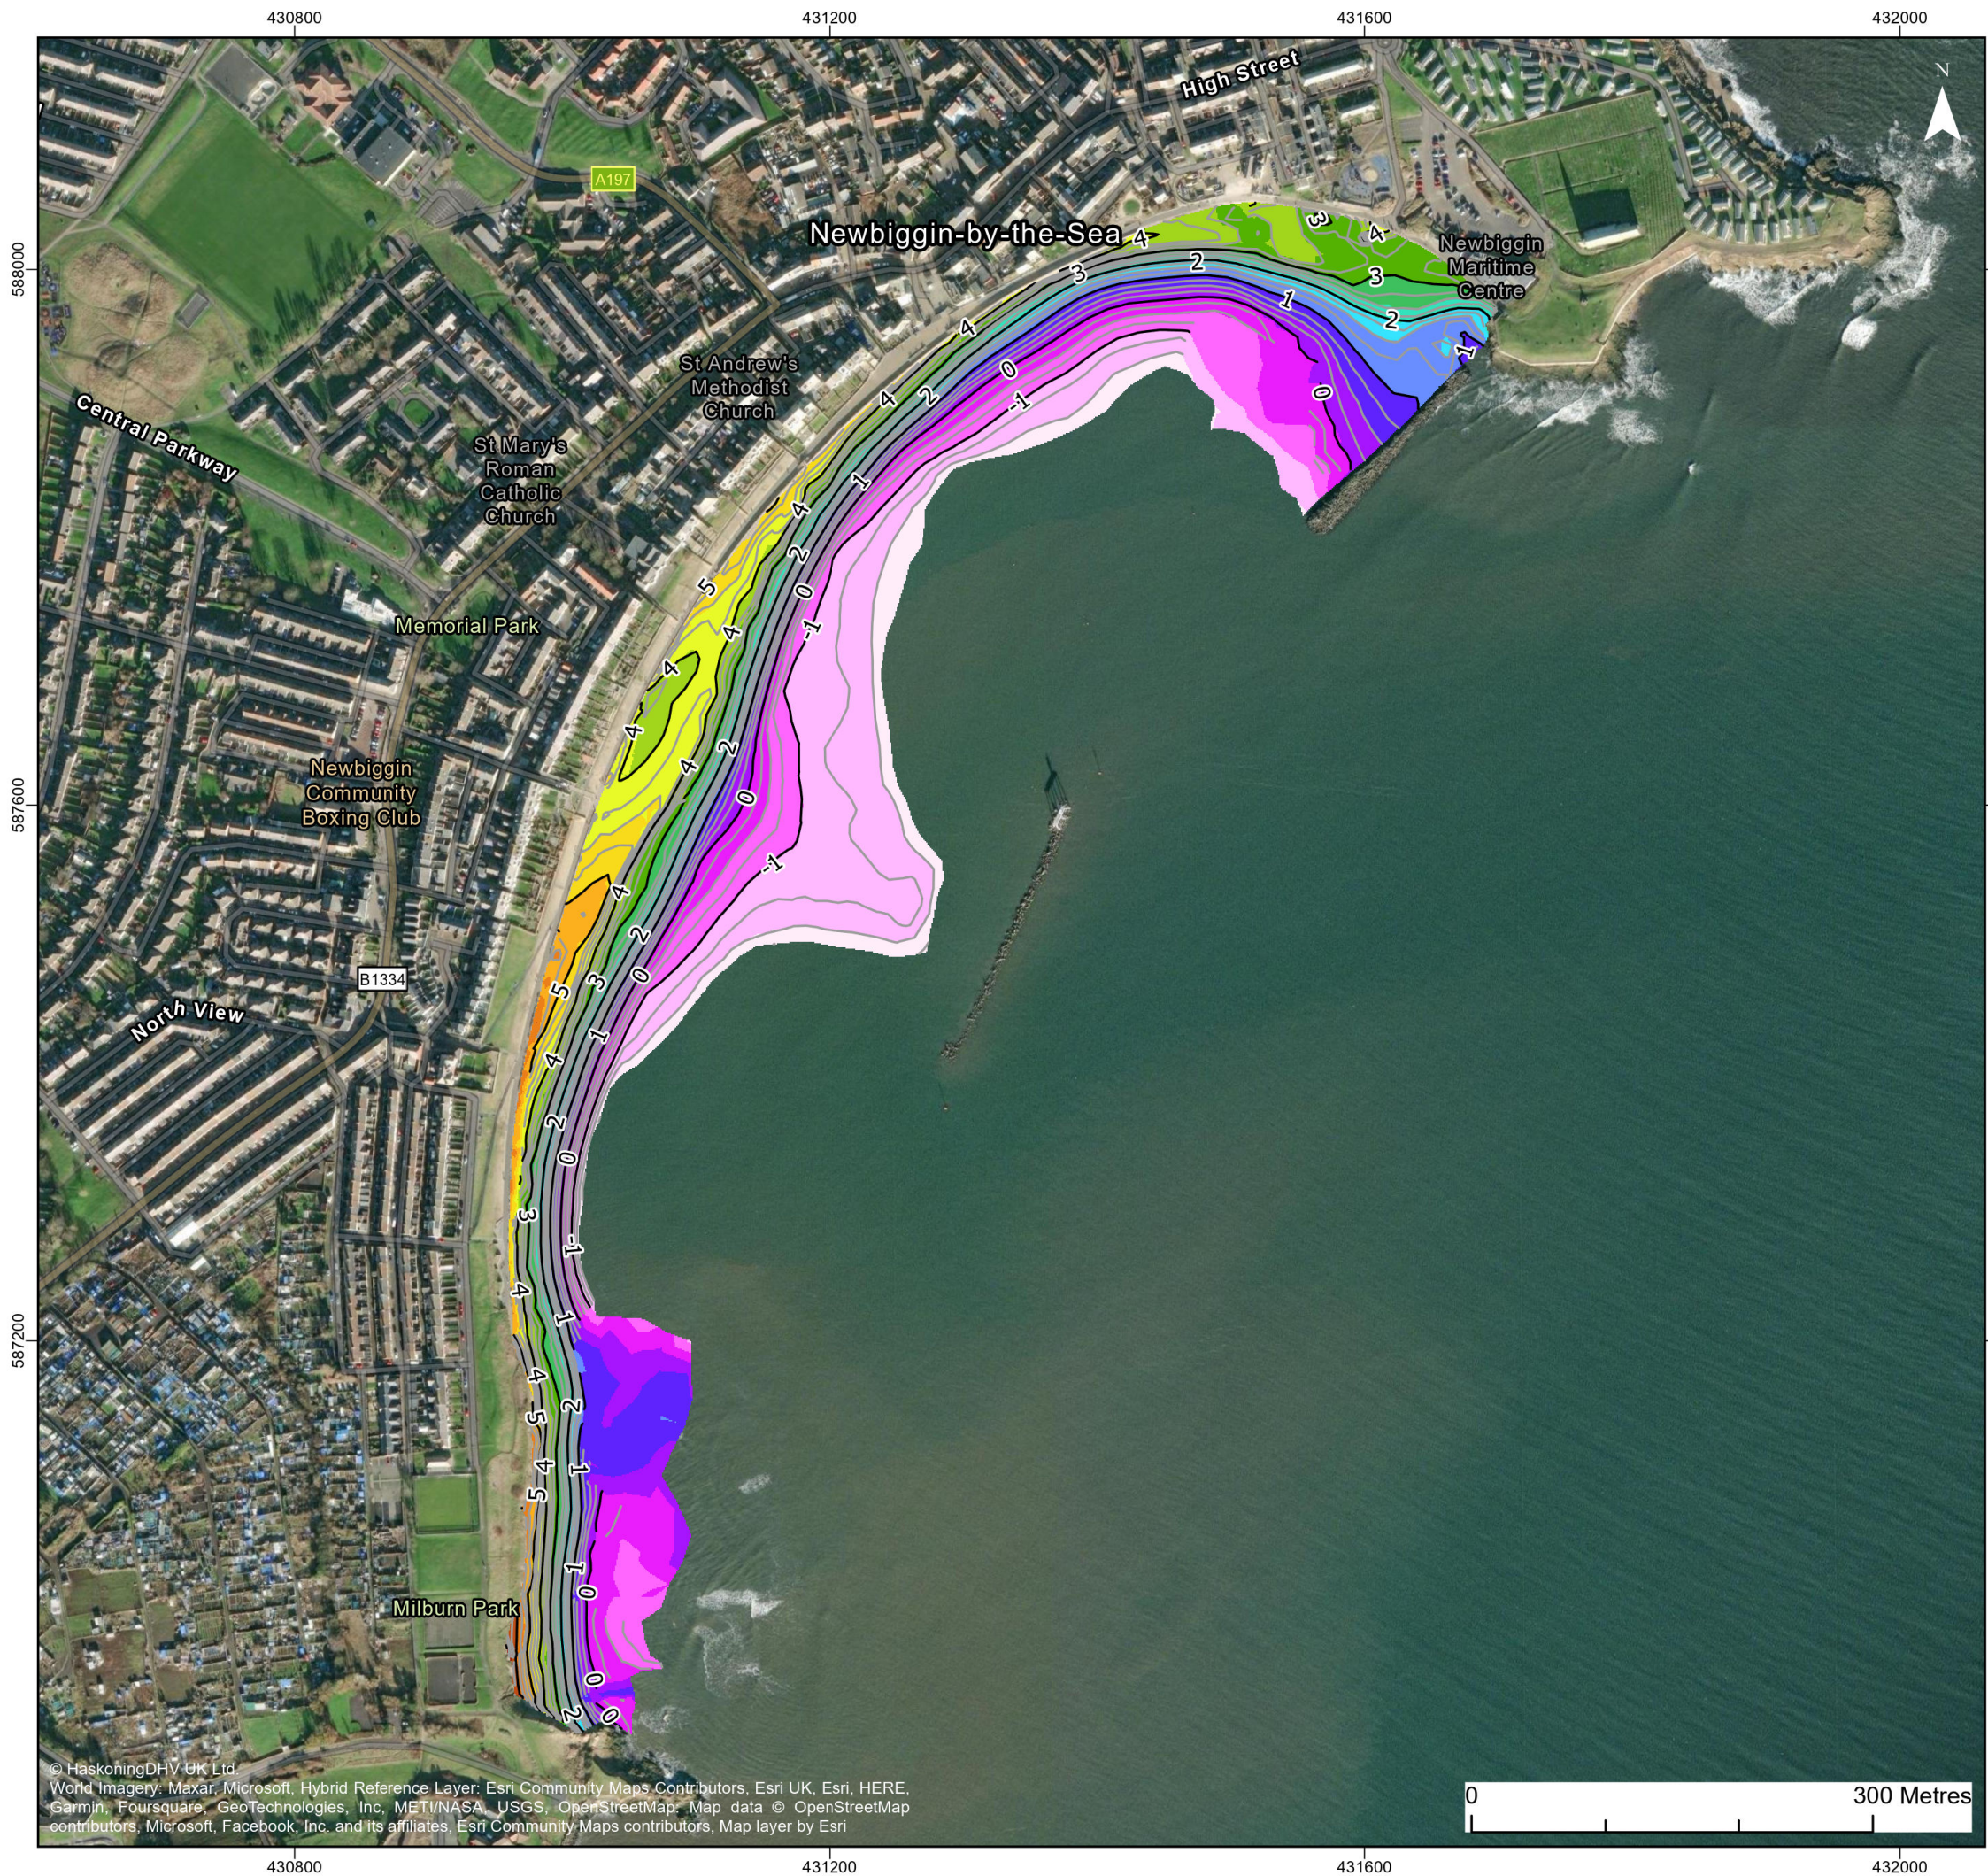
Title:
Appendix B - Map 1
Newbiggin Bay
Northumberland County Council Frontage

TOPOGRAPHIC SURVEY (13th November 2023)

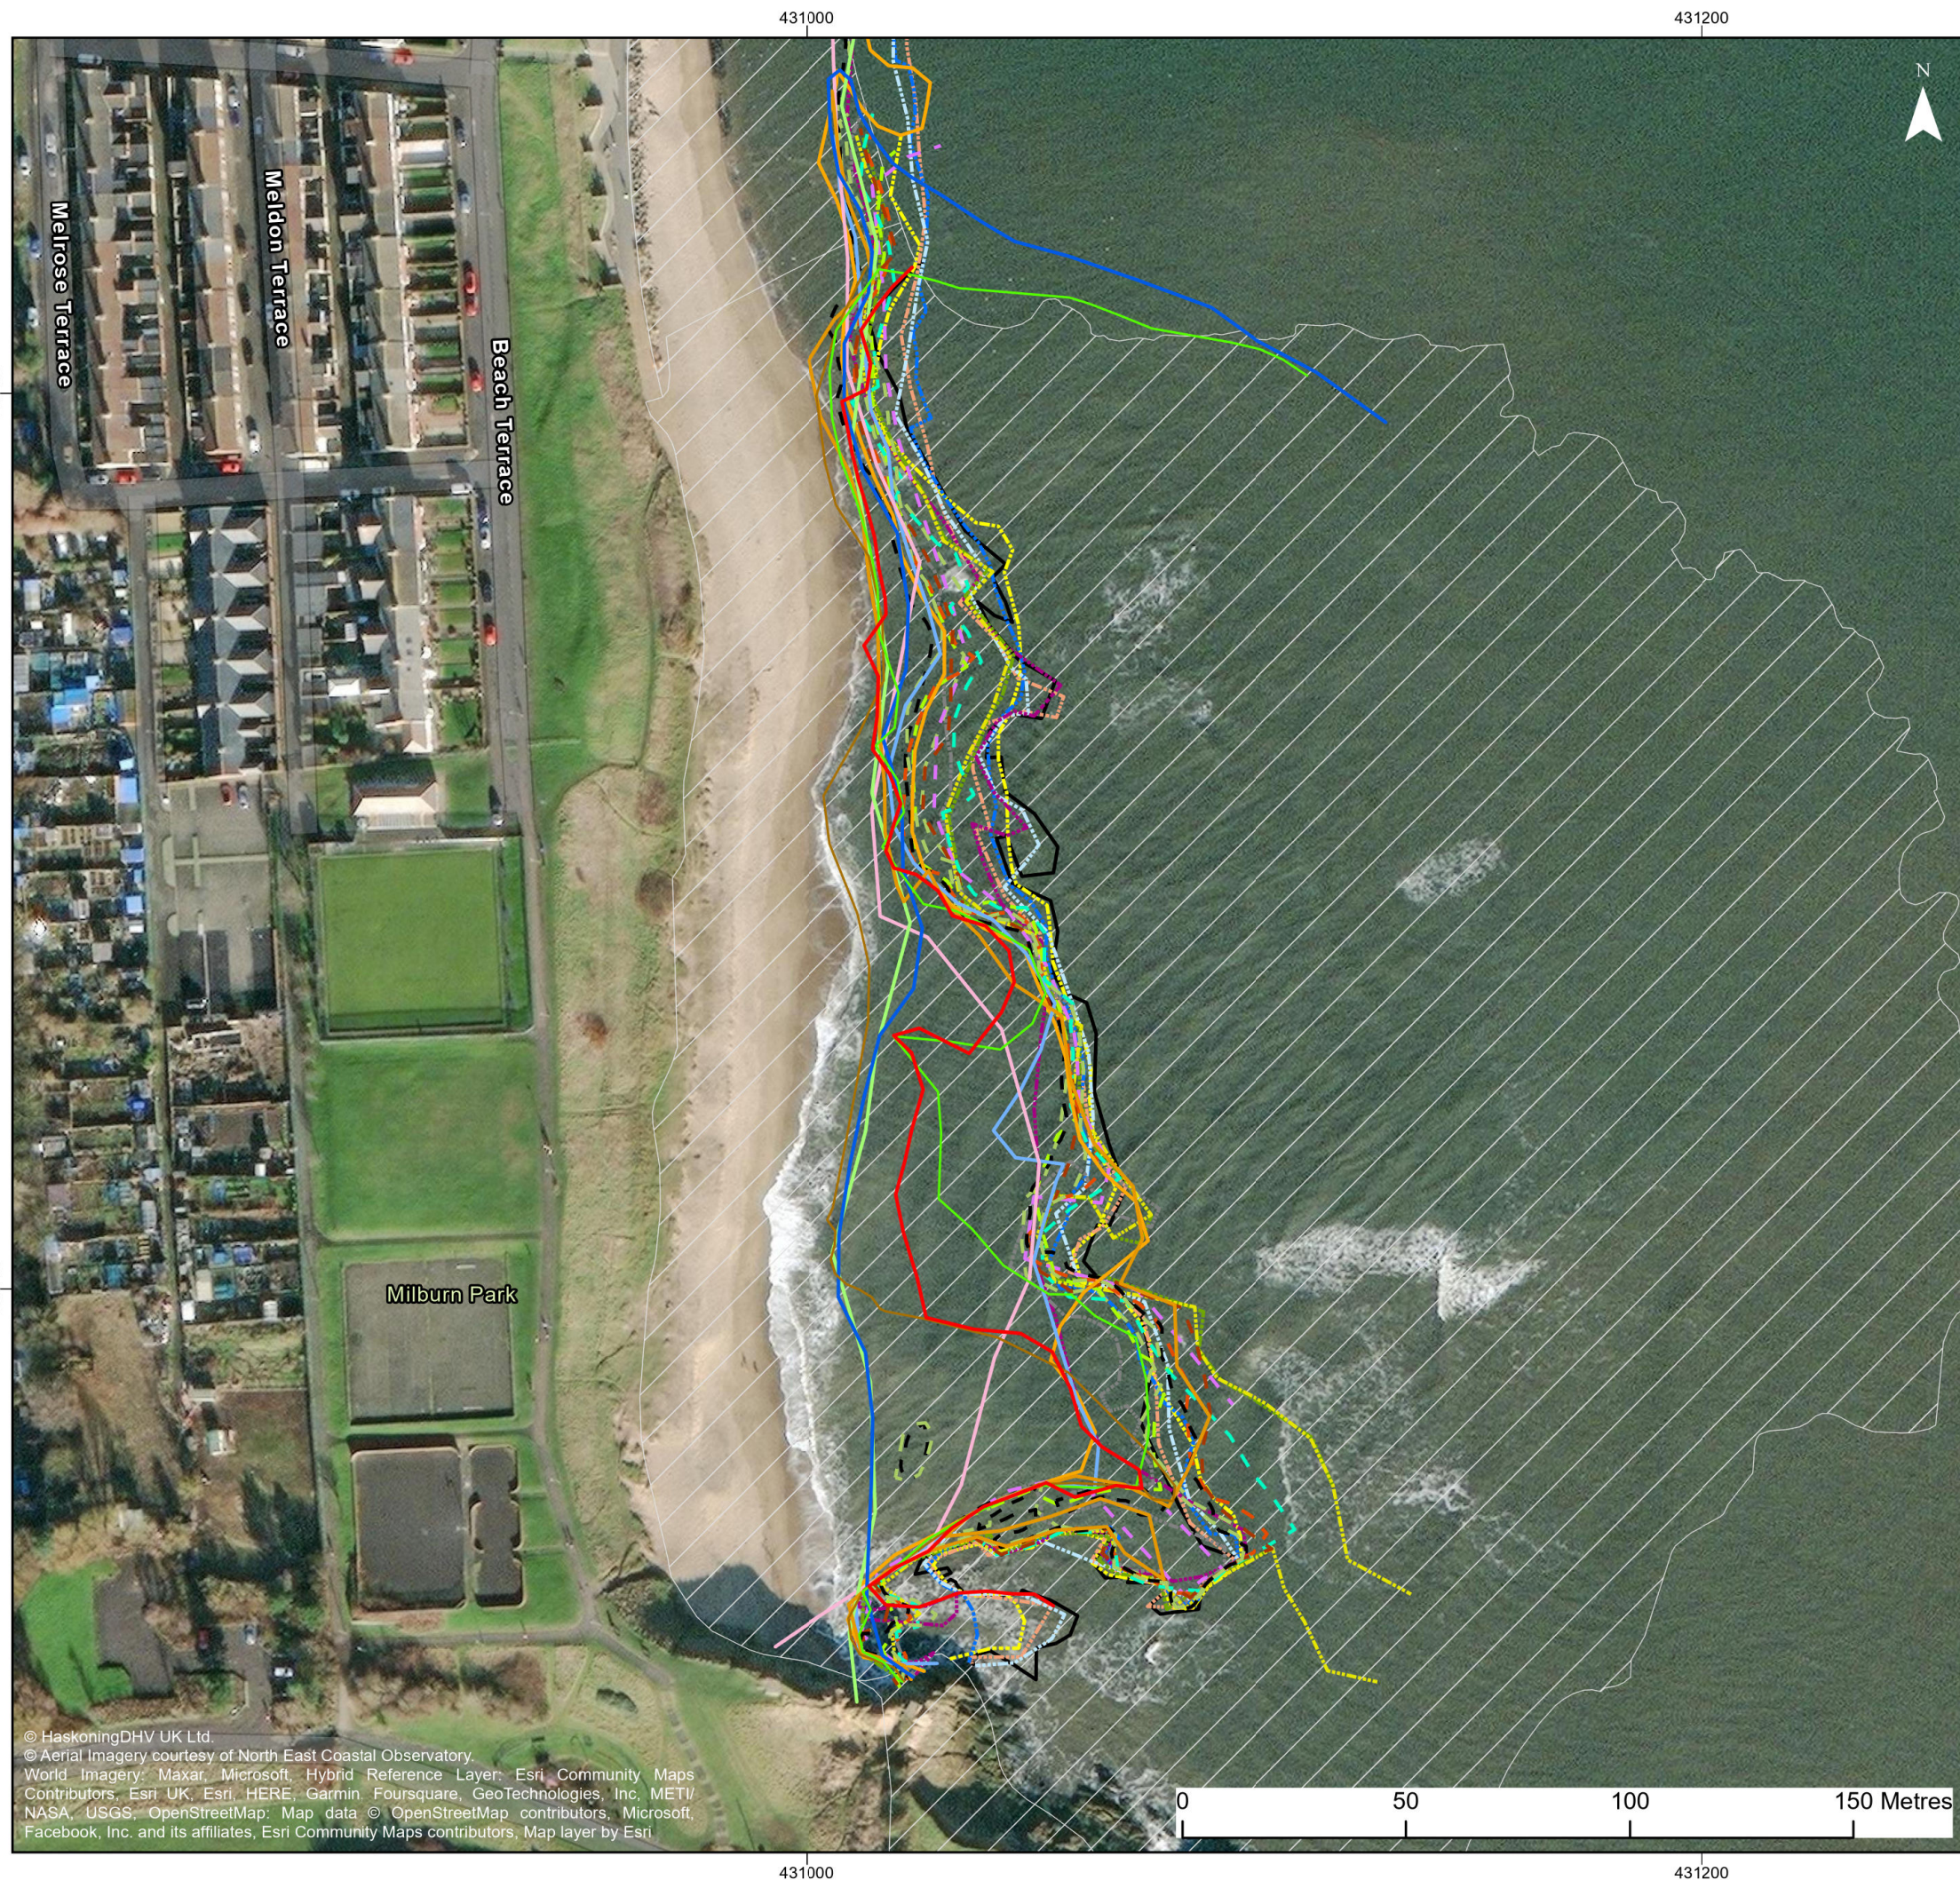
Appendix C - Map 1

Survey Date	Description of Changes Since Last Survey	Interpretation
<p>13th November 2023</p>	<p>Sand Extent Survey:</p> <p>Spital Carrs is located to the south of Newbiggin Bay and is covered by a bi-annual sand extent survey, which commenced in 2012. The survey was designed to address concerns that the beach recharge scheme undertaken in the Newbiggin Bay may have impacts on the Spital Carrs SSSI and SPA if sand from the recharge scheme moves to the south. The sand extent survey therefore identifies the boundary of the sand beach on the rock platform.</p> <p>Data from the November 2023 post storm survey has been plotted onto aerial imagery (refer to Appendix C – Map 1). The plot generally shows that the extent of sand has retreated as a result of the storms. An approximate 110m length towards the south of the extents has retreated by up to 20m. At the very northern extents a 20m length has accreted by up to 6m. Compared to the range of the previous survey, the post storm survey is at landward position overall.</p>	<p>Since the last survey, there has been a retreat of sand cover across the majority of the survey extent.</p> <p>Longer term trends: Since 2014, there has been a general trend for advance in the summer and retreat in the winter.</p>
