**Cell 1 Regional Coastal Monitoring Programme
Analytical Report 1: 'Full Measures' Survey 2009**

**Northumberland County Council
& North Tyneside Council
Final Report**

Document title North East Coastal Monitoring
Document sub title Analytical Report 2008
Document short title NE Monitoring
Date April 2009
Project name North East Coastal Monitoring
Project number 9T7624
Client Northumbrian Coastal Authorities Group

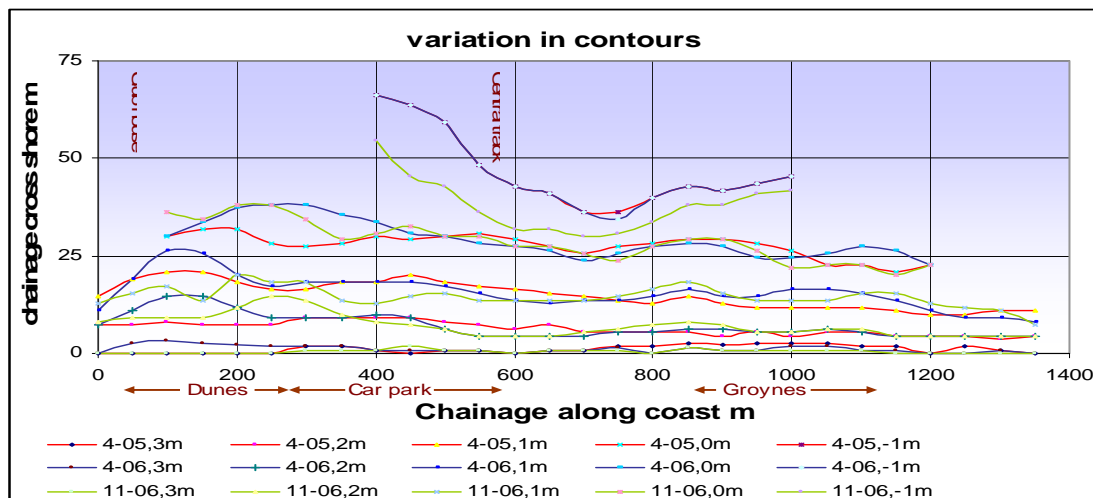
Comparison of surveys, plotted as contours along a straightened frontage

The growth in the beach (as shown by the 2m contour) is obvious in the area of the groynes. This is strongly linked to the presence of the Marden rocks. These act as a breakwater and were effective even given the higher water level storms recorded during March 2006. This effect may have led to some loss of material from the upper beach over the central section of the frontage. The impression is that material is moved from the centre, to both north and south, with pressure on the central frontage to erode.

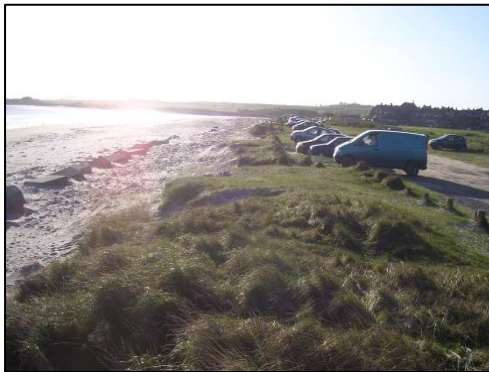
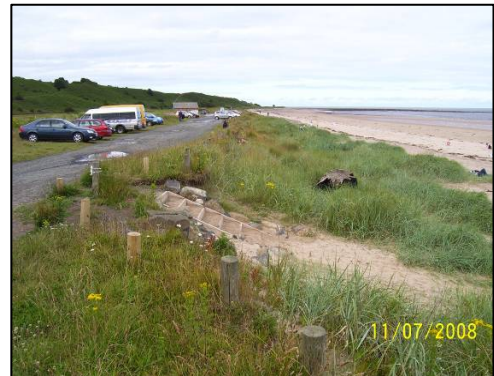
The control of access across the dunes has shown significant benefit and this is highlighted in the comparison of photographs presented below. It should be noted, however, that this control, while improving retention of available sediment, will have only limited benefit if the frontage is subject to a major storm.
