**Cell 1 Regional Coastal Monitoring Programme
Analytical Report 4: 'Full Measures' Survey 2011**

**Northumberland County
Council
Final Report**

October 2012

Analytical Report 4
 Full Measures Survey
 Winter 2011

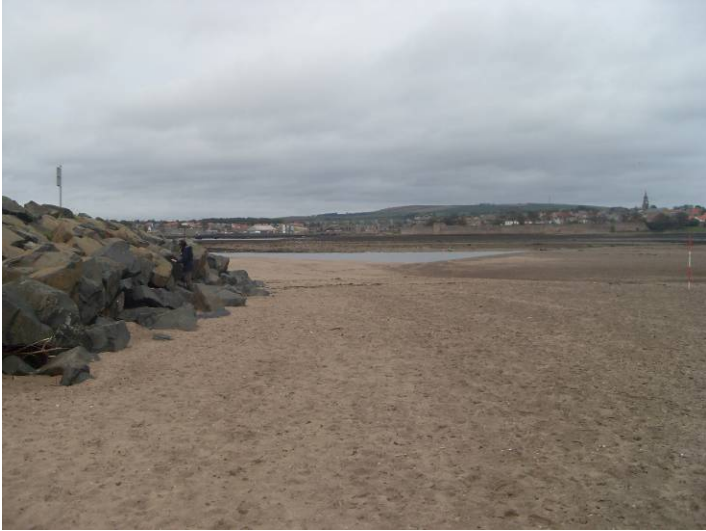
Plate 1 – Survey photograph 1aBTBC04_20111013_W3.JPG

<p>Nov 2011</p>	<p>Topographic Survey:</p> <p>Due to the significant changes that have been observed from the beach profiles along the spit at Sandstell Point, and the three dimensional nature of these changes, a topographic survey was introduced to the monitoring programme in November 2009.</p> <p>Data from the most recent topographic survey (full measures, winter 2011) have been used to create a digital ground model (DGM) (Appendix B – Map 1a) using a Geographical Information System (GIS). A difference plot has also been produced using the DGM (Appendix B – Map 1b) produced from the last produced topographic survey (partial measures, spring 2011) and the present survey.</p> <p>In particular, the difference plot shows: (i) an increase in beach elevation seaward of the dunes around the u-bend of the River Tweed; (ii) a significant increase in beach levels at the landward end of profile 1aBTBC04; (iii) a reduction in beach levels around the tip of the Spittal headland up to 2m; and (iv) adjacent to that a band of accretion (approximately 100m x 500m) orientated north to south that extends along the length of the spit.</p>	<p>The topographic survey shows a band of increased elevation (i.e. accretion) around the landward end of the spit, which is fronted by a band of reduced elevation (i.e. erosion). It is likely that the material eroded from the zone of reduced elevation is deposited in the zone of increased elevation to form a bank. This change is reflected in the beach profiles for the same areas, where this accretion reflects the bank that is likely to have formed under storm conditions.</p> <p>Longer term trends: A comparison of the topographic survey to the two previous surveys shows that the linear formations observed in November 2011 and similar to those observed in October 2011. This suggests that there could be trend in the behaviour of the spit. Between the winter and summer months the spit is likely to be subject to storms where the resultant waves and currents act to move the material around. Over the summer calmer conditions lead to the formation of berms and troughs (or in the case of 1aBTBC04, a bank), as seen in the present survey.</p>

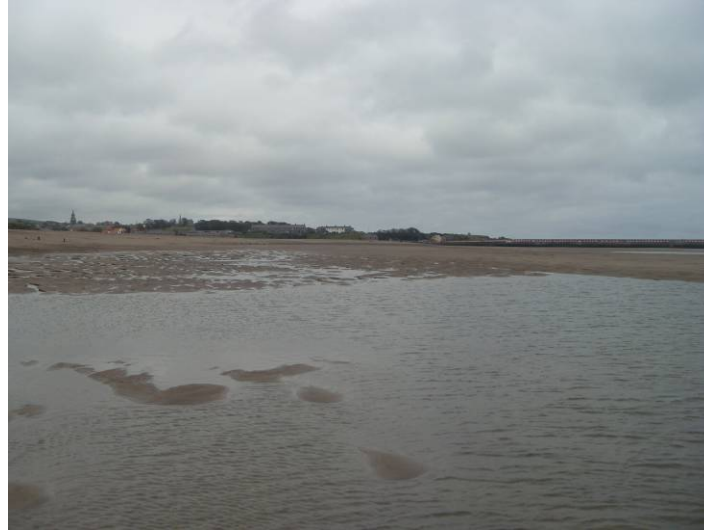
Plate 2 – Survey photograph 1aBTBC10_20111013_N6.JPG

Survey Date	Description of Changes Since Last Survey	Interpretation
	<p>Profiles 1aBTBC07 to 1aBTBC10 are located along the open coast, at the intersection of the southern side of the spit at Sandstell Point and northern end of Spittal Beach. The changes observed for this frontage are repeated for each survey from north to south: (i) increase in beach levels between a height of 4m and 1m, however, this does not correspond to features on the beach and it is thought that this is actually the rock revetment; (ii) drop in beach levels around a height of 0.6m to form a concave form. The survey photographs (Plate 2 and Plate 3) shows the presence of ripples and ponded water and it is likely that this feature is a trough or runnel; (iii) seaward, at a height of -0.8m beach levels have increased. The profile shape here is a dome indicating the formation of a bar.</p>	<p>observed from the survey photographs, suggest that the channel is formed by waves and tides funnelling along the beach.</p>

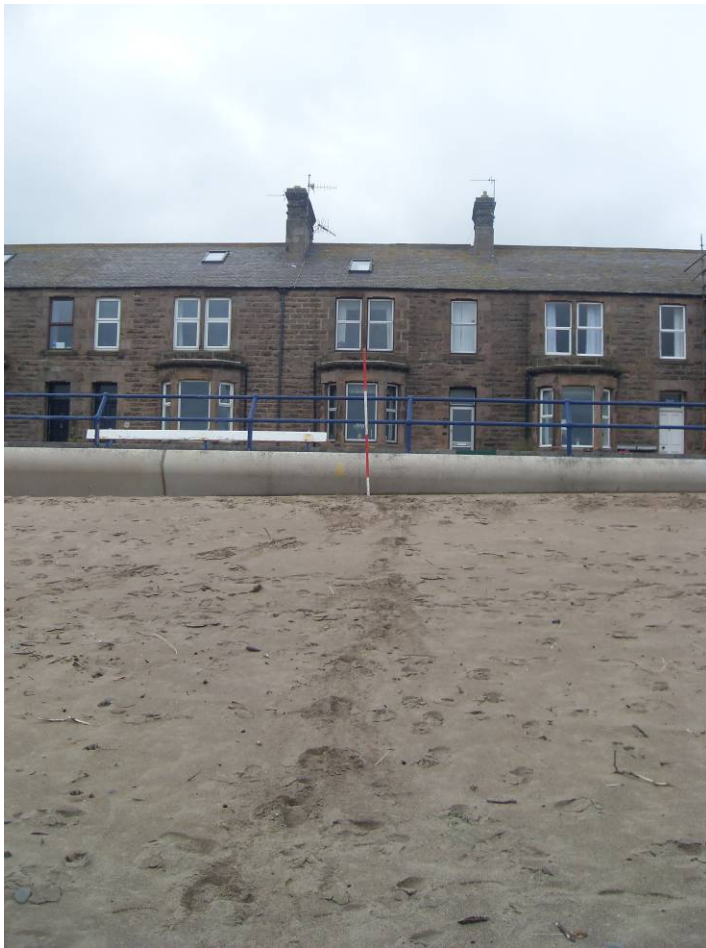
Plate 4 – Survey photograph 1aBTBC11_20111013_Up.JPG

Survey Date	Description of Changes Since Last Survey	Interpretation
Oct 2011	<p>Beach Profiles:</p> <p>Spittal B is covered by four beach profile lines for the Full Measures survey (Appendix A).</p> <p>At profile 1aBTBC11 there has been a significant increase in beach levels, of up to 1.8m, between a chainage of 10m and 60m. This is accompanied by a similar reduction in beach levels between a chainage of 60m and 130m. This indicates cross-shore movement of beach material from the middle to upper beach. The survey photograph (Plate 4) shows accumulation of material up to the underside of the seawall bullnose.</p> <p>The beach at profile 1aBTBC12 has behaved similarly to 1aBTBC11, with a significant increase in beach levels, up to 1.6m, between a chainage of 0m and 60m. This is accompanied by a similar reduction in beach levels of up to 1m seaward of a chainage of 60m.</p> <p>Profile 1aBTBC13 is the most dynamic of all profiles along this frontage. The pattern of beach level change from the toe of the seawall to seaward is: increase (0.2m), reduction (0.2), increase (up to 1m, chainage 35m-80m) and reduction (up to 0.4m). This suggests a cross-shore movement of material across the beach.</p> <p>At profile 1aBTBC14 there has been substantial accretion across the length of the profile, which is in the order of 1m at a chainage of 55m. This is possibly recovery of material following a significant reduction in beach levels in 2008 (full measures, winter 2008).</p>	<p>There are significant cross-shore processes operating along this coastline.</p> <p>To the north end of the Spittal Beach at 1aBTBC11 and 1aBTBC12, there is a redistribution of beach material from the middle beach to the upper beach. This cross-shore transport is likely to be driven by waves and wind-blow processes. If sand is blown over the crest of the seawall onto the promenade and it is not returned to the beach, this could represent a permanent loss of material from the system.</p> <p>At the centre of Spittal beach, the beach is more dynamic with alternating areas of erosion and accretion. The survey photograph shows a small amount of accretion against the toe of the seawall. The observed increase in levels between 35m-80m chainage is infilling of the trough (its formation was described in the previous (2011) full measures report).</p> <p>To the south, the beach has accreted significantly.</p> <p>Longer term trends: The previous (2011) full measures report relates the changes previously observed to changes occurring at the estuary, Given the proximity of the mouth of the River Tweed to this frontage, it is likely that the changes again this year observed are related to an interaction of waves and currents flowing from and into the estuary.</p>

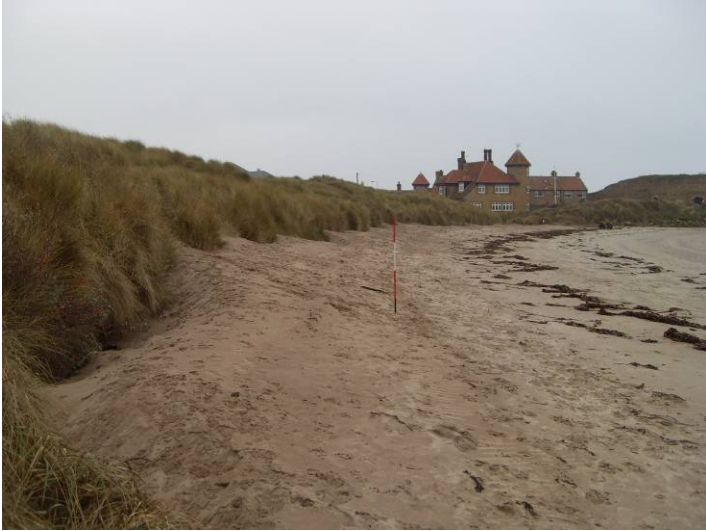
Plate 5 – Survey photograph 1aBTBC33_20111114_E3.JPG

Survey Date	Description of Changes Since Last Survey	Interpretation
Nov 2011	<p>Beach Profiles:</p> <p>Beadnell Bay is covered by nine beach profile lines for the Full Measures survey (Appendix A).</p> <p>1aBTBC32 to 1aBTBC34 are located to the north of Beadnell Bay, in Beadnell Harbour. BTBC32 is immediately in the lee of Beadnell Harbour. The dunes at a1aBTBC32 and 1aBTBC34 have not changed from or position. At 1aBTBC33, the profile shows erosion of the dune face, however, the survey photograph (Plate 5) shows the dune to be well vegetated and stable. At all profiles there has been an increase in beach levels at the toe of the dune erosion to mid-way across the profile and a reduction in beach levels from a level of approximately 0.8m to seawards.</p> <p>1aBTBC35 to 1aBTBC38 are located between Burn Carrs and the outfall of Brunton Burn/Long Nanny. Since the last survey (partial measures, spring 2011), with the exception of 1aBTBC37, the dune face has not changed from or position. At 1aBTBC37, the bottom of the dune has accreted out by approximately 2m. This is also acknowledged in the survey report for the North East Coast, which notes '<i>sand accumulation at foot of dune</i>'.</p> <p>Beach levels at 1aBTBC35 and 1aBTBC36 have changed very little, with only a slight reduction in beach levels of 0.1-0.2m at the dune toe at 1aBTBC35. At profiles 1aBTBC37 and 1aBTBC38, a reduction in beach levels is equated with an increase in levels and vice-versa in a seaward direction to form an undulating profile. This demonstrates the cross-shore movement and redistribution of material by waves. This pattern is particularly pronounced at profile 1aBTBC38, which is reflective of the proximity and influence of the outfall of Brunton Burn/Long Nanny on tidal currents, sediment transport and therefore beach dynamics.</p> <p>1aADC01 and 1aADC02 are located along the frontage to the south of the outfall of Brunton Burn/Long Nanny. Since the last survey (partial measures, spring 2011), the dune face has eroded by approximately 0.5m; a continuation of historical trends. At profile 1aADC01, beach levels reduced by approximately 0.2m between MHWS and a chainage of approximately 300m. Seaward of there, beach levels increased by approximately 0.2m. This suggests the cross-shore movement of material from the upper to lower beach. At profile 1aADC02, beach levels reduced by approximately 0.2-0.3m around MHWS, but have remained relatively stable seaward to MWLS.</p>	<p>In the lee of Beadnell harbour the dunes are stable. Beach levels have increased from the beach toe out to the middle of the profile, seaward of which beach levels have reduced. Material eroded from the lower beach could be redistributed to the middle and upper beach by wind-blown transport.</p> <p>Generally the dunes and beaches in the north of Beadnell Bay are stable. There is evidence of some cross-shore movement, likely to be instigated through wind-blown transport or waves. The beach at profiles 1aBTBC37 and 1aBTBC38 undulates slightly along the length of the profile.</p> <p>To the south of Beadnell Bay, the dune face is eroding, a continuation of trends observed in previous surveys. Generally the beaches are stable, with some erosion of the beach at the dune toe and some cross-shore movement at profile 1aADC01, which is likely to be a result of wave and tidal currents relating to the proximity of the beach to the outfall of Brunton Burn/Long Nanny.</p>

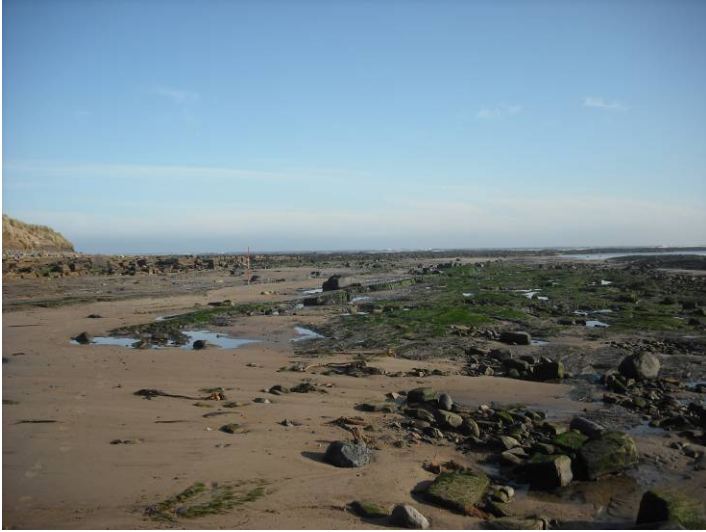
Plate 6 – Survey photograph 1aADC16B_20111026_N8.JPG

Survey Date	Description of Changes Since Last Survey	Interpretation
Oct 2011 to Nov 2011	<p>Beach Profiles:</p> <p>High Hauxley to Druridge Bay is covered by nine beach profile lines for the Full Measures survey (Appendix A). Four of these (with 'A' or 'B' suffixes) were added to the programme in October 2007.</p> <p>Profile 1aADC15 extends across the extensive dunes at Amble Links and foreshore. The dunes along this profile have remained stable since the last survey (full measures, winter 2010). The upper beach, which is comprised of gravel and extends from the dune toe to 0m (chainage approximately 140m), has flattened out since the last survey. Beach levels at the toe the dunes have increased, but increases in levels seaward of this point and the berm present in the last survey, have disappeared. Below an elevation of 0m, there is fluctuating pattern of change, with lowering between a chainage of 150m and 190m, and rising levels from a chainage of 190m. This suggests cross-shore movement of material in bars.</p> <p>1aADC15A, 1aADC16 and 1aADC16A are located around Hauxley Haven. The dunes at all three profiles have remained largely unchanged since the last survey. At profile 1aADC15A, beach levels have increased across the whole profile in the region of 0.2m. The rocky lower shore is unchanged. At profile 1aADC16, there has been a fall in beach levels between HAT and 1m, however, seaward of this to MLWS (and the rocky foreshore), beach levels have increased in the region of 0.1m to 0.2m. At profile 1aADC16A, with the exception of a small increase in beach levels at the toe of the rock revetment and around MLWS on the rocky foreshore, beach levels have fallen by approximately 0.2m.</p> <p>1aADC16B, 1aADC17 and 1aADC17A are located to the north of Druridge Bay, between Bondi Carrs and Hadston Carrs and extend seawards from Togston Links. Generally no change to the dunes was observed since the last survey. At 1aADC16B beach levels have fallen at the toe of the dunes and across the profile. The survey photograph (Plate 6) for this profile shows only a thin veneer of sand over a rock/boulder shore platform. At 1aADC17 beach levels have increased at the toe of the dune by up to 0.4m, however, the survey photograph (Plate 7) shows erosion of the shoreline / dune toe. Across the remainder of the profile beach levels have fallen slightly, in the region of 0.1m. At 1aADC17 beach levels have fallen at the toe of the dune, increased by approximately 0.2m between a chainage of 40m and 140m, and reduced seaward of 140m.</p>	<p>The dunes at profile location 1aADC15 have remained stable over the past year. Accretion at the toe of the dunes is likely to be deposition of wind blown sand. The survey photograph shows the presence of seaweed, which will assist in this deposition. Beach material eroded from around the 0m levels is likely to have been redistributed lower in the profile. This cross-shore movement is likely to have occurred during a recent storm.</p> <p>At Hauxley Haven, the dunes have remained stable. However, with the exception of 1aADC15A, the beach is showing evidence of cross-shore movement, with the redistribution of material from the upper/middle beach to the lower beach. This is likely to have occurred under storm conditions. The survey photograph shows large amounts of seaweed spread across the beach, which also suggests a recent storm. It is possible that beach material eroded from 1aADC15A during the storm has been moved north towards 1aADC15A, 1aADC16.</p> <p>Between Bondi Carrs and Hadston Carrs, the shoreline and dunes are experiencing erosion. The low till cliffs that form the coastline in this location are being actively eroded, causing the capping of dune sand to slump to the beach below and be rapidly reworked into the beach system (Plate 7). Despite the shoreline erosion, the beaches are relatively stable, with only small changes to the beach levels, which can</p>

- At High Hauxley & Druridge Bay, between Bondi Carrs and Hadston Carrs (profiles 1aADC16B to 1aADC17A), the low till cliff and overlying dunes are experiencing erosion. The cliff toe is being cut-back and undermined and the dune material above then slumps to the beach below. Along the rest of the frontage, the recorded profiles present no causes for concern.

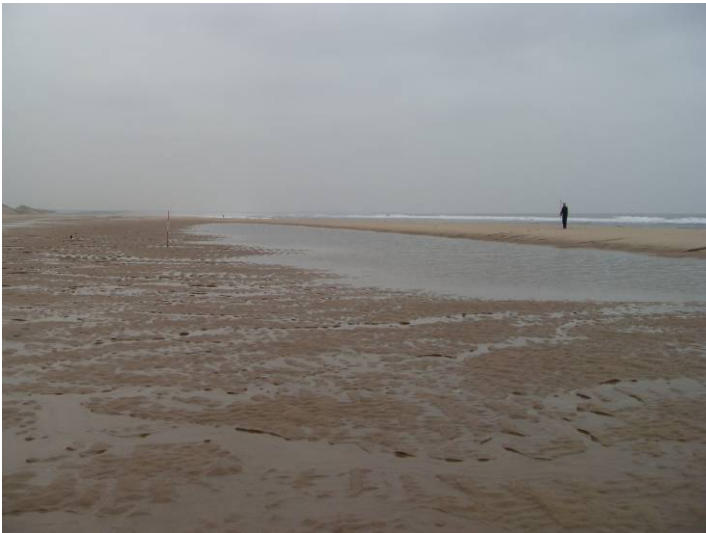
Plate 8 – Survey photograph 1aCMBC01_20111109_N19.JPG

Survey Date	Description of Changes Since Last Survey	Interpretation
	<p>1aCMBC01 and 1aCMBC02 are located in the southern section of Druridge Bay. Since the last survey (partial measures, spring 2011), the dunes have remained stable, with some accretion on the seaward face of the dunes at 1aCMBC02. The beach at both locations has experienced some re-profiling. At 1aCMBC01 beach levels at the toe of the dunes has increased and the upper beach berm has prograded seaward so the berm is now located further seaward and lower down the profile. Between 260m and 280m, beach levels have fallen by 0.4m, but seawards of this beach levels have increased to form a domed profile. The survey photograph (Plate 8) shows some ponding of water in the lee of a large bar. At 1aCMBC02 beach levels below MHWS have fallen in the order of 0.5m, but increased beyond a level of 0.5m and a chainage of 320m.</p>	<p>be attributed to a cross-shore shift of material in response to tides and waves.</p> <p>The southern central part of Druridge Bay is accreting, evident by a prograding shoreline. The large bar and trough have formed where sediment carried shoreward meets with sand withdrawn from the beach by backwash. The bar and trough are likely to migrate and break-down as weather conditions change over time.</p>

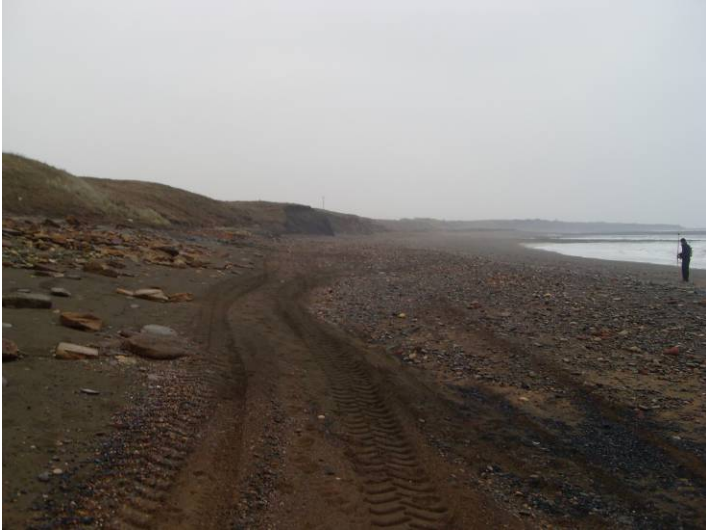
Plate 9 – Survey photograph 1aCMBC03A_20111108_N7.jpg

Survey Date	Description of Changes Since Last Survey	Interpretation
Oct 2011	<p>Beach Profiles:</p> <p>Lynemouth Bay is covered by six beach profile lines for the Full Measures survey (Appendix A). Two of these, profiles CMBC03A and CMBC03B, were added to the programme in October 2007.</p> <p>1aCMBC03 is located just to the south of Snab Point. The profile extends across the cliff and the rock platform below. The profile has not exhibited any change since the last surveys indicating a stable cliff and rocky shore.</p> <p>1aCMBC03A is located opposite Lynemouth and extends across the extensive slag banks before reaching the foreshore. A line of boulders exists along the upper beach around HAT. The slag bank has not experienced any change since the last survey (partial measures, spring 2011). Beach levels dropped by approximately 0.5m between a chainage of 100m and 110m. This area is located between the boulders and the top of the gravel berm that marks the start of the lower beach (Plate 9). The lower beach between a chainage of 130m and 160m has also experienced a reduction in beach levels in the region of 0.2m.</p> <p>1aCMBC03B is located to the north of Lynemouth Power Station and extends across the extensive slag banks before reaching the foreshore. The process of slag bank erosion has been progressively ongoing for some years. The most recent survey reveals further cut back of the seaward edge of the bank in the region of 5m between March and November 2011. Seaward of MHWS, beach levels have fallen by approximately 1m across the length of the profile.</p> <p>1aWDC01 extends from seaward of the rock revetment down to low water across the extensive slag banks. Beach levels have fallen since the last survey, by up to 0.5m at the toe of the revetment.</p> <p>1aWDC02 is located to the south of the Power Station. Since the last survey (full measures, winter 2010), the dunes, the muddy backshore (slag bank) and upper boulder beach (chainage 0m to 170m) have not experienced any significant change. Seaward of the boulder beach, at HAT (3m), chainage 180m, beach levels have increased to form a berm. Between MHWS and MLWS (190m to 220m chainage, beach levels have fallen by up to 0.35m. This indicates cross-shore movement of material to the upper beach.</p>	<p>The north of Lynemouth Bay (between Snab Point and Headagee), the cliffs, beach and rocky foreshore has remained stable.</p> <p>Between Headagee and Lynemouth Power Station, erosion of the upper beach could be attributed to use of vehicles, as tyre tracks were observed during the survey (Plate 9).</p> <p>To the north of Lynemouth Power Station, in the centre of the Bay, there has been significant erosion, with cut-back of the slag banks and lowering of the beach. The survey report notes that at profile 1aCMBC03B '<i>previously graded profile has been eroded to form cliff face</i>'.</p> <p>Between Lynemouth Power Station and Beacon Point, in front of the dunes and slag bank, the berm on the upper beach has accreted, whilst middle and lower foreshore levels have fallen. The previous full measures report (winter 2010) attributes this to the landward movement of material from the lower to upper beach by overwashing.</p> <p>To the south, between Beacon Point and Newbiggin Point, the cliffs that line the backshore appear to have remained unchanged. Accretion at the toe, but a reduction in beach levels between MHWS and the exposed rock platform has led to the development of a more concave beach.</p>

- To the north of Lynemouth Power Station, in the centre of the Bay, there has been significant erosion, with cut-back of the slag banks and lowering of the beach. The survey report notes that at profile 1aCMBC03B 'previously graded profile has been eroded to form cliff face'. The previous survey report (partial measures, spring 2011) noted that '*the slag banks that were previously being eroded at a rapid rate along parts of Lynemouth Bay have been mechanically re-graded to a shallower slope angle, with some of the material contributing to notable accretion on the foreshore. Continued monitoring will be necessary to determine whether this has been successful in slowing or arresting the recession rates*'. These observations may be related to beach regrading work.

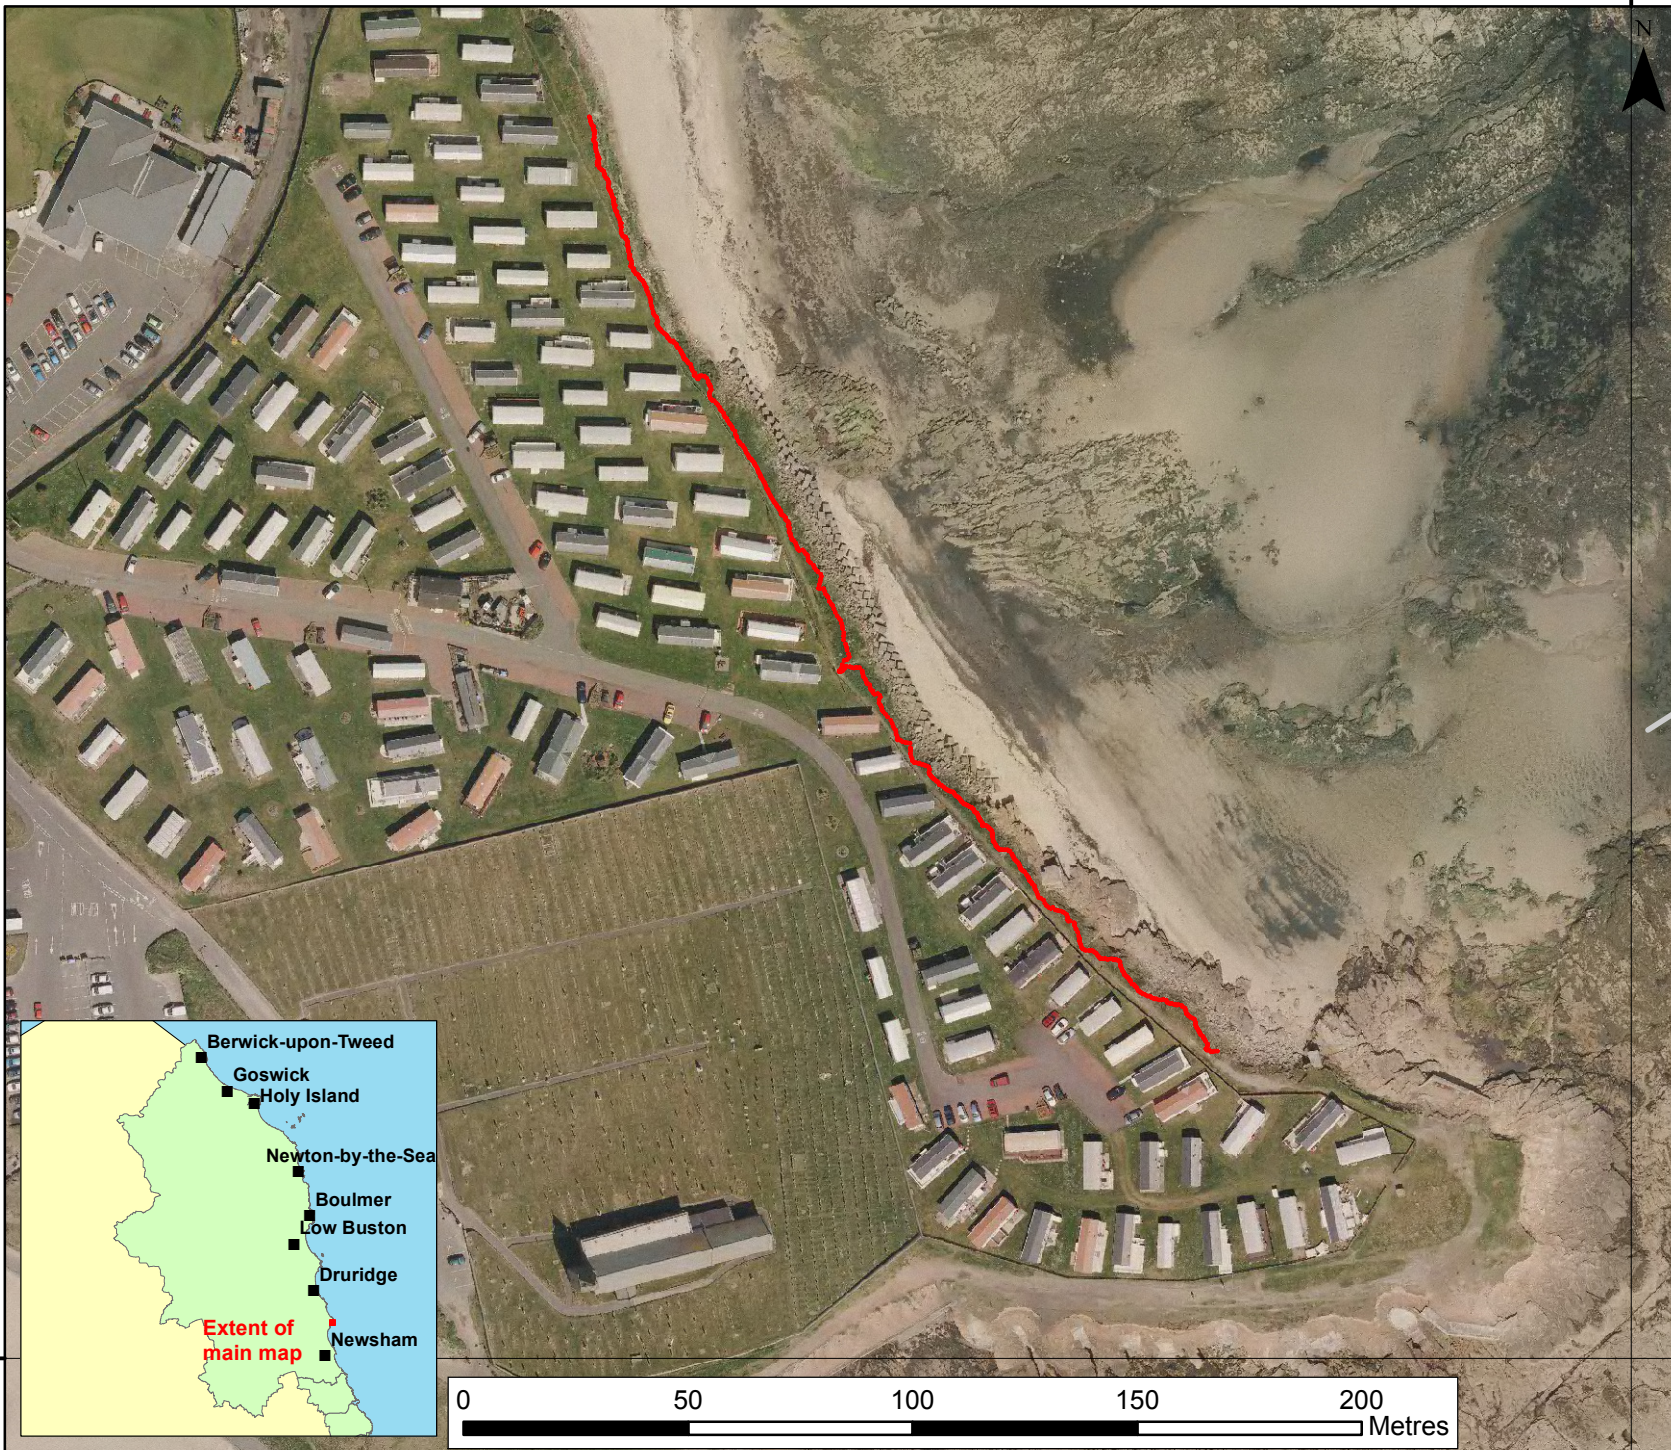
Appendix C
Cliff Top Survey

— Cliff Top (winter 2011)
