**Cell 1 Regional Coastal Monitoring Programme
Analytical Report 5: 'Full Measures' Survey 2012**

**Northumberland County
Council
Final Report**

March 2013

(*) The present report is **Analytical Report 5** and provides an analysis of the 2012 Full Measures survey for Northumberland Council's frontage.

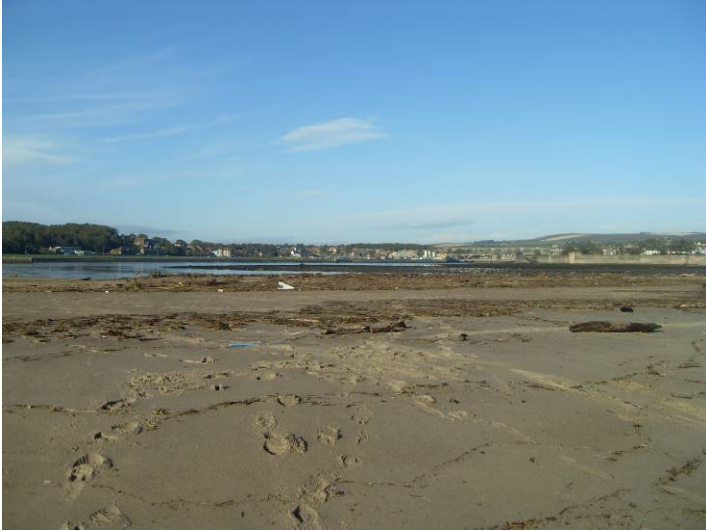
Plate 1 – Survey photograph 1aBTBC04_20121018_W14.JPG

Sept 2012	<p>Topographic Survey:</p> <p>Due to the significant changes that have been observed from the beach profiles along the spit at Sandstell Point, and the three dimensional nature of these changes, a topographic survey was introduced to the monitoring programme in November 2009.</p> <p>Data from the most recent topographic survey (full measures, autumn 2012) have been used to create a digital ground model (DGM) (Appendix B – Map 1a) using a Geographical Information System (GIS). A difference plot has also been produced using the DGM (Appendix B – Map 1b) produced from the last produced topographic survey (partial measures, spring 2012) and the present survey.</p> <p>In particular, the difference plot shows: (i) with the exception of an area of decrease in elevation, a slight increase in beach elevation seaward of the dunes around the u-bend of the River Tweed (the survey report for Berwick notes ‘band of small dunes forming along top of river beach’); (ii) a band of reduced beach elevation orientated north to south that runs parallel to Sandstell Point and abuts the headland; (iii) a band of increased beach elevation orientated north to south that runs parallel to Sandstell Point; (iv) on the seaward side of the berm beach elevation has reduced. The latter repeats the findings of the beach profile analysis above, which suggests the development of a berm to the east. These trends are</p>	<p>Comparison of the present topographic survey with the previous partial measures (spring 2012) survey shows a band of reduced elevation (i.e. erosion) that abuts and extends past the headland. Adjacent to this, to the east, is a parallel band of increased elevation. It is likely that the material eroded from the zone of reduced elevation is deposited in the zone of increased elevation to form a bank and represents the eastwards movement of the berm. This change is reflected in the beach profiles and suggests a bank that is likely to have formed under autumn storm conditions.</p> <p>Longer term trends: The longer term trends are covered by the long term topographic trends autumn 2010 to autumn 2012 (see below).</p>

Survey Date	Description of Changes Since Last Survey	Interpretation
	<p>similar to those observed in the Partial Measures, spring 2012 survey.</p> <p>Long Term Topographic Trends Autumn 2011 to Autumn 2012:</p> <p>The long term difference plot (Appendix B – Map 1c) shows the net change in beach levels between autumn 2011 and autumn 2012. The plot shows distinct zones of beach elevation increase and decrease. On the southern side of the River Tweed, around the u-bend, beach levels have mostly increased. Two linear bands of beach elevation decrease extend along the length of the spit from north to south; one abuts the tip of the spit, and the other extends along the lower shore. Between is a band of beach elevation increase.</p>	<p>Long term topographic trends Autumn 2011 to Autumn 2012: The plot shows distinct zones of beach elevation increase and decrease. This is reflective of a spit, with berms and troughs generated via seasonal changes and fluvial/ tidal flows along the spit.</p>

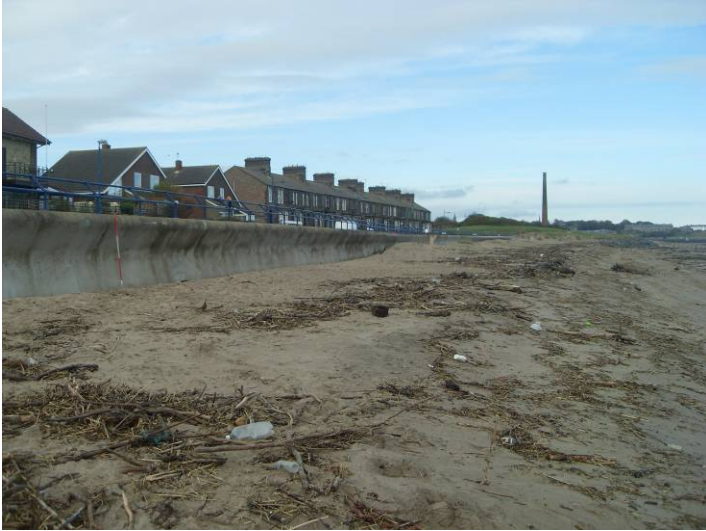
Plate 4 – Survey photograph 1aBTBC12_20121018_N1.JPG

Survey Date	Description of Changes Since Last Survey	Interpretation
Oct 2012	<p>Beach Profiles:</p> <p>Spittal B is covered by four beach profile lines for the Full Measures survey (Appendix A).</p> <p>At profile 1aBTBC11 there has been a reduction in beach levels, of up to 0.8m, between a chainage of 15m and 40m. This is accompanied by a similar reduction in beach levels between a chainage of 70m and 135m. A small increase in beach levels in the order of 0.2m occurred between a chainage of 45m and 70m and seawards of 140m.</p> <p>At profile 1aBTBC12, between a chainage of 0m and 10m, beach levels have increased by up to 0.8m, as shown by the survey photographs in Plates 4 and 5 where the tidal flap is not visible. Also notable from the survey photographs for the present survey is the large amount of seaweed and debris on the beach, which has been deposited by storms. Beach levels have decreased by up to 2m between a chainage of 10m and 55m, and increased by over 1m seaward of chainage 55m,. This is likely to reflect the cross-shore movement of material from the upper to lower beach.</p> <p>Similarly to profile 1aBTBC11, beach levels at profile 1aBTBC13 have decreased above MHWS and seaward of 75m chainage, but increased by approximately 0.2m in between.</p> <p>At profile 1aBTBC14 beach levels have decreased across the majority of the profile, particularly between 0m and 25m chainage where they fell by approximately 1.5m (see survey photographs in Plates 6 and 7), and 35m and 80m chainage, where they fell by up to 0.6m. Beach levels increased slightly (0.2m) between a chainage of 25m and 35m and seaward of chainage 80m. The overall result is a shallower and flatter profile.</p>	<p>Since the last survey (partial measures, 2012), the beach at 1aBTBC11 and 1aBTBC13 have behaved similarly with a reduction in beach levels above MHWS and seaward of a chainage of 75m, however between beach levels have increased.</p> <p>Since the last survey (full measures, 2011), the upper beach at 1aBTBC12 and the upper beach / lower beach 1aBTBC14 has significantly decreased in height. The overall result is a shallower and flatter profile.</p> <p>Longer term trends: At all profile locations along Spittal Beach, the changes observed in the present survey are within the bounds of previous surveys. Notable differences are at: (i) profile 1aBTBC12 where beach levels at the toe of the seawall and between a chainage of 90m and 130m are the highest observed to date; (ii) similarly at profile 1aBTBC13, beach levels between a chainage of 35m and 75m are the highest observed to date; and (iii) at profile 1aBTBC14 beach levels at the toe of the seawall are the lowest observed to date, by as much as 1m.</p> <p>However, the presence of significant volumes of seaweed, drift wood and other debris on the beach and the notable fall in beach levels at the toe of the seawall at profile 1aBTBC14, suggest the occurrence of a particularly strong storm since the last survey. The notable fall in beach levels at 1aBTBC14 and</p>

Survey Date	Description of Changes Since Last Survey	Interpretation
		increase in beach levels (in part) at the profiles to the north suggests a trend in the movement of material from the south of Spittal beach to the north.

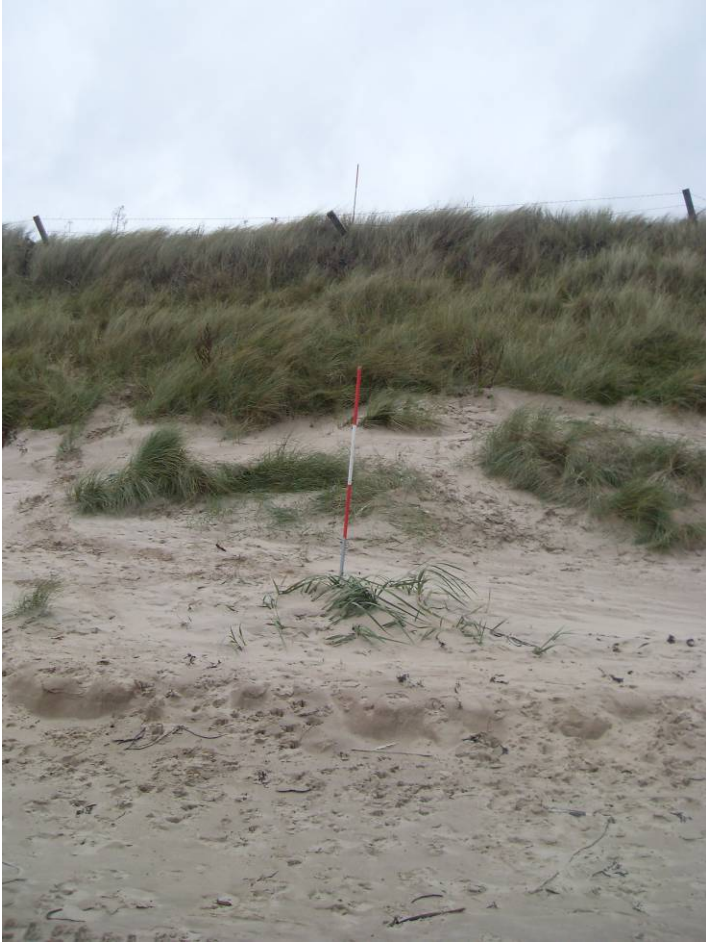
Plate 8 – Survey photograph 1aBTBC38_20121031_Up2.JPG

Survey Date	Description of Changes Since Last Survey	Interpretation
	and just above MLWS.	of a ridge/berm and a runnel/ponded water to form a higher, flatter and less undulating profile not seen from previous surveys.

- At Beadnell Bay, the survey report notes that for profile 1aBTBC33 '*middle of dunes missing due to dense vegetation*'. This could impact on the accuracy of subsequent survey interpretation or volume calculations for this profile. At profile 1aBTBC38, which is located adjacent to the outfall of Brunton Burn/Long Nanny, the changes observed in the present survey are the most notable to date with a flattening of the profile and disappearance of a ridge/berm and a runnel/ponded water to form a higher, flatter and less undulating profile not seen from previous surveys.

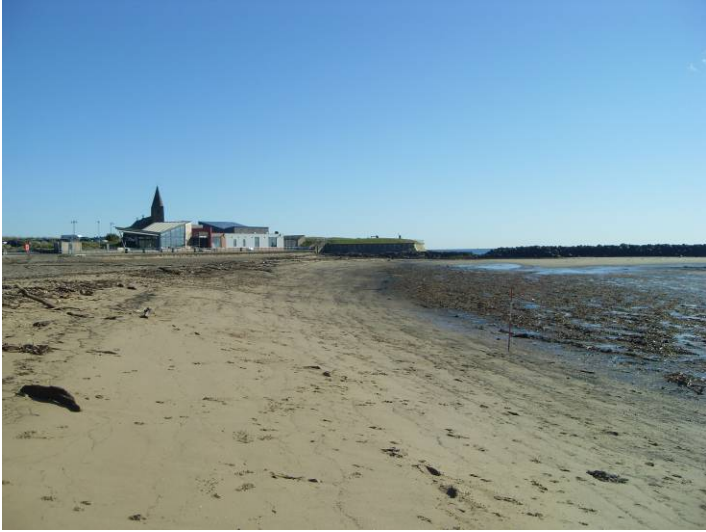
Plate 17 – Survey photograph 1aWDC05A_20121004_E5.jpg

Survey Date	Description of Changes Since Last Survey	Interpretation
	<p>revetment and between a chainage of 22m and 34m, and an increase in beach levels between with the formation of a small berm at a chainage of 18m. This suggests some cross-shore movement of sediment, from the upper beach to the lower beach. Seaward of a chainage of 18m, beach levels have increased by approximately 0.4m. Similarly to profile 1aWDC05A, the presence of seaweed on the beach (as observed from the survey photographs) and the cross-shore movement of material are likely to be related to re-profiling due to storm conditions.</p>	<p>suggest that there has been particularly strong storm conditions since the last surveys that could explain these low levels.</p>
<p>Oct 2011</p>	<p>Topographic Survey:</p> <p>Newbiggin-by-the-Sea is covered by bi-annual topographic survey, which commenced in September 2010 specifically to help assess the performance of the capital scheme that was constructed in 2007, which involved beach replenishment and an offshore breakwater. The topographic survey comprises a series of 26 beach profiles plus additional intervening spot heights. Prior to incorporation in the programme, these surveys were undertaken on occasions between 2007 and 2010 as part of the scheme development.</p> <p>Data from the most recent topographic survey (full measures, autumn 2012) have been used to create a DGM (Appendix B – Map 4a) using a Geographical Information System (GIS). A difference plot has also been produced using the DGM (Appendix B – Map 4b) produced from the last produced topographic survey (partial measures, spring 2012) and the present survey.</p> <p>The topographic survey shows areas of both gain and loss across the beach. However there are some noticeable differences at the following locations: (i) an overall trend of beach elevation decrease and (ii) small pockets of beach elevation increase, namely to the north of the frontage in the lee of the breakwater and along the lower shore.</p> <p>Long Term Topographic Trends Autumn 2011 to Autumn 2012:</p> <p>The long term difference plot (Appendix B – Map 4c) shows the net change in beach levels between autumn 2011 and autumn 2012. A distinct band of beach elevation increased has formed along the backshore to the north and centre of Newbiggin Bay, however, this changes to beach elevation reduction to the south. Along the middle of the beach, and particularly in the lee of the offshore breakwater and to the north of the bay, in the lee of the northern breakwater, beach elevation has decreased.</p>	<p>The findings of the topographic survey shows that since the last survey, there has been an overall trend of beach elevation decrease, with small pockets of beach elevation increase located to the north of the frontage in the lee of the breakwater and along the lower shore. These findings do not directly reflect the findings of the topographic survey report, which notes '<i>sand spit almost reaches central breakwater, approx 10-15m of water to breakwater at low tide</i>', nor the beach profile survey, however, the extent of the beach elevation reduction may be explained by the storm conditions over the past 6 months.</p> <p>Longer term trends: The longer term trends are covered by the long term topographic trends autumn 2011 to autumn 2012 (see below).</p> <p>Long term topographic trends Autumn 2011 to Autumn 2012: The long term difference plot of topography shows a distinct band of beach elevation increase along the backshore to the north and centre of Newbiggin Bay and along the lower shore. There is a decrease along the middle of the beach. It is difficult to discern any particular trends from this data, but it is possible that the distinct bands of alternating beach elevation increase and decrease across the beach are</p>

Survey Date	Description of Changes Since Last Survey	Interpretation
		a result of beach response to cross-shore movement of sediment and/or beach re-profiling.
Nov 2012	<p>Sand Extent Survey:</p> <p>Spital Carrs is located to the south of Newbiggin Bay and is covered by a bi-annual sand extent survey, which commenced in 2012. The survey was designed to address concern that the beach recharge scheme undertaken in the Newbiggin Bay may have impacts on the Spital Carrs SSSI and SPA if sand from the recharge scheme moves to the south. The sand extent survey therefore identifies the boundary of the sand beach on the rock platform.</p> <p>Data from the most recent sand extent survey (partial measures, spring 2012) has been plotted onto aerial imagery (refer to Appendix D – Map 1). The plot shows that there is some variation of the extent of sand between the spring 2012 and the autumn 2012 survey. There is some movement to the south and centre-north where the sand extent has moved slightly seaward, however to the north of that it has moved landwards. Otherwise, there are no discernible trends suggesting the seawards extension of sand.</p>	<p>Since the last survey, there has been some movement to the south and centre-north where the sand extent has moved slightly seaward. However to the north of that it has moved landwards. Otherwise, there are no discernible trends suggesting the seawards extension of sand.</p> <p>Longer term trends: Review of the sand extent surveys for the past three surveys, shows that extent of the sand has oscillated and there are no clear discernible trends.</p>

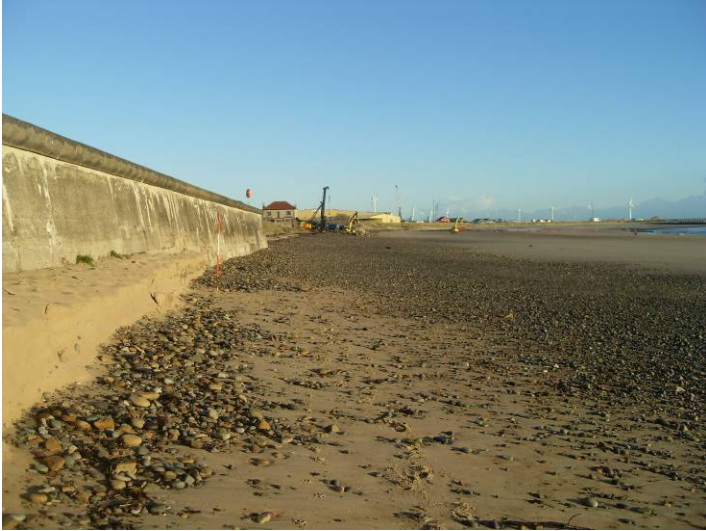
Plate 20 – Survey photograph 1aBVBC02_20121015_N2.JPG

Survey Date	Description of Changes Since Last Survey	Interpretation
Oct 2012	<p>Beach Profiles:</p> <p>Blyth South Beach is covered by six beach profile lines for the Full Measures survey (Appendix A).</p> <p>1aBVBC01 is located towards the north of South Beach, in front of the area of land owned by Port of Blyth. There have been no significant changes to the position and form of the dunes since the last survey (partial measures, spring 2012). With the exception of the a length of profile at the dune toe, and between a chainage of 65m and 70m, beach levels across the majority of the profile have decreased.</p> <p>Beach levels at 1aBVBC02 have fallen by up to 1m at the toe of the seawall seaward to a chainage of 30m, resulting in removal of the sand beach to leave a small sand step and exposure of the underlying sand and cobble beach (as seen in the survey photographs, see Plates 21 and 22). Seaward of a chainage of 35m, beach levels increased. This suggests some cross-shore movement of sediment, from the upper beach to the lower beach, likely to have occurred as material was drawn down during storm conditions.</p> <p>At 1aBVBC03 there have been no significant changes to the position and form of the dunes since the last survey (partial measures, spring 2012). Beach levels have decreased along the majority of this profile, in particular around HAT/MHWS where the upper beach berm has receded to form a narrower and steeper beach profile. Beach levels have increased between a chainage of 120m and 130m and 200m and 240m. As with 1aBVBC02, this suggests some cross-shore movement of sediment, from the upper beach to the lower beach, likely to have occurred as material was drawn down during storm conditions.</p> <p>Beach level change at 1aBVBC04 has been quite dynamic across the profile, with a reduction in beach levels around HAT/MHWS, to form a more gently sloping profile, and between a chainage of 100m and 160m, where they have decreased over 1m reflecting the flattening of the berm there. The overall result is the formation of a more concave and uniform sloping beach profile.</p> <p>At 1aBVBC05 there have been no significant changes to the position and form of the dunes since the last survey (partial measures, spring 2012). Beach levels have decreased from the toe of the dunes to a chainage of 180m, however, they have decreased seaward of there. The result is the formation a</p>	<p>Along the length of the coastline, with the exception of the locations where a seawall is present, the dunes have remained largely stable since the last survey. The beaches have behaved in a similar way, with a reduction in beach levels on the upper beach around HAT/MHWS and an increase in beach levels on the lower beach. In between, the beaches have been dynamic with discrete lengths of beach level increase/fall, i.e. accretion/erosion. This beach behaviour is likely to be driven by seasonal changes, occurring as material was transported across the beach during storm conditions.</p> <p>Longer term trends: Similarly to Cambois Bay, although there have been some quite significant changes since the last survey in autumn 2011, the changes observed since then are within the bounds of previous surveys and these beach levels have been observed in the past.</p>

Survey Date	Description of Changes Since Last Survey	Interpretation
	<p>smooth, more gently sloping profile and the flattening of the beach berm that formed between the last two surveys (full measures, October 2011 and partial measures, March 2012).</p> <p>Profile 1aBVBC06 is located at the southern end of the beach, towards Seaton Sluice. Similarly to profile 1aBVBC04, beach levels have decreased along the majority of this profile, in particular around HAT/MHWS and between a chainage of 190m and 230m. Seaward of there, beach levels have increased. As with 1aBVBC03, this suggests some cross-shore movement of sediment, from the upper beach to the lower beach, likely to have occurred as material was drawn down during storm conditions.</p>

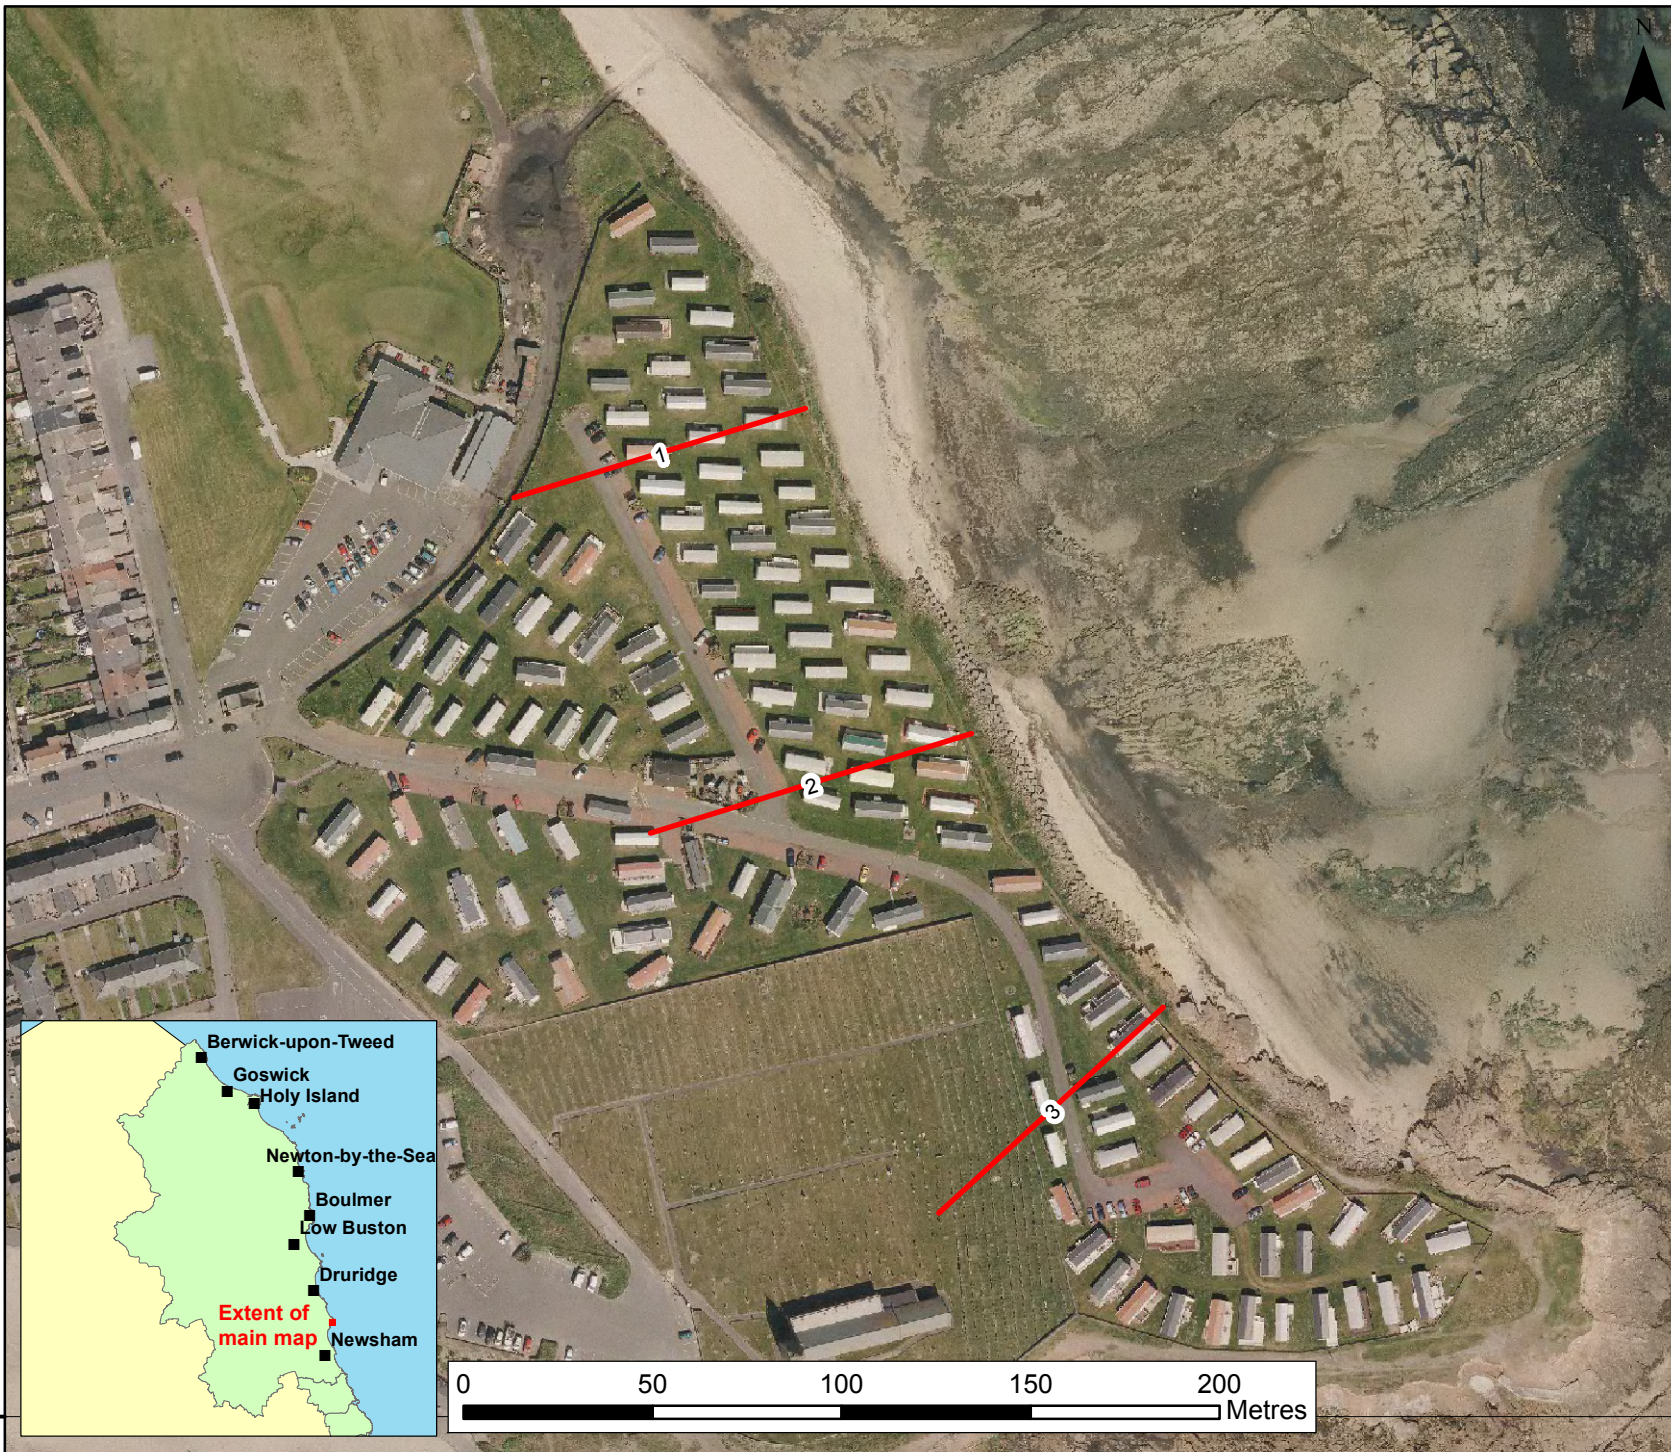
Table C1 – Cliff Top Surveys at Lynemouth Bay

Ground Control Point Details		Distance to Cliff Top (m)			Total Erosion (m)		Erosion Rate (m/year)
Ref	Type	Baseline Survey (Oct 2008)	Previous Survey (Apr 2012)	Present Survey (Oct 2012)	Baseline (Oct 2008) to Present (Oct 2012)	Previous (Apr 2012) to Present (Oct 2012)	Baseline (Oct 2008) to Present (Oct 2012)
1	Cliff	80.62	80.0	80.3	-0.4	0.3	-0.1
2	Defended	88.88	88.8	88.7	-0.2	-0.1	0.0
3	Cliff	80.23	80.5	80.4	0.2	0.0	0.0

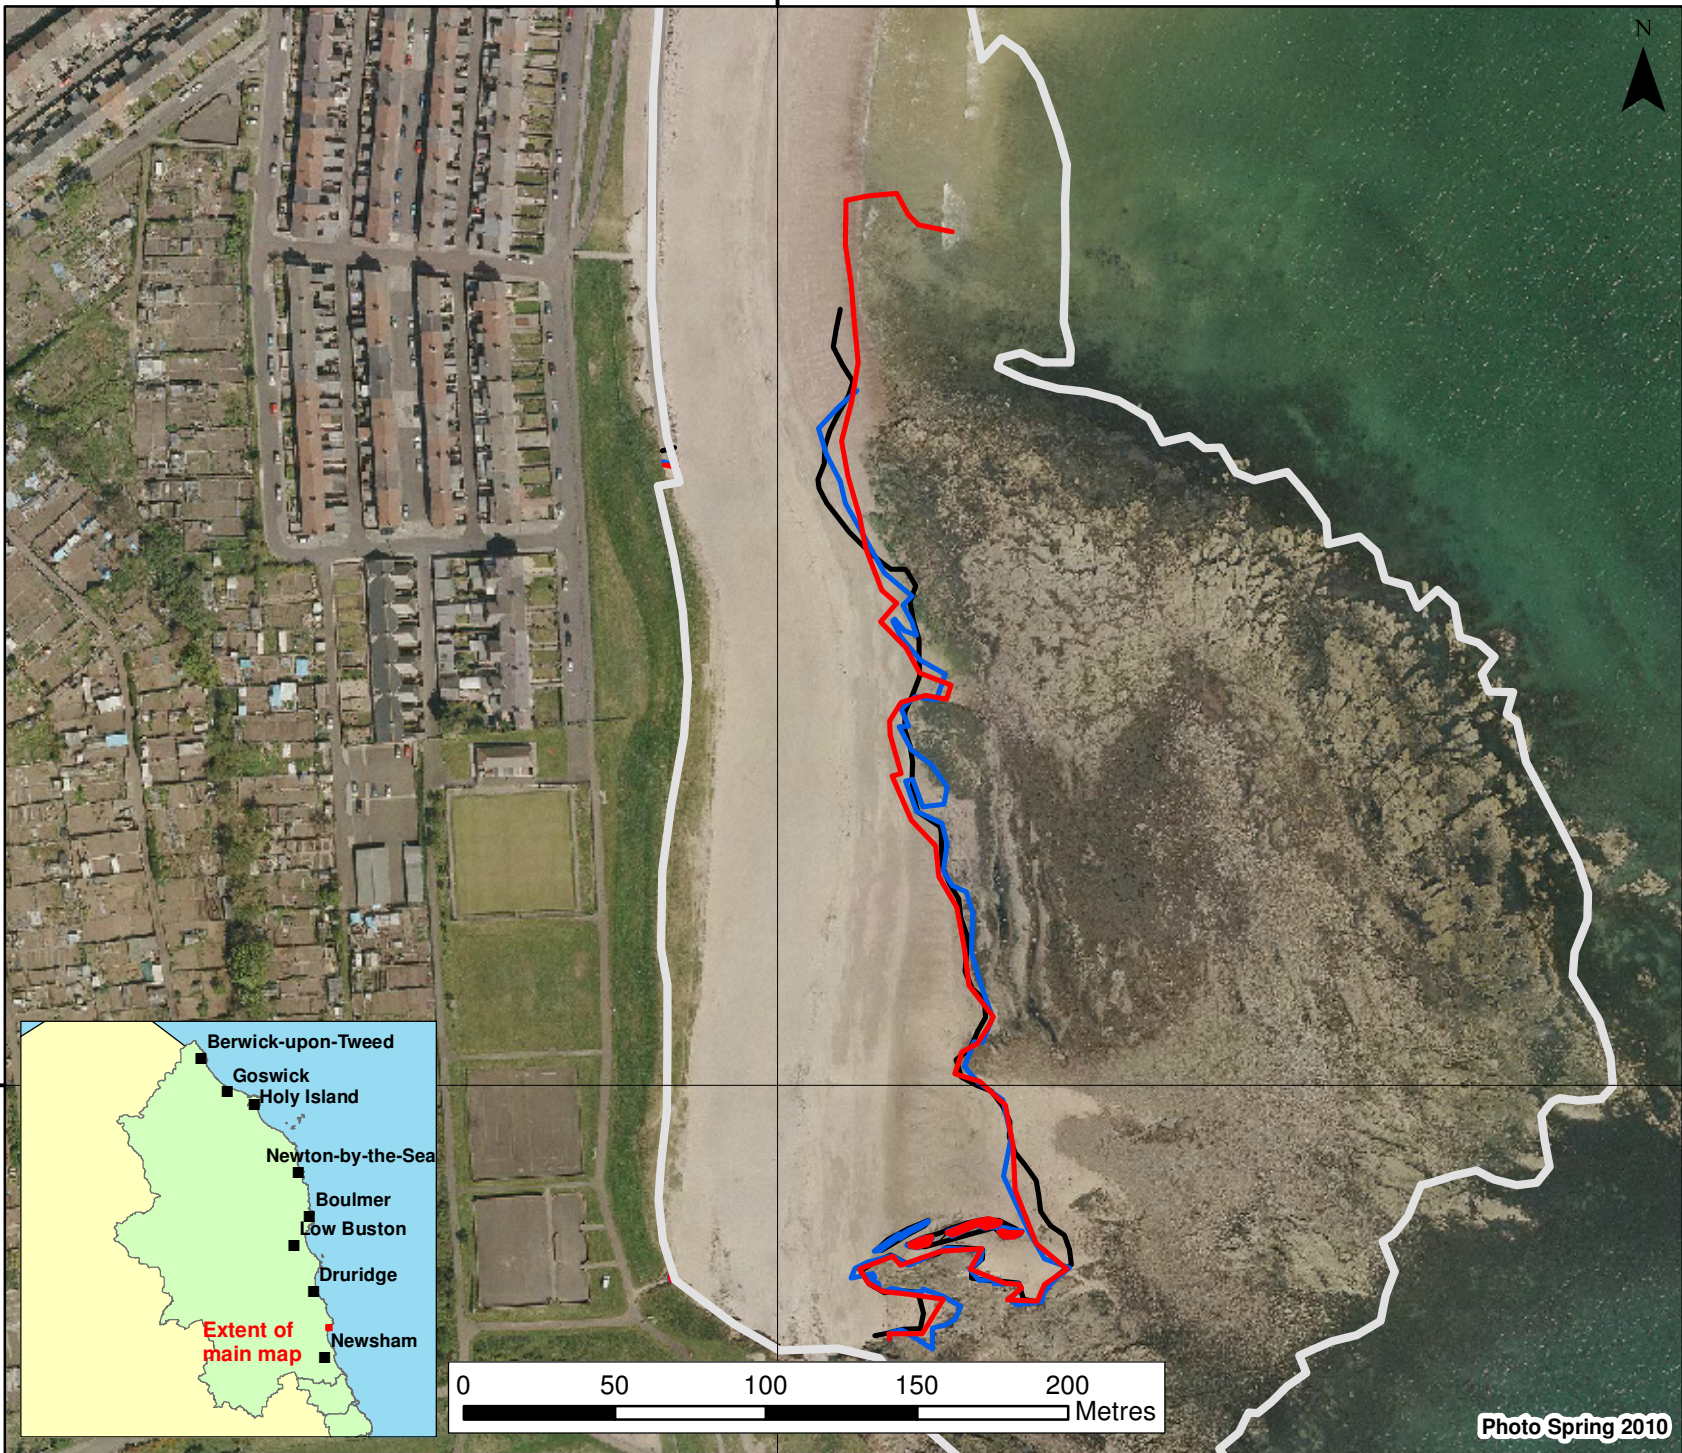
Appendix D
Sand Extent Survey

- Extent of sand (Autumn 2011)
- Extent of sand (Spring 2012)
- Extent of sand (Autumn 2012)
- Rock (Autumn 2011)
- Rock (Spring 2012)
- Rock (Autumn 2012)
- Extent of SSSI
