**Cell 1 Regional Coastal Monitoring Programme  
Analytical Report 6: 'Full Measures' Survey 2013**

**Northumberland County  
Council  
Final Report**

**February 2014**

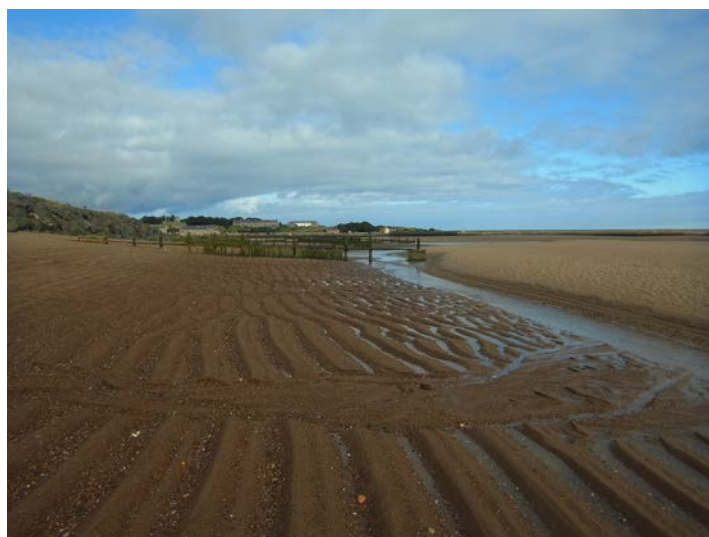
**Plate 1 – Survey photograph 1aBTBC09\_20130920\_SN5.JPG**

Survey Date	Description of Changes Since Last Survey	Interpretation
	<p>of about 0.6m (previously -1.0m). The eastern peak on the beach has increased in height to about 1.4m from 0.7m and has widened. Previous survey reports have noted a seasonal trend along this profile, however, a seasonal trend is not clear in this survey.</p> <p>Profiles <b>1aBTBC07</b> to <b>1aBTBC10</b> are located along the open coast, at the intersection of the southern side of the spit at Sandstell Point and northern end of Spittal Beach. At profile <b>1aBTBC07</b>, beach levels have fallen by up to 1.7m between the backshore/rock revetment and approximately 110m chainage. Below this a bar has formed with an elevation of just below 0.3m, resulting in increased beach levels between 110m and 165m chainage and lower beach levels from 165m seawards. The changes observed at profiles <b>1aBTBC08</b> to <b>1aBTBC10</b> are repeated for each survey from north to south: (i) a drop in beach levels between the backshore/rock revetment and a approximately 60m chainage; (ii) the formation of a bar feature at the centre of the profile, at around a height of 0.8m (60m to 140m chainage); (iii) seaward of there, formation of a smaller bar feature at around 200m chainage, resulting in higher beach levels at the toe of the profile; (iv) photographs indicate that the ponded water observed to have not been present in the previous survey has returned (see Plate 1).</p>

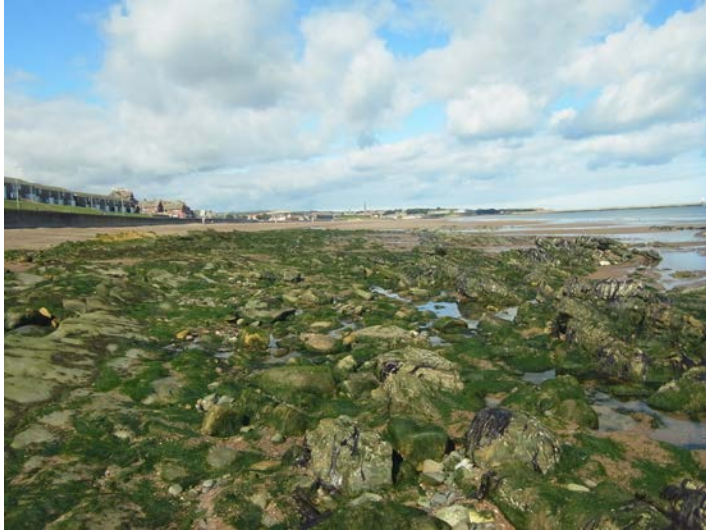
**Plate 2 – Survey photograph 1aBTBC14\_20130920\_N4.JPG**

Survey Date	Description of Changes Since Last Survey	Interpretation
Sept 2013	<p><b>Beach Profiles:</b></p> <p>Spittal B is covered by four beach profile lines for the Full Measures survey (Appendix A). Profiles 1aBTBC11 and 1aBTBC13 were last surveyed during the partial measures spring survey, 2013. Profiles 1aBTBC12 and 1aBTBC14 were last surveyed during the full measures autumn survey 2012.</p> <p>At profile <b>1aBTBC11</b> there has been a reduction in beach crest level of about 1m. The beach has then built out at around MHWS (between 19m and 39m chainage). From 39m chainage the beach steepens and three ridges with intervening troughs have formed. The reforming of the beach profile has resulted in an overall lowering of the beach levels between 40m to 89m chainage and 137m to 200m chainage, but an increase in beach level between 118m and 134m chainage. Visual observations indicate that this may have overall resulted in decreased beach volumes.</p> <p>At profile <b>1aBTBC12</b>, a similar pattern to <b>1aBTBC11</b> is noted. There has been a reduction in beach crest level of up to 0.5m. The beach has then built out at around the MHWS level, between 12m and 32m chainage. From 32m chainage the beach has then steepened and a trough has formed at about 50m chainage, resulting in erosion of up to 1.2m at this location. Beach levels then raise into a bar feature resulting in a slight increase in beach level between 70m and 105m chainage.</p> <p>Similarly to profile 1aBTBC11 and 12, the crest level at profile <b>1aBTBC13</b> has decreased by c. 0.3m and the beach below this has built outwards around the MHWS level. As with other profiles along Spittal, the beach then steepens following erosion of the beach levels between 45m and 65m chainage. Seawards of this however the bar feature previously present has lowered resulting in a drop in beach elevation of up to 0.6m from 80m chainage to the end of the profile. At profile <b>1aBTBC14</b> beach levels at the top of the beach have increased by approximately 1.3m between 0m and 12m chainage. This brings the beach crest level closer to the 2011 level, indicating recovery of this part of the beach following the drop in beach crest level recorded in the 2012 survey. However, beach levels seawards of this have significantly decreased along the rest of the profile, with bedrock now being exposed where it was previously covered with sand (see Plates 2 and 3). This bedrock was exposed in the 2003 profile survey but has been mostly covered since 2004.</p>	<p>At profiles surveys 6-monthly, since the last survey, the beach at 1aBTBC11 and 1aBTBC13 have behaved similarly with a reduction in level of the crest and development of berms and troughs. At profiles surveys annually, since the last survey the beach levels across much of 1aBTBC12 and 1aBTBC14 have significantly decreased in height, with bed rock being exposed at 1aBTBC14.</p> <p>The lowering of the beach levels and formation of bars and troughs is likely to be the result of storm conditions experienced on 10<sup>th</sup> September 2013 recorded by the wave buoy.</p> <p>The crest level at 1aBTBC14 has increased from the previous survey (that noted a 1.5m drop), recovering to a more typical elevation.</p> <p><b>Longer term trends:</b> At all profile locations along Spittal Beach, the changes observed in the present survey are within the bounds of previous surveys.</p> <p>The one notable difference is at profile 1aBTBC12, where the beach level at the base of the trough feature (50m chainage) is at the lowest level of all surveys to date for this part of the profile.</p> <p>The notable fall in beach levels at 1aBTBC14 and smaller fall in beach levels (in part) at the profiles to the north suggests a trend in the movement of material from the south of Spittal beach to the north.</p>

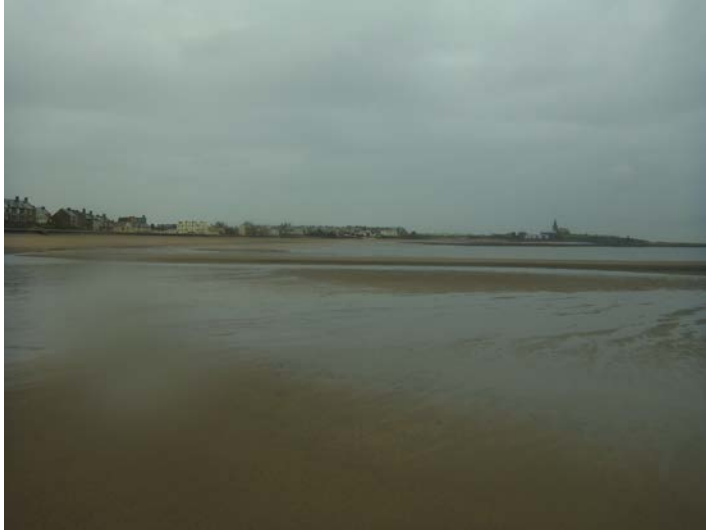
**Plate 4 – Survey photograph 1aWDC06A\_20130919\_EN8.jpg**

Survey Date	Description of Changes Since Last Survey	Interpretation
	beach, increasing to nearly 1m at the seawards end.	<p>Profile 1aWDC06a is also generally within the bounds of previous surveys, but the runnels either side of the sand ridge dip outside of the previous survey envelope.</p> <p>The slope of 1aWDC07 has cut back further than previous surveys carried out since the capital works in 2007. Further monitoring will indicate whether this profile will recover..</p>
Oct 2013	<p><b>Topographic Survey:</b></p> <p>Newbiggin-by-the-Sea is covered by bi-annual topographic survey, which commenced in September 2010. The surveys are planned to help assess the performance of a capital scheme constructed in 2007, which involved beach replenishment and construction of an offshore breakwater. The topographic survey comprises a series of 26 beach profiles plus additional intervening spot heights. Prior to incorporation in the programme, these surveys were undertaken on occasions between 2007 and 2010 as part of the scheme development.</p> <p>Data from the most recent topographic survey (full measures, autumn 2013) have been used to create a DGM (Appendix B – Map 4a) using a GIS. A difference plot has also been produced using the DGM (Appendix B – Map 4b) produced from the last produced topographic survey (partial measures, spring 2013) and the present survey.</p> <p>The topographic survey shows areas of both erosion and accretion across the beach. The difference plot shows: (i) small changes in beach elevation generally less than 0.5m (ii) greatest erosion in the lee of the breakwater, particularly on the southern face of the developing tombolo (iii) erosion over the rock outcrop in the bay to the south of the breakwater (iv) alternating bands of change in the bay to the north of the breakwater (v) greatest accretion in the less of the breakwater on the northern page of the tombolo.</p> <p><b>Longer Term Topographic Trends Autumn 2011 to Autumn 2013:</b></p> <p>The long term difference plot (Appendix B – Map 4c) shows the net change in beach levels between autumn 2012 and autumn 2013. A distinct band of beach elevation increase has formed along the much</p>	<p>The findings of the topographic survey show small changes in beach elevation, with no discernible trend in beach elevation increase or decrease. Although beachmanagement works have been carried at this beach out in the past, none have been undertaken since the previous survey.</p> <p><b>Long term trends:</b> The changes experienced are similar to those seen in past years and reflect ongoing development of stable bays either side of a tombolo. The erosion of the southern face of the tombolo has occurred in past years and reflects transient effects of winter storms.</p> <p><b>Longer term topographic trends Autumn 2011 to Autumn 2012:</b> The long term difference plot of topography shows the development of a bay north of the breakwater, with a consistent strip of erosion of up to 1m across the beach face and accretion at the shoreline. A bay has also developed to the south of the breakwater but the amount of erosion has been less. The shoreline in this area has experienced little change. In the lee of the breakwater, both erosion and accretion has occurred, suggesting that a stable</p>

Survey Date	Description of Changes Since Last Survey	Interpretation
	of the backshore, dissected by a pocket of decreased beach elevation to the centre and south of Newbiggin Bay. A distinct area of decreased beach elevation extends across the middle of the beach for much of the bay, at places reaching onto the lower foreshore and split into pockets in the southern part of the bay by the band of beach elevation increase.	tombolo feature has not yet developed. This area has experienced the greatest erosion at the shoreline.
<b>Oct 2013</b>	<p><b>Sand Extent Survey:</b></p> <p>Spital Carrs is located to the south of Newbiggin Bay and is covered by a bi-annual sand extent survey, which commenced in 2012. The survey was designed to address concerns that the beach recharge scheme undertaken in the Newbiggin Bay may have impacts on the Spital Carrs SSSI and SPA if sand from the recharge scheme moves to the south. The sand extent survey therefore identifies the boundary of the sand beach on the rock platform.</p> <p>Data from the most recent sand extent survey (full measures, autumn 2013) has been plotted onto aerial imagery (refer to Appendix D – Map 1). The plot shows that there is subtle variation of the extent of sand between the spring 2013 and the autumn 2013 survey, but no evidence for net advance of the beach over the rock platform. There is movement to the south and centre-north where the sand extent has moved slightly seaward, while to the north it has moved landwards or remained the same.</p>	<p>Since the last survey, there has been some fluctuation in the limit of the sand, but no net change in either direction.</p> <p><b>Longer term trends:</b> Review of the sand extent surveys for the past three surveys, shows that edge of the beach typically fluctuated by c. 10m, but there has been no underlying trend.</p>

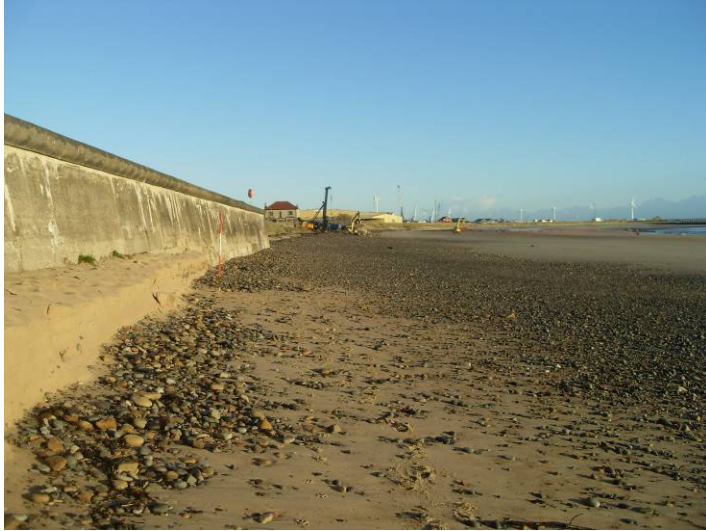
**Plate 6– Survey photograph 1aBVBC02\_20121015\_N2.JPG**

Survey Date	Description of Changes Since Last Survey	Interpretation
	<p>the upper beach has accreted by up to 0.7m.</p> <p>At <b>1aBVBC05</b> shows a similar pattern to 1aBVBC04. Material has been moved up the beach resulting in erosion between 128m and 180m chainage of up to 1.2m and accretion of the upper beach between 80m and 128m chainage of up to about 1.8m. The survey report noted a sand bar out to sea at profiles <b>1aBVBC04</b> and <b>1aBVBC05</b> indicating an availability of sediment,</p> <p>Profile <b>1aBVBC06</b> is located at the southern end of the beach, towards Seaton Sluice. Unlike other profiles in this bay this profile has eroded on the lower slope and remains stable on the upper slope. The beach remains stable down to approximately 137m chainage. From 137m chainage to the seaward end of the profile (270m chainage) the beach levels have dropped to form a smoother profile, in places dropping by as much as 1.5m, and the ridges present in the previous surveys are no longer present.</p>	<p>are generally within the bounds of previous surveys. The exceptions to this are <b>1aBVBC02</b> where the middle of the profile is lower than previously measured and rocks have been exposed, and the profile toe at <b>1aBVBC03</b> and <b>1aBVBC04</b> which are both lower than previously measured.</p>

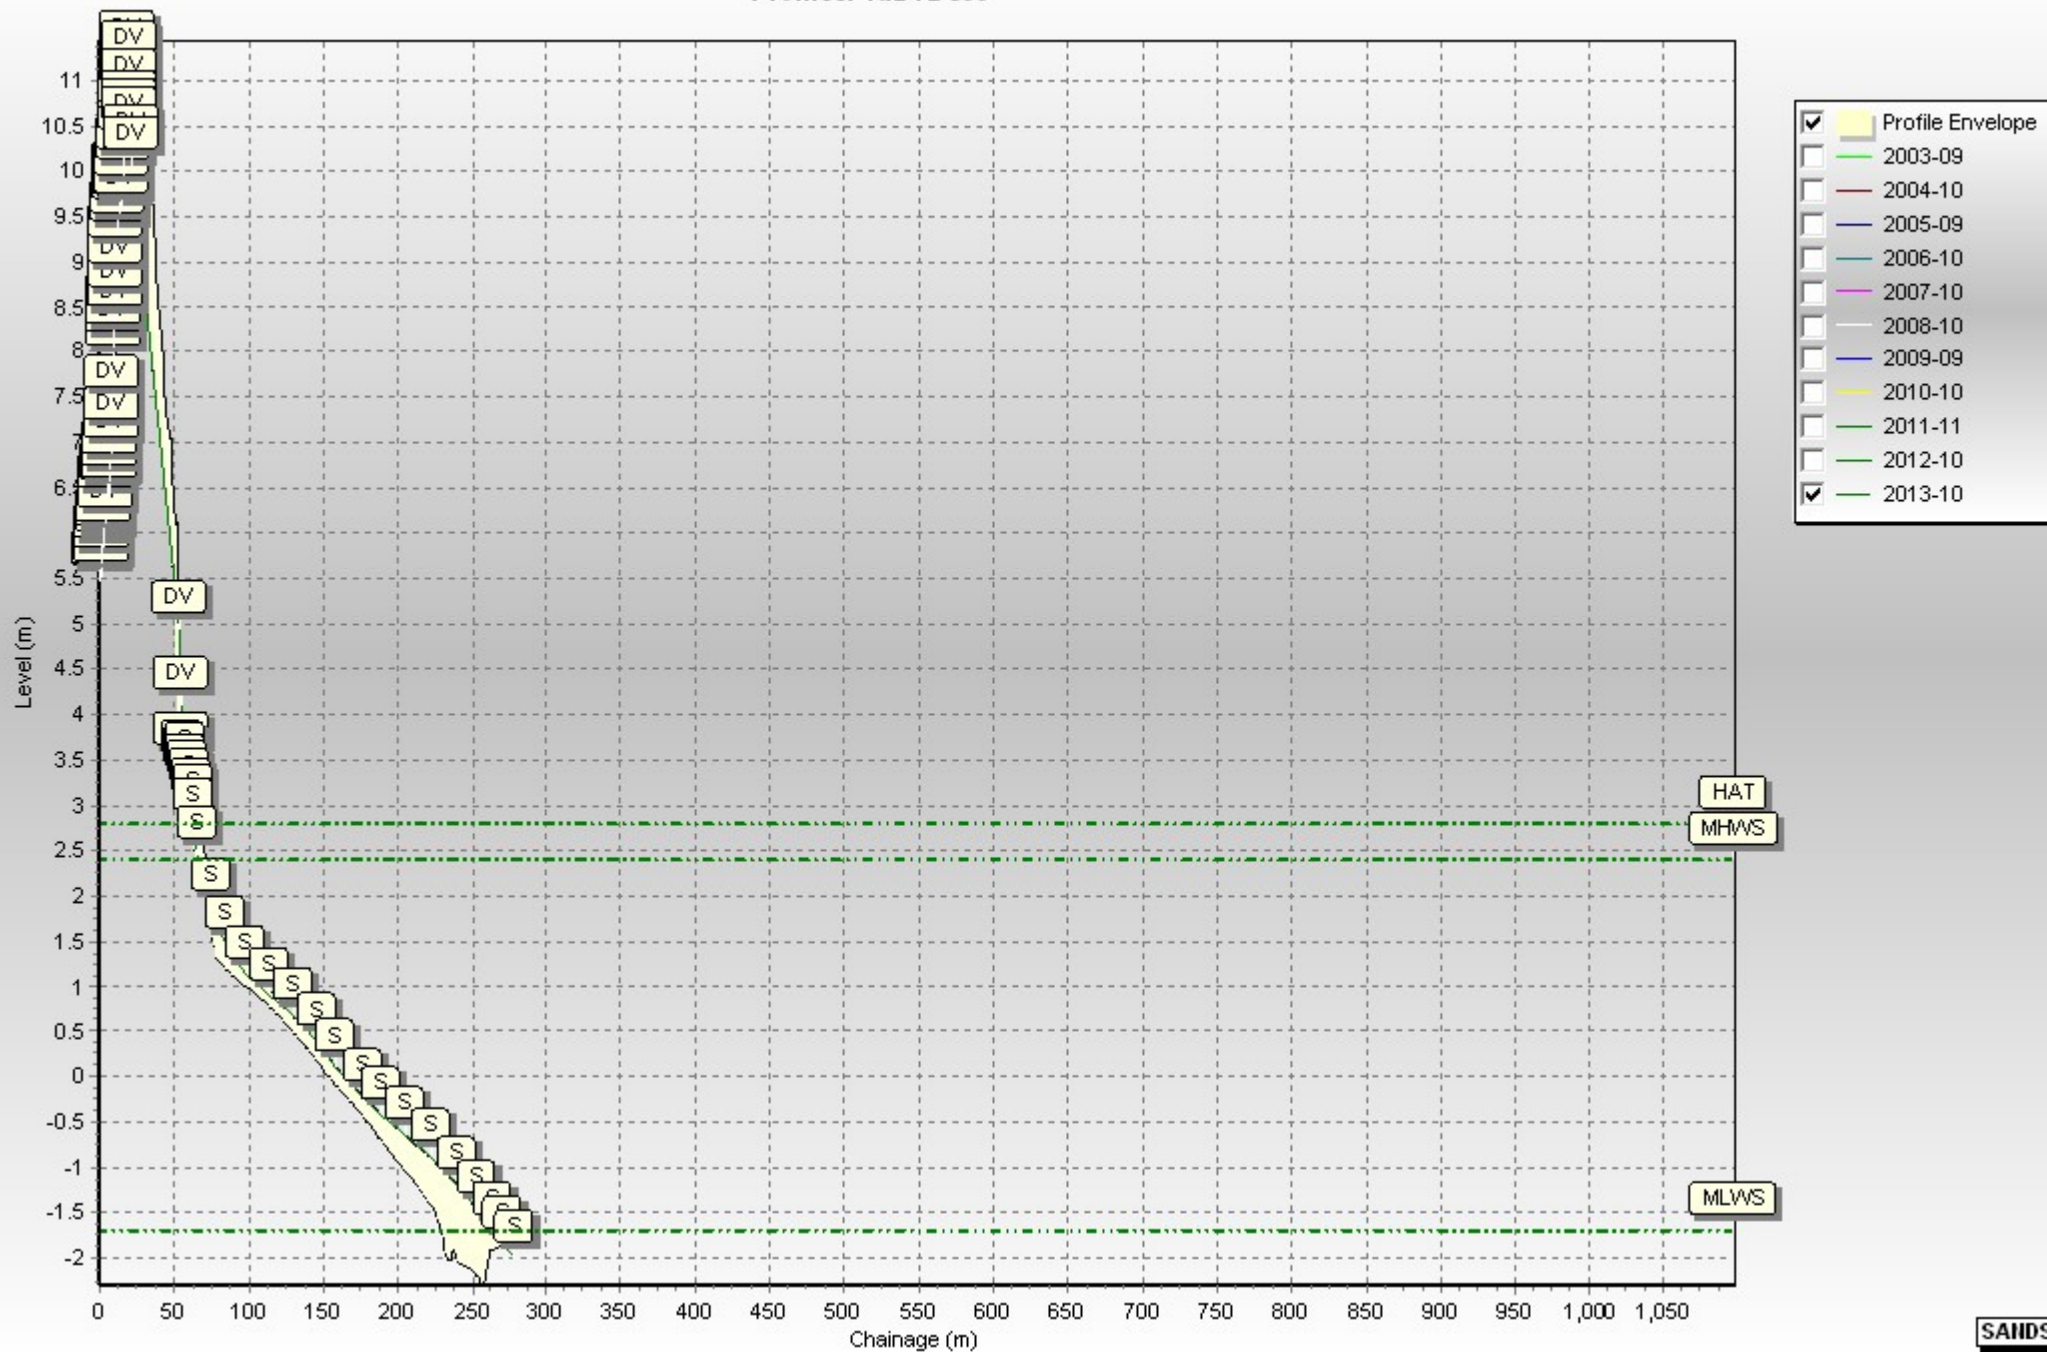
# Profiles: 1aBTBC33

- At Beadnell Bay, the survey report notes that for profile 1aBTBC33 '*middle of dunes missing due to dense vegetation*'. This could impact on the accuracy of subsequent survey interpretation or volume calculations for this profile.

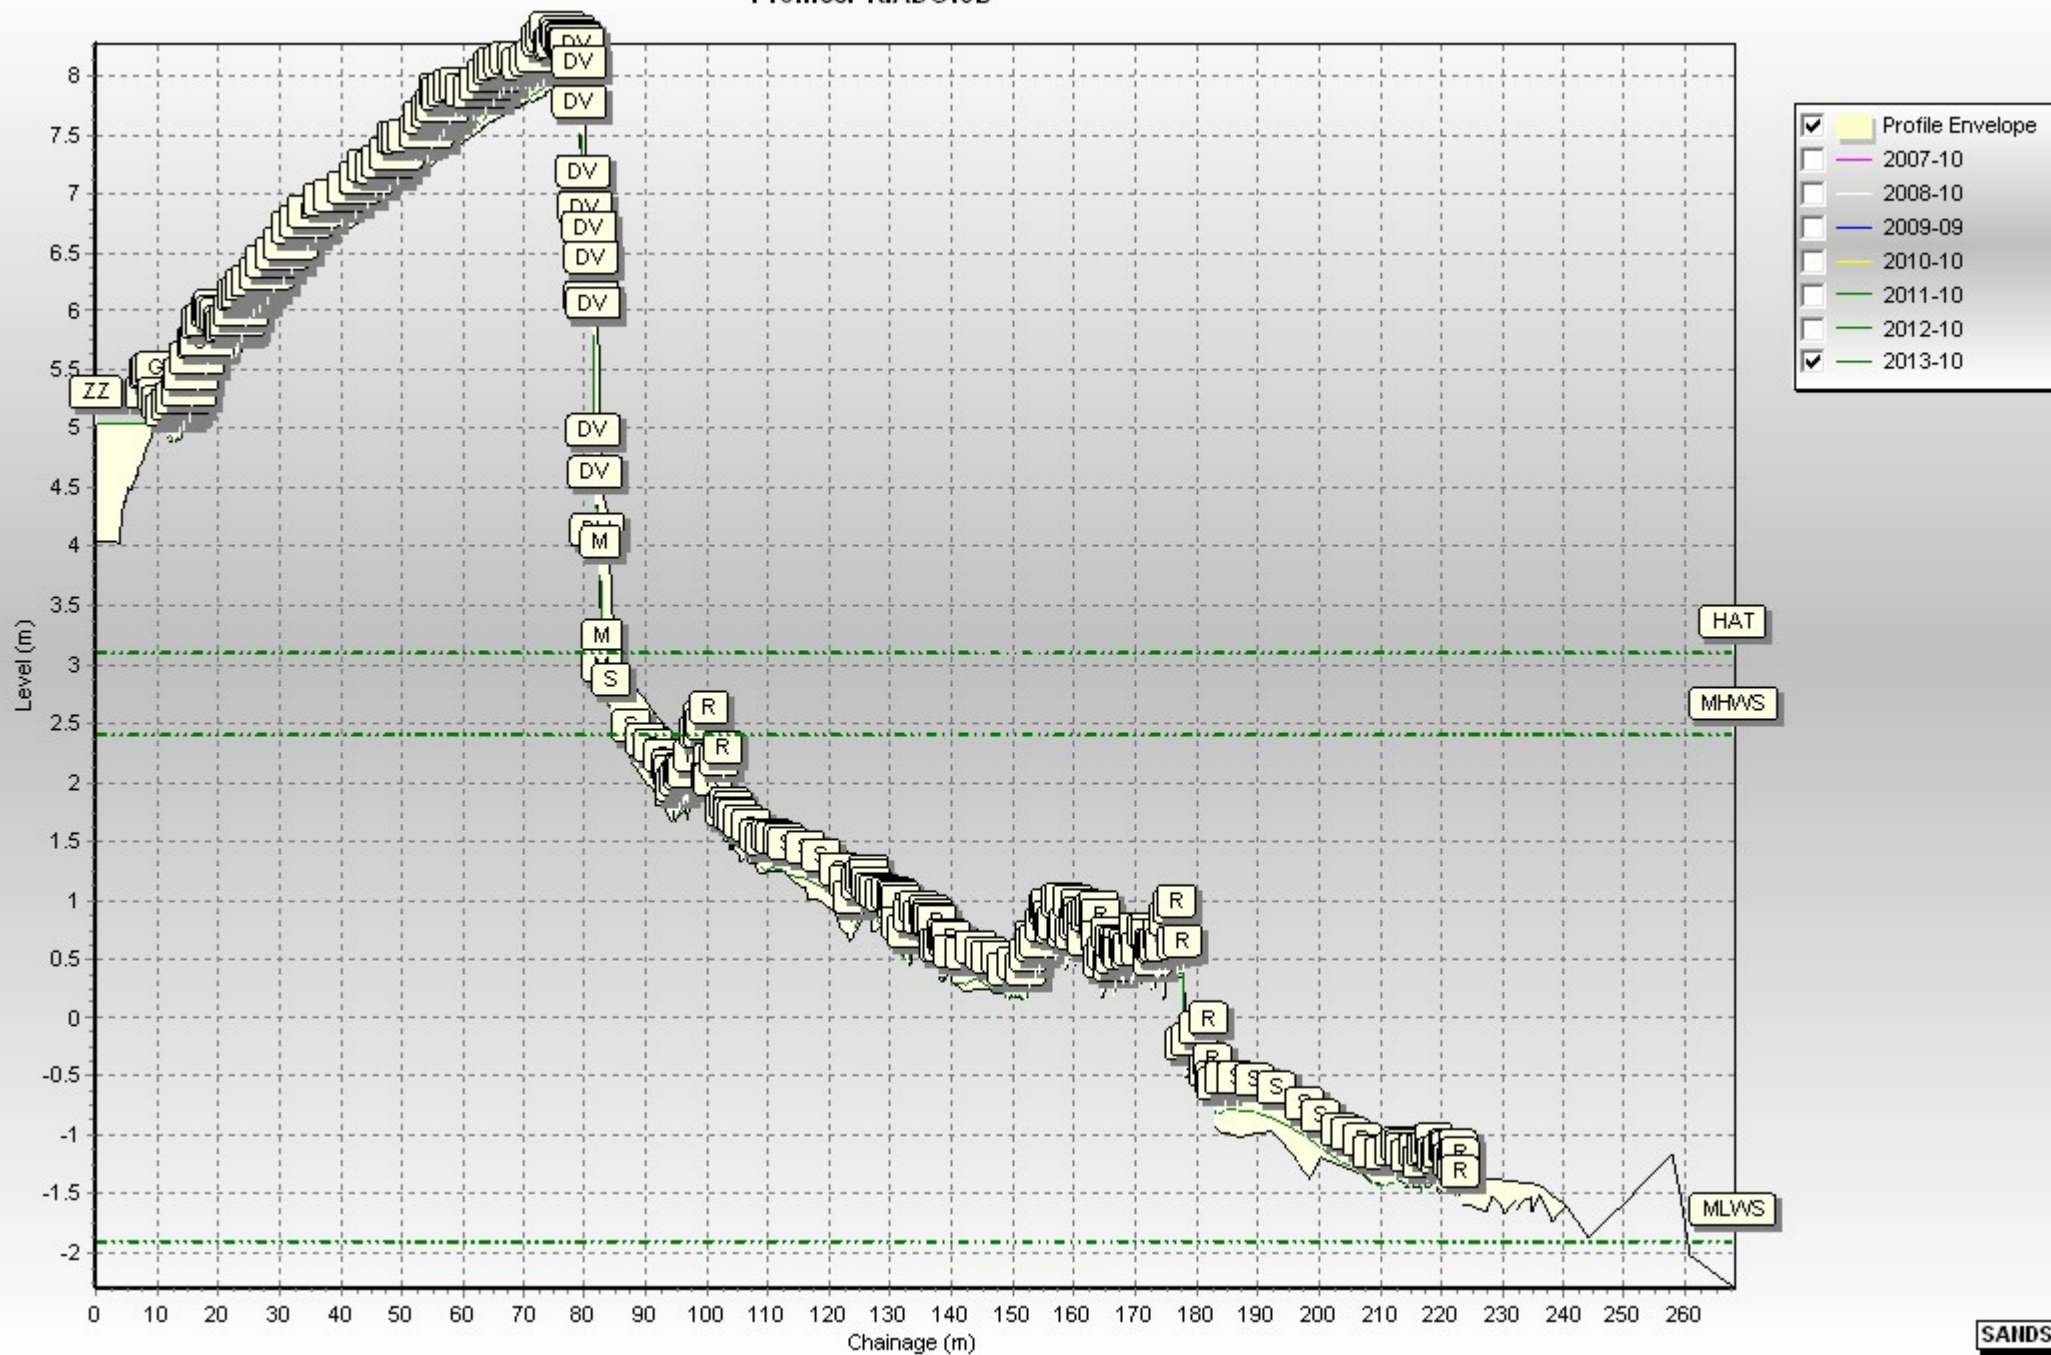
Profiles: 1aADC16B

- Elsewhere at Alnmouth Bay, the recorded profiles and topographic survey present no causes for concern.
- At High Hauxley & Druridge Bay, beach levels are the lowest observed to date at 1aADC16B, levels at the dune toe; and at 1aADC17A, between a chainage of 180m and 190m, where there appears to a small runnel, suggesting potential deepening of the channel.

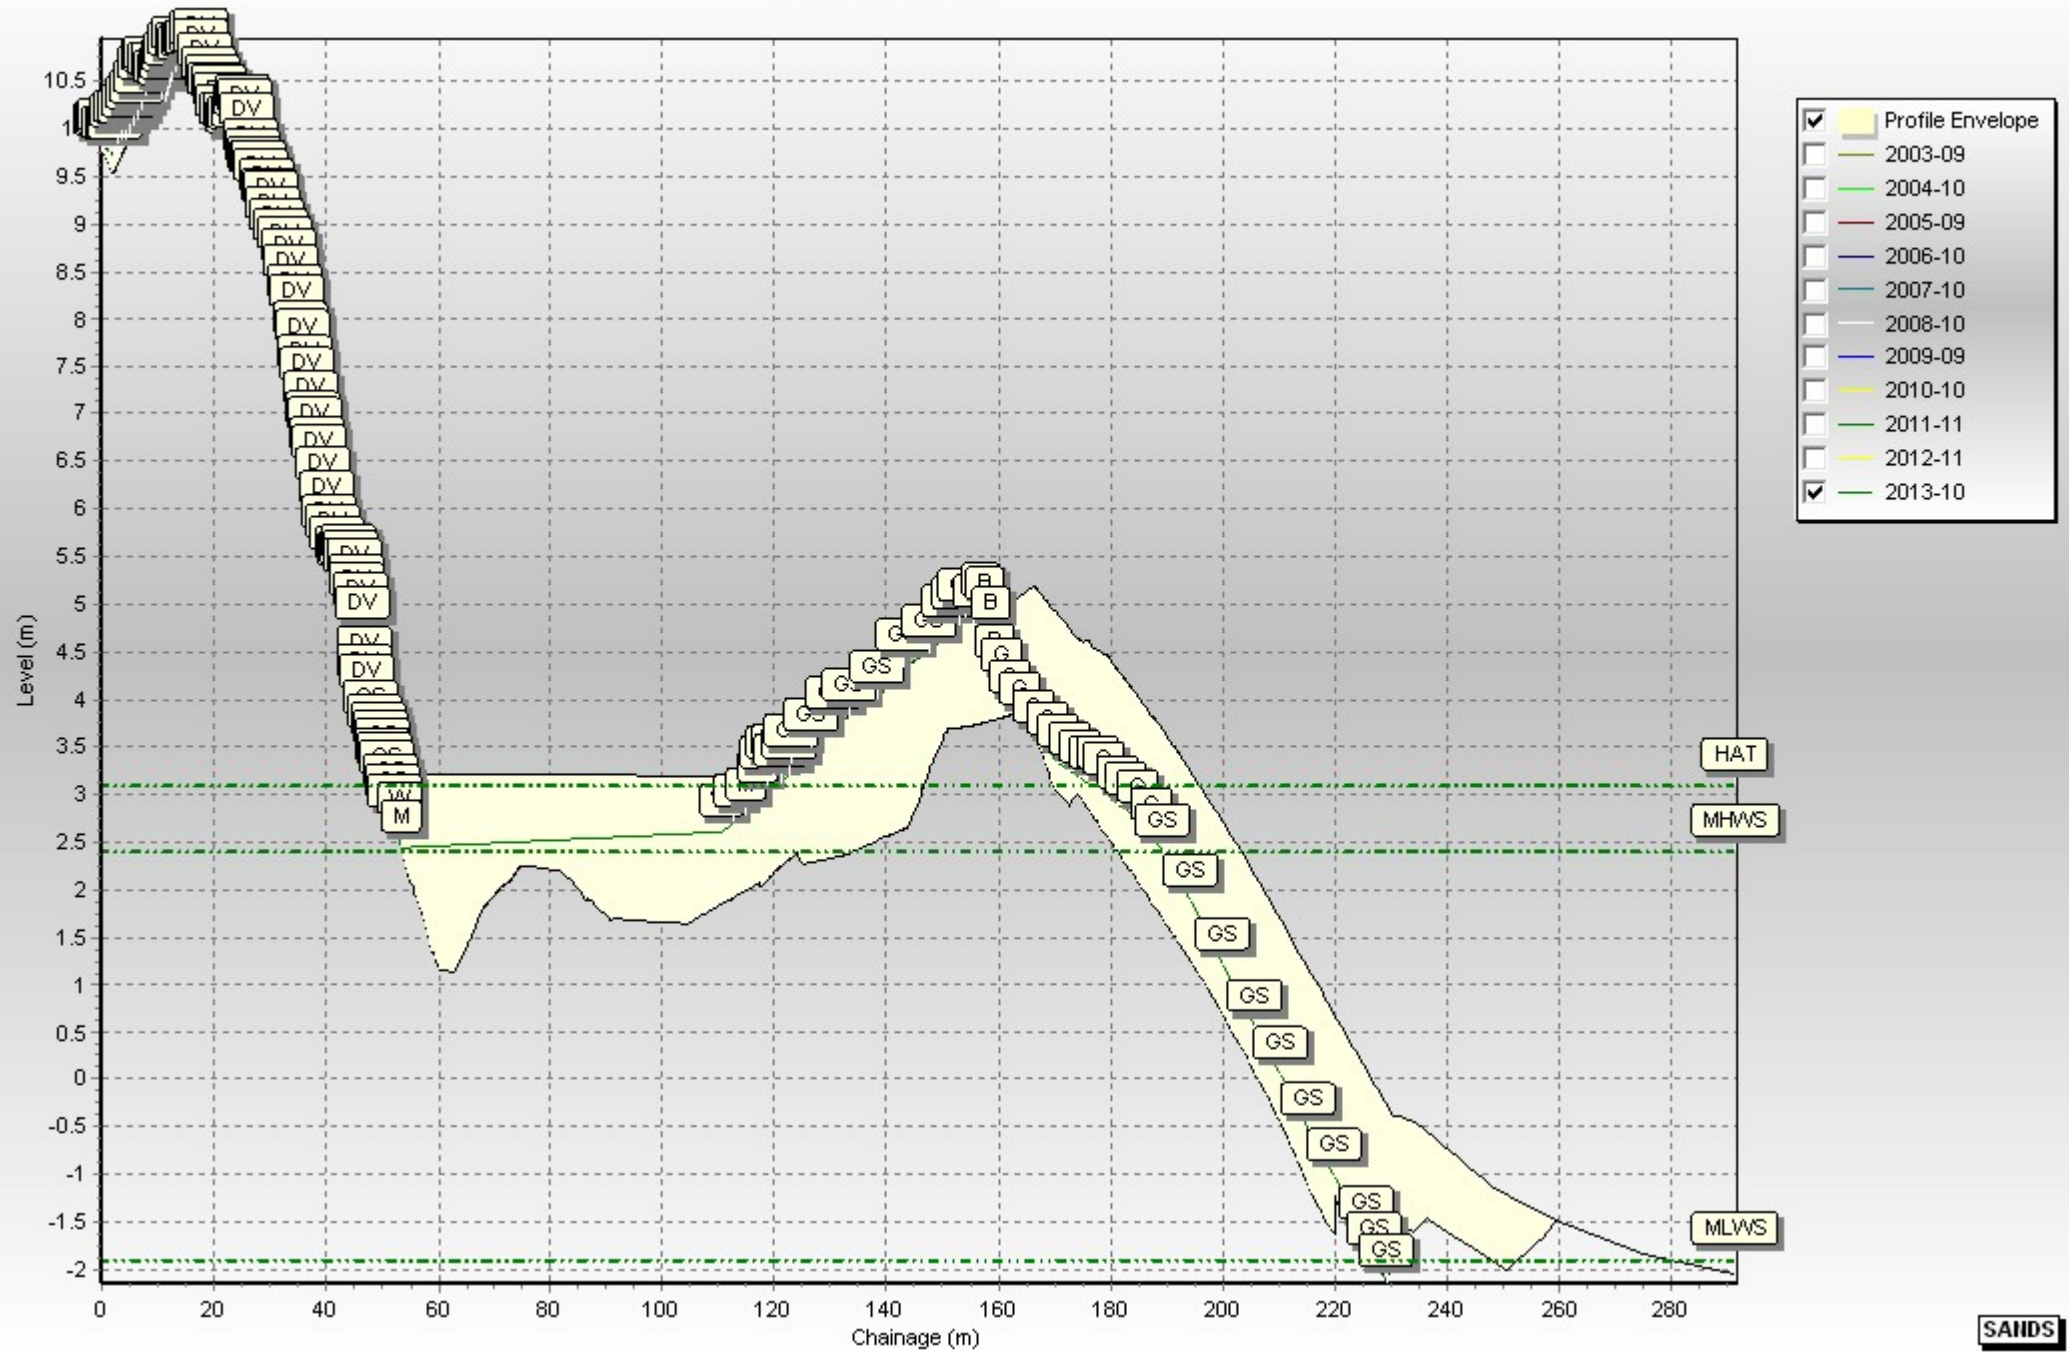
# Profiles: 1aWDC02

- At profile WDC02 in Lynemouth Bay there was a large body of water trapped mid section and the surveyors were unable to measure land levels through the mud. The body of water was larger than that observed during previous surveys.
