**Cell 1 Regional Coastal Monitoring Programme
Analytical Report 8: 'Full Measures' Survey 2015**

**Northumberland County
Council
Final Report**

February 2016

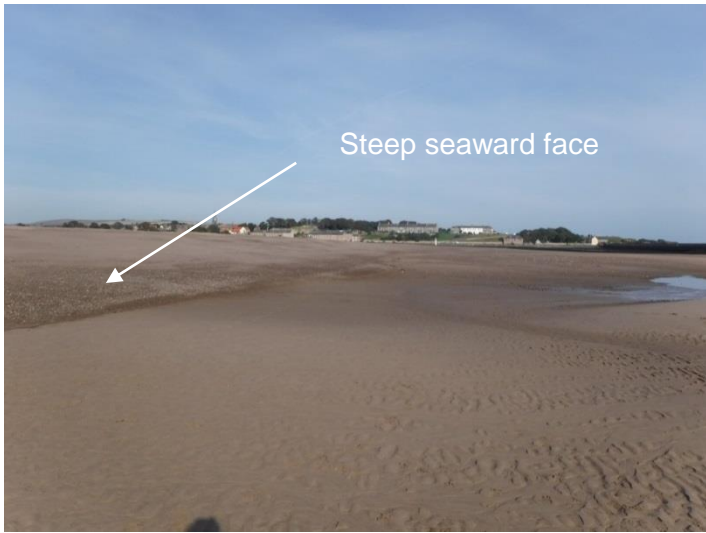
Plate 1 – Survey photograph 1aBTBC04_20150927_NW12

Survey Date	Description of Changes Since Last Survey	Interpretation
	<p>has meant the foreshore between 200m chainage and the end of the profile at 280m chainage has reduced by up to 1m.</p> <p>At profile 1aBTBC10 the beach levels have increased up to 1m between the rock revetment and 190m, with beach levels falling by over 1m seaward of this to the end of the profile.</p>	
Oct 2015	<p>Topographic Survey:</p> <p>Due to the significant changes that have been observed from the beach profiles along the spit at Sandstell Point, and the three dimensional nature of these changes, a topographic survey was introduced to the monitoring programme in November 2011. The previous survey was undertaken for the Partial Measures survey in spring 2015.</p> <p>Data from the most recent topographic survey (Full Measures, autumn 2015) have been used to create a digital ground model (DGM) (Appendix B – Map 1a) using a Geographical Information System (GIS). A difference plot has also been produced using the DGM (Appendix B – Map 1b) produced from the last topographic survey and the present survey.</p> <p>The difference plot shows movement of sediment from the seaward parts of the spit to the middle of the beach and a linear strip of erosion c.10-20m from the rock revetment which extends towards the river, becoming more intense (up to 3m of change) further north. A contrasting, narrow, linear strip of accretion is also evident immediately in front of the rock revetment which also grows in intensity nearer the river (up to 3m of accretion at the very edge of the survey).</p> <p>Longer Term Topographic Trends autumn 2008 to autumn 2015:</p> <p>The long term difference plot (Appendix B – Map 1c) shows the net change in beach levels between autumn 2011 and autumn 2015. The plot shows that over the long term, the pattern of change is similar to the short term, with erosion and accretion up to c.1m in the foreshore and south bank of the River Tweed and an intense strip of erosion running north-south across the spit and along the open coastline.</p>	<p>Together the changes shown in the topographic survey comparison indicate a redistribution of sediment across the spit over summer, resulting in a repositioning of the berm crest further towards the river mouth.</p> <p>Longer term topographic trends autumn 2011 to autumn 2015: The plot shows distinct zones of beach elevation increase and decrease, similar to earlier surveys. This is characteristic of a spit, with berms and troughs generated from seasonal changes in fluvial or tidal flows at the river mouth. While there have been areas of significant erosion, these are matched by areas of significant accretion indicating that the spit is a dynamic landform in the short term but stable over the longer term.</p>

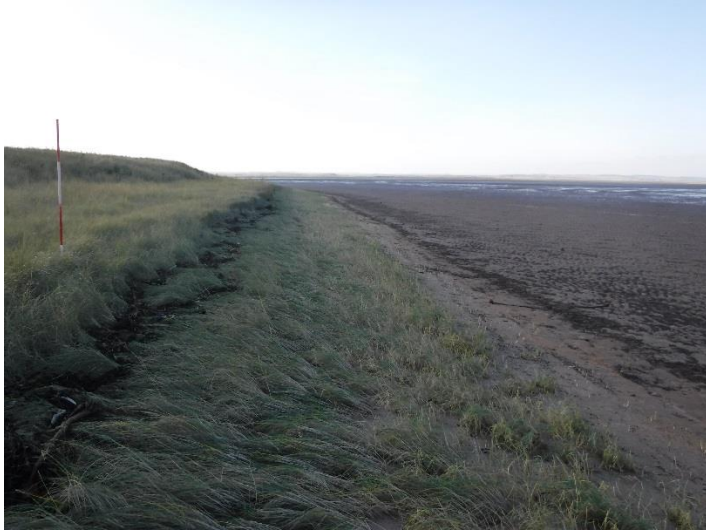
Plate 3 – Survey photograph 1a BTBC21_20151101_N7

Survey Date	Description of Changes Since Last Survey	Interpretation
	<p>plot has also been produced using the DGM (Appendix B – Map 2b) produced from the last produced topographic survey (Full Measures, autumn 2014) and the present survey.</p> <p>In particular, the difference plot shows overall stability with pockets of elevation change in the order of +/-0.5m.</p> <p>Longer Term Topographic Trends autumn 2008 to autumn 2015:</p> <p>The long term difference plot (Appendix B – Map 2c) shows the net change in beach levels between autumn 2010 and autumn 2015. The plot shows that over the long term, there has been a trend of overall stability to the east and pockets of elevation increase and decrease to the west in the order of +/-0.5m. As observed previously, the area of most change is associated with the channel.</p>	<p>change is associated with natural migration of a channel.</p>

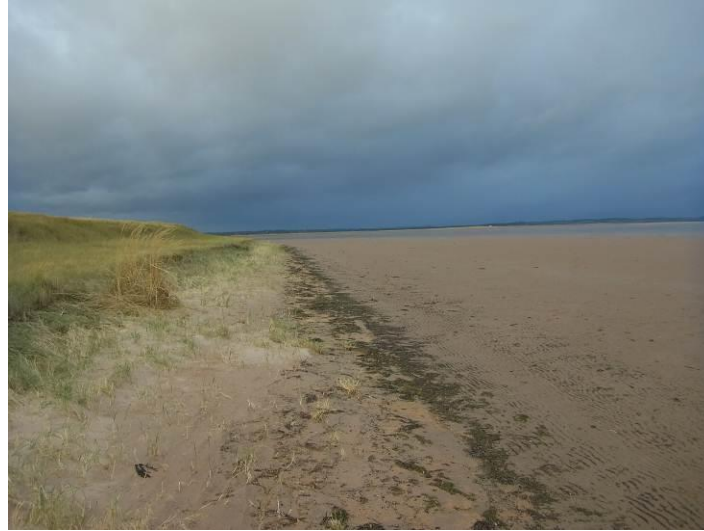
Plate 4 - Survey photograph 1a BTBC21_20141027_W6

Nov 2015	<p>Topographic Survey:</p> <p>Holy Island causeway and the adjacent sand flats are covered by an annual topographic survey, which commenced in October 2004. The purpose of this survey was to determine whether raising the level of the causeway had any adverse impacts on the adjacent sand flats.</p> <p>Data from the most recent topographic survey (Full Measures, autumn 2015) have been used to create a DGM (Appendix B – Map 2a) using a Geographical Information System (GIS). A difference</p>	<p>The topographic survey shows that the causeway has remained stable since the last survey.</p> <p>Longer term topographic trends autumn 2010 to autumn 2014: The long term difference plot of topography shows that over the long term, there has been very little change, with elevation difference being a general increase of less than 0.5m. Greatest</p>

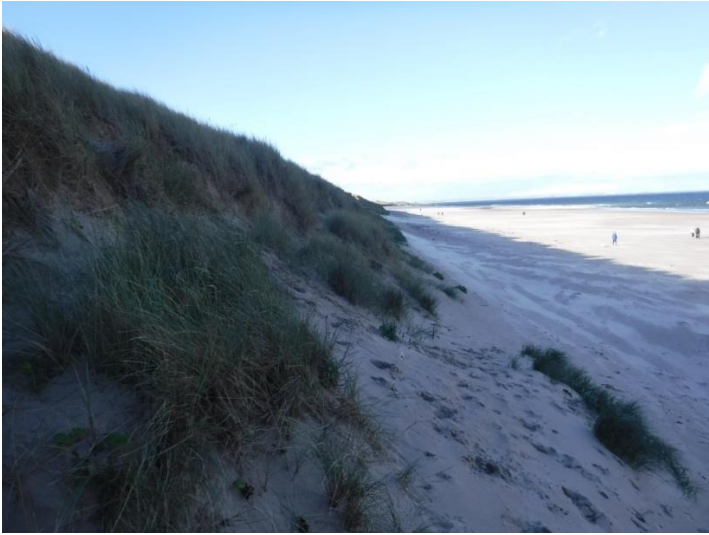
Plate 5 – Survey Photograph 1aBTBC29_20151113_N26

Survey Date	Description of Changes Since Last Survey	Interpretation
Nov 2015	<p>Beach Profiles:</p> <p>Bamburgh is covered by one beach profile line for the Full Measures survey (Appendix A). Profile 1aBTBC29 was last surveyed during the Full Measures autumn survey, 2014.</p> <p>Profile 1aBTBC29 is located approximately 750m south-east of the castle. The seaward face of the dune has advanced since the last survey, by up to 3m, from vertical accretion of up to 1m. Beach levels seaward of the dune toe (367m chainage) as far as 400m chainage have increased c.0.4m. Beyond this changes in elevation are ≤ 0.1m.</p>	<p>The dunes at Bamburgh have remained stable, and the seaward face of the dune and the upper beach have accreted (see Plate 5) indicating recovery following the erosion (likely caused by the December 2013 storm surge event) noted in the previous analytical report.</p> <p>Longer term trends: The 2015 profile shows that the seaward face of the dune is still near its most eroded position since 2004, but also shows signs of recovery since the erosion noted in the 2014 analytical report. The beach is at a low-medium level compared to earlier surveys.</p>

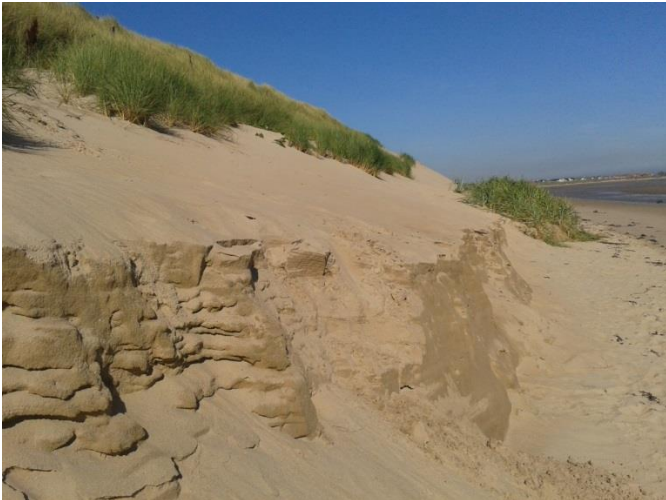
Plate 8 – Survey photograph 1aBTBC38_20150930_N3

Survey Date	Description of Changes Since Last Survey	Interpretation
Sept 2015	<p>Beach Profiles:</p> <p>Beadnell Bay is covered by nine beach profile lines for the Full Measures survey (Appendix A). Profiles 1aBTBC33 to 1aBTBC34, 1aBTBC37 and 1aADC01 to 1aDC02 were last surveyed during the Partial Measures spring survey, 2015. Profiles 1aBTBC32, 1aBTBC35 to 1aBTBC36 and 1aBTBC38 were last surveyed during the Full Measures autumn survey, 2014.</p> <p>1aBTBC32 to 1aBTBC34 are located at the northern end of Beadnell Bay, in Beadnell Harbour. At profile 1aBTBC32, the dune ridge has generally remained stable since the last survey. The dune toe and upper beach between HAT and 2m OD (7m to 22m chainage) have accreted by up to 0.4m since the last survey. Seaward of this point, beach levels have reduced by up to 0.3m. This is almost an exact reversal of the pattern seen during the previous survey.</p> <p>At profile 1aBTBC33, the back of the dunes has remained stable since the last survey. The survey report notes '<i>middle of dunes missing due to dense vegetation</i>', as it did in the previous survey, so the profile for the dune face has not been analysed any further. The beach has remained stable, with change limited to the accumulation of up to c.0.4m sand to form a small berm at the dune toe.</p> <p>At profile 1aBTBC34, the crest of the seaward dune has continued to erode. This is recorded in the survey photograph (Plate 6) that shows dune face collapse. Throughout the rest of the profile change is mostly <0.2m.</p> <p>1aBTBC35 to 1aBTBC38 are located between Burn Carrs and the outfall of Brunton Burn/Long Nanny. The dunes along this northern section of coast have remained stable since the last survey, although at some locations there has been some erosion of the dune face and advance at others.</p> <p>At profile 1aBTBC35, there has been up to 0.4m of accretion at the dune toe and in the upper beach to form a small berm with its crest at c.15m chainage. Between 15m chainage and 120m chainage there has been up to 0.3m of accretion but no change seaward of 120m chainage.</p> <p>At profile 1aBTBC36, beach levels have remained stable since the last survey, except for accretion of c.0.5m to form a berm at HAT level. There has also been c.0.3m of accretion on the lower dune face.</p>	<p>Along the length of Beadnell Bay, the dunes have remained stable, however, the dune face and dune toe has been subject erosion in some locations and accretion in others. Beach levels generally remained stable throughout the bay except for minor variations in the upper beach.</p> <p>Longer term trends: Along the length of Beadnell Bay, the majority of the dune and beach form are similar to those observed in the past and the profile form and position is within the bounds of previous surveys. Exceptions include:</p> <ul style="list-style-type: none"> • The most seaward extent of profile 1aBTBC32 where the foreshore is at its lowest level to date. • The foreshore 1aBTBC35 is at its highest level to date. • The upper beach at 1aBTBC38 is at its lowest level to date, due to the erosion evident in Plate 8.

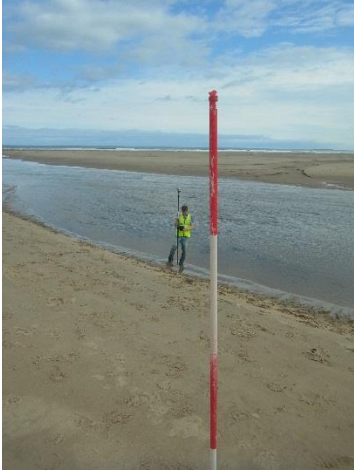
Plate 10 - Survey photograph 1aADC09_20150904_Dwn4

Survey Date	Description of Changes Since Last Survey	Interpretation
	<p>At profile 1aADC08 beach levels between the dune toe and 85m chainage beach levels have increased by 0.2m, and decreased by 0.3m between 85m chainage and 140m chainage. Between 140m and 340m chainage, two bars separated by a runnel have developed through the deposition of up to 0.6m of sand where the bars are present and erosion of 0.4m of sand from the runnel. Upper beach and lower foreshore levels remain relatively high compared to earlier surveys, but middle foreshore levels remain low.</p> <p>At profile 1aADC09, accretion of 0.2m has occurred at the dune toe as far as 26m chainage. Between 26m chainage and 46m chainage up to 0.3m of erosion has occurred, whereas up to 0.5m of deposition has occurred to infill a depression between 46m chainage and 90m chainage. Seaward of 90m chainage, the profile descends into the Aln channel (see Plate 10) which has migrated 5m seaward since the previous survey.</p> <p>1aADC10 to 1aADC14 are located between the south bank of the River Aln Estuary and the north breakwater of Warkworth Harbour at the mouth of the estuary of the River Coquet.</p> <p>At profile 1aADC10, the eroding dune face has been re-exposed (see Plate 11) and the c.25m wide berm in the upper beach has been reduced to c.5m wide through the erosion of up to 1.5m of sediment, lowering the berm crest by c.0.5m. Between 70m chainage and 220m chainage the beach level has increased by up to 0.5m, indicating that the material eroded from the upper beach has been redistributed across the foreshore. The beach toe has steepened seaward of 220m through the removal of up to 0.8m of sediment. The upper beach is at its lowest level on record but the foreshore is relatively high.</p> <p>At profile 1aADC11, around 0.4m of sand has accumulated at the dune toe, extending it seaward c.2-3m. A berm has been eroded between 50m and 65m chainage to make a more concave profile. Seaward of 65m chainage to the end of the profile at 280m chainage there has been limited accretion (up to 0.4m). Except at the upper dune face, the profile is at a relatively high level compared to earlier surveys.</p> <p>At profile 1aADC12, beach levels have changed relatively little (<0.3m) landward of 130m chainage. Only limited accretion has occurred at HAT which has formed a small berm. There has also been limited erosion in the upper foreshore. The lower foreshore seaward of 130m chainage has accreted by up to 0.5m, pushing MHWS c.40m seaward.</p>	<p>Changes in beach profile form and position observed since the last survey are generally within the bounds of previous surveys although the middle foreshore is low in some profiles.</p>

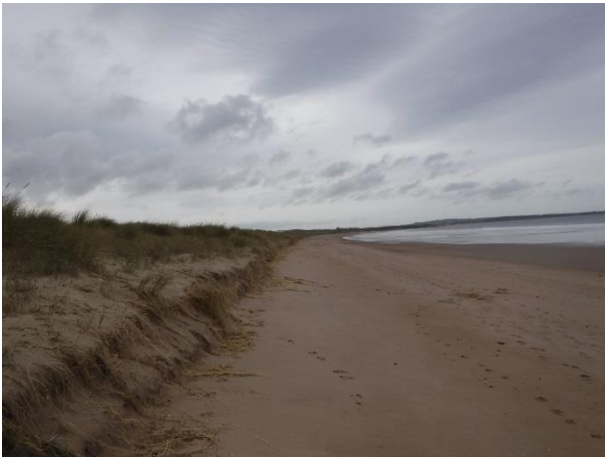
Plate 12 – Survey photograph 1 aADC14_20151114_N14

Survey Date	Description of Changes Since Last Survey	Interpretation
	<p>At profile 1aADC13, the dunes and dune face have remained stable since the last survey albeit with a small amount of accretion at the dune toe. Further seaward, there has been limited change with erosion of up to 0.5m between 150m and 200m chainage and a similar level of accretion between 200m chainage and the end of the profile at 310m chainage.</p> <p>At profile 1aADC14, the dune toe has been eroded, causing it to recede up to 6m since the last survey (see Plate 12). Erosion and accretion in the rest of the profile is <0.2m. The profile is low relative to previous surveys.</p>	
<p>Sept 2015</p>	<p>Topographic Survey:</p> <p>The northern part of Alnmouth Bay (to the north of the River Aln Estuary) is covered by a bi-annual topographic survey, which commenced in April 2005. Data from the most recent topographic survey (Full Measures, autumn 2015) have been used to create a DGM (Appendix B – Map 3a) using GIS. A difference plot has also been produced using the DGM (Appendix B – Map 3b) comparing the last produced topographic survey (Partial Measures, Spring 2015) with the present survey.</p> <p>The difference plots shows clear zones of beach elevation increase and decrease; (i) largely shore parallel areas of erosion and accretion in the northern part of the survey area indicating cross-beach movements; (ii) erosion in front of the village near the channel of the Aln, but accretion at the toe of the dunes and (iii) alternating areas of erosion and deposition along the northern edge of the Aln channel indicating possible minor variations in its course since the last survey.</p> <p>Longer Term Topographic Trends autumn 2011 to autumn 2015:</p> <p>The long term difference plot shows a large area of erosion (up to 1.5m) in the northern part of the survey area. There is an area of accretion to the south of this which may account for some of the eroded sediment. In the southern and central area of the survey area, there are areas of erosion and accretion where beach elevation has changed up to 2m.</p>	<p>The findings of the topographic survey show cross beach movements of sediment related to seasonal effects in the northern part of the survey area and effects relating to migration of the Aln river channel in the southern part of the survey area.</p> <p>Longer term topographic trends autumn 2011 to autumn 2015: From a comparison of 2015 aerial photography to 2010 aerial photography, the alternating patterns of erosion and deposition in the south of the survey area can be attributed to migration of the river channel across the beach. Those further north are more likely associated with marine processes redistributing sediment to different areas of the beach.</p>

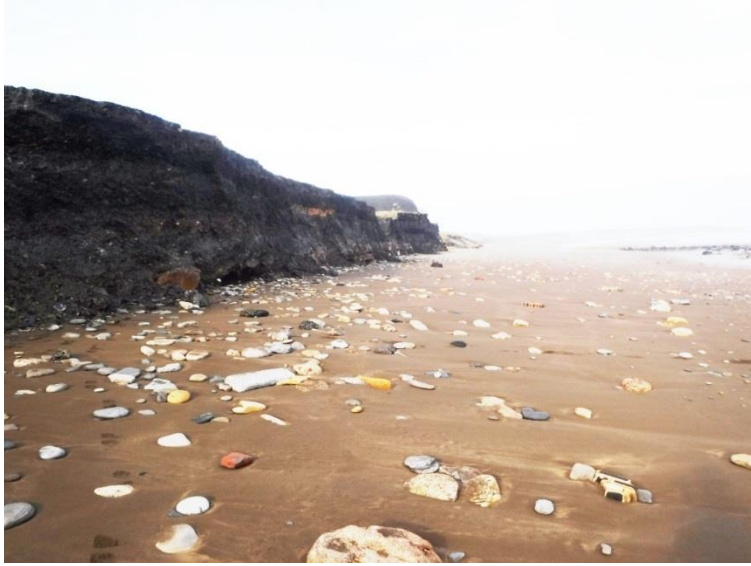
Plate 13 - Survey photo 1aCMBC03B_20151031_N18 (brightness adjusted)

Survey Date	Description of Changes Since Last Survey	Interpretation
Oct 2015	<p>Beach Profiles:</p> <p>Lynemouth Bay is covered by six beach profile lines for the Full Measures survey (Appendix A). Profiles CMBC03A and CMBC03B were added to the programme in October 2007.</p> <p>Profiles 1aCMBC03a to 1aWDC01 were last surveyed during the Partial Measures spring survey, 2015. Profiles 1aCMBC01 and 1aWDC02 to 1aWDC05 were last surveyed during the Full Measures autumn survey, 2014.</p> <p>1aCMBC03 is located just to the south of Snab Point. The profile extends across the cliff and the rock platform below. The profile has not changed since the last survey indicating a stable cliff and rocky foreshore.</p> <p>1aCMBC03A is located opposite Lynemouth and extends across the extensive slag banks before reaching the foreshore. A line of cobbles and small boulders is present at around HAT. The slag bank has not experienced any change since the last survey (Partial Measures, spring 2015) and changes to beach level are minimal, with the greatest change being a reduction of the beach level by 0.2m just above HAT</p> <p>1aCMBC03B is located to the north of Lynemouth Power Station and extends across the extensive slag banks before reaching the foreshore. The process of slag bank erosion has been progressively ongoing for some years. Since the last survey, the slag bank has retreated by about 2.5m (Plate 13 shows cliff in slag bank), which is more than the recession in the previous period (autumn 2014 to spring 2015, but less than the two periods before that (between the winter 2013 and spring 2014 survey, there was 15m of recession). A very small amount of accretion has occurred on the upper beach between -17m chainage and -11m chainage, possibly residual sediment from the slag bank retreat. The foreshore has experienced variable erosion and accretion of up to 1m between 5m chainage and 80m chainage to create a distinctively convex profile.</p> <p>1aWDC01 extends from seaward of the rock revetment down to low water across the extensive slag banks. The survey report notes, '<i>unable to measure the face of the revetment - blocks to[o] slippery</i>'. The beach levels seaward of the rock revetment appear to have dropped slightly but this could be an</p>	<p>To the south of Snab Point, the shoreline has not changed in form or position since the last survey. Opposite Lynemouth, the slag bank and beach have remained stable.</p> <p>To the north of the power station, the slag bank has continued to erode, retreating by approximately 2.5m. The beach has also eroded by up to 1m to present a concave profile. Beach levels have fallen since the last survey.</p> <p>To the south of the power station, between Lyne Sands and Beacon Point, with the exception of 1aWDC02 where the beach level has fallen, there has been accretion or no change indicating a possible southwards movement of sediment. There have been no major changes in form at these profiles.</p> <p>Longer term trends:</p> <p>To the south of Snab Point, the changes observed from the present beach profiles are within the bounds of previous surveys.</p> <p>Opposite Lynemouth, the slag bank has demonstrated a long term trend of stability. The changes in beach profile form and position observed since the last survey are within the bounds of previous surveys.</p> <p>To the north of the power station, the slag bank has continued to erode and the beach has level has also</p>

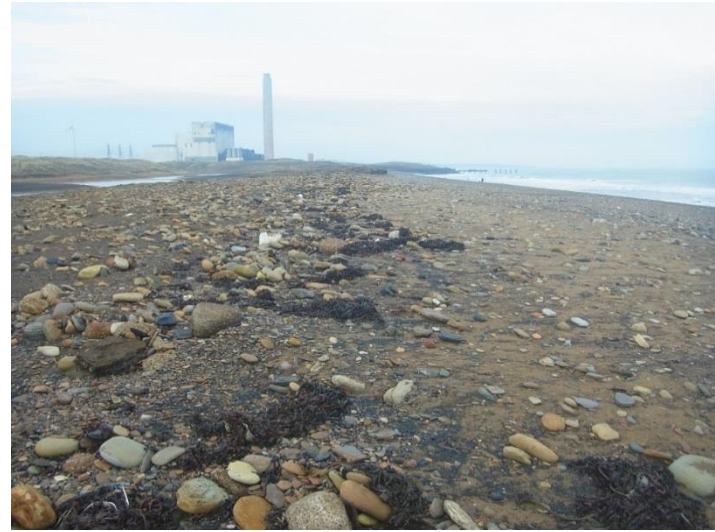
Plate 14 - Survey photo 1aWDC03_20151031_N14

Survey Date	Description of Changes Since Last Survey	Interpretation
	<p>error in the survey data as fewer points than usual were measured due to the slippery rocks and the change in level is small.</p> <p>1aWDC02 is located to the south of the Power Station. The beach profile has lowered by up to 0.6m and has steepened slightly as erosion is slightly greater in the lower foreshore.</p> <p>1aWDC03 is located to the south of the Power Station and to the north of Beacon Point. There has been very little change (<0.1m accretion) as far as 90m chainage. Seaward of 90m chainage, accretion of up to 0.4m has occurred, increasing the crest height of the prominent berm (see Plate 14) and the elevation of its seaward face. The berm remains in roughly the same position as the previous two surveys, the last change in form being between the Full Measures 2012 and Full Measures 2013 survey</p> <p>1aWDC04 and 1aWDC05 are located between Beacon Point and Newbiggin Point.</p> <p>At profile 1aWDC04, the dunes have remained stable. The profile shows the dune face remains steep and there is accretion in the upper beach. The accretion is greatest at the dune toe where there has been up to 0.6m of accretion since the last survey. Seaward of 70m chainage change has been minimal (<0.1m). The beach is high relative to earlier surveys.</p> <p>At 1aWDC05, the cliffed section has remained stable. A berm, with its crest at 15m chainage, has developed in the upper beach against the cliff toe. Seaward of 40m chainage no change has occurred.</p>	<p>fallen, indicating that this section of shoreline has returned to its normal trend of progressive erosion of the slag bank cliff and beach.</p> <p>To the south of the power station, the prominent berm crest has increased a little in height, but has retained the same form since 2013.</p> <p>At the southern end of the bay, between Beacon Point and Newbiggin Point, the changes in beach profile form and position observed place the current beach levels at medium to high levels relative to earlier surveys dating back to 2002.</p>

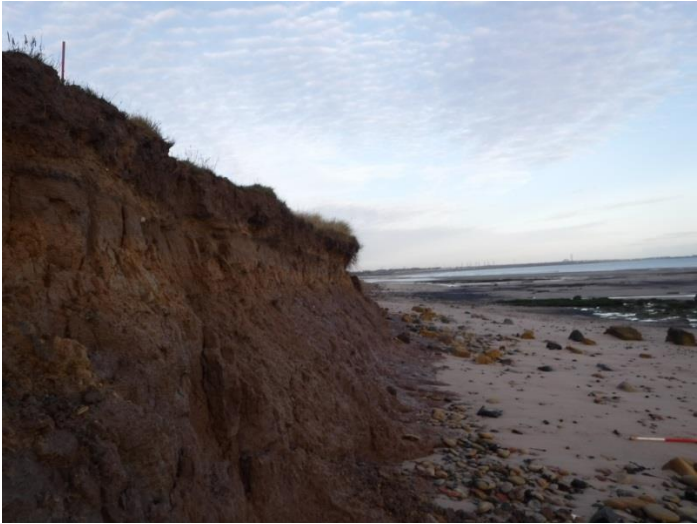
Plate 15 - Survey photograph 1aWDC14_20151125_N2

Survey Date	Description of Changes Since Last Survey	Interpretation
	<p>there has been up to 0.6m of deposition which has increased the height of the bar in the lower foreshore. Beach levels remain high compared to earlier surveys</p> <p>1aWDC12 is situated approximately mid-way along Cambois Bay. Since the last survey (Full Measures, autumn 2014), the face of the dune cliffs has remained stable with a small accumulation of sand occurring at the cliff toe. The upper beach shows very limited change as far as 70m chainage. Seaward of 70m chainage, the beach has accreted, with the maximum accretion at 190m chainage where a berm crest has formed in the lower foreshore. The beach is at medium to high levels throughout.</p> <p>At 1aWDC13 is located to the centre-south of Cambois Bay. There has been no change to the dune cliff face and a small amount of gravel and sand has accumulated to form a narrow berm at the toe of the dune cliff. Beach levels have fallen by up to 0.3m between HAT and 145m chainage, and a low bar has formed seaward of 145m chainage through the accumulation of 0.3m of sand. Except in the lower foreshore, beach levels are at their lowest recorded level.</p> <p>1aWDC14 is located to the south of Cambois Bay, at North Blyth. Minor recession is evident in the lower cliff and the survey photograph indicates ongoing erosion (See Plate 15). A small amount (0.2m) of deposition has occurred at the cliff toe to straighten the upper beach profile but throughout the rest of the profile the beach level has fallen slightly to expose more of the shore platform, with one exception between 80m and 110m chainage where there appears to have been limited accumulation to cover the shore platform. Beach levels are low compared to earlier surveys.</p>

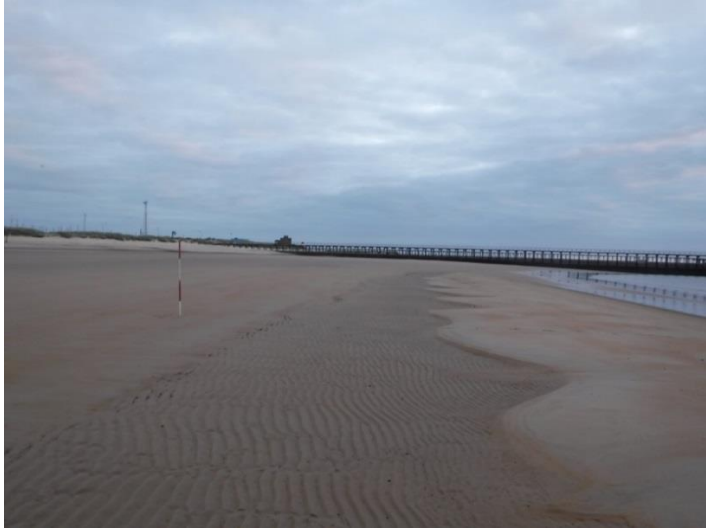
Plate 16 – Survey photograph 1aBVBC01_20152609_N15

Survey Date	Description of Changes Since Last Survey	Interpretation
Sept 2015	<p>Beach Profiles:</p> <p>Blyth South Beach is covered by six beach profile lines for the Full Measures survey (Appendix A). All profiles are resurveyed every 6-months.</p> <p>1aBVBC01 is located towards the north of South Beach, in front of the area of land owned by Port of Blyth. There have been no significant changes to the position and form of the dunes since the last survey (Partial Measures, spring 2015). The upper beach has retained roughly the same form, accreting up to 0.3m between the dune toe and 100m chainage. Seaward of 100m chainage the beach profile is unchanged until 140m chainage where a small berm has formed with upward facing lobate features (possibly formed as waves at low tide just over top the berm and drain into a runnel on its landward side, see Plate 16). Seaward of 170m chainage there has been minor (up to 0.2m) lowering of the lower foreshore. The beach is generally at a medium to high level compared to earlier surveys.</p> <p>Beach levels at 1aBVBC02 have fallen in the upper beach between the sea wall and 40m chainage, increased by up to 0.4m between 40m chainage and 110m chainage, and fallen in the lower foreshore between 100m chainage and the end of the profile at 180m chainage by a similar amount. The combined effect of these changes is a straighter profile - flatter in the upper beach and steeper at the toe. The beach is generally at a medium level compare to earlier surveys.</p> <p>At 1aBVBC03 there have been no significant changes to the position and form of the dunes since the last survey (Partial Measures, spring 2015), which remain at their most landward extent since 2002. The runnel which was present in the previous two surveys at the toe of the dunes has infilled to create a slightly higher berm in the upper beach. Between 105m chainage and 170m chainage beach levels have fallen by up to 0.4m and between 190m chainage and 290m chainage also fallen by 0.3m. The intervening section of no change between 170m and 190m has formed a berm, on the seaward side of which a runnel (see Plate 17) has formed where the fall in beach elevation has been greatest. Seaward of 290m chainage there has been little change to the profile. Overall the profile is at a medium to high level compared to earlier surveys. ,</p>	<p>Since the last survey, the dunes and dune face at Blyth South Beach have remained stable, retaining the same form and position.</p> <p>Beach profiles have changed, with more pronounced changes being in the undefended central and southern parts of the beach. Here, the beach has changed from a relatively smooth concave profile to one with comparatively sharp undulations, with some steep slopes, more pronounced berms as well as runnels and bars in the foreshore.</p> <p>Longer term trends: At Blyth South Beach, the dunes have generally demonstrated a long-term trend of stability.</p> <p>The changes in beach profile form and position observed since the last survey are within the bounds of previous surveys, however in the central and southern parts of the bay, the upper beach is relatively high, and the lower beach relatively low, leaving a steeper beach in the middle foreshore.</p>

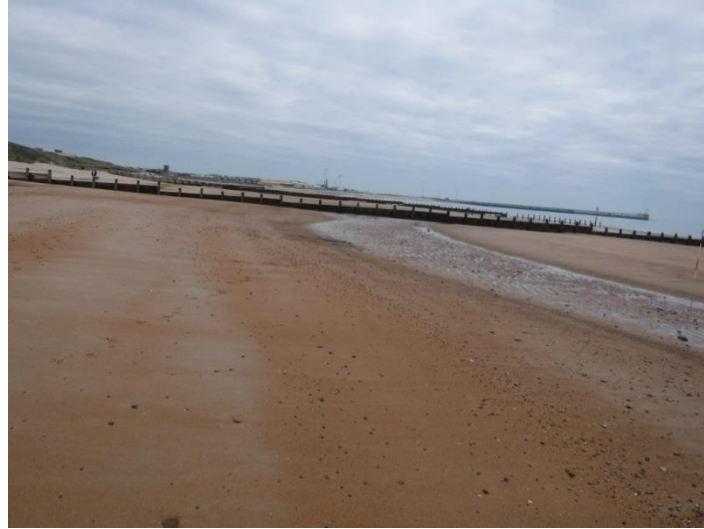
Plate 17 – Survey photograph 1aBVBC04_20152609_N17

Survey Date	Description of Changes Since Last Survey	Interpretation
	<p>At 1aBVBC04 there have been no significant changes to the position and form of the dunes since the last survey (Partial Measures, spring 2015). The crest of the berm in the upper beach has receded c.6m landward, with a commensurate fall in the level of the seaward face of this berm of up to 0.5m between 45m chainage and 90m chainage. Between 90m chainage and 140m chainage the beach level has increased by up to 0.8m to form a berm in the mid foreshore. Seaward of this the changes have been less pronounced (<0.2m) although the beach toe has extended seaward c.20m since the last survey. Overall the beach level is high compared to earlier surveys.</p> <p>At 1aBVBC05 there have been no significant changes to the position and form of the dunes since the last survey (Partial Measures, spring 2015). The uppermost berm crest has receded c.6m landward with a commensurate drop in beach level between 80m chainage and 105m chainage of up to 0.6m. Between 105m and 120m chainage there has been an increase in beach level to form a second berm lower in the beach, but between 120m chainage and 200m chainage the beach level has fallen by up to 1m. There has been limited change between 200m chainage and the end of the profile at 260m chainage. Overall the profile now has a more variable form than the previous survey and is high in the upper beach and low in the foreshore compared to earlier surveys in the record, making the upper beach profile one of the steepest on record (see Plate 18).</p> <p>At profile 1aBVBC06 there have been no significant changes to the position and form of the dunes since the last survey (Partial Measures, Spring 2015). The uppermost berm crest has receded landwards slightly, with a commensurate fall in the elevation of the seaward face of this berm by up to 0.2m. A significant berm (see Plate 19) with a steep seaward face has formed between 120m chainage and 150m chainage through the accumulation of up to 1m of sand, A runnel has formed at the toe of this berm between 150m and 200m chainage, seaward of which a bar has formed in the lower foreshore between 200m chainage and the end of the profile at 280m chainage through the accumulation of up to 0.7m of sand. Overall the profile is more variable in form than in the previous survey and within the range of levels seen in earlier surveys.</p>

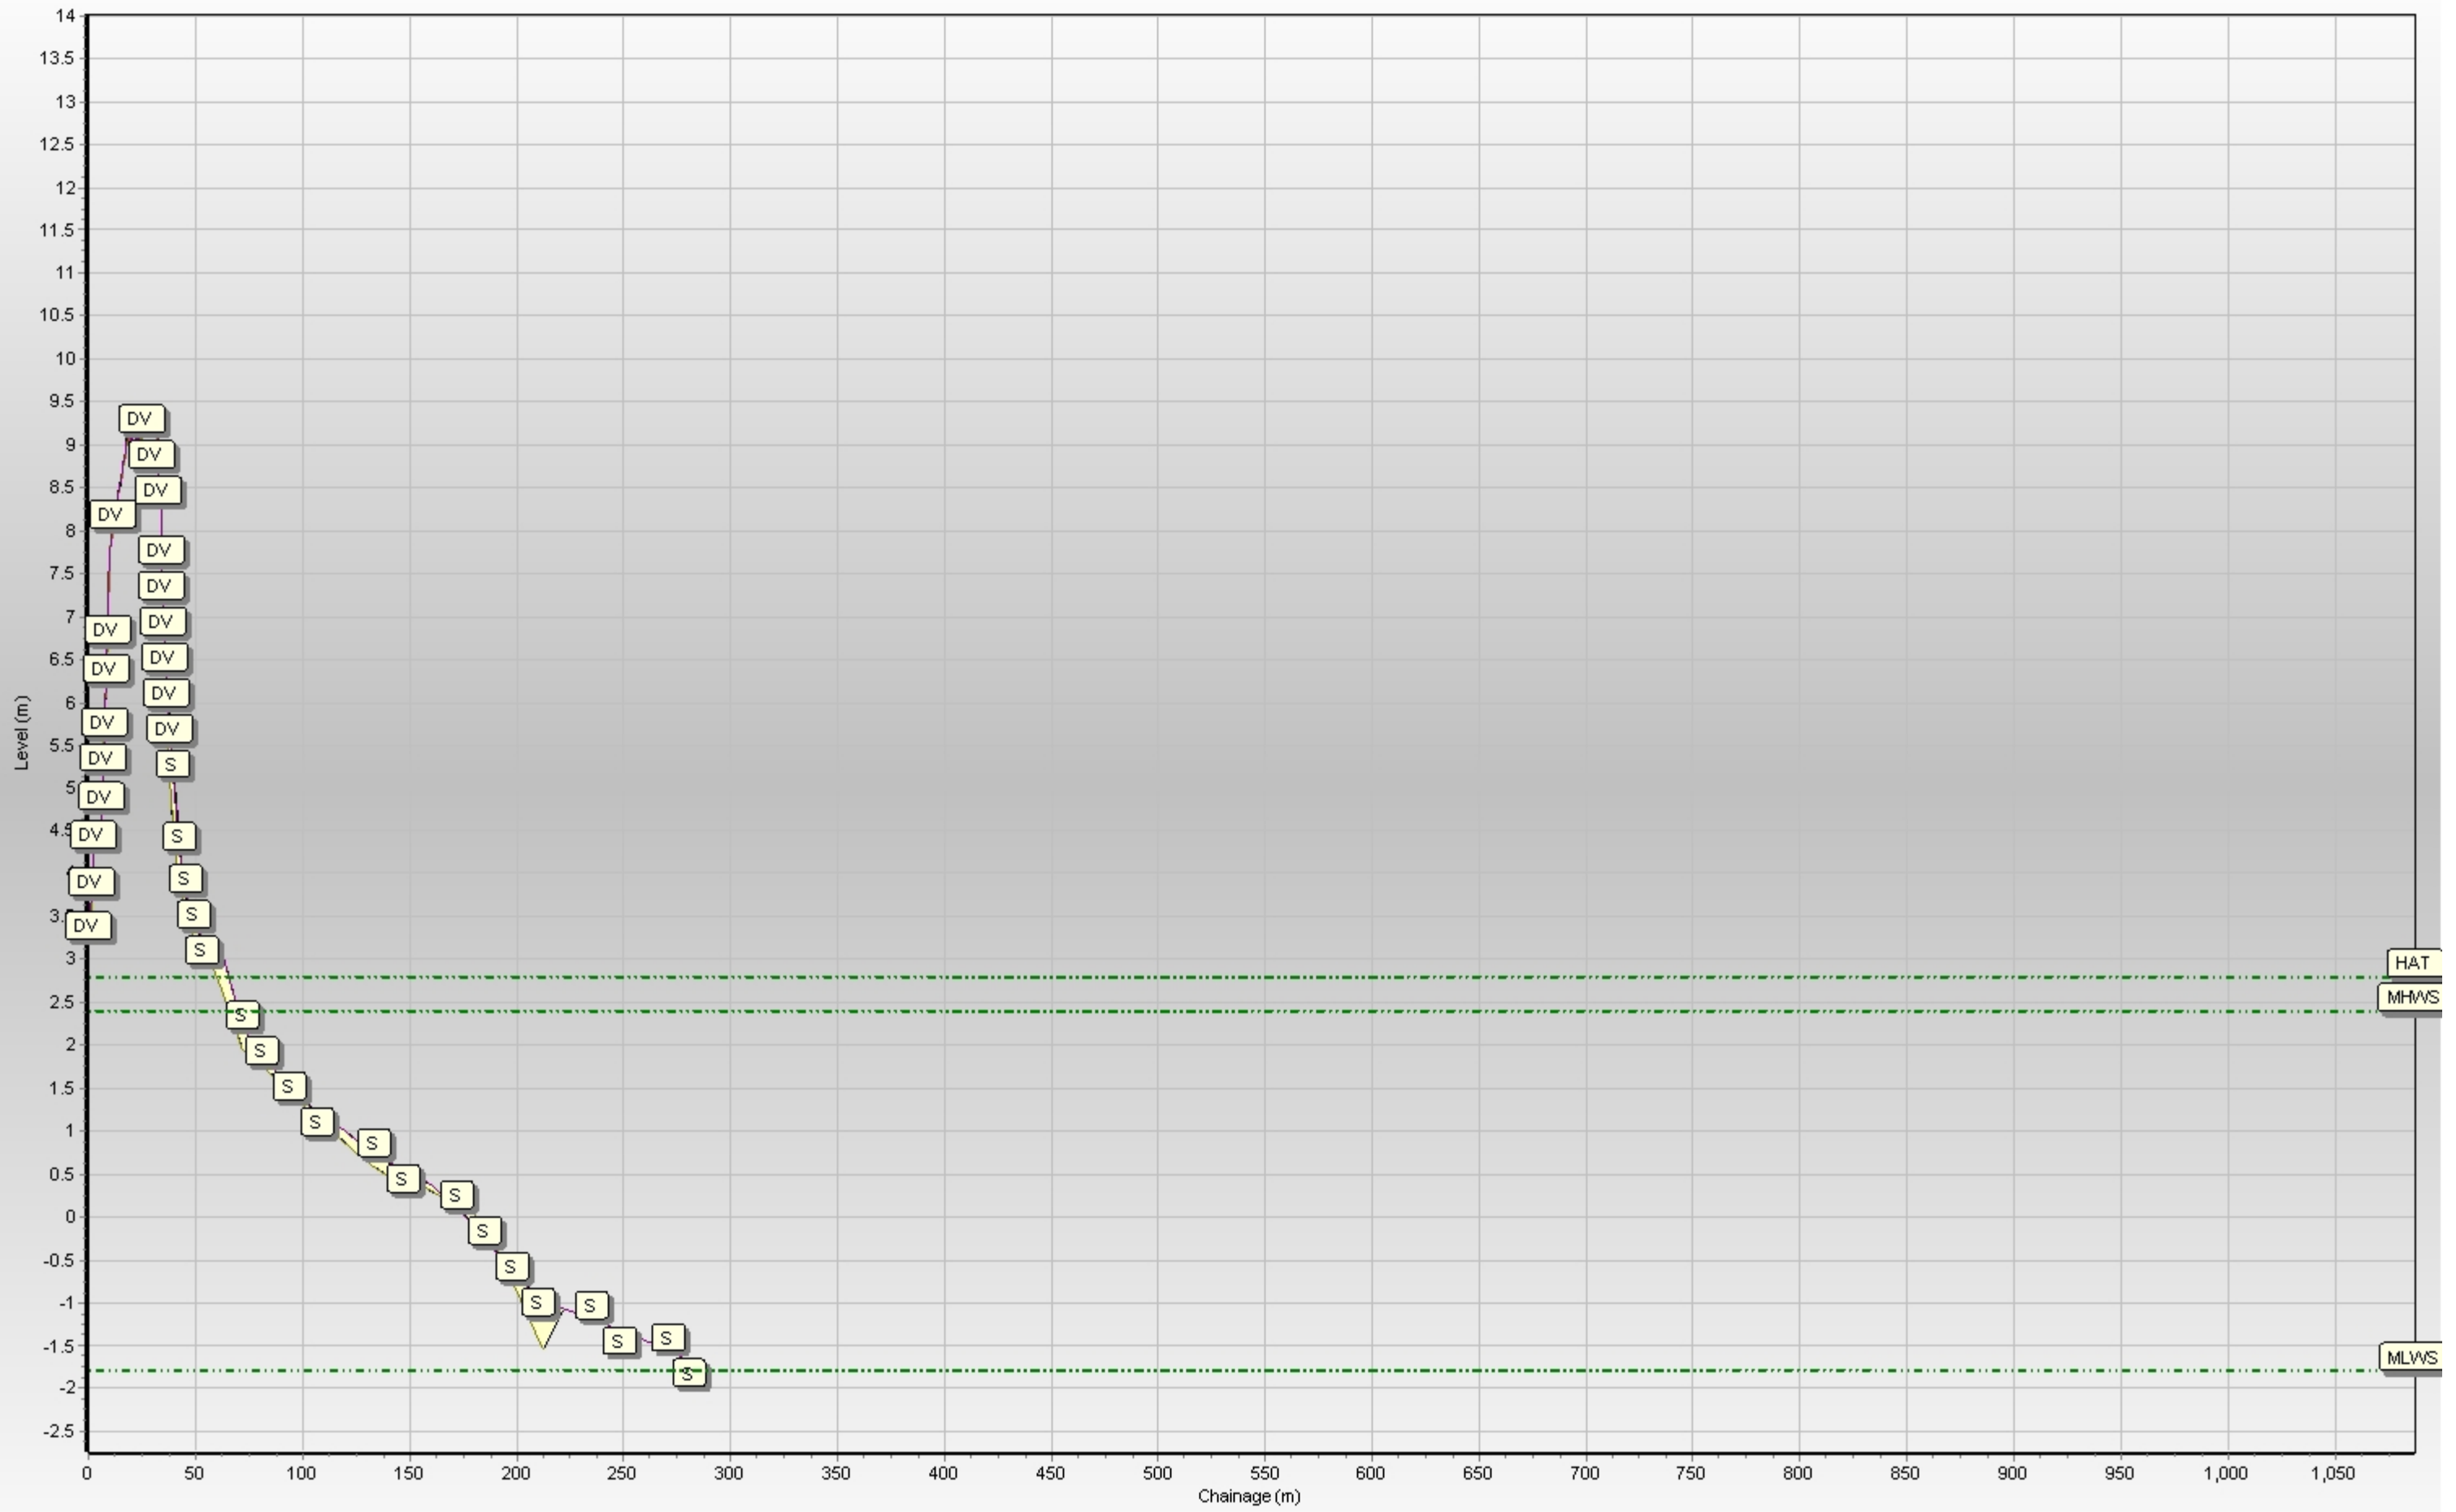
Profiles: 1aBTBC16

- At High Hauxley & Druridge Bay, the Hauxley Haven profiles are at their lowest levels on record in their most seaward extents and the most northerly profile in Druridge Bay (1aBTBC16) is at its lowest recorded level. These do not necessarily indicate a cause for concern but further surveys should be monitored specifically for any indications of accelerated recession of the cliff/dune toe.
