## Cell 1 Regional Coastal Monitoring Programme Analytical Report 12: 'Full Measures' Survey 2019

(\*) The present report is **Analytical Report 12** and provides an analysis of the 2019 Full Measures survey for Northumberland County Council's frontage.

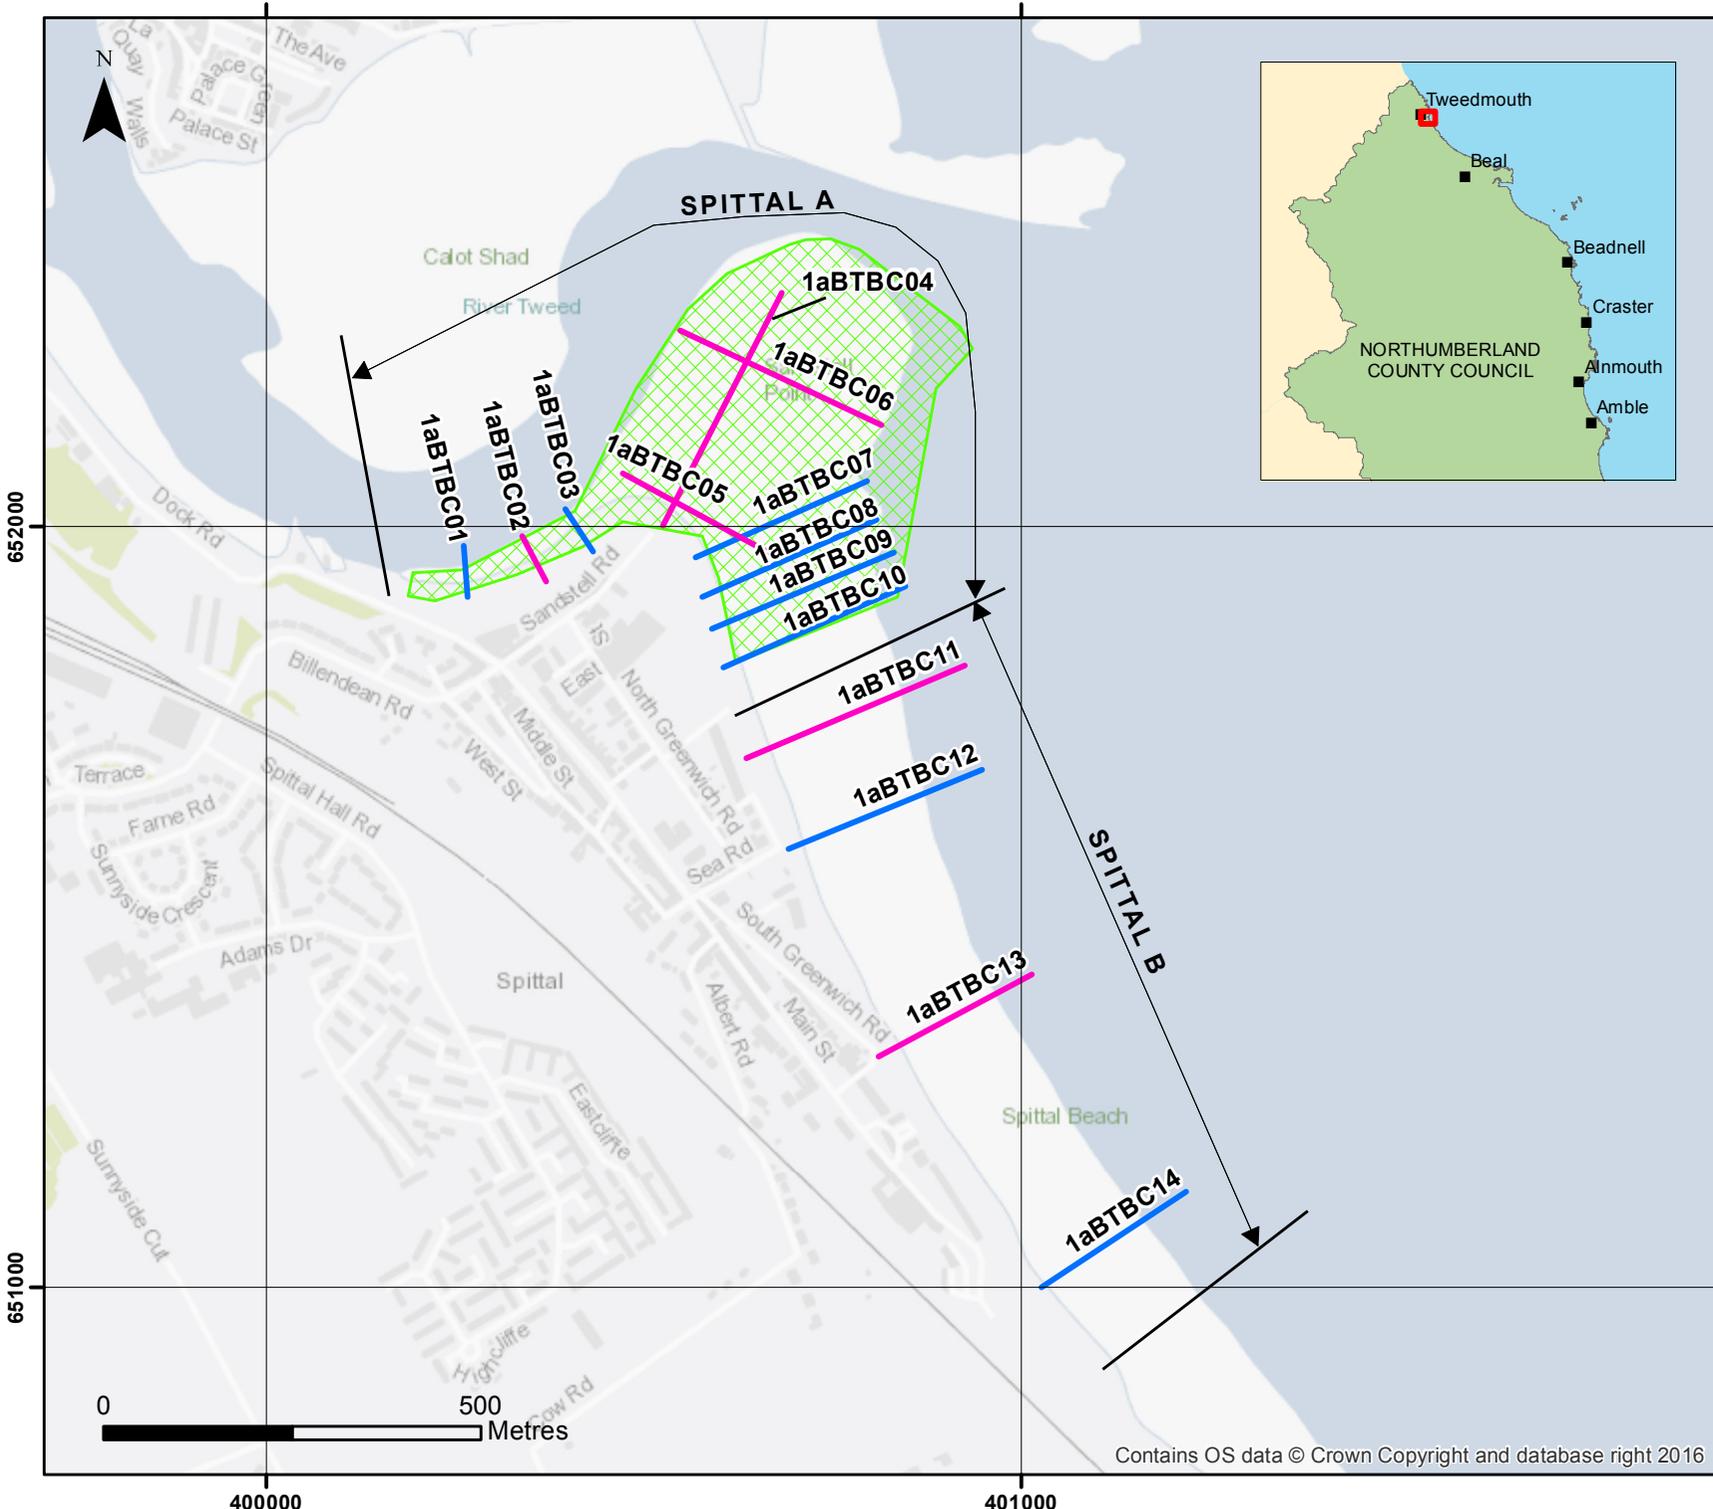
**Figure 2 - Map 1**

**SURVEY LOCATIONS**

**Topographic Profiles**

- Annual
- Bi-Annual

**Topographic Surveys**

- 6 monthly
- yearly
- 5 yearly

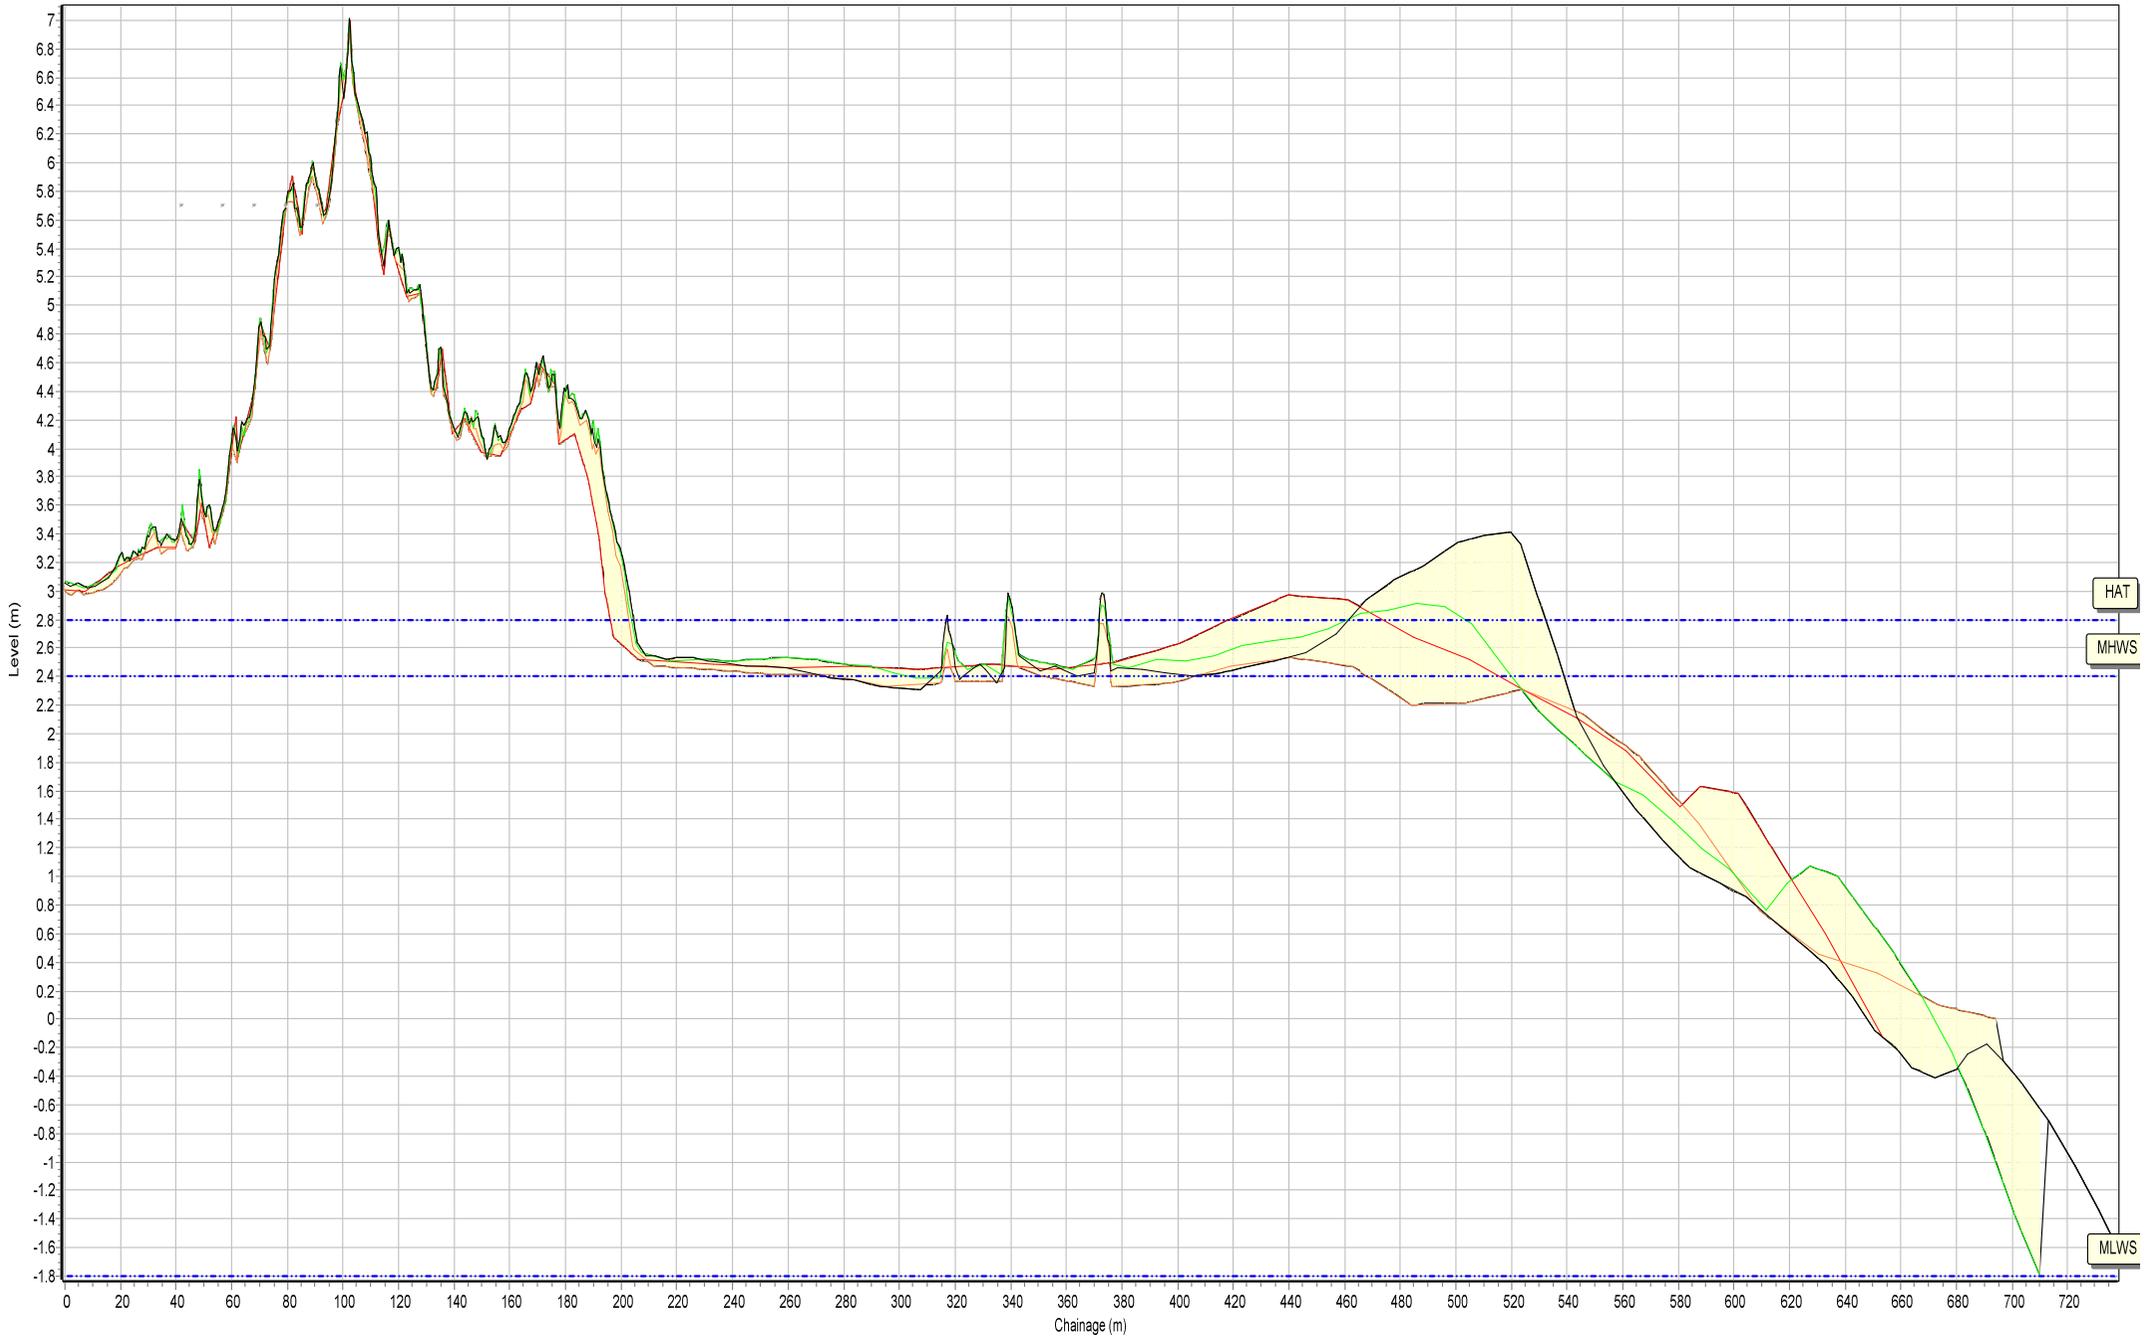
Beach Profiles: 1aBTBC18

- At Goswick Sands, the recorded profiles present no causes for concern. The barrier feature in the seaward end of profile 1aBTBC18 shows movement and is likely to be a cyclical feature.

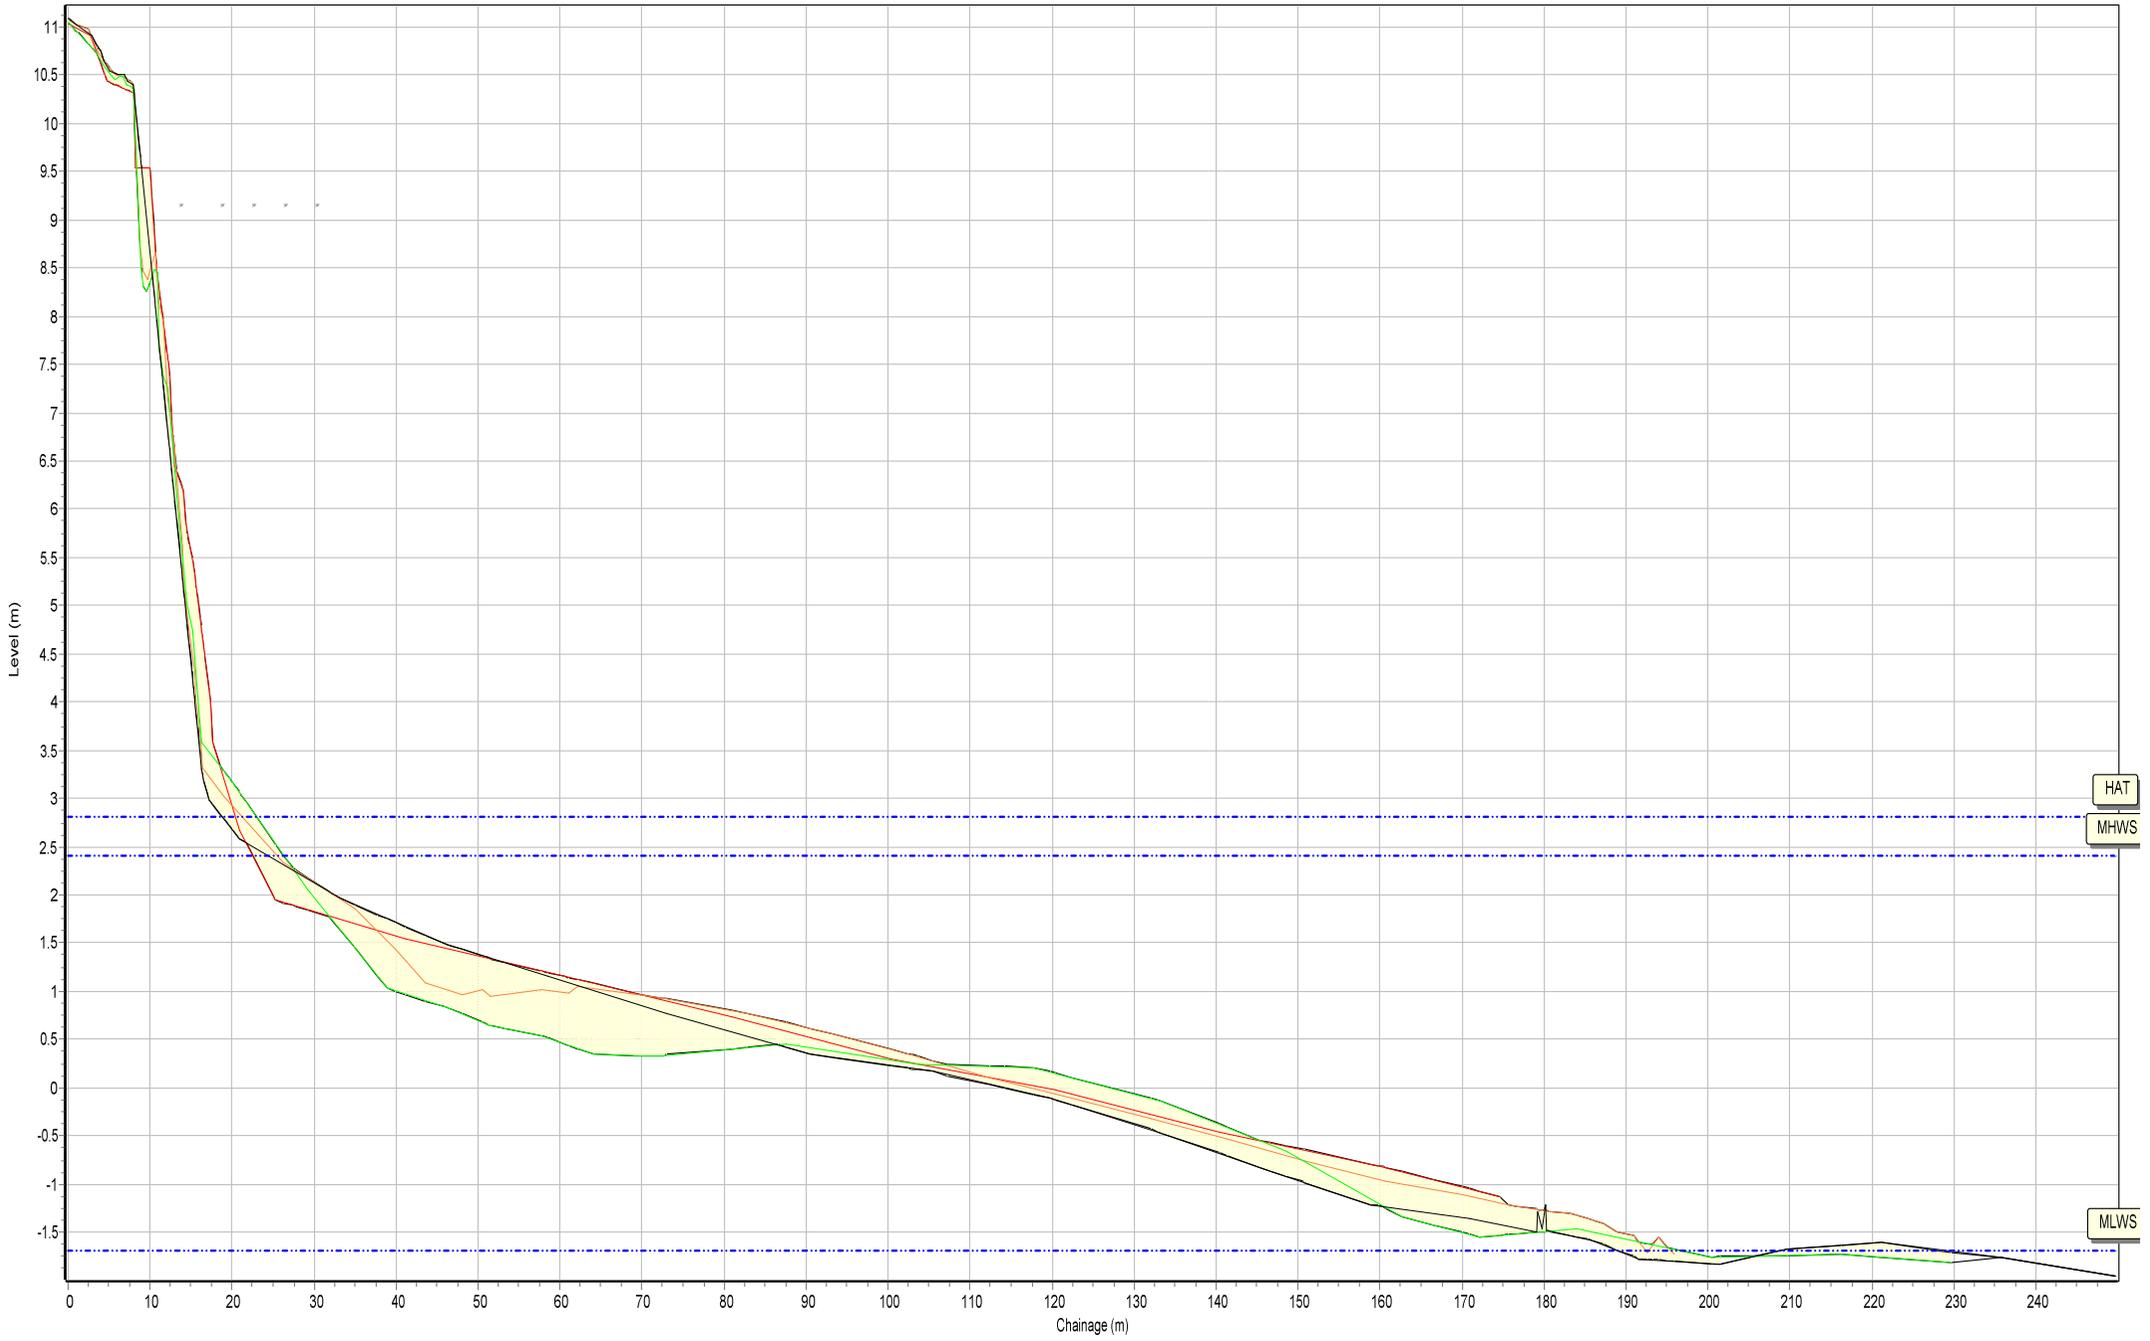
# Beach Profiles: 1aADC06

- At profile ADC05 and ADC06 there was unsafe loose material which prevented the survey of the cliff face.
- At profile ADC09, the profile ends at the river.

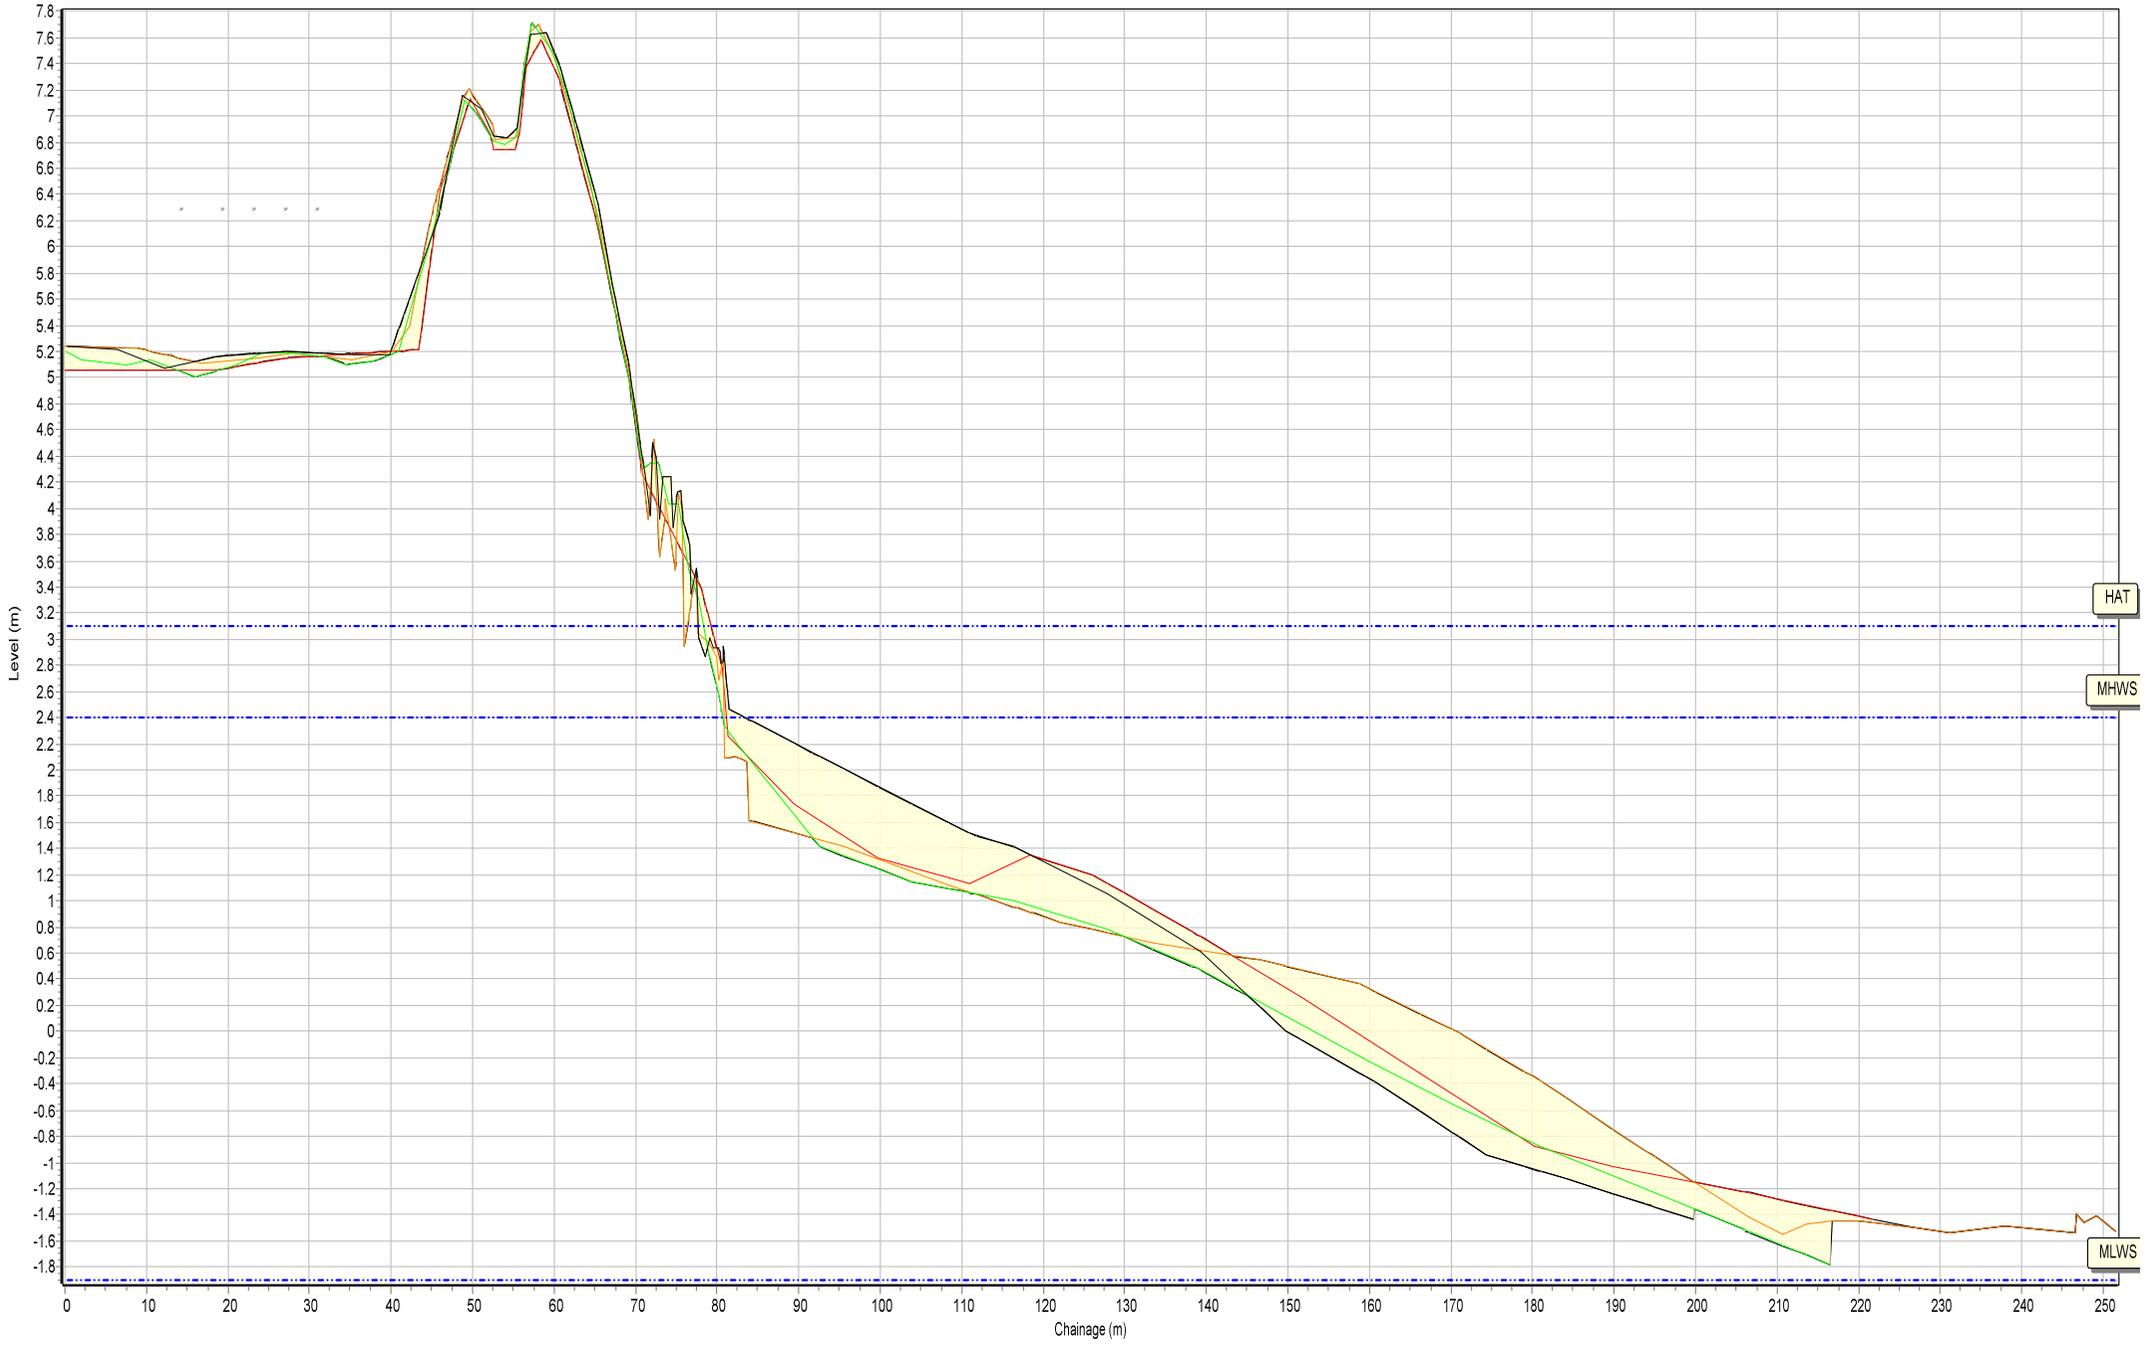
Beach Profiles: 1aADC16A

Survey Date	Description of Changes Since Last Survey	Interpretation
	<p>range recorded from previous surveys, whilst the profile from chainage 140m seawards is at a low level.</p> <p>At profile <b>1aADC16A</b>, the start of the survey is missing due to dense vegetation. There has been accretion at the toe of the rock revetment from chainage 80m to 145m of 0.5m. Over the remainder of the profile, seawards from chainage 145m till the end of the survey at chainage 200m there has been up to 0.2m of erosion. The profile is at a high level on the upper beach and low level on the lower beach when compared to the range recorded from previous surveys. Between chainage 80m and 120m the profile is at its highest level, whereas between chainage 145m to 200m the profile is at its lowest recorded level.</p> <p><b>1aADC16B</b>, <b>1aADC17</b> and <b>1aADC17A</b> are located to the north of Druridge Bay, between Bondi Carrs and Hadston Carrs and extend seawards from Togston Links. At all locations, the dunes have remained stable since the last survey (Partial Measures, spring 2019).</p> <p>At profile <b>1aADC16B</b>, there has been varying sections of minor erosion / accretion of up to 0.1m between some of the rock exposures. Overall, the profile is at a medium to low level compared to the range recorded from previous surveys.</p> <p>At profile <b>1aADC17</b>, there has been little change across the dunes and across to chainage 38m. Seaward of chainage 38m, there has been 0.2m of accretion up to chainage 130m. However, from chainage 130m to 210m there has been a similar level of erosion. Between chainage 200m and 230m a shallow lower beach berm has formed. Overall, the profile is at a medium level compared to the range recorded from previous surveys, except for a short section on the lower beach between chainage 170m and 180m which has the lowest recorded levels.</p> <p>At profile <b>1aADC17A</b>, the upper beach has experienced accretion of up to 0.2m on the upper beach between chainage 30m and 80m. On the mid-beach between chainage 80m and 160m there has been 0.6m of accretion forming a mid-beach berm. Seawards of the this point, up to the end of the survey at chainage 220m there has been erosion of up to 0.4m, exposing the rocky foreshore from chainage 195m. Overall, the profile is at a high level on the upper beach, and medium – high level on the mid beach and low level on the lower beach, when compared to the range recorded from previous surveys.</p> <p><b>1aCMBC01</b> and <b>1aCMBC02</b> are located in the southern section of Druridge Bay.</p>

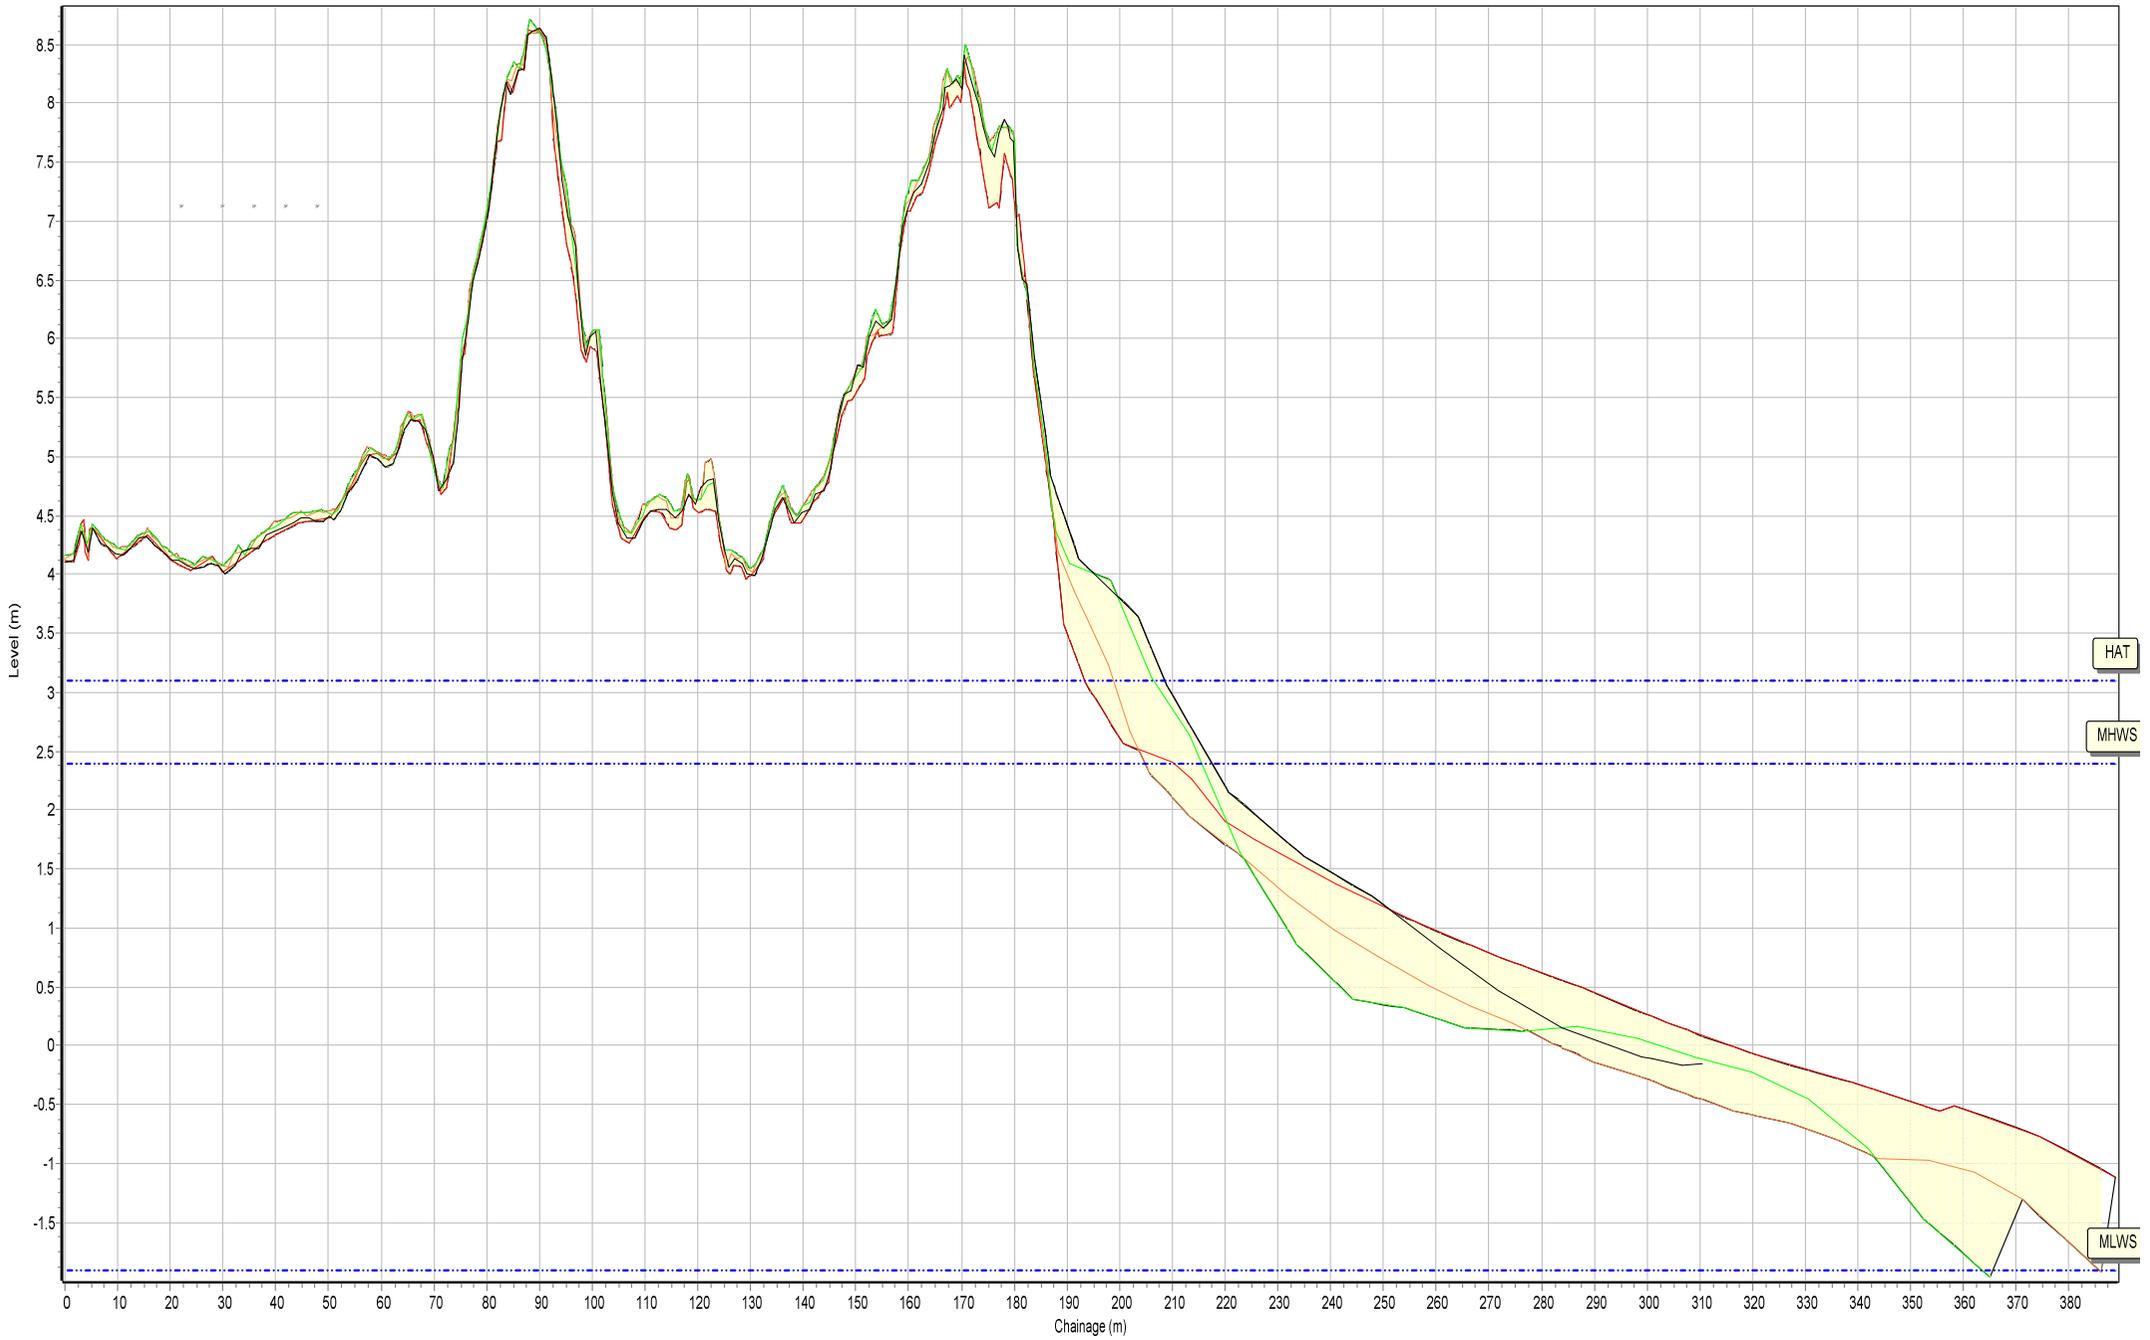
Beach Profiles: 1aCMBC01

Survey Date	Description of Changes Since Last Survey	Interpretation
	<p>At profile <b>1aCMBC01</b>, the dunes appear to have experienced minor erosion / accretion of 0.1m. At the toe of the dunes from chainage 185m to 220m there has been an accretion of up 0.2m. Seawards of this point the profile has smoothed significantly, caused by an accretion of 0.8m between chainage 220m and 285m. The lower beach has experienced some minor erosion between chainage 285m up to the end of the survey at chainage 310m although this is limited to less than 0.2m. The toe of the dunes is at a high level, whereas the remainder of the profile is at a medium level when compared to the range recorded from previous surveys.</p> <p>At profile <b>1aCMBC02</b>, the dune has remained stable since the previous survey. At the toe of the foredune there has been accretion of 0.6m from chainage 192m to 205m; whilst from chainage 205m to 220m there has been erosion of up to 0.3m, meaning that the upper beach profile has steepened somewhat since the previous survey. The remainder of the profile is dominated by two shallow berms. The upper berm is formed from up to 0.75m of accretion and lies between chainage 220m and 290m. The lower berm lies between 290m and the end of the survey at chainage 380m and is generally shallower at around 0.4m above the beach levels recorded in the previous (Spring 2019) survey. Overall, the profile is at a medium level compared to the range recorded from previous surveys and appears to have recovered from the drawdown experienced over the winter of 2019.</p>
