## Cell 1 Regional Coastal Monitoring Programme Analytical Report 13: 'Full Measures' Survey 2020

(\*) The present report is **Analytical Report 13** and provides an analysis of the 2020 Full Measures survey for Northumberland County Council's frontage.

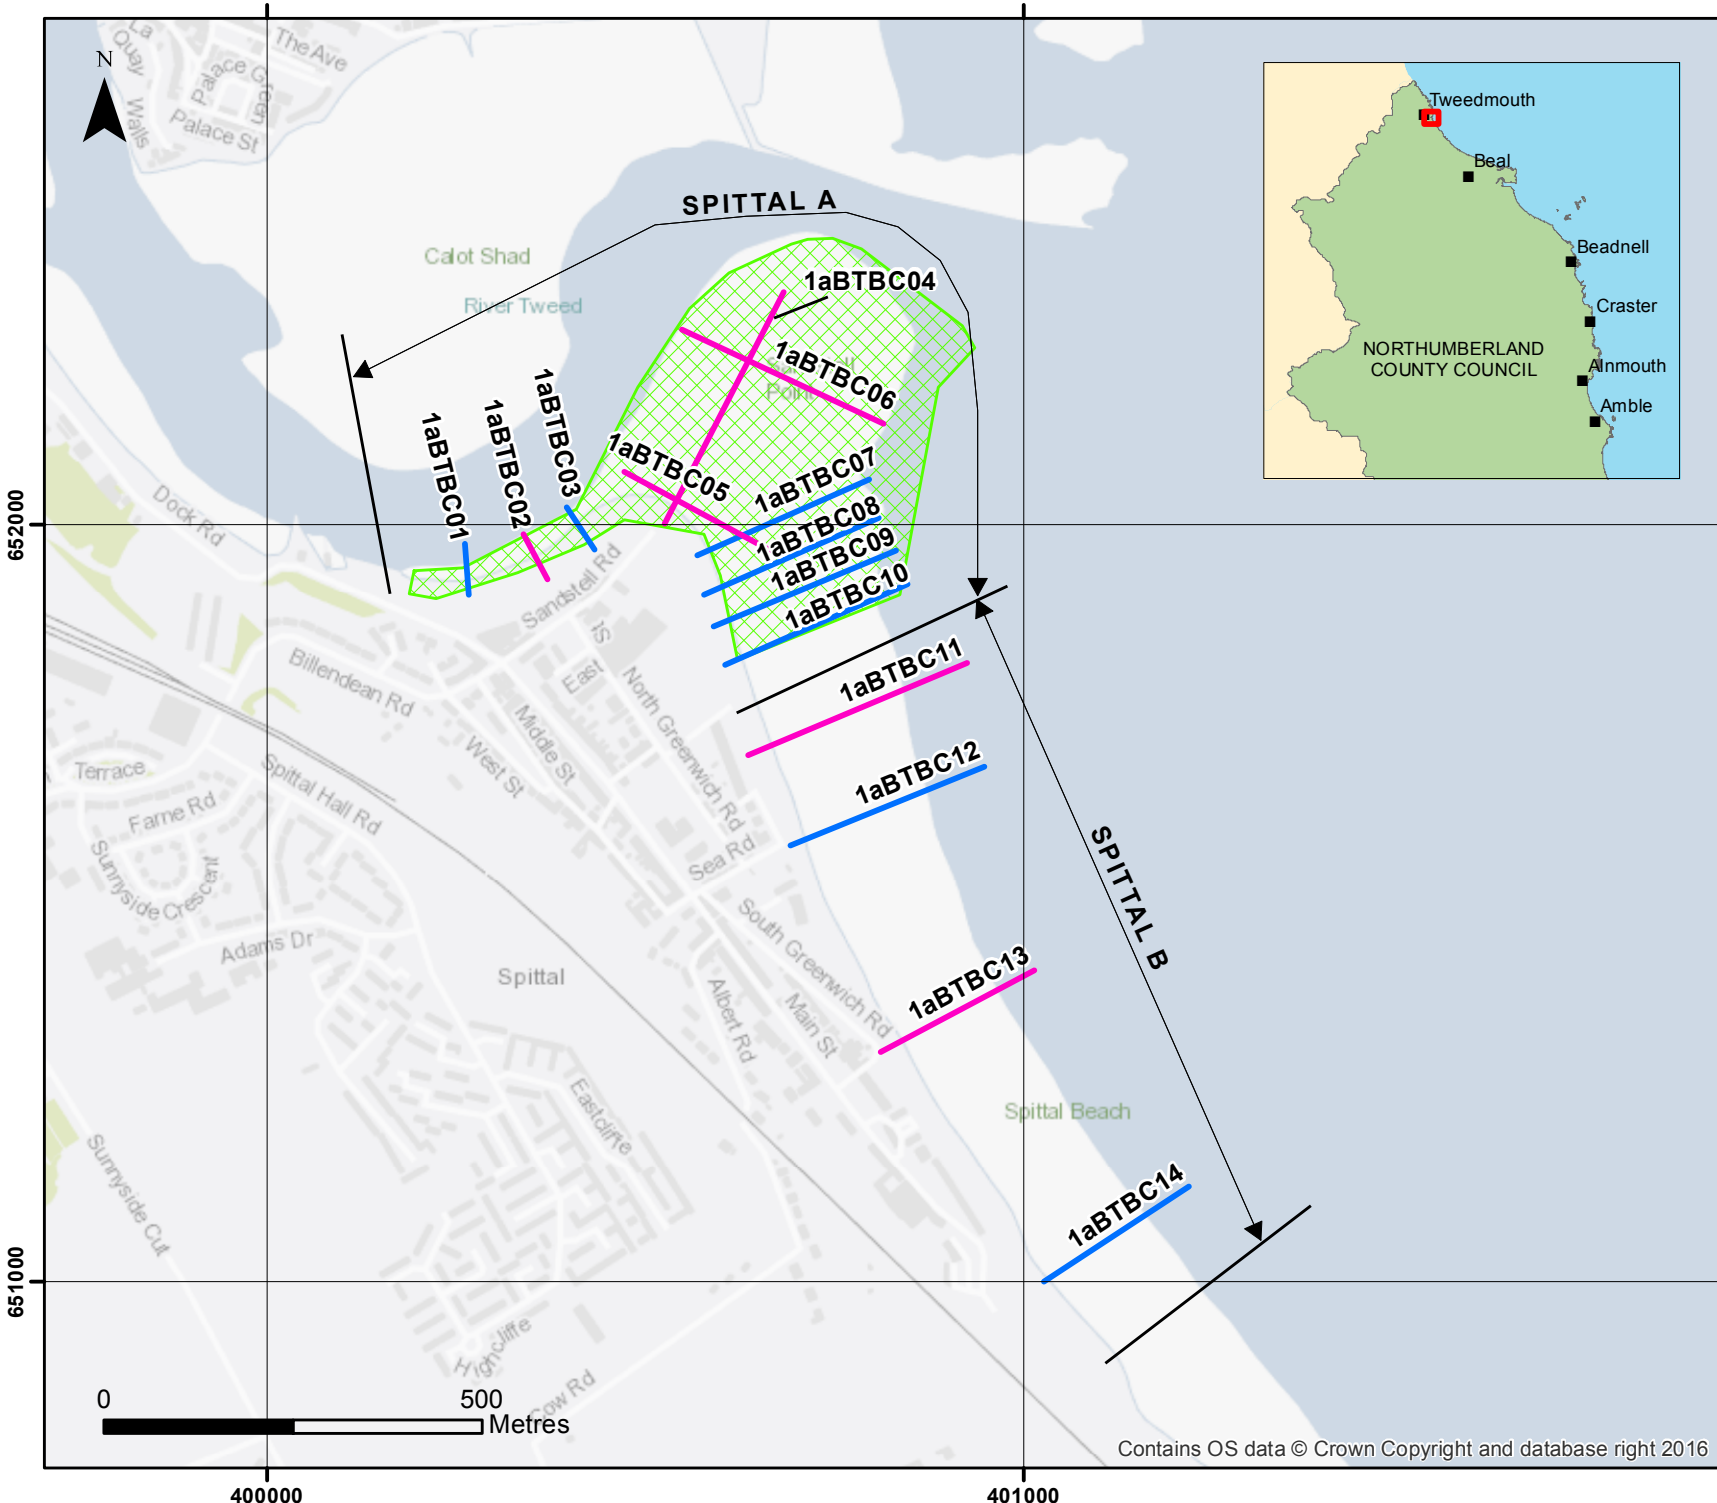
**SURVEY LOCATIONS**

The location of these surveys is shown in **Figure 2**. The Full Measures survey was undertaken on various dates along this frontage between 19<sup>th</sup> August and 30<sup>th</sup> October 2020. During this time, weather conditions varied considerably; refer to the survey reports for details of the weather conditions over this survey period.

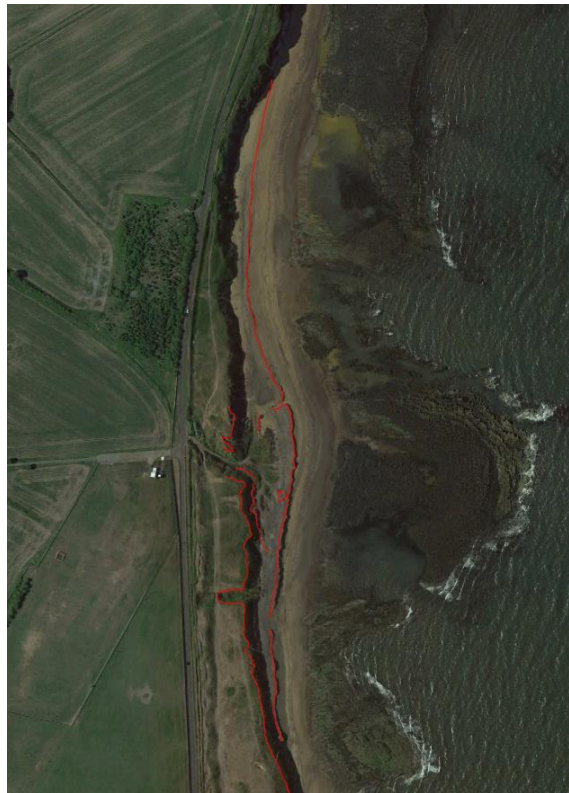
Figure 3 – Baseline cliff top survey (North)

December 2020	<p><b>Colliery Spoil Edge Survey:</b></p> <p>Colliery spoil edge survey data was collected for a baseline survey in December 2020.</p> <p>In the very north of the bay (<b>Figure 3</b>), the colliery spoil forms a beach and the survey of the low cliffed edge of this spoil beach shows a progradation of sediment in the lee of the Headagee rock outcrops. The edge of the colliery spoil beach then merges back into the colliery spoil cliff toe just to the south of the rock outcrops. It has been observed empirically that the spoil beach is eroding landwards and the point where it merges into the cliff is moving northwards, causing the cliffs to become exposed and start eroding. Further north, the remaining spoil beach protects natural cliffs/coastal slopes.</p> <p>In the centre of the bay (immediately north of the power station north towards Headagee, (<b>Figure 4</b>) the colliery spoil cliff is no longer protected by a distinct fronting colliery spoil beach (although the natural beach is very much intermixed with spoil, it does not form a distinct spoil beach like that present in the north of the bay). This results in the colliery spoil cliffs eroding landwards at a measurable rate.</p>	<p>Where a spoil beach is present on the foreshore, the backing spoil cliffs or natural cliffs/dune are stable because they are not currently affected by marine processes.</p> <p>Where the spoil beach is absent, the backing colliery spoil cliffs are actively eroding, causing measurable landward recession.</p> <p><b>Longer term trends:</b> Future repeat cliff top surveys are expected to help quantify rates of erosion (landward recession) of the historically tipped colliery spoil on a wider basis than is possible from the beach profile surveys alone.</p>

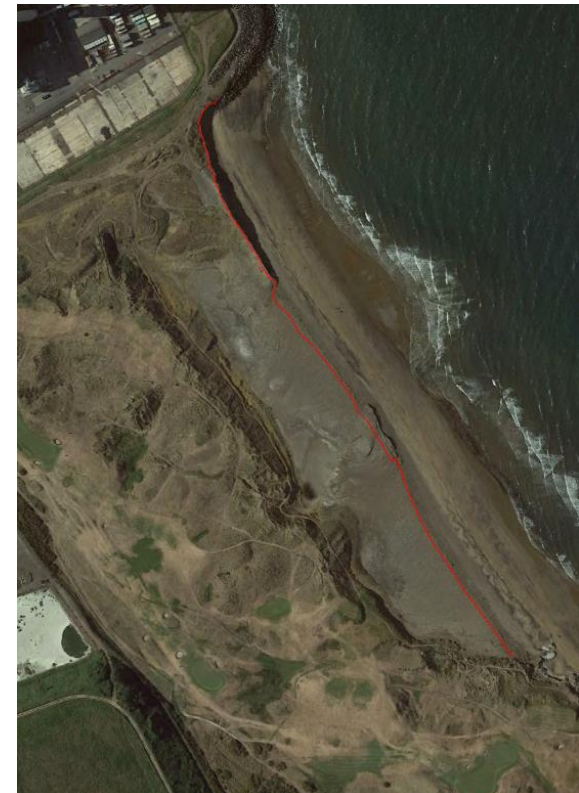
Figure 5 – Baseline cliff top survey (South)

Survey Date	Description of Changes Since Last Survey	Interpretation
	<p>In the south of the bay (north of the power station, <b>(Figure 5)</b> the colliery spoil extends some distance seaward of the backing (and underlying) natural dunes, forming a 'berm' (rather than a distinct cliff edge) at the seaward edge. This berm has been eroding landwards, but at a lesser rate than in the centre of the bay.</p>

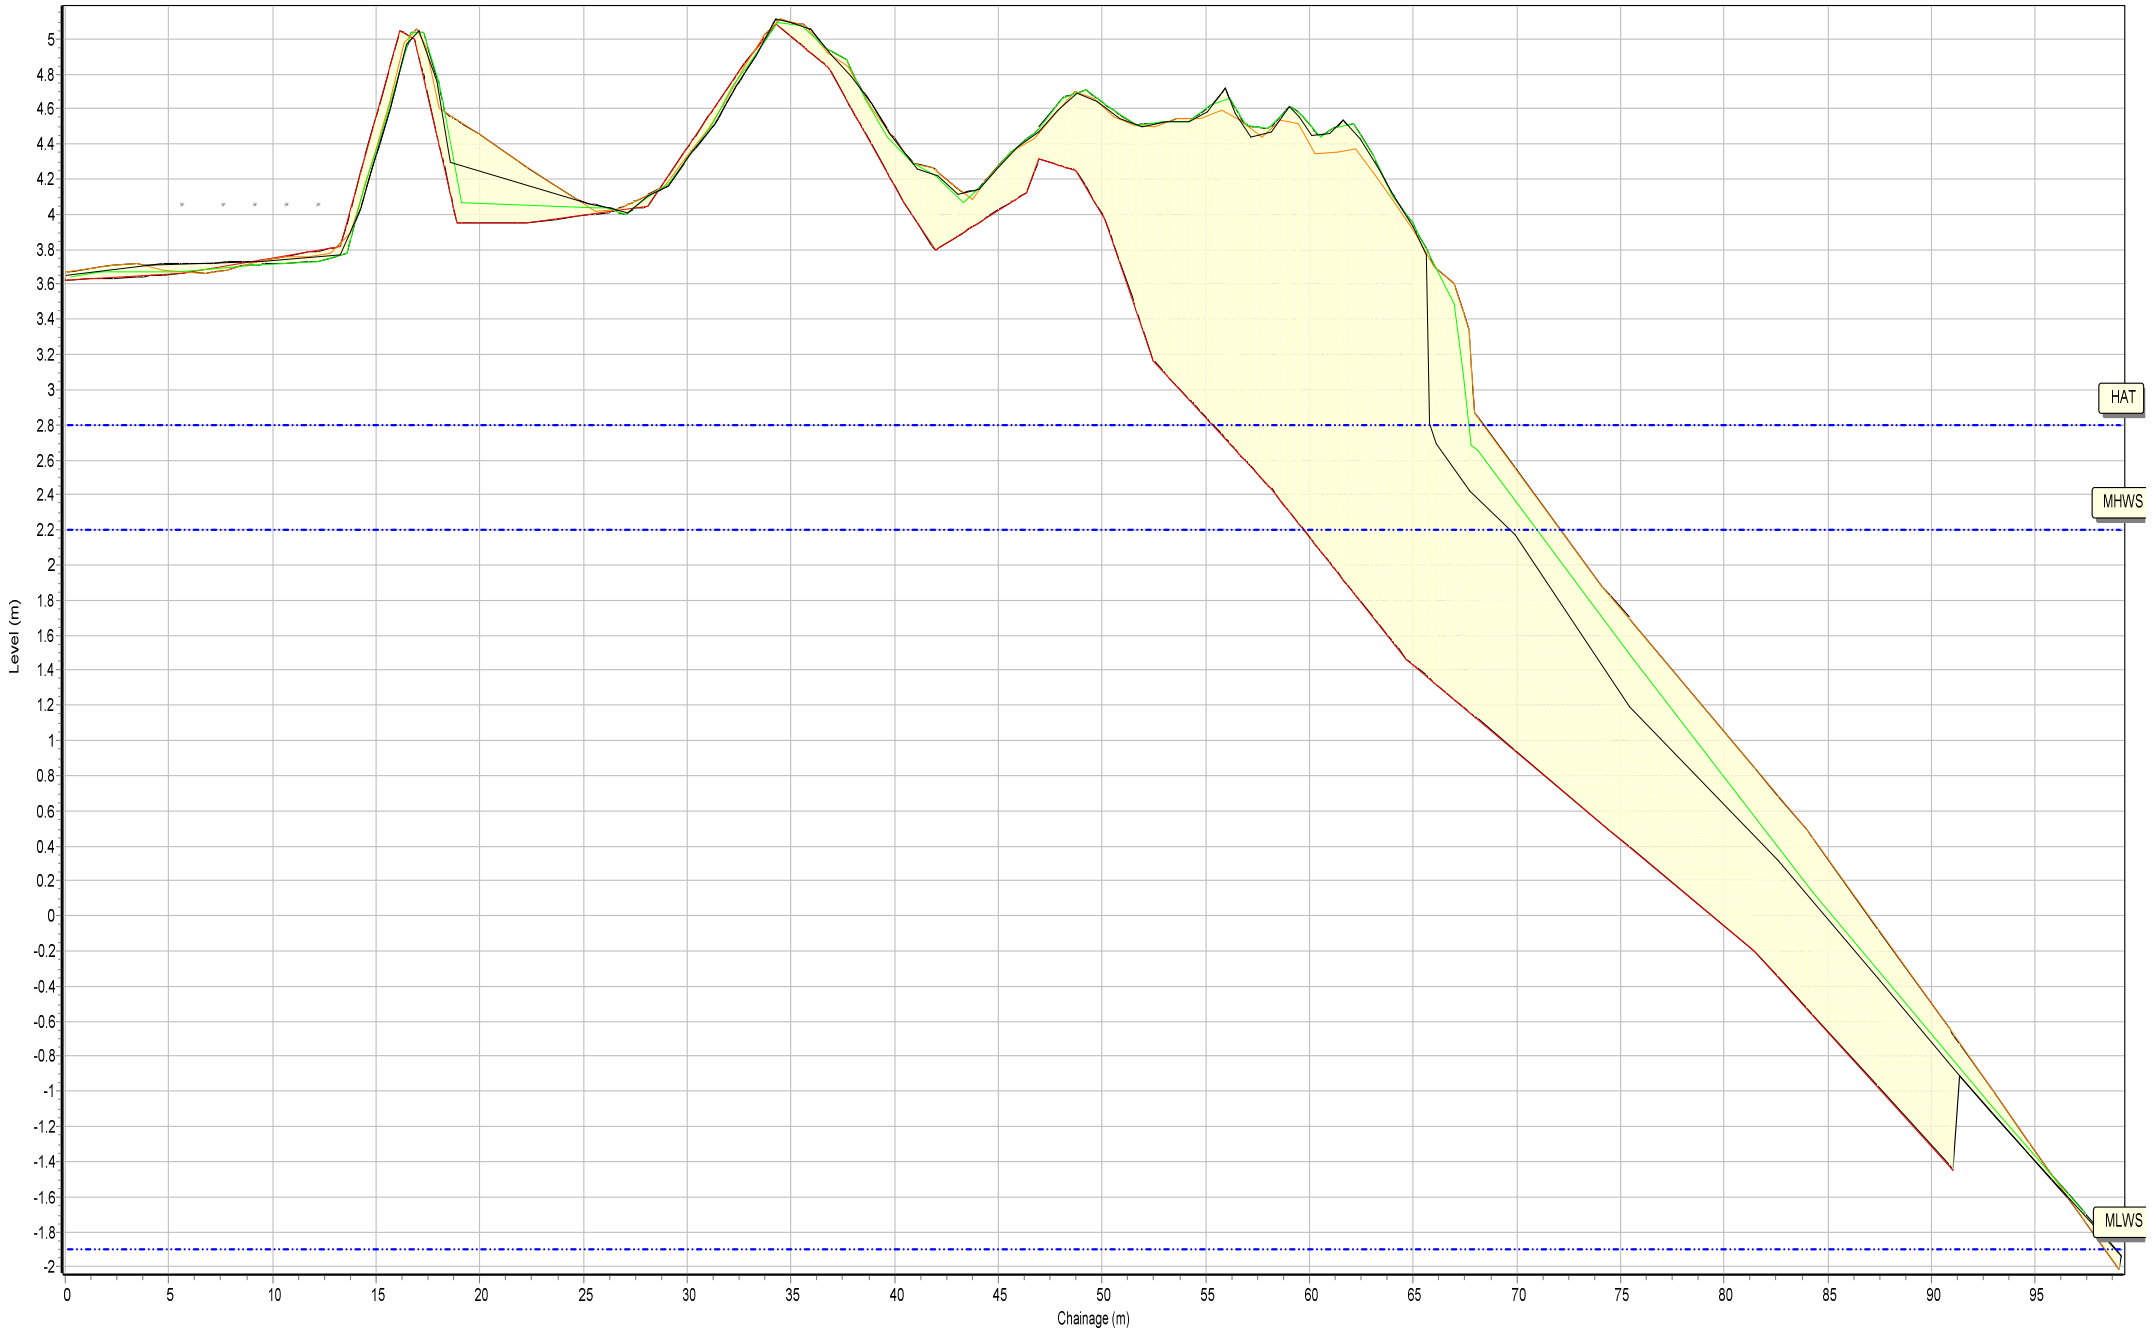
Beach Profiles: 1aBTBC03

Profiles Envelope 01/10/2006 27/11/2018 15/10/2019 20/08/2020

- At Sandstell Point (Spittal A), the recorded profiles and topographic survey present no causes for concern. However, the seaward face of the dune at profile **1aBTBC03** has shown a landward recession since November 2018.

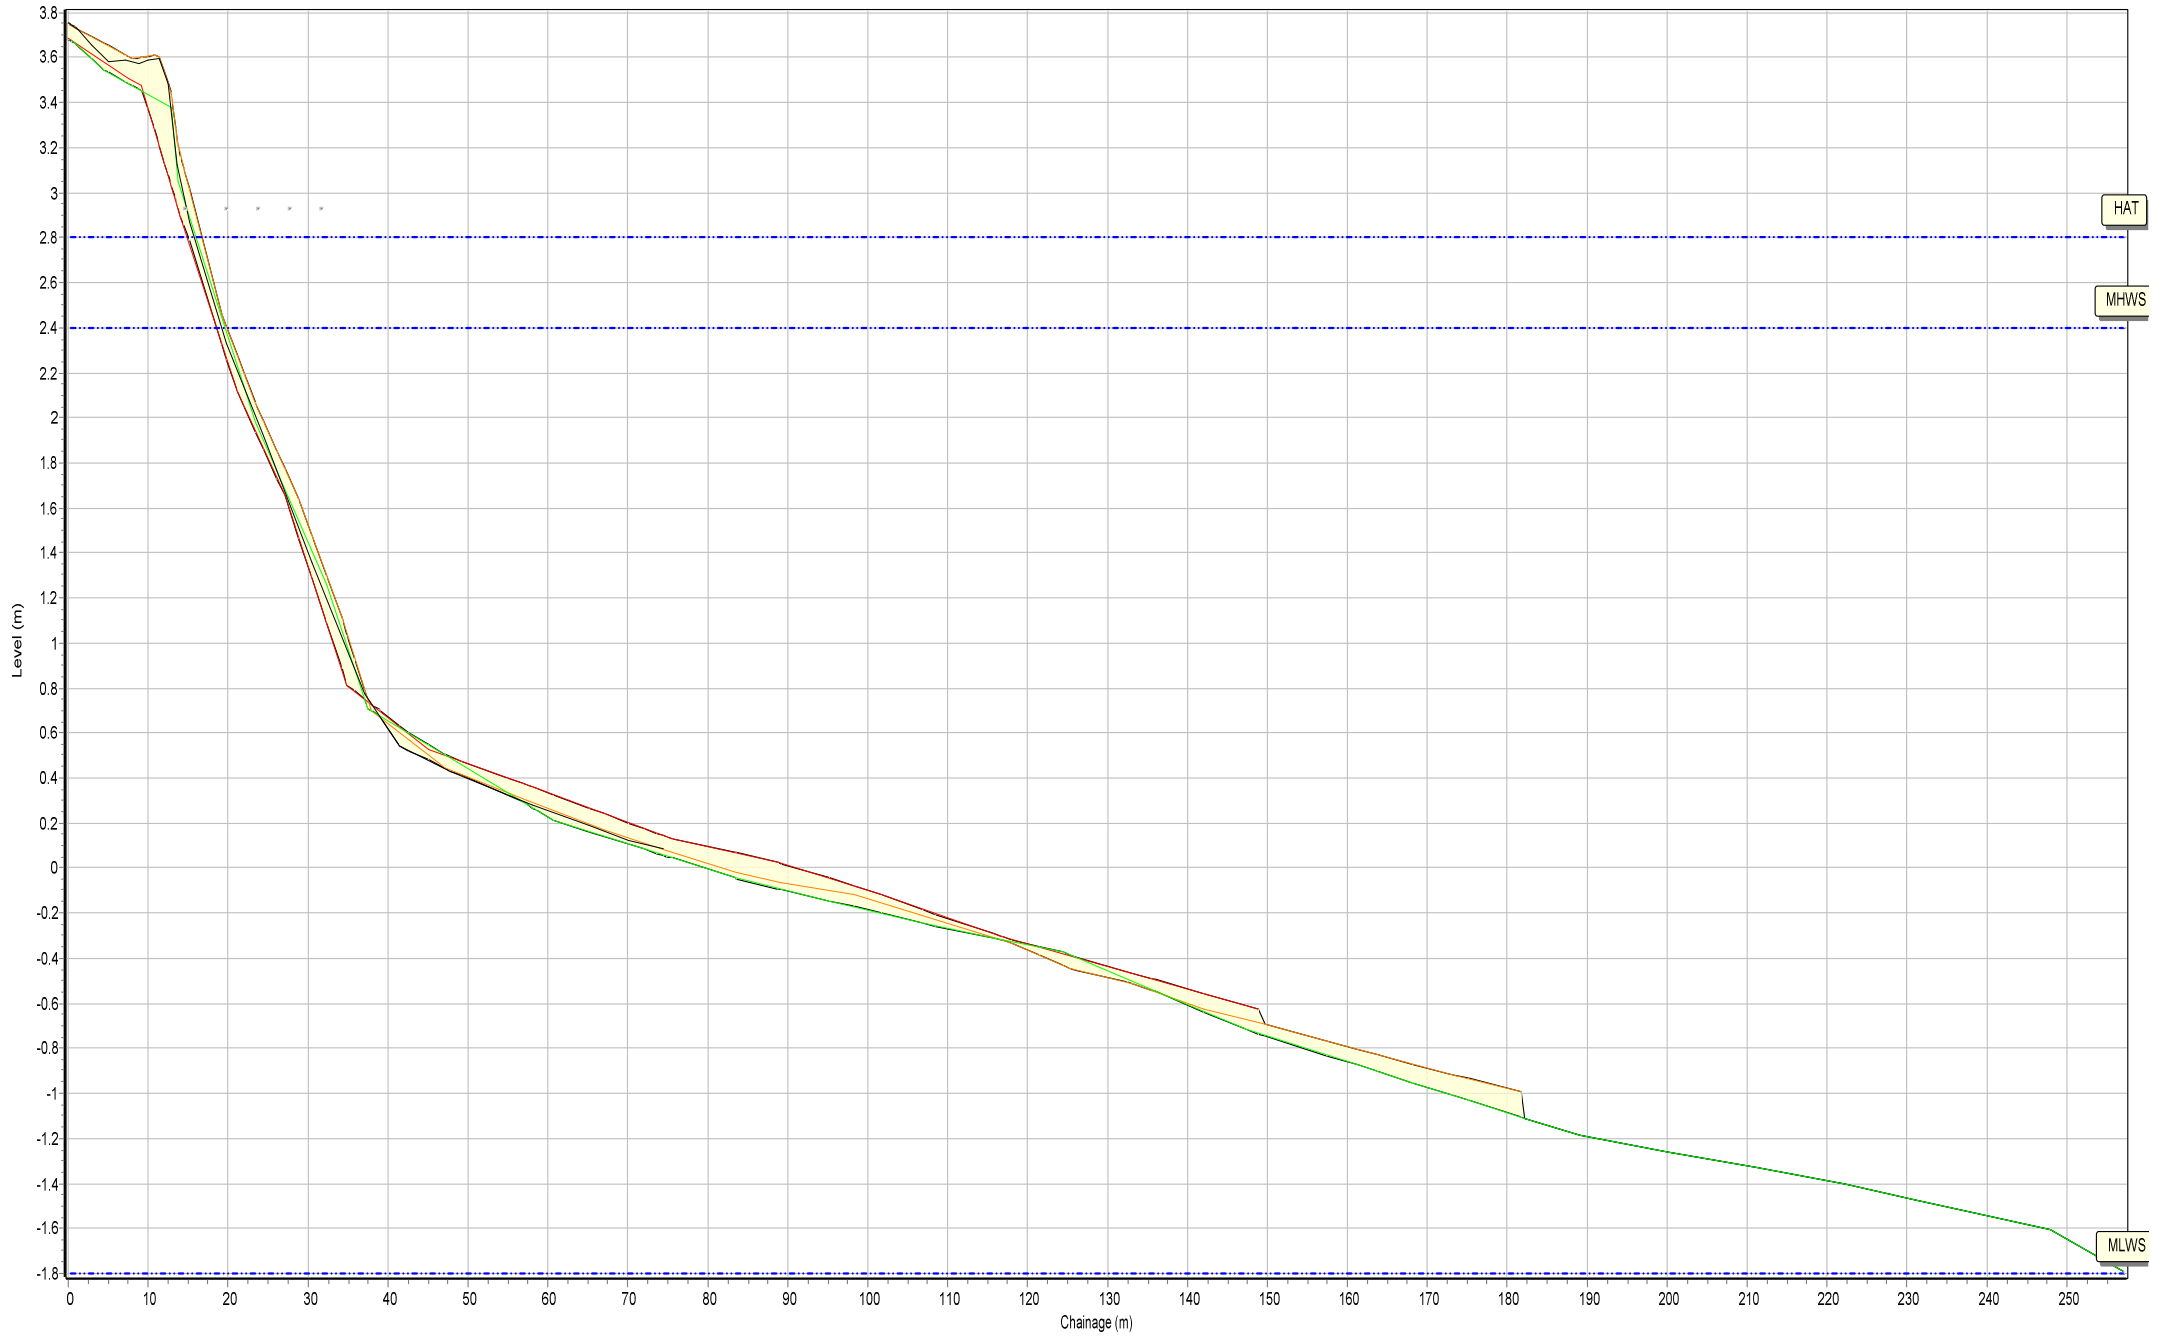
Beach Profiles: 1aBTC26

- At BTBC26, the survey report notes that it was unsafe to survey the end of the section as the mud was too thick.
- At profile BTBC33, there are gaps in the section (at the location of the middle of dunes) due to dense vegetation. This needs to be taken into account when assessing the profile data as the levels in these measurement gaps will not be reliable.

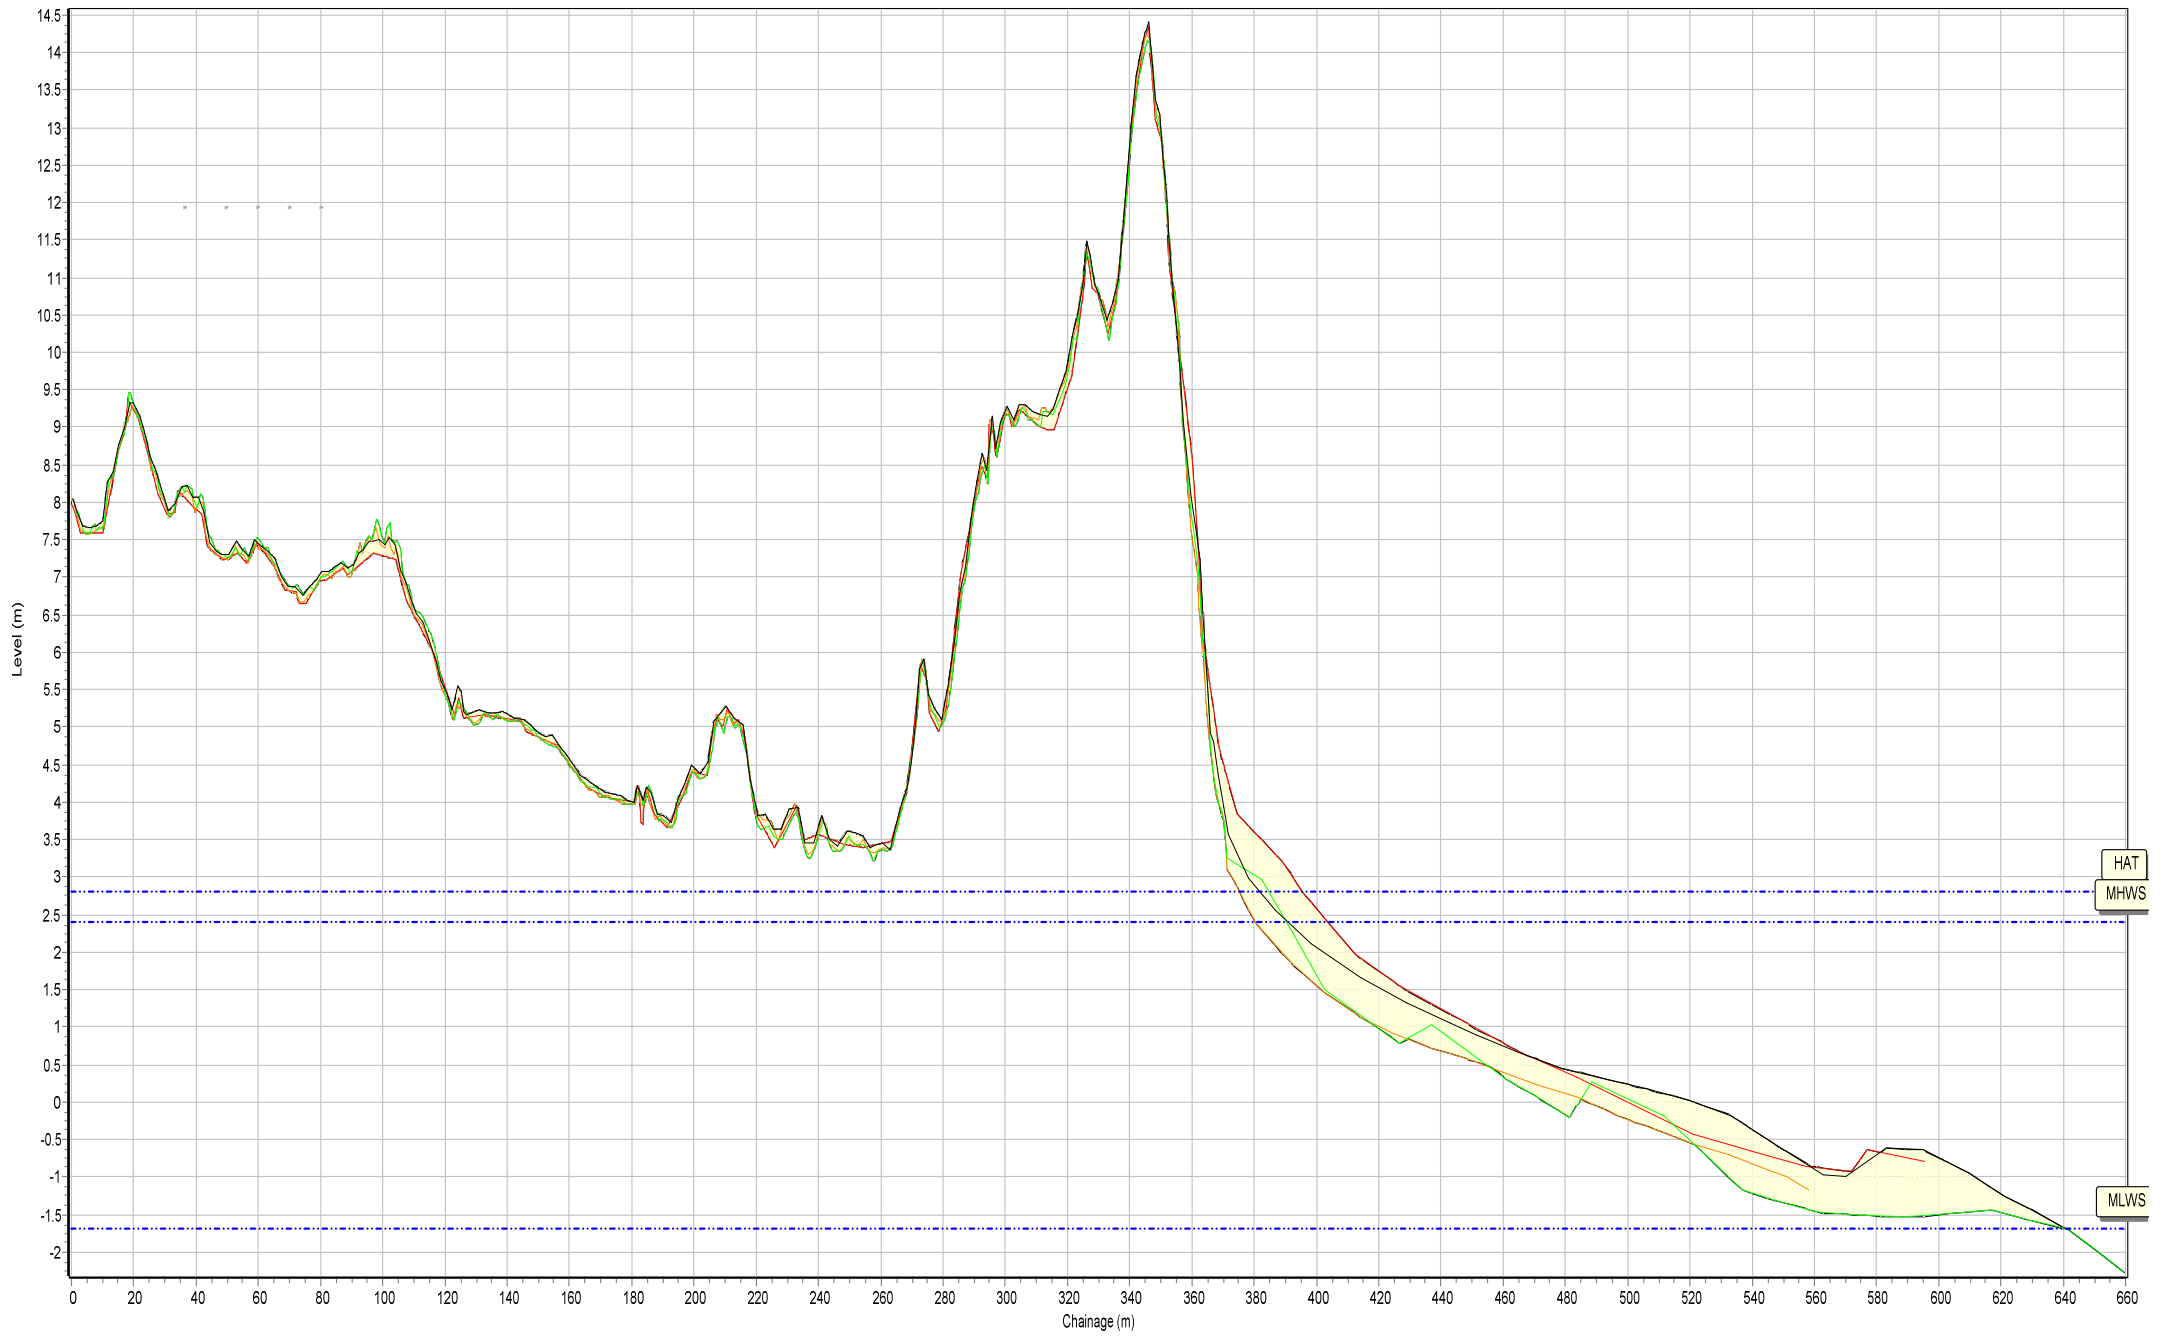
Beach Profiles: 1aBTBC29

Survey Date	Description of Changes Since Last Survey	Interpretation
5 <sup>th</sup> October 2020	<p><b>Beach Profiles:</b></p> <p>Bamburgh is covered by one beach profile line for the Full Measures survey (Appendix A). Profile 1aBTBC29 was last surveyed during the Full Measures autumn survey, 2019.</p> <p>Profile <b>1aBTBC29</b> is located approximately 750m south-east of the castle. The survey report noted the following “<i>Profile BTBC29 has historically been observed from the same GPS base station. As phone signal reception has improved in the area the opportunity was there to run the section using VRS (i.e. direct measurement without the need for a base station). This has uncovered a height error on the base station of 1.048m meaning all historical data on this section is 1.048m too low. The data recorded this time is to the correct datum value.</i>” There have been small sections of accretion within the dunes limited to &lt;0.2m, with 0.2m of accretion at the toe of the dunes. The profile has accreted by up to 0.7m and smoothed out, covering the two berms on the upper-middle beach from the previous survey. A berm has formed on the lower beach with the accumulation of 0.9m of sediment. The dunes and beach profile are at a high, particularly on the dune face between chainages 357-365m and 361-373m, and on the beach between chainages 476-542m and 575-640m which are at their highest level recorded compared to previous surveys.</p>	<p>The dunes at Bamburgh have remained stable, and the beach shows an increase in level across the profile. It is worth noting that data from previous years has been 1.048m too low due to a height error at the base station. This has been rectified.</p> <p><b>Longer term trends:</b> The 2020 profile shows that some sections of the seaward face of the dune are at their most seaward position since 2004. The beach is at a high level compared to earlier surveys.</p>

- At Holy Island, the recorded profiles and topographic survey present no causes for concern.
- At Bamburgh, the recorded profiles present no causes for concern. It is worth noting that data from previous years has been 1.048m too low due to a height error at the base station (see **Section 4** above). This has been rectified.

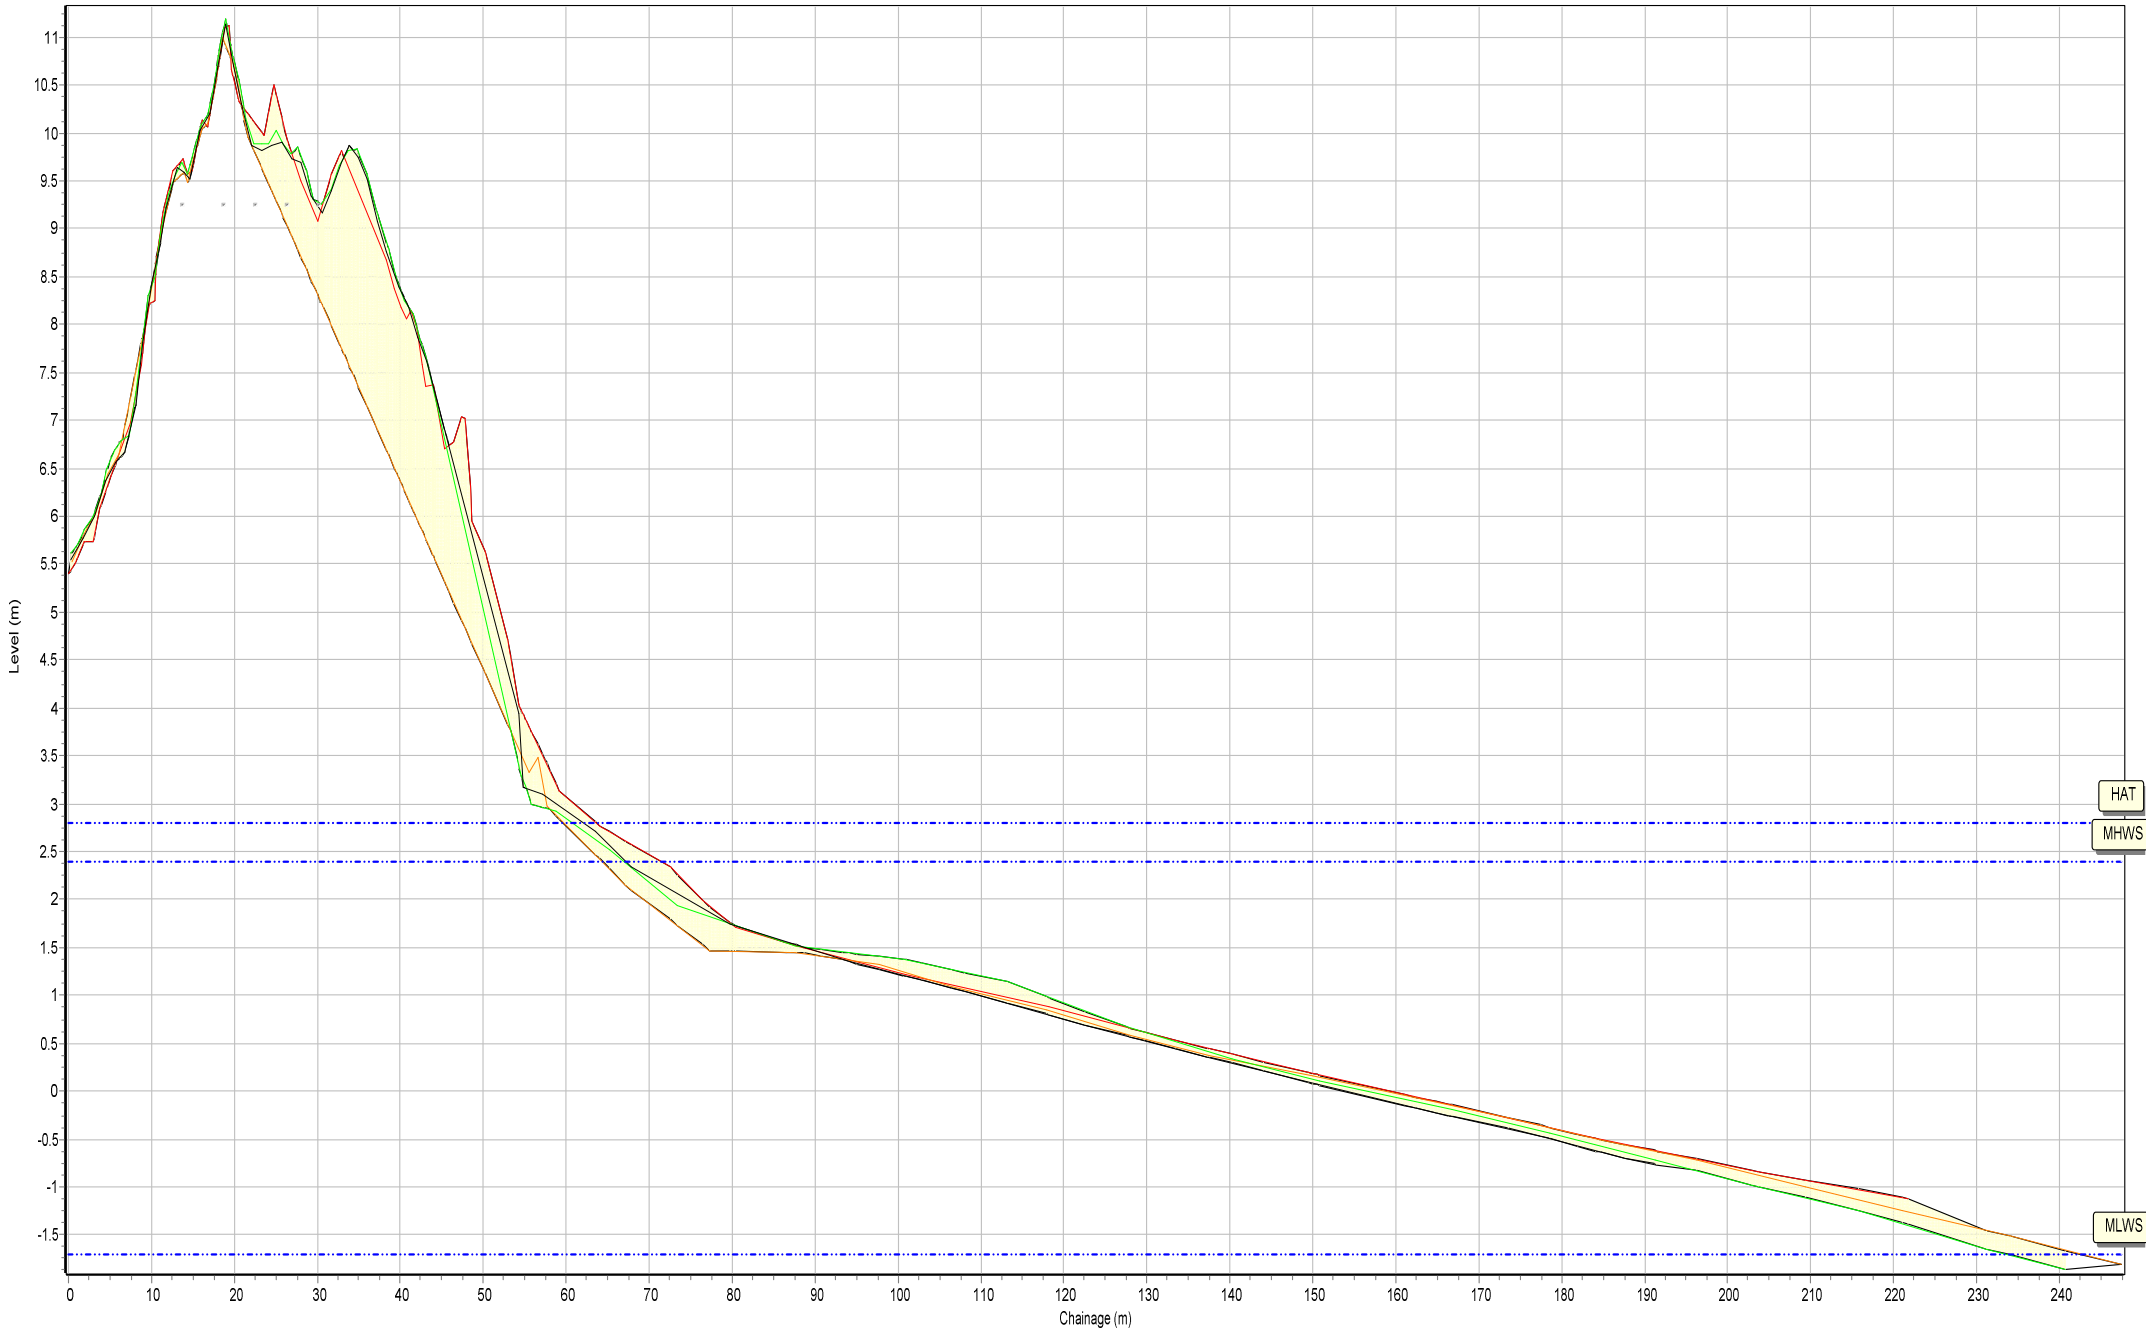
Beach Profiles: 1aBTC33

Profiles Envelope 01/04/2006 16/10/2019 23/04/2020 02/10/2020
