Cell 1 Regional Coastal Monitoring Programme Analytical Report 16: 'Full Measures' Survey 2023

**Northumberland County
Council**

February 2024

(*) The present report is **Analytical Report 16** and provides an analysis of the 2023 Full Measures survey for Northumberland County Council's frontage.

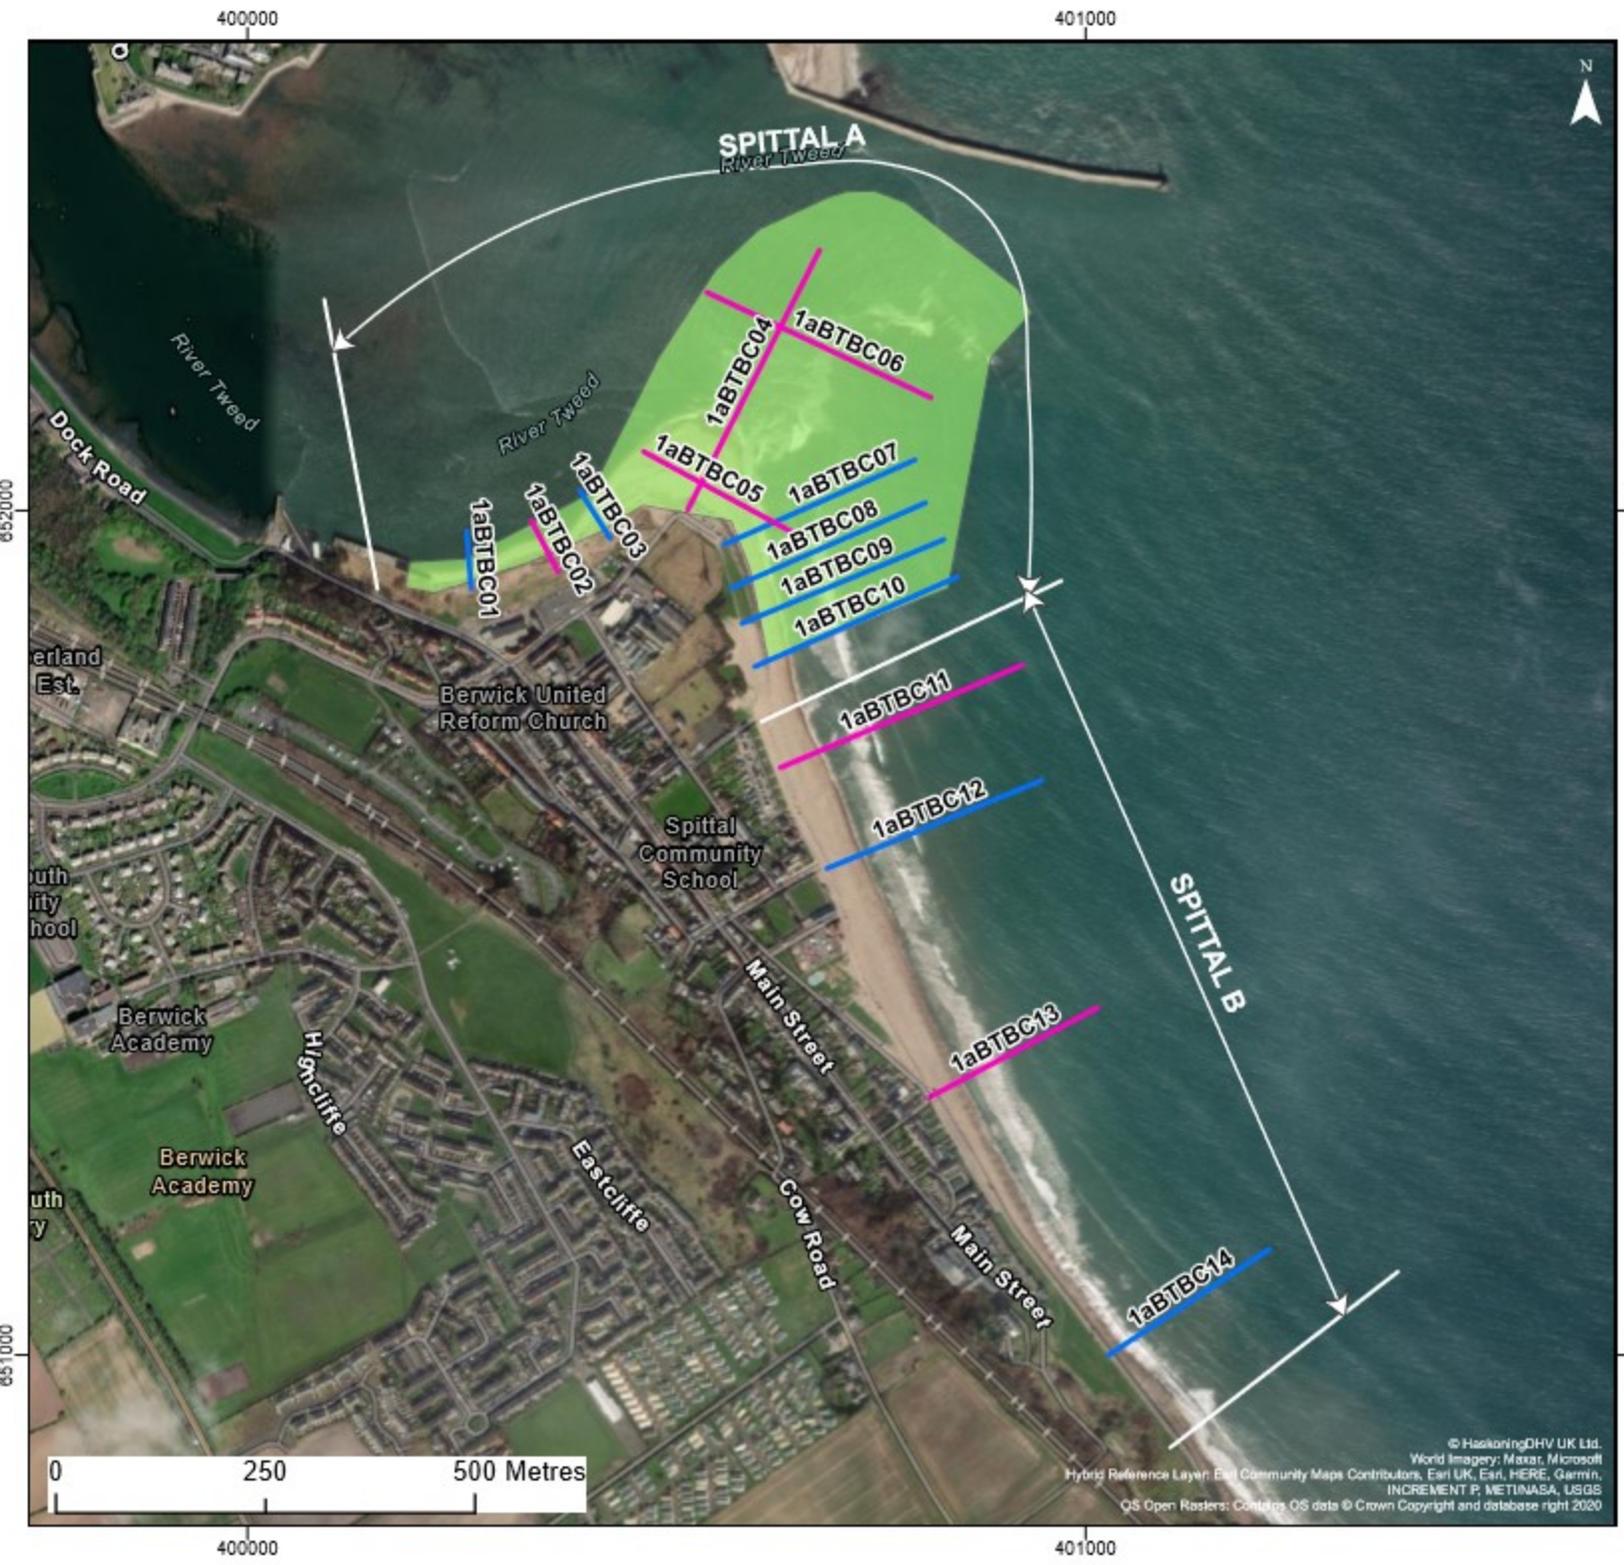
SURVEY LOCATIONS

Topographic Profile

- Annual (Blue line)
- Bi-Annual (Pink line)

Topographic Area

- 6 monthly (Light Green)
- yearly (Orange)
- 5 yearly (Light Purple)

- Cliff Top Edge Survey (Red line)
- Edge of Sand Survey (Yellow line)

The location of these surveys is shown in **Figure 2**. The Full Measures survey was undertaken on various dates along this frontage between 17th August and 19th September 2023. During this time, weather conditions varied considerably; refer to the survey reports for details of the weather conditions over this survey period.

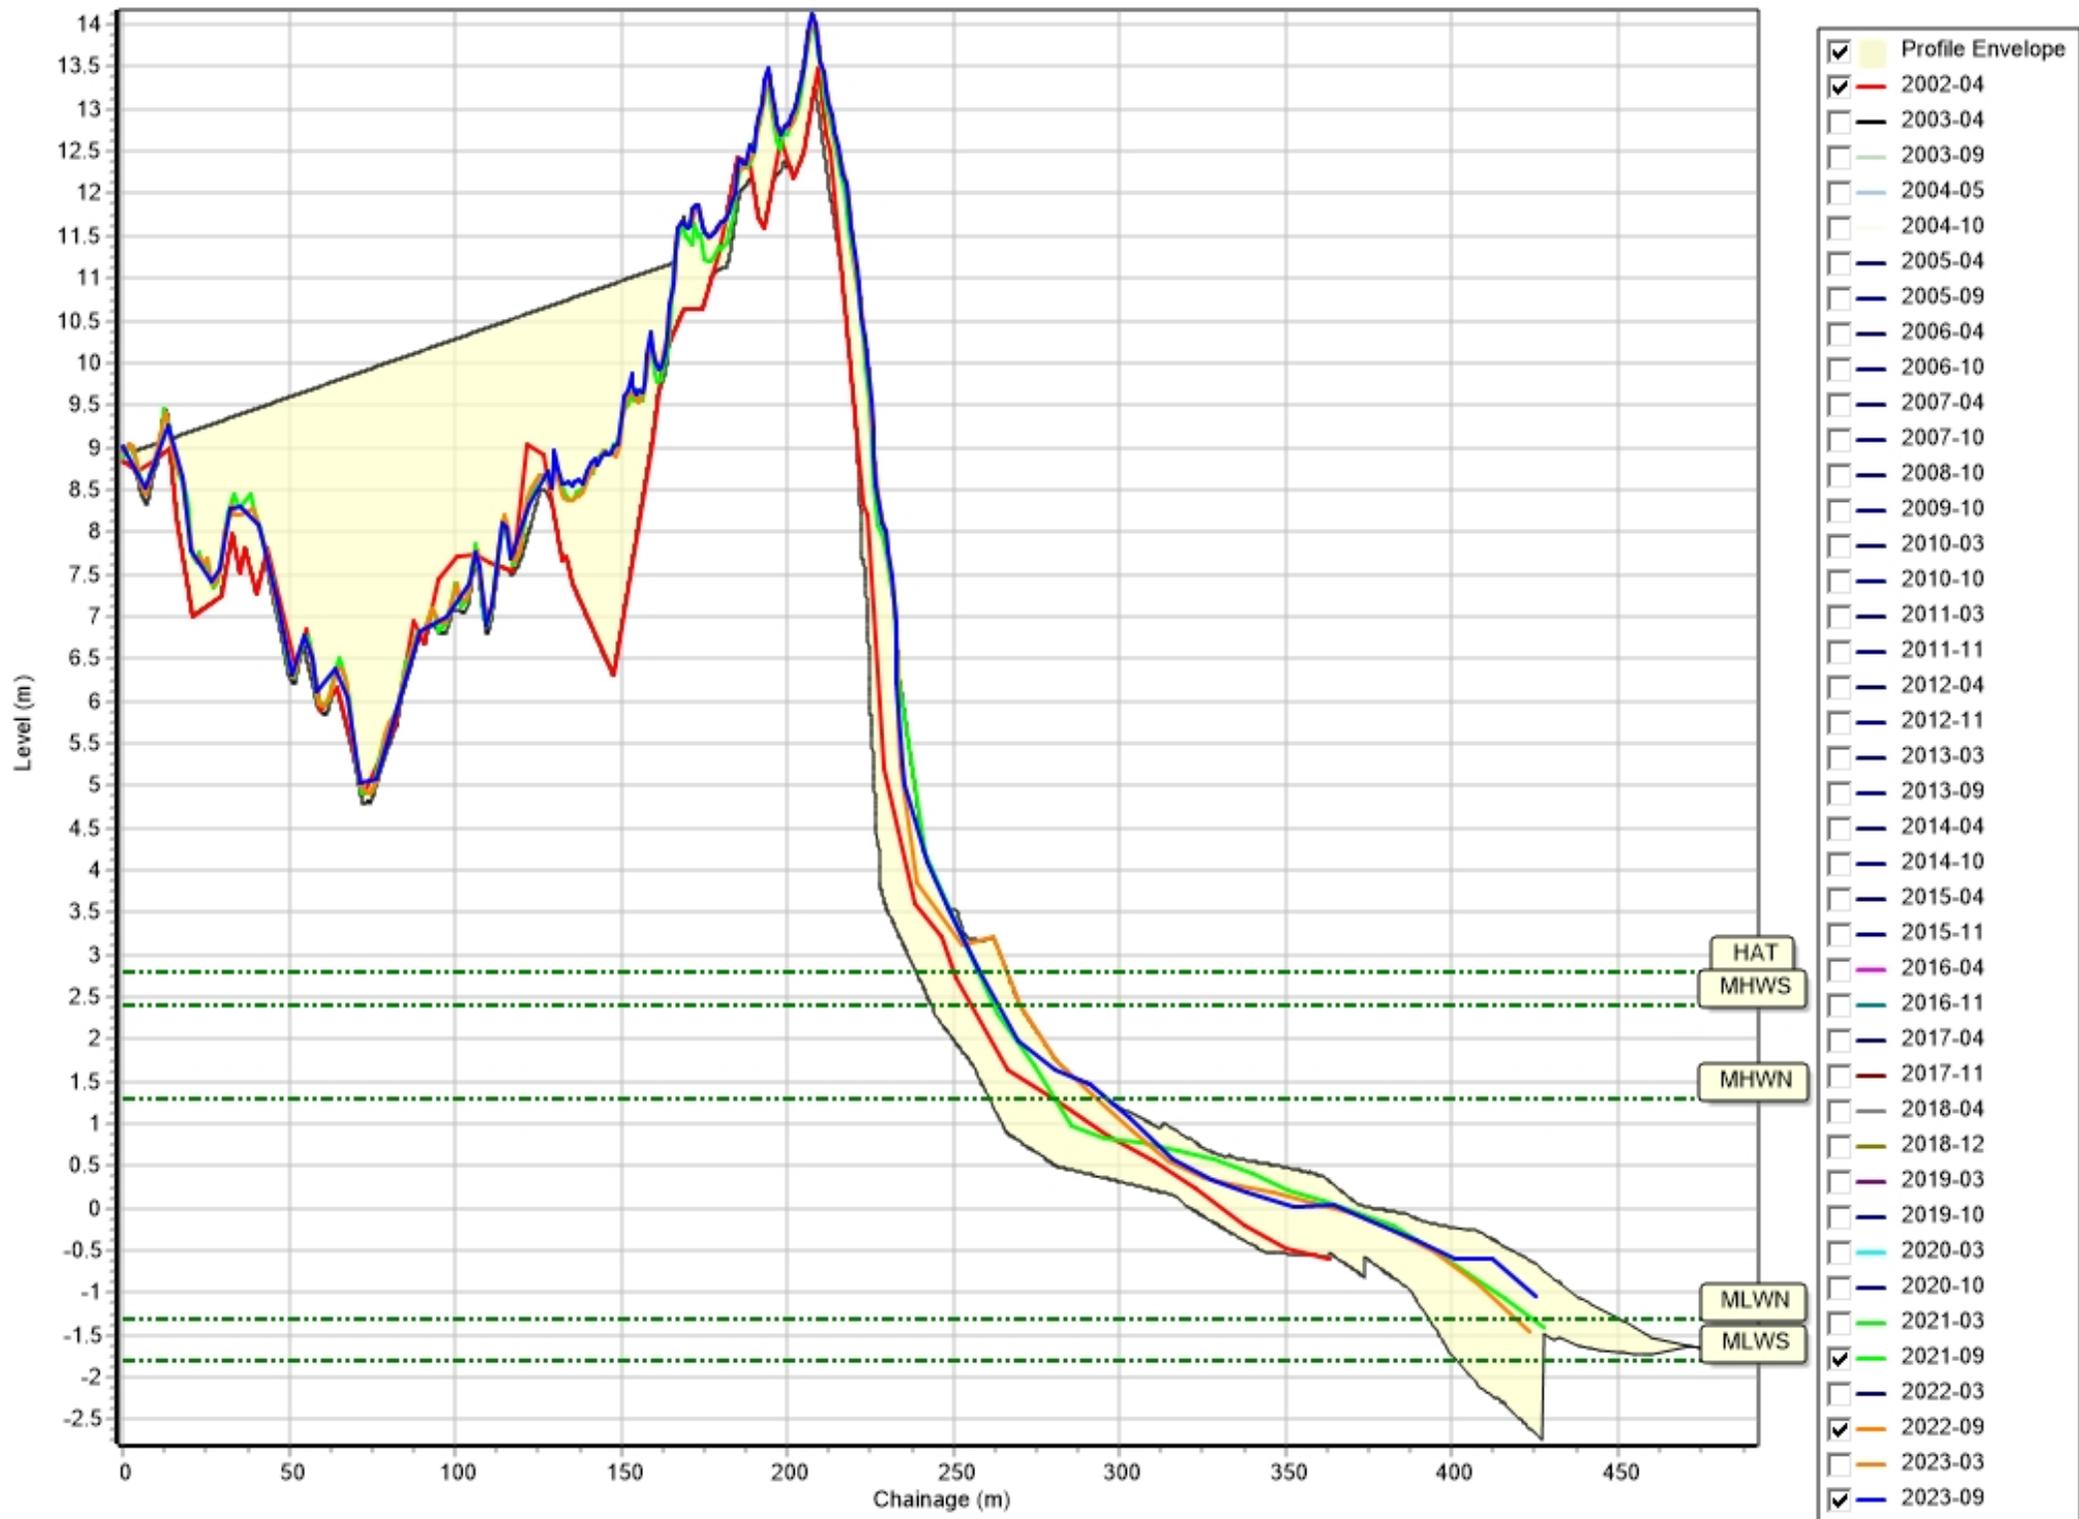
Profiles: 1aBTBC18

- At Spittal (Spittal B), the recorded profiles present no causes for concern.
- At Goswick Sands, the recorded profiles present no causes for concern. The barrier feature in the seaward end of profile 1aBTBC18 shows movement and is likely to be a cyclical feature.

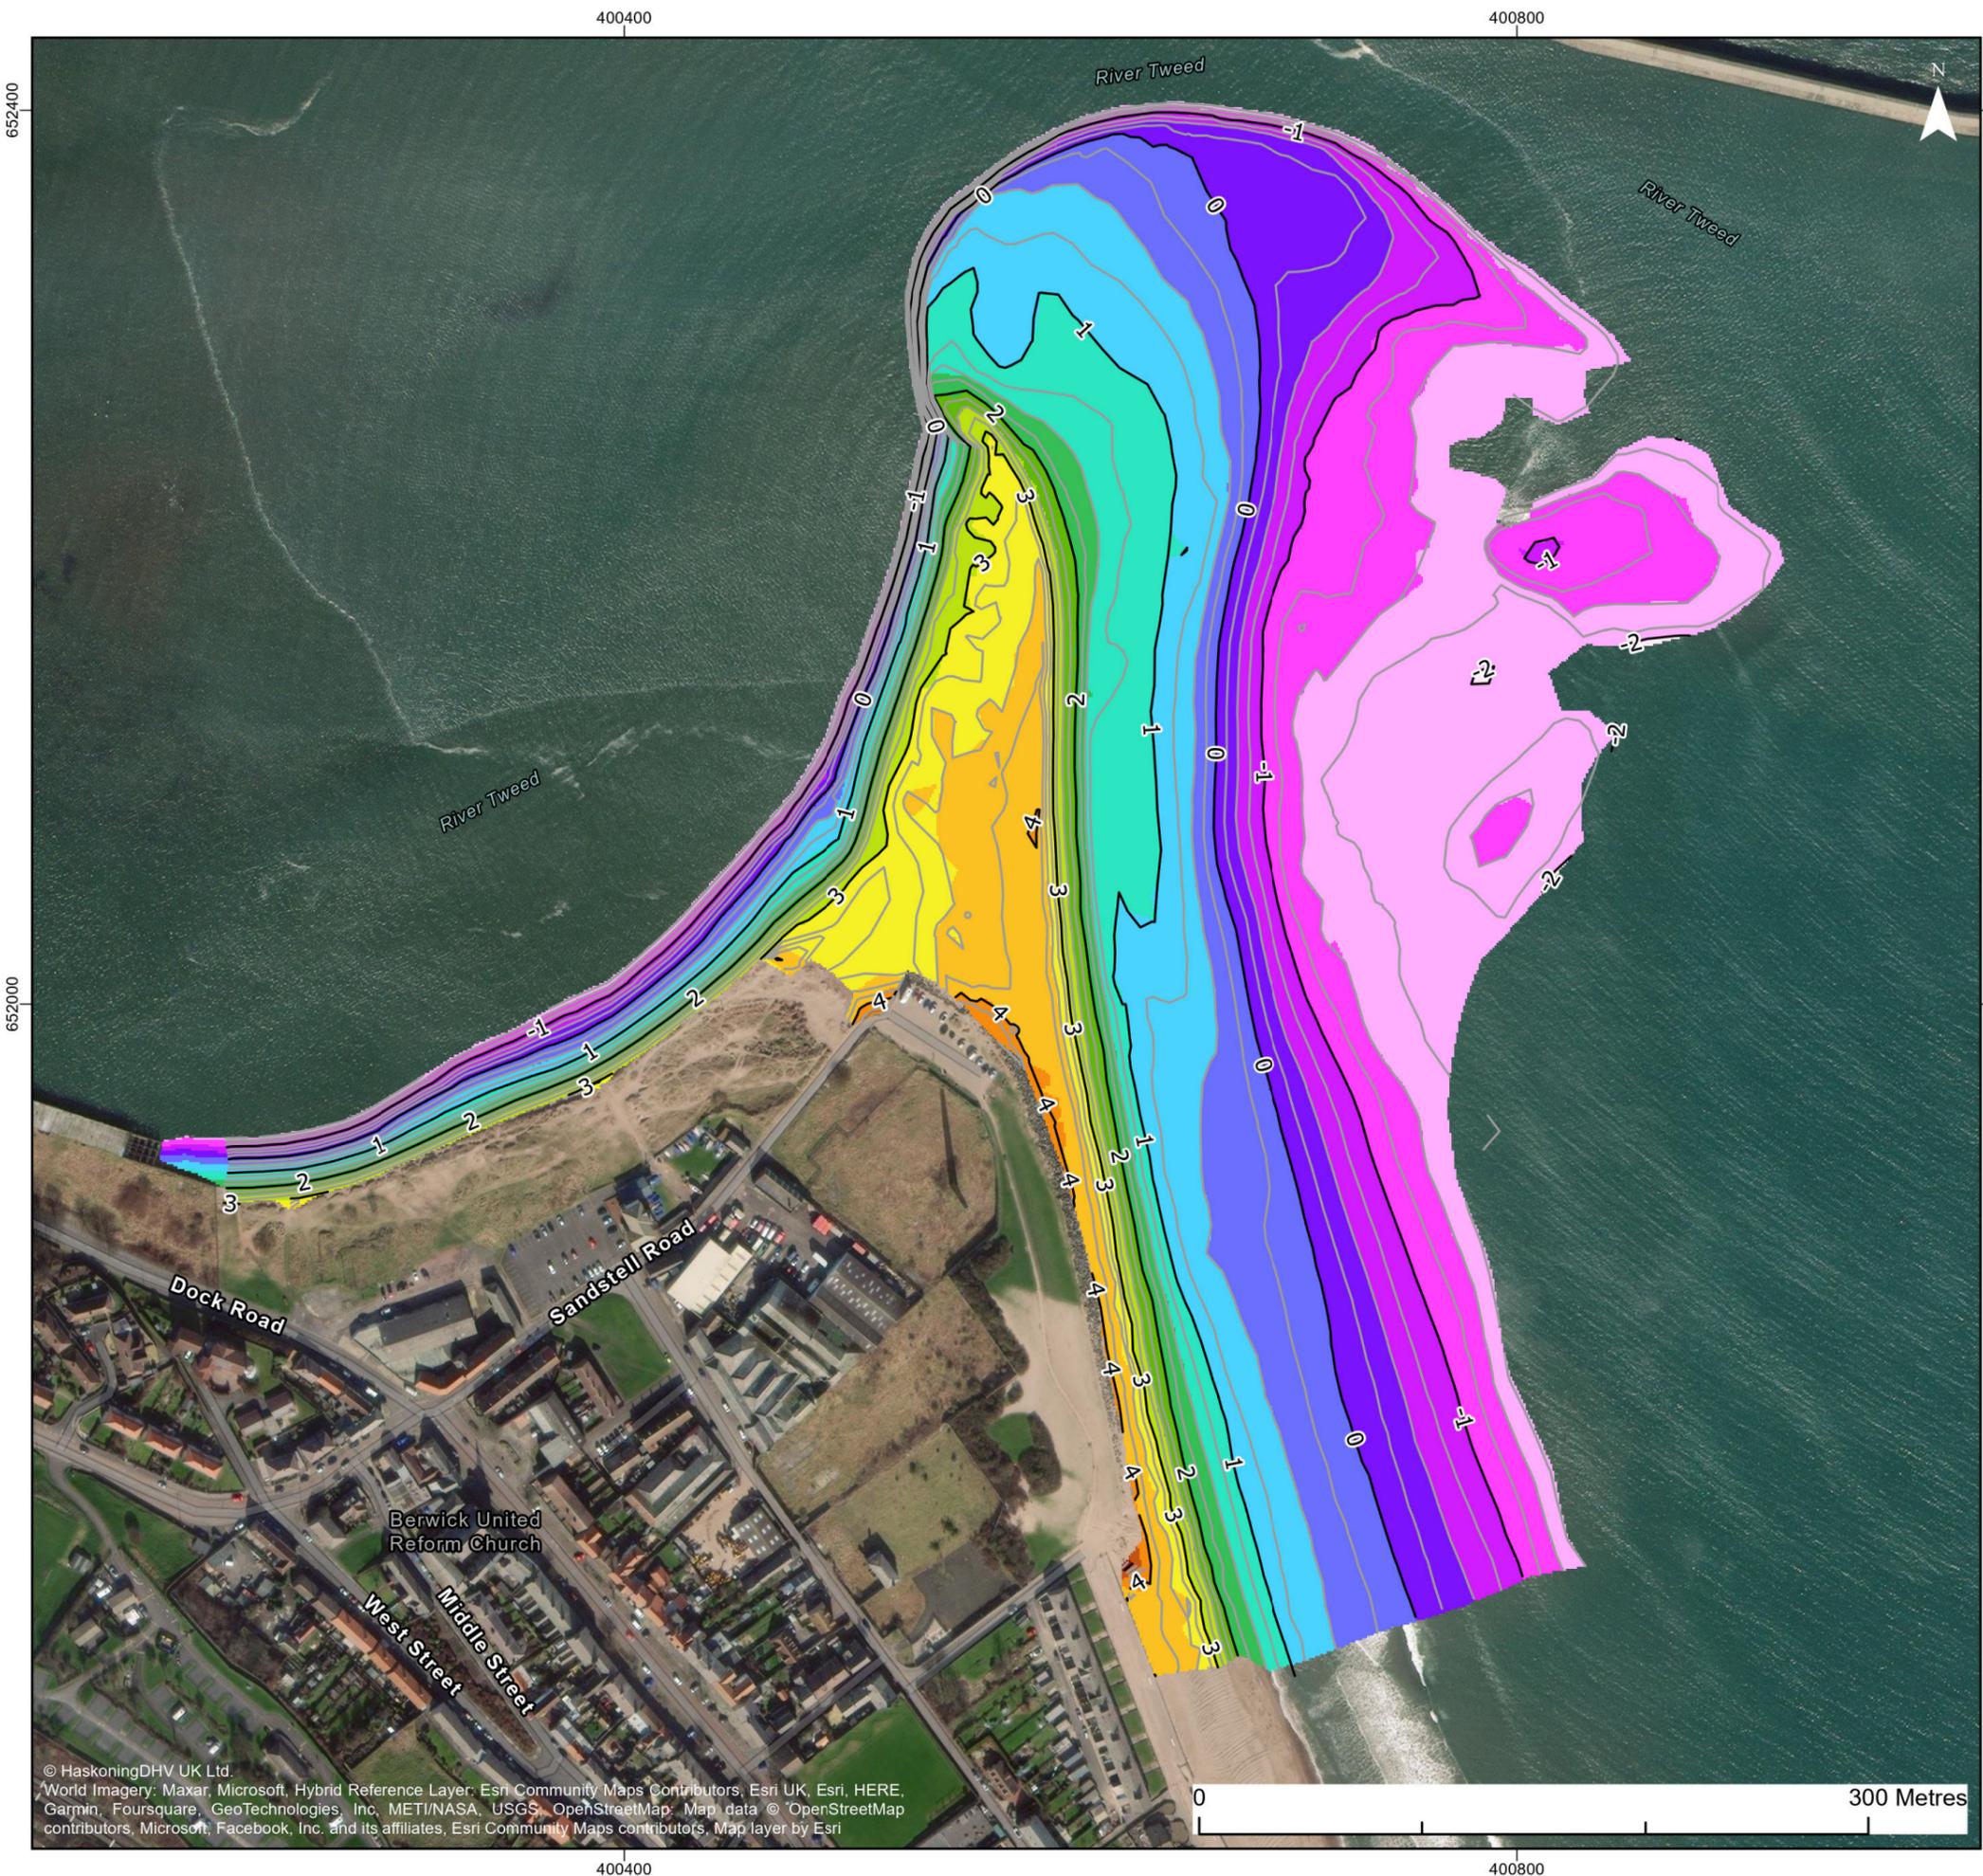
TOPOGRAPHIC SURVEY (August 2023)

Elevation (mOD)	Contours (mOD)*
-2.1 - -2	— 1.0m interval
-1.9 - -1.5	— 0.25m interval
-1.4 - -1	
-0.9 - -0.5	
-0.4 - 0	
0.1 - 0.5	
0.6 - 1	
1.1 - 1.5	
1.6 - 2	
2.1 - 2.5	
2.6 - 3	
3.1 - 3.5	
3.6 - 4	
4.1 - 4.5	
4.6 - 5	
5.1 - 5.5

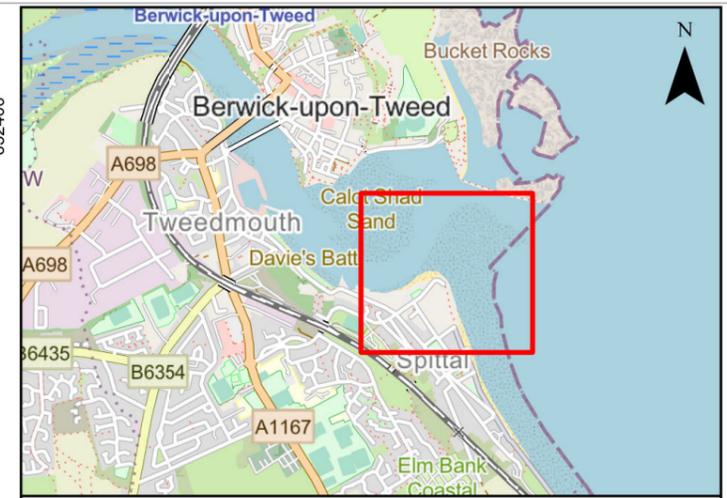
<p>Mar – Aug 2023</p>	<p>Topographic Survey:</p> <p>Due to the significant changes that have been observed from the beach profiles along the spit at Sandstell Point, and the three-dimensional nature of these changes, a topographic survey was introduced to the monitoring programme in November 2011. The previous survey was undertaken for the Partial Measures survey in spring 2023.</p> <p>Data from the most recent topographic survey (Full Measures, autumn 2023) have been used to create a digital ground model (DGM) (Appendix B – Map 1) using a Geographical Information System (GIS). A difference plot has also been produced using the DGM (Appendix B – Map 5) produced from the last topographic survey and the present survey.</p> <p>The difference plot for this survey generally shows; (i) little change in the dunes on the south bank of the River Tweed; (ii) parallel bands of alternating erosion and accretion from the centre of the spit to the seaward side, with high magnitude erosion found on the crest of the spit (2.0m); and (iii) high magnitude accretion on the distal end of the spit facing upstream.</p>	<p>Findings are similar to those seen between spring 2022 and autumn 2022.</p>

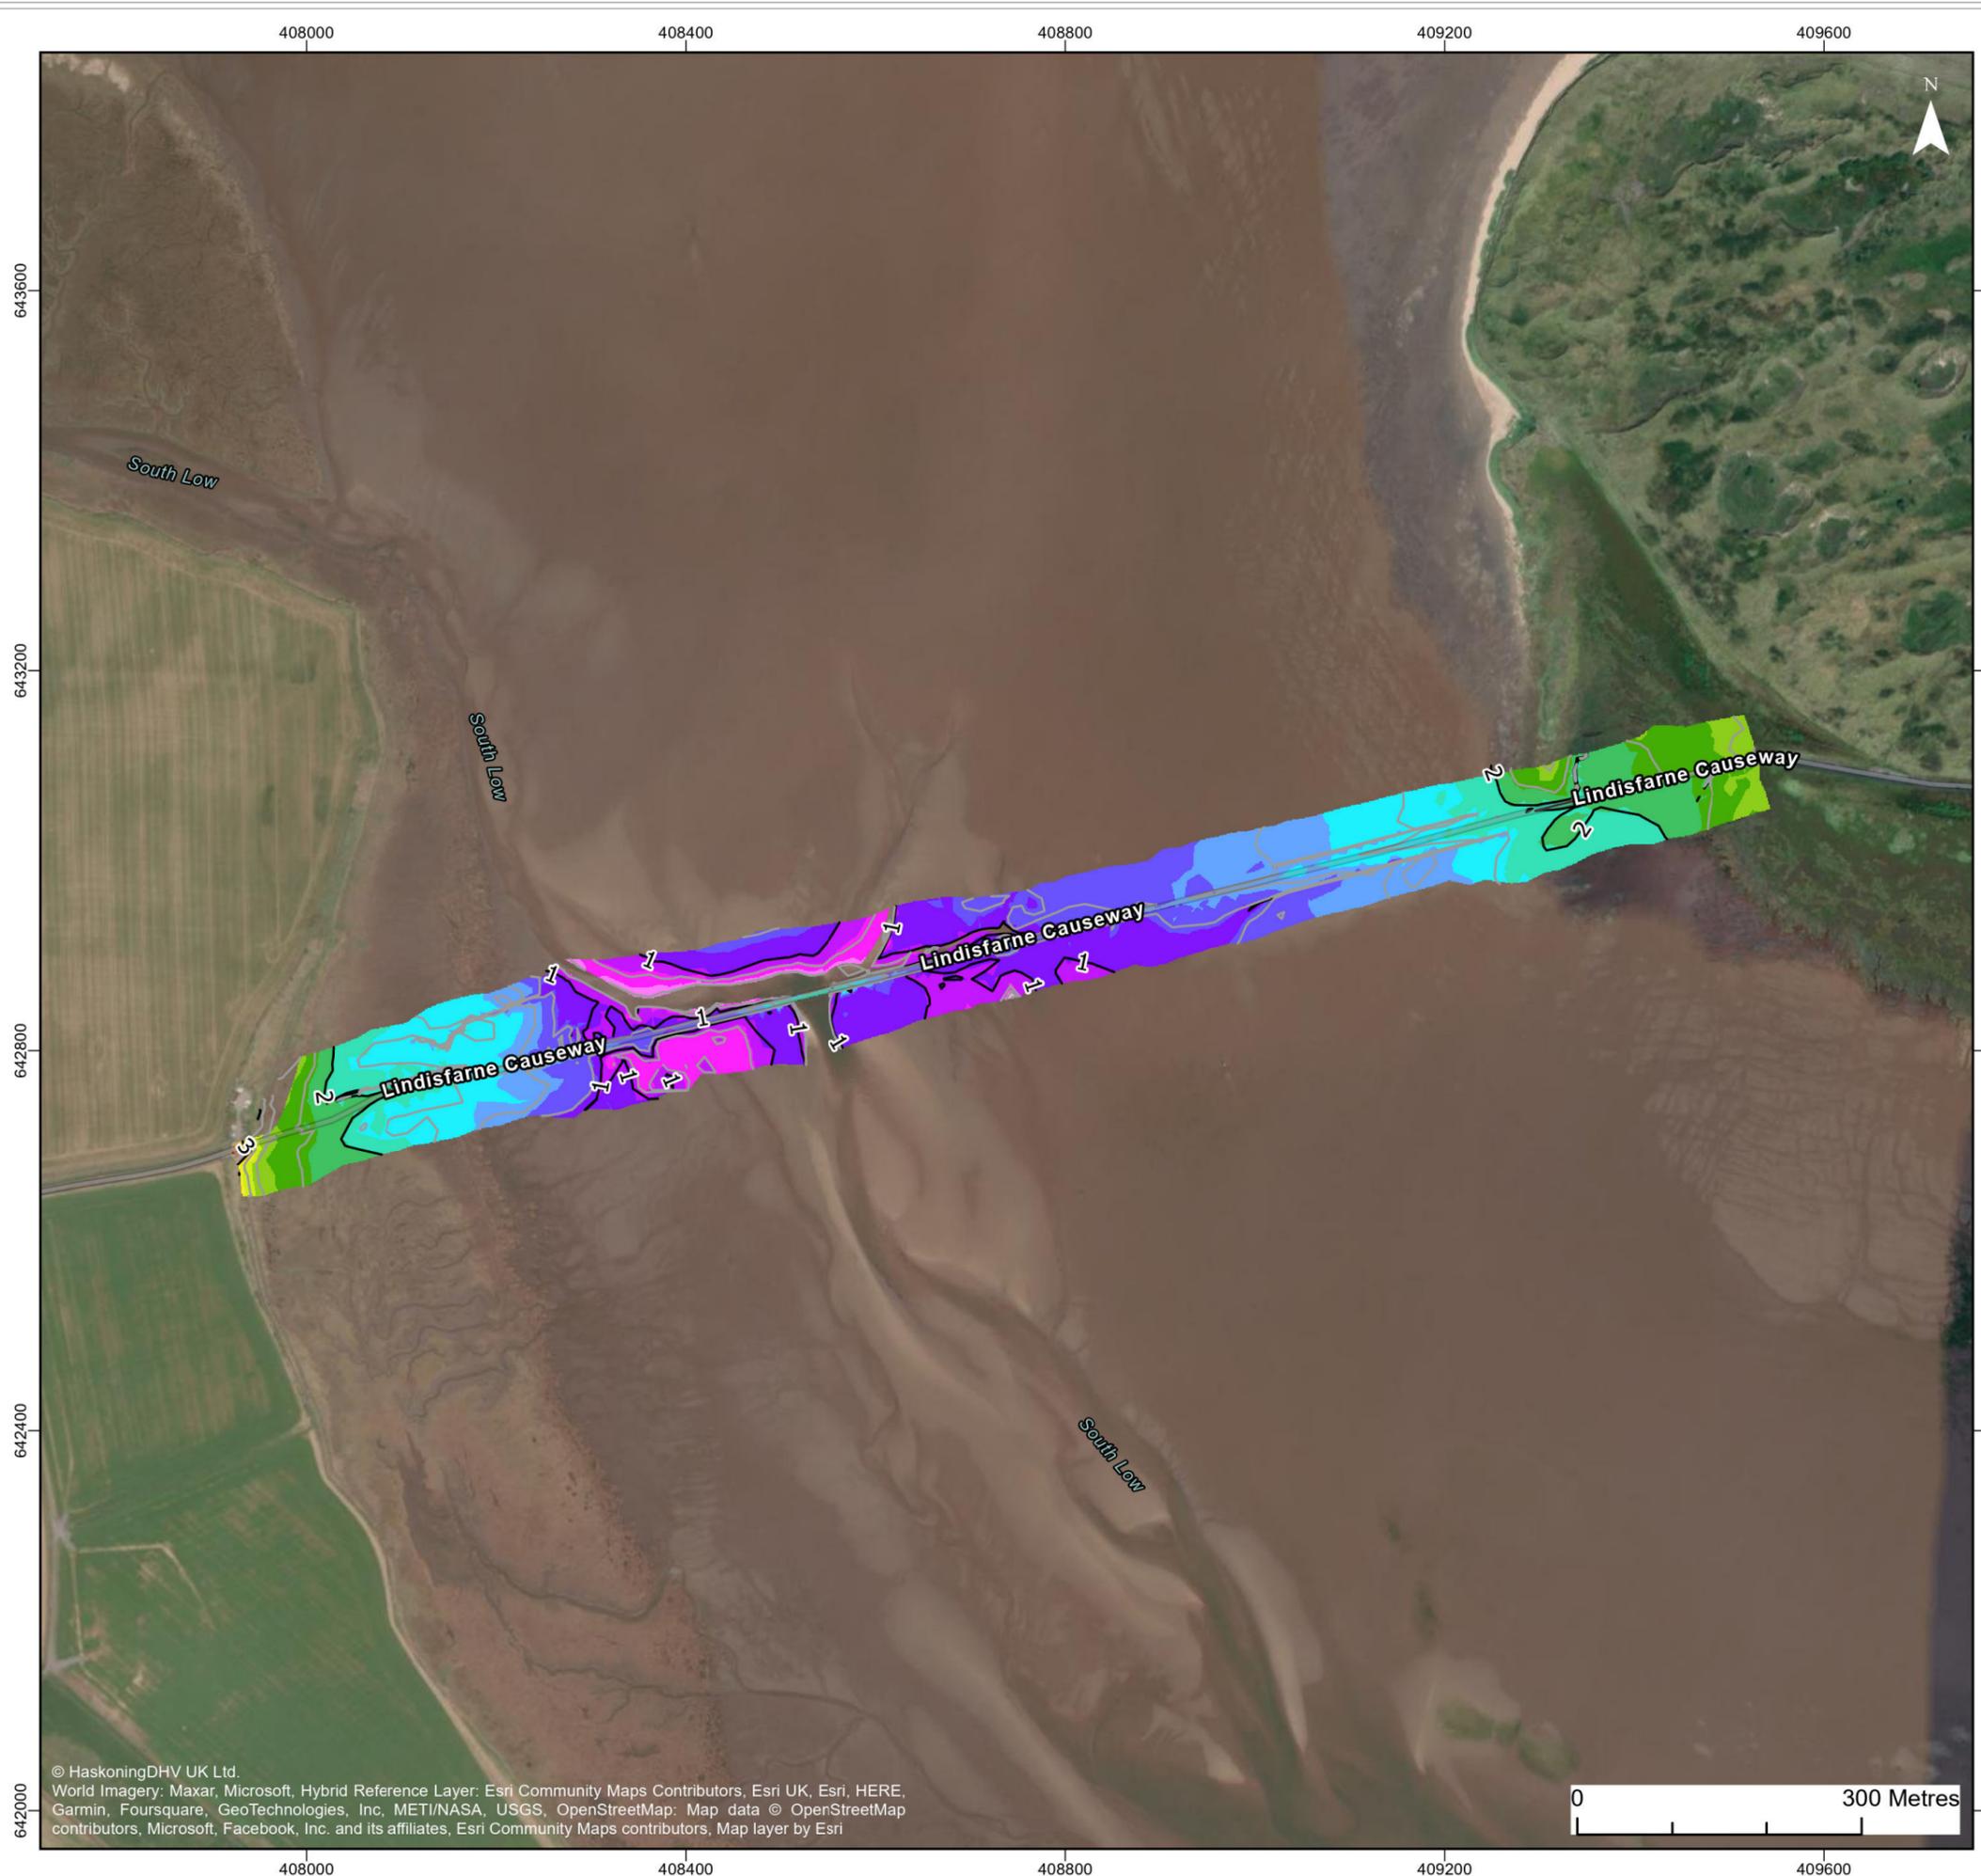
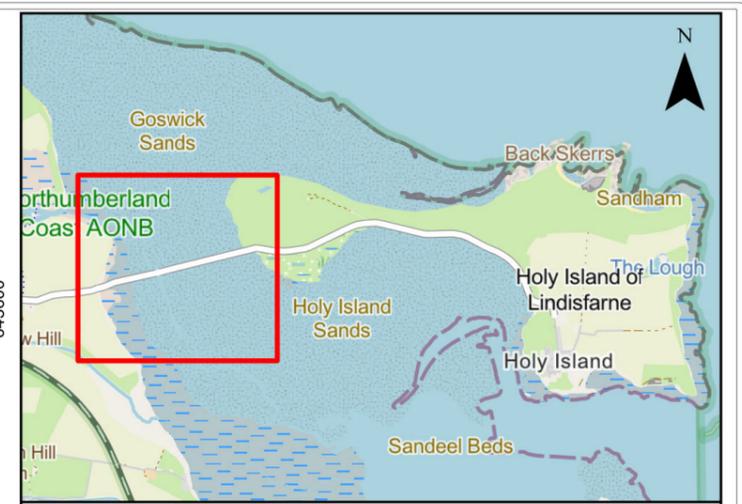
TOPOGRAPHIC SURVEY (August 2023)

<p>Sep 2022 – Aug 2023</p>	<p>Topographic Survey:</p> <p>Holy Island causeway and the adjacent sand flats are covered by an annual topographic survey, which commenced in October 2004. The purpose of this survey was to determine whether raising the level of the causeway had any adverse impacts on the adjacent sand flats.</p> <p>Data from the most recent topographic survey (Full Measures, autumn 2023) have been used to create a DGM (Appendix B – Map 2) using a Geographical Information System (GIS). A difference plot has also been produced using the DGM (Appendix B – Map 6) produced from the last produced topographic survey (Full Measures, autumn 2022) and the present survey.</p> <p>The difference plot shows overall stability with minimal pockets of elevation change in the order of +/- 0.75m. The main area of change is in the centre of the South Low channel.</p> <p>The survey report notes that new ditches are being dug on either side of the causeway in an attempt to trap sand from accumulating on the causeway.</p>	<p>The topographic survey shows that the causeway has remained stable since the last survey.</p>

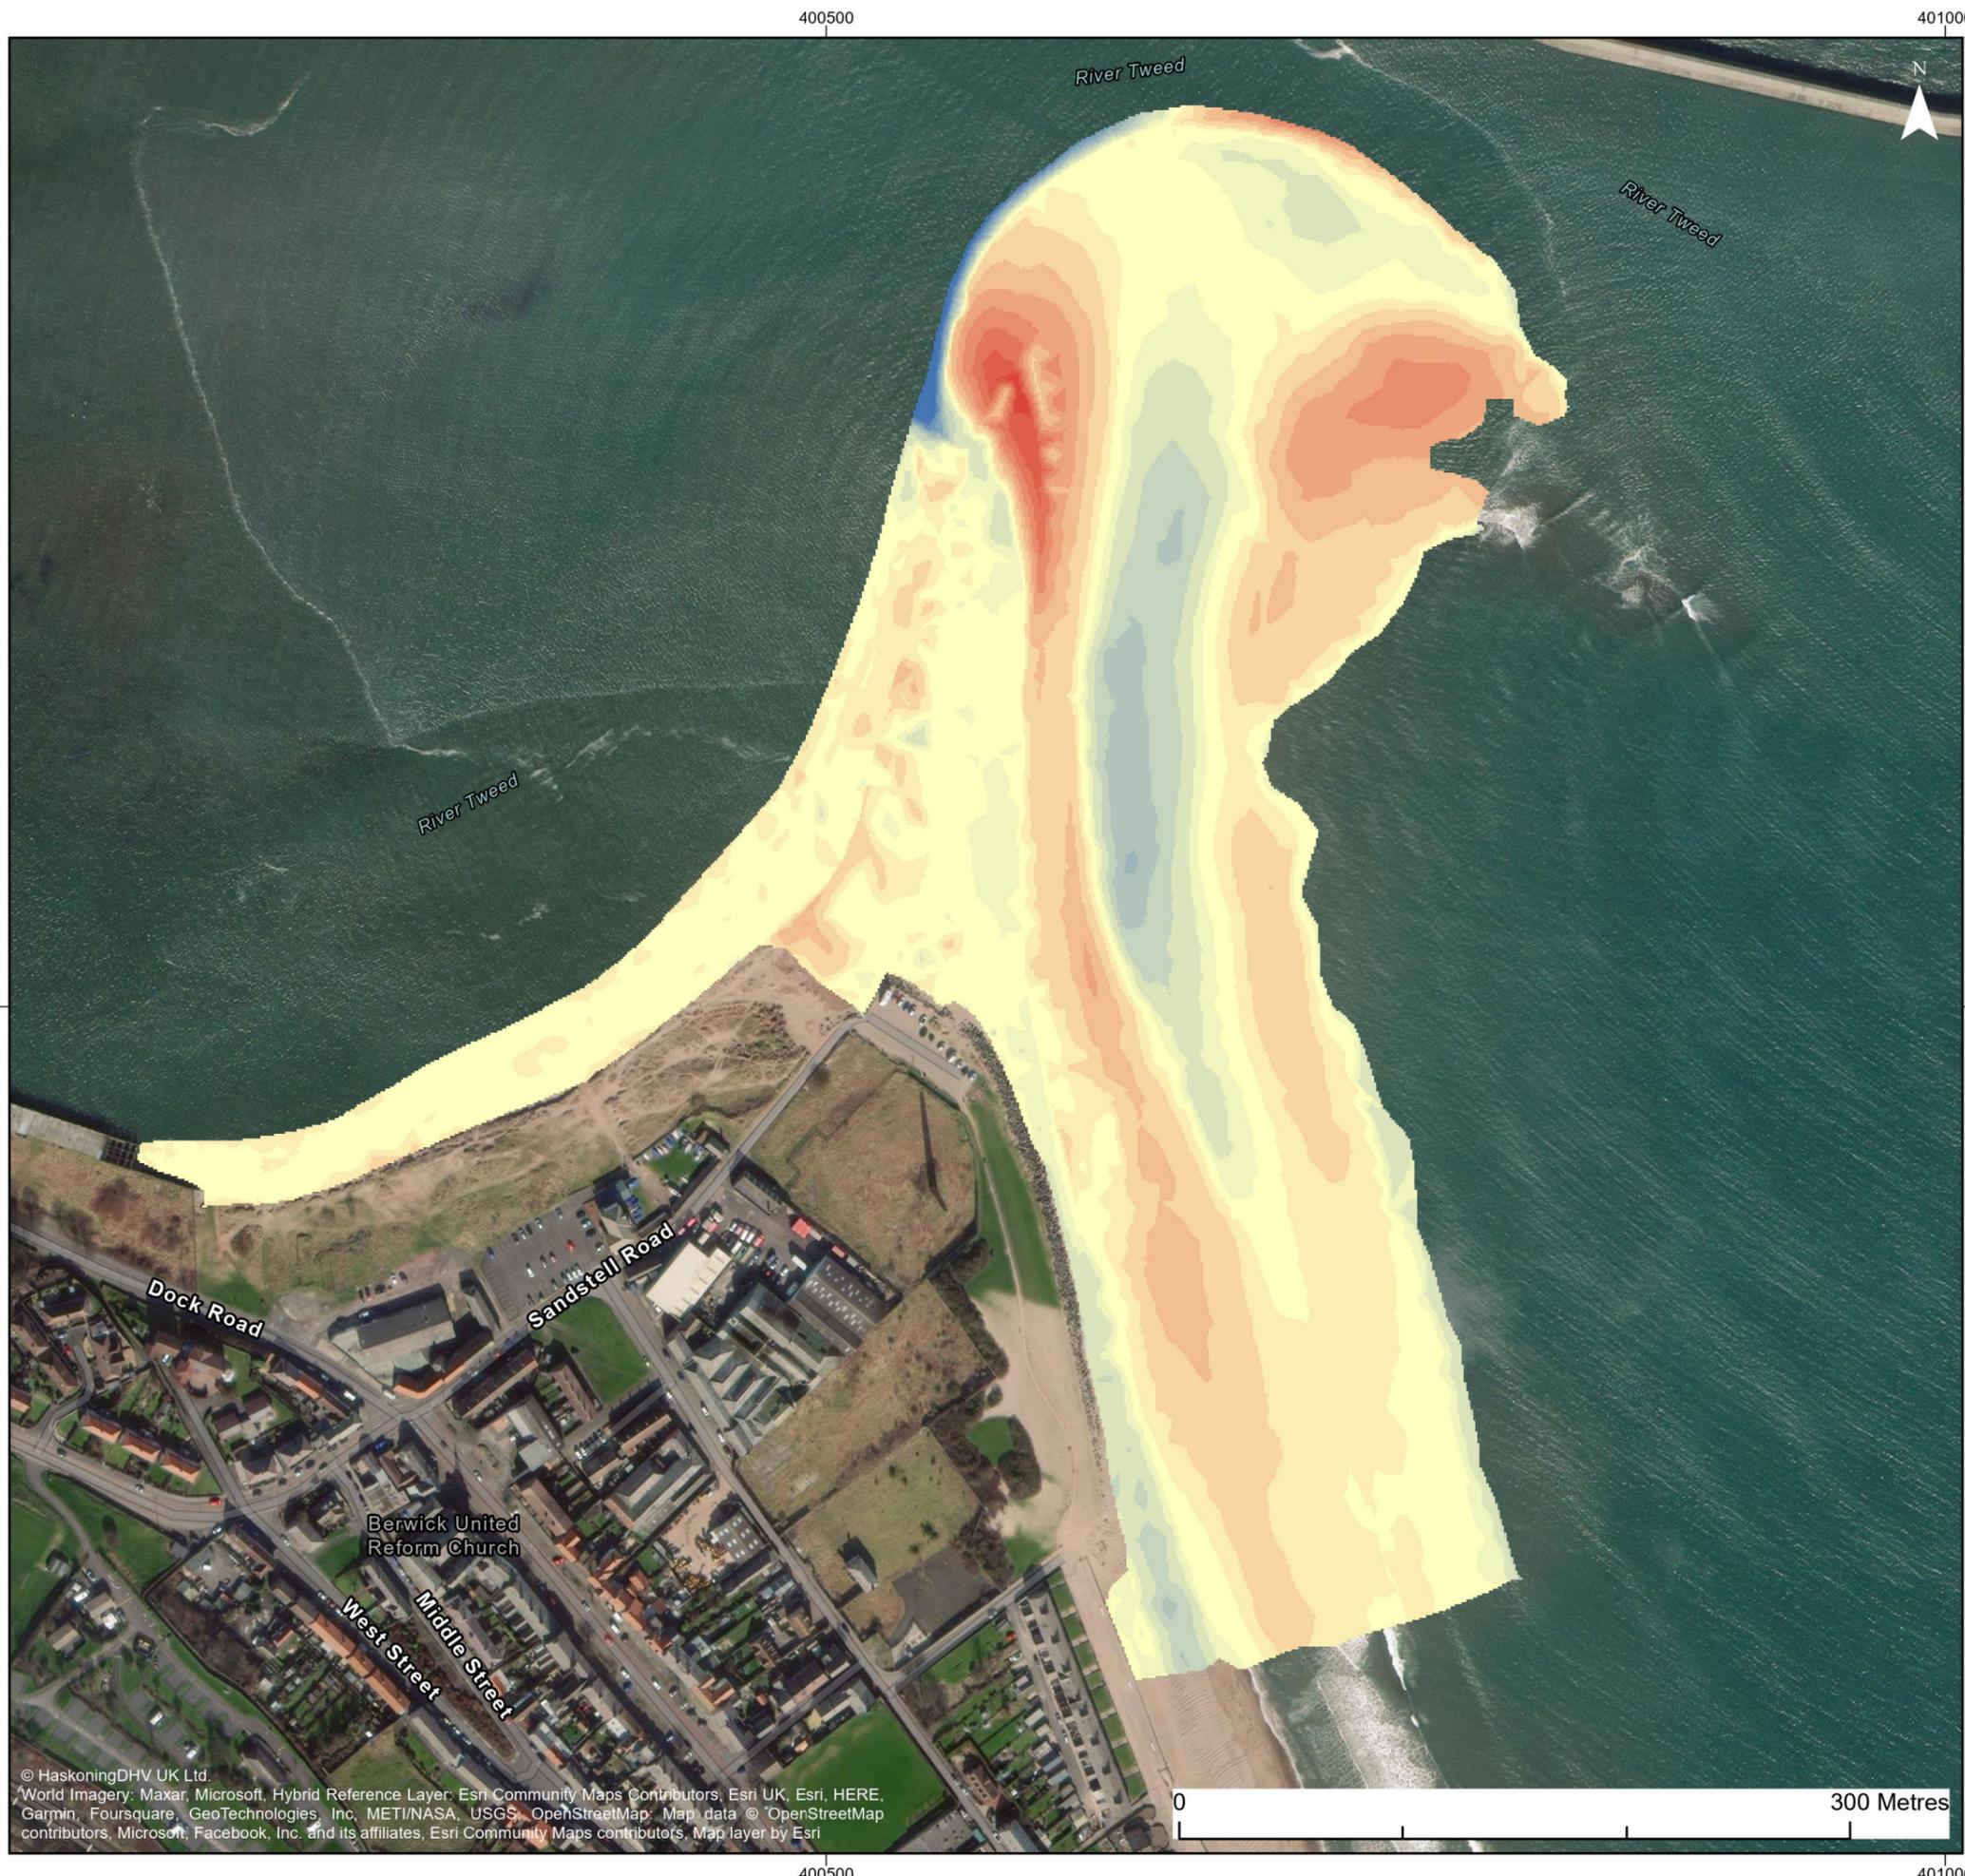
Difference between topographic surveys

(Mar 2023 to Aug 2023)

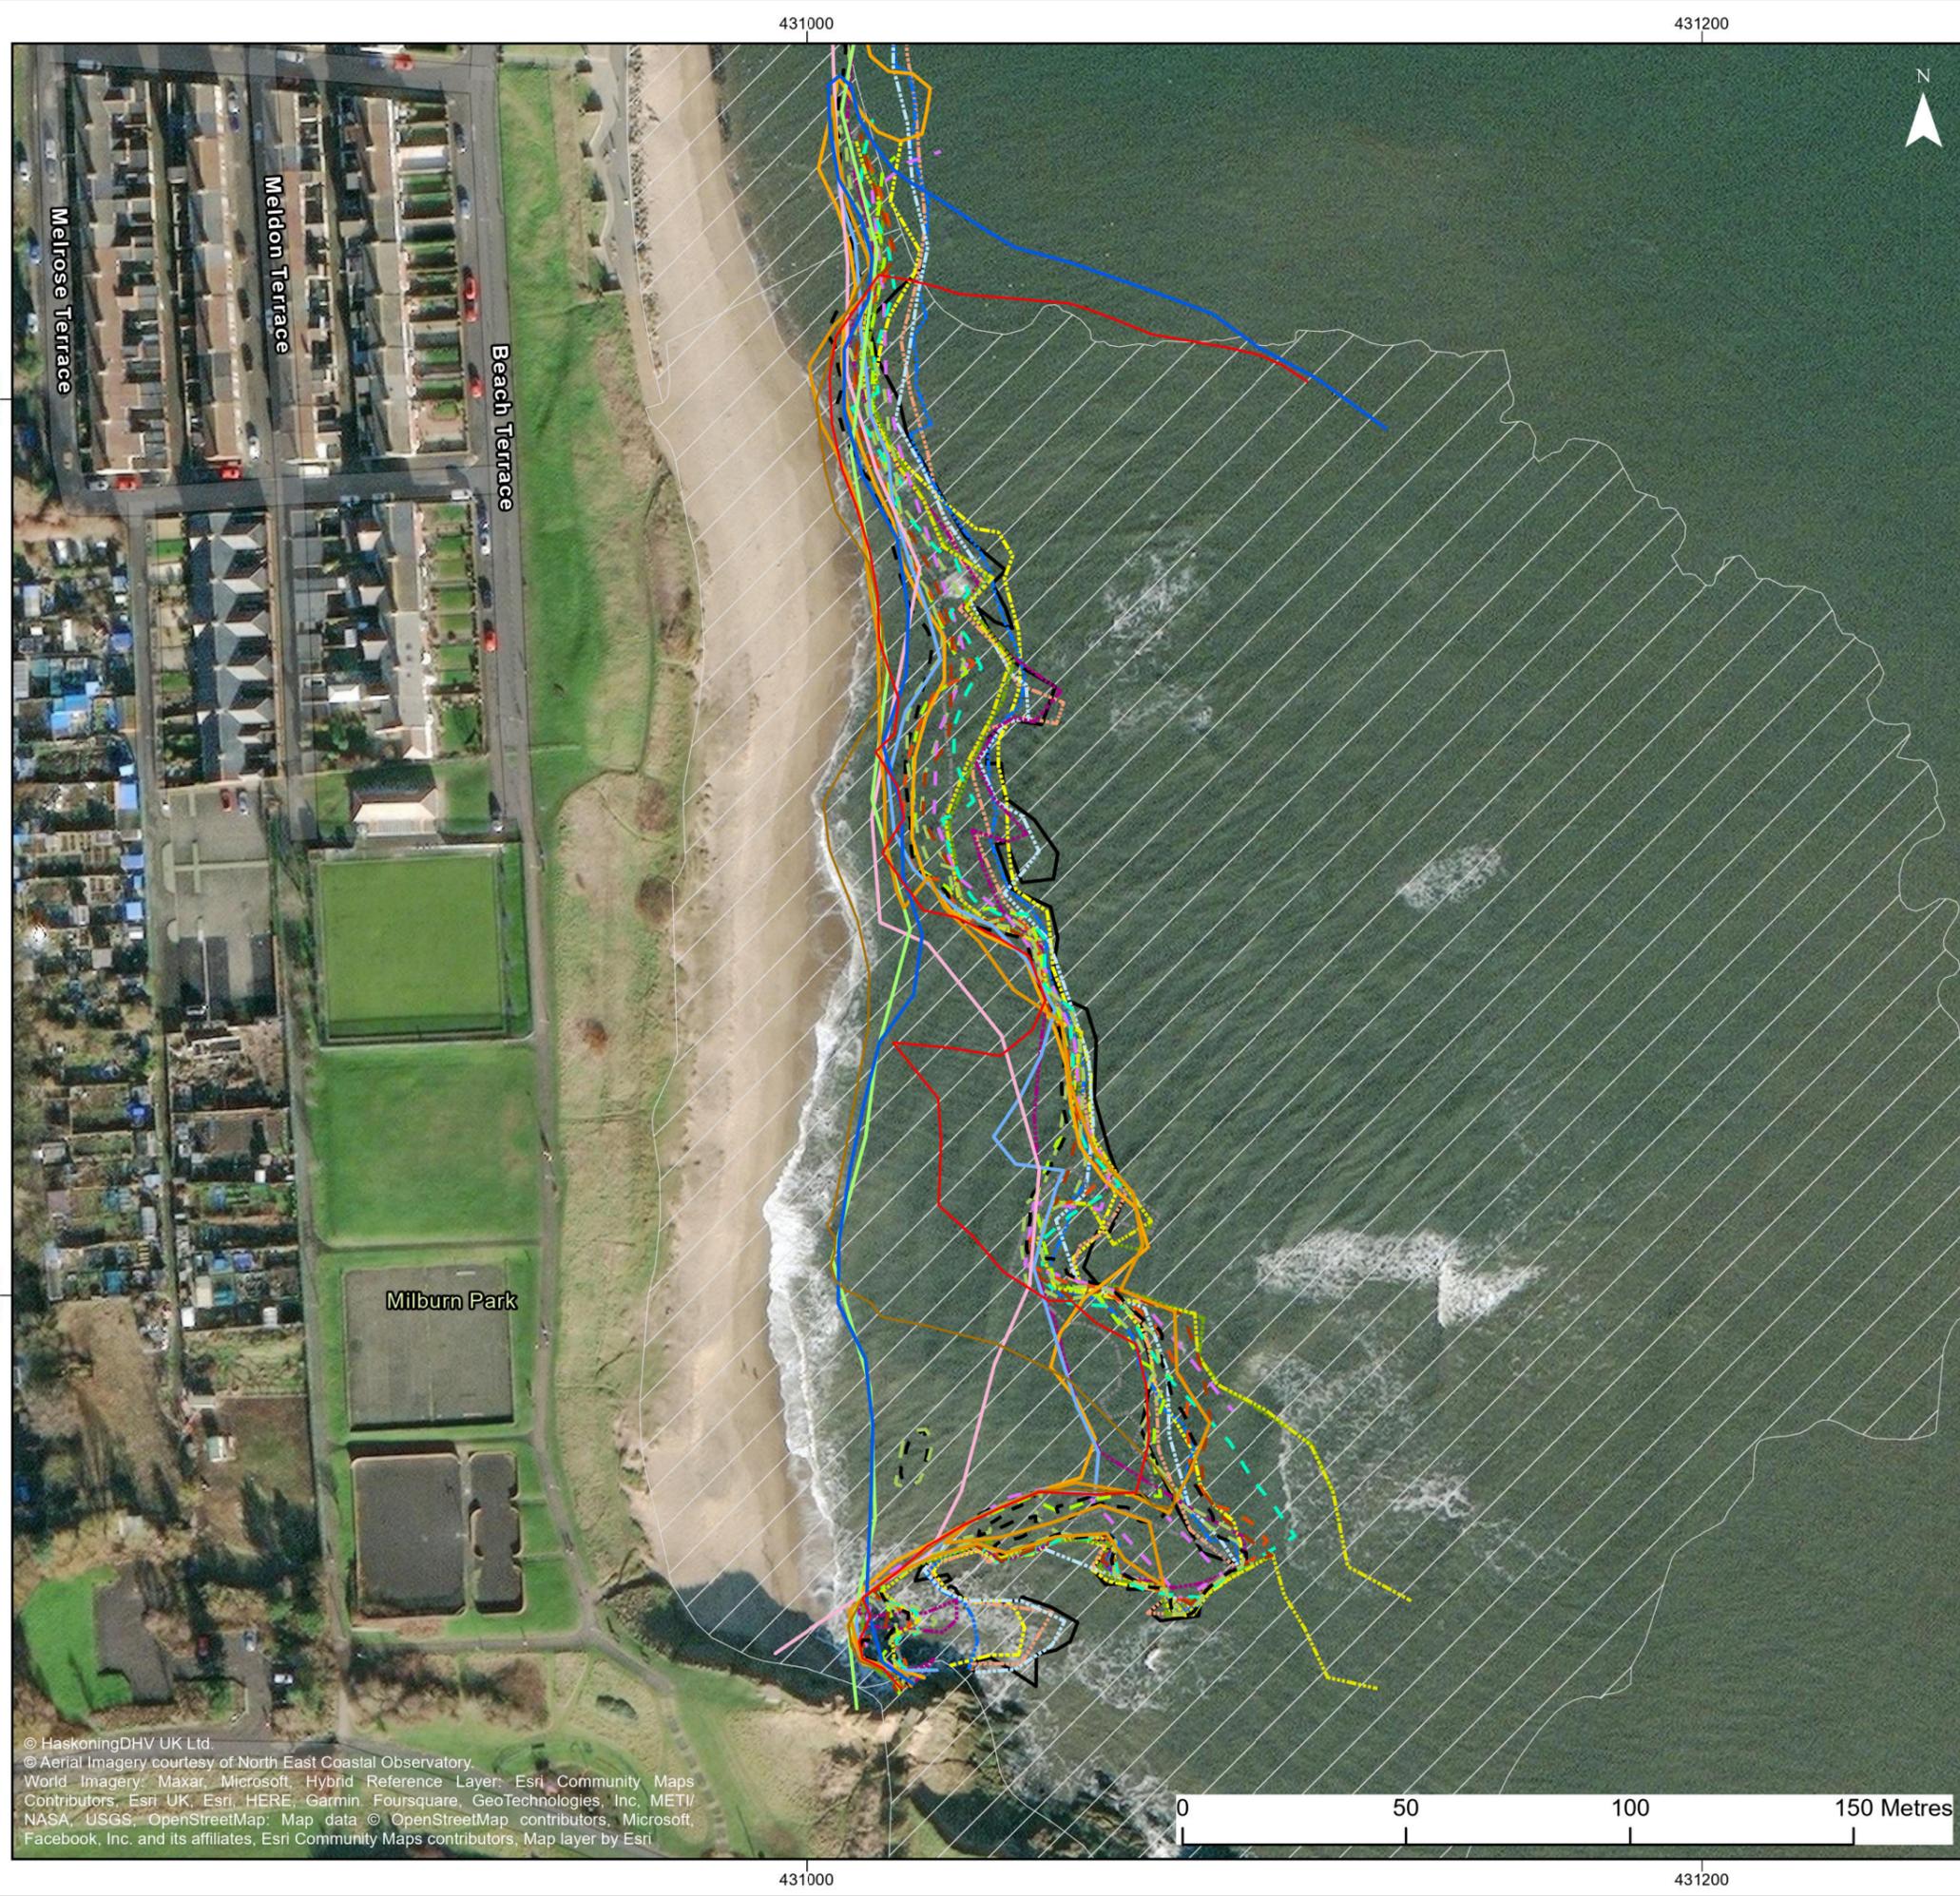
SAND EXTENT

— Autumn 2023	— Autumn 2011
— Spring 2023	— Spring 2012
— Autumn 2022	— Autumn 2012
— Spring 2022	— Spring 2013
— Autumn 2021	— Autumn 2013
— Spring 2021	— Spring 2014
— Autumn 2020	— Autumn 2014
— Spring 2020	— Spring 2015
— Autumn 2019	— Autumn 2015
— Spring 2019	— Spring 2016
— Autumn 2018	— Autumn 2016
— Spring 2018	— Spring 2017
— Autumn 2017	□ Site of Special Scientific Interest (SSSI)

- Edge of sand survey at Newbiggin Bay, Spital Carrs, (commenced 2011 to determine potential adverse impact on foreshore SSSI of the Newbiggin beach recharge scheme)
