**Cell 1 Regional Coastal Monitoring Programme  
Update Report 2: 'Partial Measures' Survey 2010**

**Figure 1 - Map 1  
 Northumberland County  
 Council Frontage**

Update Report 2  
 'Partial Measures' Survey 2010

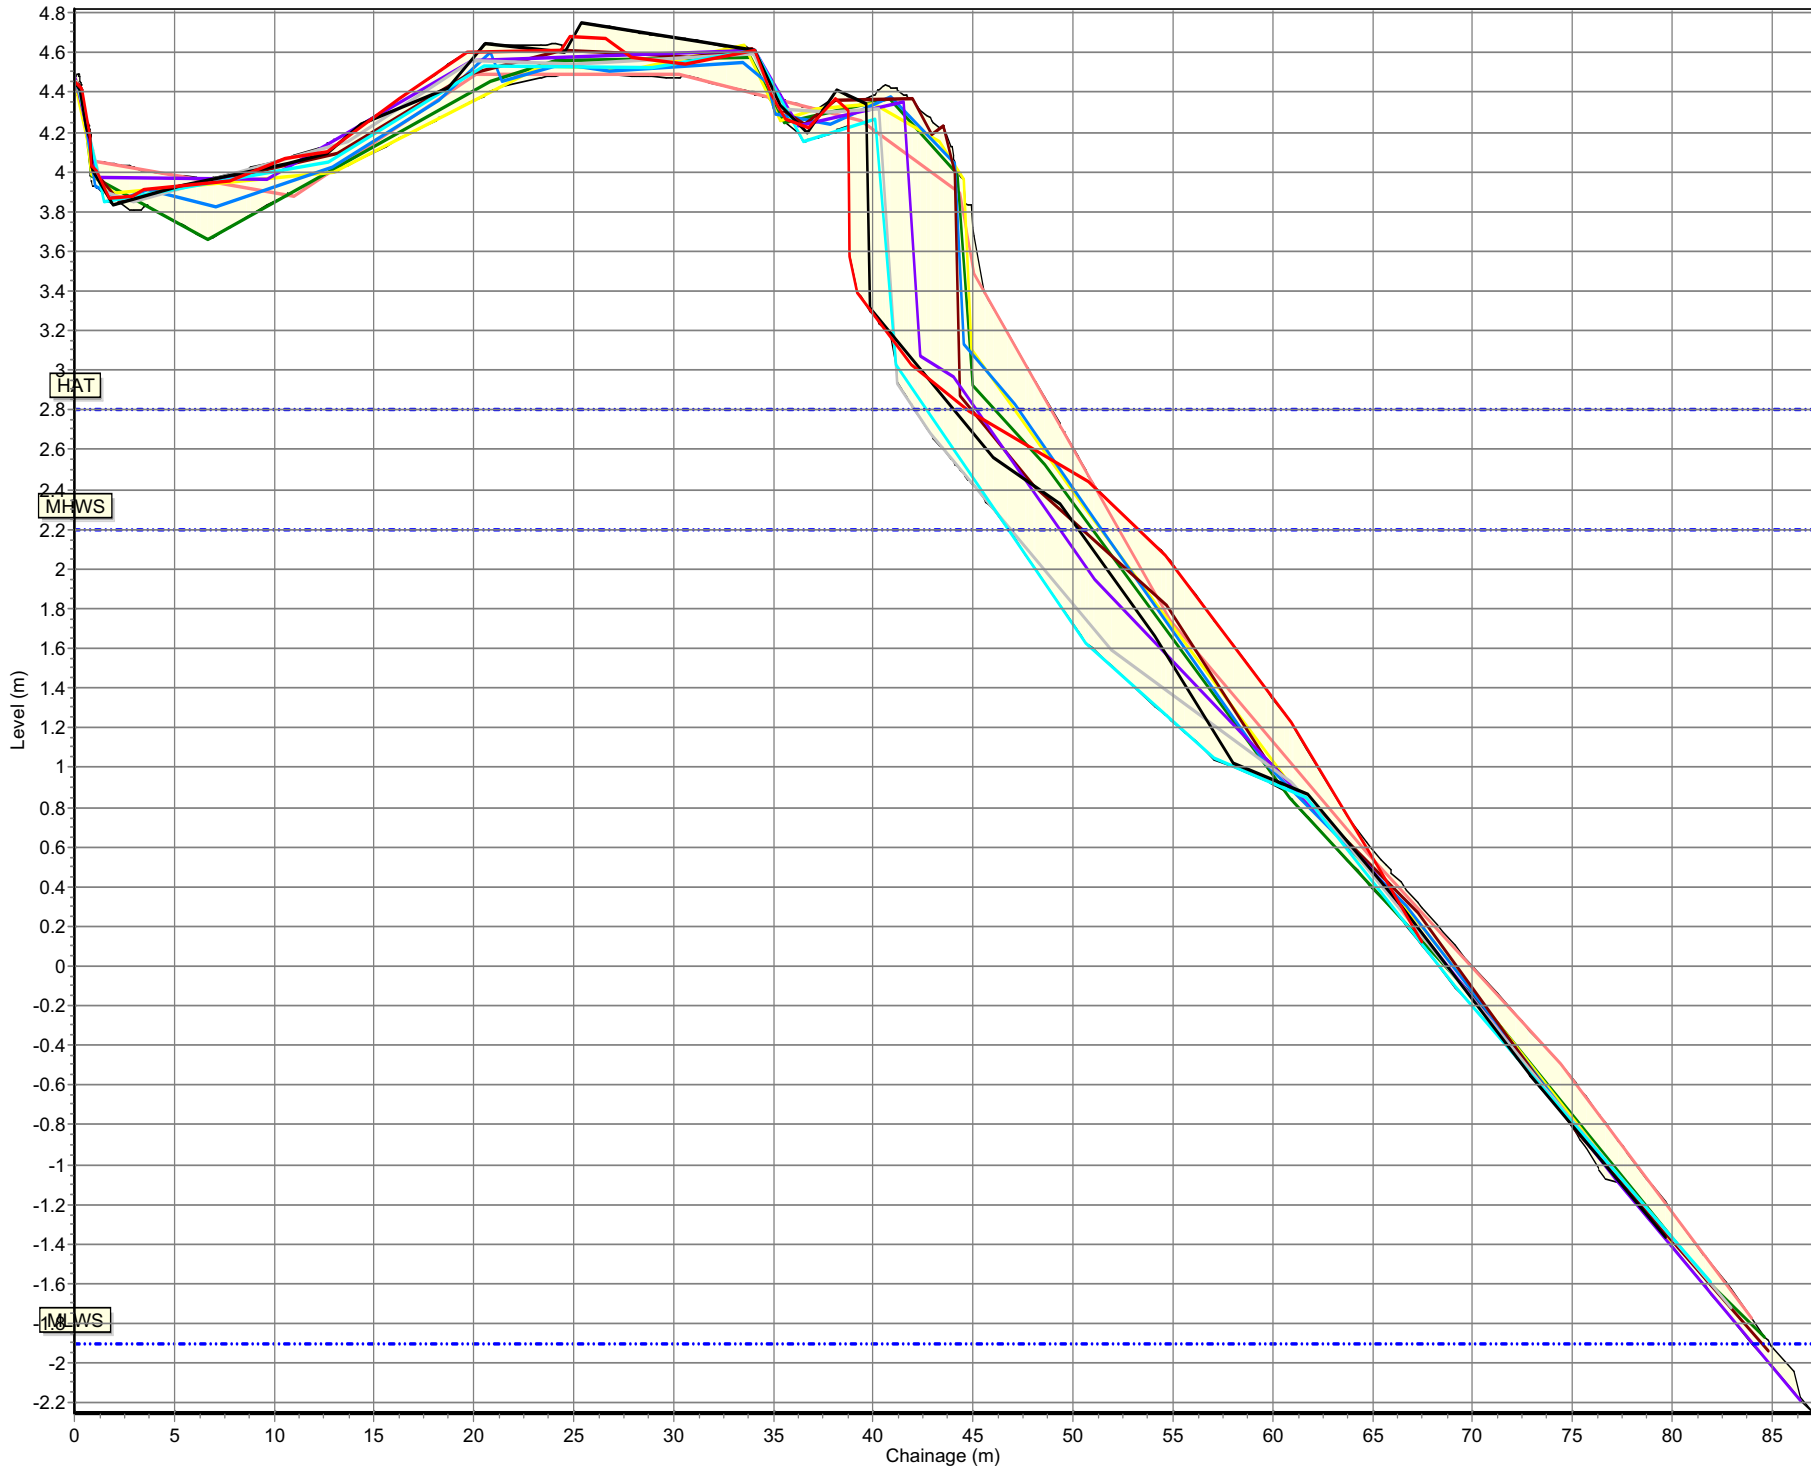
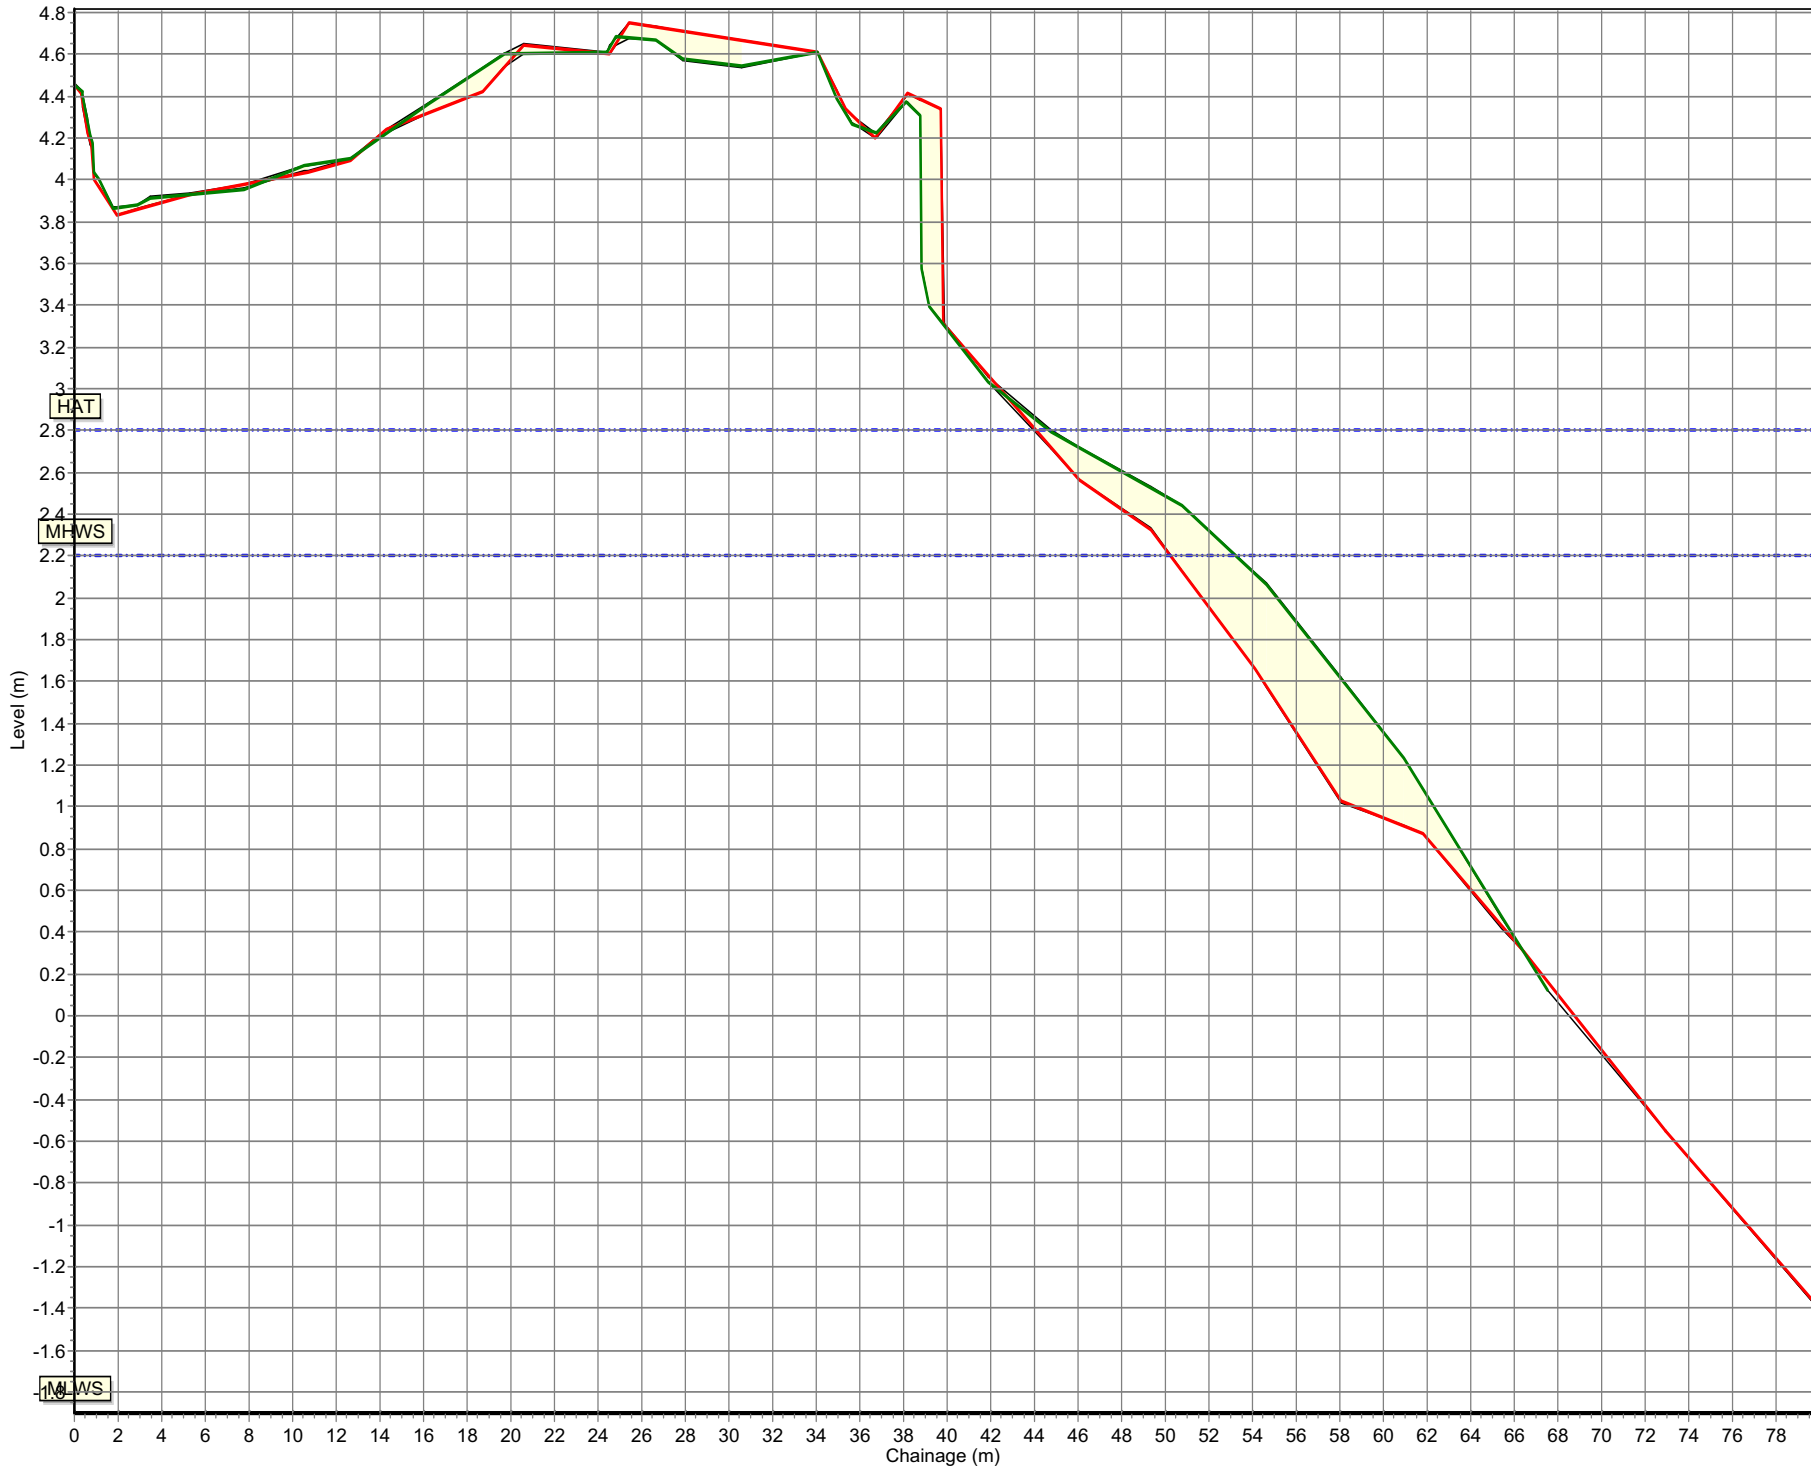
Beach Profiles: 1aBTBC02

- Profiles Envelope
- 01/04/2002
- 01/03/2003
- 01/09/2003
- 15/04/2004
- 15/10/2004
- 15/04/2005
- 18/10/2005
- 21/04/2006
- 10/11/2006
- 04/04/2007
- 15/10/2007
- 30/04/2008
- 21/10/2008
- 12/03/2009
- 21/09/2009
- 18/02/2010
- 31/03/2010

- Profiles Envelope
- 18/02/2010
- 31/03/2010

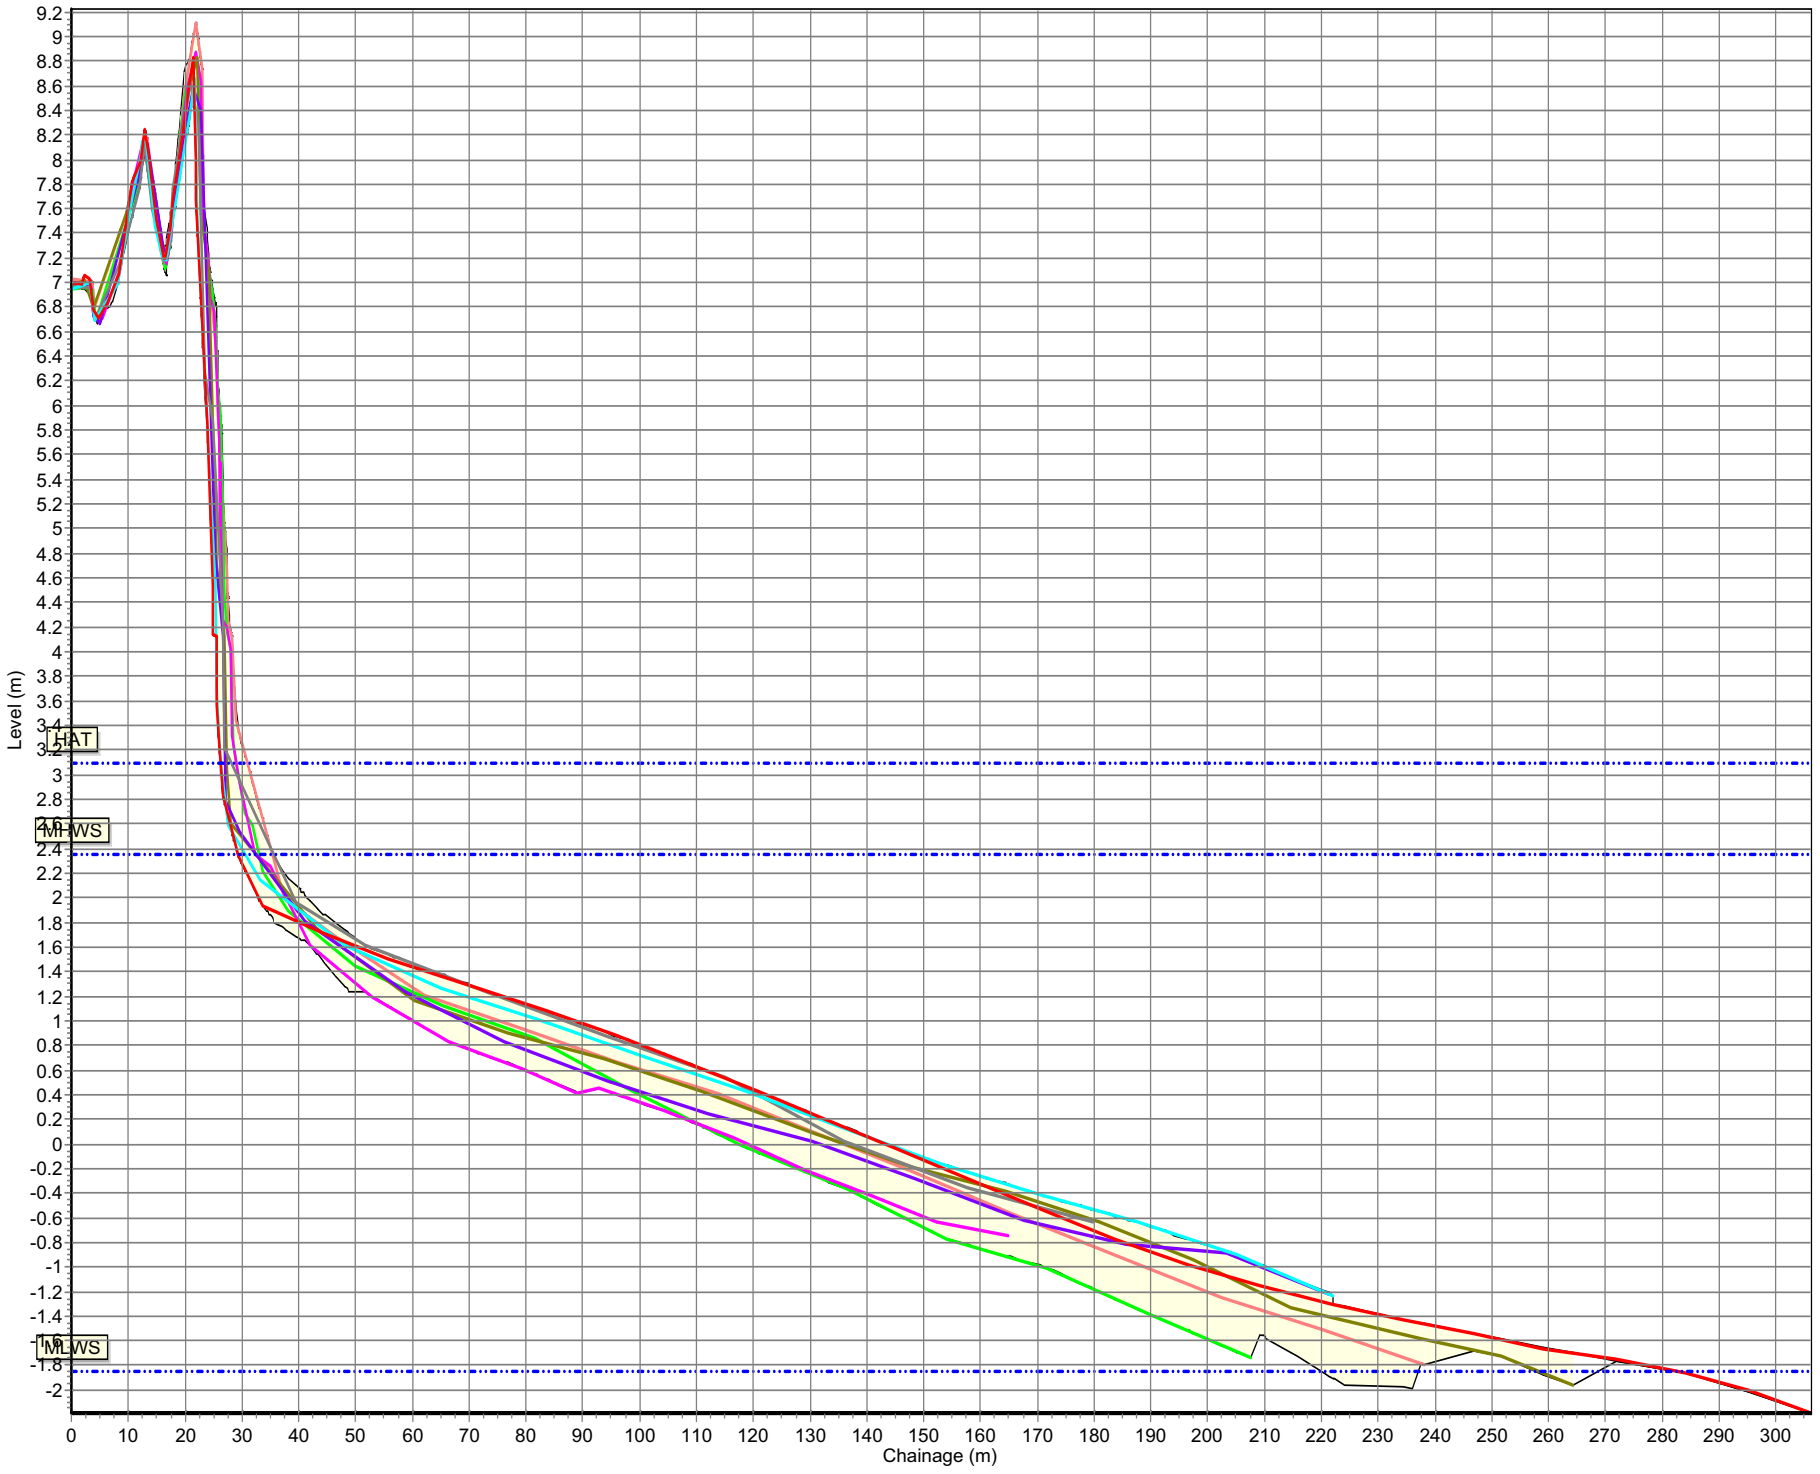
Beach Profiles: 1aADC17

- Profiles Envelope
- 01/03/2003
- 01/09/2003
- 15/04/2004
- 15/10/2004
- 15/04/2005
- 18/10/2005
- 21/04/2006
- 10/11/2006
- 04/04/2007
- 15/10/2007
- 30/04/2008
- 21/10/2008
- 10/03/2009
- 23/09/2009
- 19/02/2010
- 01/04/2010

Survey Date	Description of Changes Since Last Survey	Interpretation
	<p>Profile ADC17A also experienced cut-back of the toe of the dunes although, again, a previous survey (this time April 2008) had recorded a more landward position. Foreshore lowering extended down the upper beach from the toe of the dunes to a chainage of around 42m, but further seaward along the profile accretion was recorded, first a modest increase in levels and then, around MSL, through the formation of a large berm. The storm at the end of February 2010, caused the subsequent April 2010 survey to reveal a flattening of this berm, with some increase in mid beach levels caused by sediment redistribution from the berm, together with lowering at the dune toe</p> <p>Along CMBC01, significant lowering and landward cut-back occurred at the toe of the dunes. As measured at the line of HAT, the landward recession of the upper foreshore was of the order of 20m. Whilst the dune crest and seaward face largely remained intact (except for the marked changes at the toe), the dune is left in a near-vertical, over-steep form and unless the foreshore and dune toe recovers is likely to be highly susceptible to slumping, thus lowering the dune crest.</p> <p>A similar pattern of upper foreshore lowering and cut-back at the dune toe was observed along CMBC02, although here the changes remained within the bounds of previous surveys and the landward recession (as measured along the mark of HAT) was less, although still highly significant, at around 10m.</p>	<p>The southern part of Druridge Bay experienced significant changes, with landward recession in the width of the upper beach by 10-20m and undercutting at the dune toe leading to over-steep conditions in the dune face. Of the two profile lines, CMBC01 experienced the greatest change and it is important to monitor whether this section recovers or whether the dune face experiences a large-scale slump. The changes along CMBC02, whilst large, have previously been observed, with beach recovery following. The changes experienced along CMBC01 however have never been recorded in our surveys since 2002.</p>

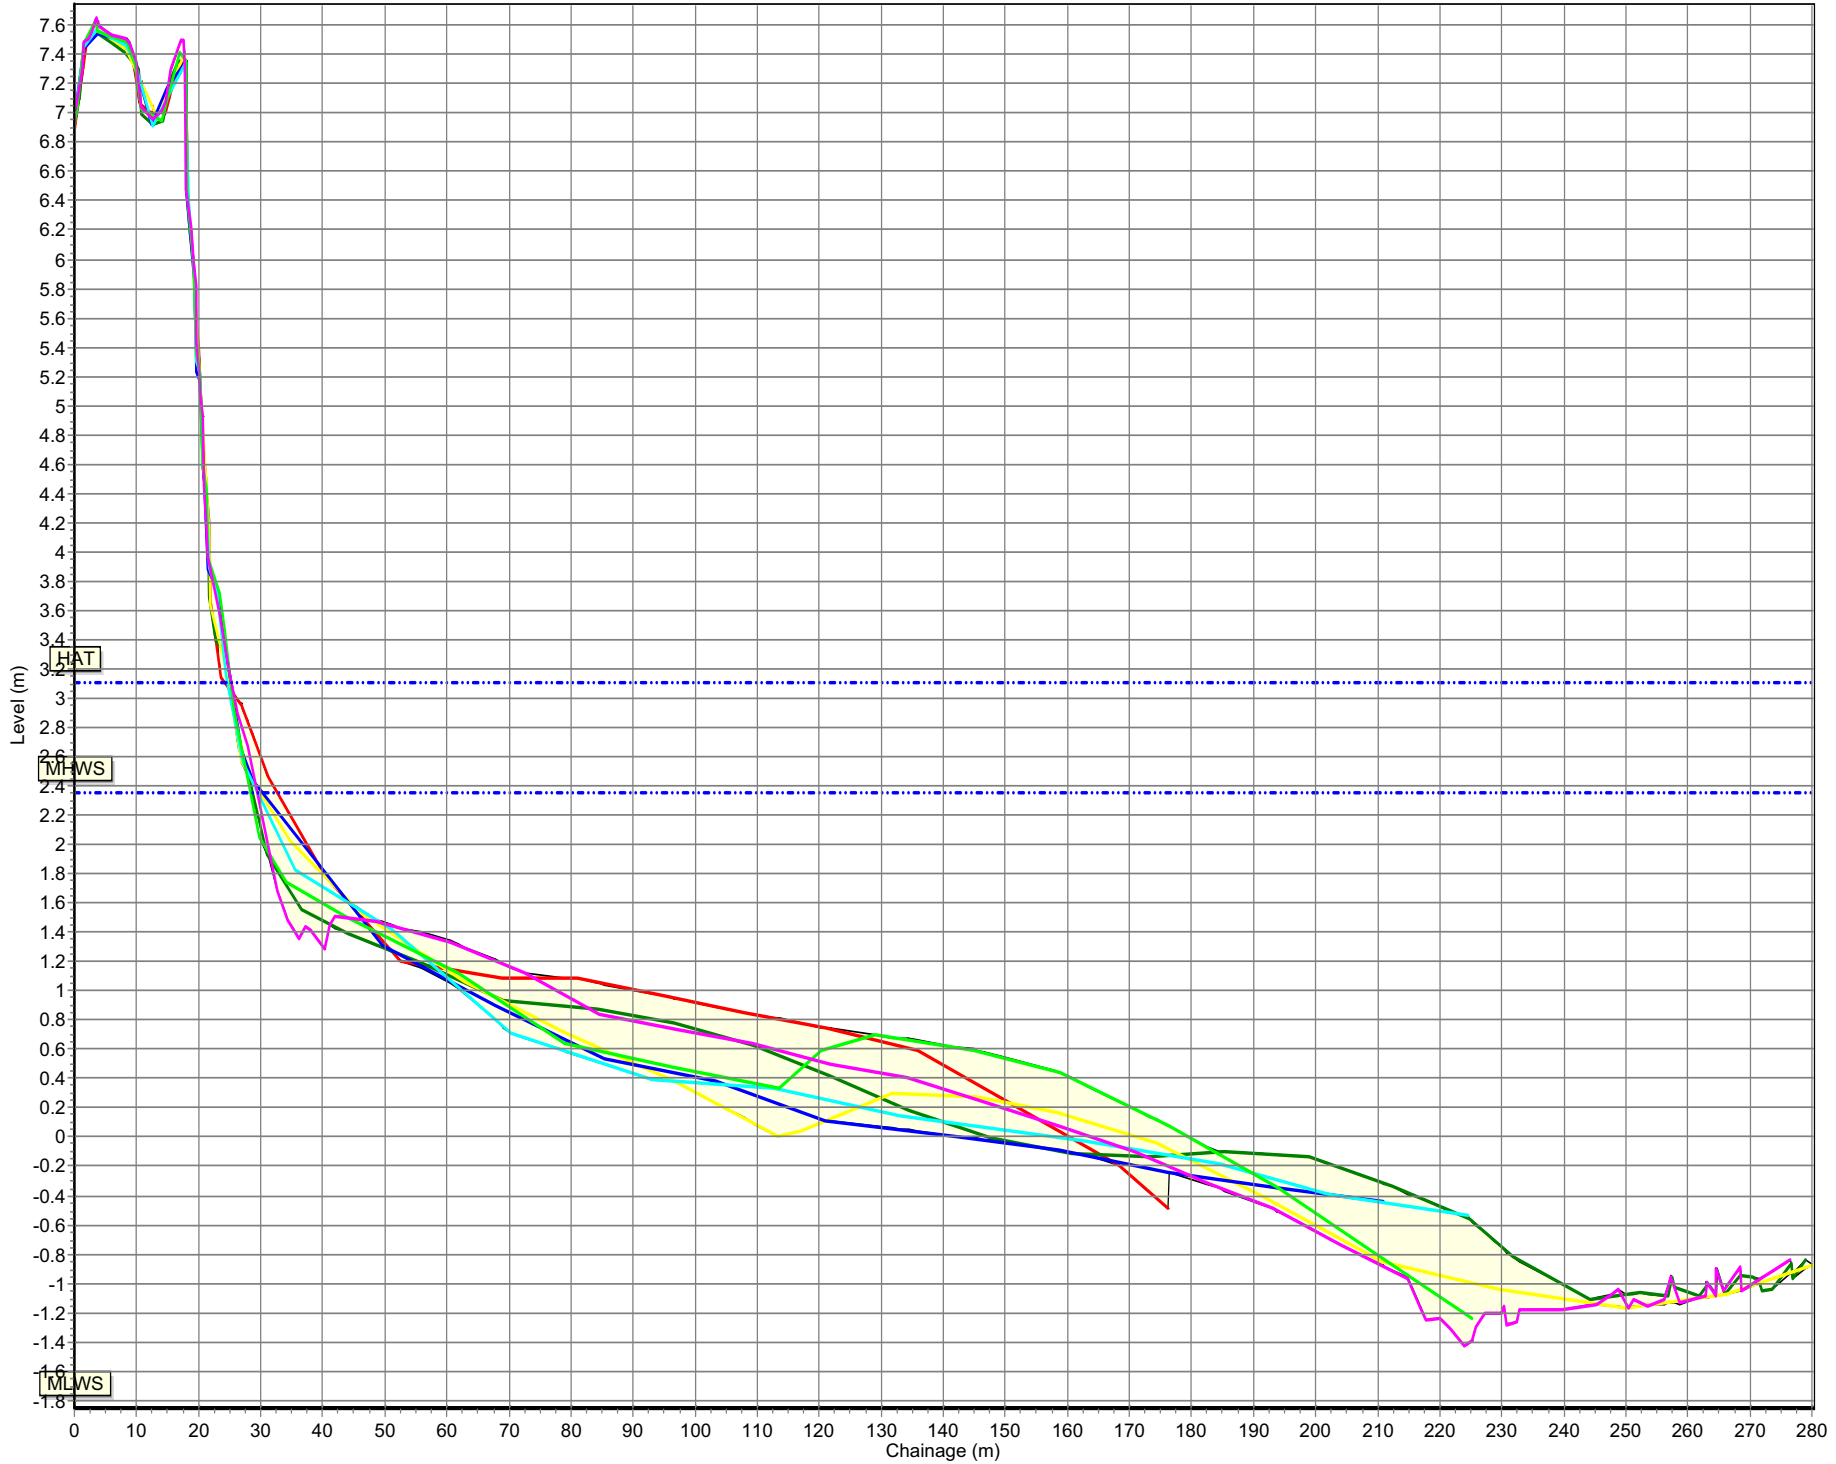
# Beach Profiles: 1aADC17A

- Profiles Envelope
- 15/10/2007
- 30/04/2008
- 21/10/2008
- 10/03/2009
- 23/09/2009
- 19/02/2010
- 01/04/2010

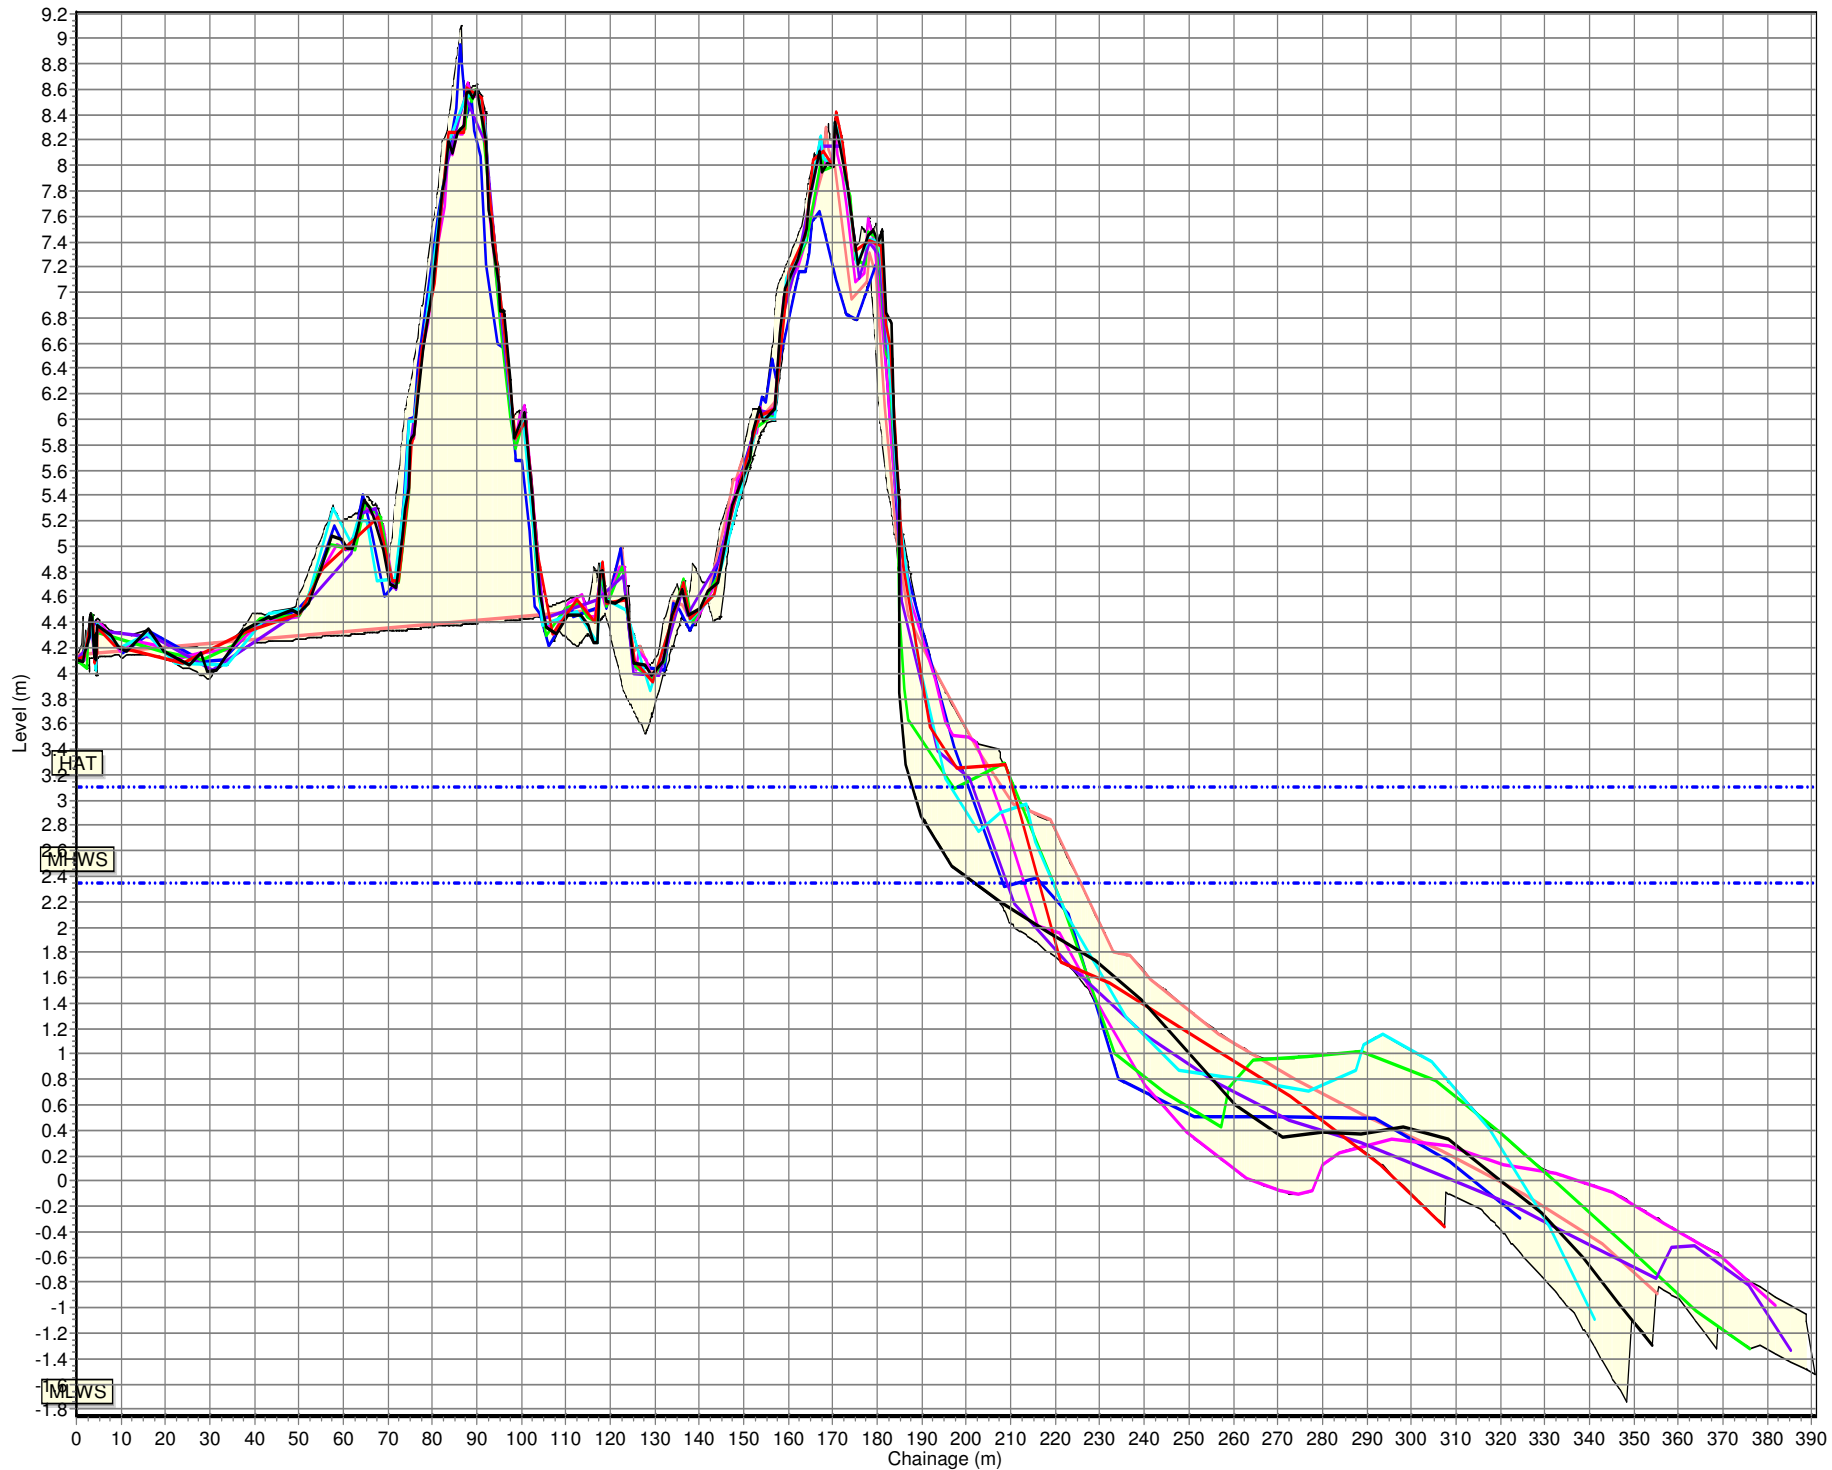
# Beach Profiles: 1aCMBC01

- Profiles Envelope
- 01/04/2002
- 01/03/2003
- 01/09/2003
- 15/04/2004
- 15/10/2004
- 15/04/2005
- 18/10/2005
- 21/04/2006
- 10/11/2006
- 04/04/2007
- 15/10/2007
- 30/04/2008
- 21/10/2008
- 10/03/2009
- 23/09/2009
- 01/04/2010

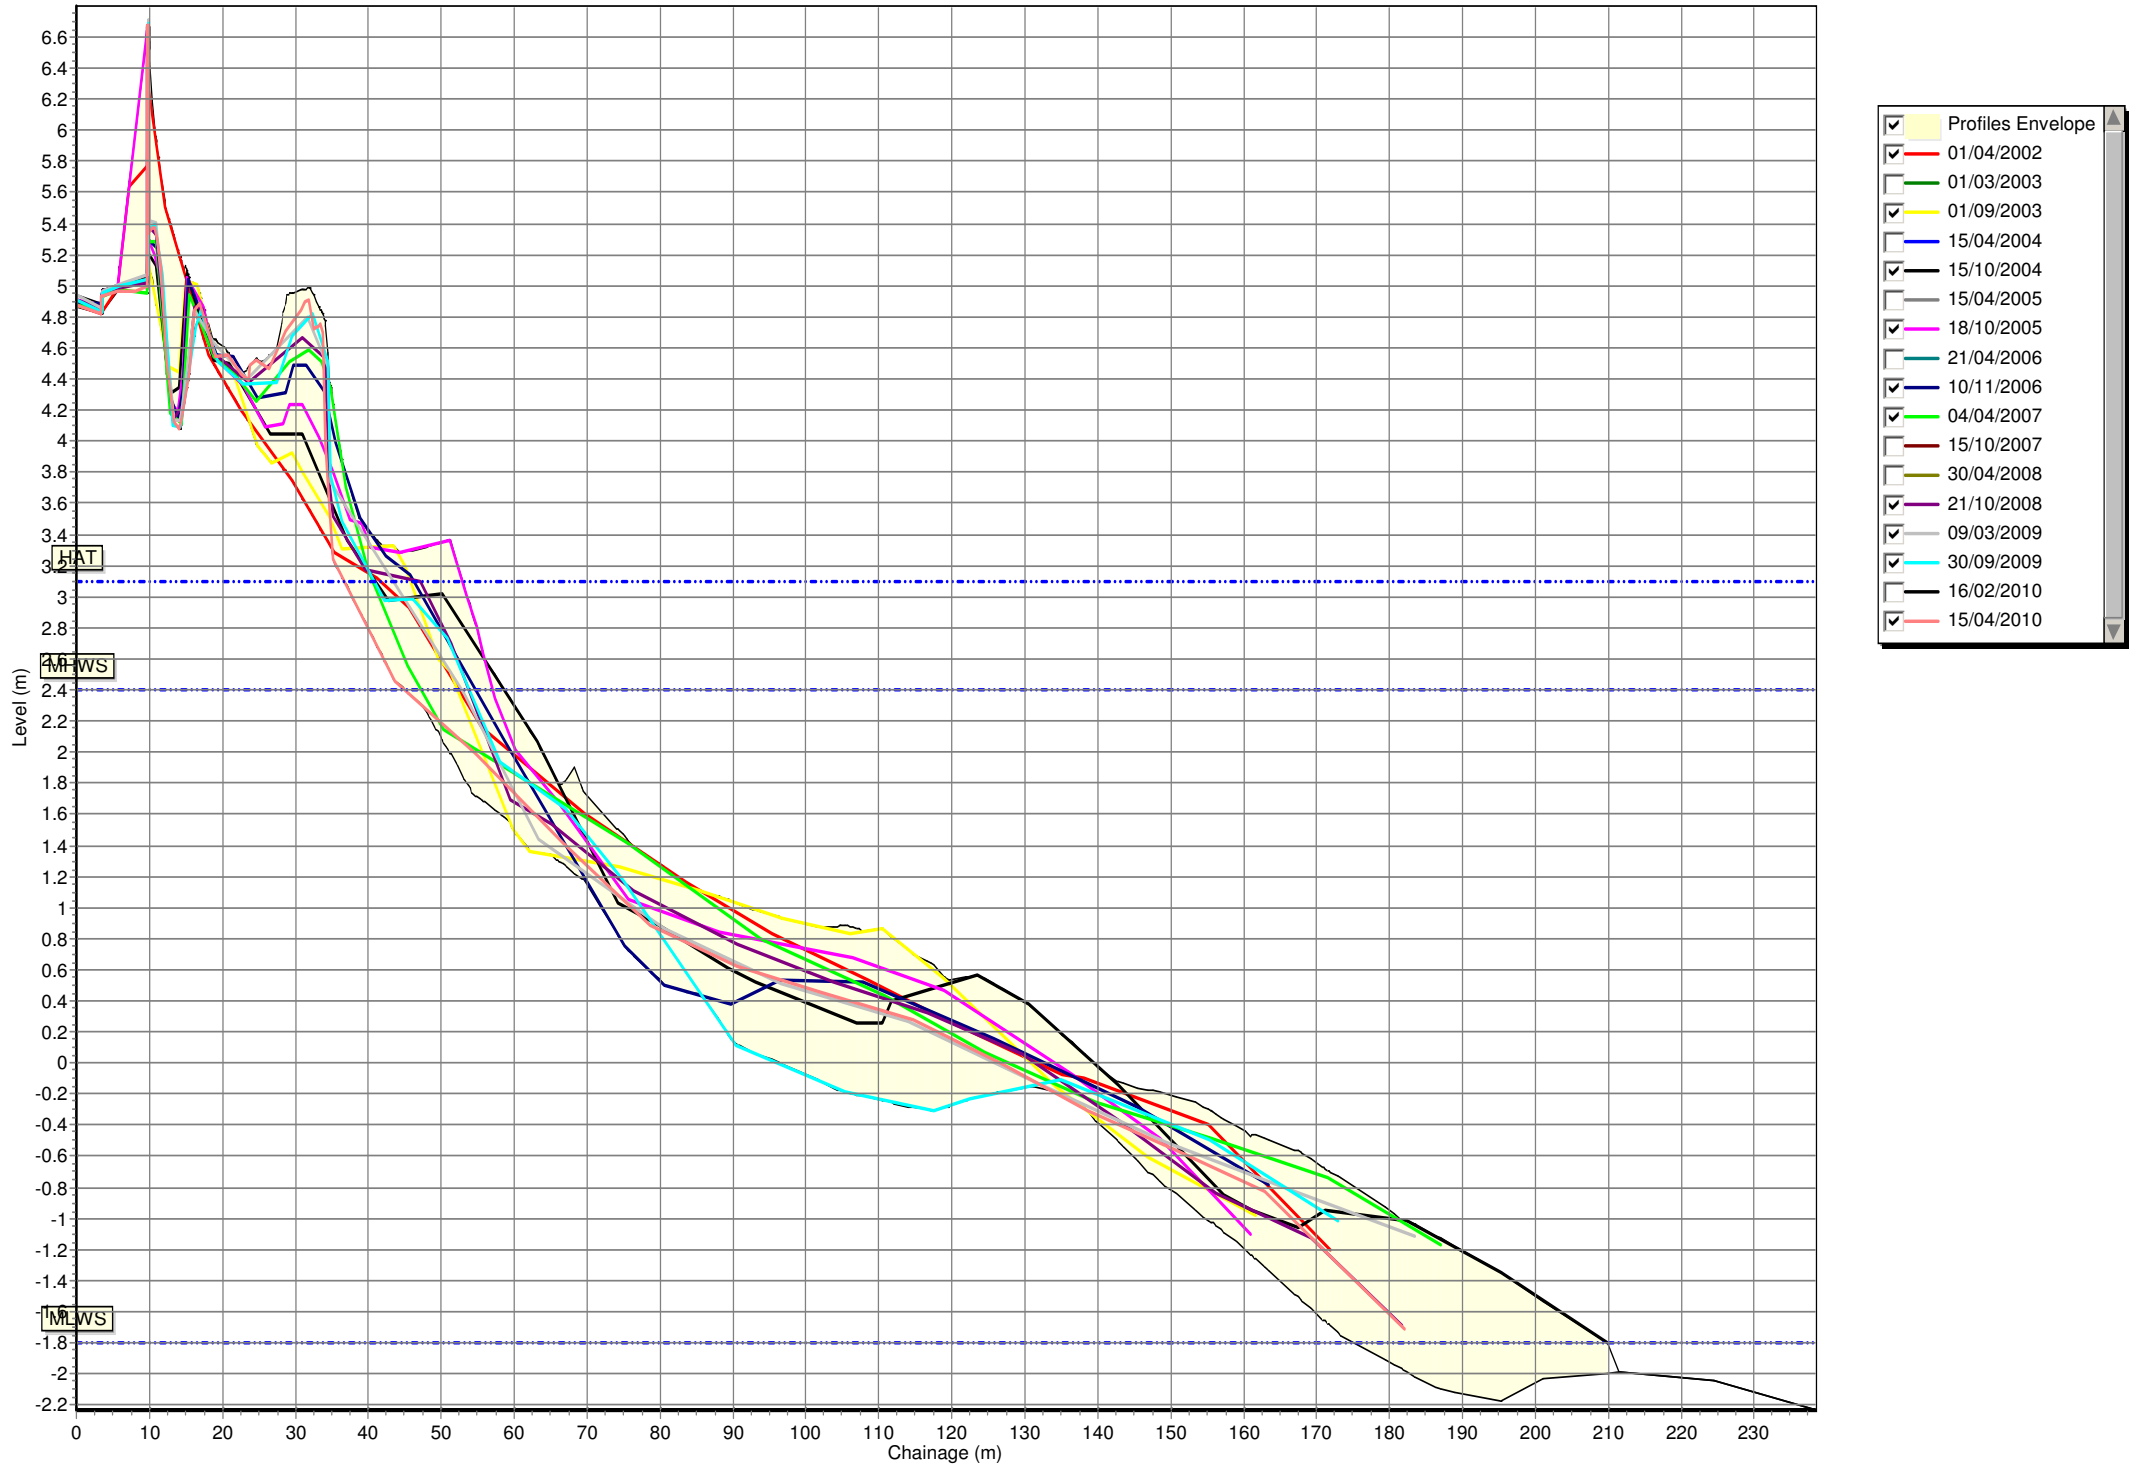
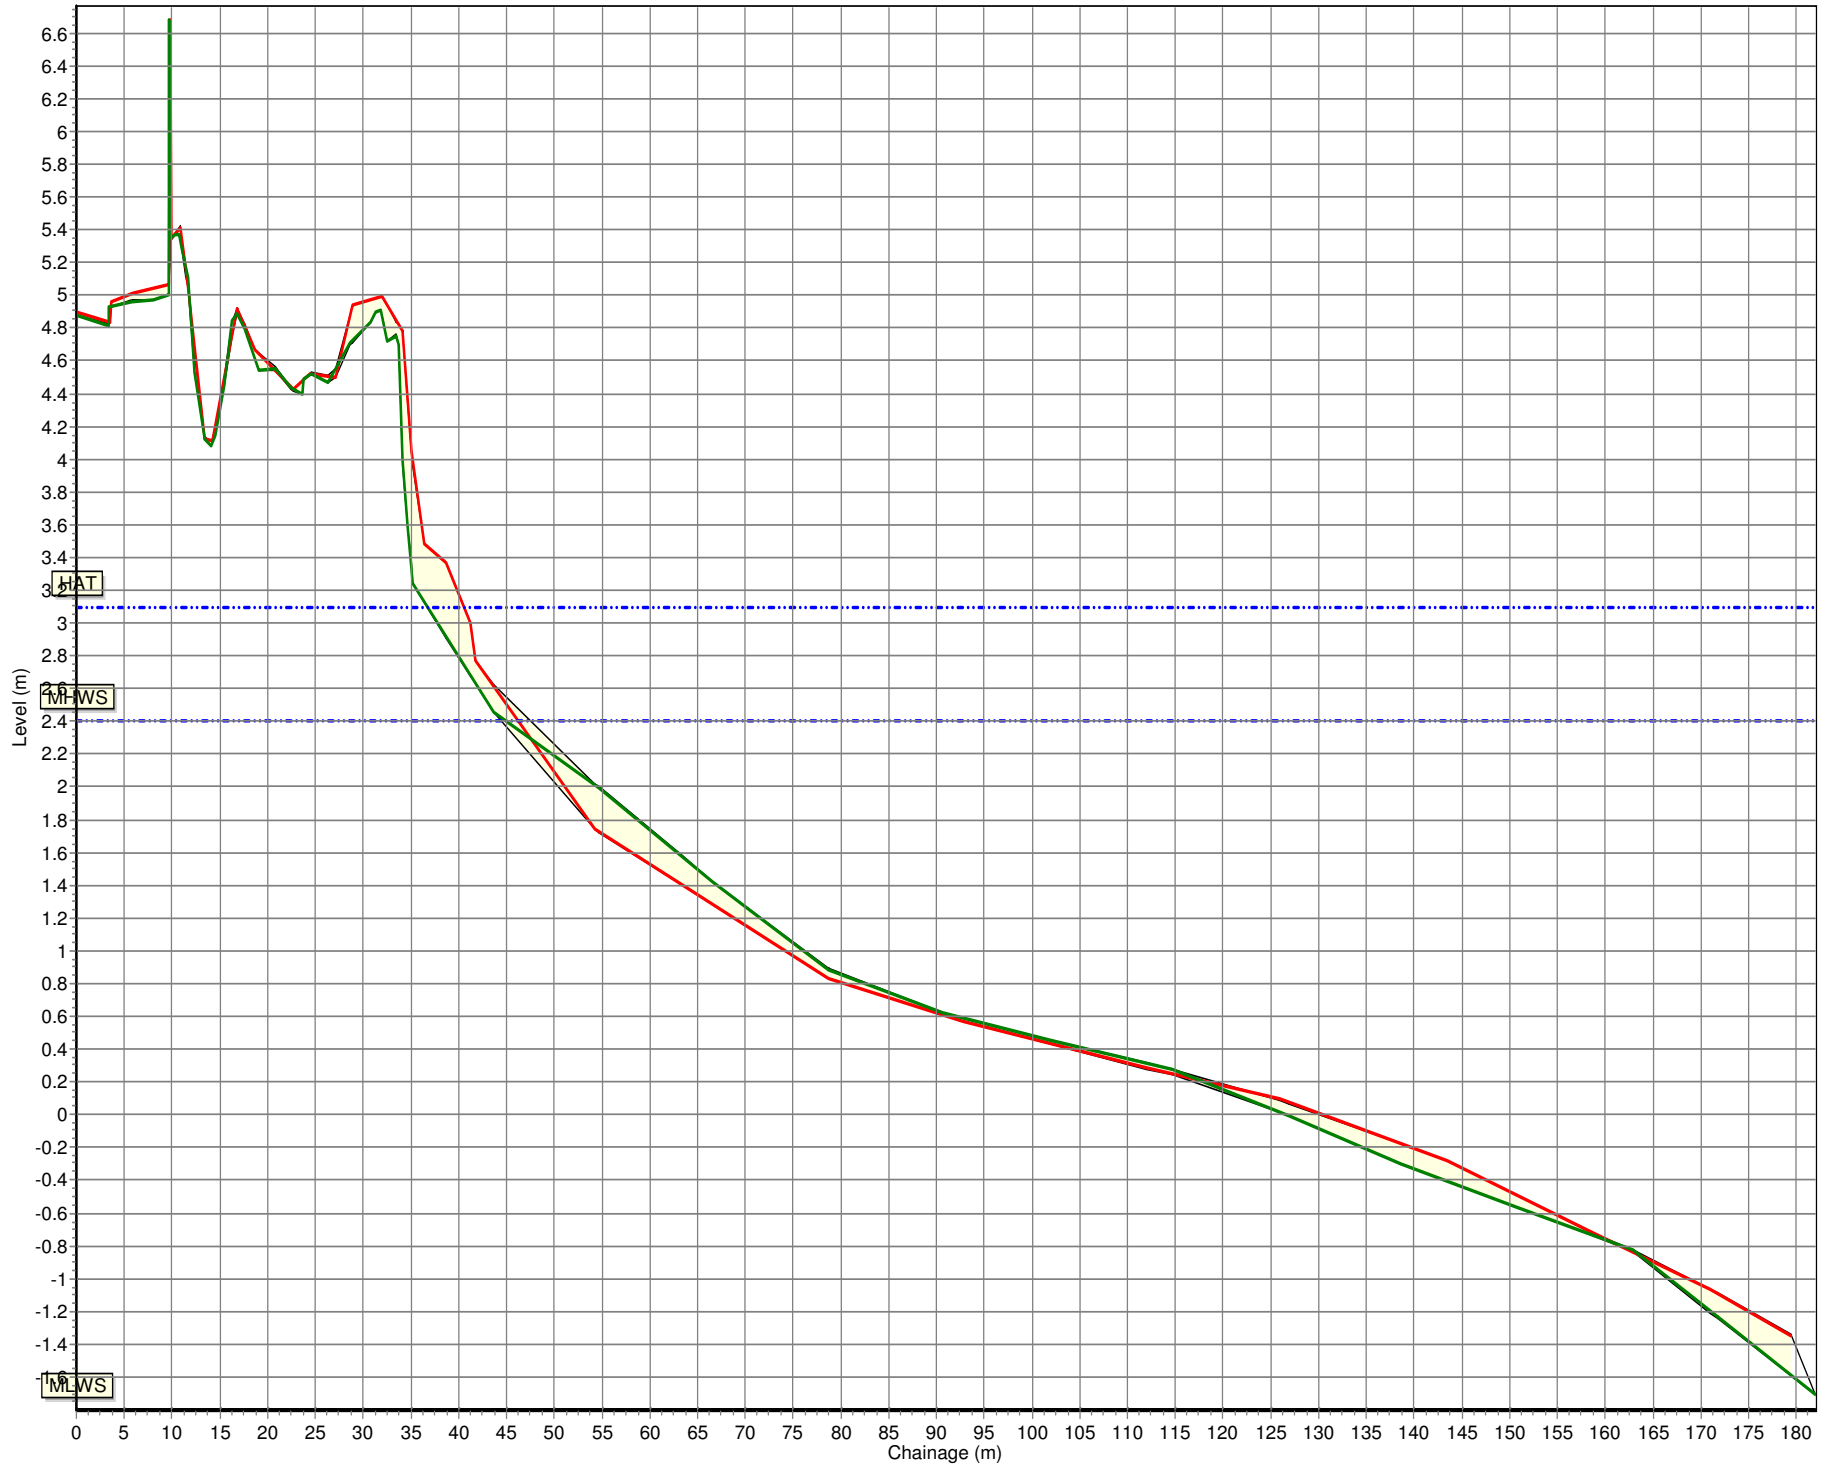
# Beach Profiles: 1aBVBC01

- Profiles Envelope
- 16/02/2010
- 15/04/2010

Survey Date	Description of Changes Since Last Survey	Interpretation
<p><b>04-2010</b></p>	<p><b>Beach Profiles:</b></p> <p>Blyth South Beach is covered by six beach profile lines during the Partial Measures survey (Appendix A).</p> <p>BVBC01 is located towards the north of South Beach, in front of the area of land owned by Port of Blyth. Between September 2009 and February 2010 notable changes occurred, especially with the lowering of the profile between MHWS and MHWN to new record low levels. The previously-recorded trough at around MSL became infilled. The storm conditions that were experienced at the end of February 2010 caused cut back at the toe and seaward face of the narrow width of dunes which front the port access road. This resulted in a near-vertical seaward face to the narrow dunes. Such an overstep condition is likely to result in slumping unless the foreshore recovers.</p> <p>Along BVBC02, notable lowering was observed between September 2009 and February 2010, particularly along the upper beach (above MHWN), although this remained within the previous envelope of behaviour, and between chainages of 80m and 100m, where new record low levels were observed. Between February and April 2010, levels at the toe of the sea wall and seaward of a chainage of 40m recovered, but modest lowering was recorded between HAT and around MHWN.</p> <p>Profile BVBC03 experienced a significant change in form, with the large berm that was recorded in September 2009 being flattened and the upper beach levels, landward of a chainage of around 150m, experiencing notable lowering, resulting in landward recession of the foreshore at around the HAT mark by around 7m. Despite this, the changes were within the bounds of previous behaviour. Between February and April 2010 slight further cut-back at the toe of the dunes and slight further lowering occurred, but again the changes just remain within the envelope of previous change.</p>	<p>Generally, Blyth South Beach appears to have experienced 'typical' winter response to storms, with signs of some recovery to April 2010, although in some places the storm-related erosion has been notable.</p> <p>This includes along BVBC01 where a narrow and now over-steep dune remains. It will be important to continue to monitor this section as there is only a thin 'buffer' between the sea and the port access road.</p>
