**Cell 1 Regional Coastal Monitoring Programme
Update Report 4: 'Partial Measures' Survey 2012**

**Northumberland County
Council
Final Report**

February 2013

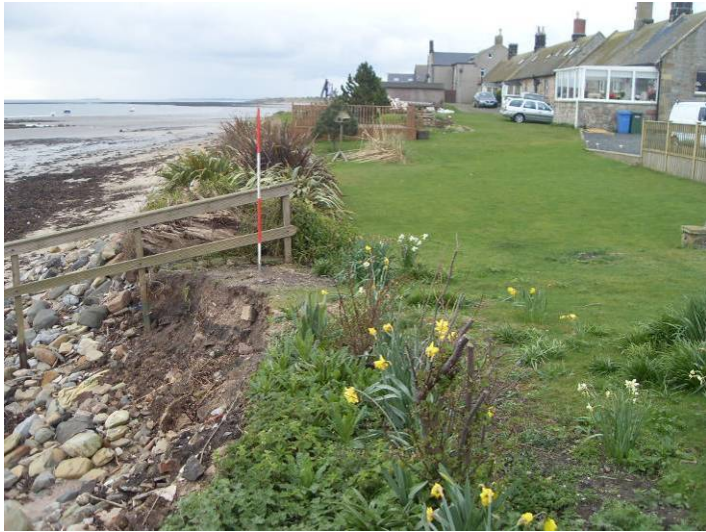
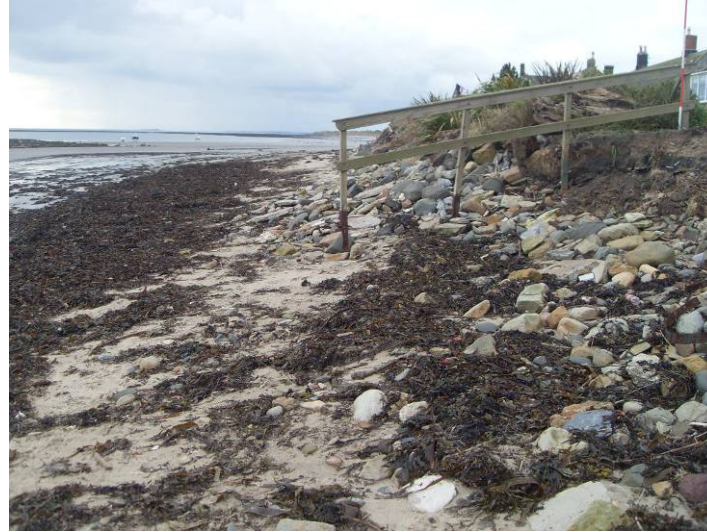
Plate 1 – Survey photograph 1aADC04A_20120411_S2.JPG Plate 2 – Survey photograph 1aADC04A_20120411_S3.JPG

Survey Date	Description of Changes Since Last Survey	Interpretation
<p>Apr 2012</p>	<p>Beach Profiles:</p> <p>Boulmer is covered by two beach profile lines for the Partial Measures survey (Appendix A). These were added to the programme in October 2007. The previous survey was undertaken for the full measures survey in winter 2011.</p> <p>At profile 1aADC04A the dune cliff backshore has eroded. This is seen clearly in the survey photograph (see Plate 1). The upper beach around HAT/MHWS has remained largely stable. From MHWS to a chainage of 45m, which marks the sand portion of the beach located between the upper cobble beach and the rocky foreshore, beach levels have reduced by 0.1m to 0.2m. The survey photograph (see Plate 2) shows a large amount of seaweed on the upper beach, which may have been deposited by storms over the winter months. Beach levels over the rocky foreshore have not changed.</p> <p>At profiles 1aADC04B, since the last survey, the dune and dune face has remained stable with no change in form or position. Beach levels at the toe of the dune/rock/cobble toe (MHWS) to a chainage of 45m have increased by 0.1m to 0.2m. Beach levels over the rocky foreshore have not changed. It is possible that material eroded from the beach at profile 1ADC04A has been transported and deposited at profile 1aADC04B.</p>	<p>The backshore at profile 1aADC04A has cut back since the last survey (full measures, winter 2011). Beach levels at have also reduced.</p> <p>To the south at profile 1aADC04B, the dune has remained stable and the beach has accreted. It is possible that this accretion could be linked to erosion at adjacent profile 1aADC04A.</p> <p>Longer term trends: Cutback of the backshore at profile 1aADC04A is part of an ongoing trend. Beach levels fluctuate throughout the seasons, and the levels observed in the present survey are within the bounds of previous surveys. To the south, the dunes are stable. Beach levels are the highest observed to date.</p>

- Elsewhere along Beadnell Bay, the recorded profiles present no causes for concern.
- At Boulmer, cutback of the dune/backshore at profile 1aADC04A is part of an ongoing trend. The low dunes here form part of private gardens. The previous partial measures report (spring 2011) noted that the changes were not of significant concern for management. This also applies to the present survey, but should be re-assessed in the next full measures report (winter 2012).

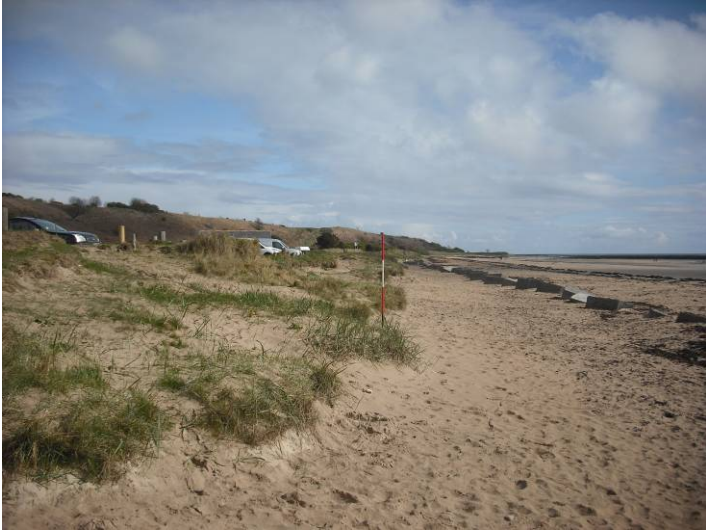
Plate 3 – Survey photograph 1aADC08_20120423_N2.JPG

<p>Apr 2012</p>	<p>Topographic Survey:</p> <p>The northern part of Alnmouth Bay (to the north of the River Aln estuary) is covered by bi-annual topographic survey, which commenced in April 2005. Data from the most recent topographic survey (full measures, winter 2011) have been used to create a DGM (Appendix B – Map 2a) using a Geographical Information System (GIS). A difference plot has also been produced using the DGM (Appendix B – Map 2b) produced from the last produced topographic survey (partial measures, spring 2011) and the</p>	<p>The findings of the topographic survey support the findings of the beach profile analysis, which indicate that the beach has accreted along the upper and middle beach and the lower beach, close to MLWS, has eroded. This compares well to the location of a water-filled trough observed from the survey photograph (see Plate 4).</p>

Survey Date	Description of Changes Since Last Survey	Interpretation
	<p>present survey.</p> <p>The difference plot shows a reduction in beach elevation on the northern bank of the estuary, on the upper beach in the lee of Marsden Rocks and on the lower shore. Along the central section of this beach length, there is a linear band where beach elevation has increased. Also, the upper beach has accreted over about a 300m length centred on the access road to the car park. These findings reflect the findings of the beach profile, where there has been accretion along the upper and middle beach and erosion of the lower beach, close to MLWS.</p>	<p>Longer term trends: Comparison of the present topographic survey with the previous full measures (winter 2011) shows that the linear band of beach elevation reduction on the upper/middle beach has been replaced with a band of beach elevation increase. A second band of beach elevation reduction that is located on the lower beach in 2011 has also moved landward.</p> <p>In addition two former zones of predominantly beach elevation gain to the north (in the lee of Marsden Rocks) and at the channel entrance have switched to beach elevation reduction.</p> <p>Similar to Sandstall Point (Spittal A), the beach form is continually changing as a result of the interaction between waves and tidal currents and the influence of the headland/rock outcrop to the north and the River AIn to the south. As in the previous full measures (winter, 2011) report, between the winter and summer months the beach is likely to be subject to storms where the resultant waves and currents act to move the material, predominantly in an offshore direction.</p>

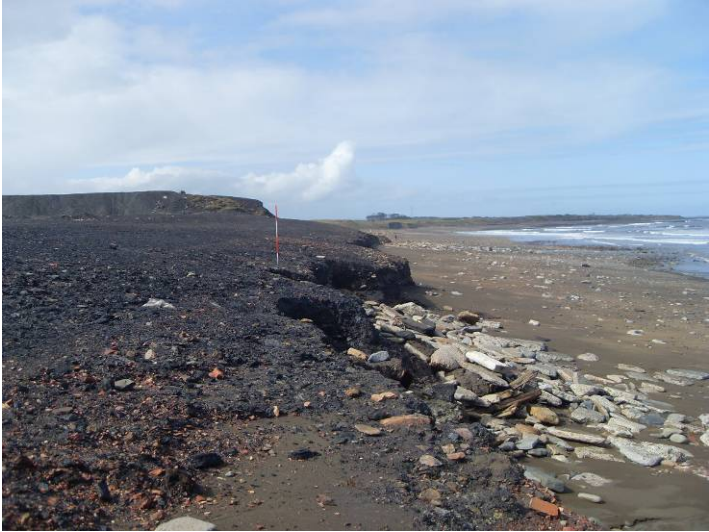
Plate 5 – Survey photograph 1aCMBC03A_20120412_N3.JPG

Survey Date	Description of Changes Since Last Survey	Interpretation
Apr 2012	<p>Cliff-top Survey:</p> <p>This is the first year that the cliff top survey data has been plotted with change measured along pre-defined, fixed transect lines. Therefore, this is the first time that a comparison with previous data has been completed. This analysis will be completed on a bi-annual basis in future reports.</p> <p>Three transect lines (numbered 1-3) were established along the cliff top in Lynemouth Bay in October 2008. Measurements are from the landward end of the transect (the fixed datum) to the surveyed cliff top. Measured distances to cliff top can then be compared to calculate erosion rates. The cliff top surveys are intended to inform on erosion rates of the sea cliffs to the south of Lynemouth Bay on the north side of Newbiggin Point. Note: the numbering of ground control points is not intended to correlate with that of the beach profile lines and reference should be made to Appendix C - Map 1 for the location of the transects ground control points.</p> <p>The results from the cliff top monitoring are anticipated to have an accuracy of $\pm 0.2\text{m}$ due to the technique used. Appendix C – Table C1 provides results from the October 2008 cliff top survey, showing the position from the datum to the edge of the cliff top along each transect. Also shown is the calculated rate of change since the October 2008 baseline survey the previous (November 2011) and survey.</p> <p>Results show that erosion or an amount of movement greater than the survey error has occurred at 2 ground control points (1 and 3) since surveys began in October 2008. At ground control point 2, movement is within the error band.</p> <p>Since the last survey in November 2011, cliff movement at all three locations is zero or within the error band.</p>	<p>This is the first year that the cliff top survey data has been calculated along transects, so it is the first time that a comparison with previous data has been completed.</p> <p>Since the last survey in November 2011, cliff movement at all three locations is zero or within the error band.</p> <p>Longer term trends: Since surveys began in October 2008, results show that erosion or an amount of movement greater than the survey error has occurred at 2 ground control points (1 and 3).</p> <p>At ground control survey point 1 this is erosion of 0.6m. The equates to an erosion rate of 0.2m/year.</p> <p>At ground control surely point 3, the cliff is recorded to have accreted by 0.3m. Cliffs are unlikely to accrete and this accretionary trend highlights the problems in identification of the cliff top due to growth of vegetation that make the short term change data unreliable.</p> <p>An additional assessment of cliff recession will be derived from analysis of time-series remote sensing data. A high quality baseline survey, comprising LiDAR and aerial photography, was collected in 2010, a repeat survey was completed in Sept/Oct 2012 and a second repeat survey is planned for 2014. These data will be analysed to give more accurate information on the behaviour of the cliffs in a separate report.</p>

- At Lynemouth Bay, opposite the Power Station (profile 1aCMBC03B), the slag bank has eroded significantly. It is possible that further mechanical re-grading of the slag tip profile has occurred between the present and previous partial measures survey and could explain the observed erosion.

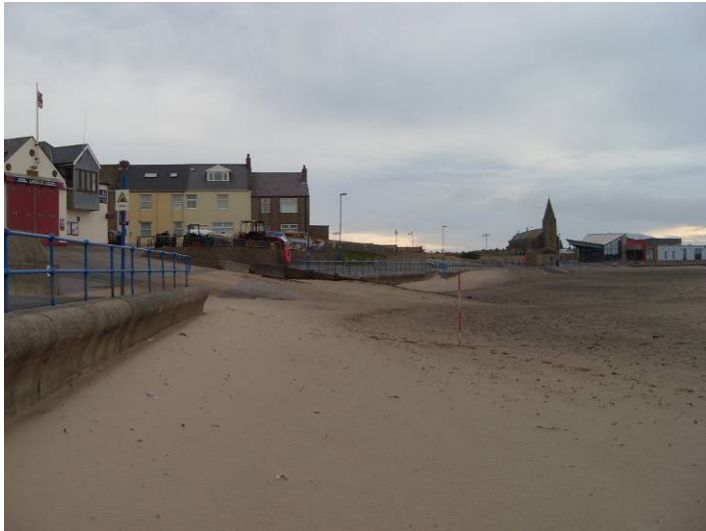
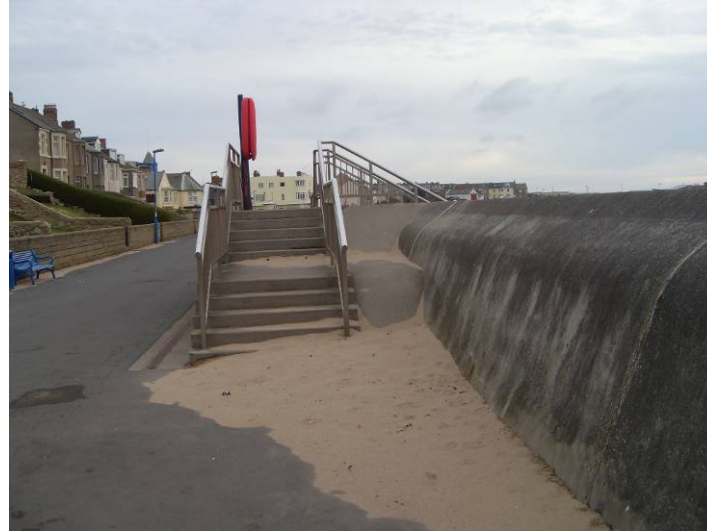
Plate 6 – Survey photograph 1aWDC05A_20120320_E2.JPG Plate 7 – Survey photograph 1aWDC06_20120320_N2.JPG

Survey Date	Description of Changes Since Last Survey	Interpretation
Mar 2012	<p>Beach Profiles:</p> <p>Newbiggin-by-the-Sea is covered by four beach profile lines during the Partial Measures survey (Appendix A). Two of these (with 'A' suffices) were added to the programme in October 2007 specifically to help assess the performance of the capital scheme involving beach replenishment and construction of an offshore breakwater. It should be noted that an extended series of profiles and a topographic survey are also recorded via the Cell 1 Regional Coastal Monitoring Programme for purposes of post-project evaluation of this capital scheme. These profiles are not analysed here, however, the findings of the topographic survey are presented below. The previous survey was the full measures assessment undertaken in winter 2011.</p> <p>1aWDC05A is in the north of Newbiggin Bay. Between the toe of the seawall and a chainage of 55m, beach levels have increased by up to 1m. This increase is greatest between HAT and MHWS. The survey photograph shows accretion of beach material against the seawall toe and slipway (see Plate 5). Beach levels between a chainage of 55m and 80m have fallen by up to 0.4m, but increased between there and the rocky foreshore.</p> <p>1aWDC06 is located in the centre of the northern part of Newbiggin Bay, between the two breakwaters. Since the last survey, beach levels have increased across the profile from the toe of the seawall to a chainage of 40m so that the stepped revetment is now covered by sand again. Between about 40m and 80m beach levels have fallen. The survey photograph shows the accumulation of sand in the lee of the seawall (see Plate 7). It is likely that material eroded from the middle/lower beach has been transported to the middle/upper beach by wind-blown transport.</p> <p>1aWDC06A is located in the centre of Newbiggin Bay, behind the offshore breakwater. Beach levels have increased by 0.2m at the seawall. The berm at HAT has extended upwards and outwards, a trend that follows on from the previous partial measures survey (spring, 2011). Between a chainage of 100m and 170m beach levels have fallen by up to 0.6m, but increased seaward of there.</p> <p>1aWDC07 is located in towards the south of Newbiggin Bay. Beach levels above MHWS have increased by up to 0.5m. Between HAT and a chainage of 56m they have fallen by up to 0.2m, but increased seaward of there.</p>	<p>Since the last survey, along the length of the Newbiggin Bay, beach levels on the upper beach have increased. The nature of the accretion (i.e. beach material in the lee of the seawall, trapped in amongst the rock revetment), suggests that this material has been deposited by wind blown transport after being entrained from the middle beach. The lower beach at all locations has accreted. This material could have been drawn-down from the beach by winter storms.</p> <p>Longer term trends: As noted in the full measures report (winter, 2011), Northumberland County Council undertook beach re-profiling during the last 3 weeks of September in 2011 and the survey from 31st October 2011 is likely to reflect the redistribution of material on the beach due to the re-profiling undertaken as part of the beach management measures. Along the profiles to the north of the bay (1aWDC05A and 1aWDC06), beach levels between HAT and MHWS appear to be returning to the levels observed prior to October 2011. As in the previous partial measures report (spring 2011), it is anticipated that ongoing maintenance aspect associated with the capital recharge scheme will again be required.</p> <p>The changes observed at profiles to the south of the bay are within the bounds of previous surveys and here too the beach above HAT appears to be returning towards profiles measured before the September 2011 beach management.</p>

- Elsewhere along Lynemouth Bay, the recorded profiles and cliff top survey present no causes for concern.
- At Newbiggin-by-the-Sea, along the profiles to the north of the bay (1aWDC05A and 1aWDC06), beach levels between HAT and MHWS appear to be returning towards the levels observed prior to October 2011. This follows beach management re-profiling during the last 3 weeks of September in 2011 undertaken by Northumberland County Council. As in the previous partial measures report (spring 2011), it is anticipated that ongoing maintenance associated with the capital recharge scheme will again be required.

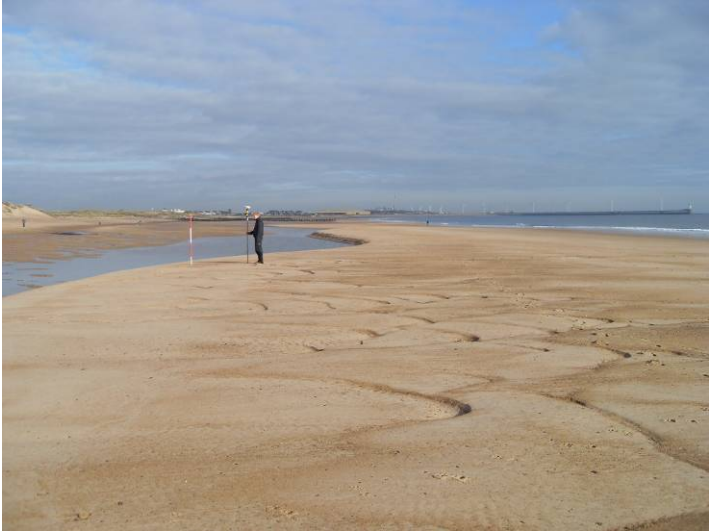
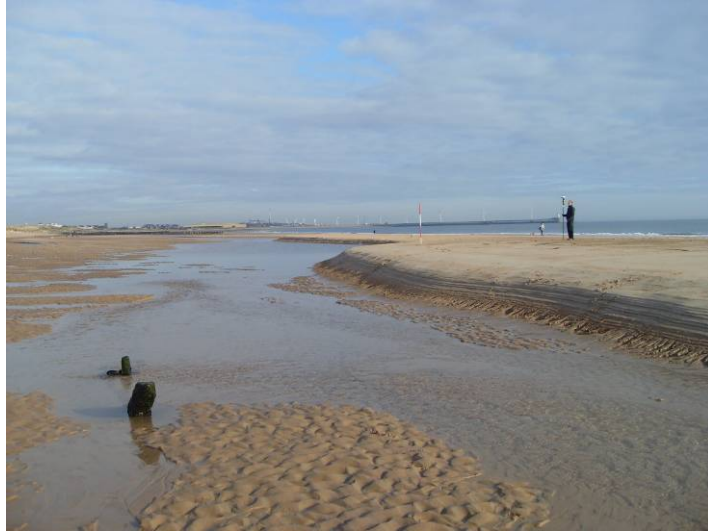
Plate 8 – Survey photograph 1aBVBC04_20120321_N10.JPG Plate 8 – Survey photograph 1aBVBC04_20120321_N9.JPG

Survey Date	Description of Changes Since Last Survey	Interpretation
Mar 2012	<p>Beach Profiles:</p> <p>Blyth South Beach is covered by six beach profile lines for the Partial Measures survey (Appendix A). The previous survey was the full measures assessment undertaken in winter 2011.</p> <p>1aBVBC01 is located towards the north of South Beach, in front of the area of land owned by Port of Blyth. 1aBVBC06 is located at the southern end of the beach, towards Seaton Sluice.</p> <p>With the exception of profile 1aBVBC02, which is protected by a seawall, at all profiles the dunes have remained stable, retaining the same form and position since the last survey.</p> <p>At profile 1aBVBC01, beach levels at the dune toe have increased, however, seaward to a chainage of 100m beach levels have fallen by up to 0.8m. Seaward of a chainage of 100m beach levels have increased by up to 0.8m. This is likely to represent the cross-shore movement of material, and the beach is drawn-down during storms.</p> <p>This pattern of change is repeated at profiles 1aBVBC02 through to 1aBVBC06, with an increase in beach levels at the dune/seawall toe and around HAT/MHWS. Seaward of that is a zone of beach level reduction and seaward again, there is a zone of beach level increase. The extent of the fall and increase becomes more prominent to the south of the beach. At profiles 1aBVBC04 and 1aBVBC05 in particular, a berm has formed in the zone of beach level increase and is also acknowledged in the survey report for the North East Coast, which notes '<i>large sand bar formed</i>'. This is shown in the survey photograph (see Plate 8).</p>	<p>Since the last survey, the beach has been subject to cross-shore change. The beach at the toe of the dune/seawall has accreted. This could be related to beach management activities over the winter. As reported in the previous full measures report (winter 2011) '<i>there have been ongoing beach management and dune repairs since 2002, including using recycled Christmas trees to create sand traps, within the damaged areas of the dunes system. Restoration areas are then usually planted up with Marram Grass the following January if enough sand has accreted. In some years there has also been occasional recycling of sand to the toe of damaged areas of dunes from both the Blyth Harbour and Seaton Sluice end of the beach.</i>'</p> <p>On the middle beach, levels have fallen but seaward of this towards MLWS, they have increased. The cross-shore movement of material and the resultant profile is typical of a winter profile formed by storms.</p> <p>Towards the south of the beach, this increase is quite prominent such that a berm has formed. The survey photographs show (see Plate 8 and Plate 9), the berm and trough is very prominent and is similar to a ridge/runnel feature. The beach here is likely to be influenced by tidal flows, which are themselves affected by flows in and out of the Blyth River. Similar observations have been made at Alnmouth, where the</p>

Survey Date	Description of Changes Since Last Survey	Interpretation
		<p>beach can be affected by the influence of the Aln Estuary.</p> <p>At profile 1aVBVC06, nearest to Seaton Sluice, the change is dominated by accretion.</p> <p>Longer term trends: The changes observed from the present survey are within the bounds of the previous surveys. Beach levels do fluctuate across the length of the profile and the movement of berms and troughs occurs across the seasons. The upper beaches and dunes here are likely to be affected by a combination of natural accretion processes and beach management activity.</p>

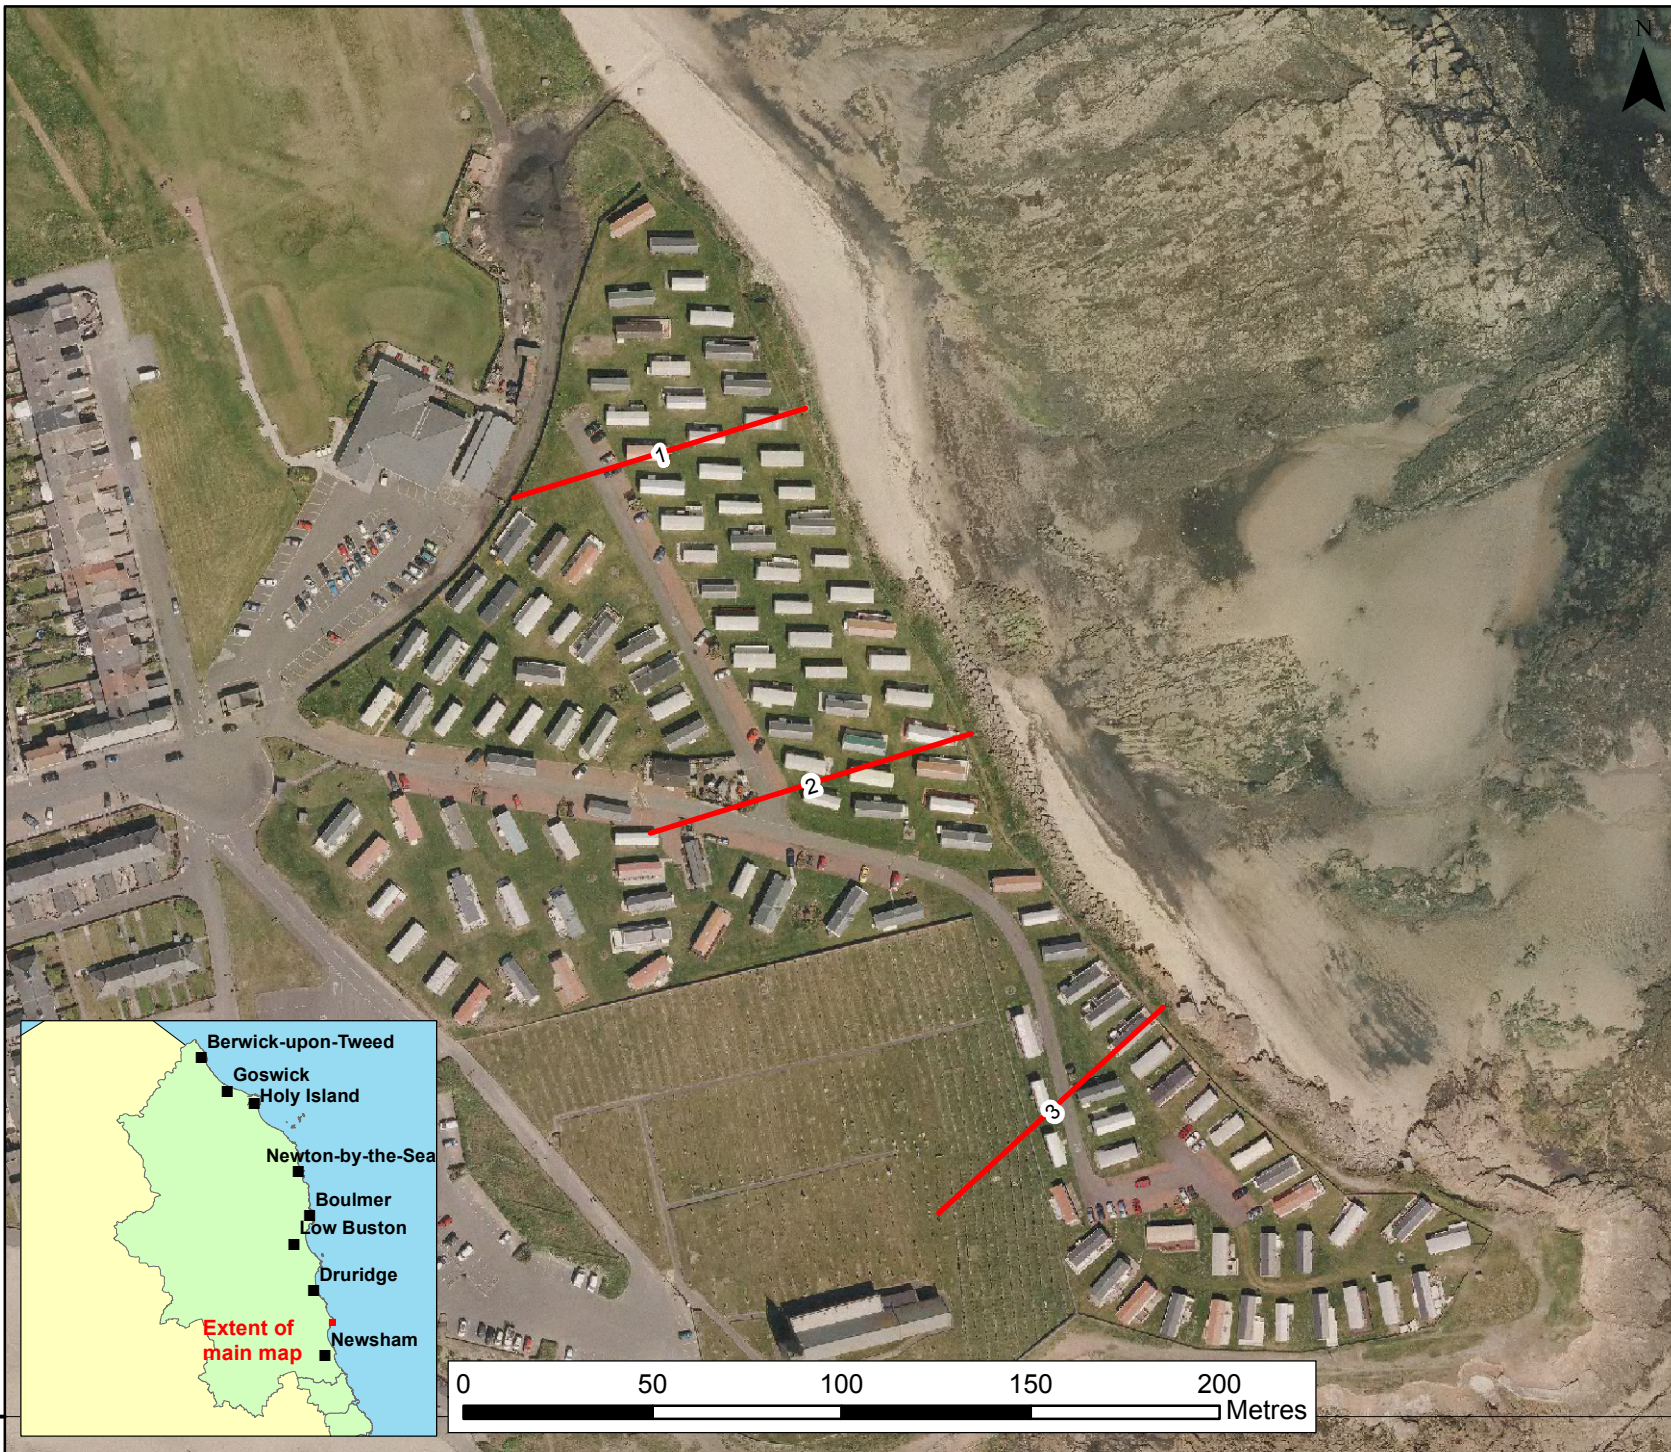
Table C1 – Cliff Top Surveys at Lynemouth Bay

Ground Control Point Details		Distance to Cliff Top (m)			Total Erosion (m)		Erosion Rate (m/year)
Ref	Type	Baseline Survey (Oct 2008)	Previous Survey (Nov 2011)	Present Survey (Apr 2012)	Baseline (Oct2008) to Present (Apr 2012)	Previous (Nov 2011) to Present (Apr 2012)	Baseline (Oct 2008) to Present (Apr 2012)
1	Cliff	80.62	80.0	80.0	-0.6	0.0	-0.2
2	Defended	88.88	88.9	88.8	-0.1	-0.1	0.0
3	Cliff	80.23	80.6	80.5	0.3	-0.1	0.1

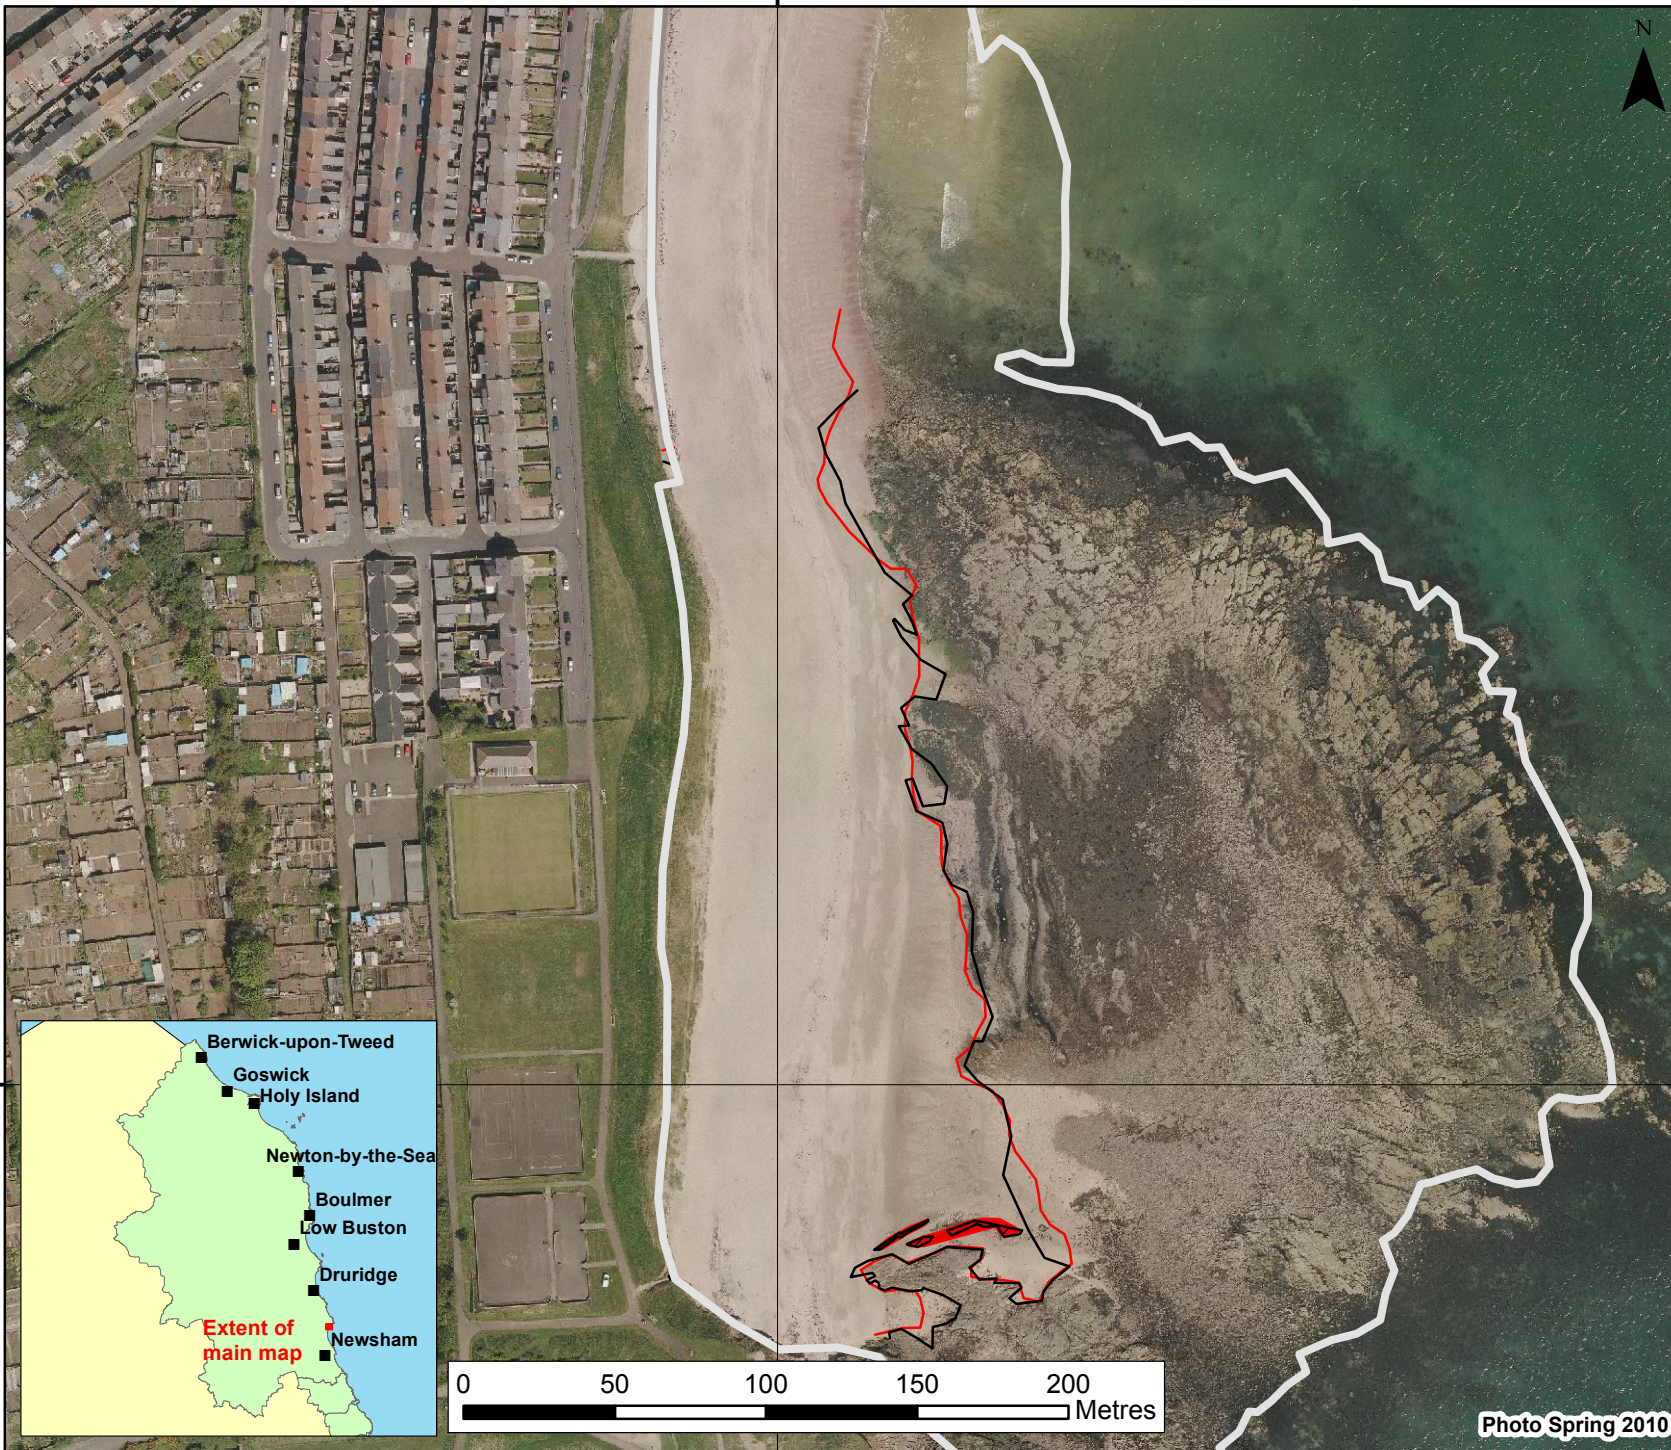
<p>Apr 2012</p>	<p>Sand Extent Survey:</p> <p>Spital Carrs is located to the south of Newbiggin Bay and is covered by a bi-annual sand extent survey, which commenced in 2012. The survey was designed to address concern that the beach recharge scheme undertaken in the Newbiggin Bay may have impacts on the Spital Carrs SSSI and SPA if sand from the recharge scheme moves to the south. The sand extent survey therefore identifies the boundary of the sand beach on the rock platform.</p> <p>This is the first year that the sand extent survey data has been plotted as a line on an aerial map, so it is the first time that a comparison with previous data has been completed. This will be completed on a bi-annual basis thereafter.</p> <p>Data from the most recent sand extent survey (partial measures, spring 2012) has been plotted onto</p>	<p>This is the first comparison with previous data and will be completed on a bi-annual basis thereafter.</p> <p>There is some movement to the south, where the sand extent has moved slightly seaward, however, further north of that it has moved landwards. Otherwise, there are no discernable trends suggesting the seawards extension of sand.</p>

Survey Date	Description of Changes Since Last Survey	Interpretation
	<p>aerial imagery (refer to Appendix D – Map 1). The plot shows that there is some variation of the extent of sand about the winter 2011 survey extent. There is some movement to the south, where the sand extent has moved slightly seaward, however, further north of that it has moved landwards. Otherwise, there are no discernable trends suggesting the seawards extension of sand.</p>
