## Cell 1 Regional Coastal Monitoring Programme Update Report 11: 'Partial Measures' Survey 2019

(\*) The present report is **Update Report 11** and provides an analysis of the 2019 Partial Measures survey for Northumberland County Council's frontage.

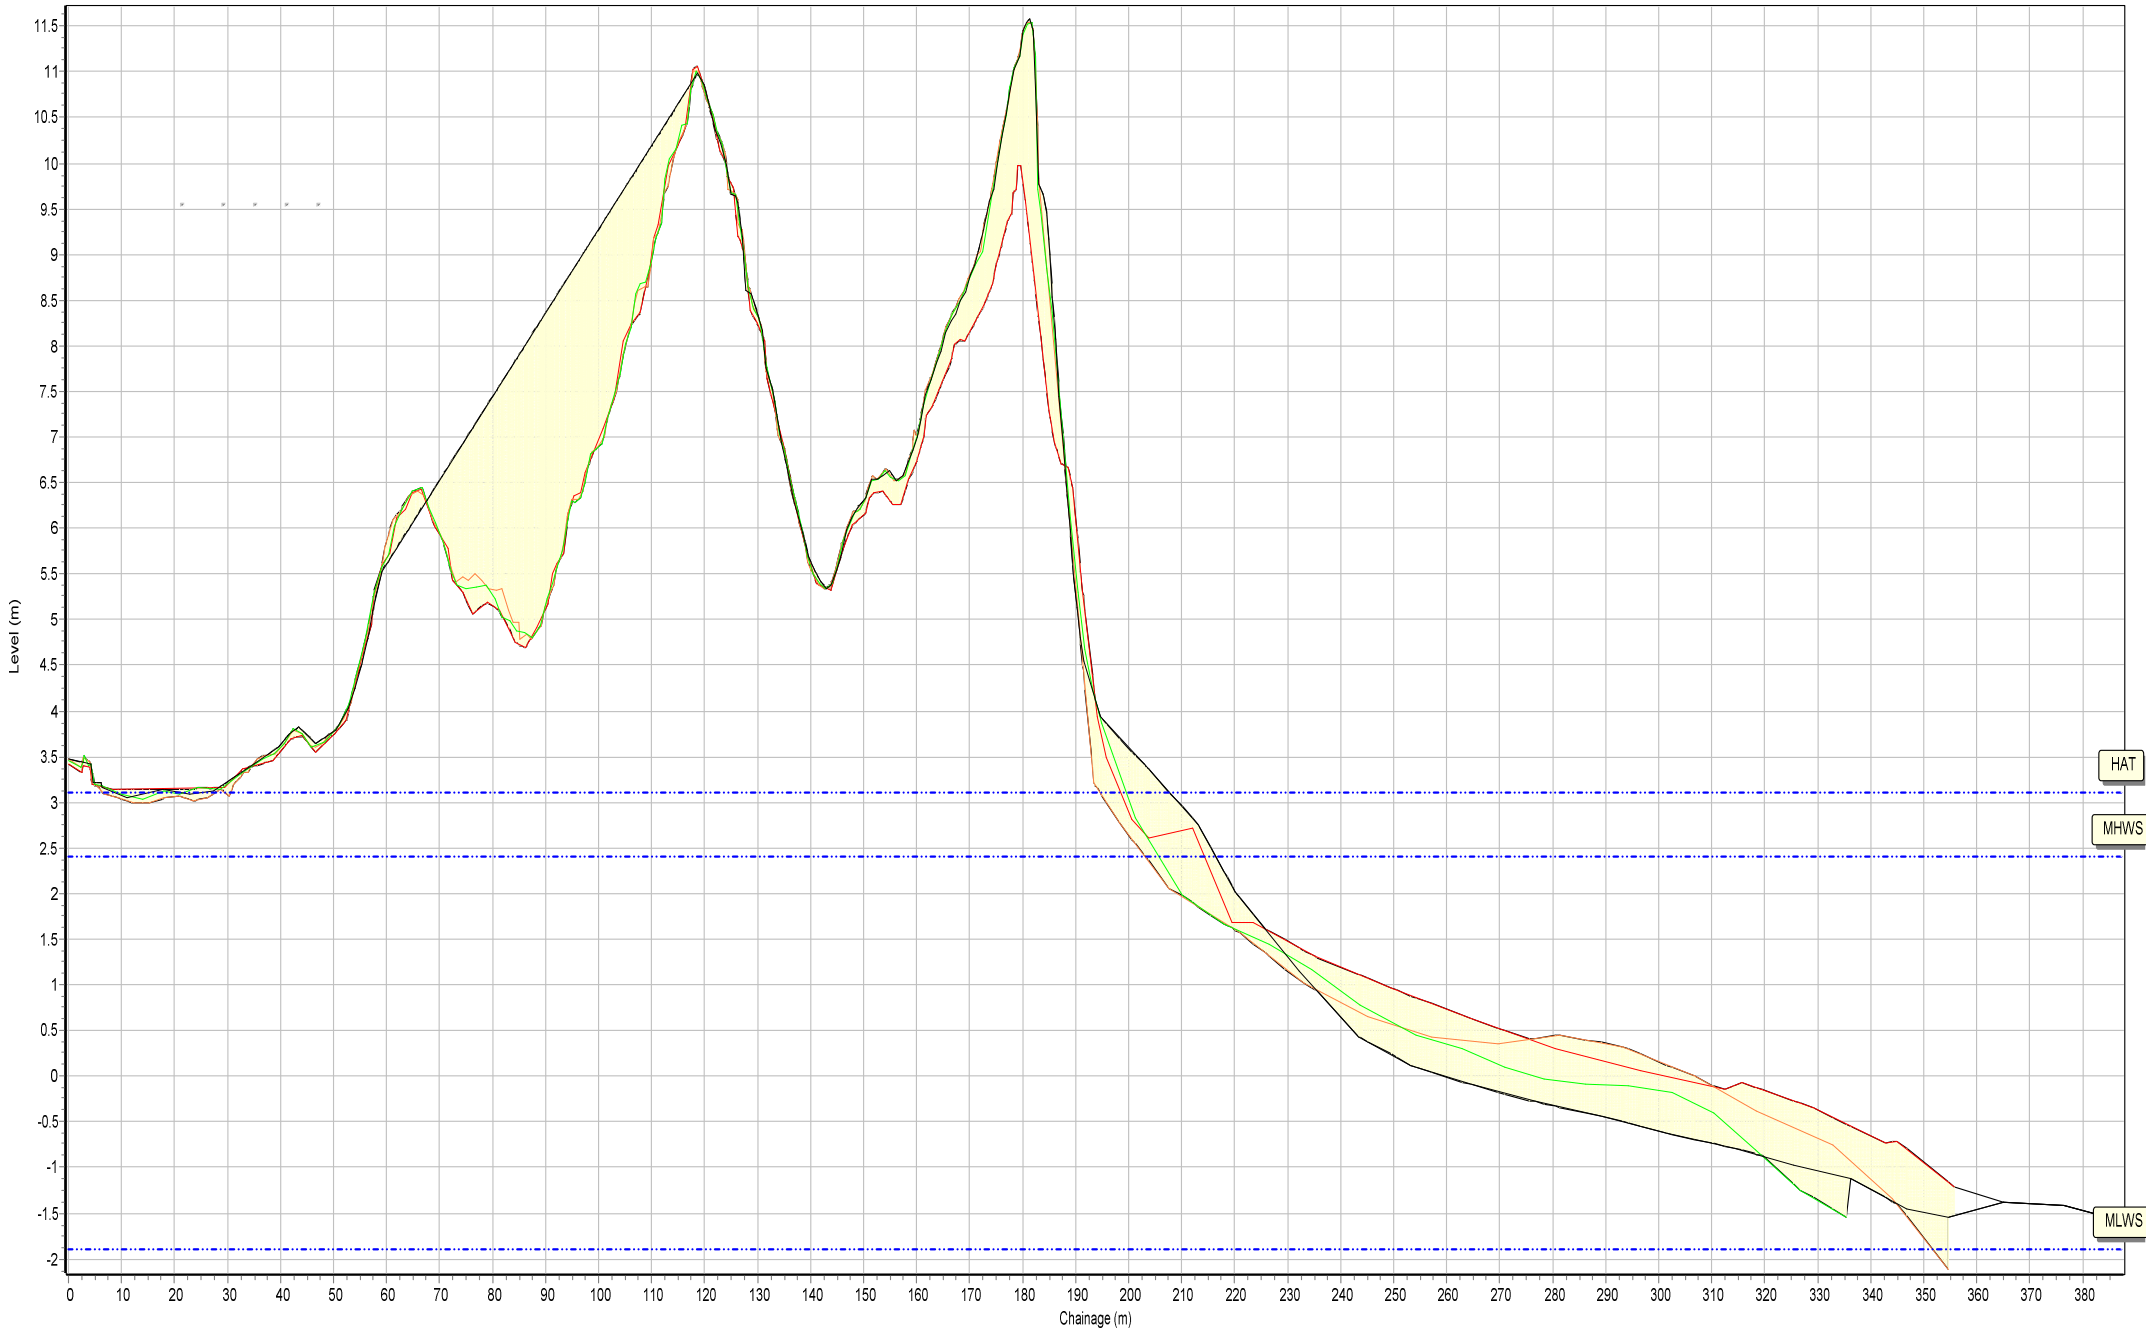
Beach Profiles: 1aCMBC02

Survey Date	Description of Changes Since Last Survey	Interpretation
	<p>At profile <b>1aCMB02</b>, the dunes have remained stable. The surveyor's report notes that "<i>a section of field and dunes is missing from the profile due to pregnant livestock and livestock with young animals in the area</i>". The upper beach has experienced up to 1m of accretion between the toe of the dunes at chainage 195m and chainage 230m. There has been a small amount of erosion between chainage 230m and 320m of up to 0.4m. Seawards of chainage 320m beach levels have increased by up to 0.3m, with the toe of the beach moving seawards by around 50m. Compared to the range recorded from previous surveys the profile is a medium to low level.</p>
