Cell 1 Regional Coastal Monitoring Programme Update Report 12: 'Partial Measures' Survey 2020

(*) The present report is **Update Report 12** and provides an analysis of the 2020 Partial Measures survey for Northumberland County Council's frontage.

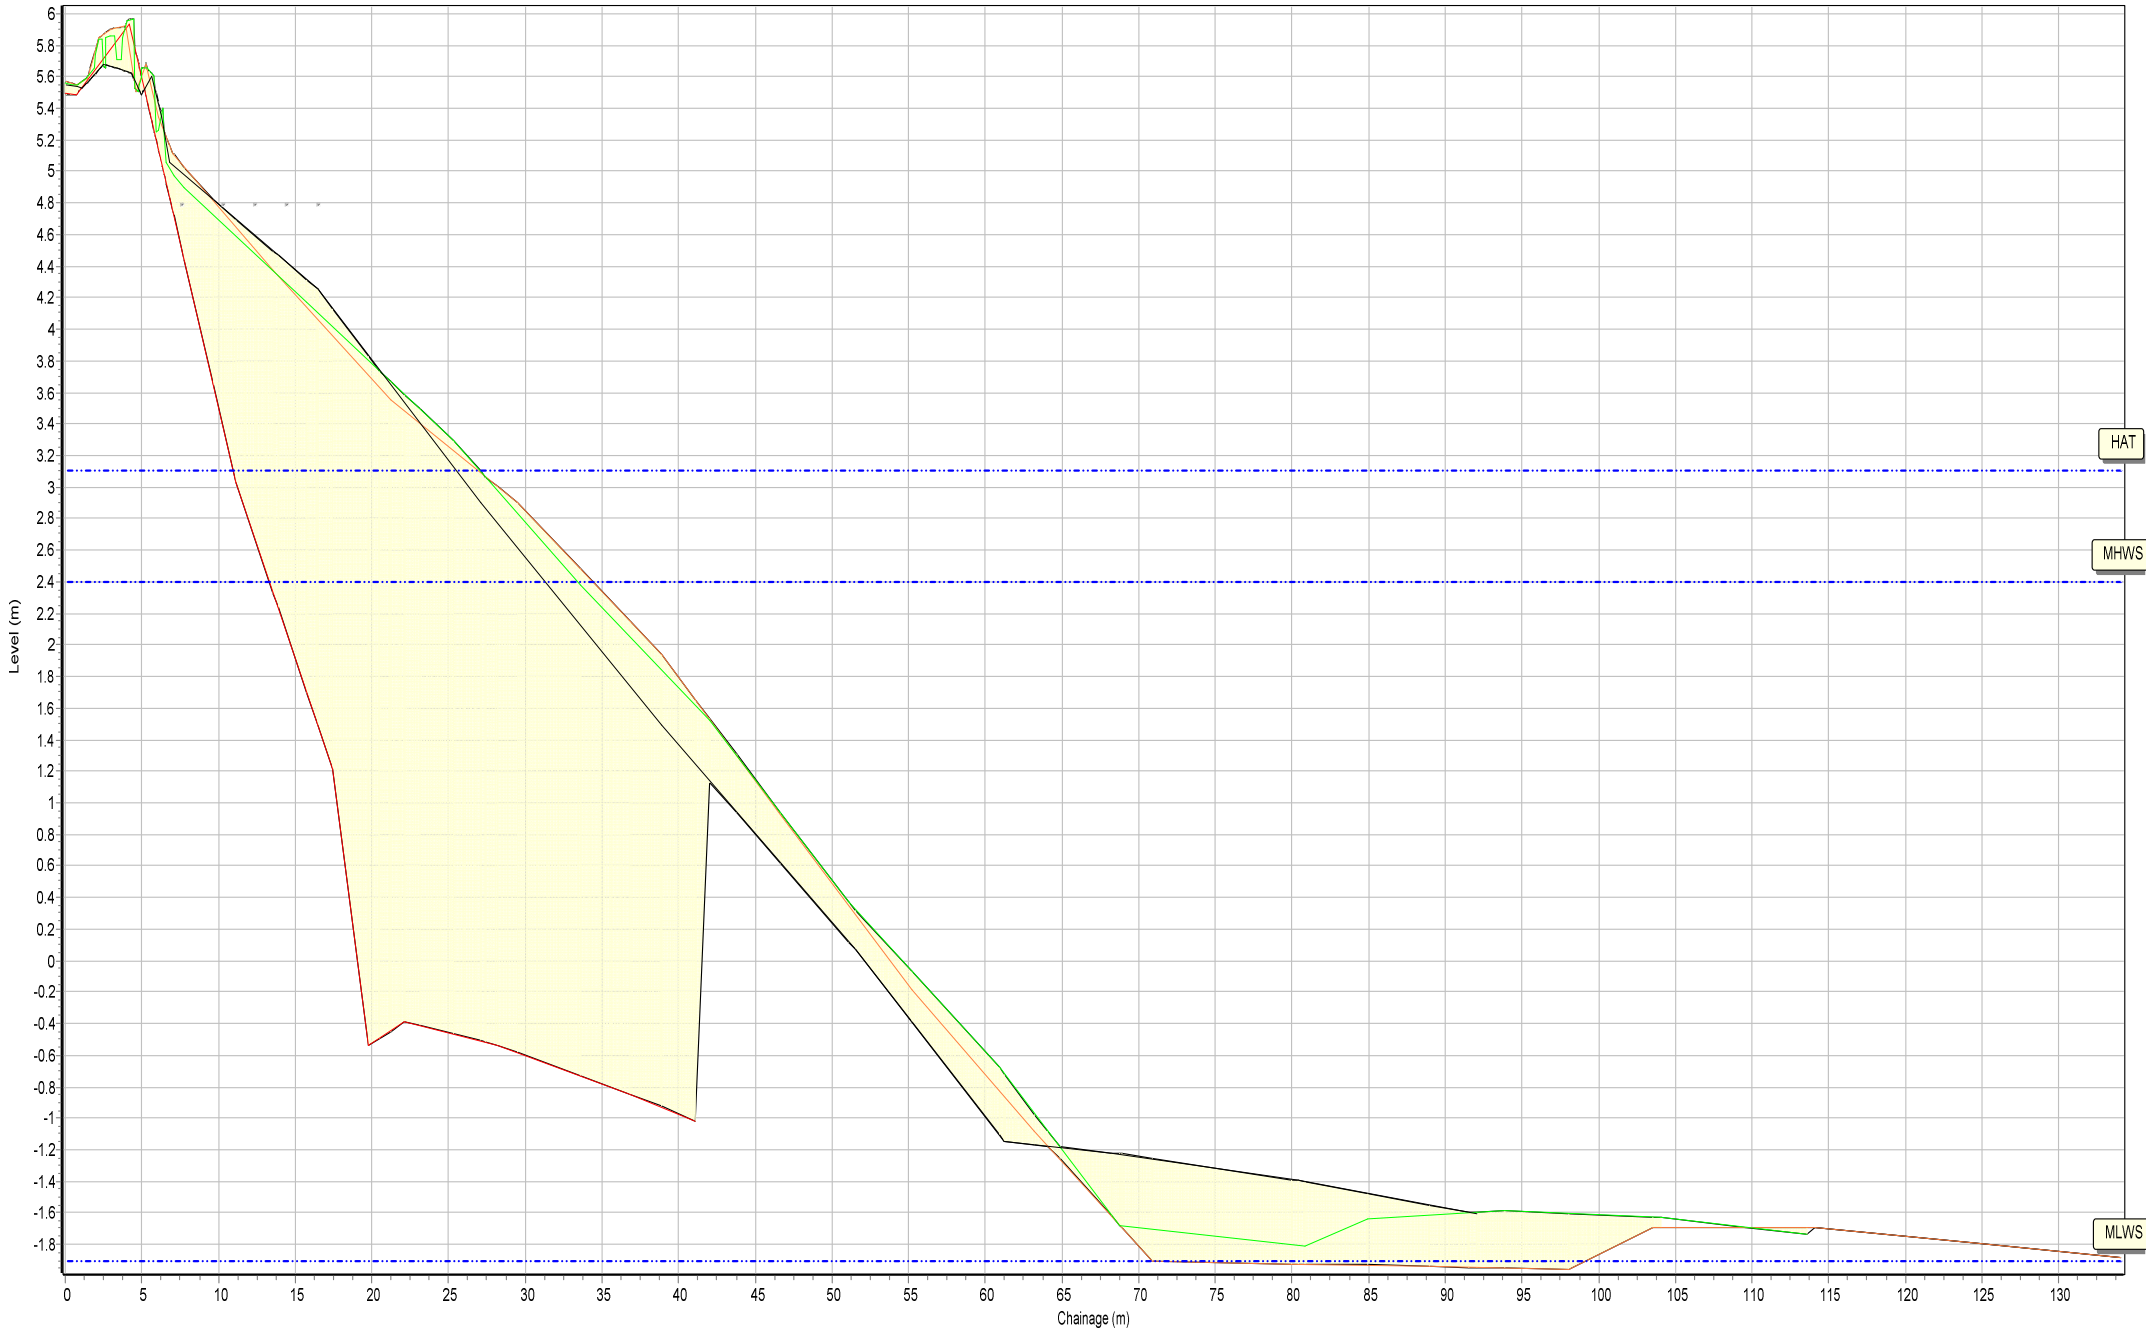
Beach Profiles: 1aWDC07

- At Newbiggin Bay, there is no cause for concern, with the upper and lower beach experiencing accretion and the middle beach experiencing more erosion. The profiles range in level, but are generally at a medium level except profile 1aWDC07 which is at its most landward position recorded
