Cell 1 Regional Coastal Monitoring Programme Update Report 14: 'Partial Measures' Survey 2022

**Northumberland County
Council**

August 2022

(*) The present report is **Update Report 14** and provides an analysis of the 2022 Partial Measures survey for Northumberland County Council's frontage.

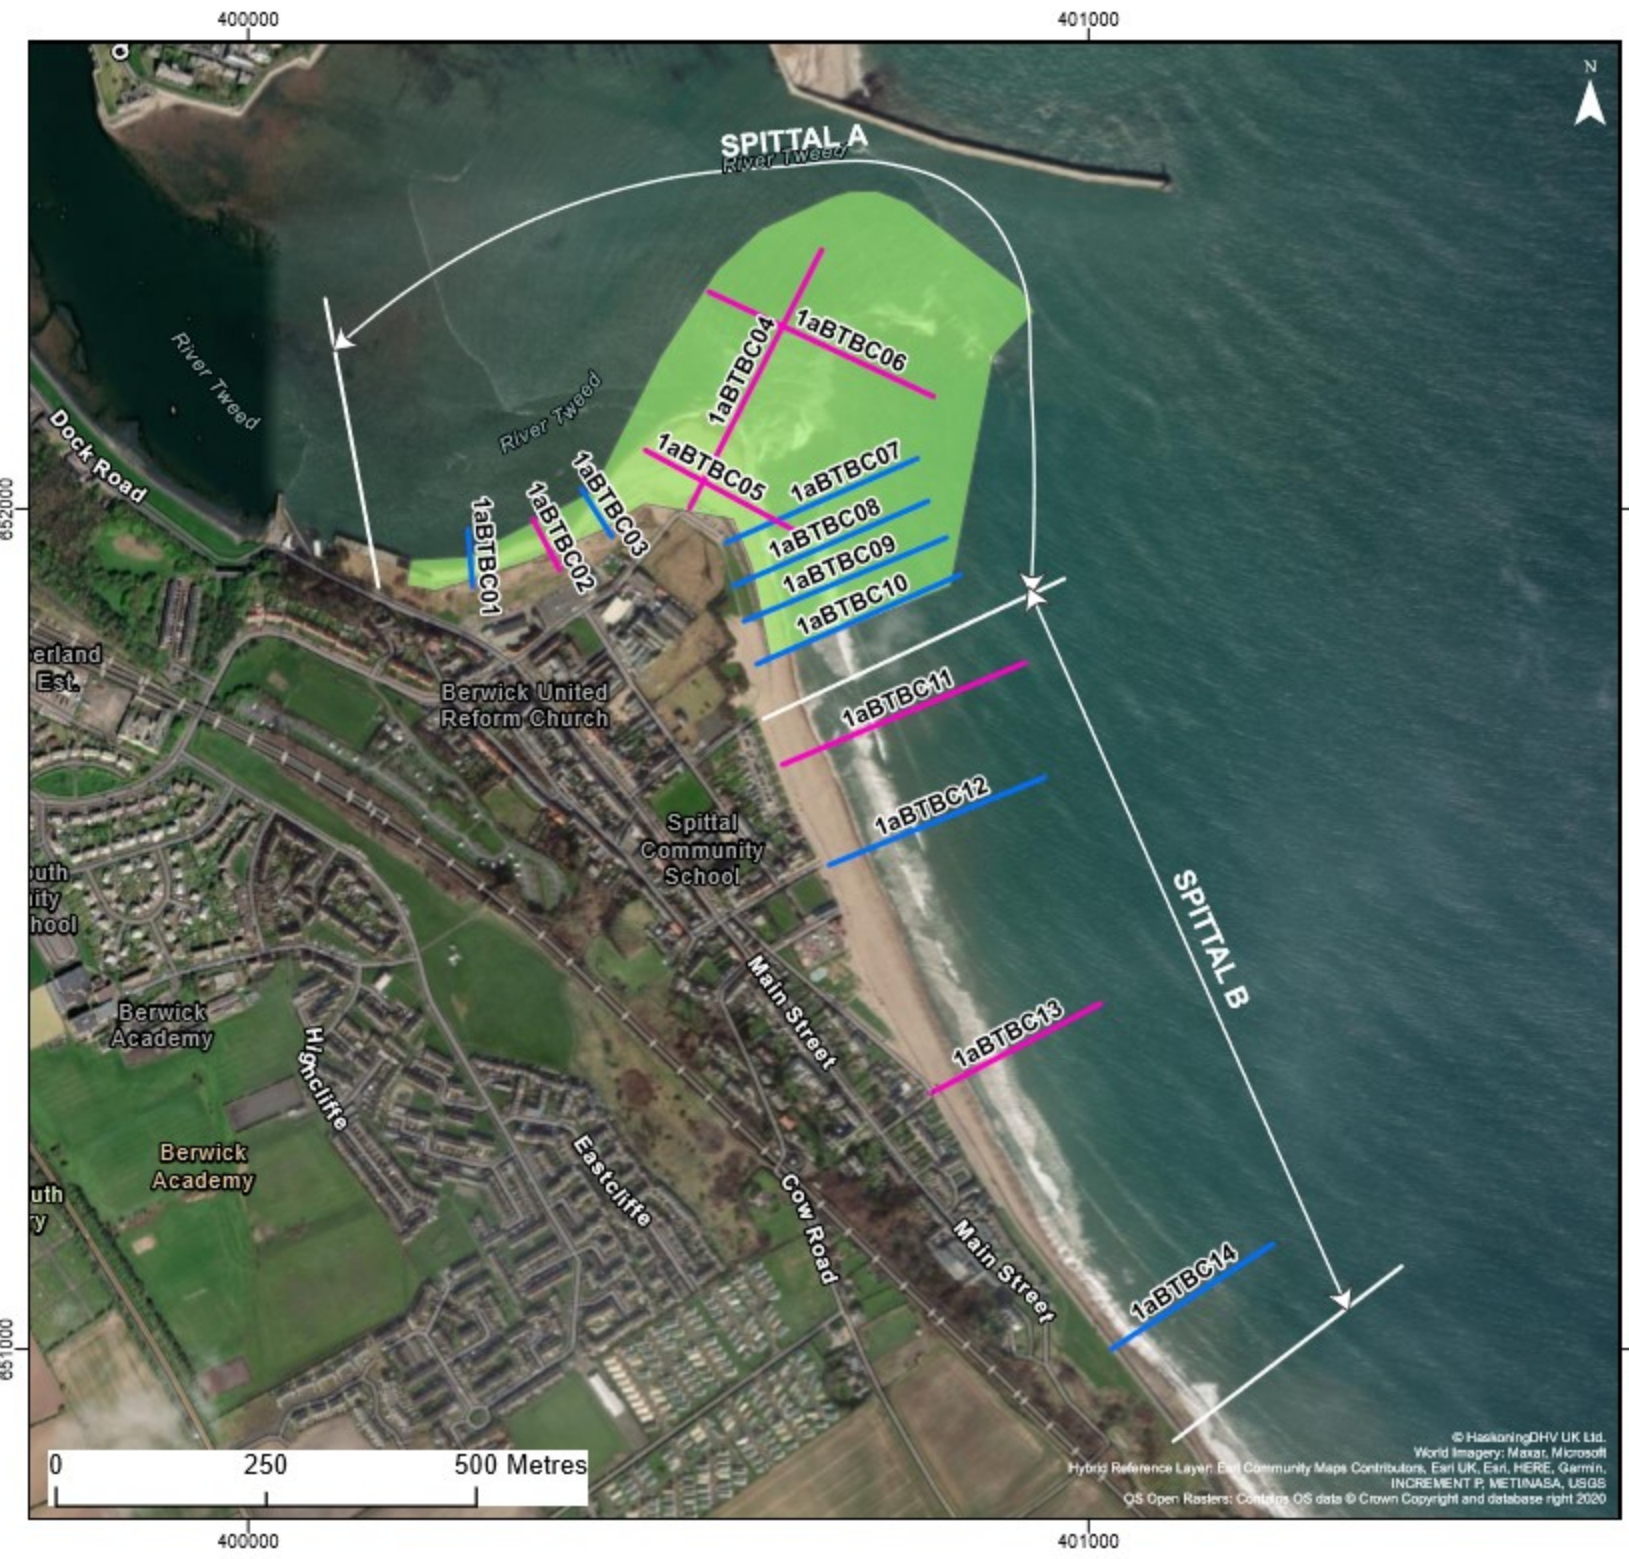
Figure 2 - Map 1
SPITTAL A and B
Northumberland County Council Frontage

The location of these surveys is shown in Figure 2. The Partial Measures survey was undertaken along this frontage between 21st February 2022 to 4th April 2022. During this time weather conditions varied considerably; refer to the survey reports for details of the weather conditions over this survey period.

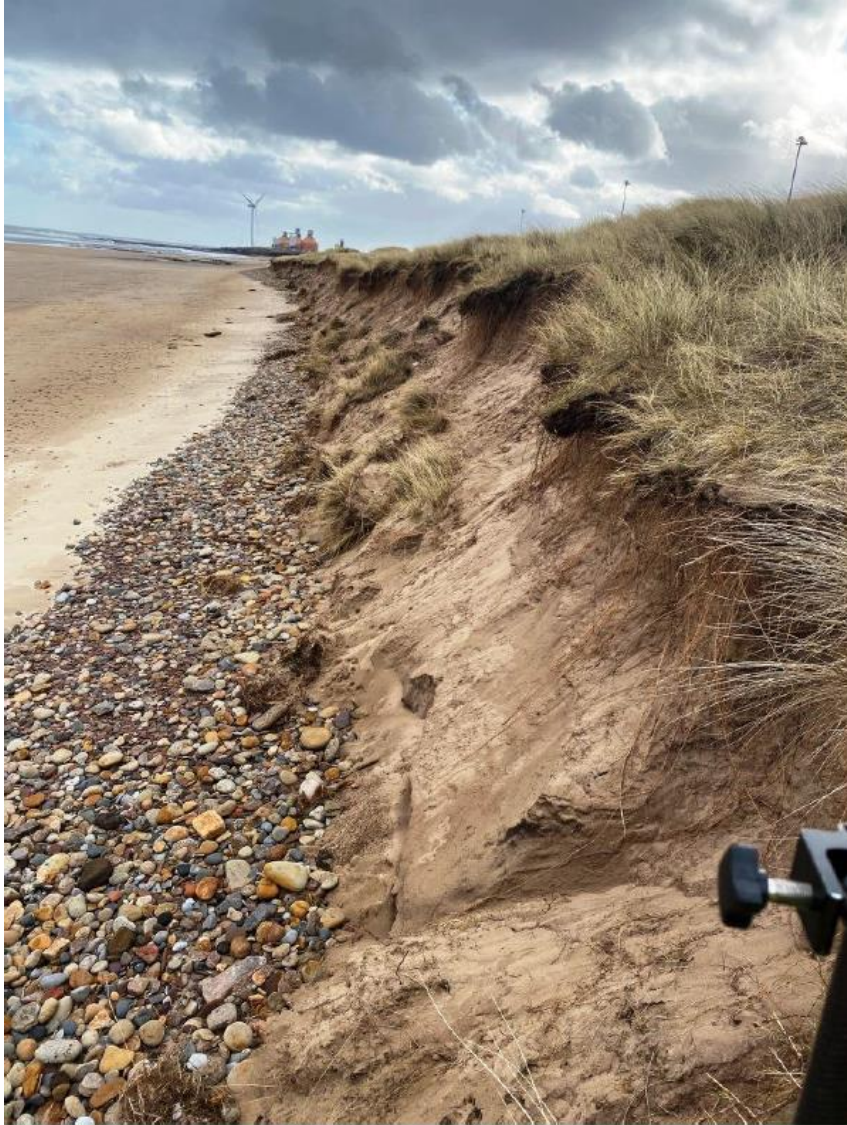
Survey Date	Description of Changes Since Last Survey	Interpretation
<p>21st - 23rd February 2022</p>	<p>Cliff-top Survey:</p> <p>Cliff top survey data collected for baseline survey (spring, 2009), the previous Full Measures survey (autumn 2021) and the present Partial Measures survey (spring 2022) is presented in this report.</p> <p>The cliff top survey is carried out as a continuous cliff edge line survey in two locations within Cambois Bay; at Sandy Bay Caravan Park to the north of the River Wansbeck estuary, and Cambois Bay from south of the River Wansbeck to the breakwater at the southern end of the bay. The results from the cliff top monitoring are anticipated to have an accuracy of $\pm 0.2\text{m}$ due to the technique used. Furthermore, problems in precisely locating the cliff top, due to vegetation growth or the indistinct form of the cliff top, have also affected the data quality. The survey report noted that '<i>very thick dense vegetation at north end of Cambois cliff top hinders survey of line</i>', '<i>a small section of the gabion baskets at Cambois have been displaced</i>' and a '<i>small section of cliff approx. 380m long and up to 8m wide has collapsed</i>' which has been described further below.</p> <p>Overall, the majority of the position of the cliff top at Sandy Bay Caravan Park has remained stable since the previous survey in autumn 2021. There are relatively few sections of erosion, with the largest section (11m) located to the north of the river which has retreated landwards by up to 1.6m. In the south, several sections (up to a maximum of 6m in length) have eroded by up to 2.5m since the previous survey. The dunes on the southern bank of the River Wansbeck show very little change since the previous survey in autumn 2021.</p> <p>There has generally been very little change along the majority of the survey length in Cambois Bay, with small isolated sections of retreat of typically less than 0.1m. The largest area of retreat is located in the centre of the survey extent, where the vegetation line has eroded up to a maximum of 7.0m along a length of 368m. This was noted in the survey report and photos are provided in Plate 1 and Plate 2.</p>	<p>Since the last survey in autumn 2021, there has been relatively little change except for a few sections of erosion along the northern-most and southern-most Sandy Bay Caravan Park survey area measuring up to 1.6m.</p> <p>In Cambois Bay the erosion is generally localised small sections, with the most notable section of retreat in the south of the bay of up to 7.0m.</p> <p>Longer term trends: At Sandy Bay Caravan Park the cliff top retreat has been more significant in the southern part of the survey area with up to 5.0m of erosion since 2013, whilst the northern part has eroded by c.1-3m since 2013.</p> <p>In Cambois Bay, the area of greatest cliff top retreat since the surveys began in 2009 is in the centre of the bay opposite the car park in the dunes, Cambois, where up to 12m of erosion has occurred. The north and south of the bay have more typical retreats of c.3-7m.</p>

Plate 1 Section of erosion along Cambois bay

- At Newbiggin Bay, the beach has remained stable, and the recorded profiles present no cause for concern.
- At Cambois Bay, the cliff top survey shows localised small sections of erosion, with the most notable section of retreat in the south of the bay of up to 7.0m. At the Sandy Bay Caravan Park survey area, there has been relatively little change since the previous survey.

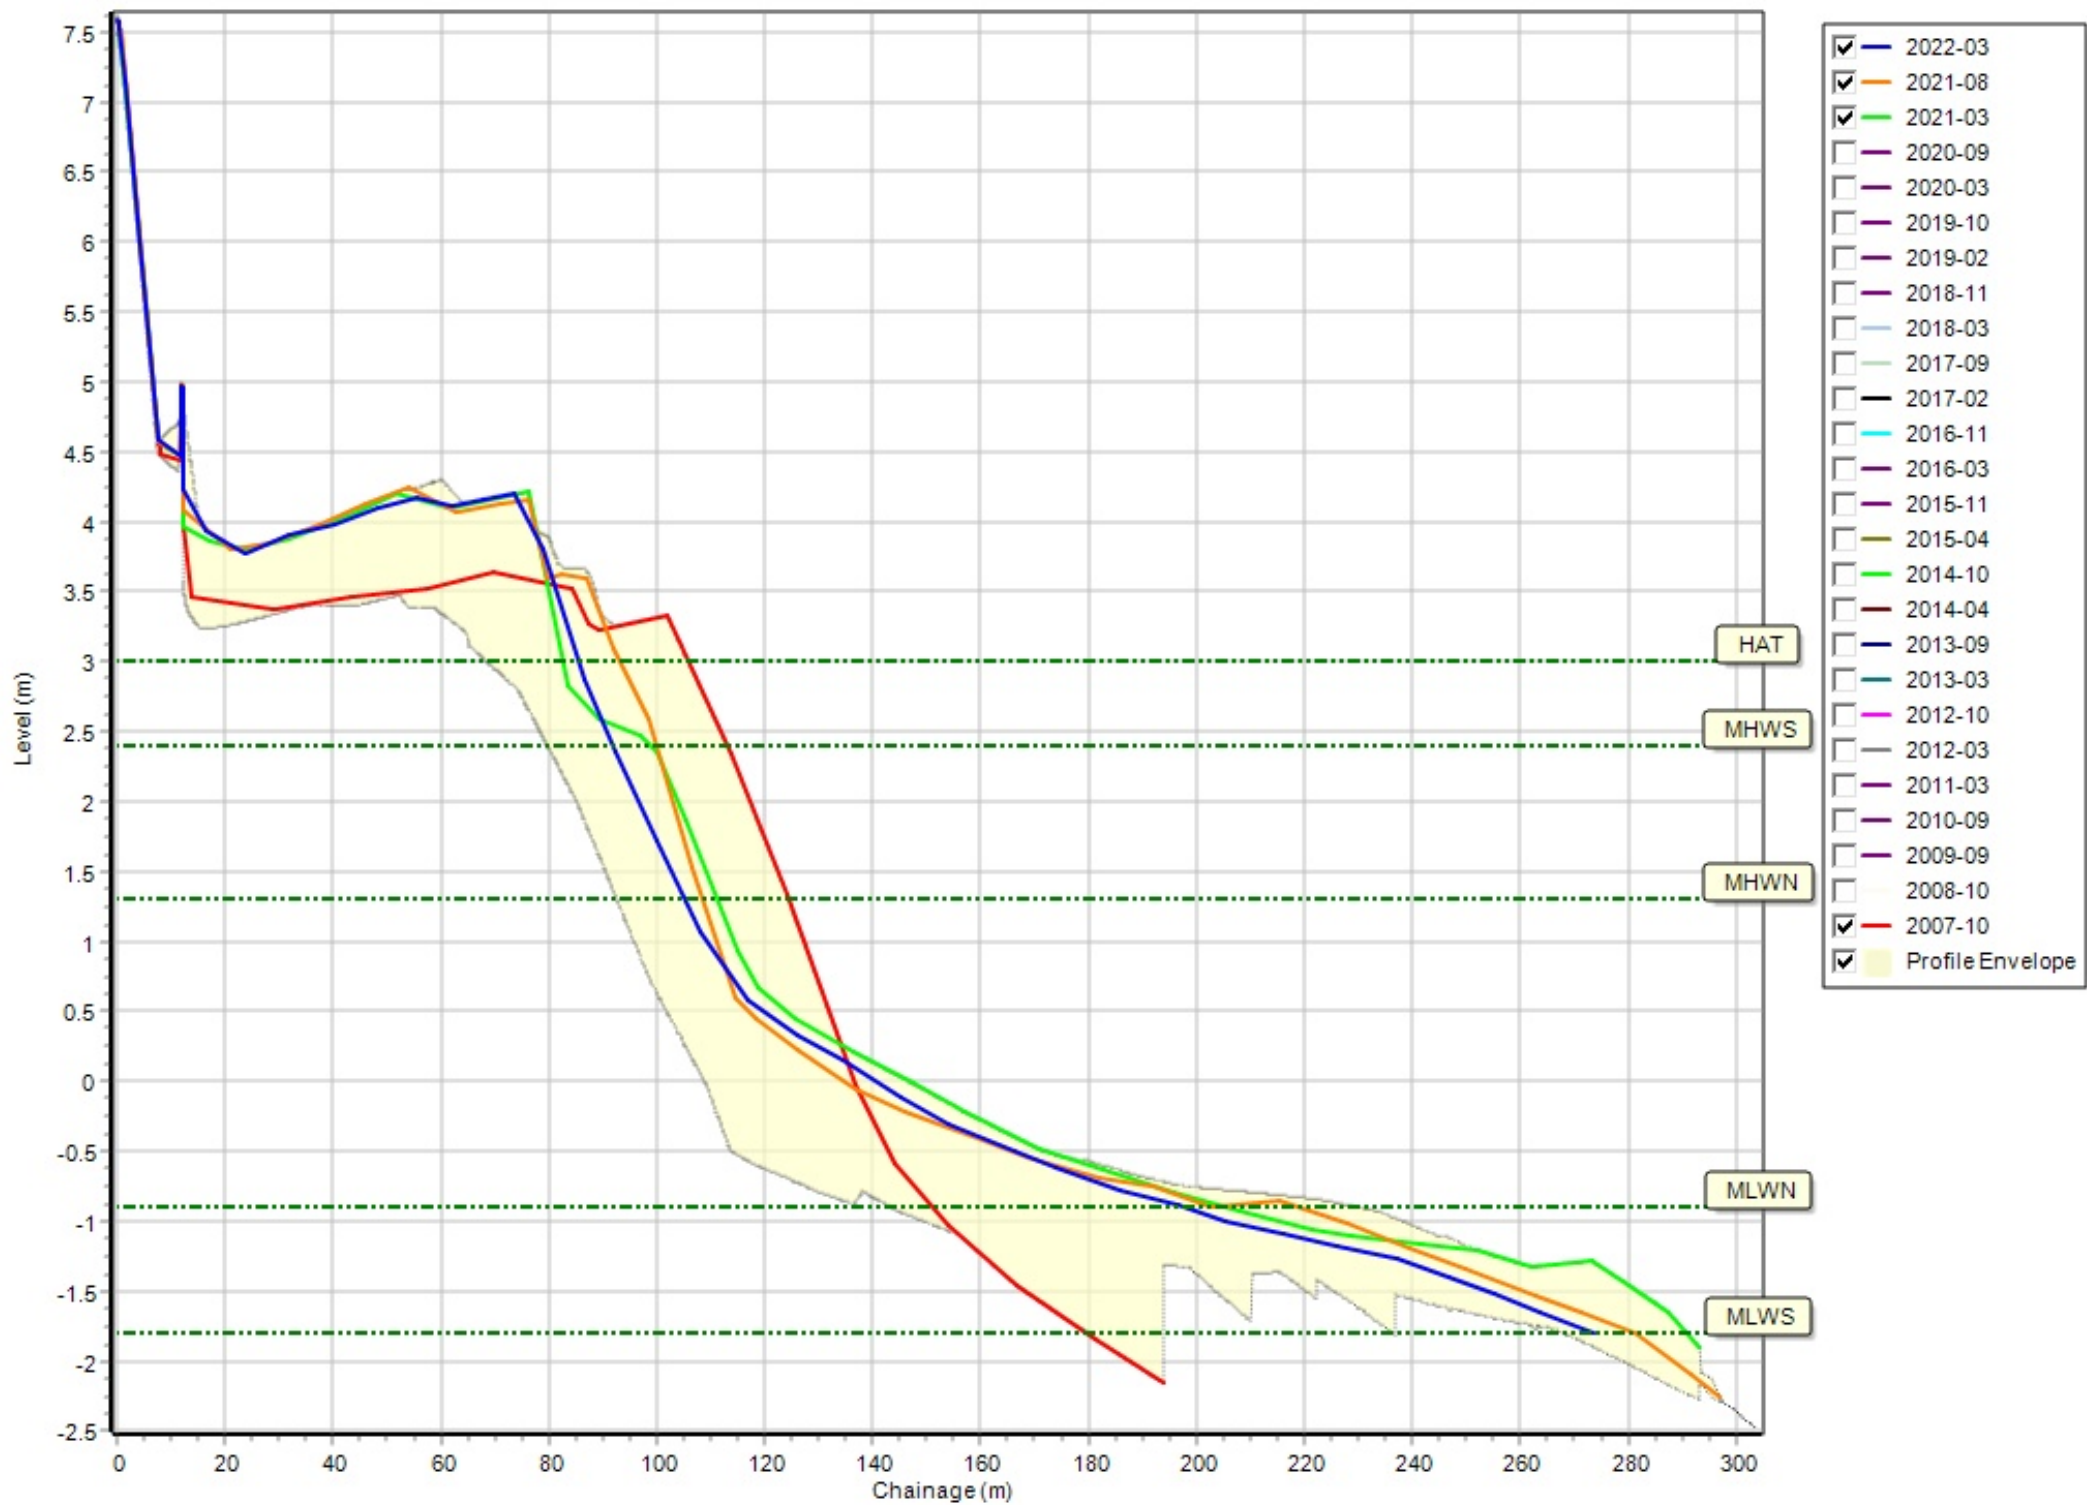
Profiles: 1aWDC07

Survey Date	Description of Changes Since Last Survey	Interpretation
3rd March 2022	<p>Beach Profiles:</p> <p>Newbiggin-by-the-Sea is covered by four beach profile lines during the Partial Measures survey (Appendix A). Two of these (with an 'A' suffix) were added to the programme in October 2007 specifically to help assess the performance of the capital scheme involving beach replenishment and construction of an offshore breakwater. It should be noted that an extended series of profiles and a topographic survey are also recorded via the Cell 1 Regional Coastal Monitoring Programme for purposes of post-project evaluation of this capital scheme. These profiles are not analysed here, however, the findings of the topographic survey are presented below. The previous survey was the Full Measures assessment undertaken in autumn 2021. The survey report noted that “sand was covering most of the revetment rocks at the back of the beach”, “concrete steps were exposed for stretches at the back of the beach” and “Section 4 promenade has increased in height to accommodate new ramping”.</p> <p>Profile 1aWDC05A is in the north of Newbiggin Bay. There has been accretion of up to 0.6m on the landward side of the seawall caused by the wash-over of sediment from the beach. Between the sea wall and chainage 60m the upper beach has lowered by up to 0.5m. The middle beach has risen by up to 0.3m until the rock platform at chainage 112m. The rock platform remains exposed seaward of chainage 112m. The profile is at a medium level across the upper beach, rising to a high level on the middle beach compared to the range recorded from previous surveys. The landward side of the seawall is at its highest level recorded.</p> <p>Profile 1aWDC06 is located in the centre of the northern part of Newbiggin Bay, between the two breakwaters. There has been no change from the base of the seawall to chainage 21m. The upper beach between chainages 21-49m has lowered by up to 0.6m followed by a rise in beach level of 0.3m across the middle beach to chainage 88m. The lower beach seaward of chainage 88m has undergone no change (the survey terminates at chainage 101m). The beach profile is at a relatively medium-high level compared to the range recorded from previous surveys.</p> <p>Profile 1aWDC06A is located in the centre of Newbiggin Bay, behind the offshore breakwater. There has been varying sections of erosion and accretion from the base of the breakwater to chainage 80m limited to ± 0.1m. The upper-middle beach has lowered by up to 0.7m to chainage 113m before</p>	<p>Since the last survey, the beach at Newbiggin-by-the-Sea generally shows erosion on the upper – middle beach and accretion on the lower beach. The profiles are generally at a medium-high level, except profile 1aWDC07 which is at a low level (relative to post-2007 beach replacement levels).</p> <p>Longer term trends: Data collected since the start of monitoring in May 2002 reflects the change in beach width resulting from the beach nourishment scheme implemented at Newbiggin-by-the-Sea. This change is also reflected in the beach profile plot in Appendix A.</p> <p>The changes in beach profile form and position observed since the last survey are within the bounds of previous surveys, except profile 1aWDC07 which is generally continuing to decrease in level.</p>

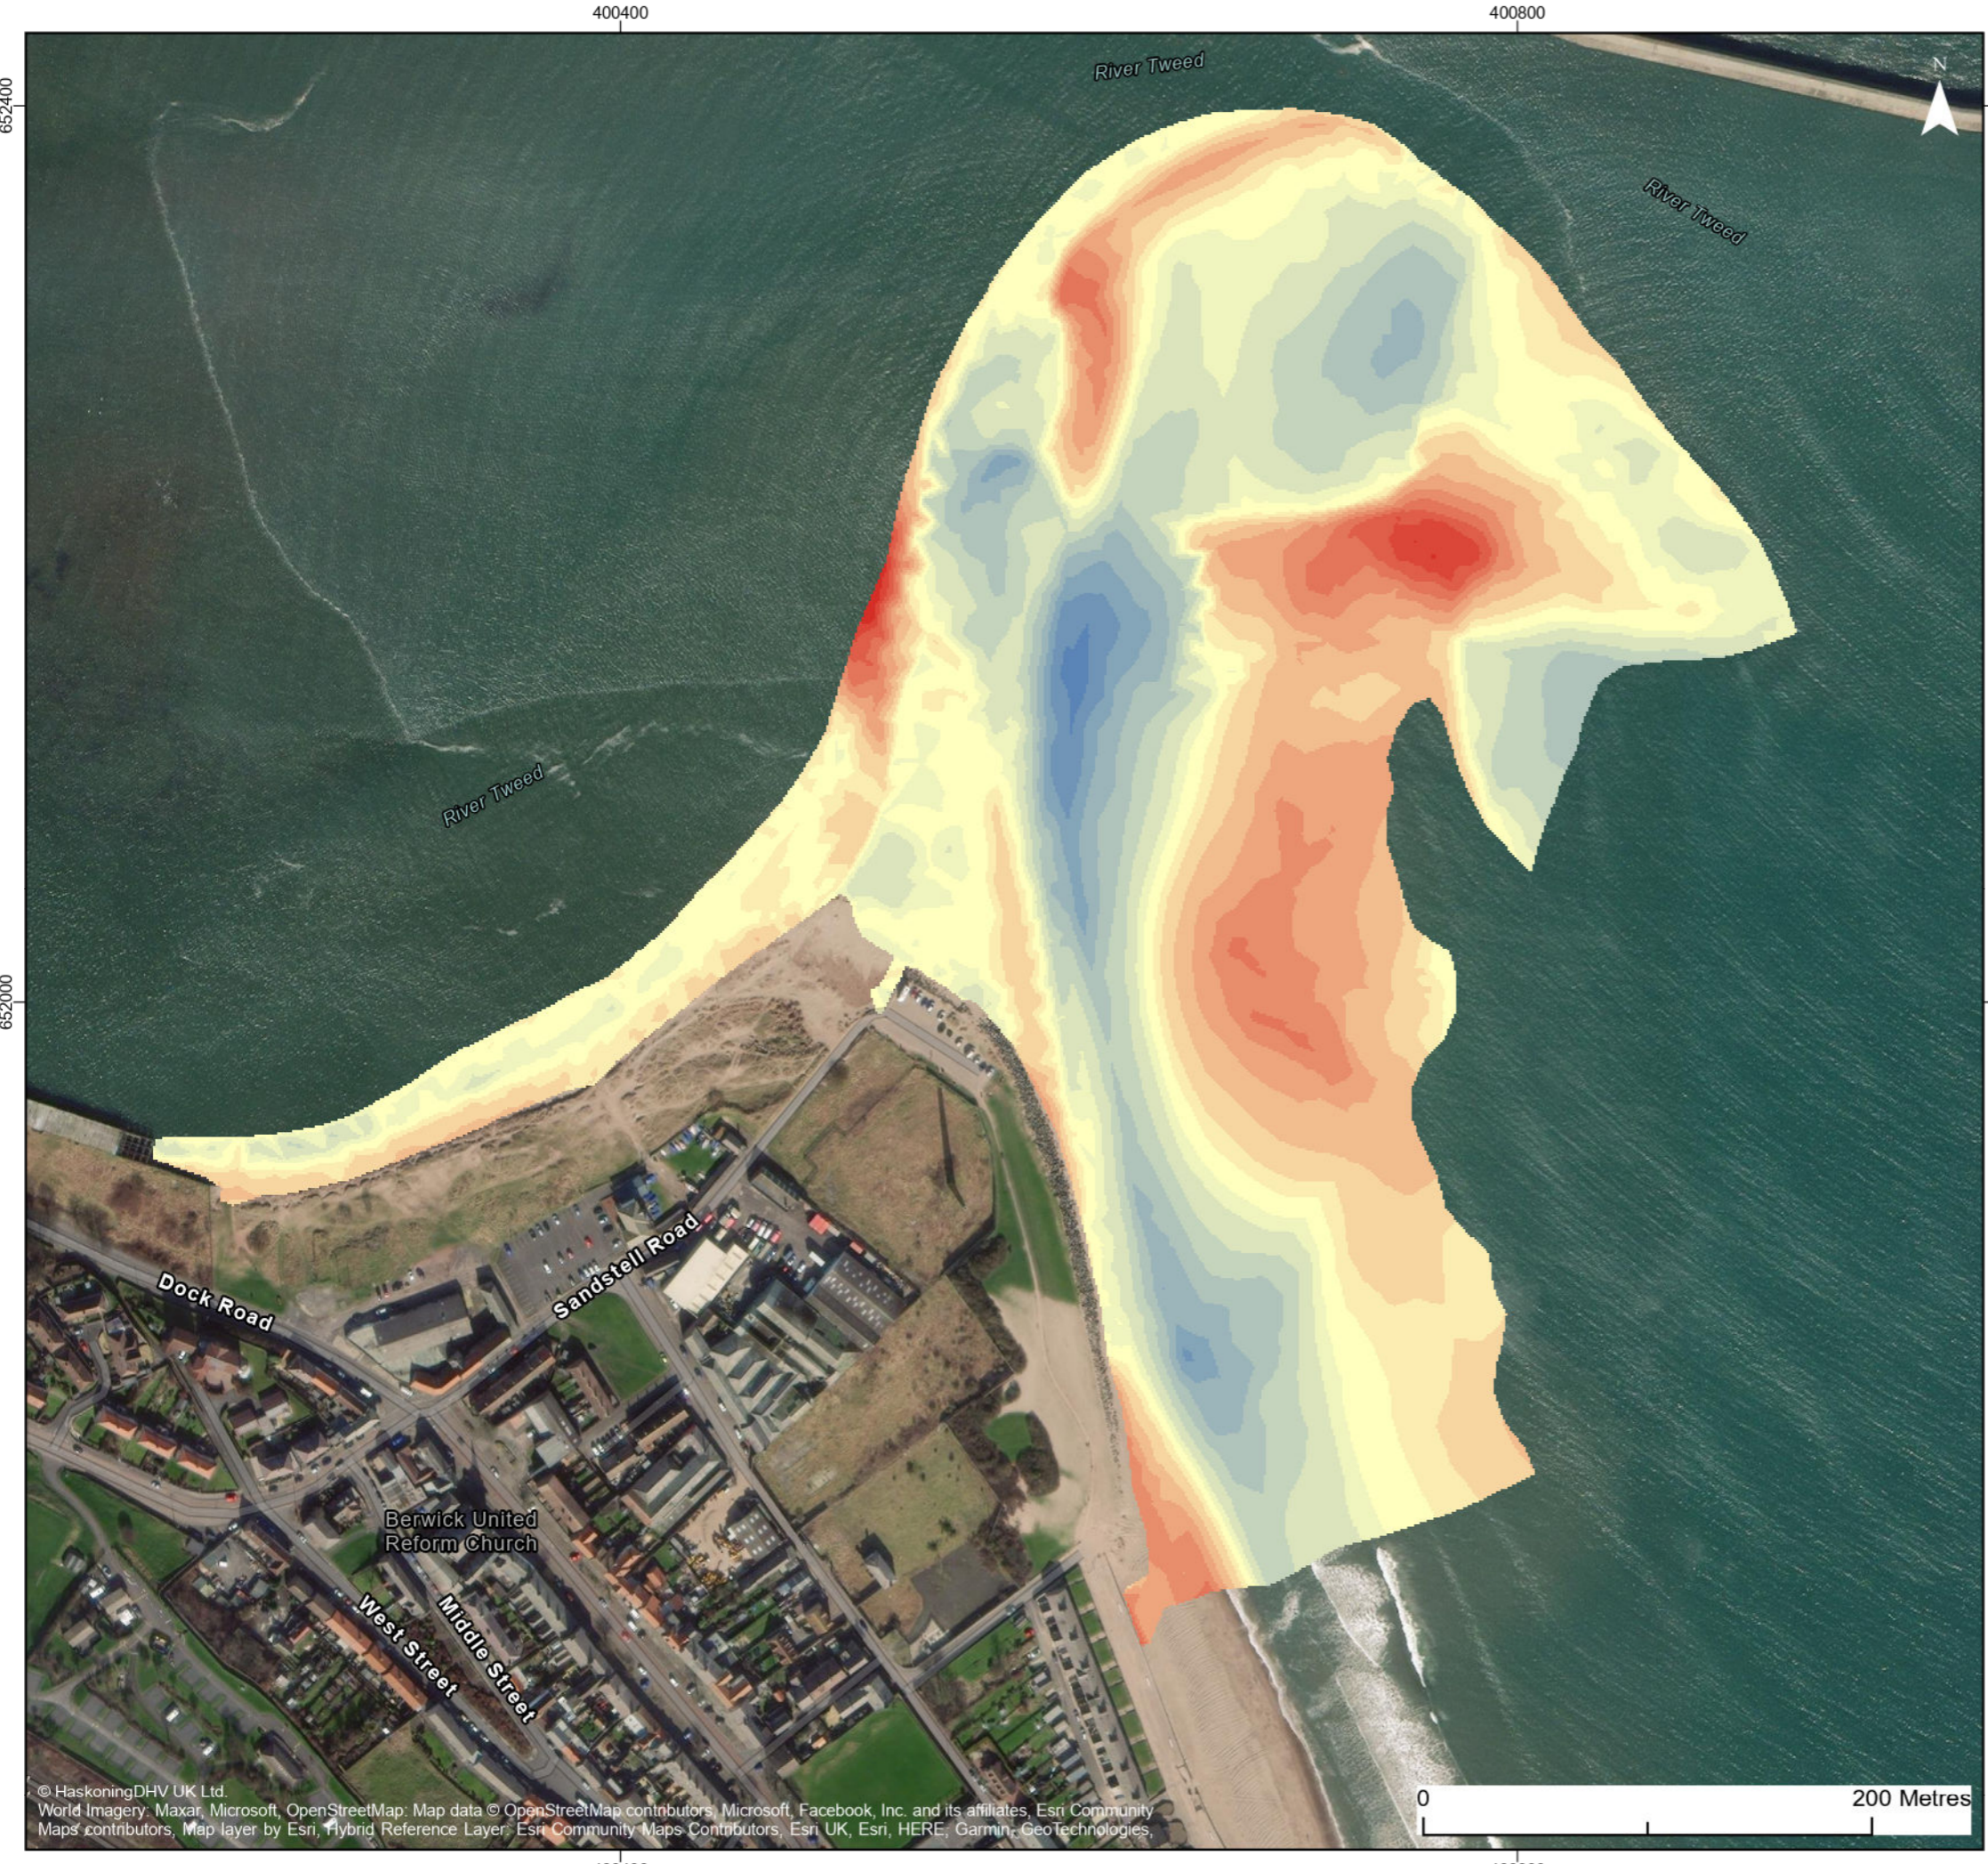
Appendix B - Map 4

TOPOGRAPHIC SURVEY (March 2022)

Newbiggin Bay

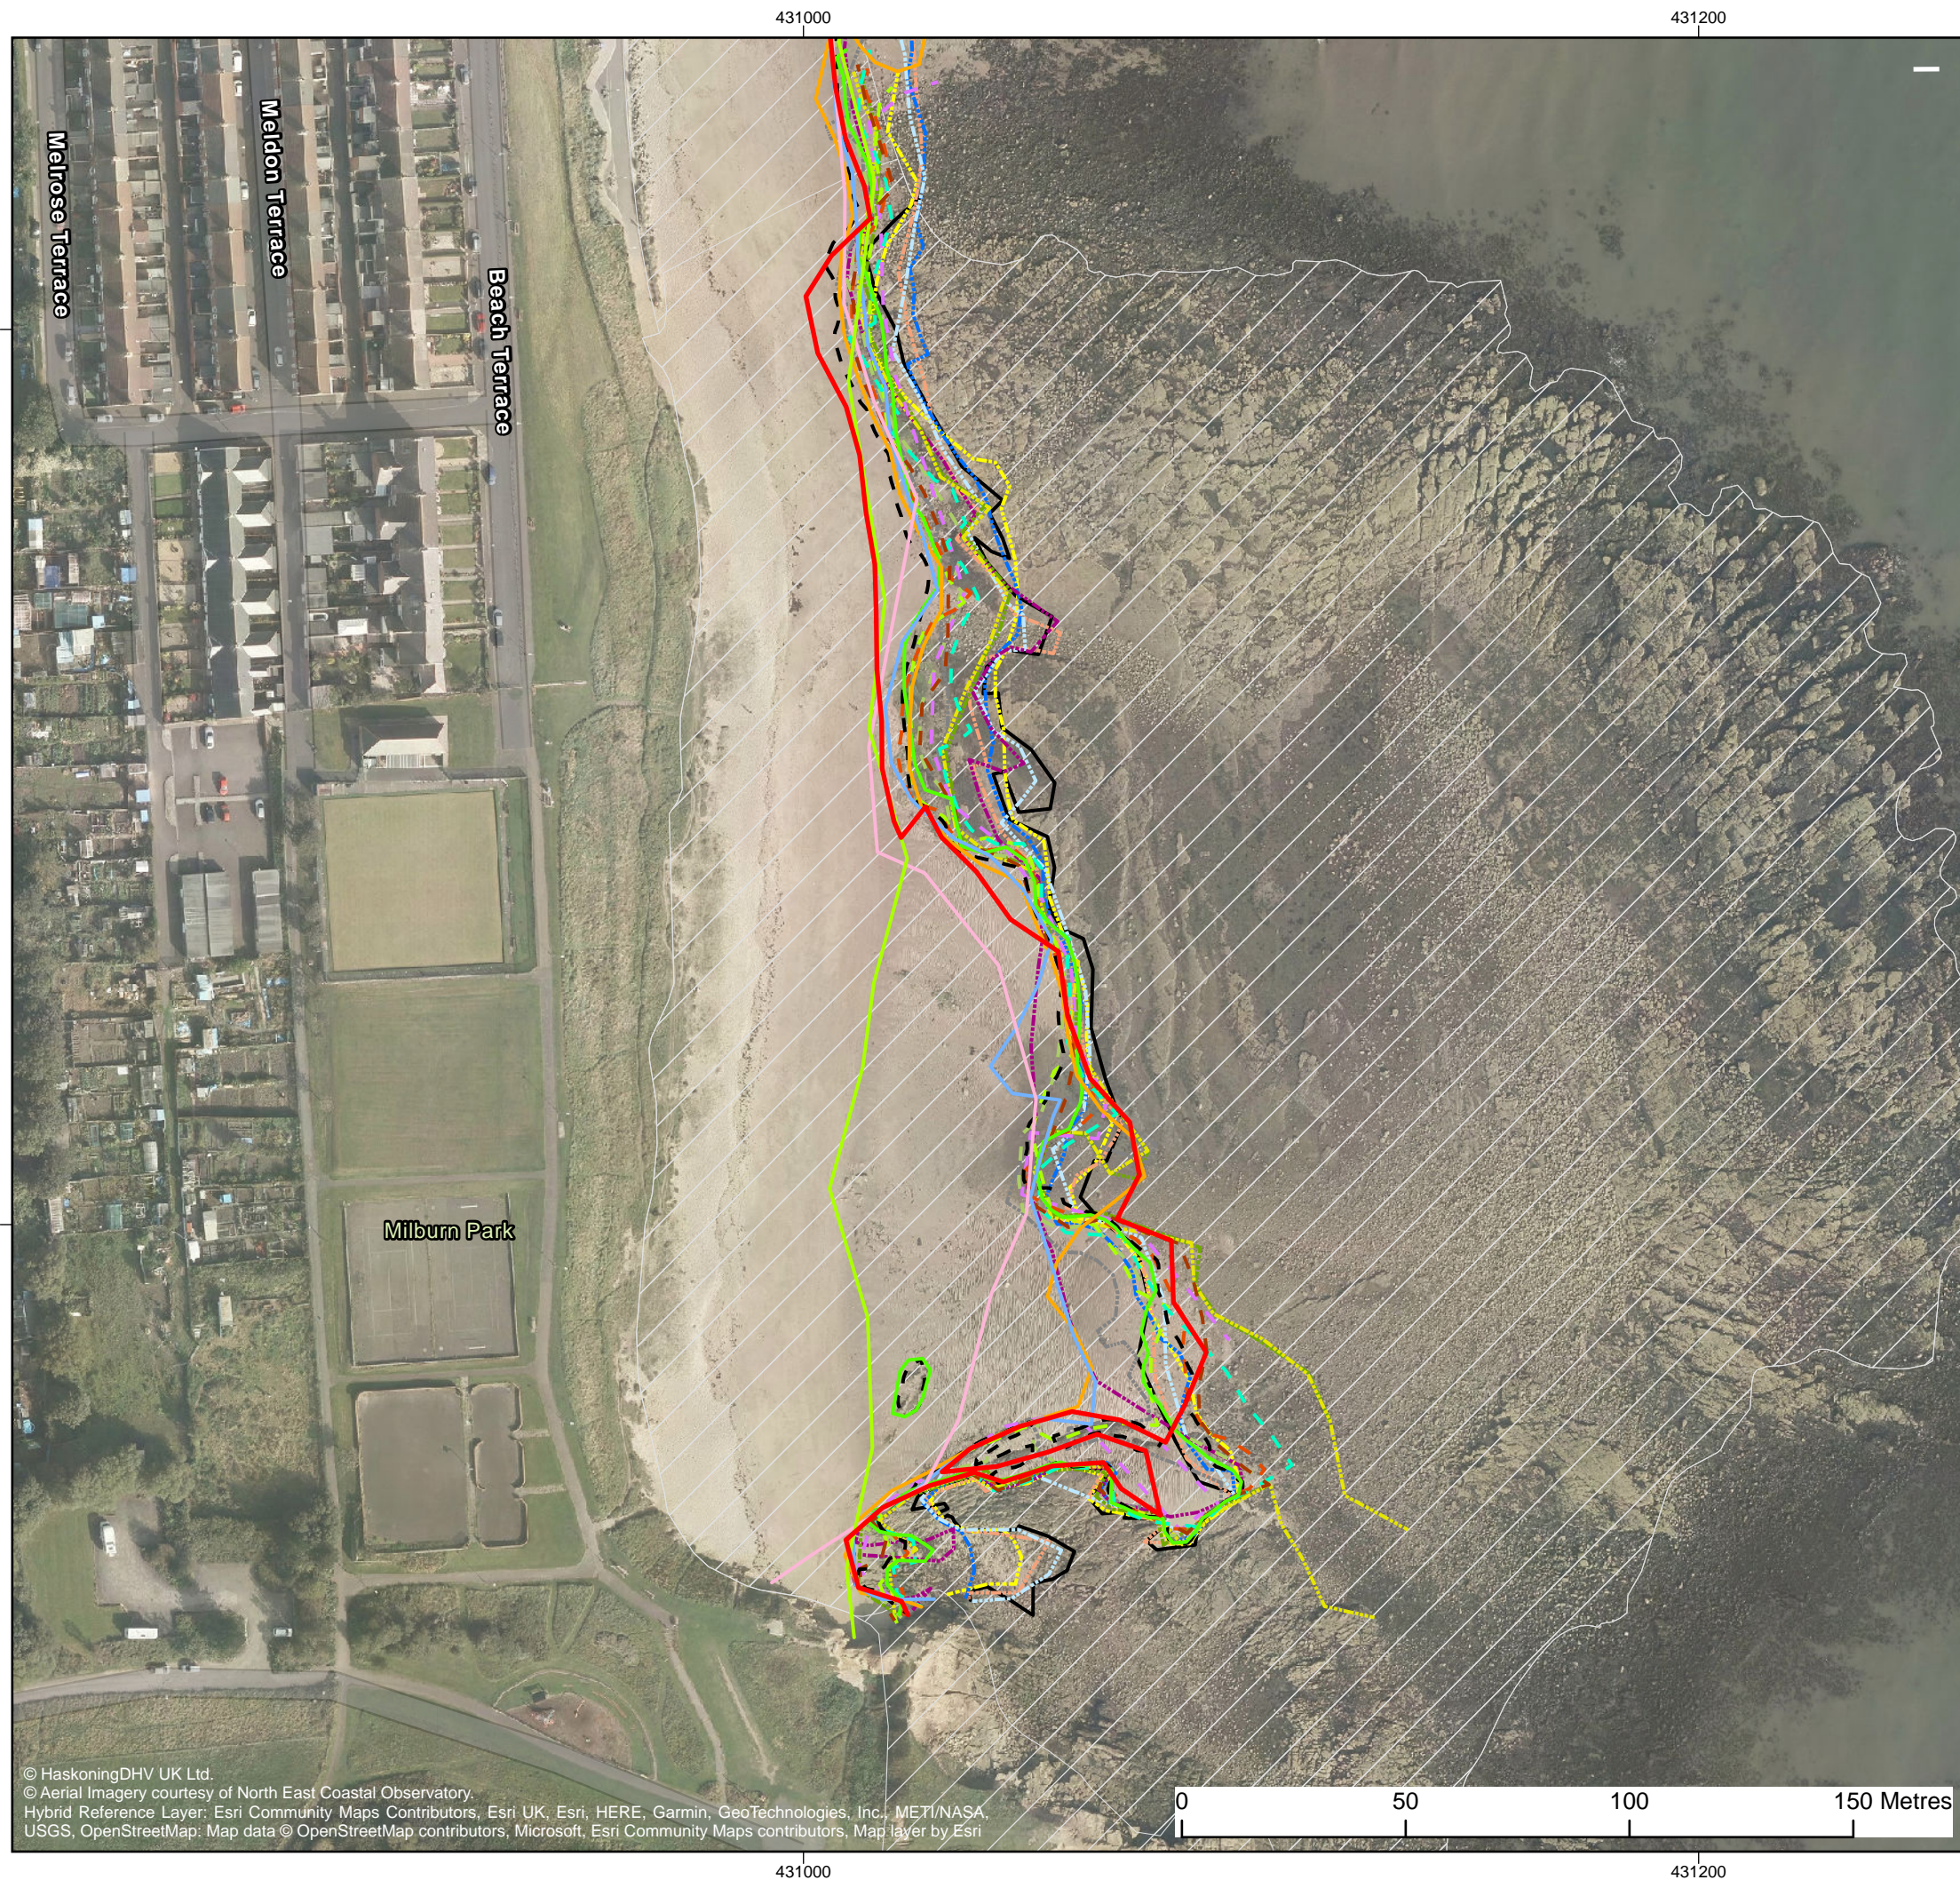
SAND EXTENT

- Edge of sand survey at Newbiggin Bay, Spital Carrs, (commenced 2011 to determine potential adverse impact on foreshore SSSI of the Newbiggin beach recharge scheme)

Spring 2022	Autumn 2016
Autumn 2021	Spring 2016
Spring 2021	Autumn 2015
Autumn 2020	Spring 2015
Spring 2020	Autumn 2014
Autumn 2019	Spring 2014
Spring 2019	Autumn 2013
Autumn 2018	Spring 2013
Spring 2018	Autumn 2012
Autumn 2017	Spring 2012
Spring 2017	Autumn 2011
