## Cell 1 Regional Coastal Monitoring Programme Analytical Report 14: 'Full Measures' Survey 2021

**North Tyneside Council**

December 2021

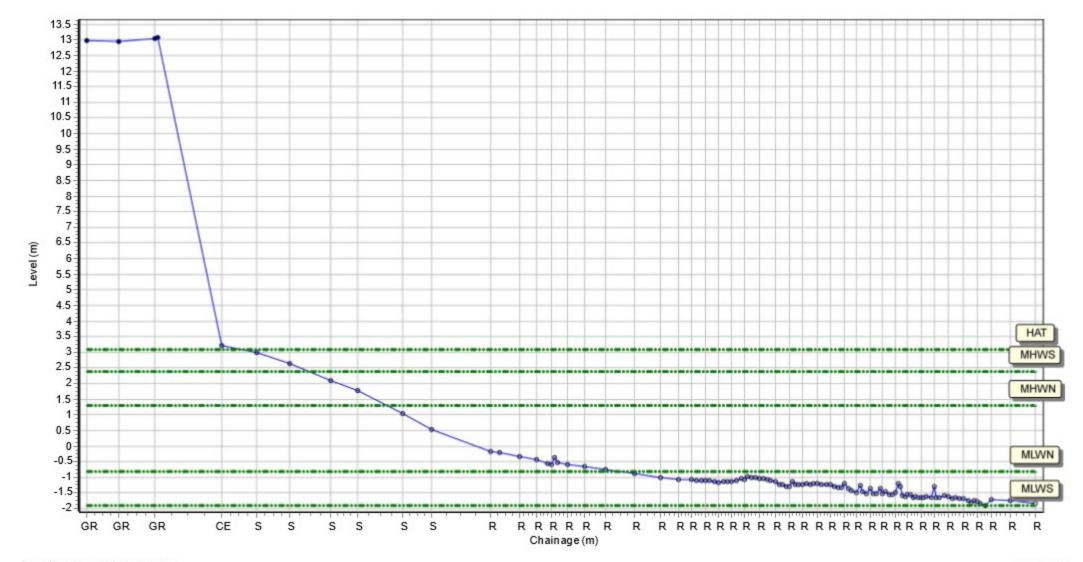
Location: 1aNTDC01

Survey Date	Description of Changes Since Last Survey	Interpretation
	Beach Profiles:  Whitley Sands is covered by five beach profile lines for the Full Measures survey (Appendix A). Four of these (1aNTDC01 to 1aNTDC04) were initially surveyed in April 2002 and were surveyed annually to 2009 (Full Measures, autumn 2009) and bi-annually thereafter. From March 2010 (Partial Measures, spring 2010) onwards, an additional beach profile line (NTDC04A) has been surveyed at the southern end of the frontage. All profiles were last surveyed in March 2021 for the Partial Measures survey.	Since the last survey, there has generally been accretion on the upper and middle beach, and erosion on the lower beach, except in the south of the bay where accretion has occurred across the beach profile. The trend indicates a landward movement of material, which is characteristic of summertime conditions.
26 <sup>th</sup> August 2021	<b>1aNTDC01</b> is located in the north of Whitley Sands, along the undefended cliffs immediately south of Trinity Road car park. The cliff was not measured due to dangerous access. There has been accretion of up to 0.5m of material at the toe of the cliff between chainage 30m and 65m. Across the remainder of the beach, from chainage 30m to the end of the survey at chainage 206m there has been erosion of up to 1.5m on the middle beach (removing a berm) and up to 0.1m on the lower beach, exposing rocks seaward of chainage 144m. Overall the upper beach profile is at a medium level, whilst the mid and lower beach profile is at a low level when compared to the range recorded from previous surveys.	Longer term trends: Beach levels are generally at a medium-high range compared to earlier surveys.

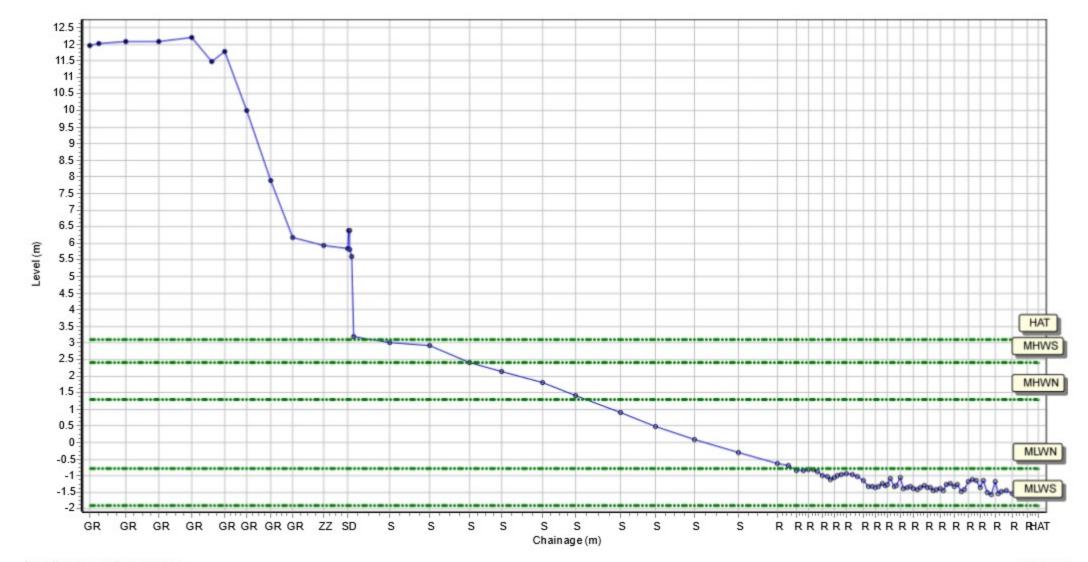
Location: 1aNTDC02

Profile <b>1aNTDC02</b> is located in the northern part of Whitley Sands. A seawall is present at the back of the beach. On the upper beach, between the seawall at chainage 50m and chainage 125m there has accretion of up to 1.2m. From chainage 125m to the end of the survey at chainage 175m there has been erosion of a lower beach berm of up to 1.2m. The removal of this material has exposed the rocky foreshore seaward of chainage 130m. The profile is generally at a high level on the upper beach, a medium level on the middle beach and a low level on the lower beach when compared with the range recorded from previous surveys.	
	Profile <b>1aNTDC03</b> is located at the centre of Whitley Sands. Accretion of up to 1.0m has occurred between the seawall and chainage 78m. The lower beach seaward of chainage 78m has eroded by up to 1.2m. A rock outcrop at chainage 90m is exposed as in previous surveys. The profile is at a

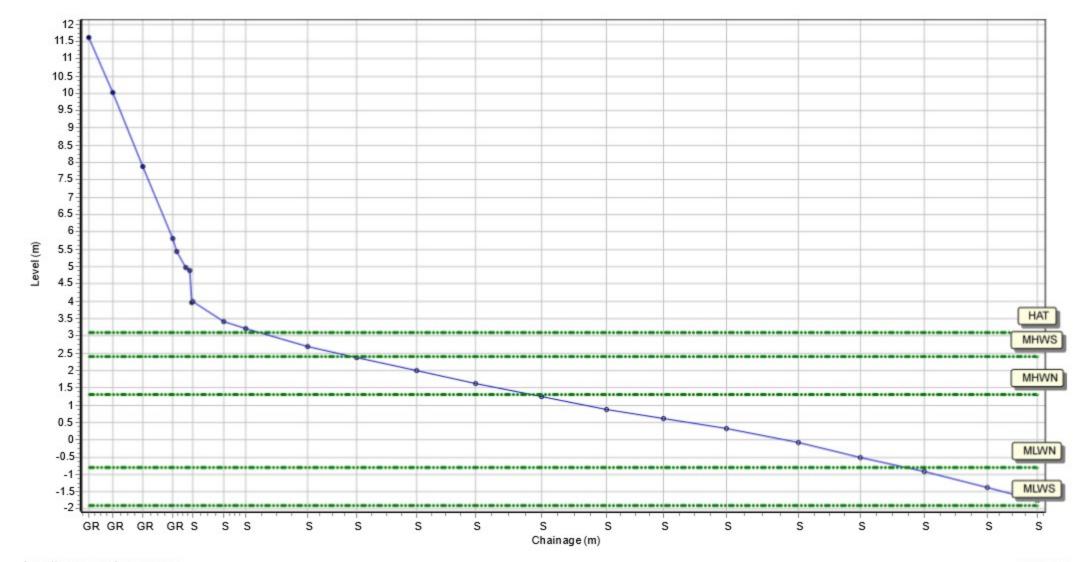
Location: 1aNTDC04

Survey Date	Description of Changes Since Last Survey	Interpretation
	medium-high level the upper and middle beach, whilst the lower -beach is at a low level compared to the range recorded from previous surveys.	
	Profile <b>1aNTDC04</b> is located in the southern part of Whitley Sands. There has been relatively little change between the seawall and chainage 30m. The middle beach between chainages 30m and 100m has accreted by up to 0.6m, covering a previously exposed rock patch at chainage 65m. The lower beach seaward of chainage 100m has eroded by up to 0.9m. Overall, the beach is at a medium level compared with the range recorded in previous surveys.	
	Profile <b>1aNTDC04a</b> is located towards the southern end of Whitley Sands. There has been accretion across the entire beach profile, by up to 1.2m on the upper beach, 0.9m on the middle beach and 0.2m on the lower beach. Overall, the profile is at a high level on the upper and middle beach, and a medium level on the lower beach compared to the range recorded from previous surveys.

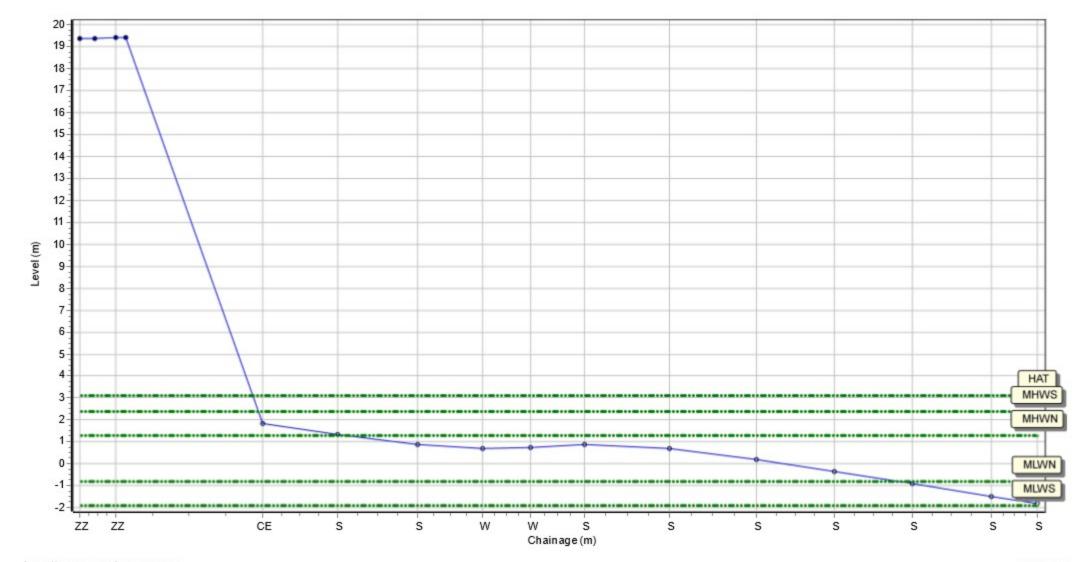
Location: 1aNTDC05

Survey Date	Description of Changes Since Last Survey	Interpretation
26th – 27 <sup>th</sup> August 2021	Beach Profiles:  Cullercoats Bay is covered by one beach profile line for the Full Measures survey (Appendix A). This was surveyed annually each autumn between 2002 and 2009. From spring 2010 onwards, it has been surveyed bi-annually.  At profile 1aNTDC05, the survey report notes that the cliff was not measured due to dangerous access. There has been variable change across the beach profile. Erosion occurs on the upper-middle beach and the lower beach by up to 0.3m. Accretion occurs at the toe of the cliff and on the middle beach by up to 0.4m. The August 2021 profile is generally at a medium level, except on the upper beach where it is at a high level compared to the range recorded from previous surveys.	As in previous surveys access to the cliff has not been possible.  The data shows only limited change related to short-term patterns of sediment movement.  Longer term trends: The amount of change is within the past range. Much of the profile is at medium level compared with previous surveys.

- At Cullercoats Bay, at profile 1aNTDC05, there has been variable change across the beach profile, limited to ±0.4m. The results fall within the range of previously recorded results and there are no causes for concern.

It is recommended that the beach profile at 1aNTDC05 in Cullercoats Bay should start at the cliff toe and that the cliff be monitored using the aerial survey data.

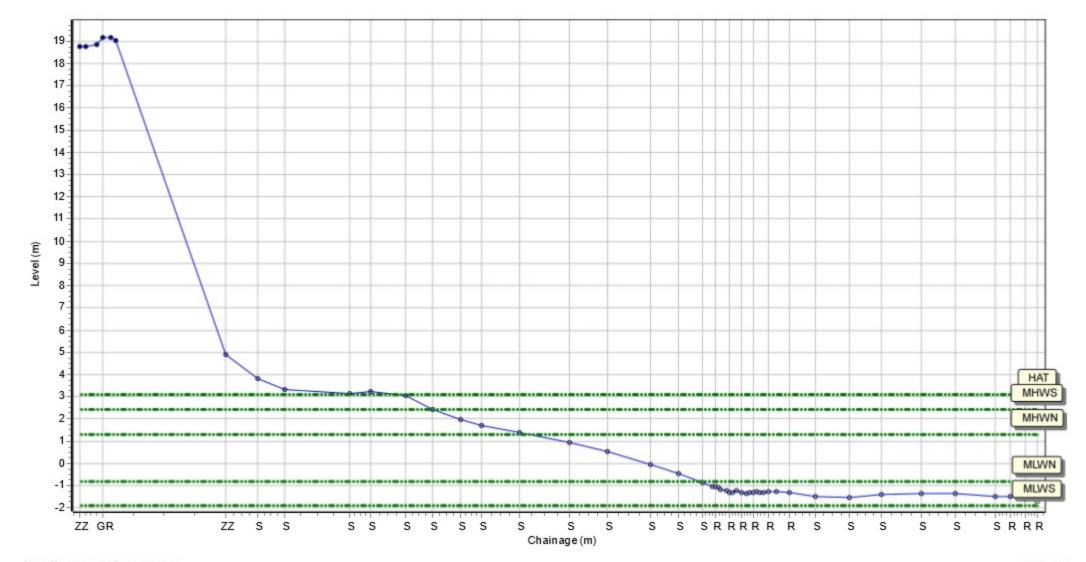
Location: 1aNTDC06

Survey Date	Description of Changes Since Last Survey	Interpretation
27th August 2021	Beach Profiles:  Tynemouth Long Sands is covered by three beach profile lines for the Full Measures survey (Appendix A). Profiles 1aNTDC06 and 1aNTDC07 were initially surveyed annually each autumn between 2002 and 2009. A third profile, 1aNTDC06A, was then added in the centre of the frontage. From spring 2010 (Partial Measures) onwards, all profiles have been surveyed bi-annually.  Profile 1aNTDC06 is located approximately 150m south of the access ramp towards the north of the bay. The top of the cliff has not changed since the last survey however, the remainder of the cliff profile cannot be reviewed due to lack of data points in the profile plot as the survey report notes 'no access to middle of section 6 due to seed protection fences'. The beach profile starts at c.35m chainage and shows accretion of up to 0.3 to chainage 44m, increasing to 1.3m between chainages 30m and 136m, forming a berm at chainage 70m. The lower beach between chainages 136m and 206m has eroded by up to 1.2m, removing a lower beach berm. At the end of the survey, seaward of chainage 206m, the beach profile has increased by up to 0.5m. Overall, the upper and middle beach is at a high level compared with the range from previous surveys, particularly between chainages 58-84m where the upper beach berm has reached its highest level recorded. The lower beach is at a low level, particularly between chainages 138-164m where the beach is at its lowest level recorded.  At profile 1aNTDC06A, the dune-cliff face has not significantly changed in form or position. As with section 6, the survey report notes 'no access to middle of section 6a due to seed protection fences'. There has generally been accretion across the beach profile, by up to 0.6m on the upper and middle beach, and 0.3 on the lower beach. Small sections of erosion occur throughout the profile, however these are generally less than 0.1m. Overall, the autumn 2021 profile is at a high level compared to the range recorded from the previous surveys, particularly between chainages 94-106m a	Since the last survey the dunes have retained the same form and position.  The profiles in the centre and south of Long Sands show variable erosion and accretion, with no clear trend. The northern profile shows a similar trend to Whitley Sands, with movement of material onshore.  Several sections have reached their highest (profile 1aNTDC06 (58-84m) and 1aNTDC06A (94-106m and 154-190m)) and lowest (profile 1aNTDC06A (138-164m)) levels recorded.  Longer term trends: Overall, the beaches have retained a similar form and are in the medium-high range of previous surveys, with the exception of the lower beach at profile 1aNTDC06 which is at its lowest level since records began in 2002.

- At Tynemouth Long Sands, the majority of recorded profiles are within the previously recorded range with berm building processes dominating. Several sections are at their highest levels recorded since 2002 (58m-84m at profile NTDC06, and 94m-106m & 154m-190m at profile 1aNTDC06A). The profiles present no cause for concern. The topographic survey results demonstrate a low level of accretion and erosion in the south of the bay, with changes more pronounced in the northern half of the bay.

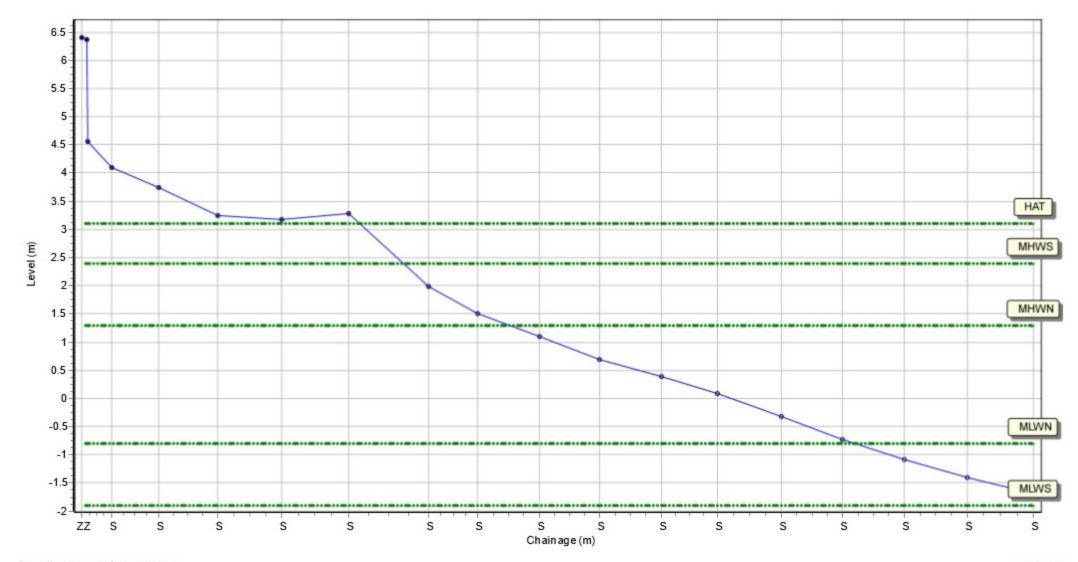
Location: 1aNTDC08

Survey Date	Description of Changes Since Last Survey	Interpretation
26th – 27 <sup>th</sup> August 2021	Beach Profiles:  King Edward's Bay is monitored by one beach profile line for the Full Measures survey (Appendix A). This was surveyed annually between 2002 and 2009. From spring 2010 onwards, it has been surveyed bi-annually.  At profile 1aNTDC08, there has been minimal change on the upper beach to chainage 25m (<0.1m). There has been accretion by up to 1.3m between chainage 25-115m, forming a large berm at chainage 47m. Seaward of chainage 115m the lower beach has eroded by up to 1.1m, resulting in the removal of a lower beach berm. The beach profile is at a medium-high level on the upper and middle beach and a low level on the lower beach when compared with the range recorded from previous surveys.	Since the last survey, the upper beach at King Edward's Bay has experienced movement of sediment in a landward direction.  Longer term trends: The profile is at a medium-high level on the upper and middle beach, and a low level on the lower beach compared with the range of previously observed surveys at this location. Changes between the spring 2021 and autumn 2021 survey show a seasonal movement of sediment across the beach in the form of a berm.

- At King Edward's Bay, there appears to have been a landward movement of sediment in the form of a berm. There are no causes for concern and the results fall within the range recorded in previous surveys.
