## Cell 1 Regional Coastal Monitoring Programme Update Report 16: 'Partial Measures' Survey 2024

North Tyneside Council

June 2024

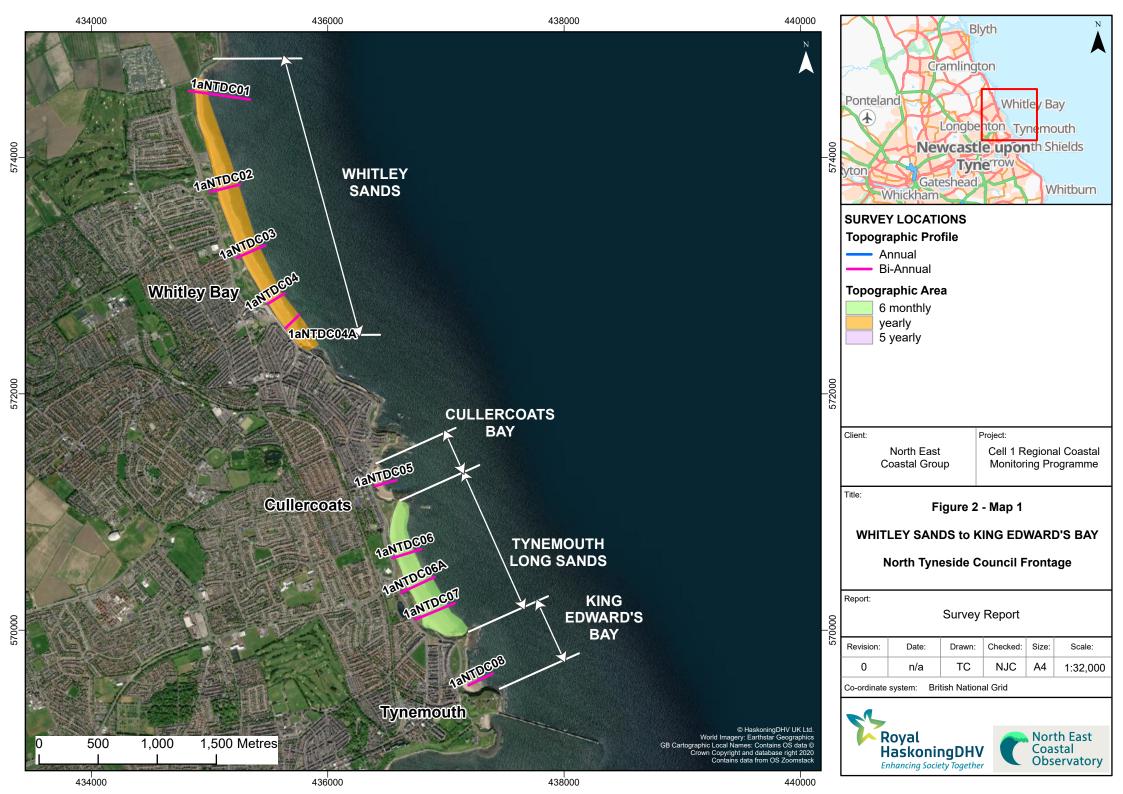
The location of these surveys is shown in Figure 2. The Partial Measures 2022 surveys were undertaken along this frontage on the 11<sup>th</sup> March and 25<sup>th</sup> March 2024. During this time weather conditions varied; refer to the survey reports for details of the weather conditions over this survey period.

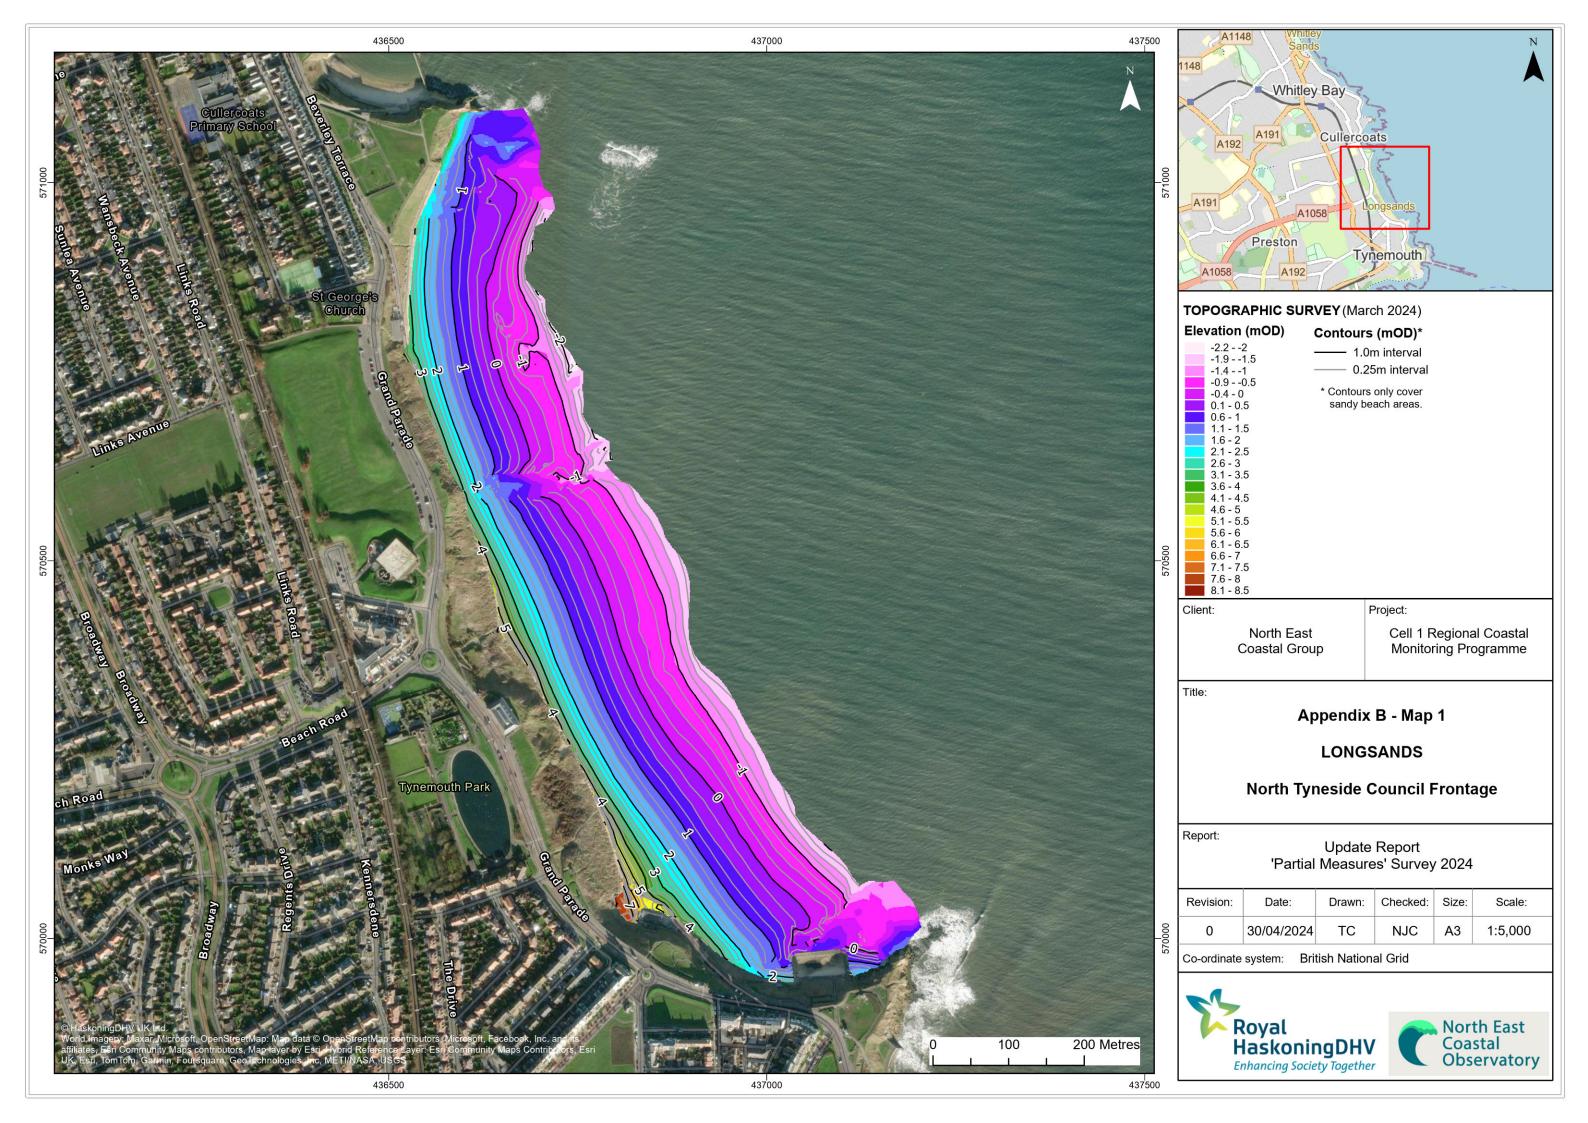
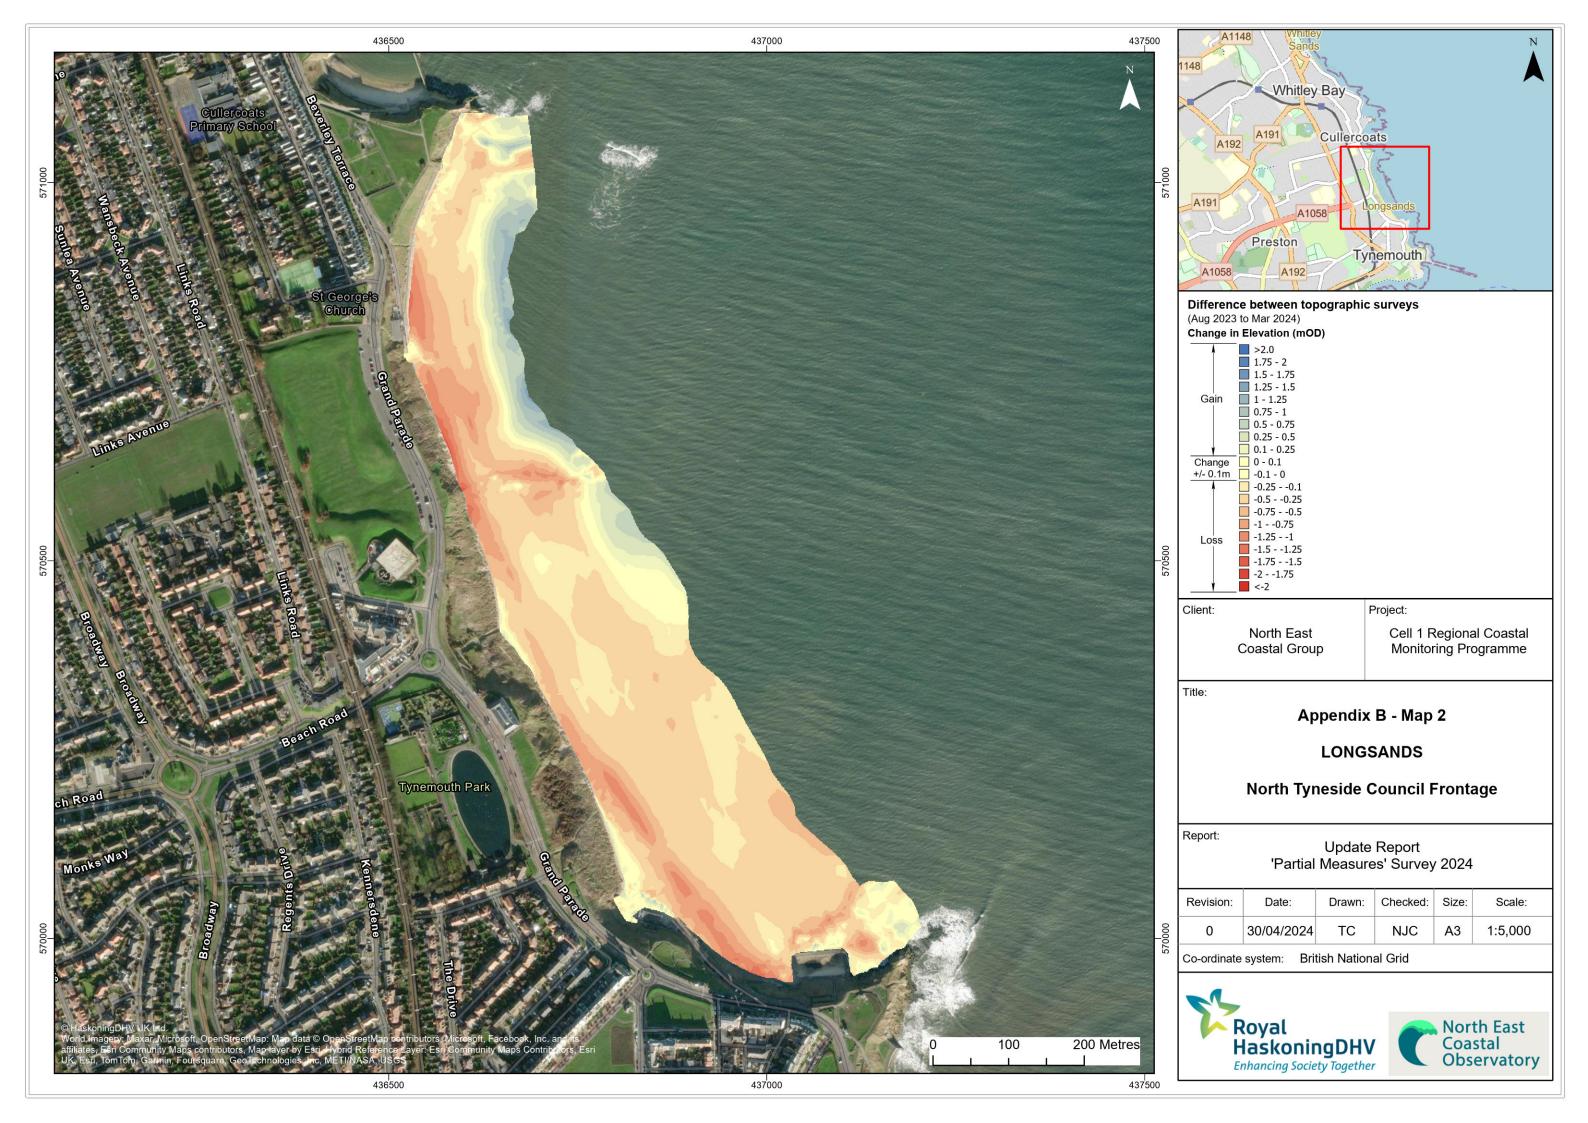
# Appendix B Topographic Survey

Survey Date	Description of Changes Since Last Survey	Interpretation
	range recorded from previous surveys.	
March 2024	Topographic Survey:  The first survey for Tynemouth Long Sands was undertaken for the Full Measures survey in October 2010.  Data from the current topographic survey have been used to create a digital ground model (DGM) (Appendix B – Map 1) using a Geographical Information System (GIS). A difference plot has also been produced by comparing the current DGM (Appendix B – Map 2) with that produced from the last topographic survey (August 2023).  The difference plot shows that the bay is dominated by erosion across the upper and middle beach. Erosion rates vary between 1.5-1.75m at the top of the dunes in the centre of the bay, to lower rates of erosion (0.5m) on the middle to lower beach. Accretion is isolated to the lower beach of the northern half of the bay, with rates up to 1.5m. There is patchier areas of change at the northern and southern extent of the bay, with lower rates of erosion / accretion.	Since the last survey, the beach at Tynemouth Long Sands is generally dominated by erosion, except for the lower beach in the northern half of the bay. There is no clear trend of sediment movement since the previous survey.
