**Cell 1 Regional Coastal Monitoring Programme
Analytical Report 5: 'Full Measures' Survey 2012**

**South Tyneside Council
Final Report**

March 2013

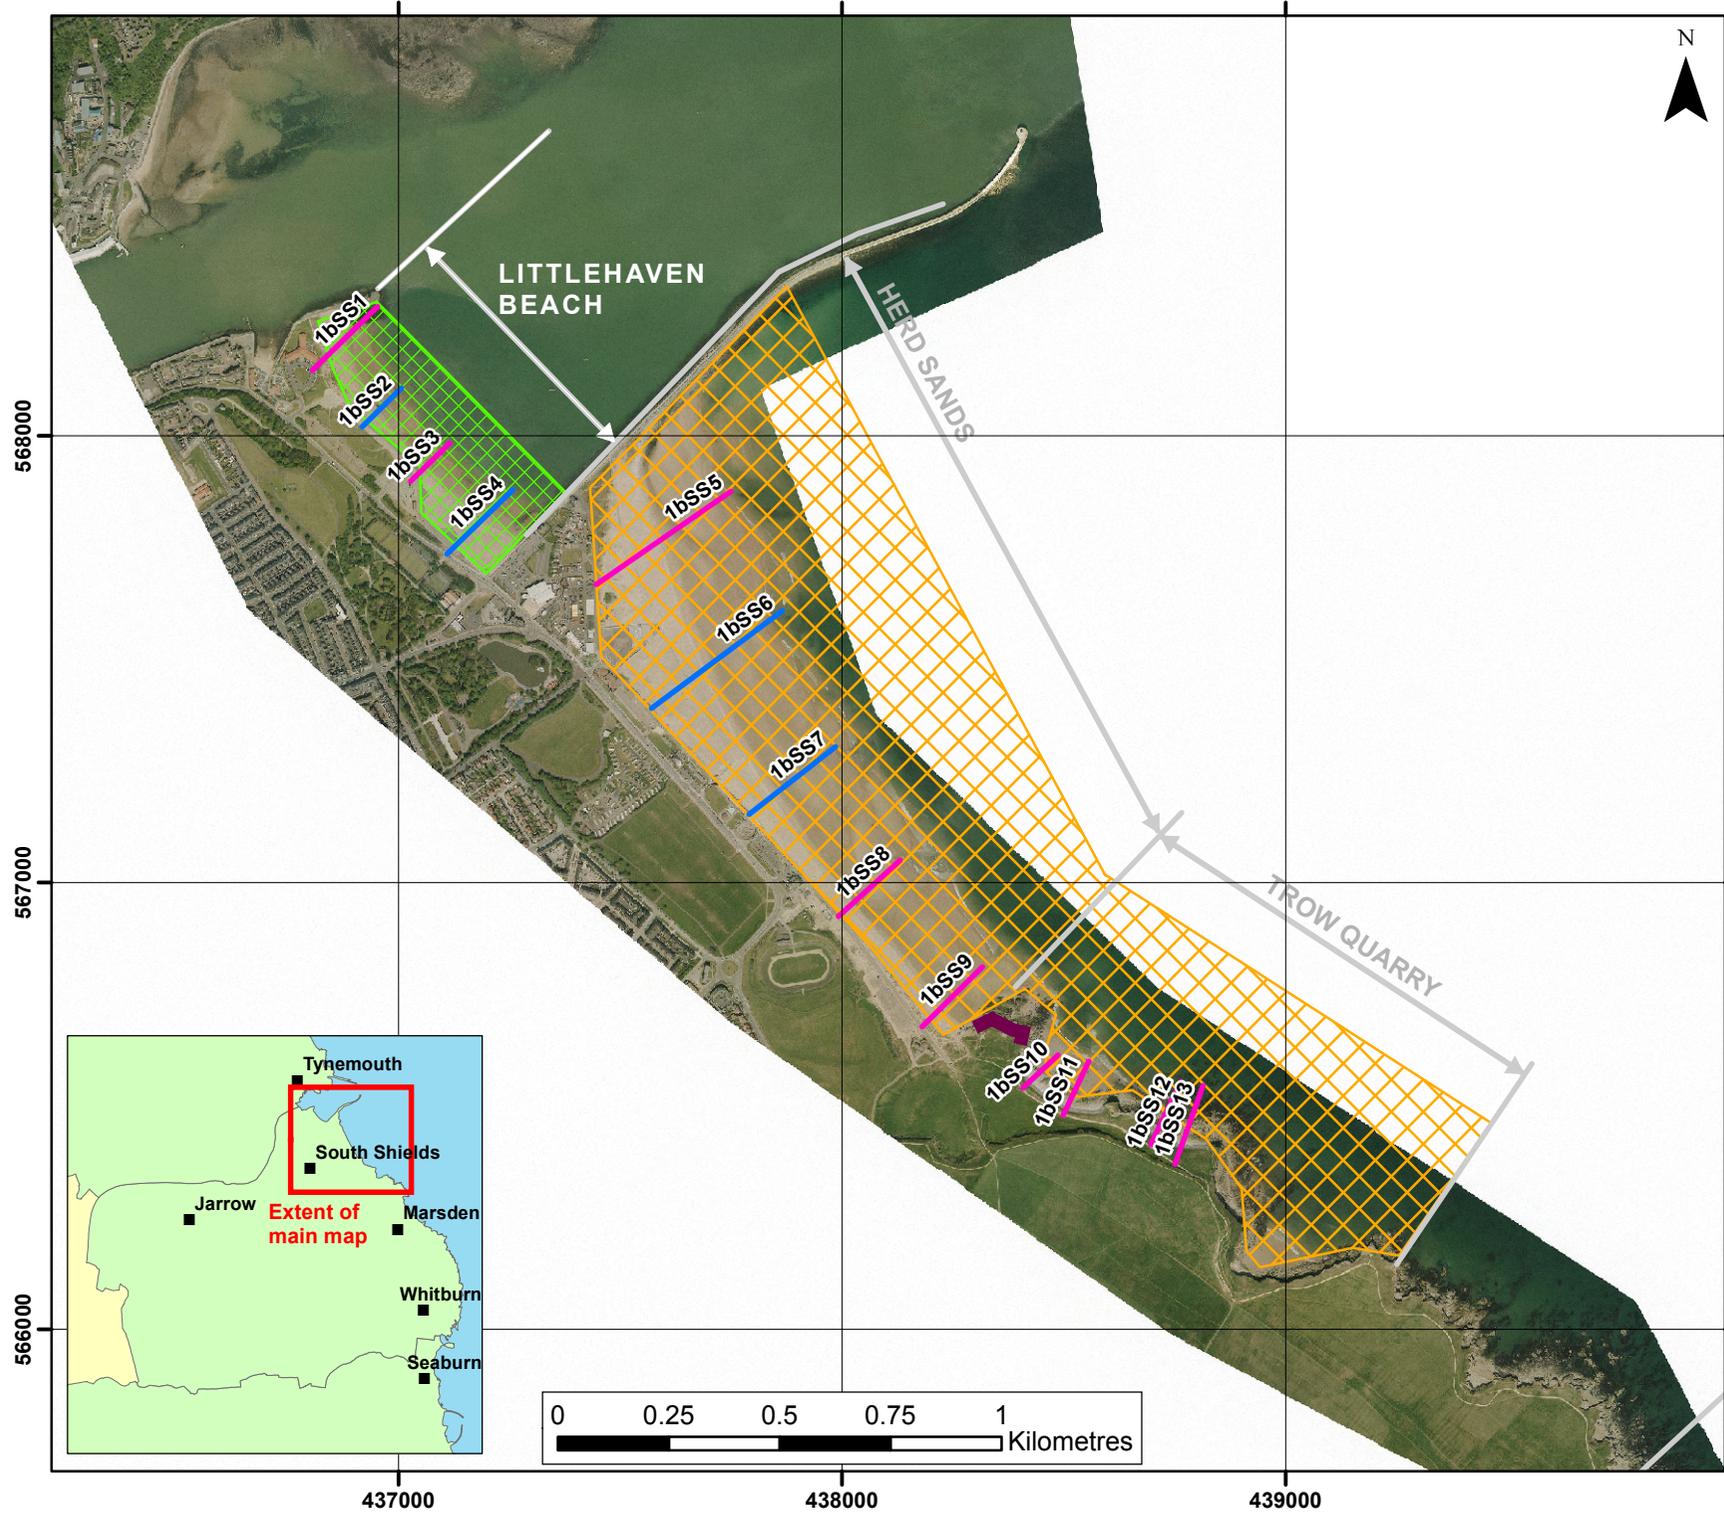
**Figure 2- Map 1
 Survey Locations
 Littlehaven Beach to
 Trow Quarry
 South Tyneside Council**

The location of these surveys is shown in Figure 2. The Full Measures survey was undertaken along this frontage between 12th and 14th November 2012. During this time weather conditions varied considerably; refer to the survey reports for details of the weather conditions over this survey period.

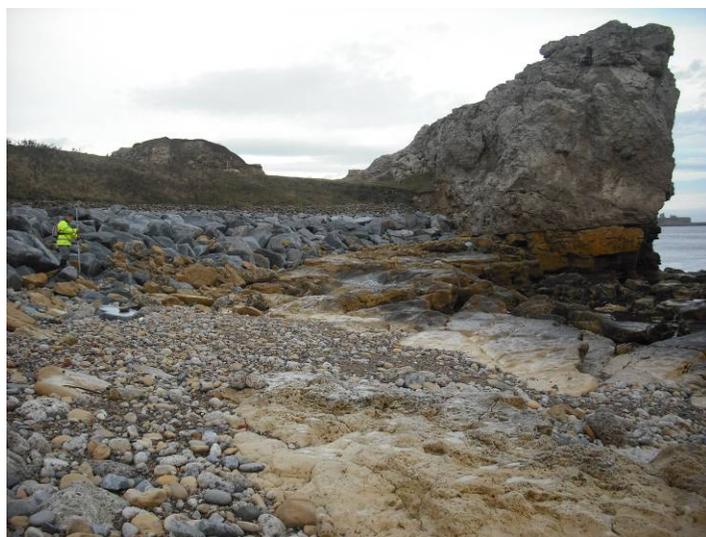
Plate 1 – Survey photograph 1bSS12_20121113_N5.JPG (FM 2012)

Survey Date	Description of Changes Since Last Survey	Interpretation
	<p>this to another dataset. The indicated cliff advance is likely to represent error in the survey, probably as a result of vegetation growth making identification of the cliff line difficult. Review and analysis of the 2012 aerial photography will allow the nature of change to be better understood. Points 4, 5 and 6, which are located on the east/south-east side of the headland, have eroded by 0.1m, 0.6m, and 0.1m respectively.</p>

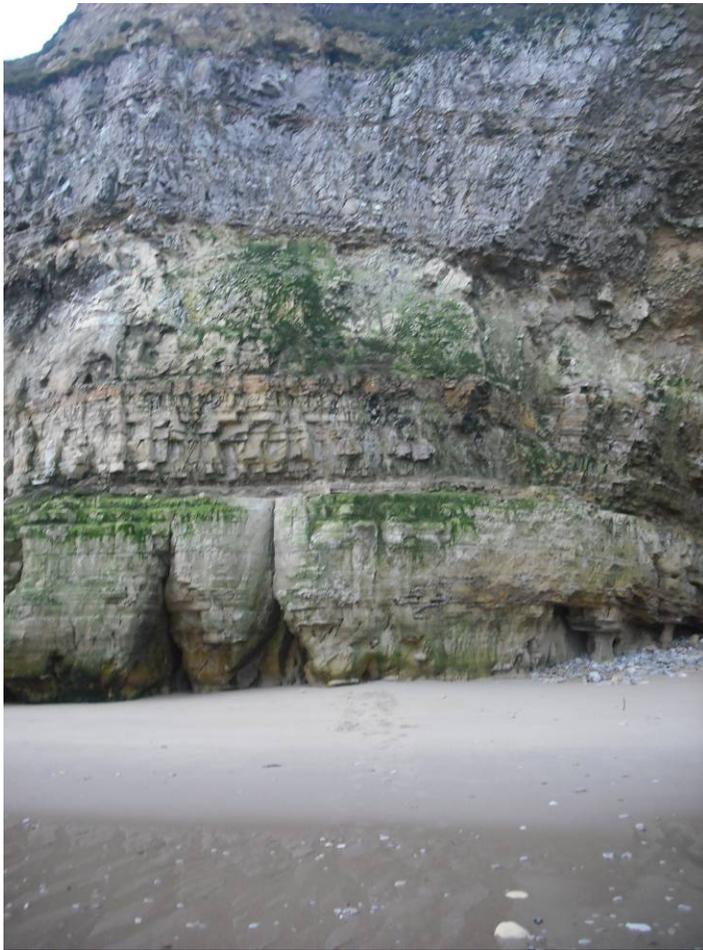
Plate 3 – Survey photograph 1bSS17_20121112_Up1.JPG (FM 2012)

At profile 1bSS17 (Appendix A) the cliff profile suggests that the cliff face has advanced by up to 3m, however, the survey photographs do not reflect this change and it is more likely that this is due to error in the survey.

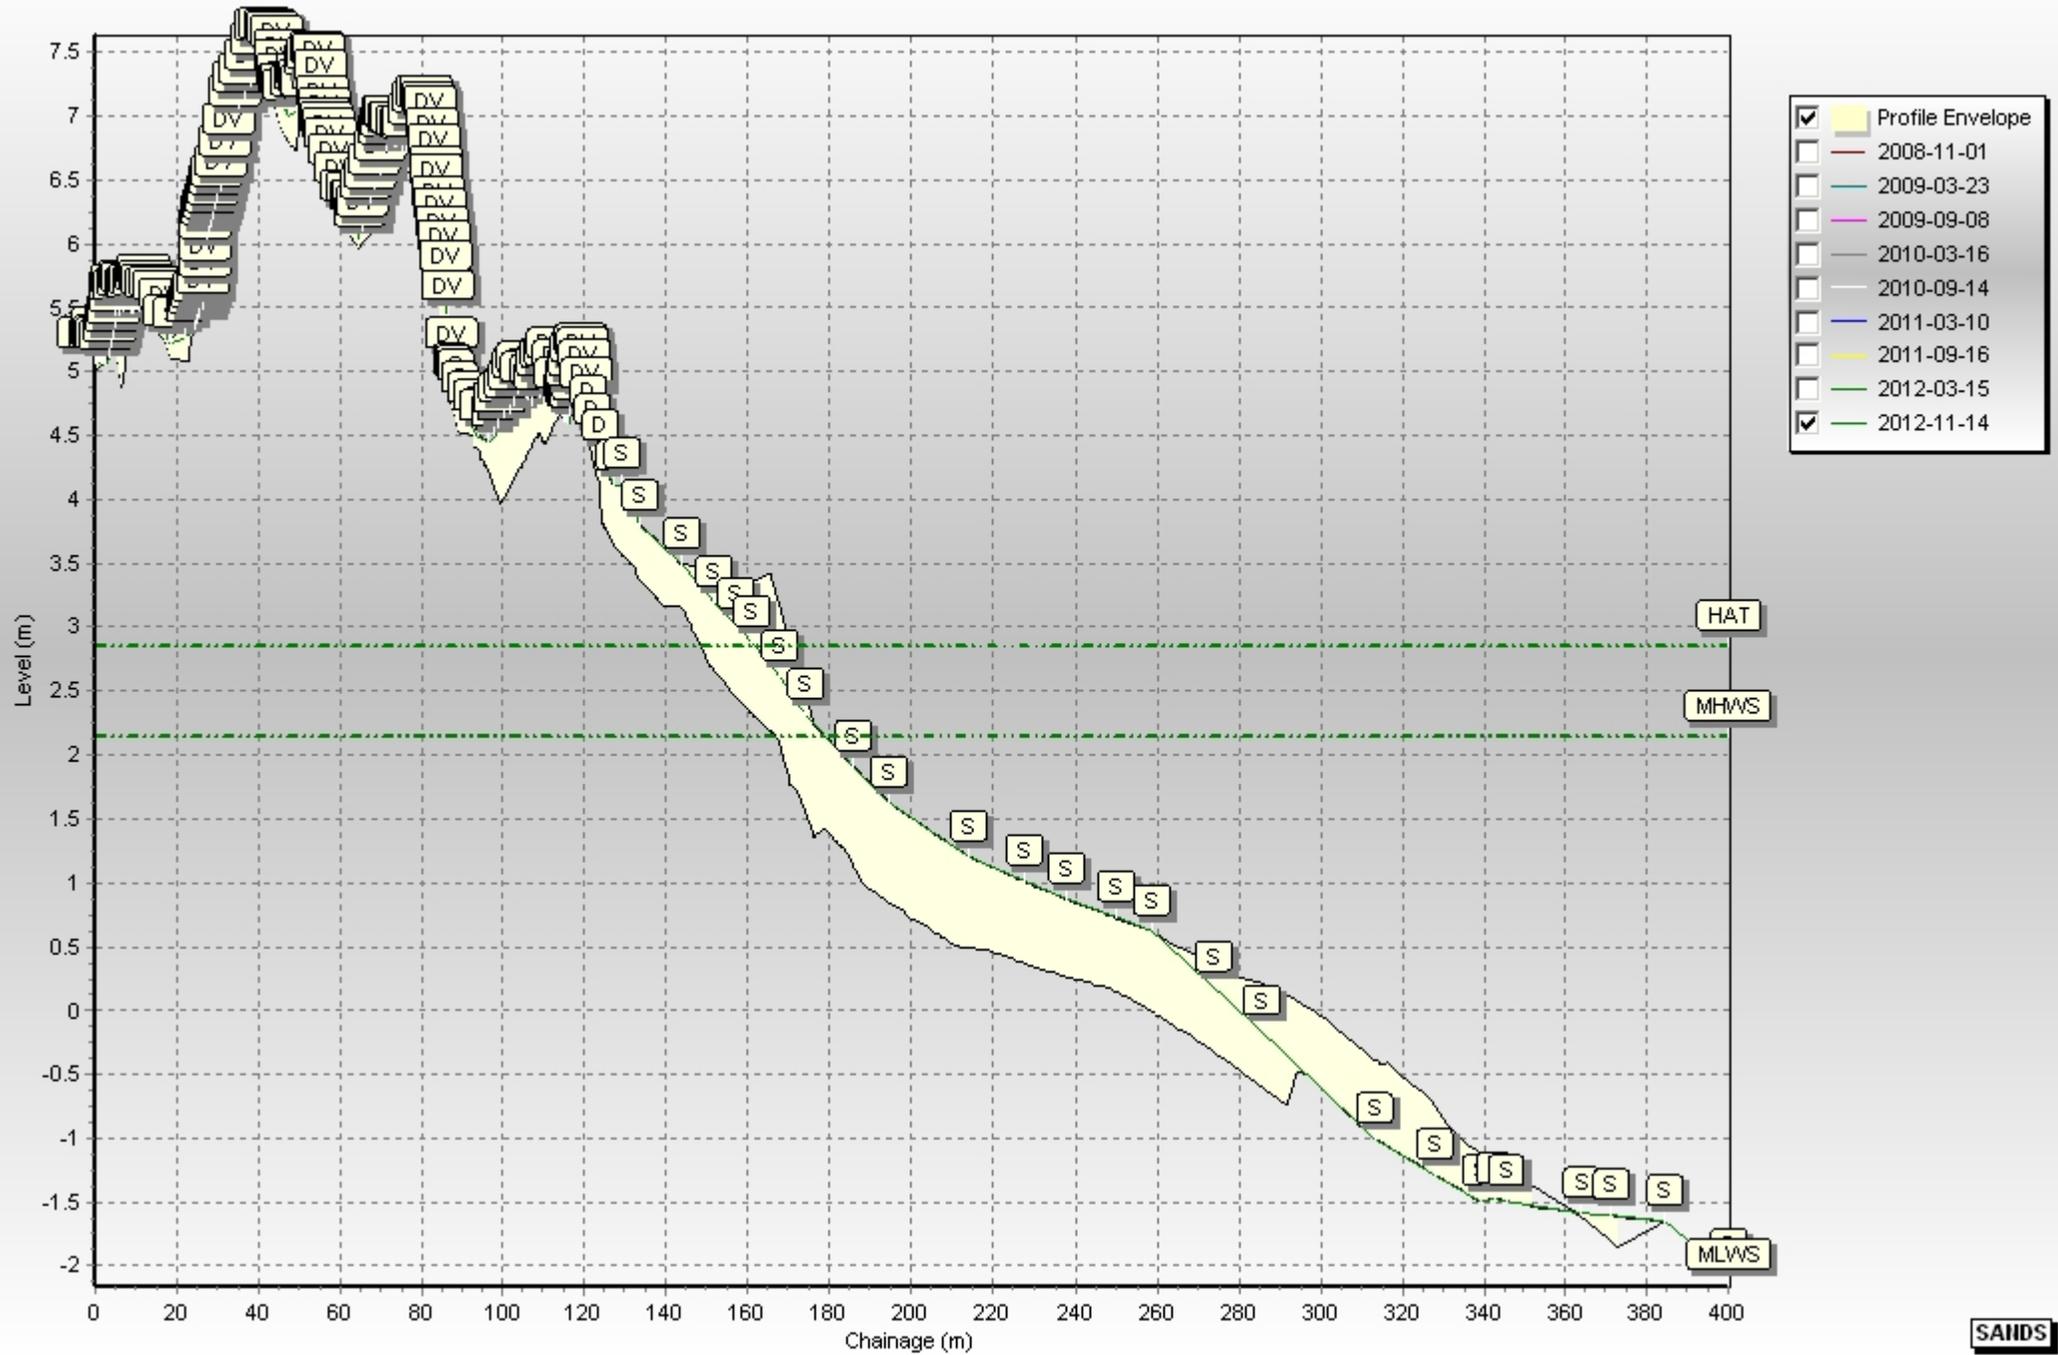
Beach Profiles: 1bSS5

To the very north, at profile 1bSS5, the previous survey report noted '*at profile 1bSS5, numerous sand fences have been installed in the dunes at start of the section. The next full measures survey (autumn, 2012) should show the impact that they have had on sediment retention on the beach*'. The observed changes of accretion, suggest that sand fences have been a success.

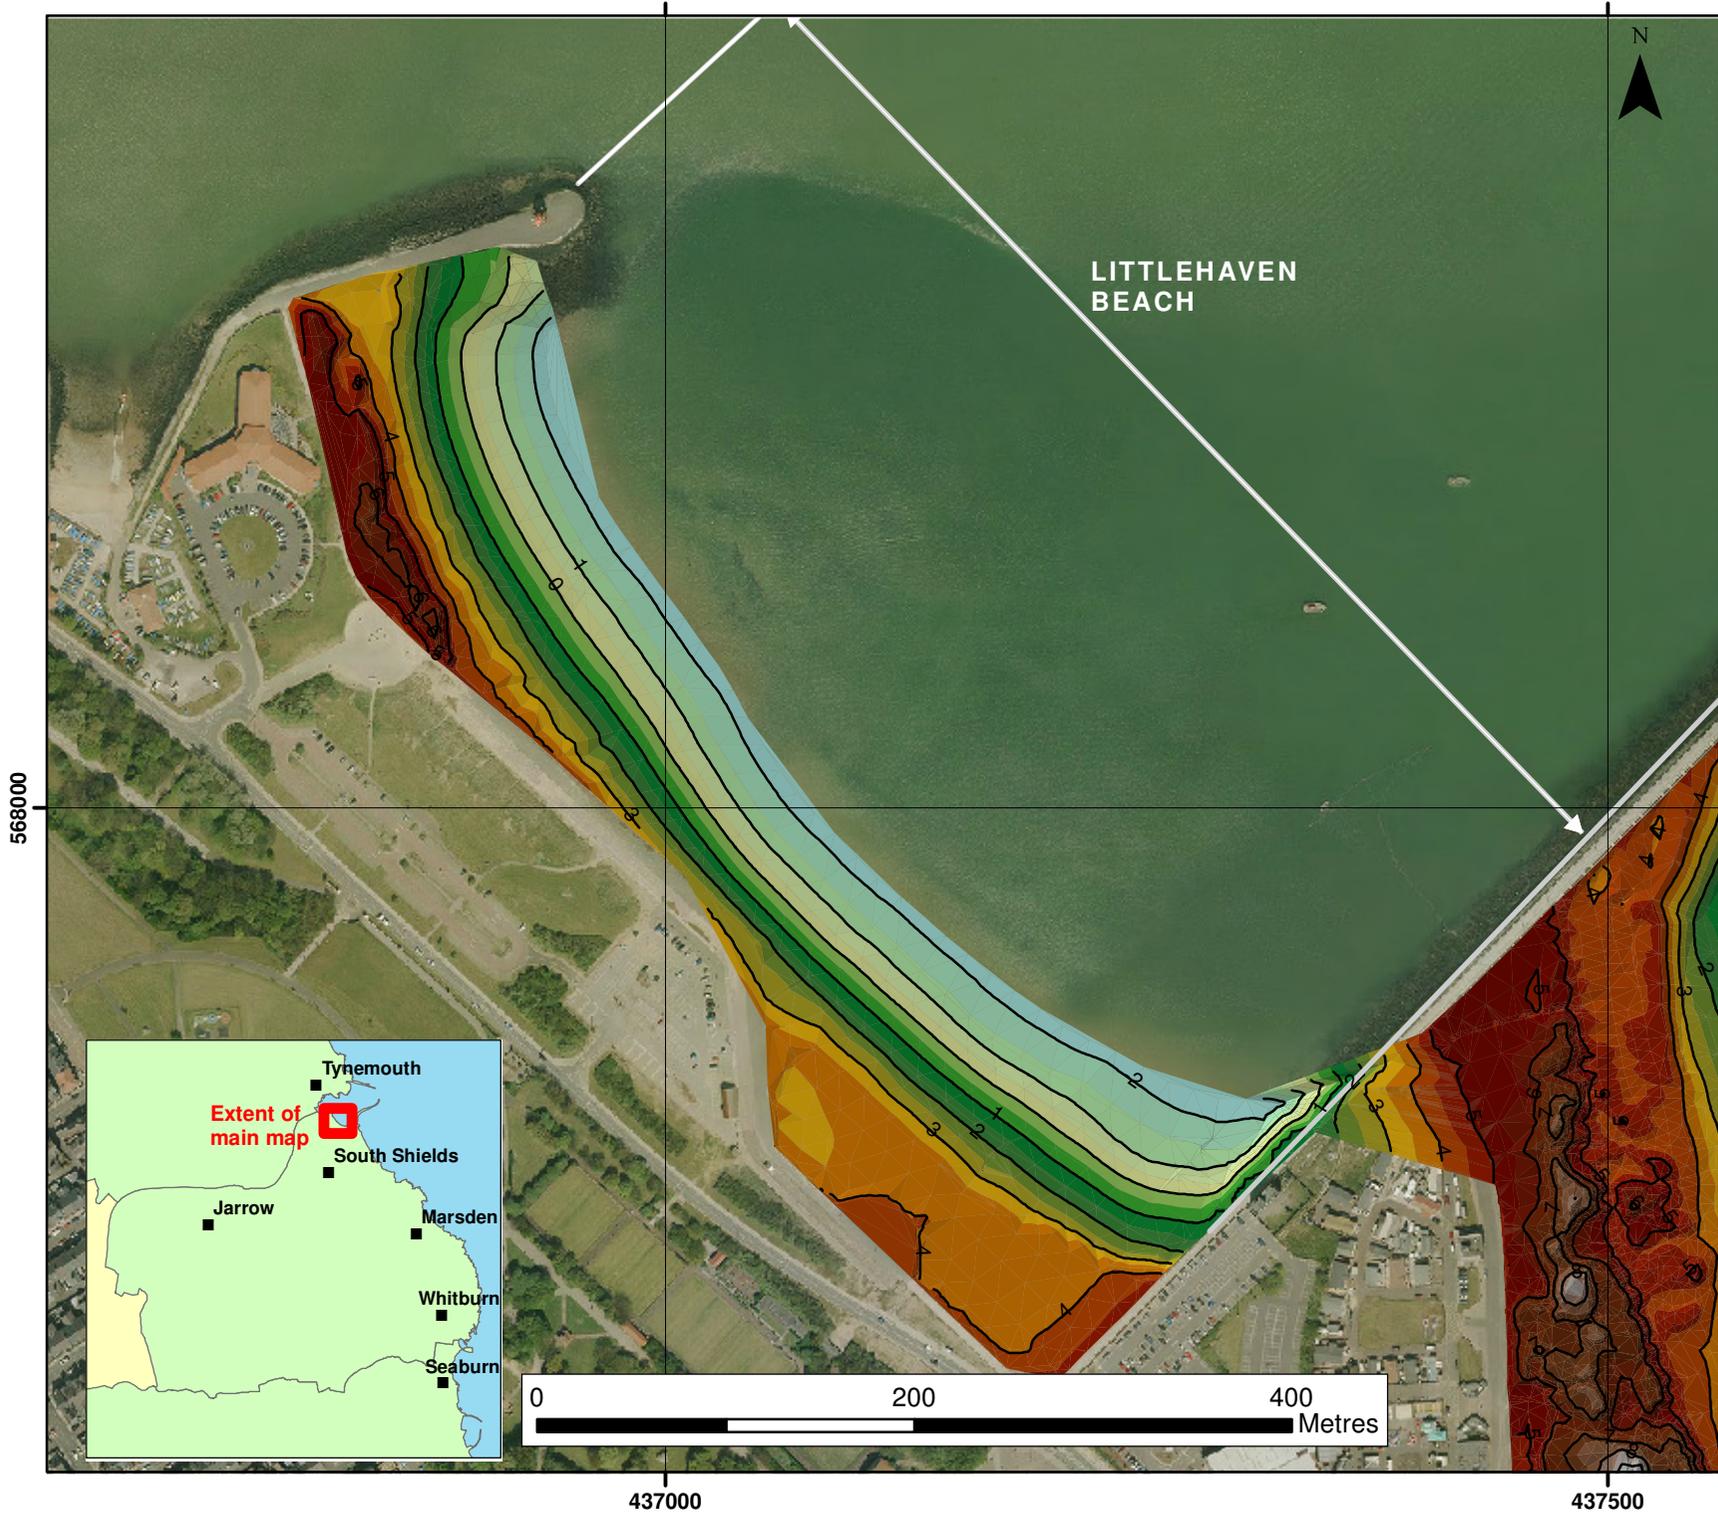
**Appendix B - Map 1a
 Topographic Survey
 Littlehaven Beach
 South Tyneside Council**

Survey Date	Description of Changes Since Last Survey	Interpretation
Nov 2012	<p>Topographic Survey:</p> <p>Littlehaven Beach is covered by bi-annual topographic survey between the South Groyne and the South Pier, which commenced in March 2010.</p> <p>Data from the most recent topographic survey (full measures, autumn 2012) have been used to create a DGM (Appendix B – Map 1a) using a Geographical Information System (GIS). A difference plot has also been produced using the DGM (Appendix B – Map 1b) produced from the last produced topographic survey (partial measures, spring 2012) and the present survey.</p> <p>In particular, the difference plot shows: (i) general stability, with elevation increase is less than 0.1m across the beach; and (ii) pockets of areas where beach elevation has reduced along the length and width of the beach.</p> <p>Long Term Topographic Trends Autumn 2010 to Autumn 2012:</p> <p>The long term difference plot (Appendix B – Map 1c) shows the net change in beach levels between autumn 2010 and autumn 2012. The plot shows an overall increase in beach elevation along the length and width of Littlehaven Beach, with isolated pockets of beach elevation decrease in the top left and bottom right corners of this length of coastline along the backshore, i.e. in the lee of the breakwaters.</p>	<p>Comparison of the present topographic survey with the previous partial measures (spring, 2012) shows that the beach is generally stable with small pockets of areas where beach elevation has reduced. These findings do not link directly with the findings of the beach profile surveys.</p> <p>Longer term trends: The longer term trends are covered by the long term topographic trends autumn 2010 to autumn 2012 (see below).</p> <p>Long term topographic trends Autumn 2010 to Autumn 2012: The plot shows an overall pattern of accretion along the length and width of Littlehaven Beach, with isolated pockets of beach erosion at the northern and southern parts of the backshore that are in the lee of the breakwaters.</p>

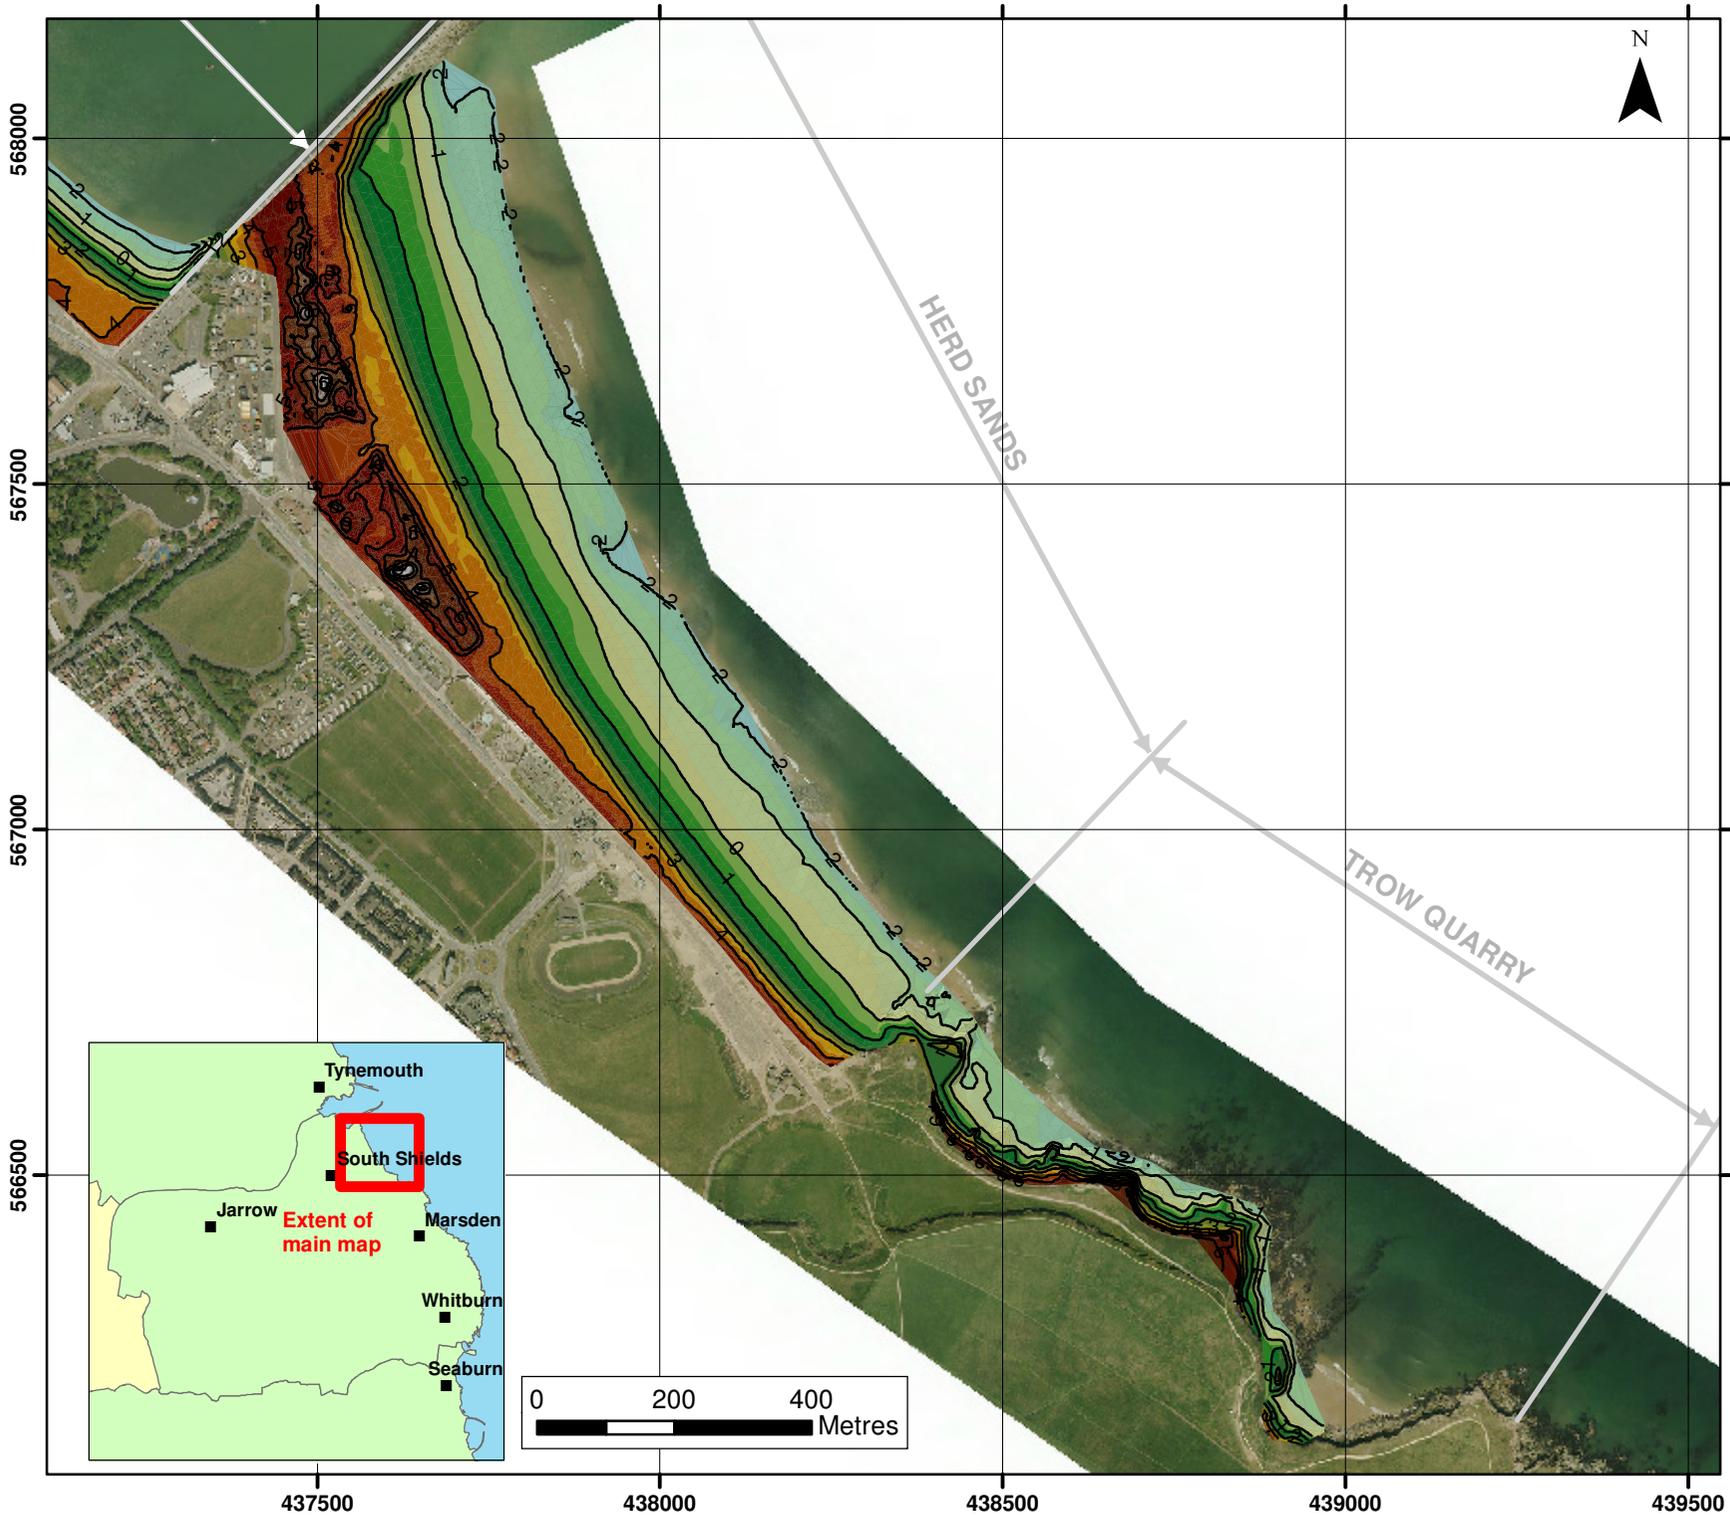
**Appendix B - Map 2a
 Topographic Survey
 Herd Sands and
 Throw Quarry
 South Tyneside Council**

Survey Date	Description of Changes Since Last Survey	Interpretation
Nov 2012	<p>Beach Profiles:</p> <p>Herd Sands is covered by five beach profile lines for the Full Measures survey (Appendix A). The previous survey was the full measures survey undertaken in autumn 2011 and the previous partial measures survey was undertaken in spring 2012.</p> <p>Profile 1bSS5 is located to the north of Herd Sands and is located in the lee of the breakwater. The dunes have largely retained a similar form since the last survey (partial measures, spring 2012), however, they have accreted between a chainage of 80m and 120m by up to 0.2m and at the toe of the dunes by up to 0.4m. The previous survey report noted <i>'at profile 1bSS5, numerous sand fences have been installed in the dunes at start of the section. The next full measures survey (autumn, 2012) should show the impact that they have had on sediment retention on the beach'</i>. The observed changes of accretion, suggest that sand fences have been a success. Intermittent beach levels increase and decrease along the profile has resulted in a less undulating and more gently sloping beach profile. The HAT berm has been eroded and the donkey track, previously exposed, is now covered with sand.</p> <p>Since the last survey (full measures, autumn 2011) the beach at profile 1bSS6, has been very active. Beach levels between the primary and secondary dune ridge have fallen by 0.2m, a reverse of the trends observed since autumn 2008. The top of the primary dune has accreted by 0.2m, however, the dune face has receded by approximately 5m. Beach levels on the berm between the toe of the dunes and HAT has increased by approximately 0.4m. Between MHWS and a chainage of 280m beach levels have increased by up to 0.4m, and seaward of 280m, they have decreased by up to 0.4m. This change does suggest the cross-shore movement of material, however unlike profiles at Littlehaven beach, the direction of transport is likely to be onshore.</p> <p>Profile 1bSS7 is located at the centre of Herd Sands. Beach levels between 0m and 70m and 80m to 190m chainage have increased by up to 0.4m, a reverse of the change observed from the previous survey (full measures, autumn 2011). Between HAT and MHWS and seaward of a chainage of 190m, beach levels have decreased. Similarly to profile 1bSST, this change does suggest the cross-shore movement of material, likely to have occurred in an onshore direction.</p> <p>At 1bSS8 beach levels across the majority of this profile have increased, including at the toe of the</p>	<p>Along the length of Herd Sands, there is a consistent change in beach profile, irrespective of the previous survey being full measures (autumn 2011) or partial measures (spring, 2012). Beach levels at the toe of the dunes and seaward of MHWS have accreted, however, the beach crest around HAT/MHWS has been lowered. The overall impact is a flatter and more gently sloping beach profile.</p> <p>To the very north, at profile 1bSS5, the previous survey report noted <i>'at profile 1bSS5, numerous sand fences have been installed in the dunes at start of the section. The next full measures survey (autumn, 2012) should show the impact that they have had on sediment retention on the beach'</i>. The observed changes of accretion, suggest that sand fences have been a success.</p> <p>Longer term trends: The beach profile form observed since the last survey is within the bounds of previous surveys. However, to the north, at profiles 1bSS5 and 1bSS6, and to the south, at profiles 1bSS8 and 1bSS9, the beach levels on the middle of the beach are the highest observed to date. At profiles 1bSS6 and 1bSS7, beach levels on the beach crest (above HAT) are the highest observed to date.</p>

Nov 2012	<p>Topographic Survey:</p> <p>Trow Quarry is covered by an annual topographic survey within Graham's Sand, Southern Bay and Frenchman's Bay, which commenced in November 2008.</p> <p>Data from the most recent topographic survey (full measures, autumn 2012) have been used to create a DGM (Appendix B – Map 2a) using a Geographical Information System (GIS). A difference plot has also been produced using the DGM (Appendix B – Map 2b) produced from the last topographic survey (full measures, autumn 2011) and the present survey.</p> <p>In particular, the difference plot shows: (i) a sporadic change in beach elevation; and (ii) an increase in elevation on and around the headland that separates Graham's Sand and Southern Bay, suggesting accretion of sediment. However, the latter changes are assumed to be artificial due different survey</p>	<p>Comparison of the present topographic survey with the previous full measures (autumn, 2012) shows a sporadic change in beach elevation.</p> <p>Longer term trends: The longer term trends are covered by the long term topographic trends autumn 2010 to autumn 2012 (see below).</p> <p>Long term topographic trends Autumn 2010 to Autumn 2012: The plot shows that the majority of the beach has experienced an increase in beach levels, particularly on and around the headlands that separate Graham's Sand and Southern Bay and</p>

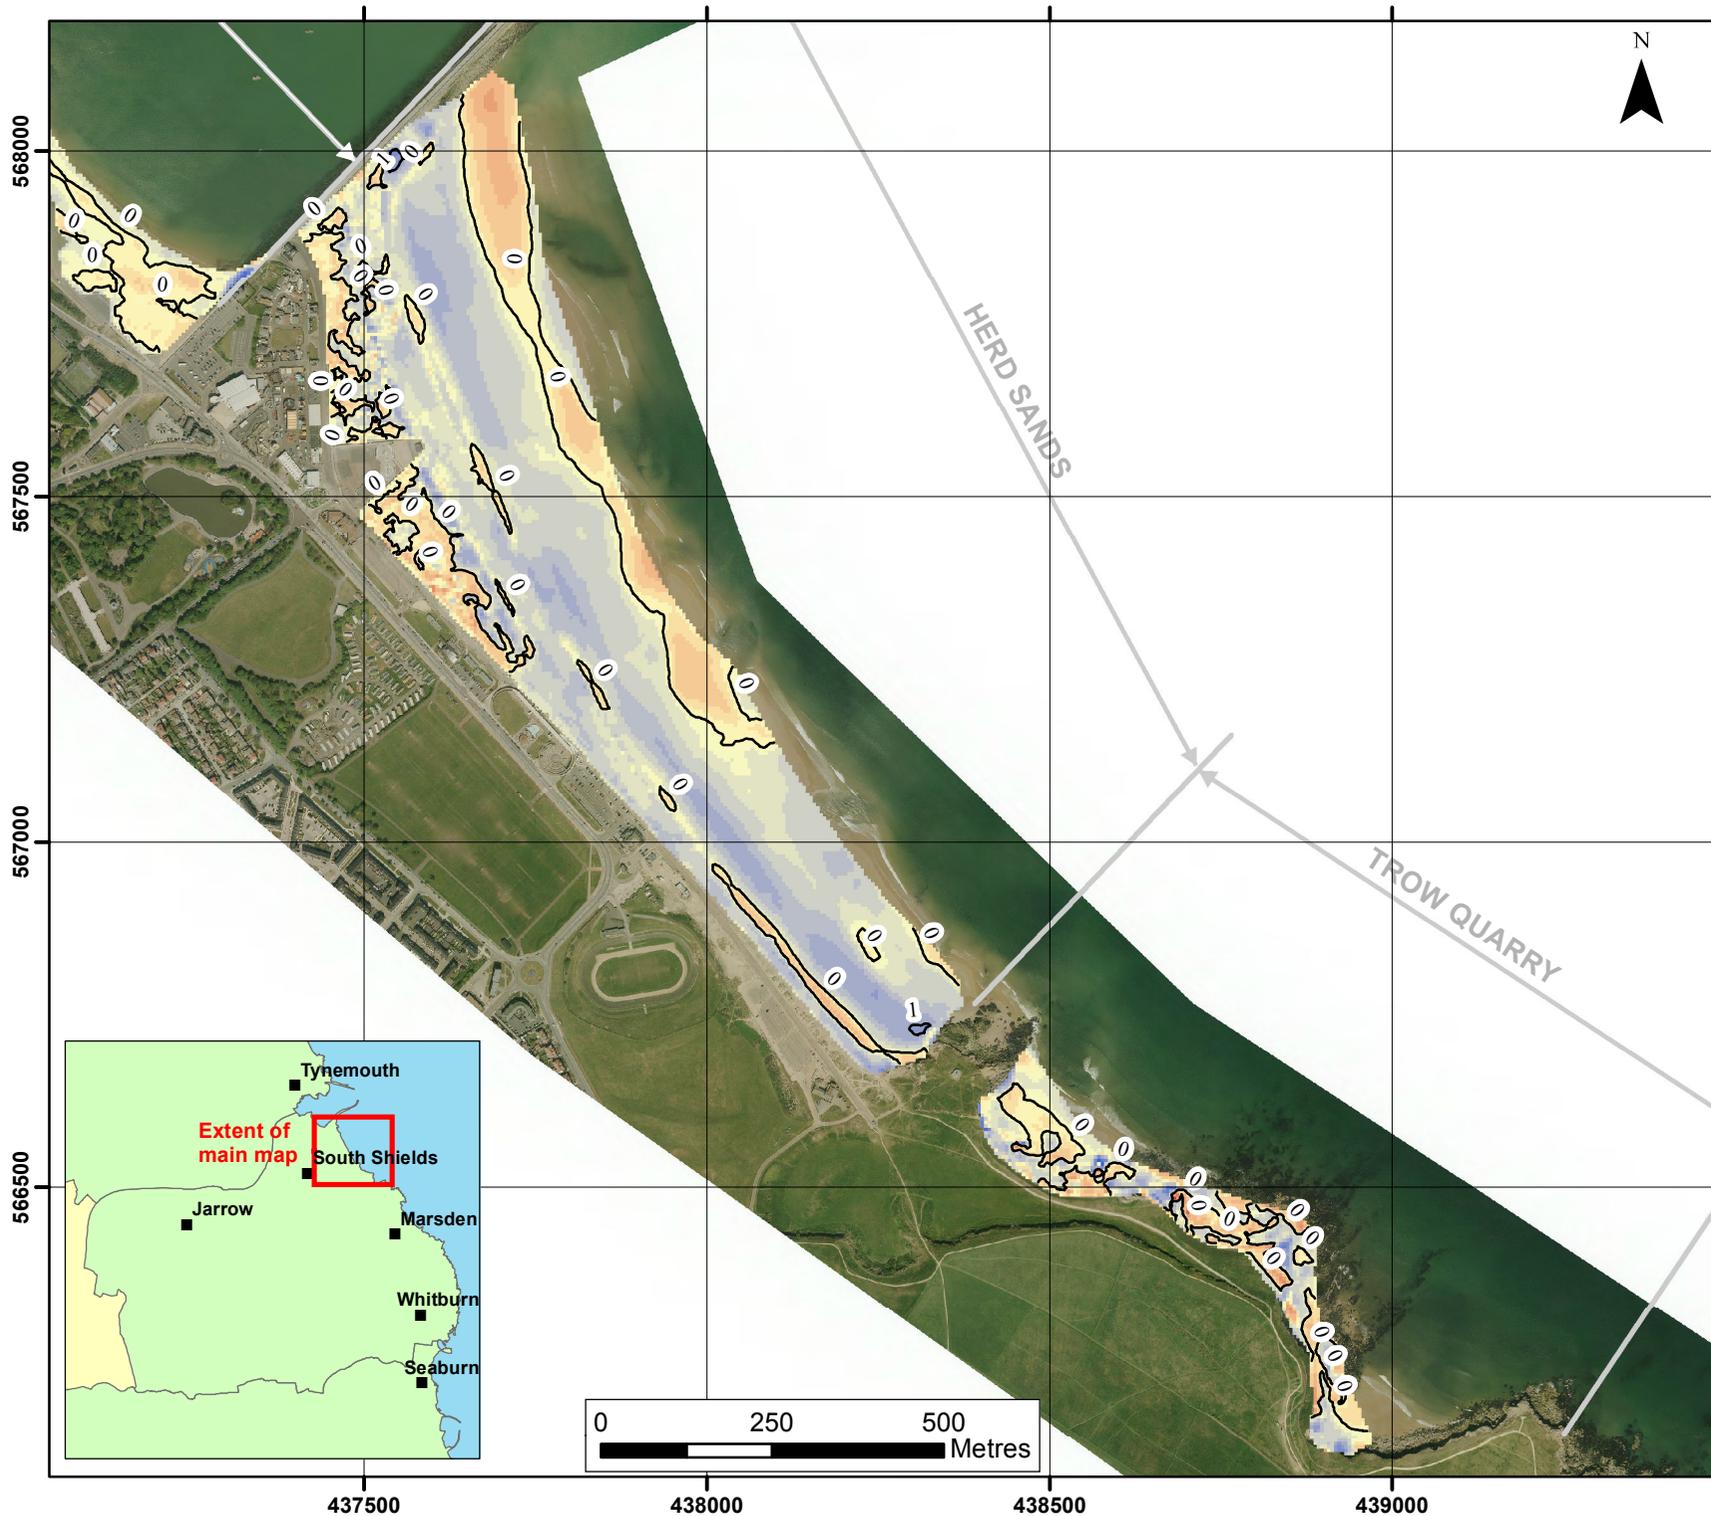
Appendix B- Map 2b
Short-term
Elevation change
Herd Sands and
Trow Quarry
South Tyneside Council

Survey Date	Description of Changes Since Last Survey	Interpretation
	<p>promenade revetment and seaward of a chainage of 50m. The beach berm at HAT has receded by up to 10m. The overall impact is a flatter and more gently sloping beach profile.</p> <p>Profile 1bSS9 is located to south of Herd Sands. The dune face has retained the same form and position since the last survey. Similarly to profile 1bSS8, beach levels across the majority of this profile have increased, including at the toe of the dunes and seaward of a chainage of 70m. Between a chainage of 40m and 70m, beach levels have decreased by up to 0.5m. The overall impact is a flatter and more gently sloping beach profile.</p>	
<p>Nov 2012</p>	<p>Herd Sands is covered by an annual topographic survey between the South Pier and Trow Point, which commenced in November 2008.</p> <p>Data from the most recent topographic survey (full measures, autumn 2012) have been used to create a DGM (Appendix B – Map 2a) using a Geographical Information System (GIS). A difference plot has also been produced using the DGM (Appendix B – Map 2b) produced from the last topographic survey (full measures, autumn 2011) and the present survey.</p> <p>In particular, the difference plot shows: (i) beach elevation of the upper beach in the lee of the breakwater has reduced; (ii) across the majority of the beach, beach elevation has increased; and (iii) beach levels within a narrow band along the lower beach extending from the north to the south-centre of Herd Sands have reduced in elevation.</p> <p>Long Term Topographic Trends Autumn 2010 to Autumn 2012:</p> <p>The long term difference plot (Appendix B – Map 2c) shows the net change in beach levels between autumn 2010 and autumn 2012. The plot shows a reduction in beach elevation of the upper beach in the lee of the breakwater and a narrow band of beach elevation reduction along the lower beach extending from the north to the south-centre of Herd Sands have reduced in elevation. Otherwise, there has been a general trend of beach elevation increase across the beach, with a narrow band of gain in the region of +1m.</p>	<p>Comparison of the present topographic survey with the previous full measures (autumn, 2012) shows a reduction in beach levels in the lee of the breakwater, but an increase along the back of beach to the south. This agrees with the findings of the beach profiles, which suggest that the beach levels at the toe of the dunes and seaward of MHWs have accreted. Across the majority of the beach, beach elevation has increased; and (beach levels within a narrow band along the lower beach extending from the north to the south-centre of Herd Sands have reduced in elevation.</p> <p>Longer term trends: The longer term trends are covered by the long term topographic trends autumn 2010 to autumn 2012 (see below).</p> <p>Long term topographic trends Autumn 2010 to Autumn 2012: The plot shows a reduction in beach elevation of the upper beach in the lee of the breakwater and a narrow band of beach elevation reduction along the lower beach extending from the north to the south-centre of Herd Sands have reduced in elevation. Otherwise, there has been a general trend of beach accretion across the beach, focussed</p>

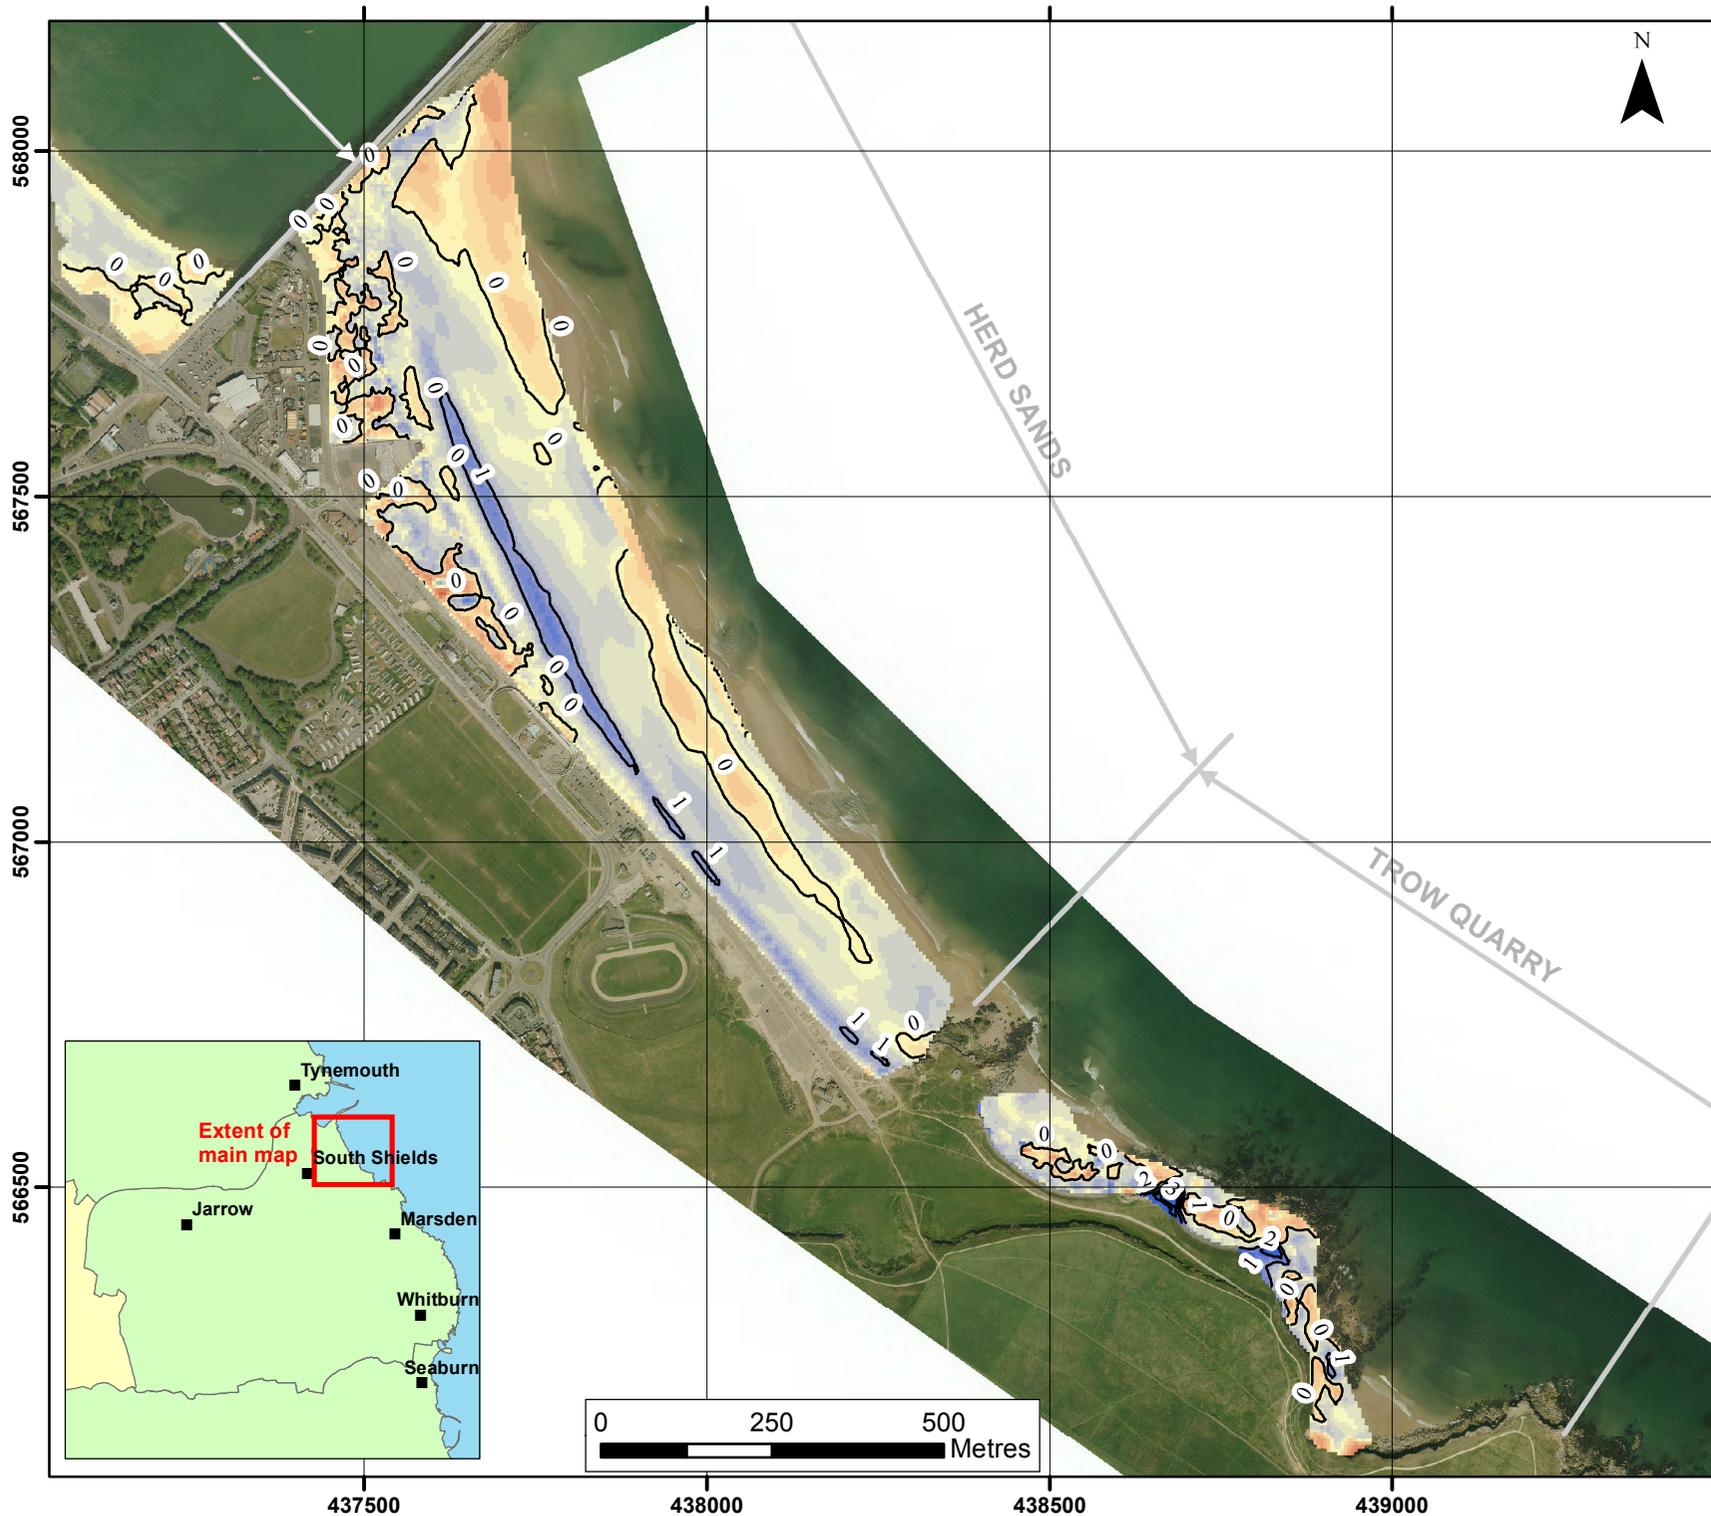
Appendix B- Map 2c
Long-term
Elevation change
Herd Sands and
Trow Quarry
South Tyneside Council

Survey Date	Description of Changes Since Last Survey	Interpretation
	<p>extents and the data interpolation used to create the difference grids.</p> <p>Long Term Topographic Trends Autumn 2010 to Autumn 2012:</p> <p>The long term difference plot (Appendix B – Map 2c) shows the net change in beach levels between autumn 2010 and autumn 2012. The plot shows that the majority of the beach has experienced an increase in beach levels, particularly on and around the headlands that separate Graham’s Sand and Southern Bay and Southern Bay and Frenchman’s Bay, suggesting accretion of sediment. However, the latter changes are assumed to be artificial due different survey extents and the data interpolation used to create the difference grids. Small pockets of beach elevation reduction are interspersed across the beach.</p>	<p>Southern Bay and Frenchman’s Bay, suggesting accretion of sediment. Small pockets of beach erosion are interspersed across the beach.</p>
