**Cell 1 Regional Coastal Monitoring Programme
Analytical Report 5: 'Full Measures' Survey 2012**

**South Tyneside Council
Final Report**

March 2013

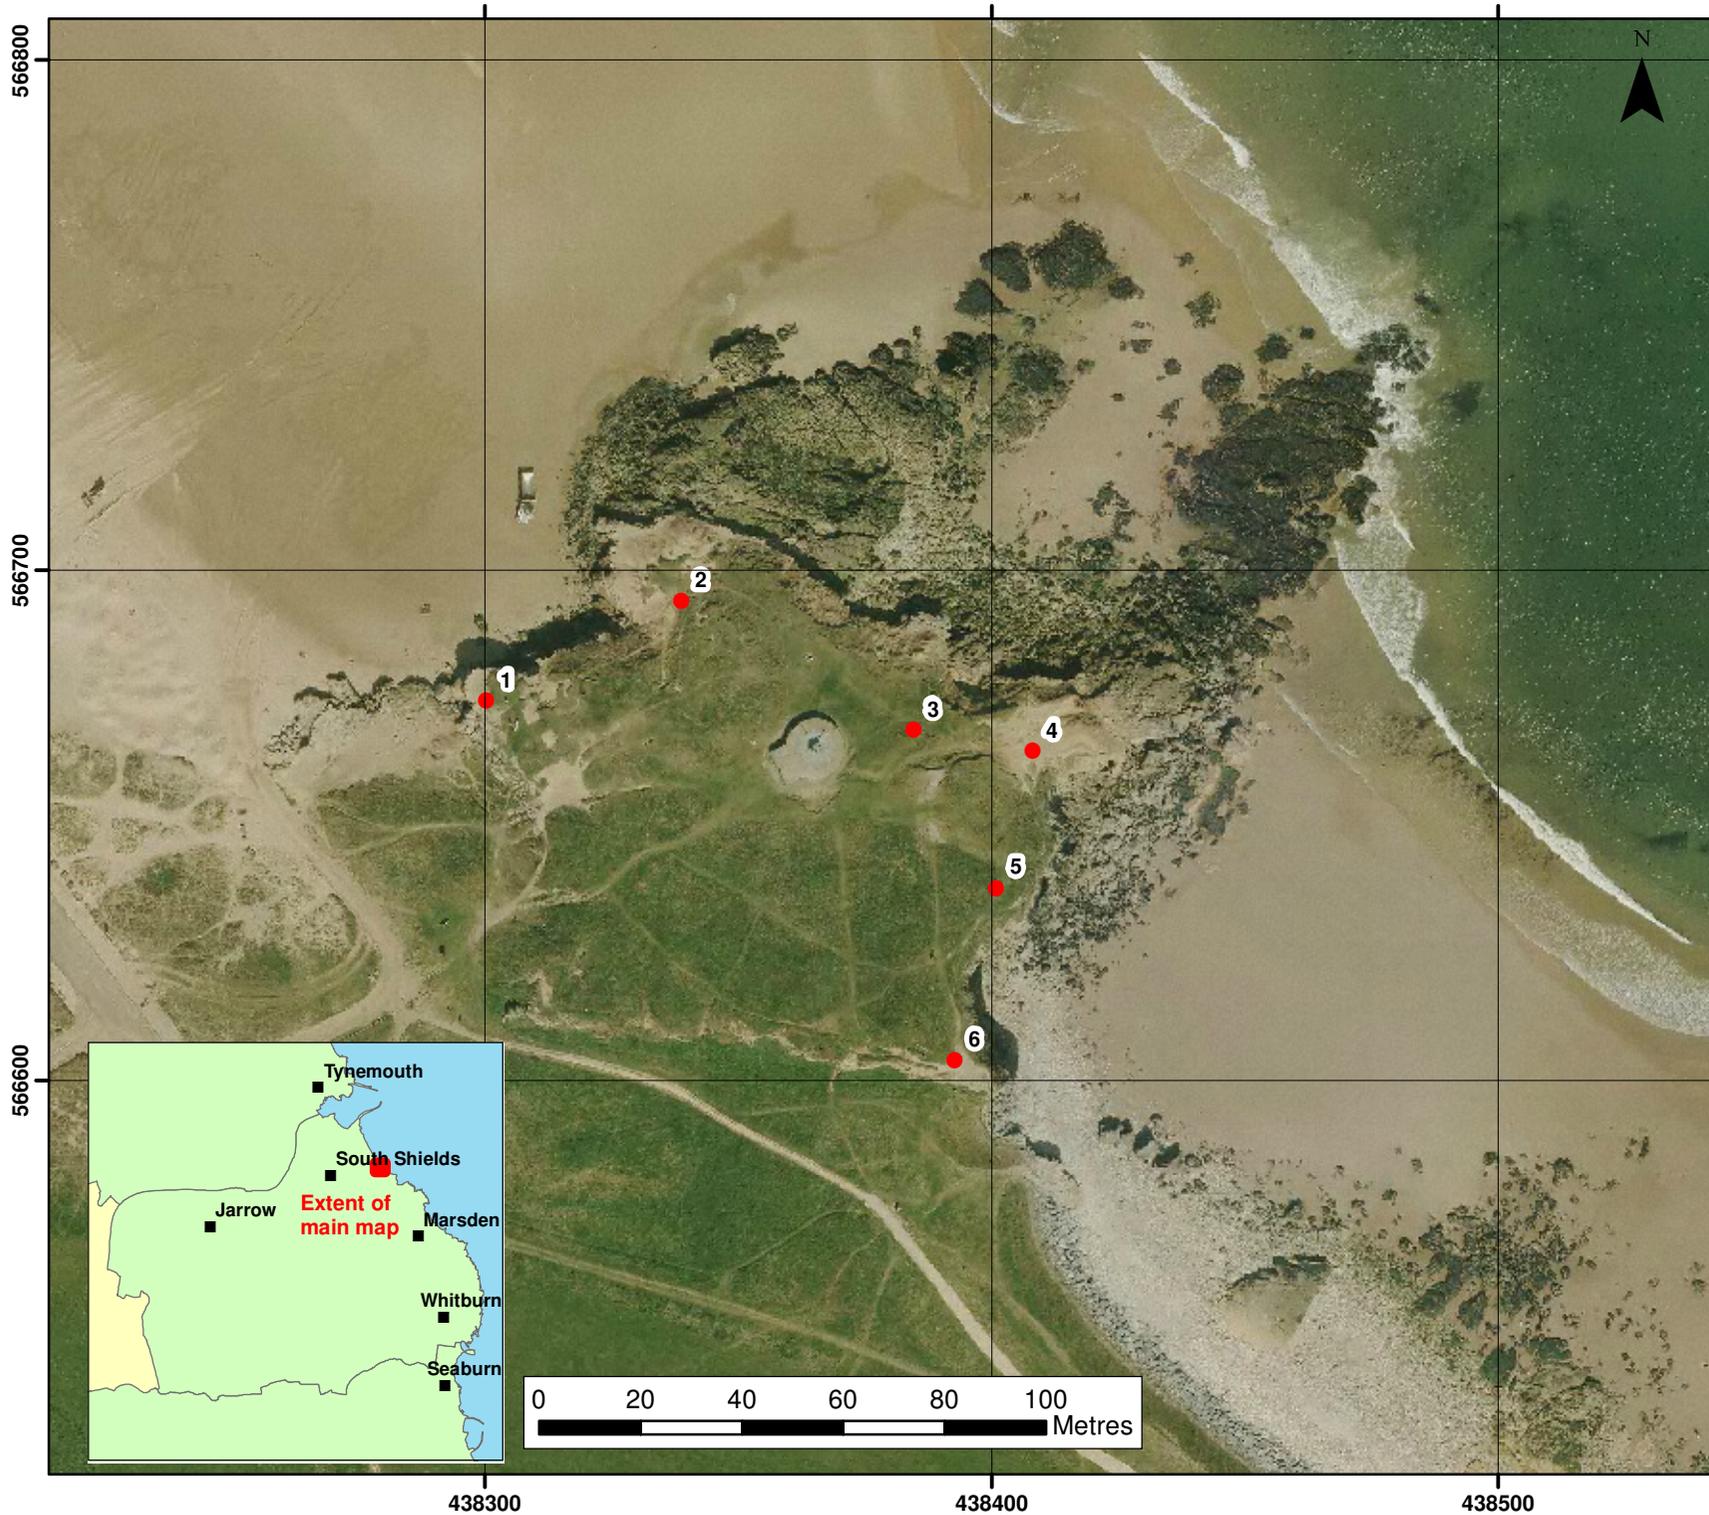
Appendix C- Map 1
Cliff Top Survey
Trow Quarry
South Tyneside Council

<p>Nov 2012</p>	<p>Cliff Top Survey:</p> <p>Cliff top survey data collected for baseline survey (autumn, 2011), the partial measures survey (spring 2012) and the present full measures survey (autumn, 2012) is presented in this report.</p> <p>Six ground control points (numbered points 1 to 6) were established along the cliff top at Trow Point in 2008 to monitor cliff erosion at the site of a former landfill. Note: the numbering of ground control points is not intended to correlate with that of the beach profile lines and reference should be made to Appendix C – Map 1 for the location of ground control points.</p> <p>These cliff top surveys are undertaken bi-annually. Measurements are taken from each ground control point along a fixed bearing to the edge of the cliff top. The results from the cliff top monitoring are anticipated to have an accuracy of $\pm 0.2\text{m}$ due to the technique used.</p> <p>The results from the cliff top survey are presented in Appendix C – Table C1, showing the position from the ground control point to the edge of the cliff top along a defined bearing.</p> <p>Results show that erosion or an amount of movement greater than the survey error has occurred at ground control point 5 since surveys began in September 2011. Points 3 and 6 are observed to have advanced by 0.4m and 0.1m respectively. All other points show no movement.</p> <p>Since the last survey in March 2012, Point 1, which is located on the north-west side of the headland, and Point 3, which is located on the north-east side of the headland, have advanced by 0.1m and 0.3m respectively. The beach profile has not been surveyed at this location so it is not possible to compare</p>	<p>A comparison of the cliff erosion data from the last survey to the present survey, suggests some erosion on east to south-east side of the headland. Points 3 and 6 are observed to have advanced by 0.4m and 0.1m respectively, but this is likely to result from problems in precise identification of the cliff edge due to vegetation growth.</p> <p>Longer term trends: The long term data (i.e. back to the 2011 baseline), suggests that generally the cliffs have remained stable or advanced. Point 5, located on the south-east side of the headland, is the only location observed to have eroded (by 0.5m).</p> <p>Points 3 and 6 are observed to have advanced by 0.4m and 0.1m respectively, but this is likely to result from problems in precise identification of the cliff edge due to vegetation growth. Review and analysis of the 2012 aerial photography will allow the nature of change to be better understood.</p>

Six ground control points have been established at Trow Quarry (Figure C1). The maximum separation between any two points varies along the coast, reflecting the degree of risk from the erosion.

The cliff top surveys at Trow Quarry are undertaken bi-annually. Measurements are taken from a fixed ground control point along a fixed bearing to the edge of the cliff top.
