Cell 1 Regional Coastal Monitoring Programme Analytical Report 3: 'Full Measures' Survey 2011

**Sunderland City Council
Final Report**

October 2012

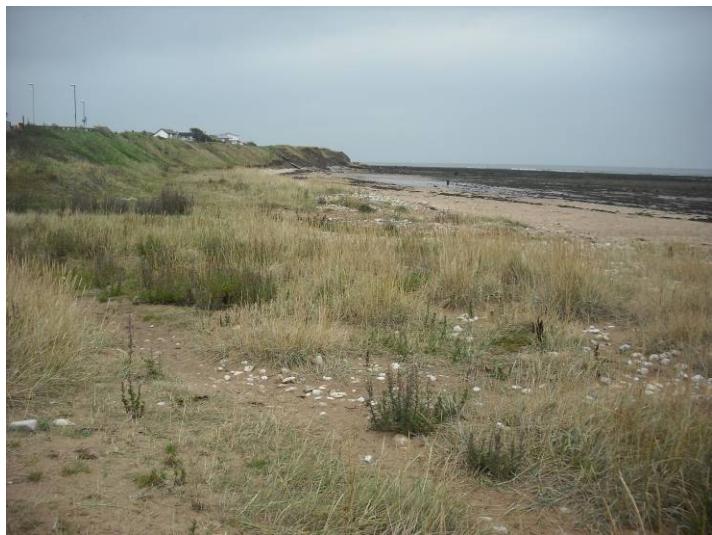
Plate 1 – Survey photograph 1bSNN1_20111013_N2.jpg

Survey Date	Description of Changes Since Last Survey	Interpretation
	Whitburn Steel. The map in Figure 2 – Map 1 shows that beach material has been removed from the beach, exposing the rock below, however, the rock of Whitburn Steel has been covered with a layer of sand. Between these locations is a band of sand material, similar to a tombolo (i.e. an accretionary landform that links an island to the mainland). This suggests that material is being drawn down from the beach and deposited on the rock shore platform.

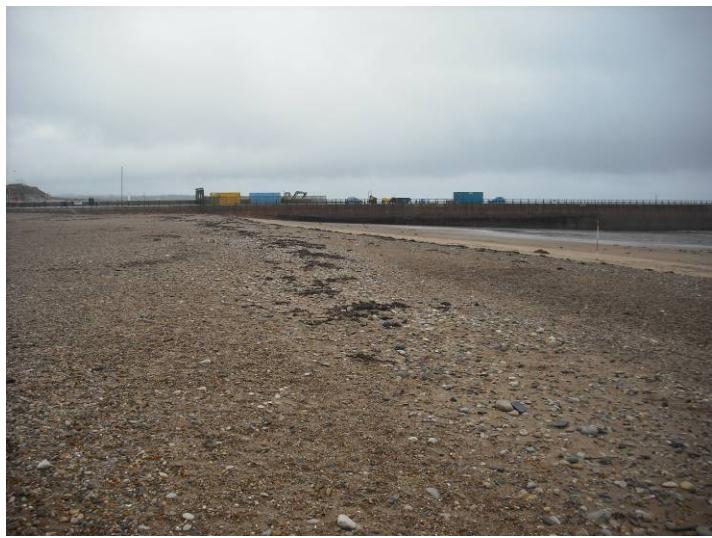
Plate 5 – Survey photograph 1bSNN12_20111013_N4.JPG

Survey Date	Description of Changes Since Last Survey	Interpretation
Nov 2011	<p>Beach Profiles:</p> <p>Sunderland Harbour and Docks is covered by eleven beach profile lines (Appendix A).</p> <p>1bSNN12 and 1bSNN13 are both located within the shelter of Roker Pier. At profile 1bSNN12, beach levels between a chainage of 15m and 45m, beach levels have increased to from a wider berm at the back of the beach. The berm at HAT has not changed position or form. Seaward of HAT to a chainage of 115m, beach levels have increased across the profile. This increase (0.3m) is greatest between HAT and MHWS. The survey photographs (Plate 5 and Plate 6) show that the upper beach is comprised of shingle and sand, whereas the middle and lower beach is comprised of sand. This accretion could be attributed to the sorting of sediment as more coarse shingle and pebbles are moved to the upper beach to form a berm. At 1bSNN13 beach levels increased by approximately 0.1m from a height of 4.6m to 1m. Seaward of there, they increased out to -0.6m up to 0.6m to form a more gently sloping beach.</p> <p>1bSNC1 and 1bSNC2 are located within the shelter of New South Pier. Profile 1bSNC1 starts at the seaward edge of the dock building and extends across an earth mound before reaching the stepped landward face of the dock wall. The profile then drops from the wall crest directly into deep water. For this reason, profile 1bSNC1 has not been analysed. Profile 1bSNC2 starts at the crest of New South Pier and drops several metres to foreshore level. Beach levels at the toe of the pier have increased by up to 0.5m out to a chainage of 50m.</p> <p>1bSNC3 to 1bSNC7 are on the seaward face of the dock. Profile 1bSNC3 extends from the dock yard across a back flood wall, which has a crest level of around 7.2mODN, and promenade to the main seaward dock wall, which has a crest level of 7.55mODN. The profile then extends down the seaward face of the wall into deep water. For this reason, profile 1bSNC3 has not been analysed. Profiles 1bSNC4 and 1bSNC5 extend from the rock armoured revetment across the short width of foreshore down to low water. Profile 1bSNC4 suggests that beach levels have increased by over 1.5m and it is possible that this is due to survey error. No further analysis of this profile has been undertaken for this reason. At 1bSNC5 the position of the defences has changed which is likely to reflect the survey technique used rather than actual change. Seaward of a chainage of 7m, beach levels have increased across the profile by 0.2m between a chainage of 6m and 24m and up to 0.6m seaward of there. This</p>	<p>To the north of Sunderland Harbour and Docks (profiles 1bSNN12 to 1bSNS2), within the breakwaters (and to the north and south of the River Wear), beach levels have increased since the last survey (full measures inter 2011).</p> <p>Longer term trends: The beaches are showing a tendency to return to the levels they were in at the time of the 7th September 2009 / 5th October 2009 survey (full measures, winter 2009).</p> <p>Within the centre of this frontage (1bSNC3 to 1bSNC7), there is only one profile which can be assed with confidence - Profile 1bSNC5. At this location, beach levels have increased since the last survey and are their highest since 5th October 2009 survey (full measures, winter 2009).</p> <p>To the south of Sunderland Harbour and Docks (profiles 1bSNC8 and 1bSNC9), is a beach located between the North East Pier and South West Breakwater. Levels on the northern side of the beach have fallen since the last survey, but increased on the southern side. For the southern side of the beach in particular, this is a trend that has continued since 5th October 2009 survey (full measures, winter 2009).</p>

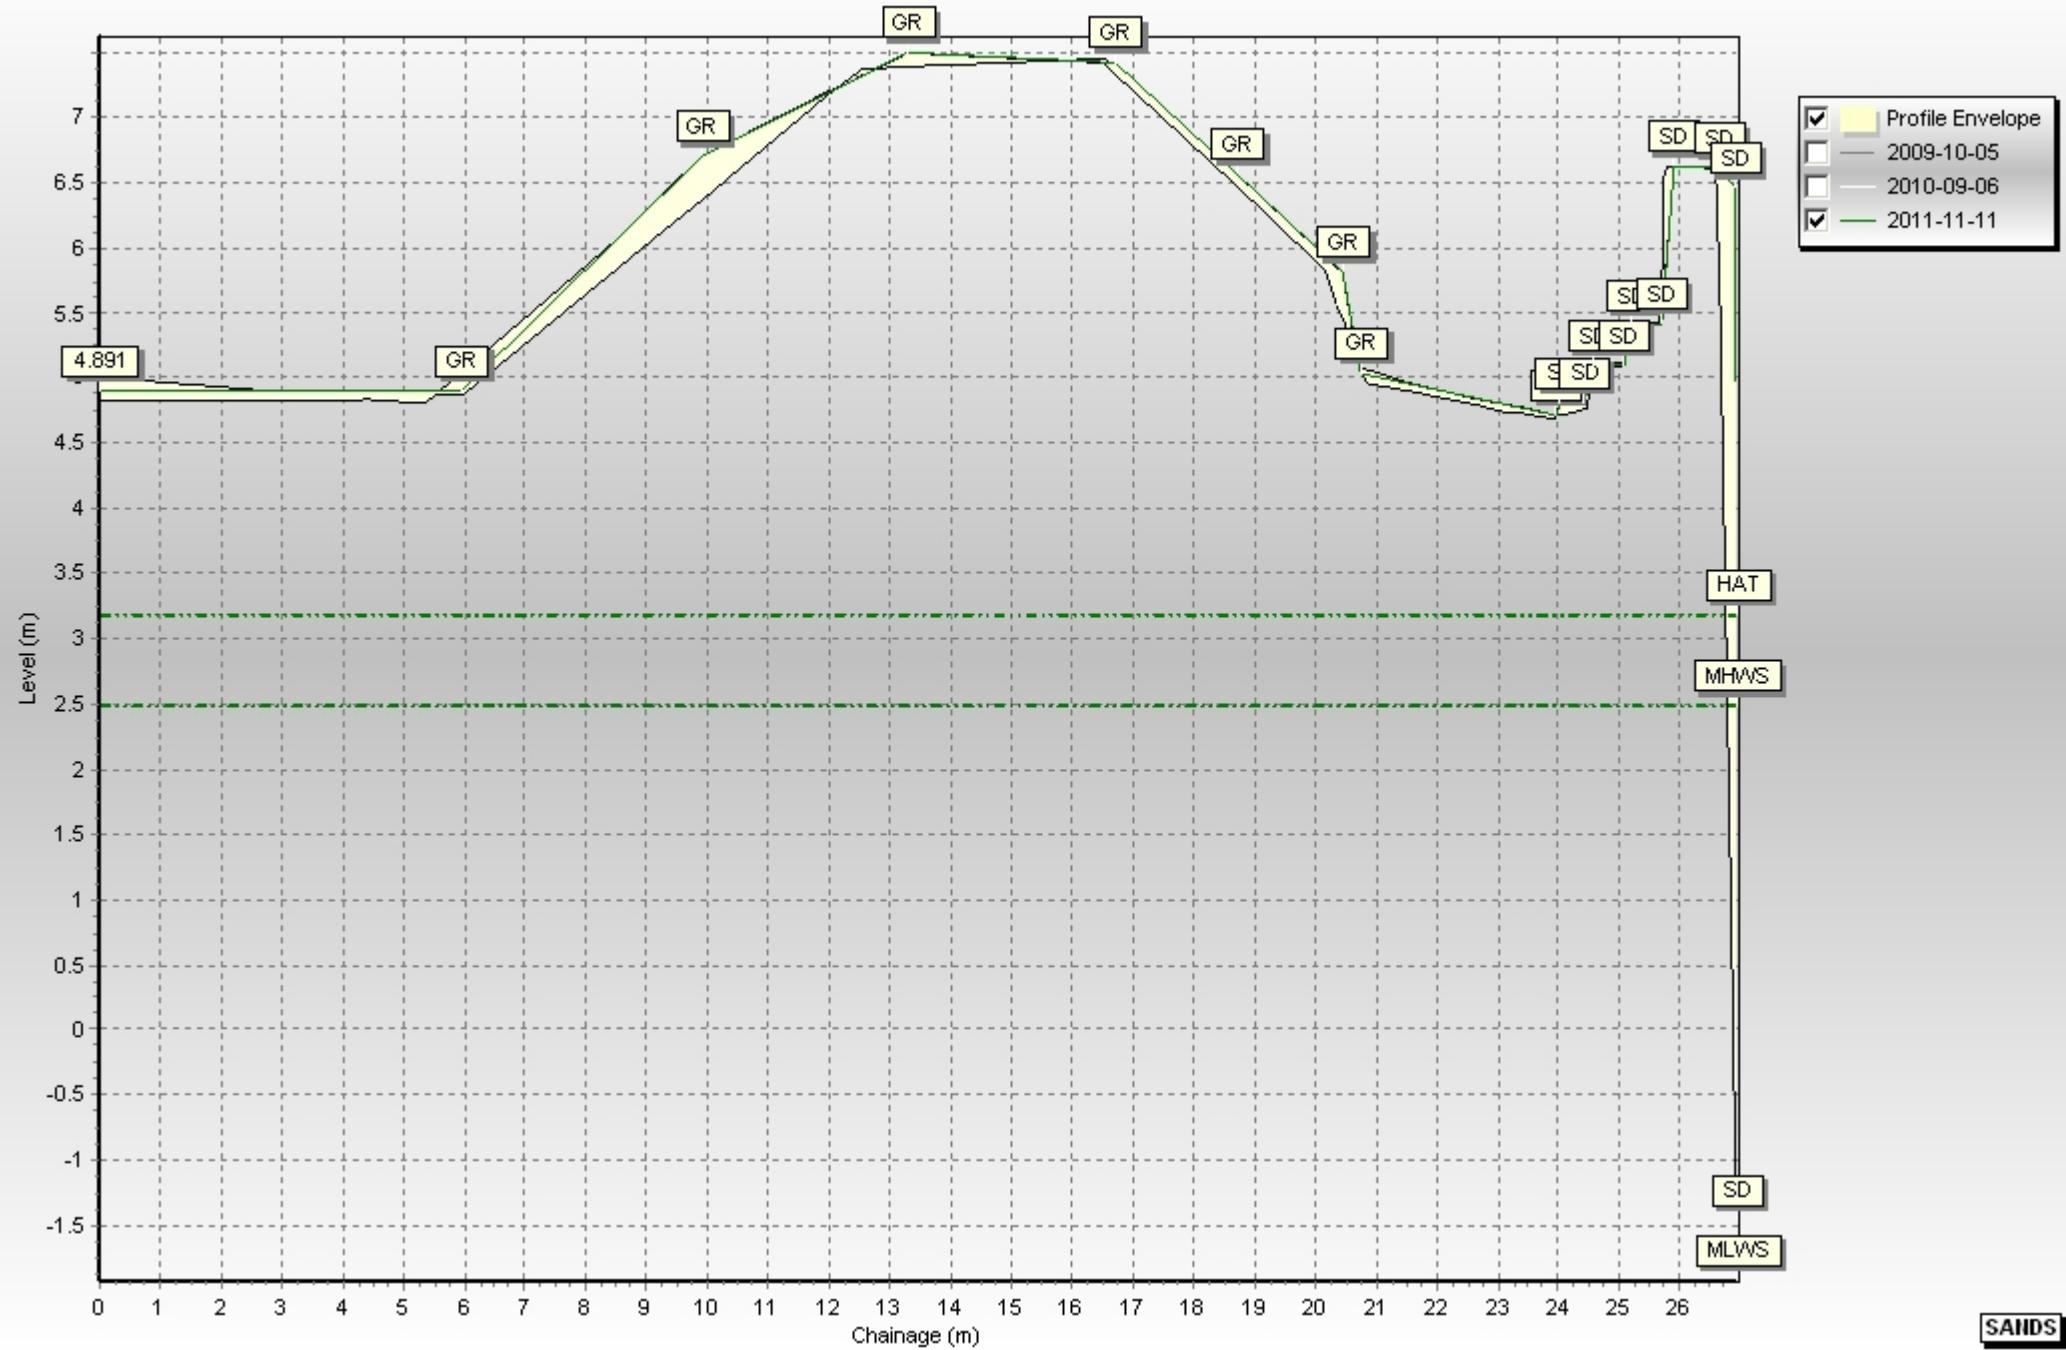
Beach Profiles: 1bSNC1

At profile 1bSNC1, the profile drops from the wall crest directly into deep water and has therefore not been analysed.

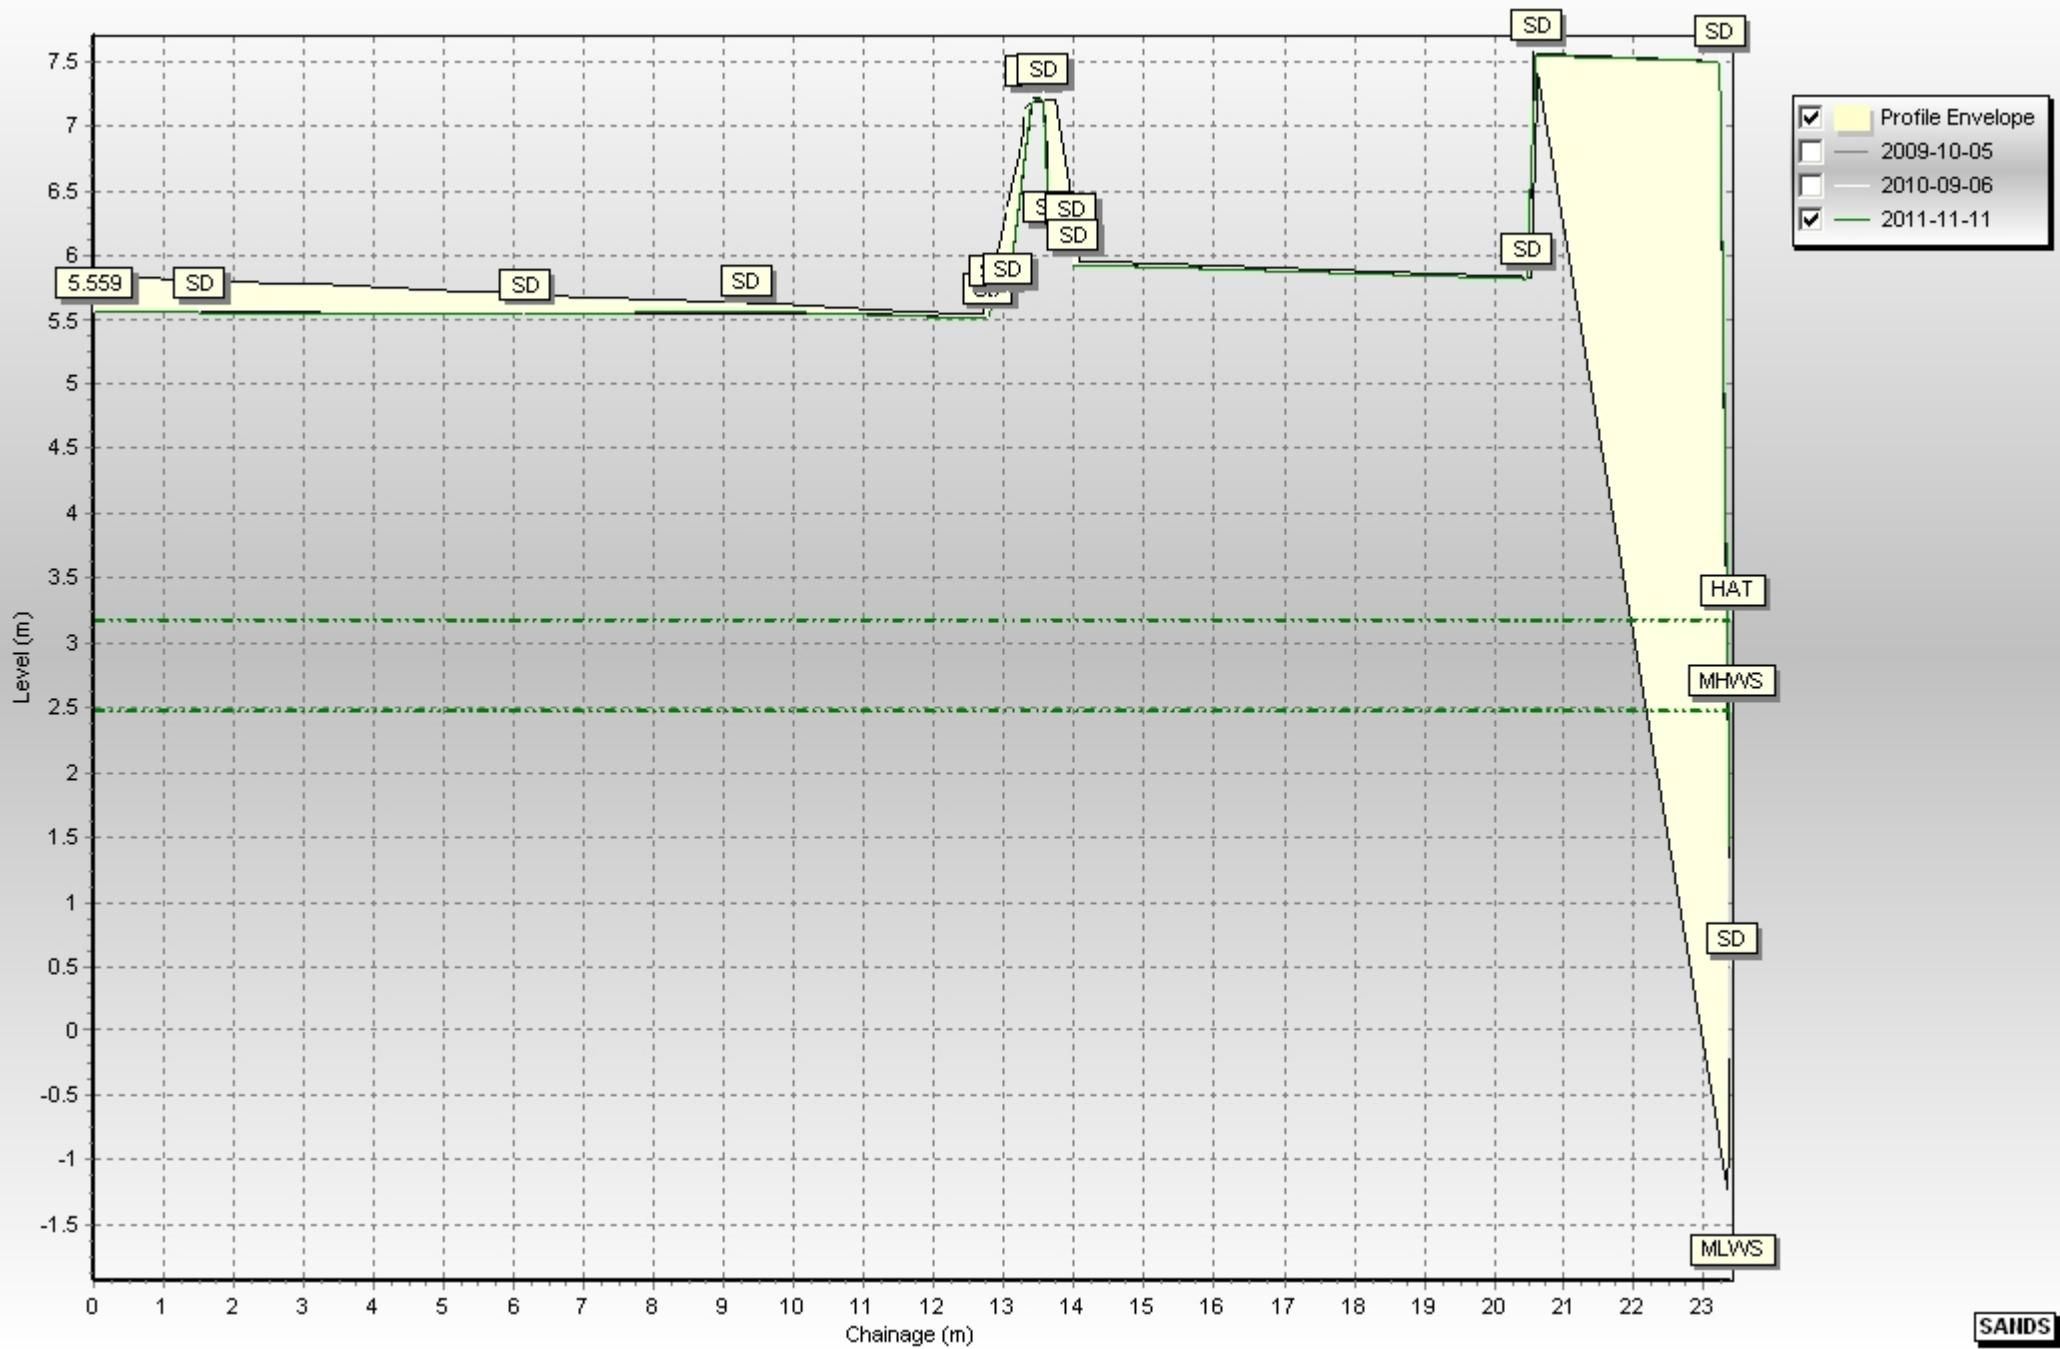
Beach Profiles: 1bSNC3

Profile 1bSNC3 extends down the seaward face of the wall into deep water and has therefore not been analysed.

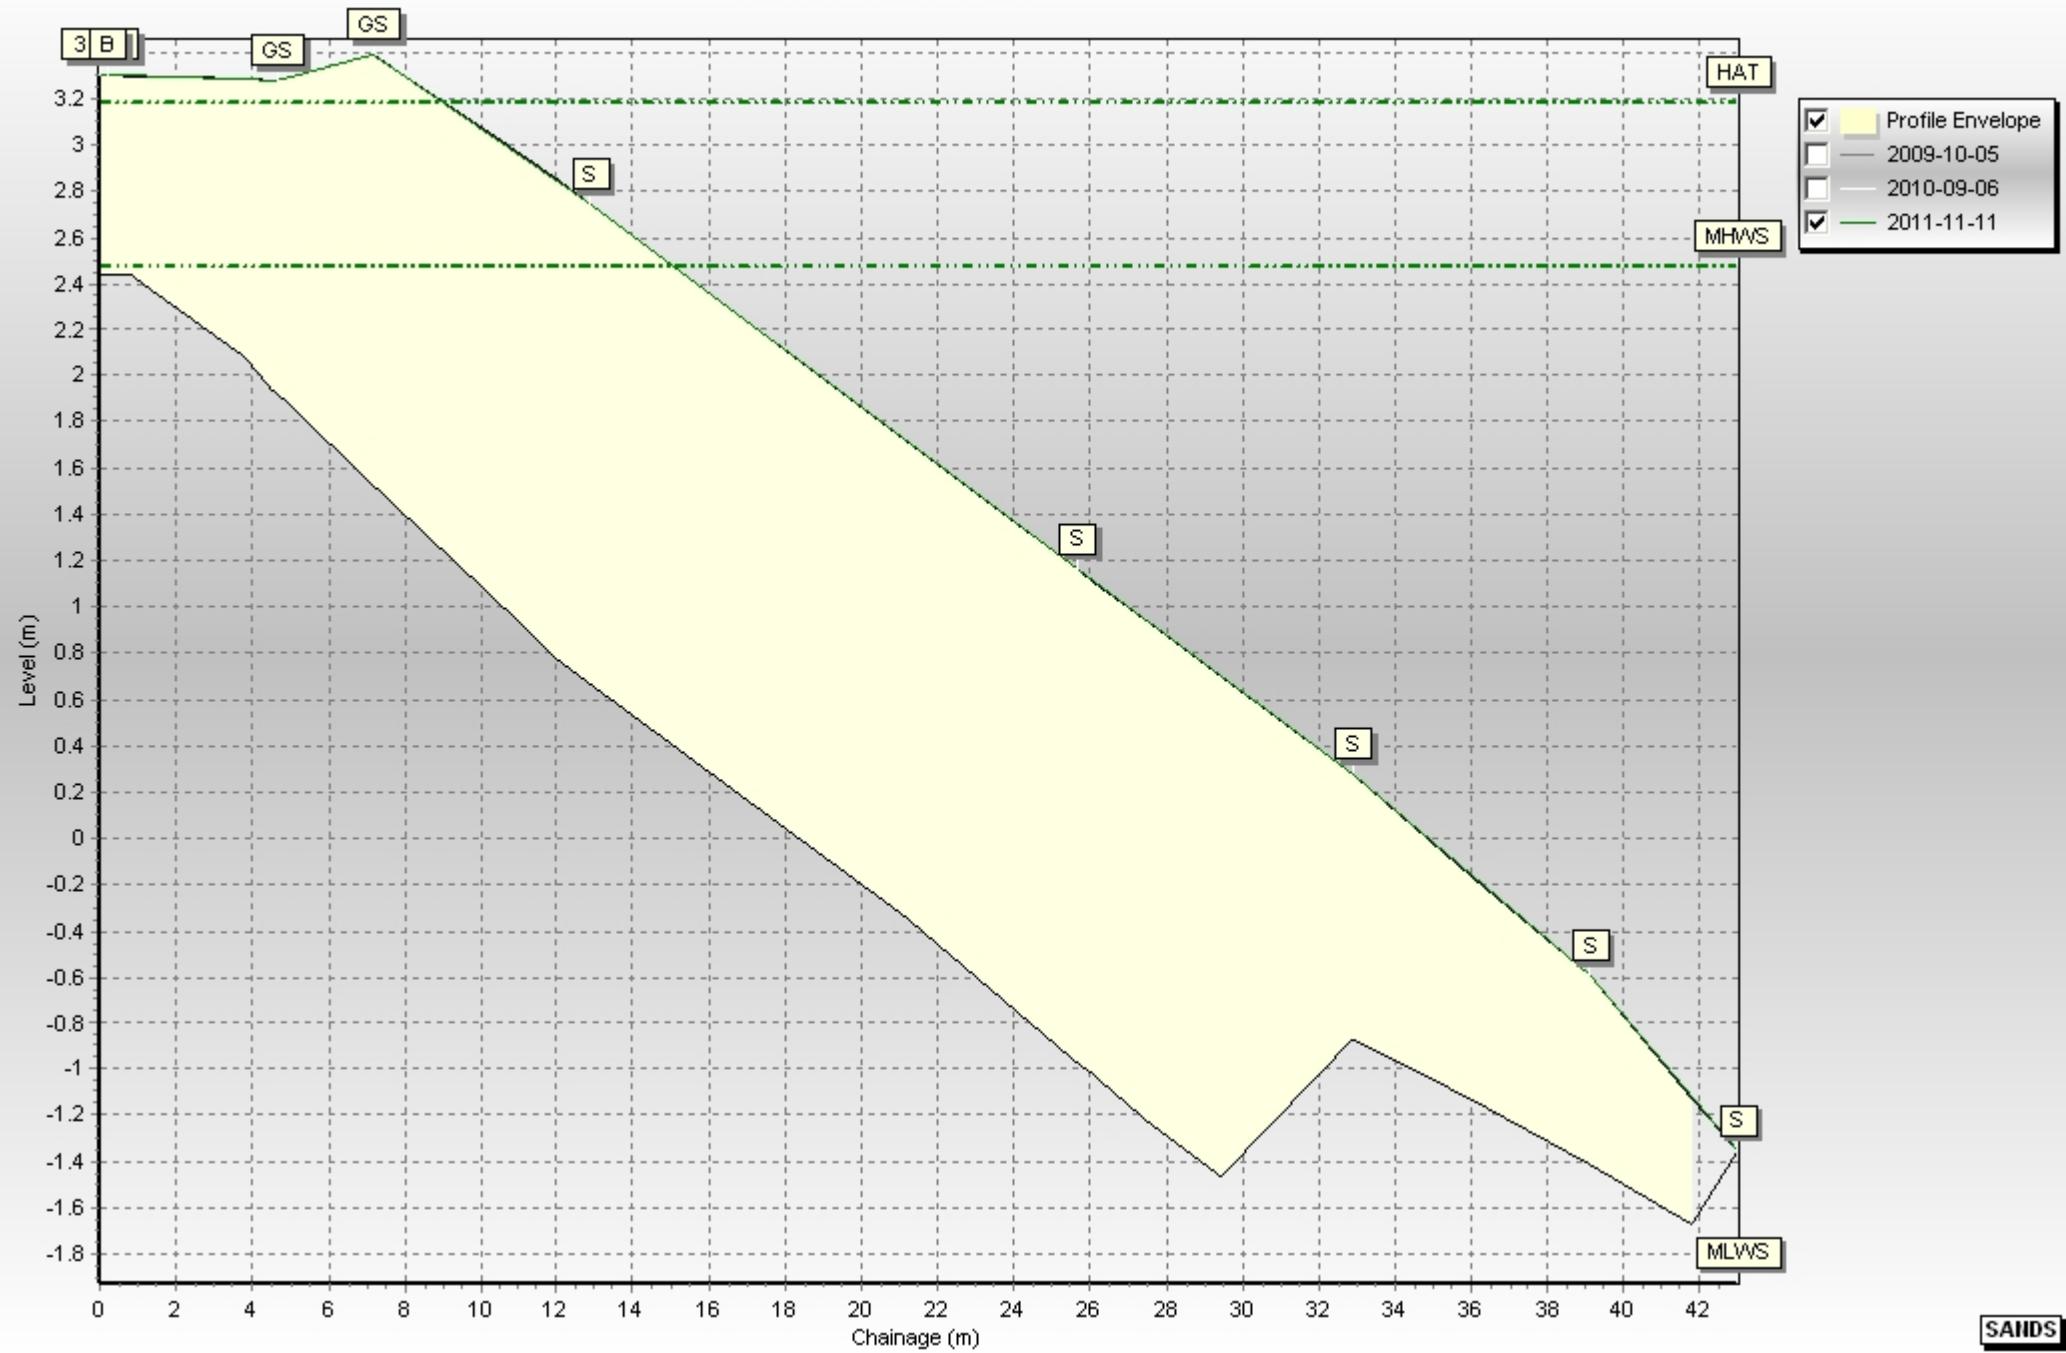
Beach Profiles: 1bSNC4

Profile 1bSNC4 suggests that beach levels have increased by over 1.5m, which is unlikely and it is possible that this is due to survey error. No further analysis of this profile has therefore been undertaken.

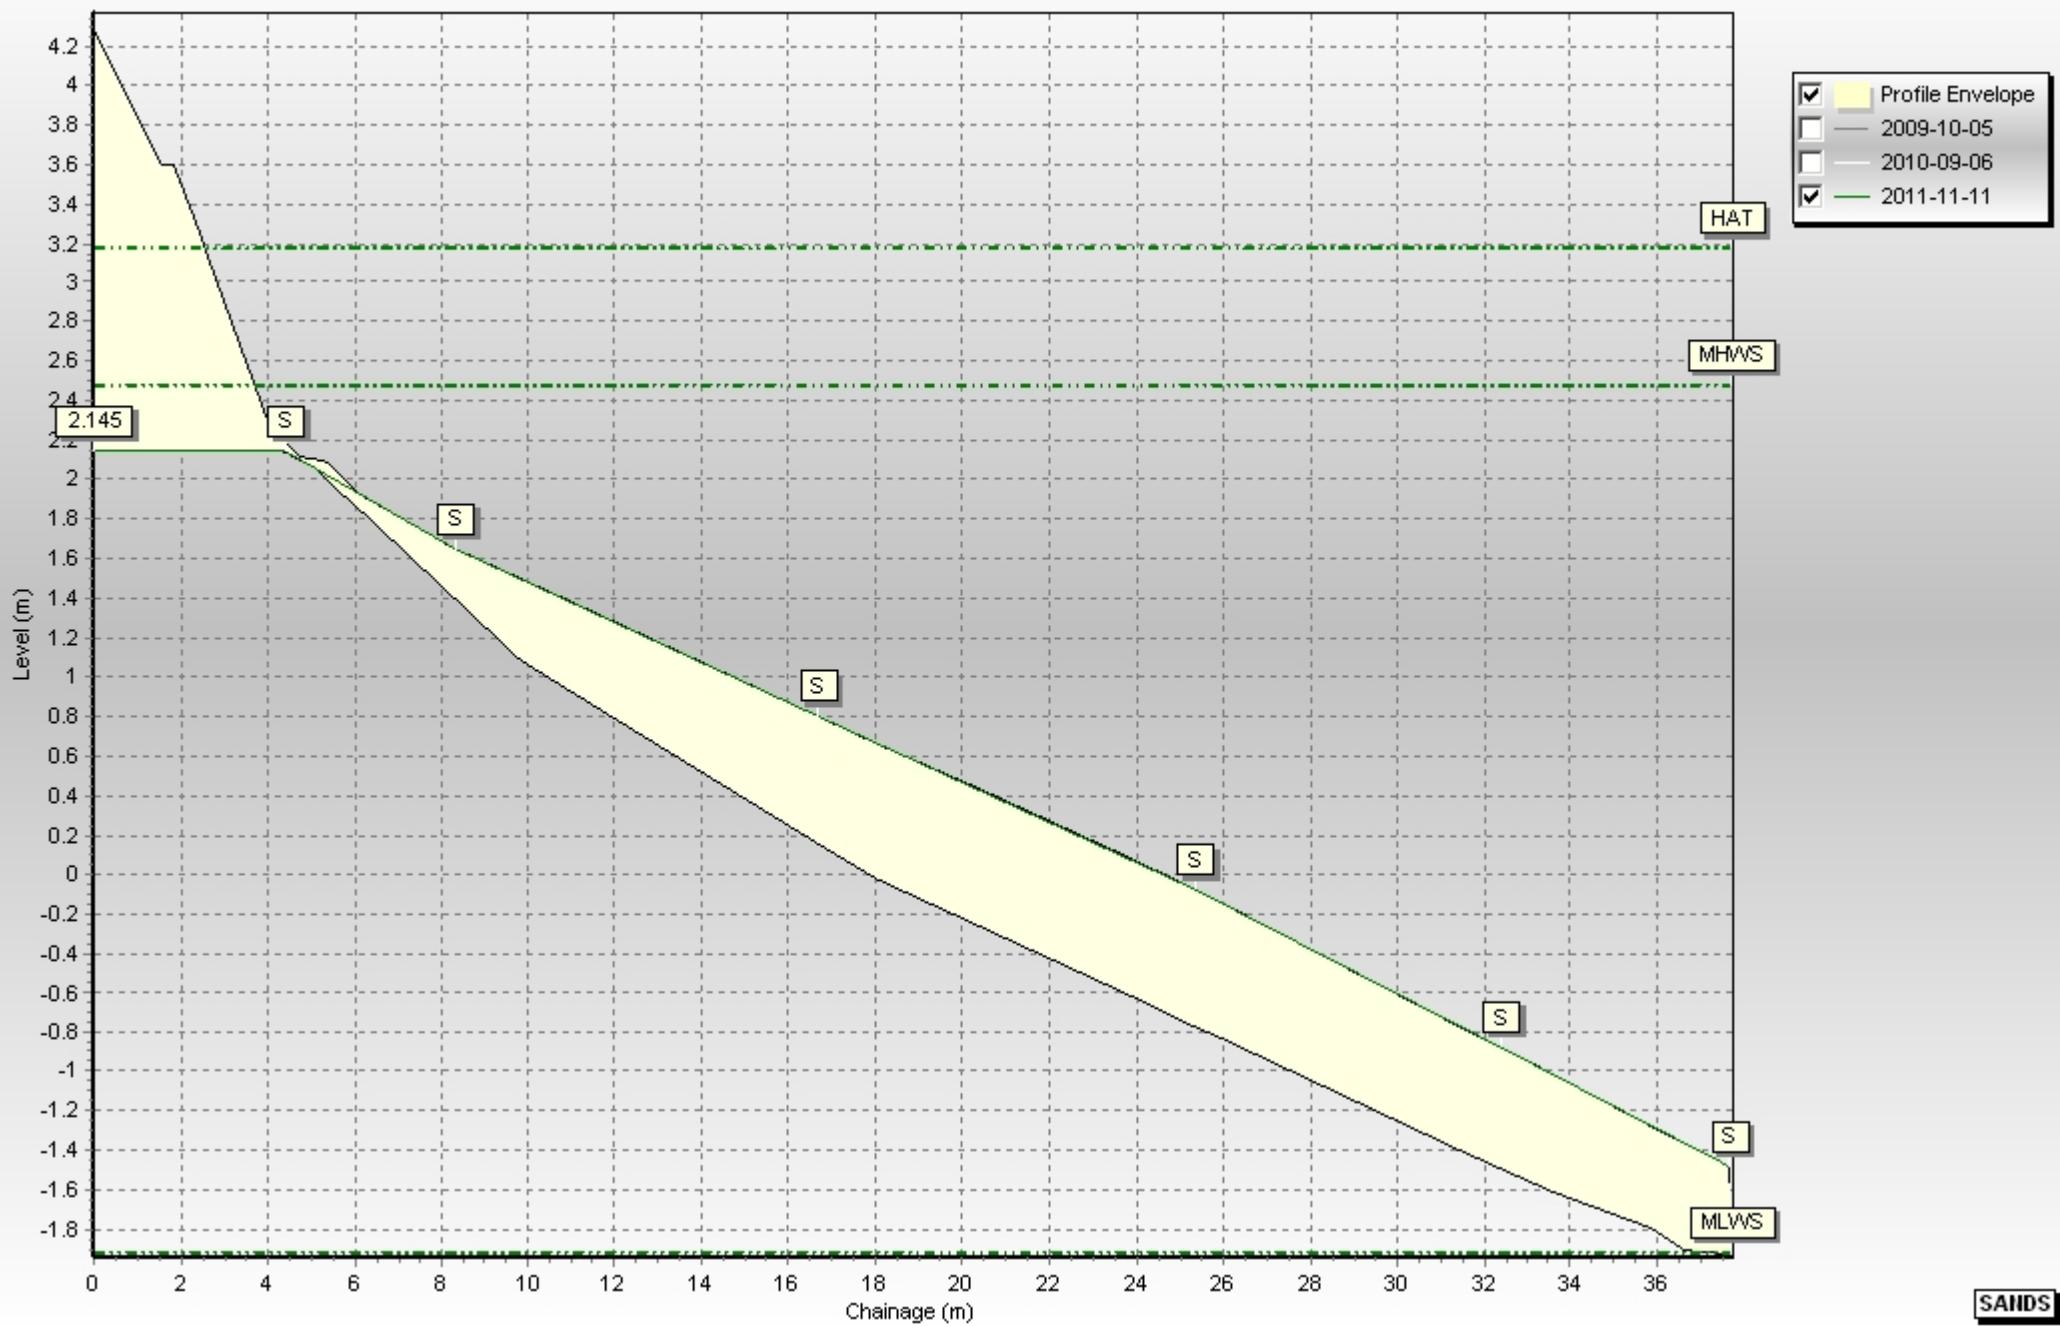
Beach Profiles: 1bSNC5

At 1bSNC5 the position of the defences is indicated to have changed, which is likely to reflect the survey technique used rather than actual change.

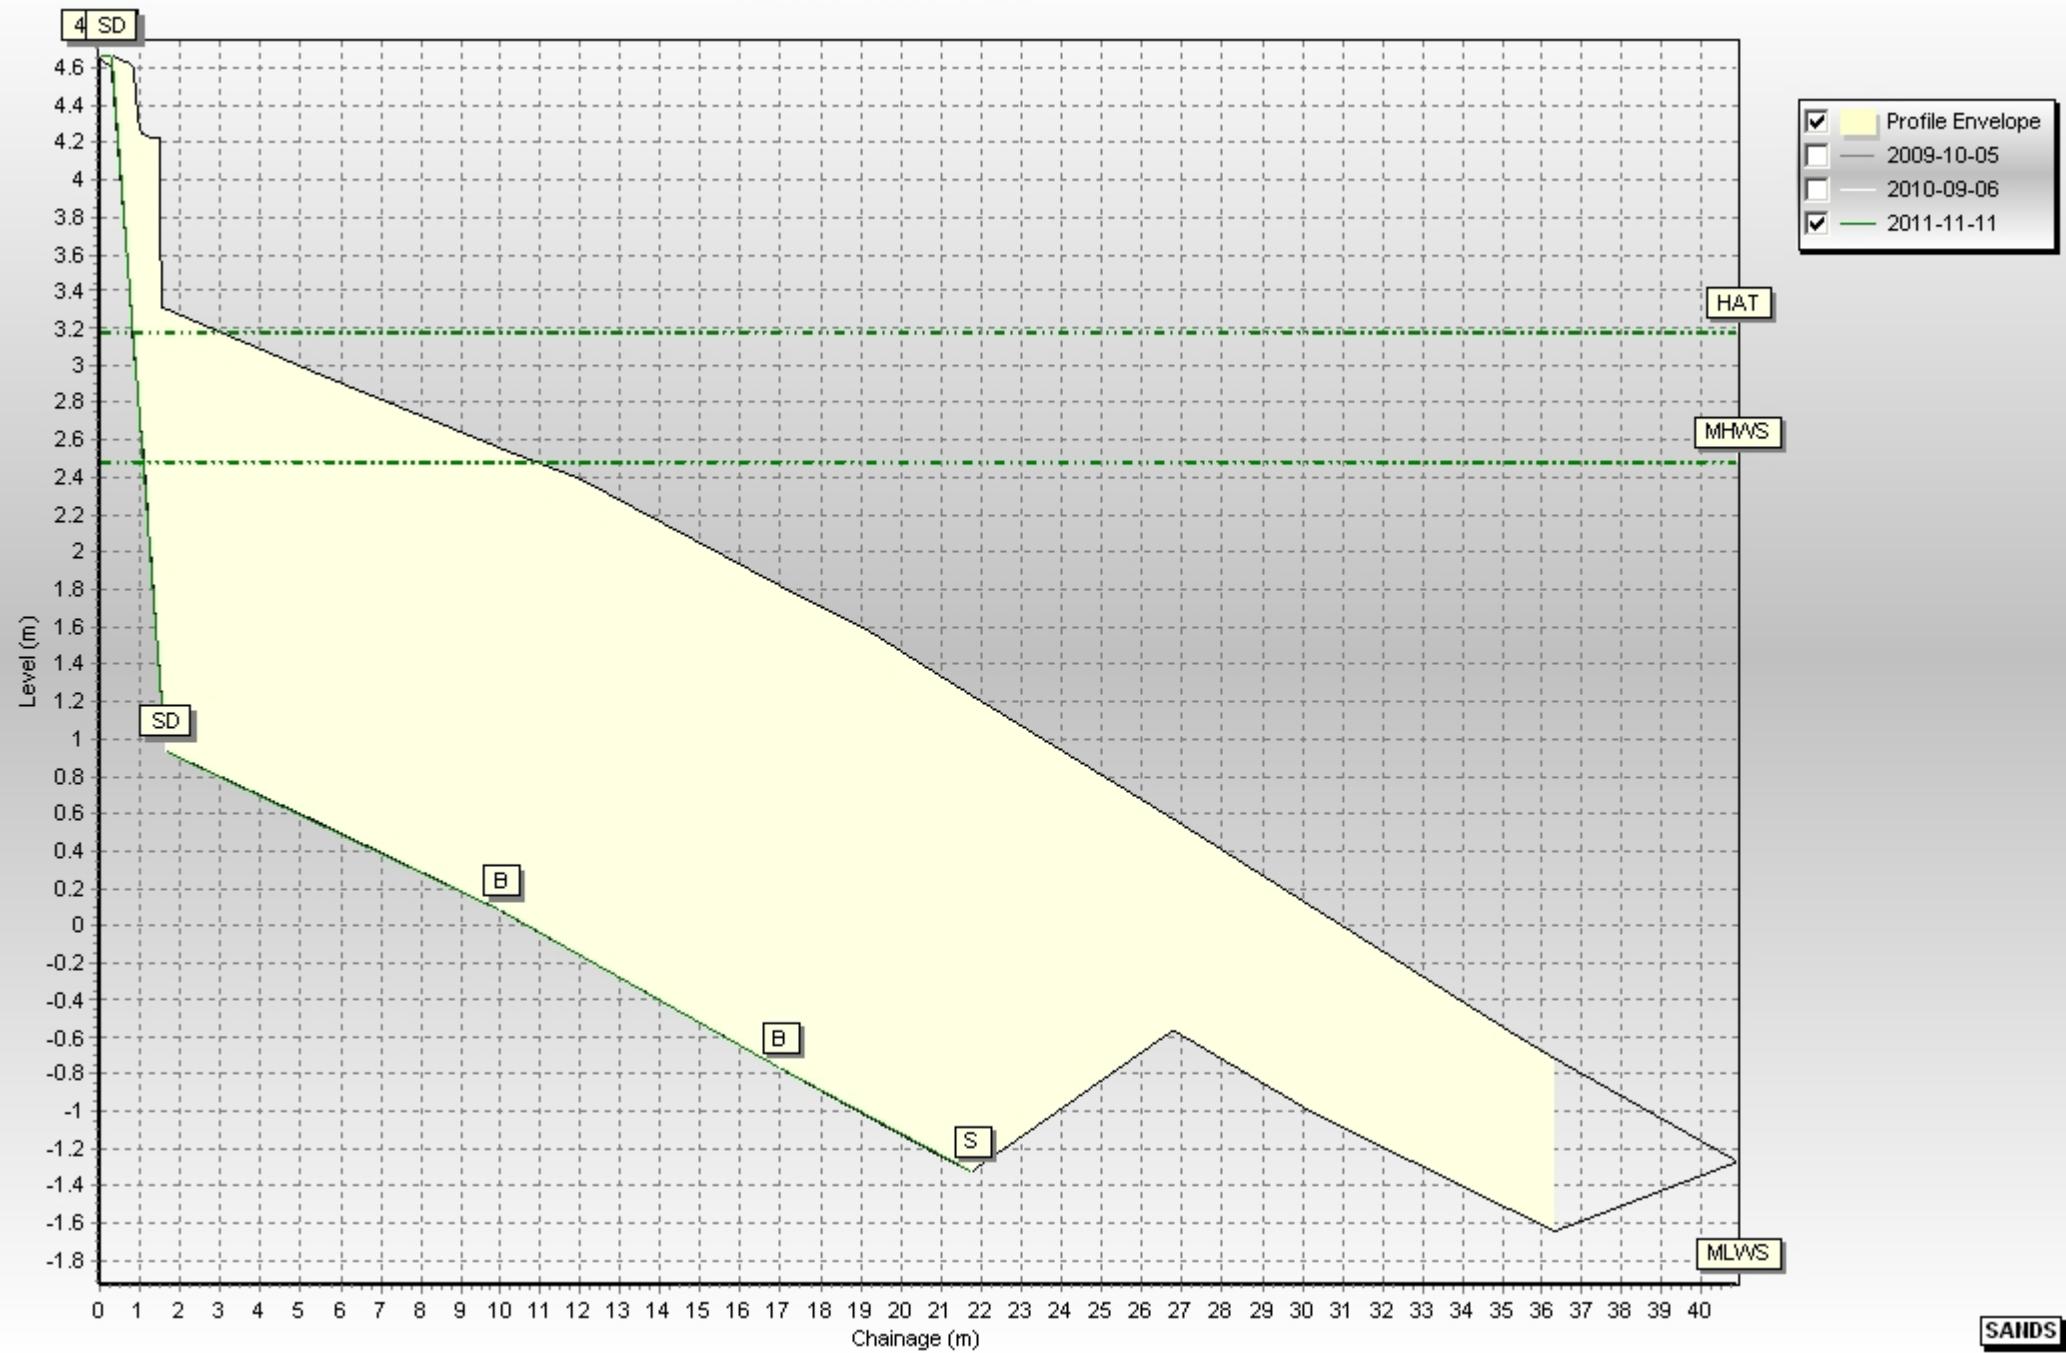
Beach Profiles: 1bSNC6

Profile 1bSNC6 suggests that beach levels have fallen by almost 2m, which is unlikely and it is possible that this is due to survey error. No further analysis of this profile has been undertaken for this reason.

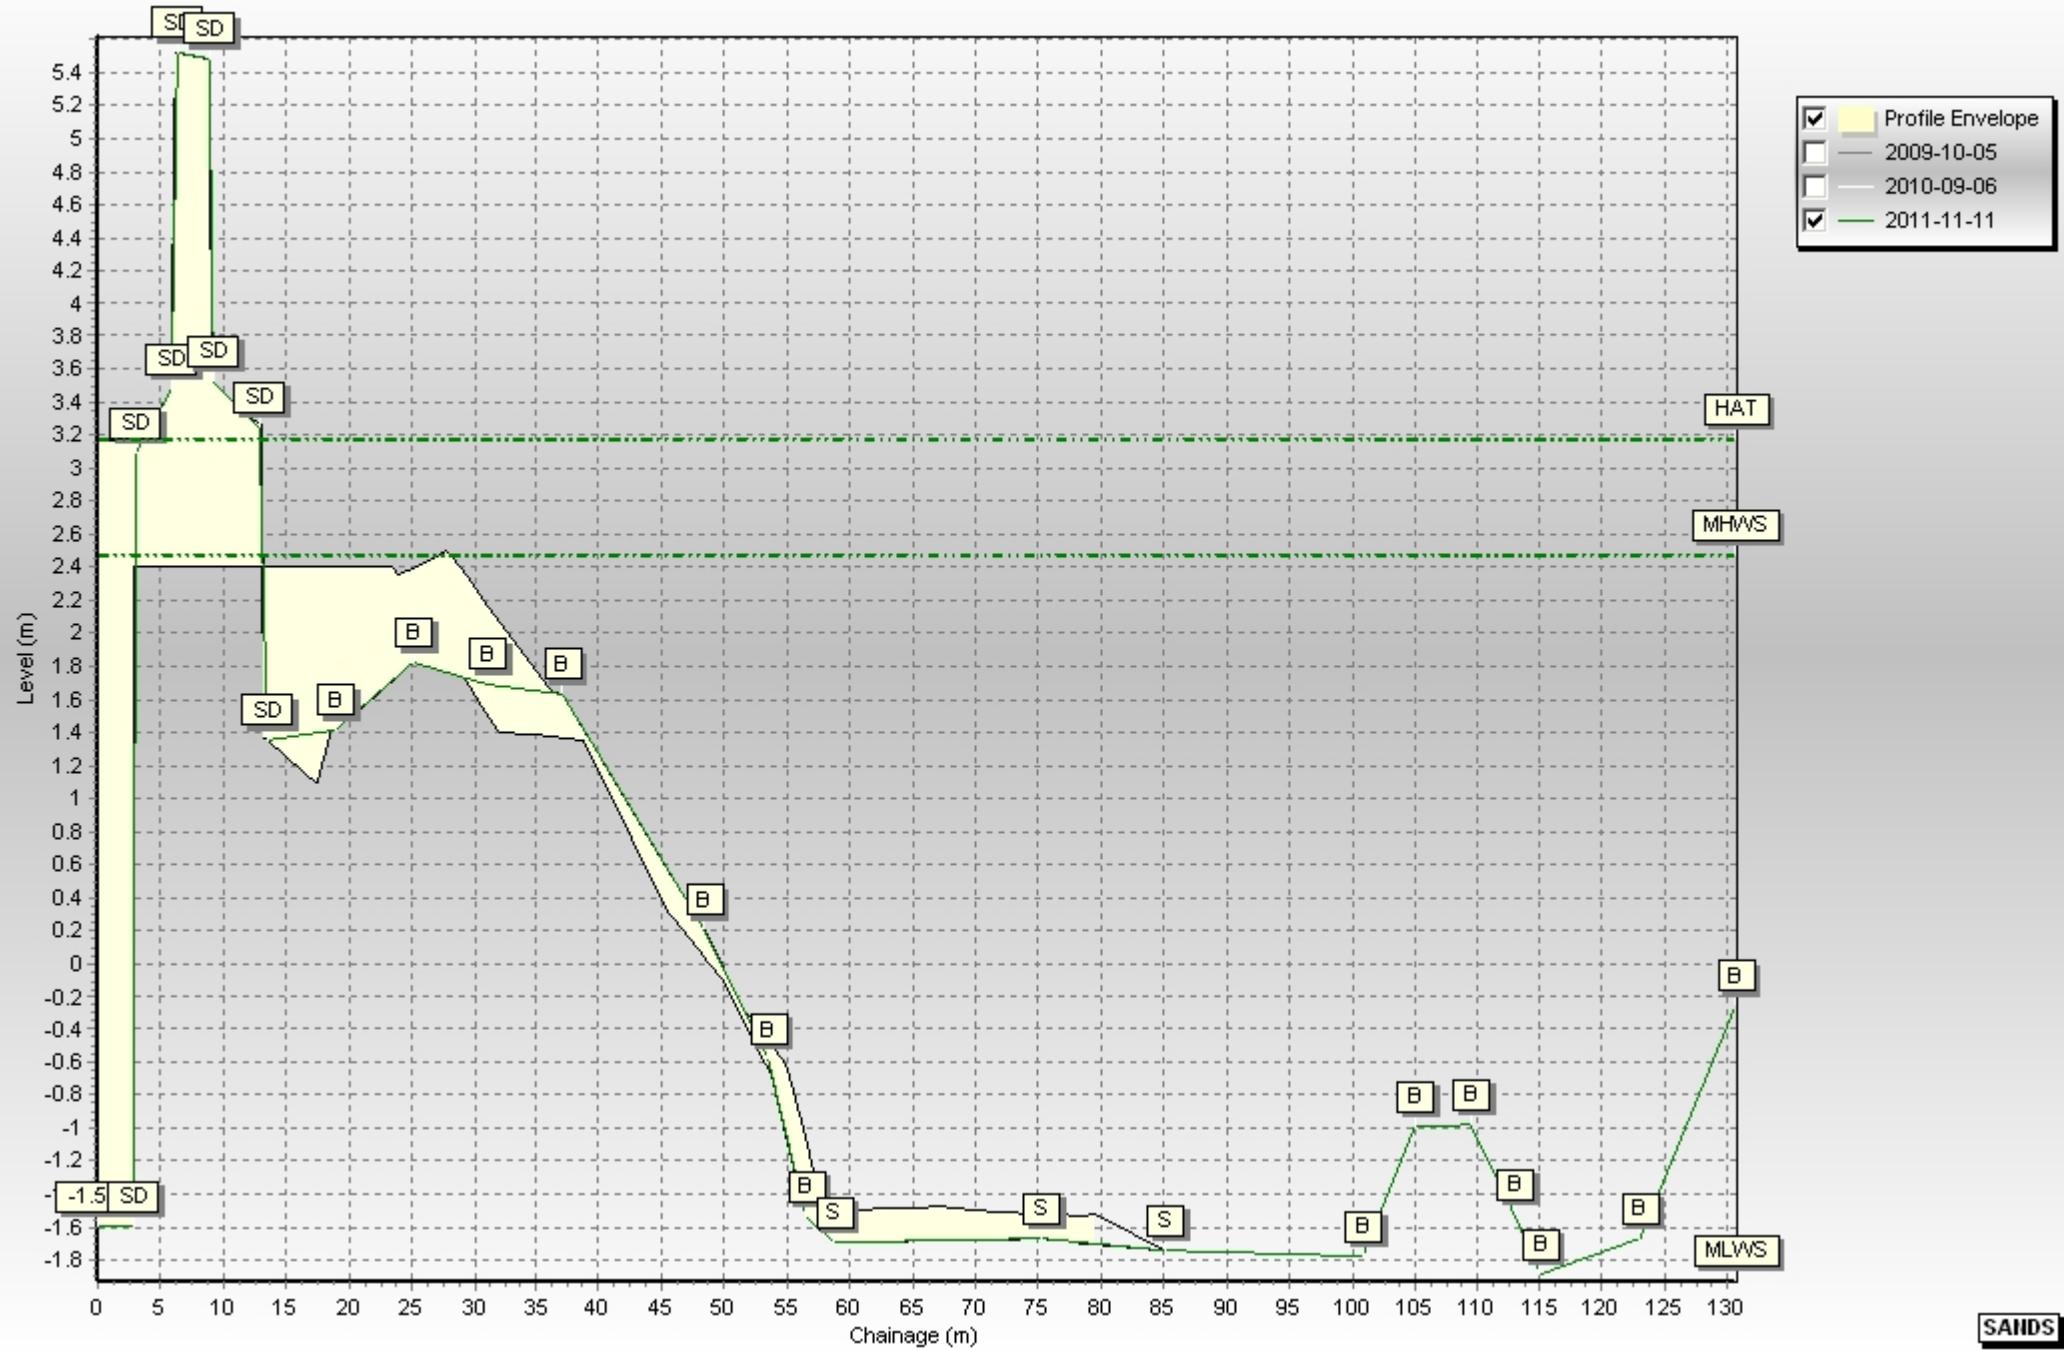
Beach Profiles: 1bSNC7

Profile 1bSNC7 is a section across North East Pier and shows the terraced nature of the landward face of the pier wall, extending across rock to the small sheltered bay between the two structures. No further analysis of this profile has been undertaken for this reason.

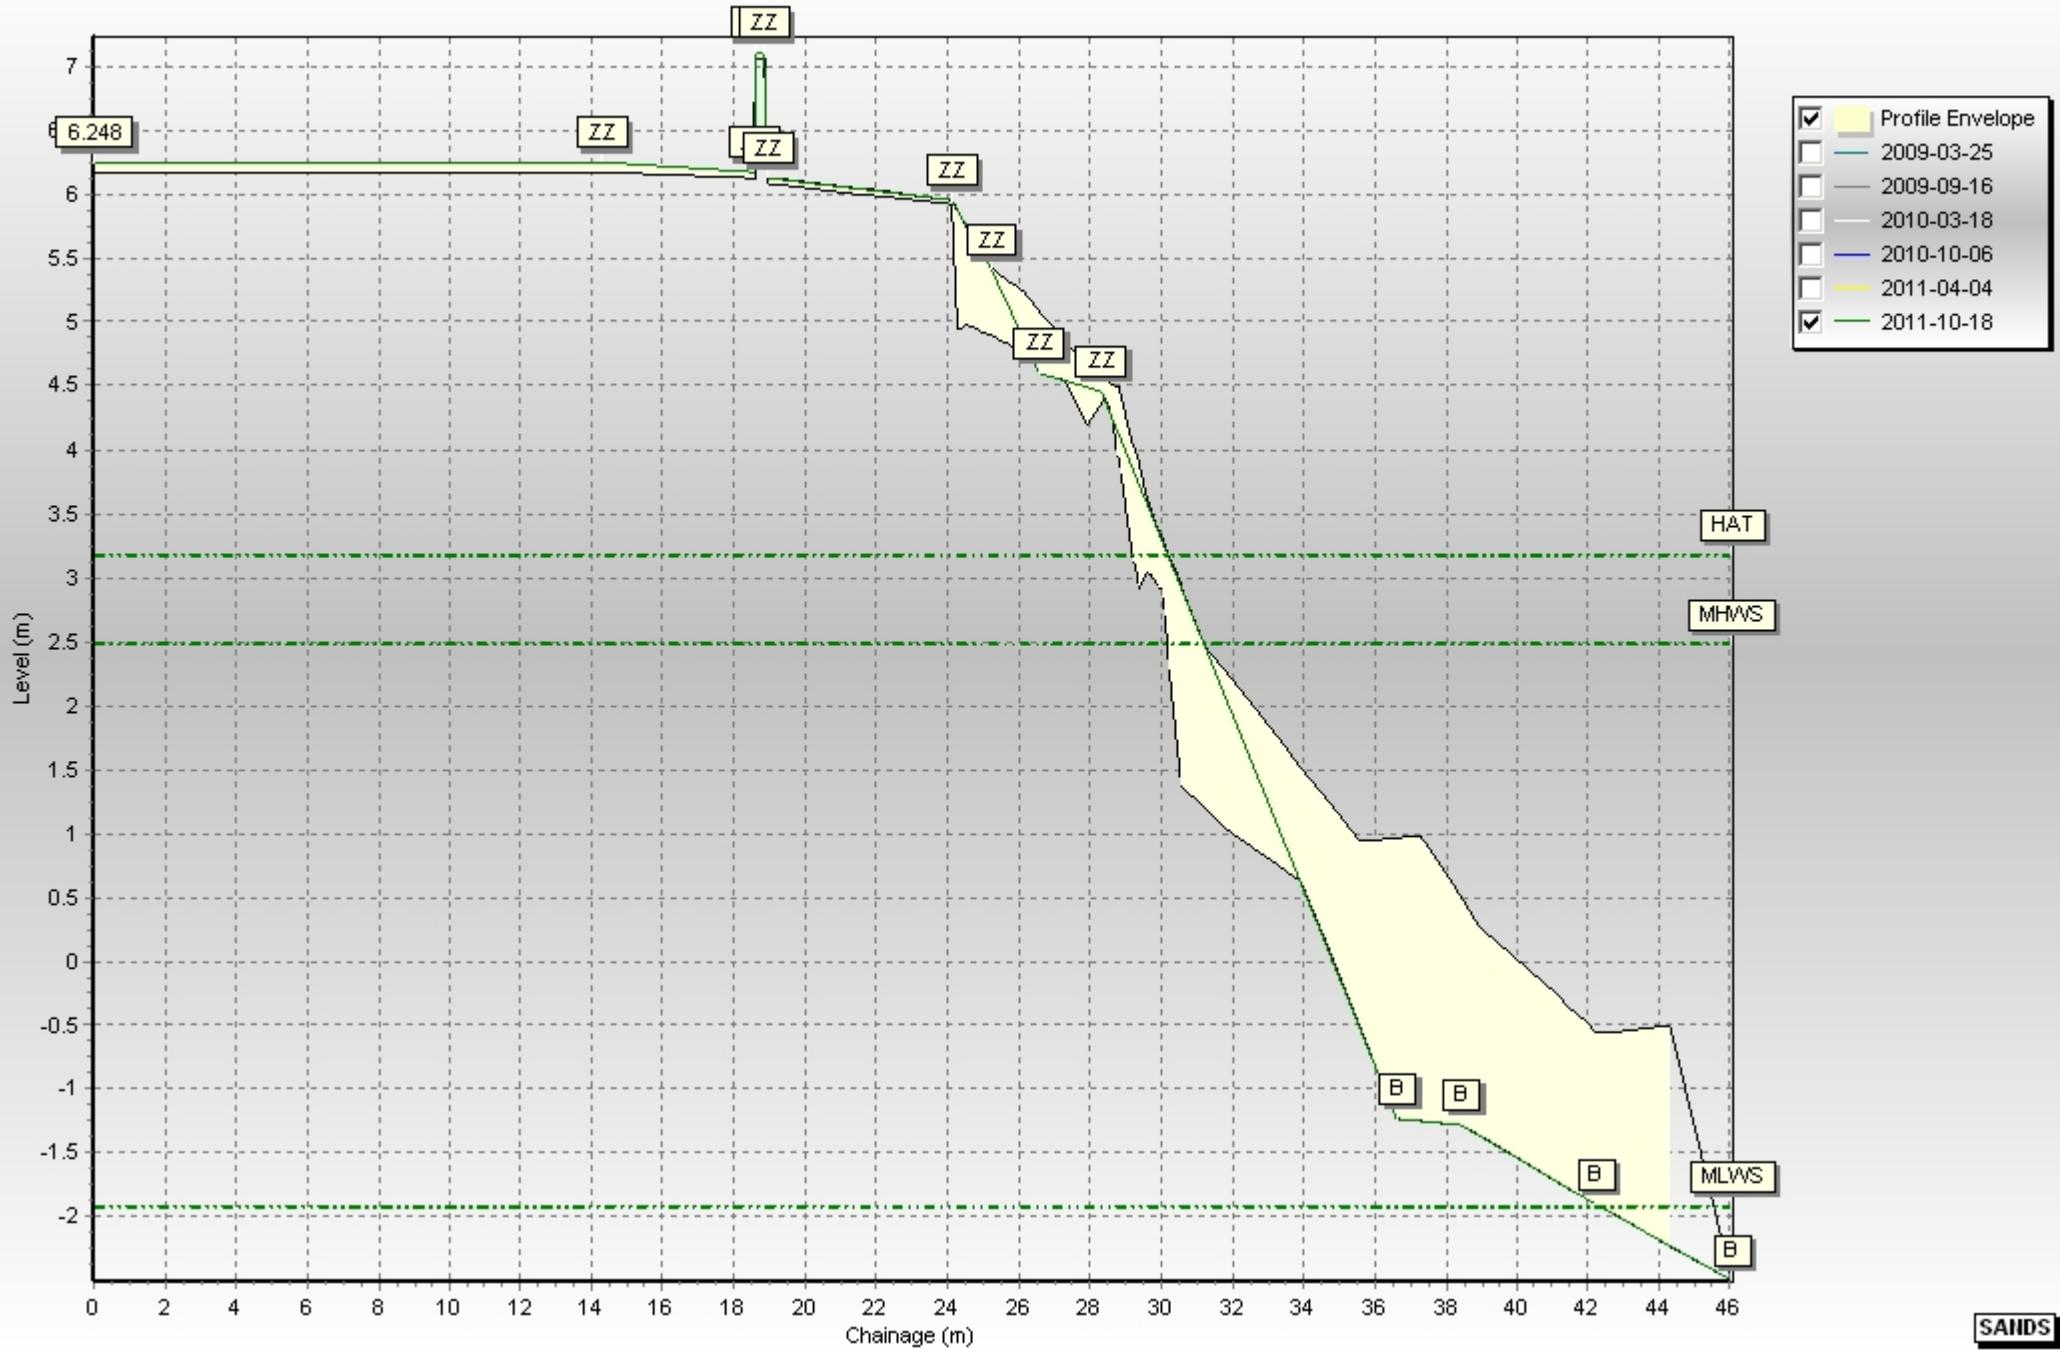
Beach Profiles: 1bSNS4

Profile 1bSNS4 extends into water and has therefore not been analysed.
