Cell 1 Regional Coastal Monitoring Programme Analytical Report 3: 'Full Measures' Survey 2011

**Sunderland City Council
Final Report**

October 2012

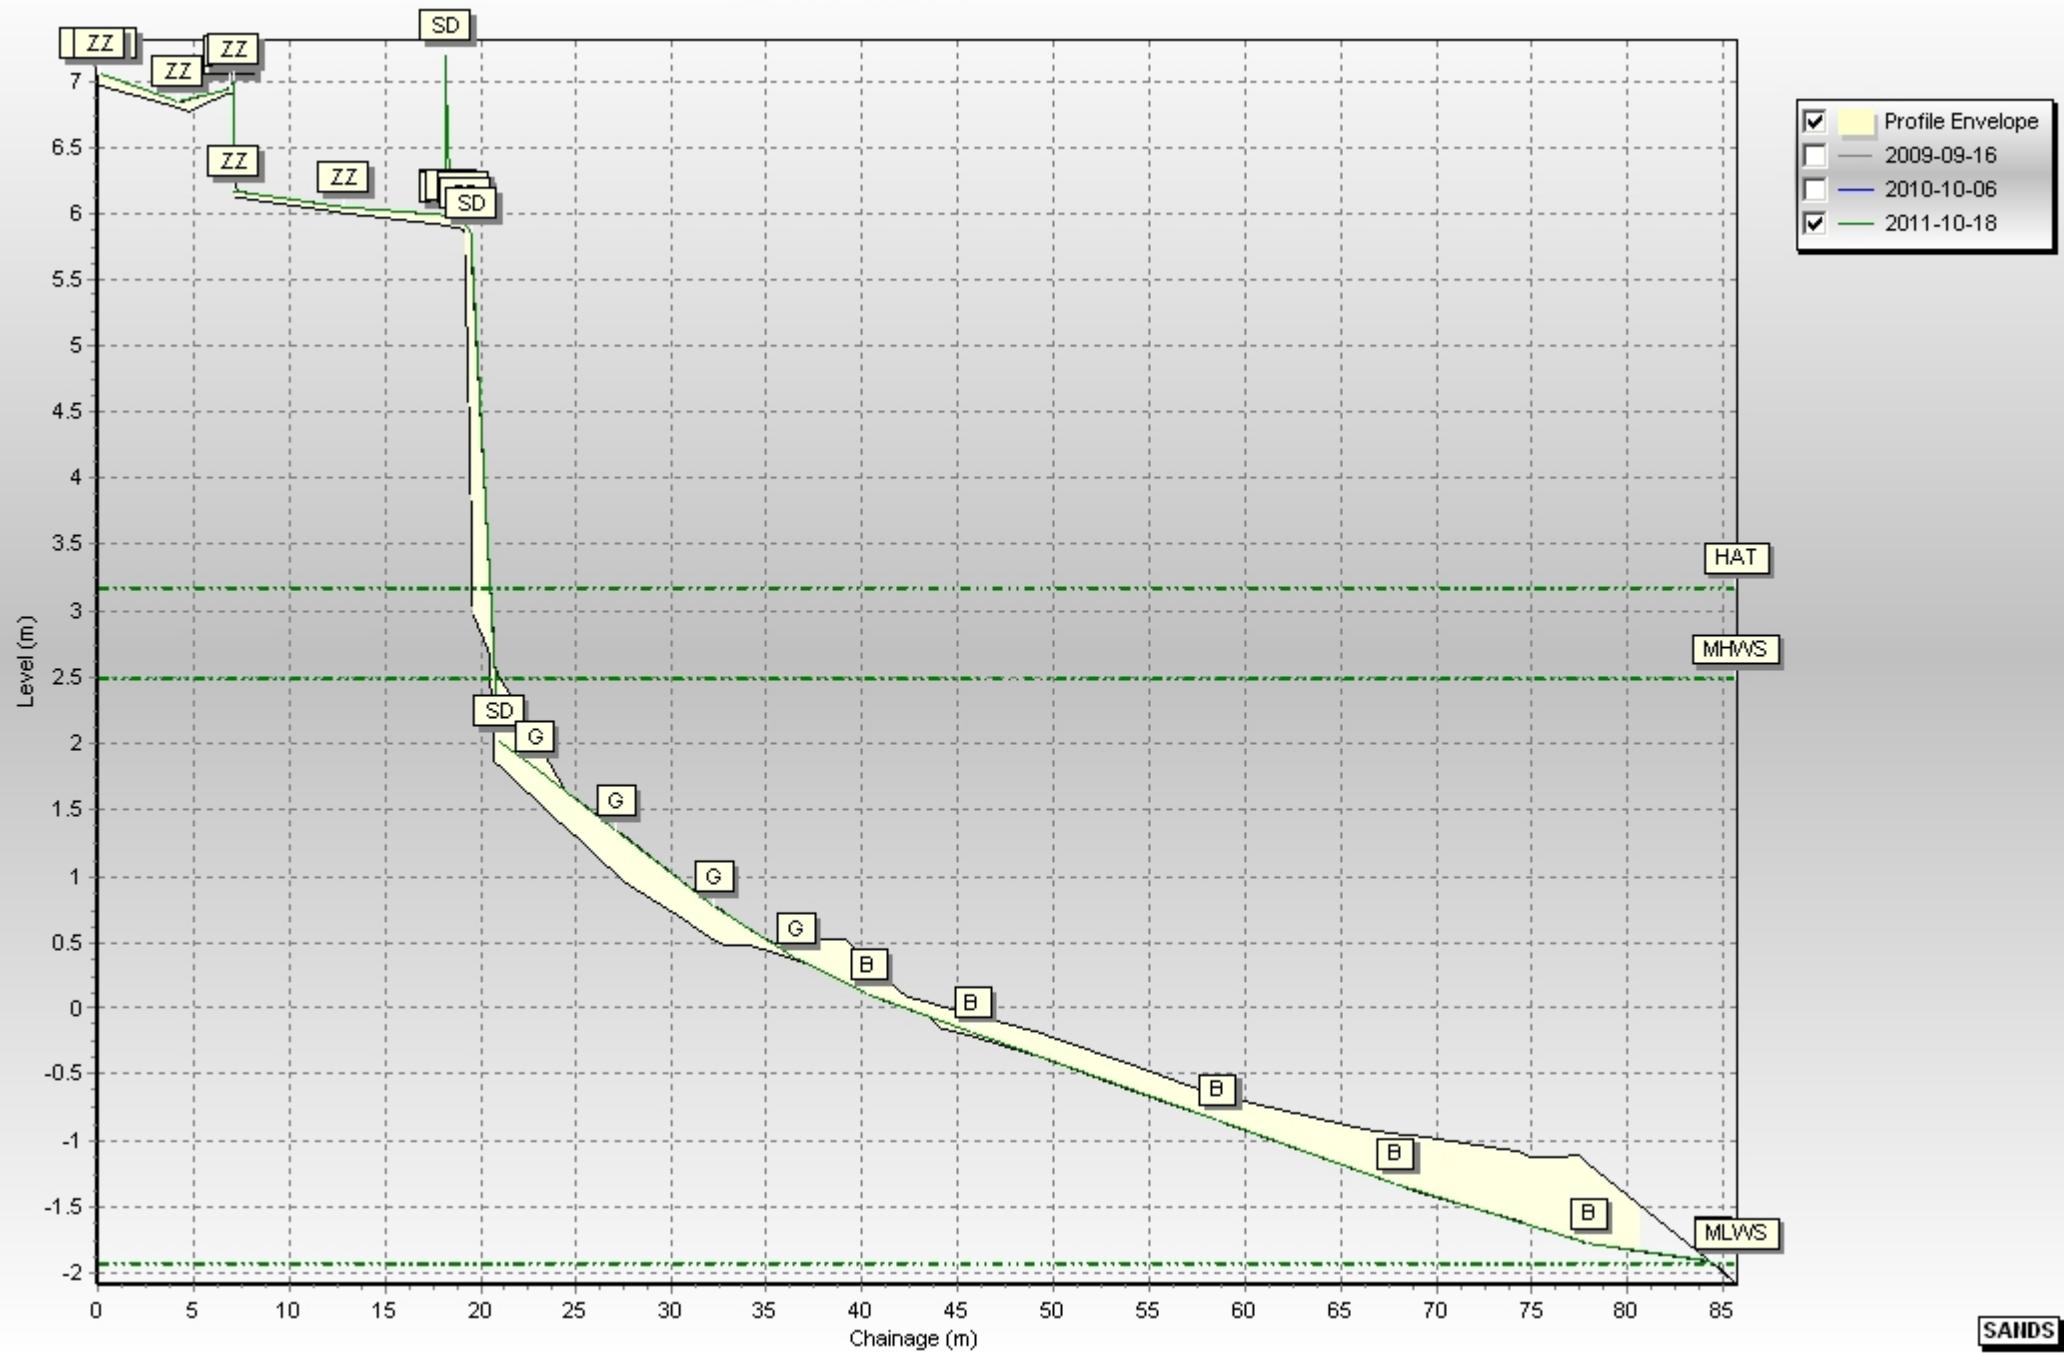
Beach Profiles: 1bSNS7

On profile 1bSNS7 an additional data point is showing on the full measures profile at a 20m chainage, which is likely to relate to survey technique rather than actual change.

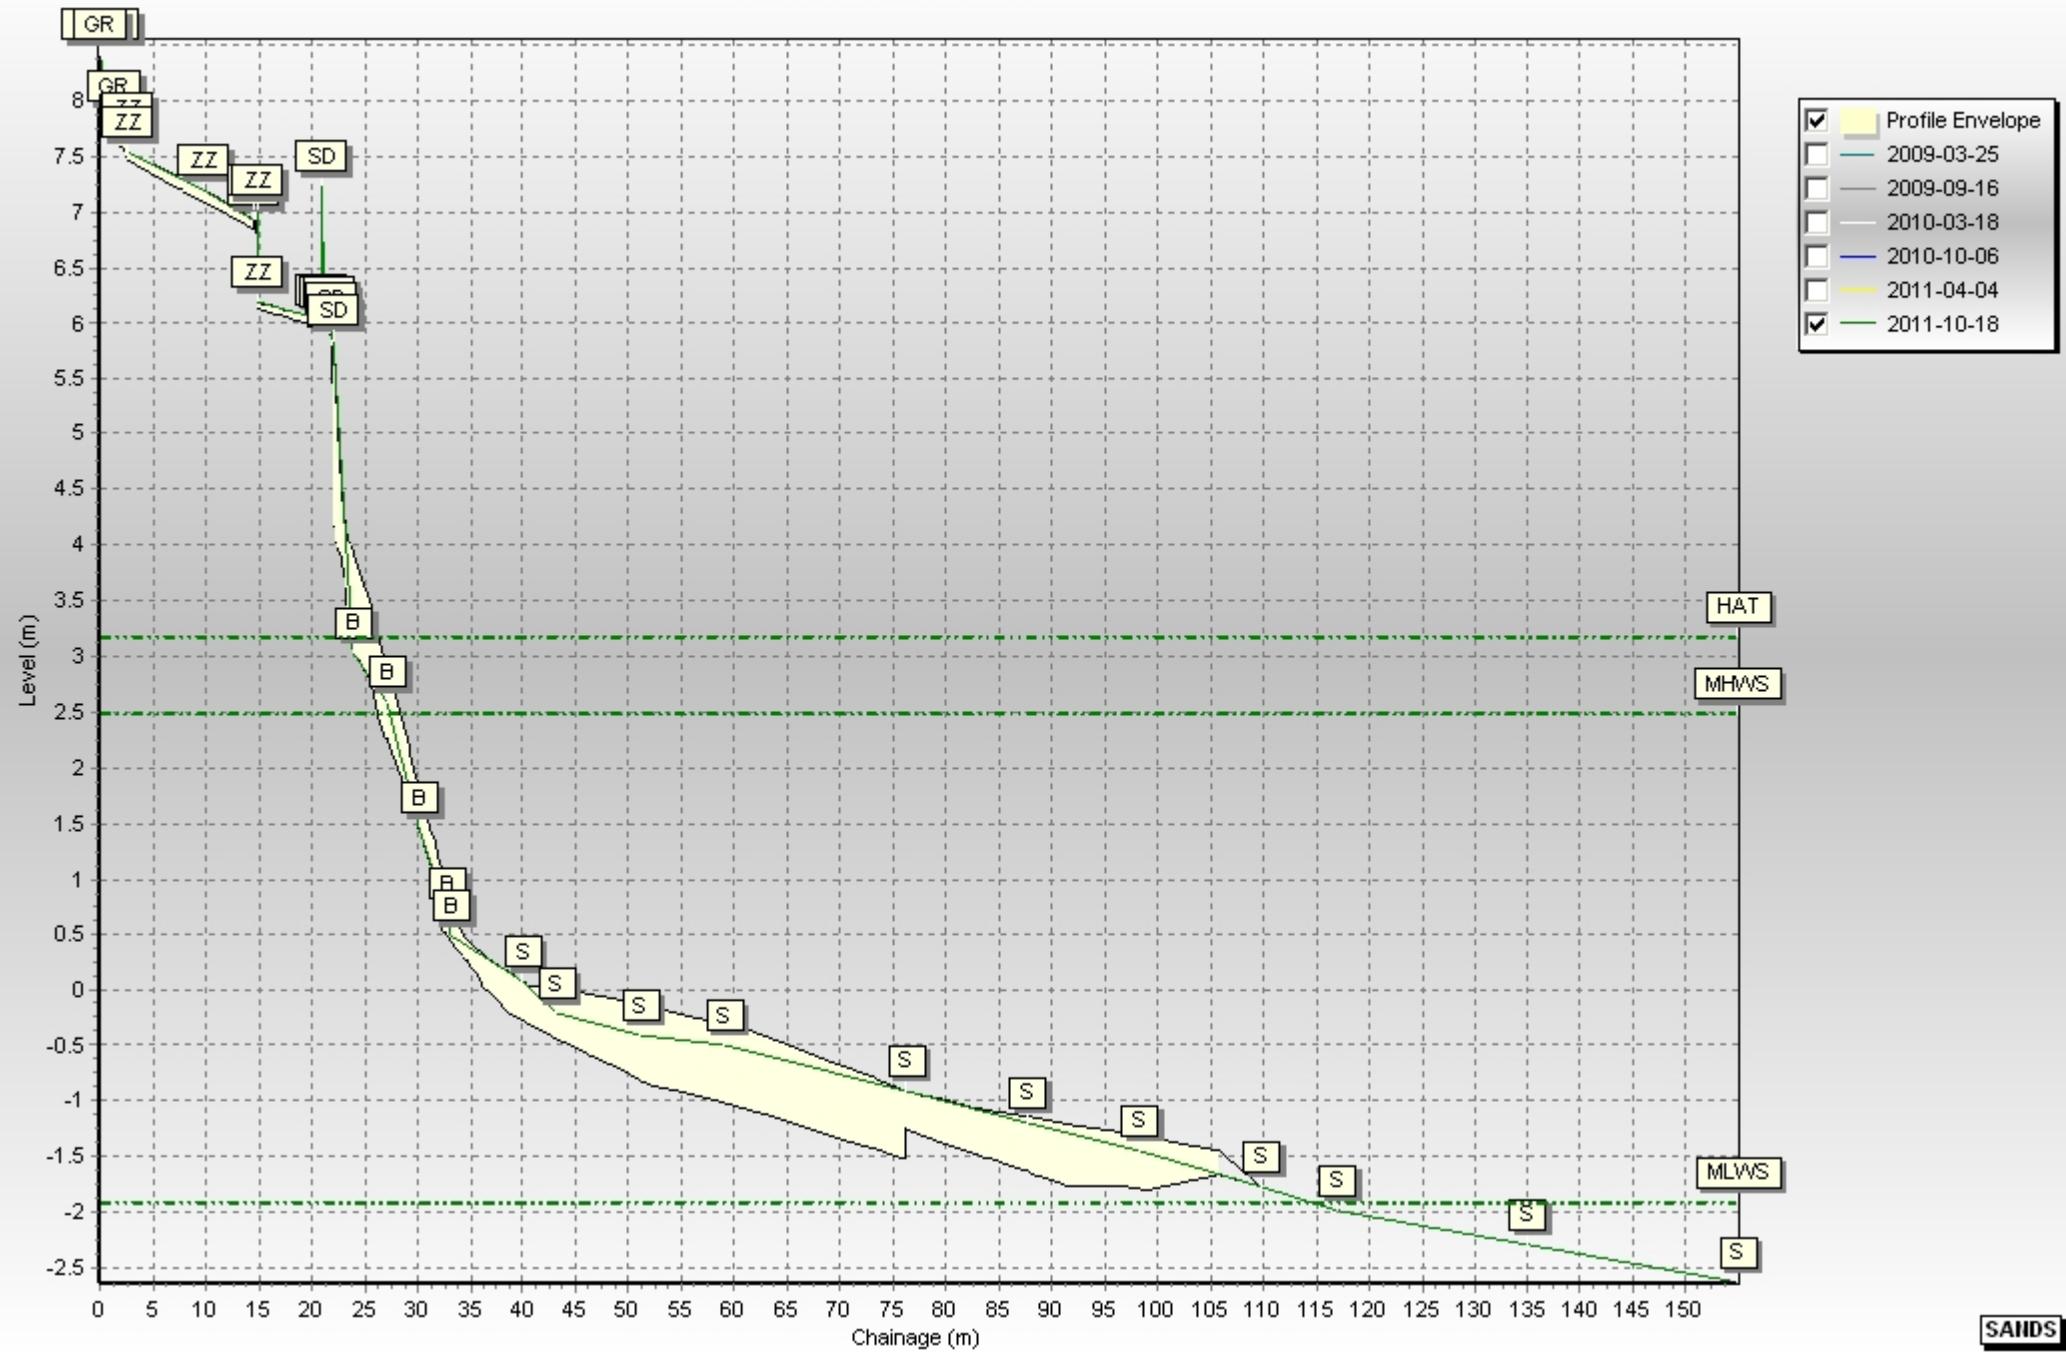
Beach Profiles: 1bSNS8

On profile 1bSNS8 an additional data point is showing on the full measures profile at a 25m chainage, which is likely to relate to survey technique rather than actual change.

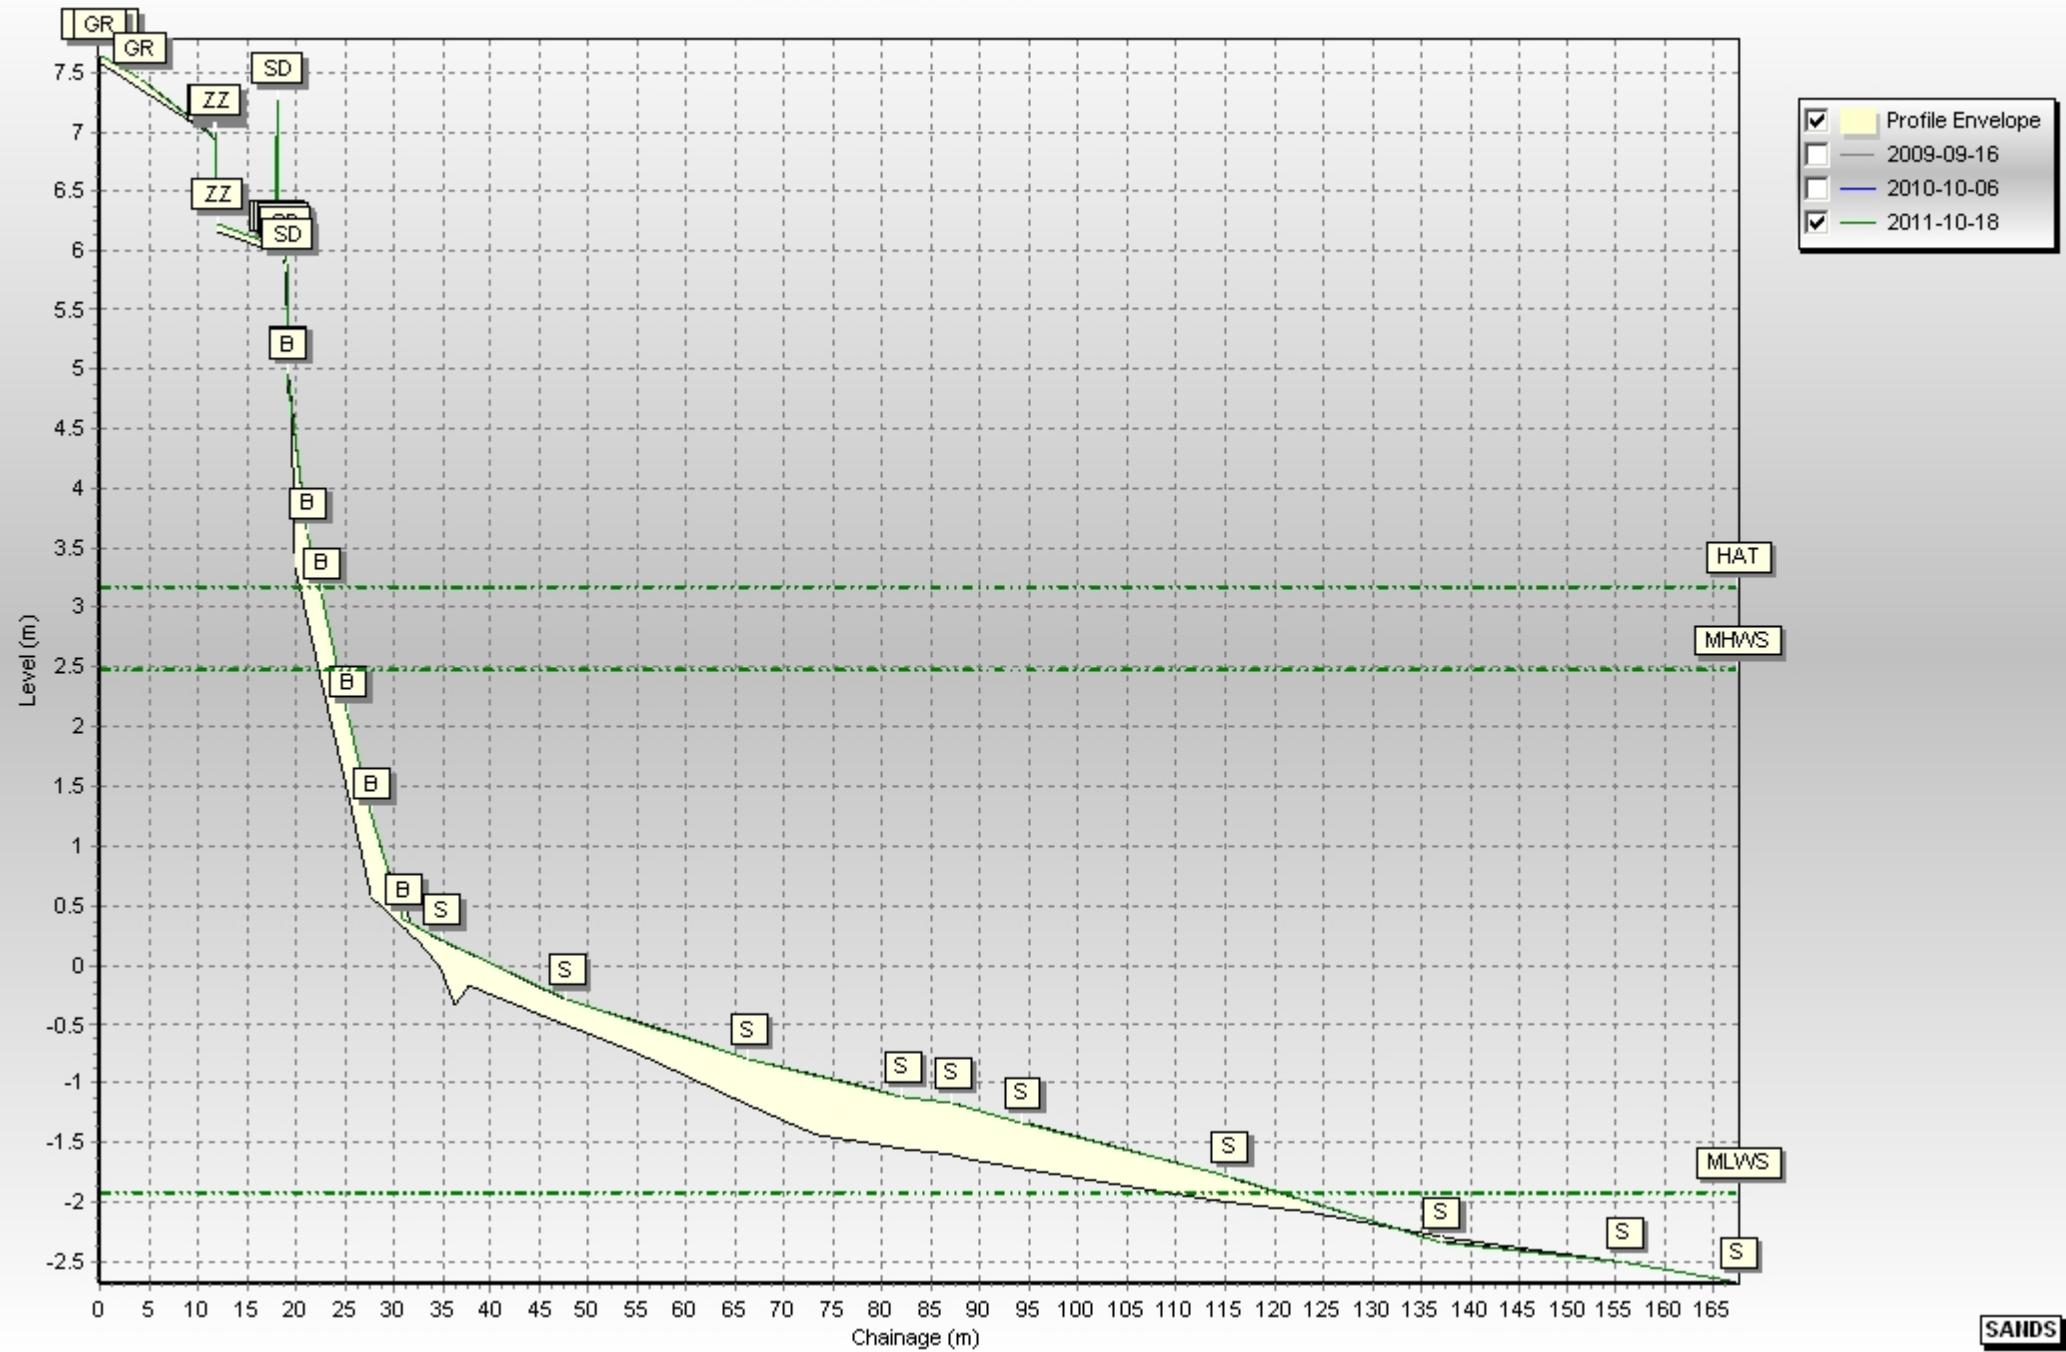
Beach Profiles: 1bSNS9

On profile 1bSNS9 an additional data point is showing on the full measures profile between a chainage of 20m to 25m, which is likely to relate to survey technique rather than actual change.

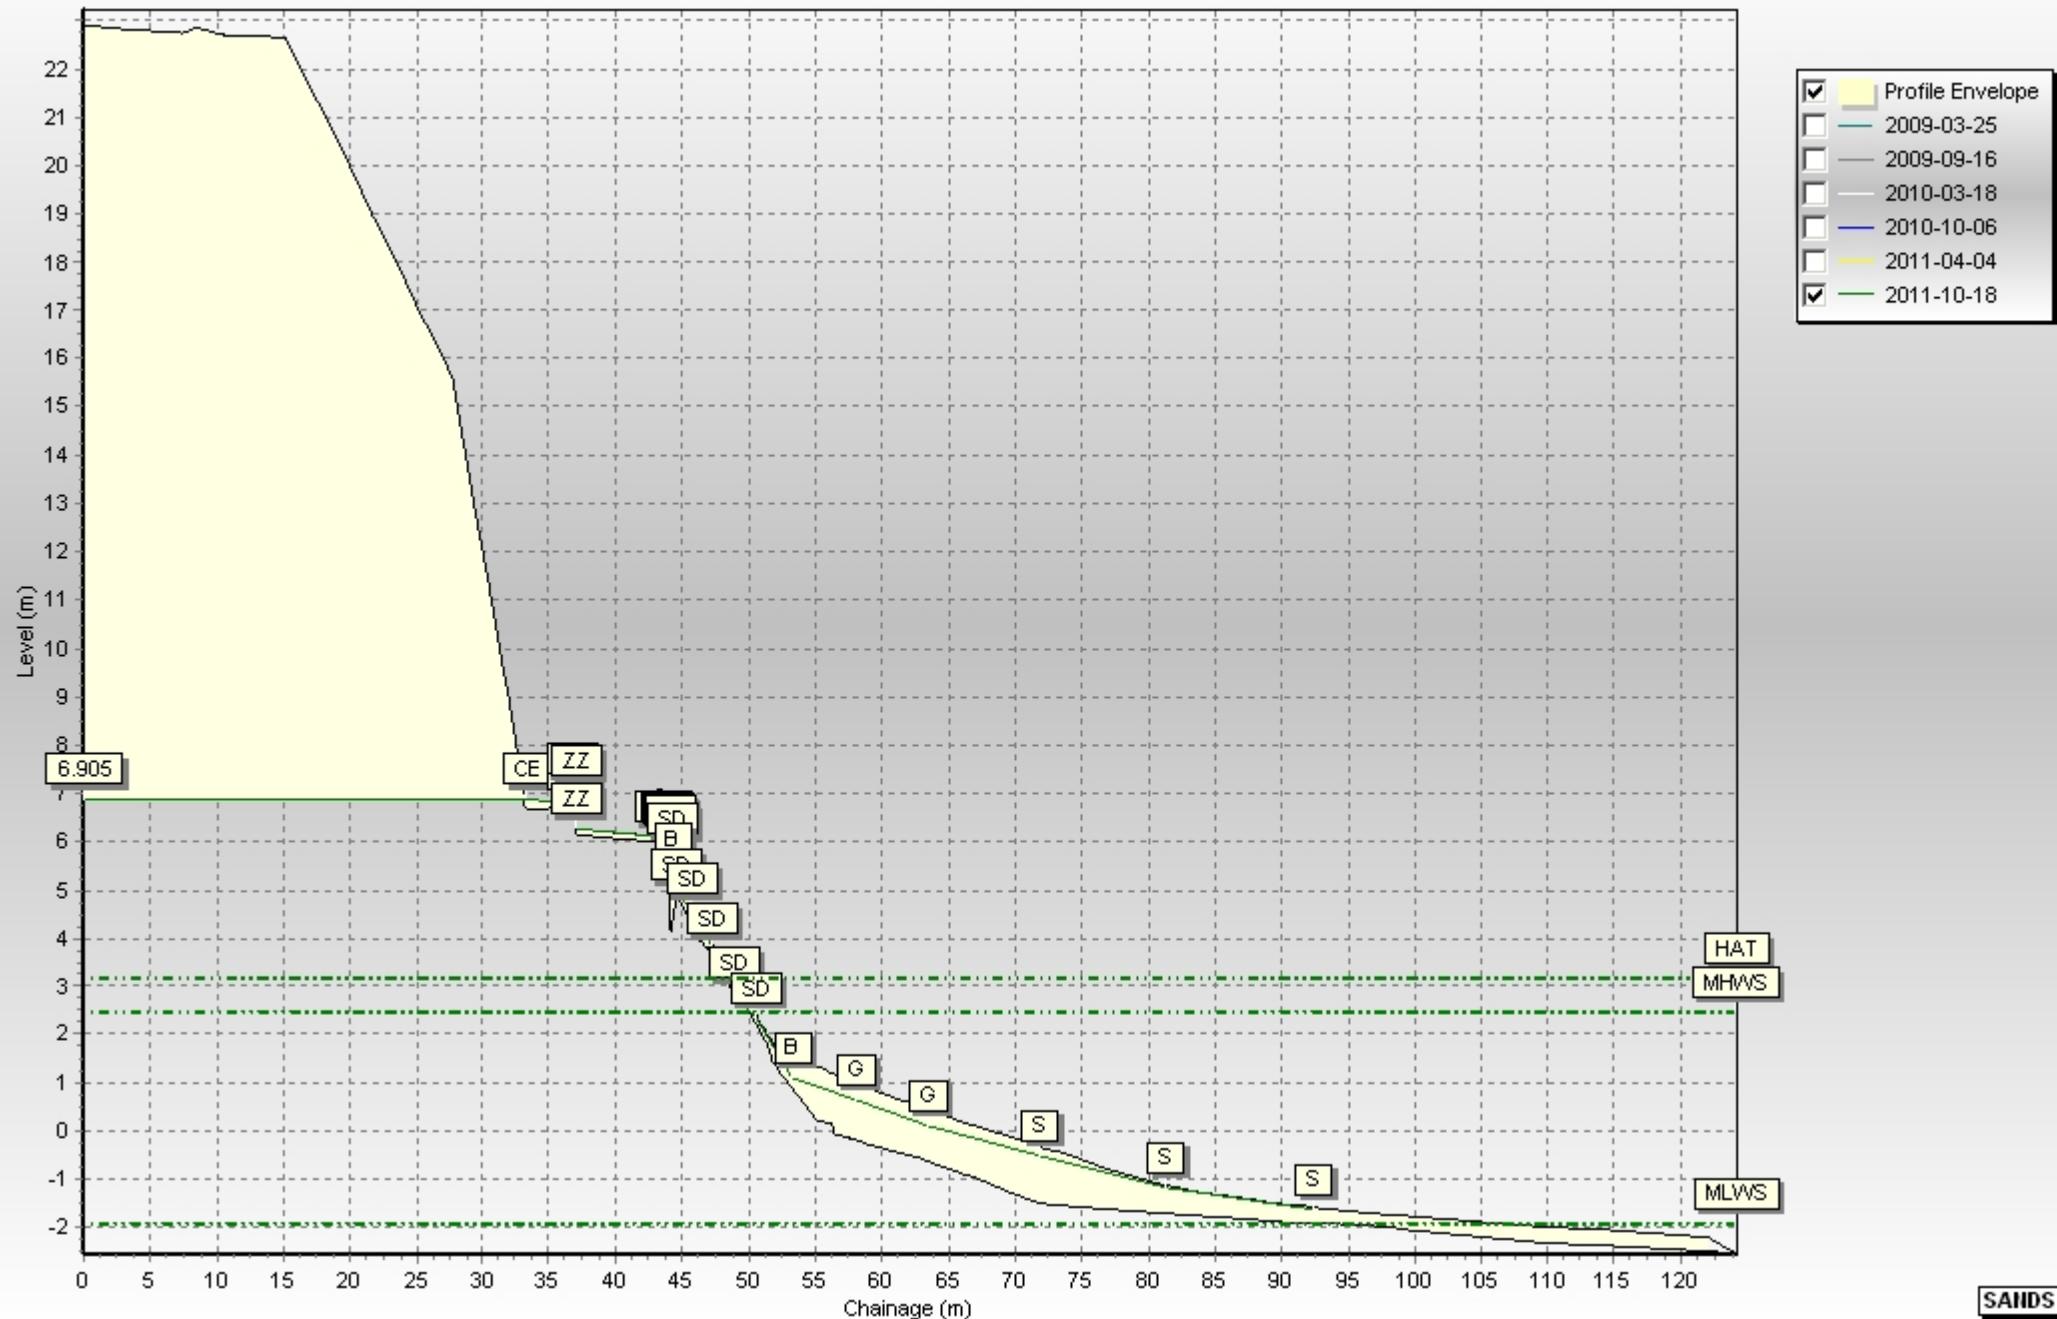
Beach Profiles: 1bSNS11

At profile 1bSNS11 the cliffs have not been surveyed and the profile starts from a height of 7m.

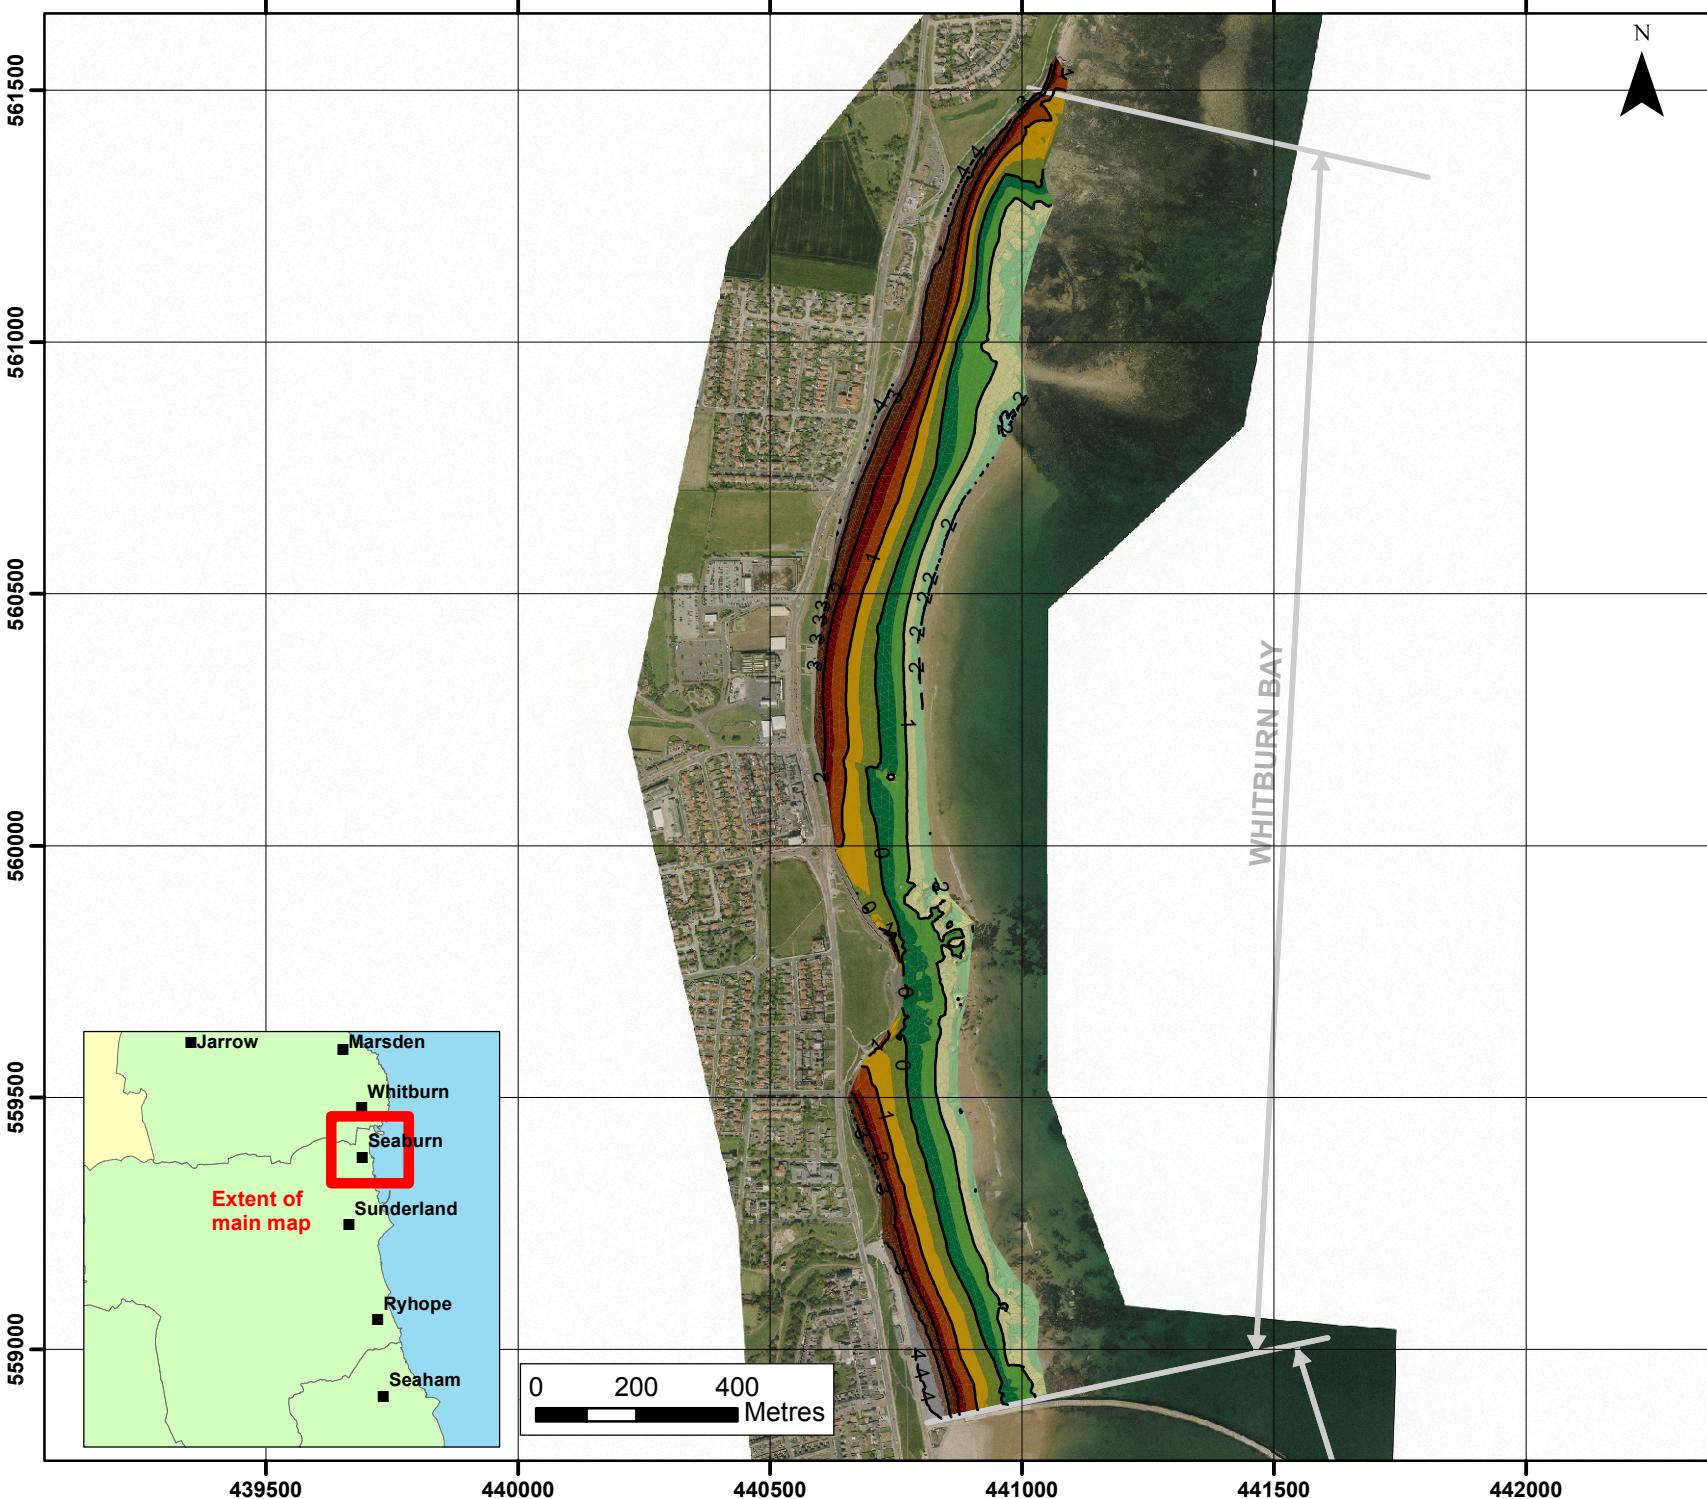
Topographic Survey

Oct 2011	<p>Topographic Survey:</p> <p>Whitburn Bay, between the Bents and Roker Pier, is covered by an annual topographic survey which commenced in September 2010.</p> <p>Data from the most recent topographic survey (full measures, winter 2011) have been used to create a DGM (Appendix B – Map 1a) using a Geographical Information System (GIS). A difference plot has also been produced using the DGM (Appendix B – Map 1b) produced from the last produced topographic survey (partial measures, spring 2011) and the present survey.</p> <p>The difference plot shows a general pattern of elevation increase across the beach. This increase is greatest along the backshore to the north of the Bay. Beach elevation has fallen on the middle and lower beach. This change is greatest to the north of the Bay in the lee of the rock platform, called Whitburn Steel where material is being drawn down from the beach and deposited on the rock shore platform.</p>

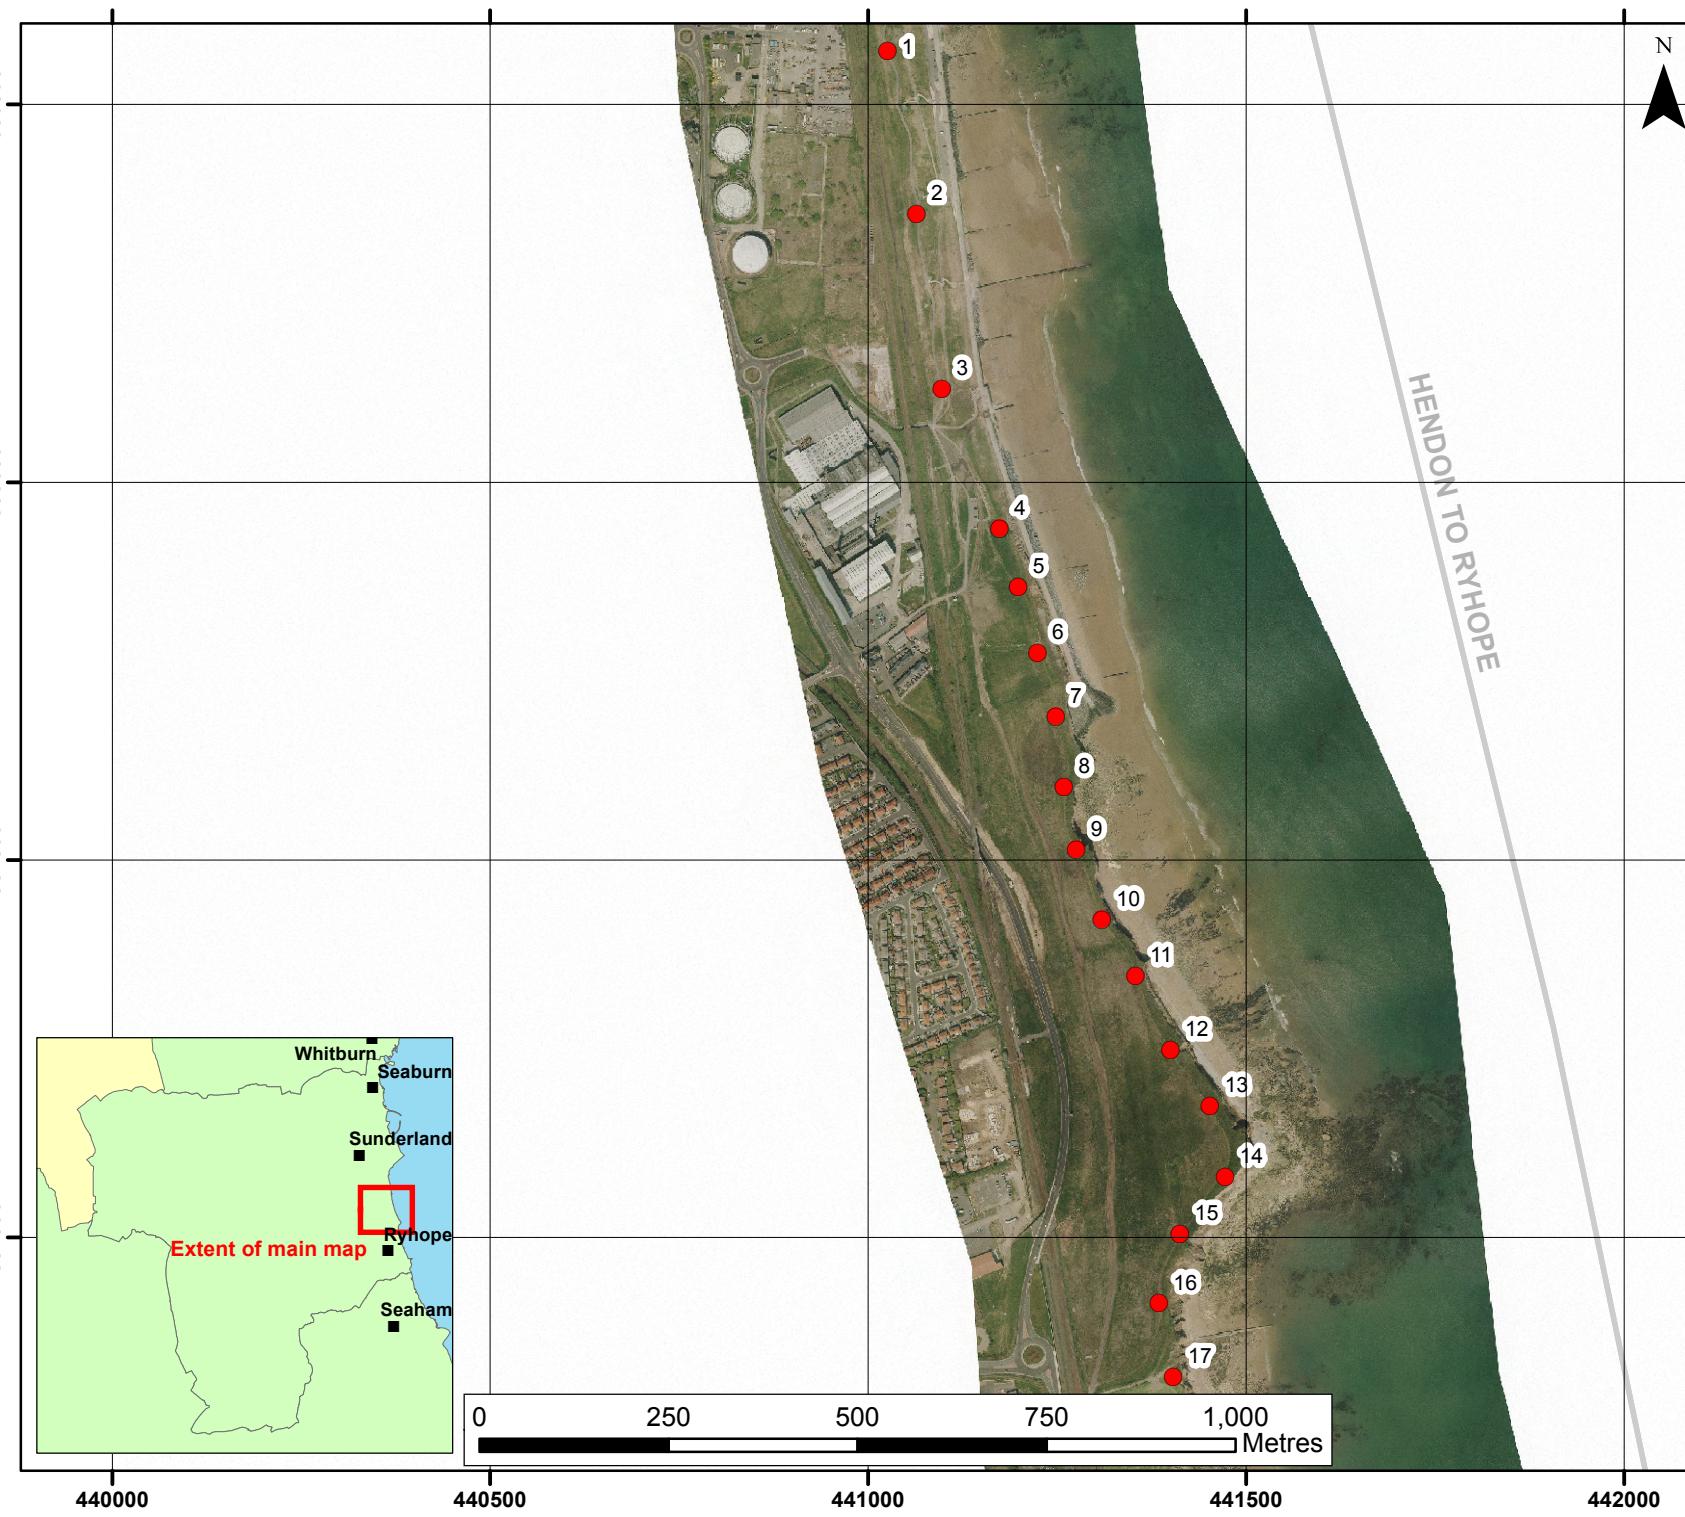
**Appendix C - Map 1
Ground Control Points
Hendon to Ryhope a
Sunderland City Council**

Thirty-two ground control points have been established between Hendon and Ryhope (Figure C1). The maximum separation between any two points varies along the coast, reflecting the degree of risk from the erosion.

The cliff top surveys between Hendon and Ryhope are undertaken bi-annually. Measurements are taken from a fixed ground control point along a fixed bearing to the edge of the cliff top.
