**Cell 1 Regional Coastal Monitoring Programme  
Analytical Report 5: 'Full Measures' Survey 2012**

**Sunderland City Council  
Final Report**

**March 2013**

(\*) The present report is **Analytical Report 5** and provides an analysis of the 2012 Full Measures survey for Sunderland City Council's frontage.

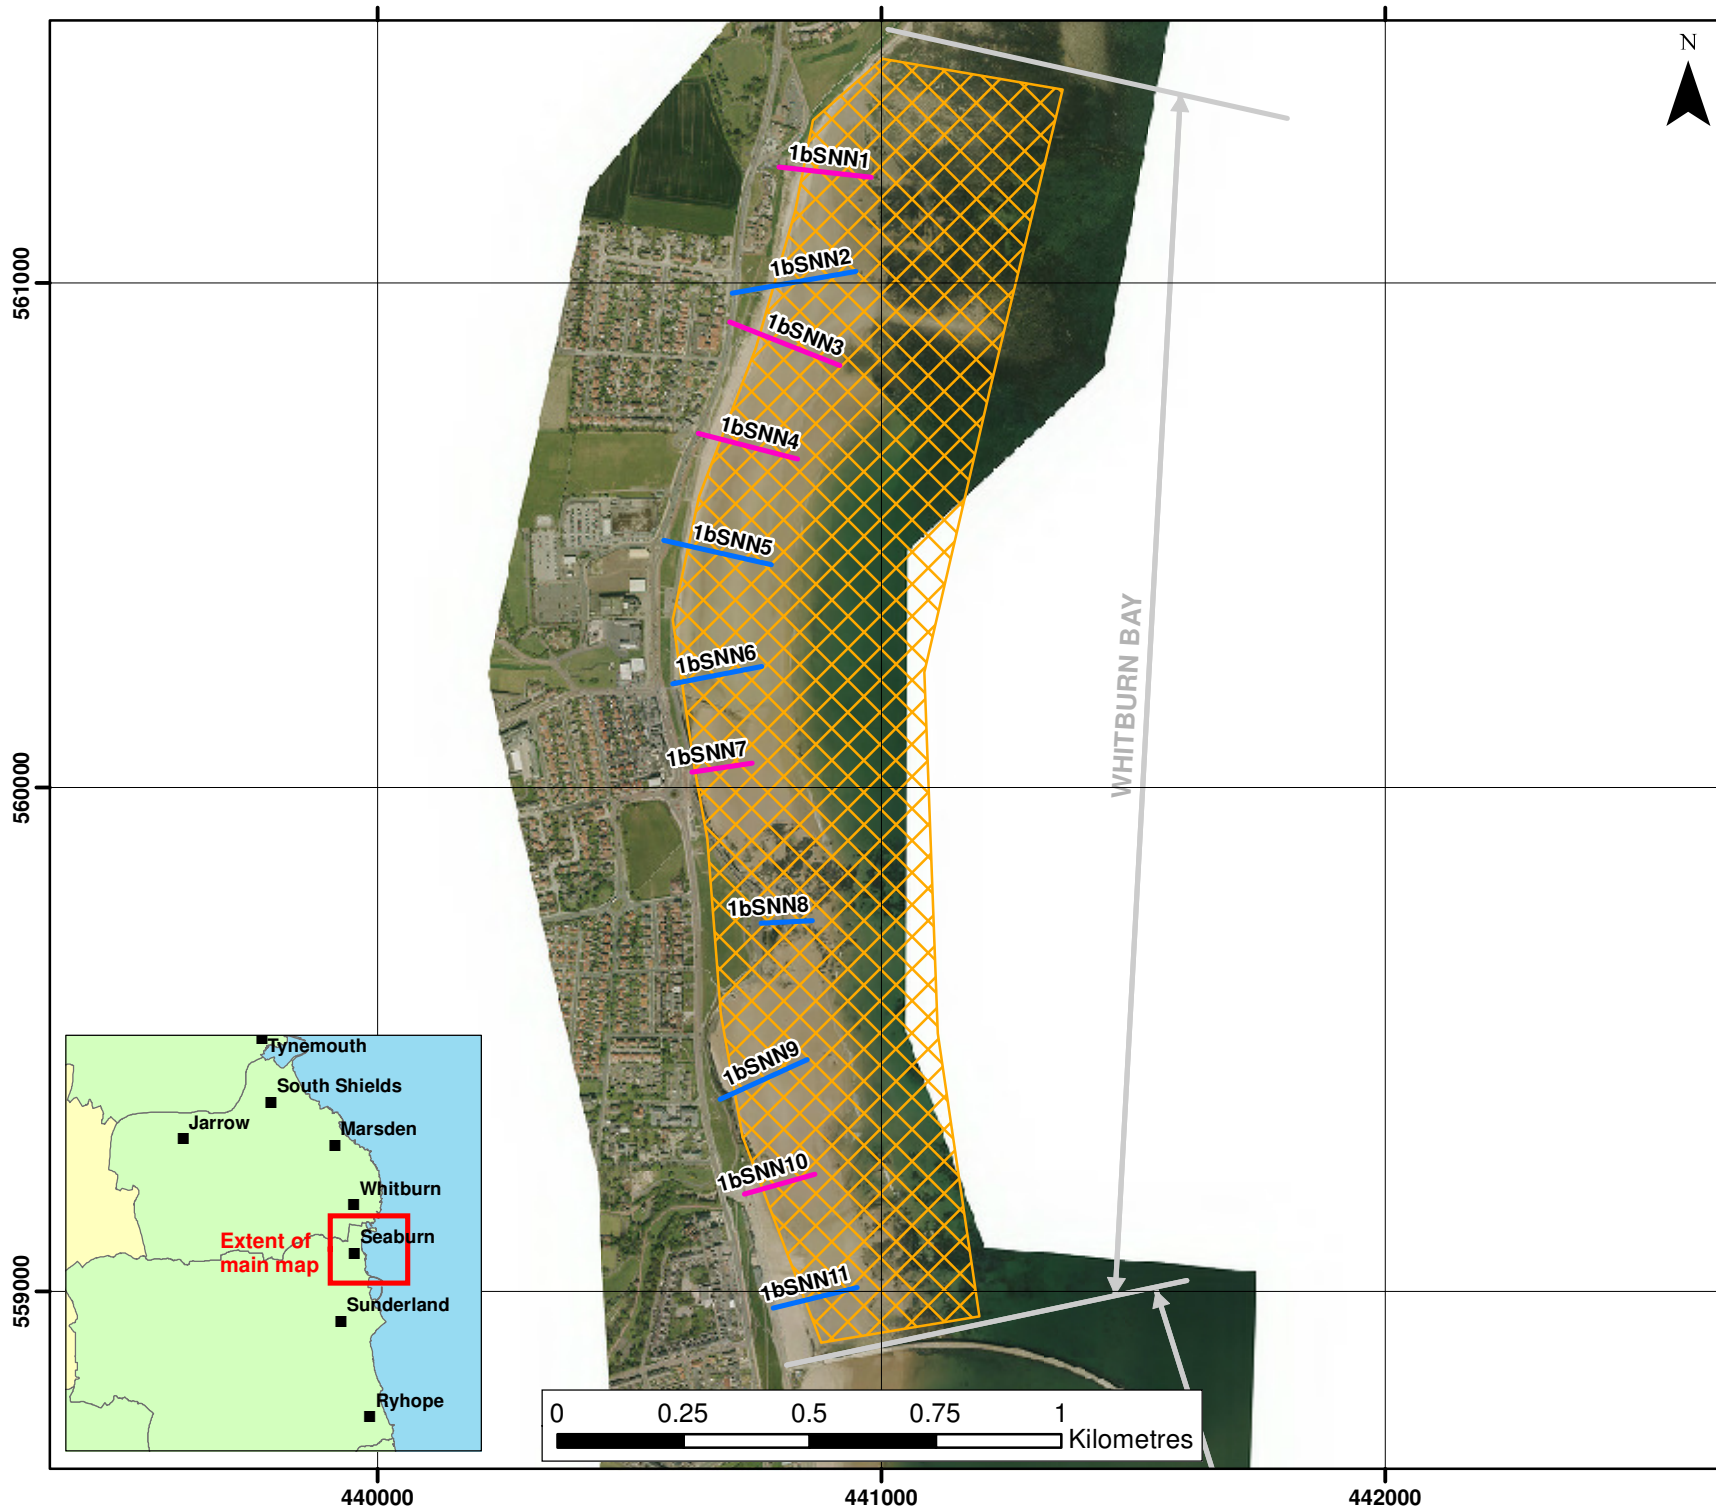
**Figure 2- Map 1  
Survey Locations  
Whitburn Bay  
Sunderland City Council**

The location of these surveys is shown in Figure 2. The Full Measures survey was undertaken along this frontage between 3<sup>rd</sup> and 7<sup>th</sup> September 2012, 18<sup>th</sup> September 2012, and 3<sup>rd</sup> and 4<sup>h</sup> October 2012. During this time weather conditions varied considerably; refer to the survey reports for details of the weather conditions over this survey period.

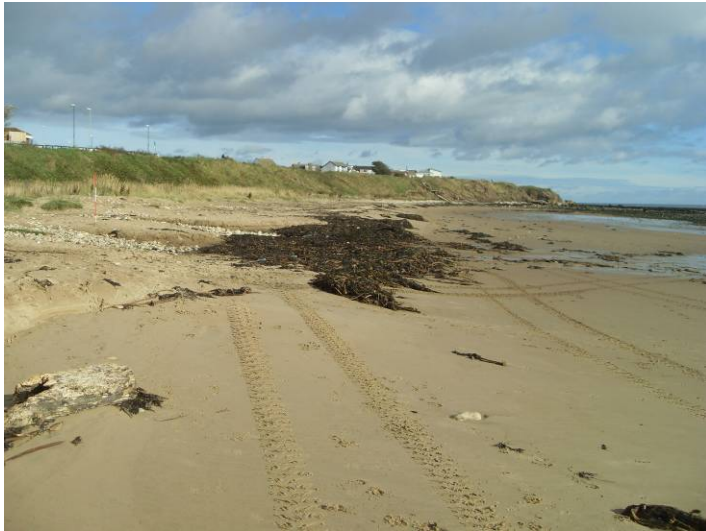
Plate 1 – Survey photograph 1bSNN1\_20121004\_N4.jpg (FM 2012)

Survey Date	Description of Changes Since Last Survey	Interpretation
	<p>approximately 0.2m, and seaward of a chainage of 210. However, across the majority of the frontage, beach levels have fallen by approximately 0.2m. At profile <b>1bSNN6</b>, beach levels have fallen quite significantly across the centre profile; by up to 2m at the revetment steps and between 0.2-0.4m across the beach profile. The result is the exposure of 5 of the access steps (as shown by the survey photographs in Plates 3 and 4) and the presence of a channel (see Plates 5 and 6), carved by the outflow of water from the storm water outfall adjacent to the access steps. This is evidence of both storm conditions (resulting in beach lowering) and high surface water flows from heavy rainfall.</p> <p><b>1bSNN7</b> is at Seaburn, just to the north of Parson's Rock. From the toe of the seawall to a chainage of 40m, beach levels have increased by approximately 0.3m since the last survey (partial measures, spring 2012). Seaward of there, they have decreased across the profile by up to 0.3m, however, the beach has retained the same form and slope.</p> <p>Profile <b>1bSNN8</b> extends across Parsons Rock. Beach levels at the toe of the seawall have decreased to expose the rocks below. This is a return to the beach levels observed in September 2010 (full measures, autumn 2010). Seaward of there, there is little discernible change.</p> <p>Profile <b>1bSNN9</b> drops from the cliff top to the foreshore at Roker. Beach levels have decreased across the majority of the profile by approximately 0.2m.</p> <p><b>1bSNN10</b> is located approximately mid-way between Parson's Rock and Roker Pier. Since the last survey (partial measures, spring 2012), between a chainage of 35m and 70m, beach levels have fallen by approximately 0.2m. As observed from the survey photographs for this profile (see Plates 7 and 8), at the foot of the access ramp and between the seawall, the amount of sand accumulated there has decreased. The sand is wet and there is a large amount of seaweed. This suggests that higher water levels have reached the seawall in response to storm conditions, thus preventing the sand from drying out and being blown inshore as observed in the previous survey.</p> <p><b>1bSNN11</b> is located to the south of Whitburn. Beach levels have decreased across the profile in the region of 0.5m to from a lower beach with a more concave profile.</p>

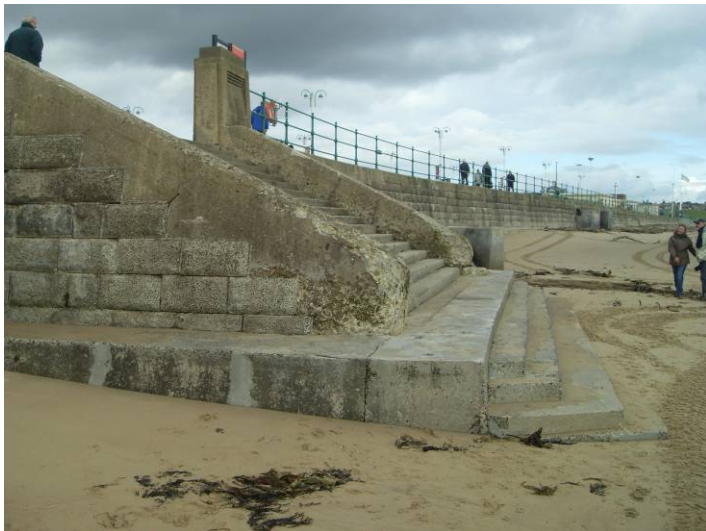
Plate 3 – Survey photograph 1bSNN6\_20121004\_N1.jpg (FM 2012)

At profile 1bSNN6, beach levels have fallen quite significantly across the centre profile; by up to 2m at the revetment steps and between 0.2-0.4m across the beach profile. The result is the exposure of five of the access steps and erosion of a channel by water flowing from the storm water outfall adjacent to the access steps. This is evidence of both storm conditions (resulting in beach lowering) and high surface water flows from heavy rainfall.

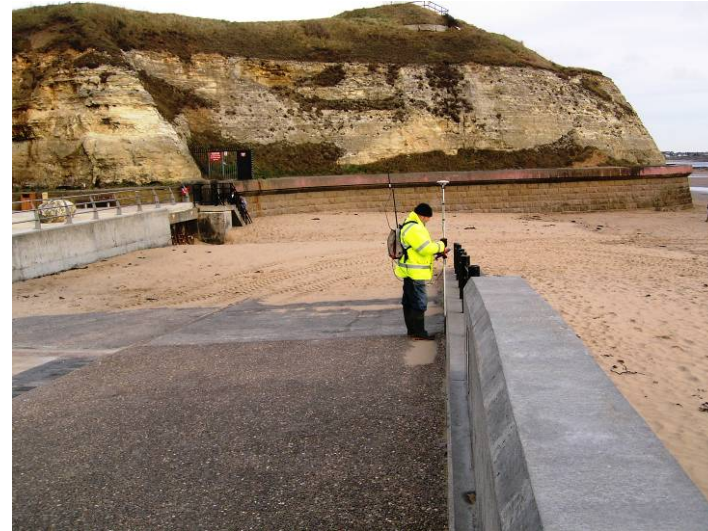
**Plate 8 – Survey photograph 1bSNN10\_20120320\_N1.JPG (PM 2012)**

1bSNN10 is located approximately mid-way between Parson's Rock and Roker Pier. Since the last survey (partial measures, spring 2012), between a chainage of 35m and 70m, beach levels have fallen by approximately 0.2m. As observed from the survey photographs for this profile, at the foot of the access ramp and between the seawall, the amount of sand accumulated there has decreased. The sand is wet and there is a large amount of seaweed. This suggests that higher water levels have reached the seawall in response to storm conditions, thus preventing the sand from drying out and being blown inshore as observed in the previous survey.

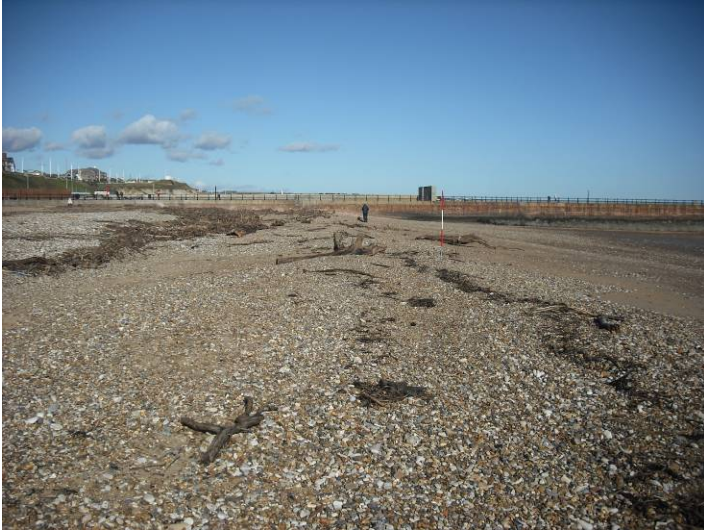
Plate 9 – Survey photograph 1bSNN12\_20121004\_N6.JPG (FM 2012)

Survey Date	Description of Changes Since Last Survey	Interpretation
	<p>the survey photographs (see Plates 11 and 12) shows the placement of new rock adjacent to the seawall and on the backshore. A review of the survey photograph for two years ago in 2010 (full measures, autumn 2010), shows the rock to be present. It was noted in the previous survey report (full measures, autumn 2011), <i>'the change in profile from 2010 to 2011 suggested that beach levels have increased by over 1.5m and it is possible that this is due to survey error.'</i> Therefore, the particularly high levels observed in autumn 2011 are likely to be associated with the removal of the rock and possibly beach management that occurred at that time. At profile <b>1bSNC5</b>, beach levels have decreased by approximately 0.2m across the profile. <b>1bSNC6</b> extends across the revetment and seawall. A small veneer of sand covers the rock at the toe of the coastal defences. Beach levels have increased by over 1m along the length of this profile, covering the underlying boulders with a veneer of sand and shingle closer towards MLWS.</p> <p><b>1bSNC7 to 1bSNC9</b> are within the shelter of North East Pier and South West Breakwater. <b>1bSNC7</b> is a section across North East Pier and shows the terraced nature of the landward face of the pier wall, extending across rock to the small sheltered bay between the two structures. For this reason, profile 1bSNC7 has not been analysed. Profile <b>1bSNC8</b> crosses the boulders and rubble, which reaches a level of around 6.2mODN, and then extends across the sandy but boulder strewn foreshore. Beach levels on the foreshore between a chainage of 30m and 70m have increased by up to 0.2m. Profile <b>1bSNC9</b> extends from the dock facilities and crosses a short length of concrete wall before extending across the sand foreshore to reach and cross a large boulder mound that is towards the seaward end of the south west breakwater. There is little discernible change in beach levels.</p>	<p>locations, they have decreased. This could potentially reflect the transfer of material from one profile to another.</p> <p><b>Longer term trends:</b> The beaches within the breakwaters are showing signs of the most extreme change observed to date. The changes that have occurred since the last survey are particularly significant, and suggest that the beach has responded to particularly strong storm conditions. This is notable at: (i) profile 1bSNN13, where beach levels at the toe of the revetment are the lowest observed to date (by a margin of 0.8m, the second lowest observed in September 2009 (full measures survey, autumn 2009); and (ii) profile 1bSNC2, where beach levels at the toe of the pier are the highest observed to date and seaward of a chainage of 100m, the lowest observed to date.</p> <p>To the centre and south of Sunderland Harbour and Docks, although changes observed, the beaches are in generally of similar form and position to those profiles observed in the past. To note is 1bSNC4 (as described above).</p>

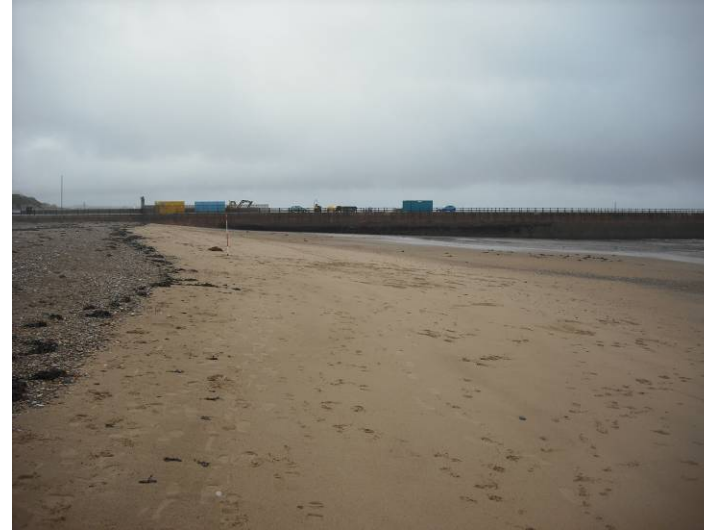
Plate 10 – Survey photograph 1bSNN12\_20111013\_N5.JPG (PM, 2011)

At 1bSNN13 beach levels at the toe of the revetment have dropped significantly, by as much as 1.5m, exposing a collection of cobbles/ boulders. Seaward of a chainage of 52m, beach levels have increased by 0.2m. It is likely that during storm conditions, beach material has been scoured from in front of the revetment and drawn-down the beach and deposited on the lower shore.

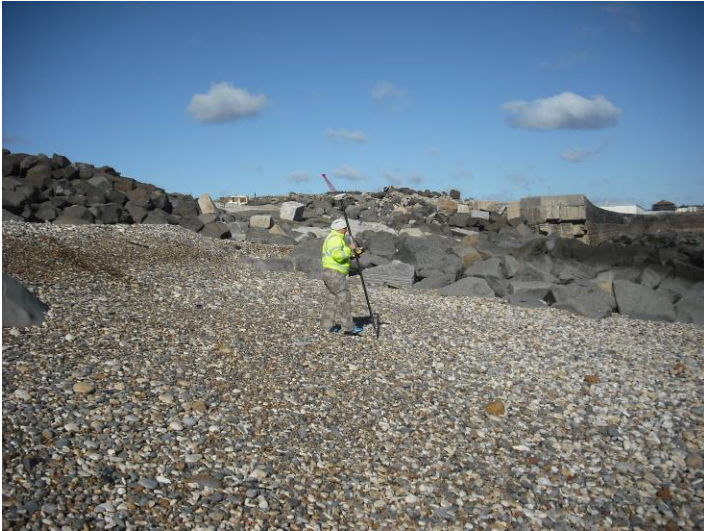
Plate 11 – Survey photograph 1bSNC4\_20120918\_N1.JPG (FM 2012)

At profile 1bSNC4, beach levels have reduced by approximately 2m across the length of the profile and a change from a mainly sandy beach to one comprised of shingle. Review of the survey photographs shows the placement of new rock adjacent to the seawall and on the backshore. A review of the survey photograph for two years ago in 2010 (full measures, autumn 2010), shows the rock to be present. It was noted in the previous survey report (full measures, autumn 2011), *'the change in profile from 2010 to 2011 suggested that beach levels have increased by over 1.5m and it is possible that this is due to survey error.'* Therefore, the particularly high levels observed in autumn 2011 are likely to be associated with the removal of the rock and possibly beach management that occurred at that time.

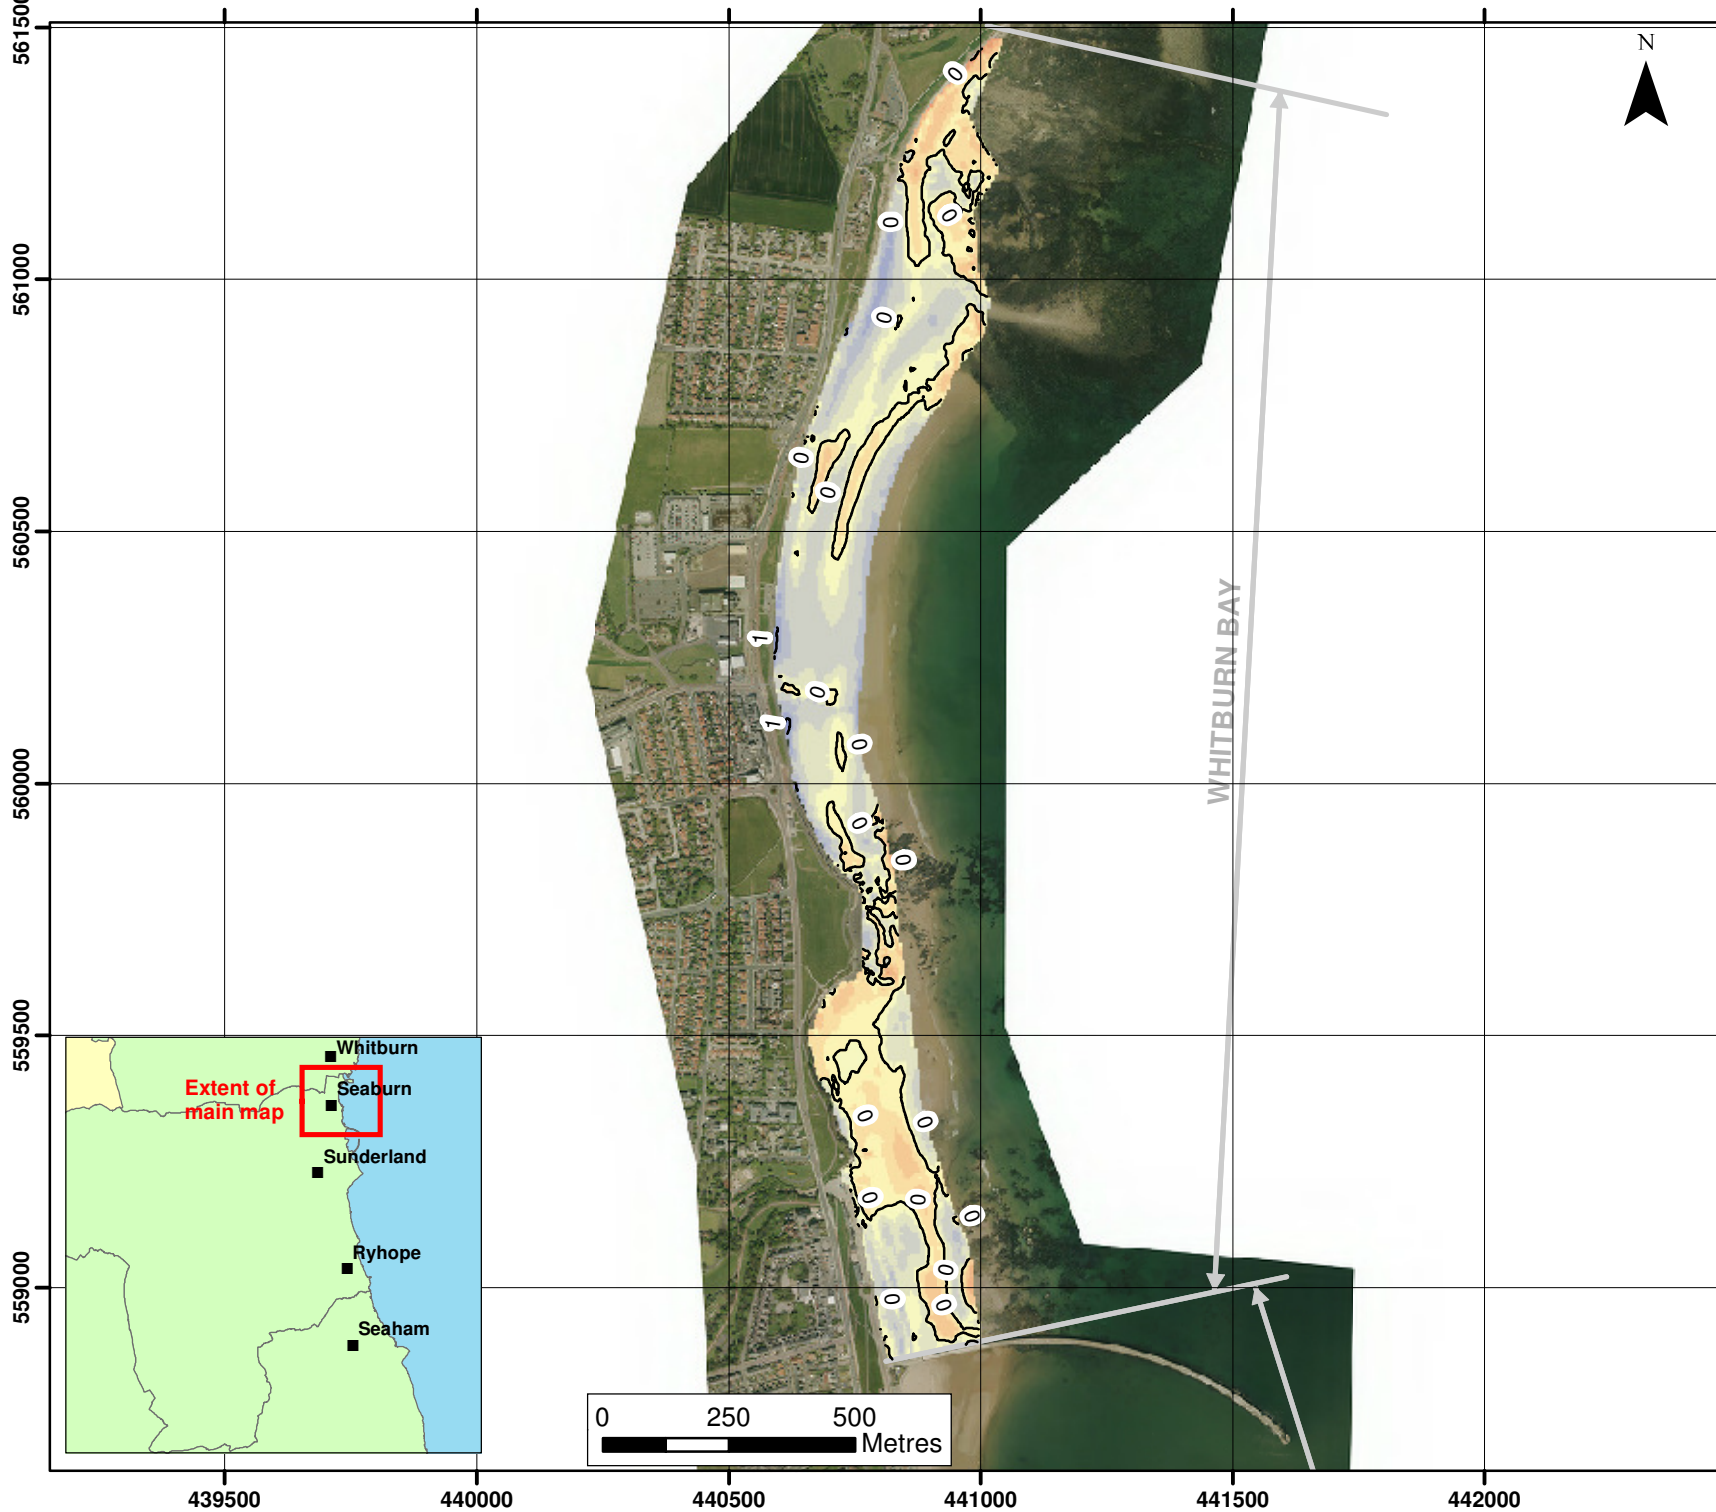
**Appendix B- Map 1c**  
**Long-term**  
**Elevation change**  
**Whitburn Bay**  
**Sunderland City Council**

Survey Date	Description of Changes Since Last Survey	Interpretation
Oct 2012	<p><b>Topographic Survey:</b></p> <p>Whitburn Bay, between the Bents and Roker Pier, is covered by an annual topographic survey which commenced in September 2009.</p> <p>Data from the most recent topographic survey (full measures, autumn 2012) have been used to create a digital ground model (DGM) (Appendix B – Map 1a) using a Geographical Information System (GIS). A difference plot has also been produced using the DGM (Appendix B – Map 1b) produced from the last produced topographic survey (full measures, autumn 2011) and the present survey.</p> <p>The difference plot showing changes occurring in beach elevation since the last survey, shows a mixture of beach elevation increase and decrease across the beach. Overall, there is reduction in beach levels generally across the middle of the beach along the length of this frontage, with beach elevation increase along the back of the beach and the lower shore. There is also a notable increase in beach elevation to the north, in the lee of Whitburn Steel Rocks.</p> <p><b>Long Term Topographic Trends Autumn 2010 to Autumn 2012:</b></p> <p>The long term difference plot (Appendix B – Map 1c) shows the net change in beach levels between autumn 2010 and autumn 2012. The plot shows an increase in beach levels along Whitburn Sands, from Whitburn Steel to Parsons Rock. Beach levels have fallen immediately to the north of Whitburn Steel and on the middle beach between Parsons Rocks and Roker Park. Between Roker park and Roker Pier, beach elevation has predominantly increased.</p>	<p>The topographic survey shows that since the last survey, there has been a mixture of beach elevation increase and decrease across the beach. Overall, there is reduction in beach levels generally across the middle of the beach along the length of this frontage, with beach elevation increase along the back of the beach and the lower shore. There is a notable increase in beach elevation to the north, in the lee of Whitburn Steel Rocks, where the protective function of the offshore rocks provides shelter from incoming waves encouraging accretion.</p> <p><b>Longer term trends:</b> The longer term trends are covered by the long term topographic trends autumn 2009 to autumn 2012 (see below).</p> <p><b>Long term topographic trends Autumn 2009 to Autumn 2012:</b> The plot shows an increase in beach levels along Whitburn Sands, from Whitburn Steel to Parsons Rock. As noted in the previous full measures report (autumn 2011), it is likely that material is being removed from the beach to the north and deposited in the lee of Whitburn Steel, where it is more sheltered. To the south, beach levels along Whitburn Sands, from Whitburn Steel to Parsons Rock have increased. Further south, between Parsons Rocks and Roker Park, there is a trend of beach elevation reduction, however, between Roker park and Roker Pier, beach levels have predominantly increased. This is due to the shelter provided by the pier.</p>
