**Cell 1 Regional Coastal Monitoring Programme
Analytical Report 6: 'Full Measures' Survey 2013**

**Sunderland City Council
Final Report**

February 2014

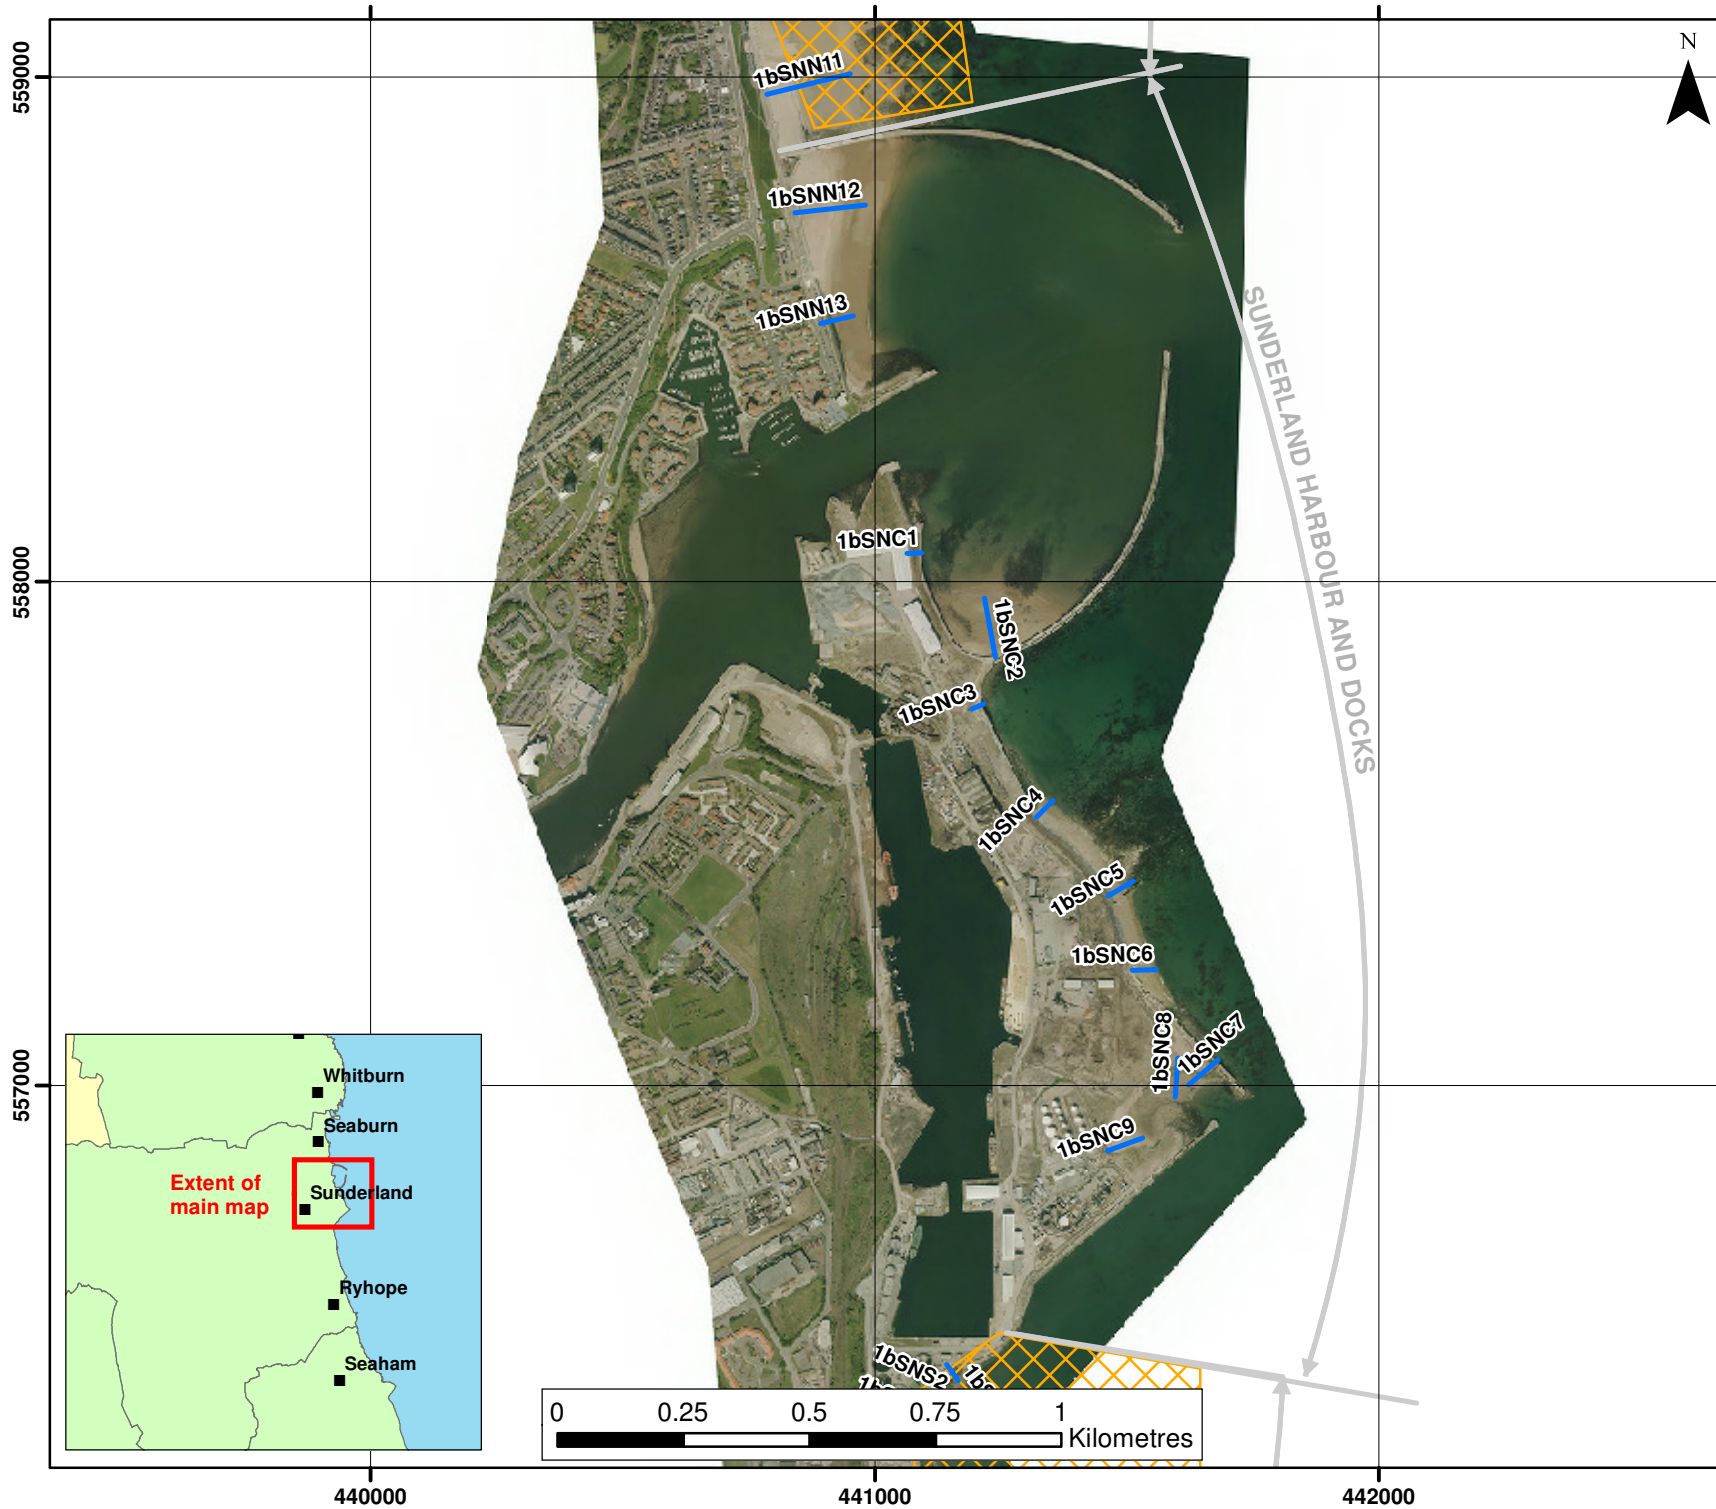
**Figure 2- Map 1
 Survey Locations
 Whitburn Bay
 Sunderland City Council**

The location of these surveys is shown in Figure 2. The Full Measures survey was undertaken along this frontage between 2nd and 11th September 2013, and 3rd and 4^h October 2013. During this time weather conditions varied considerably; refer to the survey reports for details of the weather conditions over this survey period.

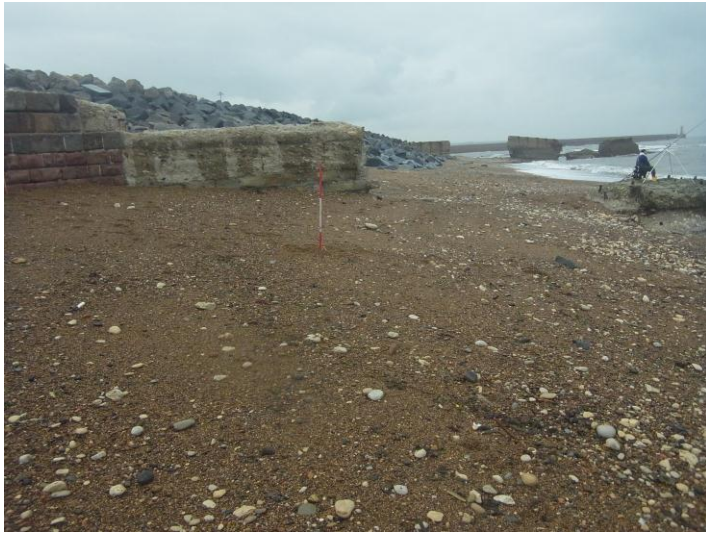
Plate 8 – Survey photograph 1bSNC6_20130911_N4.JPG (FM 2013)

| Survey Date | Description of Changes Since Last Survey | Interpretation |
|---|--|---|
| | <p>level decreasing more at the toe (by up to 0.7m) than at the top of the beach (approximately 0.2m).</p> <p>1bSNC6 extends across the revetment and seawall. A small veneer of sand covers the rock at the toe of the coastal defences. Beach levels have increased by 0.5m at the toe of the sea wall along about a 6m stretch. The remainder of the beach profile has increased by a smaller amount (approximately 0.1m), but with a slight decrease in level at toe (24m chainage seawards). Survey photographs and feature coding of the profile data indicate that the beach composition has changed with a greater proportion of gravel present on the surface at the top of the beach (Plates 8 and 9).</p> <p>1bSNC7 to 1bSNC9 are within the shelter of North East Pier and South West Breakwater in the former South Outlet, parts of which have been in-filled with tipped rubble. 1bSNC7 is a section across North East Pier and shows the terraced nature of the landward face of the pier wall, extending across rock to the small sheltered bay between the two structures. For this reason, profile 1bSNC7 has not been analysed. Profile 1bSNC8 crosses the boulders and rubble, which reaches a level of around 6.2mODN, and then extends across the sandy but boulder strewn foreshore. Beach levels have dropped steeply at the base of the boulder and rubble section, at approximately 30m chainage, dropping by nearly 0.9m by 36m. As such the measured profile for Autumn 2013 stops at 37m chainage, whereas it previously extended across the foreshore up to 120m.</p> <p>Profile 1bSNC9 extends from the dock facilities and crosses a short length of concrete wall before extending across the sand foreshore to reach and cross a large boulder mound that is towards the seaward end of the south west breakwater. Although there seems to be an increase in level of the sand dunes and boulder mound, a closer investigation indicates that this is due to the location of survey measurement points and there is no significant difference in land elevation. Across the sand and gravel section (approximately 65m to 105m chainage), there is a slight increase in bed level of just 0.1m to 0.2m. The profile can be considered stable.</p> | <p>beach levels are some of the lowest recorded.</p> <p>Within New South Pier, profile 1bSNC2 shows the lowest recorded level at the seaward end of the profile as result of beach steepening.</p> <p>The profiles towards the middle and south of the area (1bSNC4 to 9) are within the bounds of previous surveys, apart from profile 1bSNC8, located within the shelter of North East Pier and South West Breakwater, which shows beach levels lower than those previously recorded.</p> |

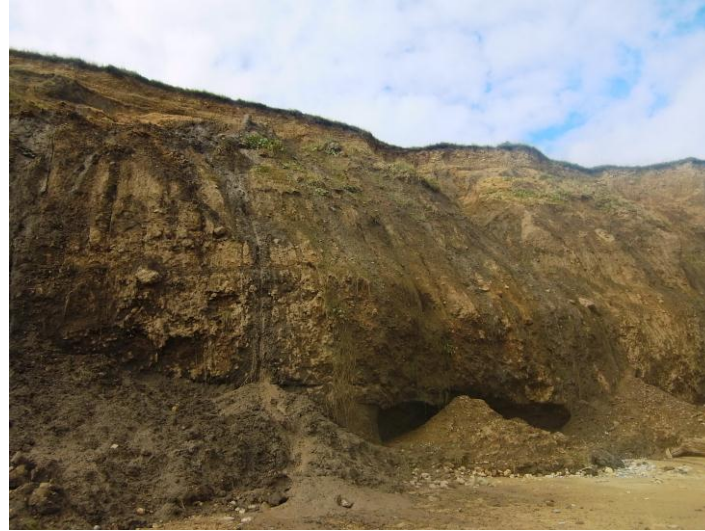
Plate 11 – Survey photograph 1bSNC24_20130913_N5.JPG (FM 2013)

| Survey Date | Description of Changes Since Last Survey | Interpretation |
|---|---|---|
| | <p>beach levels have decreased across the profile, particularly at the toe of the beach resulting in a steeper beach profile.</p> <p>At 1bSNS24, the cliff top has remained stable, but there is evidence in the photographs of a cliff fall part way down the cliff face (Plate 11). This can be observed in the measured profile as the toe of the cliff has accreted as a result of material falling from the cliff face. Across the foreshore, the upper beach has increased in level since the previous survey (autumn 2011/2) while the middle to lower beach (90m to 140m chainage) has decreased in level resulting in a steeper beach profile. The sand previously present between 82m and 135m chainage is no longer present and rock has been exposed. This is a return to the levels recorded in 2011.</p> <p>At profile 1bSNS25, the cliff top has remained stable but a cliff fall has occurred on the cliff face (Plate 12), depositing cliff material at the toe of the cliff. As a result beach levels have increased at the cliff toe down to 74m chainage. Seawards of 74m chainage the profile has remained the same as the previous survey (spring 2013).</p> <p>Profiles 1bSNS26 to 1bSNS32 are located at Halliwell Banks specifically to assess risks from erosion at a former land fill. Cliff height is characteristically around 26m and 27mODN, with beaches at the toe typically at levels between 3.3m and 3.9mODN.</p> <p>At profiles 1bSNS26 to 1bSNS32 fluctuations in the cliff face and toe since the previous survey (spring 2013) are small enough that they can be attributed to survey interpretation or access difficulties. Beach levels have generally fallen by a small amount on all profiles in this section, but with a greater decrease in level on the lower part of the profile. The feature coding and photographs indicate that there is less sand present on the beach and the survey report notes "<i>the beach seems lower than usual with very little sand in its usual places</i>".</p> <p>Profiles 1bSNS33 to 1bSNS36 are all located around the Pincushion Headland. At locations 1bSNS33 to 1bSNS35 the cliff face has retained the same form and position since the last surveys. At locations 1bSNS35 to 1bSNS36 the cliff top shows a small amount of retreat, in the region of 0.5m, which is an ongoing trend in this location.</p> <p>At profile 1bSNS33 and 1bSNS34 there are no discernible changes to the beach levels.</p> <p>At profile 1bSNS35, beach levels have fallen marginally across the profile, with the fall in level increasing</p> | <p>oscillated, which is not typical of cliff behaviour and it is therefore likely that the cliff position is related to survey interpretation and not actual change. However, at 1bSNS35 and 1bSNS36, there is an ongoing cliff retreat. At profiles 1bSNS33 and 1bSNS36 beach levels are at the lower bound of previous surveys.</p> |
