## **Cell 1 Regional Coastal Monitoring Programme Analytical Report 16: 'Full Measures' Survey 2023**

**Sunderland City Council**

**January 2024**

(\*) The present report is **Analytical Report 16** and provides an analysis of the 2023 Full Measures survey for Sunderland City Council's frontage.

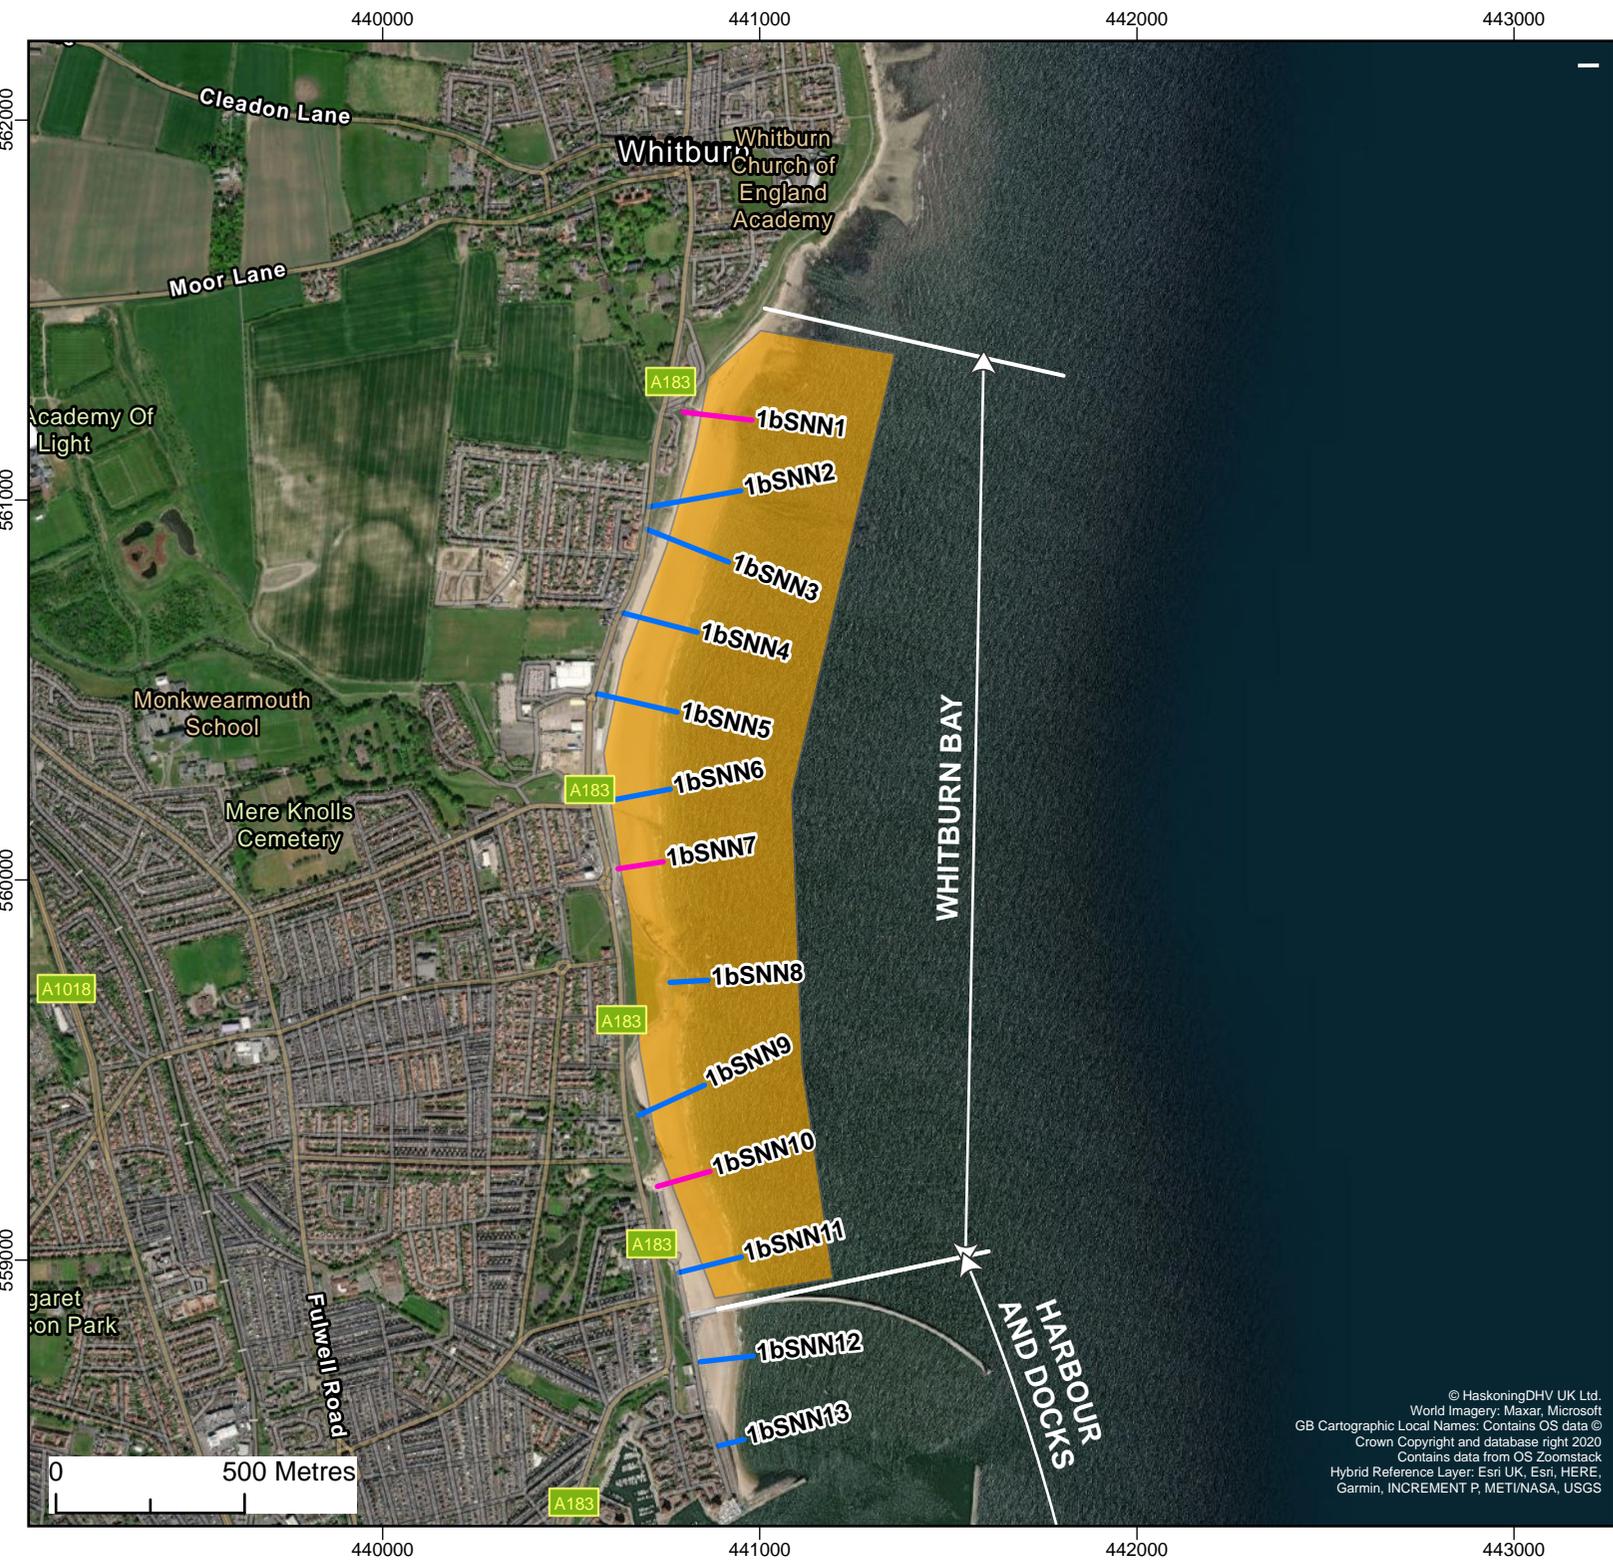
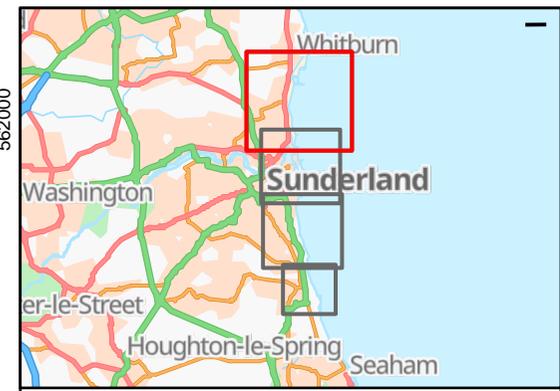
**Figure 2 - Map 1**

**Topographic Profile**

- Annual (Blue line)
- Bi-Annual (Pink line)

**Topographic Area**

- 6 monthly (Light Green)
- yearly (Yellow)
- 5 yearly (Light Purple)

- Cliff Top Survey Points (Red dot)

**WHITBURN BAY**

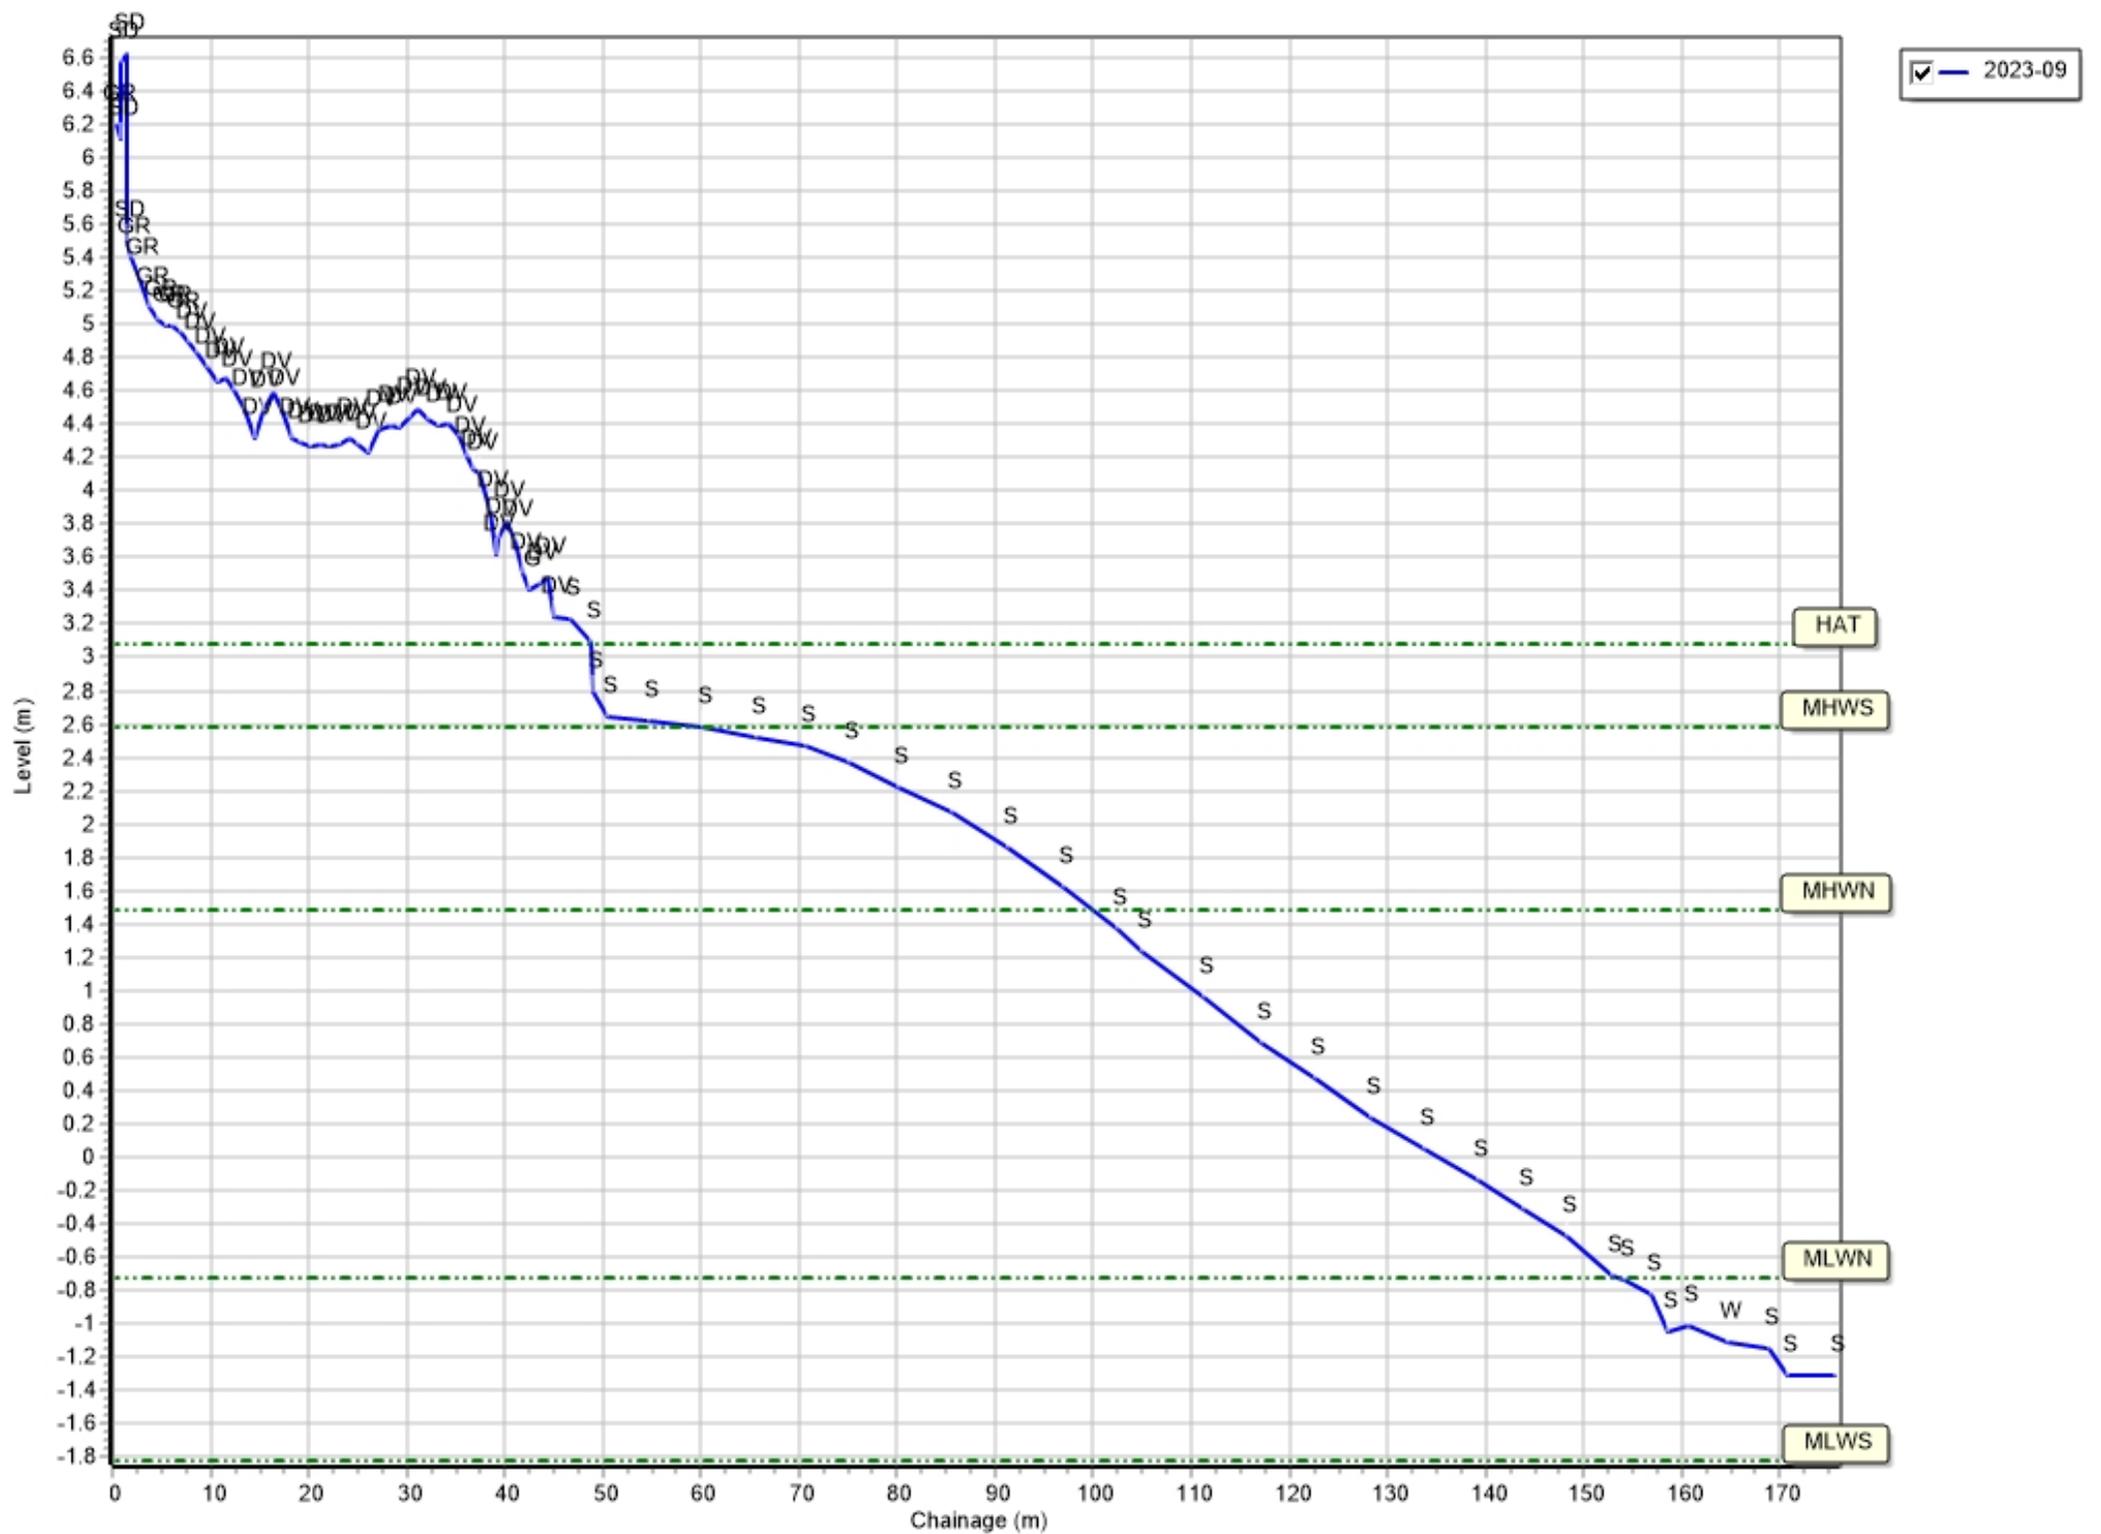
# Profiles: 1bSNN1

Survey Date	Description of Changes Since Last Survey	Interpretation
19 <sup>th</sup> Nov 2023	<p><b>Beach Profiles:</b></p> <p>Whitburn Bay is covered by eleven beach profile lines for the Full Measures survey (Appendix A). The previous survey was the Partial Measures survey undertaken in April 2022 and the previous Full Measures survey was undertaken in November 2022. Profiles <b>1bSNN1</b>, <b>1bSNN7</b> and <b>1bSNN10</b> were last surveyed during the Partial Measures spring survey, 2023. The remaining profiles were last surveyed during the Full Measures autumn survey, 2022.</p> <p><b>1bSNN1</b> is immediately south of Sunderland City Council's northern boundary. There are small sections of accretion and erosion on the dunes landward of 40m chainage, limited to <math>\pm 0.1</math>m. The beach profile at the dune toe has lowered by up to 0.8m to chainage 65m. The upper beach between chainages 65-111m and lower beach between chainages 140-160m has risen by up to 0.4m. The middle beach between chainages 111-140m has lowered by up to 0.1m. Overall, the beach level is at medium-high level compared to the range recorded from previous surveys.</p> <p>Profiles <b>1bSNN2</b> and <b>1bSNN3</b> are located towards the north of Whitburn Bay and extend across scrubland before reaching the upper gravel foreshore and then dropping across the lower sandy foreshore towards the rocky outcrop of Whitburn Steel.</p> <p>At profile <b>1bSNN2</b>, the dune has remained stable since the last survey, with only a small amount of erosion occurring by up to 0.1m to chainage 80m. The beach at the dune toe has risen by up to 0.2m between chainages 80-111m. Seaward of chainage 111m has lowered by up to 0.7m. Overall, the profile is at a medium-high level recorded from previous surveys.</p> <p>At <b>1bSNN3</b>, the dunes remain stable since the previous survey, showing accretion by up to 0.1m. The upper and middle beach to chainage 210m has risen by up to 0.4m, whilst the lower beach has lowered by up to 0.3m. Overall, the beach profile is at a medium-high level compared to the range recorded from the previous surveys.</p>	<p>Along the length of Whitburn Bay profiles have undergone variable change since the previous survey. The majority of beach profiles are within the range of previous recorded surveys.</p> <p><b>Longer term trends:</b> All the profiles in Whitburn Bay are at medium to high levels compared to earlier surveys in the record. The beaches show frequent fluctuation in levels due to sediment being naturally redistributed across the shoreface.</p>

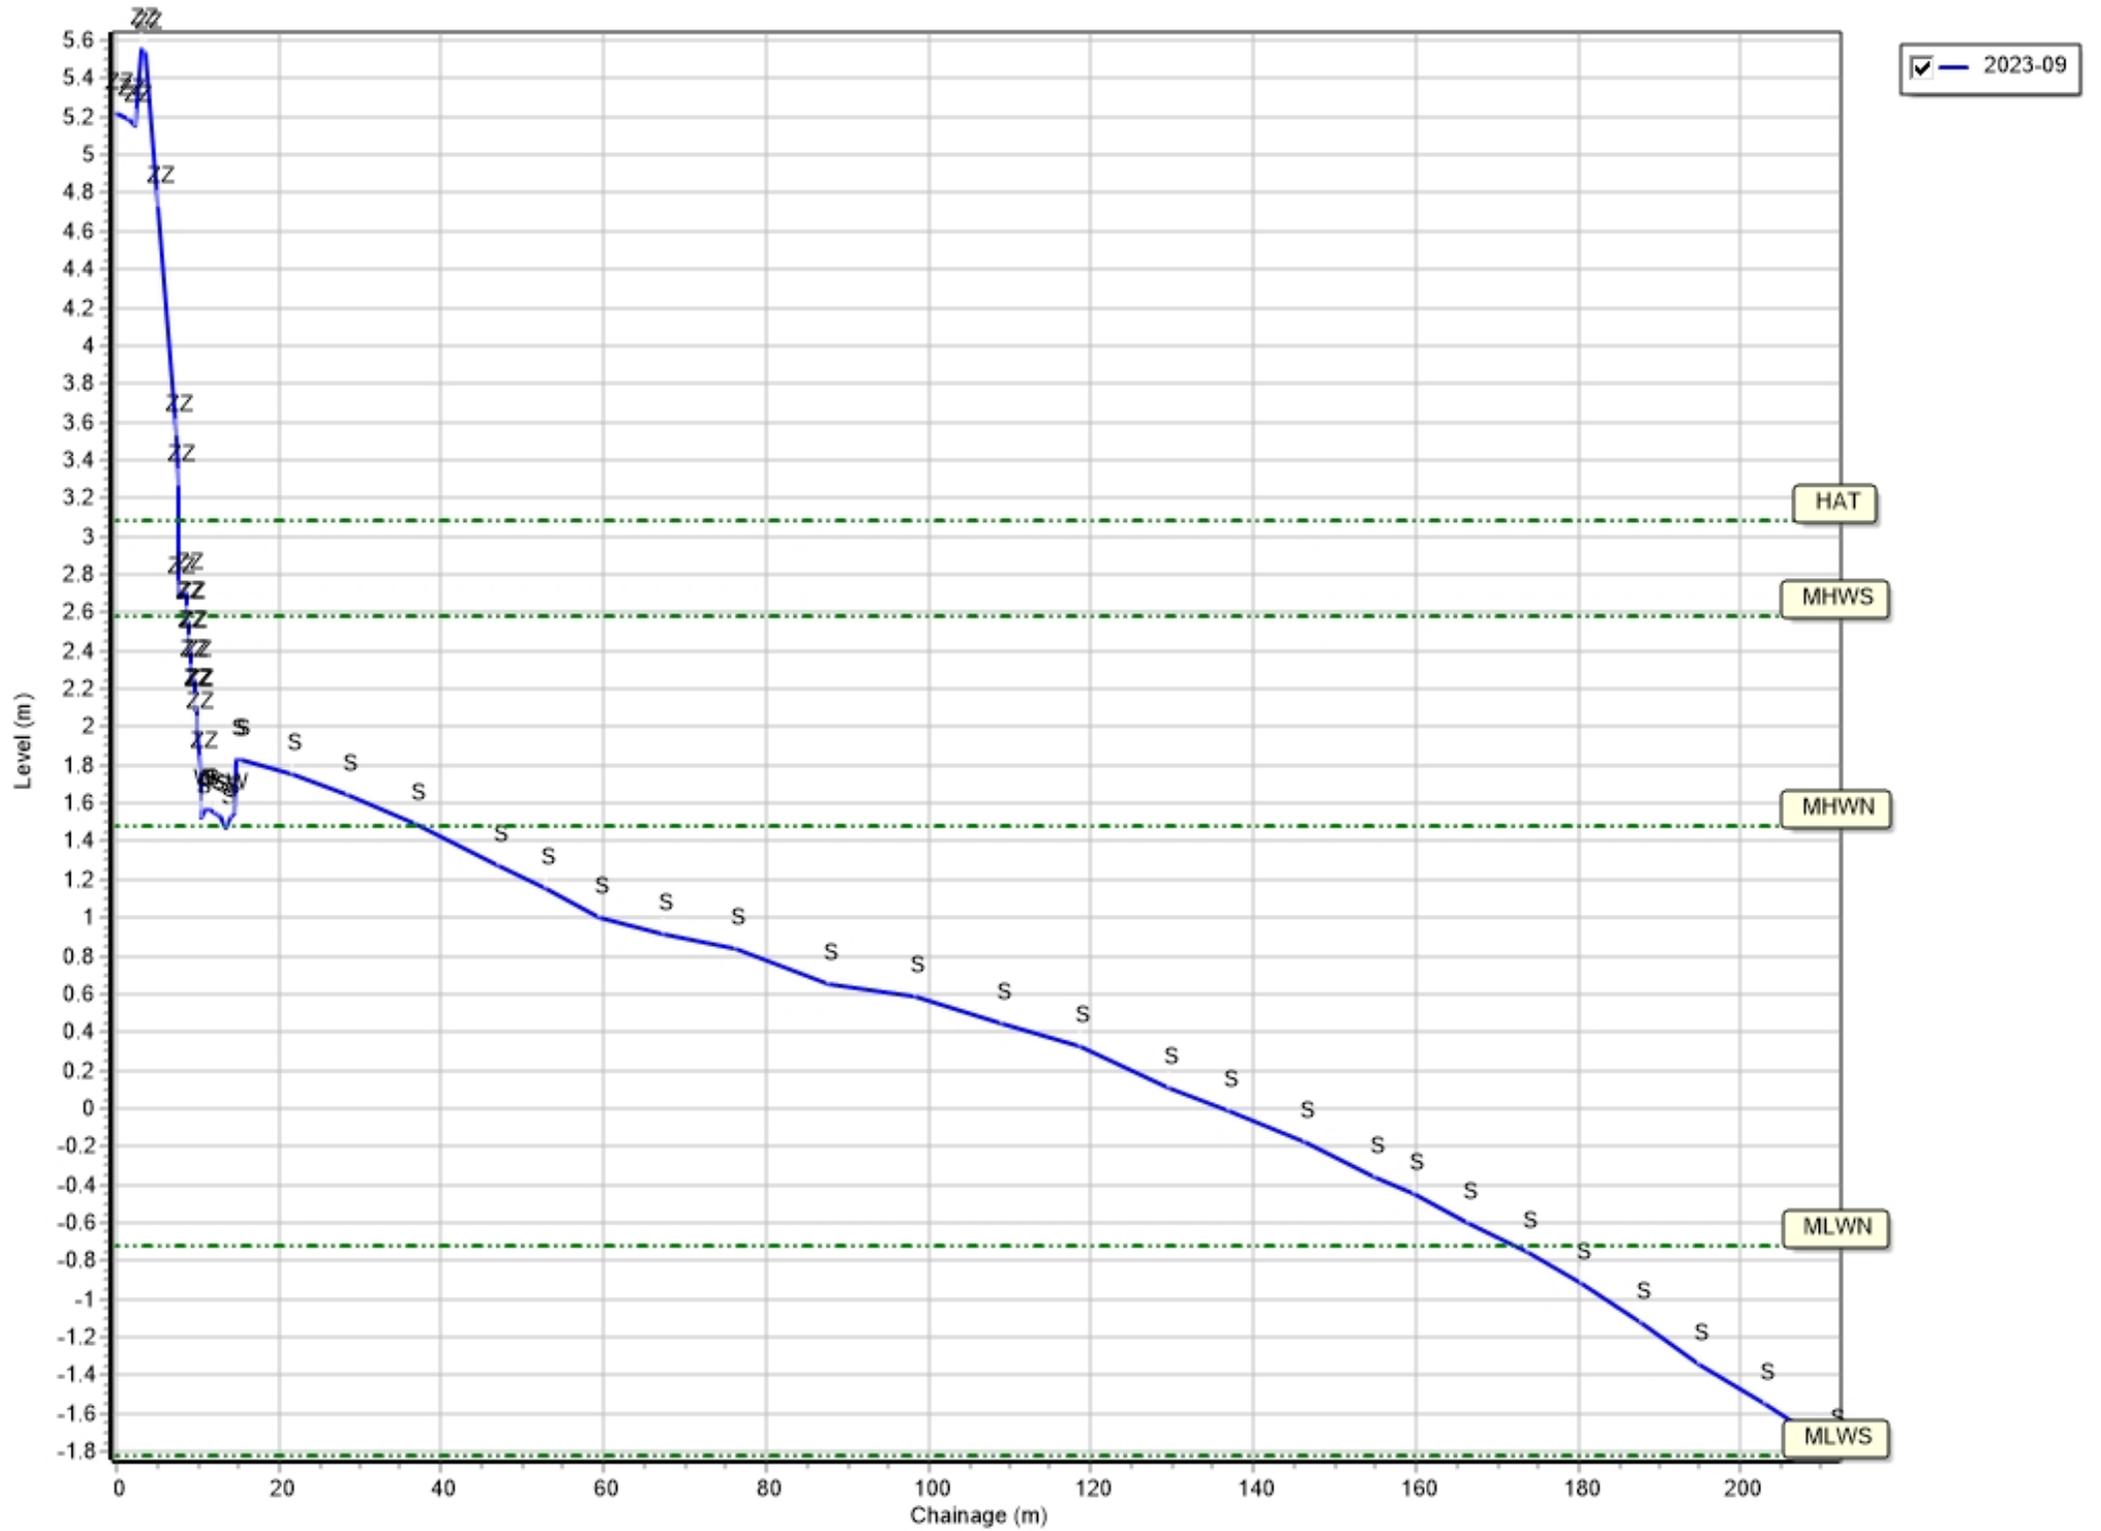
# Profiles: 1bSNN6

Survey Date	Description of Changes Since Last Survey	Interpretation
	<p>Profiles <b>1bSNN4</b> to <b>1bSNN6</b> are between the shoreline opposite the southern edge of South Bents housing estate and Parsons Rock.</p> <p>Profile <b>1bSNN4</b> shows the beach has generally lowered by 0.2m across the profile, except on the middle beach between chainages 105-170m which has risen by up to 0.3m. Overall, the upper and lower beach is at a medium level, whilst the middle beach is at a high level compared to the range recorded from previous surveys.</p> <p>At profile <b>1bSNN5</b>, from the toe of the sea wall to chainage 46m the beach profile has fallen by 0.2m. A small berm has formed between chainages 46-74m with the accumulation of sediment up to 0.6m. The beach profile alternates between erosion and accretion for the remaining beach profile, limited to <math>\pm 0.4</math>m. Overall, the beach is at a medium-high level when compared to the range recorded from previous surveys.</p> <p>At profile <b>1bSNN6</b>, the beach from the toe of the sea wall to chainage 90m has lowered by up to 1.8m which now exposes the toe of the sea wall and is at its second lowest level recorded (the lowest being recorded in the autumn 2019 survey). The middle beach between chainages 90-185m has risen by up to 0.2m. The lower beach seaward of chainage 185m has lowered by less than 0.1m. The profile is at a low level on the upper beach, rising to a high level across the rest of the beach profile compared to the range recorded from previous surveys</p> <p>Profile <b>1bSNN7</b> is at Seaburn, just to the north of Parson's Rocks. The upper beach between chainages 7-60m has risen by up to 0.4m. Seaward of this point, the middle beach has lowered by up to 0.1m and the lower beach has lowered by up to 0.5m. Overall, the profile is at a high level compared to the range recorded from previous surveys, particularly between chainages 18-44m which is at its highest level recorded.</p> <p>Profile <b>1bSNN8</b> extends across Parsons Rocks. The beach profile remains stable and has exhibited little change except for differences in rock location between the two surveys. Overall, the profile is at a medium level compared to the range recorded from previous surveys.</p> <p>Profile <b>1bSNN9</b> drops from the cliff top to the foreshore at Roker. The upper beach from the toe of the cliff to chainage 36m has risen by up to 0.5m. The middle-upper beach between chainages 36-75m has lowered by up to 0.2m. Seaward of chainage 75m the middle and lower beach has lowered by up to 0.2m. Overall, the profile is at a high level compared to the range recorded from previous surveys.</p>

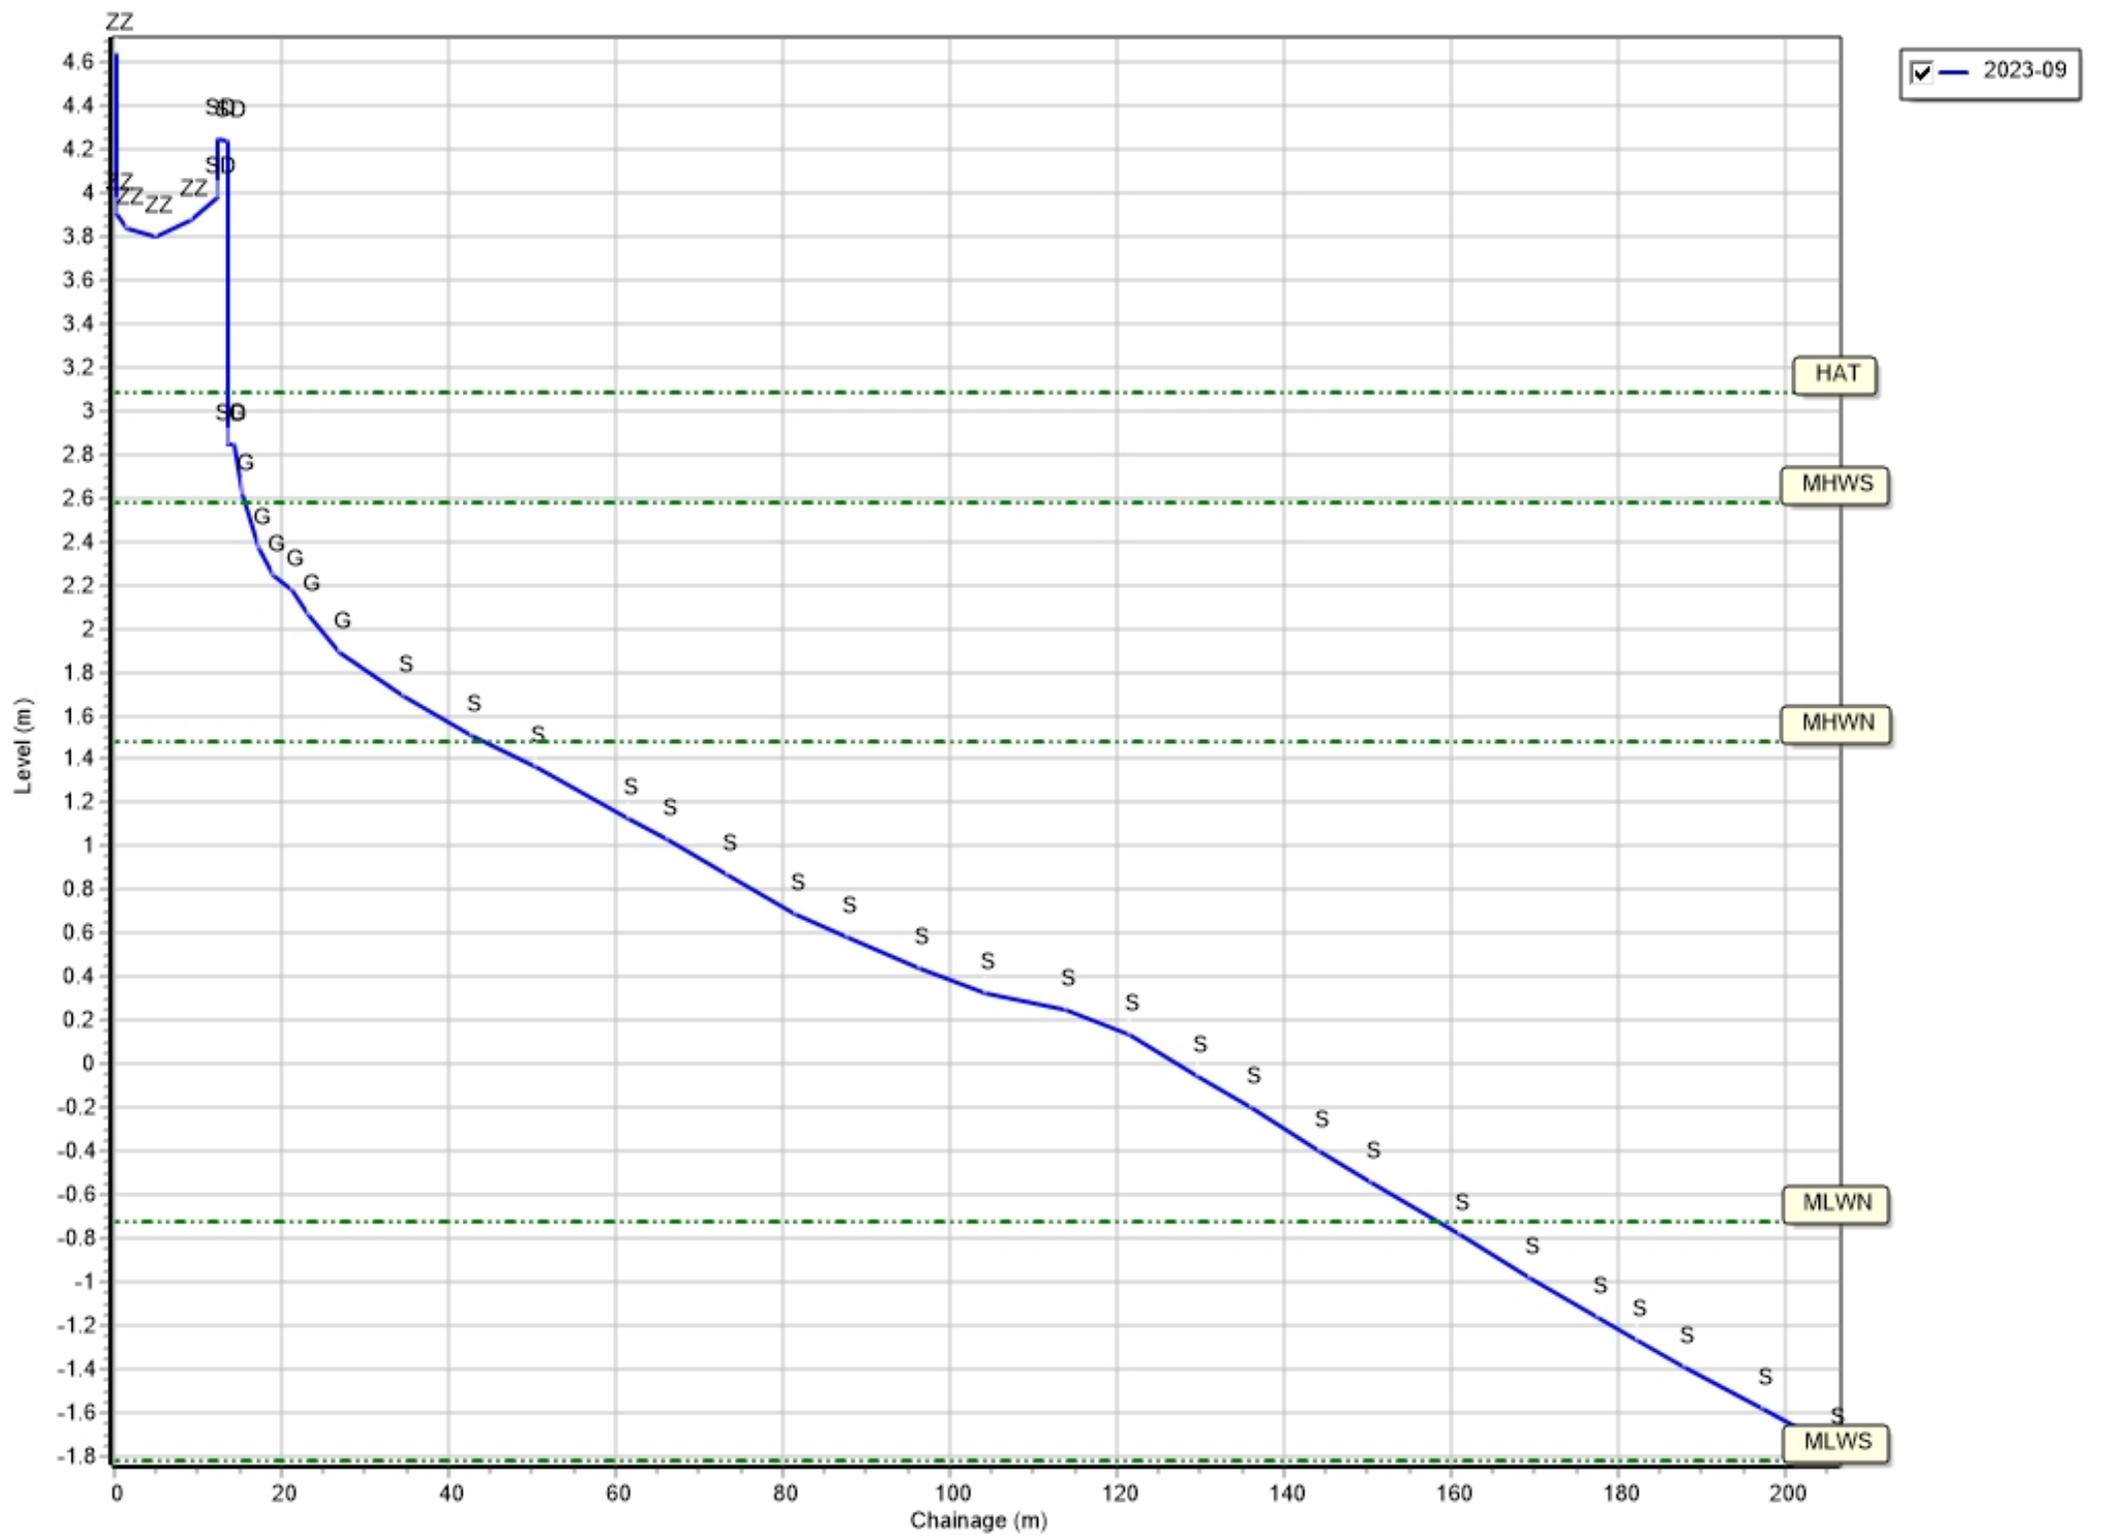
# Profiles: 1bSNN10

Survey Date	Description of Changes Since Last Survey	Interpretation
	<p>Profile <b>1bSNN10</b> is located approximately mid-way between Parson's Rocks and Roker Pier. Between the toe of the seawall and chainage 16m, the beach has risen by up to 0.3m. The middle-upper beach between chainages 16-36m has lowered by up to 0.1m. The middle beach between chainage 36-160m has risen by up to 0.3m, switching to erosion on the lower beach by up to 0.4m. Overall, the beach is at a medium-high level compared to the range recorded in previous surveys.</p> <p>Profile <b>1bSNN11</b> is located to the south of Whitburn. The beach level has alternated between erosion and accretion, but has generally risen by up to 0.3m on the upper beach, 0.1m on the middle beach and 0.4m on the lower beach. Short sections of erosion are found on the middle-upper and middle-lower beach by up to 0.1m. The beach ranges between a medium-high level compared to the range recorded from previous surveys, particularly between chainages 34-50m and 98-108m which are at their highest levels recorded.</p>

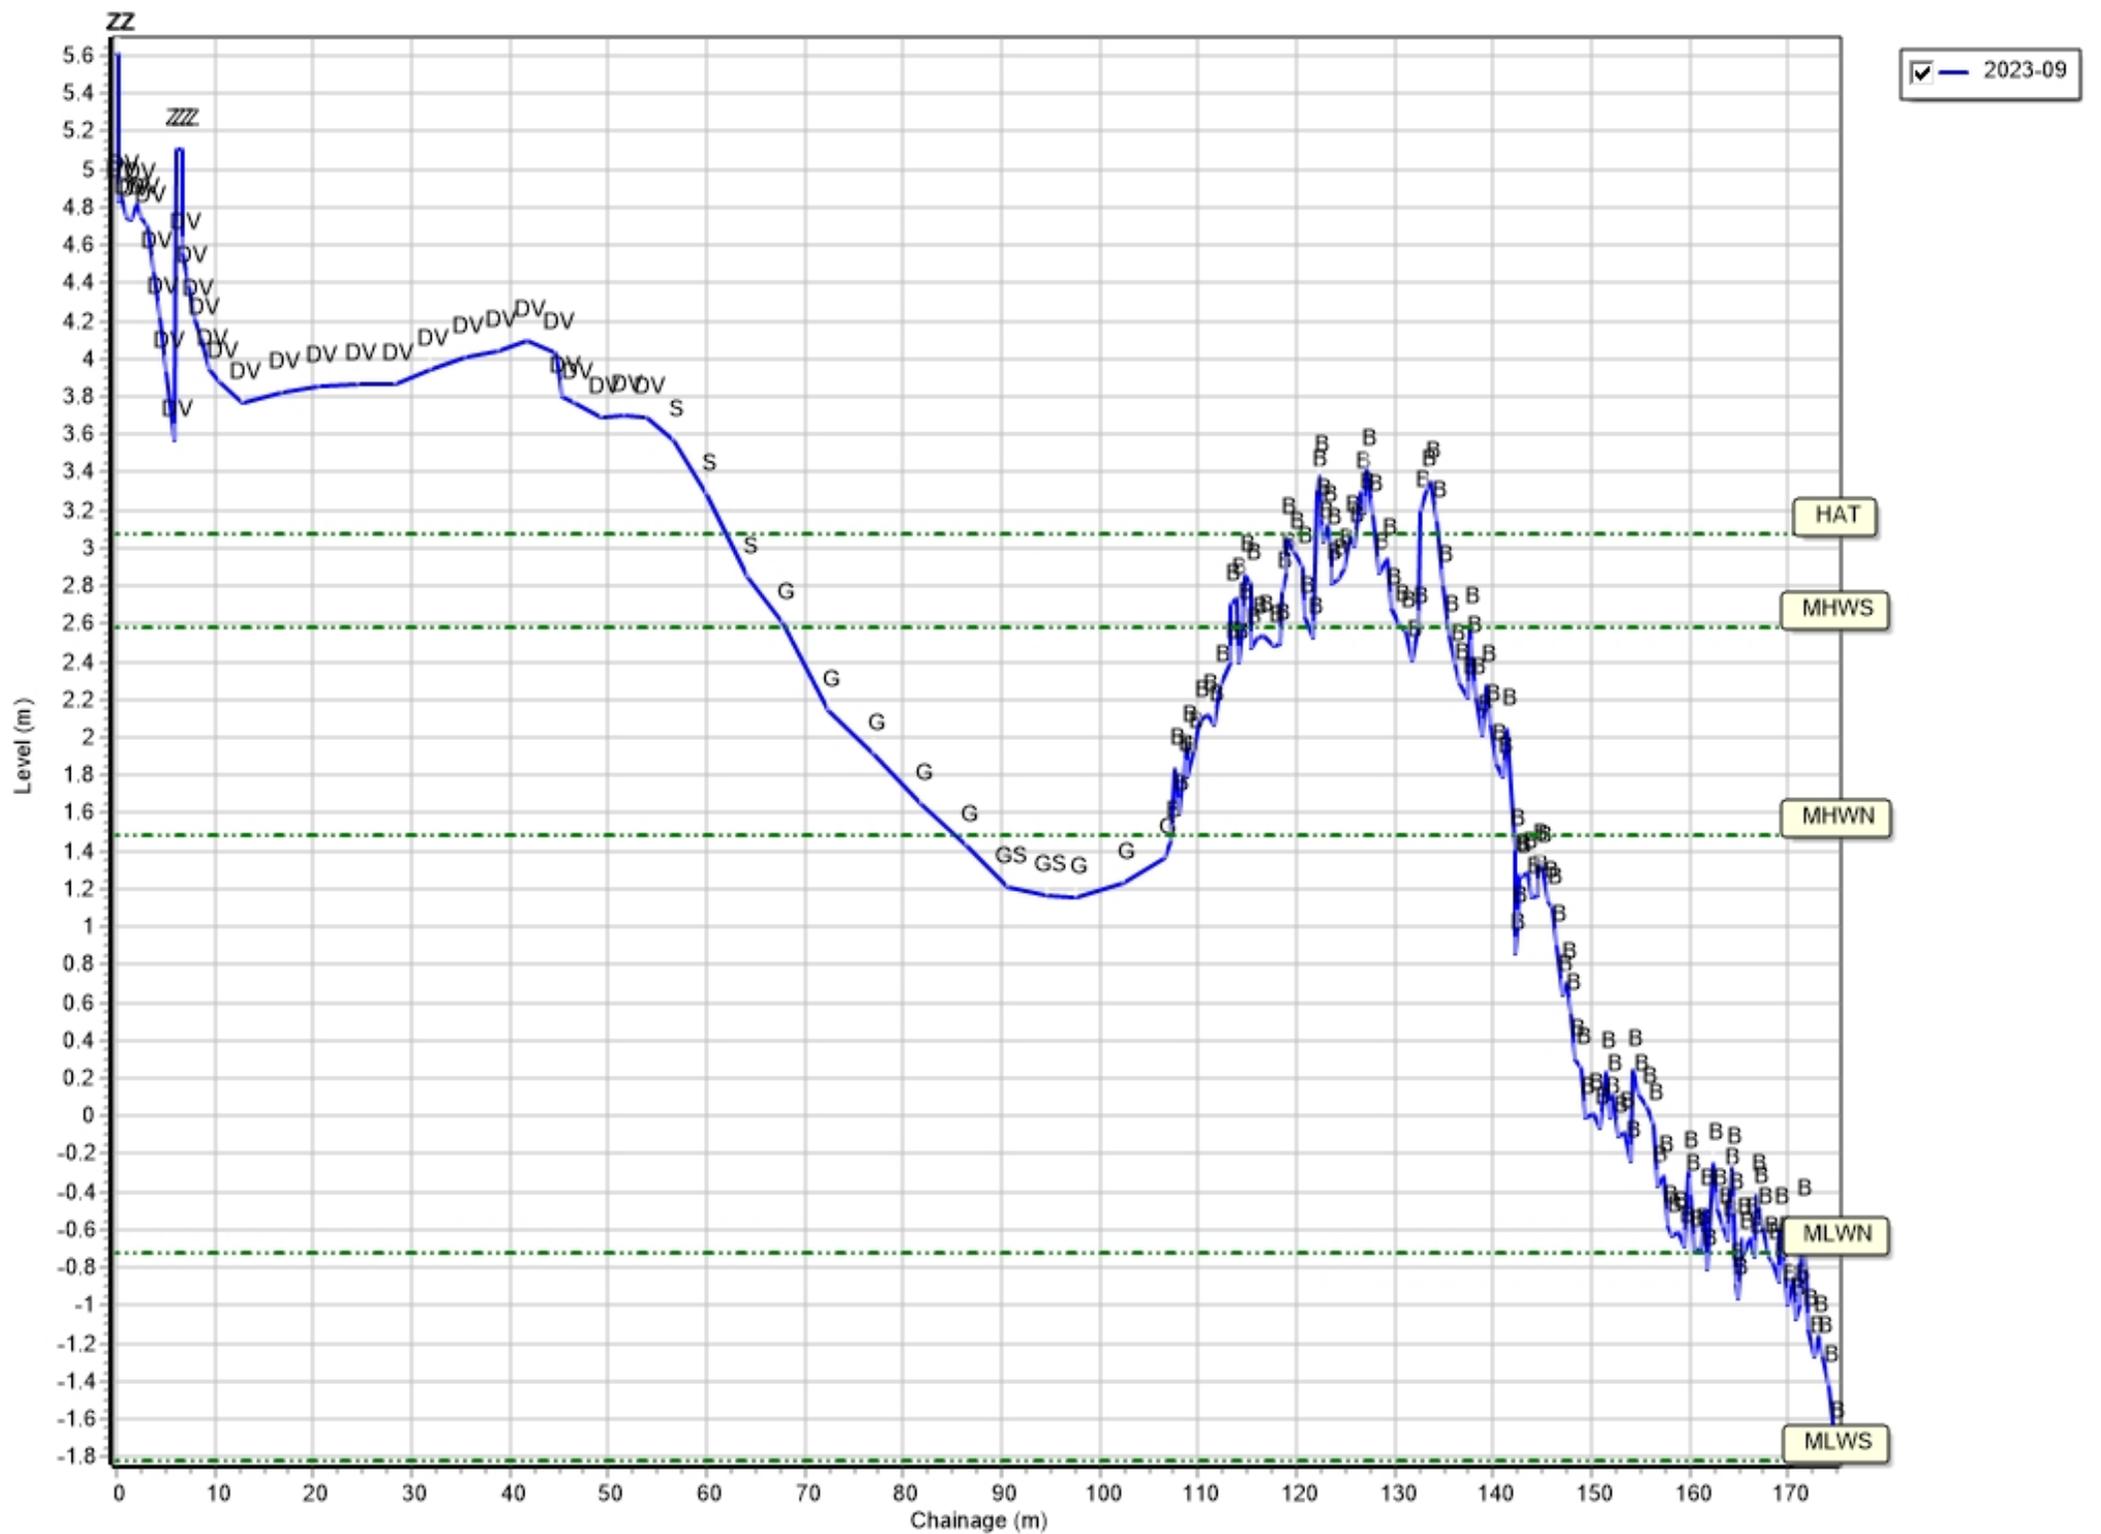
# Profiles: 1bSNC9

- The survey report notes that the beginning of profile 1bSNC9 was unsafe to access at the time of the survey
- An area at the north of Whitburn Bay beach was unsafe to survey due to heavy wet mud.

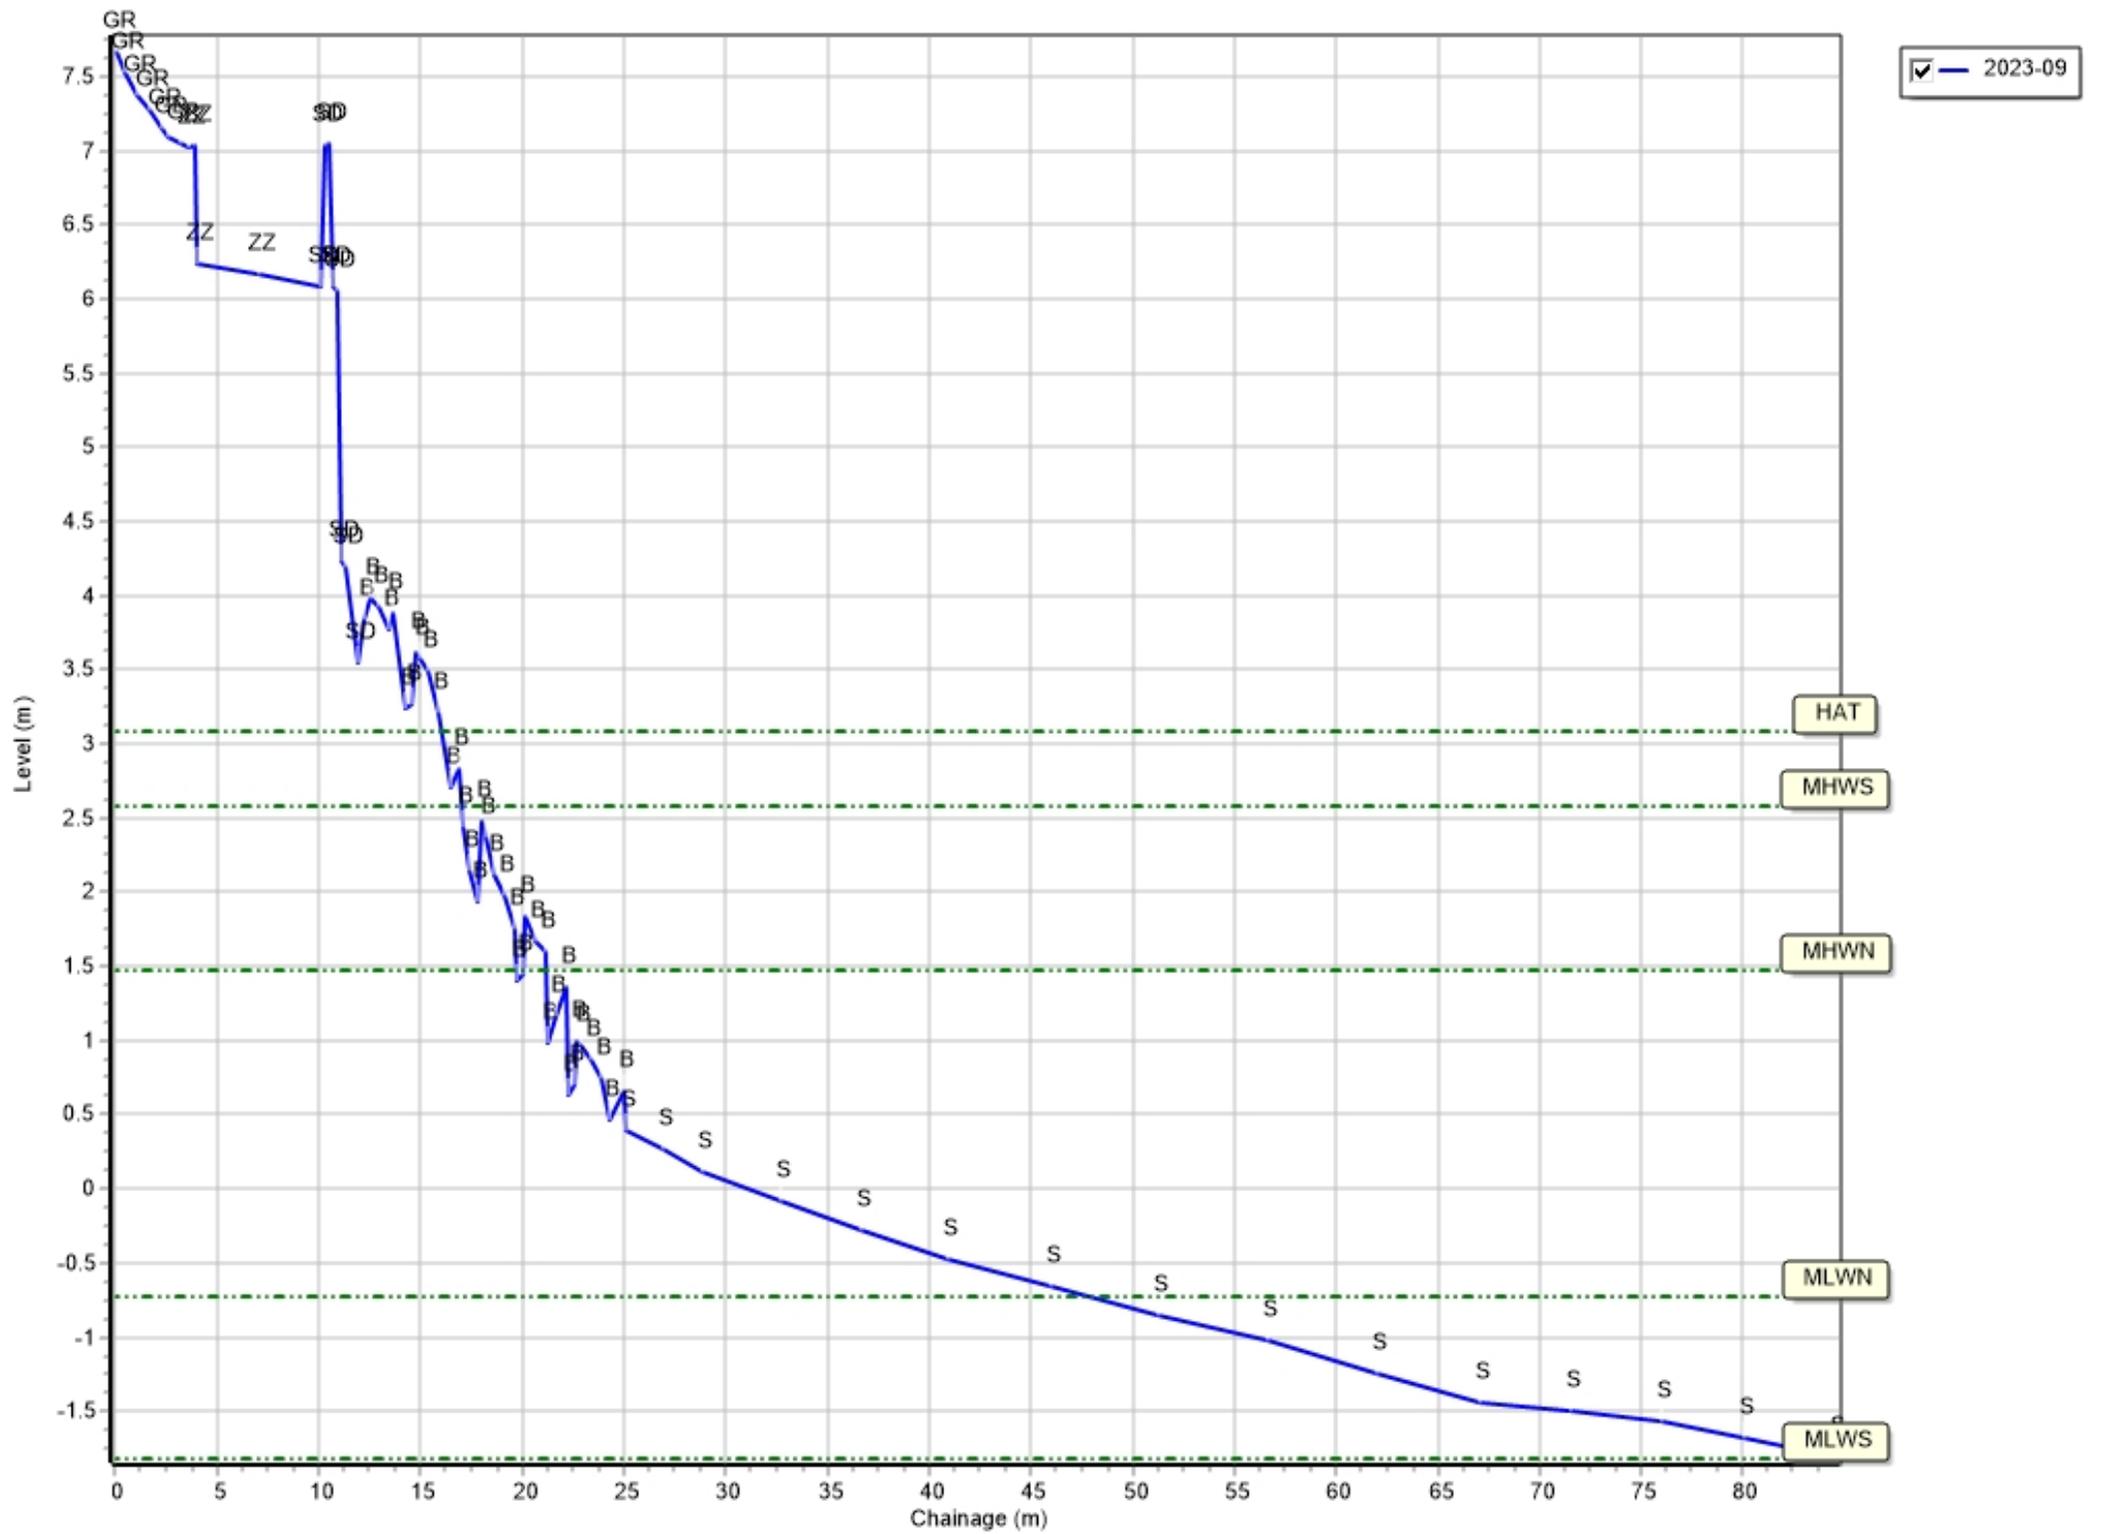
Profiles: 1bSNS10

Survey Date	Description of Changes Since Last Survey	Interpretation
	<p>At profile <b>1bSNS10</b>, the upper and lower beach has lowered by up to 0.5m on the upper beach and 0.2m on the lower beach. The middle beach between chainages 40-59m has risen by up to 0.1m. The beach profile is at a medium-high level across the majority of the profile compared to the range recorded from previous surveys.</p> <p>At profile <b>1bSNS11</b>, there is negligible change in the cliff profile. Beach levels have lowered from the cliff toe across the upper and middle beach by up to 0.4m to chainage 74m. The lower beach has risen by up to 0.4m covering a previously exposed boulder from the previous survey. The beach profile is at a medium level compared to the range recorded from previous surveys.</p> <p>Profiles <b>1bSNS12</b> to <b>1bSNS36</b> are located along the undefended cliffs between Grangetown and Ryhope Dene.</p> <p>Profiles <b>1bSNS12</b> to <b>1bSNS19</b> are between the end of the Hendon sea wall and Salterfen Rocks. Cliff top levels are typically between 20m and 22mOD. They are highest along the profiles further north, dropping in the centre and then increasing again to the south. Several profiles show a seaward movement of the cliff toe however this is likely to be a data artefact due to interpolation between limited data points and inaccessibility of the cliff toe due to unsafe conditions. Where this occurs, the cliff toe position is not analysed.</p> <p>Profile <b>1bSNS12</b> extends from the cliff across the boulder foreshore. The cliff toe has receded landward by approximately 1.0m since the previous survey. There have been minor changes in position of boulders recorded to chainage 64m. The beach profile seaward of chainage 64m has risen by up to 0.1m on the upper beach, 0.1m on the middle beach and 0.3m on the lower beach. Overall, the profile is at a high level recorded compared to the previous surveys.</p> <p>At profile <b>1bSNS13</b>, the beach at the toe of the cliff has risen by up to 0.2m to chainage 40m. A small section between chainages 40-54m has lowered by up to 0.2m. Seaward of this point, the beach has risen by up to 0.6m on the middle beach and approximately 0.1m on the lower beach. The beach profile is at a high level for the majority of the profile, particularly between chainages 35-40m and seaward of 60m. The rest of the beach is at a medium-high level compared to previous surveys.</p> <p>At profile <b>1bSNS14</b>, the cliff toe has receded landward by approximately 0.5m. The beach at the toe of the cliff has risen by up to 0.2m on the upper beach, 1.0m on the middle beach and 0.1m on the lower beach. The rock patch at chainage 100-119m is now covered. The cliff is at its most landward</p>	<p>high level compared to the range recorded from previous surveys.</p> <p>At Grangetown (south Hendon to Salterfen Rocks), the cliff top position has not changed substantially compared to the last survey, but since 2009 the cliff tops have receded several metres at some locations. Despite the most recent survey periods showing limited change at the cliff top, there has been erosion of the talus deposits at the cliff toe, indicating that the in-situ bedrock will once again be exposed to wave action and therefore more liable to undercutting and subsequent cliff retreat.</p> <p>Between Salterfen Rocks and the landfill at Halliwell banks (profiles 1bSNS20 to 1bSNS25). Beach levels are relatively medium across all profiles, except at profile 1bSNS20 is at a low level, particularly between chainages 54-66m which is at its lowest level recorded.</p> <p>At the landfill site (profiles 1bSSN26 to 1bSSN32), the cliff position has generally remained in the same position. Beach levels are generally at a medium-low level compared to previous records.</p> <p>To the south of Halliwell Banks at profiles 1bSNS33 to 1bSNS36, beach levels are generally at a medium level.</p>
