## **Cell 1 Regional Coastal Monitoring Programme Analytical Report 16: 'Full Measures' Survey 2023**

**Sunderland City Council**

**January 2024**

(\*) The present report is **Analytical Report 16** and provides an analysis of the 2023 Full Measures survey for Sunderland City Council's frontage.

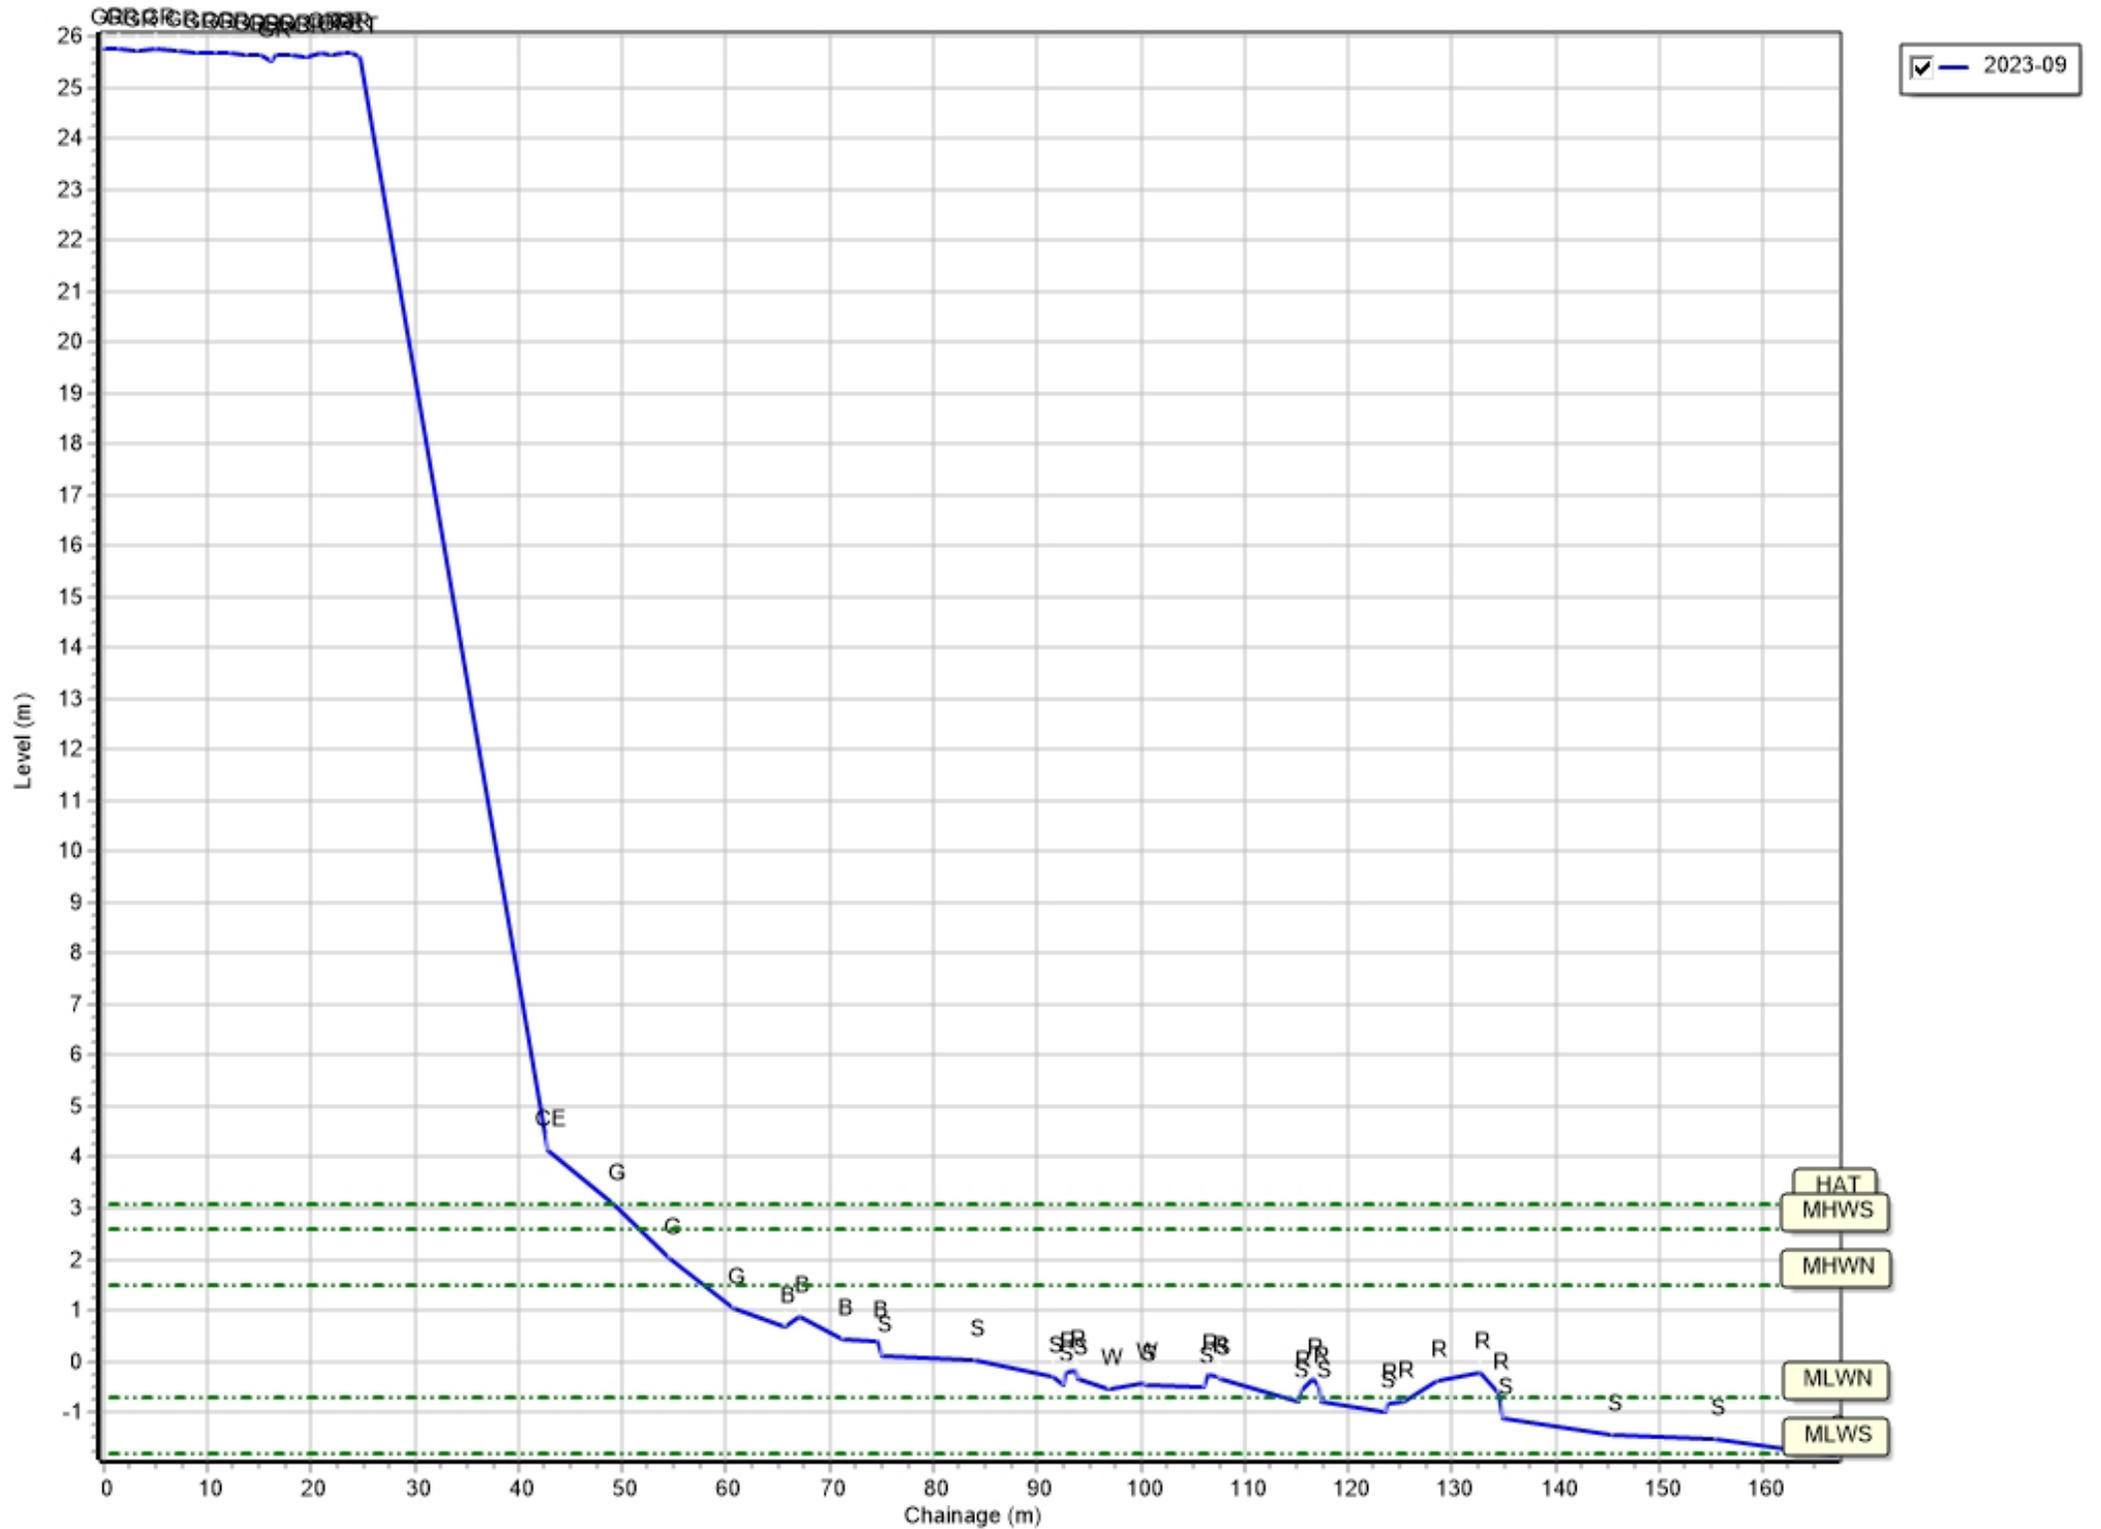
# Profiles: 1bSNS20

Survey Date	Description of Changes Since Last Survey	Interpretation
	<p>At profile <b>1bSNS20</b>, the cliff toe also appears to have prograded by approximately 1.0m. The rest of the beach profile has generally risen by up to 0.4m on the upper beach, 0.2m on the middle beach and 0.5m on the lower beach. One section of erosion occurs between chainages 52-66m by up to 0.4m. Overall, the upper beach is at a low level, particularly between chainages 54-66m which is at its lowest level recorded. The rest of the beach profile is at a medium level compared to the range recorded from previous surveys.</p> <p>At <b>1bSNS21</b>, the dune toe has prograded by up to 2.0m since the previous survey. Seaward of this point, the beach has alternated between erosion and accretion generally limited to <math>\pm 0.1</math>m. Overall, the beach is at a medium level compared to the range recorded from previous surveys.</p> <p>At profile <b>1bSNS22</b>, the cliff toe has retreated by up to 2.0m. The shore platform remains largely unchanged. Overall, the beach profile is at a low level on the upper and middle beach, but a high level on the lower beach compared to the range recorded from previous surveys.</p> <p>At profile <b>1bSNS23</b>, the cliff top has retreated by up to 2.0m, whilst the cliff toe has prograded seaward by up to 2.0m. The beach profile has generally risen by up to 0.4m, covering up previously exposed rocks between chainage 61-86m. Overall, the beach profile is at a medium-high level compared to the range recorded from previous surveys.</p> <p>At profile <b>1bSNS24</b>, the cliff top has retreated by approximately 0.5m, and the cliff toe has remained stable. The beach from the cliff toe to chainage 80m has lowered by up to 0.5m, whilst the middle and lower beach has risen by up to 0.2m. Overall, the upper beach profile is at its lowest level recorded (between chainages 44-78m). The middle and lower beach is at a medium-high level. The cliff top is at its most landward position recorded.</p> <p>At profile <b>1bSNS25</b>, the beach at the cliff toe and middle beach have risen by up to 0.8m. The middle-upper beach (between chainages 58-80m) and lower beach (seaward of chainage 128m) have lowered by up to 0.6m. A patch of rocks between chainage 89-104m has been covered up since the previous survey. Overall, the upper beach is at a low level, middle beach is at a medium level and lower beach is at a high level compared to the range recorded from previous surveys.</p> <p>Profiles <b>1bSNS26</b> to <b>1bSNS32</b> are located at Halliwell Banks specifically to assess risks from erosion at a former land fill. Cliff height is between 26m and 27mOD, with beaches at the toe typically at levels between 3.3m and 3.9mODN.</p>

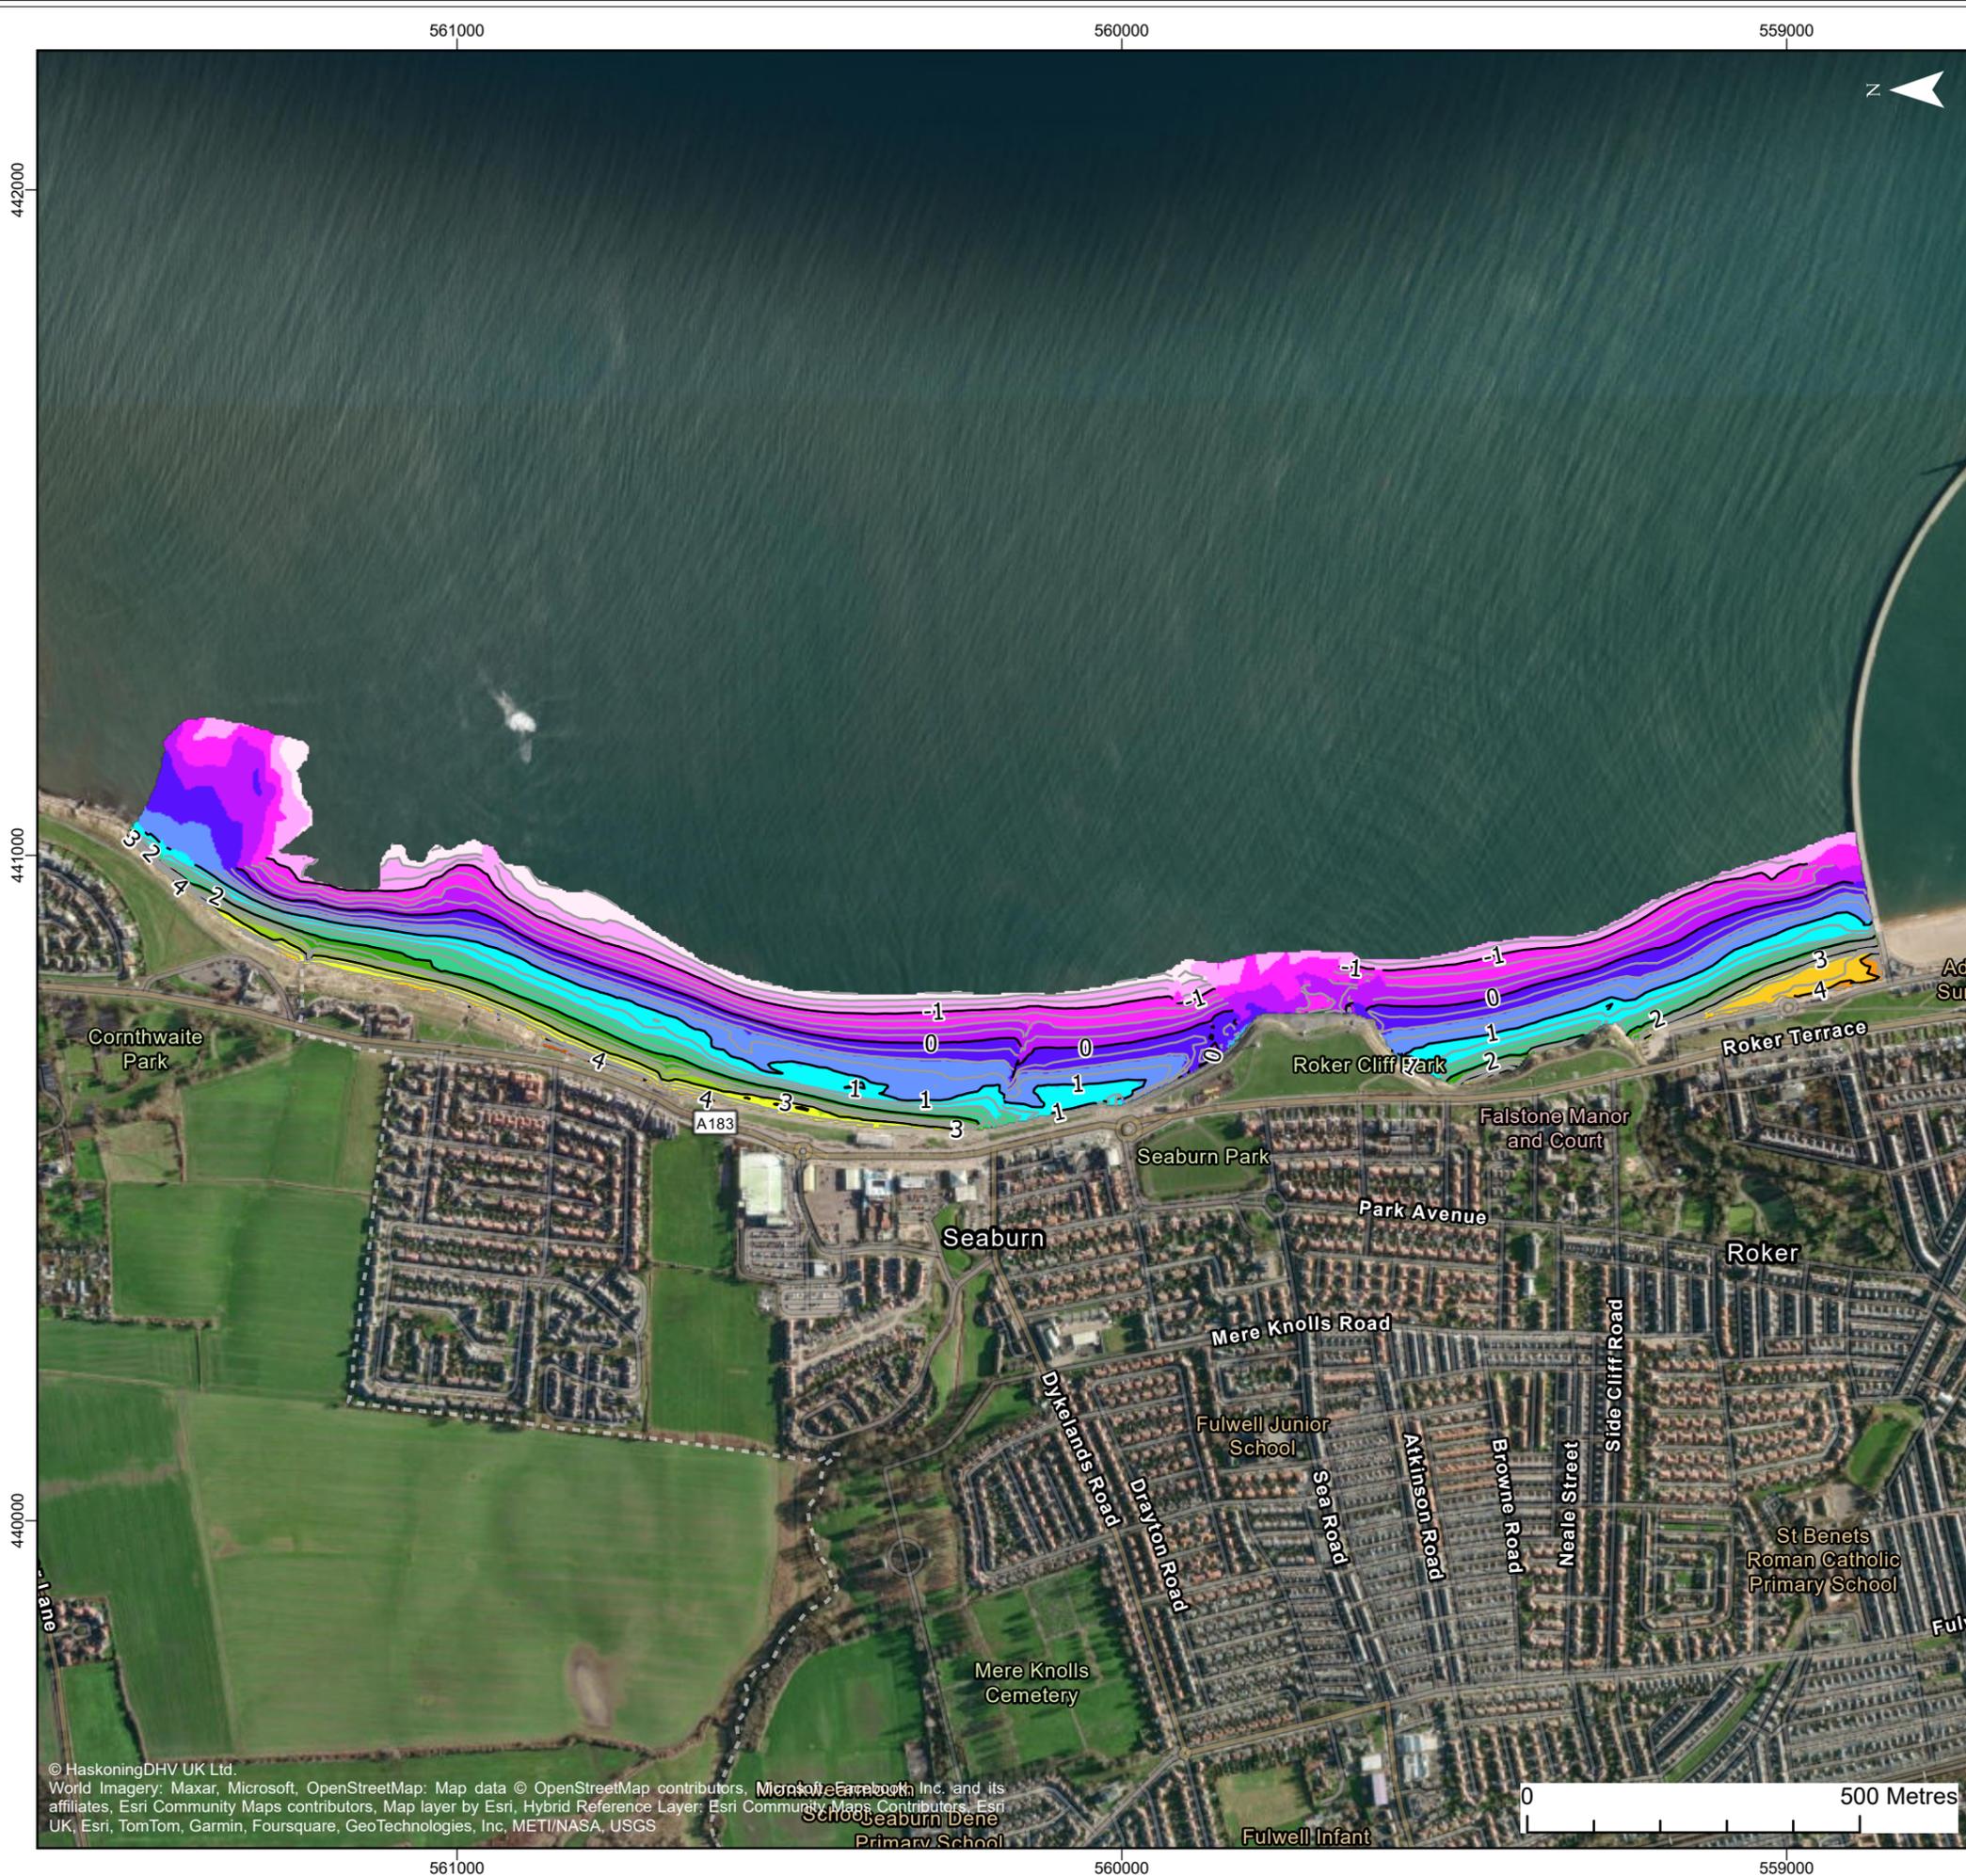
**TOPOGRAPHIC SURVEY** (September 2023)

Sept 2023	<p><b>Topographic Survey:</b></p> <p>Whitburn Bay, between the Bents and Roker Pier, is covered by an annual topographic survey which commenced in September 2009.</p> <p>Data from the most recent topographic survey (Full Measures, autumn 2023) have been used to create a digital ground model (DGM) (Appendix B – Map 1) using GIS. A difference plot has also been produced using the DGM (Appendix B – Map 3) produced from the last produced topographic survey (Full Measures, autumn 2022) and the present survey.</p> <p>The most northerly survey extent has undergone patchy erosion by up to 1.25m. To the south of this, there has been high magnitude erosion across the beach profile (0.75-1.5m). The central beach is dominated by shore-parallel bands of accretion and erosion, generally limited to <math>\pm 0.75</math>m. The south of the survey area has generally undergone little change (<math>\pm 0.1</math>m), with only a few narrow bands of accretion on the middle and lower beach. There are isolated patches of erosion and accretion around Parsons Rocks.</p>	<p>The topographic survey shows that since the last survey, erosion has dominated in the north of the survey area, accretion in the south, with shore-parallel bands of erosion and accretion in the central survey area.</p> <p><b>Longer term trends:</b> The most recent topographic survey is generally in line with topographic trends seen since autumn 2009, showing a dominant trend of accretion with isolated areas of erosion in the north and south of the bay and around Parsons Rocks.</p>
