**Cell 1 Regional Coastal Monitoring Programme
Update Report 4: 'Partial Measures' Survey 2012**

**Sunderland City Council
Final Report**

February 2013

(*) The present report is **Update Report 4** and provides an analysis of the 2012 Partial Measures survey for Sunderland Council's frontage.

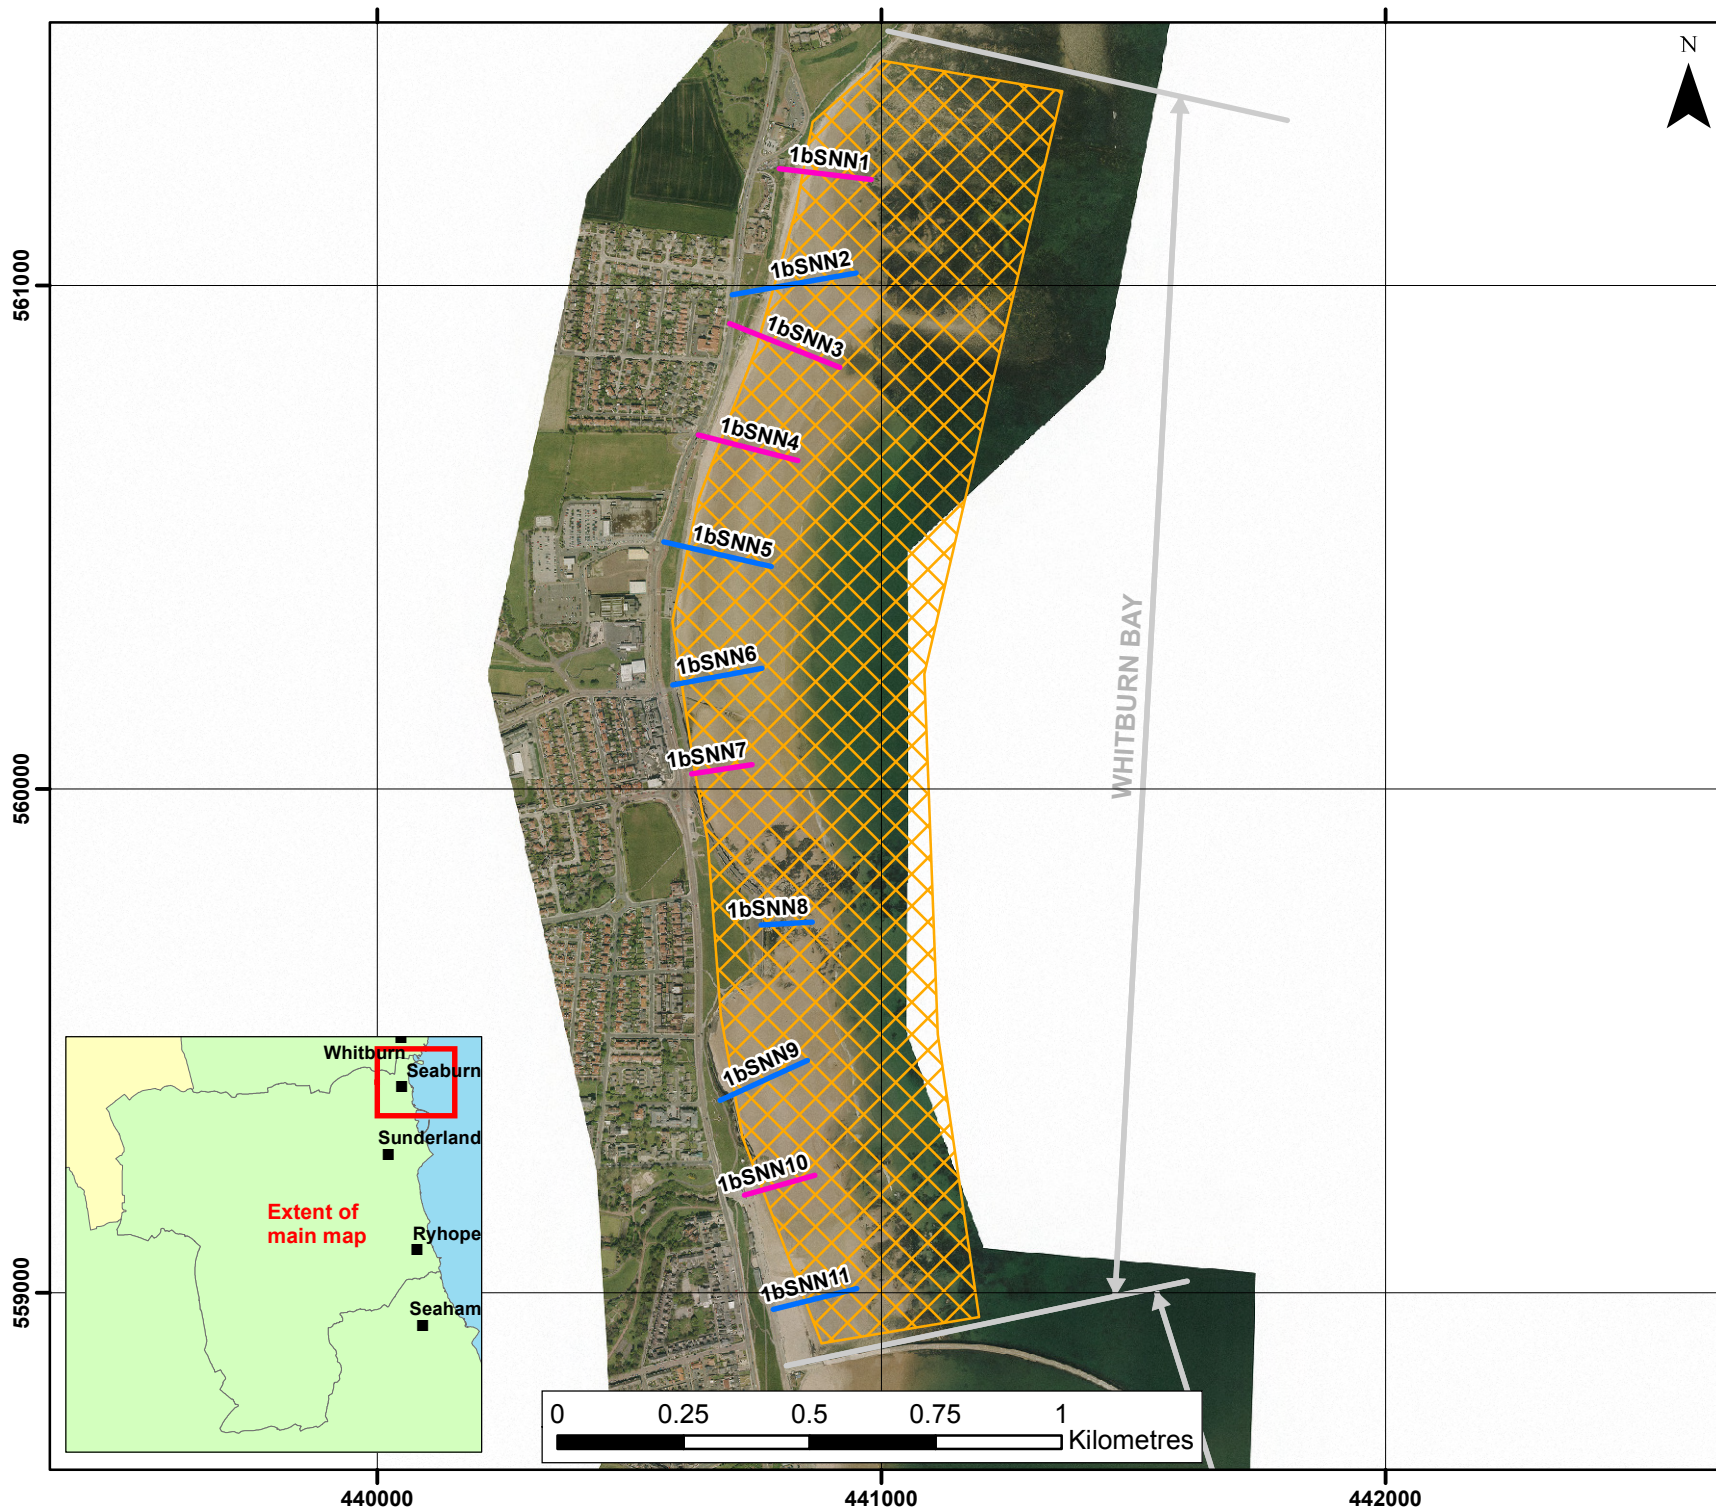
**Figure 2- Map 1
Survey Locations
Whitburn Bay
Sunderland City Council**

The location of these surveys is shown in Figure 2. The Partial Measures survey was undertaken along this frontage on the 20th March 2012 (Whitburn Bay) and between 20th March 2012 and 21st March 2012 (Hendon to Ryhope (incl. Halliwell Banks)). During this time weather conditions varied considerably. Refer to the survey reports for details of the weather conditions over this survey period.

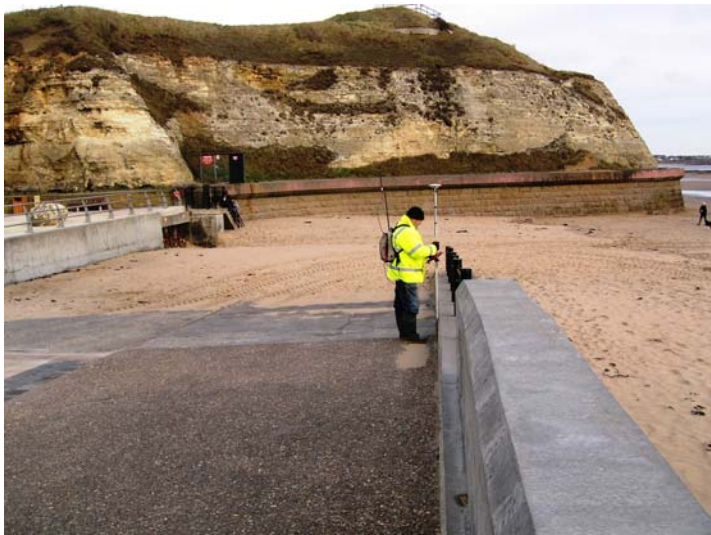
Plate 1 – Survey photograph 1bSNN10_20120320_N1.JPG

Survey Date	Description of Changes Since Last Survey	Interpretation
Mar 2011	<p>Beach Profiles:</p> <p>Whitburn Bay is covered by three beach profile lines for the Partial Measures survey (Appendix A). The last survey was full measures, undertaken in winter 2011.</p> <p>1bSNN1 is just to the south of Sunderland City Council's northerly boundary of jurisdiction. Since the last profile, beach levels at HAT (between 3.6m and 2.8m) have increased by 0.2m. The beach profile seaward of MHWS has retreated by 5m to 10m, however, the beach has retained the same form and gradient as in winter 2011. This suggests some cross-shore movement of material to the upper beach around HAT, which is likely to be due to higher water levels and waves from winter storms. The lower beach (i.e. seaward of a height of 1m / chainage 90m), with the exception of spring 2011 (partial measures) is similar to the profile observed in previous surveys.</p> <p>1bSNN7 is at Seaburn, just to the north of Parson's Rock. Since the last survey, beach levels at the toe of the seawall have dropped up to 0.4m. Seaward of a chainage of approximately 20m, there has been little movement of the beach levels. A drop in levels at the toe of the seawall would be expected over the winter in response to higher water levels and waves from winter storms.</p> <p>1bSNN10 is located approximately mid-way between Parson's Rock and Roker Pier. Since the last survey, beach levels at the toe of the seawall, from HAT to MHWS have increased by up to 0.2m. The survey photograph (see Plate 1) shows the accumulation of sand at the toe of the seawall and on the slipway. The sand is dry and looks to be blown by wind up the slipway. Between a level of 2.0m and -2.0m (chainage 35m and 130m respectively), beach levels have increased by 0.2m. Seaward of -0.2m (chainage 130m), they have increased by approximately 0.1m.</p>	<p>Since the last survey, the beach profiles in Whitburn Bay are showing signs of upper beach accretion and erosion across the middle and lower beach. This behaviour is to be expected over the winter months as some material is moved up the beach to form a berm, whilst other material is drawn down from the beach by storm water levels and waves.</p> <p>Longer term trends: The levels on the upper beach from the full measures (winter 2011) and the present partial measures surveys (spring 2012) are generally the highest observed to date. The partial measures survey for spring 2010 shows that beach levels experienced a significant reduction. Profiles 1bSNN1 and 1bSNN7 have been increasing since then, but experienced a slight reduction since the last survey. The upper beach at 1bSNN10 has continued to accrete since the last survey. This profile is located to the south of the bay and likely to be fed with material supplied from up-drift. The observed wind blown sand suggests that the beach is drying out and material is entrained from the foreshore and then trapped and deposited within the lee of the headland/ seawall/ slipway complex (seen in the photo in Plate 1).</p>

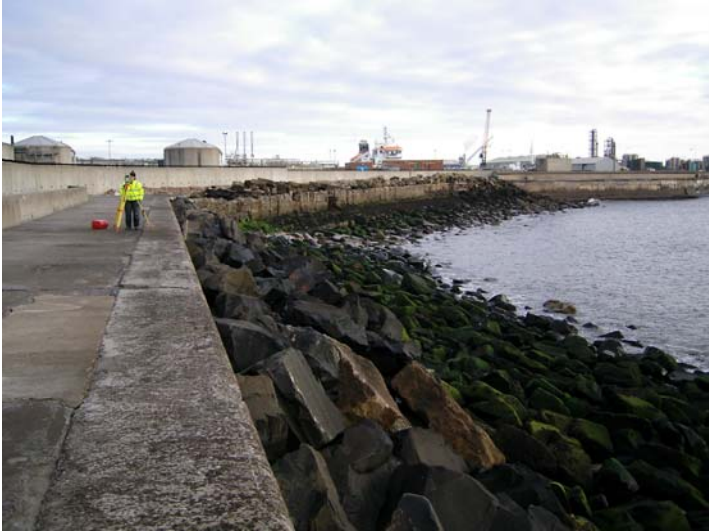
Plate 2 – Survey photograph 1bSNS4_20120321_N2.jpg

Survey Date	Description of Changes Since Last Survey	Interpretation
Mar 2011	<p>Beach Profiles:</p> <p>Hendon to Ryhope is covered by thirteen beach profile lines for the Partial Measures survey (Appendix A). The last survey was full measures, undertaken in winter 2011.</p> <p>Profile 1bSNS4 includes a seawall and rock revetment, after which it extends into water (refer to the survey photograph shown in Plate 2). Therefore it has not been analysed.</p> <p>Profile 1bSNS8 extends across the seawall, rock revetment, a rocky upper beach and sandy middle and lower beach. Since the last survey, beach levels at the toe of the rock revetment to a chainage of 65m, have increased by up to approximately 0.4m. These levels are similar to those observed at a similar time in the previous year (April 2011, partial measures, 2011). Seaward of 65m chainage, the short length of profile surveyed shows no change from the previous survey. Beach levels are similar to those last observed in October 2010 (full measures, winter 2010) and in March 2010 (partial measures, spring 2010). Between those surveys, the beach was higher, suggesting a fluctuation between seasons, whereby beach levels are higher during summer months and lower during winter months.</p> <p>Profile 1bSNS11 starts at the coastal slope/cliff backing the Hendon Sea Wall and extends across the wall and fronting rock armour before reaching sand levels and then extending down to low water. Compared to the last survey, beach levels at the toe of the rock revetment to a chainage of 72m have increased by up to approximately 0.2m. Between a chainage of 72m and 82m, beach levels remain the same. Seaward of 72m to 92m chainage, beach levels have fallen by approximately 0.2m. Beach levels are similar to those last observed in March 2010 (partial measures, spring 2010), which suggests that the beaches have recovered from a previous erosional period.</p> <p>Profile 1bSNS20 is located at Shirley Banks. Since the last survey, the top half of the cliff face appears to have advanced by approximately 0.5m-1m. The cliff has remained stable below this. This may be caused by survey interpretation or the cliffs tendency to heave seawards prior to toppling failure. Beach levels have changed across the foreshore to a chainage of 100m, but very minimally and variably, with some increase and some decrease. The beach here is mostly cobbles and rock with sand interspersed between. The largest increase is located further seaward, between a chainage if 100m and 120m,</p>	<p>Since the last survey, at Hendon (profiles 1bSNS8 and 1bSNS11) beach levels at the toe of the defences have increased. The remainder of the beach has generally remained stable.</p> <p>To the south, at Shirley Banks (south of Saltfern Rocks), the top half of the cliff face appears to have advanced, however, the bottom half of the cliffs have remained stable. The beaches have changed slightly, however, this change is similar to that observed for previous surveys.</p> <p>The cliffs at Halliwell Banks, between profiles 1bSNS25 and 1bSNS33 are eroding, which is evident by accumulation of debris at the cliff toe. Beach levels have largely stayed the same, however, between a level of 0m and 1m, beach levels have reduced by approximately 0.1m. This would be expected as sand is drawn down from the beach during from the beach by storm water levels and waves.</p> <p>Longer term trends: At Hendon, beach levels are similar to those last observed in October 2010 (full measures, winter 2010) and in March 2010 (partial measures, spring 2010), however, between those surveys, beach levels were higher. This suggests that beach levels fluctuate between seasons, being her in the summer months and lower in the winter months.</p>

Profile 1bSNS4 includes a seawall and rock revetment, after which it extends into water. Therefore it has not been analysed. It is uncertain why this profile has been surveyed, unless it is specifically to monitor changes to the rock revetment. If so, it is suggested that the method used to survey this profile is reviewed for suitability.

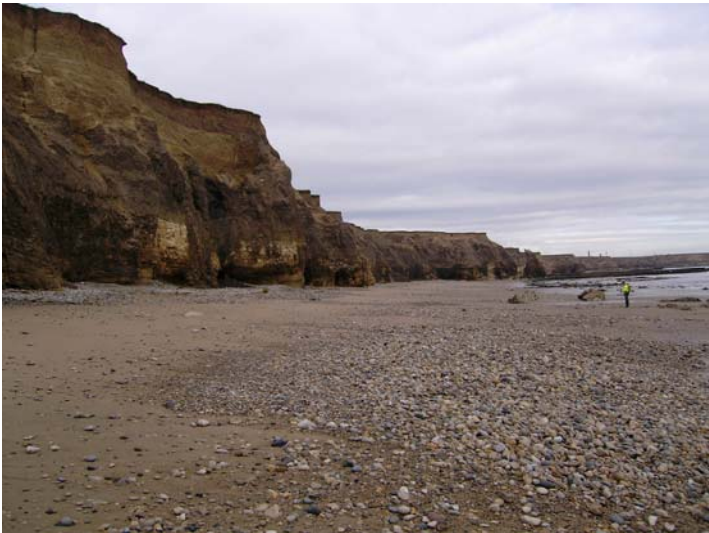
Plate 3 – Survey photograph 1bSNS25_20120321_N4.JPG

Survey Date	Description of Changes Since Last Survey	Interpretation
	<p>where the beach is mostly sand. Here beach levels have increased by approximately 0.5m. This change is very similar to that observed for previous surveys.</p> <p>Profile 1bSNS25 is located at Halliwell Banks. Since the last survey, the cliff face has retained the same form and position since the last survey. Beach levels have increased slightly across most of the profile by up to 0.2m, with the exception to a level of between 0m and 1m where they have reduced. The survey photograph (see Plate 3) shows the accumulation of shingle at the toe of the cliff and across the upper beach.</p> <p>Profiles 1bSNS26 to 1bSNS33 are all located at close spacings at Halliwell Banks specifically to assess risks from erosion at a former land fill. Cliff height is characteristically around 26m and 27mODN, with beaches at the toe typically at levels between 3.3m and 3.9mODN.</p> <p>At Profiles 1bSNS26, 1bSNS28, 1bSNS30 and 1bSNS32, the cliff toe has moved seawards and beach levels at the cliff toe (around HAT/MHWS) have increased. At profile 1bSNS27, the cliff face at the top of the cliff appears to have moved seawards by about 0.5m. The survey report for Sunderland South notes that <i>'there are a number of cliff top and bottom slumps that are evident.'</i> As with the previous survey report, the changes observed for the cliffs could therefore relate to slumping of the toe of this cliff, the cliffs tendency to heave seawards prior to toppling failure, or it may be caused by survey interpretation. At profile 1bSNS29, the cliff toe has receded. At profile 1bSNS33, the cliff face has not changed in form or position since the last survey.</p> <p>At all profiles, from 1bSNS26 to 1bSNS33, beach levels have largely stayed the same since the last survey. There is noticeable trend, whereby at all profiles, between a level of 0m and 1m, beach levels have reduced by approximately 0.1m. This zone of the beach is comprised of sand, and is a well defined zone that is seawards of the upper shingle beach that has accumulated at the cliff toe. This is shown in the survey photograph for profile 1bSNS28 (see Plate 4).</p>	<p>At Shirley Banks, the cliffs have remained stable and beach levels have fluctuated, but overall remained largely stable.</p> <p>At Halliwell Banks, the cliffs have been subject to erosion. Material eroded from cliff top retreat has been deposited at the cliff toe. As the previous reports (full measures, winter 2010 and winter 2011), notes <i>'the cliffs along this frontage have a characteristic tendency to heave seawards prior to a toppling failure, leading to apparent discrepancies in the data where the cliff edge can appear to 'grow' seawards.'</i> This cliff behaviour may also result in health and safety issues for the survey team relating to the access under potentially unstable cliffs. Refer to additional data analysis of cliff top survey data below.</p> <p>Beach levels have fluctuated since the last survey (full measures, 2010), the sand portion of the beach between the shingle at the cliff toe and the shingle on the middle beach has been subject to erosion. However, over the longer term, present beach levels are the highest since those observed in March 2010.</p>

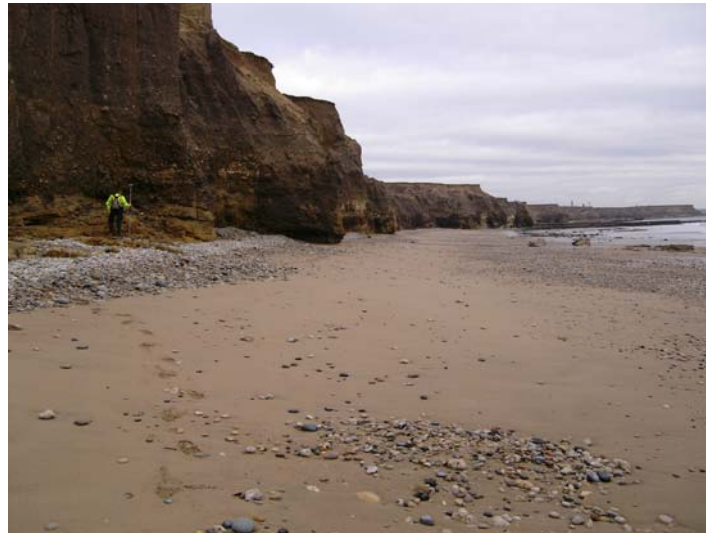
Plate 4 – Survey photograph 1bSNS28_20120321_N4.JPG

Oct 2011	<p>Cliff-top Survey:</p> <p>32 ground control points (numbered 1-32) were established along the cliff top between Hendon and Ryhope in March 2009, with a further three (28A, 28B and 28C) added in September 2009. Note: the numbering of ground control points is not intended to correlate with that of the beach profile lines and reference should be made to Appendix B - Map 1 and Appendix B – Map 2 for the location of ground</p>	<p>Since the last survey, the cliffs to the south of Sunderland Docks, at Hendon, opposite the works have eroded.</p> <p>To the south of there, Points 7 to 32 are recorded to have accreted, due to problems in identification of the cliff top where thick vegetation is present.</p>

At profiles 1bSNS26 to 1bSNS32, the plotted profiles appear to show the cliff face to have accreted. This could be related to debris from cliff falls at the toe, slumping of the toe of this cliff, the cliffs tendency to heave seawards prior to toppling or survey interpretation (as described in Cliff Top Surveys below). Such cliff behaviour could bring about health and safety issues relating to the surveying of the cliff toe where the cliffs are unstable or overhanging, resulting in different interpretation of the survey locations.
