**Cell 1 Regional Coastal Monitoring Programme  
Update Report 5: 'Partial Measures' Survey 2013**

**Sunderland City Council  
Final Report**

**June 2013**

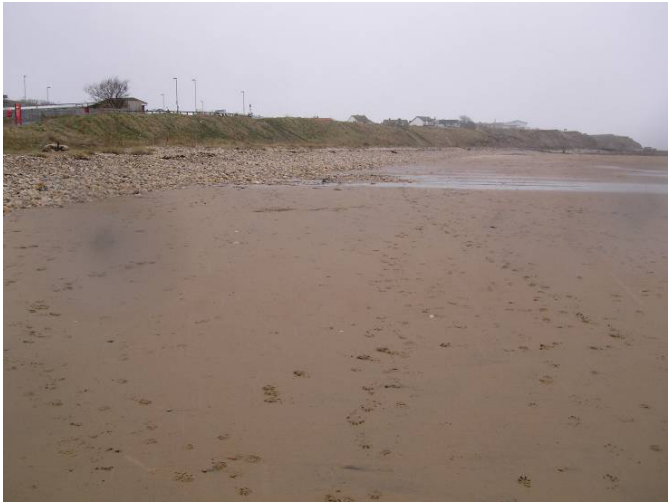
Plate 1 – Survey photograph 1bSNN1\_20130313\_N3.JPG

Survey Date	Description of Changes Since Last Survey	Interpretation
Mar 2013	<p><b>Beach Profiles:</b></p> <p>Whitburn Bay is covered by three beach profile lines for the Partial Measures survey (Appendix A). The last survey was Full Measures, undertaken in autumn 2011.</p> <p><b>1bSNN1</b> is just to the south of Sunderland City Council's northerly boundary of jurisdiction. Since the last survey, beach levels on the upper beach (between HAT and a level of 1.4m) have reduced by 0.4m. As shown by the survey photographs in Plate 1 and Plate 2, the composition of the upper beach has changed from cobbles overlain by sand to just cobbles. This suggests some form of sediment sorting has occurred with preferential draw down of sand-sized sediment, which is a typical response to storm waves. Seaward of a level of 1.4m (chainage 80m), beach levels have increased by up to 0.6m to form a berm. The survey photograph in Plate 3 shows the presence of small berms/hummocks, indicative of stormy conditions. Material eroded from the upper beach could have also been transported across shore and deposited here.</p> <p><b>1bSNN7</b> is at Seaburn, just to the north of Parson's Rock. Beach levels have dropped considerably since the last survey, with up to 1.4m loss at the seawall/beach interface. The amount of change in beach level decreases in a seaward direction, such that the profile of the beach is flatter than the previous survey.</p> <p><b>1bSNN10</b> is located approximately mid-way between Parson's Rock and Roker Pier. Since the last survey, beach levels have dropped considerably across the profile, by up to 1m. The beach profile has changed from one with a continuous slope to one that is more steeply sloping to a chainage of 100m, seaward of which a large, low berm has formed.</p>	<p>Along the length of Whitburn Bay since the last survey, beach levels have fallen across the width of the beach. To the north of the bay, lowering of beach levels of the upper beach is offset by an increase of beach levels on the lower shore. However, to the centre and south of the bay, beach levels have fallen across the profile. Sediment sorting, with preferential erosion of sand, has occurred, leading to the upper beach having a surface of cobbles. These changes suggest the occurrence of significant storms over the winter months, which has resulted in draw-down of the overlying sand (and a lowering of beach levels), and its storage on the lower beach or further offshore.</p> <p><b>Longer term trends:</b> At all locations in Whitburn Bay, beach levels are the lowest observed to date (April 2009, when monitoring began). This suggests that the storms that occurred over the winter 2012/2013 were particularly strong.</p>

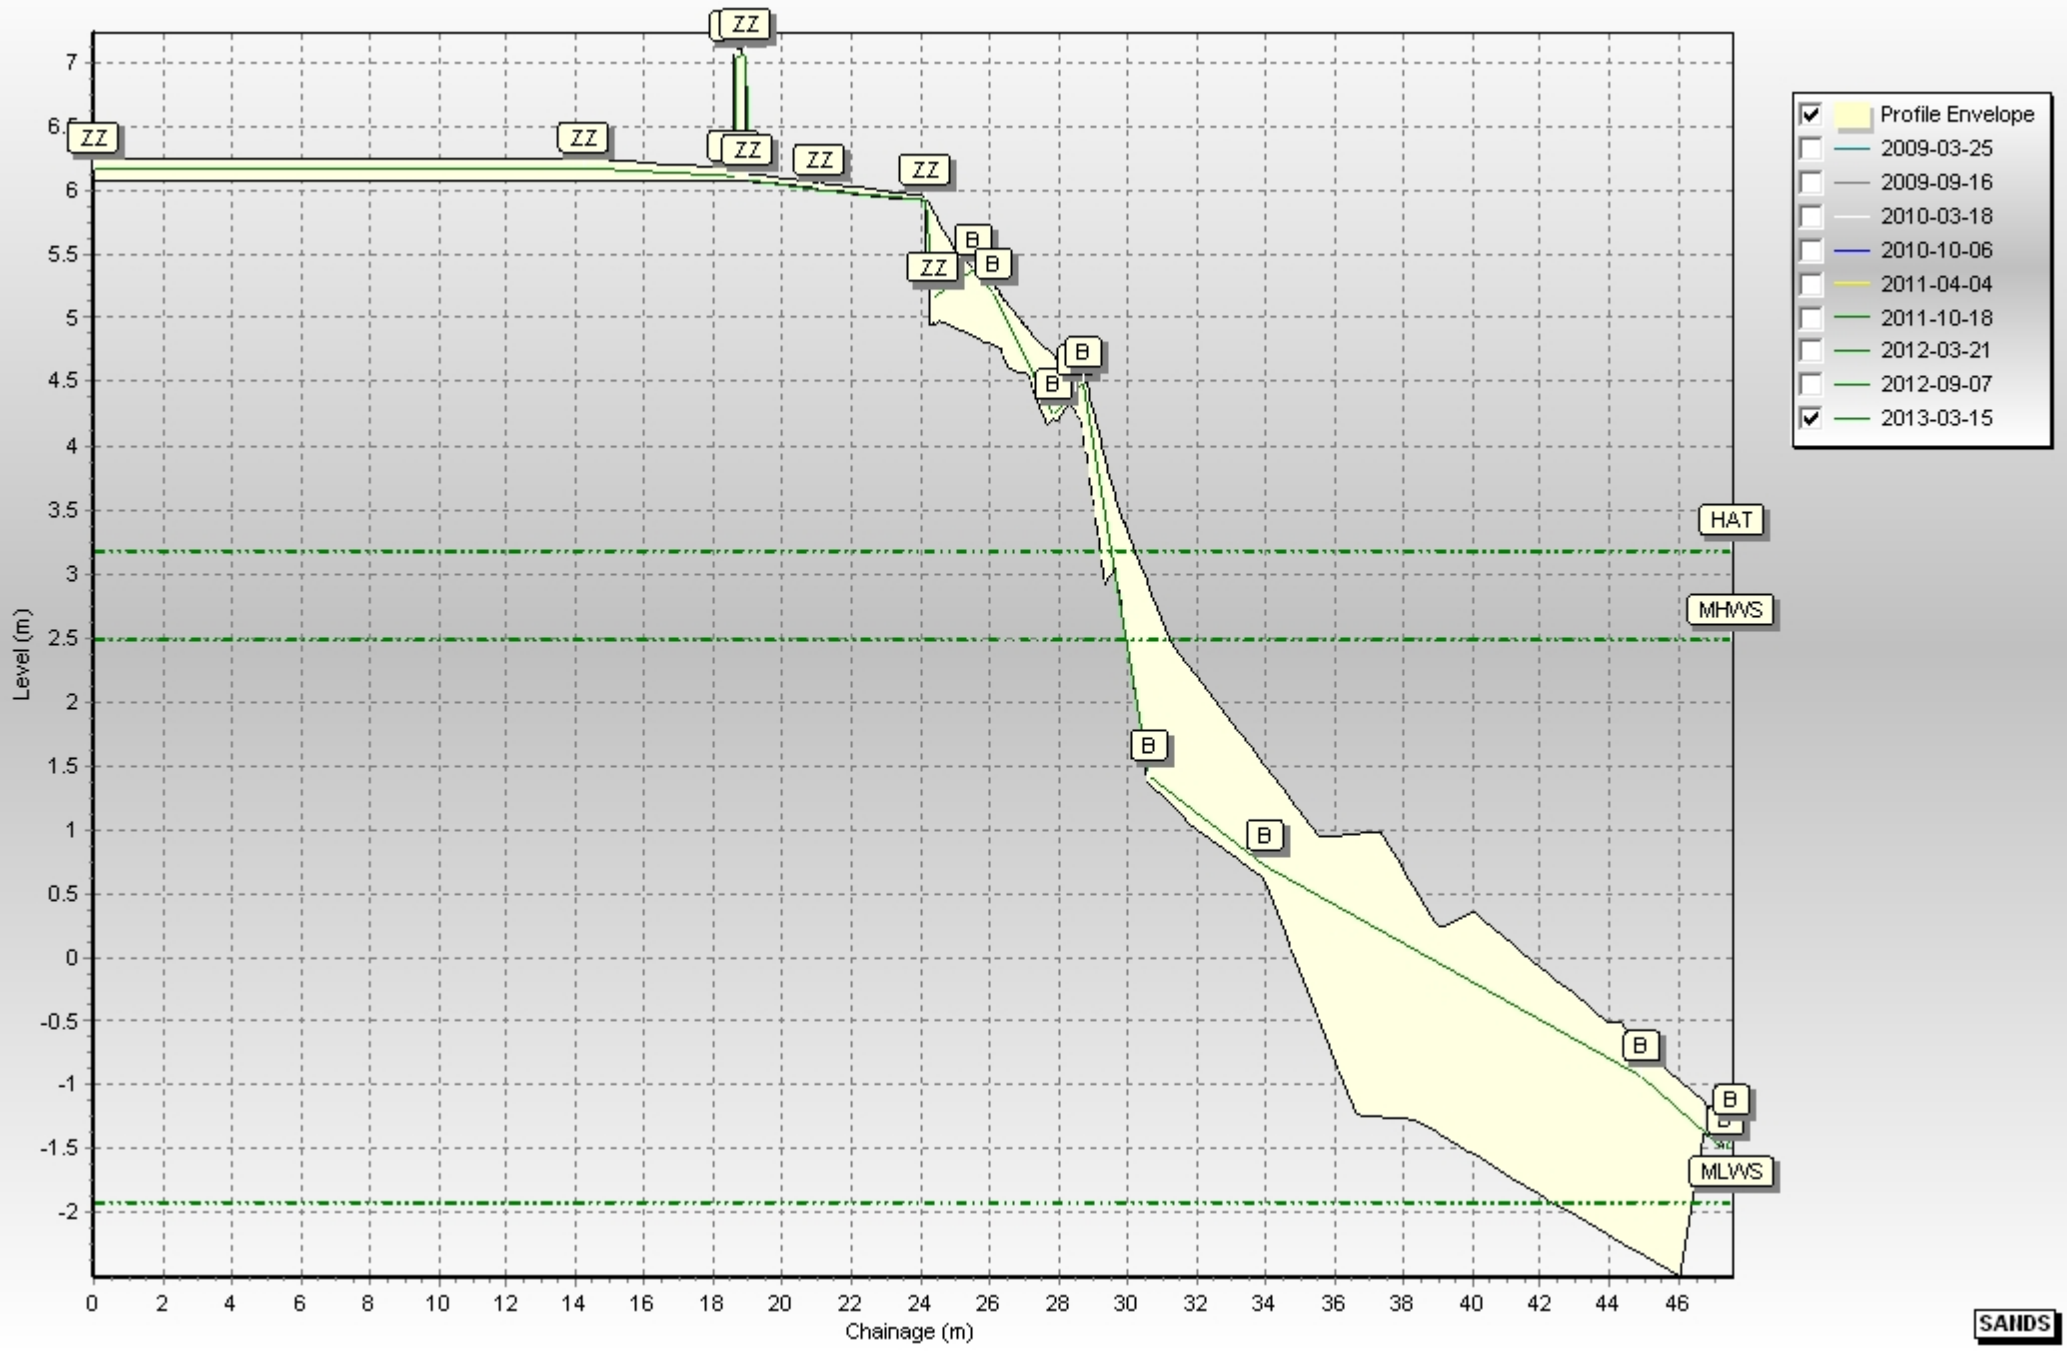
Profiles: 1bSNS4

Profile 1bSNS4 includes a seawall and rock revetment, after which it extends into water. Therefore it has not been analysed. It is uncertain why this profile has been surveyed, unless it is specifically to monitor changes to the rock revetment. If so, it is suggested that the method used to survey this profile is reviewed for suitability.

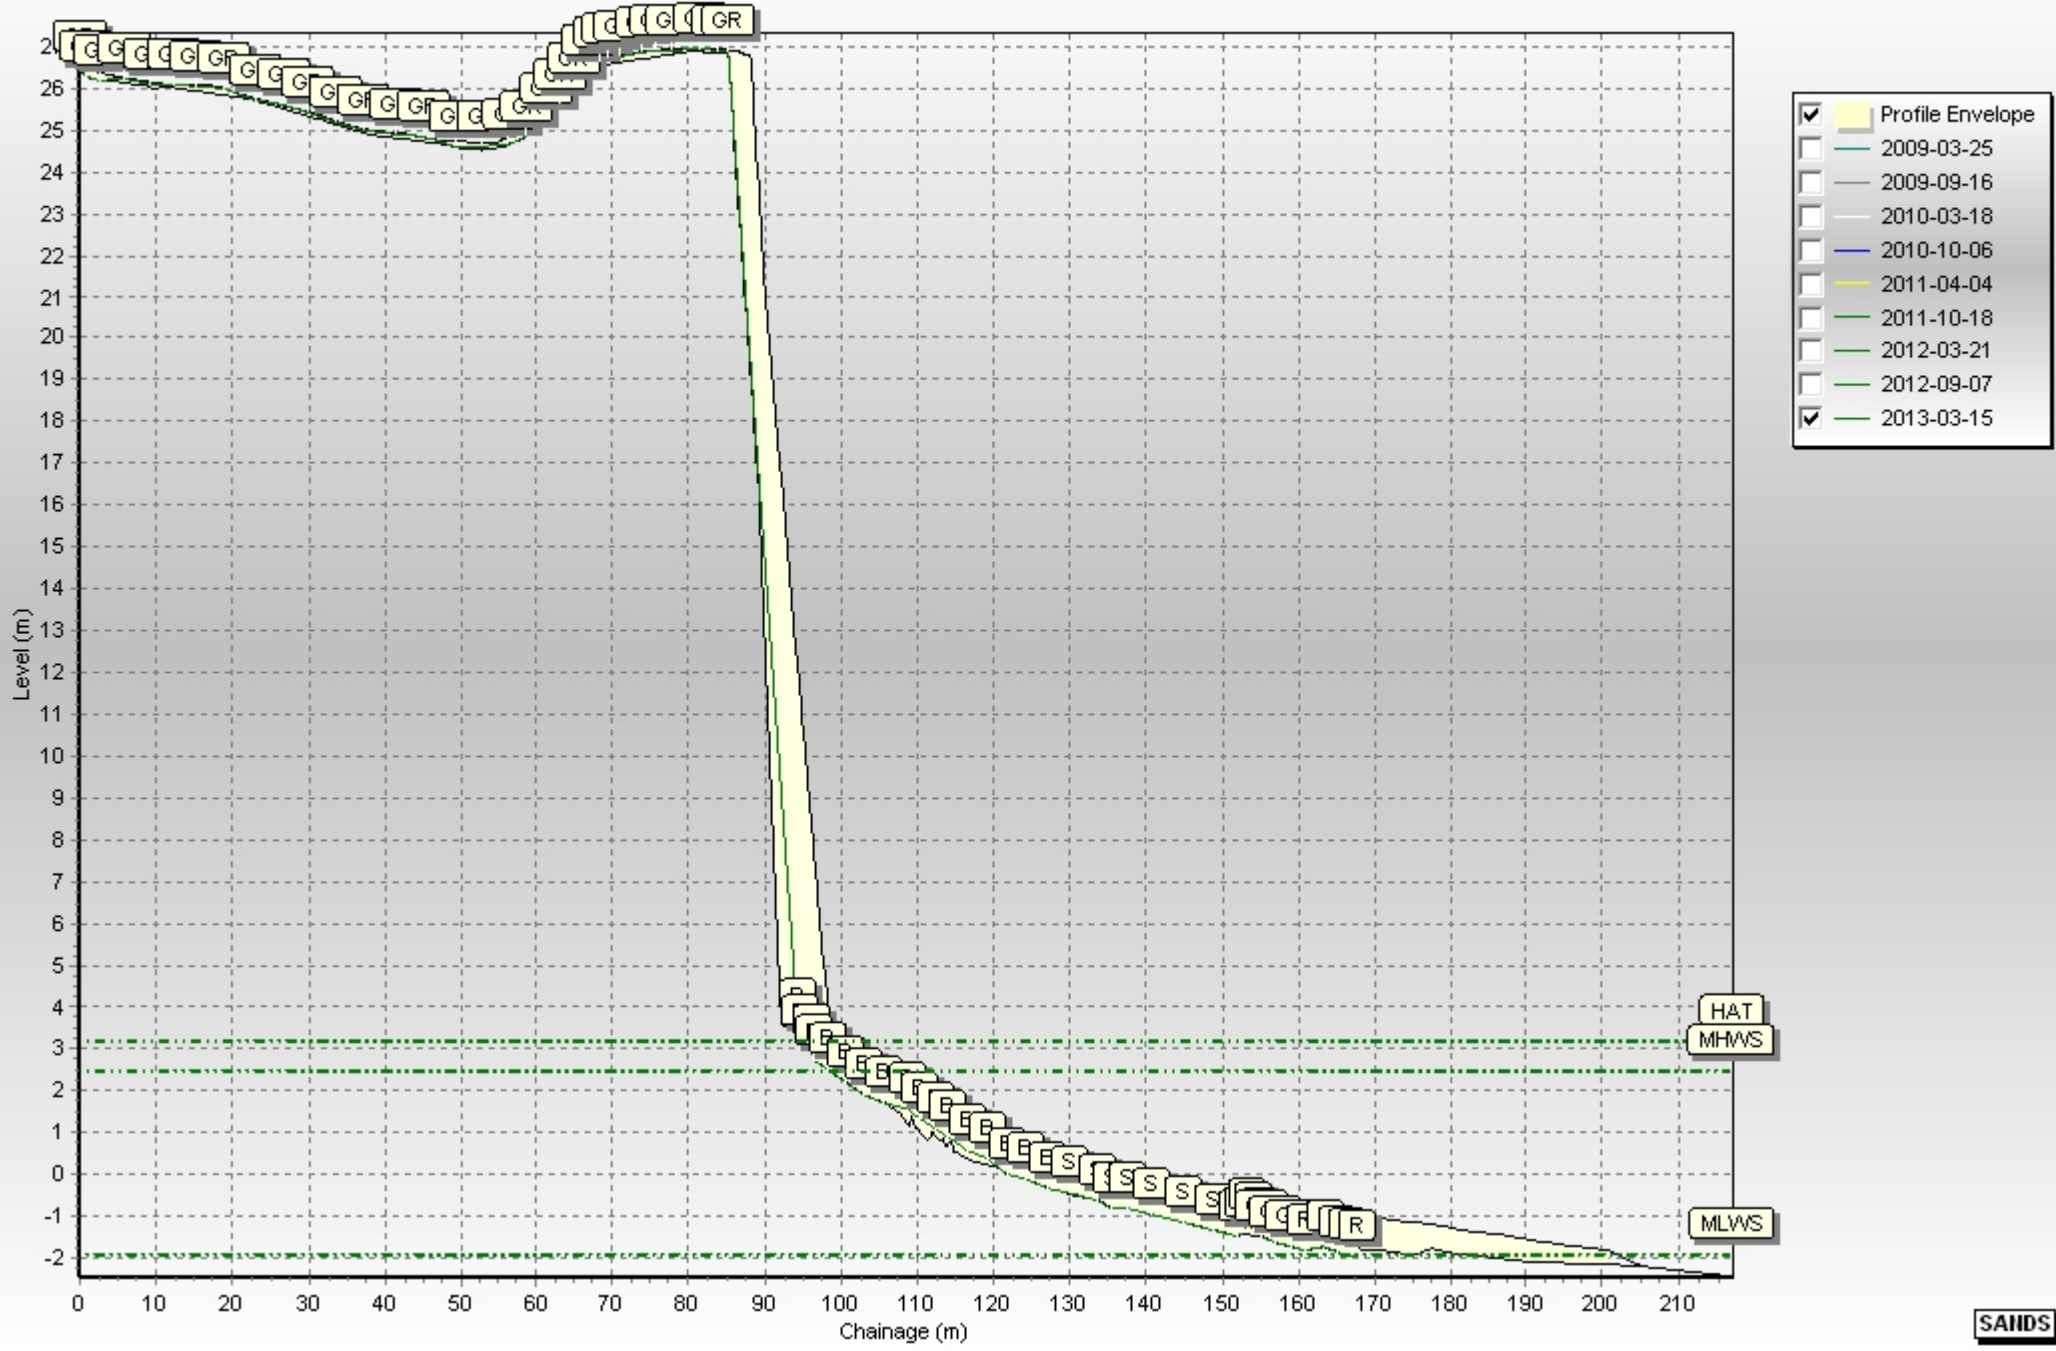
Profiles: 1bSNS27

At profiles 1bSNS27, the plotted profile appears to show the cliff face to have accreted. This could be related to debris from cliff falls at the toe, slumping of the toe of this cliff, the cliffs tendency to heave seawards prior to toppling or survey interpretation (as described in Cliff Top Surveys below). Such cliff behaviour could bring about health and safety issues relating to the surveying of the cliff toe where the cliffs are unstable or overhanging, resulting in different interpretation of the survey locations.

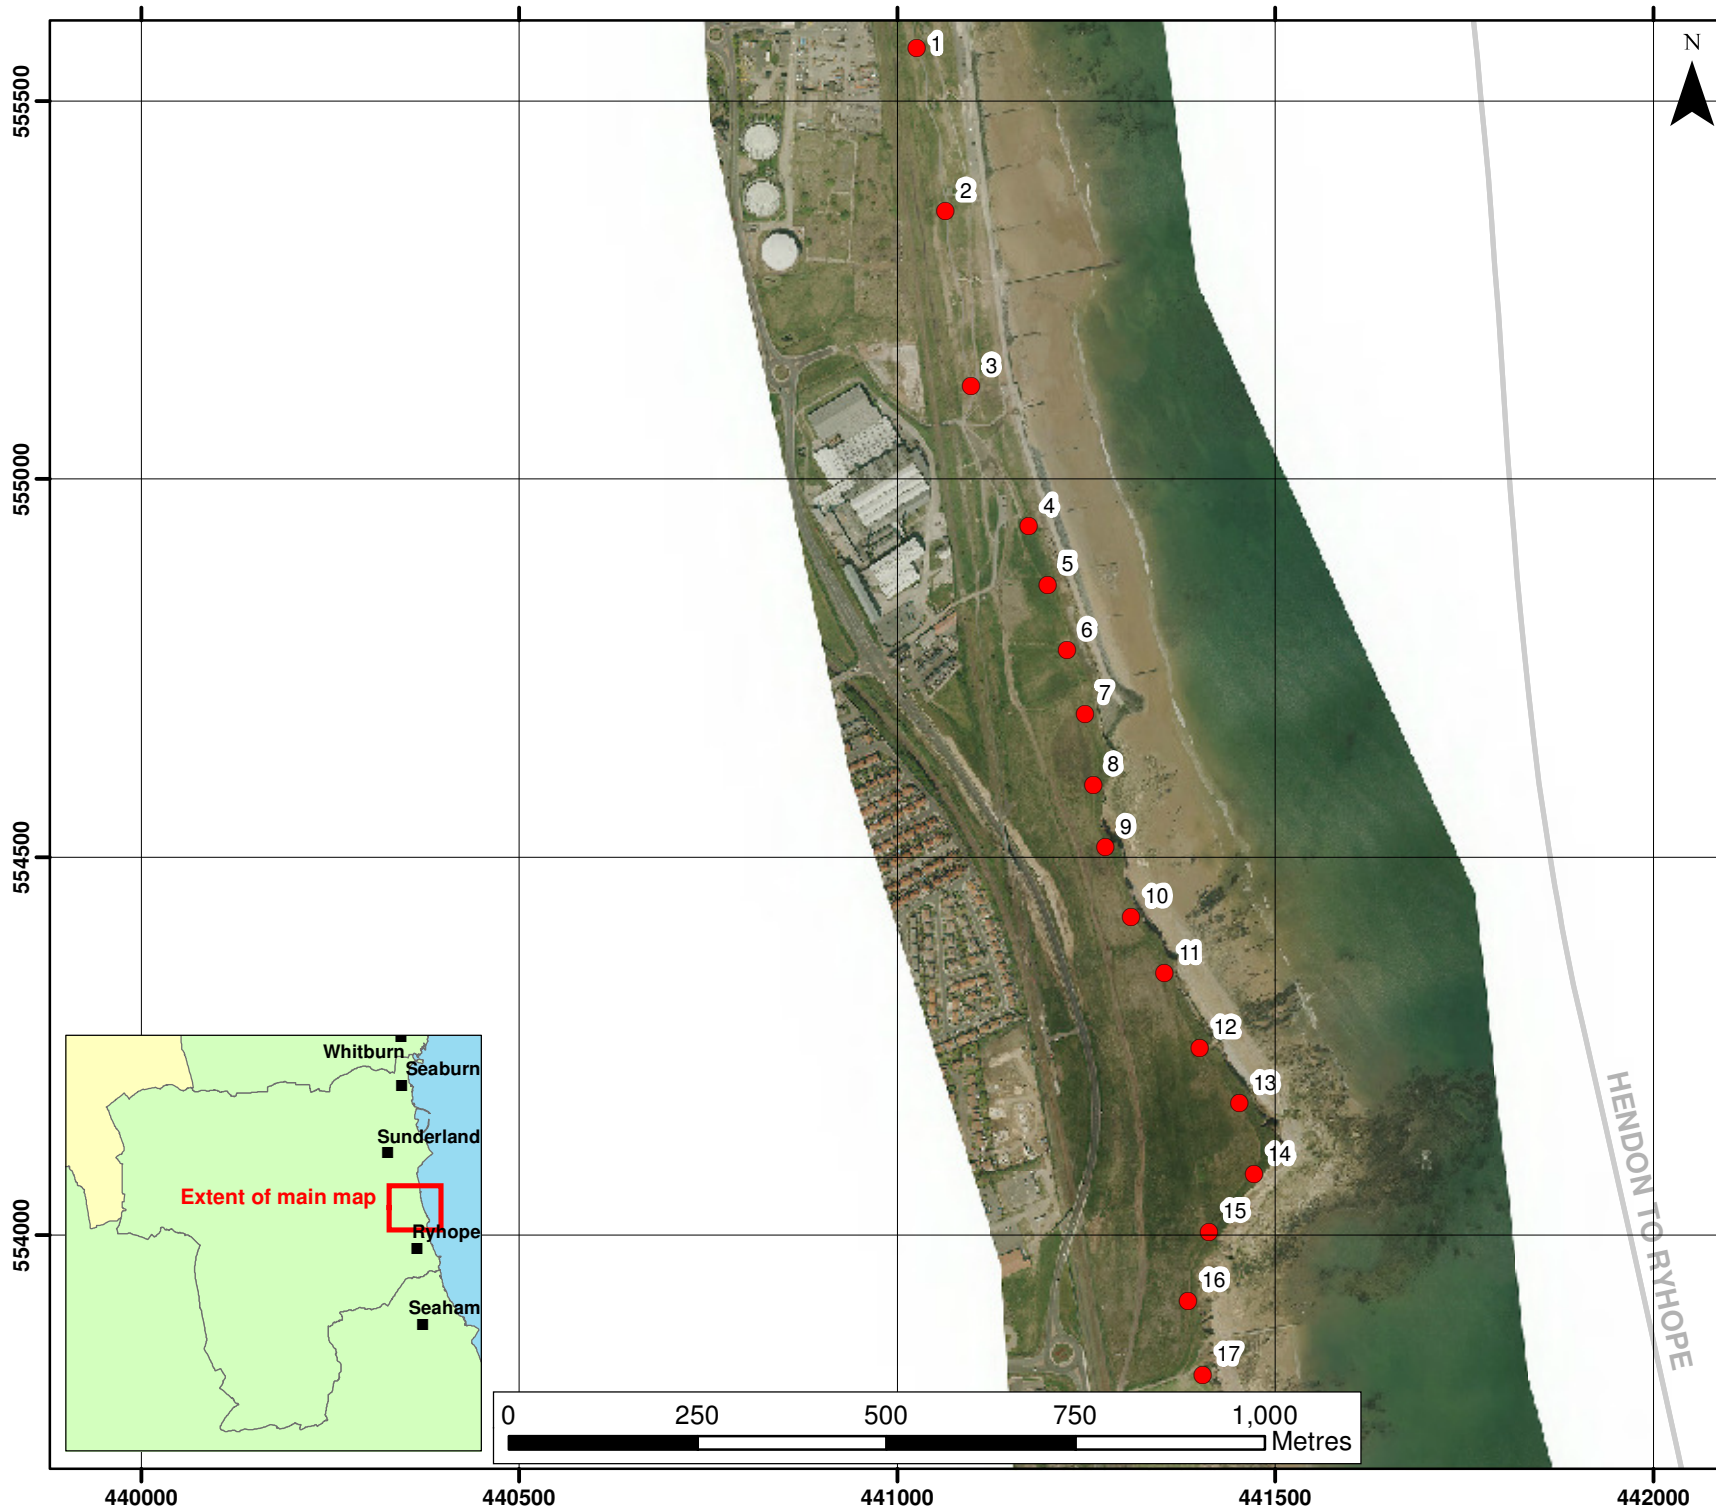
**Appendix B - Map 1  
Ground Control Points  
Hendon to Ryhope North  
Sunderland City Council**

Thirty-two ground control points have been established between Hendon and Ryhope (Map 1 and Map 2). The maximum separation between any two points varies along the coast, reflecting the degree of risk from the erosion.

The cliff top surveys between Hendon and Ryhope are undertaken bi-annually. Measurements are taken from a fixed ground control point along a fixed bearing to the edge of the cliff top.
