**Cell 1 Regional Coastal Monitoring Programme
Update Report 6: 'Partial Measures' Survey 2014**

**Sunderland City Council
Final Report**

July 2014

(*) The present report is **Update Report 6** and provides an analysis of the 2014 Partial Measures survey for Sunderland City Council's frontage.

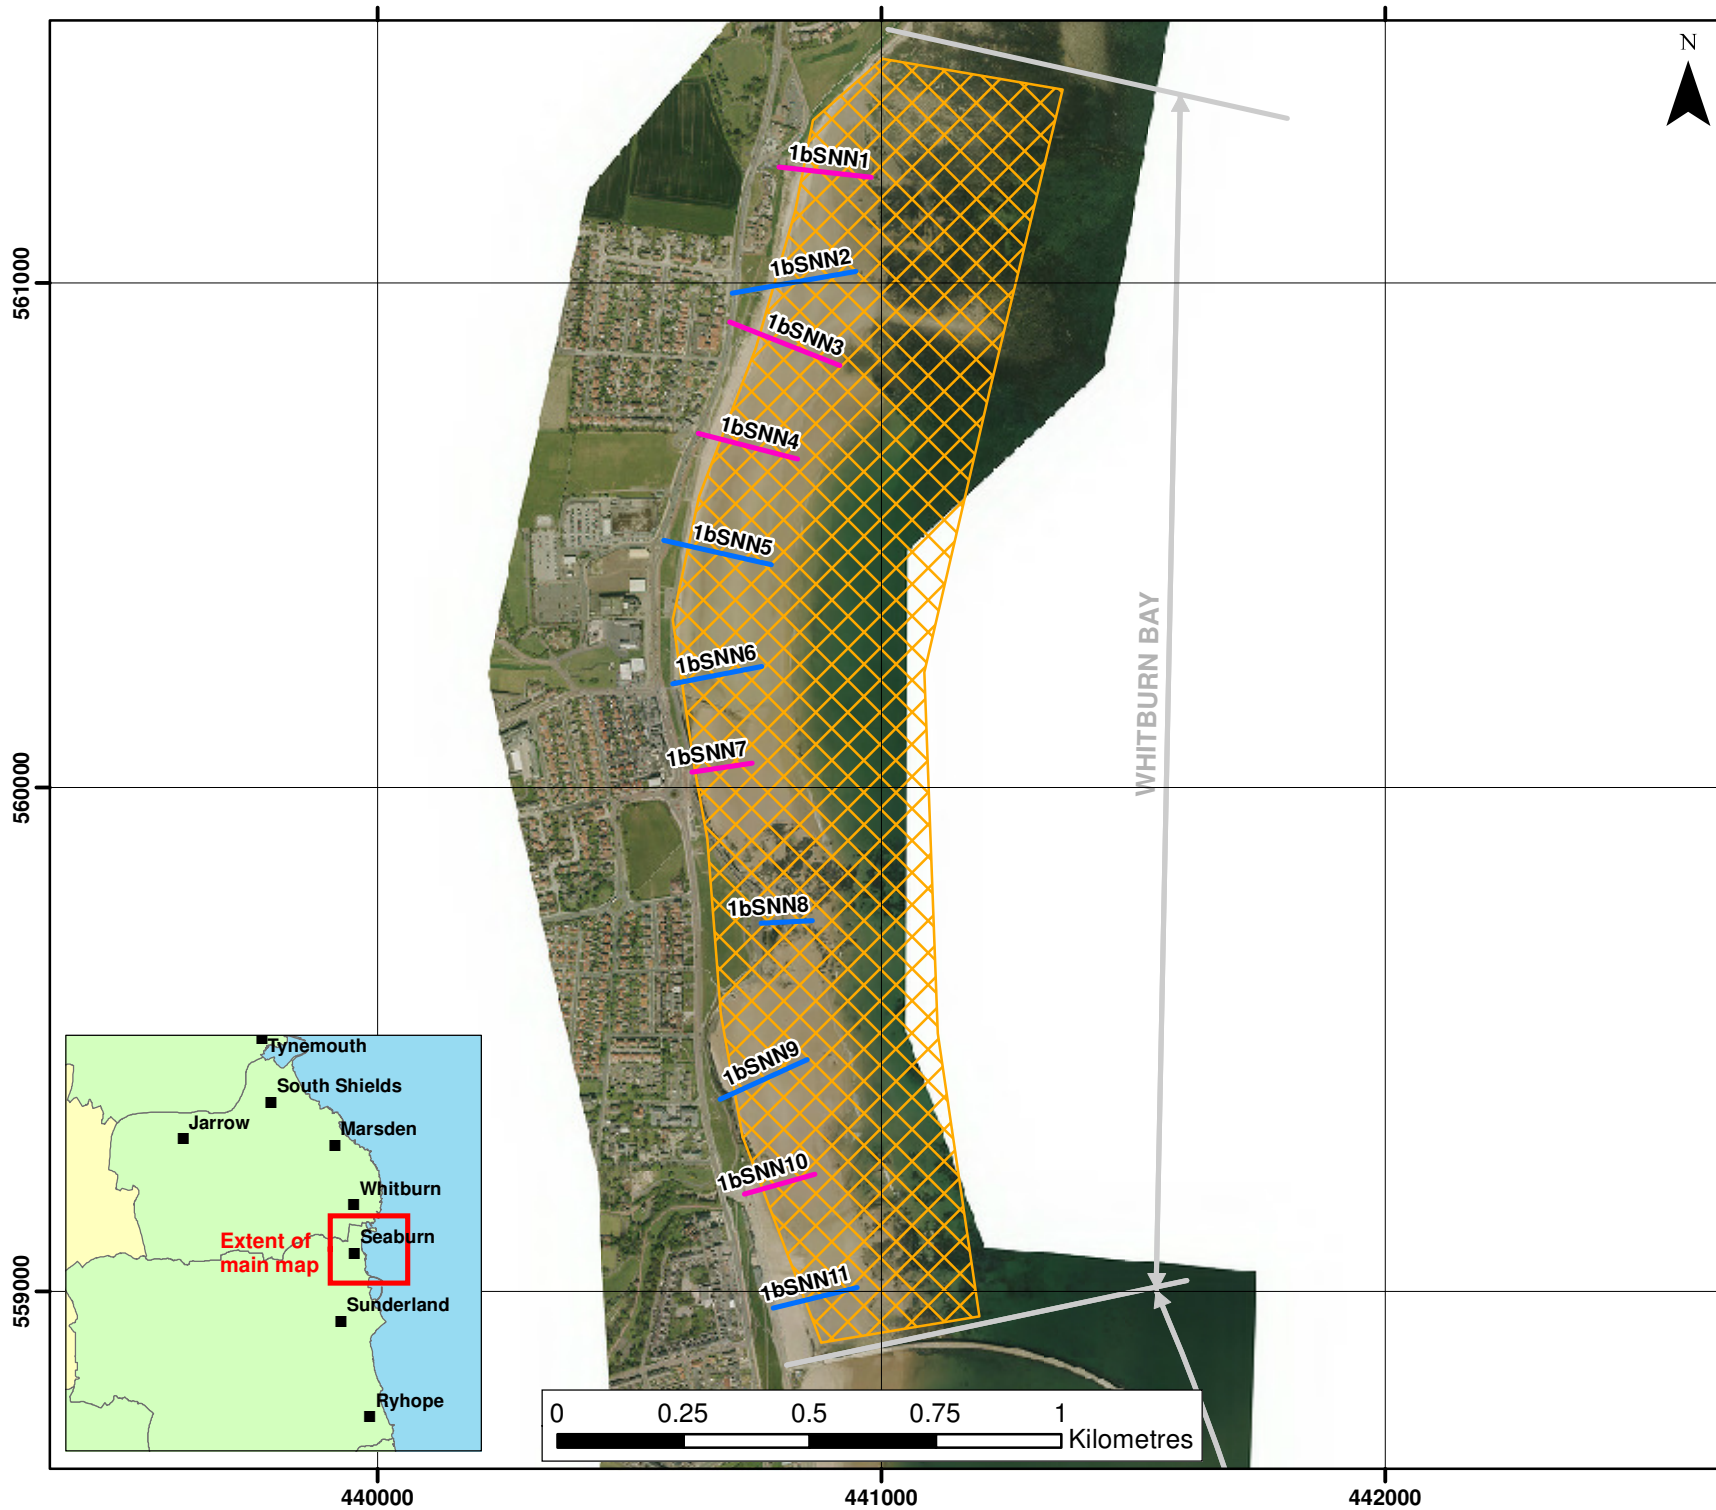
Figure 2- Map 1
Survey Locations
Whitburn Bay
Sunderland City Council

The location of these surveys is shown in Figure 2. The Partial Measures survey was undertaken along this frontage on the 20th March 2014 (Whitburn Bay) and 5th March 2014 (Hendon to Ryhope (incl. Halliwell Banks)). During this time weather conditions varied considerably. Refer to the survey reports for details of the weather conditions over this survey period.

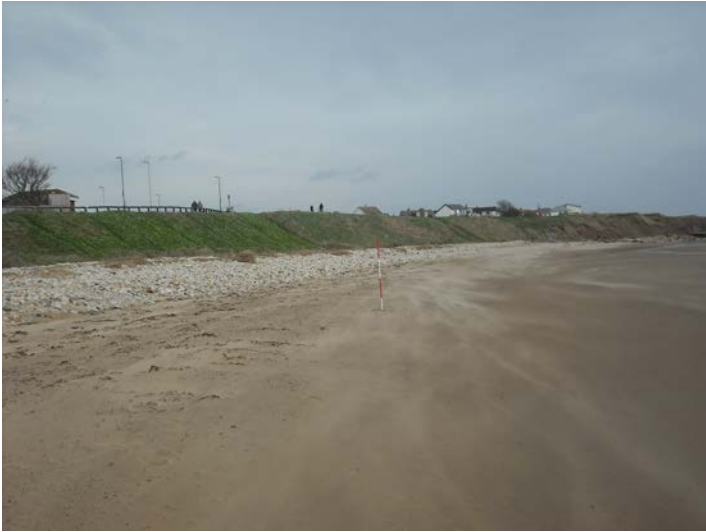
Plate 1 – Survey photograph 1bSNN1_20140320_N3.JPG

Survey Date	Description of Changes Since Last Survey	Interpretation
Mar 2014	<p>Beach Profiles:</p> <p>Whitburn Bay is covered by three beach profile lines for the Partial Measures survey (Appendix A). The last survey was Full Measures, undertaken in autumn 2013.</p> <p>1bSNN1 is just to the south of Sunderland City Council's northern boundary. Since the last survey the boulder section at the toe of the dunes down to HAT has increased in level. Here boulders and cobbles have filled in a trough in the vegetated dune area (Plate 1 and Plate 2). This material may have been transported here by wave action during the winter storms. From here the upper beach has steepened and cut back slightly. On the lower beach, seaward of a level of 1.4m, beach levels have increased by up to 0.5m to form a berm. 1bSNN7 is at Seaburn, north of Parson's Rock. Beach levels have varied since the last survey, with the berm feature moving landwards up the beach. Levels have reduced at the toe of the seawall (within 2.5m of the structure). The upper beach and around MLW show an increase in level of up to 0.5m and the middle beach, between 100m and 140m chainage, shows a decrease in level of up to 0.45m.</p> <p>1bSNN10 is located approximately mid-way between Parson's Rock and Roker Pier. Since the last survey, the beach profile has flattened out to form a more continuous slope with less gradient changes. The beach levels have increased by up to 0.3m on the upper beach (above 0m ODN). On the lower beach the berm previously present at around 0mODN is no longer present and beach levels have decreased by approximately 0.4m.</p>	<p>Along the length of Whitburn Bay there is no significant trend of erosion or accretion since the last survey. However, there has been a change in profile shape as material has been redistributed. To the north of the bay, a berm feature has developed on the lower beach with steepening of the upper beach. To the centre of the beach the berm has moved landwards. To the south of the bay, the upper beach has accreted while the lower beach has eroded and the previously observed berm is no longer present.</p> <p>Longer term trends: In general profiles in Whitburn Bay are within the bounds of previous surveys and impacts of the storm surge cannot be identified. The exceptions to this are:</p> <p>At 1bSNN1 the profile shows the highest level recorded to date at the location of the berm (chainage 100m to 180m).</p> <p>At 1bSNN10 the toe of the profile is the lowest recorded to date, (seaward of a chainage of 100m).</p>

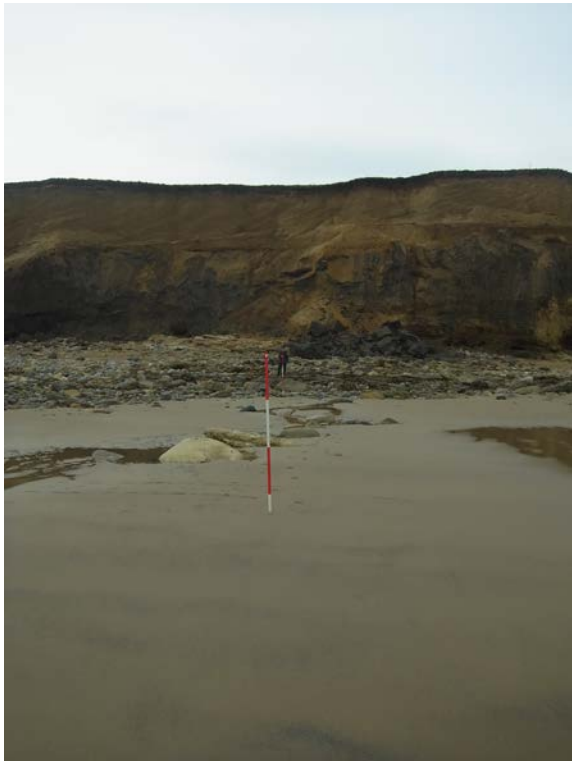
Plate 3 – Survey photograph 1bSNS28_20140305_Up2.JPG

Survey Date	Description of Changes Since Last Survey	Interpretation
	<p>toe of the beach, seawards of the rocky middle beach.</p> <p>At Profiles 1bSNS27 and 1bSNS28, the cliff has eroded by approximately 2m and 1m respectively. Plate 3 shows evidence of a landslide in this area, indicating the cause of the cliff recession. Beach levels have dropped slightly across the beach profiles.</p> <p>At profiles 1bSNS29 to 1bSNS33, the cliff top has remained stable, but the cliff toe has cutback, indicating that waves have removed material from the top of the beach during the winter storms. The upper beach levels have decreased across each of the profiles. Erosion seems to be greater at the southernmost profiles with cliff recession of just over 1m and beach lowering of 0.65m at profile 1bSNS29 and cliff recession of 5m and beach lowering of about 0.8m at profile 1bSNS33.</p>	
Mar 2014	<p>Cliff-top Survey:</p> <p>32 ground control points (numbered 1-32) were established along the cliff top between Hendon and Ryhope in March 2009, with a further three (28A, 28B and 28C) added in September 2009. Note: the numbering of ground control points is not intended to correlate with that of the beach profile lines and reference should be made to Appendix B - Map 1 and Appendix B – Map 2 for the location of ground control points.</p> <p>Measurements are taken from each ground control point along a fixed bearing to the edge of the cliff top. These cliff top surveys are undertaken bi-annually and are intended to inform on erosion rates of the sea cliffs extending from the defended industrial areas at Hendon southwards along the undefended cliffs to Ryhope Dene.</p> <p>The results from the cliff top monitoring are anticipated to have an accuracy of $\pm 0.2\text{m}$ due to the technique used. These cliff top surveys are undertaken bi-annually and are intended to inform on erosion rates of the sea cliffs extending from the defended industrial areas at Hendon southwards along the undefended cliffs to Ryhope Dene. Appendix B – Table B1 provides results from the March 2009 cliff top survey, showing the position from the ground control point to the edge of the cliff top along a defined bearing. Also shown is the change in measurement since the original (March 2009) and previous (October 2011) cliff top surveys.</p> <p>Results show erosion or an amount of movement greater than the survey error has occurred at 22 ground control points since surveys began in March 2009 (or September 2009 for 28A and 28B). Other</p>	<p>Since the last survey, the cliffs immediately north of and around Salterfern Rocks, at the northern end of Halliwell Banks, and immediately north and south of Pincushion have eroded by an amount greater than the survey error.</p> <p>Longer term trends: Erosion has occurred at 22 ground control points since surveys began in March 2009 (or September 2009 for 28A and 28B). The maximum rate is 1.5m/yr at location 25, but erosion of less than 1.0m/yr is more common.</p>

The survey report notes '*landslide visible at section 27*'. Erosion continues to be recorded at locations along the cliffs, with long-term rates typically less than 1.0m/yr, but locally as high as 1.5m/yr.
