**Cell 1 Regional Coastal Monitoring Programme  
Update Report 7: 'Partial Measures' Survey 2015**

**Sunderland City Council  
Final Report**

**July 2015**

(\*) The present report is **Update Report 7** and provides an analysis of the 2015 Partial Measures survey for Sunderland City Council's frontage.

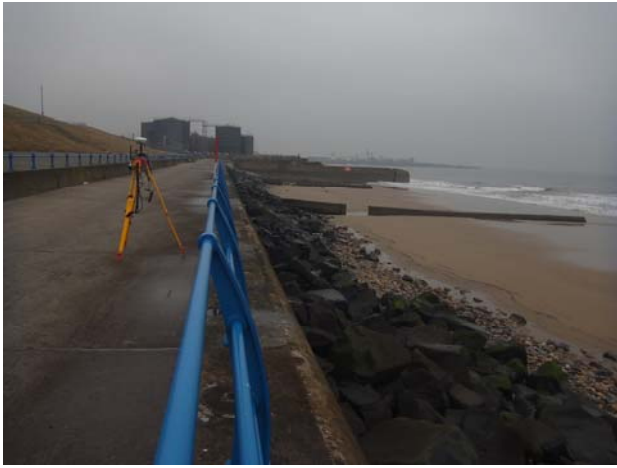
Plate 1 – Survey photograph 1bSNS8\_20150308\_N5.JPG

Survey Date	Description of Changes Since Last Survey	Interpretation
<p><b>March 2015</b></p>	<p><b>Beach Profiles:</b></p> <p>Hendon to Ryhope is covered by thirteen beach profile lines for the Partial Measures survey (Appendix A). The last survey was Full Measures, undertaken in autumn 2014.</p> <p>Profile <b>1bSNS4</b> includes a seawall and rock revetment, after which it extends across boulders to low water. There is no change compared to previous surveys.</p> <p>Profile <b>1bSNS8</b> extends across the seawall, rock revetment, a rocky upper beach and sandy middle and lower beach. Beach levels at the toe of the rock revetment have reduced slightly and this is evident from the survey photograph where there has been some scour around the rock toe (see Plate 1). Seaward of the rock revetment beach levels have increased across the profile to a chainage of 85m by approximately 0.4m.</p> <p>Profile <b>1bSNS11</b> starts at the coastal slope backing the sea wall and extends over the rock armour and beach. Beach levels have reduced from the toe of the rock armour to the seaward end of the profile. Erosion is greatest at the toe of the rock armour where up to 1m lowering has occurred resulting in exposure of rock and a change in beach sediment type from sand to shingle (Plates 2 and 3).</p> <p>Profile <b>1bSNS20</b> is located at Shirley Banks. The cliff and beach has not changed since the last survey.</p> <p>Profile <b>1bSNS25</b> is located at Halliwell Banks. The top of the cliffs, cliff face and cliff toe have not changed since the last survey. Beach levels are generally unchanged, with the exception of the formation of a small berm at the cliff toe that is approximately 0.5m in height (Plate 4).</p> <p>Profiles <b>1bSNS26 to 1bSNS33</b> are located on Halliwell Banks to assess erosion of a former land fill site. Cliff tops are between 26m and 27mOD, with fronting beaches typically around 1m lower than previously seen. At profiles <b>1bSNS26, 1bSNS27</b> and <b>1bSSN28</b>, the cliff face has eroded by approximately 1m at the toe and beach levels have decreased by 0.2m to 0.4m across the profile. At profiles <b>1bSNS29</b> and <b>1bSNS30</b>, the pattern of change is similar to profiles 1bSN26 to 1bSNS28, with erosion of up to 5m at the cliff toe. Beach levels have fallen across the profile by approximately 0.4m. At profiles <b>1bSNS31</b> to <b>1bSNS33</b>, the cliff has remained stable while beach levels have fallen by approximately 0.4m.</p>	<p>Profile 1bSNS4 extends onto rocks and then into water and shows no change.</p> <p>At South Hendon (1bSNS8), sand levels have generally increased across the beach profile but at profile 1bSNS11, beach levels have fallen.</p> <p>At Profile 1bSNS20 the cliff and beach has remained stable since the last survey.</p> <p>At profile 1bSNS25, to the north of the landfill site, the cliff and beach are unchanged.</p> <p>At the landfill site (profiles 1bSSN26 to 1bSSN33) the cliff has eroded, up to 5m loss recorded at the toe. To the south of the landfill site at profile 1bSNS33, the cliff top has remained stable. At all locations the beach has lowered although the overall form of the profile has remained the same.</p> <p><b>Longer term trends:</b> In general, the profile change along the Hendon to Ryhope frontage is within the bounds of previous surveys; the only exception is at profile 1bSNS8 where beach levels between a chainage of 50m and 90m are the highest recorded since surveys began in March 2009.</p> <p>At the landfill site (profiles 1bSSN25 to 1bSSN33), the cliff and beach are within the bounds of previous surveys. However, profiles 1bSNS26 to 1bSNS31 show significant recession of the cliff toe.</p>

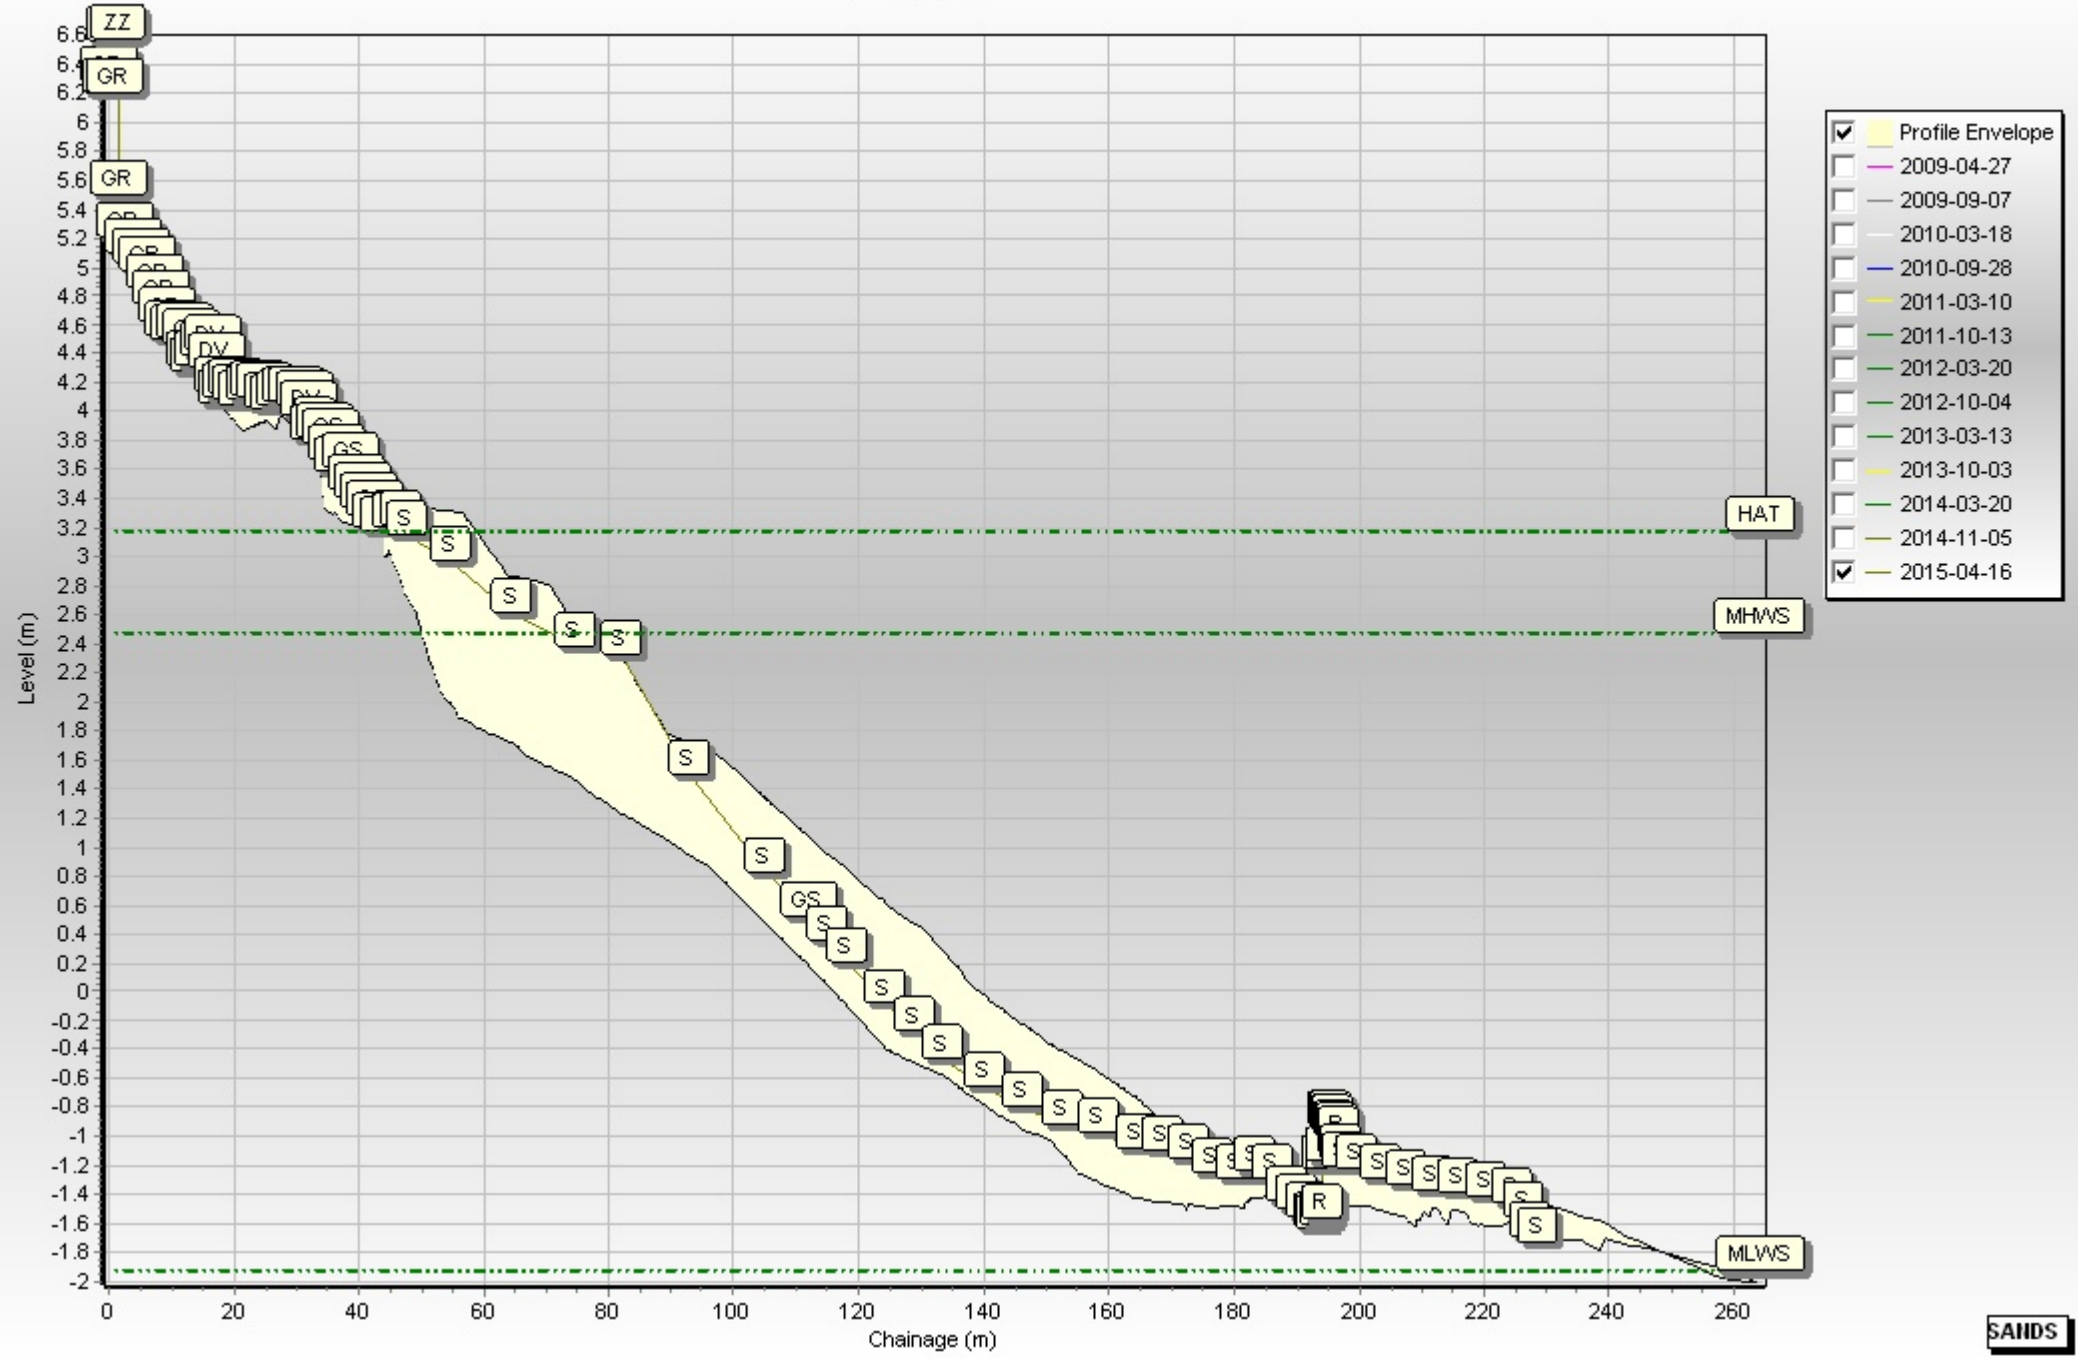
Profiles: 1bSNN1

Survey Date	Description of Changes Since Last Survey	Interpretation
April 2015	<p><b>Beach Profiles:</b></p> <p>Whitburn Bay is covered by three beach profile lines for the Partial Measures survey (Appendix A). The last survey was Full Measures, undertaken in autumn 2014.</p> <p><b>1bSNN1</b> is just to the south of Sunderland City Council's northern boundary. Since the last survey the boulders at the toe of the dunes have not changed. Beach levels around a chainage of 80m have increased to form a small berm approximately 4m high, but seaward of chainage 80m to chainage 180m, beach levels have fallen by approximately 0.6m.</p> <p><b>1bSNN7</b> is at Seaburn, north of Parson's Rock. Beach levels in front of the seawall have increased across the length of the profile by approximately 0.4m. The profile form has remained the same.</p> <p><b>1bSNN10</b> is located mid-way between Parson's Rock and Roker Pier. Beach levels have generally reduced across the profile by up to 0.4m, with the exception of a small section between a chainage of 20m and 30m where a small berm has formed approximately 0.4m in height.</p>	<p>Along the length of Whitburn Bay beaches have been dynamic, with a widespread fall of 0.4m to 0.6m and formation of a berm on the upper beach. This probably reflects storm conditions over the winter/spring. In the centre of Whitburn Bay at profile 1bSNN7, beaches have accreted.</p> <p><b>Longer term trends:</b> Profiles in Whitburn Bay are within the bounds of previous survey, although between a chainage of 30m and 60m of profile 1bSNN10, beach levels at the lowest since surveys began in 2009.</p>

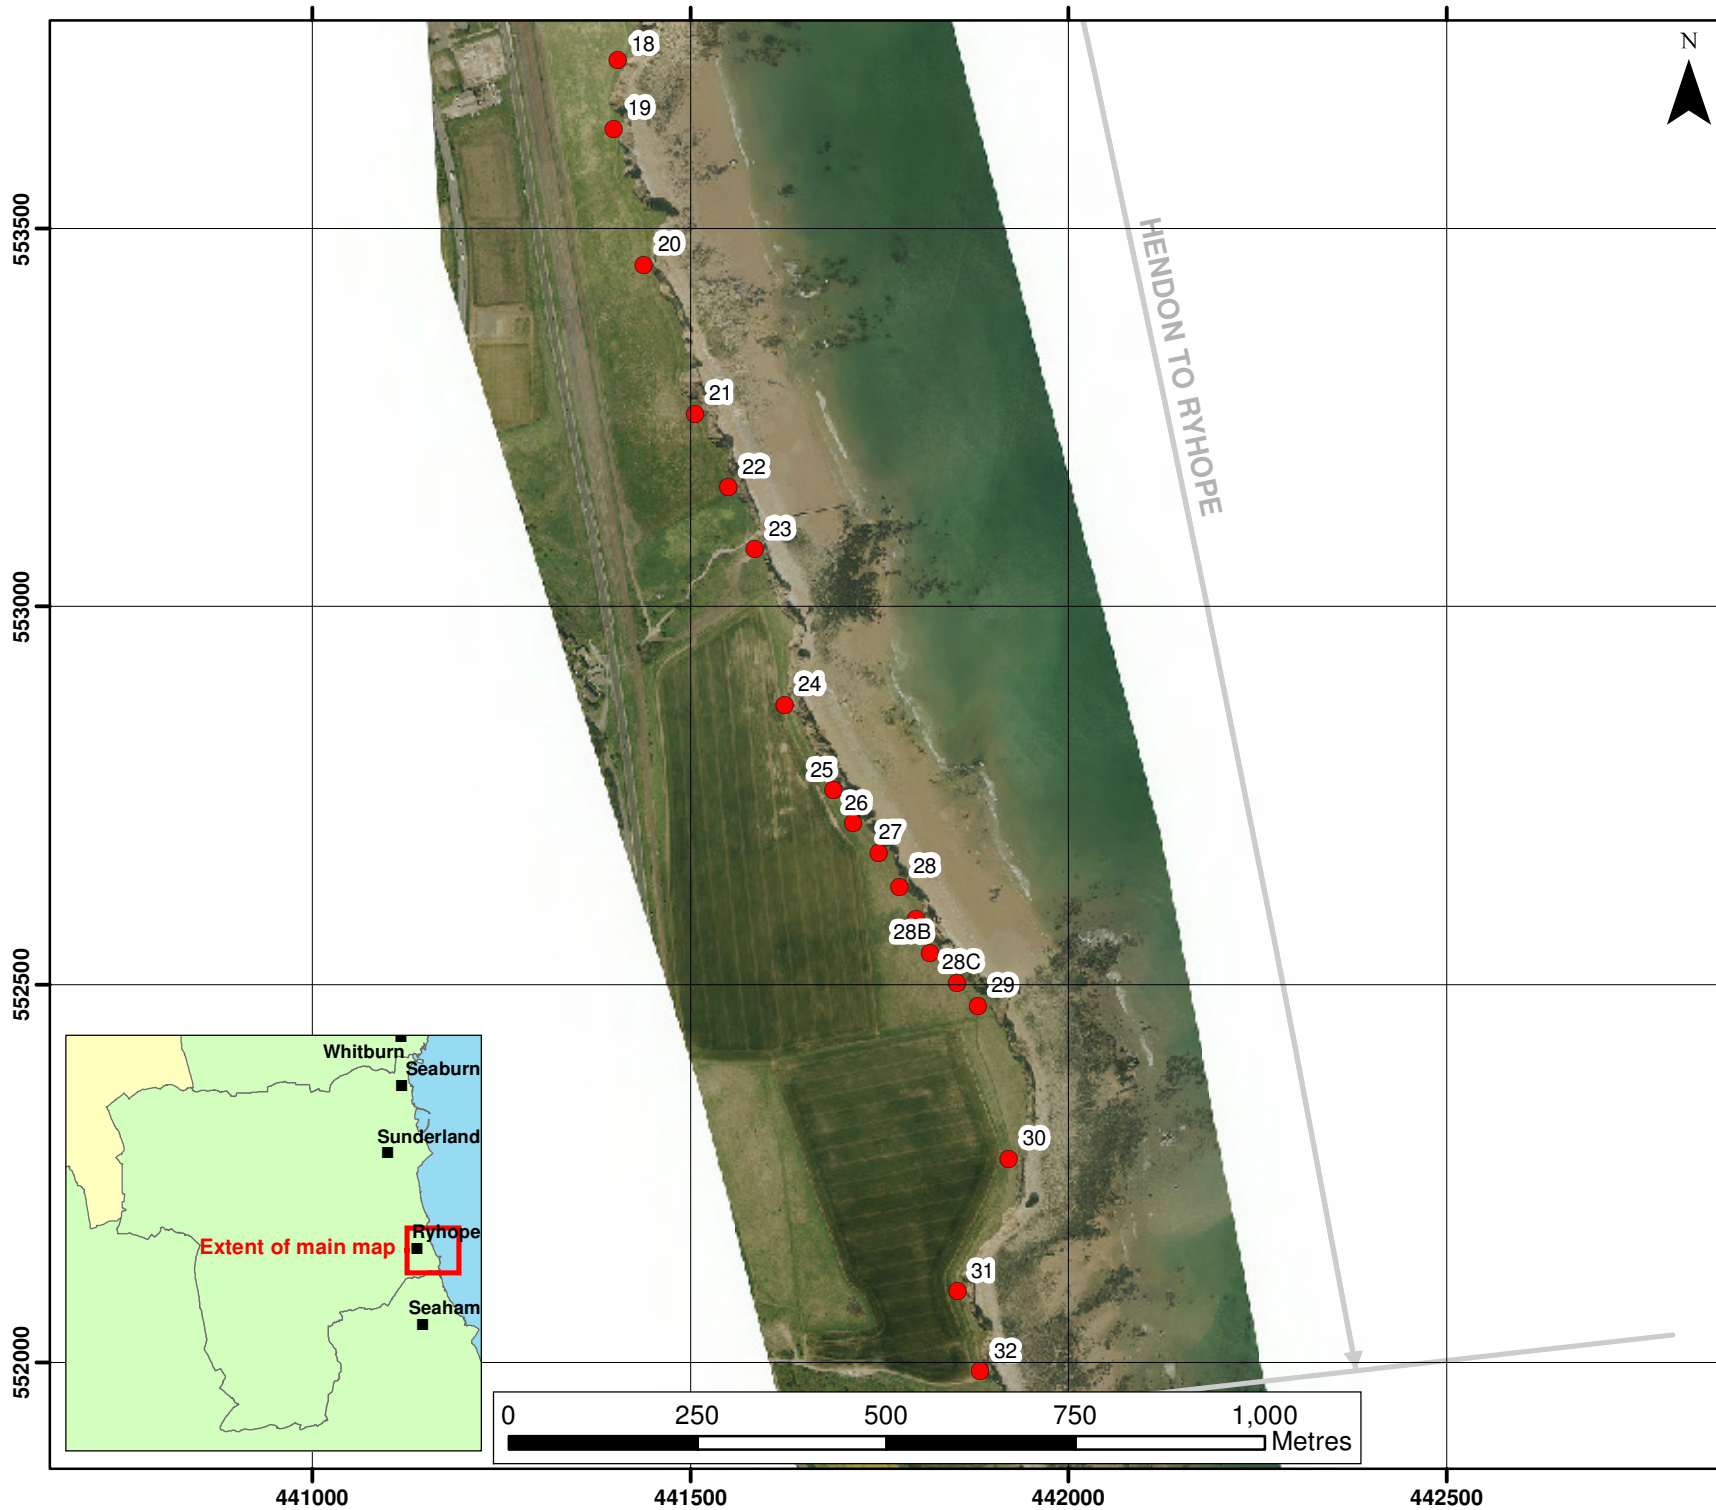
**Appendix B - Map 2  
Ground Control Points  
Hendon to Ryhope South  
Sunderland City Council**

- At Whitburn Bay, the recorded profiles present no causes for concern.
- At Hendon to Ryhope (incl. Halliwell Banks), the greatest amount of erosion of 10.7m was recorded to have taken place between March 2009 and March 2015 and 6.7m since the last survey, is at Point 27, which is on the northern border of the landfill site. Erosion either side varies from 1.6m to 7.6m erosion and should therefore be monitored closely.
- Elsewhere at Hendon to Ryhope (incl. Halliwell Banks), the cliff the recorded profiles and cliff top surveys present no causes for concern.

Thirty-two ground control points have been established between Hendon and Ryhope (Map 1 and Map 2). The maximum separation between any two points varies along the coast, reflecting the degree of risk from the erosion.
