**Cell 1 Regional Coastal Monitoring Programme  
Update Report 12: 'Partial Measures' Survey 2020**

(\*) The present report is **Update Report 12** and provides an analysis of the 2020 Partial Measures survey for Sunderland City Council's frontage.

**Sunderland Council Frontage**

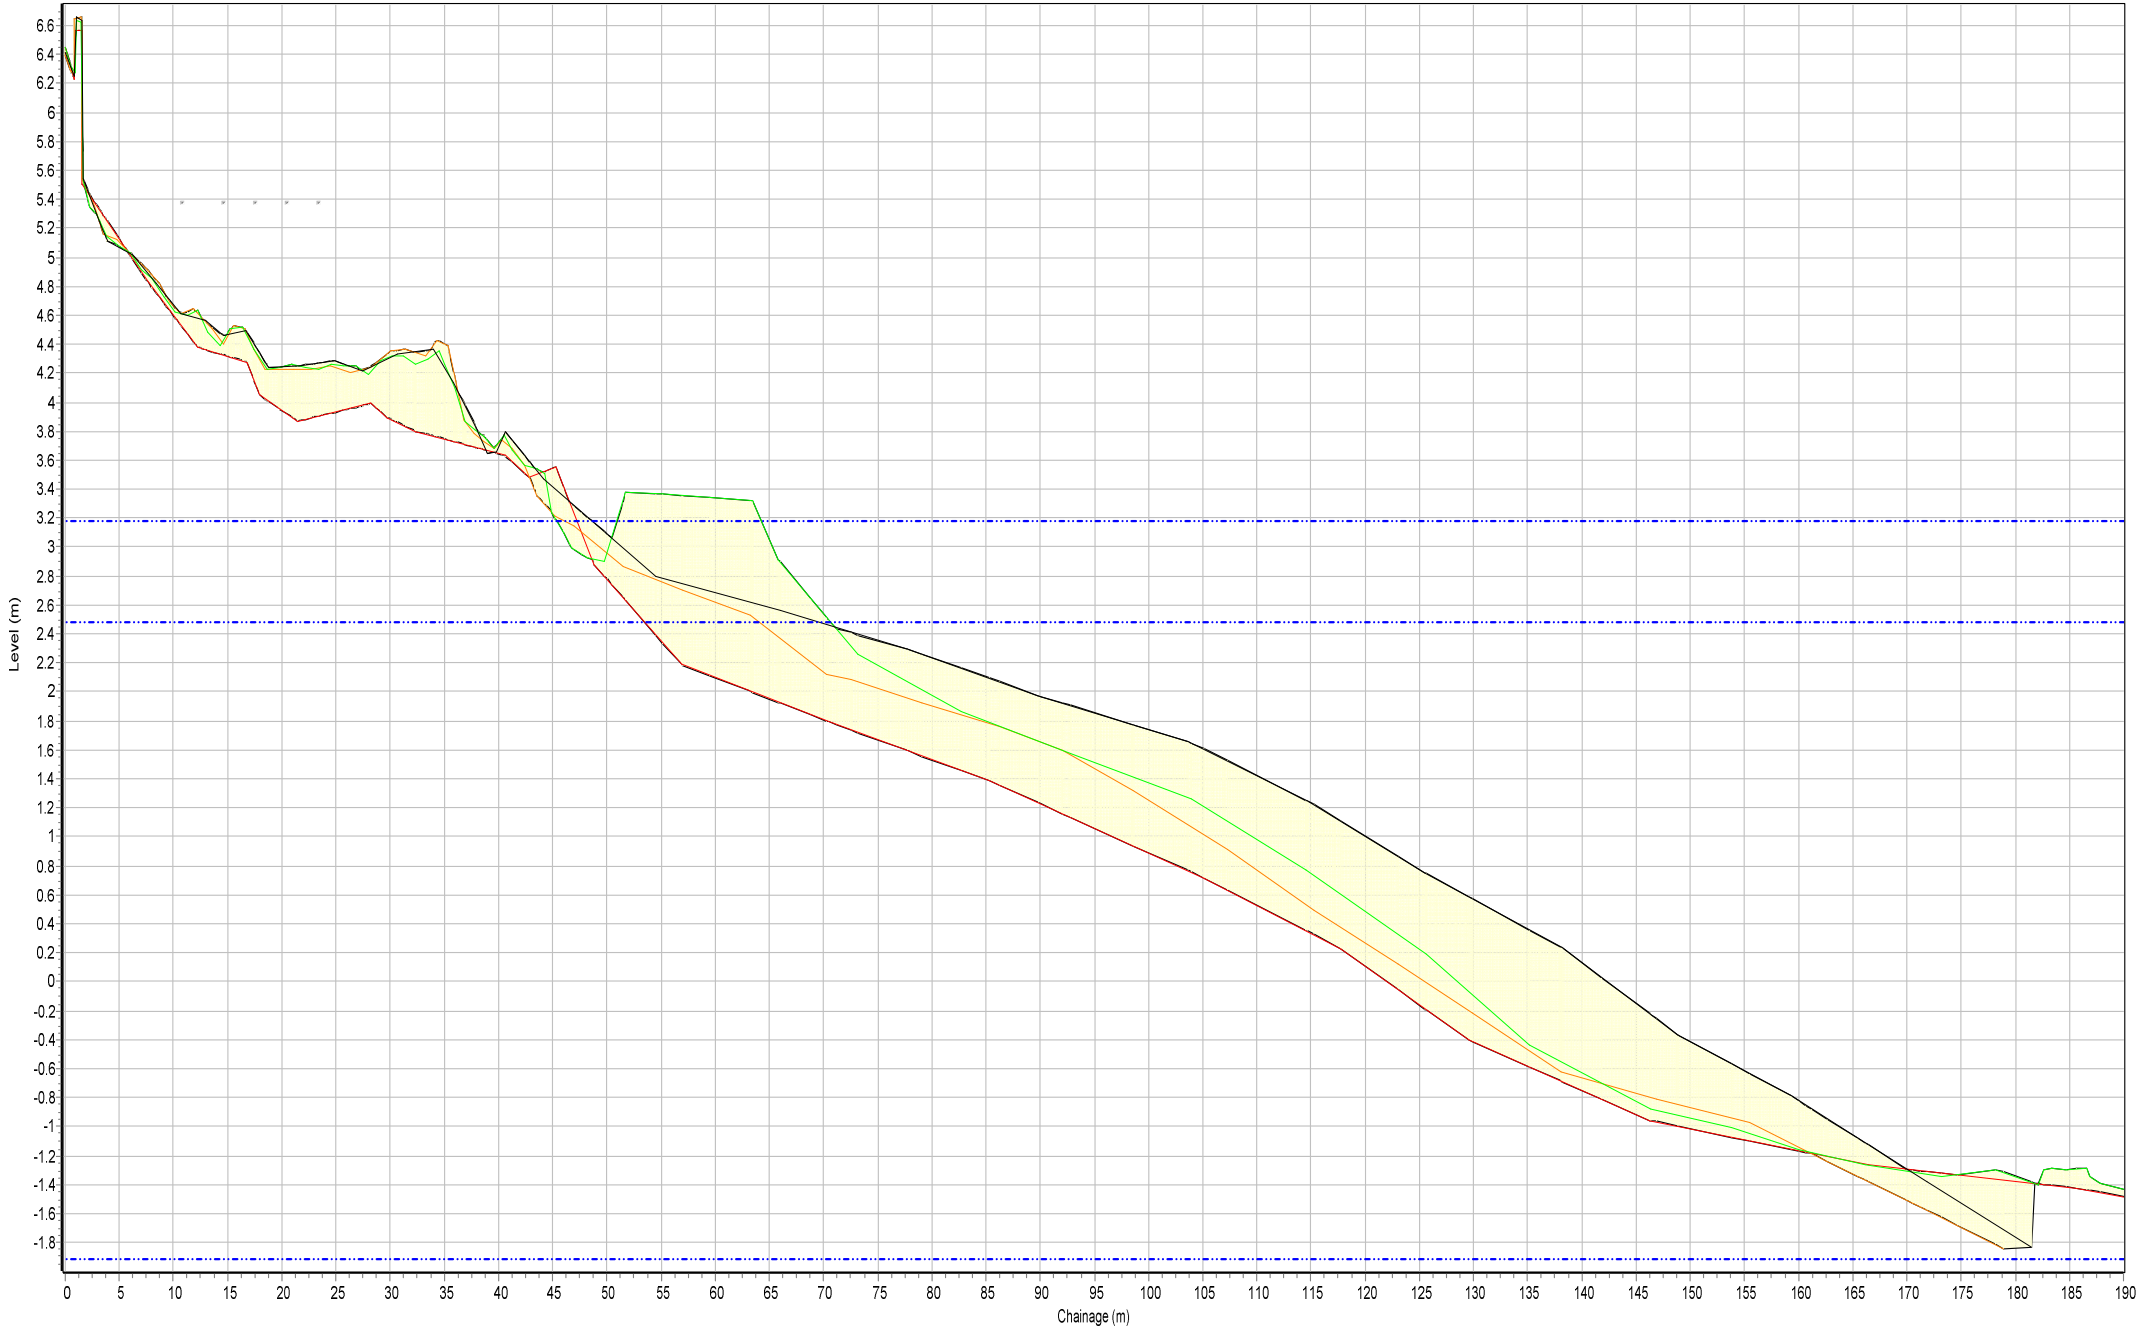
# Beach Profiles: 1bSNN1

Survey Date	Description of Changes Since Last Survey	Interpretation
<p>8<sup>th</sup>-11<sup>th</sup> March 2020</p>	<p><b>Beach Profiles:</b></p> <p>Whitburn Bay is covered by three beach profile lines for the Partial Measures survey (Appendix A). The last survey was Full Measures, undertaken in Autumn 2019.</p> <p><b>1bSNN1</b> is just to the south of Sunderland City Council's northern boundary. Since the last survey the backshore above HAT has changed little, with small sections of accretion of up to 0.1m. From chainage 45m to 50m there has been infilling of a hollow by up to 0.3m. From chainage 50m to 71m, there has been erosion of an upper beach berm by up to 0.6m. There has been uniform accretion across the middle and lower beach of up to 0.8m. Seawards of chainage 170m, the beach toe has eroded by 0.5m. The upper and middle beach are at a relatively high level compared to the range recorded from previous surveys, particularly between chainages 85m and 117m which is at its highest level recorded. The beach toe is recorded at a low level compared to the range recorded from previous surveys.</p> <p><b>1bSNN7</b> is at Seaburn, north of Parson's Rock. Beach levels in front of the seawall have risen by up to 0.3m to chainage 14m, where a small level of erosion occurred to chainage 28m by up to 0.1m. The profile from chainage 28m to 148m shows accretion by up to 0.3m on the middle beach and 0.1m on the lower beach. Seaward of chainage 148m the beach toe has eroded by 0.6m and migrated landward by 28m. Overall the upper and middle beach profile is at a high level compared to the range recorded from previous surveys., whilst the lower beach is at a medium level.</p> <p><b>1bSNN10</b> is located mid-way between Parson's Rock and Roker Pier. There has been accretion on the upper beach from the seawall to chainage 41m of up to 0.7m. Between chainages 41m and 60m there has been a small amount of erosion of up to 0.1m, switching to accretion across the middle beach between chainages 60m and 121m by up 0.2m. Seaward of chainage 121m the lower beach erodes by 0.4m and the beach toe has migrated landward by 16m. Overall, the beach profile has steepened compared to the previous survey. The profile across the upper, middle and lower beach is at a medium level compared to the range recorded from previous surveys.</p>	<p>Along the length of Whitburn Bay beaches have accreted across the upper and middle beach profile, whilst the beach toe has eroded at all profiles and moved landward since the previous survey.</p> <p><b>Longer term trends:</b> Profiles in Whitburn Bay are generally within the bounds of previous surveys, however chainage 85-117m at profile 1bSNN1 is now at its highest level recorded.</p>

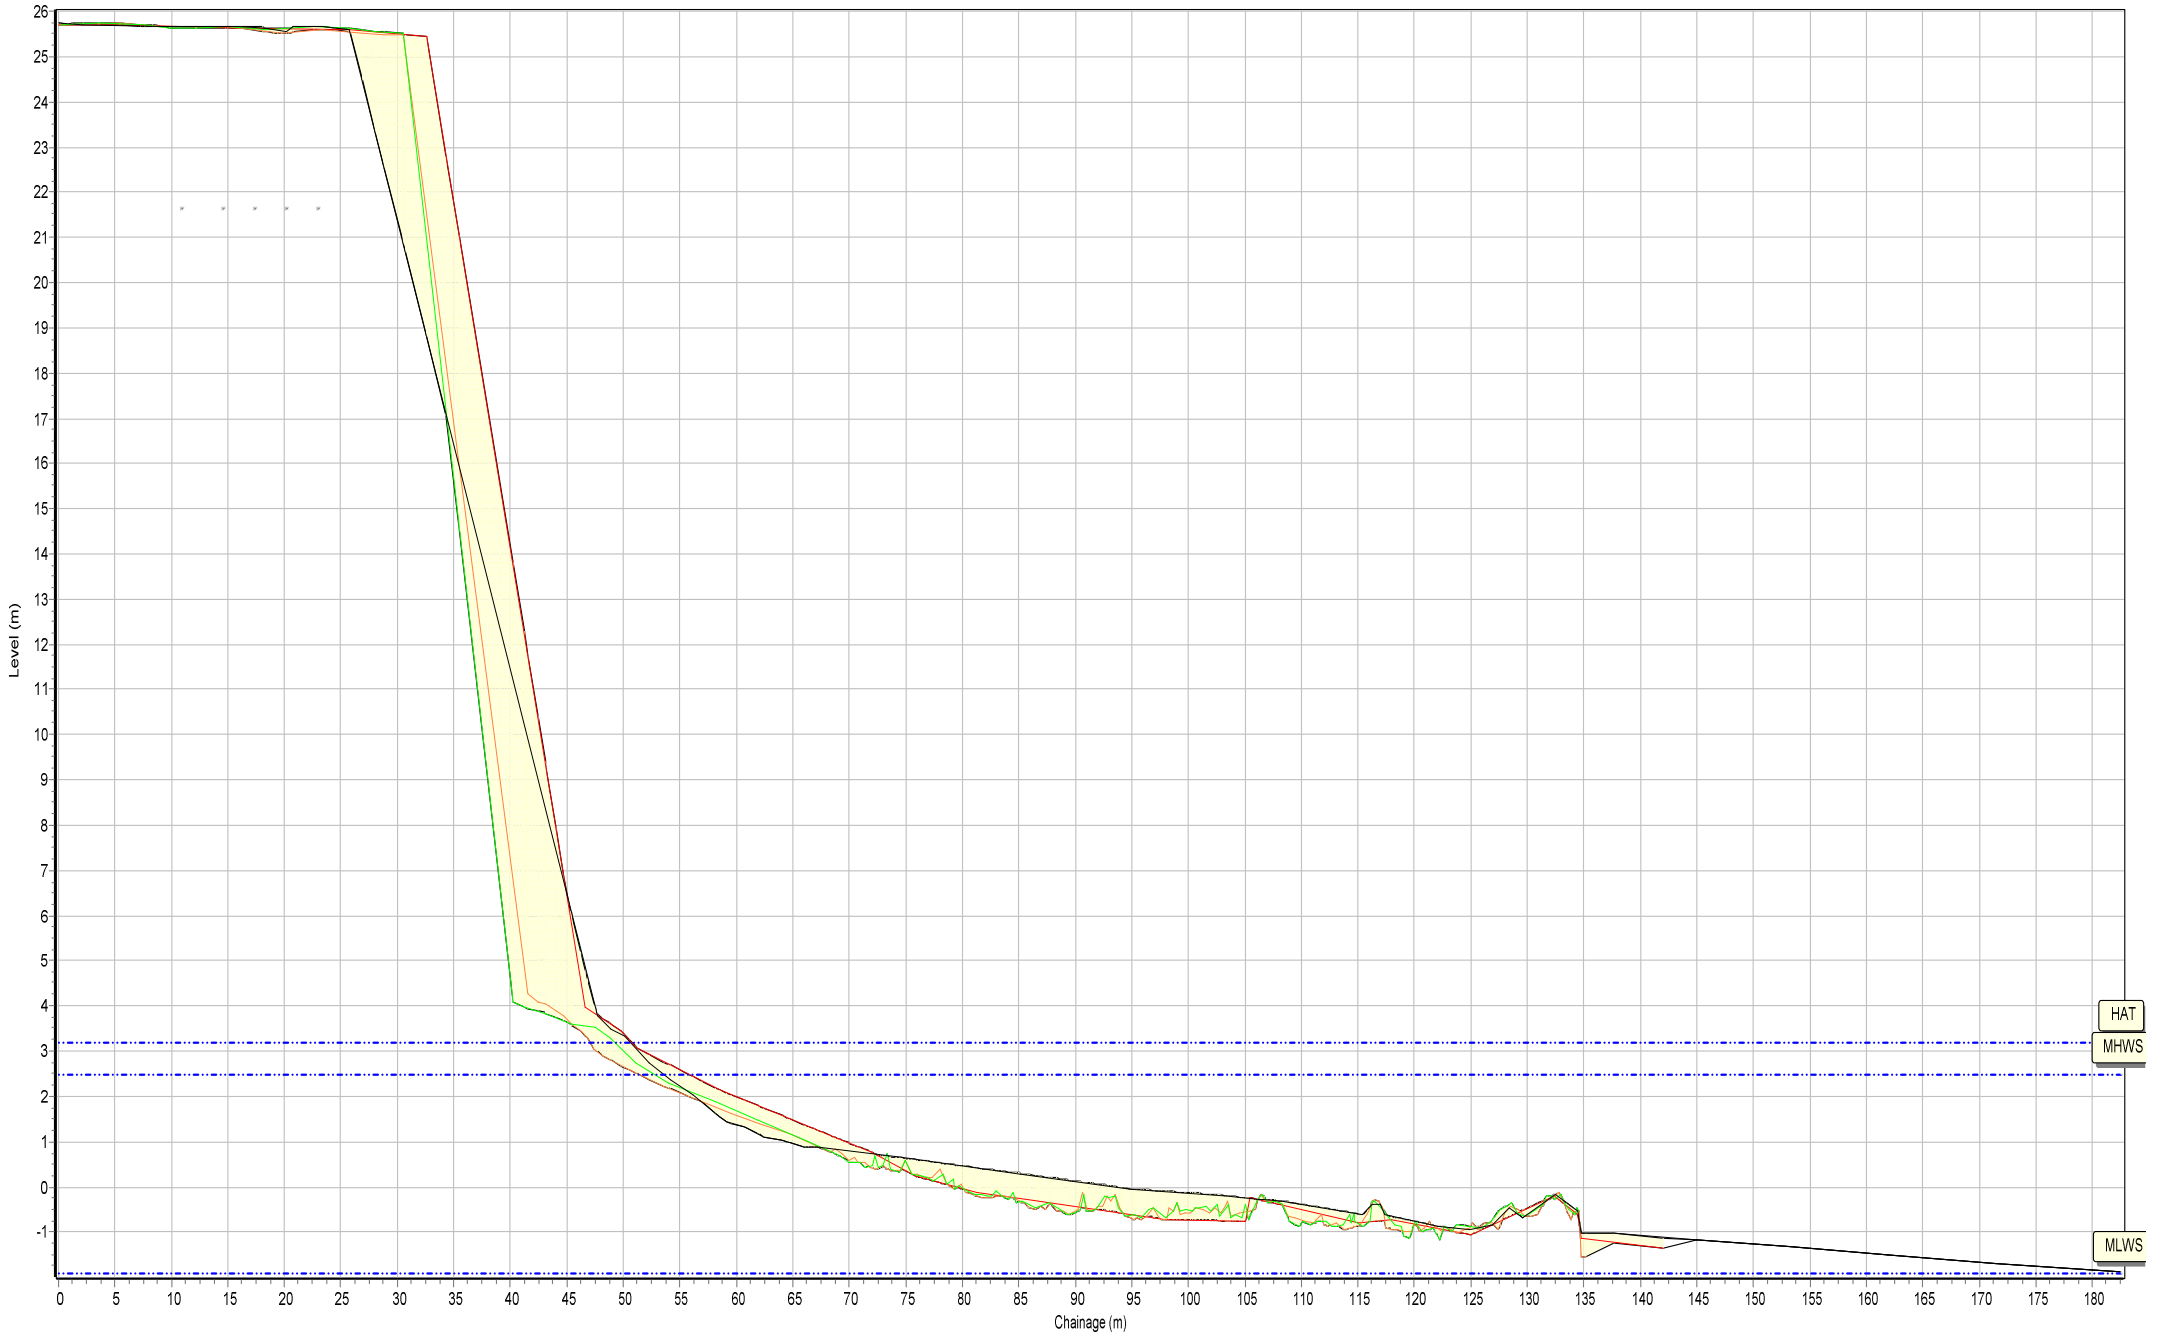
# Beach Profiles: 1bSNS20

- Significant erosion was encountered at Section 20 of this survey.

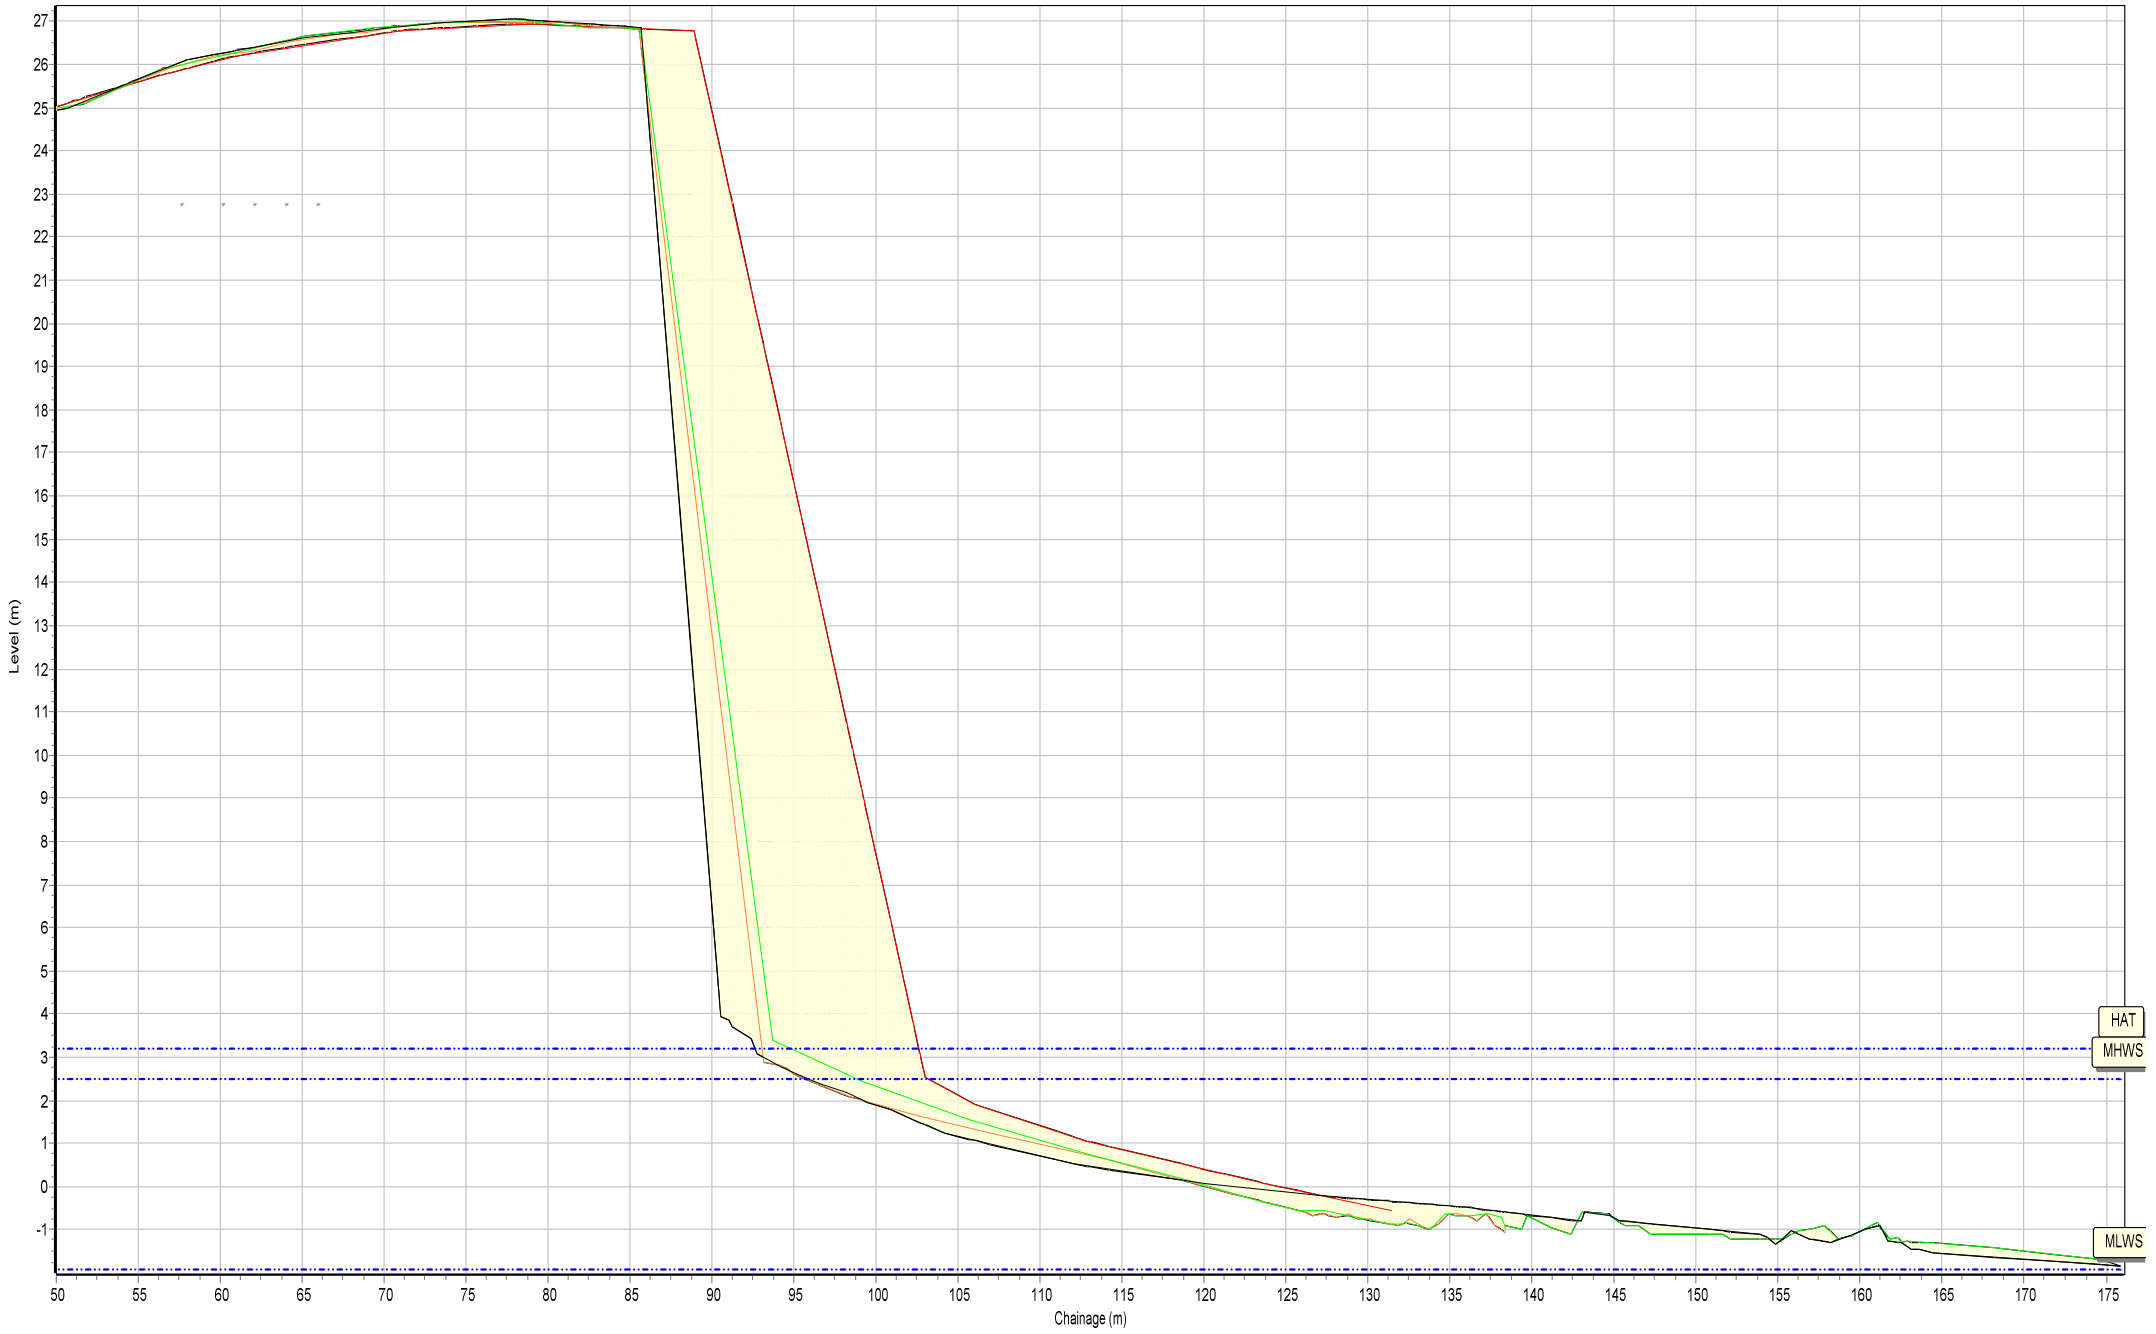
Beach Profiles: 1bSNS26

Survey Date	Description of Changes Since Last Survey	Interpretation
	<p>Cliff tops are between 26m and 27mOD.</p> <p>At profiles <b>1bSNS26</b>, there has been apparent recession of the cliff toe by c.3.0m, which is now at its most landward position since records began. Between the cliff toe and chainage 119m there has been erosion of up to 0.4m. There has been accretion by up to 120m across the middle beach between chainages 119m and chainage 155m. The beach toe has eroded by up to 0.2m. Overall the profile is at a relatively low level compared to the range recorded from previous surveys.</p> <p>At <b>1bSNS27</b> there has been no change in the position of the top of the cliff or cliff face, however the toe of the cliff has receded by 2m. From the toe of the cliff to chainage 120m there has been erosion of the upper beach by up to 0.8m. On the middle beach between chainages 120m and 144m there has been accretion by up to 0.4m. Seaward of 144m there has been erosion of the beach toe by up to 0.3m. The upper beach is at a low level compared to the range recorded from previous surveys, particularly between chainages 104-113m which is at its lowest level recorded. The rest of the beach profile is at a medium level compared to the range recorded from previous surveys.</p> <p>At <b>1bSSN28</b>, the toe of the cliff has eroded by 0.6m, which continues across the upper beach to chainage 121m. There has been accretion of up to 0.4m on the middle beach between chainages 121-142m, covering a previously exposed rock patch. Seaward of chainage 142m there has been erosion of the beach toe by 0.5m. Overall the upper beach profile is at a low level compared to the range recorded from previous surveys, whilst the middle and lower beach are at a medium level.</p> <p>At profiles <b>1bSNS29</b>, between the cliff toe and chainage 122m there has been erosion of up to 0.8m. Between chainages 122m and 132m there has been accretion of up to 0.3m. On the lower beach, there has been erosion by up to 0.2m to chainage 166m. The beach toe has accreted by up to 0.5m and extended seaward by 17m. The upper beach profile is at a low level compared to the range recorded from previous surveys, particularly between chainages 108m and 118m which is at its lowest level recorded. The middle and lower beach are at a medium level.</p> <p>At <b>1bSNS30</b>, there has been a retreat of the cliff toe by up to 4m to its most landward position recorded. There has been erosion on the upper beach by up to 0.6m to chainage 125m. A small amount of accretion has occurred between chainages 125m and 136m of up to 0.2m. Between chainages 136m and 172m erosion has occurred by up to 0.2m. The beach toe has accreted by 0.1m and extended seaward by 14m. Overall the upper beach profile is at a low level compared to the range recorded from</p>

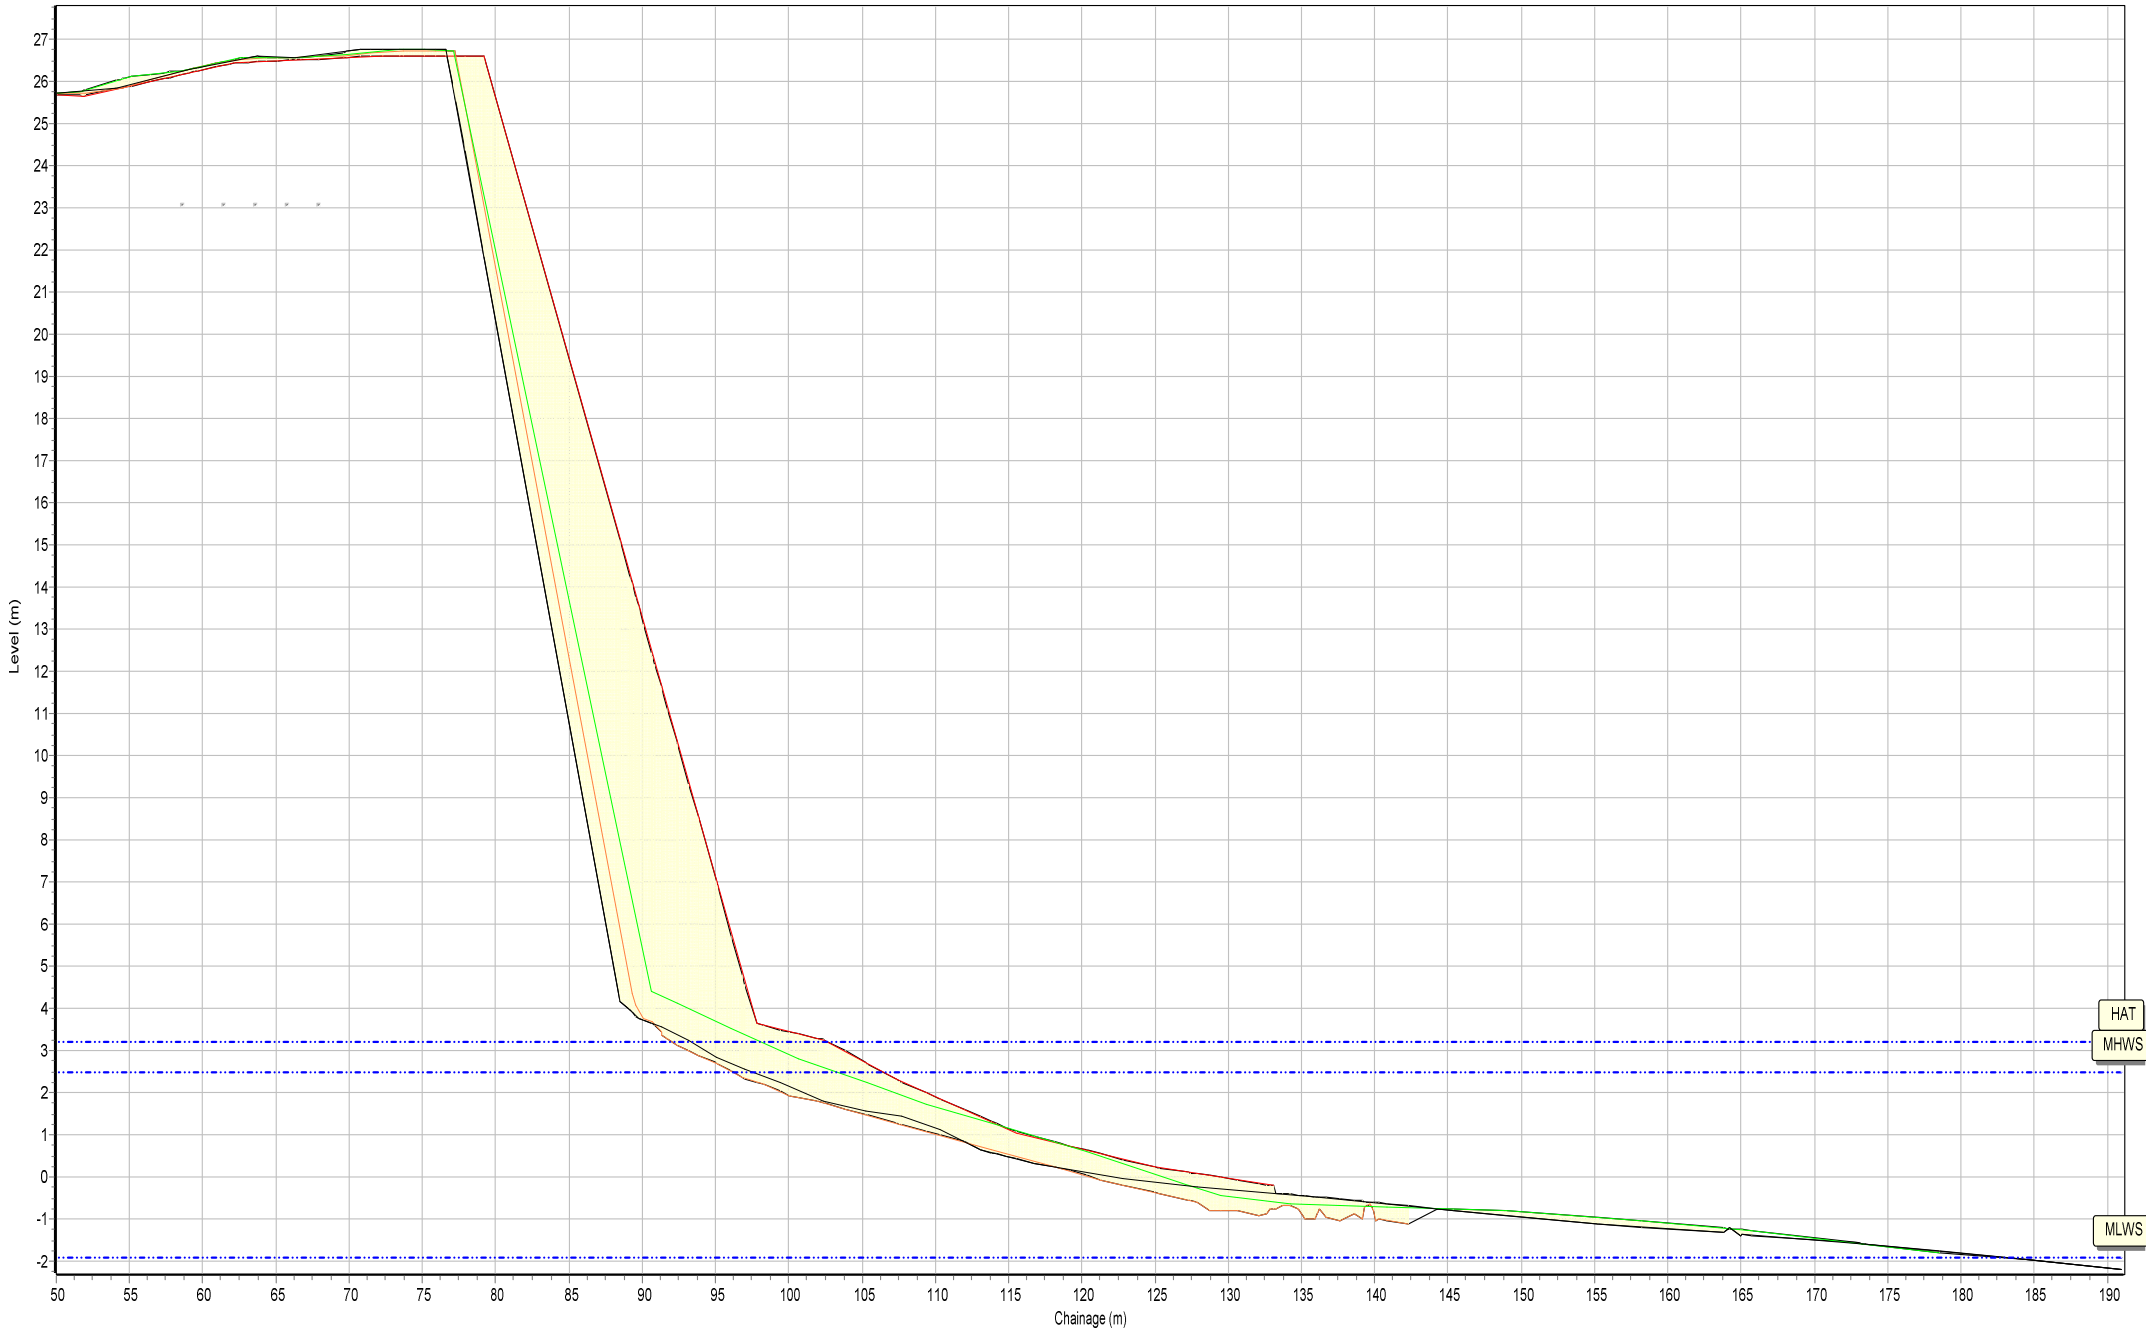
Beach Profiles: 1bSNS31

Survey Date	Description of Changes Since Last Survey	Interpretation
	<p>previous surveys, whilst the middle and lower beach are at a medium level.</p> <p>Profile <b>1bSNS31</b> shows an apparent erosion of the cliff face and toe by c.2.0m. The upper beach has eroded by up to 0.5m to chainage 126m. The middle beach shows a small amount of accretion by up to 0.2m to chainage 144m. Seaward of chainage 144m there has been an erosion of up to 0.2m, whilst the beach toe has extended seaward by 13m. Overall the profile is at a low-medium level compared to the range recorded from previous surveys.</p> <p>At <b>1BSNS32</b> the cliff shows apparent recession of 1.2m at the toe, which is now at its most landward position recorded. There has been erosion across the upper beach by 0.6m to chainage 148m. Seaward of chainage 148m there has been negligible change in the order of <math>\pm 0.1</math>m. The beach toe has extended by 10m. Overall the upper beach profile is at a low level compared to the range recorded from previous surveys, whilst the middle and lower beach is at a medium level.</p> <p>At <b>1bSNS33</b>, the cliff shows apparent recession of the cliff toe of c.1.0m. The upper beach eroded by 0.8m to chainage 95m. There is accretion of up to 0.6m across the middle beach between chainages 95-120m. The beach toe has accreted by 0.2m and extended by 14m. Overall the upper beach profile is at a low level compared to the range recorded from previous surveys, whilst the middle and lower beach is at a medium level.</p>
