**Cell 1 Regional Coastal Monitoring Programme  
Update Report 13: 'Partial Measures' Survey 2021**

(\*) The present report is **Update Report 13** and provides an analysis of the 2021 Partial Measures survey for Sunderland City Council's frontage.

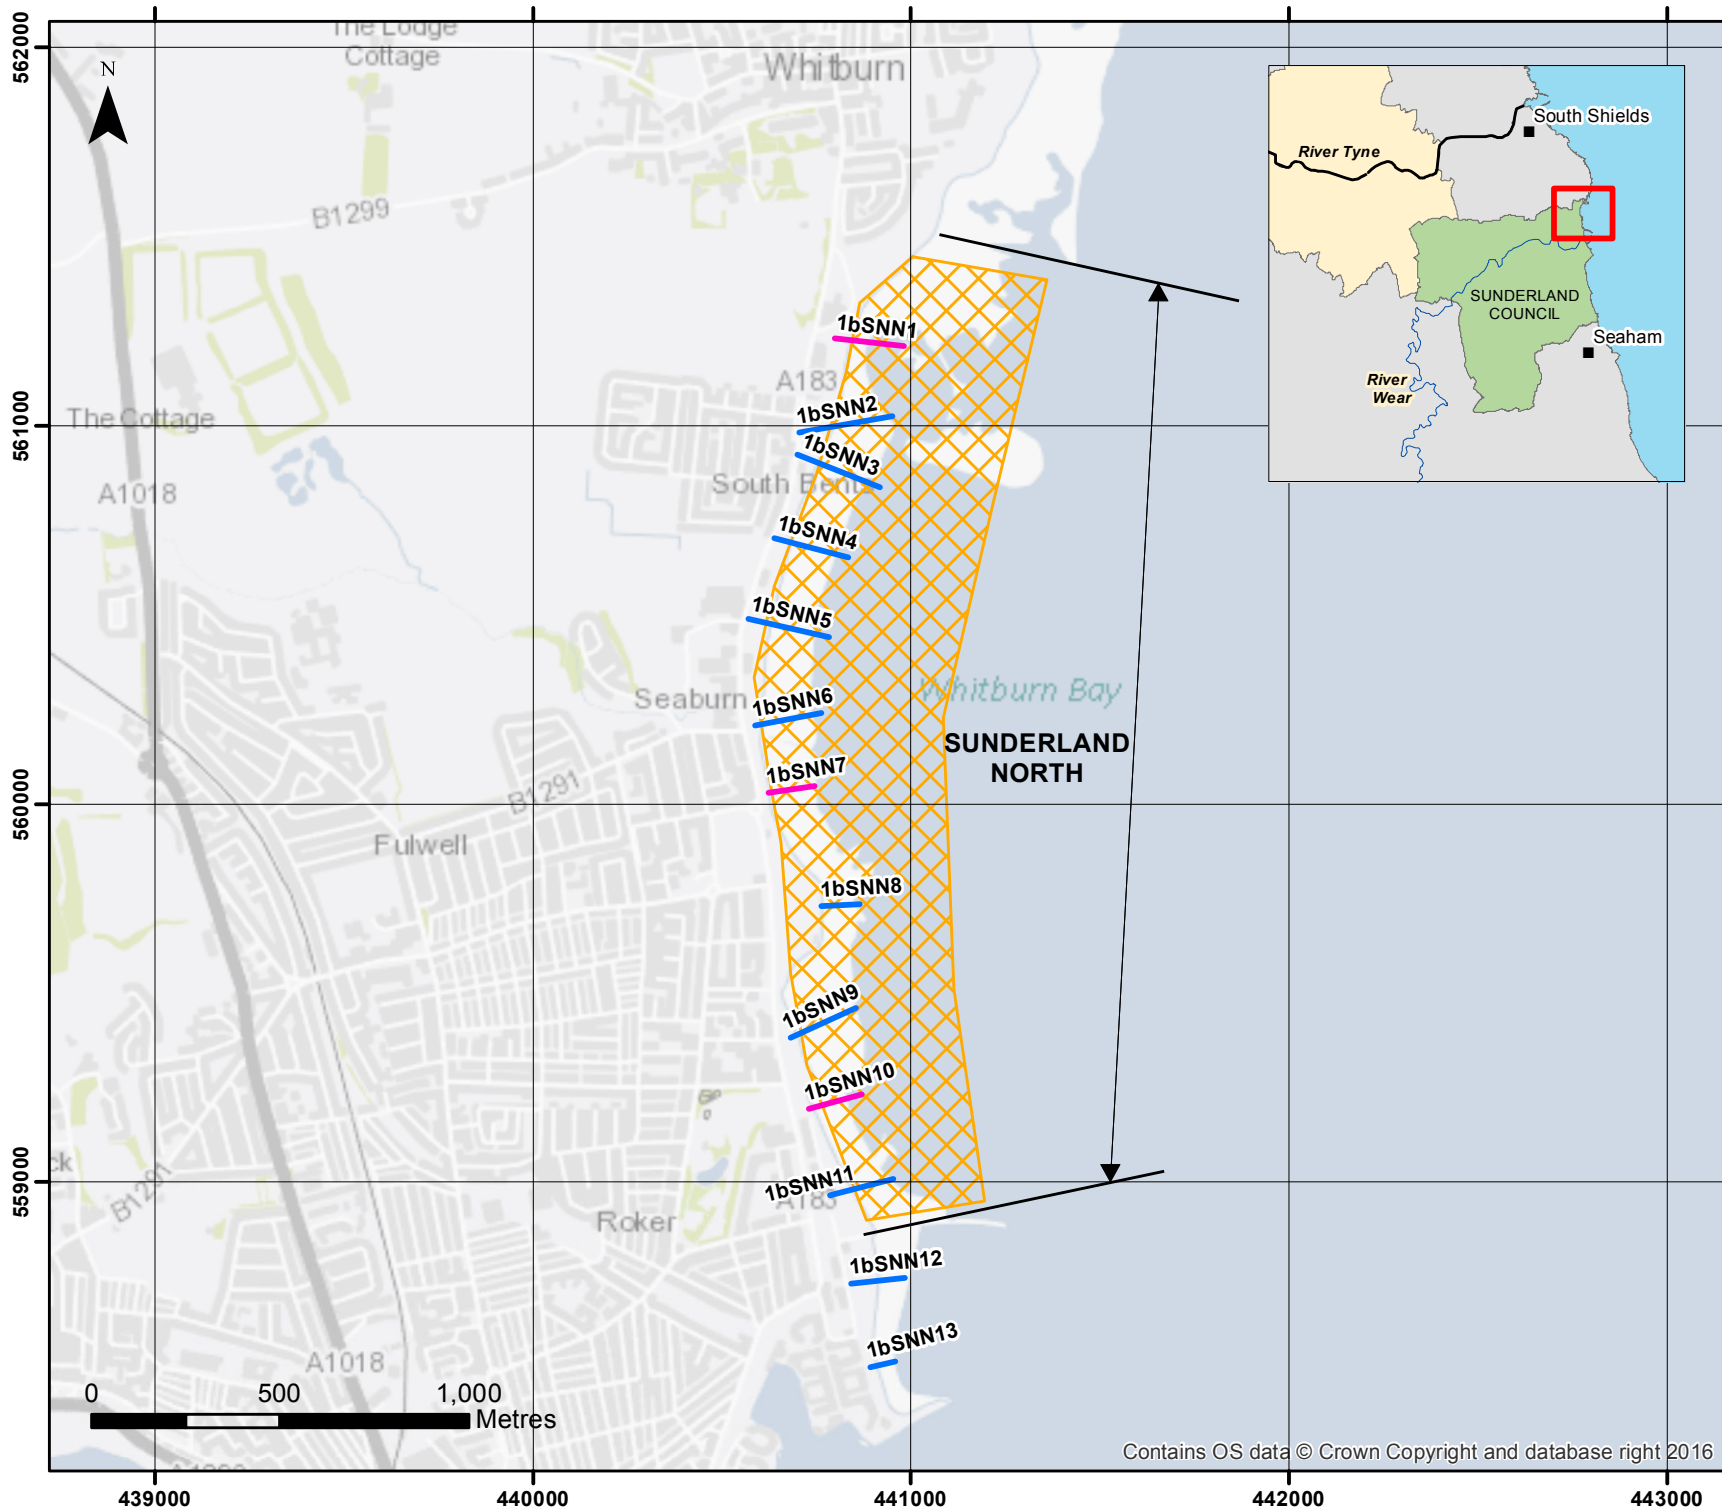
**Figure 2 - Map 1**

The location of these surveys is shown in Figure 2. The Partial Measures survey was undertaken along this frontage on 4<sup>th</sup> March 2021 (Whitburn Bay), and between 15<sup>th</sup> and 16<sup>th</sup> April 2021 (Hendon to Ryhope, including Halliwell Bank). During this time weather conditions varied, see surveyors reports for details.

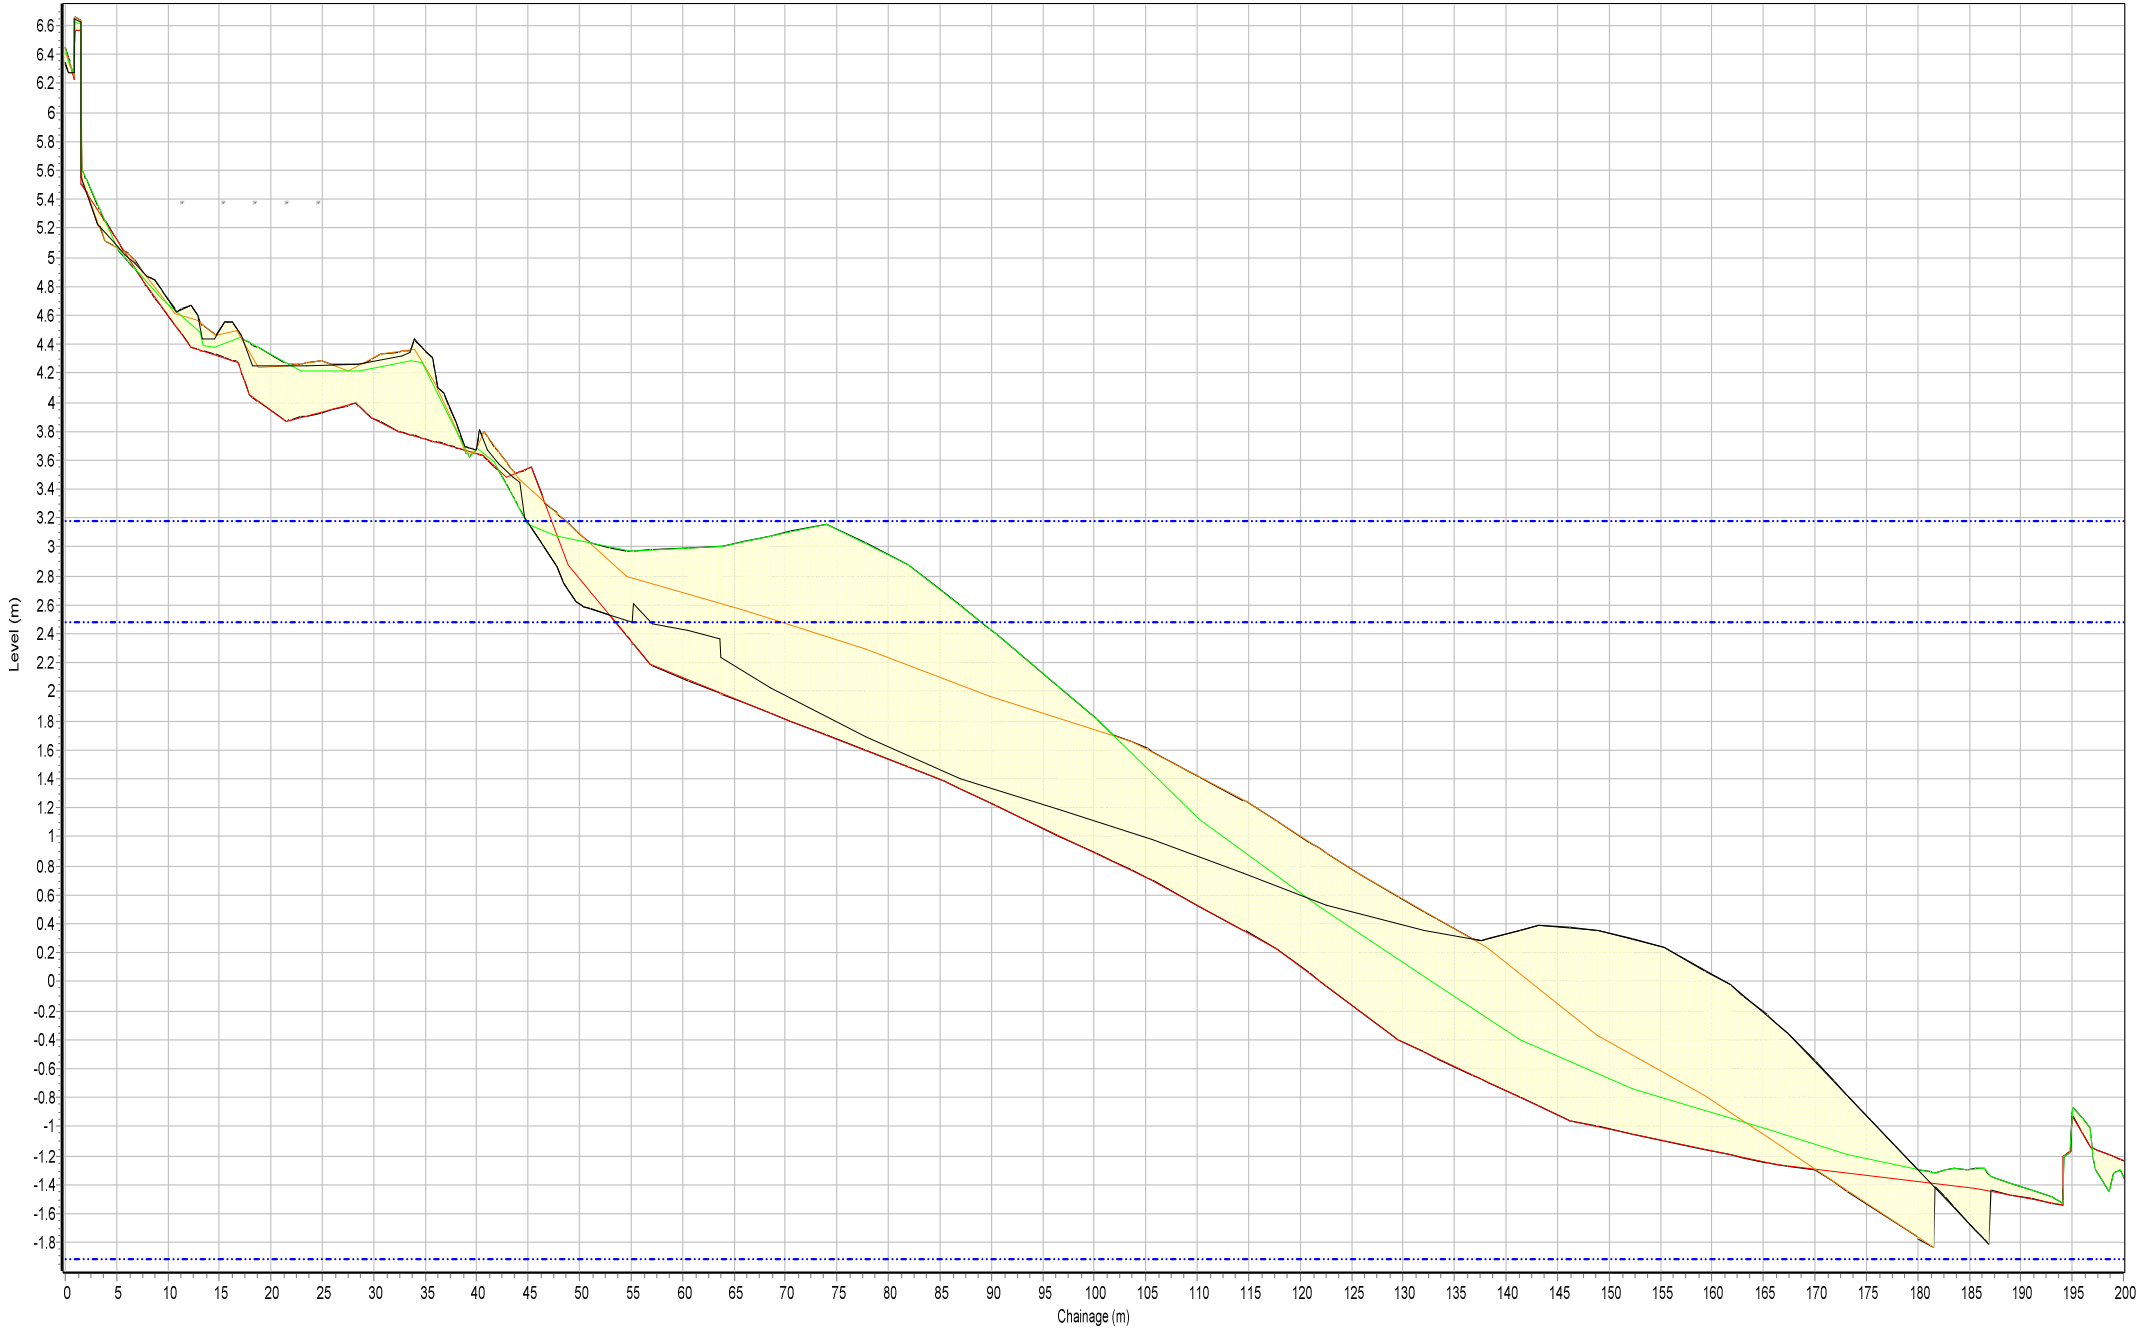
Beach Profiles: 1bSNN1

Survey Date	Description of Changes Since Last Survey	Interpretation
4 <sup>th</sup> March 2021	<p><b>Beach Profiles:</b></p> <p>Whitburn Bay is covered by three beach profile lines for the Partial Measures survey (Appendix A). The last survey was Full Measures, undertaken in Autumn 2020.</p> <p><b>1bSNN1</b> is just to the south of Sunderland City Council's northern boundary. Since the last survey, the backshore above HAT has changed little, with small sections of accretion of up to 0.1m. From chainage 45m to 121m, an upper beach berm has been removed and the beach has lowered by up to 1.4m. Between chainages 121-180m beach levels have risen by 1.0m, forming a prominent lower beach berm. The beach toe has lowered by up to 0.5m. The upper and lower beach are at a relatively high level compared to the range recorded from previous surveys, particularly between chainages 140m and 175m which is at its highest level recorded. The middle beach is at a medium level. The beach toe is at one of its lowest levels recorded, in line with Spring 2019 and Spring 2020 levels.</p> <p><b>1bSNN7</b> is at Seaburn, north of Parson's Rock. Beach levels have lowered evenly across the beach profile seaward of the seawall by up to 0.5m to the end of the survey at chainage 174m. Overall, the entire beach profile is at a medium level compared to the range recorded from previous surveys.</p> <p><b>1bSNN10</b> is located mid-way between Parson's Rock and Roker Pier. Similar to profile 1bSNN7, the beach profile seaward of the seawall has lowered evenly by up to 0.4m on the upper beach and up to 0.2m on the middle and lower beach. The profile across the upper, middle and lower beach is at a medium level compared to the range recorded from previous surveys.</p>	<p>Beach levels in the centre and south of Whitburn Bay have lowered evenly by up to 0.5m. The northern beach profile has experienced draw down of sediment from the upper beach to the lower beach.</p> <p><b>Longer term trends:</b> Profiles in Whitburn Bay are generally within the bounds of previous surveys, however beach levels between chainages 140-175m at profile 1bSNN1 is now at its highest level recorded, whilst the beach toe is at one of its lowest levels recorded.</p>

- At Whitburn Bay, the recorded profiles are generally within the bounds of previous surveys and present no causes for concern. The only exception is at profile 1bSNN1 where the beach level between chainages 140-175m is at its highest level recorded, and the beach toe is at one of its lowest levels recorded.

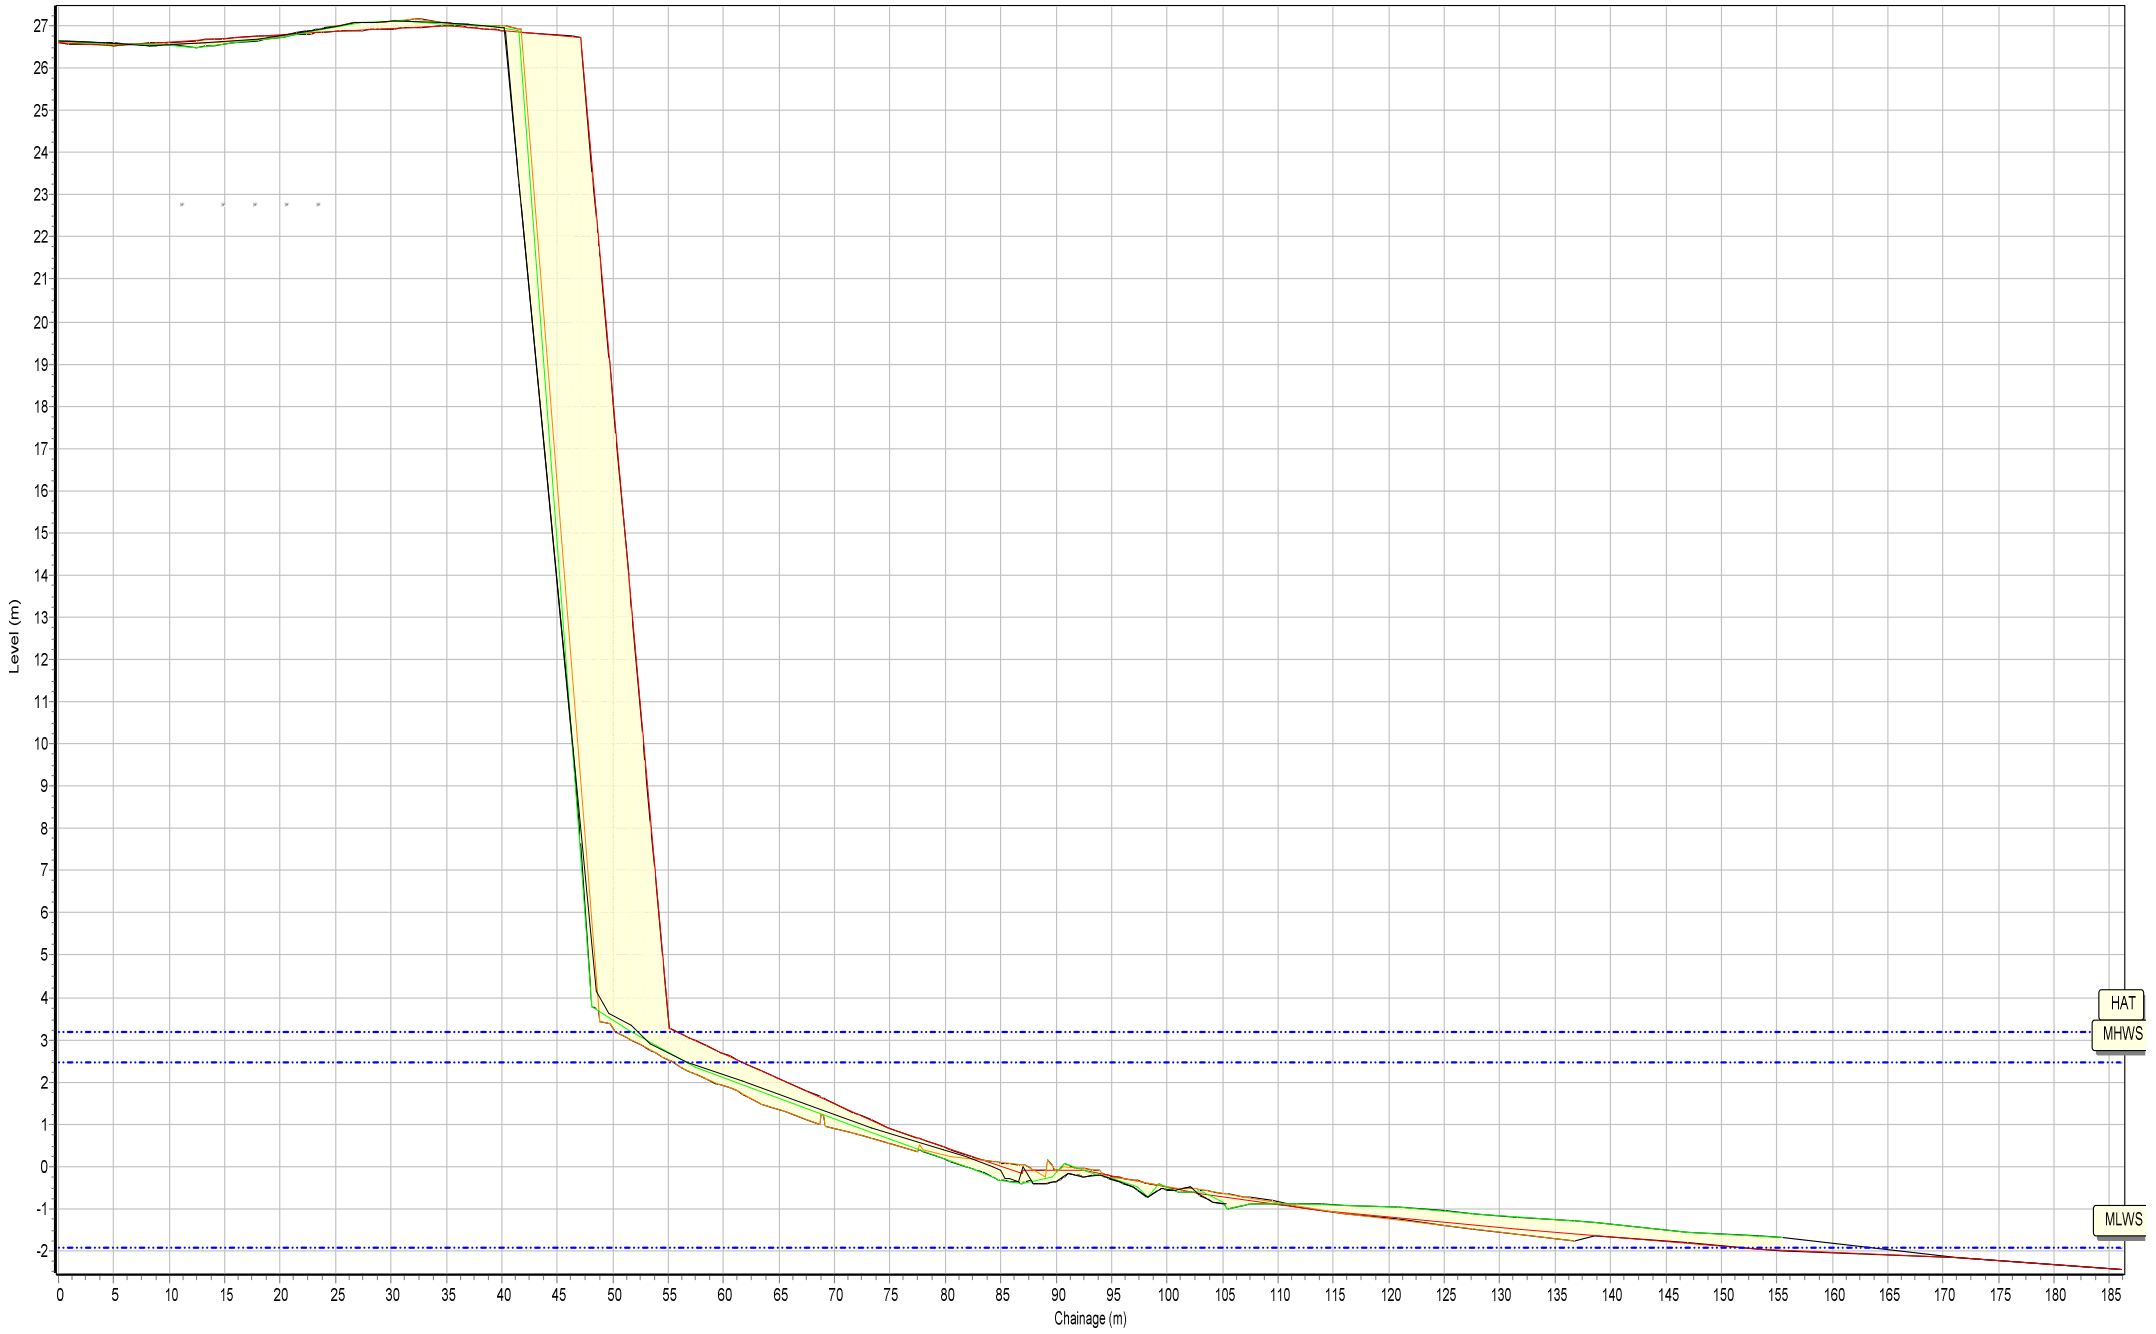
Beach Profiles: 1bSNS25

- Elsewhere at Hendon to Ryhope, the recorded profiles and cliff top surveys show no cause for concern. Profiles in the north have generally lowered, with small sections of accretion on the upper or middle beach. Profile SNS25 has accreted across the beach profile. The profiles at the landfill sites have mostly eroded, with a landward retreat of the cliff top and toe at the majority of profiles. Beach levels are at a medium-low levels compared to the range recorded from previous surveys.

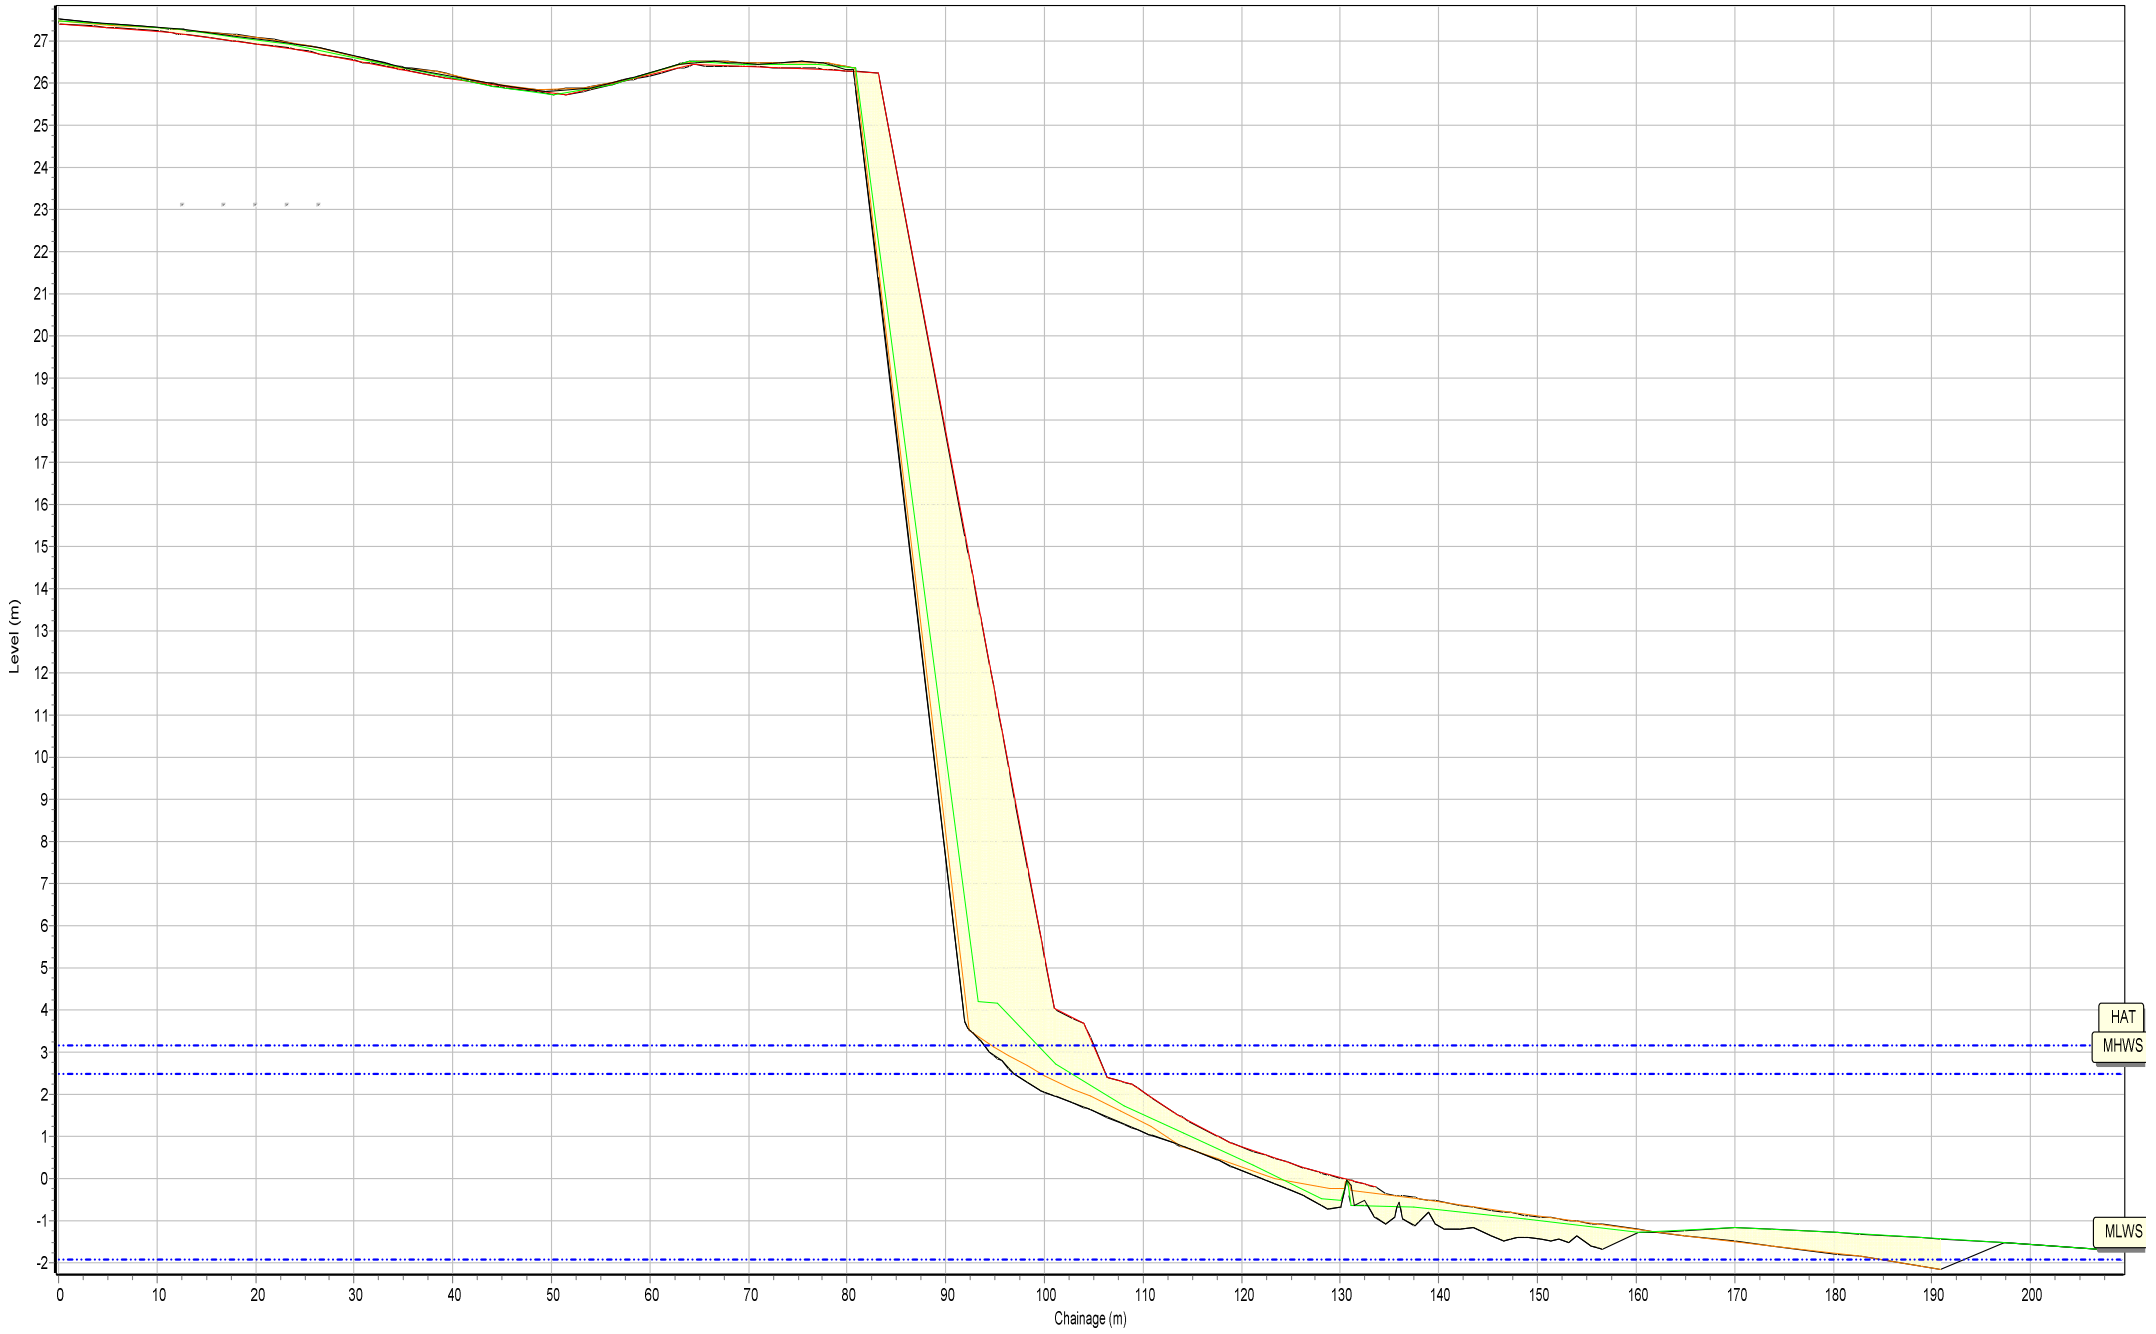
Beach Profiles: 1bSNS32

Survey Date	Description of Changes Since Last Survey	Interpretation
	<p>At profile <b>1BSNS32</b>, the cliff shows apparent recession of 1.2m at the toe, which is now at its most landward position recorded. The beach profile has lowered by up to 1.4m on the upper beach, 0.2m on the middle beach, and 0.4m on the lower beach. The rock patch seaward of chainage 130m is now exposed. Overall the beach profile is at a low level compared to the range recorded from previous surveys.</p> <p>At profile <b>1bSNS33</b>, the cliff shows apparent recession of approximately 1.0m at the cliff toe, which is now at its most landward position recorded. Overall the beach profile is at a low level compared to the range recorded from previous surveys, particularly between chainages 93-120m which is at its lowest level recorded.</p>	
<p><b>8<sup>th</sup>-11<sup>th</sup> March 2020</b></p>	<p><b>Cliff-top Survey:</b></p> <p>32 ground control points (numbered 1-32) were established along the cliff top between Hendon and Ryhope in March 2009, with a further three (28A, 28B and 28C) added in September 2009 (Figure 3). Note: the numbering of ground control points is not intended to correlate with that of the beach profile lines.</p> <p>Measurements are taken from each ground control point along a fixed bearing to the edge of the cliff top. These cliff top surveys are undertaken bi-annually and are intended to inform on erosion rates of the sea cliffs extending from the defended industrial areas at Hendon southwards along the undefended cliffs to Ryhope Dene.</p> <p>The results from the cliff top monitoring are anticipated to have an accuracy of <math>\pm 0.2\text{m}</math> due to the technique used. These cliff top surveys are undertaken bi-annually and are intended to inform on erosion rates of the sea cliffs extending from the defended industrial areas at Hendon southwards along the undefended cliffs to Ryhope Dene. Appendix B – Table B1 provides results from the March 2009 cliff top survey, showing the position from the ground control point to the edge of the cliff top along a defined bearing. Also shown is the change in measurement since the original (March 2009) and previous (October 2020) cliff top surveys.</p> <p>Results show that since the last survey, fourteen locations have shown erosion greater than the anticipated survey error; Point 3 by 0.21m, Point 5 by 3.41m, Point 11 by 0.59m, Point 13 by 0.44m, Point 16 by 0.24m, Point 23 by 1.16m, Point 24 by 0.69m, Point 25 by 1.31m, Point 26 by 0.22m, Point</p>	<p>Since the last survey, the cliffs at Points 3, 5, 11, 13, 16, 23-28, 28B, 29 and 30 have eroded, with very little change elsewhere. Point 5 shows the greatest amount of erosion of 3.41m.</p> <p><b>Longer term trends:</b> Since 2009, the majority of the points south of the sea defences have eroded. The greatest erosion has occurred at points 10, 25, 26, 27, 28A and 31 where between 7.48m and 12.26m have been lost.</p>

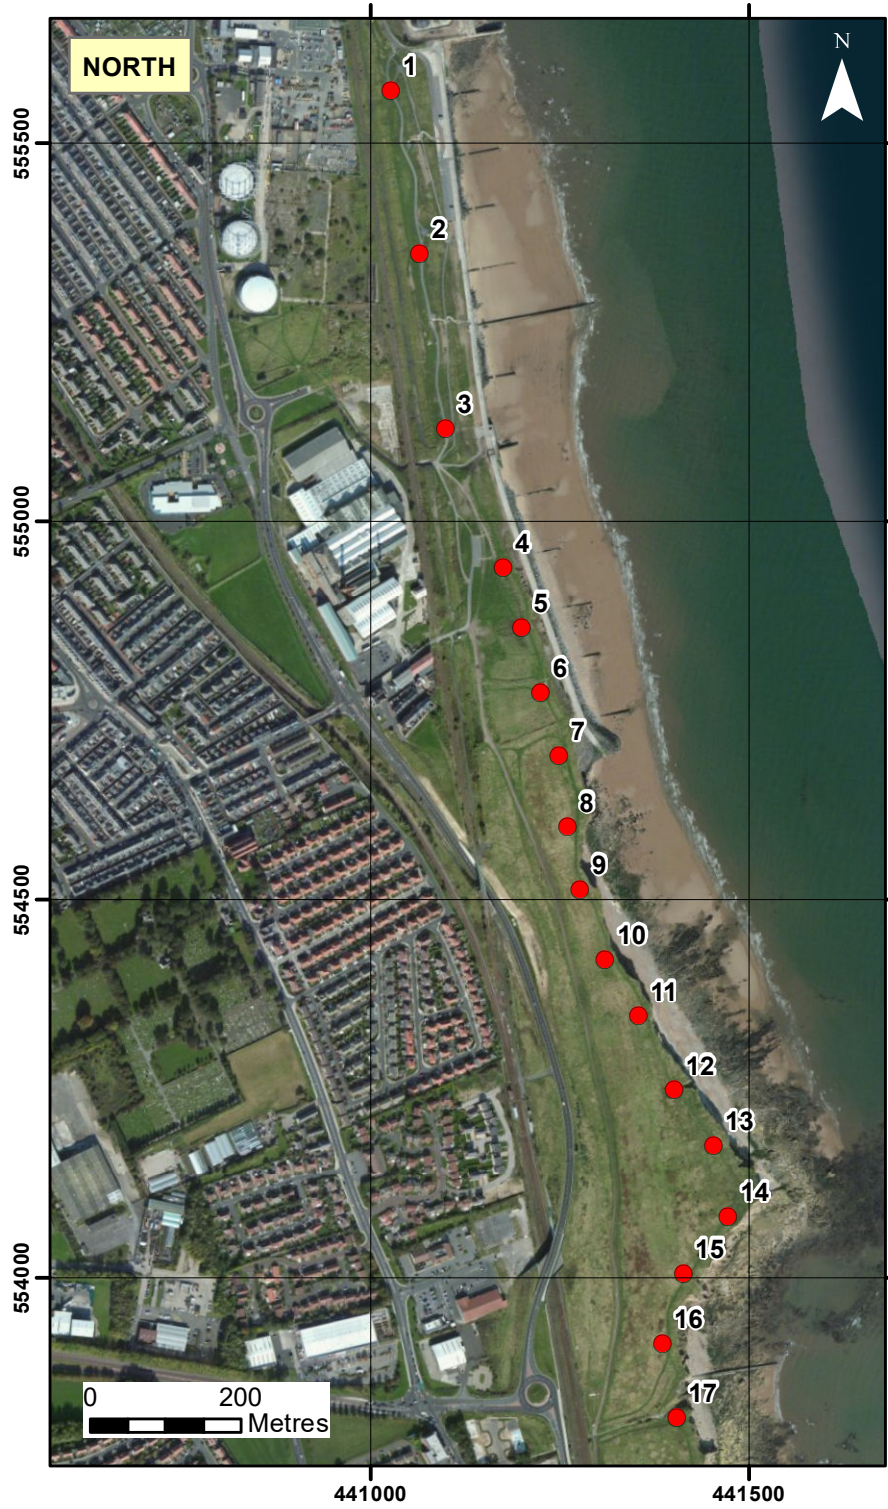
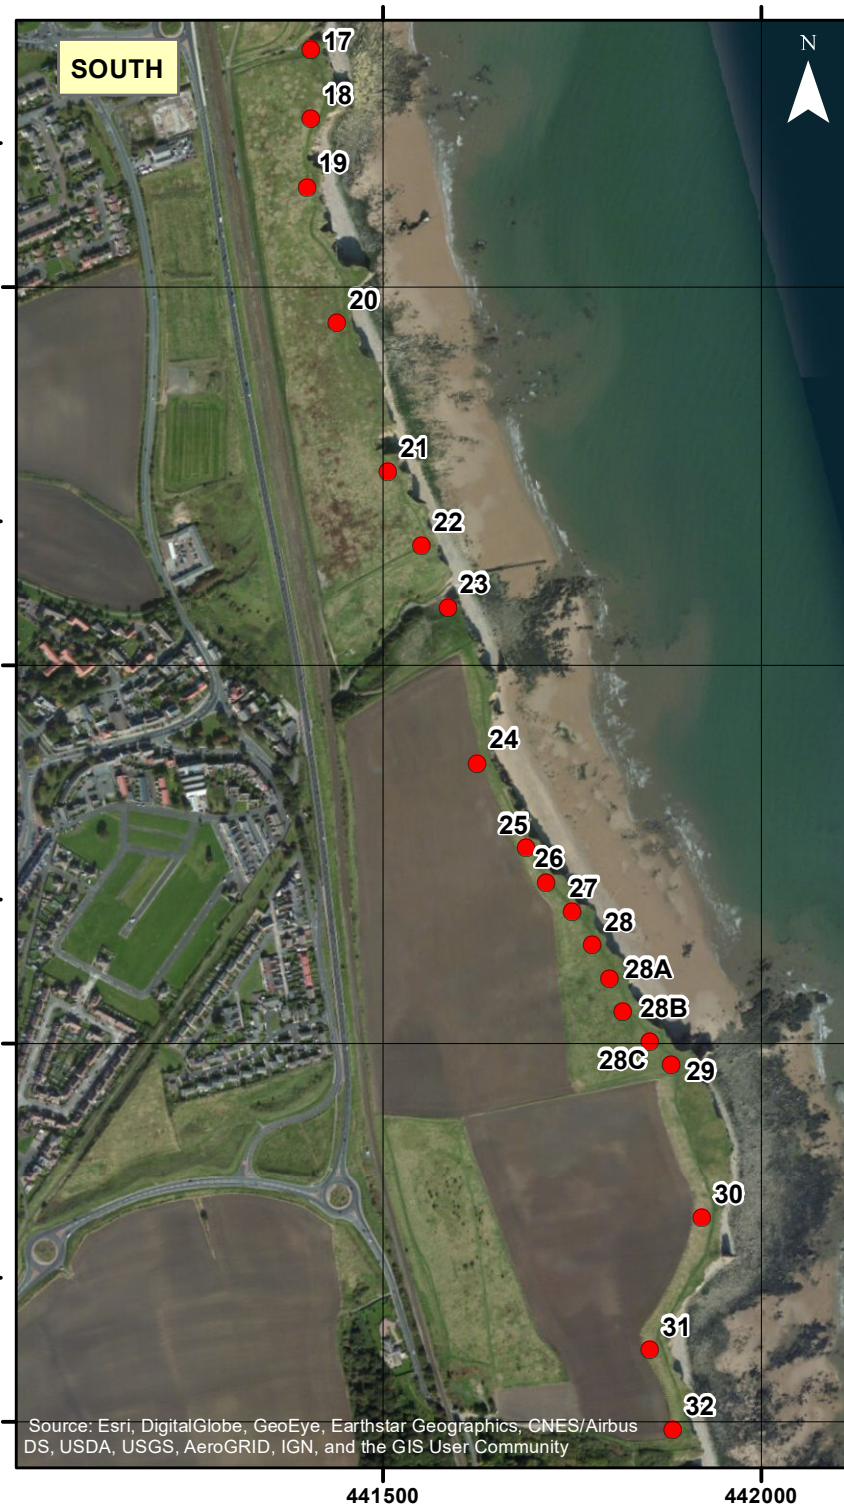
**Figure 3 - Map 1**  
**HENDON TO RYHOPE SOUTH**  
**Sunderland City Council**  
**Council Frontage**  
 Cliff Top Survey Locations

- The largest cliff erosion encountered since the previous survey was located at VMP's 5, 23, 25 and 28 where cliff top recession of between 1.16m and 3.41m was recorded.

- At Hendon to Ryhope (incl. Halliwell Banks), cliff top erosion at the landfill site in Halliwell Banks is ongoing, with several points recording erosion greater than the survey error. Points 5, 23, 25 and 28 showed between 1.16m and 3.41m of erosion since the previous survey (see Table B1 in Appendix B). The greatest amount of erosion recorded to have taken place between March 2009 and April 2021 was 12.26m at Point 25 which is along the border of the landfill site.

Thirty-two ground control points have been established between Hendon and Ryhope. The maximum separation between any two points varies along the coast, reflecting the degree of risk from the erosion.

The cliff top surveys between Hendon and Ryhope are undertaken bi-annually. Measurements are taken from a fixed ground control point along a fixed bearing to the edge of the cliff top.
