## **Cell 1 Regional Coastal Monitoring Programme Update Report 14: 'Partial Measures' Survey 2022**

**Sunderland City Council  
June 2022**

(\*) The present report is **Update Report 14** and provides an analysis of the 2022 Partial Measures survey for Sunderland City Council's frontage.

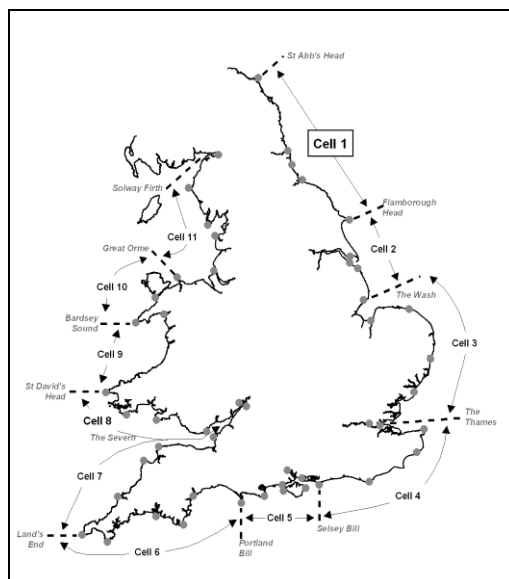
**Figure 1 Sediment Cells in England and Wales**

The Cell 1 Regional Coastal Monitoring Programme covers approximately 300km of the north east coastline, from the Scottish Border (just south of St. Abb's Head) to Flamborough Head in East Yorkshire. This coastline is often referred to as 'Coastal Sediment Cell 1' in England and Wales (Figure 1). Within this frontage the coastal landforms vary considerably, comprising low-lying tidal flats with fringing salt marshes, hard rock cliffs that are mantled with glacial sediment to varying thicknesses, softer rock cliffs and extensive landslide complexes.

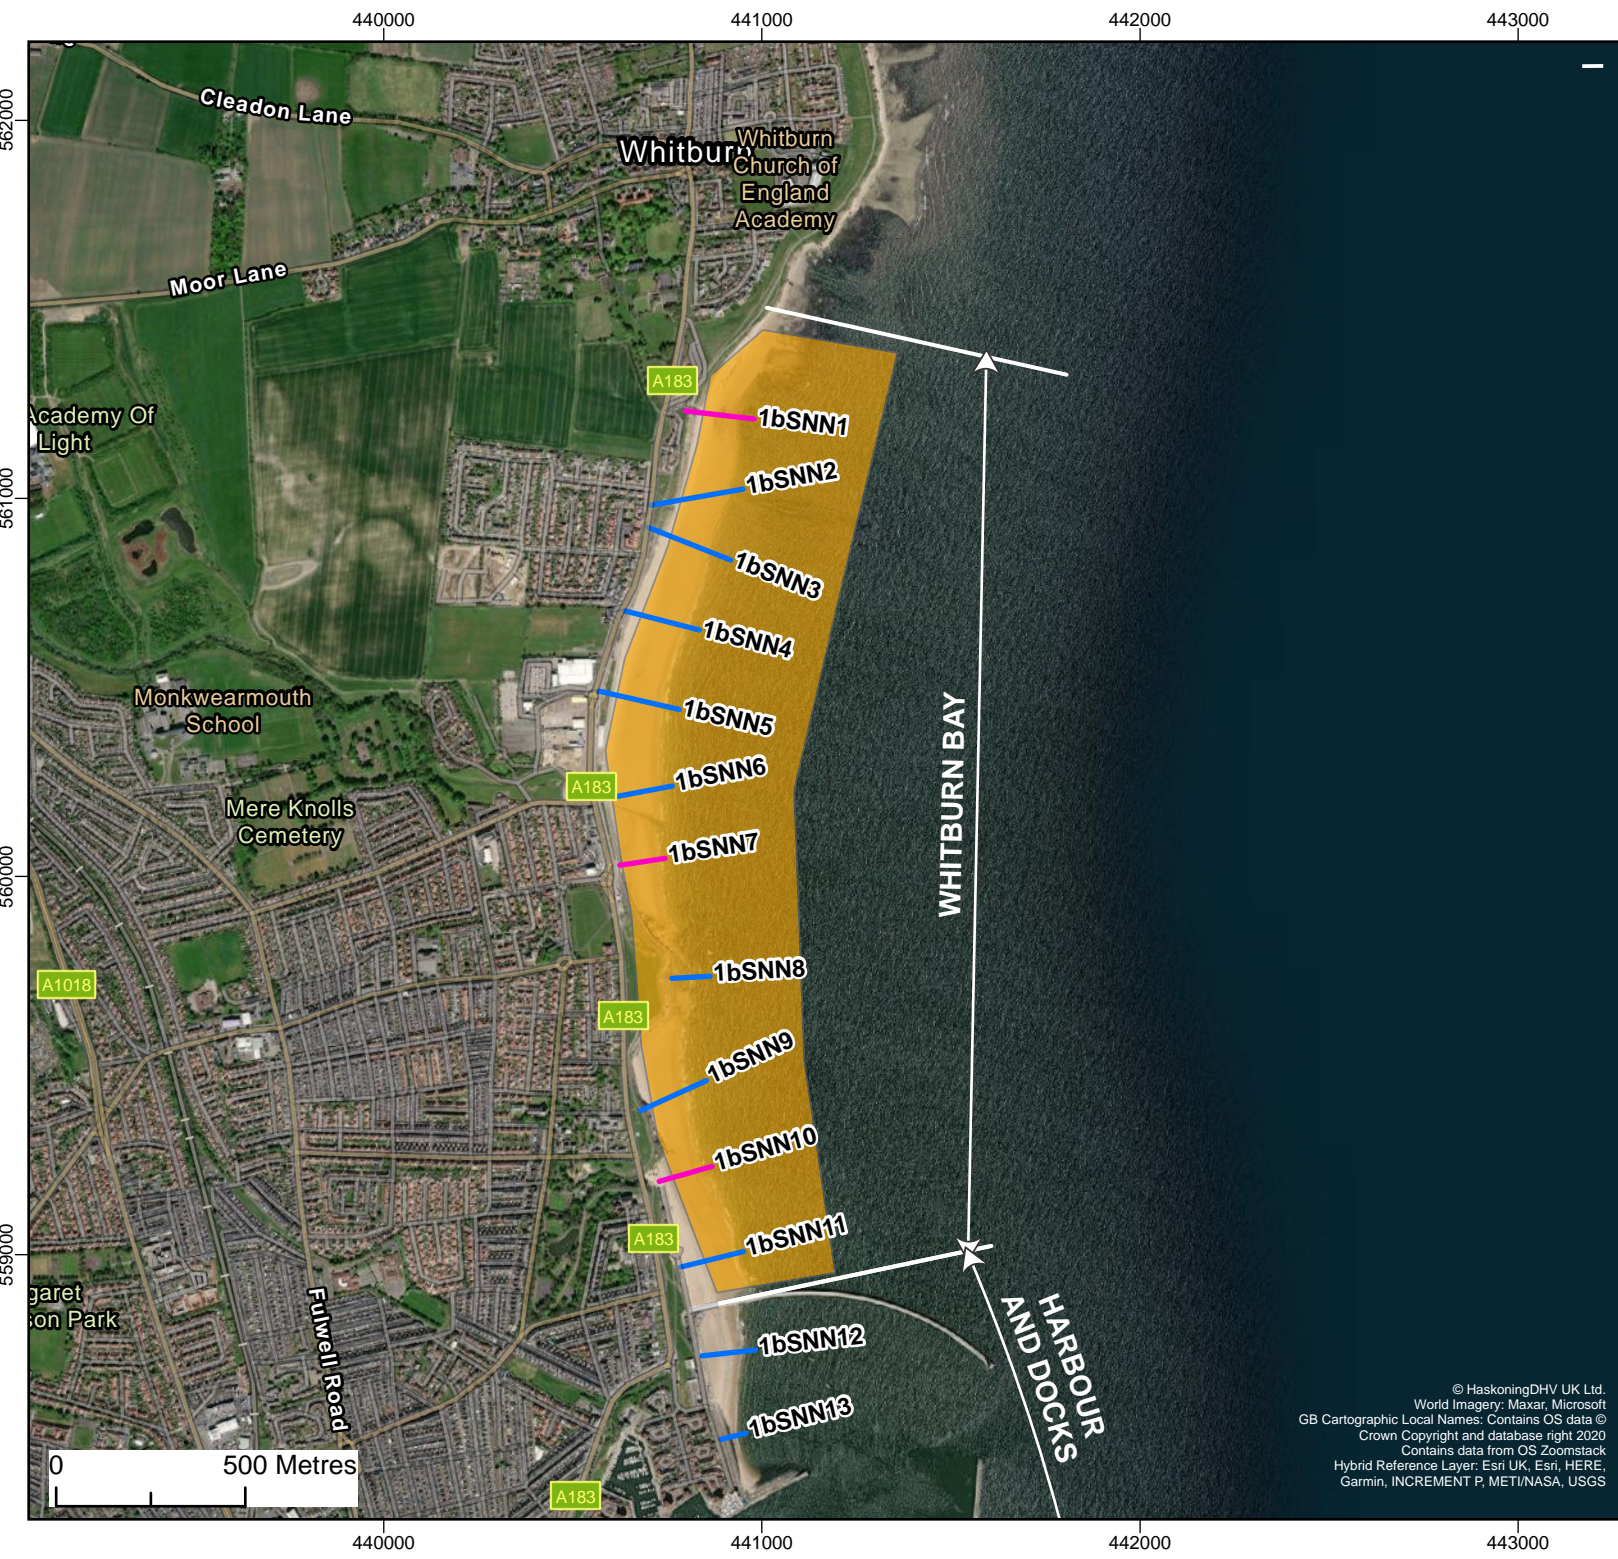
**Figure 2 - Map 1**

The location of these surveys is shown in Figure 2. The Partial Measures survey was undertaken along this frontage on 1<sup>st</sup> April 2022 (Whitburn Bay), and between 4<sup>th</sup> and 5<sup>th</sup> April 2022 (Hendon to Ryhope, including Halliwell Bank). During this time weather conditions varied, see surveyors reports for details.

**SURVEY LOCATIONS**

**WHITBURN BAY**

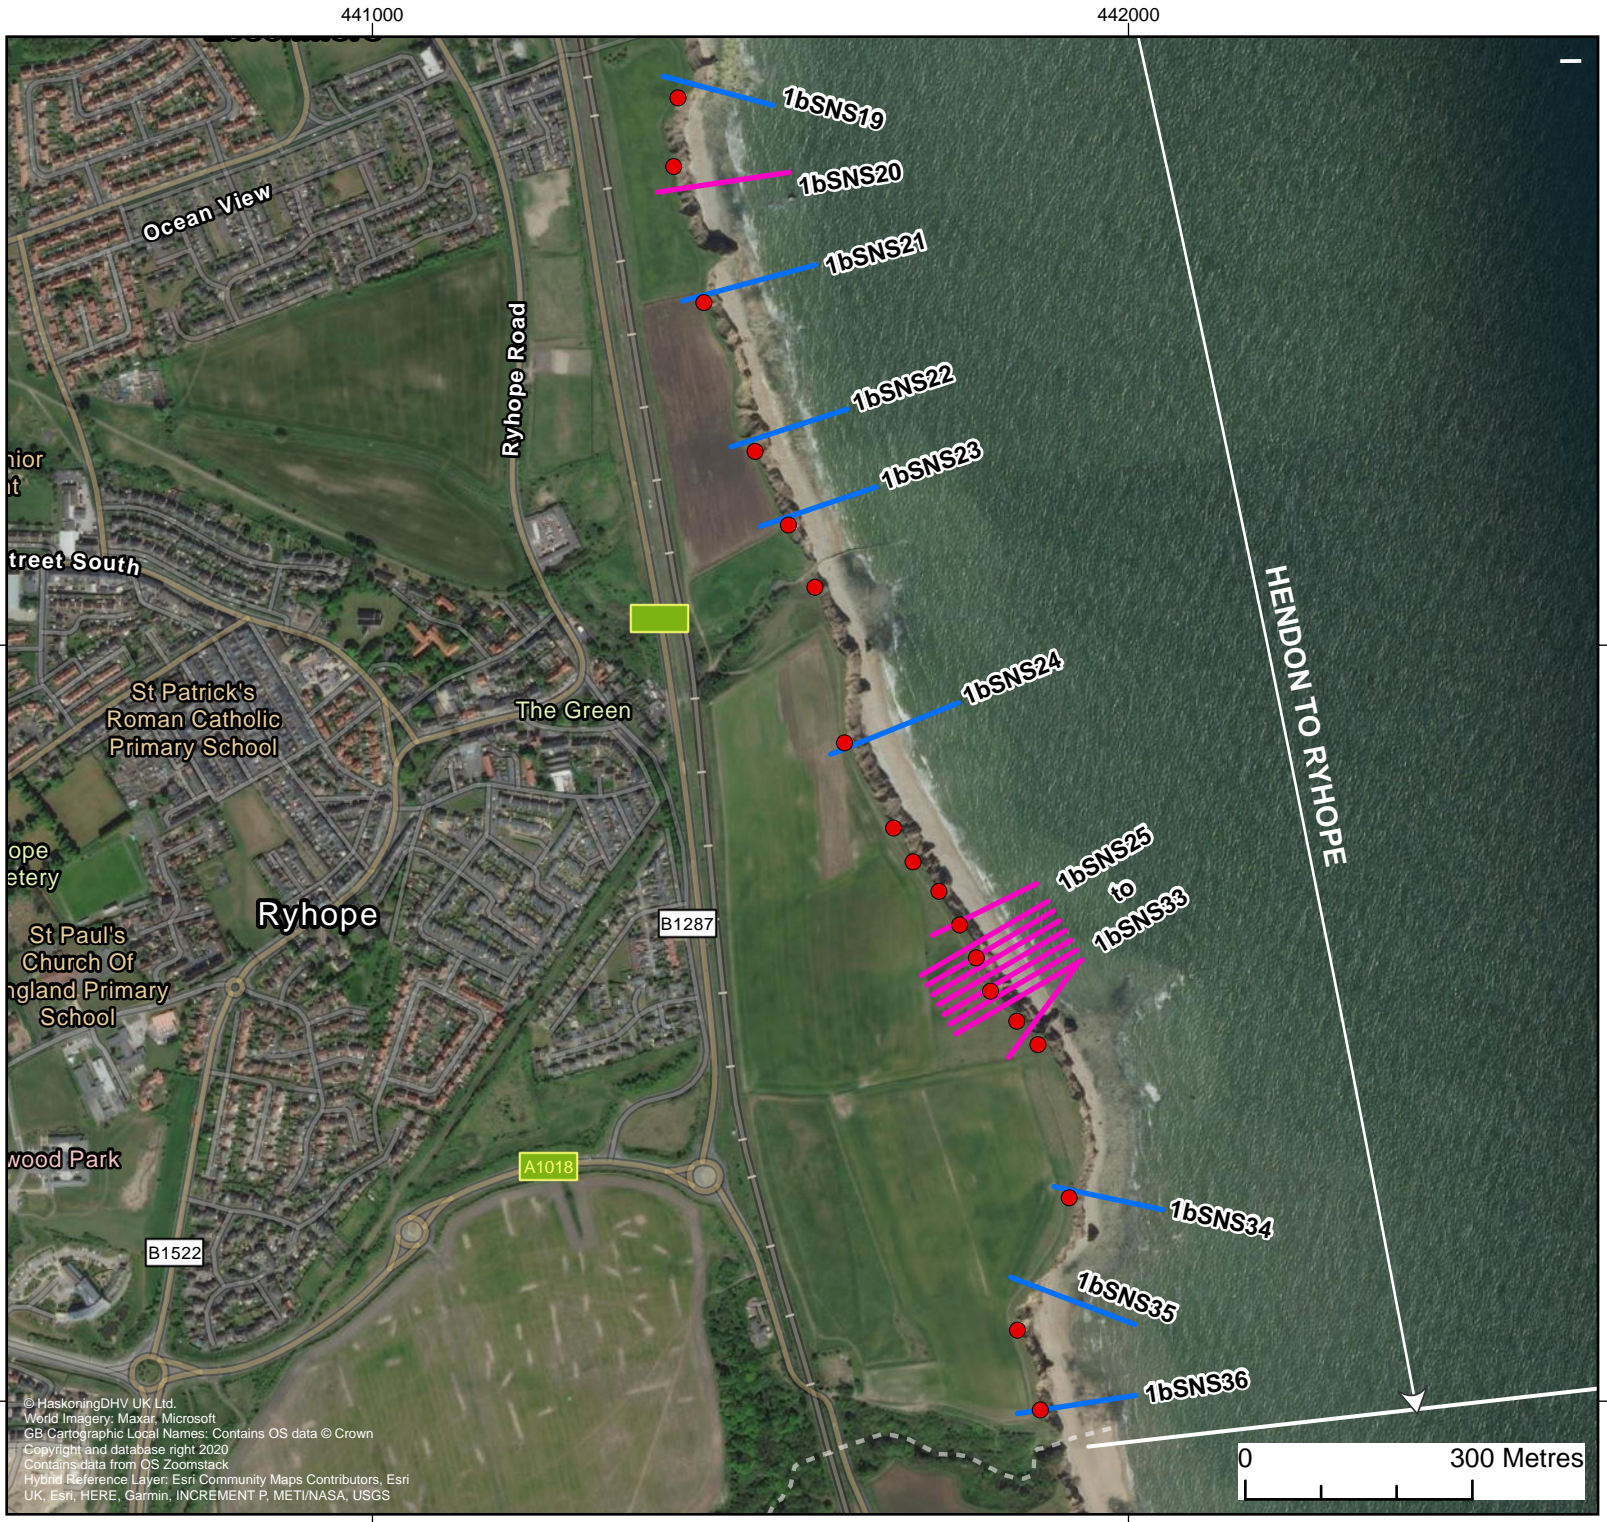
**Figure 2 - Map 4**

**SURVEY LOCATIONS**

**HENDON TO RYHOPE (SOUTH)**

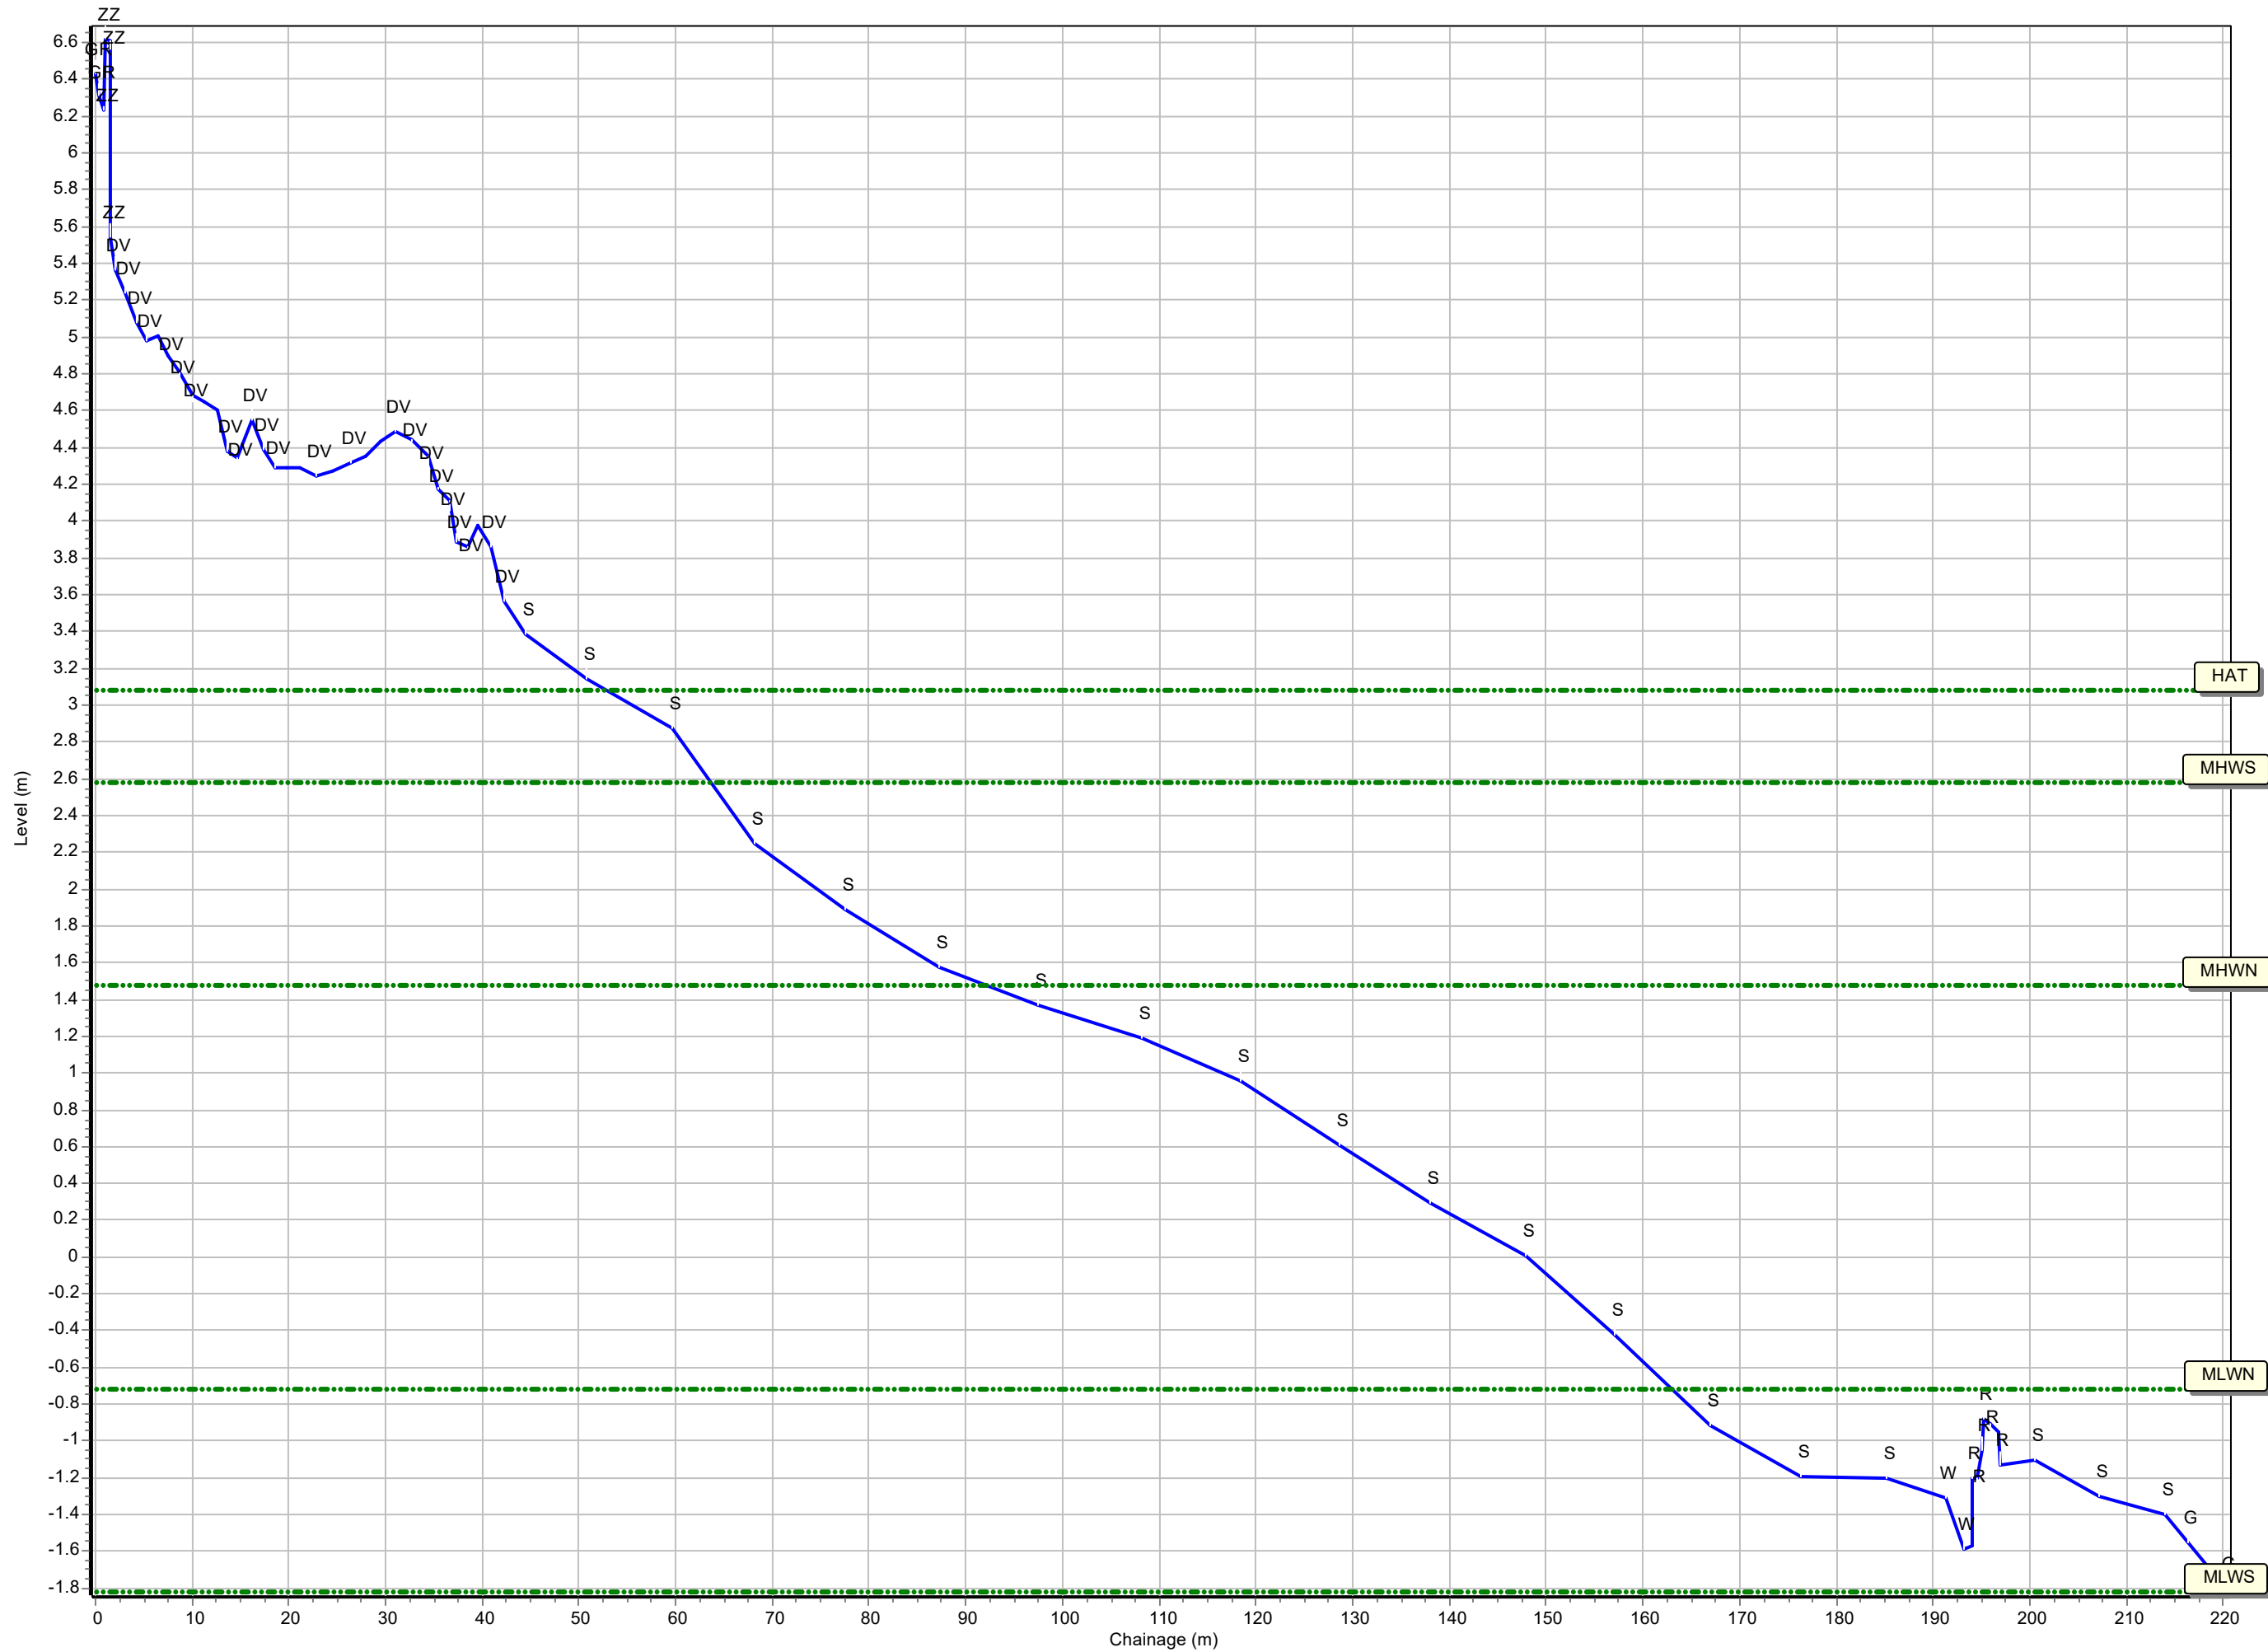
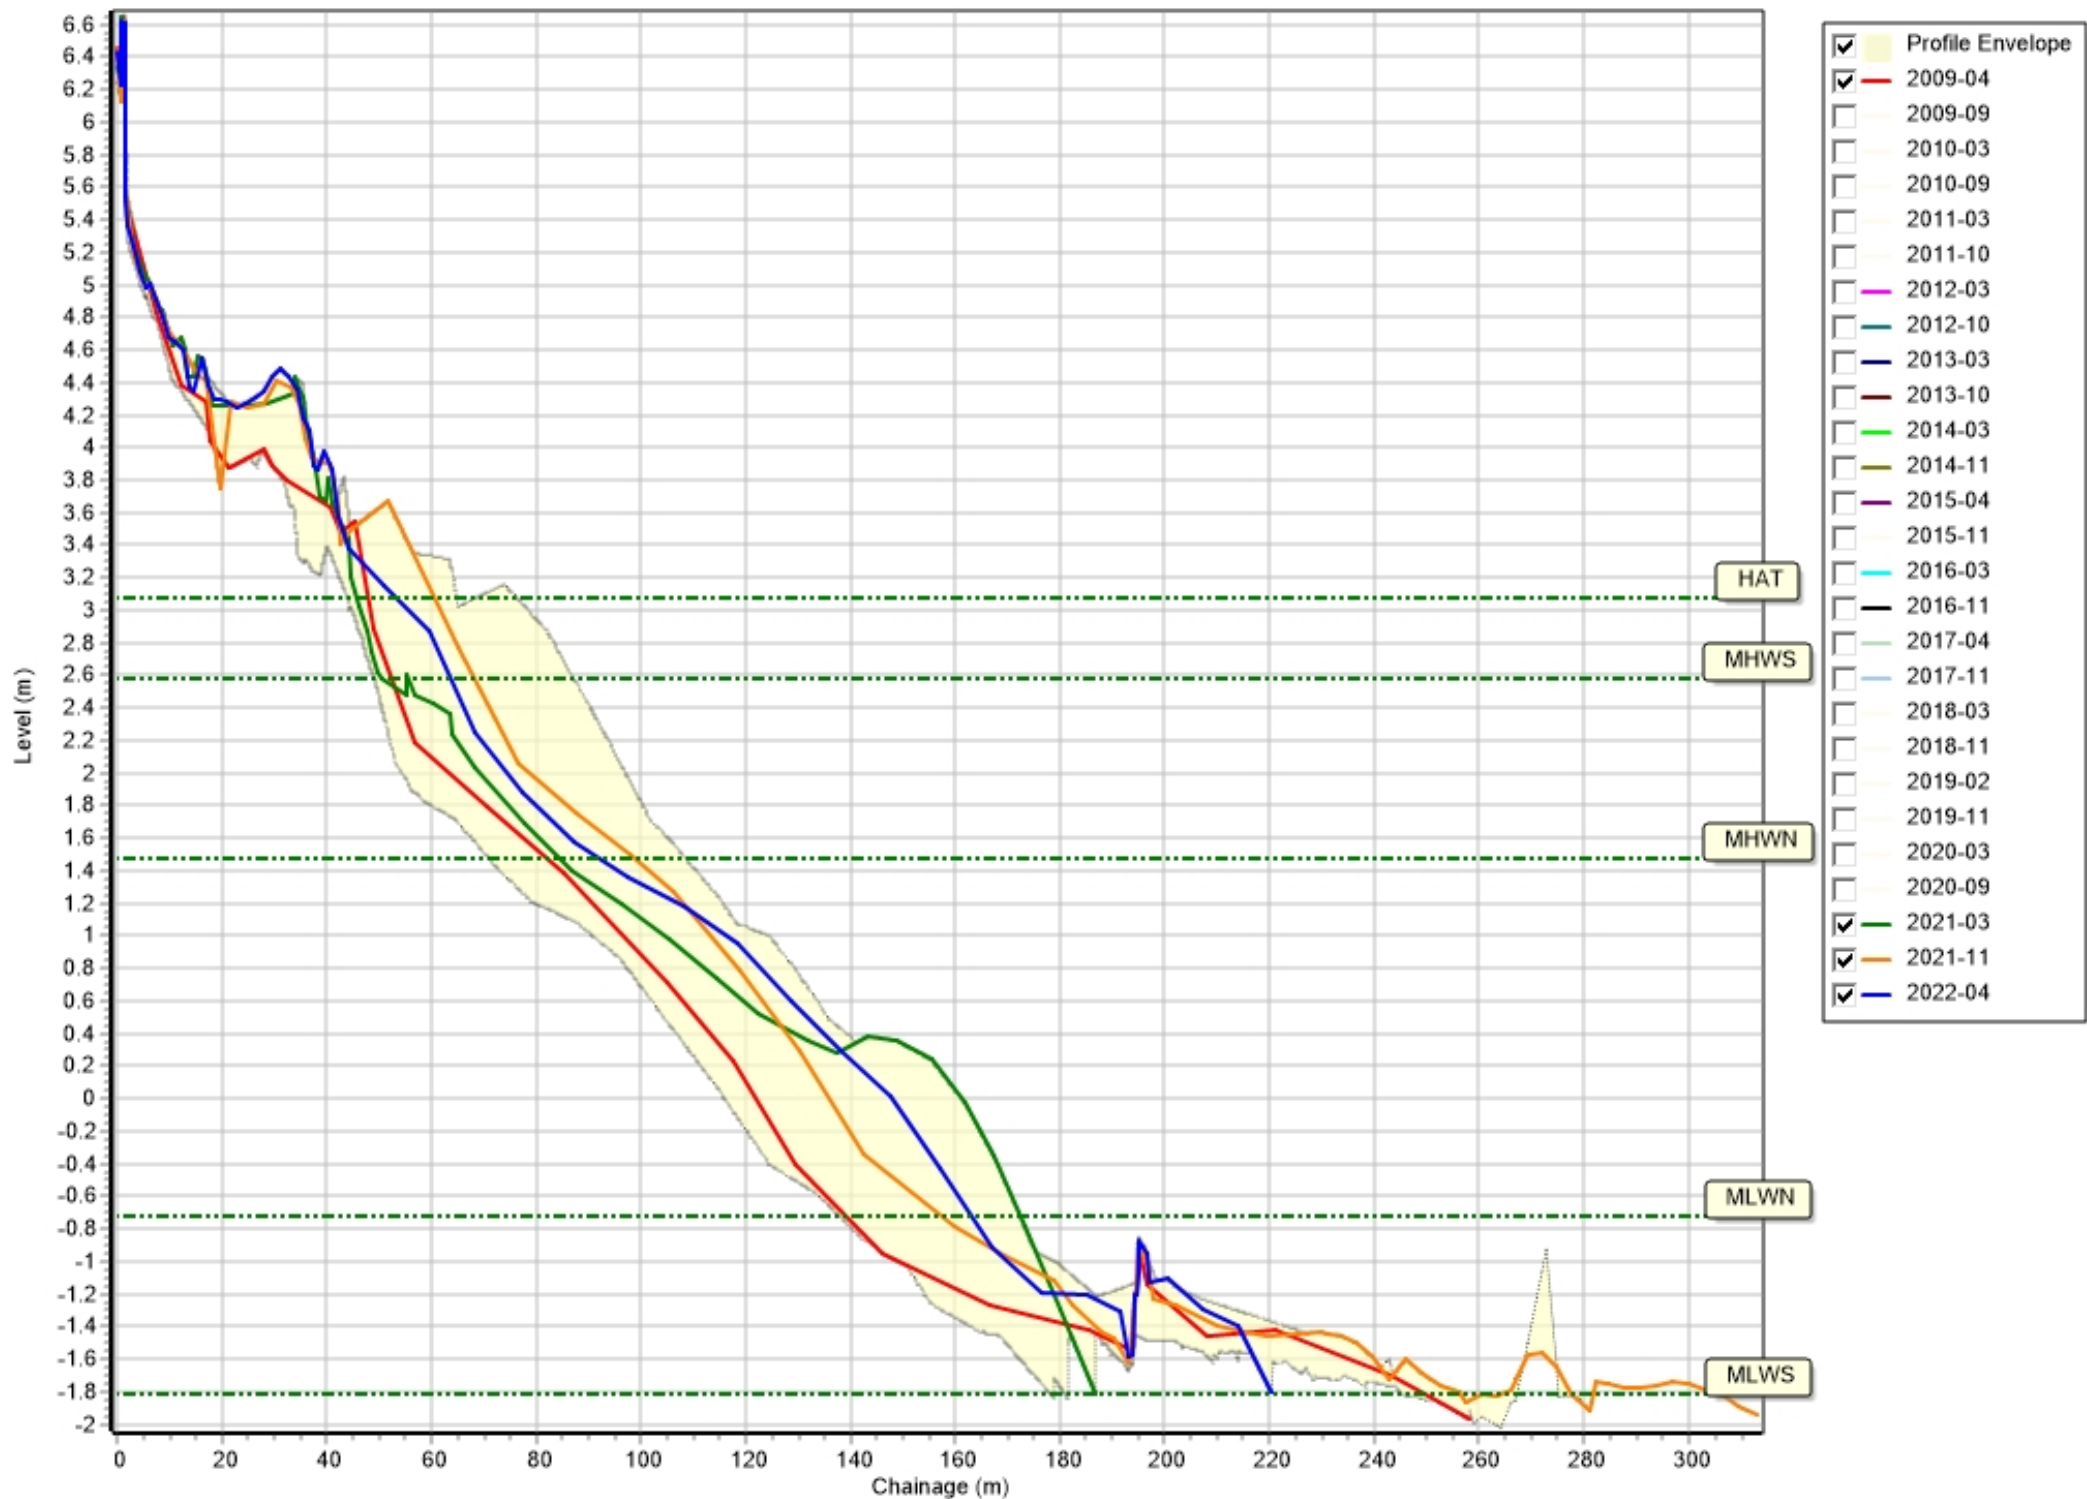
Profiles: 1bSNN1

Survey Date	Description of Changes Since Last Survey	Interpretation
1 <sup>st</sup> April 2022	<p><b>Beach Profiles:</b></p> <p>Whitburn Bay is covered by three beach profile lines for the Partial Measures survey (Appendix A). The last survey was Full Measures, undertaken in Autumn 2021.</p> <p><b>1bSNN1</b> is just to the south of Sunderland City Council's northern boundary. Since the last survey, the backshore landward of chainage 43m has mostly undergone accretion, with up to 0.5m of accretion at chainage 20m where a hollow has been infilled. The upper beach between chainage 43-109m has lowered by up to 0.5m, before switching to accretion on the lower beach by up to 0.5m. The rock at chainage 195m is still present and the beach profile terminates at chainage 220m, which is 0.3m lower than the profile from autumn 2021. Overall, the beach profile is at a medium-high level compared to the range recorded from previous surveys.</p> <p><b>1bSNN7</b> is at Seaburn, north of Parson's Rock. Beach levels have risen across the profile until the end of the survey at chainage 156m, which shows a slight lowering by less than 0.1m. A depression at chainage 7m has been infilled by up to 0.4m since the previous survey. Accretion is greatest on the middle beach where it reaches 0.35m, reducing to less than 0.1m on the lower beach. Overall, the upper and middle beach profile is at a high level and the lower beach is at a medium level compared to the range recorded from previous surveys.</p> <p><b>1bSNN10</b> is located mid-way between Parson's Rock and Roker Pier. Similar to profile 1bSNN7, the beach profile seaward of the seawall has risen since the previous survey. Accretion is greatest at the toe of the seawall where it reaches 0.6m, reducing to less than 0.1m on the middle beach and 0.2m on the lower beach. The profile across the upper, middle and lower beach is at a medium-high level compared to the range recorded from previous surveys.</p>	<p>Beach levels across Whitburn Bay have generally increased, particularly in the centre and south of the bay. The northern profile has lowered on the upper beach.</p> <p><b>Longer term trends:</b> Profiles in Whitburn Bay are within the bounds of previous surveys, with most profiles at a medium-high level.</p>

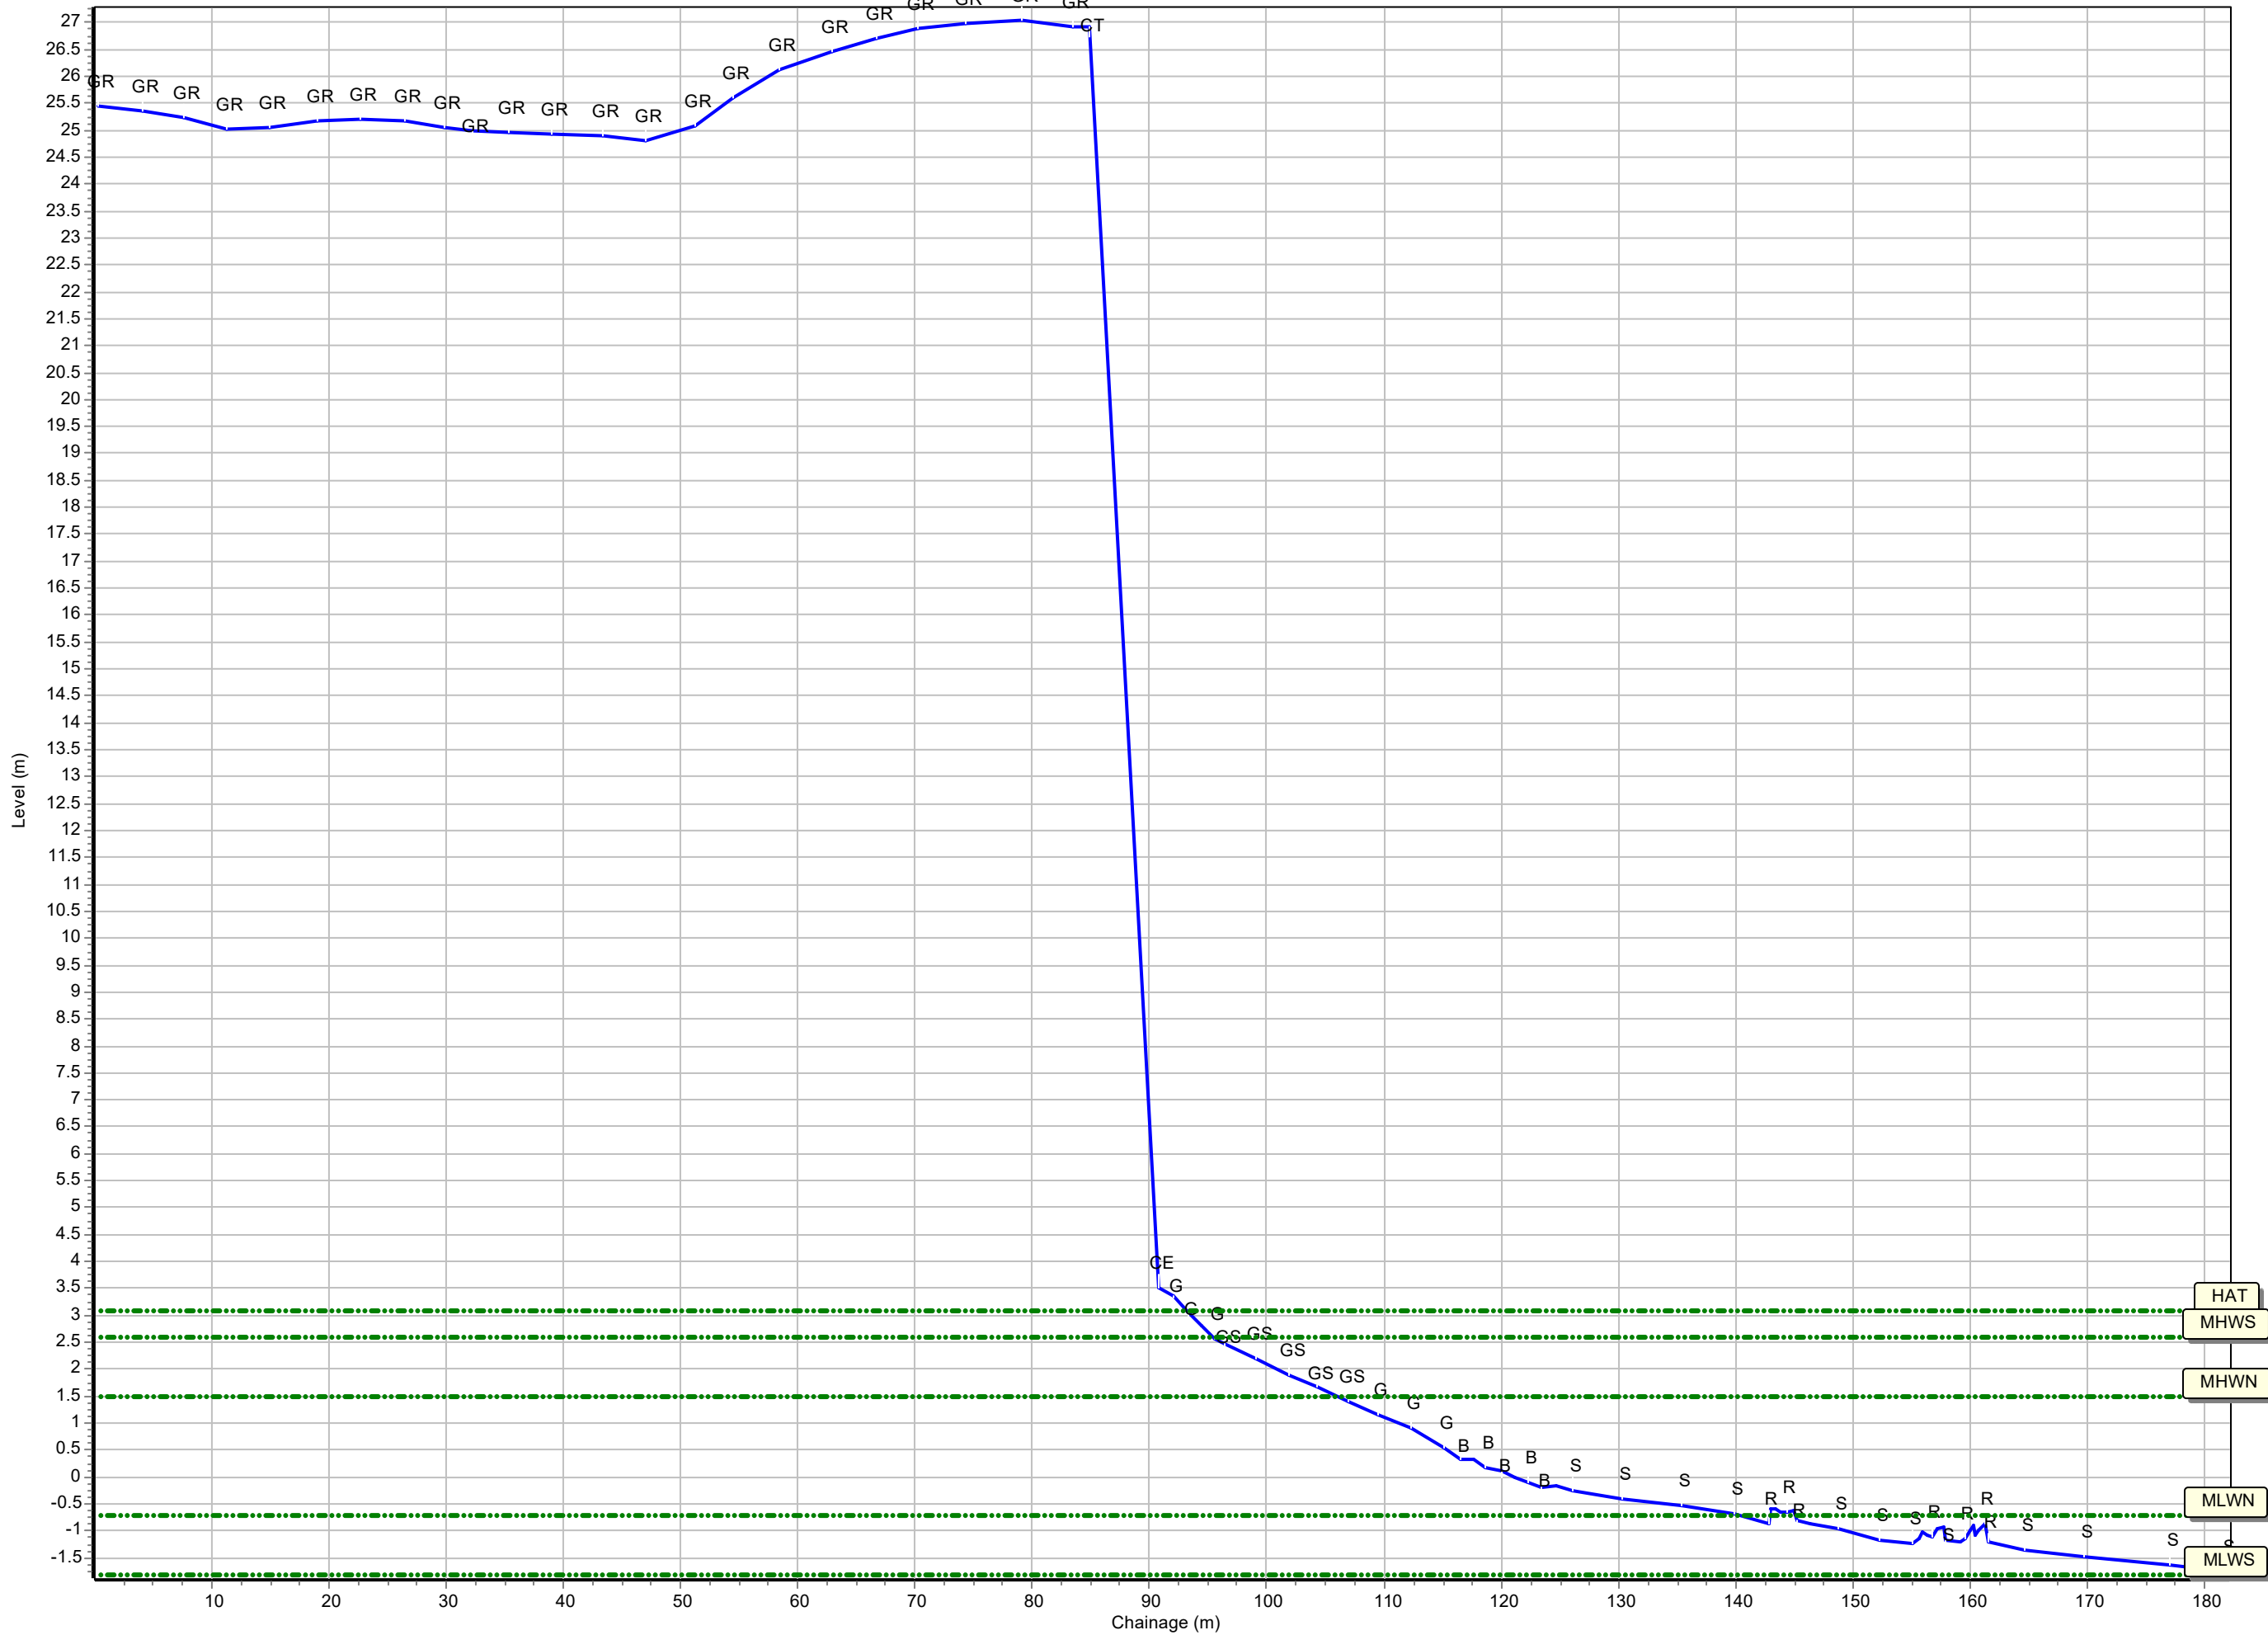
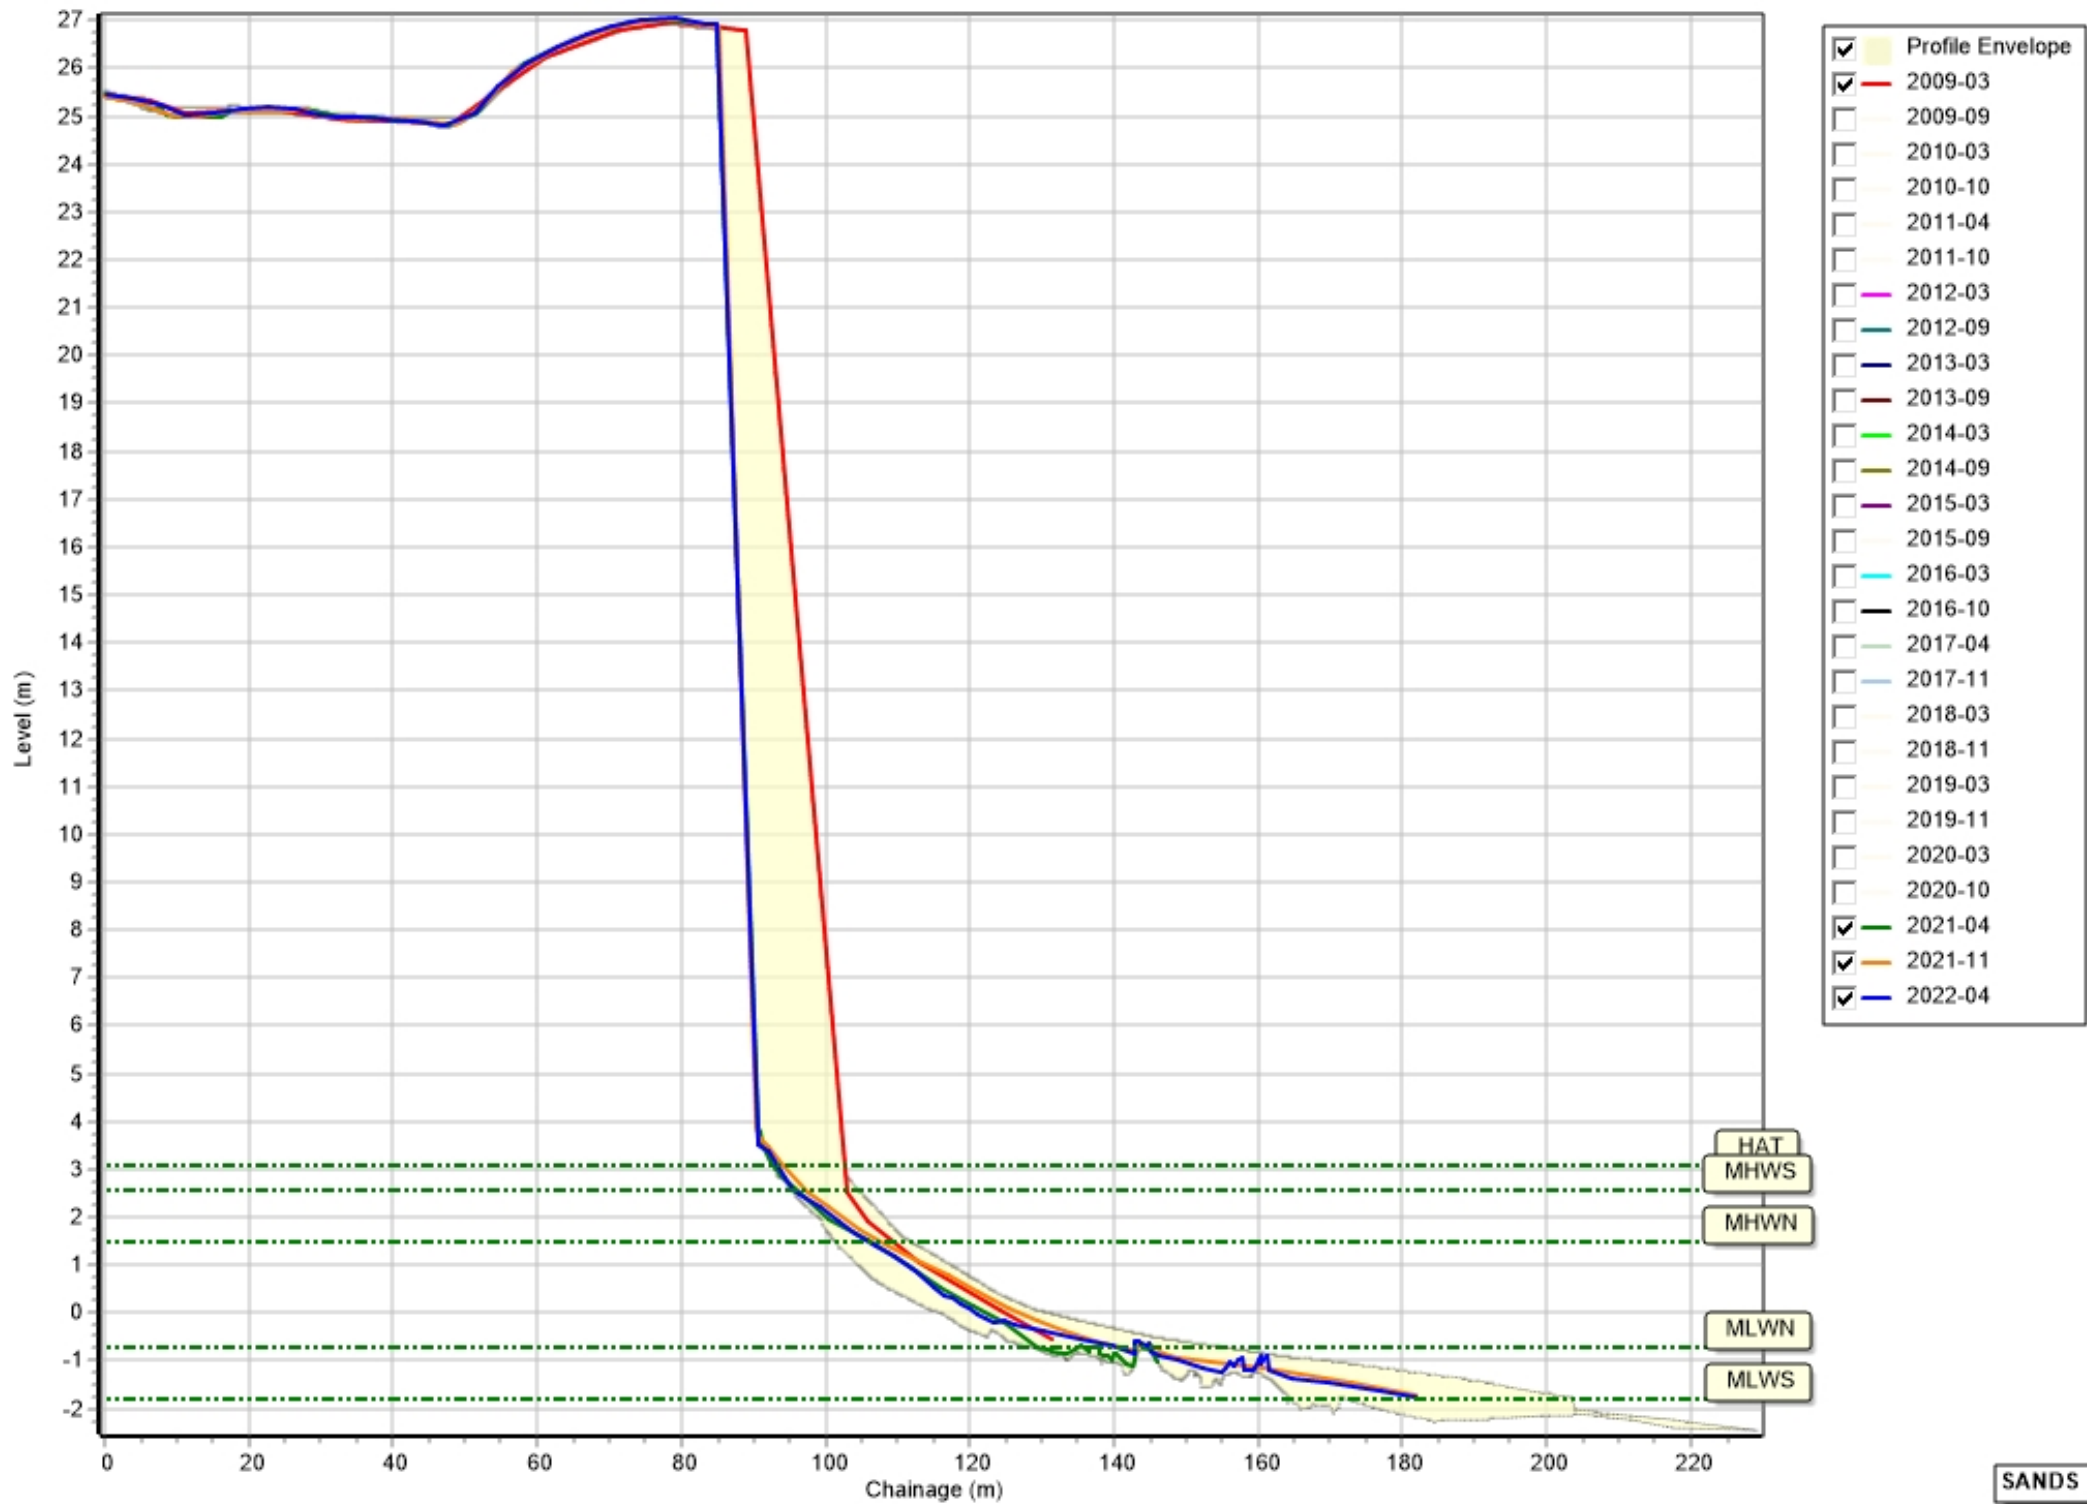
Profiles: 1bSNS26

Survey Date	Description of Changes Since Last Survey	Interpretation
	<p>At profiles <b>1bSNS26</b>, the beach level from the cliff toe to the end of the survey has lowered by up to 0.2m on the upper beach, 0.4m on the middle beach and 0.1m on the lower beach. The profile has exposed rocks at chainage 157m and 160m. Overall the profile is at a relatively medium level compared to the range recorded from previous surveys.</p> <p>At <b>1bSNS27</b> there has been a recession in the cliff top by up to 1.0m. The beach levels across the profile have lowered by up to 0.4m on the upper and middle beach and 0.2m on the lower beach. The upper cliff face is at its most landward position recorded. The beach profile is at a medium-low level compared to the range recorded from previous surveys.</p> <p>At <b>1bSNS28</b>, the beach profile has generally lowered by up to 0.3m on the upper beach, 0.4m on the middle beach and 0.2m on the lower beach. There is a small patch of accretion between chainages 141-160m however accretion levels are less than 0.1m. The beach profile is at a medium-low level on the upper and middle beach, and a middle level on the lower beach compared to the range recorded from previous surveys.</p> <p>At profile <b>1bSNS29</b>, there has been very little change in the position of the cliff face. The beach profile has undergone variable change; however erosion has dominated by up to 0.4m. Accretion is limited to 0.1m. Overall, the beach is at a low level compared to the range recorded from previous surveys.</p> <p>At profile <b>1bSNS30</b>, there has been a retreat of the cliff top by approximately 0.5m, and a retreat of the cliff toe by approximately 1.0m. The majority of the beach has lowered by up to 0.4m, except at the toe of the cliff where the beach has risen by 0.5m. Overall, the beach profile is at a medium-low level compared to the range recorded from previous surveys.</p> <p>Profile <b>1bSNS31</b> shows a similar pattern to profile 1bSNS30, with accretion at the cliff toe by up to 0.4m, and erosion across the rest of the profile by up to 0.4m. There has been relatively little change in the position of the cliff face. Overall, the profile is at a medium-low level compared to the range recorded from previous surveys.</p> <p>At profile <b>1BSNS32</b>, the beach profile has risen at the cliff toe by up to 0.4m to chainage 100m. Seaward of this point, the beach level has lowered by up to 0.4m on the middle beach and 0.1m on the lower beach. Overall, the beach profile is at a medium-low level compared to the range recorded from previous surveys.</p> <p>At profile <b>1bSNS33</b>, the cliff has not changed position since the previous survey. The beach profile has</p>
