## **Cell 1 Regional Coastal Monitoring Programme Update Report 14: 'Partial Measures' Survey 2022**

**Sunderland City Council  
June 2022**

(\*) The present report is **Update Report 14** and provides an analysis of the 2022 Partial Measures survey for Sunderland City Council's frontage.

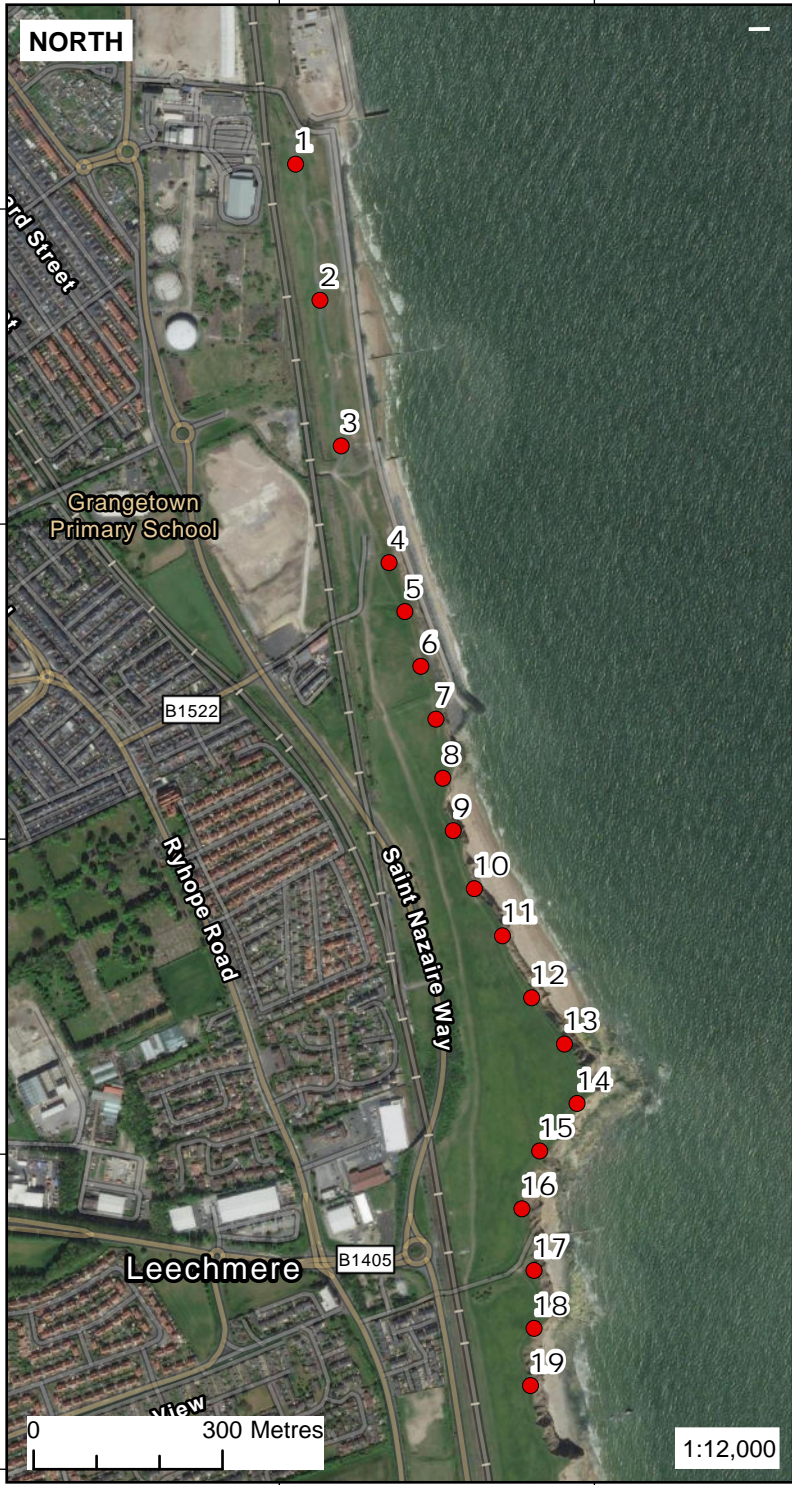
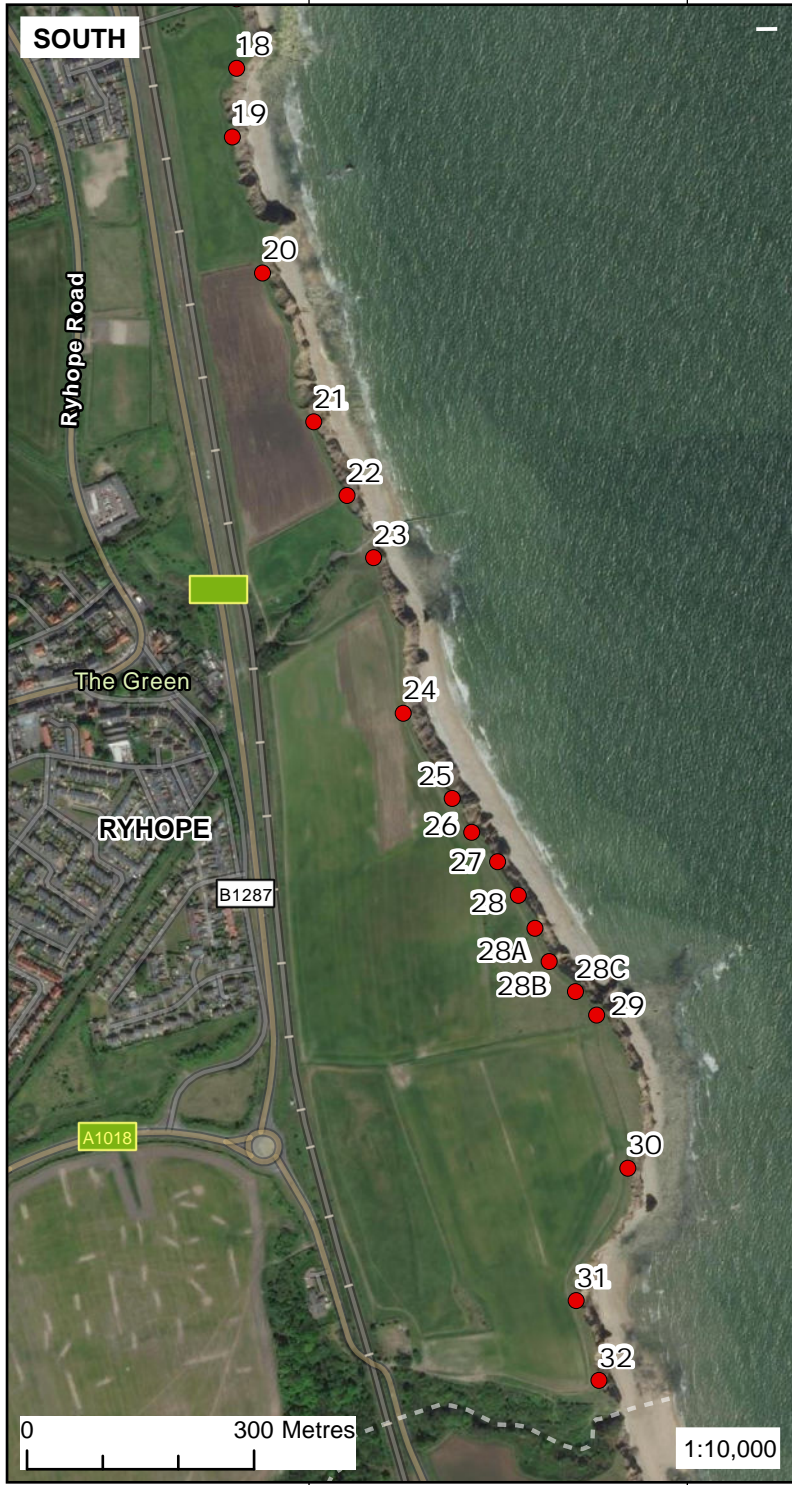
Title:  
**Figure 3 - Map 1**  
**HENDON TO RYHOPE**  
**Sunderland City Council Frontage**

Survey Date	Description of Changes Since Last Survey	Interpretation
	lowered by up to 0.6m on the upper and middle beach, and 0.2m on the lower beach. Overall, the beach profile is at a medium-low level compared to the range recorded from previous surveys.	
5 <sup>th</sup> April 2022	<p><b>Cliff-top Survey:</b></p> <p>32 ground control points (numbered 1-32) were established along the cliff top between Hendon and Ryhope in March 2009, with a further three (28A, 28B and 28C) added in September 2009 (Figure 3). Note: the numbering of ground control points is not intended to correlate with that of the beach profile lines.</p> <p>Measurements are taken from each ground control point along a fixed bearing to the edge of the cliff top. These cliff top surveys are undertaken bi-annually and are intended to inform on erosion rates of the sea cliffs extending from the defended industrial areas at Hendon southwards along the undefended cliffs to Ryhope Dene.</p> <p>The results from the cliff top monitoring are anticipated to have an accuracy of <math>\pm 0.2\text{m}</math> due to the technique used. These cliff top surveys are undertaken bi-annually and are intended to inform on erosion rates of the sea cliffs extending from the defended industrial areas at Hendon southwards along the undefended cliffs to Ryhope Dene. Appendix B – Table B1 provides results from the March 2009 cliff top survey, showing the position from the ground control point to the edge of the cliff top along a defined bearing. Also shown is the change in measurement since the original (March 2009) and previous (November 2021) cliff top surveys.</p> <p>Results show that since the last survey, five locations have shown erosion greater than the anticipated survey error; Point 4 by 0.2m, Point 11 by 0.46m, Point 23 by 1.36m, Point 24 by 0.45m and Point 28A by 0.71m.</p> <p>Since surveys began in March 2009 (or September 2009 for 28A, 28B, and 28C) erosion greater than the survey error has occurred at around 83% of the ground control points, where total losses are 12.4m (at Point 25) at their greatest, and more typically less than 5m. The long-term erosion rates are 0.95m/yr at their highest (Point 25), with up to 0.5m/yr being more typical.</p>	<p>Since the last survey, the cliffs at Points 4, 11, 23, 24 and 28A have shown erosion greater than the anticipated error of survey methods, with very little change elsewhere. Point 18 has shown 0.61m of accretion (seaward movement of the cliff top), however this is more likely due to differences in placement of survey equipment due to vegetation.</p> <p><b>Longer term trends:</b> Since 2009, the majority of the points south of the sea defences have eroded. The greatest erosion has occurred at points 10, 11, 25, 26, 27, 28A and 31 where between 7.6m and 12.4m has been lost.</p>

- The largest cliff erosion encountered since the previous survey was located at Points 4, 11, 23, 24 and 28A where cliff top recession of between 0.2m and 1.36m was recorded.

Thirty-two ground control points have been established between Hendon and Ryhope. The maximum separation between any two points varies along the coast, reflecting the degree of risk from the erosion.

The cliff top surveys between Hendon and Ryhope are undertaken bi-annually. Measurements are taken from a fixed ground control point along a fixed bearing to the edge of the cliff top.

- At Whitburn Bay, the recorded profiles are within the bounds of previous surveys and present no causes for concern.
- At Hendon to Ryhope (incl. Halliwell Banks), cliff top erosion at the landfill site in Halliwell Banks is ongoing, with several points recording erosion greater than the survey error. Points 4, 11, 23, 24 and 28A showed erosion of between 0.2m and 1.36m since the previous survey (see Table B1 in Appendix B). The greatest amount of erosion recorded to have taken place between March 2009 and April 2022 was 12.24m at Point 25 which is along the border of the landfill site.
- Elsewhere at Hendon to Ryhope, the recorded profiles and cliff top surveys show no cause for concern. Profiles have generally lowered, with small sections of accretion on the upper or middle beach. Beach levels are at a medium-low levels compared to the range recorded from previous surveys.
