**Cell 1 Regional Coastal Monitoring Programme  
Update Report 16: 'Partial Measures' Survey 2024**

**Sunderland  
City Council**

**Sunderland City Council  
May 2024**

(\*) The present report is **Update Report 16** and provides an analysis of the 2024 Partial Measures survey for Sunderland City Council's frontage.

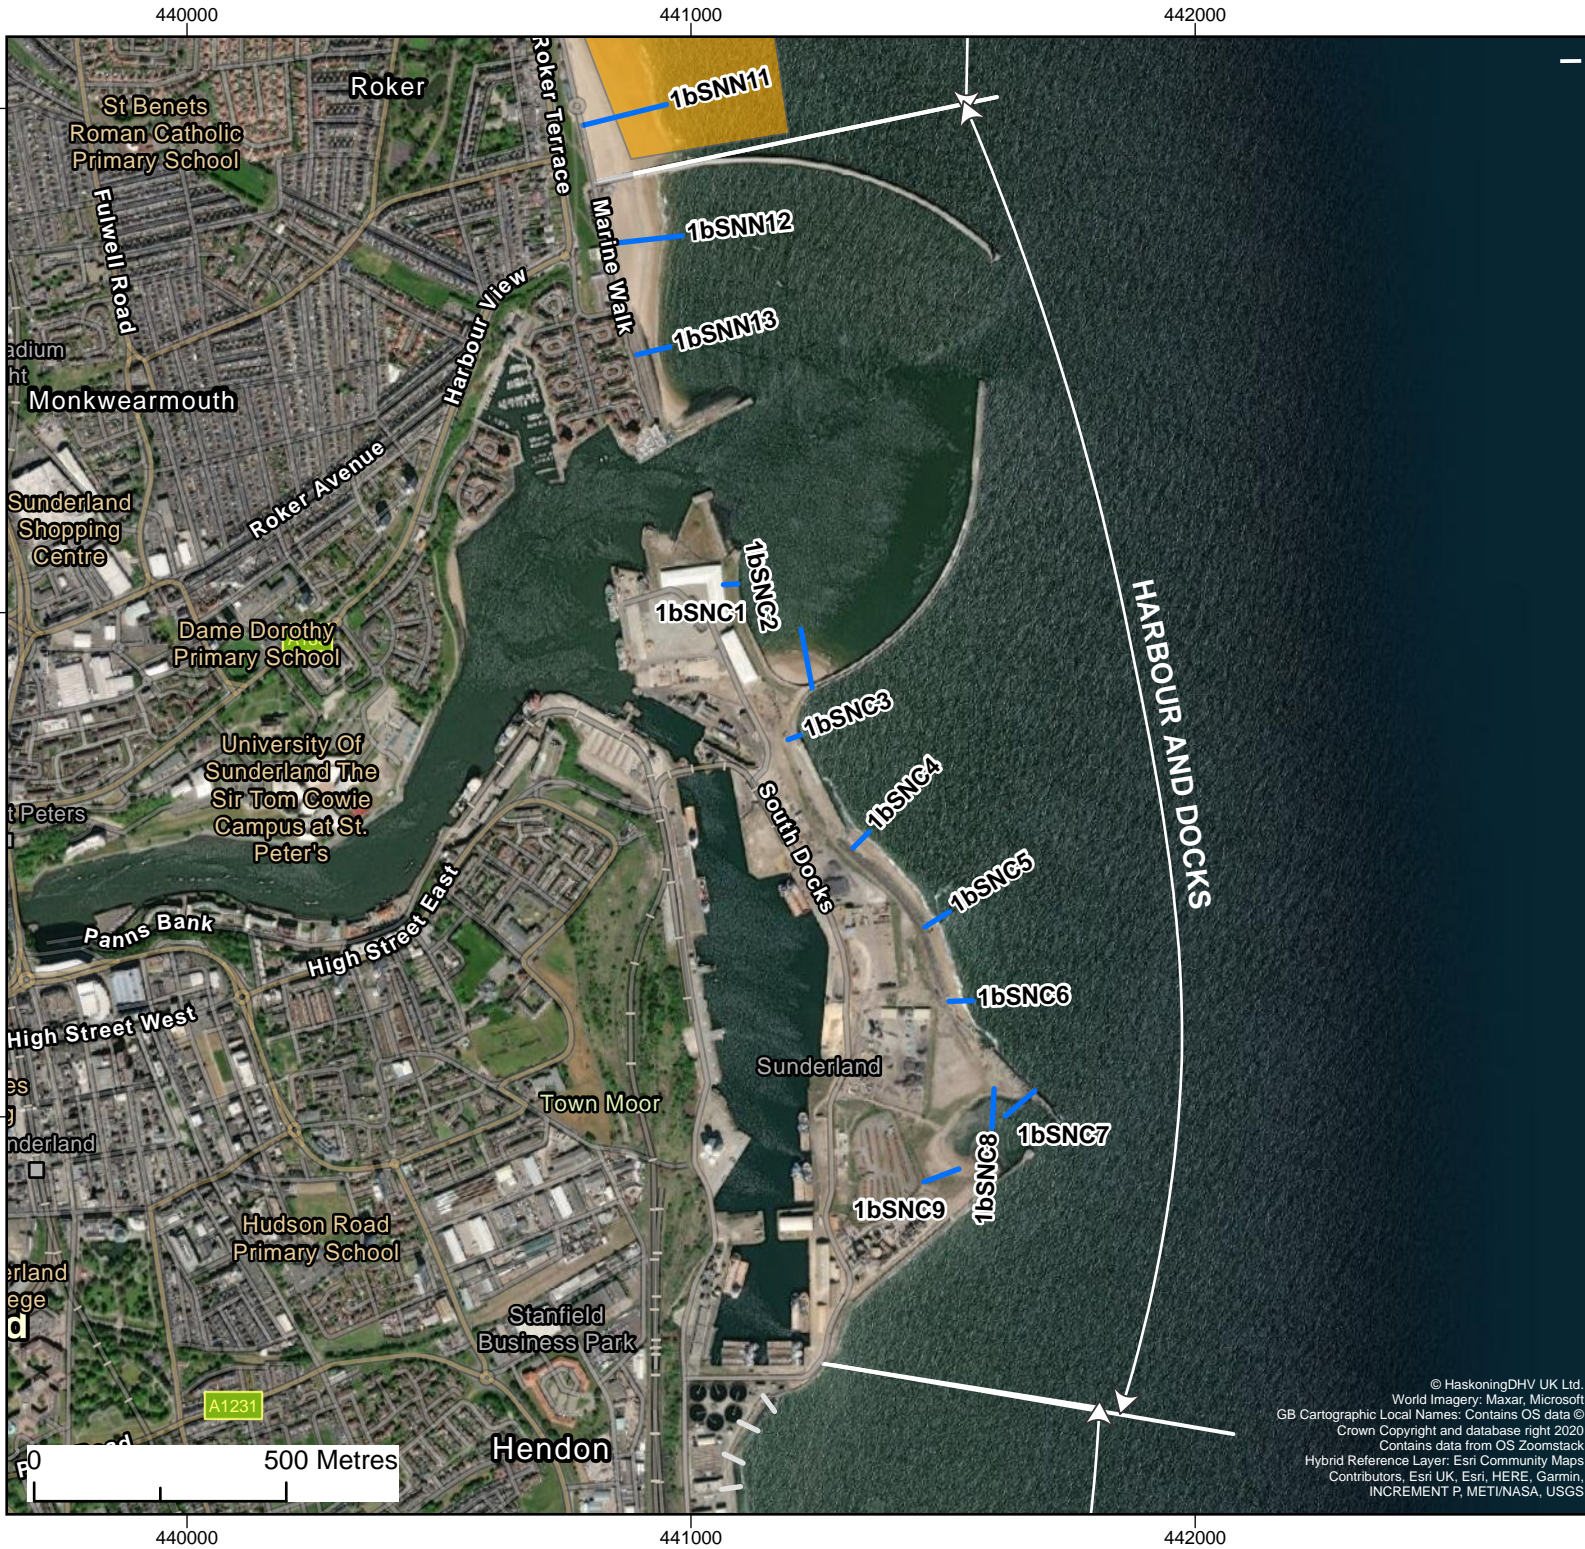
**Figure 2 - Map 2**

**HARBOUR AND DOCKS**

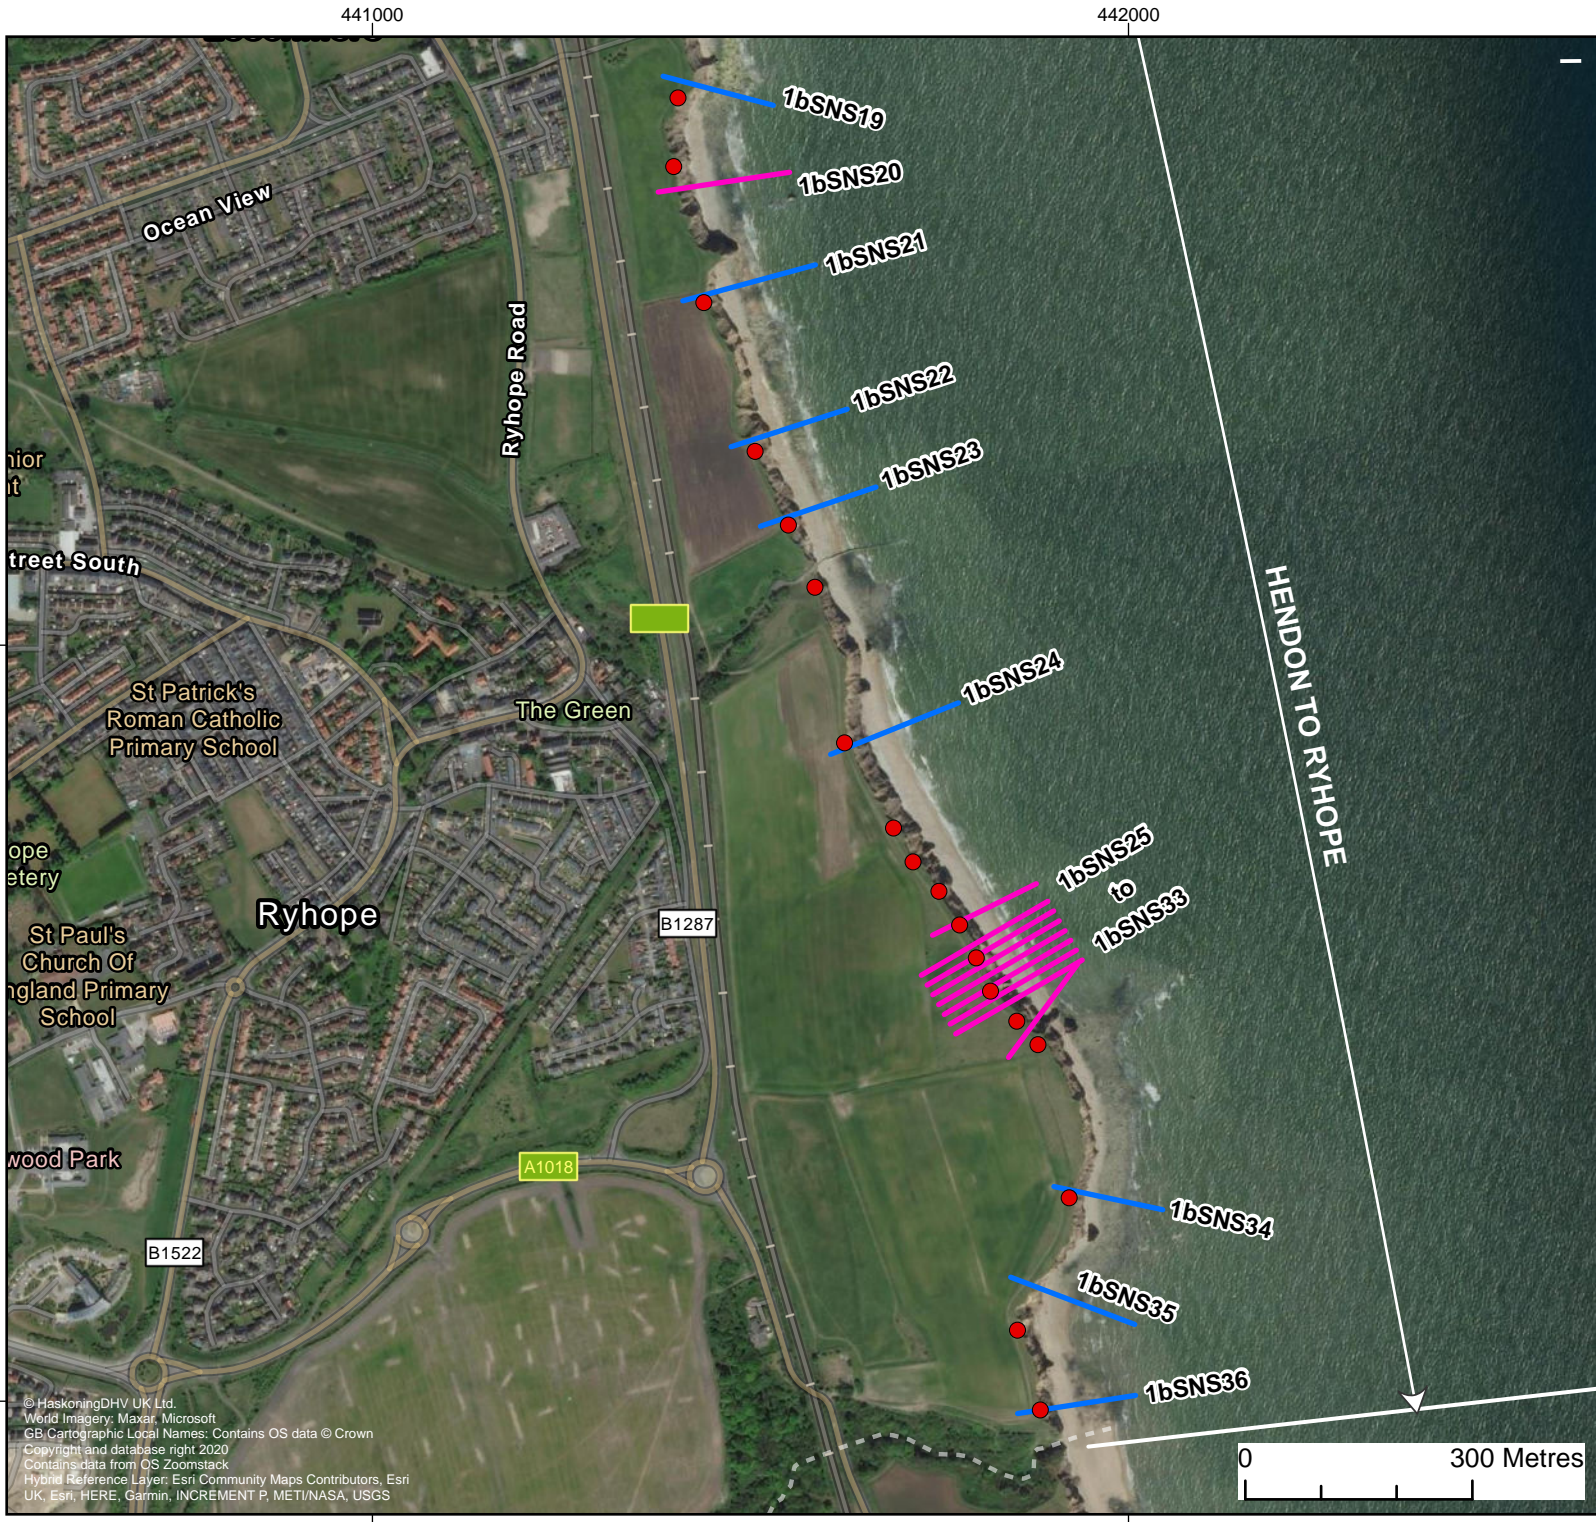
**Figure 2 - Map 4**

**HENDON TO RYHOPE (SOUTH)**

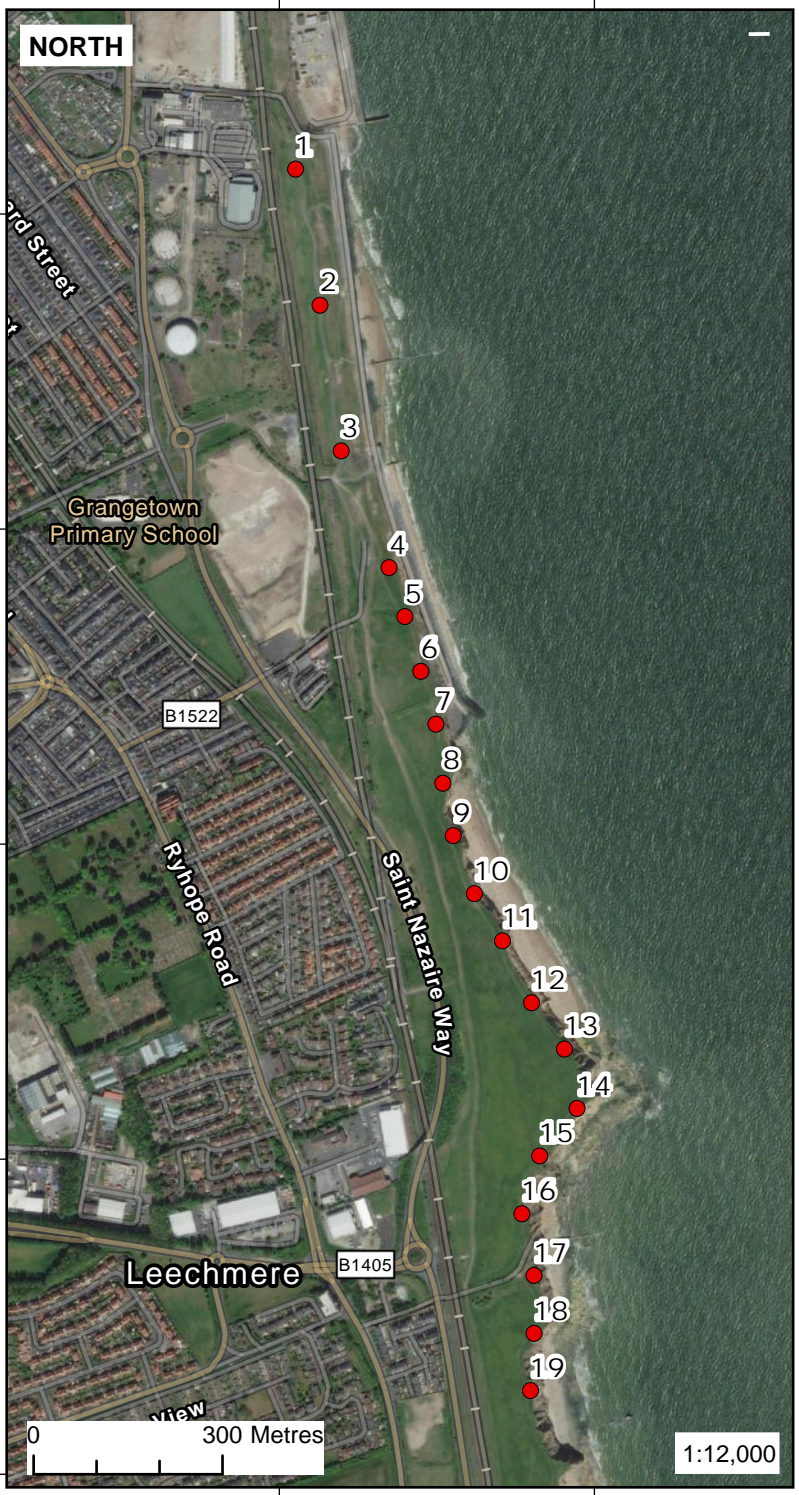
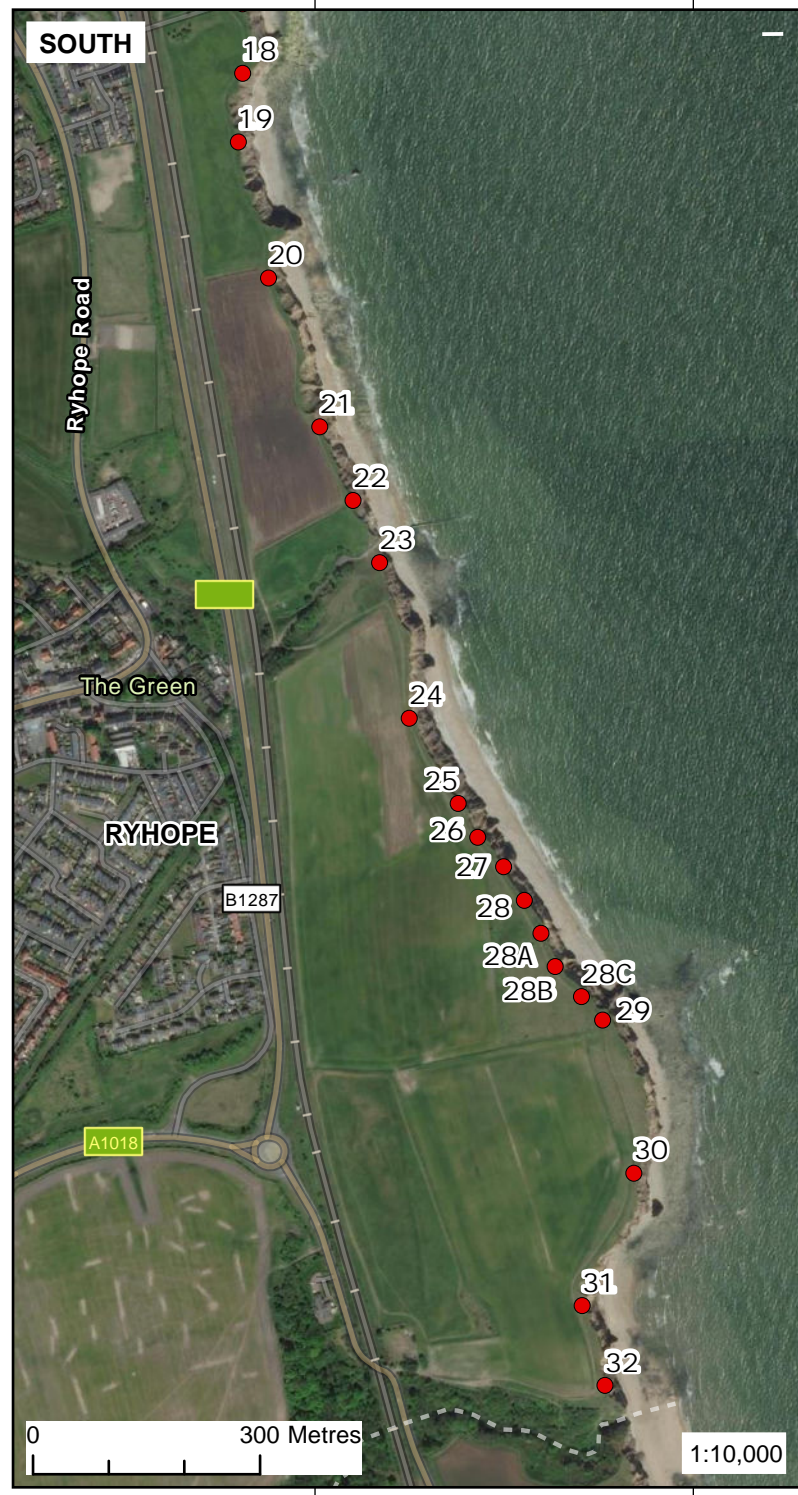
**Figure 3 - Map 1**

**HENDON TO RYHOPE**

Thirty-two ground control points have been established between Hendon and Ryhope. The maximum separation between any two points varies along the coast, reflecting the degree of risk from the erosion.

The cliff top surveys between Hendon and Ryhope are undertaken bi-annually. Measurements are taken from a fixed ground control point along a fixed bearing to the edge of the cliff top.

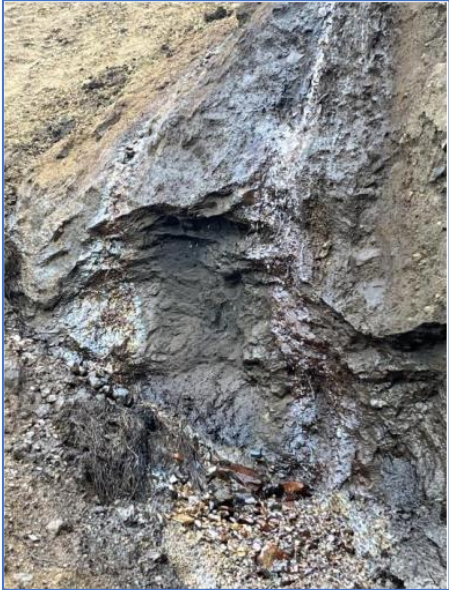
<p><i>Figure 5 – Oily leachate at Halliwell banks.</i></p>	<p>rate of retreat of 0.52m/yr. This frontage also contains four of the five control points with the greatest rate of retreat namely;</p> <ol style="list-style-type: none"> <li>1. Control Point 25 – 0.85m/yr.</li> <li>= Control Point 27 – 0.85m/yr.</li> <li>3. Control Point 21 – 0.82m/yr. (outside area)</li> <li>4. Control Point 26 – 0.74m/yr.</li> <li>5. Control Point 31 – 0.68m/yr.</li> </ol>

- Along Halliwell banks, both the cliff top survey and topographic profiles indicate that the cliffs have experienced significant erosion since the September 2023. This high level of cliff activity coincides, and is possibly as a result of, very low beach levels particularly across the lower beach where the rocky foreshore is exposed. Halliwell Banks remains a focus of concern due to the historic landfill activity in the hinterland behind the cliff line, a concern reiterated by the surveyor's report that noted 'oily substance leeching from the eroded cliff face' in this location.
