**Cell 1 Regional Coastal Monitoring Programme
Analytical Report 1: 'Full Measures' Survey 2008**

**Durham County Council
Final Report**

May 2009

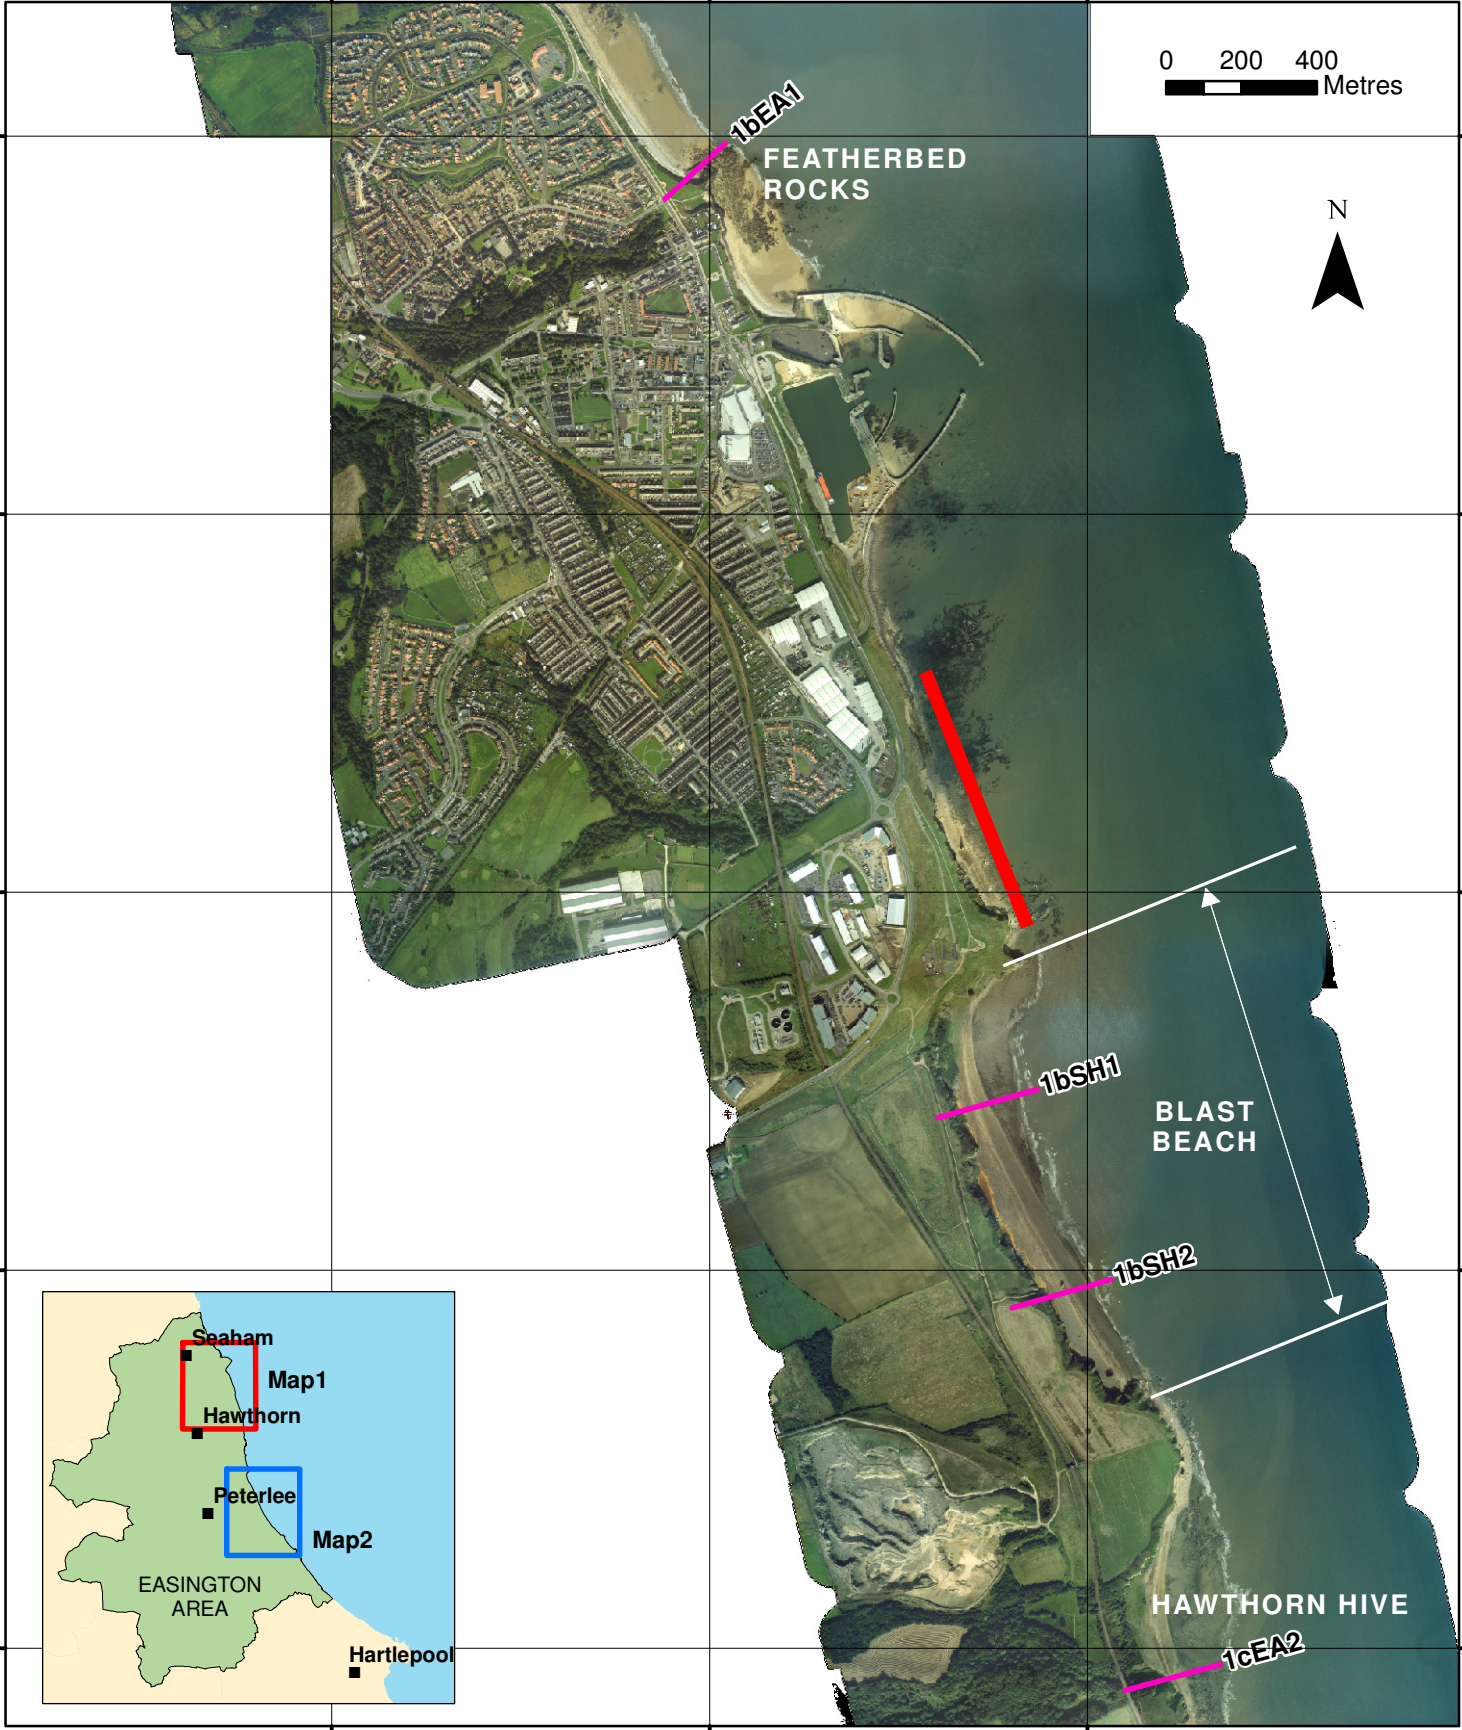
**Figure 2 - Map 1
 Durham County Council Frontage**

The location of these surveys is shown in Figure 2. Also enclosed on the accompanying CD-ROM is a file which can be opened in Google Earth showing the locations of the surveys.

- Annual Profile
- Bi-Annual Profile
- 6 monthly Survey
- Yearly Survey
- 5 yearly Survey
- Cliff Top Survey @ 50 centres
- Cliff Top Survey @ 100 centres
- Cliff Top Survey @ 300 centres

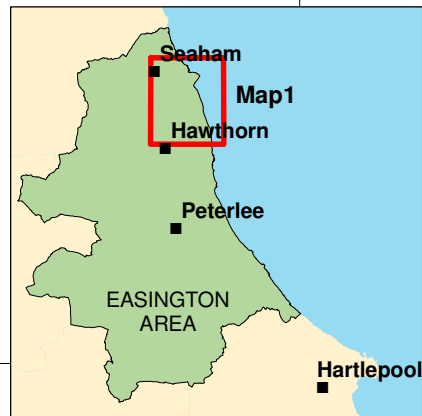
**Figure 3 - Map 1
 Durham County Council Frontage**

Re-located Profiles

- Annual Profile
- Bi-Annual Profile
- Cliff Top Survey @ 50 centres
- Cliff Top Survey @ 100 centres
- Cliff Top Survey @ 300 centres

A recommendation has been made to move the Featherbed Rocks beach profile (EA1) slightly further north to better capture the changes that are occurring at the southern end of the beach, where shingle is accumulating in significant quantities. The revised profile location is shown in Figure 3. This change can be made with no additional cost to the monitoring programme as it is 'fine-tuning' of existing arrangements.

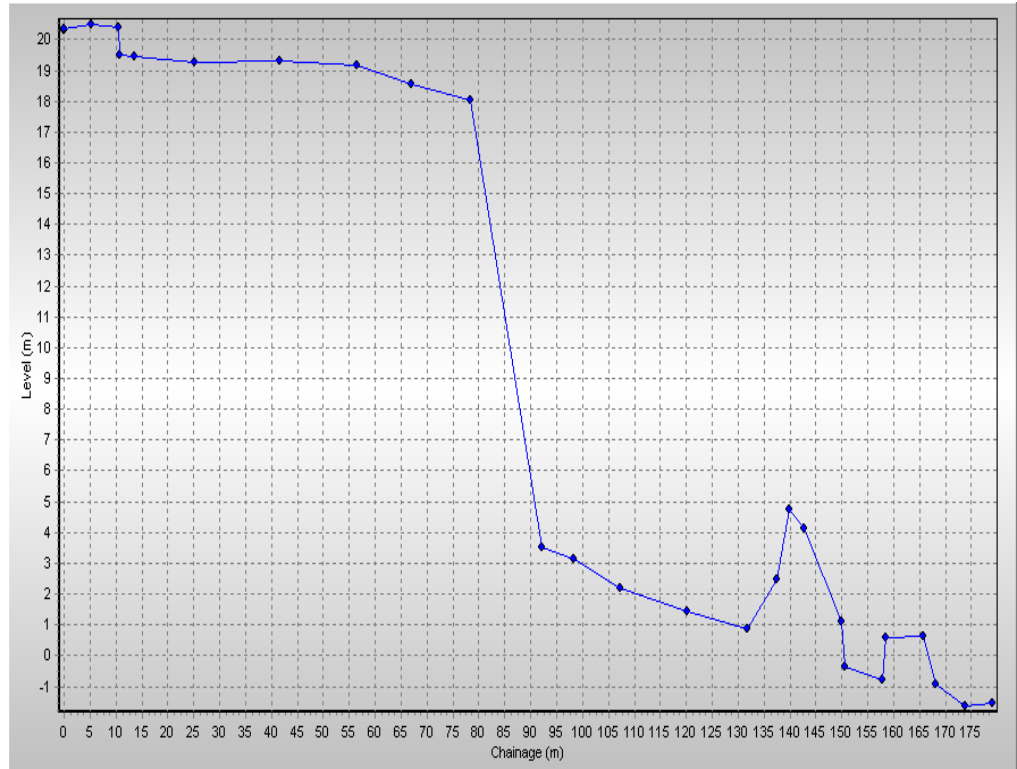
1bEA1

Survey Date	Description of Changes Since Last Survey	Interpretation
11-2008 (Baseline)	<p>Beach Profiles:</p> <p>One beach profile line (EA1) is located at Featherbed Rocks (Appendix A). This starts on the cliff top immediately adjacent (seaward side) to the B1287 North Road at an elevation of around 20.5mODN and drops to the grassland level, of just over 19mODN, after a chainage of 10m. For the next 68m chainage, the profile extends across the cliff top, dipping slightly at the cliff edge to around 18mODN. The profile then drops some 14.5m down the cliff face to the toe of the cliff and extends seaward across the foreshore until it meets the rock armour revetment placed around the headland. This is clearly distinctive from the profile, indicating a crest level of around 4.7mODN. This is over 1m higher than a 1 in 200 year extreme sea level. Further offshore from the rock armour is a rock scar outcropping from the sea bed.</p>	<p>Being protected by the rock armour revetment, it is likely that this profile will not exhibit significant signs of change. Slightly further north of here, however, it is known that erosion of the cliff face is occurring due to the 'ramping' action of the beach on wave run-up. Here significant volumes of shingle have accumulated against the sea wall, almost burying its crest in places. Due to this, it is recommended to move this profile line slightly to the north to better capture these ongoing changes. Section 3 contains further details.</p>

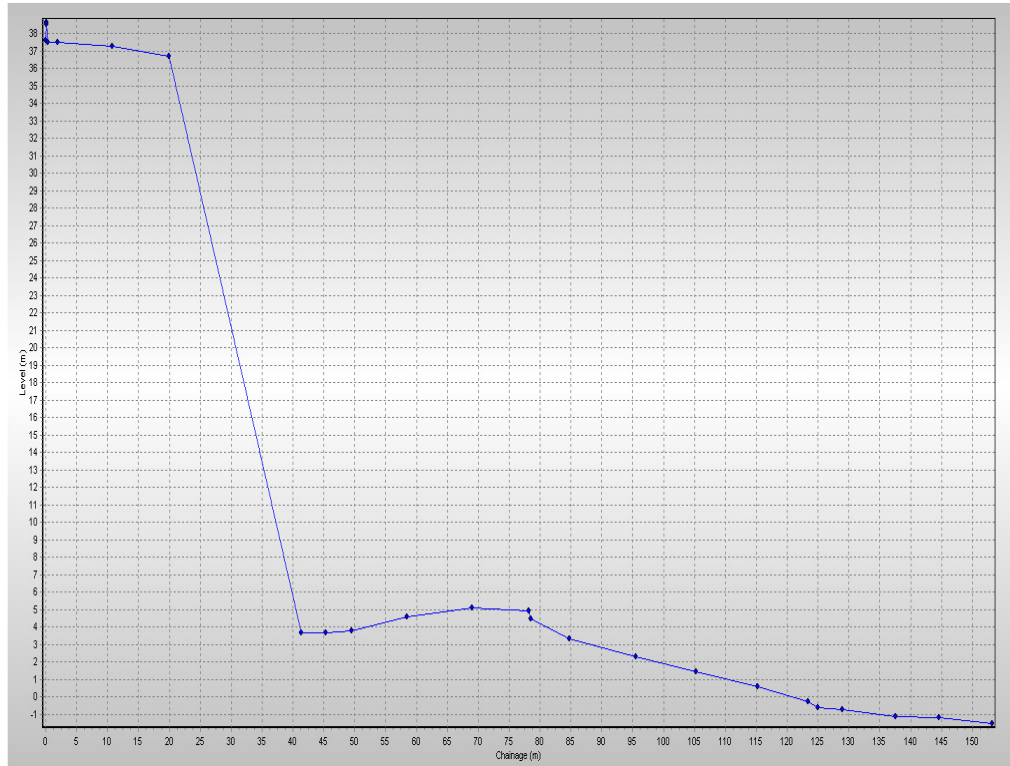
1bSH1

Survey Date	Description of Changes Since Last Survey	Interpretation
<p>11-2008 (Baseline)</p>	<p>Beach Profiles:</p> <p>Blast Beach is covered by two beach profile lines (Appendix A).</p> <p>SH1 is located in the northern half of the beach and shows a cliff top elevation of around 37.5mODN. At the toe of the cliff lies a 37m width of beach composed of colliery spoil. This has a distinct cliff edge of around 0.5m in height, dropping down to the beach 'proper' which grades away towards low water level. Levels at the toe of the cliff (3.7mODN) are lower than at the highest point within the fronting colliery spoil (5.1mODN). Whilst levels at the cliff toe remain above HAT level (3.18mODN) they are very close to the extreme water levels associated with a 1 in 200 year storm (3.7mODN) and, in the absence of the protection provided by the fronting spoil beach, such an event would directly attack the cliff toe.</p> <p>SH2 shows a similar profile shape to SH1, but with two subtle differences. First, the cliff face exhibits a gentler gradient, mainly due to the presence of talus material at the cliff toe. Second, there is a less distinct 'cliff' at the interface between the spoil beach and the natural beach and effectively the two merge with a gentler-sloping berm distinguishable. There remains around 34m width of spoil protecting the backing cliffs. Similar to SH1, the levels at the toe of the cliff (4.0mODN) are lower than the highest point within the spoil beach (5.1mODN), again showing the beneficial effect of the spoil in terms of cliff protection.</p>	<p>The cliffs along Blast Beach are protected against marine erosion by the width of colliery spoil forming an artificial beach on the foreshore. As this spoil erodes, so the risk increases that the cliffs will become re-activated once again and may start to erode back. It will be important to continue monitoring here to better understand rates of erosion of the colliery spoil.</p> <p>The area north of SH1 currently has a greater width of beach and a higher cliff edge at the seaward limit of the colliery spoil. It is recommended that an additional profile line be added here to further understand changes along Blast Beach following cessation of spoil tipping.</p>

It is also recommended that an additional profile line be added north of SH1 in Blast Beach. In this location, there is a greater width of spoil beach and a more distinct cliff at its seaward end than is observed along SH1 and additional monitoring here would provide further useful insight into erosional processes in areas where colliery spoil was formerly deposited. This change would incur additional costs to the monitoring programme since it is an addition to existing arrangements, although the additional cost is expected to be relatively minor.

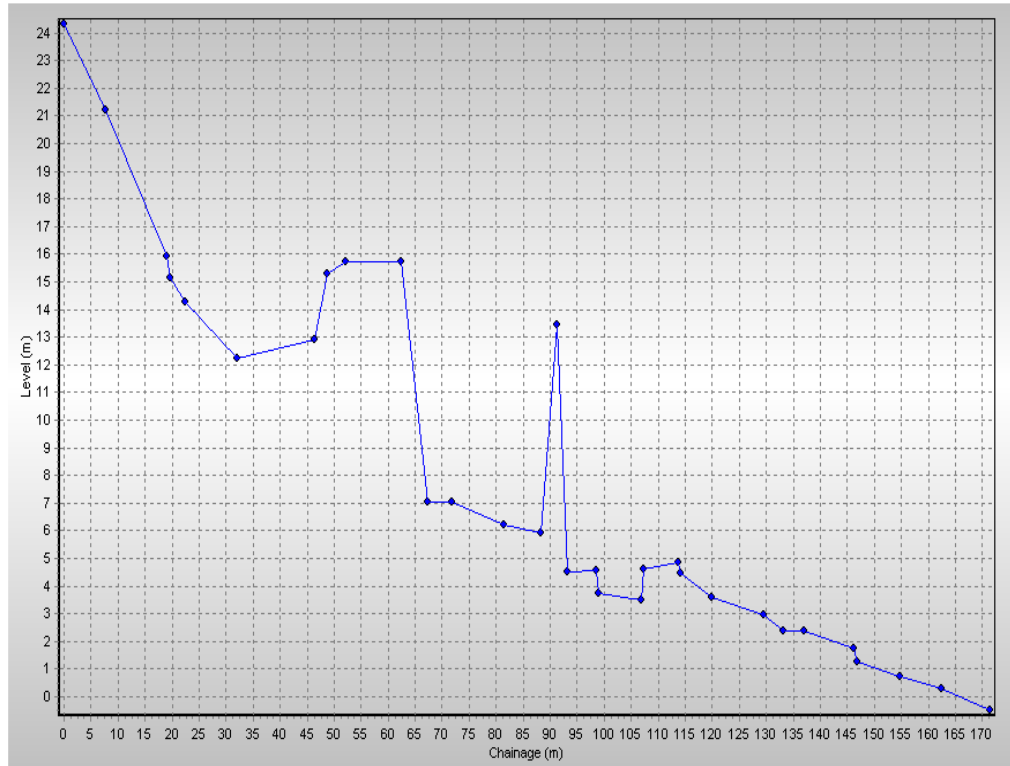
1cEA2

Survey Date	Description of Changes Since Last Survey	Interpretation
<p>11-2008 (Baseline)</p>	<p>Beach Profiles:</p> <p>One beach profile line (EA2) is located at Hawthorne Hive (Appendix A). This starts on the cliffs south of Hawthorne Burn at an elevation of around 24.3mODN and runs down the slope, crossing several subsequent cliff and plateau features, including the most seaward cliff 'ridge' seen on the front cover of this report. Almost immediately at the toe of this feature the profile cross the outlet channel of Hawthorne Burn and then continues along the beach down to low water.</p>	<p>Subsequent surveys will indicate the degree of change that occurs along this frontage in beach levels and in position and size of the outlet channel of Hawthorne Burn.</p>

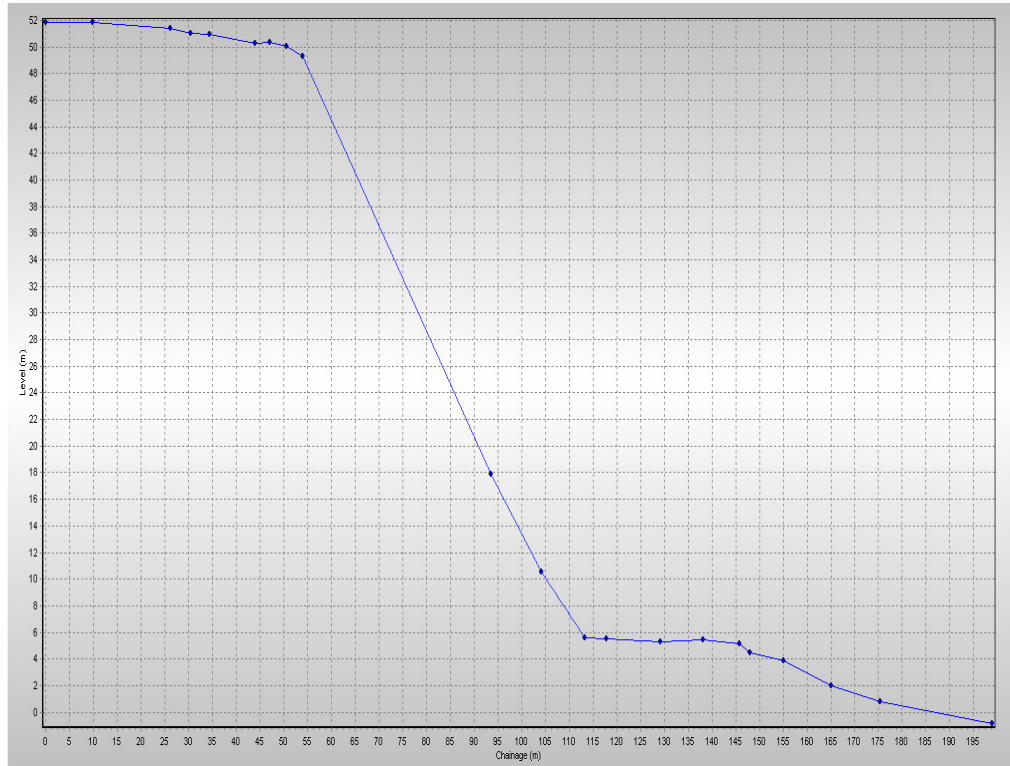
1bBH1

Survey Date	Description of Changes Since Last Survey	Interpretation
<p>11-2008 (Baseline)</p>	<p>Beach Profiles:</p> <p>Blackhall Colliery is covered by three beach profile lines (Appendix A).</p> <p>BH1 is located near Horden Point. It starts on the cliff top at an elevation of around 51.8mODN and extends some 50m to the cliff edge. It then drops to the foreshore where the elevation at the cliff toe is around 5.6mODN. Here the cliff toe is protected by a colliery spoil beach where the level is retained above the limit of marine action for around 33m before gently shelving down to low water level.</p> <p>BH2 exhibits a similar profile, with cliff top elevation being around 46.5mODN and the cliff face gently sloping down to the spoil beach at the toe. This spoil beach retains a level of between 4.5mODN and 5.5mODN, i.e. well above the limit of marine action, for over 65m before forming a very distinct cliff of around 1.5m in height at its interface with the natural beach, which then shelves down to low water level.</p> <p>BH3 also shows a similar profile, with the cliff top being around 40mODN in elevation. The cliff face gently slopes down to the spoil beach, which is at a level of between 5.0mODN and 5.5m ODN at the cliff toe. Here, however, the spoil beach is only around 20m in width before it is intersected by the outlet channel of Castle Eden Burn. Although some spoil material remains on the seaward side of this channel, the beach levels soon shelf down to low water.</p>	<p>The cliffs along the Blackhall Colliery frontage are protected against marine erosion by the width of colliery spoil forming an artificial beach on the foreshore. As this spoil erodes, so the risk increases that the cliffs will become re-activated once again and may start to erode back. It will be important to continue monitoring here to better understand rates of erosion of the colliery spoil.</p>

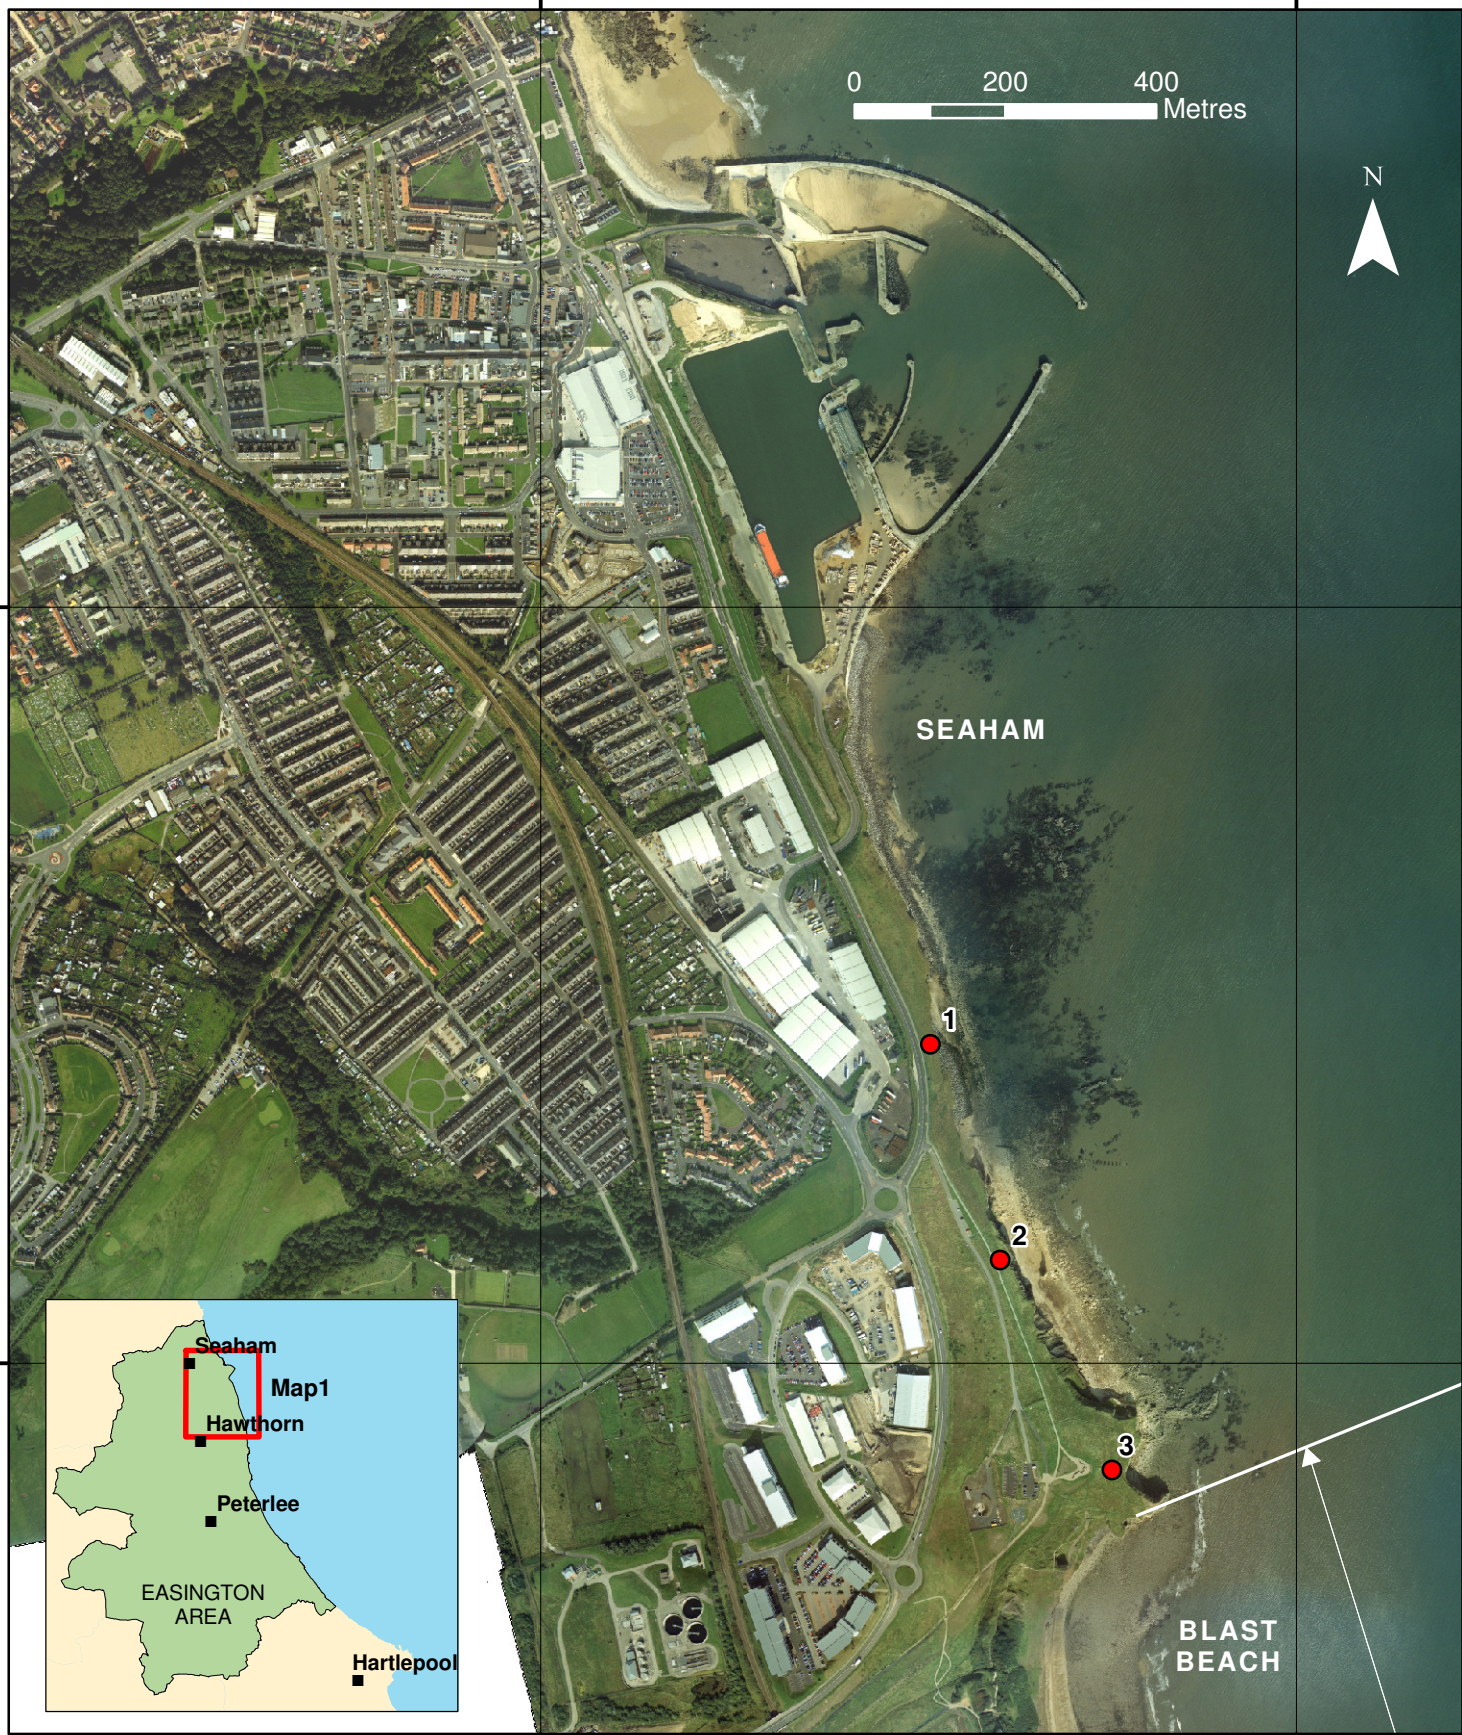
**Appendix B - Map 1
 Durham County
 Council Frontage**

Three ground control points have been established along the cliff top at Dawdon (Figure B1). The separation between any two points is nominally 300m. These cliff top surveys are intended to inform on erosion rates of the undefended sea cliffs extending south of the rock armour revetment to the south of Seaham Harbour.

The cliff top surveys at Dawdon are undertaken bi-annually. Measurements are taken from a fixed ground control point along a fixed bearing to the edge of the cliff top.

Survey Date	Description of Changes Since Last Survey	Interpretation
11-2008 (Baseline)	<p>Cliff Top Survey:</p> <p>Three ground control points have been established along the cliff top at Dawdon (Figure B1). The separation between any two points is nominally 300m. These cliff top surveys are intended to inform on erosion rates of the undefended sea cliffs extending south of the rock armour revetment to the south of Seaham Harbour. The cliff top surveys at Dawdon are undertaken bi-annually. Measurements are taken from a fixed ground control point along a fixed bearing to the edge of the cliff top.</p>	<p>Appendix B provides information about the ground control points and results from the 2008 (baseline) cliff top survey showing the position from the ground control point to the edge of the cliff top along the defined bearing. Future reports will show results from subsequent surveys and provide a means of assessing erosion since the baseline survey.</p>
