**Cell 1 Regional Coastal Monitoring Programme  
Analytical Report 3: 'Full Measures' Survey 2010**

<sup>(\*)</sup> The present report is **Analytical Report 3** and provides an analysis of the 2010 Full Measures survey for Durham County Council's frontage.

Durham County Council's frontage extends from Ryhope Dene to Crimdon Beck. For the purposes of this report, it has been sub-divided into five areas, namely:

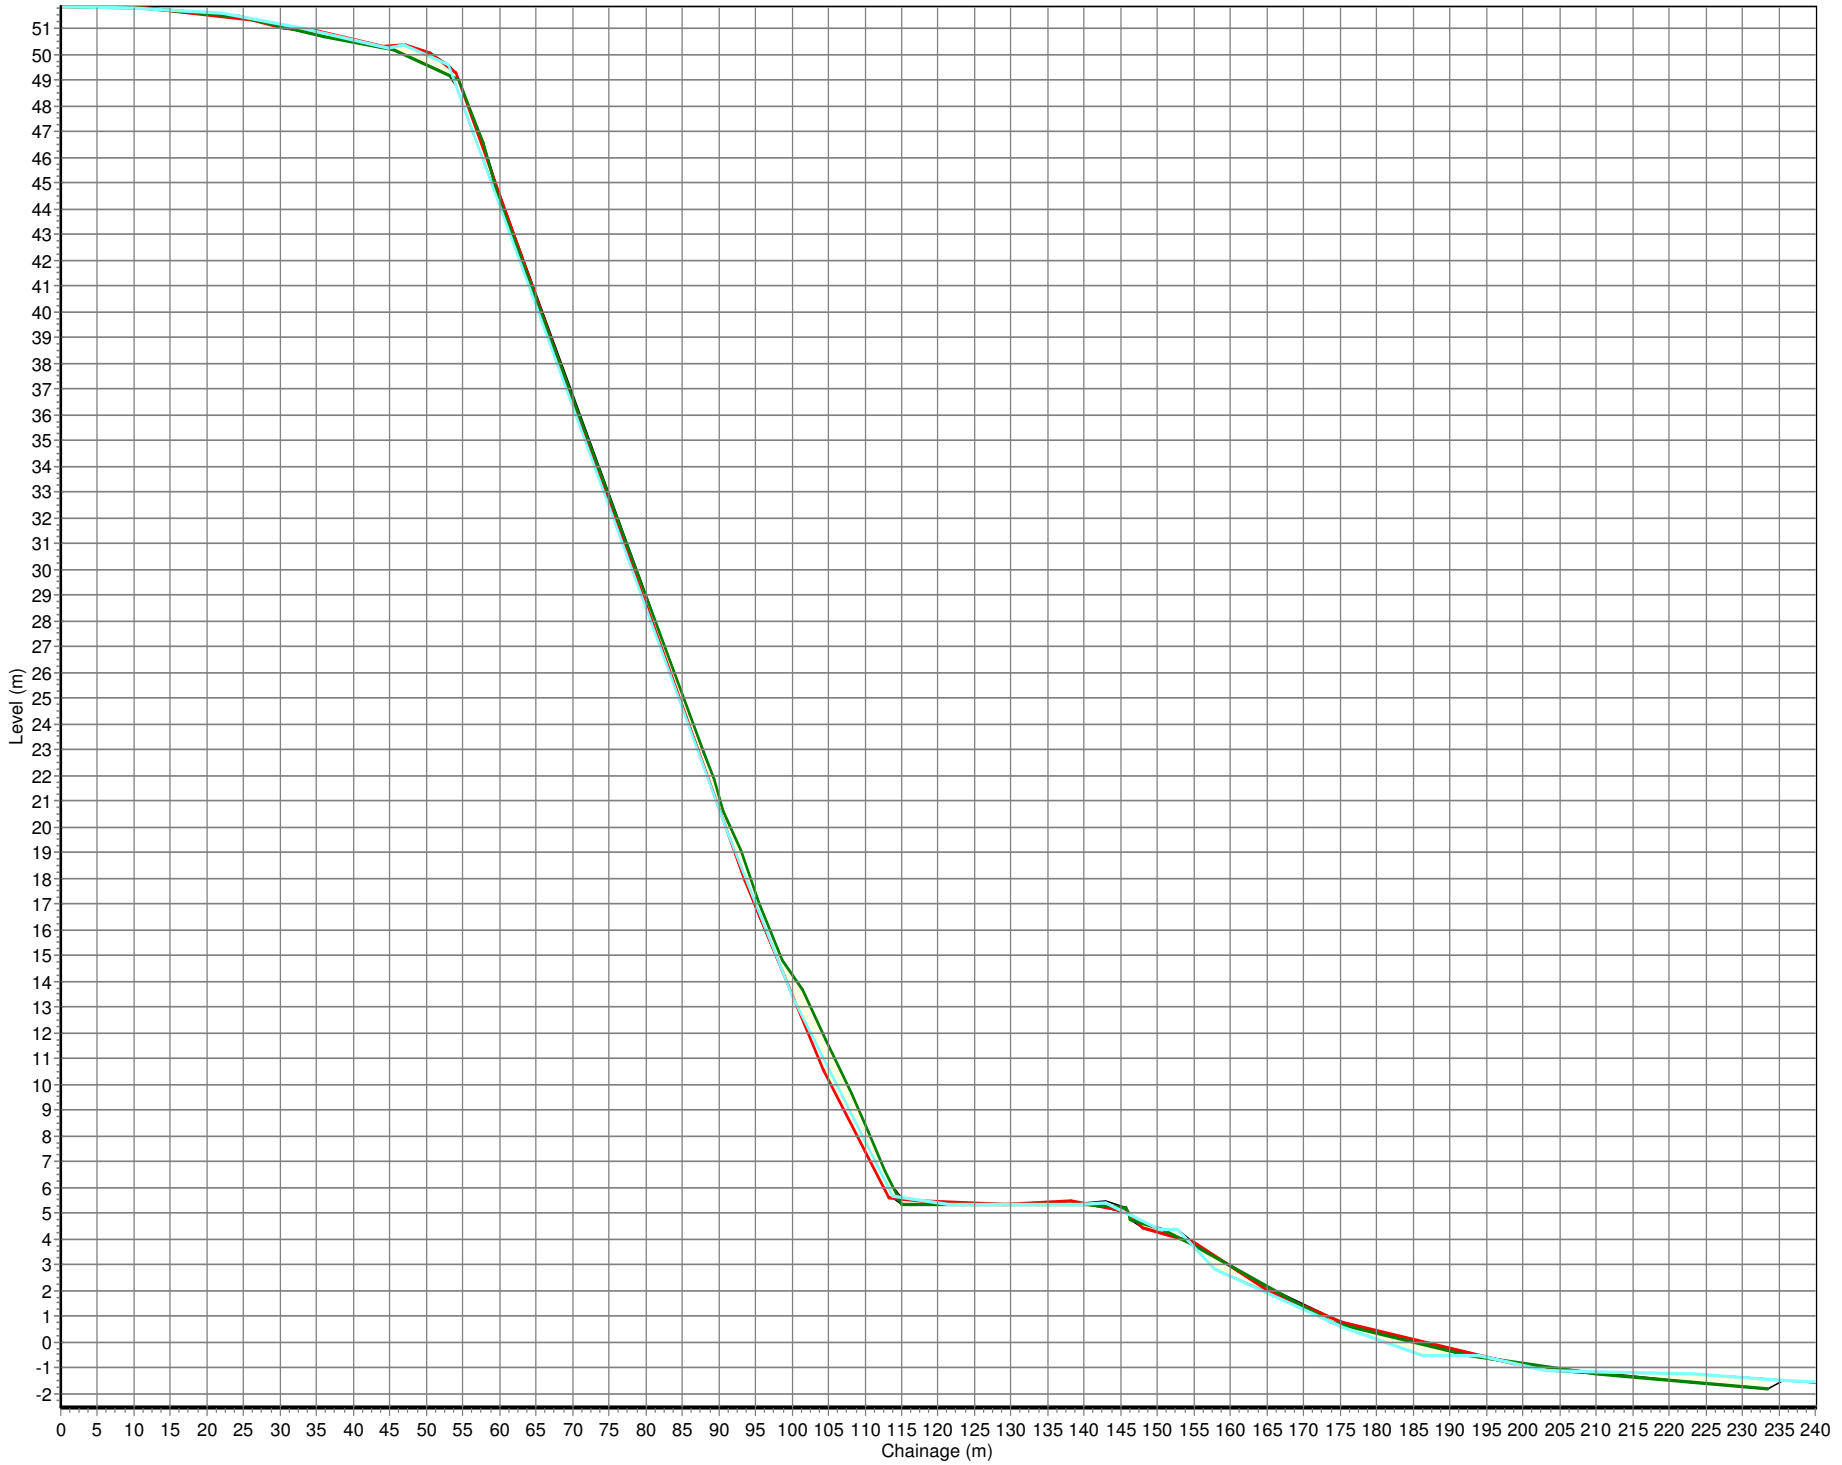
# Beach Profiles: 1cBH1

Survey Date	Description of Changes Since Last Survey	Interpretation
09-2010	<p><b>Beach Profiles:</b></p> <p>Blackhall Colliery is covered by three beach profile lines (Appendix A).</p> <p>BH1 is located near Horden Point and shows no significant change since the previous survey.</p> <p>BH2 exhibits no change in the cliff profile, but the cliffed-edge of the spoil beach has eroded landwards by a further 10m since October 2009, leaving only around 48m to the cliff toe.</p> <p>BH3 shows some apparent deepening of the outlet channel of Castle Eden Burn, which crosses the profile, and some landward cut-back, typically by around 6m, of the seaward slope of the profile.</p>	<p>The surveys show that the spoil beach along much of the Blackhall Colliery shore continues to provide effective protection to the backing cliffs, but in places is eroding landwards at high rates of retreat.</p>

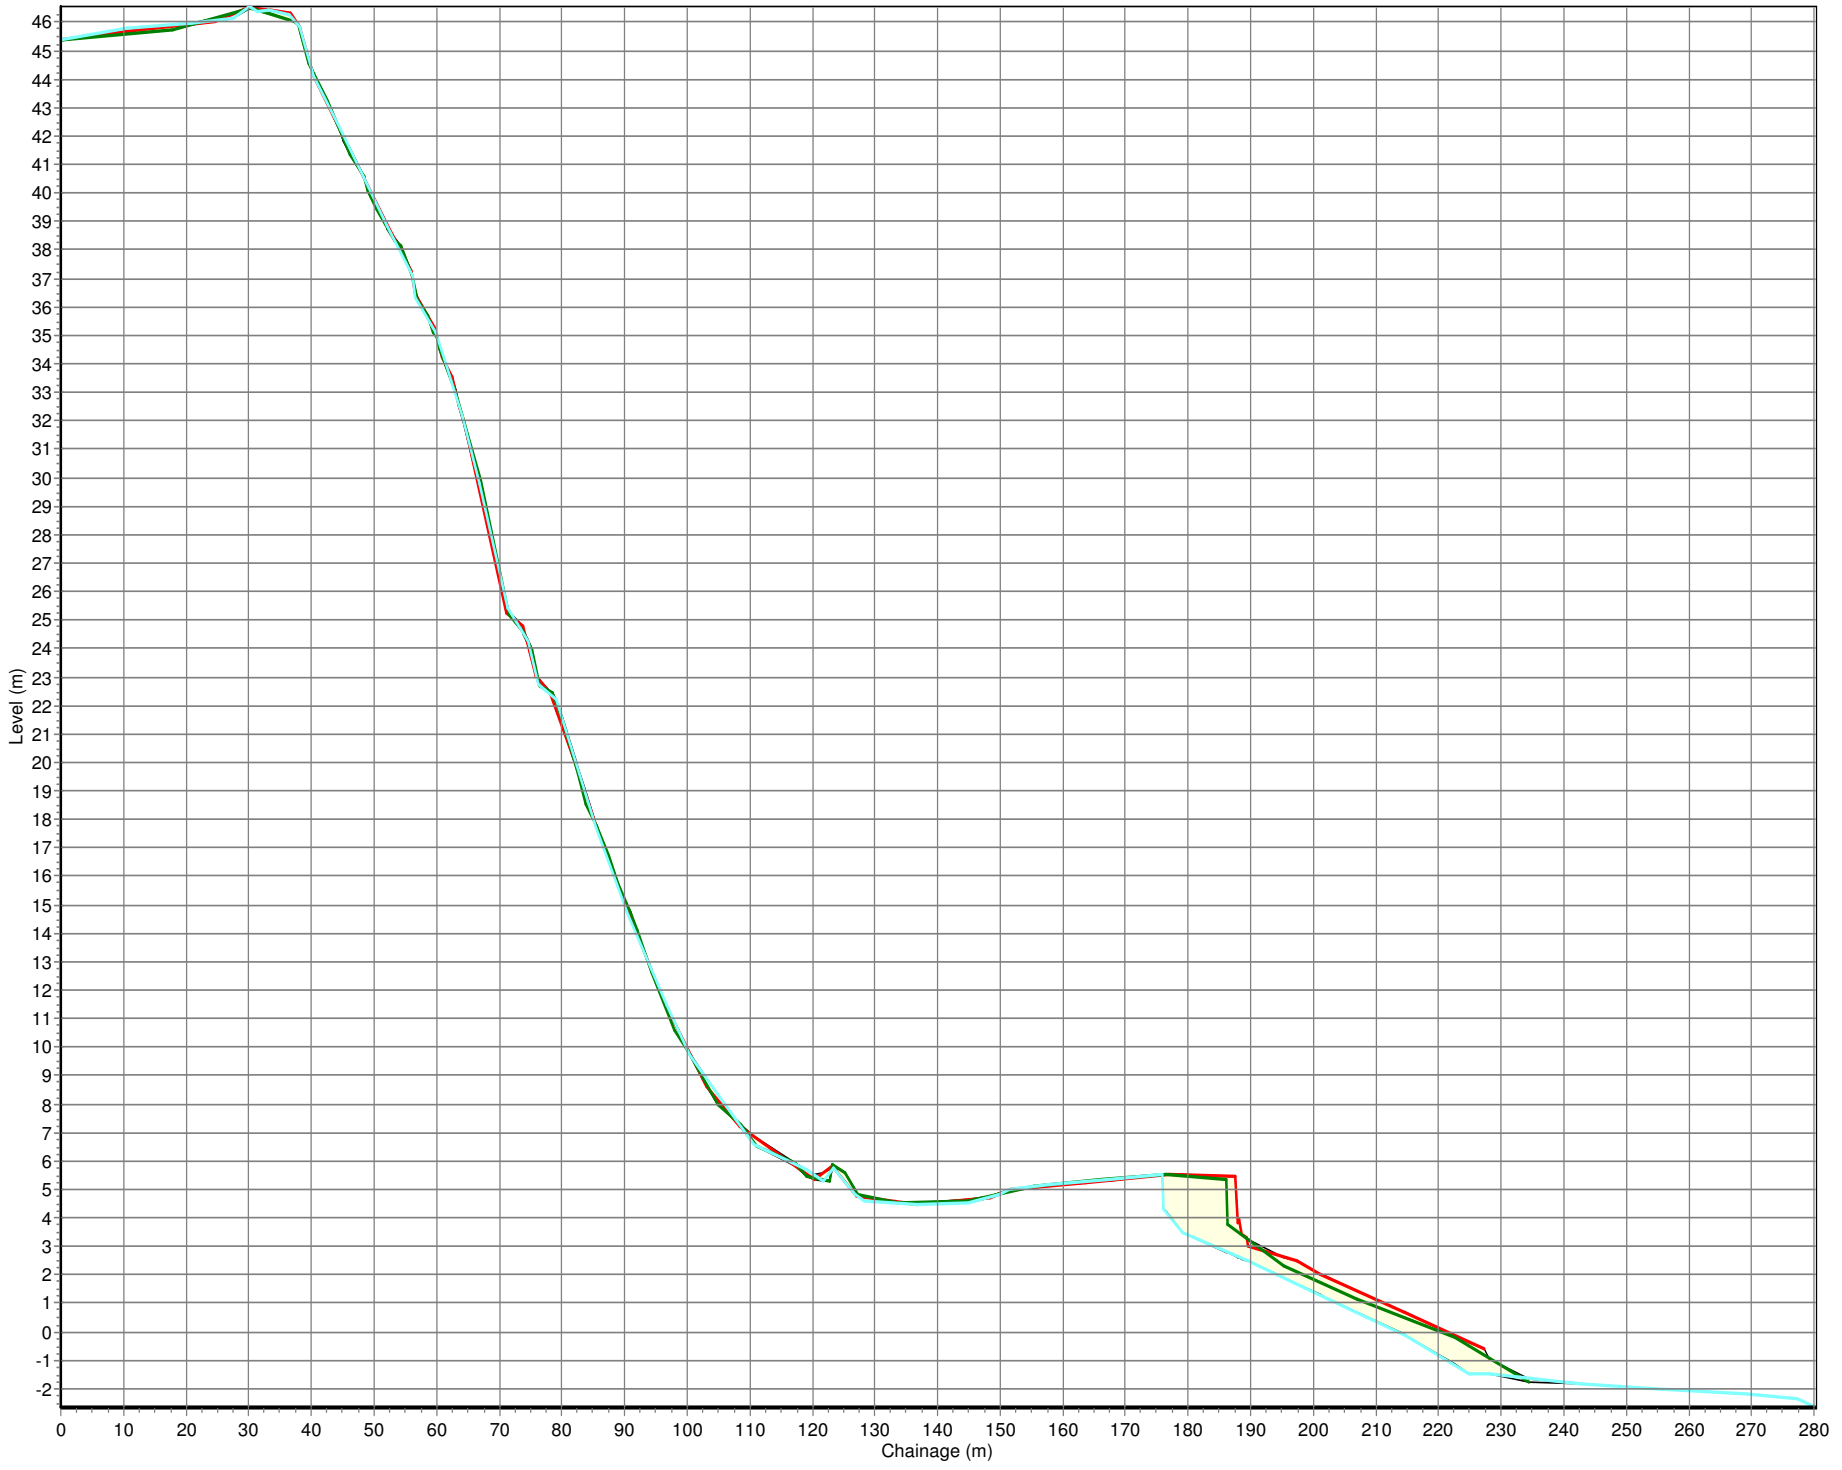
Beach Profiles: 1cBH2

- The outlet channels of Hawthorne Burn and Castle Eden Burn exhibited signs of shallowing and deepening, respectively.
- The spoil beach at Blackhall Colliery provides protection to the backing cliffs, but along one profile (BH2) the cliffed edge of the spoil has cut back landwards by around 10m since March 2010.

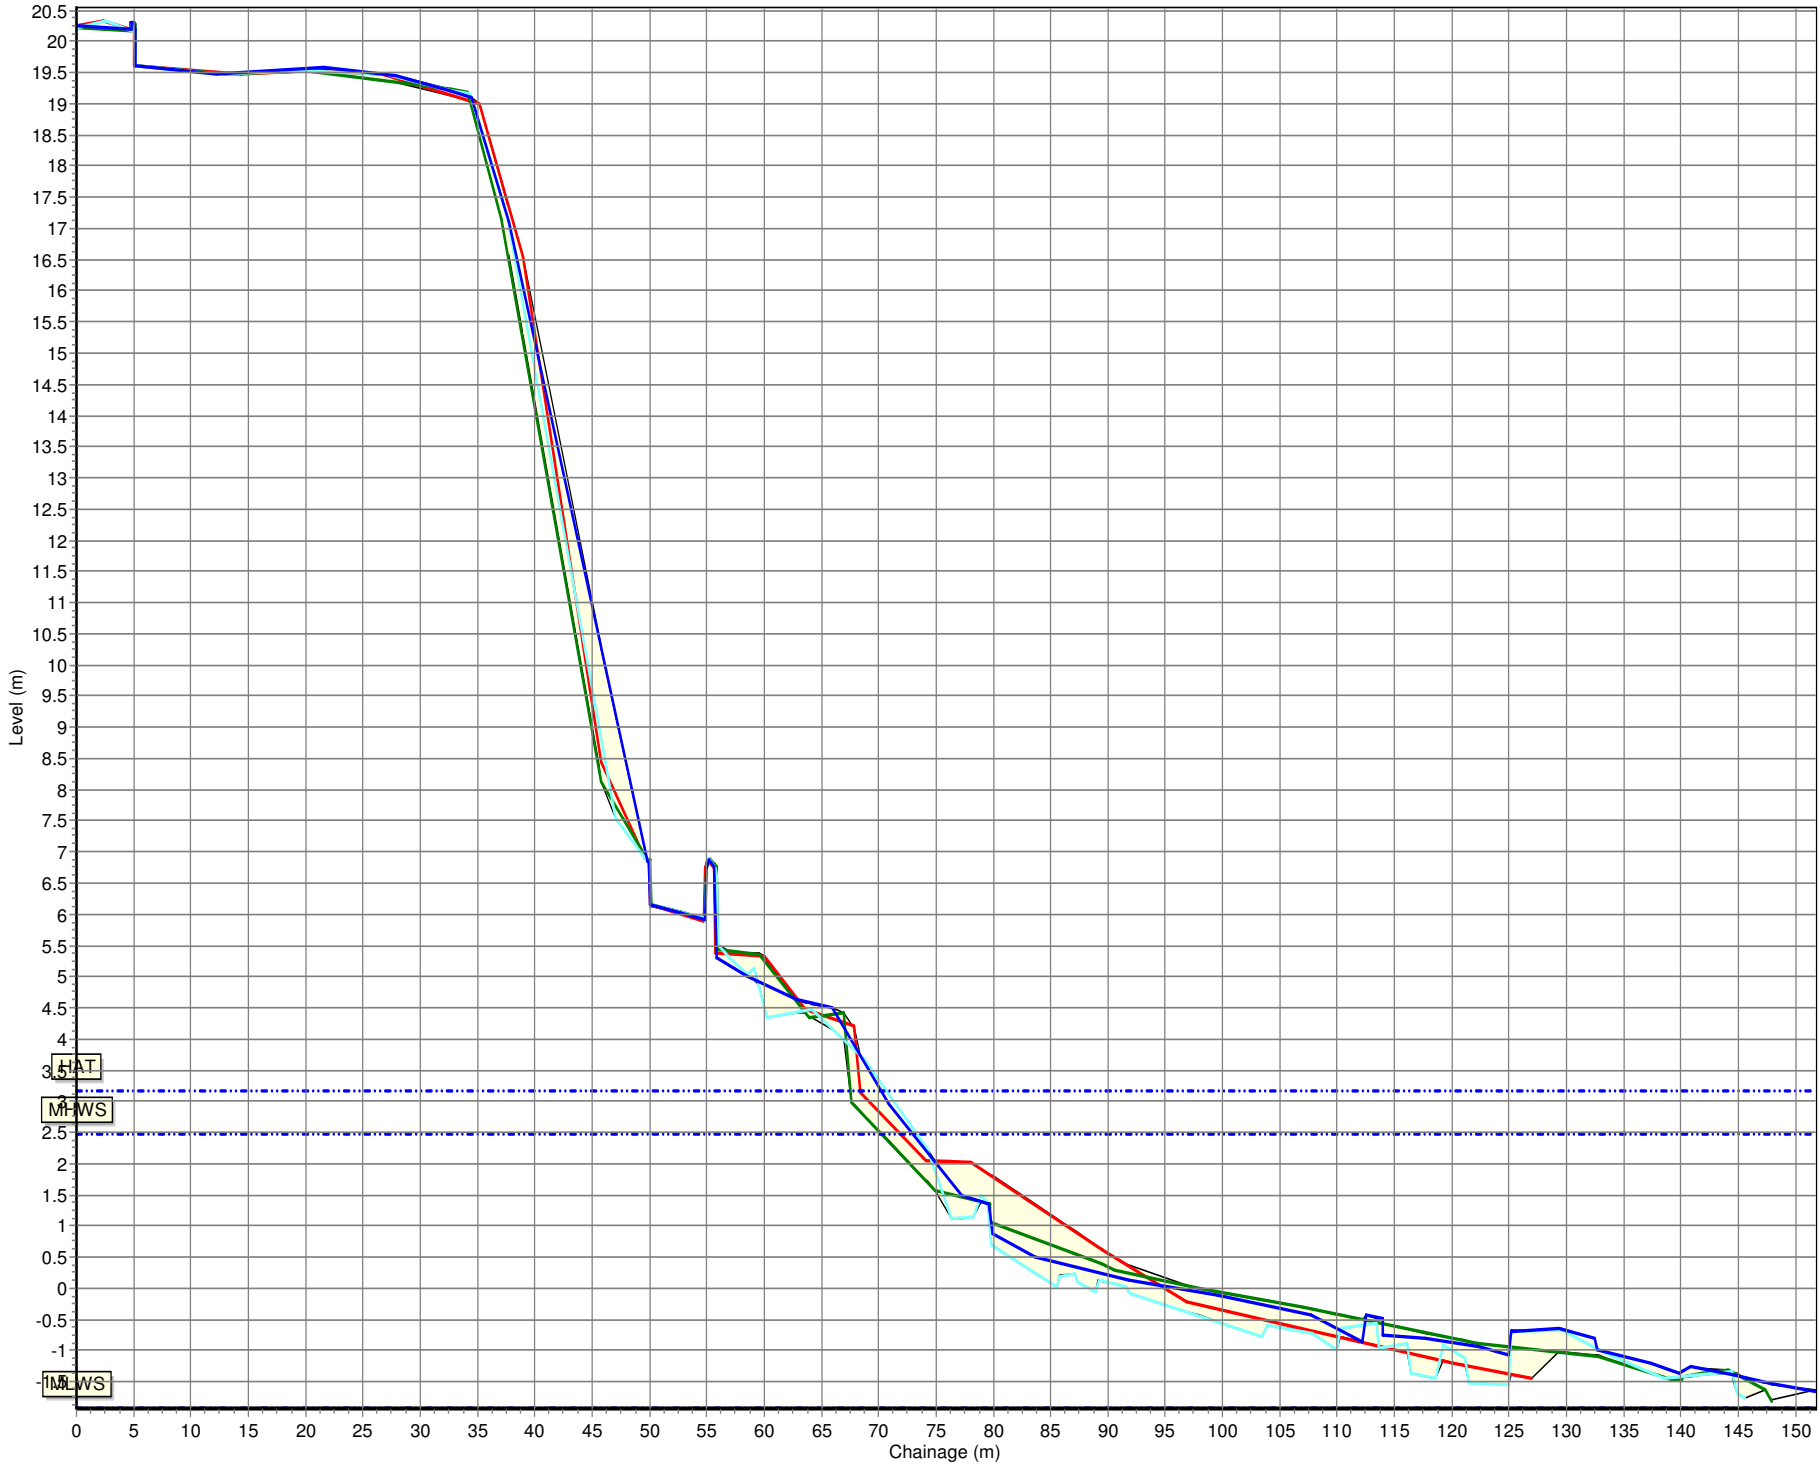
# Beach Profiles: 1bEA1

Survey Date	Description of Changes Since Last Survey	Interpretation
09-2010	<p><b>Beach Profiles:</b></p> <p>One beach profile line (EA1) is located at Featherbed Rocks (Appendix A). The profile line was relocated to its present position in March 2009. The profile extends across the cliff top, dipping slightly at the cliff edge to around 19mODN. It then drops down the cliff face to the toe of the cliff and then extends seawards across the promenade. The sea wall is then crossed, before the survey drops to beach level where a significant quantity of shingle has accumulated at the toe of the wall. The upper beach levels were similar in September 2010 to the previous survey of March 2010, but these are low than recorded on the two previous surveys where a wide berm of shingle was present at the toe of the wall. It is know from the summer 2010 walk-over inspections that shingle has again extended to the wall crest in places, so the slight reduction in levels to September 2010 must have occurred post-summer. Along the lower foreshore the levels have increased, with a veneer of sand now covering much of the previously exposed rock platform.</p>	<p>There is some degree of variability in the width of shingle present at the southern end of Seaham promenade, and a smaller degree of variability in level directly at the toe.</p> <p>There is also a tendency of a sand veneer to temporarily cover the rock foreshore, and then become stripped during high wave energy events.</p>

- There is notable variability in the foreshore sediments at the southern end of Seaham promenade. Whilst shingle has accumulated to great depths in previous surveys, there was a slightly lesser volume present in September 2010. This does, however, still reach a notable distance up the seawall. Lower down the profile temporary veneers of sand tend to intermittently cover the rock platform.

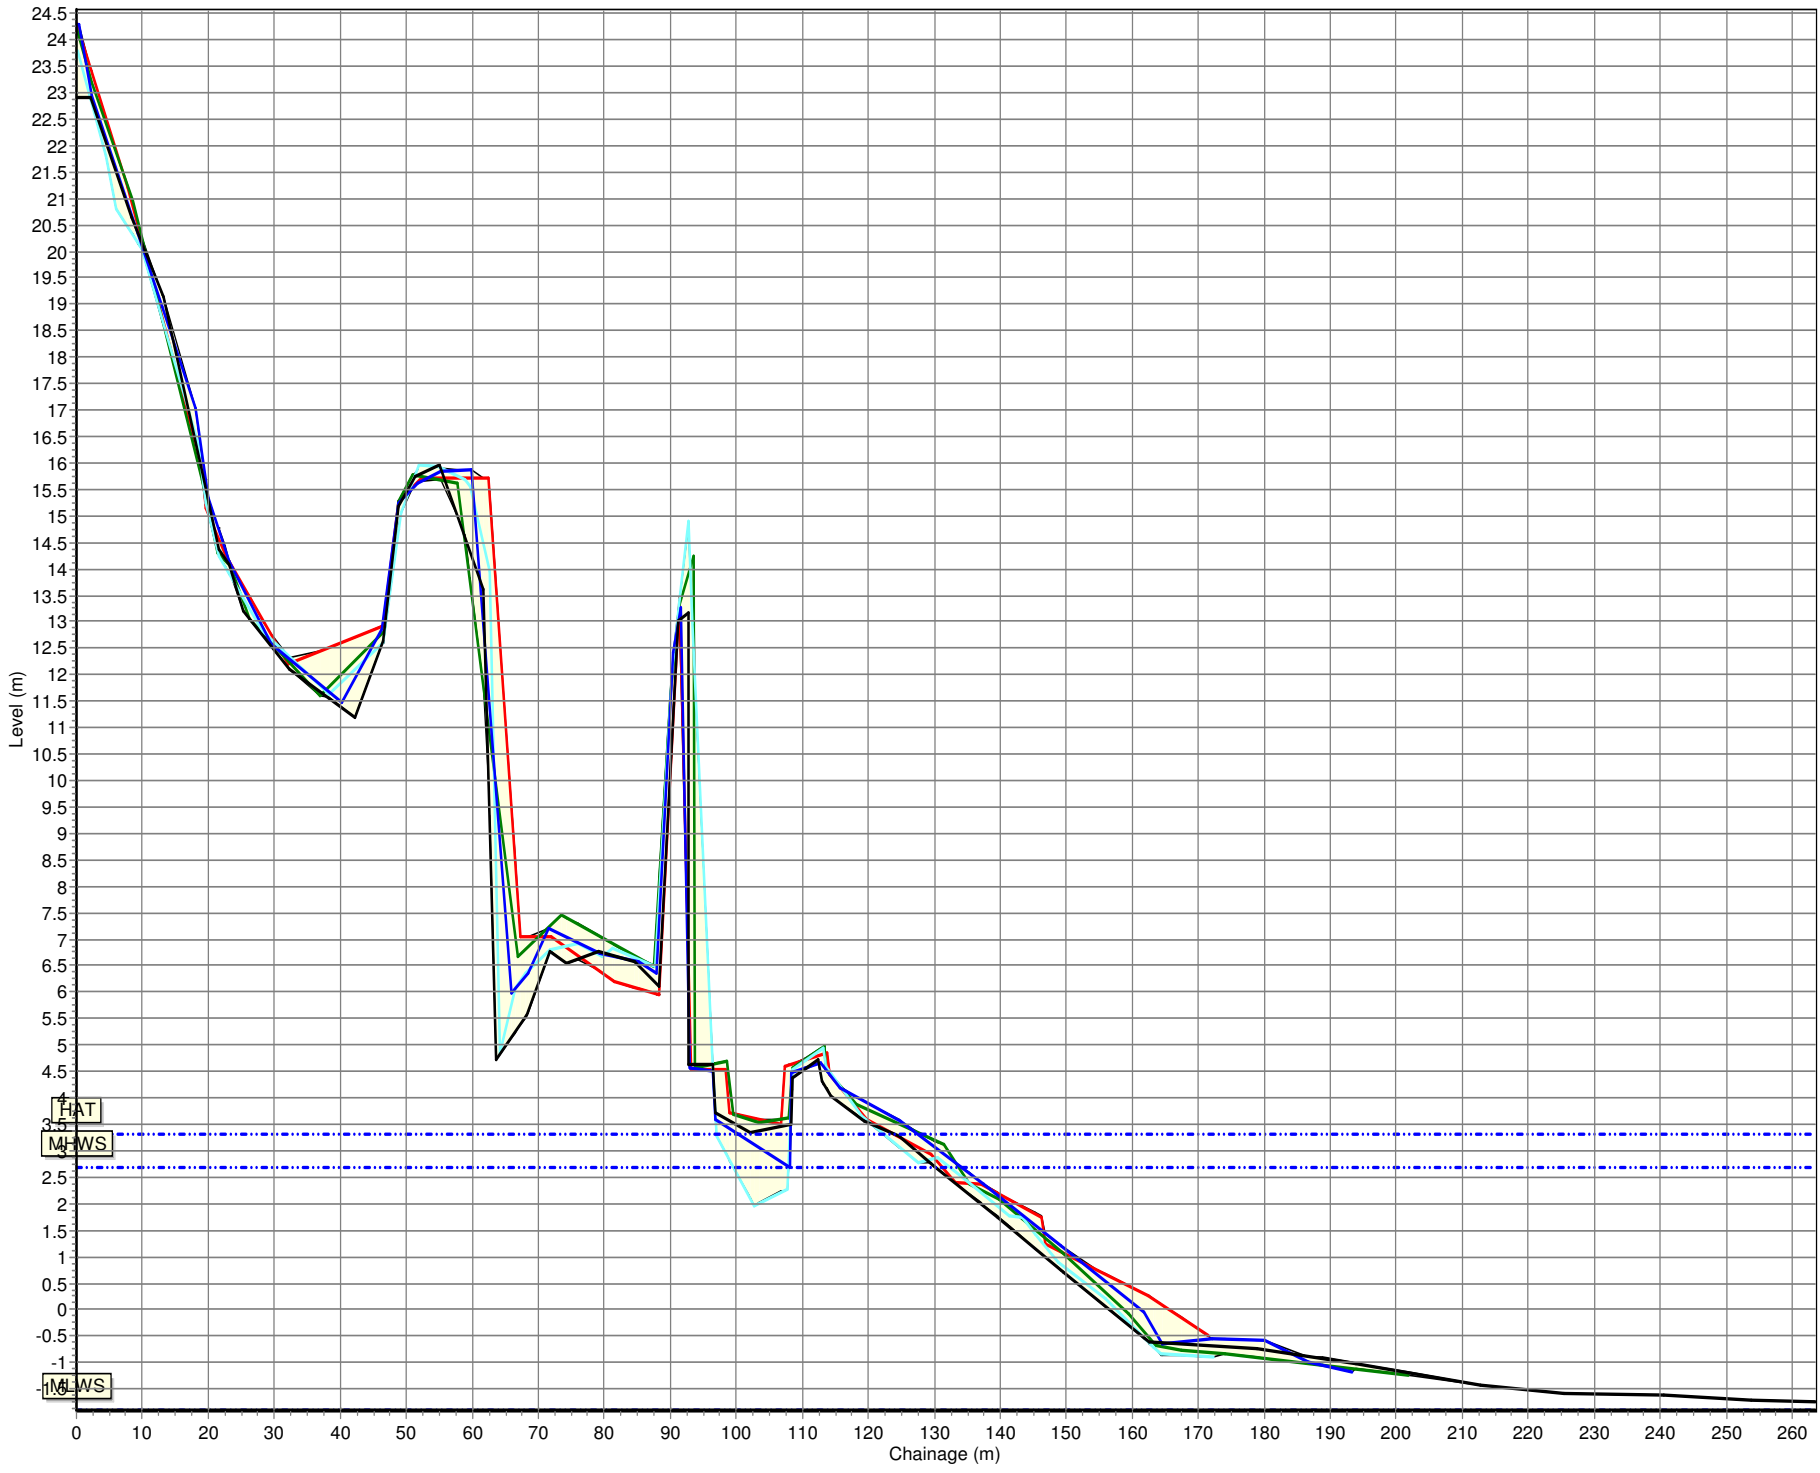
Beach Profiles: 1cEA2

Survey Date	Description of Changes Since Last Survey	Interpretation
09-2010	<p><b>Beach Profiles:</b></p> <p>One beach profile line (EA2) is located at Hawthorne Hive (Appendix A).</p> <p>The outlet channel of Hawthorne Burn was slightly shallower than in the previous survey and the foreshore levels seaward of the channel had dropped slightly to new record low values in some places.</p>	<p>Although record low levels have been set along some parts of the foreshore, this is considered to be natural variation and is likely to recover.</p>

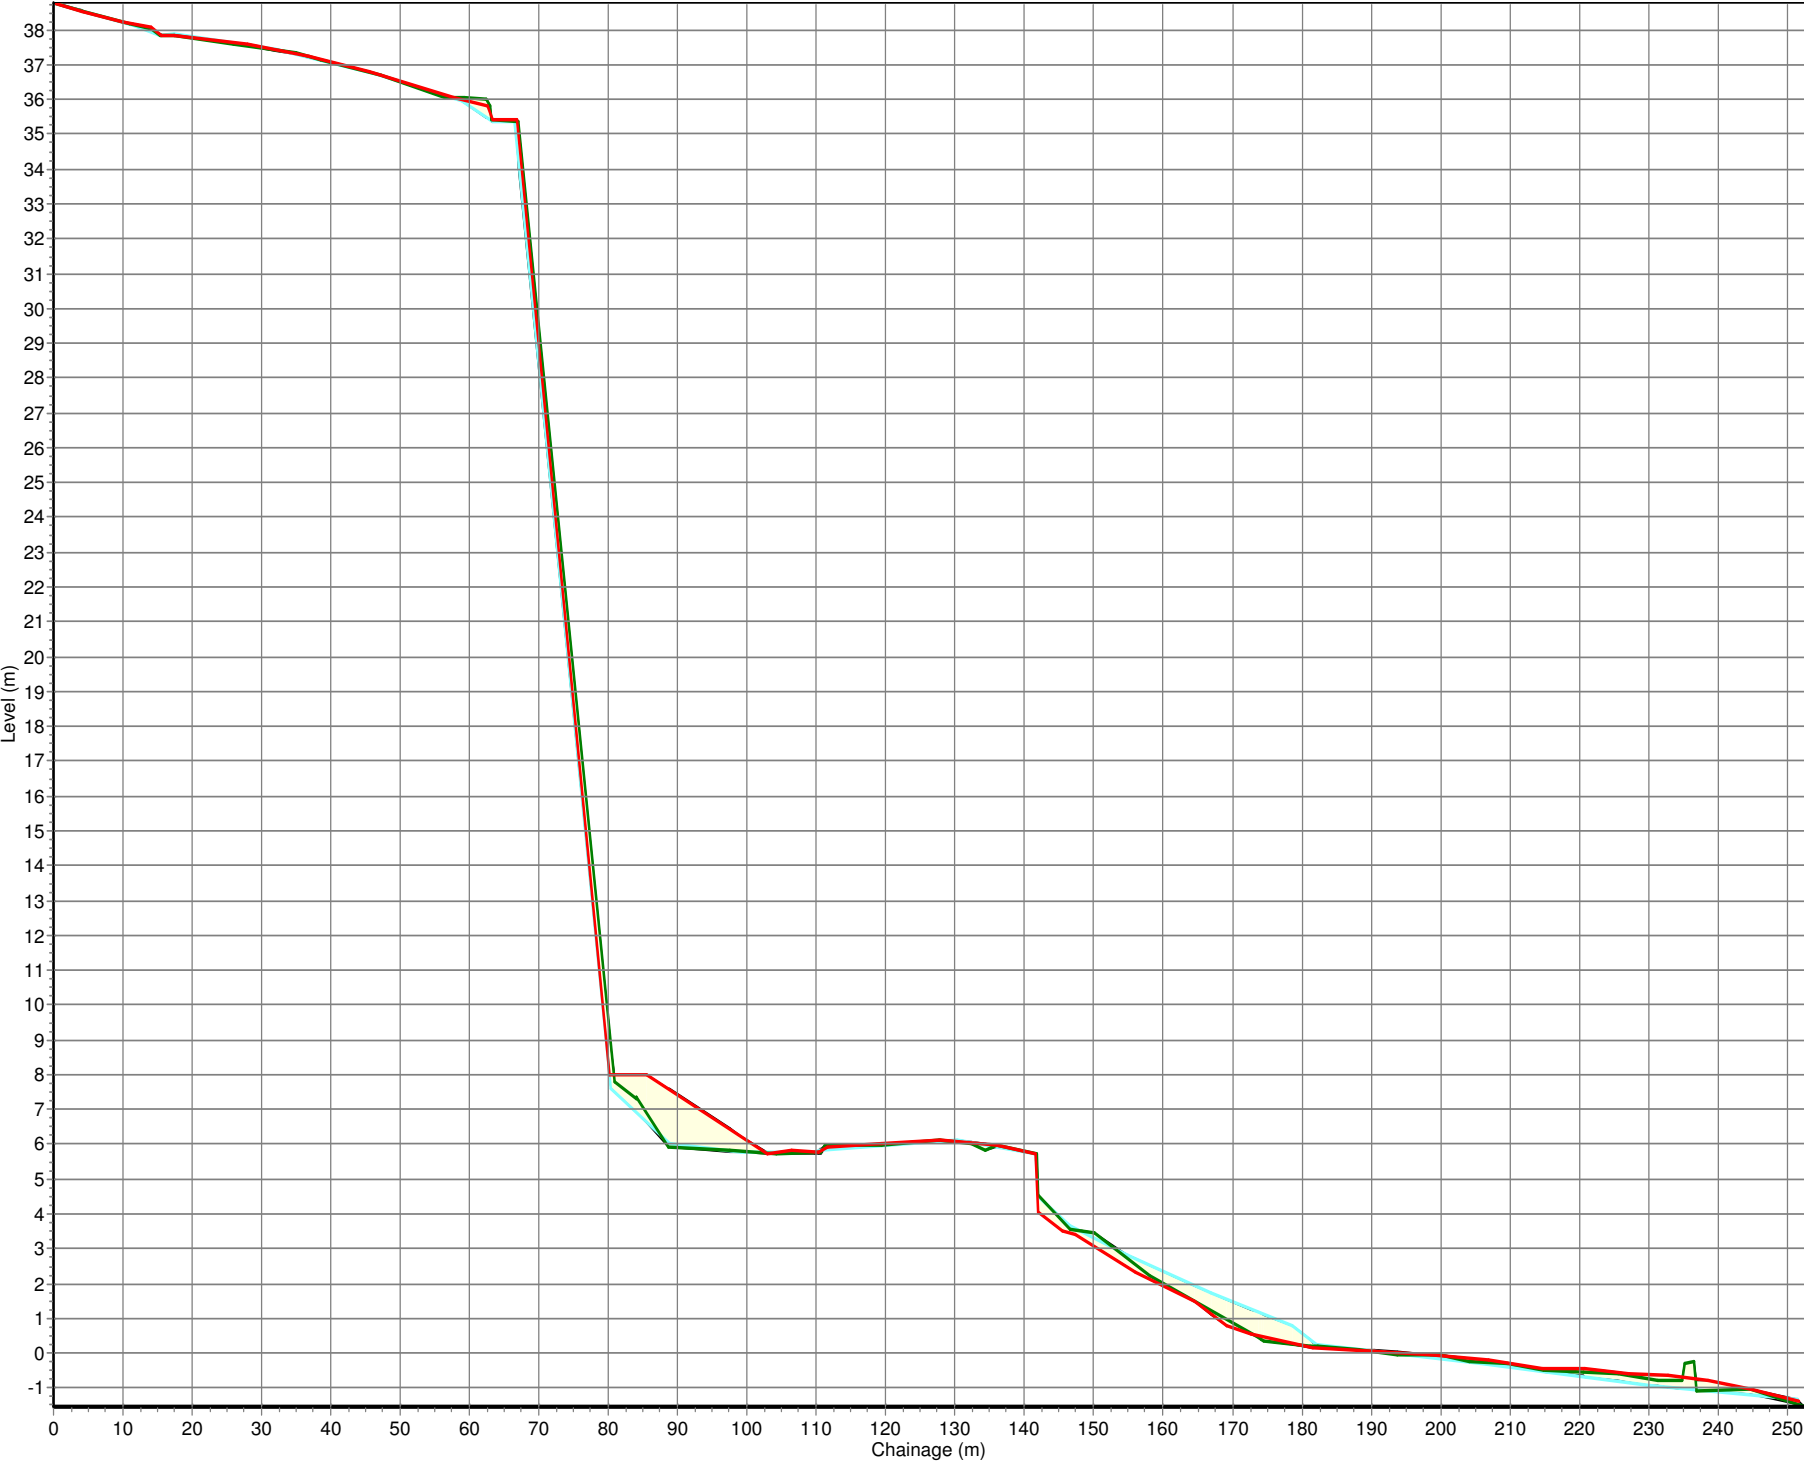
Beach Profiles: 1bSH1A

Survey Date	Description of Changes Since Last Survey	Interpretation
09-2010	<p><b>Beach Profiles:</b></p> <p>Blast Beach is covered by three beach profile lines (Appendix A).</p> <p>Profile SH1a was added to the programme during the Full Measures survey in September 2010. It is located to the north of the previously-established SH1. All three profiles along Blast Beach exhibit similar forms, with a backing cliff, wide spoil beach with a distinct cliff at the seaward margin of the spoil and a gravel and sand foreshore extending down to the low water mark. The width of the spoil beach along SH1a is around 60m, reducing to around 35m along SH1 and SH2.</p> <p>Profile SH1a shows that the position of the edge of the colliery spoil has remained unchanged since surveys began along this transect in October 2009. Along SH1 the foreshore accretion previously observed has started to become eroded, moving back towards the near vertical edge of the colliery spoil. Along SH2, the measurable erosion of the near-vertical seaward face of the colliery spoil beach has continued, with a further 2m recession between March 2010 and September 2010. Furthermore, the face of the spoil has angled back to a sloped upper section, resulting in the 'cliff top' being some 5m landward of the position recorded previously.</p>	<p>Measurable changes along parts of Blast Beach were noted between October 2009 and March 2010 and these have continued to the present survey.</p> <p>The width of protective spoil beach fronting the cliffs along profiles SH1 and SH2 has now reduced from around 40m to around 35m. Profile SS1a to date remains unaffected.</p>

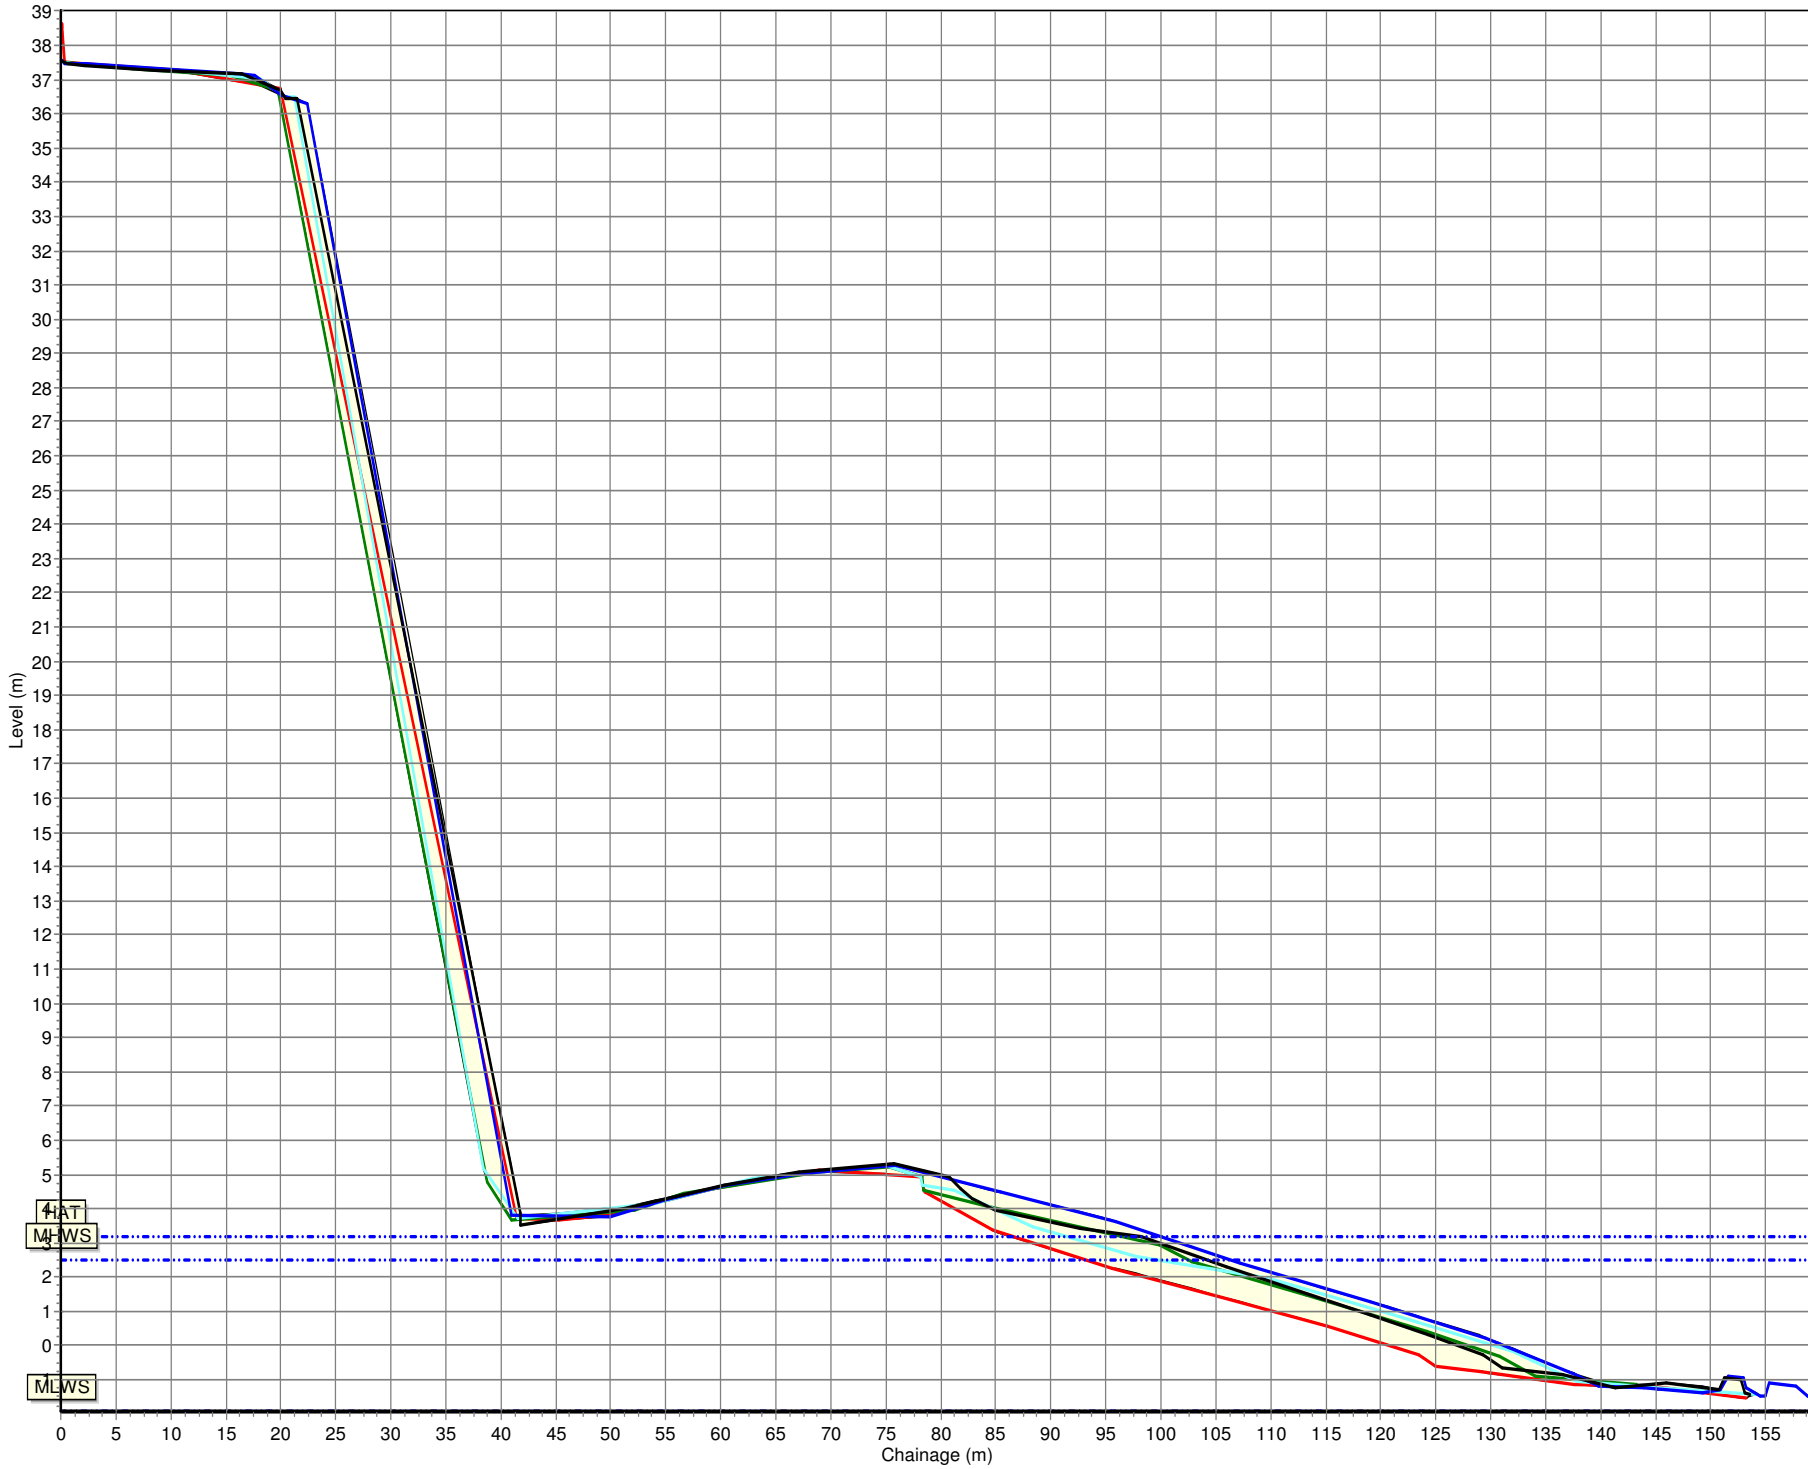
# Beach Profiles: 1bSH1

- Measurable changes continue to occur along parts of Blast Beach in the width of protective spoil beach fronting the cliffs. This has now reduced from around 40m to around 35m along profiles SH1 and SH2.

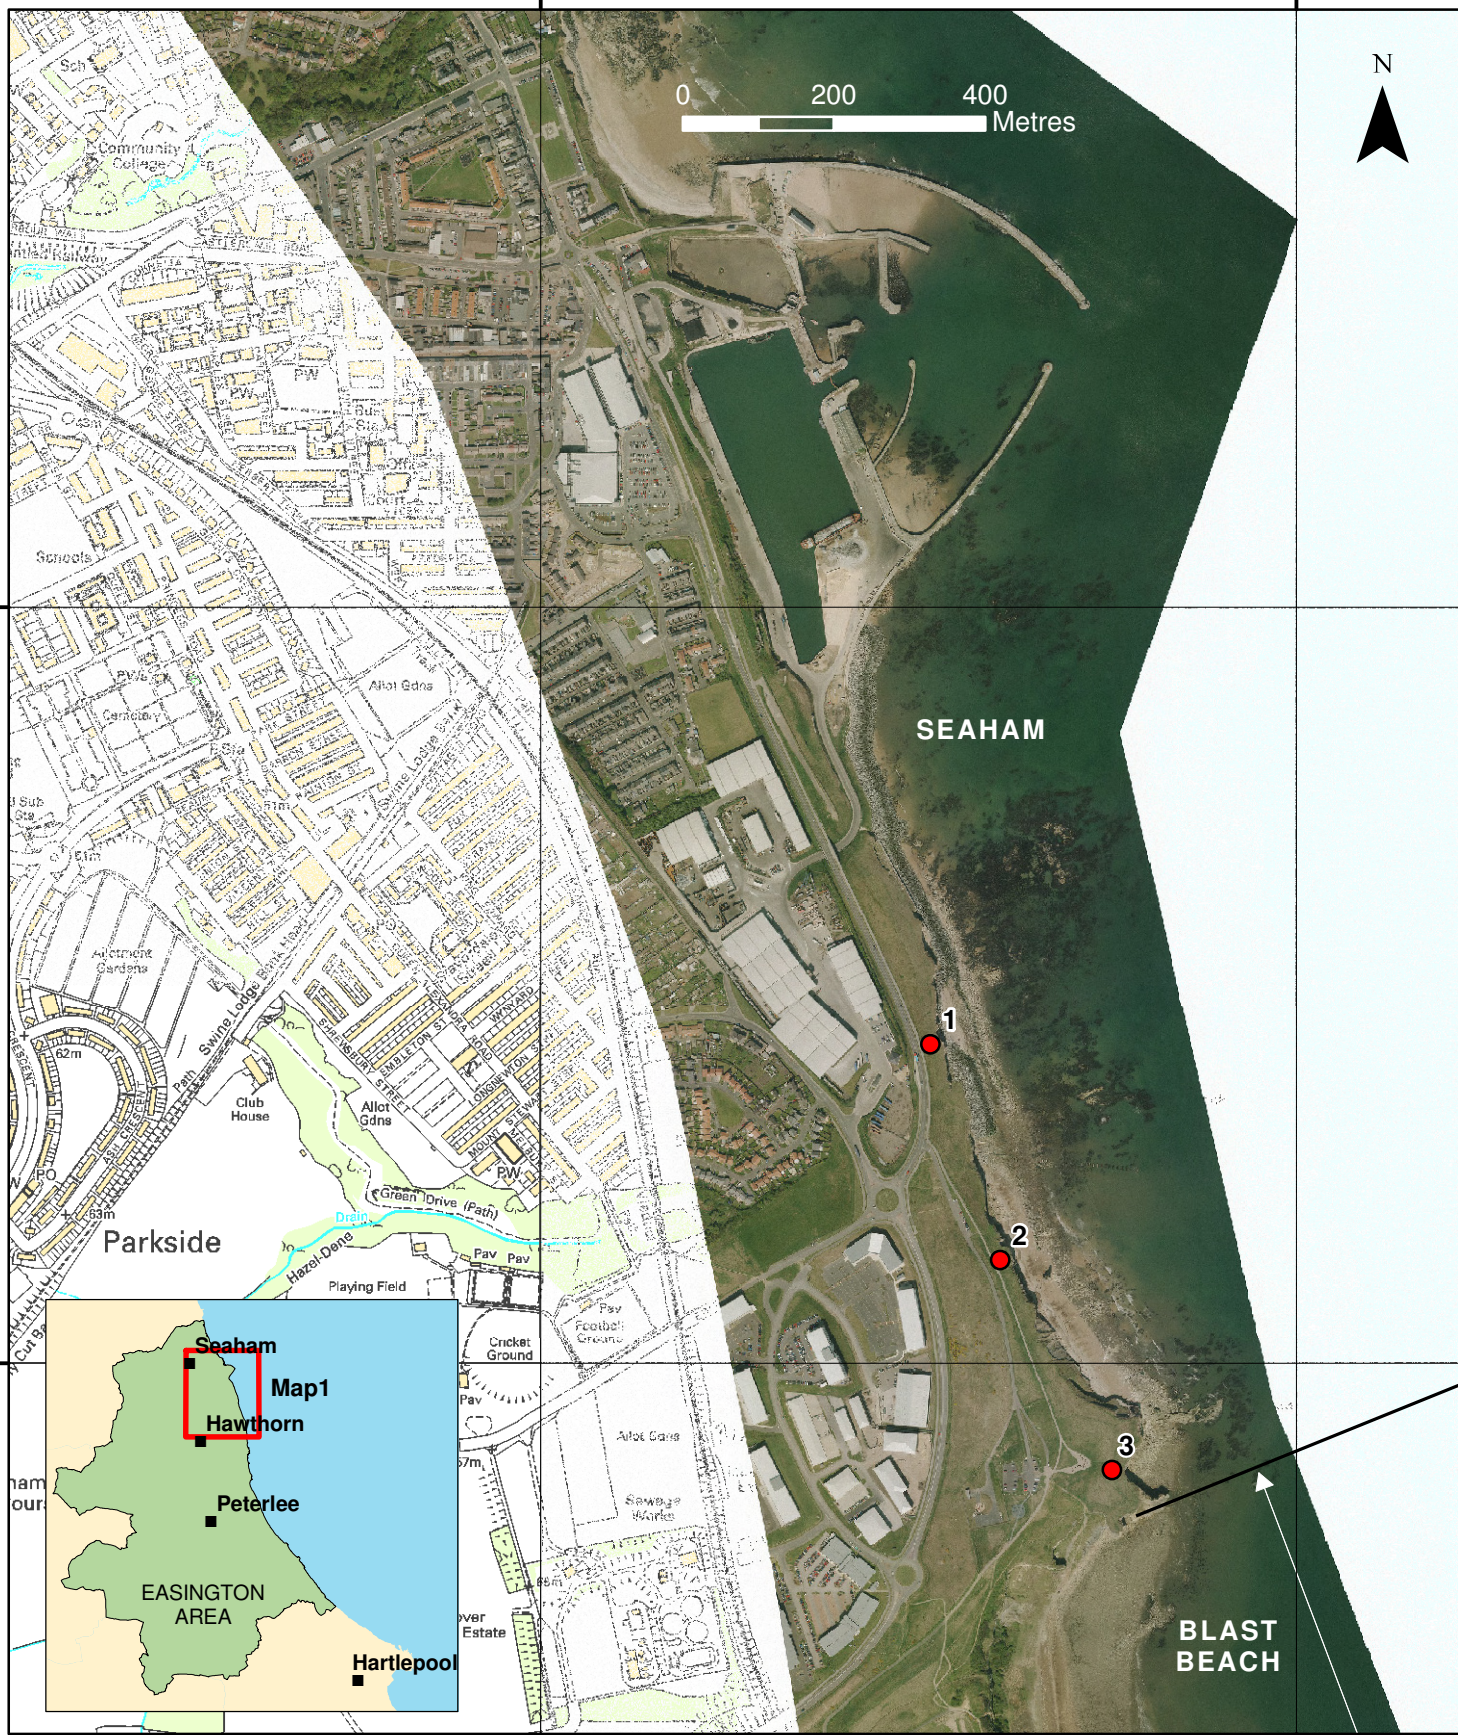
**Appendix B - Map 1  
 Durham County  
 Council Frontage**

Survey Date	Description of Changes Since Last Survey	Interpretation
09-2010	<p><b>Cliff Top Survey:</b></p> <p>Three ground control points have been established along the cliff top at Dawdon (Figure B1). The separation between any two points is nominally 300m. These cliff top surveys are intended to inform on erosion rates of the undefended sea cliffs extending south of the rock armour revetment to the south of Seaham Harbour. The cliff top surveys at Dawdon are undertaken bi-annually. Measurements are taken from a fixed ground control point along a fixed bearing to the edge of the cliff top. Appendix B provides information about the ground control points and results from between the 2008 (baseline) cliff top survey and the current (September 2010) survey.</p>	<p>Overall, there has been recession along ground control points 1 and 3 by the order of 0.6m and 0.9m, respectively, since surveys began in November 2008. Cliffs at these ground control points appear to have experienced a large erosion event over the winter of 2008/09 and a small event between March and September 2010. No significant change has occurred along ground control point 2.</p>

- Cliff top recession along some sections of the undefended Dawdon cliffs has continued. Calculation of longer-term recession rates has improved with the increased length of the dataset.

Three ground control points have been established along the cliff top at Dawdon (Figure B1). The separation between any two points is nominally 300m. These cliff top surveys are intended to inform on erosion rates of the undefended sea cliffs extending south of the rock armour revetment to the south of Seaham Harbour.

The cliff top surveys at Dawdon are undertaken bi-annually. Measurements are taken from a fixed ground control point along a fixed bearing to the edge of the cliff top.

It is also worth considering adding an additional cliff top survey point to the north of Nose's Point where the spoil beach has only a narrow width fronting the cliff. This could suitably be located mid-way between points 2 and 3.
