**Cell 1 Regional Coastal Monitoring Programme  
Analytical Report 5: 'Full Measures' Survey 2012**

**County Durham Council  
Final Report**

**March 2013**

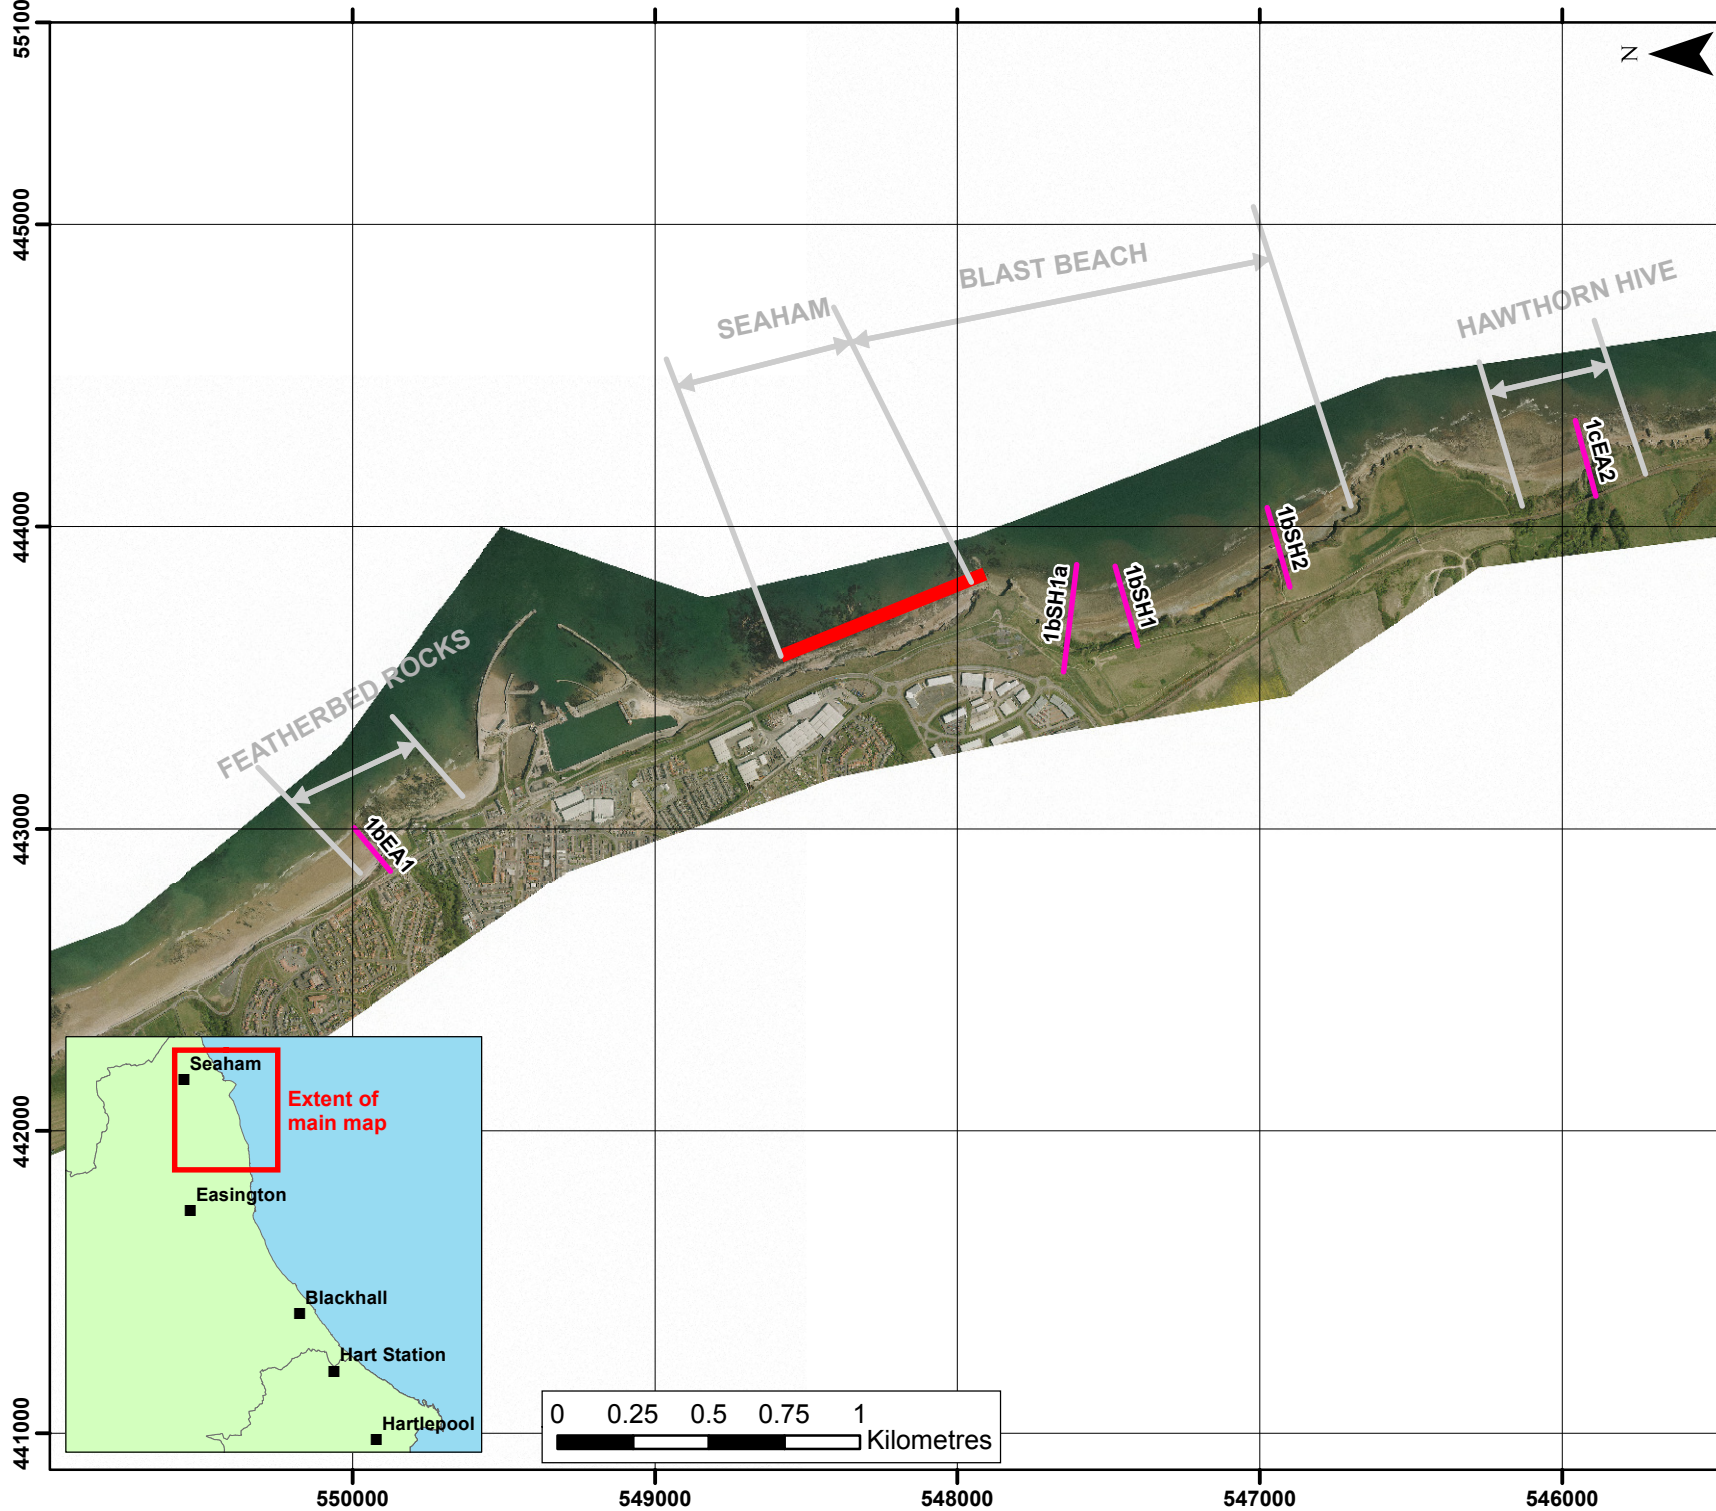
**Figure 2 - Map 1  
Survey Locations  
Featherbed Rocks to  
Hawthorne Hive  
Durham County Council**

The location of these surveys is shown in Figure 2. The 2012 Full Measures survey was undertaken along this frontage in September and October of 2012 when weather conditions were sunny and dry for Seaham and Easington, with a calm sea state. For the Blackhall survey it was raining and the sea state was calm.

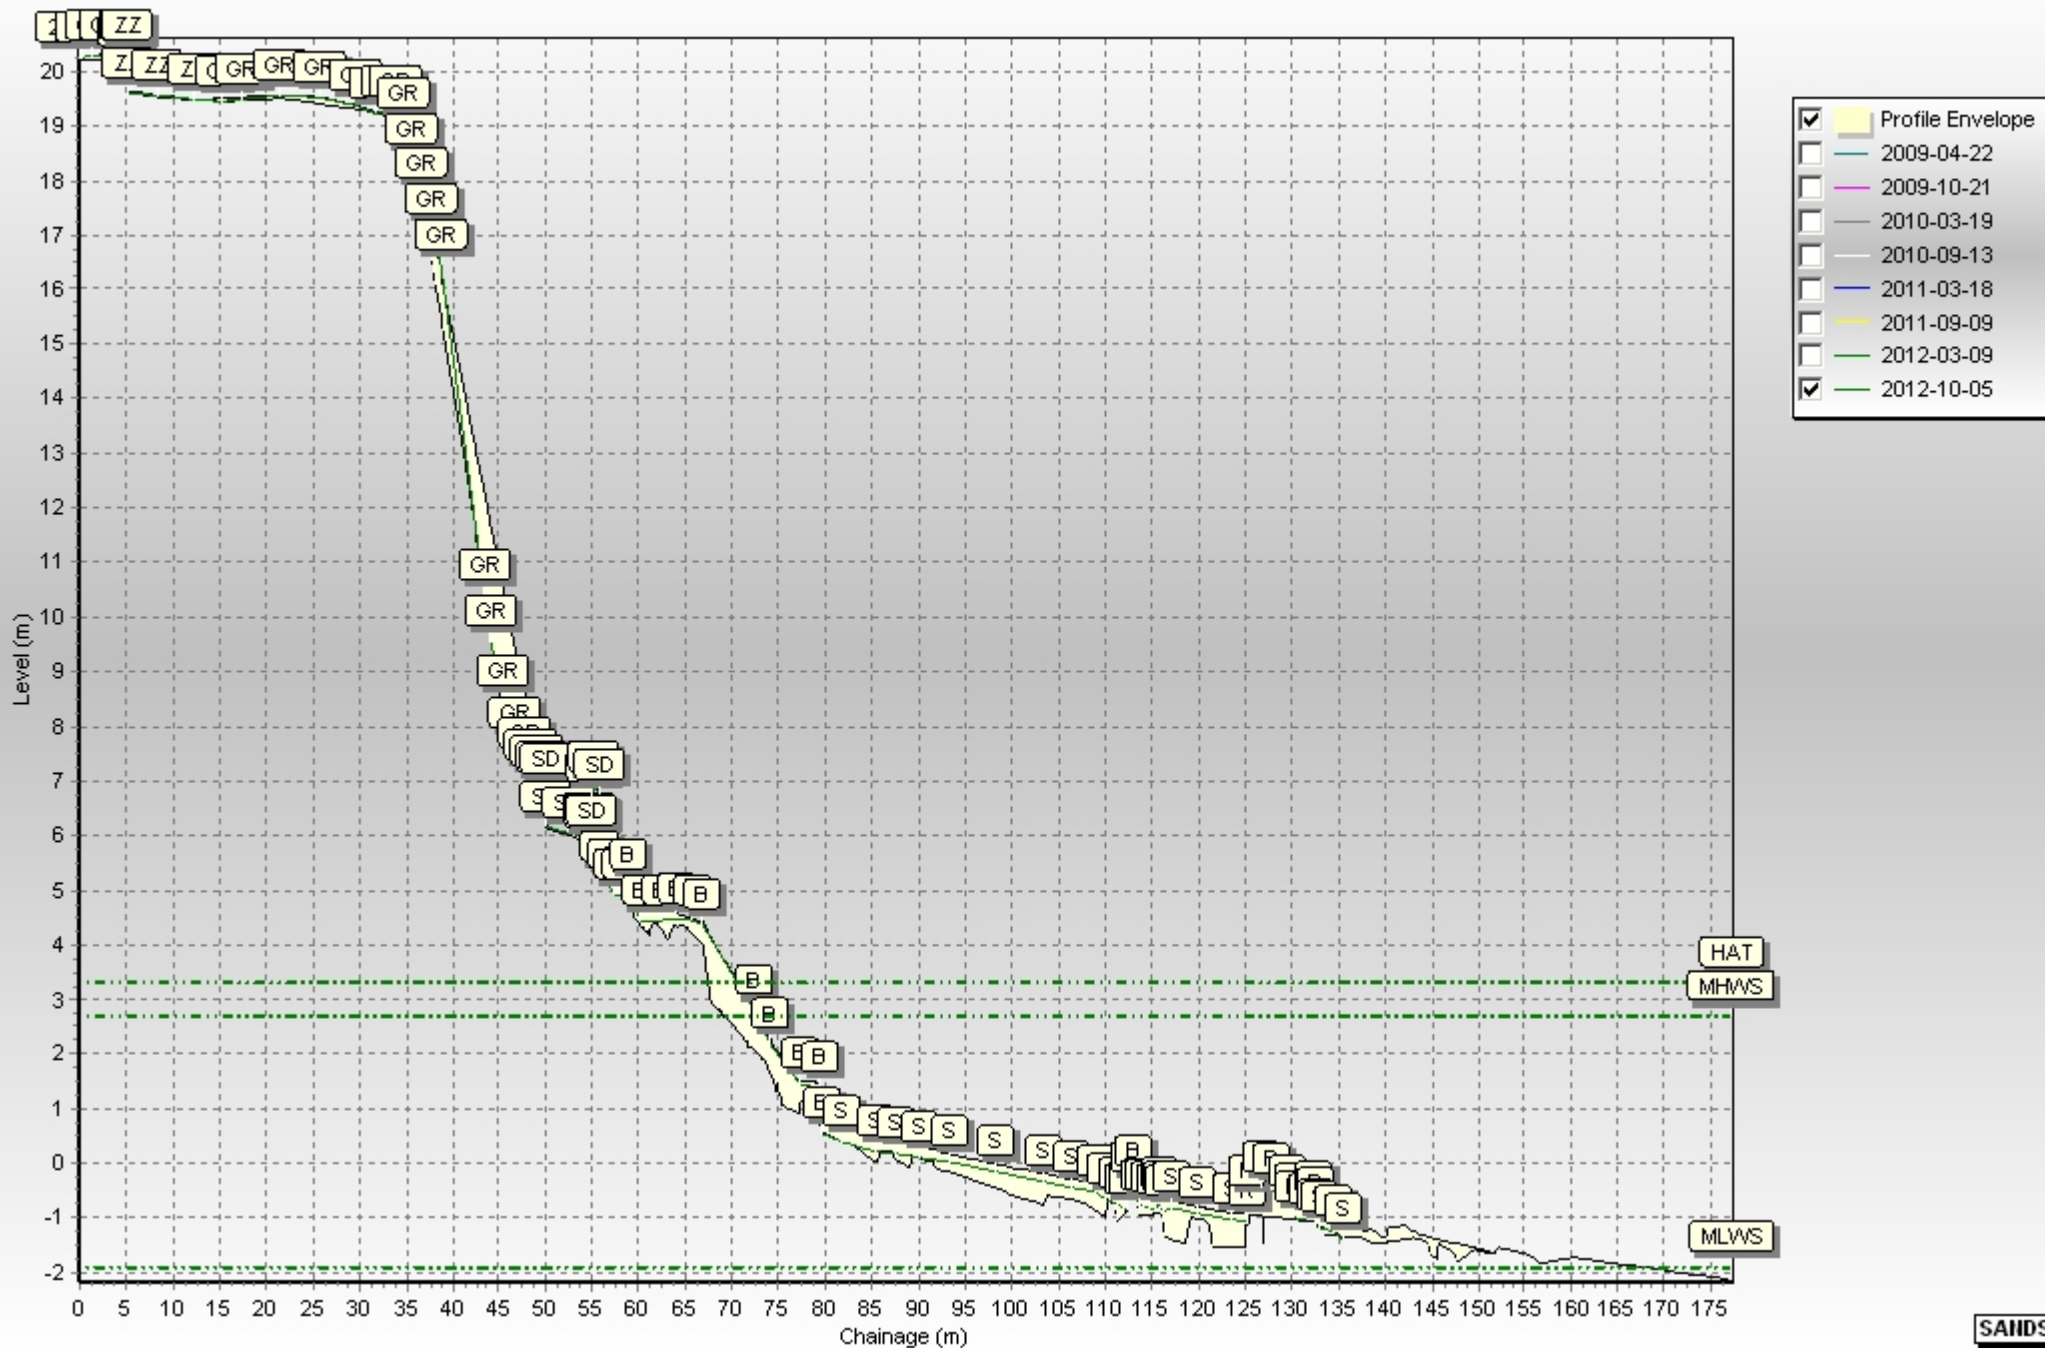
### Beach Profiles: 1bEA1

Survey Date	Description of Changes Since Last Survey	Interpretation
5 <sup>th</sup> Oct 2012	<p><b>Beach Profiles:</b></p> <p>One beach profile line, <b>1bEA1</b>, is located at Featherbed Rocks (Appendix A). The profile line was relocated to its present position in March 2009. The profile extends across the cliff top, dipping slightly at the cliff edge to around 19mODN. It then drops down the cliff face to the toe of the cliff and then extends seawards across the promenade. The sea wall is then crossed, before the survey drops to beach level where a significant quantity of shingle has accumulated at the toe of the wall.</p> <p>At the base of the sea wall there is an accumulation of sediment which has built up through the summer months. This accumulation of sediment is present from 65m to 80m chainage and is 0.5m higher than in the March 2012 surveys. From 80m chainage to the end of the survey the beach level in October 2012 is very similar to the March 2012 profile.</p>	<p>The rocky nature of this foreshore means it is unlikely to undergo significant changes in morphology unless sediment is deposited upon it. If a veneer beach is deposited over the rocky foreshore it tends to be subsequently stripped during storms.</p> <p><b>Longer term trends:</b> The beach profile looks fairly stable overall with only minor changes since it was set up in 2009, principally to the shingle accumulation at the toe of the wall, which was removed between March 2012 and October 2012.</p>

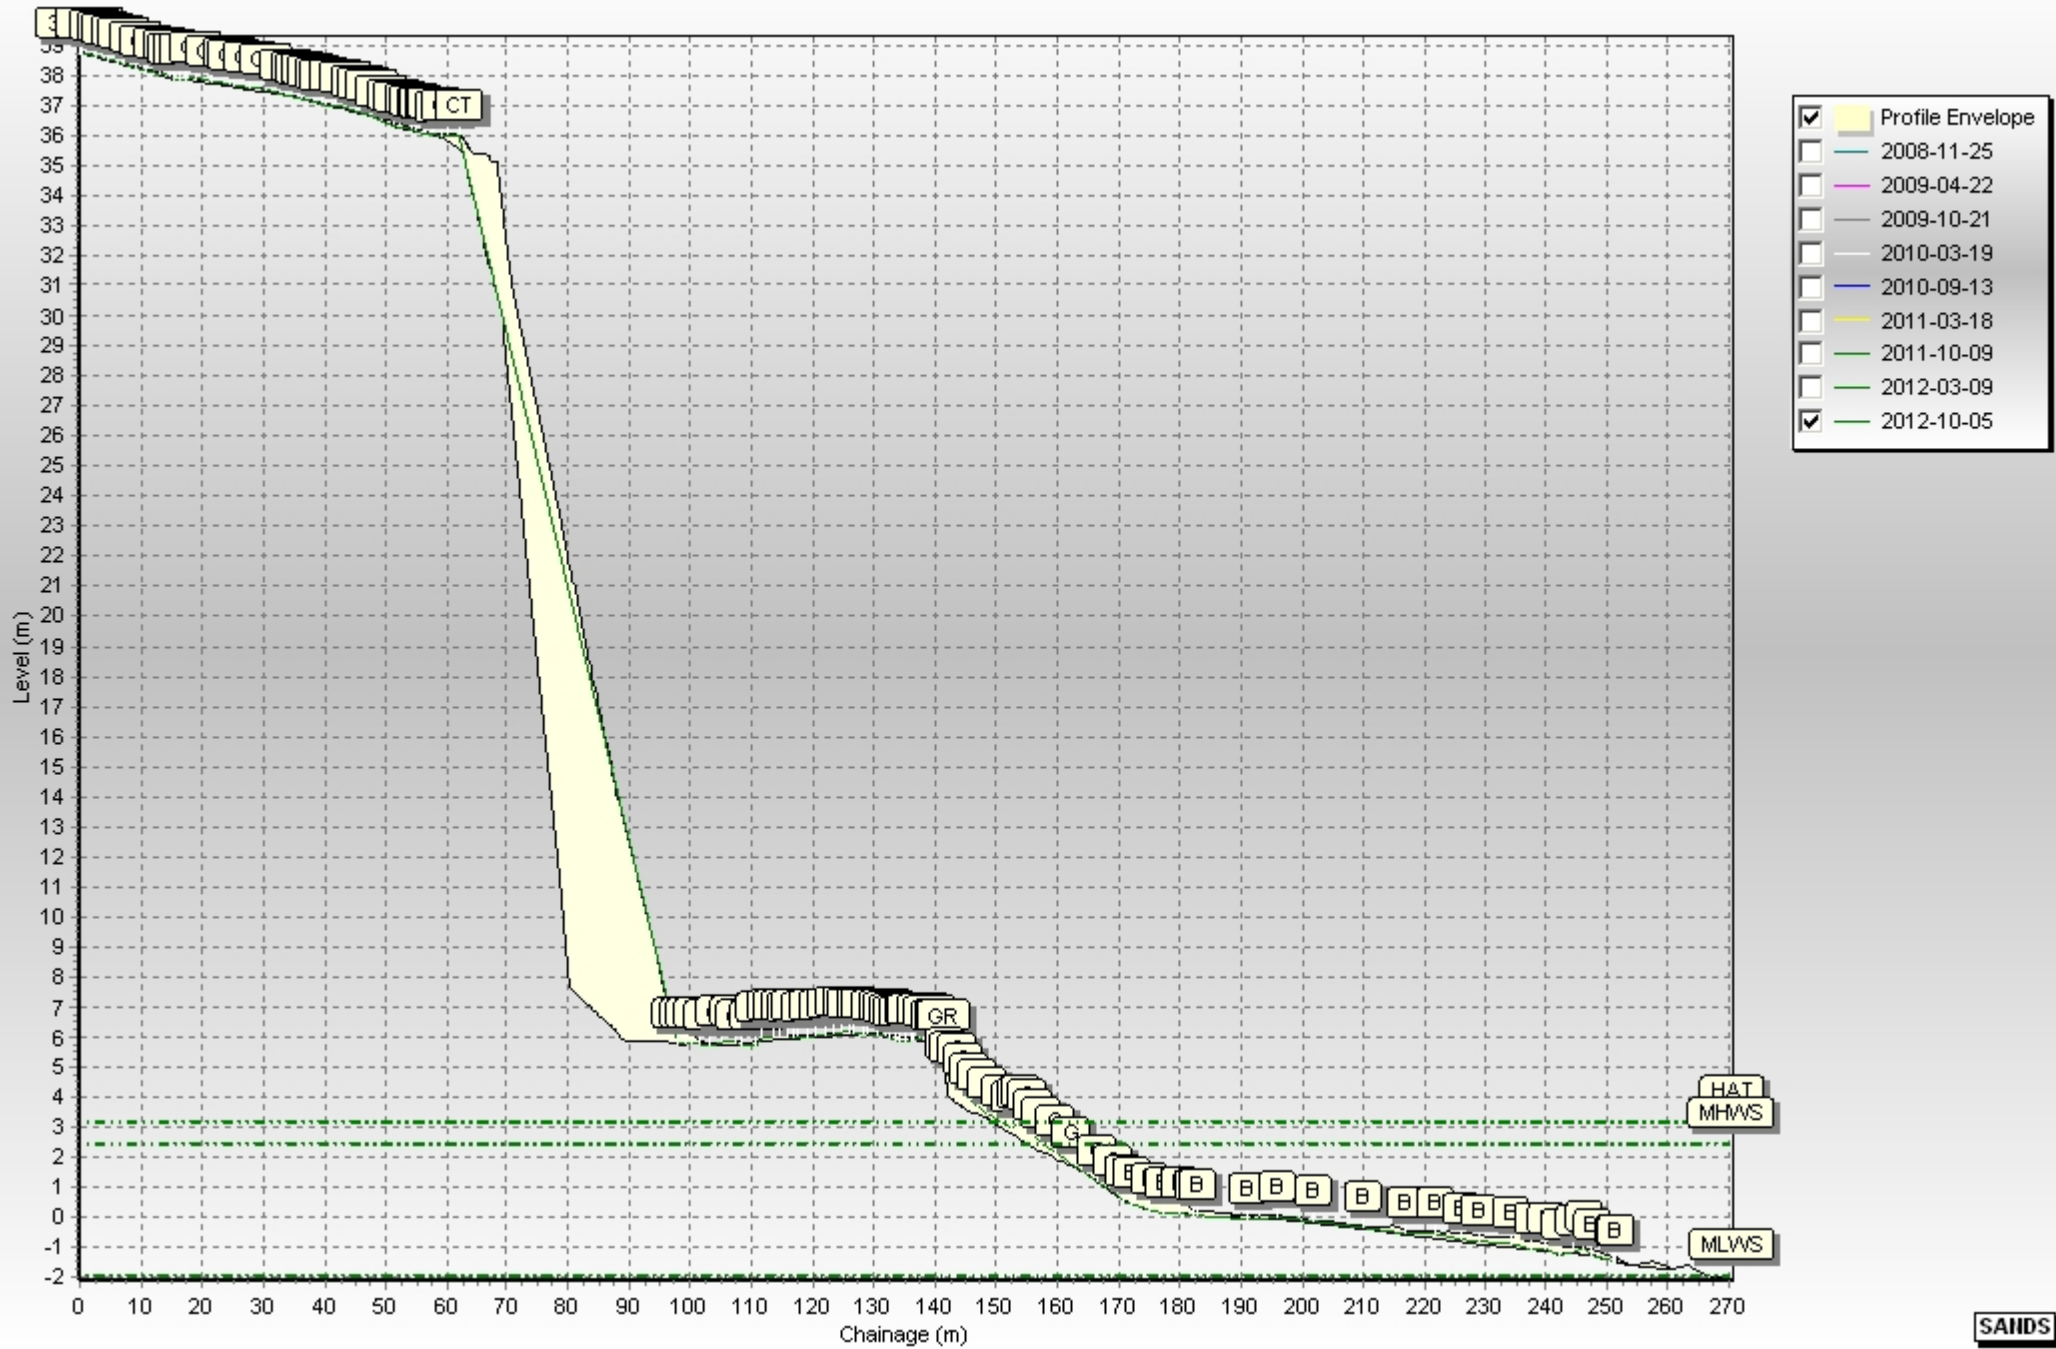
### Beach Profiles: 1bSH1A

Survey Date	Description of Changes Since Last Survey	Interpretation
5 <sup>th</sup> Oct 2012	<p><b>Beach Profiles:</b></p> <p>Blast Beach is covered by three beach profile lines (Appendix A).</p> <p>Profile <b>1bSH1a</b> was added to the programme during the Full Measures survey in September 2010. It is located to the north of the previously-established SH1. All three profiles along Blast Beach exhibit similar forms, with a rock cliff, wide spoil beach with a distinct cliff at the eroding face of the colliery spoil, and a gravel and sand foreshore that extends to MLW.</p> <p><b>1bSH1a</b> has a very similar profile to the previous year down to the eroding face of the spoil deposit. There has been some variability at the toe of the spoil cliff (between 140 and 180m chainage) with the beach being up to 1m lower in September 2012 than in March 2012, showing erosion through the summer. The remainder of the beach has remained stable since 2009 with a small amount of variability between the spring and autumn 2012 profiles.</p> <p>The width of the spoil beach along SH1a is around 60m, reducing to around 35m along SH1 and SH2.</p> <p>Profile <b>1bSH1</b> is similar to all of the previous surveys to the beach crest at 75m. The beach crest has eroded on the seaward side over the last year and the October 2012 survey shows evidence of continuation of that trend. The upper beach was not accessible at the time of survey and therefore the base of the cliff is missing from the October 2012 profile. Between March 2012 and October 2012 0.5m depth of material had been eroded from the beach around the HAT level, resulting in a retreat of the HAT contour by almost 2m. A small berm has been built up around MHWS. The rest of the beach has remained stable since March 2012.</p> <p>Profile <b>1bSH2</b> is largely similar to the previous surveys to the beach crest at 125m change. The crest in the beach has shown progressive erosion since 2009, with the crest retreating by around 12m. The beach below MHWS has accreted by up to 1m through the summer of 2012.</p>	<p>At present the cliffs at the back of Blast beach are inactive due to the protective stabilised spoil fronting the cliffs along profiles 1bSH1 and 1bSH2. The width of the spoil has now reduced from around 40m to around 35m. The spoil part of Profile SH1a remained reasonably stable since 2009.</p> <p><b>Longer term trends:</b> The sea cliffs will reactivate at in the near future as on-going erosion of the colliery spoil removes the protection it affords to the cliffs.</p>

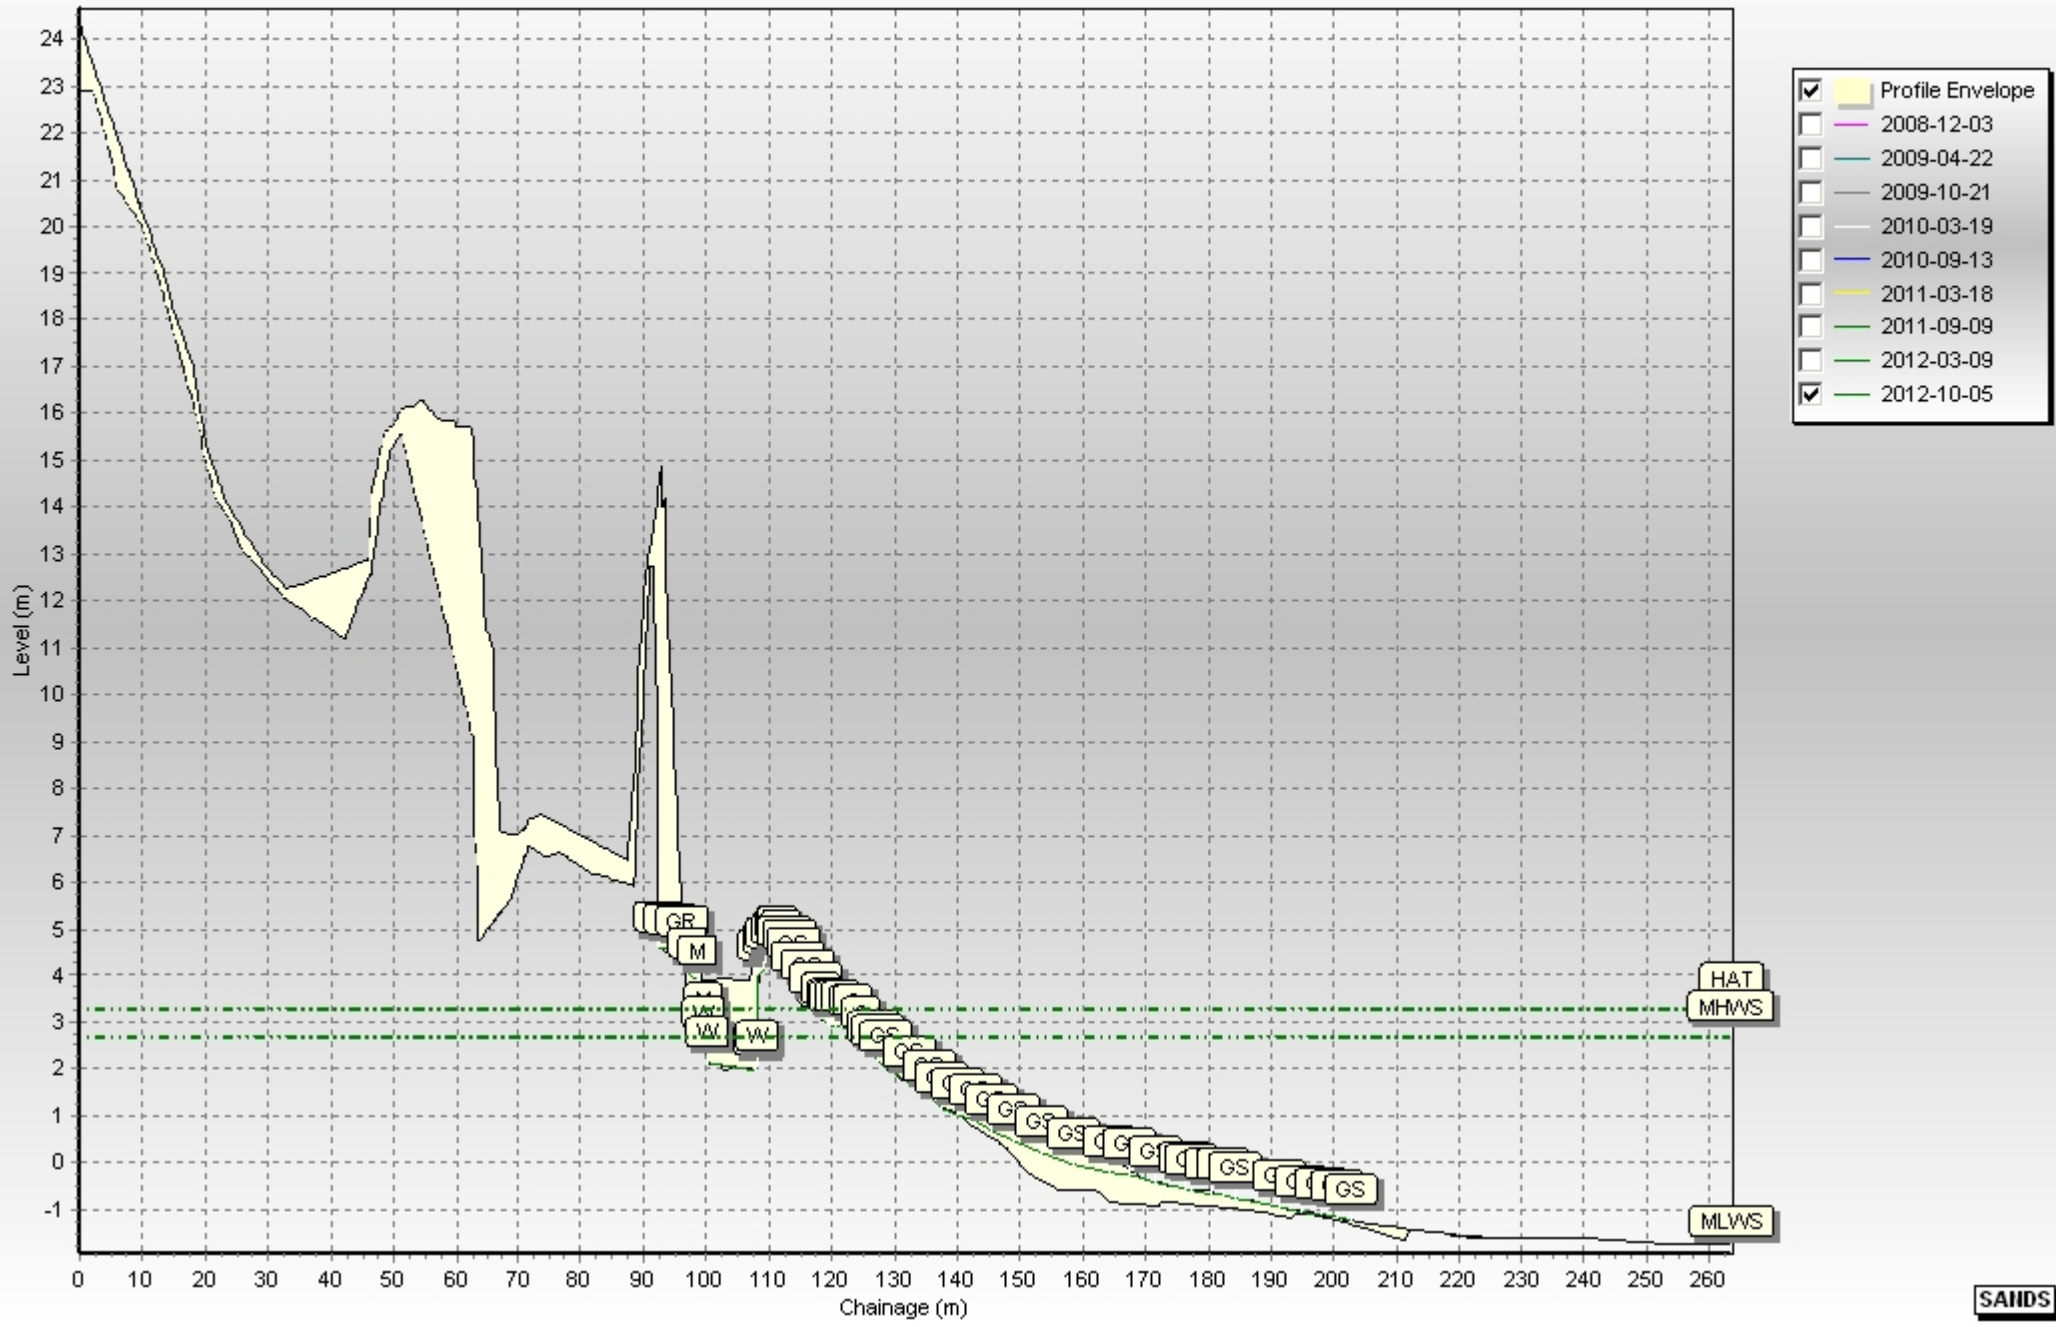
### Beach Profiles: 1cEA2

Survey Date	Description of Changes Since Last Survey	Interpretation
5 <sup>th</sup> Oct 2012	<p><b>Beach Profiles:</b></p> <p>One beach profile line, <b>1cEA2</b>, is located at Hawthorne Hive (Appendix A).</p> <p>The outlet channel of Hawthorne Burn was 2m deeper than the March 2012 survey. On the beach below HAT (115m to 145m chainage) the beach level is 0.2m lower than in March 2012. From 145m to the end of the survey the beach has accreted by up to 0.5m.</p>	<p>The beach indicates typical seasonal variability, with high spring levels and low autumn levels. These variations are likely to be due to an influx of sediment from the eroding cliffs over the winter and more aggressive autumn waves that tend to draw down sediment offshore.</p> <p><b>Longer term trends:</b> The beach level was noticeably low compared to the previous surveys dating back to December 2008. The channel was up to 2m lower, and the beach was up to 1m than previously recorded.</p>

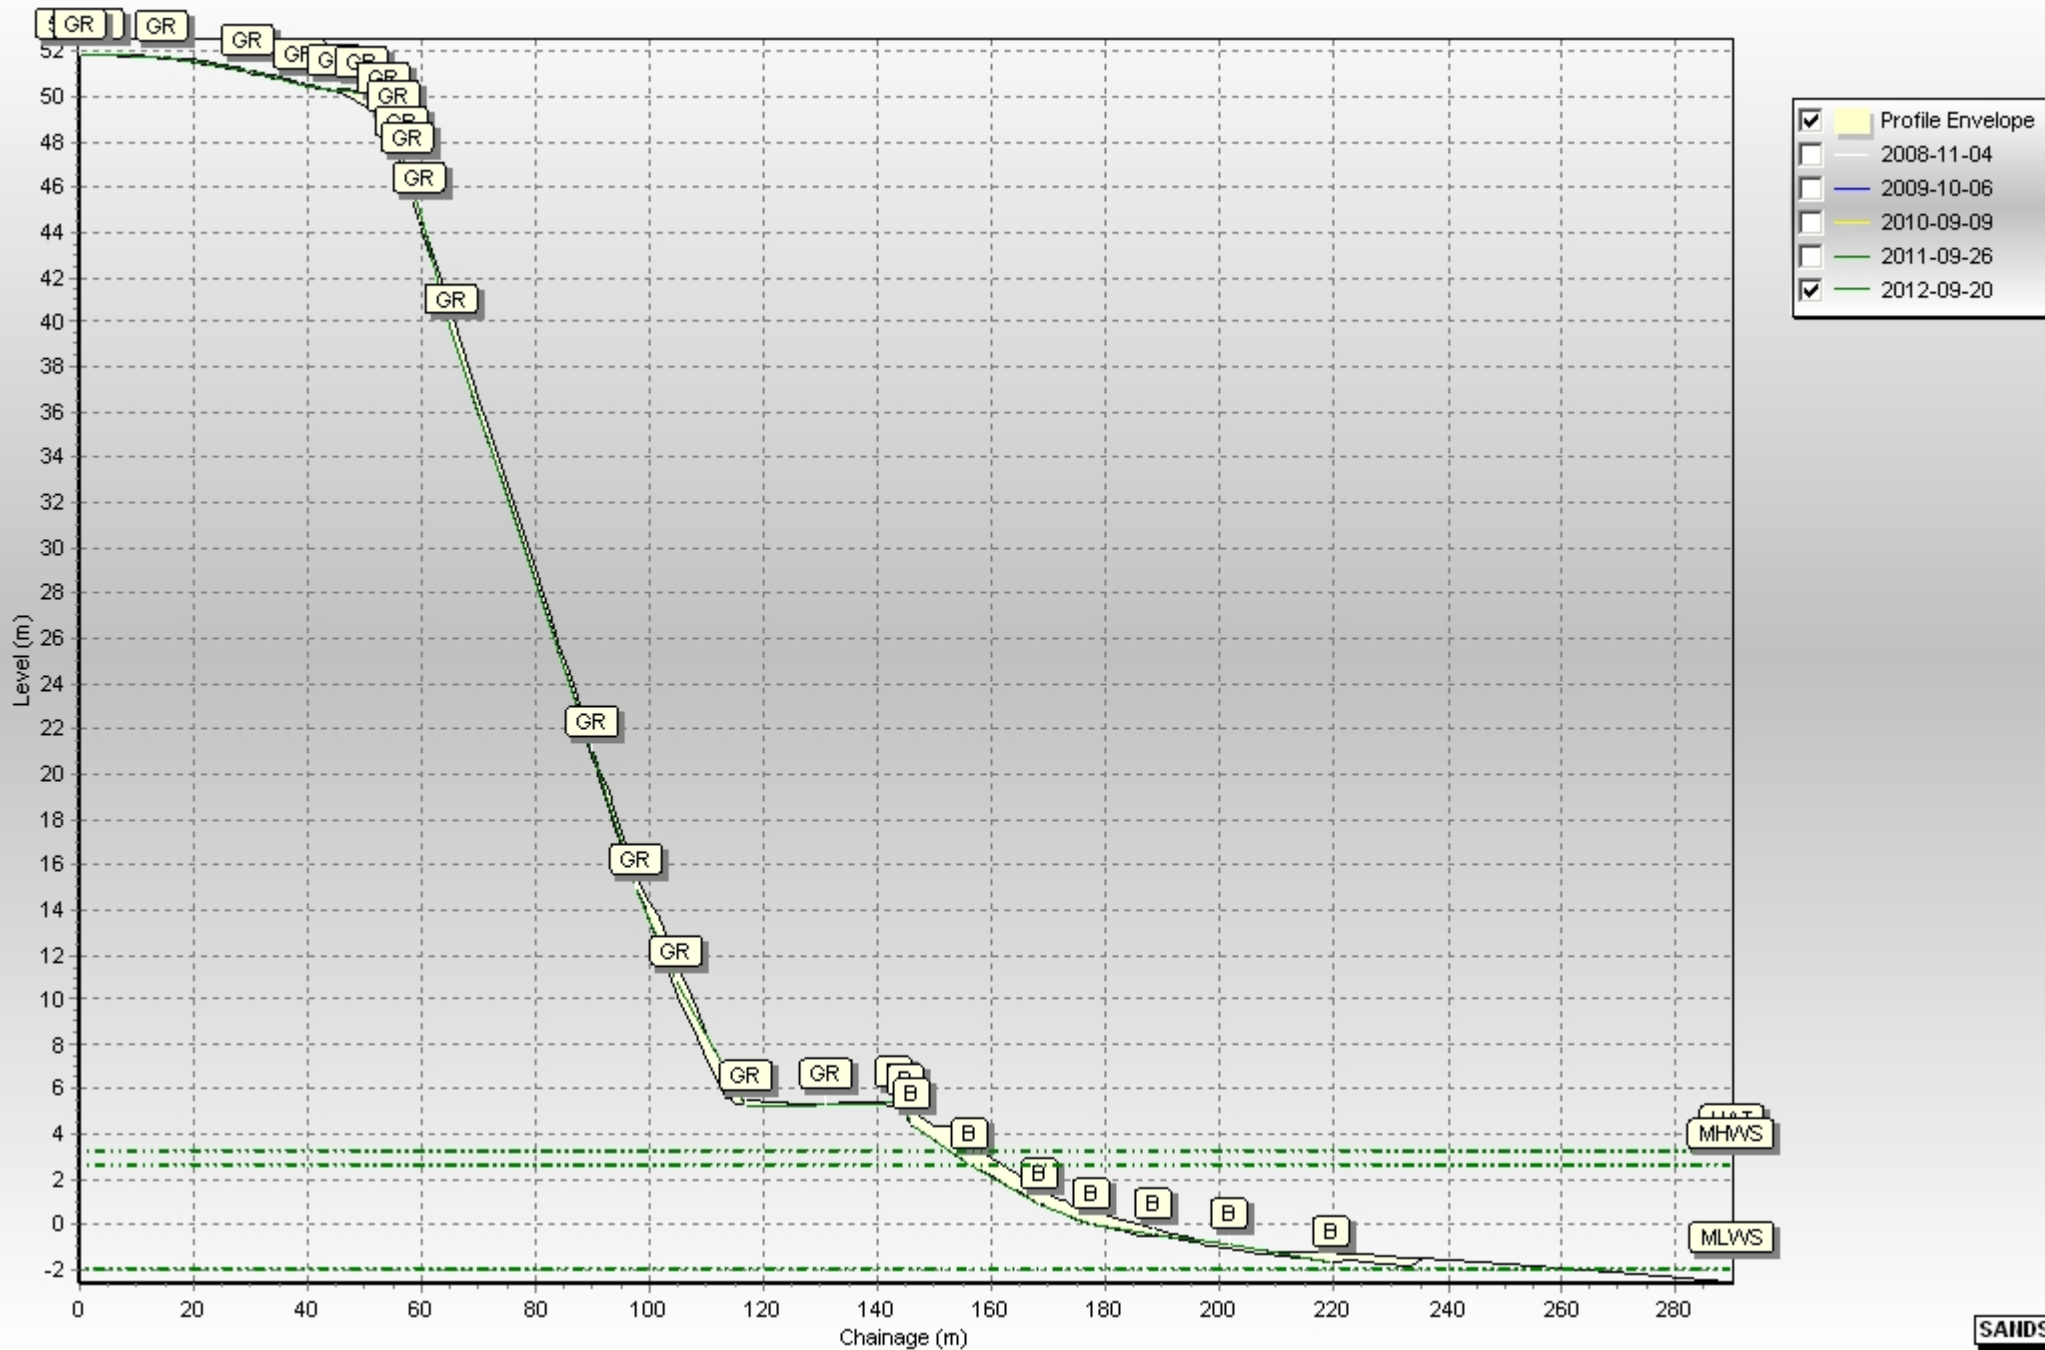
### Beach Profiles: 1cBH1

Survey Date	Description of Changes Since Last Survey	Interpretation
20 <sup>th</sup> Sept 2012	<p><b>Beach Profiles:</b></p> <p>Blackhall Colliery is covered by three beach profile lines (Appendix A). As at Blast Beach, profiles are dominated by colliery spoil and exhibit similar forms with a rock cliff, wide spoil beach with a distinct cliff at the eroding face of the colliery spoil, and a gravel and sand foreshore that extends to MLW.</p> <p><b>1cBH1</b> is located near Horden Point and shows that about 0.5m of retreat has taken place at the MHWS level contour since the previous survey in September 2011. The beach profile is very similar to September 2011 but has lowered by 0.5m, which is comparable with the retreat observed in previous years. Above and below this level the retreat is greater, with about 4m of loss at the beach crest. The profile at this location is lower than has been recorded since November 2008. The beach beyond 180m chainage is unchanged from previous surveys.</p> <p>Profile <b>1cBH2</b> exhibits no change in the cliff profile, but the cliffed-edge of the spoil beach has eroded landwards by a further 3m since September 2011, leaving only around 45m to the cliff toe. The rate of erosion in the last year was the same as the year before. Between October 2009 and September 2010 10m was lost. The gradient of the intertidal zone has remained similar throughout the profiles, but has dropped by 0.5m since September 2011.</p> <p>The profile <b>1cBH3</b> shows that since 2008 there has been periodic deepening of the outlet channel of Castle Eden Burn, which crosses the profile. The channel has infilled by 0.5m since September 2011. Below HAT the beach has eroded by 0.4m since September 2011. This recession is comparable with the recession observed for this profile in the 2011 Full Measures Report.</p>	<p>All of the Blackhall Colliery profiles have shown a similar trend. The profile above HAT stays stable while the crest of the spoil (if present) and the beach below HAT have reduced or retreated.</p> <p><b>Longer term trends:</b> The surveys show that the spoil beach along much of the Blackhall Colliery shore continues to provide effective protection to the backing cliffs. However, the spoil beach is eroding landwards at high rates of retreat (3 to 4m during 2012) and therefore the cliffs are likely to be reactivated in the near future.</p>

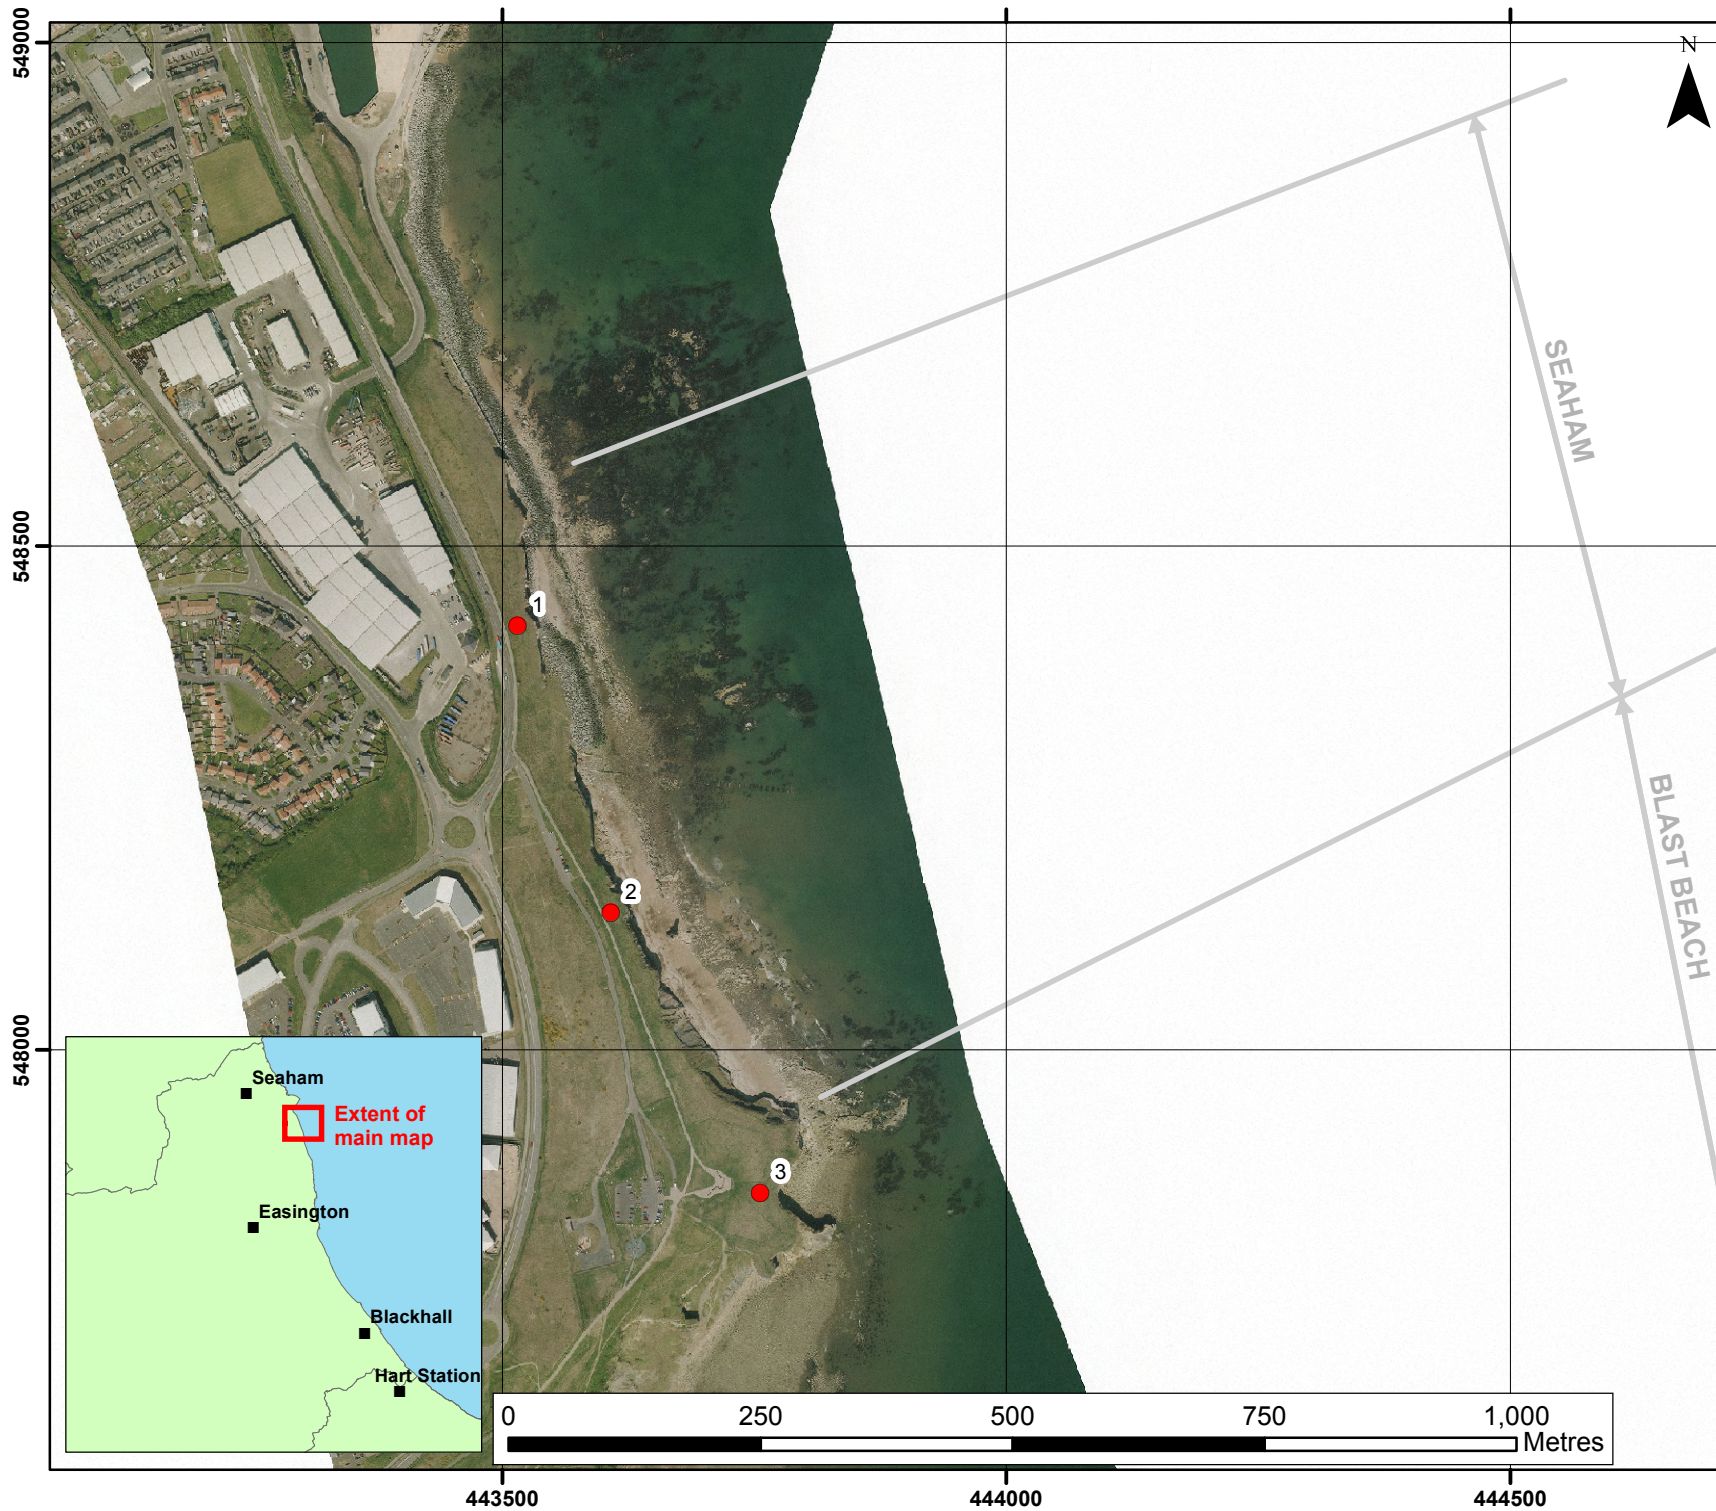
**Appendix B - Map 1  
 Ground Control Points  
 Seaham  
 Durham County Council**

Three ground control points have been established on the Seaham frontage (Figure B1). The maximum separation between any two points is nominally 300m.

The cliff top surveys at Seaham are undertaken annually. Measurements are taken from a fixed ground control point along a fixed bearing to the edge of the cliff top.

Survey Date	Description of Changes Since Last Survey	Interpretation
<p><b>October 2012</b></p>	<p><b>Cliff-top Survey:</b></p> <p>Three ground control points have been established along the cliff top at Dawdon (Figure B1). The separation between any two points is nominally 300m. These cliff top surveys are intended to inform on erosion rates of the undefended sea cliffs extending south of the rock armour revetment to the south of Seaham Harbour.</p> <p>The cliff top surveys at Dawdon are undertaken bi-annually. Measurements are taken from a fixed ground control point along a fixed bearing to the edge of the cliff top. Appendix B provides information about the ground control points and results from between the 2008 (baseline) cliff top survey and the current (October 2012) survey.</p> <p>Between March 2012 and October 2012 the cliff retreated by between 0.1m and 0.2m on each of the survey locations.</p> <p>Appendix C provides results from the October 2012 survey, showing the distance from the ground control point to the edge of the cliff top along the defined bearing and changes in position since the November 2008 baseline survey.</p>	<p>Long-term recession rates calculated from the data collected since November 2008 show that the cliffs are retreating at around 0.2-0.3m/yr. Marker 2 had a recession rate of zero because the errors in data collection have exceeded any recorded recession of the cliff. The limited time period over which the cliffs have been monitored means there is low confidence in determining the long term trends.</p> <p><b>Longer term trends:</b> the greatest recession has been observed at markers 1 and 3, which are on each end of the bay. Marker 2 is in the centre of the bay and shows little or no change over the four years that data has been collected. This shows that the bay form is reasonably stable. Continued monitoring will pick up any changes in behaviour of the bay.</p>
