**Cell 1 Regional Coastal Monitoring Programme
Analytical Report 11: 'Full Measures' Survey 2018**

Durham County Council

January 2019

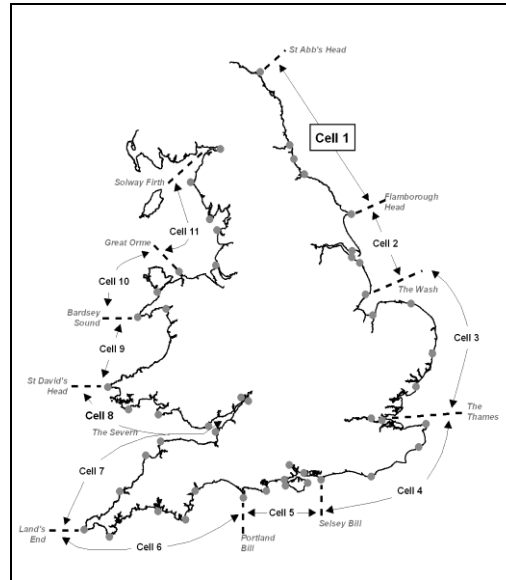
Figure 1 Sediment Cells in England and Wales

The Cell 1 Regional Coastal Monitoring Programme covers approximately 300km of the north east coastline, from the Scottish Border (just south of St. Abb's Head) to Flamborough Head in East Yorkshire. This coastline is often referred to as 'Coastal Sediment Cell 1' in England and Wales (Figure 1). Within this frontage the coastal landforms vary considerably, comprising low-lying tidal flats with fringing salt marshes, hard rock cliffs that are mantled with glacial sediment to varying thicknesses, softer rock cliffs and extensive landslide complexes.

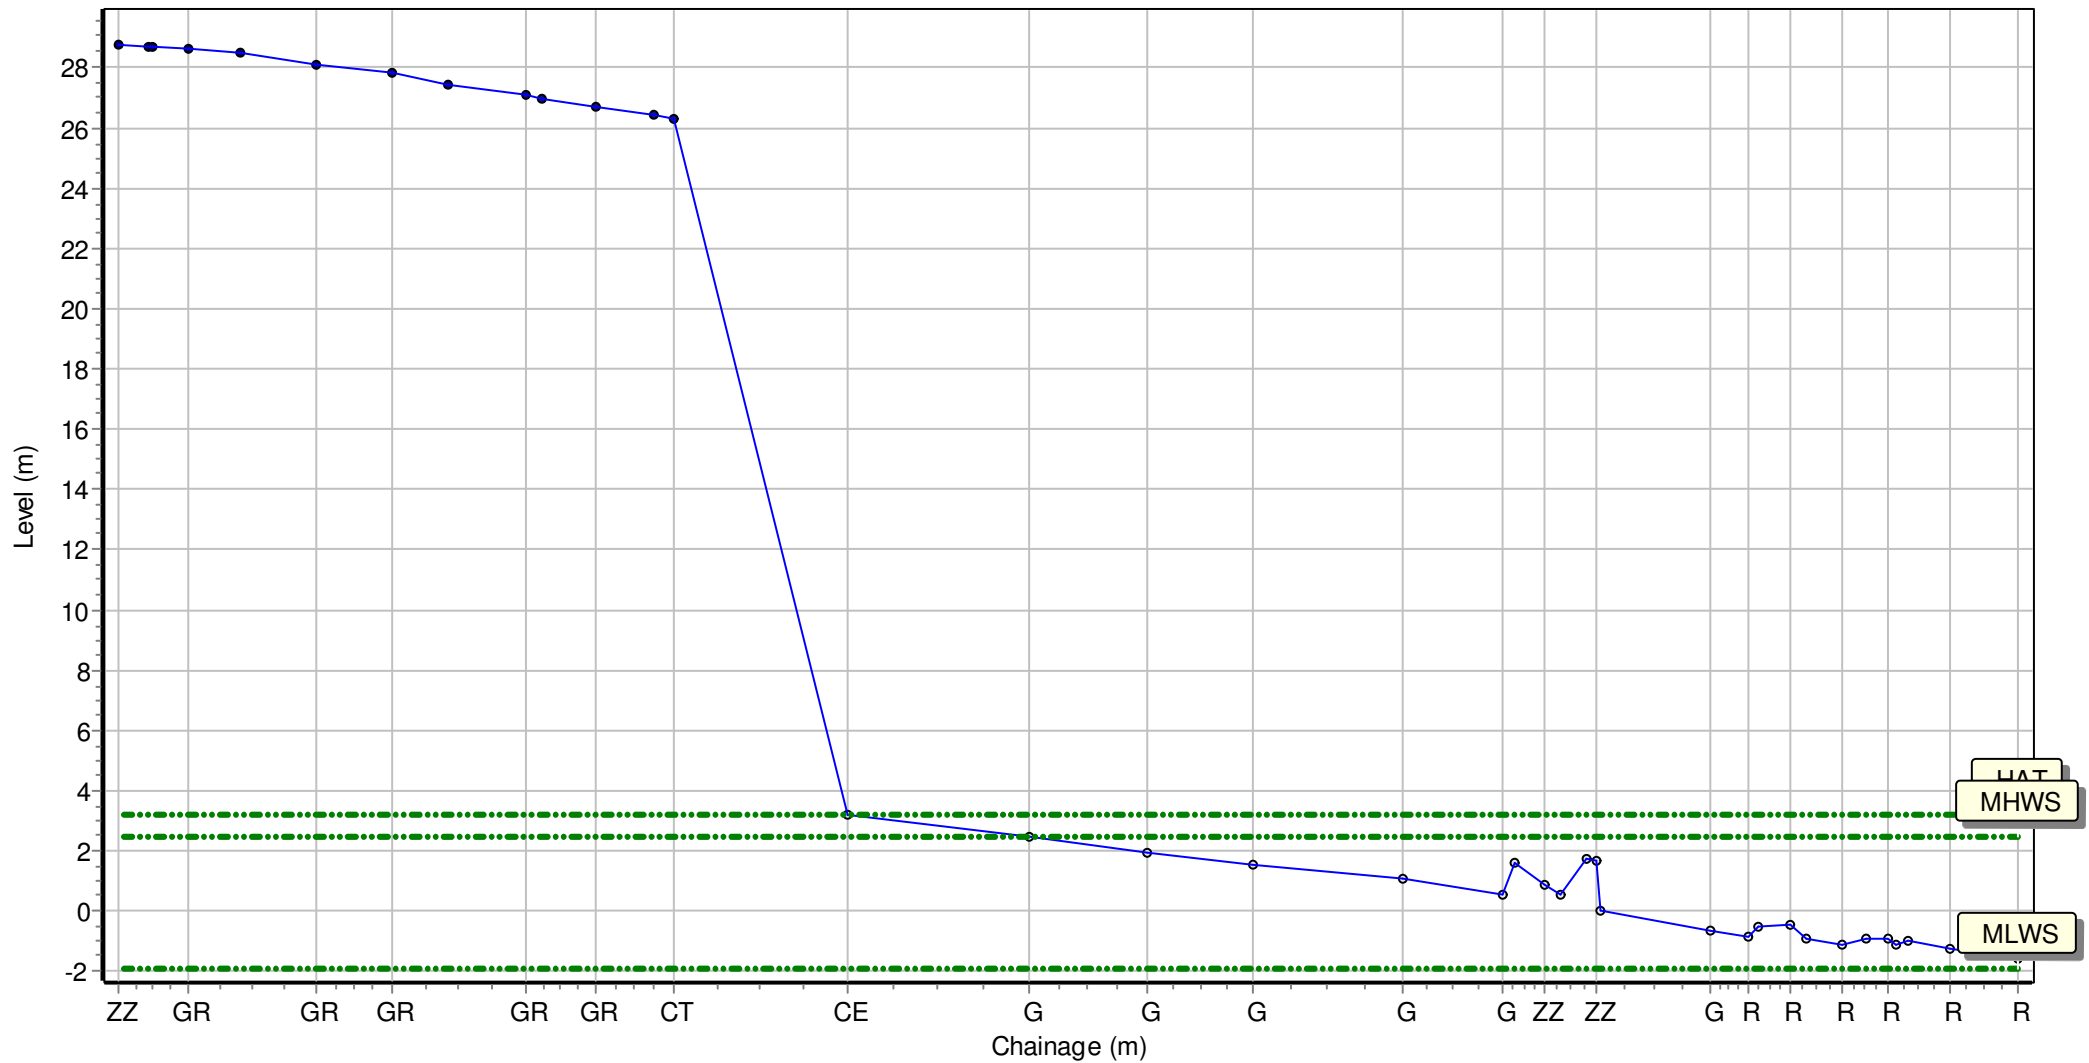
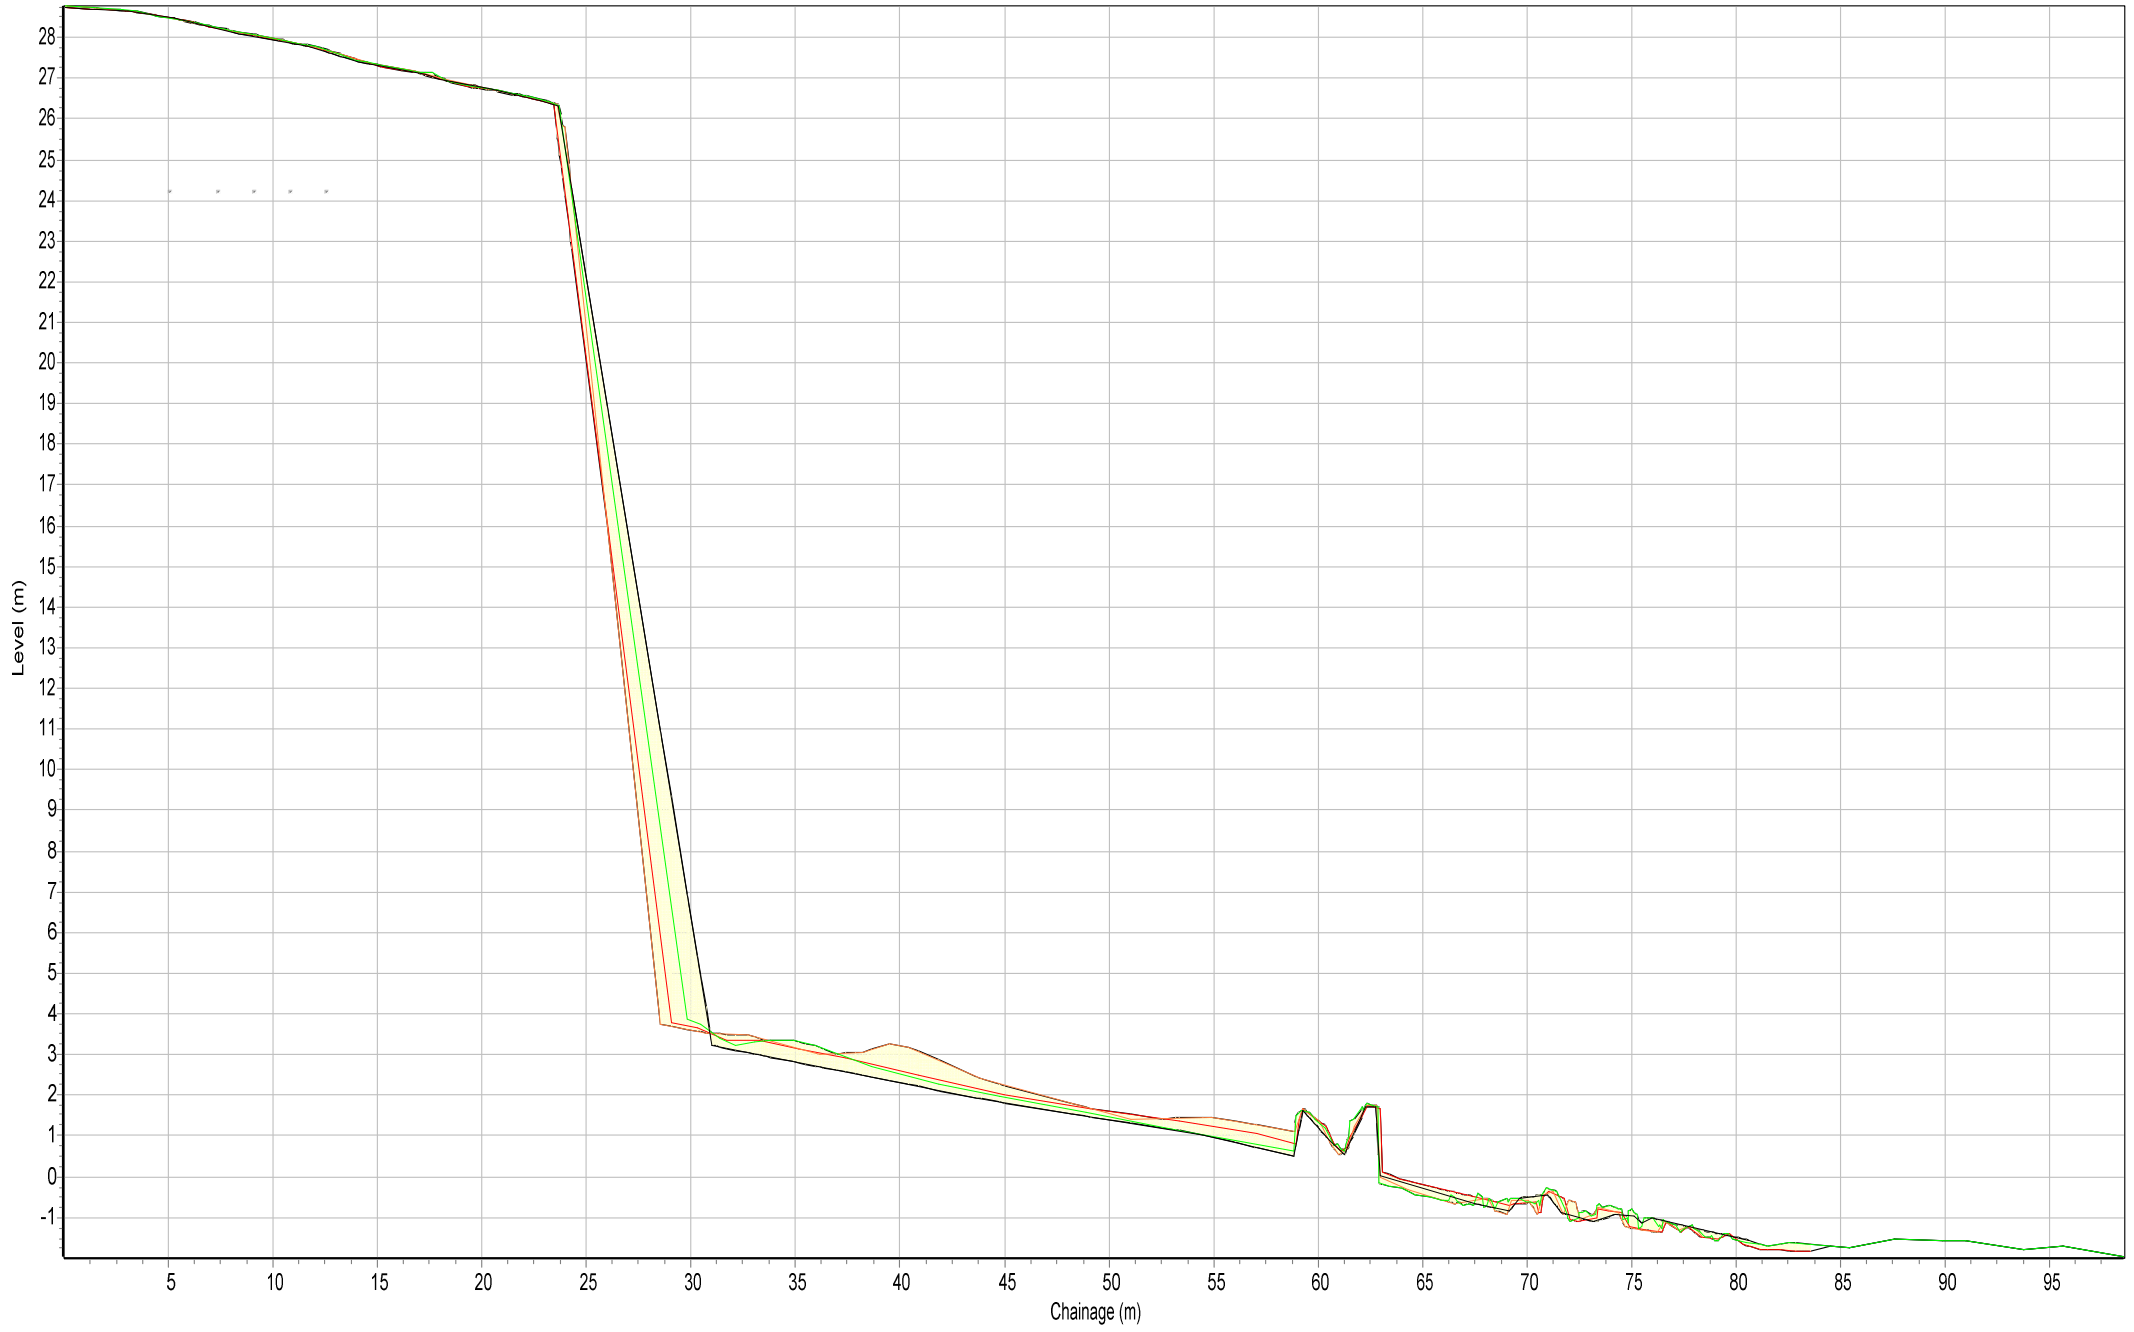
Beach Profiles: 1bSH1B

Survey Date	Description of Changes Since Last Survey	Interpretation
5 th December 2018	<p>Beach Profiles:</p> <p>Blast Beach is covered by four beach profile lines (Appendix A). All of the profiles along Blast Beach exhibit similar forms, with a rock cliff, wide colliery spoil beach with a distinct low cliff at its eroding seaward edge, and a mixed gravel and sand foreshore extending to MLW.</p> <p>Profile 1bSH1b was added to the programme during the Full Measures survey in October 2015. The profile is adjacent to the sewage works south of Seaham. The profile is cliff to 30m and then gravel beach between 30m and 60m chainage. During the 2018 Partial Measures Survey the beach level was found to have reduced by up to 0.6m, with the small upper beach berm (reported in the 2017 Full Measures Survey) having moved seaward. The 2018 Full Measure Survey showed that the berm has now disappeared entirely and the beach level has returned to a level more similar to that seen in 2016. There are two concrete blocks which have been upturned on the beach and are shown on the profiles as a protrusion in the profile between 60m and 65m chainage. The beach is visible again between 65m and 70m chainage. Below this point the rocks are exposed from 70m chainage to the end of the survey at 85m.</p> <p>Profile 1bSH1a was added to the programme during the Full Measures survey in September 2009. It is located to the north of the previously-established 1bSH1. The upper beach has a very similar profile to the previous year as far as the eroding face of the spoil deposit at 140m chainage. Between 140m chainage and 170m the small berm and entire beach face has moved seawards by approximately 5m since April 2018, and further increased in height by 0.3m. Between the spoil face and berm, a small depression has also moved seaward to approximately 152m chainage and has reduced in depth to only approximately 0.3m. From 170m chainage to the end of the survey at 260m chainage the rocks are exposed at the bottom of the beach. The autumn 2018 profile is towards the lower end of the range of previously recorded profiles.</p> <p>Profile 1bSH1 appears to show retreat of the cliff face by approximately 2.5m, however the survey photos show no evidence of movement and the survey report notes issues surveying the cliff due to vegetation growth. There has been very little change from the toe of the cliff at chainage 40m to the beach crest at 75m. Between chainages 75m and 90m there has been accretion of up to 0.4m. The</p>	<p>The cliffs behind Blast Beach are currently inactive because they are fronted by colliery spoil. The crest of the spoil material on profiles 1bSH1 and SH1a has remained stable since 2009. Profile 1bSH2 has been progressively eroding since 2009, however has remained more stable since November 2014 showing ongoing accretion in the lower beach.</p> <p>There has been little net change since the April 2018 survey. All profiles show beach levels to be within the range of historic profiles.</p> <p>At profile 1bSH1 the beach appears to have experienced some accretion in its mid and lower reaches.</p> <p>The beach at profile SH2 has shown an increase in level in its upper reaches. Whilst the mid and lower beach levels appear to have diminished.</p> <p>Longer term trends: The sea cliffs will eventually reactivate as on-going erosion of the colliery spoil removes the protection it affords to the cliffs. This is most likely to occur at the southern end of the bay where the spoil is most rapidly eroding. The accumulating sediment seaward of the colliery spoil in the northern part of the bay will offer the cliffs more protection. However, since the winter of 2014 there has been a reversal in the trend with erosion in the north of the bay and accretion in the south; this may yet be a short-term change.</p>

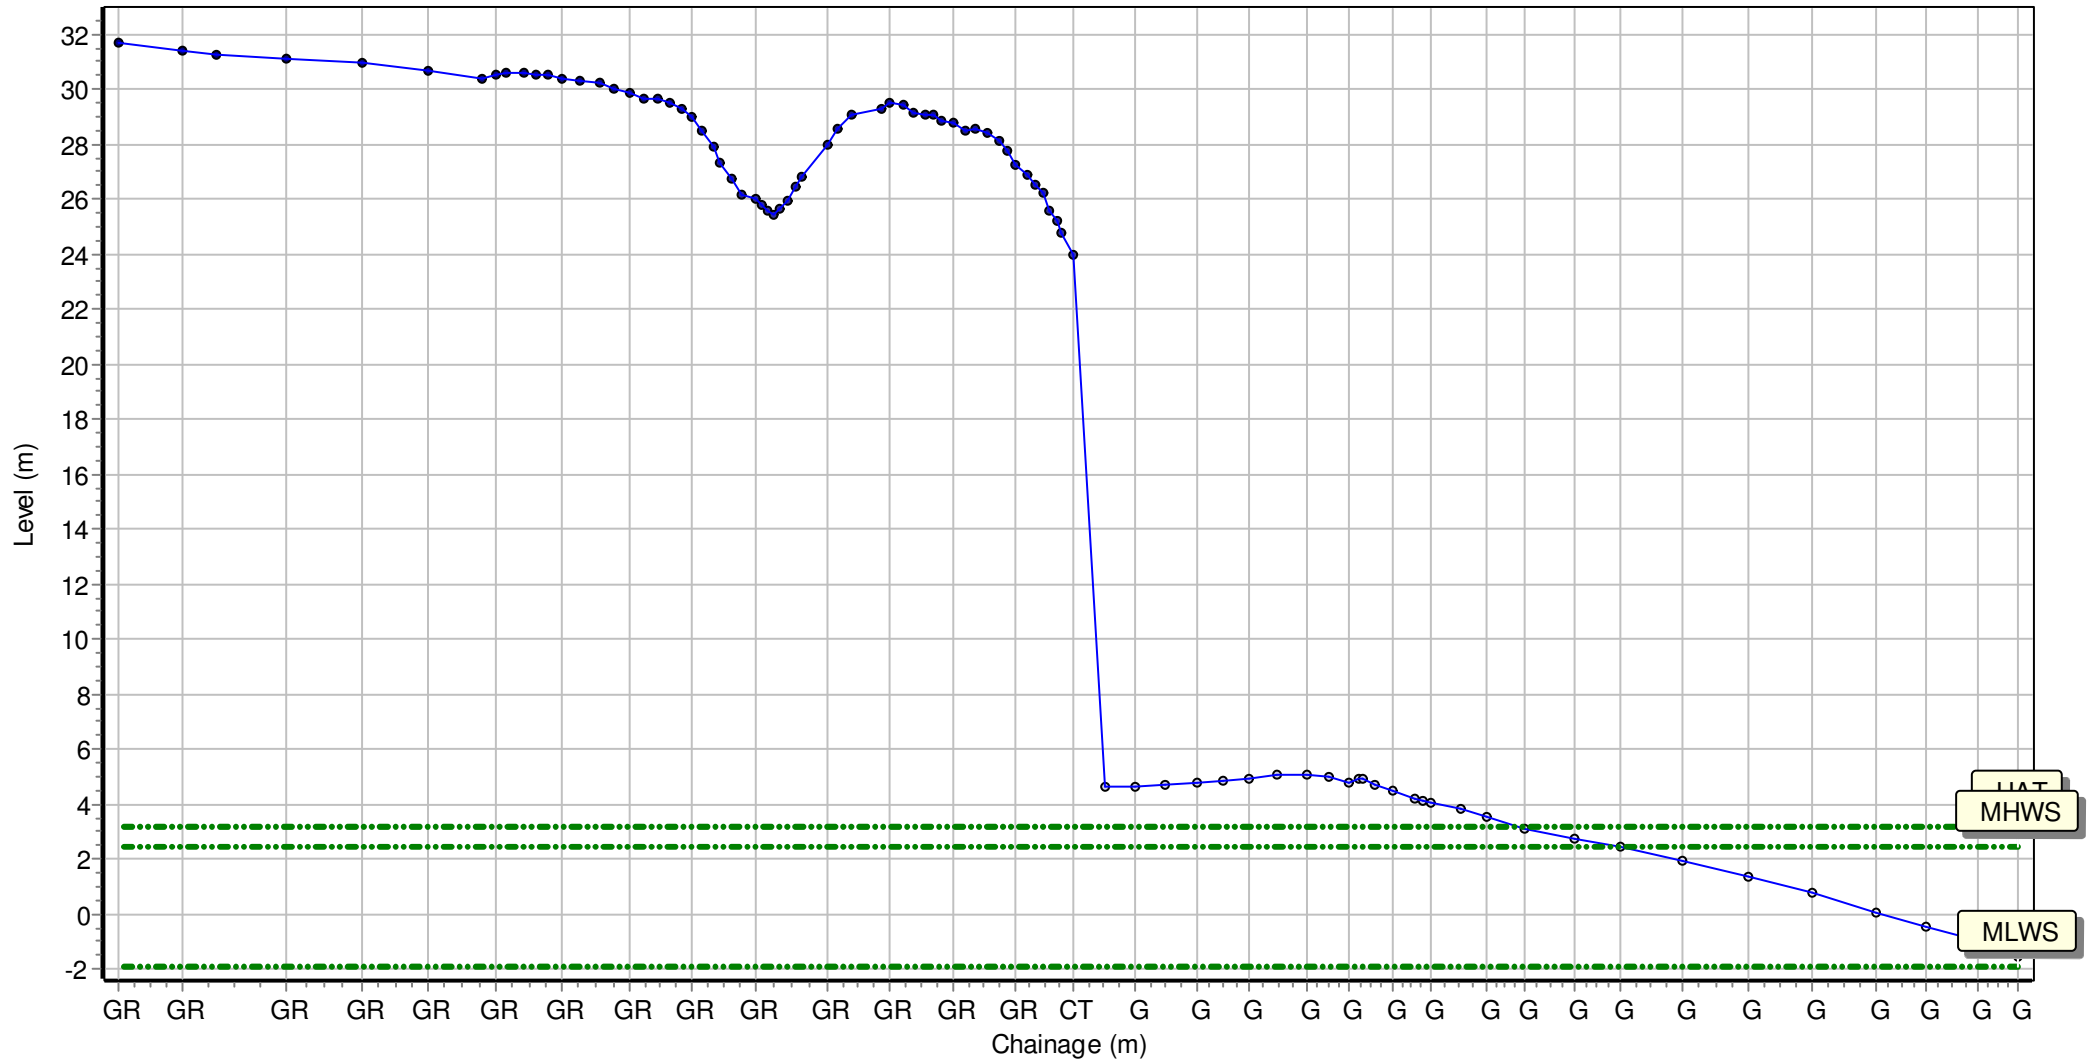
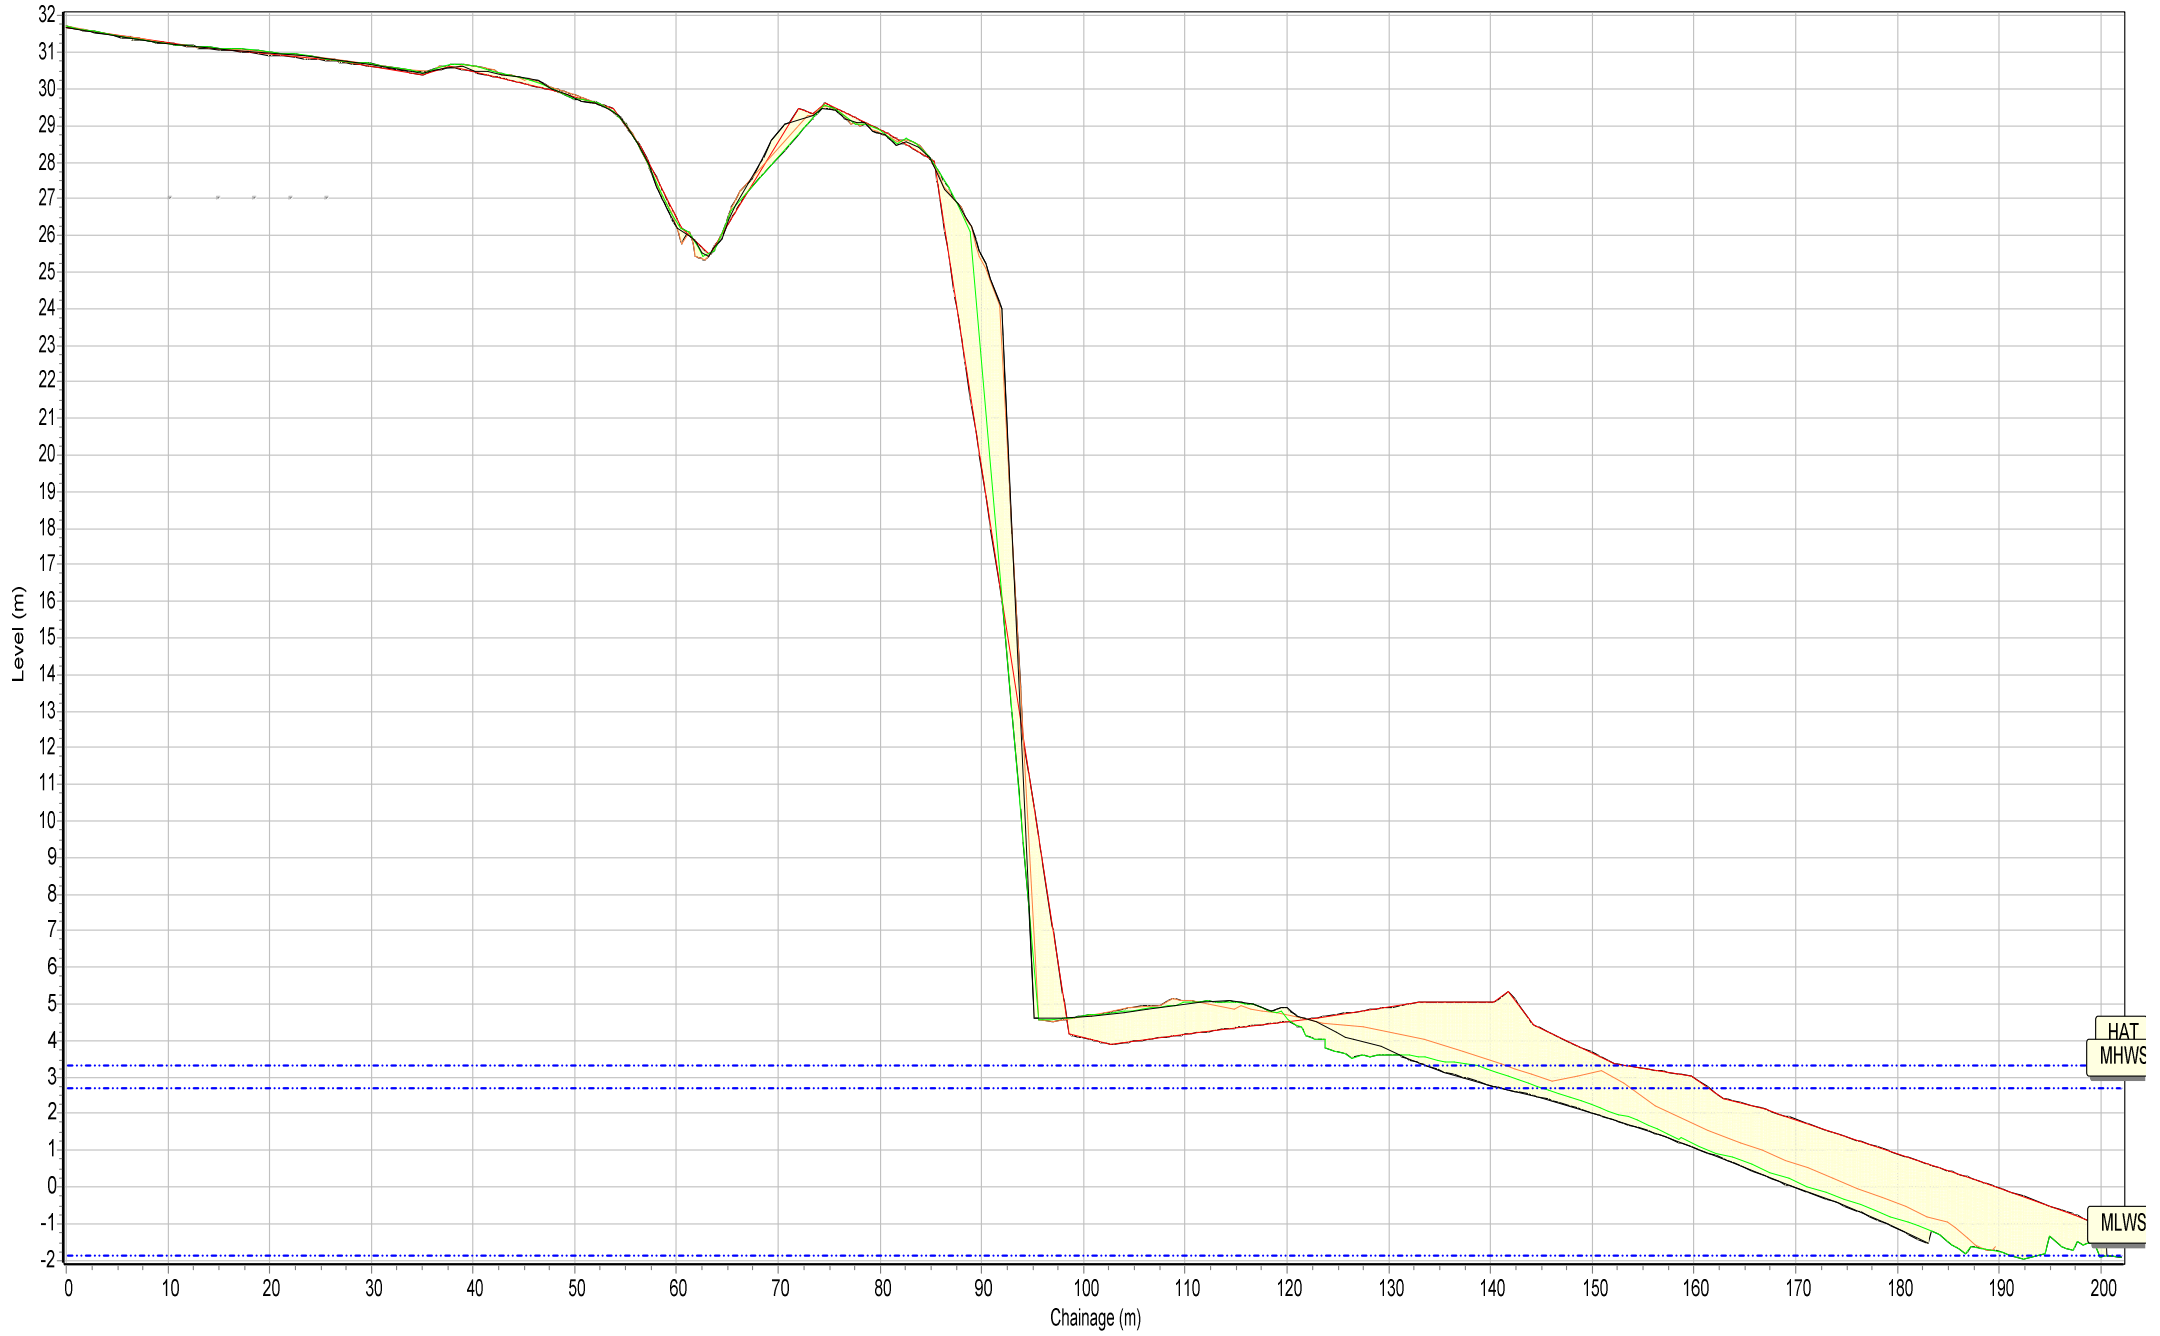
Beach Profiles: 1bSH2

Survey Date	Description of Changes Since Last Survey	Interpretation
	<p>berm present at the top of the beach in the previous survey between chainages 85m and 90m moved seawards by 10m. A small depression has now formed on the landward side of this berm, with approximately 0.4m of erosion from the beach. Between the crest of the berm (at 100m chainage) and 145m the beach gradient has eased slightly since the previous survey with an increase in level of up to 1m. The toe of the beach has advanced from 140m to 145m chainage. From 145m to the end of the survey at 170m chainage the rocks are exposed. Overall, the profile is at a medium level compared to the range recorded from previous surveys.</p> <p>Profile 1bSH2 is largely similar to the previous surveys as far as the current beach crest at 110m chainage. The crest in the beach has shown progressive net erosion since 2009, with the crest retreating by around 30m. The 2018 Full Measures Survey shows that there has been approximately 0.8m of accretion on the beach face around 125m chainage. The beach face from 130m to 190m chainage has eroded by up to 0.5m. The beach profile has a more uniform gradient and the toe appears to have retreated by approximately 2m. At the bottom of the profile at 190m to 200m chainage rocks are exposed on the beach. Overall, the profile is at a medium level compared to the range recorded from previous surveys.</p>

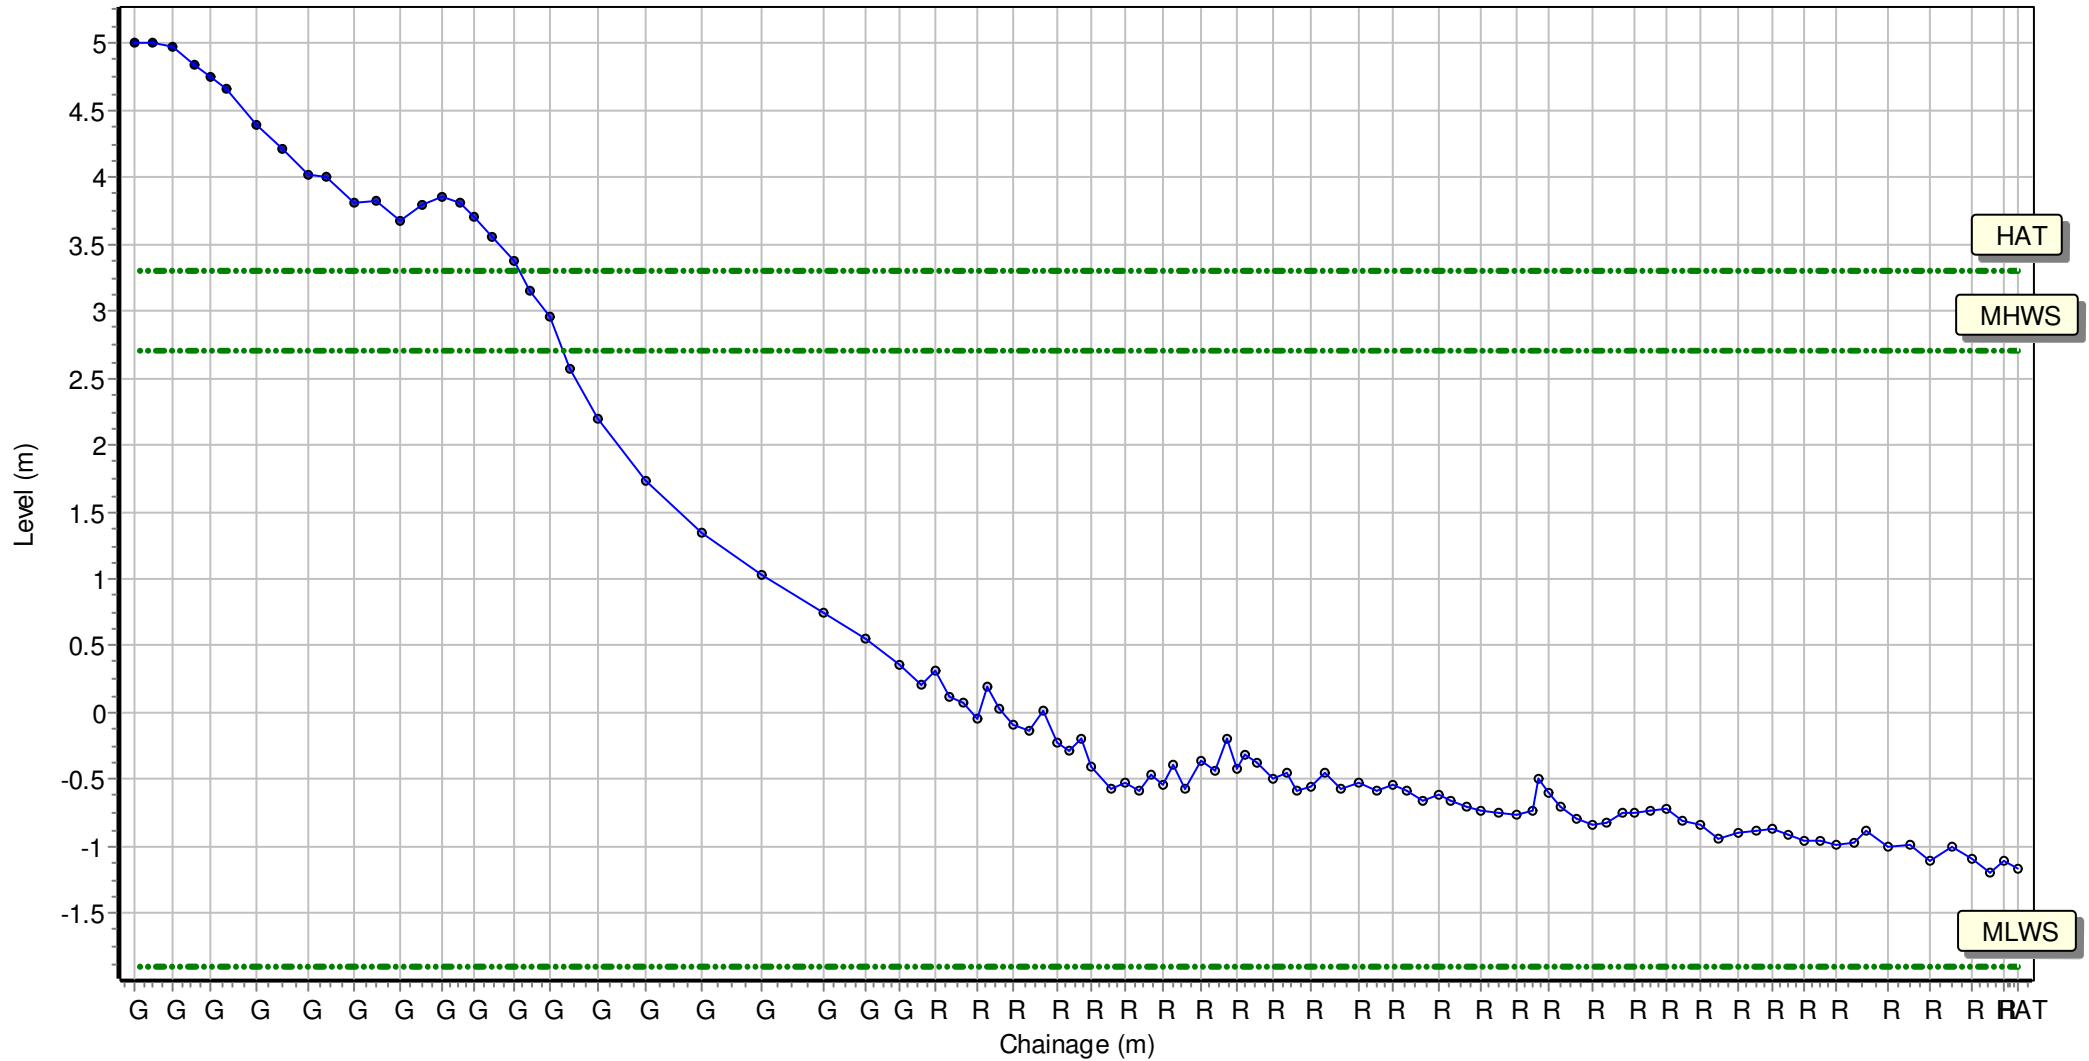
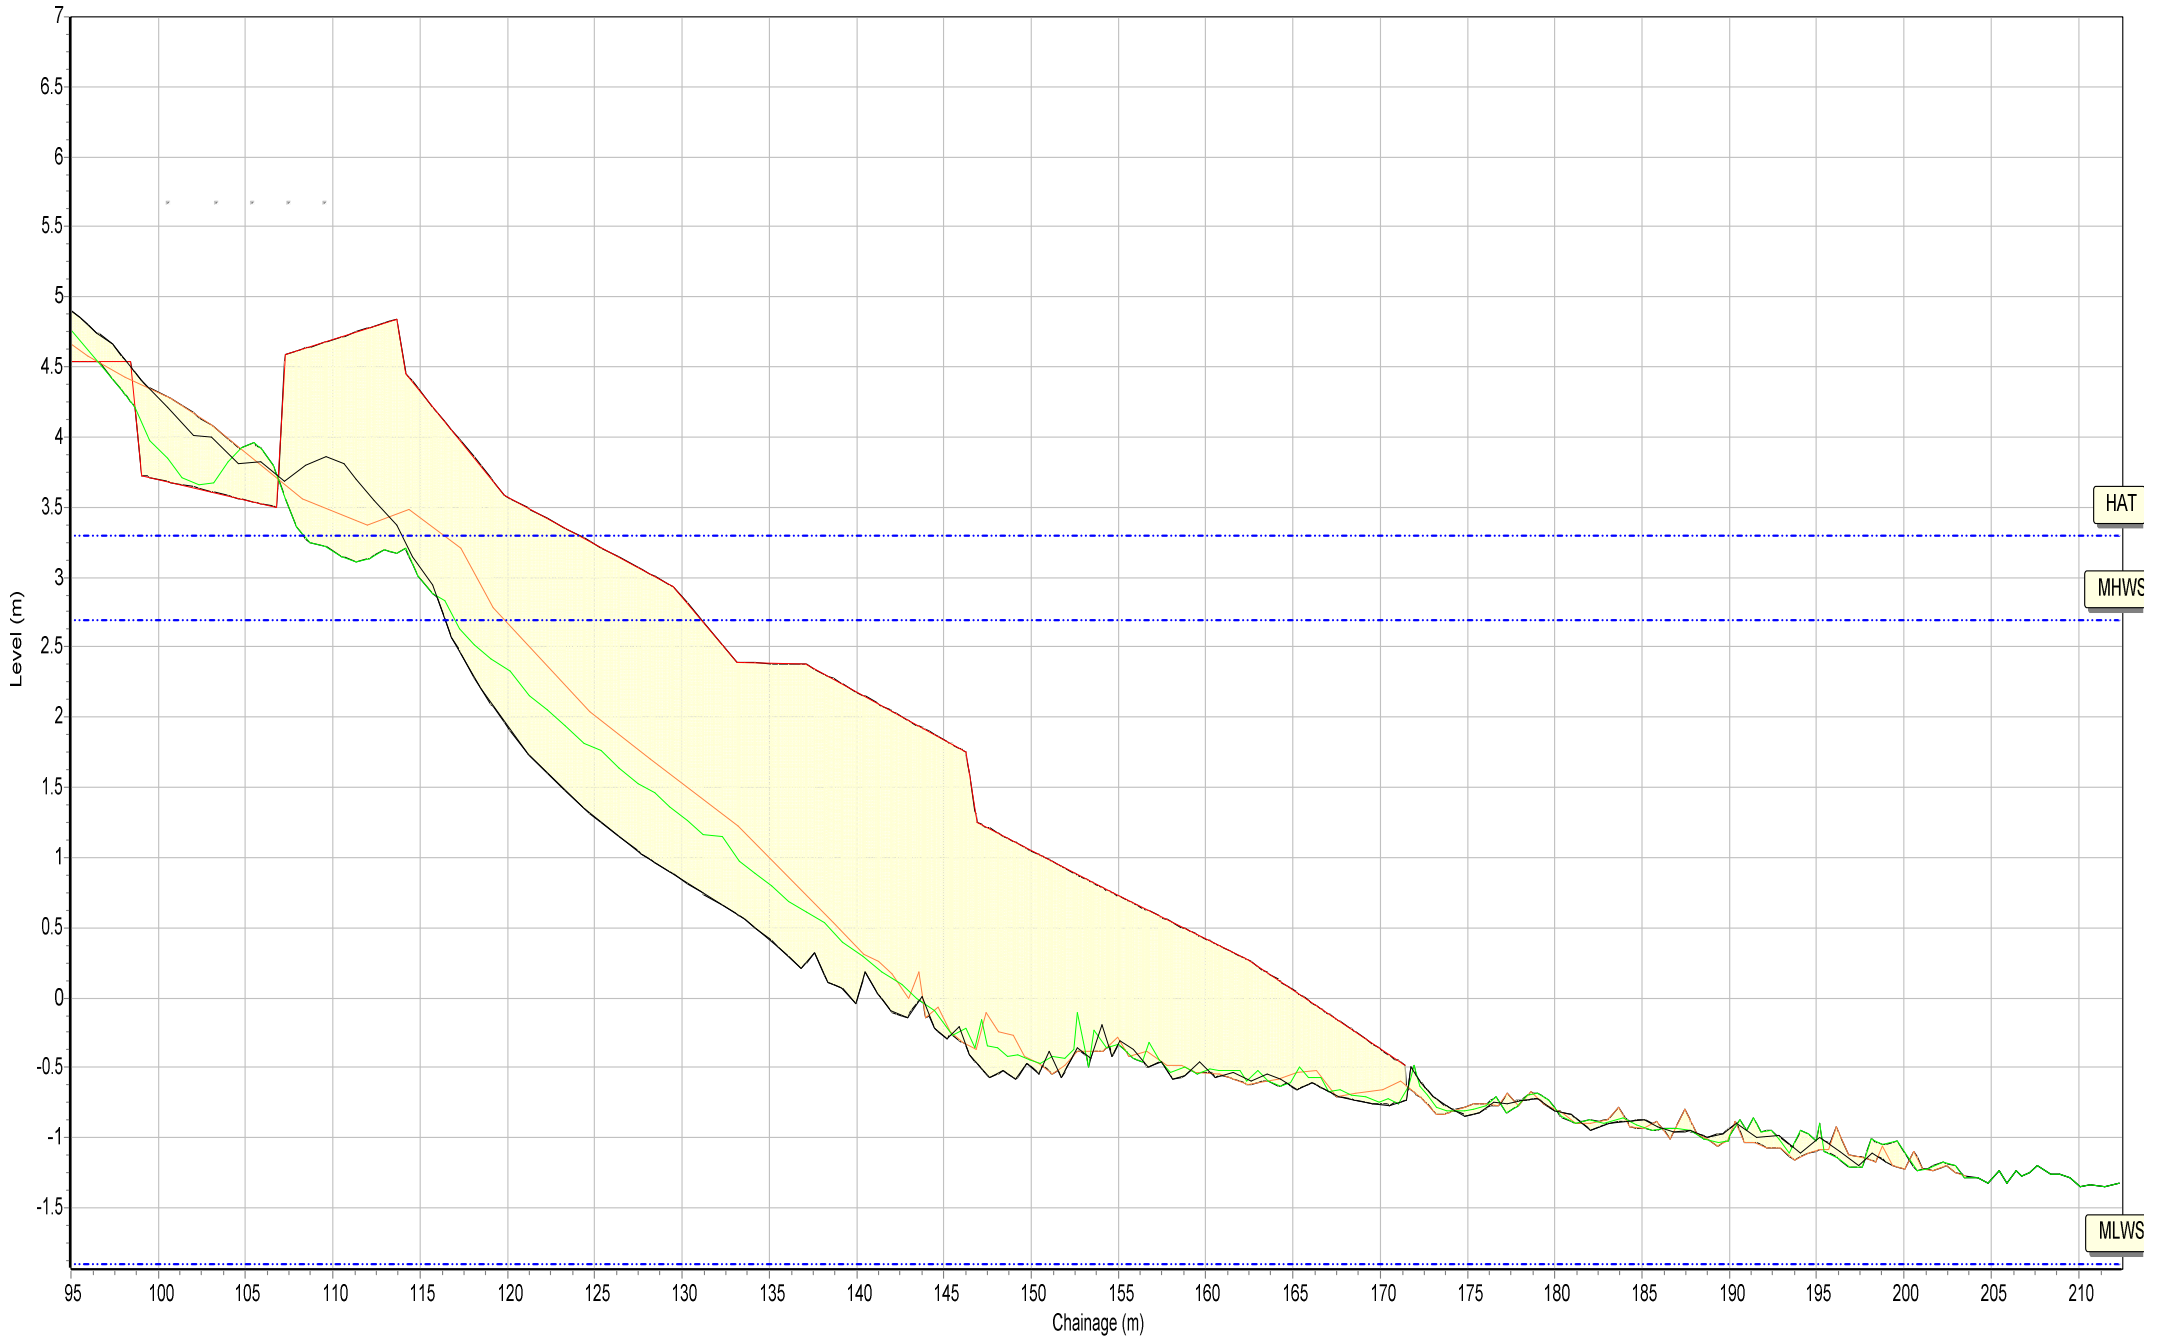
Beach Profiles: 1cEA2

Survey Date	Description of Changes Since Last Survey	Interpretation
5 th December 2018	<p>Beach Profiles:</p> <p>Hawthorne Hive is monitored by beach profile 1cEA2 (Appendix A). The survey report notes “<i>unable to measure start of Section EA2 as the vegetation has choked out the section line and route over cliff faces</i>” and therefore all surveys following October 2012 start at 95m chainage.</p> <p>In previous years there was a channel which crossed the profile; however since April 2013 it has been infilled. The majority of the beach shows an decrease in beach levels of up to 0.5m since the April 2018 survey. The berm at chainage 115m has eroded and the more landward of the two berms at 105m chainage has moved seawards by 5m. It appears that rocks are now exposed from approximately 136m chainage, a retreat of approximately 10m from April 2018. The remainder of the profile between 145m and 220m chainage has the rocks exposed at the bottom of the beach.</p> <p>Overall, the profile is at a medium-high level on the upper beach and a low level on the lower beach compared to the range recorded from previous surveys. For the majority of the profile between 134m and 150m chainage, the beach level is intermittently the lowest on record.</p>	<p>The beach levels in December 2018 are lower than the levels recorded November 2014 and in places as low as the April 2014 levels. Although there has been some healthy accretion on the upper reaches of the beach, the mid and lower sections exhibit some of the lowest levels ever recorded.</p> <p>Longer term trends: The upper beach level has recovered since the lows of 2014. However there has been a significant loss of material from the lower reaches meaning the beach lies at its lowest recorded level in this location. Limited cliff erosion occurs in this section and therefore sediment supply is limited to erosion of colliery spoil. Storm events which may block the channel and varying flows in Hawthorne Burn are likely to continue to episodically block the channel and change its course across the beach.</p>

At Hawthorne Hive the surveyor was unable to measure the start of Section 1cEA2 as the vegetation has choked out the section line and route over cliff faces.

- At Hawthorne Hive the levels on the foreshore have recovered since April and November 2014 and are continuing to increase, they are now in the middle of the range of recorded beach levels. However, it is likely that the long-term trend of progressive erosion will continue on this profile.
