**Cell 1 Regional Coastal Monitoring Programme
Analytical Report 11: 'Full Measures' Survey 2018**

Durham County Council

January 2019

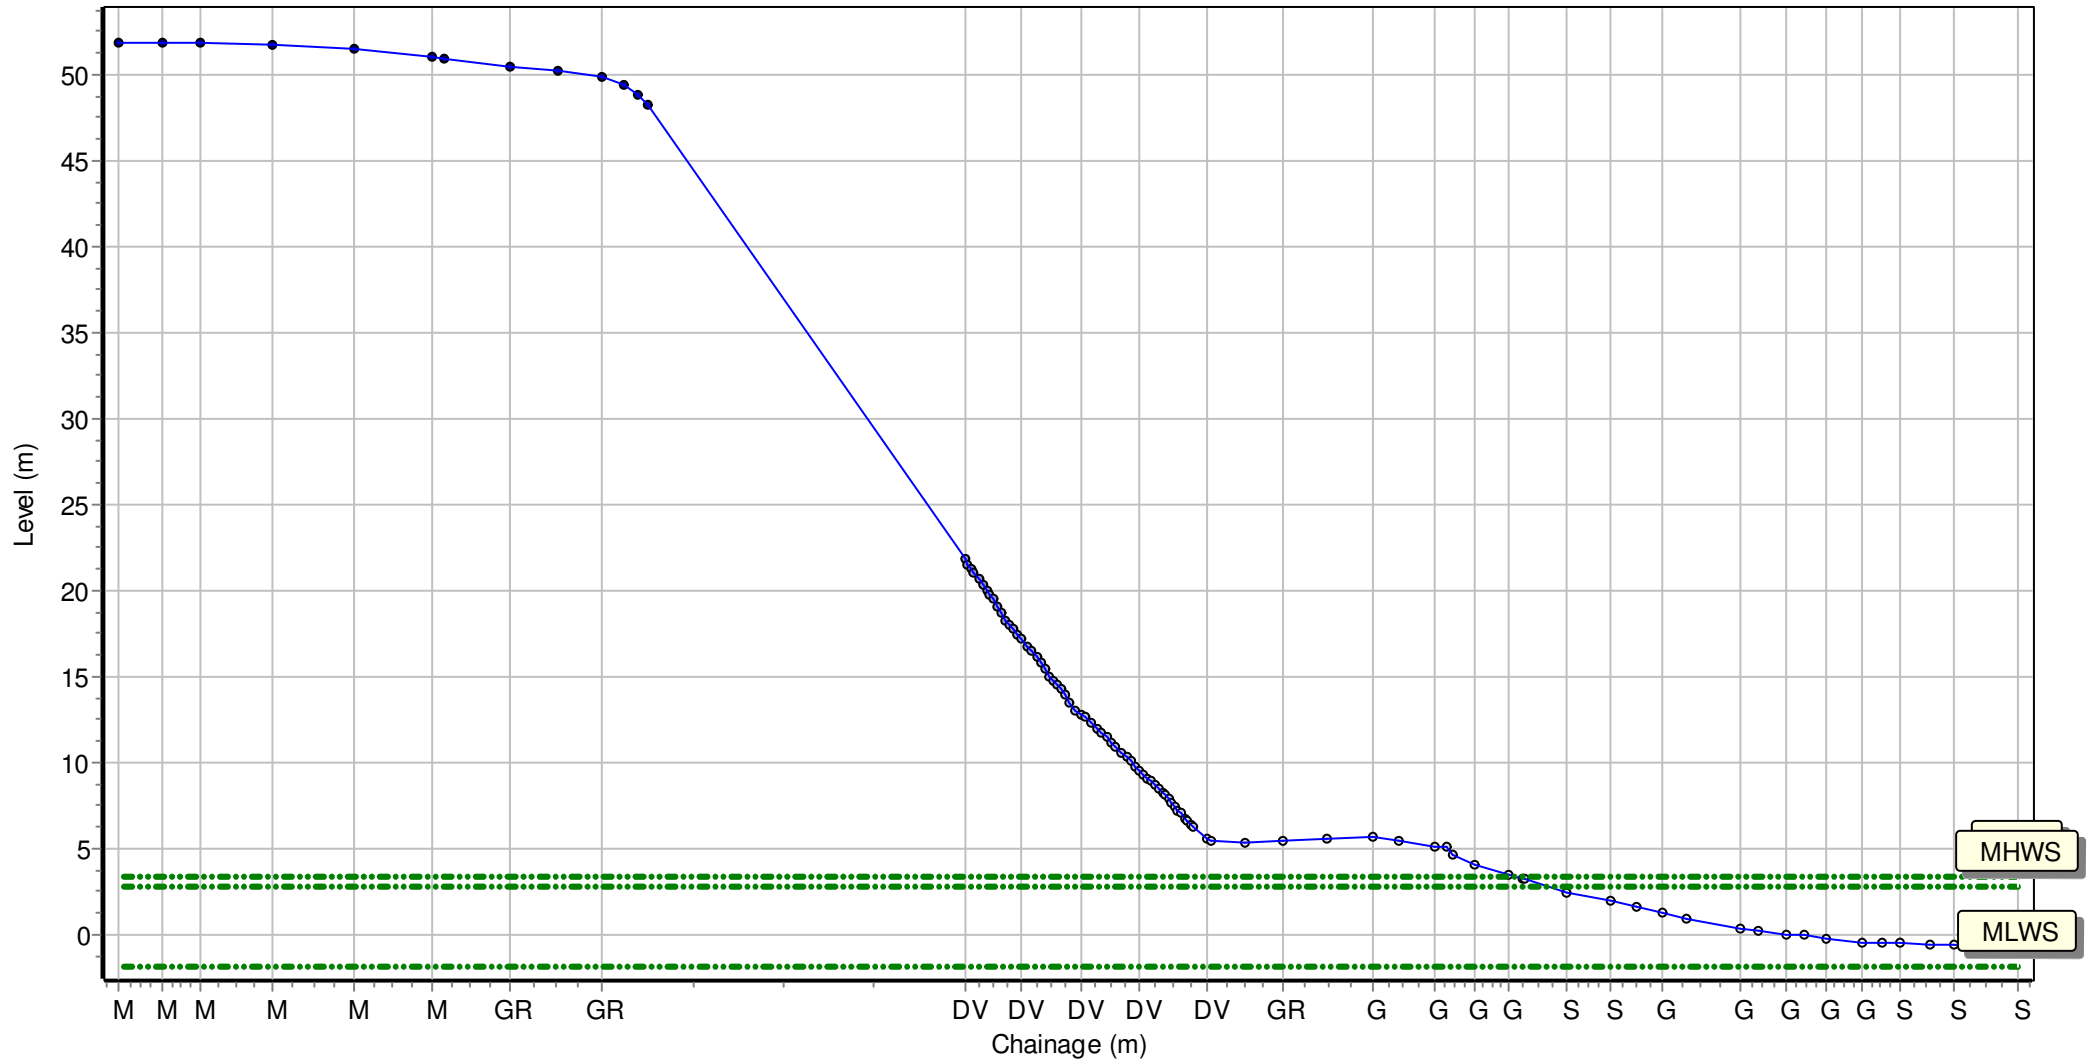
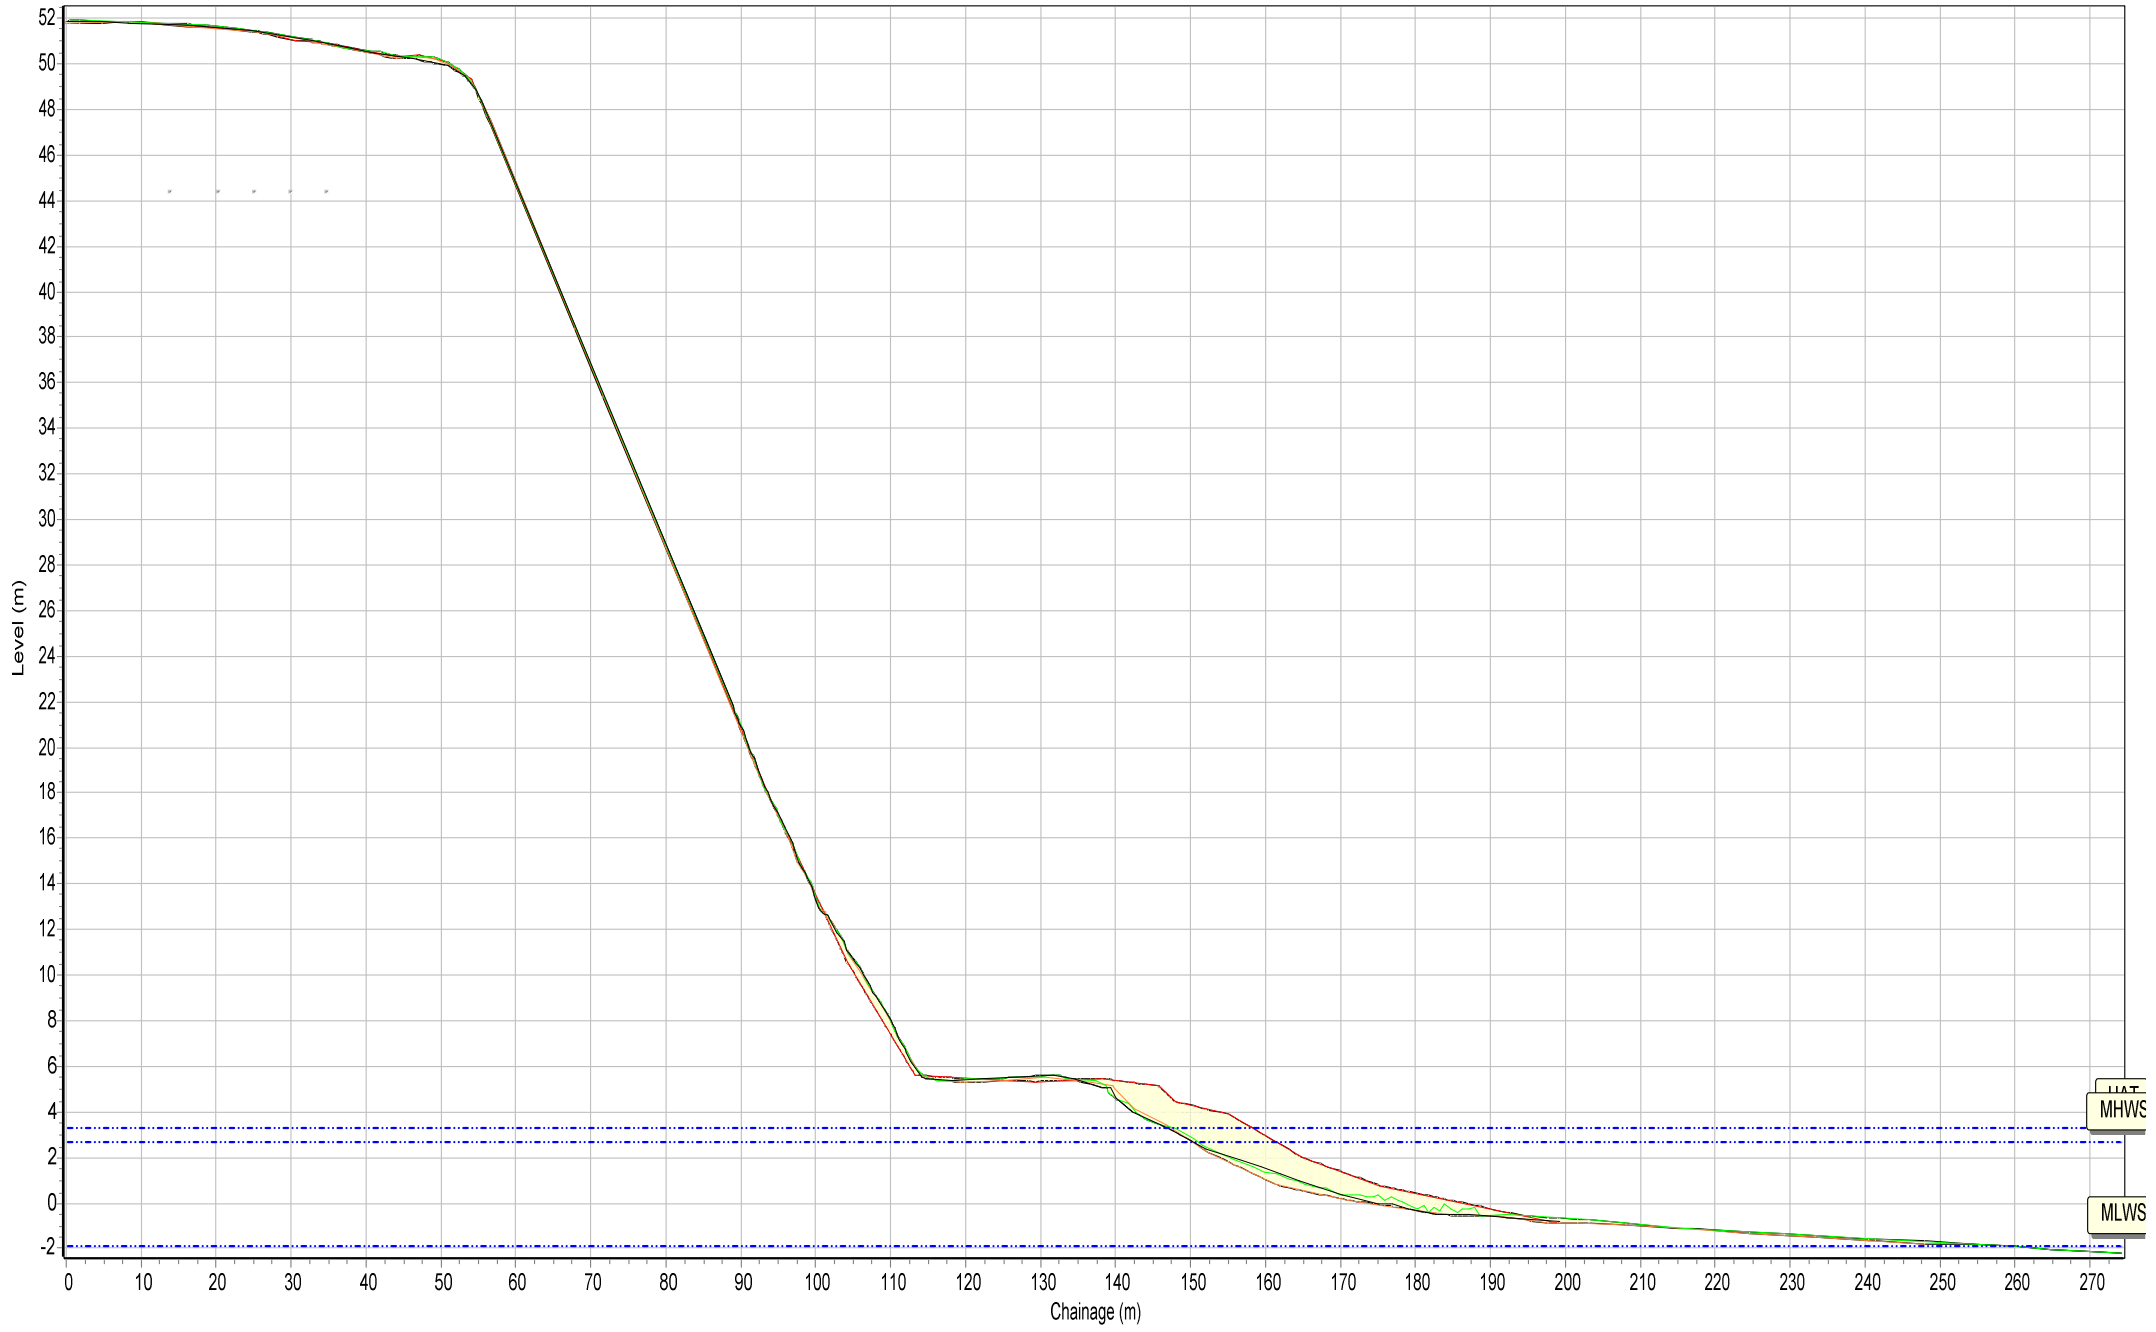
Beach Profiles: 1cBH1

Survey Date	Description of Changes Since Last Survey	Interpretation
<p>14th October 2018</p>	<p>Beach Profiles:</p> <p>Blackhall Colliery is covered by three beach profile lines (Appendix A). As at Blast Beach, profiles are dominated by colliery spoil and exhibit similar forms with a rock cliff, wide spoil beach with a distinct cliff at the eroding face of the colliery spoil, and a gravel and sand foreshore that extends to MLW.</p> <p>1cBH1 is located near Horden Point and suggests that there has been minor loss of material across the face of the colliery spoil of up to around 0.4m at 137m chainage. The rest of the beach has exhibited a slumping with a loss of around 0.2m in the upper – mid reaches, and an approximately equal accretion in the lower-mid reach. The eroding face at 140m chainage has moved seaward by approximately a metre. The overall gradient of the beach has become shallower. From 168m to 200m chainage the cobble beach has reduced in level by up to 0.5m. Overall, the profile is at a low level compared to the range recorded due to the continued regression of the spoil face.</p> <p>Profile 1cBH2 exhibits no change in the cliff profile. The cliffed-edge of the spoil beach has retreated by approximately 3m since September 2017. There is around 37m of material from the eroding face at the back of the beach to the cliff toe. From 162m the beach gradient has remained the same, however the beach levels have dropped by up to 0.6m across the rest of the profile. The beach profile is at its lowest recorded level from chainage 162m to the end of the survey extent at chainage 220m .</p> <p>The profile 1cBH3 shows that since 2008 there has been episodic migration, infilling and scouring of the outflow of Castle Eden Burn, which crosses the profile. There has been significant recession since September 2017, approximately 5m, of the landward bank of the channel, which is now only around 8m from the base of the cliffs. The channel has increased in width. From the edge of the channel at 145m to 185m chainage there is a mound where the upper beach berm is. The top of the mound has moved landward by approximately 5m and decreased in height by 0.2m. From 180m to 230m there has been very little change, <0.1m since September 2017. From chainage 230m the gradient of the toe of the beach has increased in gradient, with erosion of up to 0.2m. Overall, the profile is at a low level compared to the range recorded from previous surveys because of the progressive recession of this beach and the landward migration of the Burn channel.</p>	<p>Profile 1cBH1 shows a continued retreat of the spoil face with the beach profile now appearing shallower than in previous surveys.</p> <p>1cBH3 shows continued migration of the Castle Eden Burn channel and the beach face is dominated by erosion. Profile 1cBH2 is also dominated by erosion, though to a less significant extent.</p> <p>There has been very little change to the gradients of the profiles.</p> <p>Longer term trends: The surveys show that the spoil beach along much of the Blackhall Colliery shore is progressively eroding but continues to protect the cliffs in the short term. The spoil face has now moved landward by between 10m and 30m (since 2008), and now lies seaward of the cliff toe by approximately 8m to 40m.</p>

At Blackhall the surveyor was unable to access part of sections 1cBH1 and 1cBH2 due to dense vegetation.

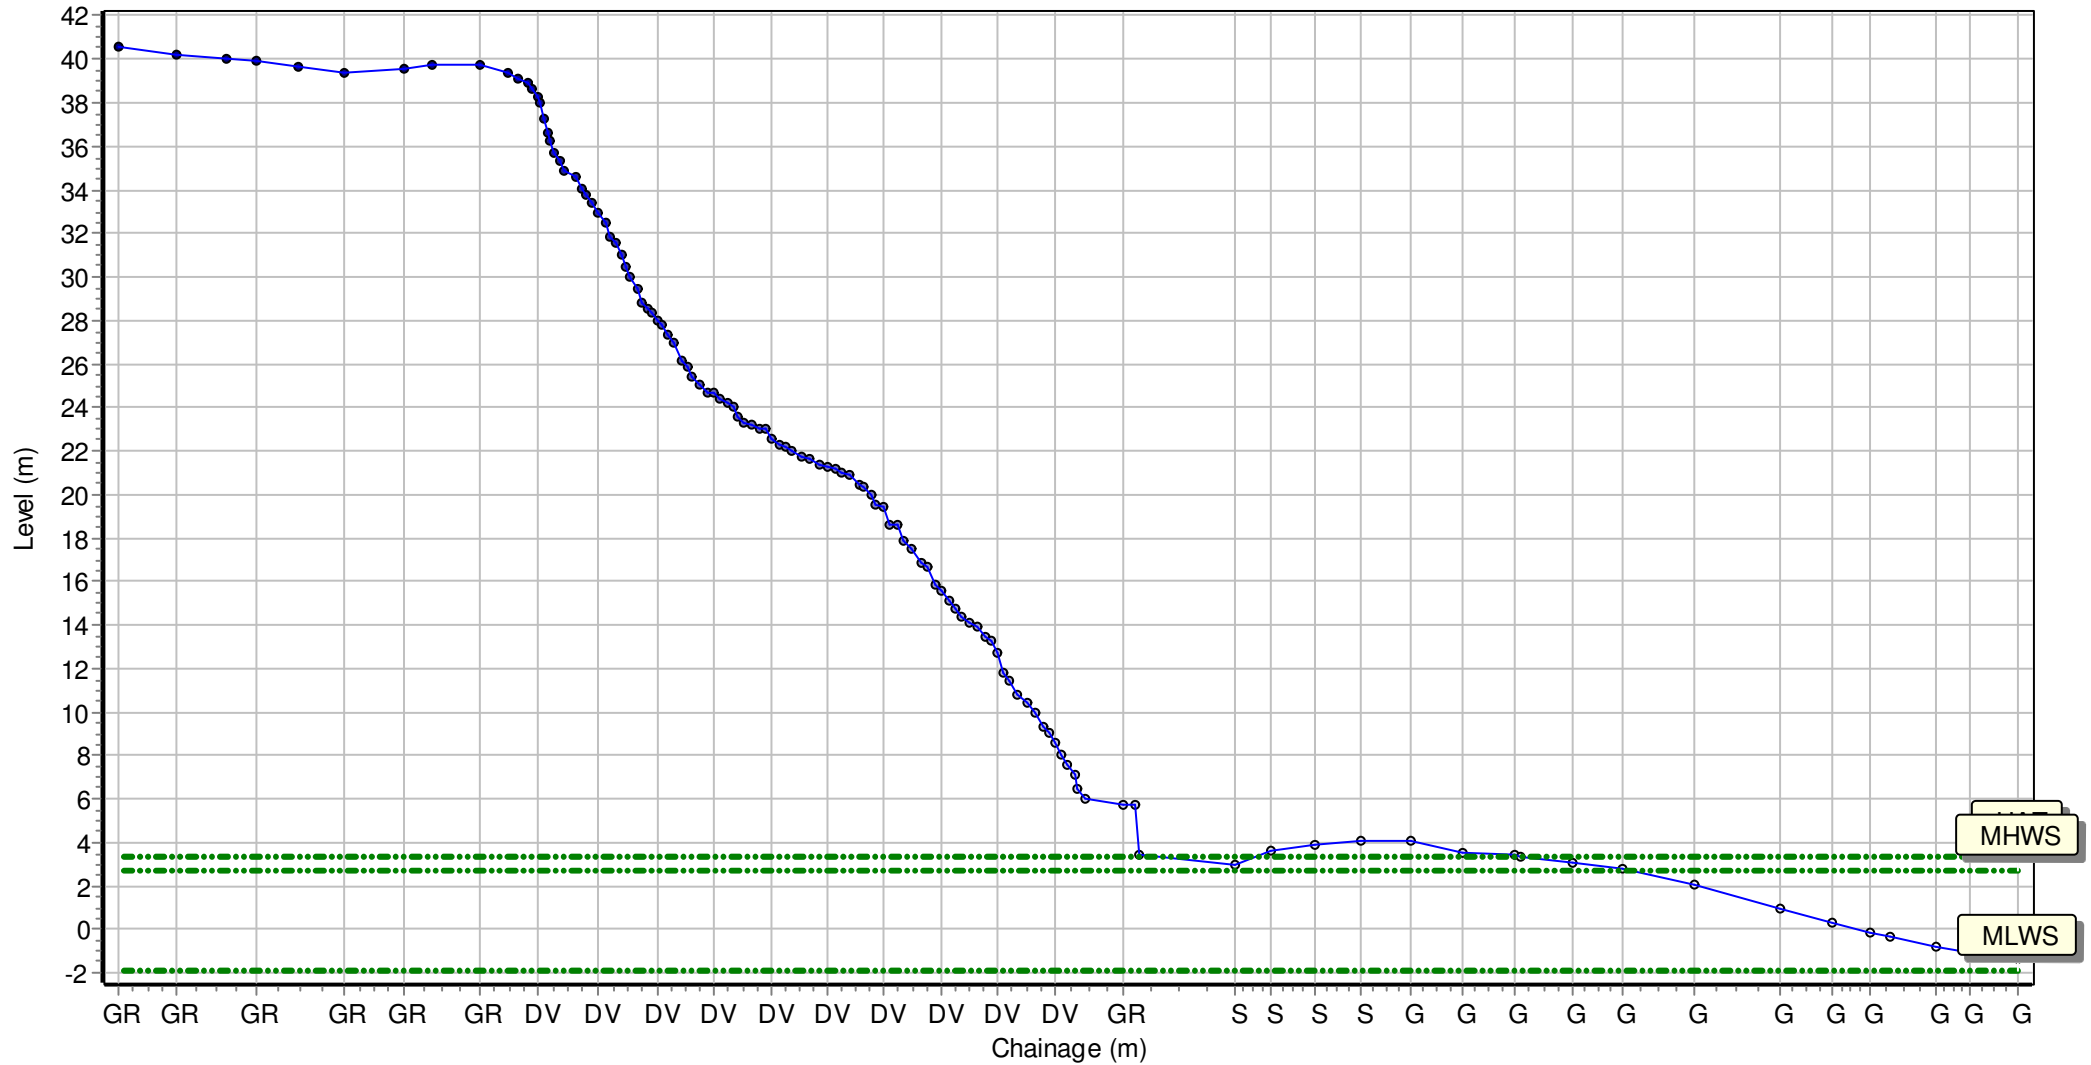
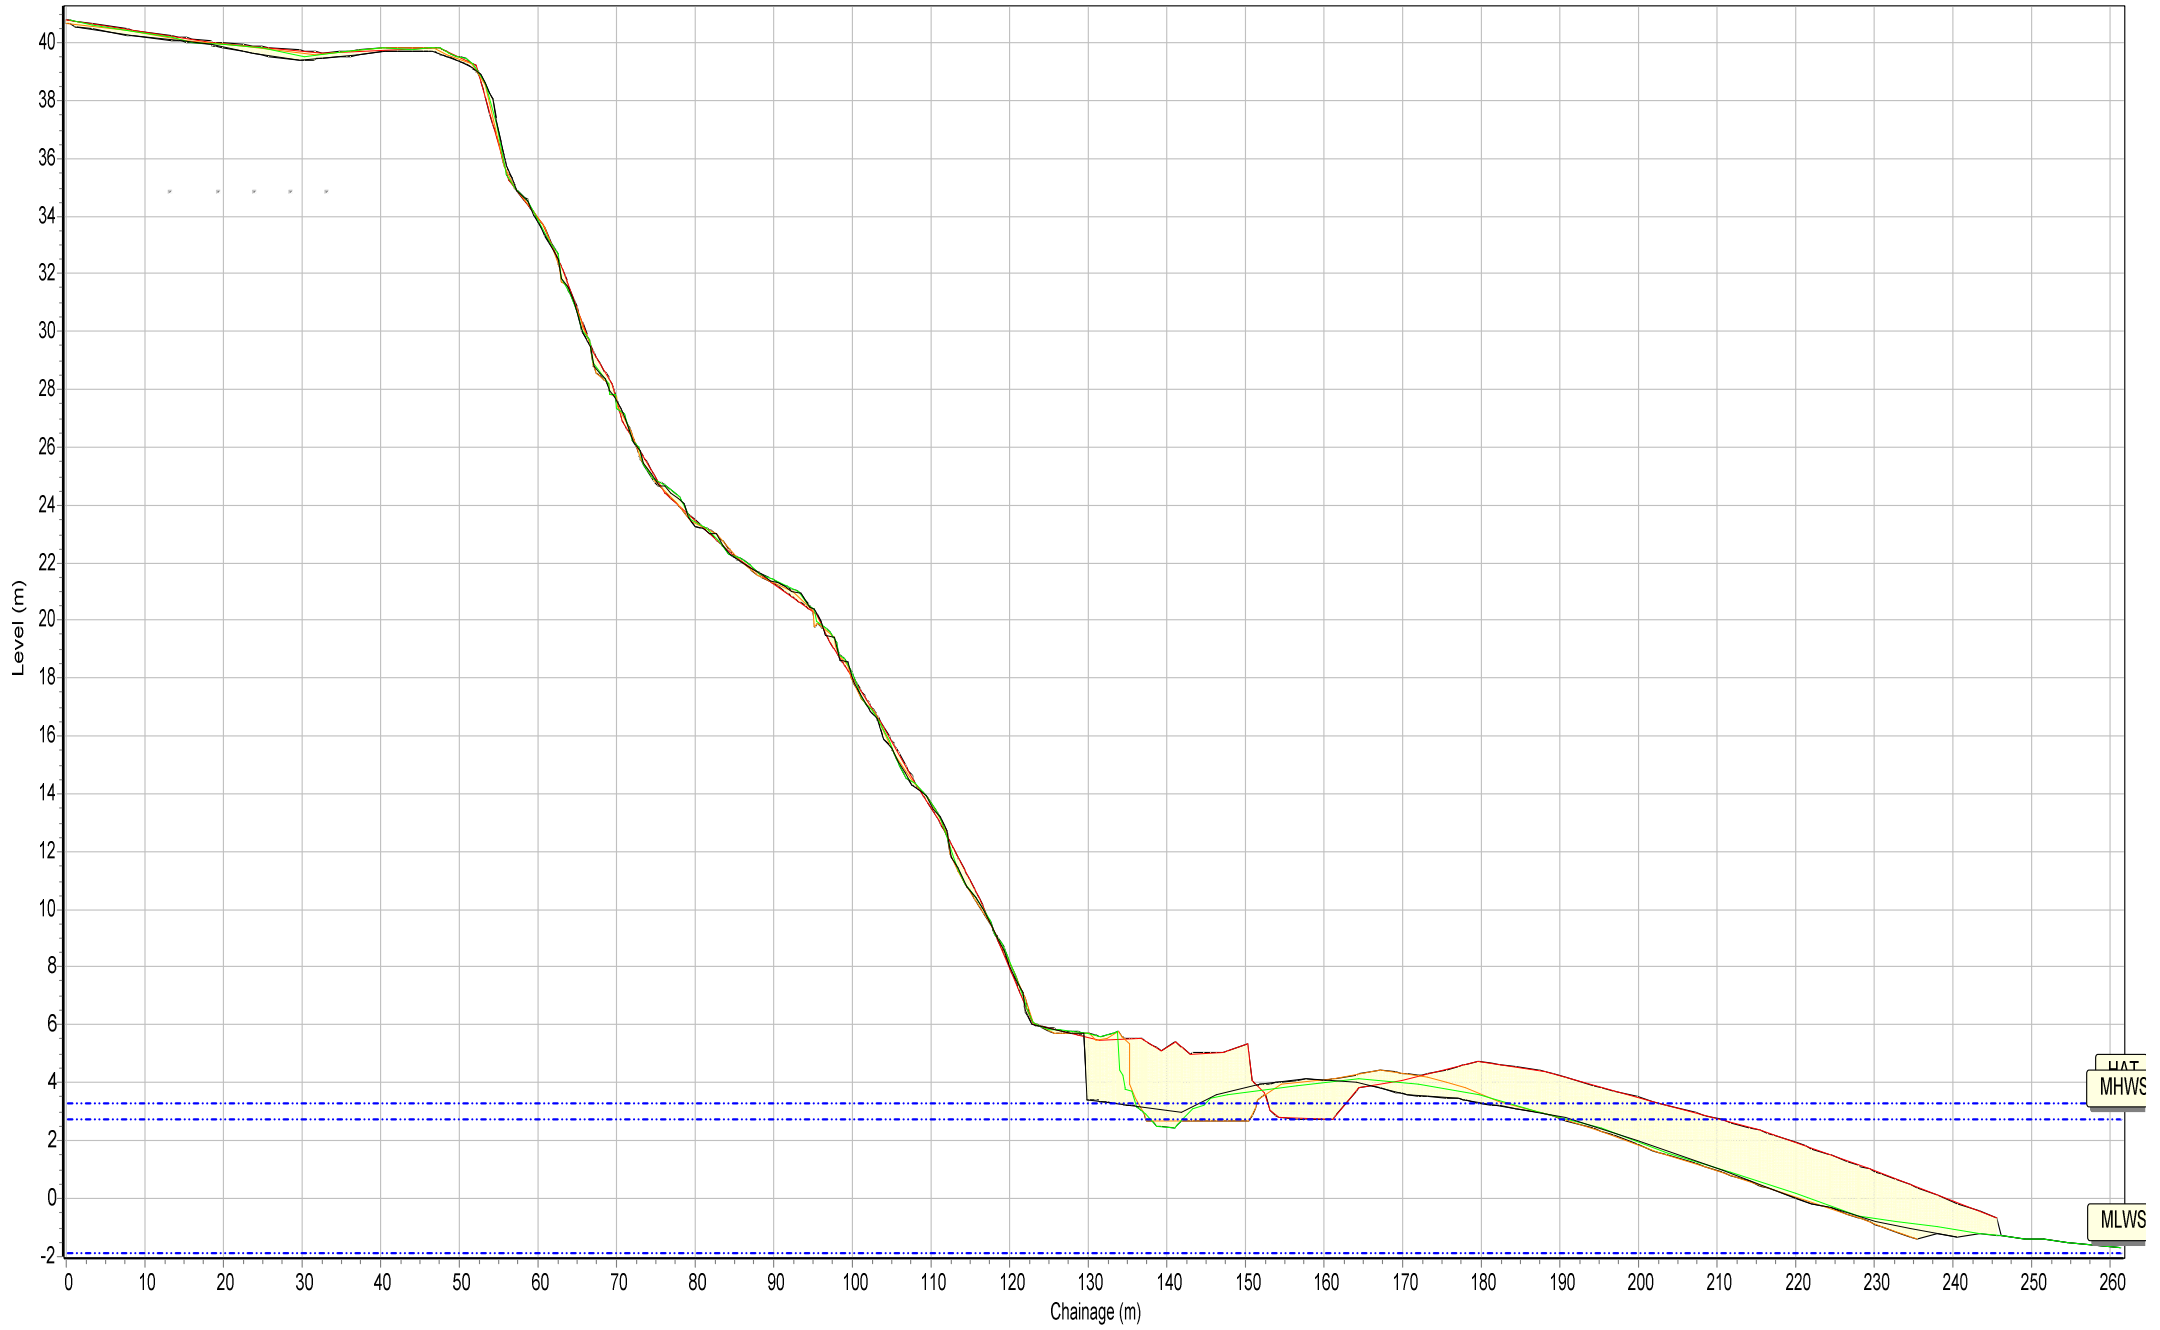
Beach Profiles: 1cBH3

- At Blackhall Colliery, the seaward face of the colliery spoil deposit continues to erode in the northern part of the bay. In the south of the bay, mound of beach material continues to erode and the channel has been moving landward. The channel is likely to scour the beach sediments under high flows, but become infilled again by wave action under storm conditions.

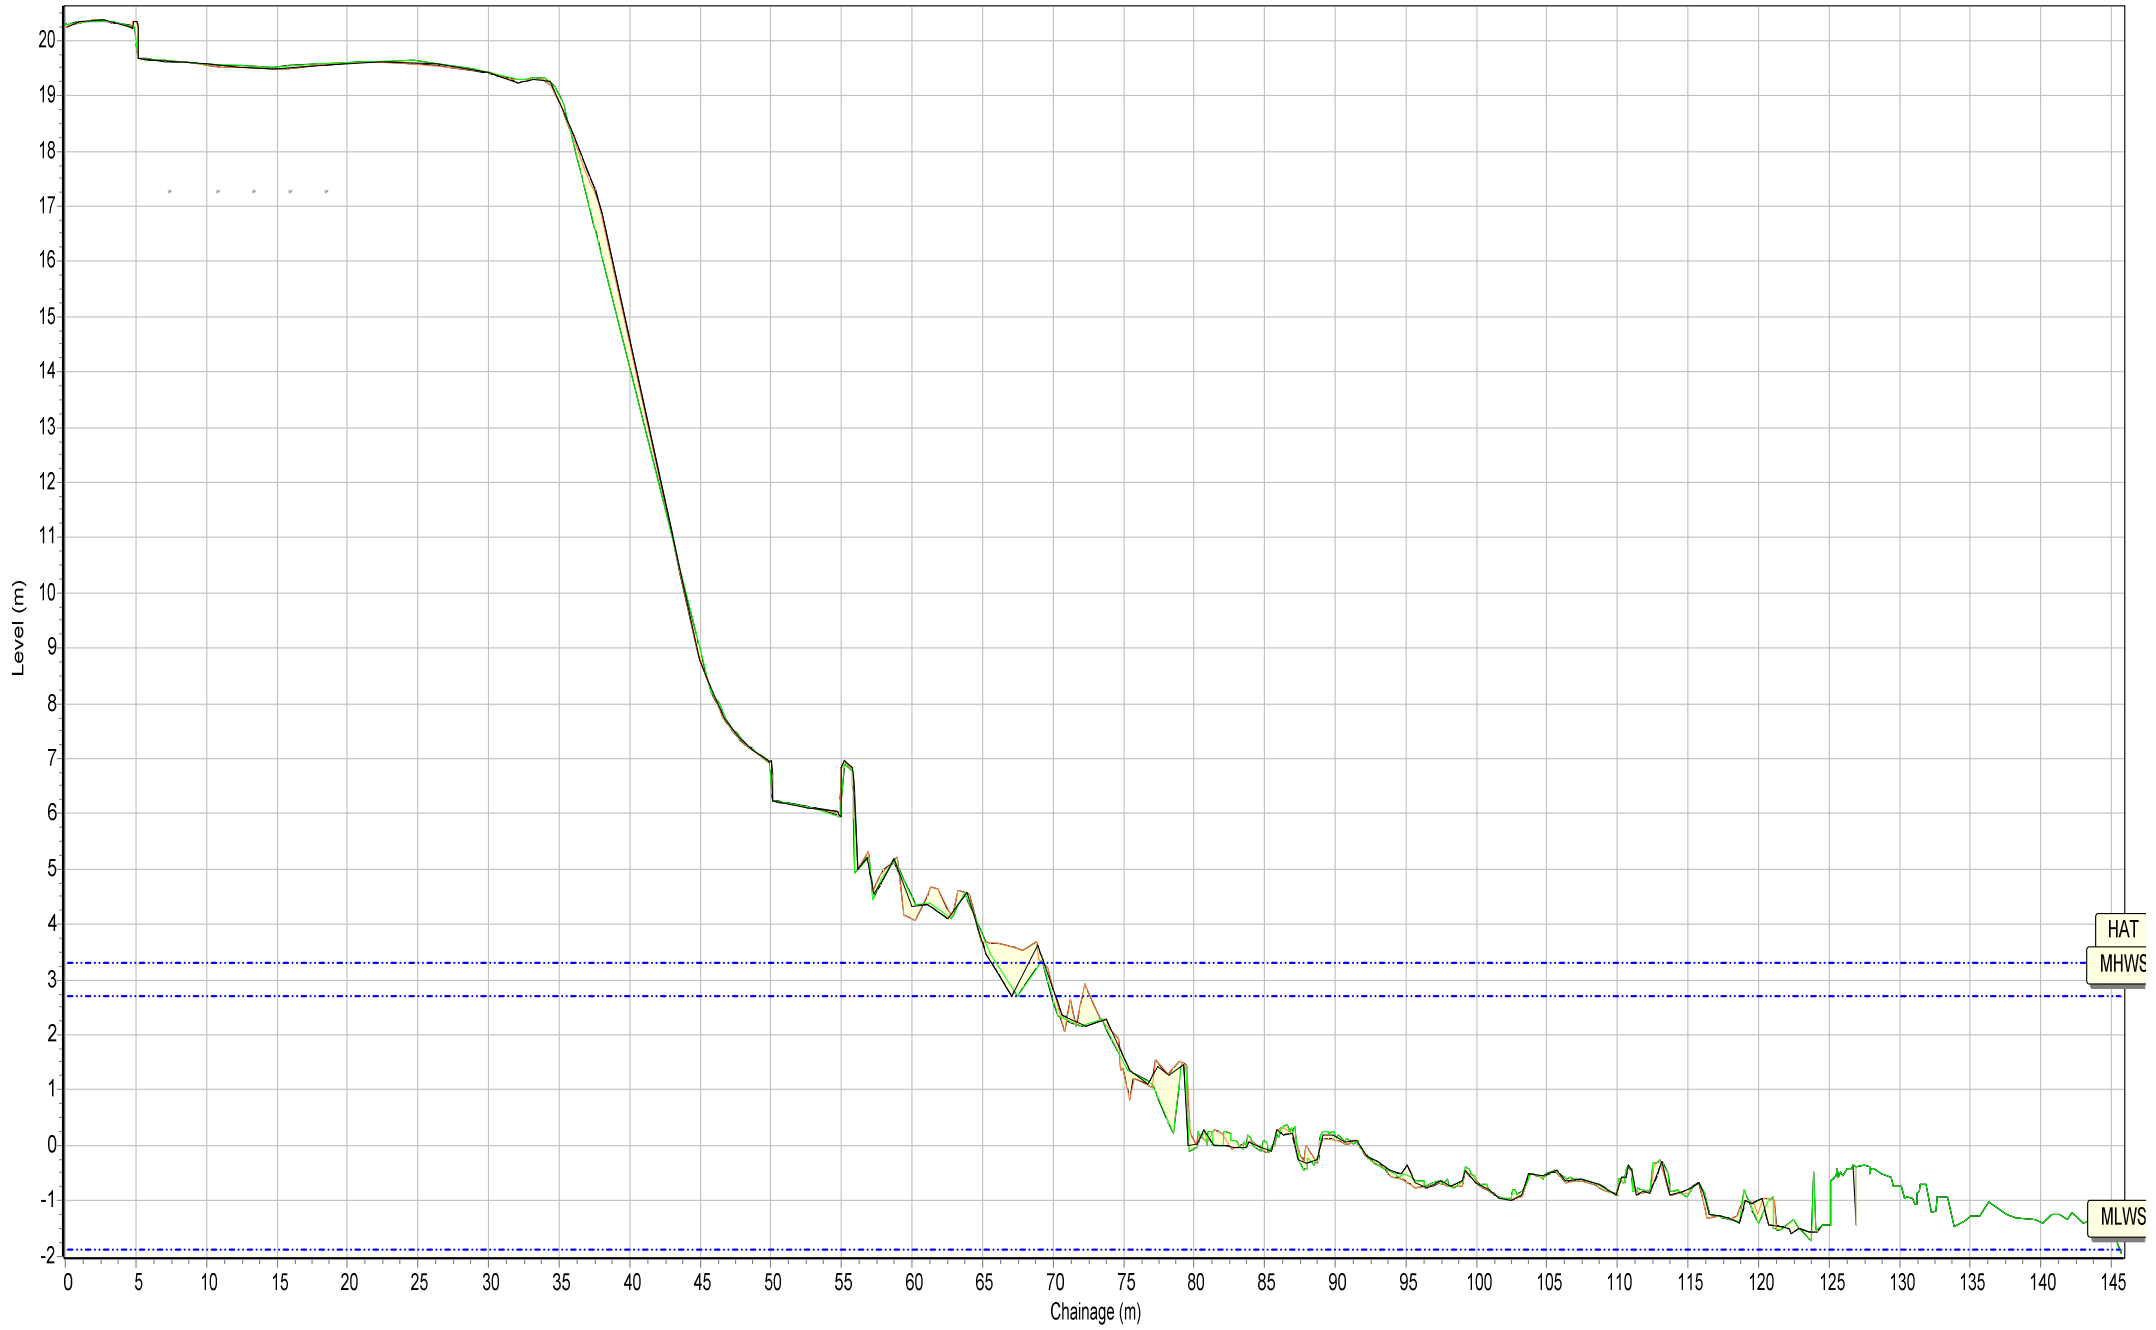
Beach Profiles: 1bEA1

Survey Date	Description of Changes Since Last Survey	Interpretation
5 th December 2018	<p>Beach Profiles:</p> <p>One beach profile line 1bEA1, located at Featherbed Rocks (Appendix A), has been monitored since March 2009. The profile extends across the cliff top and cliff face then extends across the promenade (chainage 55), rock armour sea defence (chainage 55 to 80) and beach. At the base of the sea wall rock armour extends as far as 80m chainage. Beyond 80m there has been little change over the summer of 2018, the beach profiles reflect the rocky nature of the foreshore and that there is no beach over the shore platform. Previous surveys have shown accumulations of material at the base of the revetment but this has not been present since the 2012 Full Measures survey.</p>	<p>The rocky nature of this foreshore means it is unlikely to undergo significant changes in morphology unless sediment is deposited upon it. A veneer beach has previously been present here but has not been recorded since the 2012 Full Measures survey.</p> <p>Longer term trends: Between 2010 and 2012 a thin veneer beach was present. Since 2013 the profiles recorded have all been low exposing the rocky shore platform along much of its length.</p>

- At Featherbed Rocks the rocky shore platform continues to be exposed and the veneer beach present in earlier surveys has been absent since autumn 2012.
