**Cell 1 Regional Coastal Monitoring Programme
Analytical Report 12: 'Full Measures' Survey 2019**

(*) The present report is **Analytical Report 12** and provides an analysis of the 2019 Full Measures survey for County Durham Council's frontage.

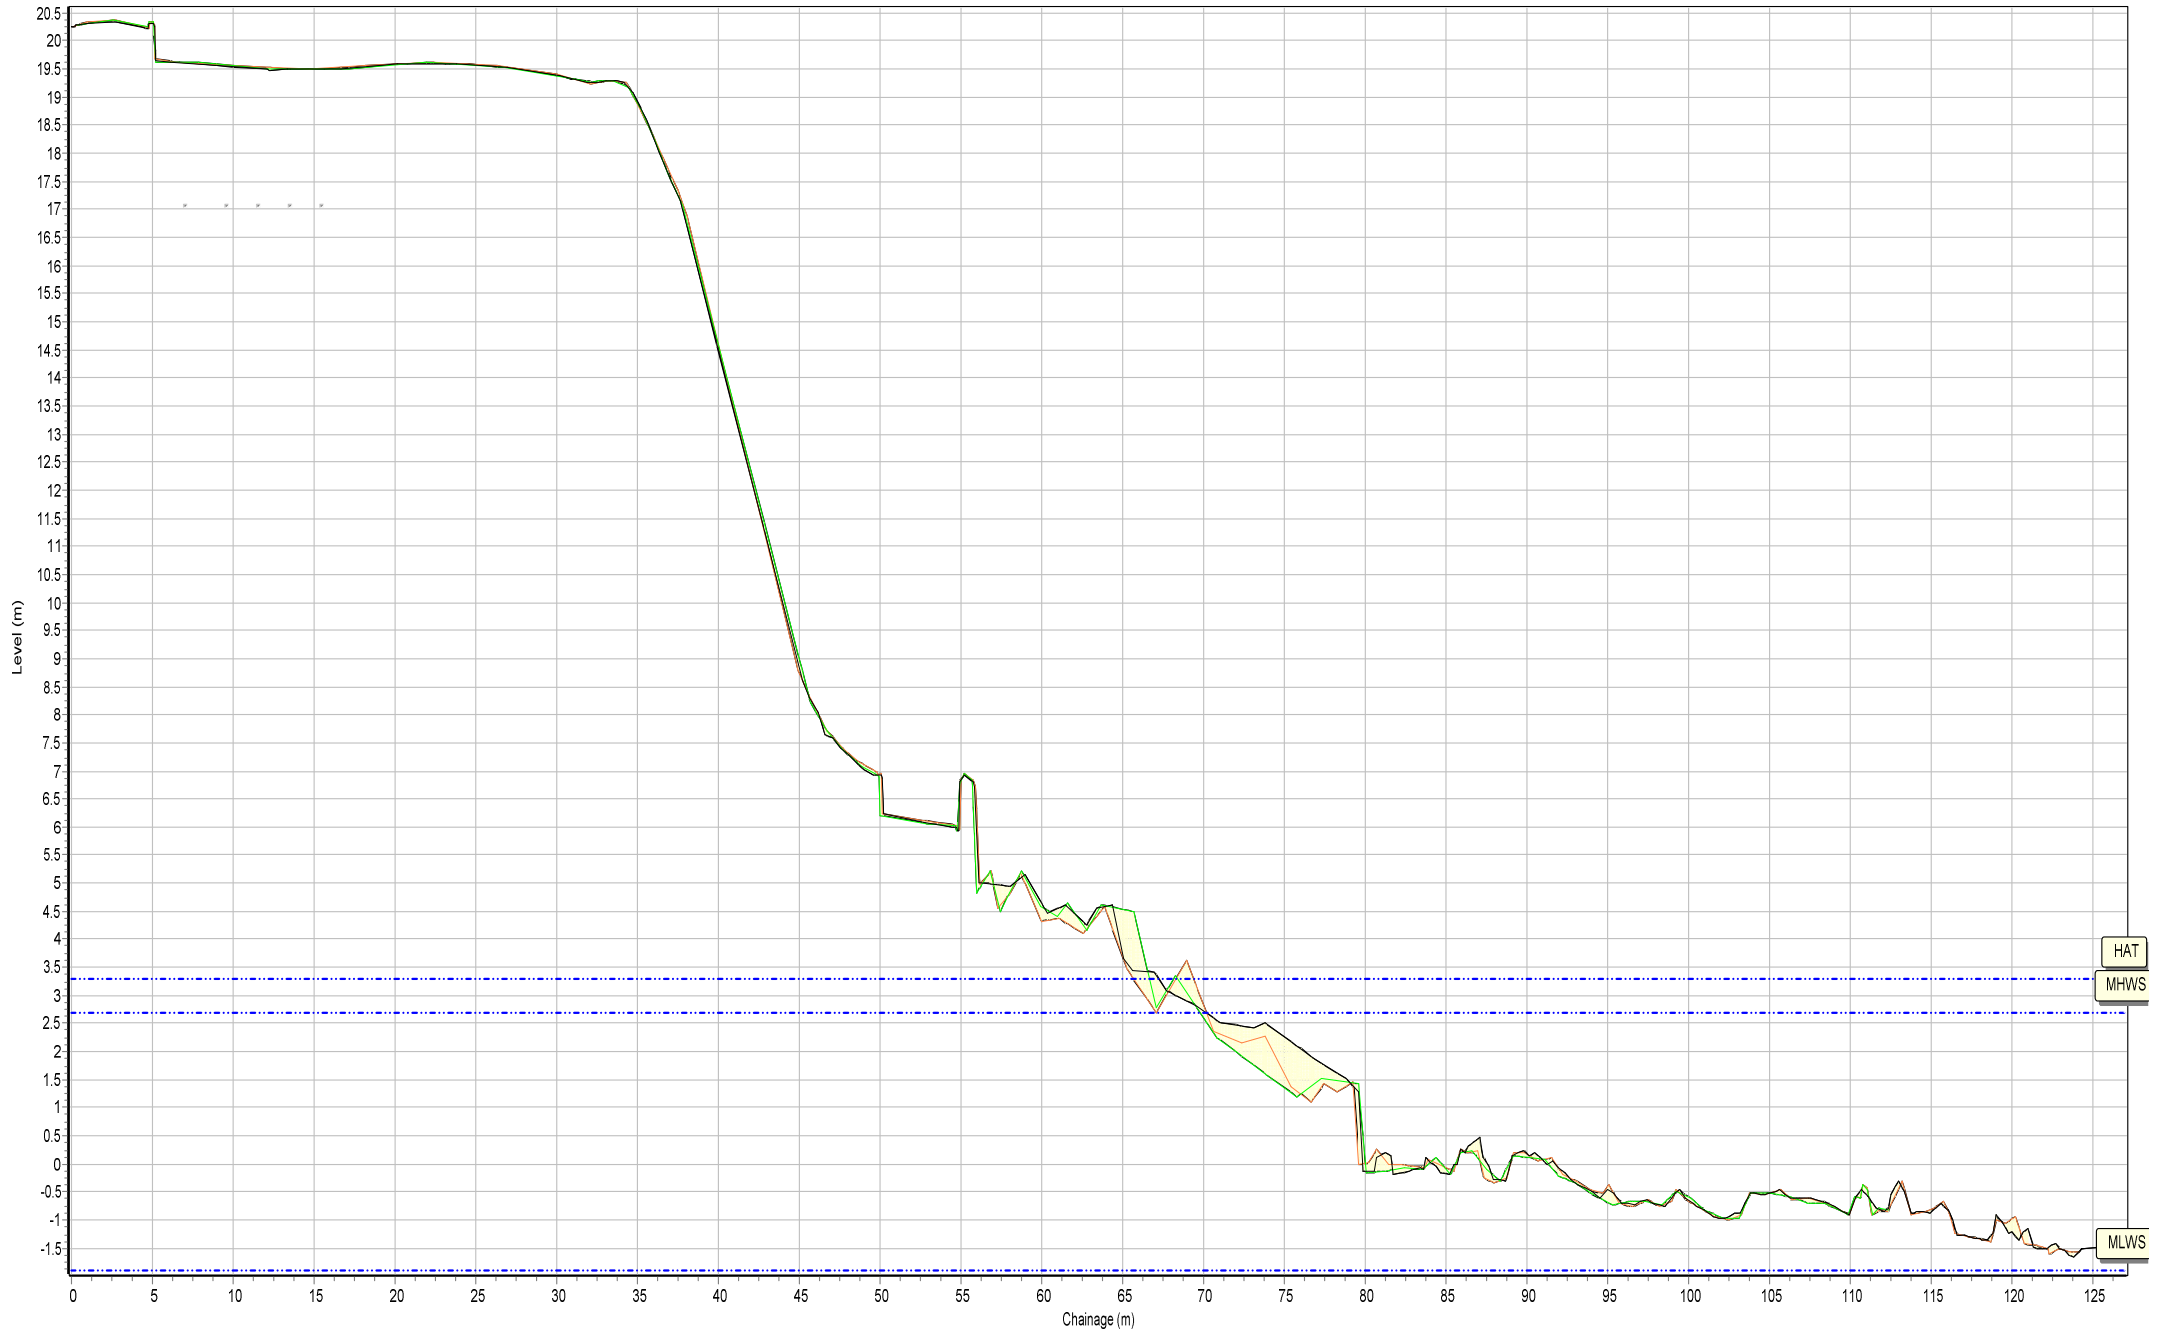
Beach Profiles: 1bEA1

Survey Date	Description of Changes Since Last Survey	Interpretation
14 th October 2019	<p>Beach Profiles:</p> <p>One beach profile line 1bEA1, located at Featherbed Rocks (Appendix A), has been monitored since April 2009. The profile extends across the cliff top and cliff face then extends across the promenade (chainage 55), rock armour sea defence (chainage 55 to 80) and beach. At the base of the sea wall rock armour extends as far as 80m chainage. Beyond 80m there has been little change over the summer of 2019, the beach profiles reflect the rocky nature of the foreshore and that there is no beach over the shore platform. Previous surveys have shown accumulations of material at the base of the revetment but this has not been present since the 2012 Full Measures survey.</p>	<p>The rocky nature of this foreshore means it is unlikely to undergo significant changes in morphology unless sediment is deposited upon it. A veneer beach has previously been present here but has not been recorded since the 2012 Full Measures survey.</p> <p>Longer term trends: Between 2010 and 2012 a thin veneer beach was present. Since 2013 the profiles recorded have all been low exposing the rocky shore platform along much of its length.</p>

- At Featherbed Rocks the rocky shore platform continues to be exposed and the veneer beach present in earlier surveys has been absent since autumn 2012.

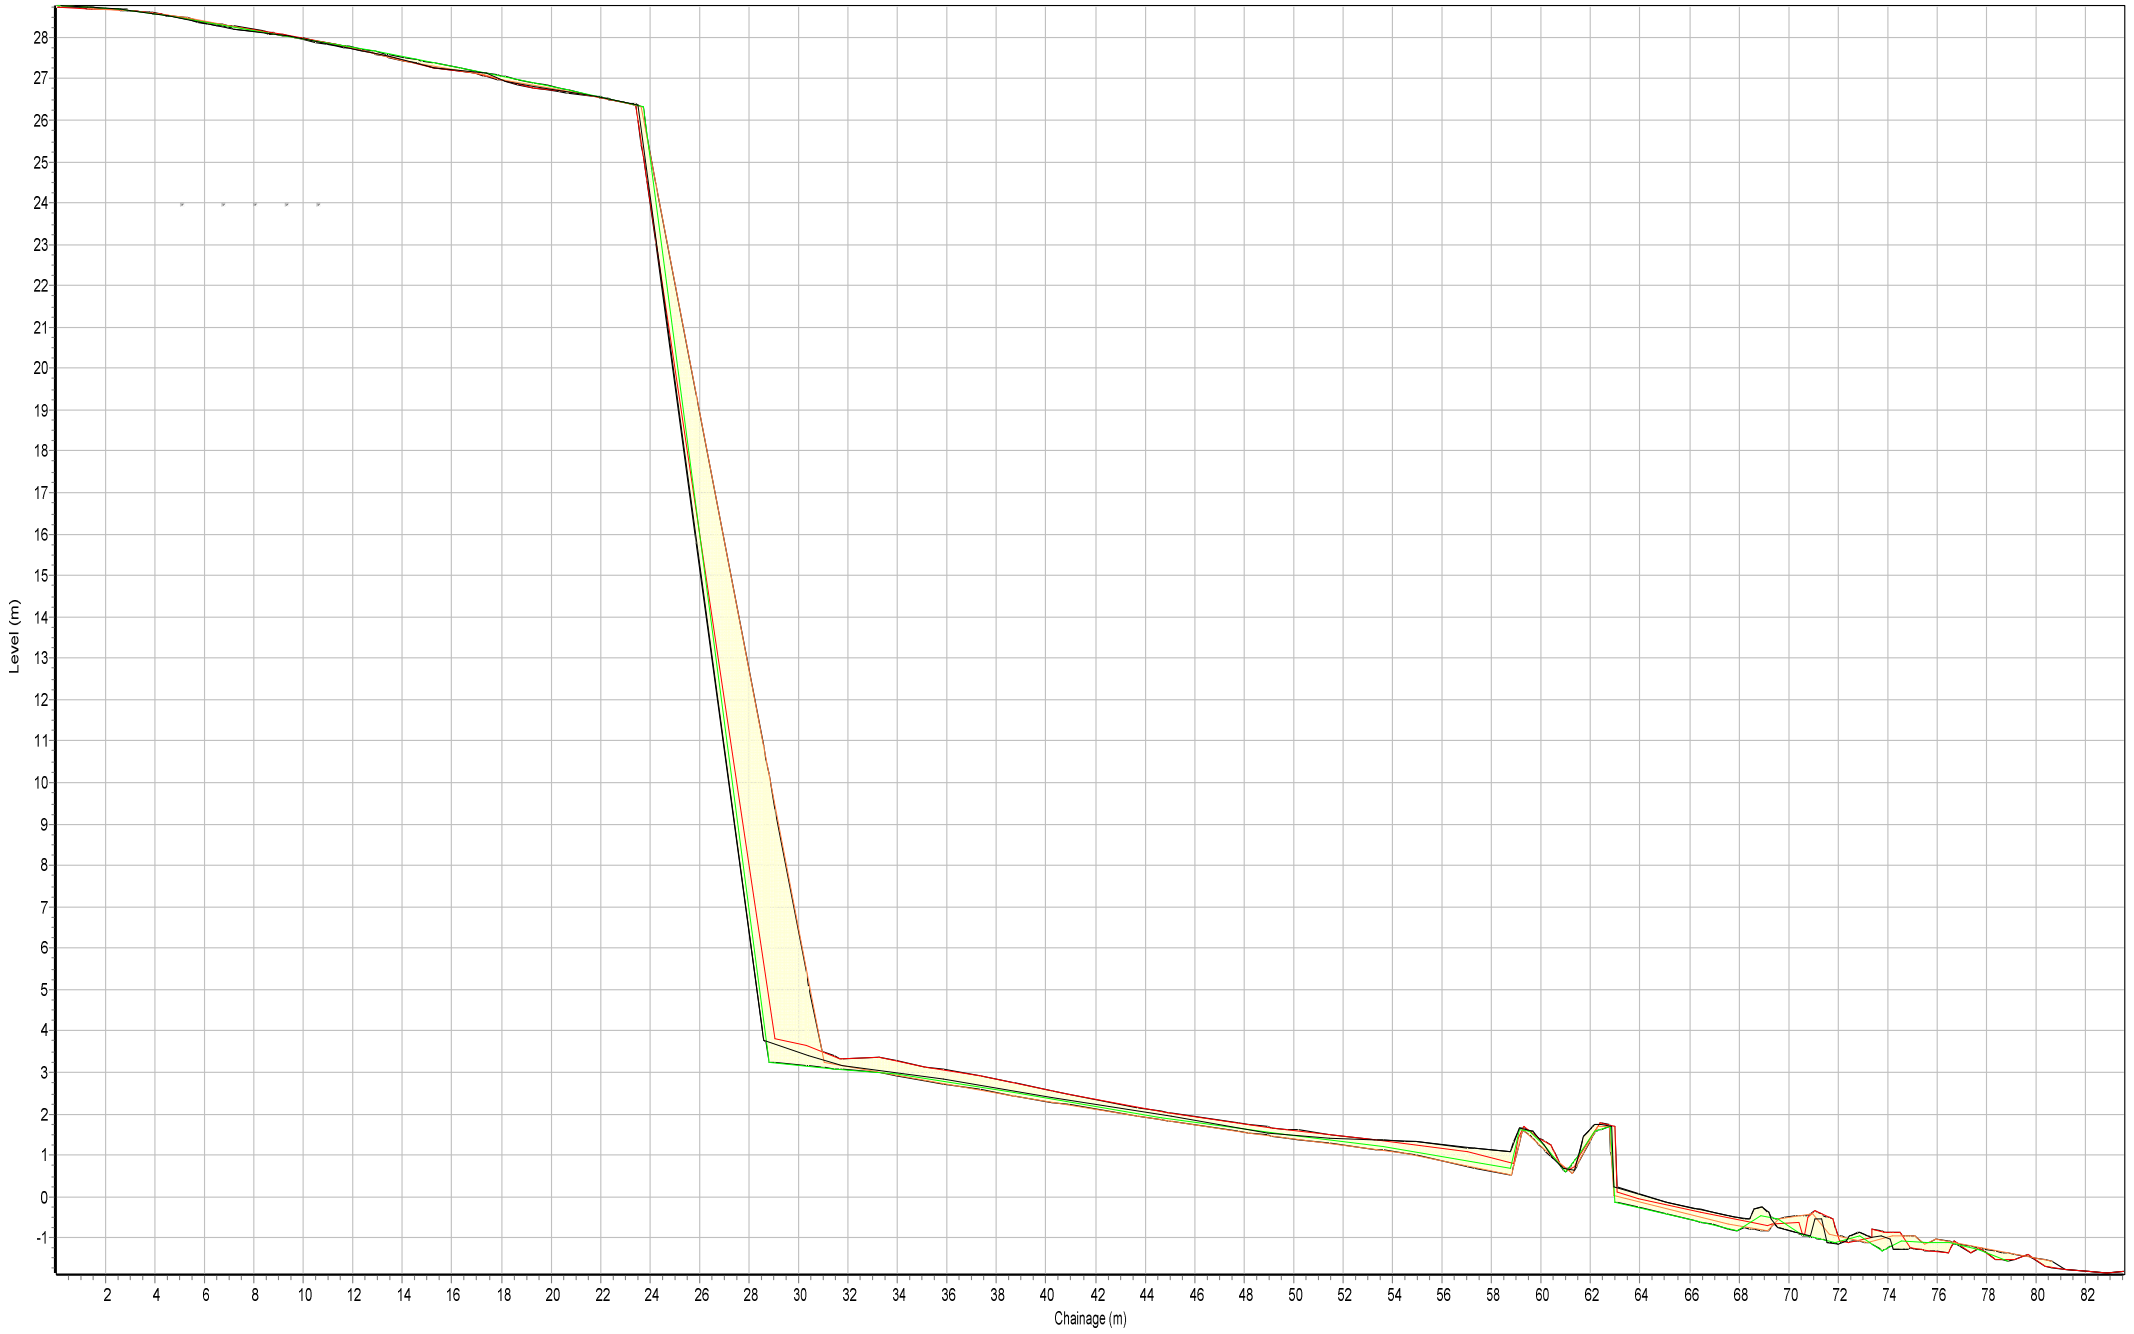
Beach Profiles: 1bSH1B

Survey Date	Description of Changes Since Last Survey	Interpretation
14 th October 2019	<p>Beach Profiles:</p> <p>Blast Beach is covered by four beach profile lines (Appendix A). All of the profiles along Blast Beach exhibit similar forms, with a rock cliff, wide colliery spoil beach with a distinct low cliff at its eroding seaward edge, and a mixed gravel and sand foreshore extending to MLW. The survey report notes that <i>'dense vegetation restricts access to the cliff tops of section SH1 and SH1A and the cliff bottom of SH1A'</i>.</p> <p>Profile 1bSH1b was added to the programme during the Full Measures survey in October 2015. The profile is adjacent to the sewage works south of Seaham. The profile is cliff to 30m and then gravel beach between 30m and 60m chainage. During the 2019 Partial Measures Survey the toe of the cliff had retreated from 31m to 29m chainage, with some minor accumulation of up to 0.1m elsewhere across the profile. The 2019 Full Measure Survey showed that there has been 0.6m of accumulation against the toe of the cliff. Across the upper beach profile between chainage 32m and 52m there has been accumulation of up to 0.2m. On the landward side of the two concrete blocks (shown on the profiles as a protrusion in the profile between 59m and 63m chainage) there has been accumulation of up 0.4m. Between chainage 63m and 68m there has been 0.3m of accumulation. Seaward of this point the rocks are exposed from 70m chainage to the end of the survey at 74m.</p> <p>Profile 1bSH1a was added to the programme during the Full Measures survey in September 2009. It is located to the north of the previously-established 1bSH1. The upper beach has a very similar profile to the previous year as far as the eroding face of the spoil deposit at 140m chainage. Between 140m chainage and 180m the small berm and significant portion of the beach face has been eroded over the last 12 months. The loss of the beach berm occurred over the winter of 2018/2019 (prior to April 2019) however this trend of erosion has continued over the summer of 2019 with further losses of up to 1.4m recorded. Seaward of the eroding spoil face these losses have caused a general smoothing of the profile, with no berms or depressions present past this point. From 170m chainage to the end of the survey at 260m chainage, the rocks are exposed at the bottom of the beach. The autumn 2019 profile is at the lower end of the range of previously recorded profiles, with the section between the chainages of 140m and 167m being the lowest on record.</p>	<p>The cliffs behind Blast Beach are currently inactive because they are fronted by colliery spoil. The crest of the spoil material on profiles 1bSH1 and SH1a has remained stable since 2009. Profile 1bSH2 has been progressively eroding since 2009, however has remained more stable since November 2014 showing ongoing accretion in the lower beach.</p> <p>There has been little net change since the April 2019 survey for profiles 1bSH1b and 1bSH1 and 1bSH2. Profile 1bSH1a appears to have been affected more significantly by erosion.</p> <p>At profile 1bSH1 the beach appears to have experienced some accretion in its and lower reaches.</p> <p>The beach at profile SH2 has shown an increase in level in its upper and lower reaches. Whilst the mid beach levels appear to have diminished.</p> <p>Longer term trends: The sea cliffs will eventually reactivate as on-going erosion of the colliery spoil removes the protection it affords to the cliffs. This is most likely to occur at the southern end of the bay where the spoil is most rapidly eroding. The accumulating sediment seaward of the colliery spoil in the northern part of the bay will offer the cliffs more protection. However, since the winter of 2014 there has been a reversal in the trend with erosion in the north of the bay and accretion in the south; this may yet be a short-term change.</p>

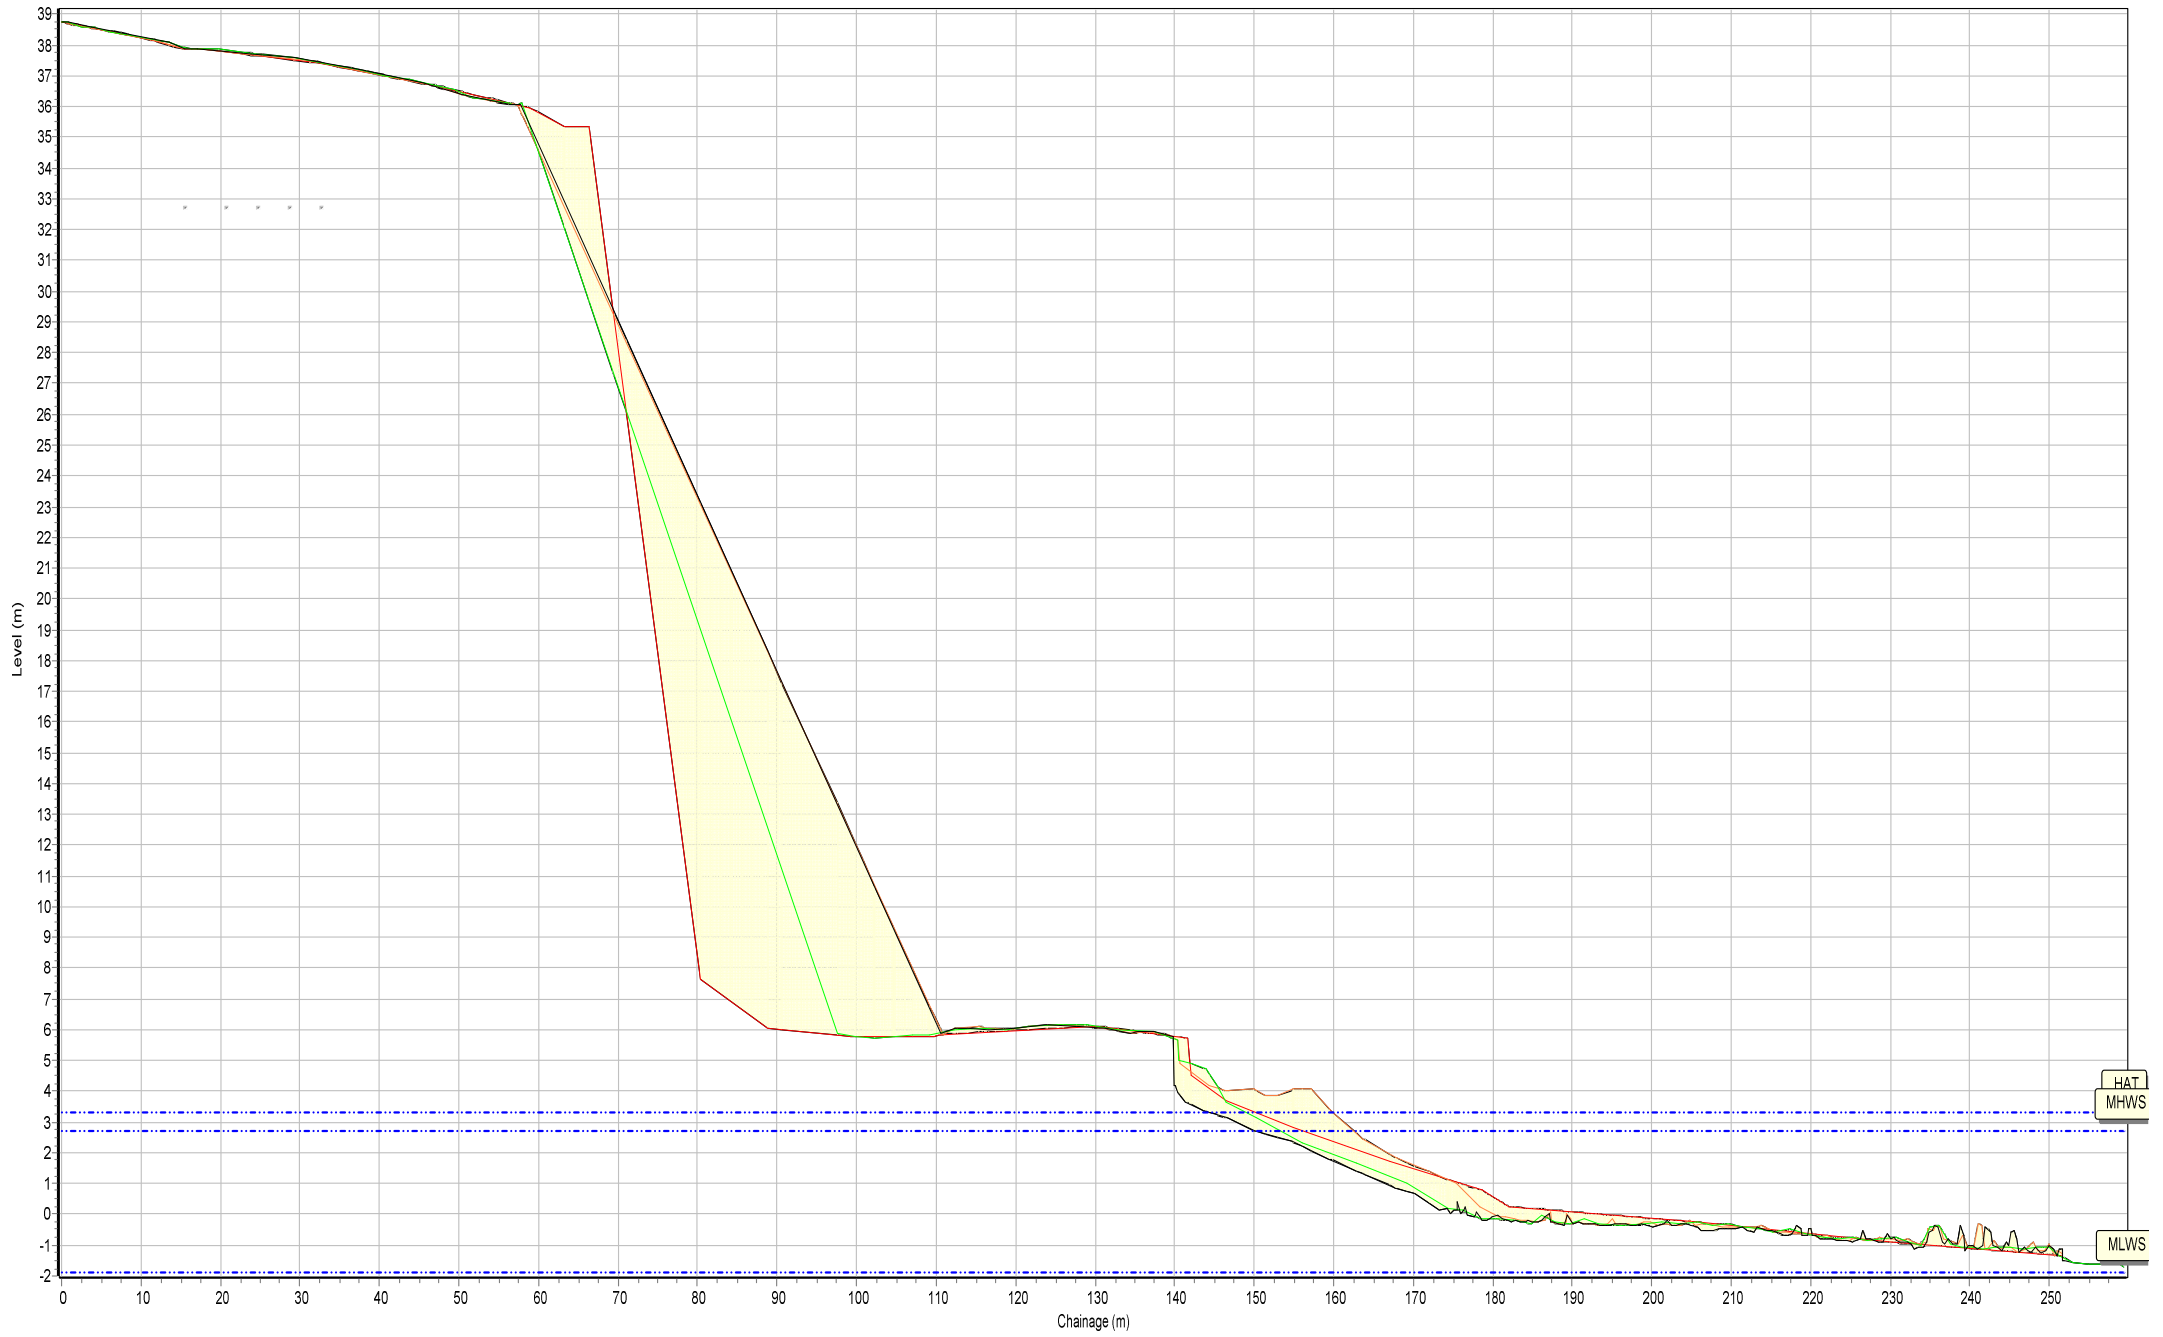
Beach Profiles: 1bSH1A

At Blast Beach 1bSH1 and 1bSH1A there was no access to the cliff top and at the cliff bottom of 1bSH1A due to dense vegetation.

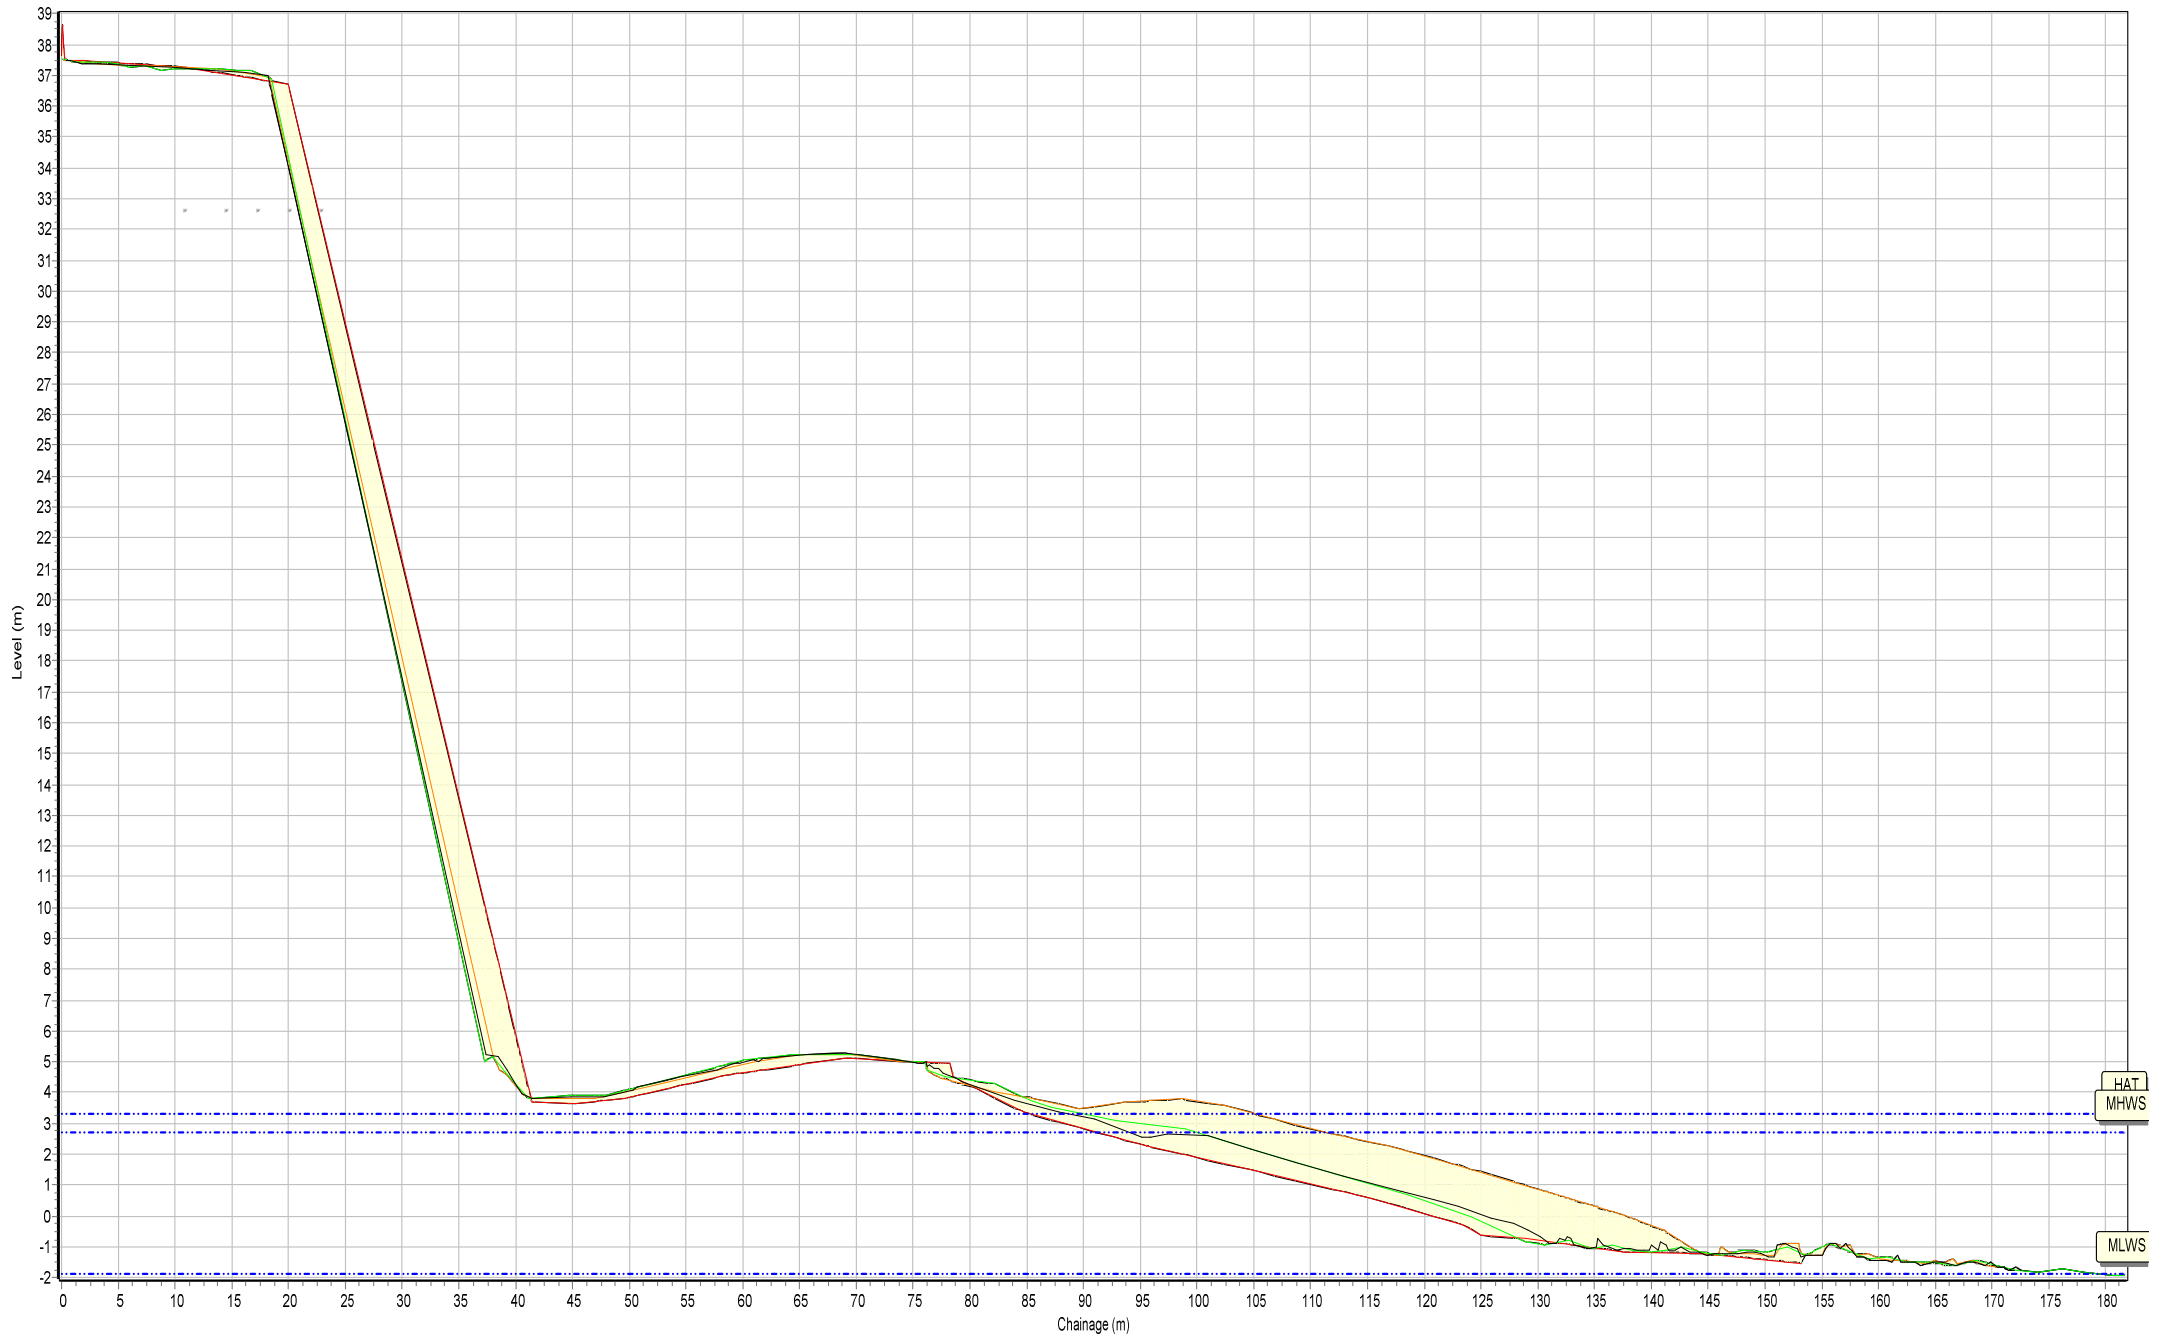
Beach Profiles: 1bSH1

Survey Date	Description of Changes Since Last Survey	Interpretation
	<p>There has been no change to profile 1bSH1 up to chainage 75m. There has been no discernible change to the cliff face or the shallow trench which runs along the upper beach. Photographs of the profile show attenuated water in this trench. At chainage 76m there has been accretion of up to 0.3m against the spoil face. From chainage 78m to 100m there has been erosion of up to 0.5m, and a shallow berm has formed at chainage 95m. Seaward of chainage 100m there has been little change to the mid beach, however there has been some accretion at the interface between the beach proper and the rocky foreshore, with the toe of the beach advancing by around 6m to chainage 136m. From chainage 136m until the end of the survey at chainage 173m the rocks are exposed. The profile is at a low level compared the range recorded from previous surveys.</p> <p>Profile 1bSH2 is largely similar to the previous surveys as far as the current beach crest at 110m chainage. The crest in the beach has shown progressive net erosion since 2009, with the crest retreating by around 30m. The 2019 Full Measures Survey shows that there has been approximately 0.2m of accretion on the beach face around 125m chainage. Between this point and chainage 140m there has been minor accretion (less than 0.2m). Between chainage 140m and 170m a shallow beach berm has been eroded causing a loss of up to 0.4m from the mid beach. Between chainage 170m and 190m there has been some accretion, with the toe of the beach moving seaward by around 3m. The beach profile has a more uniform gradient than the previous survey. At the seaward end of the profile from chainage 190m to the end of the survey at chainage 200m, rocks are exposed on the beach. Overall, the profile is at a medium level compared to the range recorded from previous surveys.</p>

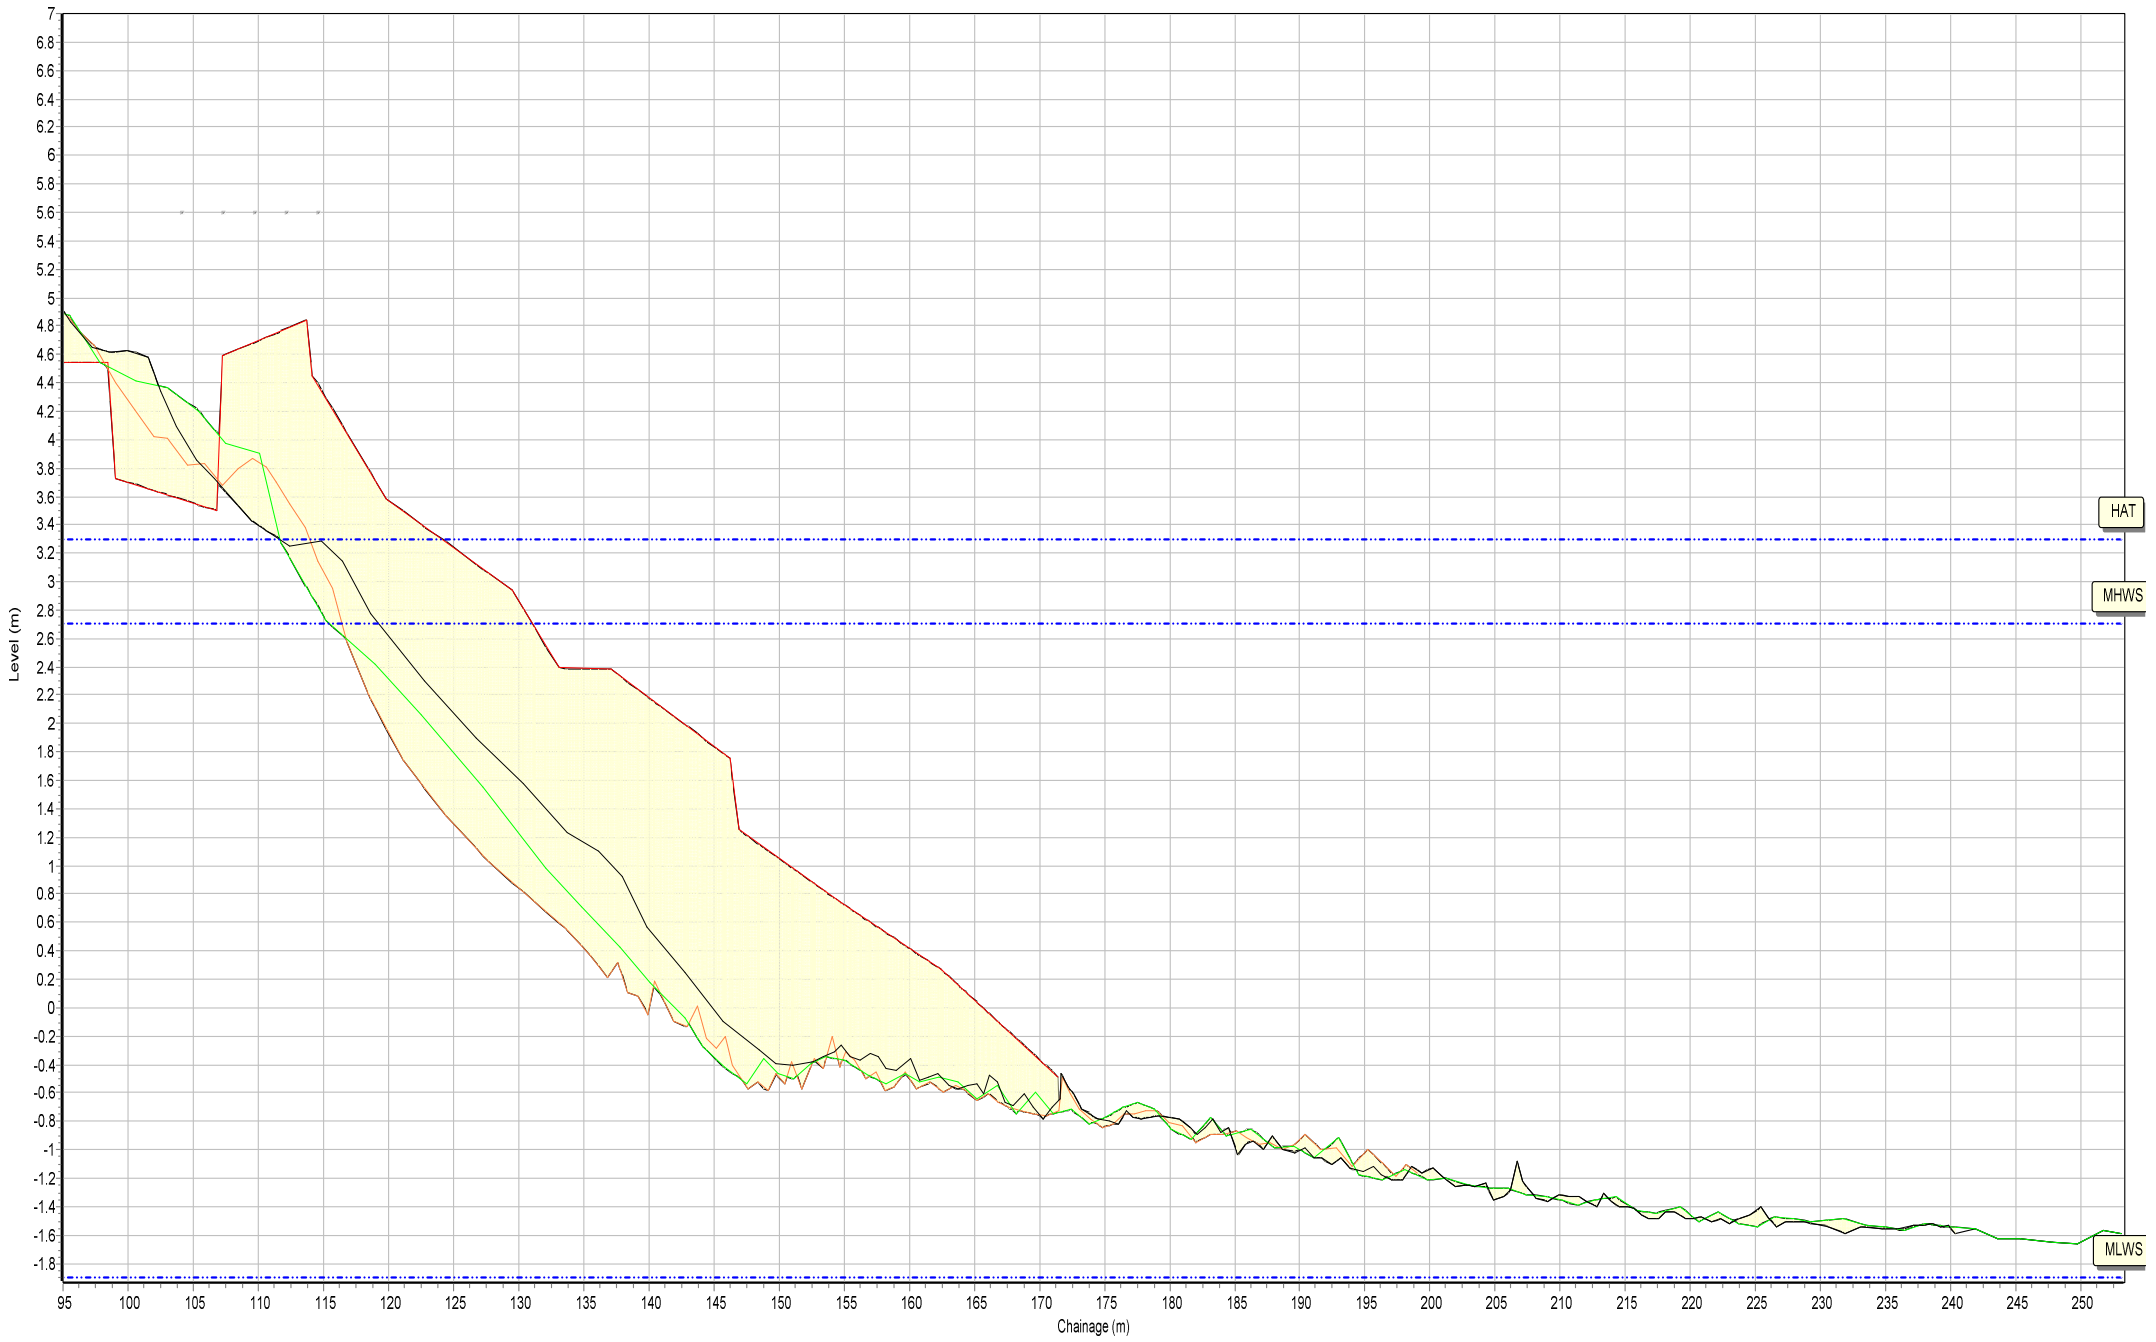
Beach Profiles: 1cEA2

Survey Date	Description of Changes Since Last Survey	Interpretation
<p>14th October 2019</p>	<p>Beach Profiles:</p> <p>Hawthorne Hive is monitored by beach profile 1cEA2 (Appendix A). The survey report notes “<i>unable to measure start of Section EA2 as the vegetation has choked out the section line and route over cliff faces</i>” and therefore all surveys following October 2012 start at 95m chainage.</p> <p>In previous years there was a channel which crossed the profile; however since April 2013 it has been infilled. There has been some minor accretion at the landward end of the profile around chainage 100m, however between chainage 103m and 112m the upper beach berm has eroded by 0.5m. There is shallow crested berm at chainage 115m. Between chainage 115m and 150m there has been a relatively uniform accretion of 0.4m. The rocky foreshore is exposed from chainage 155m to the end of the survey at chainage 240m. Overall, the profile is at a medium-high level on the upper beach and a medium-low level on the lower beach compared to the range recorded from previous surveys. The small upper beach berm is the highest recorded level between chainages 98m and 102m.</p>	<p>The beach levels in November 2019 appear to have recovered from the low levels recorded in the previous Full Measure survey (December 2018) however, most of this accumulation of material appears to have occurred prior to the previous Partial Measure survey in April 2019.</p> <p>Longer term trends: The upper beach level has recovered since the lows of 2014. Over the last 12 months the mid-beach has recovered from the loss of material noted in December 2018. Limited cliff erosion occurs in this section and therefore sediment supply is limited to erosion of colliery spoil. Storm events which may block the channel and varying flows in Hawthorne Burn are likely to continue to episodically block the channel and change its course across the beach.</p>

At Hawthorne Hive the surveyor was unable to measure the start of Section 1cEA2 as the vegetation has choked out the section line and route over cliff faces.

- At Hawthorne Hive the levels on the foreshore have recovered since April and November 2014 and are continuing to increase, they are now in the middle of the range of recorded beach levels. However, it is likely that the long-term trend of progressive erosion will continue on this profile.

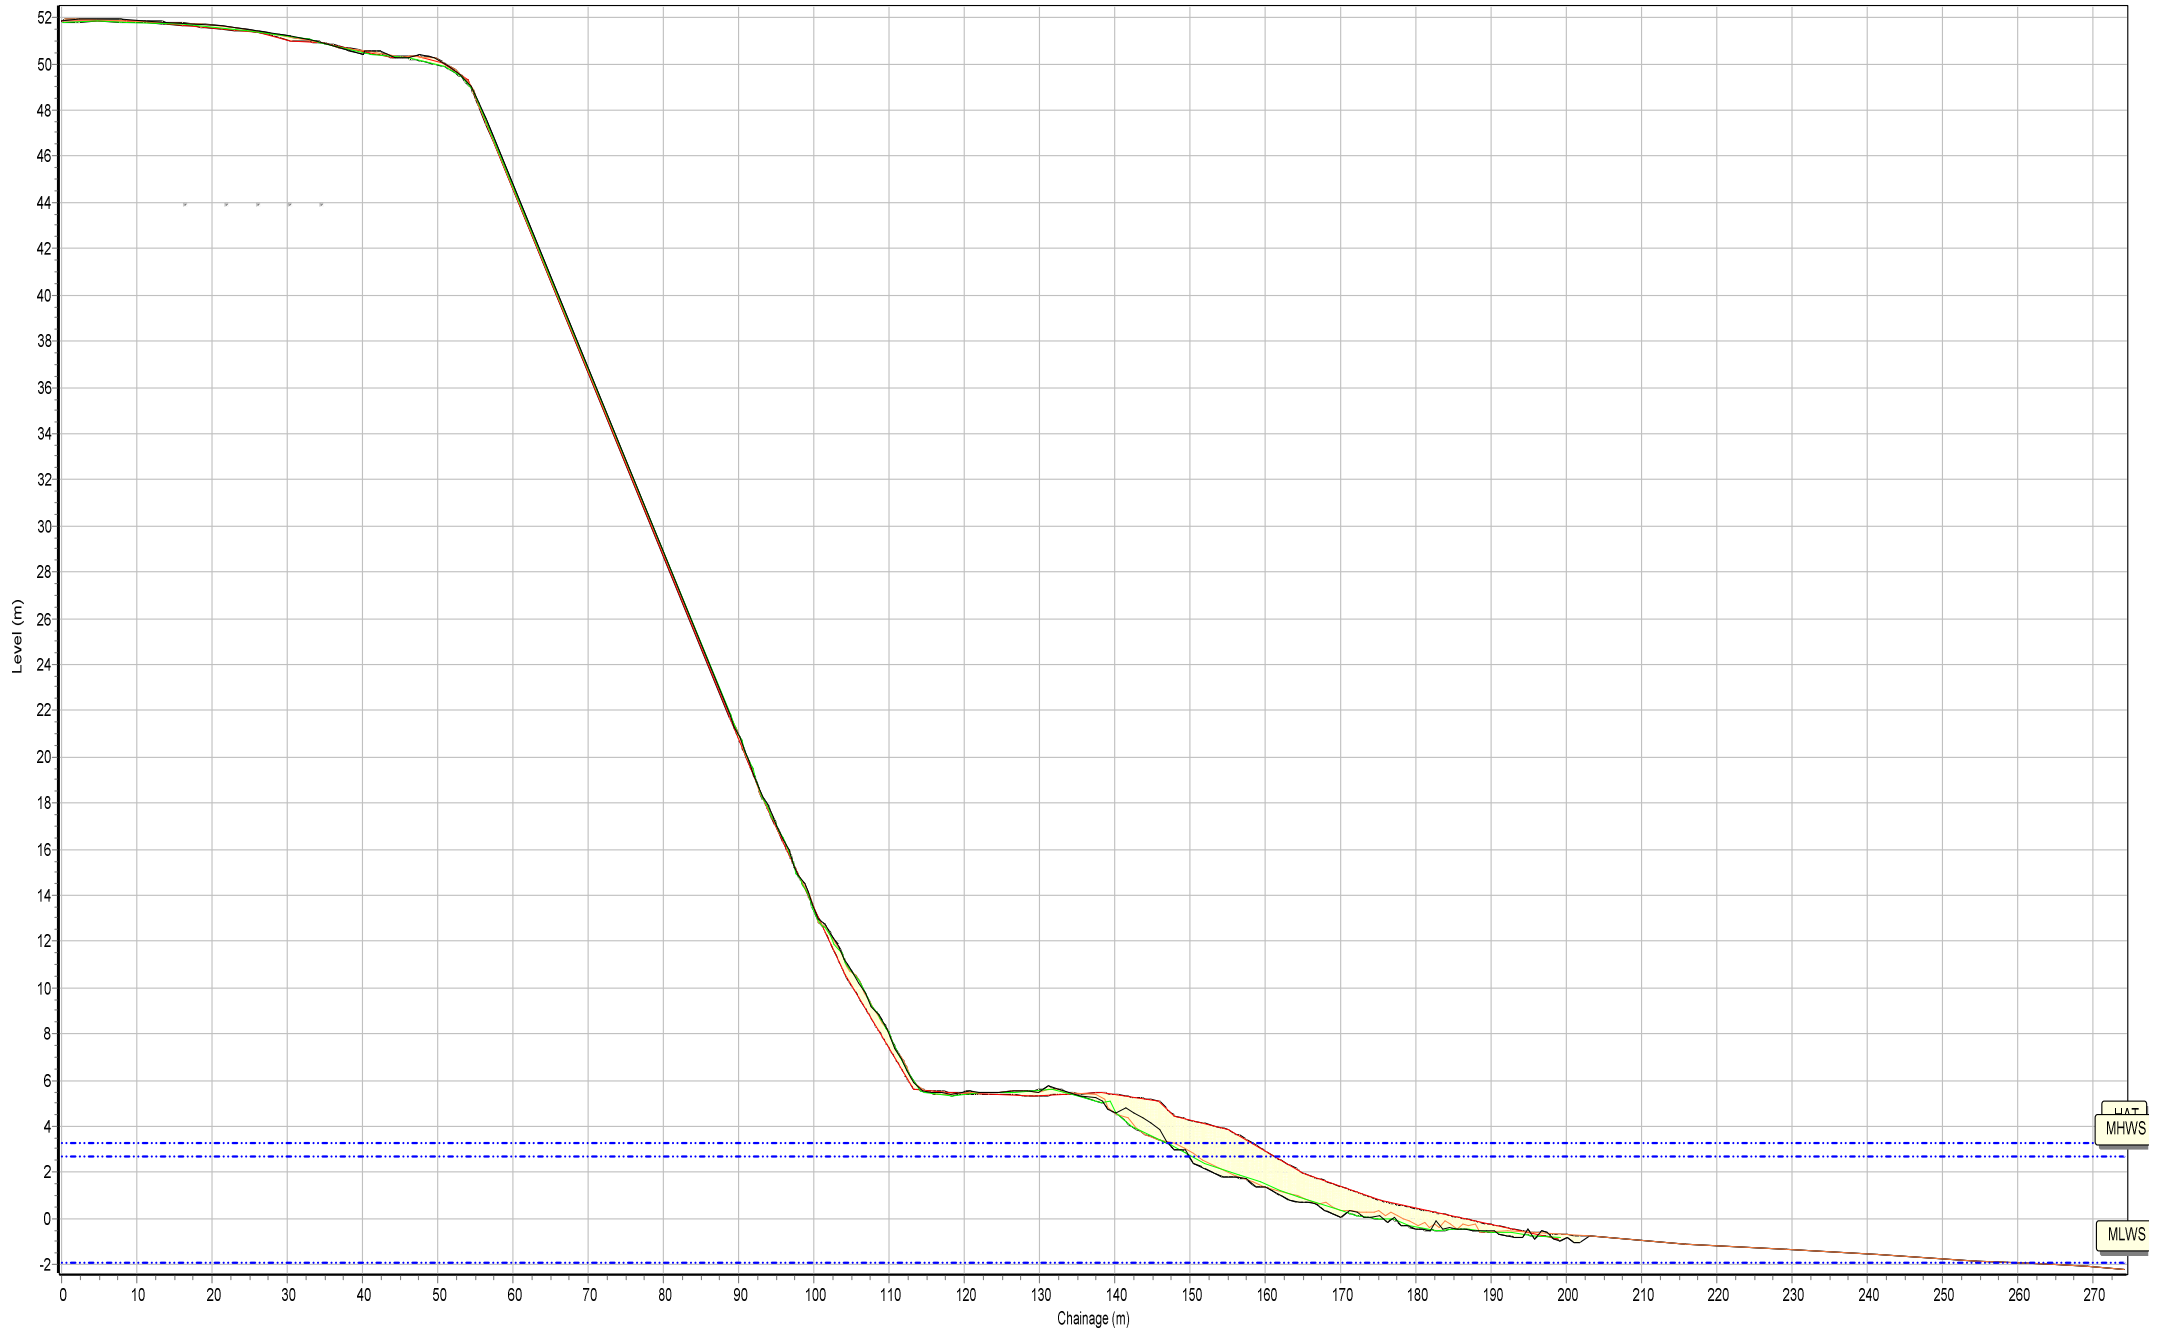
Beach Profiles: 1cBH1

Survey Date	Description of Changes Since Last Survey	Interpretation
27th November 2019	<p>Beach Profiles:</p> <p>Blackhall Colliery is covered by three beach profile lines (Appendix A). As at Blast Beach, profiles are dominated by colliery spoil and exhibit similar forms with a rock cliff, wide spoil beach with a distinct cliff at the eroding face of the colliery spoil, and a gravel and sand foreshore that extends to MLW. The survey report notes that the surveyor was <i>'unable to survey part of section BH1 and BH2 due to dense vegetation'</i> furthermore, the surveyor was <i>'unable to survey part of section BH3 due to deep water at the back of the beach'</i>.</p> <p>1cBH1 is located near Horden Point and suggests that there has been some minor loss of material across the face of the colliery spoil, however between chainages 140m and 148m a shallow berm of approximately 0.6m has formed. The eroding face at 140m chainage has moved seaward by approximately 2m. Seaward of this point the profile has been dominated by erosion with up to 0.3m lost from the mid beach between chainage 148m and 170m. Seaward of chainage 168m, until the end of the survey at chainage 200m the rocky foreshore is exposed. Overall, the profile is at a low level compared to the range recorded due to the continued loss of material from the mid beach. The section of beach between chainage 150m and 155m is at its lowest recorded level, and there are several other sporadic instances of extremely low levels when compared with the range of previously recorded results.</p> <p>Profile 1cBH2 exhibits no change in the cliff profile. The cliffed-edge of the spoil beach has retreated by approximately 1m since October 2018. There is around 36m of material from the eroding face at the back of the beach to the cliff toe. The beach has increased slightly with little erosion on the upper-mid beach increasing to up to 0.4m around chainage 200m. Seaward of this point, between chainage 210m and 270m there has been accretion of up to 0.8m meaning the toe of the lower beach has extended seaward by around 50m. The profile is generally low when compared with the range of previously recorded results. Between chainages 166m and 210m the profile is at its lowest recorded level.</p> <p>The profile 1cBH3 shows that since 2008 there has been episodic migration, infilling and scouring of the outflow of Castle Eden Burn, which crosses the profile. There appears to have been slumping of the cliff toe since October 2018. However, from observing the survey photographs and report it is noted that the surveyors were unable to survey part of the profile due to deep water in the channel. This has caused a</p>	<p>Profile 1cBH1 shows slight slumping and accumulation against the spoil face with the beach profile continuing to become shallower year on year. No significant retreat of the spoil face was recorded in November 2019; however, the changes are in line with the general trend of retreat.</p> <p>1cBH3 shows continued migration of the Castle Eden Burn channel and the beach face is dominated by erosion. Profile 1cBH2 is also dominated by erosion, though to a less significant extent.</p> <p>There has been very little change to the gradients of the profiles.</p> <p>Longer term trends: The surveys show that the spoil beach along much of the Blackhall Colliery shore is progressively eroding but continues to protect the cliffs in the short term. The spoil face has now moved landward by between 10m and 30m (since 2008), and now lies seaward of the cliff toe by approximately 8m to 40m.</p>

At Blackhall the surveyor was unable to access part of sections 1cBH1 and 1cBH2 due to dense vegetation. The surveyor was also unable to survey part of Section BH3 due to deep water at the back of the beach.
