**Cell 1 Regional Coastal Monitoring Programme
Analytical Report 12: 'Full Measures' Survey 2019**

(*) The present report is **Analytical Report 12** and provides an analysis of the 2019 Full Measures survey for County Durham Council's frontage.

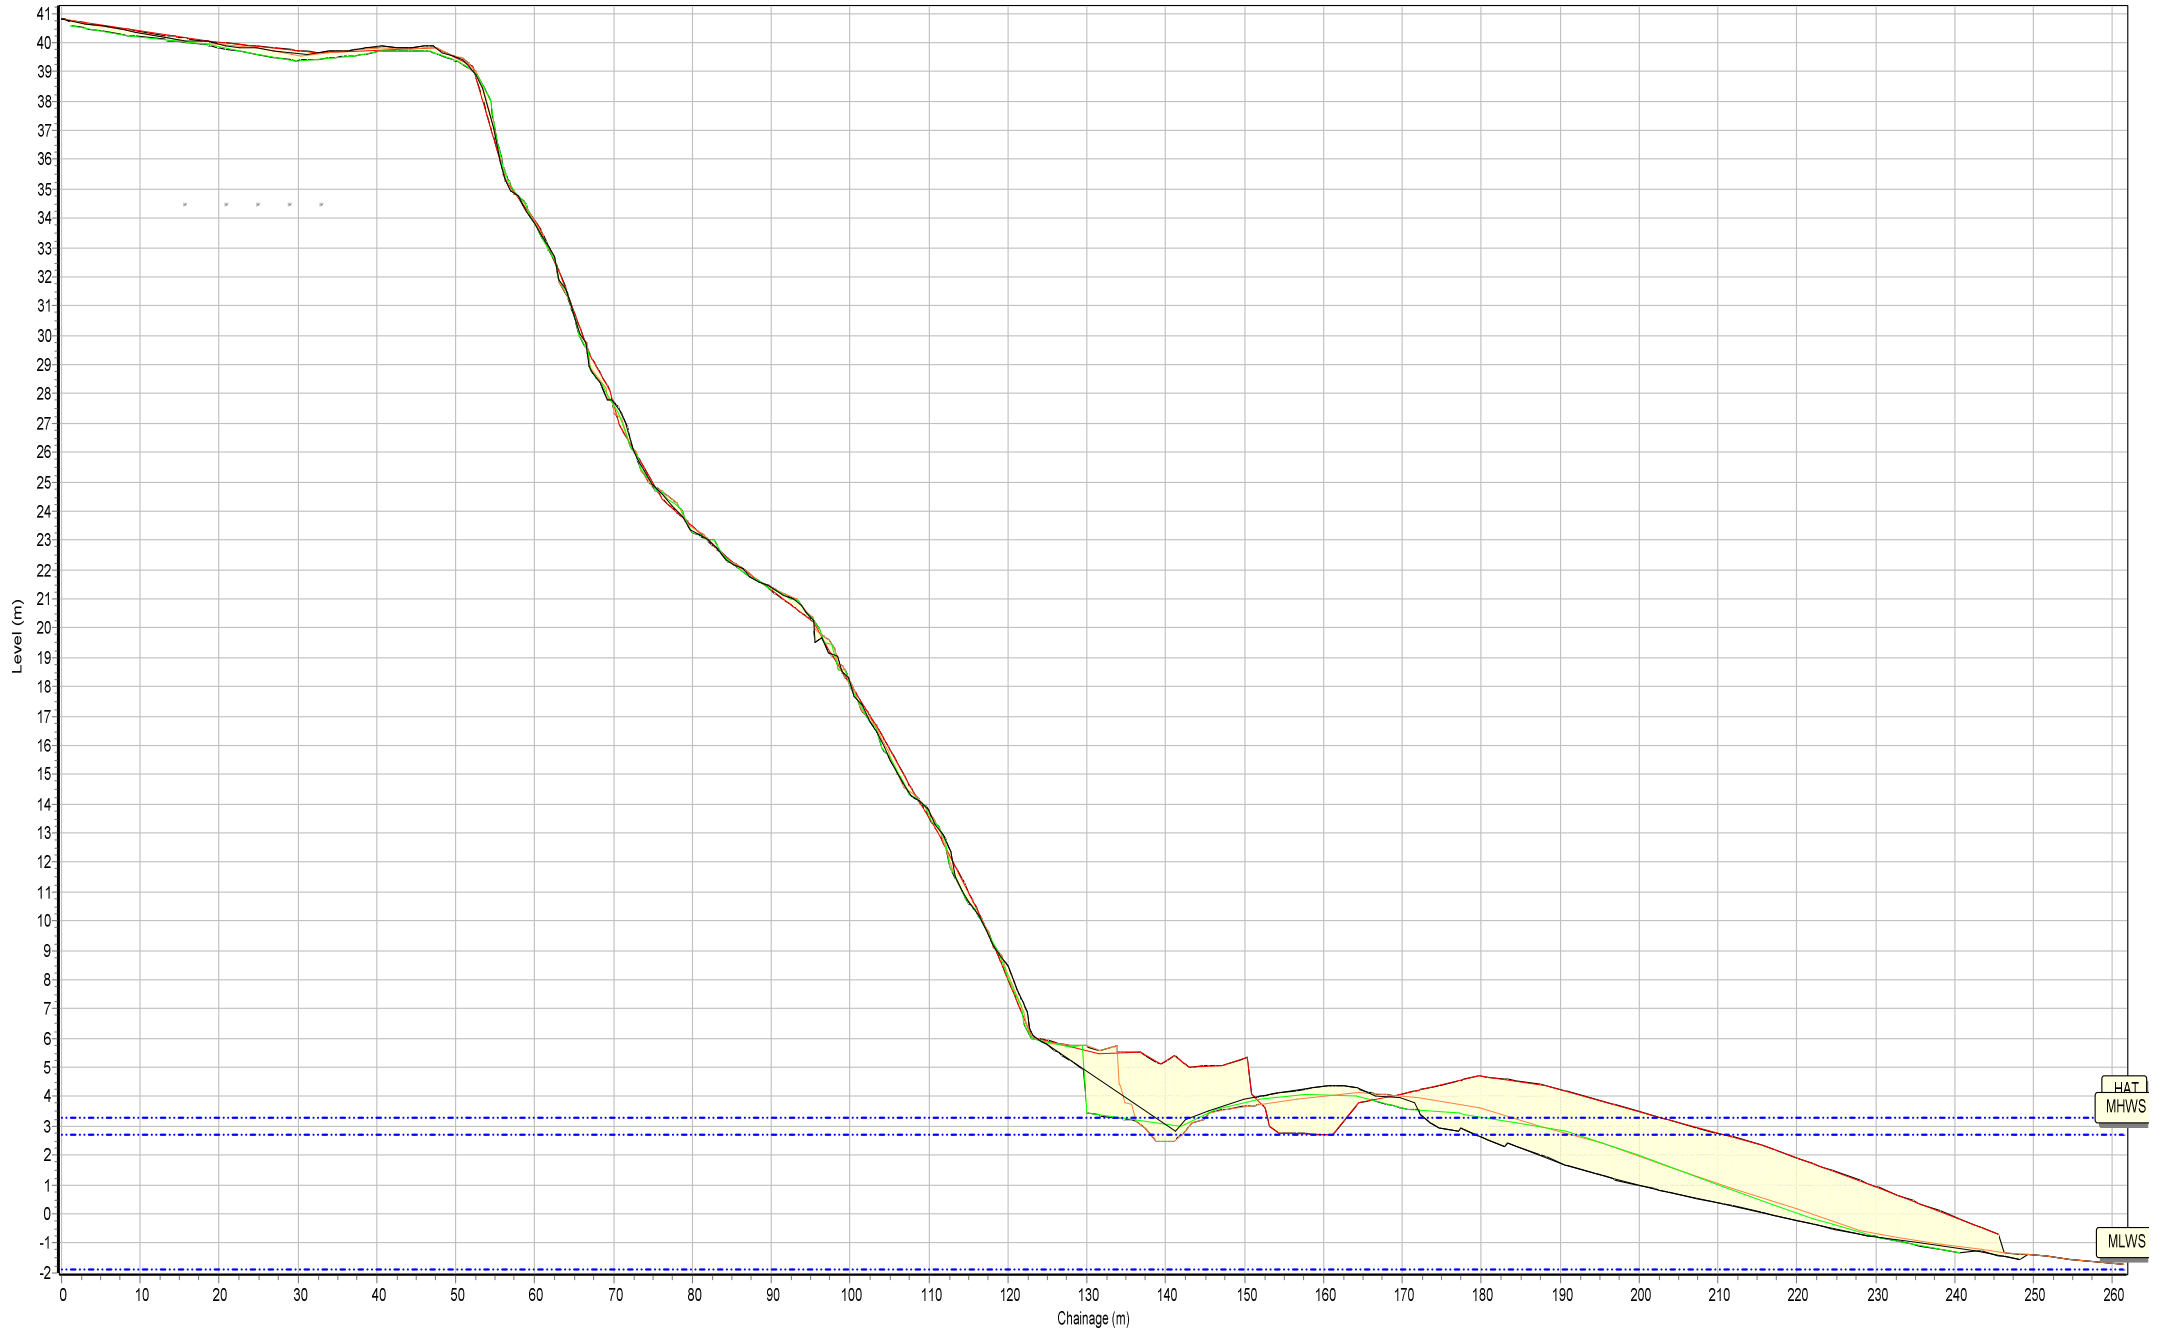
Beach Profiles: 1cBH3

Survey Date	Description of Changes Since Last Survey	Interpretation
	<p>smoothing of the profile over the channel, this is noted as being an error. There appears to have been little change to the landward edge of the channel. The seaward edge of the channel is marked by a shallow berm, the 2019 Full Measure survey records; little change to the landward face of the berm, slight accretion of 0.3m to the crest, and a significant erosion to the seaward face. The seaward face of the berm, between chainages 172m and 230m has been cut back, losing up to 1m in height, which has led to a landward retreat of the beach face by around 15m. The profile is now at its lowest recorded level along this extent. From chainage 230m to the end of the survey at 250m there has been a small amount of accretion of up to 0.2m. Overall, the profile is at a low level compared to the range recorded from previous surveys because of the progressive recession of this beach and the landward migration of the Burn channel.</p>

At Blackhall the surveyor was unable to access part of sections 1cBH1 and 1cBH2 due to dense vegetation. The surveyor was also unable to survey part of Section BH3 due to deep water at the back of the beach.

- At Blackhall Colliery, the seaward face of the colliery spoil deposit continues to erode in the northern part of the bay. In the south of the bay, mound of beach material continues

to erode and the channel has been moving landward. The channel is likely to scour the beach sediments under high flows, but become infilled again by wave action under storm conditions.
