**Cell 1 Regional Coastal Monitoring Programme
Analytical Report 13: 'Full Measures' Survey 2020**

(*) The present report is **Analytical Report 13** and provides an analysis of the 2020 Full Measures survey for County Durham Council's frontage.

Durham County Council's frontage extends from Ryhope Dene to Crimdon Beck. For the purposes of this report and for consistency with previous reporting, it has been sub-divided into five areas, namely:

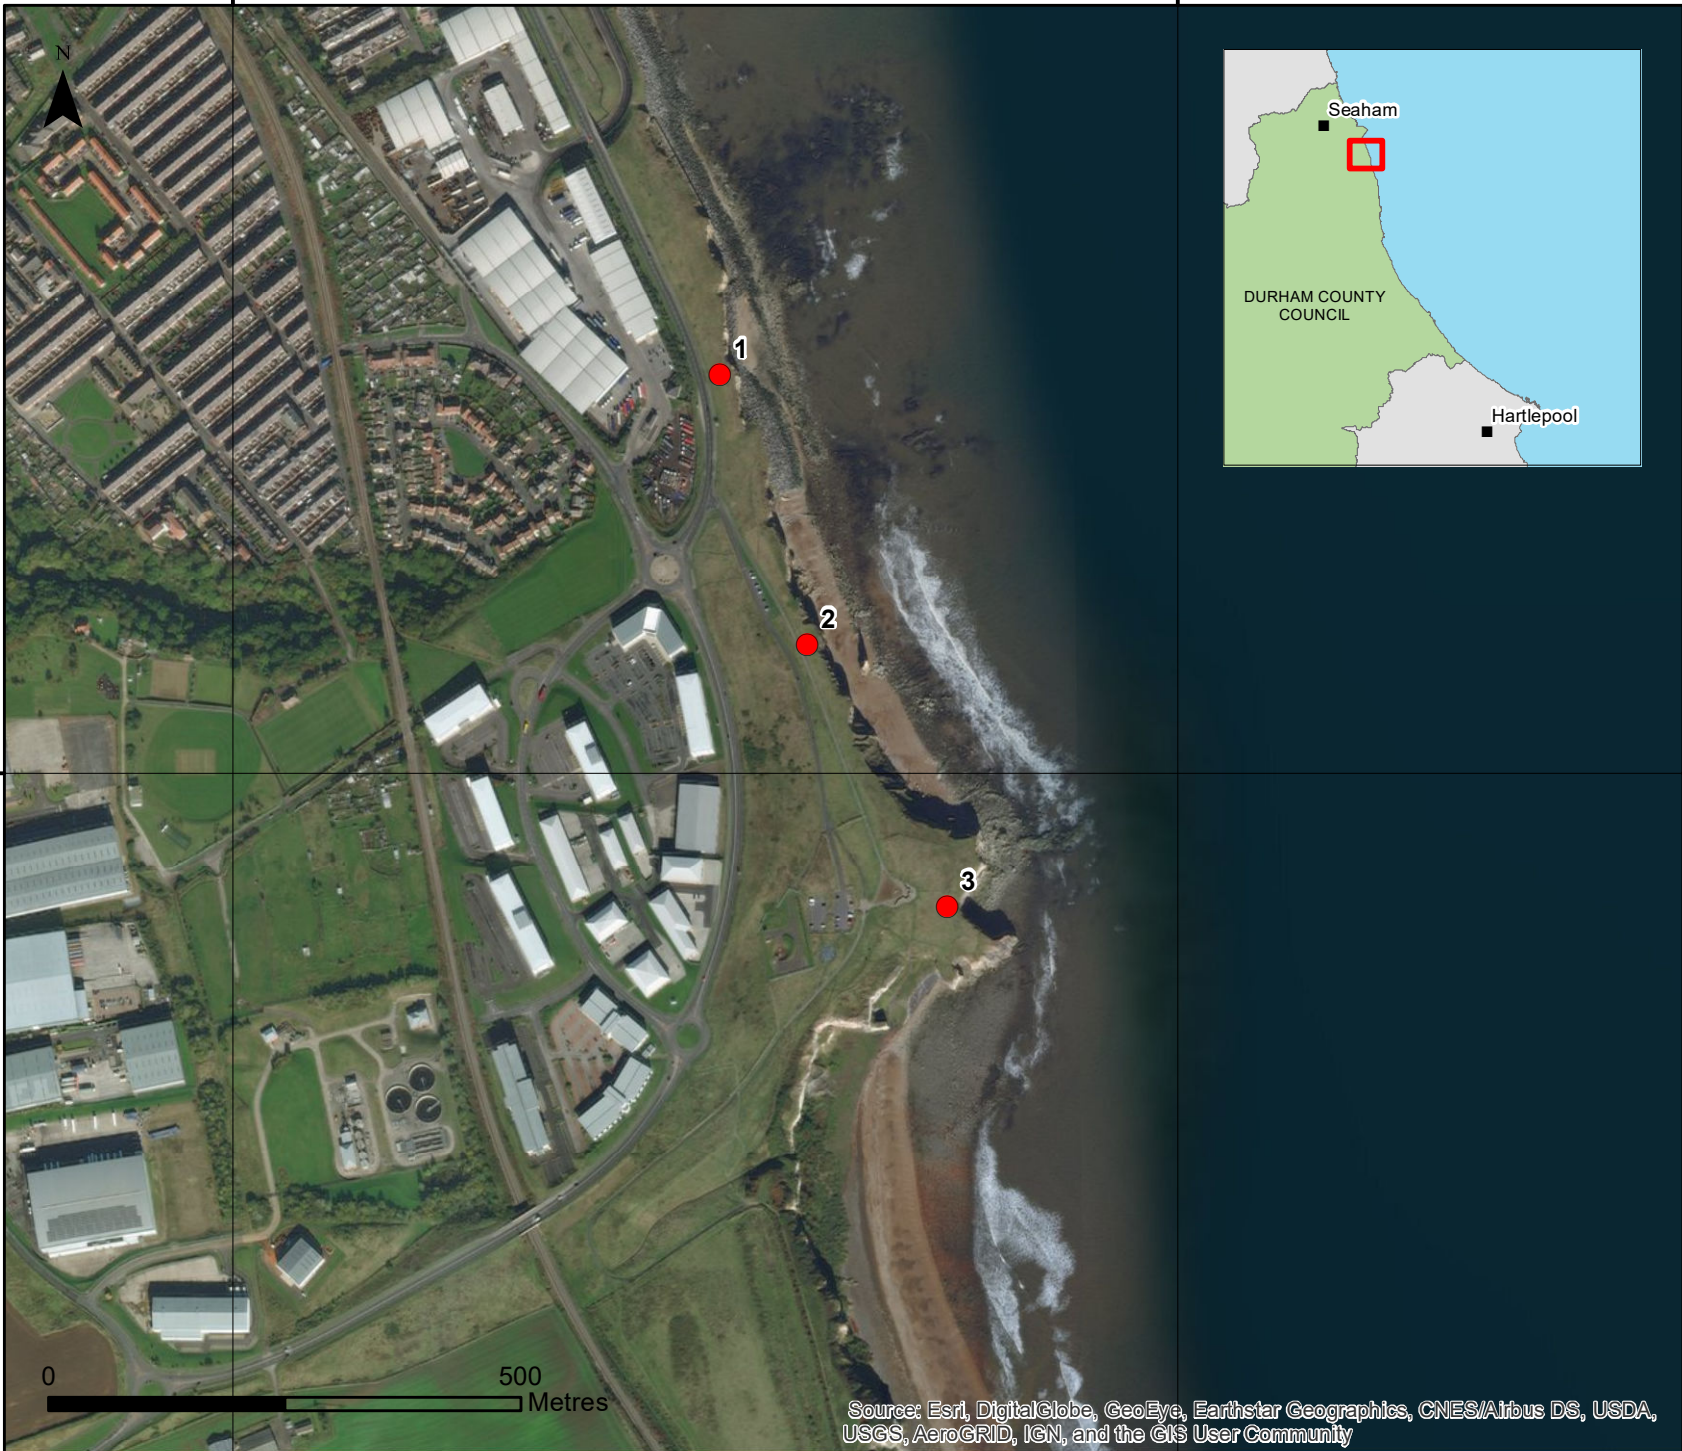
Figure 3 - Map 1

SEAHAM

Cliff Top Survey Locations

Three ground control points have been established on the Seaham frontage (Figure B1). The maximum separation between any two points is nominally 300m.

The cliff top surveys at Seaham are undertaken biannually. Measurements are taken from a fixed ground control point along a fixed bearing to the edge of the cliff top.

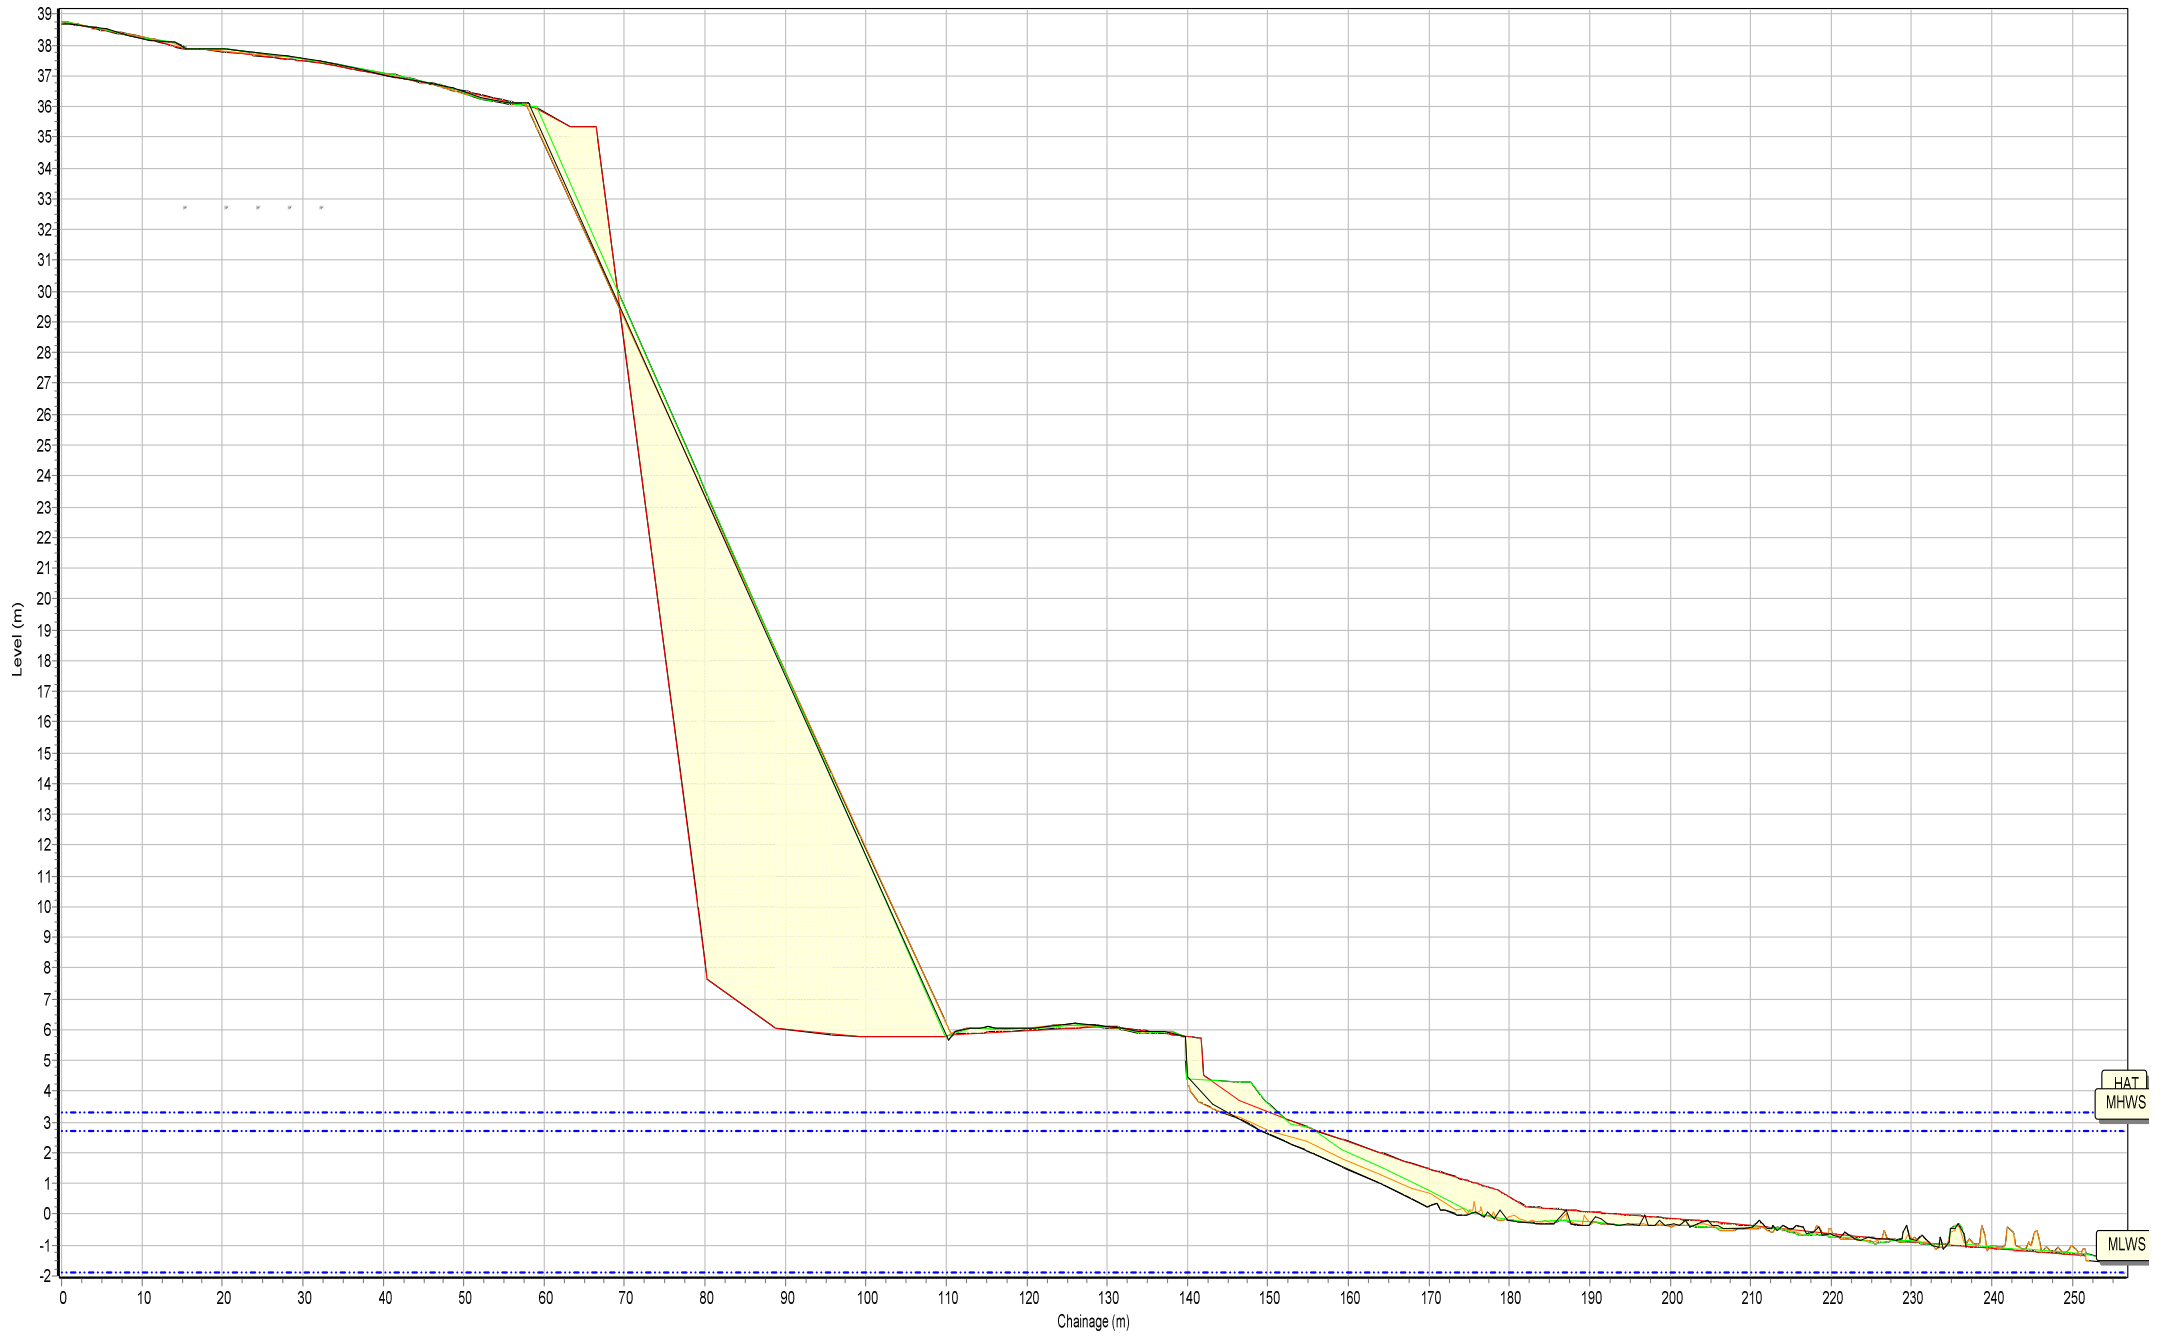
Beach Profiles: 1bSH1A

Profiles Envelope 21/10/2009 14/10/2019 23/05/2020 17/10/2020

Survey Date	Description of Changes Since Last Survey	Interpretation
17 th October 2020	<p>Beach Profiles:</p> <p>Blast Beach is covered by four beach profile lines (Appendix A). All of the profiles along Blast Beach exhibit similar forms, with a rock cliff, wide colliery spoil beach with a distinct low cliff at its eroding seaward edge, and a mixed gravel and sand foreshore extending to MLW. The survey report notes that; <i>'dense vegetation restricts access to the cliff tops of section SH1 and SH1A and the cliff bottom of SH1A'</i> and <i>'SH2 cliff top vegetation has made it [the cliff top] no longer safe to survey'</i>.</p> <p>Profile 1bSH1b was added to the programme during the Full Measures survey in October 2015. The profile is adjacent to the sewage works south of Seaham. The profile is cliff to 30m and then gravel beach between 30m and 60m chainage. The 2020 Full Measure Survey showed that there has been 0.6m of accretion in level from the toe of the cliff and across the upper beach between chainage 30m and 37m. Across the remainder of the upper beach profile between chainage 37m and 60m there has been erosion of up to 0.2m in level. Seaward of the two concrete blocks (shown on the profiles as a protrusion in the profile between 59m and 63m chainage) there has been little change. There has been some erosion of up to 0.4m in level of previously accreted material on the foreshore between chainage 70m and 78m. Elsewhere on the lower beach the rocky foreshore remains exposed. It is worth noting that the Full Measures 2020 survey extends a further 25m seawards than the Partial Measures 2020 survey, although the more recent survey profile remains well within the range of previously recorded results.</p> <p>Profile 1bSH1a was added to the programme during the Full Measures survey in September 2009. It is located to the north of the previously-established 1bSH1. The upper beach has a very similar profile to the previous year as far as the eroding face of the spoil deposit at 140m chainage. Between 140m chainage and 180m the beach face has been eroded by 0.8m in level which since the previous Spring 2020 Partial Measures survey. This has resulted in a landward retreat of up to 8m across the face of the mid-beach from the eroding spoil face up to chainage 175m. From 175m chainage to the end of the survey at chainage 2360m, the rocks are exposed across the foreshore. The autumn 2020 profile is at the low end of the range of previously recorded profiles, with the section between the chainages of 146m and 175m being the lowest on record.</p>	<p>The cliffs behind Blast Beach are currently inactive because they are fronted by colliery spoil. The crest of the spoil material on profiles 1bSH1 and SH1a has remained stable since 2009. Profile 1bSH2 has been progressively eroding since 2009, however has remained more stable since November 2014 showing ongoing accretion in the lower beach.</p> <p>There has been little net change since the May 2020 survey for profiles 1bSH1b and 1bSH1 and 1bSH2. Profile 1bSH1a appears to have been affected more significantly by erosion.</p> <p>At profile 1bSH1 the beach has experienced some lowering across the mid-beach.</p> <p>The beach at profile SH2 has shown an increase in level in its mid and lower sections, whilst the upper beach levels remain stable.</p> <p>Longer term trends: The sea cliffs will eventually reactivate as on-going erosion of the colliery spoil removes the protection it affords to the cliffs. This is most likely to occur at the southern end of the bay where the spoil is most rapidly eroding. The accumulating sediment seaward of the colliery spoil in the northern part of the bay will offer the cliffs more protection. However, since the winter of 2014 there has been a reversal in the trend with erosion in the north of the bay and accretion in the south; this may yet be a short-term change.</p>

At Blast Beach 1bSH1, 1bSH1A and 1bSH2 there was no access to the cliff top and at the cliff bottom of 1bSH1A due to dense vegetation.
