Cell 1 Regional Coastal Monitoring Programme Analytical Report 14: 'Full Measures' Survey 2021

Durham County Council

January 2022

(*) The present report is **Analytical Report 14** and provides an analysis of the 2021 Full Measures survey for County Durham Council's frontage.

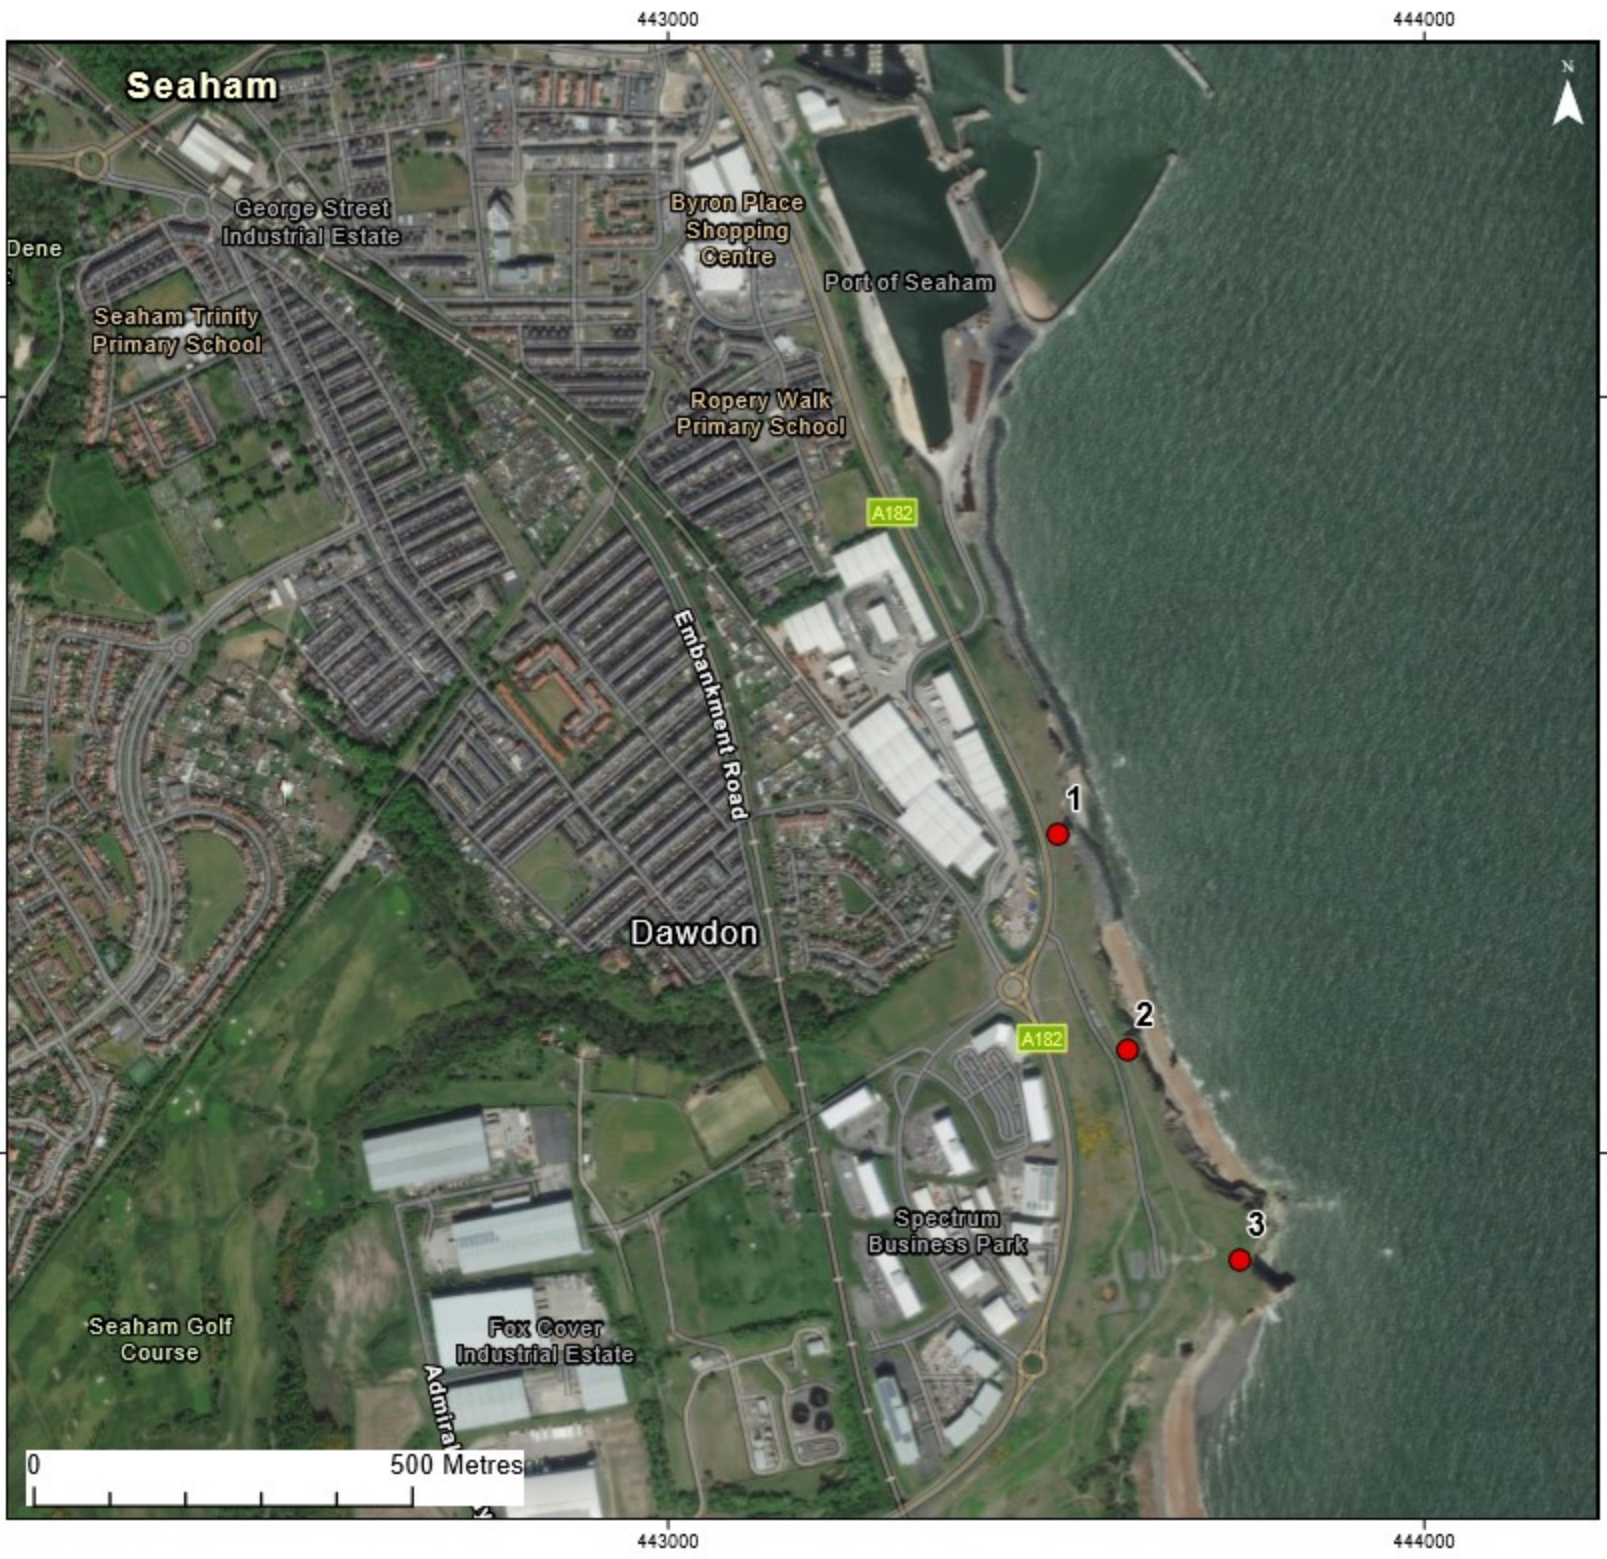
Figure 3 - Map 1

SURVEY LOCATIONS

- Cliff Top Survey Points

Three ground control points have been established on the Seaham frontage (Figure B1). The maximum separation between any two points is nominally 300m.

The cliff top surveys at Seaham are undertaken biannually. Measurements are taken from a fixed ground control point along a fixed bearing to the edge of the cliff top.

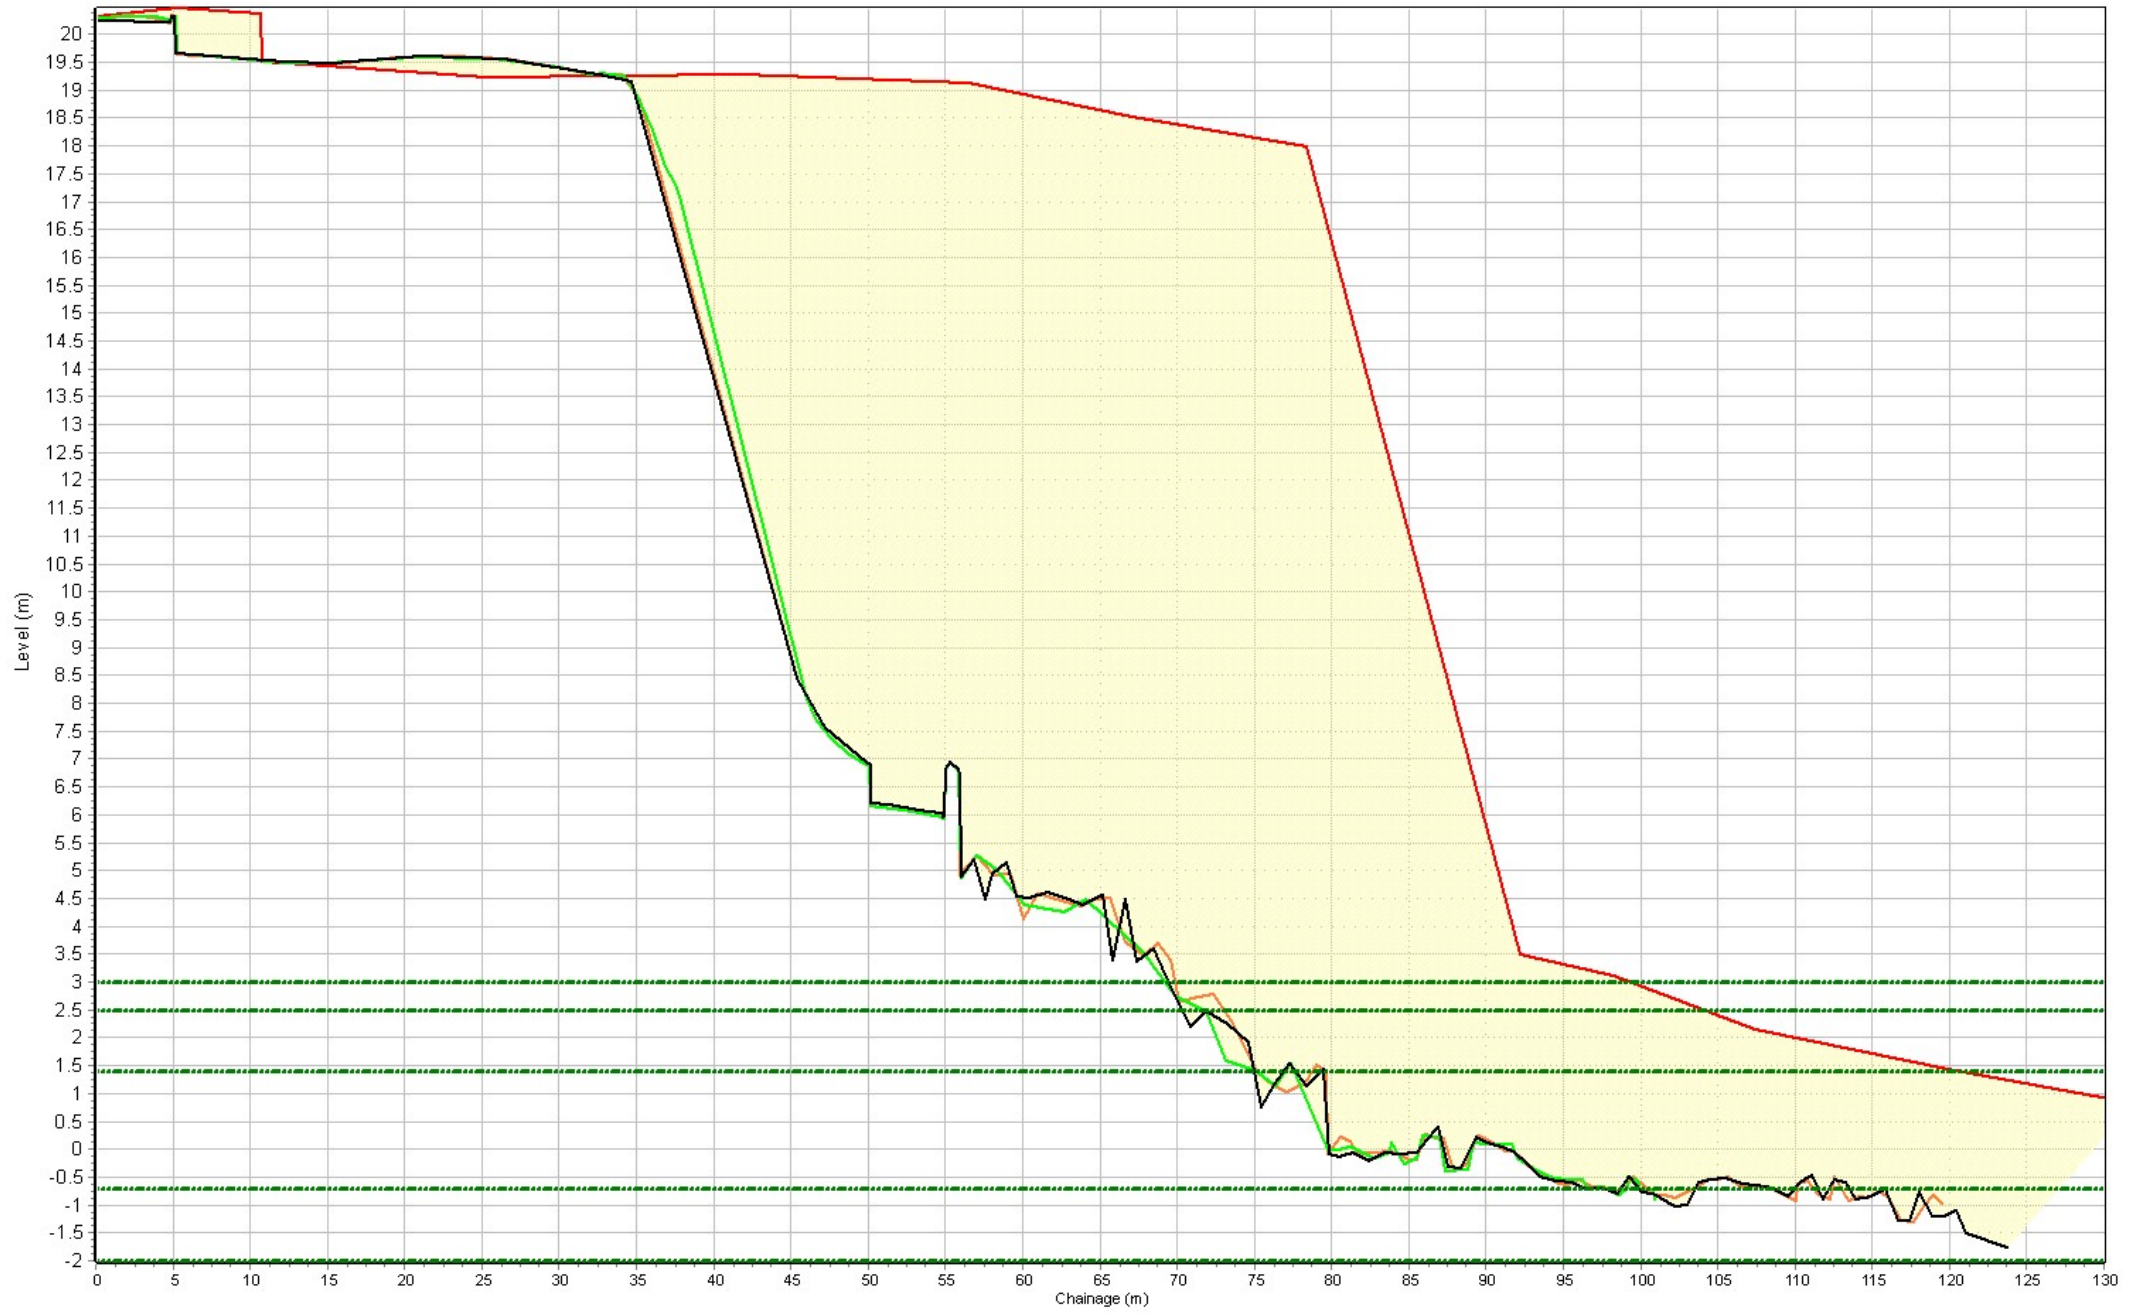
Profiles: 1bEA1

Survey Date	Description of Changes Since Last Survey	Interpretation
3 rd November 2021	<p>Beach Profiles:</p> <p>One beach profile line 1bEA1, located at Featherbed Rocks (Appendix A), has been monitored since April 2009. The profile extends across the cliff top and cliff face then extends across the promenade (chainage 55m), rock armour sea defence (chainage 55m to 80m) and beach. Beyond the rock armour at chainage 80m, there has been little change to the beach over the summer of 2021, the beach profiles reflect the rocky nature of the foreshore and that there is no beach over the shore platform. Previous surveys have shown accumulations of material at the base of the revetment, but this has not been present since the 2012 Full Measures survey.</p>	<p>The rocky nature of this foreshore means it is unlikely to undergo significant changes in morphology unless sediment is deposited upon it. A veneer beach has previously been present here but has not been recorded since the 2012 Full Measures survey.</p> <p>Longer term trends: Between 2010 and 2012 a thin veneer beach was present. Since 2013 the profiles recorded have all been low exposing the rocky shore platform along much of its length.</p>

- At Featherbed Rocks the rocky shore platform continues to be exposed and the veneer beach present in earlier surveys has been absent since autumn 2012.

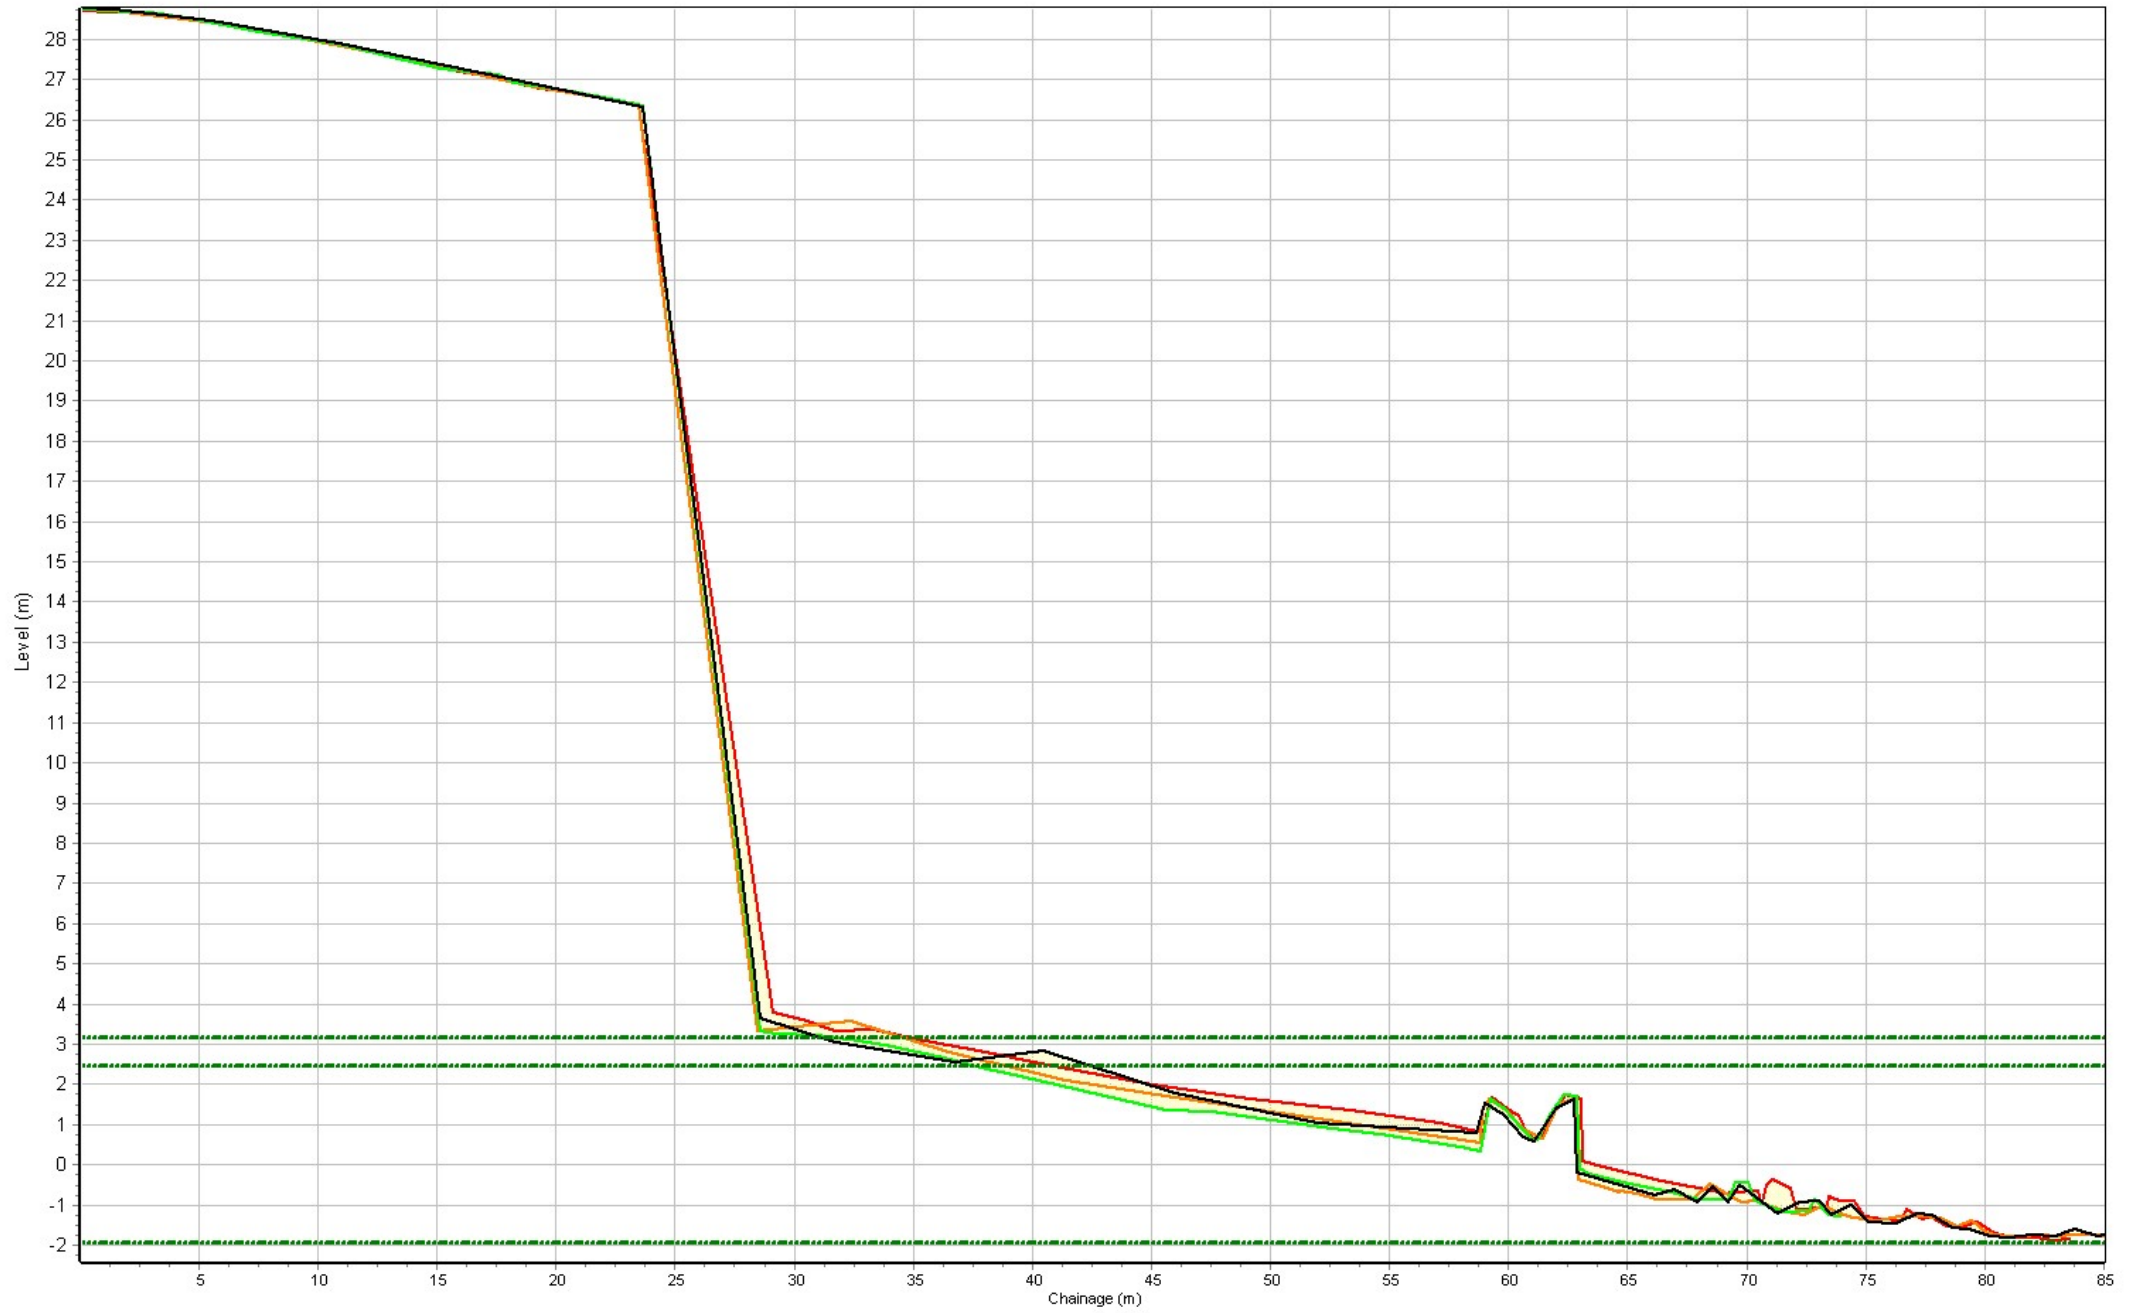
Profiles: 1bSH1B

Survey Date	Description of Changes Since Last Survey	Interpretation
<p>3rd November 2021</p>	<p>Beach Profiles:</p> <p>Blast Beach is covered by four beach profile lines (Appendix A). All of the profiles along Blast Beach exhibit similar forms, with a rock cliff, wide colliery spoil beach with a distinct low cliff at its eroding seaward edge, and a mixed gravel and sand foreshore extending to MLW. The survey report notes that; <i>'dense vegetation restricts access to the cliff tops of section SH1 and SH1A and the cliff bottom of SH1A'</i> and <i>'SH2 cliff top vegetation has made it [the cliff top] no longer safe to survey'</i>.</p> <p>Profile 1bSH1b was added to the programme during the Full Measures survey in October 2015. The profile is adjacent to the sewage works south of Seaham. The profile is cliff to 30m and then gravel beach between 30m and 60m chainage. The 2021 Full Measure Survey showed that there has been local accretion of up to 0.8m in level between chainages 37m up to the concrete blocks at chainage 59m. Seaward of the concrete blocks, the lower foreshore has experienced little to no change. The accretion on the upper beach means the levels are now at medium level compared with the previous survey range. The lower beach remains at a low level.</p> <p>Profile 1bSH1a was added to the programme during the Full Measures survey in September 2009. It is located to the north of the previously-established 1bSH1. The upper beach remained stable as far as the eroding face of the spoil deposit at 140m chainage. Between 140m chainage and 176m the beach face has been eroded by 1m in level since Spring 2021, as a result the beach berm deposited at chainage 155m has been eroded. From 176m chainage to the end of the survey at chainage 250m, the rocks are exposed across the foreshore and remain stable. The November 2021 profile is very low compared to the range of previously recorded profiles. The November 2021 profile is very similar to the Full Measures profile in October 2020 and October 2019, suggesting seasonal patterns.</p> <p>At 1bSH1, the profile shows that the whole cliff face, from chainage 19m to 38m, has appeared to retreat 2m since the May 2021 survey. This is actually due to the surveyor in May 2021 picking a slightly seaward definition of the cliff edge and is an apparent change rather than a real change. From chainages 50m to 76m at the colliery spoil face, there has been no change. At chainage 76m, erosion has exaggerated the cliffing in the colliery spoil which is now 0.6m in height. Seawards of colliery spoil cliffing, the beach has experienced wide scale erosion up to 2.2m in level in places. The rocky foreshore</p>	<p>The crest of the spoil material on all profiles across Blast Beach appears to have remained stable since the Spring 2021 survey. The beach material fronting the spoil has experienced varying erosion and accretion across the bay. To the north, the beach profiles (1bSH1a and 1bSH1) show significant erosion up to 2.2m in places. In contrast the southern profile shows accretion of up to 1.1m level on the lower beaches.</p> <p>Longer term trends: The cliffs behind Blast Beach are currently inactive because they are fronted by colliery spoil. The sea cliffs will eventually reactivate as on-going erosion of the colliery spoil removes the protection it affords to the cliffs. This is most likely to occur at the southern end of the bay where the spoil is most rapidly eroding. The accumulating sediment seaward of the colliery spoil in the northern part of the bay will offer the cliffs more protection. However, since the winter of 2014 there has been a reversal in the trend with erosion in the north of the bay and accretion in the south, this trend was continued in the November 2021 and so should remain area of focus.</p>

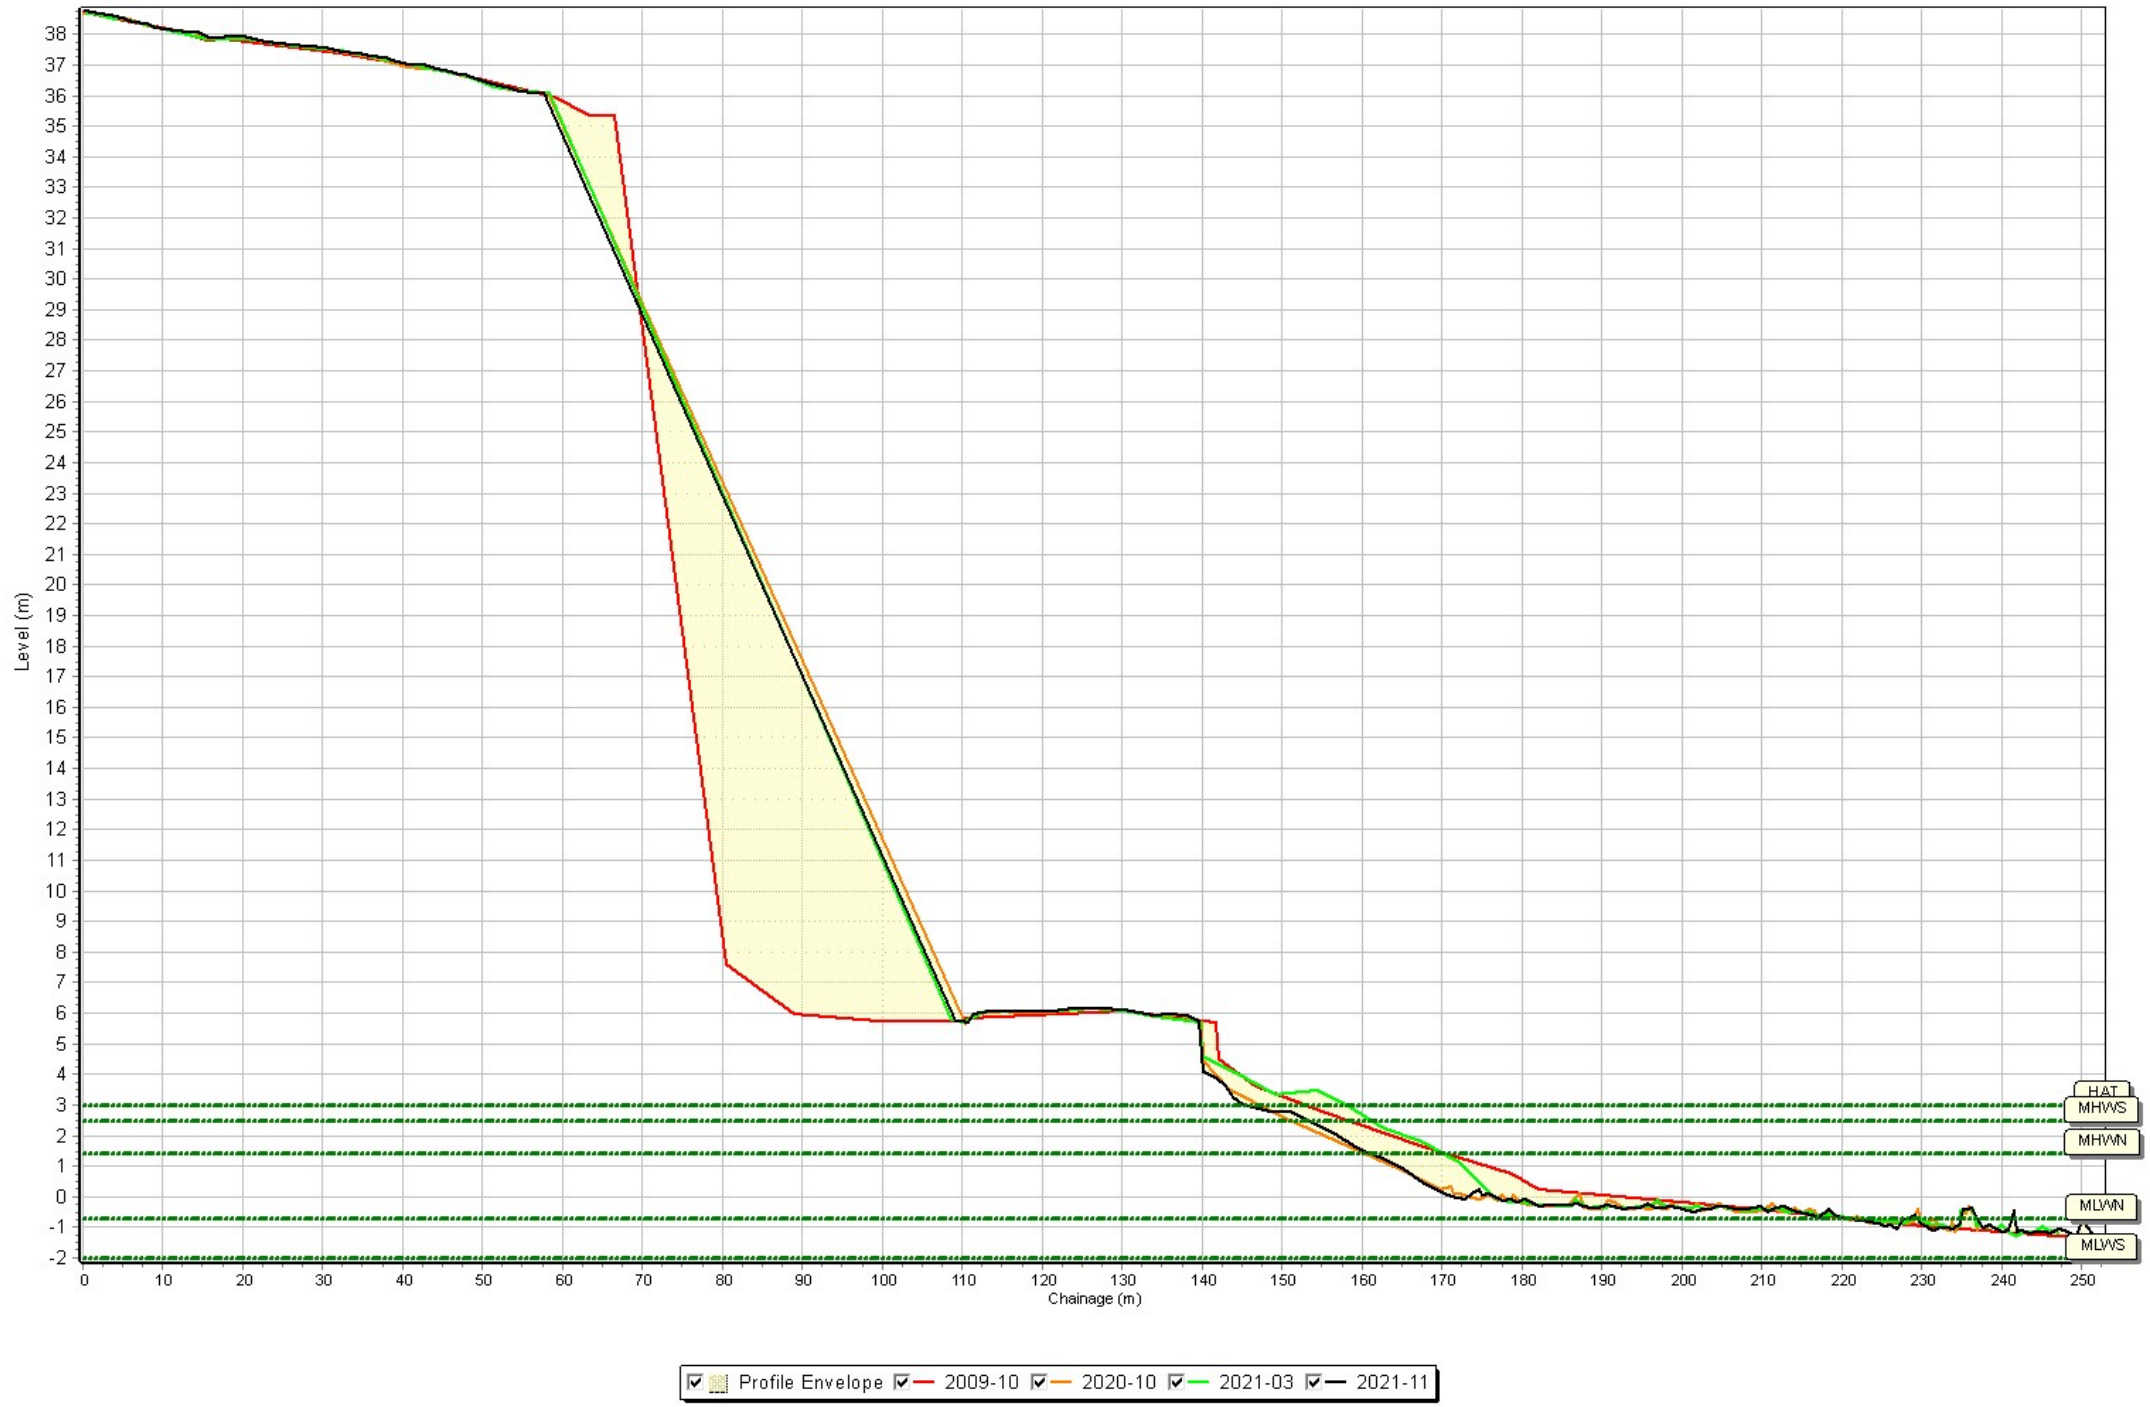
Profiles: 1bSH1A

At Blast Beach 1bSH1, 1bSH1A and 1bSH2 there was no access to the cliff top and at the cliff bottom of 1bSH1A due to dense vegetation.

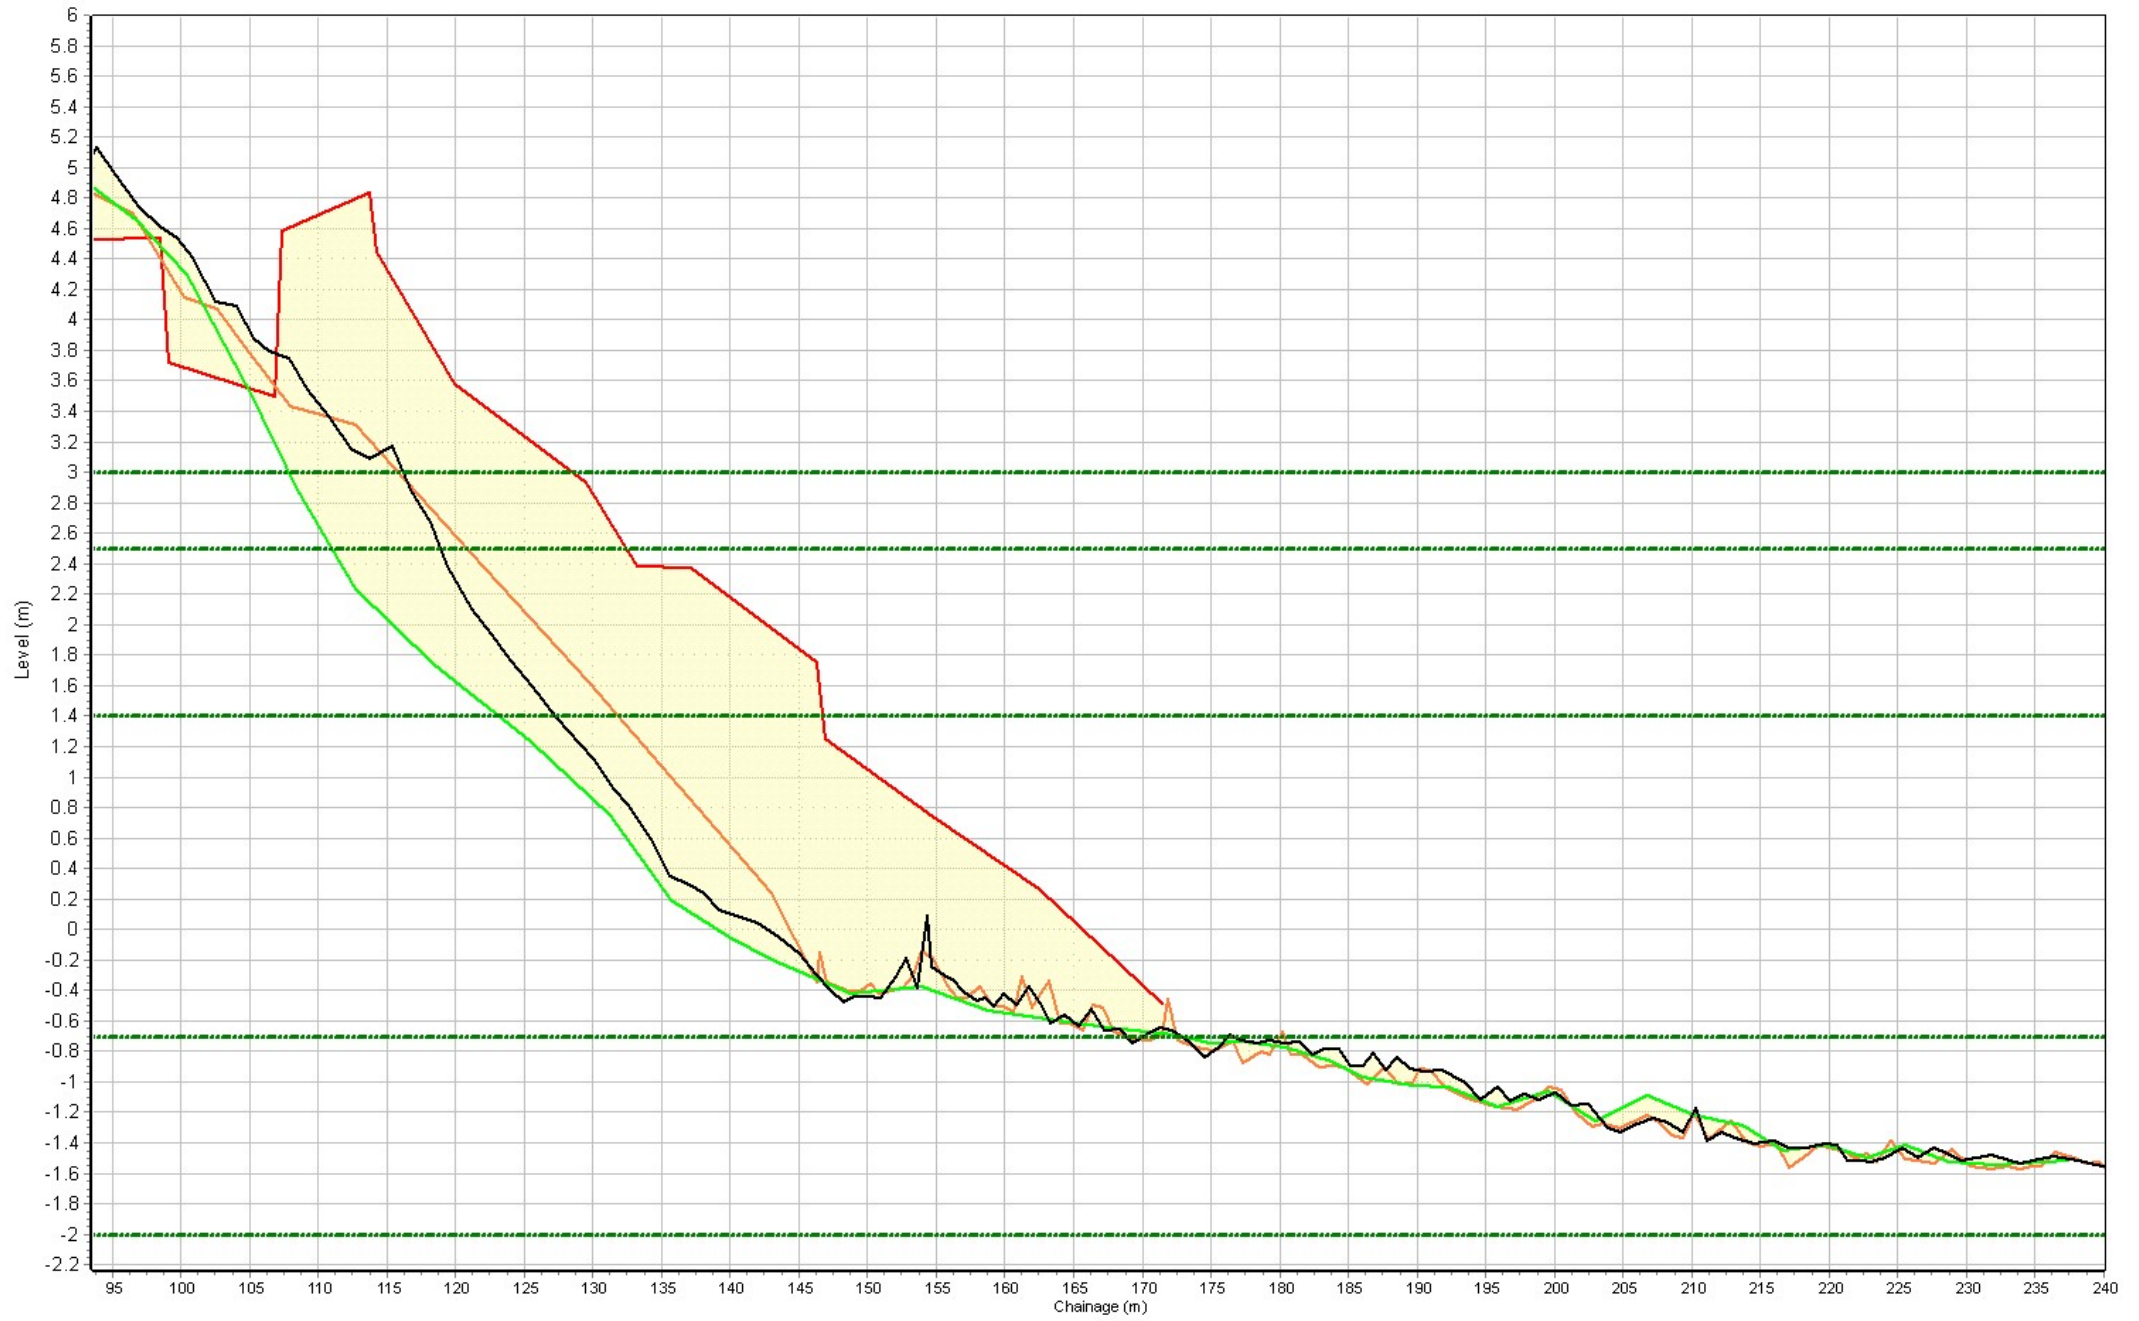
Profiles: 1cEA2

Survey Date	Description of Changes Since Last Survey	Interpretation
<p>3rd November 2021</p>	<p>Beach Profiles:</p> <p>Hawthorne Hive is monitored by beach profile 1cEA2 (Appendix A). The survey report notes “<i>unable to measure start of Section EA2 as the vegetation has choked out the section line and route over cliff faces</i>” and therefore all surveys following October 2012 start at 95m chainage.</p> <p>In previous years there was a channel which crossed the profile; however, since April 2013 it has been infilled. Since the previous survey in May 2021, the upper beach levels, between chainages 95m and 150m, appear to show signs of recovery. The beach has accreted by up to 1m in level at chainage 115m. The rocky foreshore remains exposed from chainage 150m to the end of the survey at chainage 240m and remains stable. Overall, the profile is at a medium level when compared to the range recorded from previous surveys.</p>	<p>In November 2021, the rocky foreshore from chainage 150m remains stable. The upper beach levels show signs of recovery since the previous survey in May 2021 where the levels were recorded to be at the lowest level on record.</p> <p>Longer term trends: The upper beach levels were recorded to be notably low in 2014, 2018 and more recently in May 2021. On all occasion the beach levels appeared to recovery. In November 2021 the beach was recorded to accrete up to 1m in places since the latest dip. Despite the recovery the profiles show the beach is undergoing progressive erosion.</p> <p>Limited cliff erosion occurs in this section and therefore sediment supply is limited to erosion of colliery spoil. Storm events which may block the channel and varying flows in Hawthorne Burn are likely to continue to episodically block the channel and change its course across the beach.</p>

At Hawthorne Hive the surveyor was unable to measure the start of Section 1cEA2 as the vegetation has choked out the section line and route over cliff faces.

- At Hawthorne Hive the levels on the foreshore have recovered since the latest low in May 2021 showing signs of accretion up to 1m. The levels are now back towards the middle of the range of previous surveys. However, it is likely that the long-term trend of progressive erosion will continue on this profile.

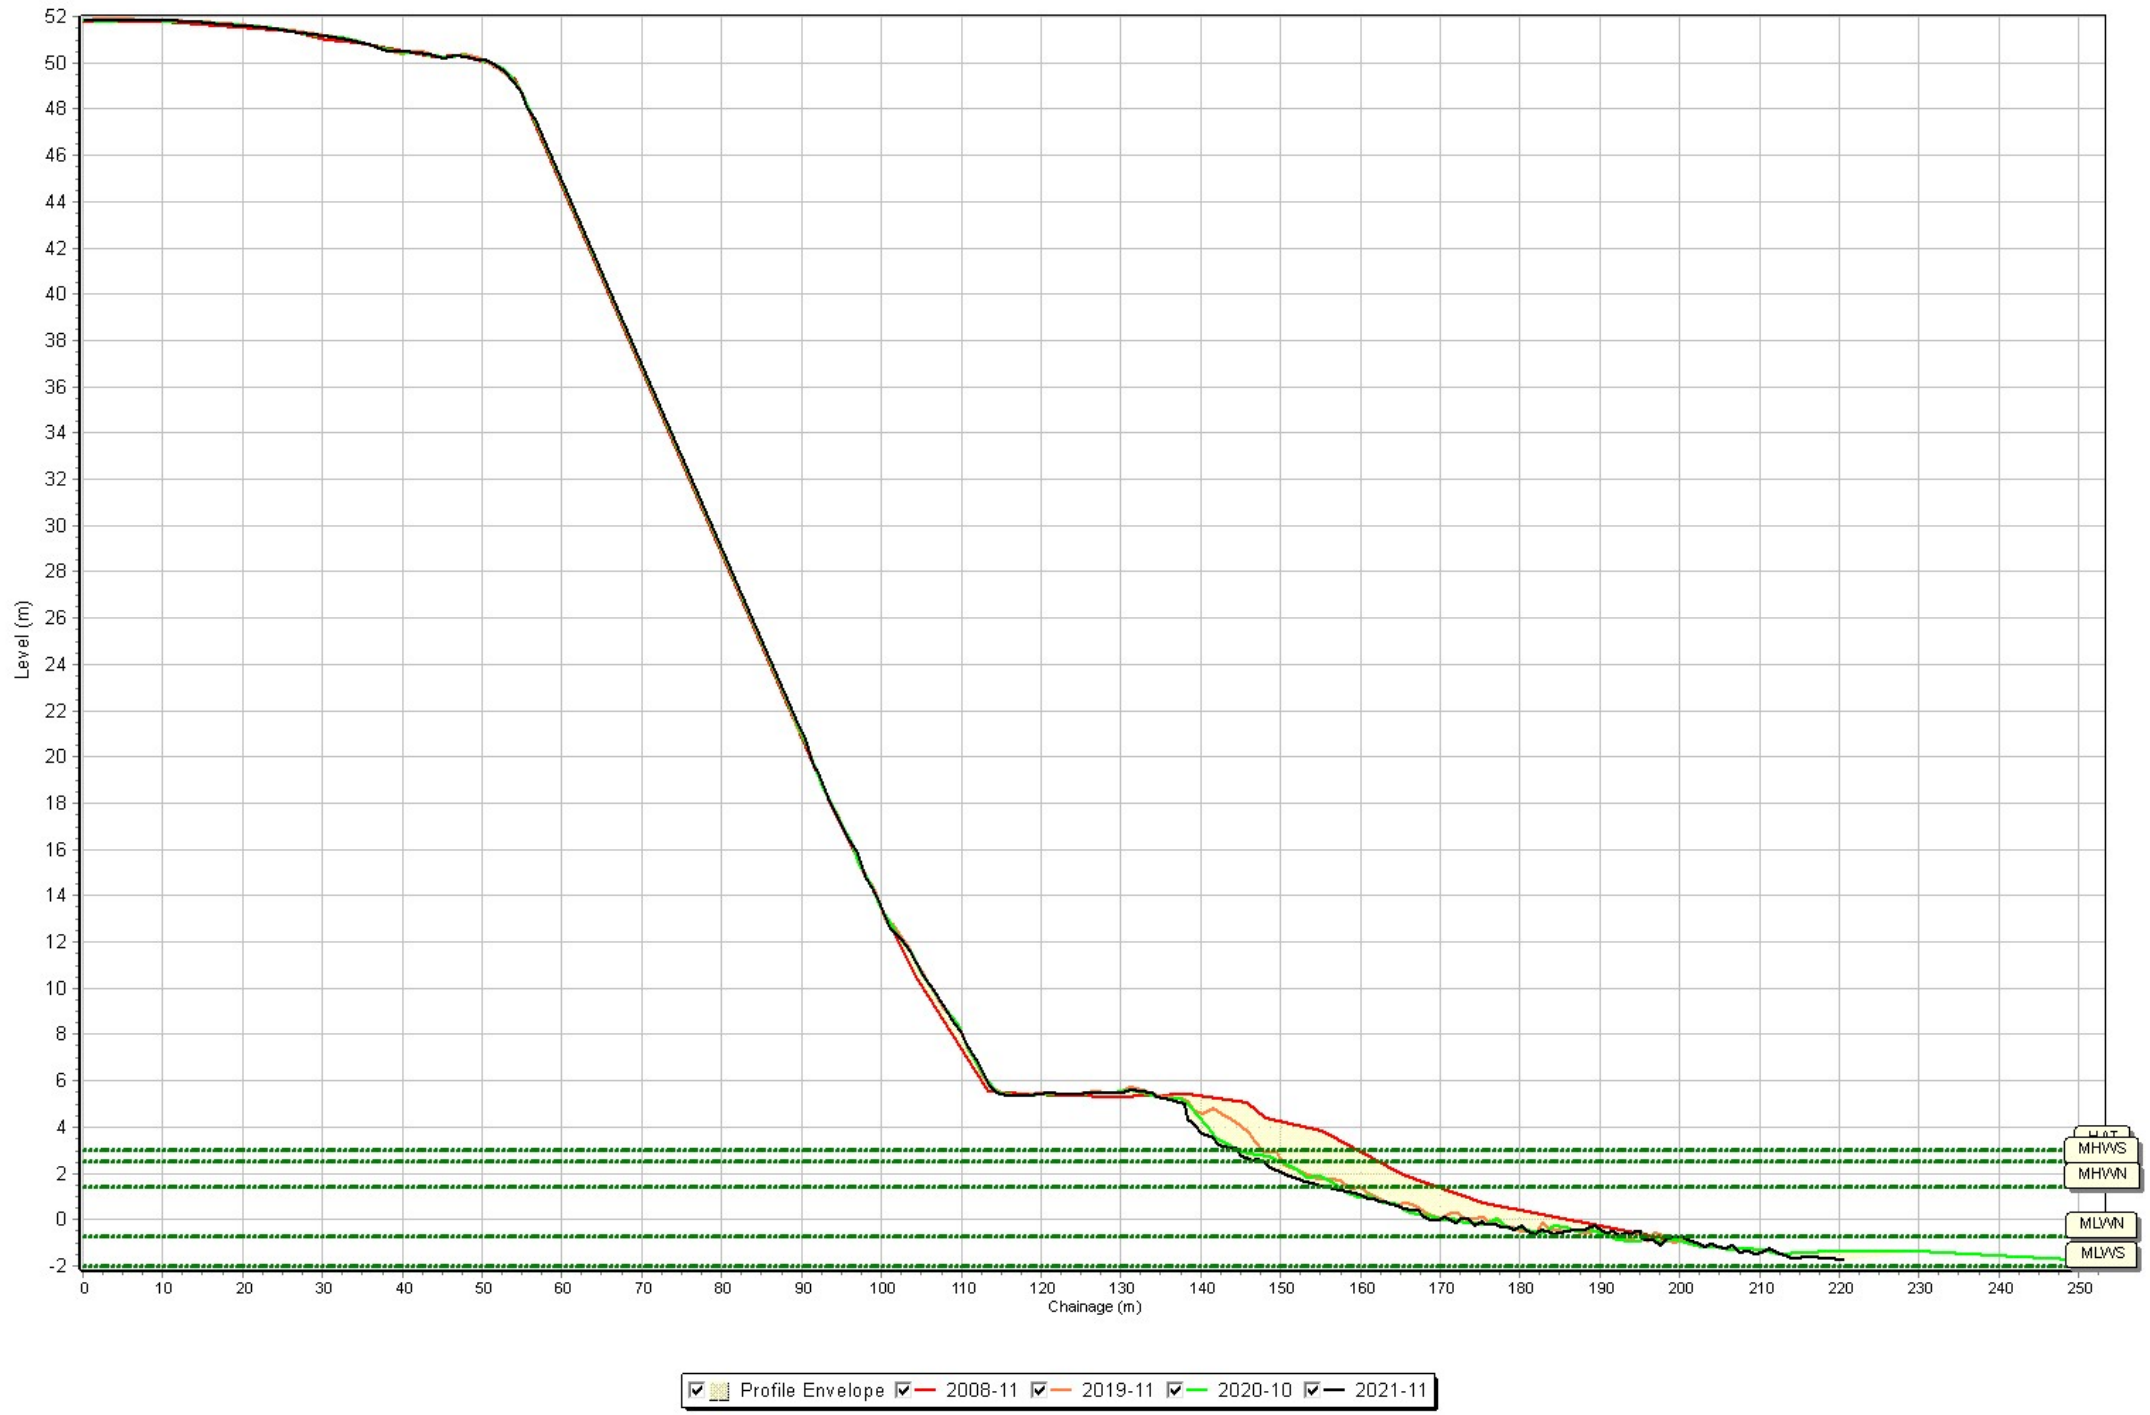
Profiles: 1cBH1

Survey Date	Description of Changes Since Last Survey	Interpretation
4 th November 2021	<p>Beach Profiles:</p> <p>Blackhall Colliery is covered by three beach profile lines (Appendix A). As at Blast Beach, profiles are dominated by colliery spoil and exhibit similar forms with a rock cliff, wide spoil beach with a distinct cliff at the eroding face of the colliery spoil, and a gravel and sand foreshore that extends to MLW. The survey report notes that the surveyor was <i>'unable to survey part of section BH1 and BH2 due to dense vegetation'</i> furthermore, the surveyor was <i>'unable to survey part of section BH3 due to deep water at the back of the beach'</i>.</p> <p>1cBH1 is located near Horden Point and the Full Measures 2021 survey shows that the profile has remained stable up to the toe of the cliff at chainage 115m. Between chainage 115m and the crest of the upper beach at chainage 131m there has been no discernible change. Across the face of the colliery spoil there has been some slumping and erosion, causing the crest of the spoil to retreat 2m. A similar level of erosion is observed from the spoil face to chainage 160m where there has been a drop in level of up to 0.4m. This has resulted in this section of the profile being at its lowest when compared to the range of previous surveys. Seawards of chainage 160m the boulder foreshore has experience little change limited to the local movement of the rocks.</p> <p>Profile 1cBH2 exhibits no change in the cliff profile. The cliffed-edge of the spoil beach has retreated landwards by approximately 5m since October 2020. There is around 30m of material from the eroding face at the back of the beach to the cliff toe. From the toe of the spoil face, now at chainage 156m, across the upper beach to chainage 189m there has been erosion of up to 0.7m in level. Seawards of chainage 189m, the mid to lower beach has accreted as a result of the draw down of material from the upper beach. The maximum accretion is 1.2m in level at chainage 207m. The profile is generally low when compared with the range of previously recorded results particularly at the spoil face and upper beach. The mid to lower beach is medium when compared with the previous results.</p> <p>The profile 1cBH3 shows that since 2008 there has been episodic migration, infilling and scouring of the outflow of Castle Eden Burn, which crosses the profile. In the November 2021 profile there has been no change at the toe of the cliff at chainage 128m. The profile suggest that the channel bed has accreted by 0.3m in level, however the surveyors noted that access was limited in this area due to deep water</p>	<p>Profile 1cBH1 shows slumping and erosion across the spoil face with the beach profile continuing to become shallower year on year. The spoil face has retreated 2m between May and November 2021.</p> <p>Similarly, the spoil face at profile 1cBH2 has retreated 5m, leaving 30m of material to the cliff toe. This erosion has caused drawn down of material resulting in accretion of the lower beach.</p> <p>1cBH3 shows continued migration of the Castle Eden Burn channel, the beach berm forming the seaward edge has retreated 2m landwards.</p> <p>Longer term trends: The surveys show that the spoil beach along much of the Blackhall Colliery shore is progressively eroding but continues to protect the cliffs in the short term. There is approximately 24m of spoil between the eroding face and cliff toe at profile 1cBH1 and 30m at 1cBH2, with both experiencing further erosion in 2021.</p>

At Blackhall the surveyor was unable to access part of sections 1cBH1 and 1cBH2 due to dense vegetation. The surveyor was also unable to survey part of Section BH3 due to deep water at the back of the beach.

- At Blackhall Colliery, the seaward face of the colliery spoil deposit continues to erode in the northern part of the bay (2m at profile 1cBH1 and 5m at profile 1cBH2) . In the south of the bay, mound of beach material has retreated landward, narrowing the channel. The channel is likely to scour the beach sediments under high flows but become infilled again by wave action under storm conditions.
