Cell 1 Regional Coastal Monitoring Programme Analytical Report 14: 'Full Measures' Survey 2021

Durham County Council

January 2022

(*) The present report is **Analytical Report 14** and provides an analysis of the 2021 Full Measures survey for County Durham Council's frontage.

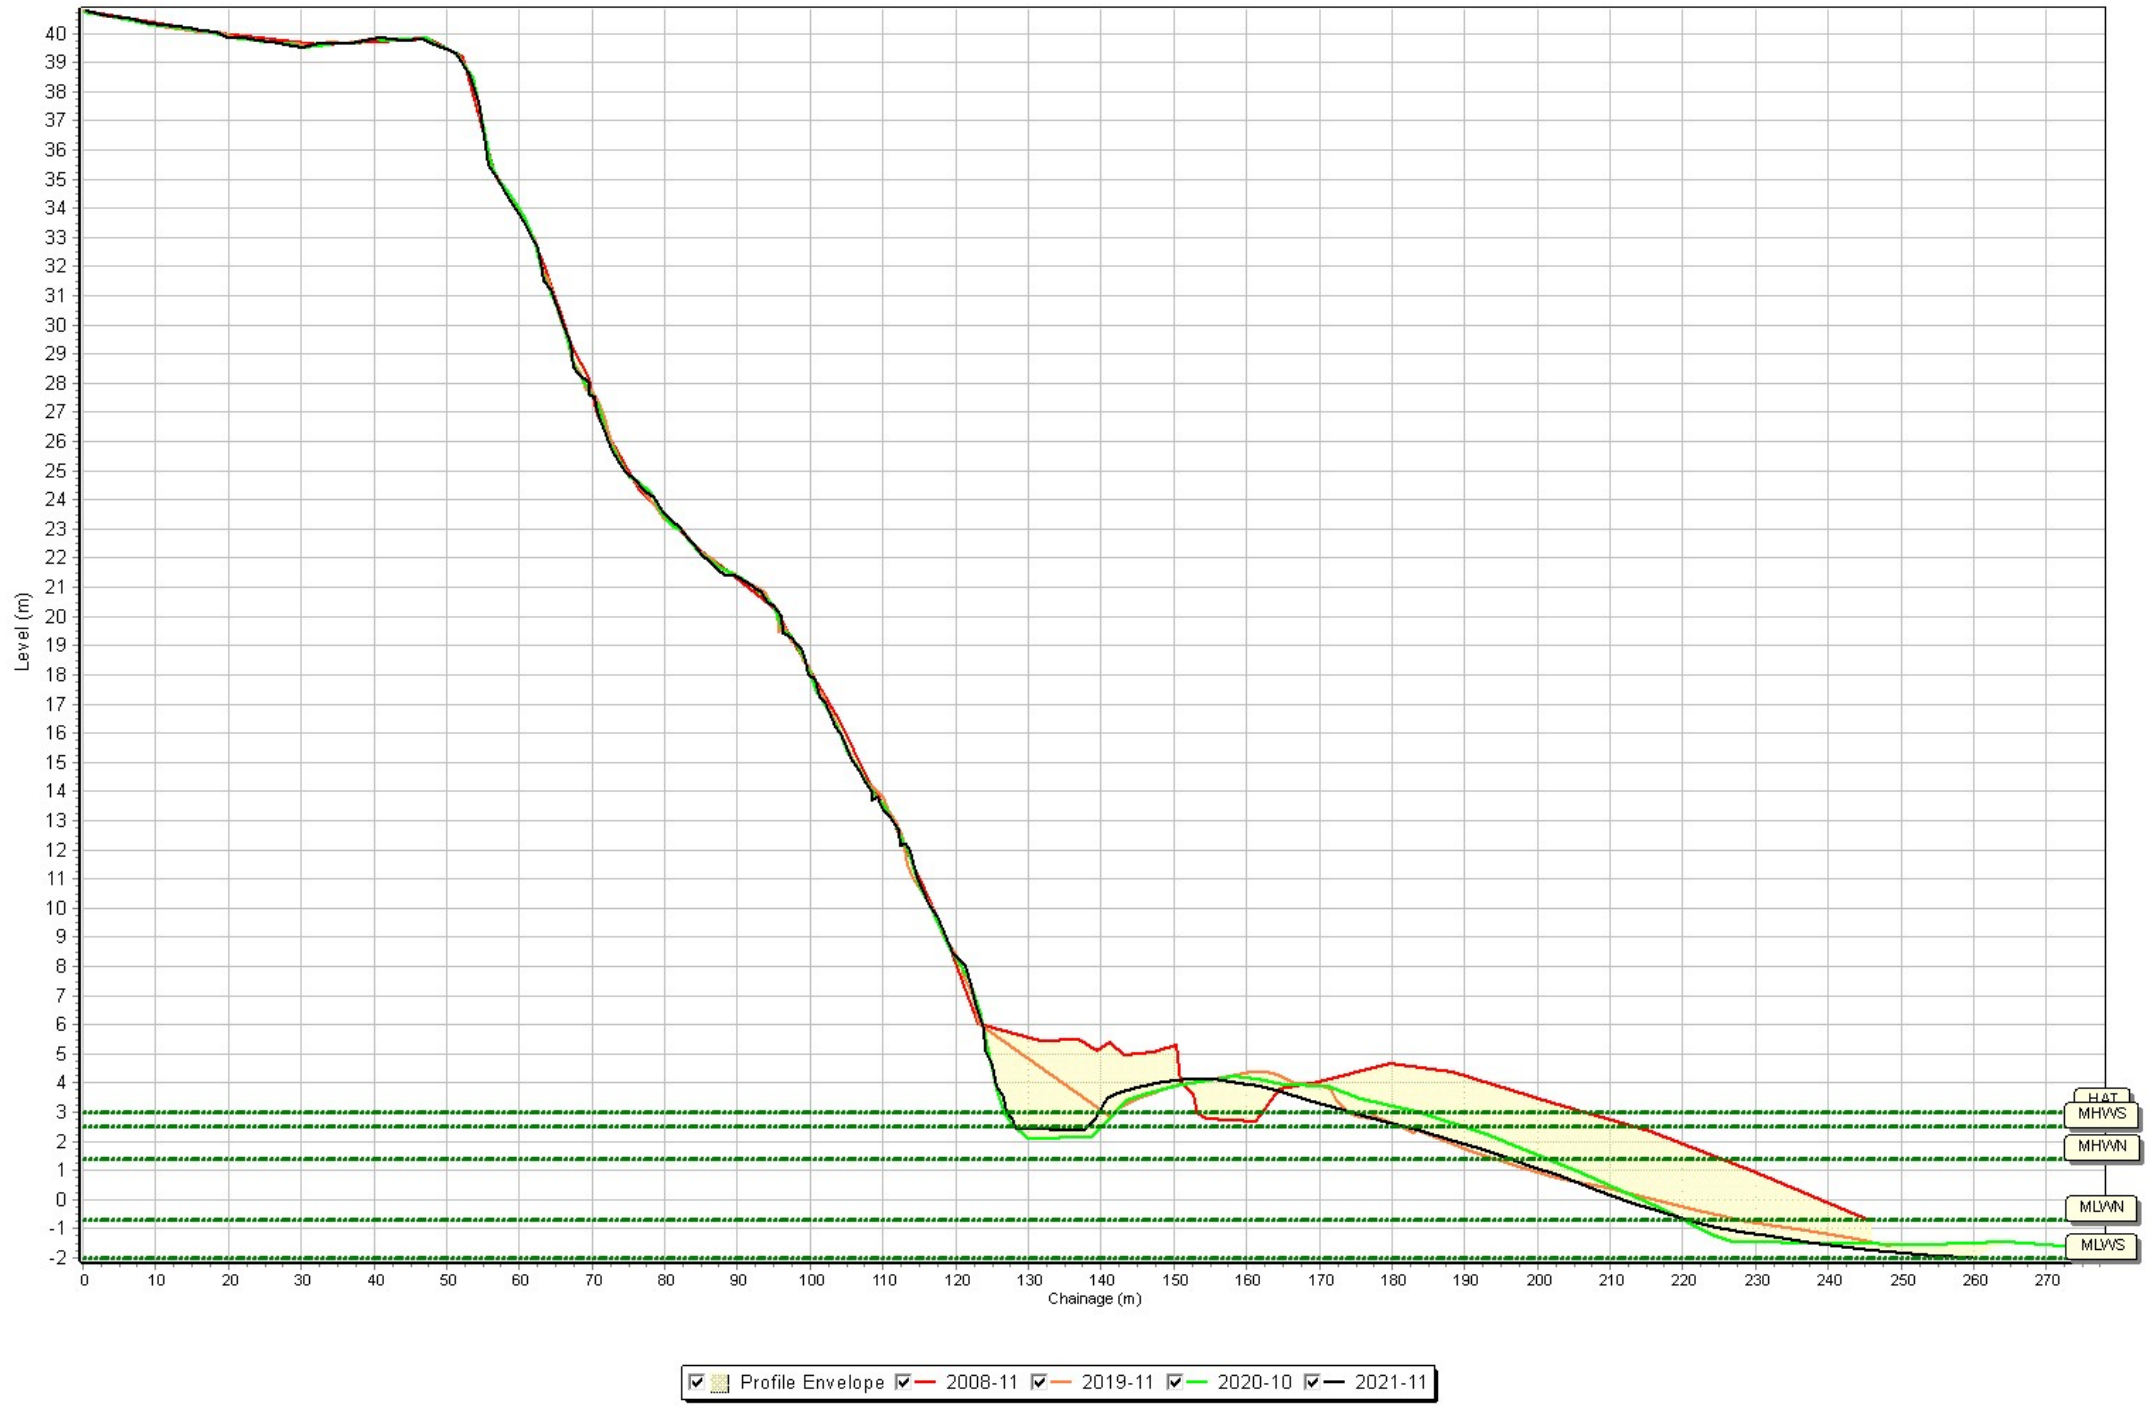
Profiles: 1cBH3

Survey Date	Description of Changes Since Last Survey	Interpretation
	<p>and therefore this change may not be reflective of actual changes. The berm that forms the seaward edge of the channel and beach has shifted 2m landward since the previous survey, narrowing the channel. When comparing the levels of the beach to the range from previous it appears the beach is at its lowest on record, however this not necessarily due to loss of material but more a reflection of the beach berm shifting landwards.</p>

At Blackhall the surveyor was unable to access part of sections 1cBH1 and 1cBH2 due to dense vegetation. The surveyor was also unable to survey part of Section BH3 due to deep water at the back of the beach.
