Cell 1 Regional Coastal Monitoring Programme Analytical Report 15: 'Full Measures' Survey 2022

Durham County Council

January 2023

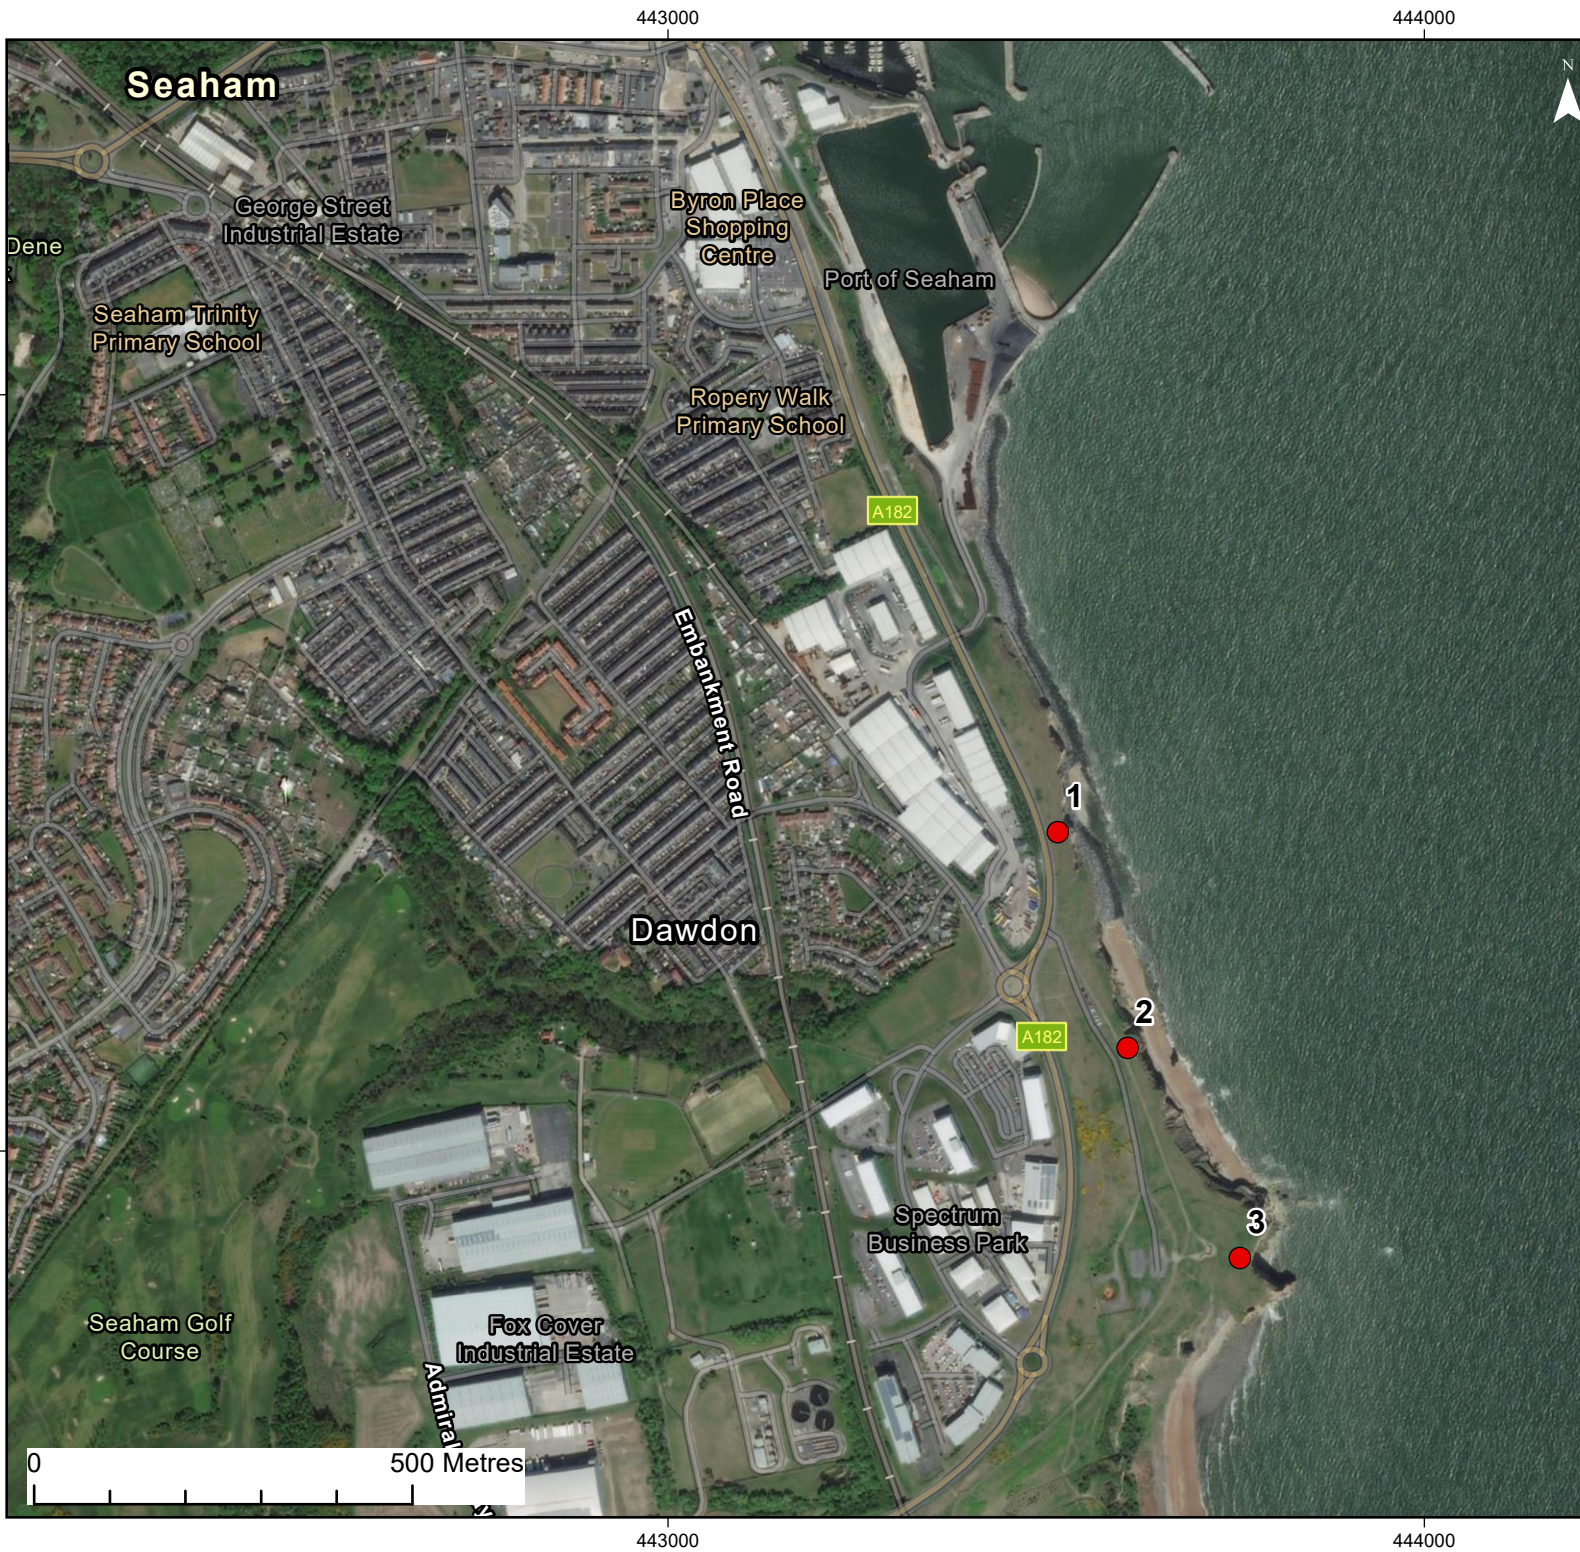
Figure 3 - Map 1

SURVEY LOCATIONS

- Cliff Top Survey Points

Survey Date	Description of Changes Since Last Survey	Interpretation
<p>24th November 2022</p>	<p>Cliff-top Survey:</p> <p>Three ground control points have been established along the cliff top at Dawdon (Figure B1). The separation between any two points is nominally 300m. These cliff top surveys are intended to inform on erosion rates of the undefended sea cliffs extending south of the rock armour revetment to the south of Seaham Harbour.</p> <p>The cliff top surveys at Dawdon are undertaken bi-annually. Measurements are taken from a fixed ground control point along a fixed bearing to the edge of the cliff top. Appendix B provides information about the ground control points and results from between the 2008 (baseline) cliff top survey and the current (November 2021) survey.</p> <p>Between April 2022 and November 2022, none of the three control points have experienced any significant movement (>0.1m), recording 0.07m, -0.03m and 0.03m respectively. Any movement less than the 0.1m is considered within the margin of error of the monitoring technique, highlighted by the apparent advancement in cliff line in Point 2.</p> <p>Appendix B provides results from the November 2022 survey, showing the distance from the ground control point to the edge of the cliff top along the defined bearing and changes in position since the November 2008 baseline survey.</p>	<p>None of the three control points recorded a retreat greater than the margin of error (0.1m) over of the summer of 2022 indicating a period of stability which is to be expected in calmer summer months.</p> <p>Longer term trends: Long-term recession rates calculated from the data collected since November 2008 show retreat at 0.09m/yr. for Point 1, 0.03m/yr. for point 2 and 0.10m/yr. at Point 3.</p>

Three ground control points have been established on the Seaham frontage (Figure B1). The maximum separation between any two points is nominally 300m.

The cliff top surveys at Seaham are undertaken biannually. Measurements are taken from a fixed ground control point along a fixed bearing to the edge of the cliff top.

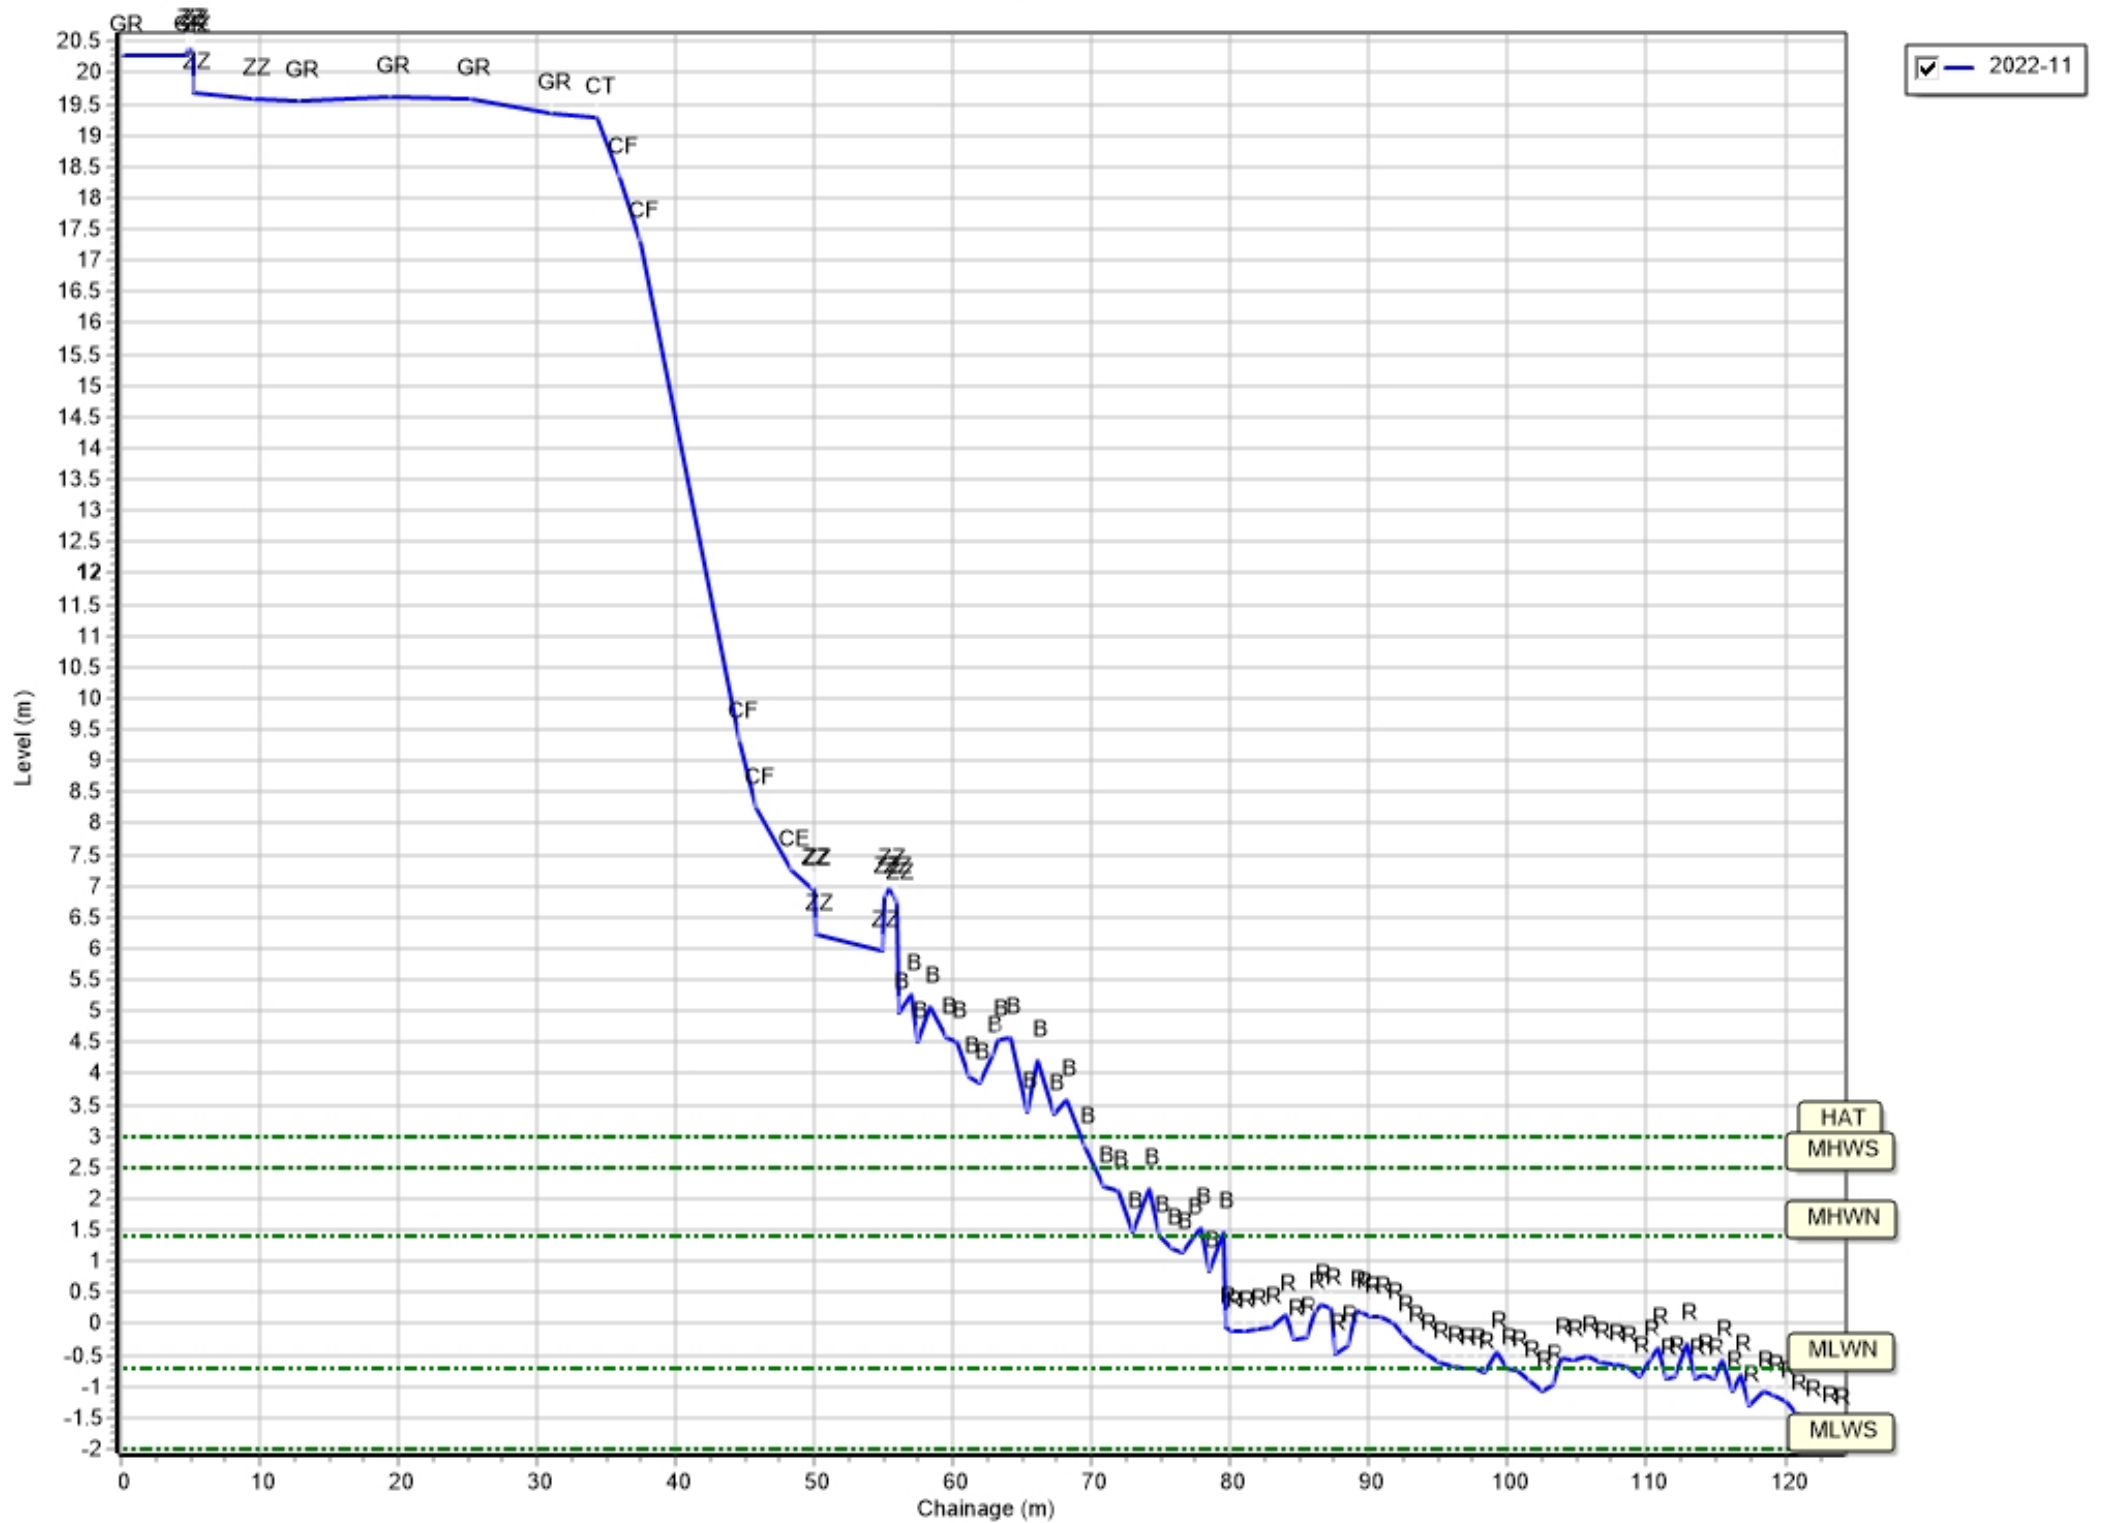
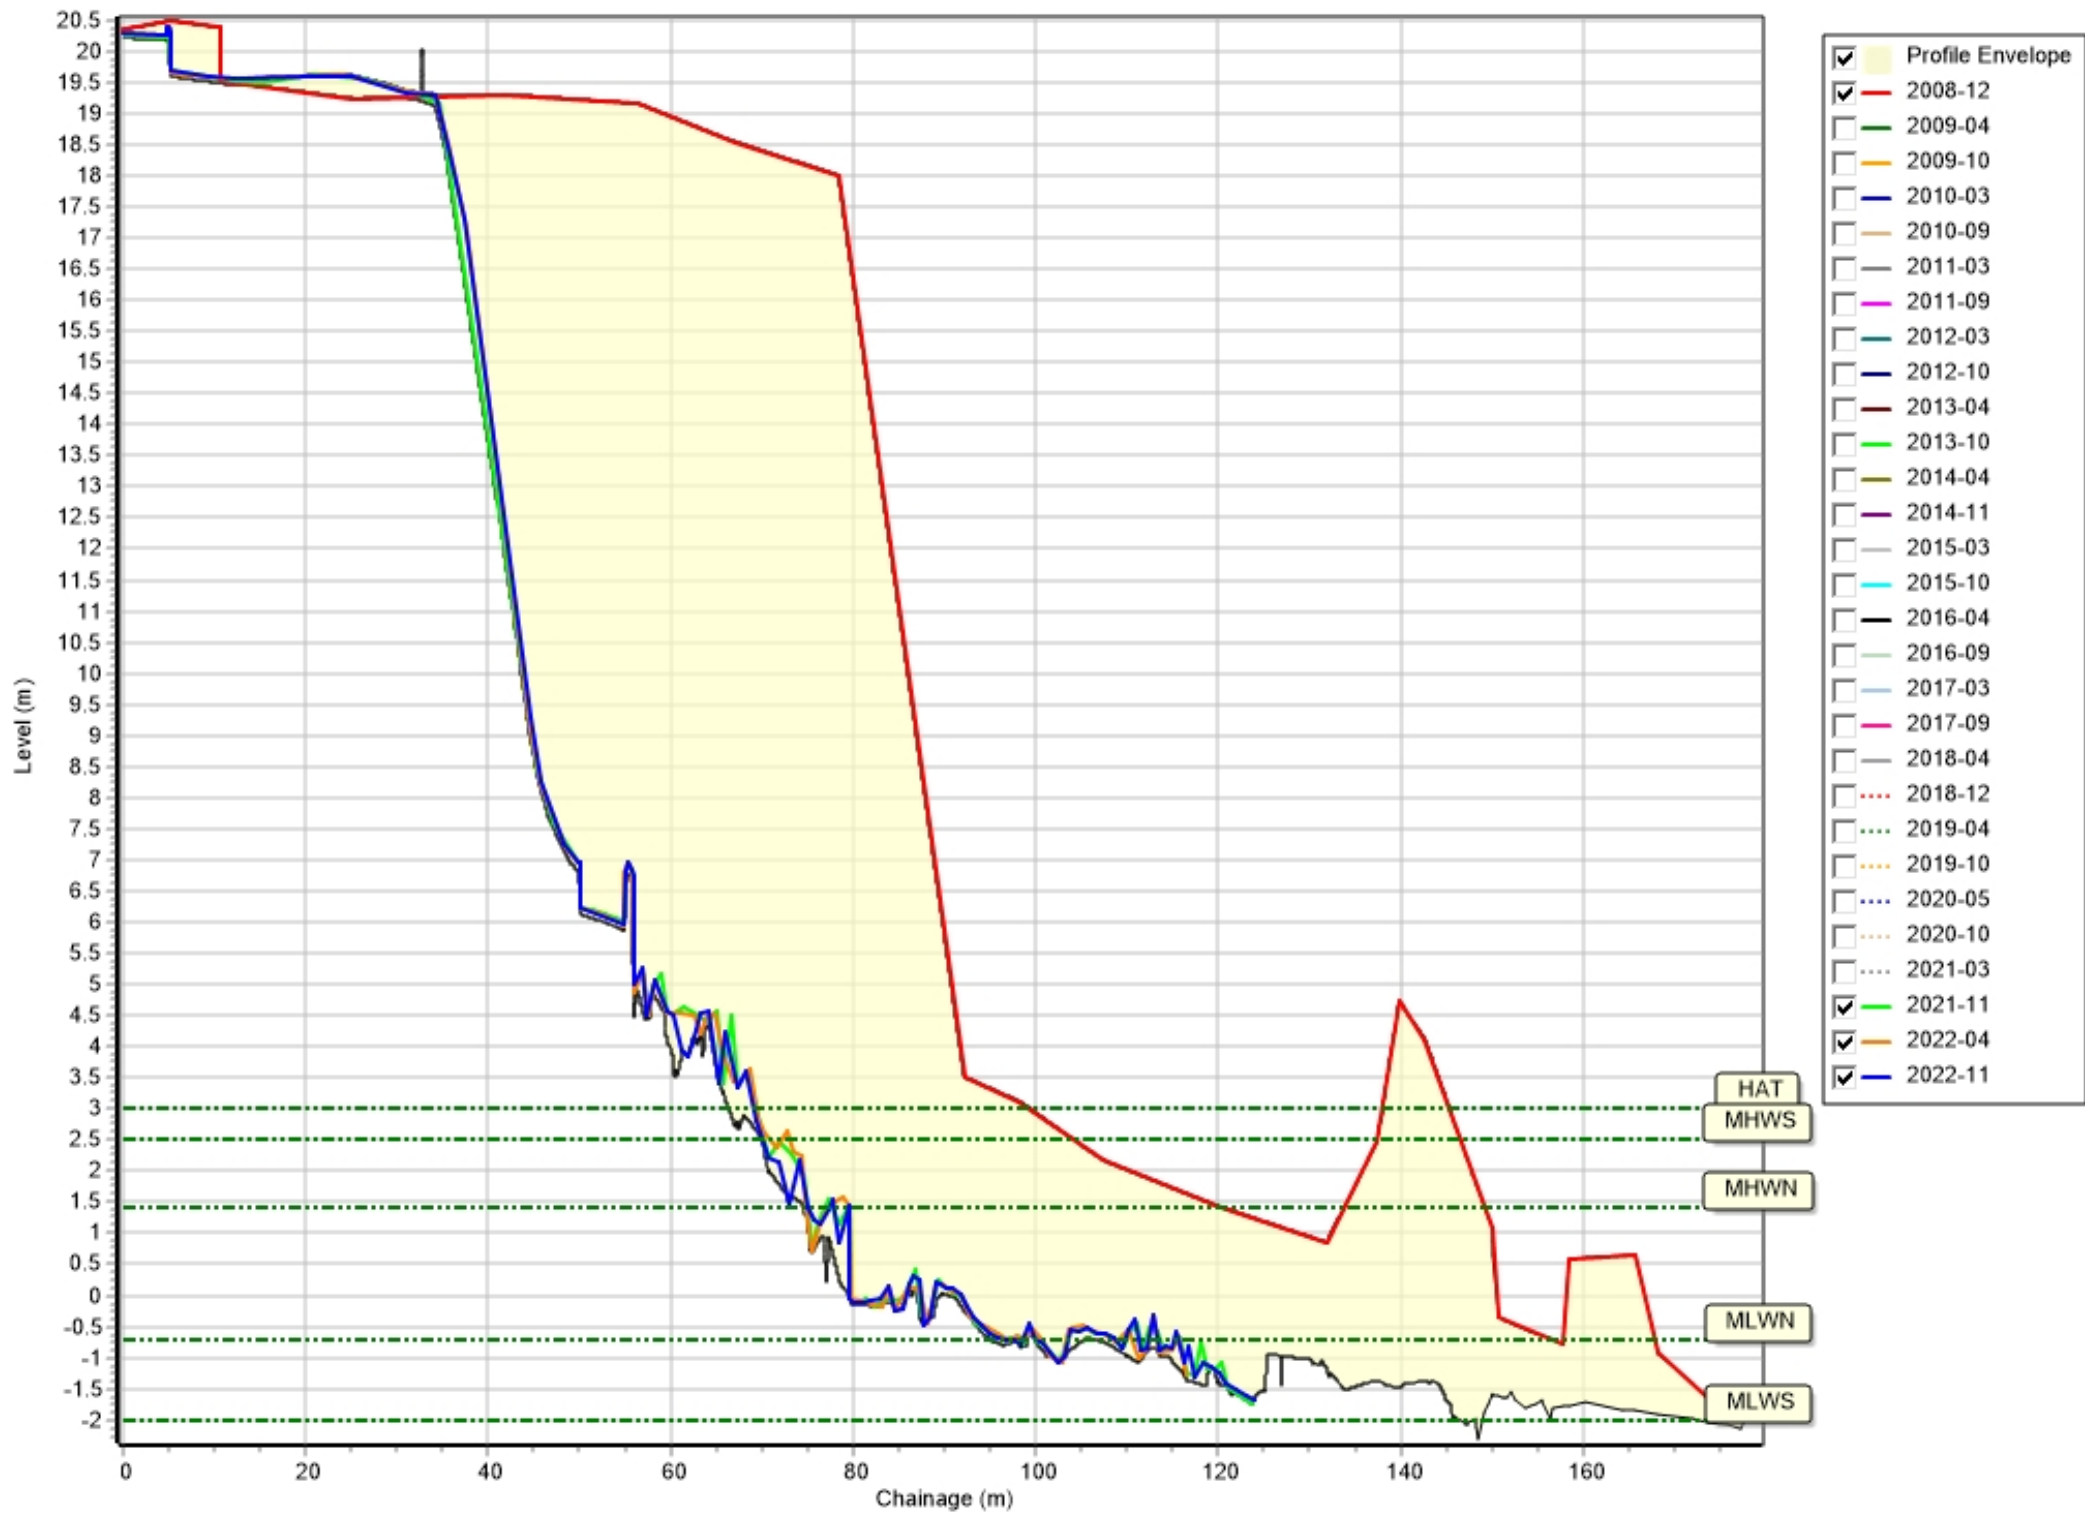
Profiles: 1bEA1

Survey Date	Description of Changes Since Last Survey	Interpretation
24 th November 2022	<p>Beach Profiles:</p> <p>Beach profile line 1bEA1, located at Featherbed Rocks (Appendix A), has been monitored since April 2009. The profile extends across the cliff top and cliff face then extends across the promenade (chainage 55m), rock armour sea defence (chainage 55m to 80m) and beach. Seaward of the rock armour at chainage 80m, there has again been very little change over the summer of 2022. The beach profile reflects the rocky nature of the foreshore with any minor change reflecting the movement of pockets of sediment between the rock outcrops. Previous surveys have shown accumulations of material at the base of the revetment, but this has not been present since the 2012 Full Measures survey.</p>	<p>Longer term trends: The cliff top and cliff face in this location appear stable and are unlikely to activate whilst the coastal defences remain present.</p> <p>The rocky nature of this foreshore means it is unlikely to undergo significant changes in morphology unless sediment is deposited upon it. A veneer beach was reportedly present between 2010 and 2012 but has not been recorded since.</p>

- There has been little change at Featherbed Rocks. The rocky shore platform remains exposed with the veneer beach that was present in earlier surveys still absent since autumn 2012.

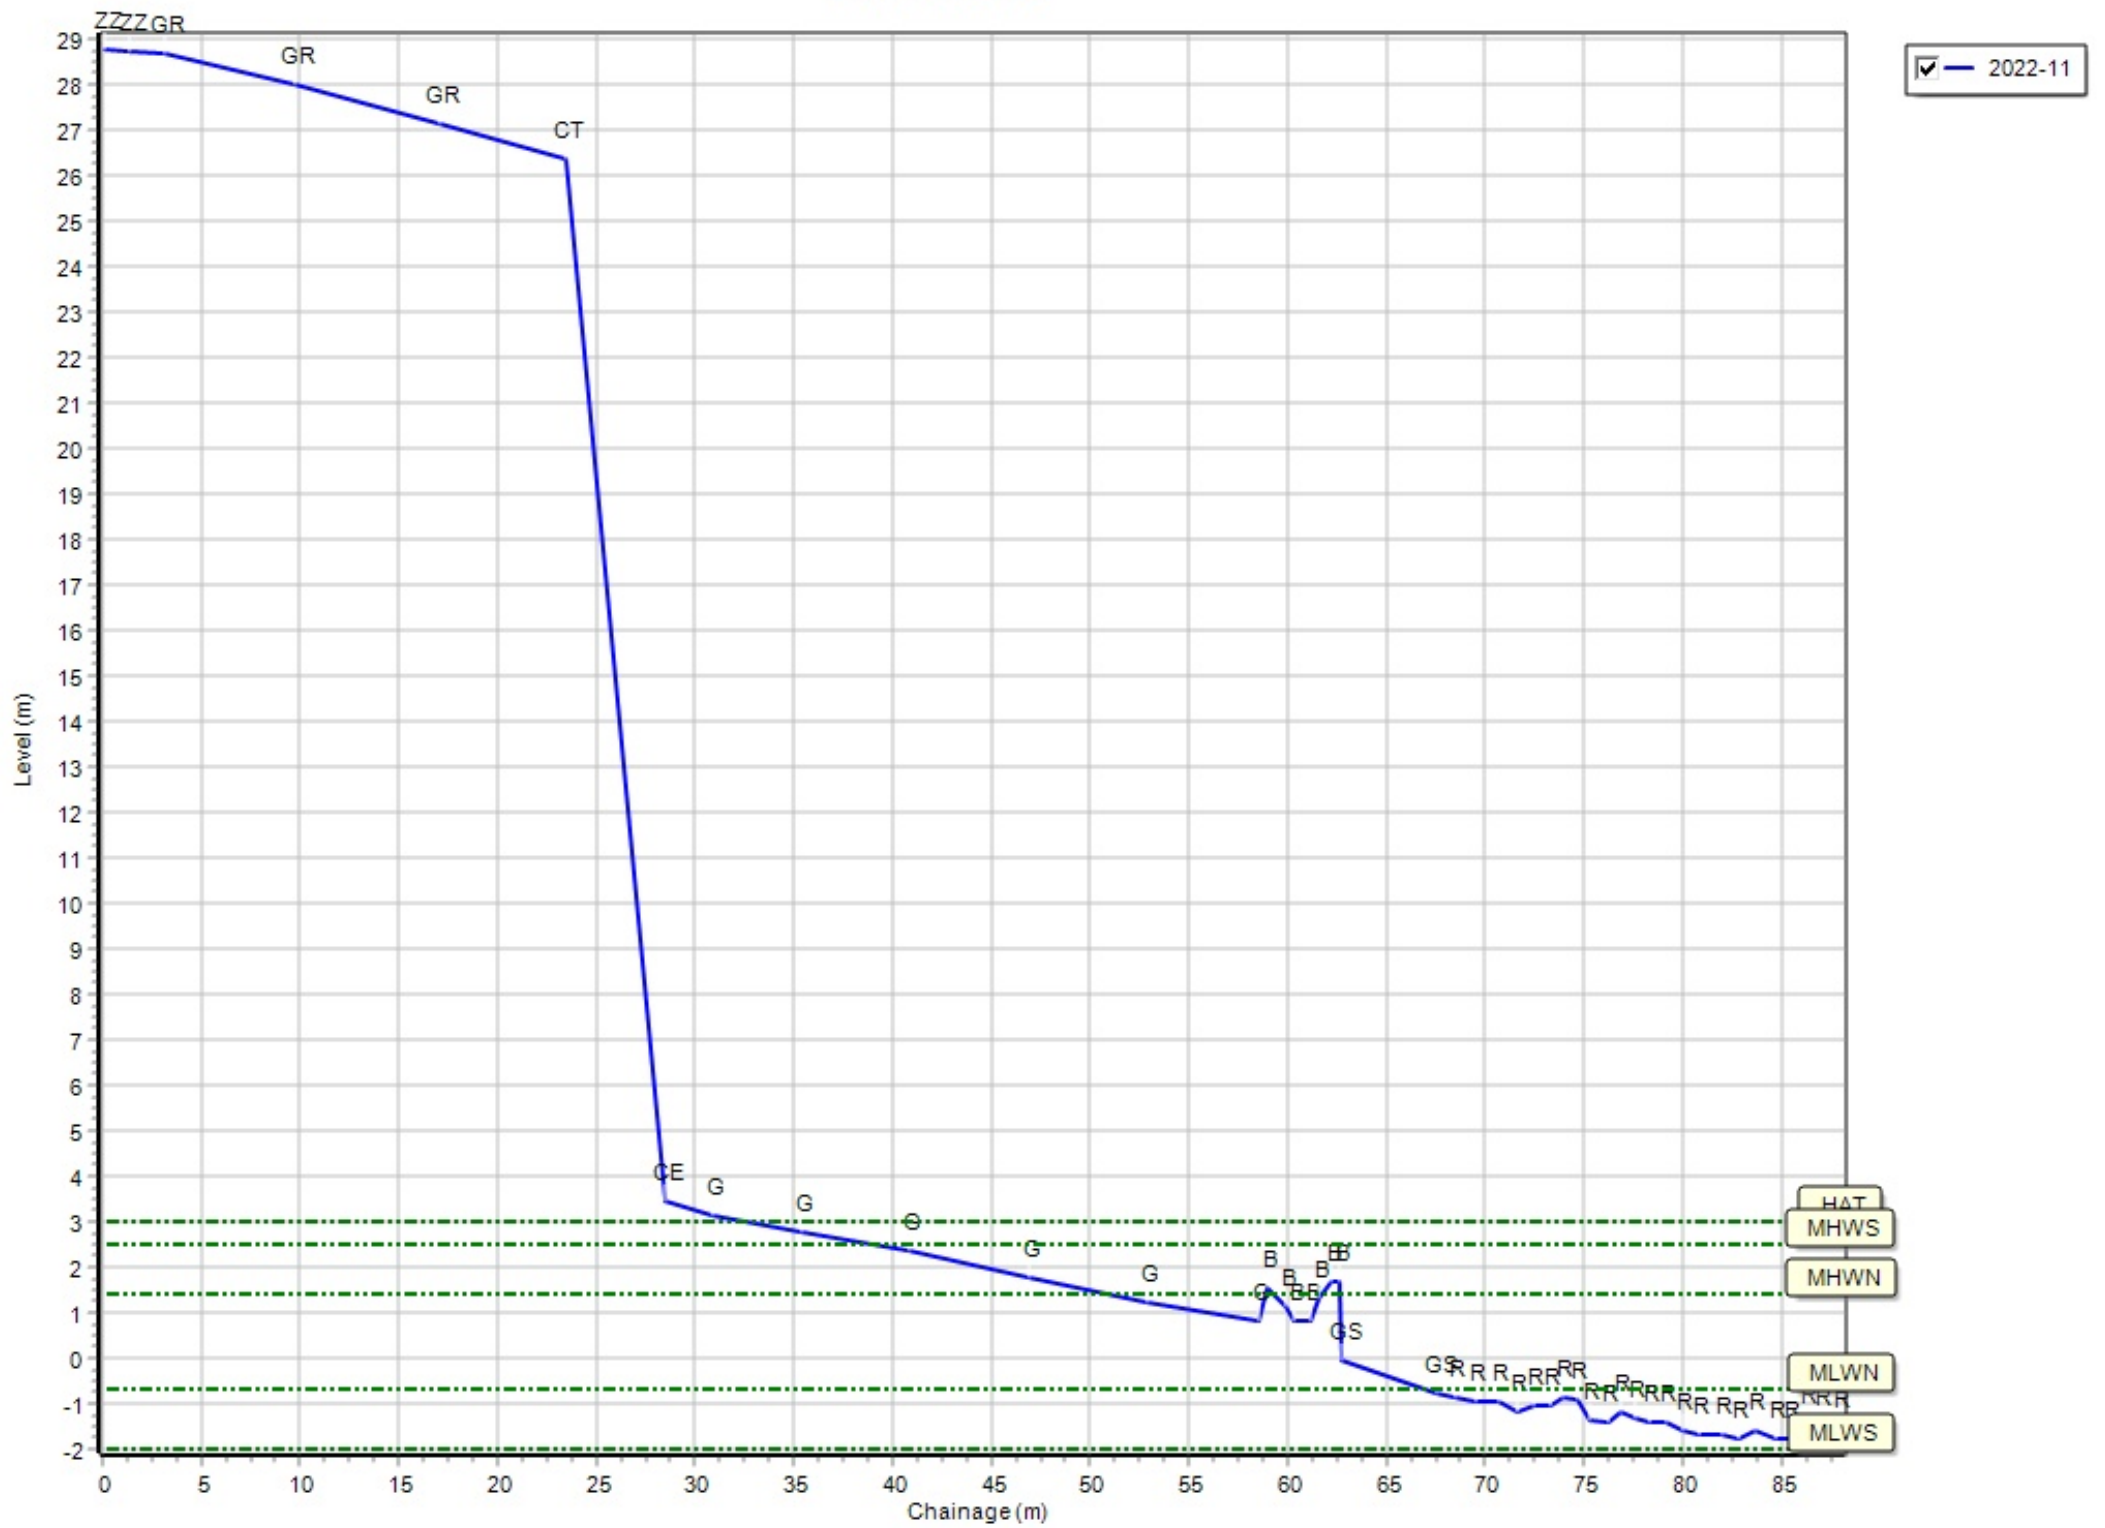
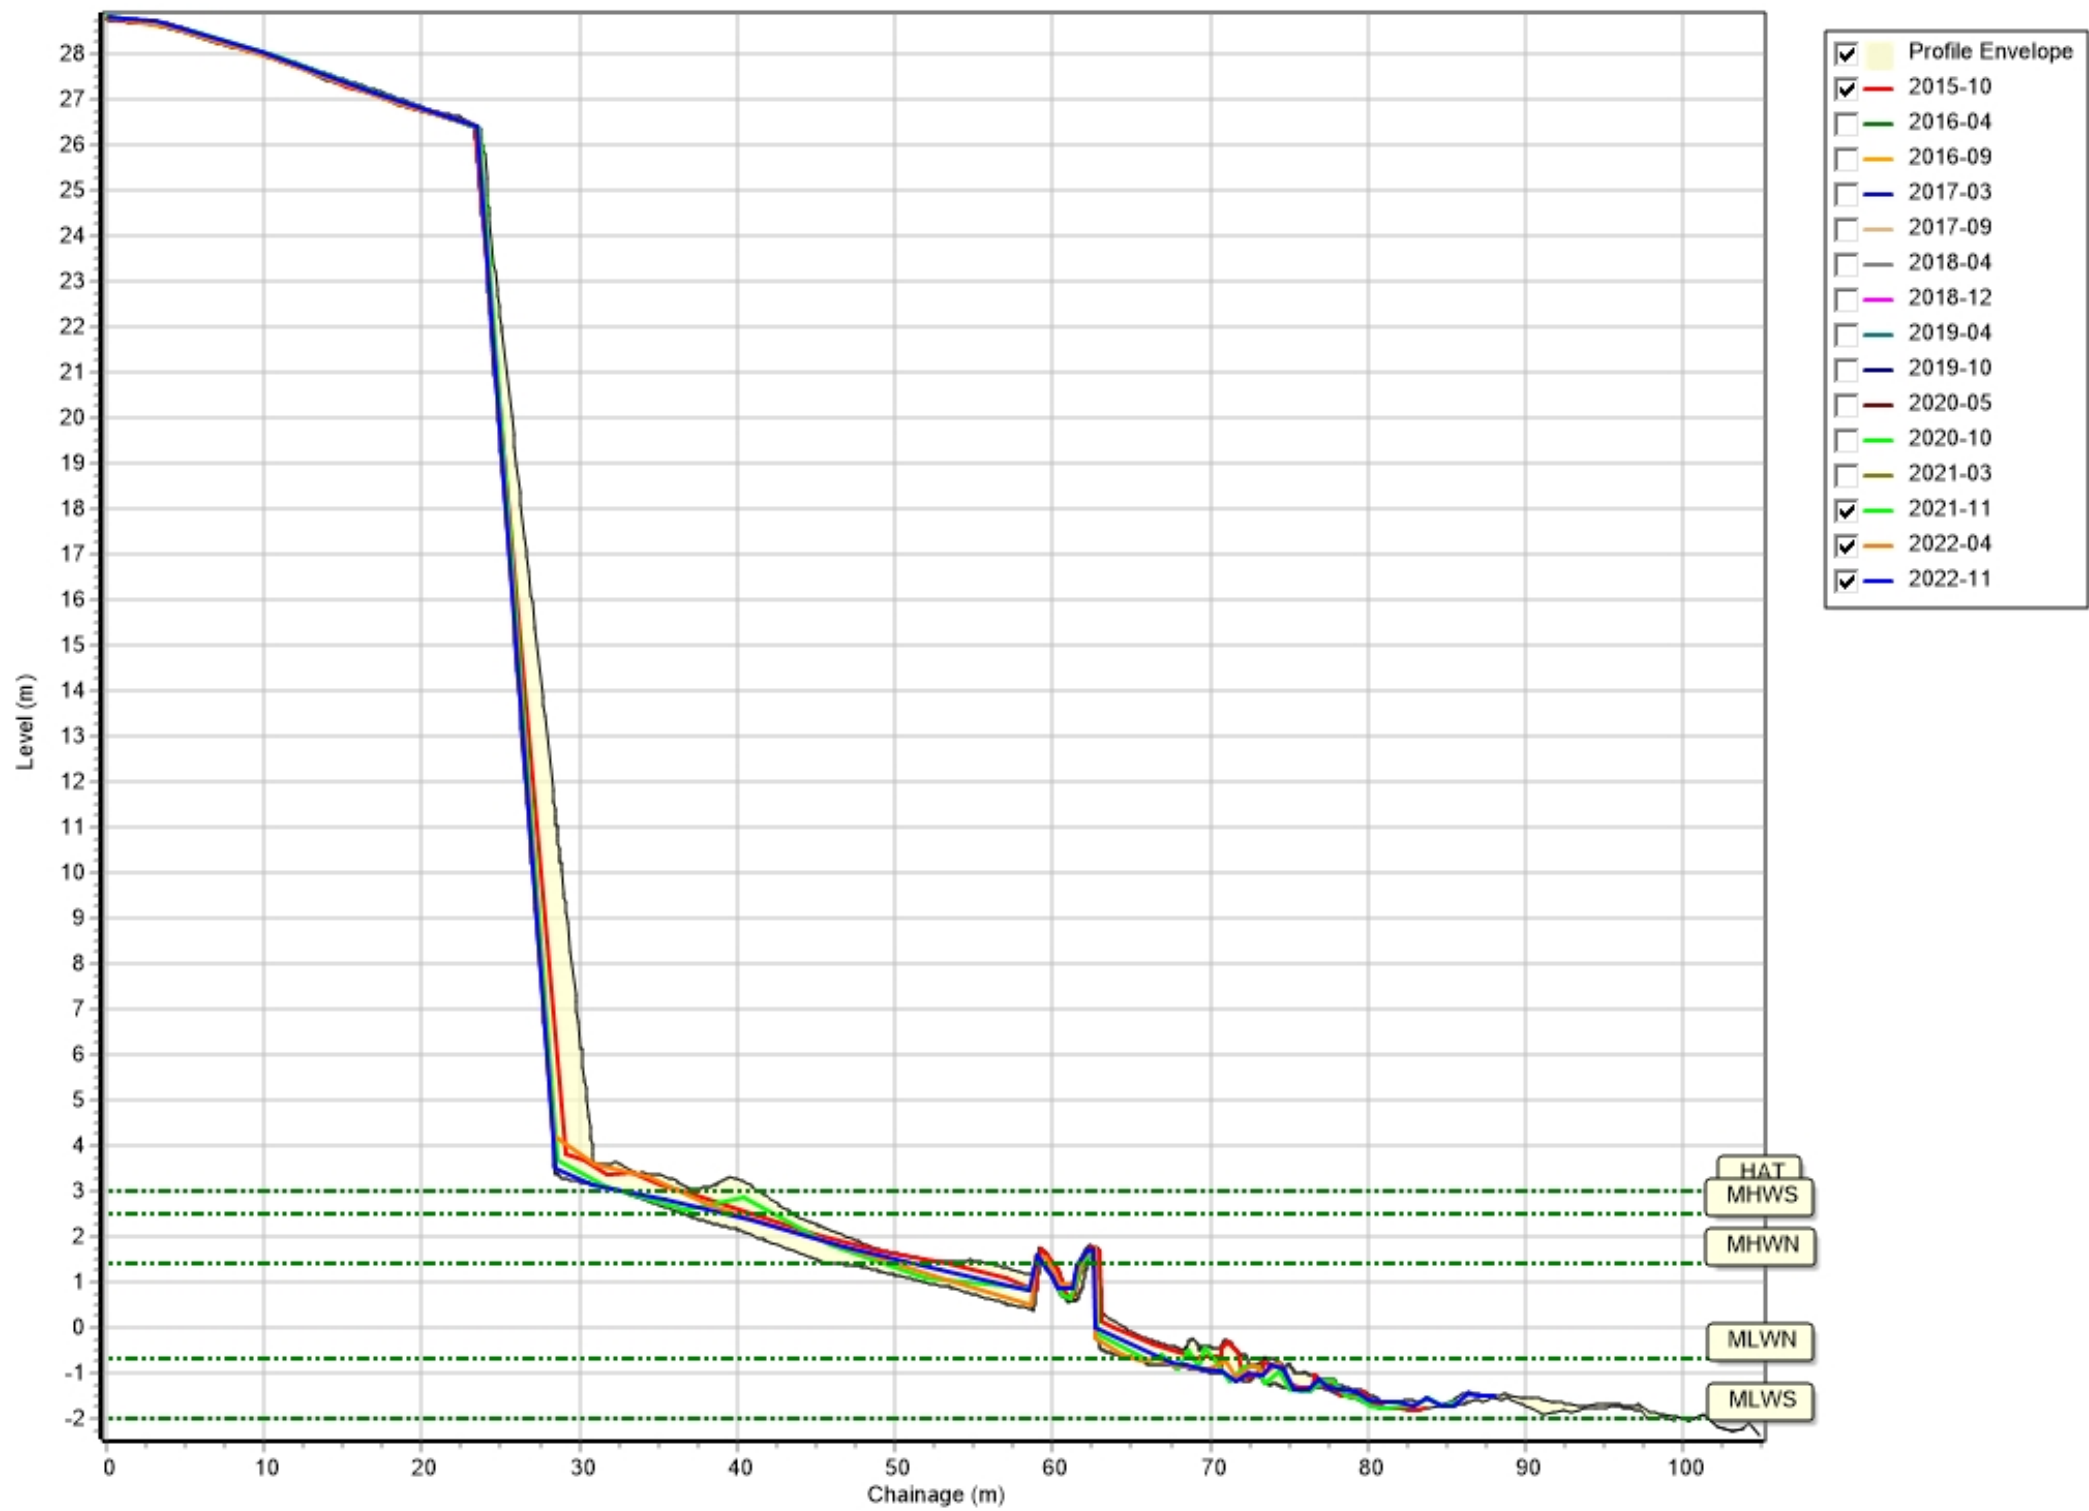
Profiles: 1bSH1B

Survey Date	Description of Changes Since Last Survey	Interpretation
<p>24th November 2022</p>	<p>Beach Profiles:</p> <p>Blast Beach and Chemical Beach are covered by four beach profile lines (Appendix A). All the profiles exhibit similar forms, with a rock cliff, wide colliery spoil beach with a distinct low cliff at its eroding seaward edge, and a mixed gravel and sand foreshore extending to MLW. The survey report notes that; <i>'Dense vegetation restricts access to the cliff tops of sections SH1, SH2 & SH1A and the cliff base of SH1A.'</i></p> <p>Profile 1bSH1b was added to the programme during the Full Measures survey in October 2015. The profile is located on Chemical Beach, adjacent to the sewage works south of Seaham. The profile consists of cliff to chainage 30m, fronted by a gravel beach. The beach is bisected by a large concrete block between chainage 59m and 63m. Over the summer 2022, there has been a slight steepening of the upper beach resulting in accretion at the toe of cliff (0.6m in level) and erosion at the seaward face of the concrete blocks (0.4m in level). Seaward of the concrete blocks, beach levels have dropped by 0.25m in level over a 5m length before the foreshore is exposed. On average beach levels are at a medium level when compared to the envelope of previous inspections.</p> <p>Profile 1bSH1a was added to the programme during the Full Measures survey in September 2009. It is located to the north of the previously established 1bSH1. The cliff top, face and landward extents of the colliery spoil platform have all remained unchanged since the previous survey. The eroding face of the spoil, now at chainage 135m, has retreated an additional 0.5m over the summer of 2022. The spoil platform is fronted by a small, steep sediment beach followed an exposed rocky platform. The beach (between 135m and 166m) has accreted in level by up to 1.2m in level in places, supplemented by the eroding spoil. From 166m chainage to the end of the survey at chainage 250m, the foreshore remains exposed and stable. The November 2022 profile remains low compared to the range of previously recorded profiles, except for the beach fronting the spoil platform.</p> <p>At 1bSH1, the beach profile has remained unchanged across the cliff top and cliff face up to chainage 40m. At the toe of the cliff, on the colliery spoil platform, an incised channel holds water. The beach profile shows that the channel has deepened by 0.4m over summer 2022, however it is unclear whether this true change or in fact a reflection of varying water levels altering where the surveyors could take</p>	<p>The colliery spoil platform on all profiles across Blast Beach appears to have remained stable over the summer 2022, particularly to the south, where the spoil has not retreated. The northern most profile has experienced a small amount of change retreating 0.5m in the 6-month period. Beach levels have also remained stable, with a net accretion across the bay observed, no doubt supplemented by the eroding spoil. This stability is to be expected during the calmer summer months</p> <p>Longer term trends: The cliffs behind Blast Beach are currently inactive because they are fronted by colliery spoil. The sea cliffs will eventually reactivate as on-going erosion of the colliery spoil removes the protection it affords to the cliffs. This is most likely to occur at the southern end of the bay where the spoil is most rapidly eroding. The accumulating sediment seaward of the colliery spoil in the northern part of the bay will offer the cliffs more protection. However, since the winter of 2014 there has been a reversal in the trend with erosion in the north of the bay and accretion in the south, this trend was continued in the November 2022 and so should remain area of focus.</p>

Survey Date	Description of Changes Since Last Survey	Interpretation
	<p>readings. The spoil platform face (chainage 75m), previously shown to be retreating, has remained unchanged. Seawards of colliery spoil cliff, the beach has been dominated by accretion up to 0.9m in level in places. The rocky foreshore from chainage 130m to 180m remains exposed.</p> <p>At 1bSH2, the most southerly profile along Blast Beach, dense vegetation at the cliff top (noted in the survey report) has resulted in anomalous readings on the profile between chainage 64m and the toe of the cliff at chainage 95m. Between the toe of the cliff and the edge of the colliery spoil, the profile has remained unchanged, There is little to no cliffing between the edge of the spoil and the beach sediment unlike elsewhere on Blast Beach. Other than between chainage 129m and 144m, which has experienced a drop in level of 0.4m, the beach profile in general has experienced little to no change across its length, limited to ± 0.1m. Overall, the profile is at a medium to high level compared to the range recorded from previous surveys.</p>
