Cell 1 Regional Coastal Monitoring Programme Analytical Report 15: 'Full Measures' Survey 2022

Durham County Council

January 2023

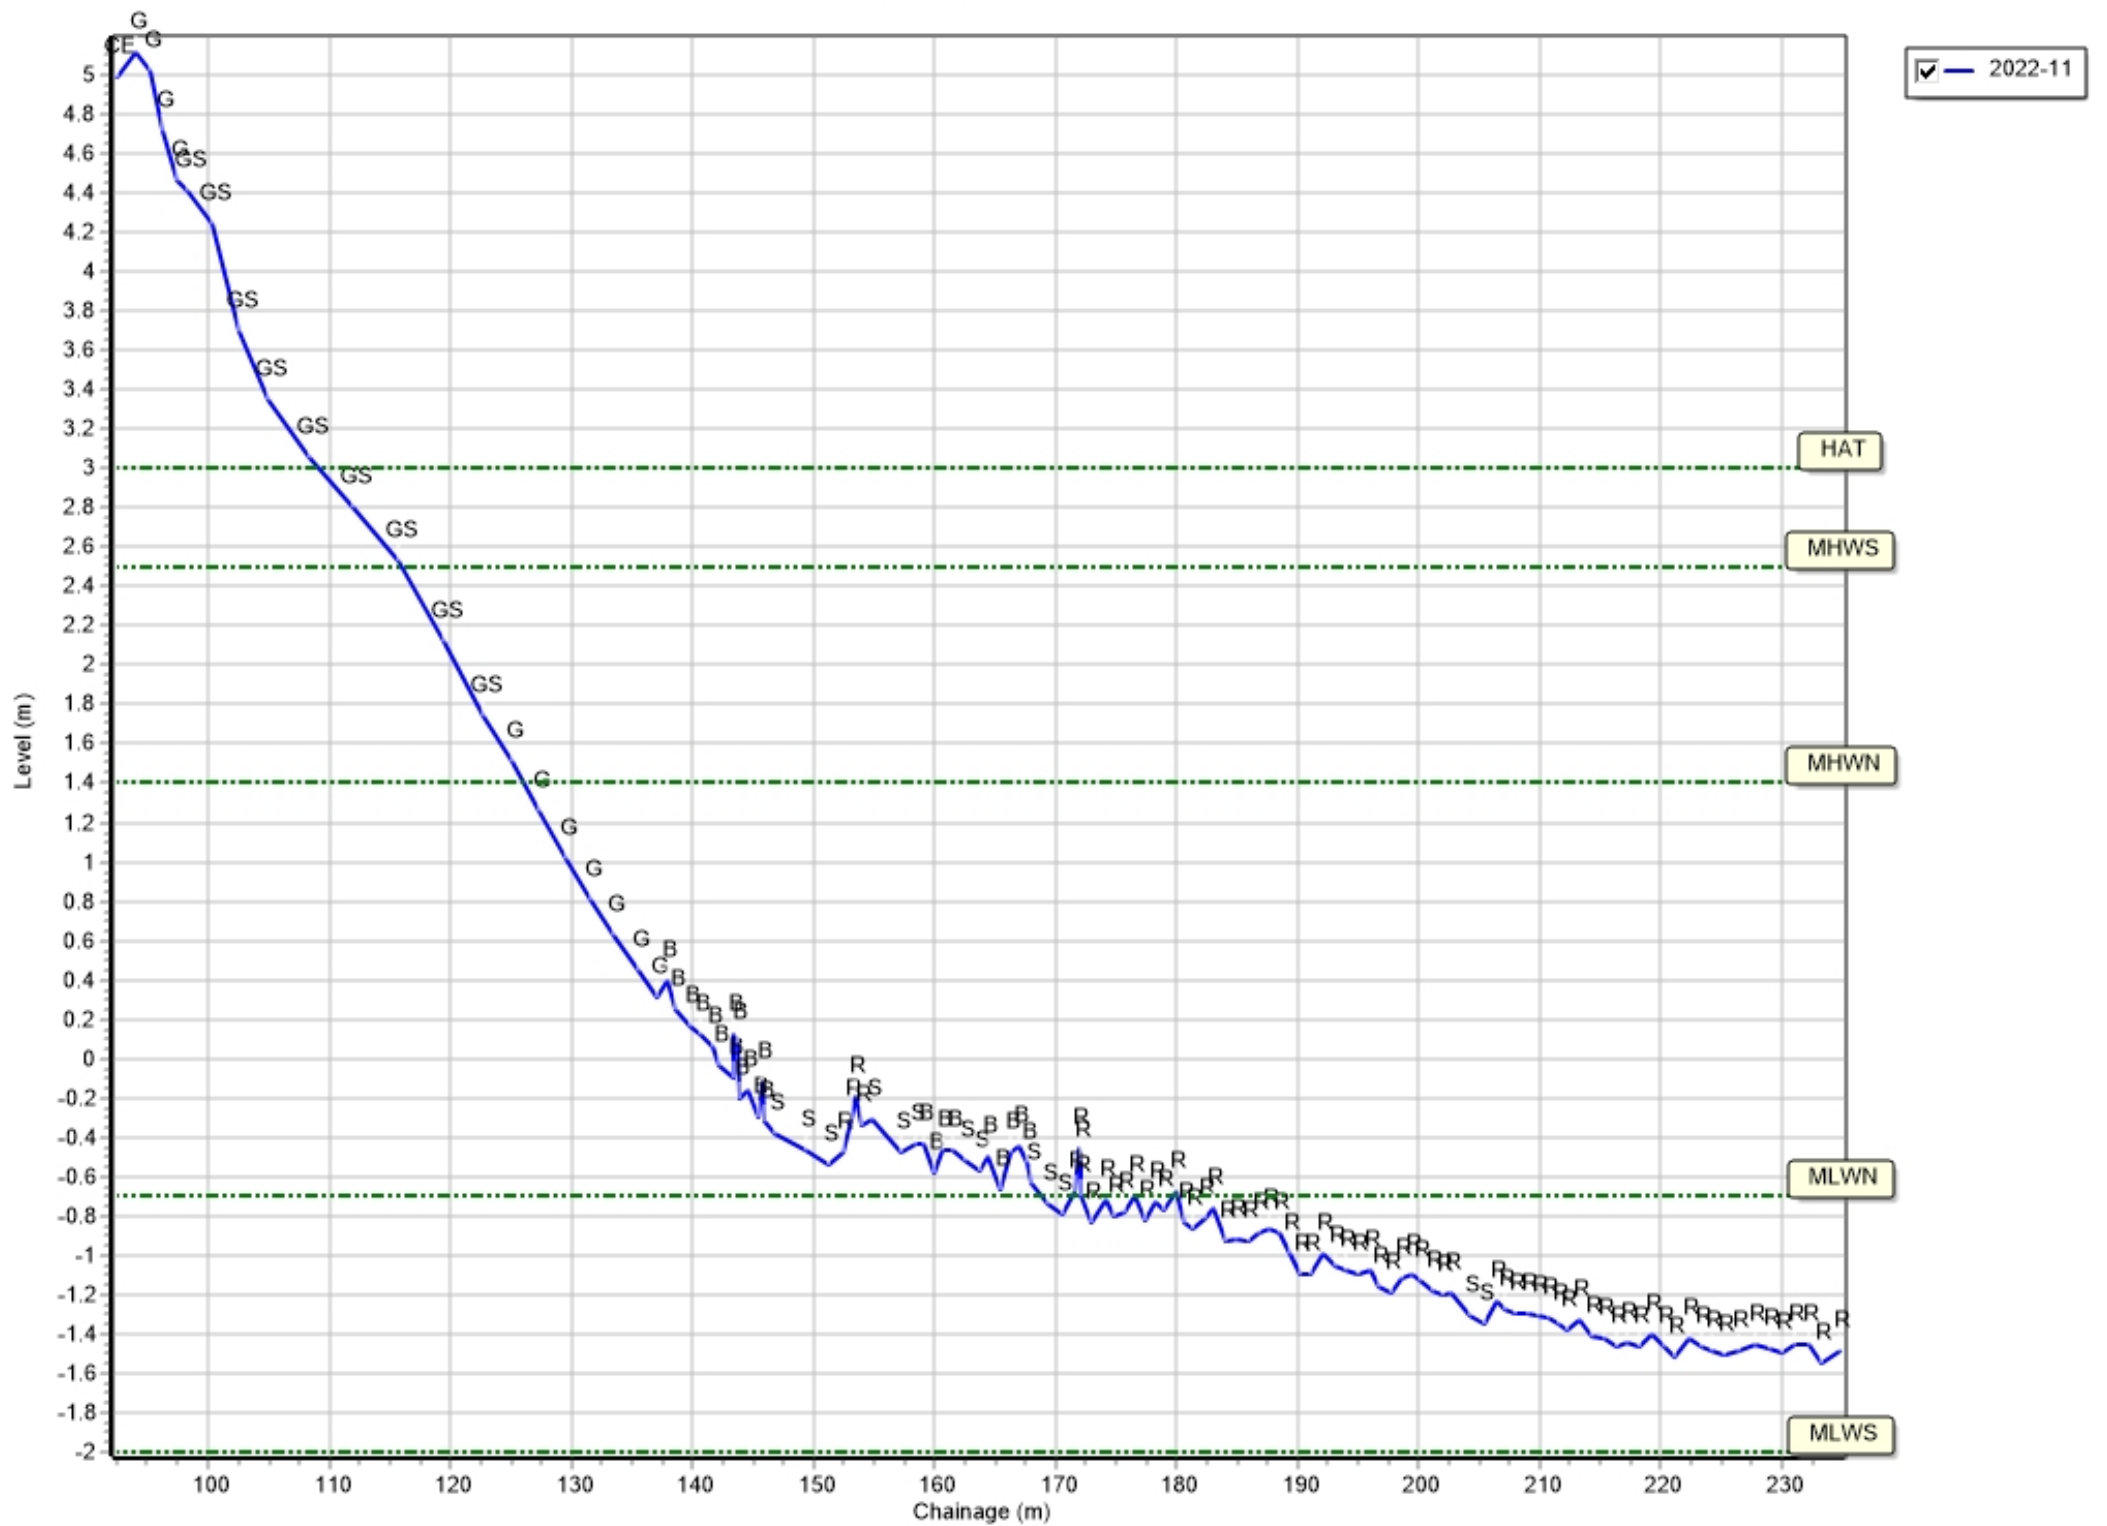
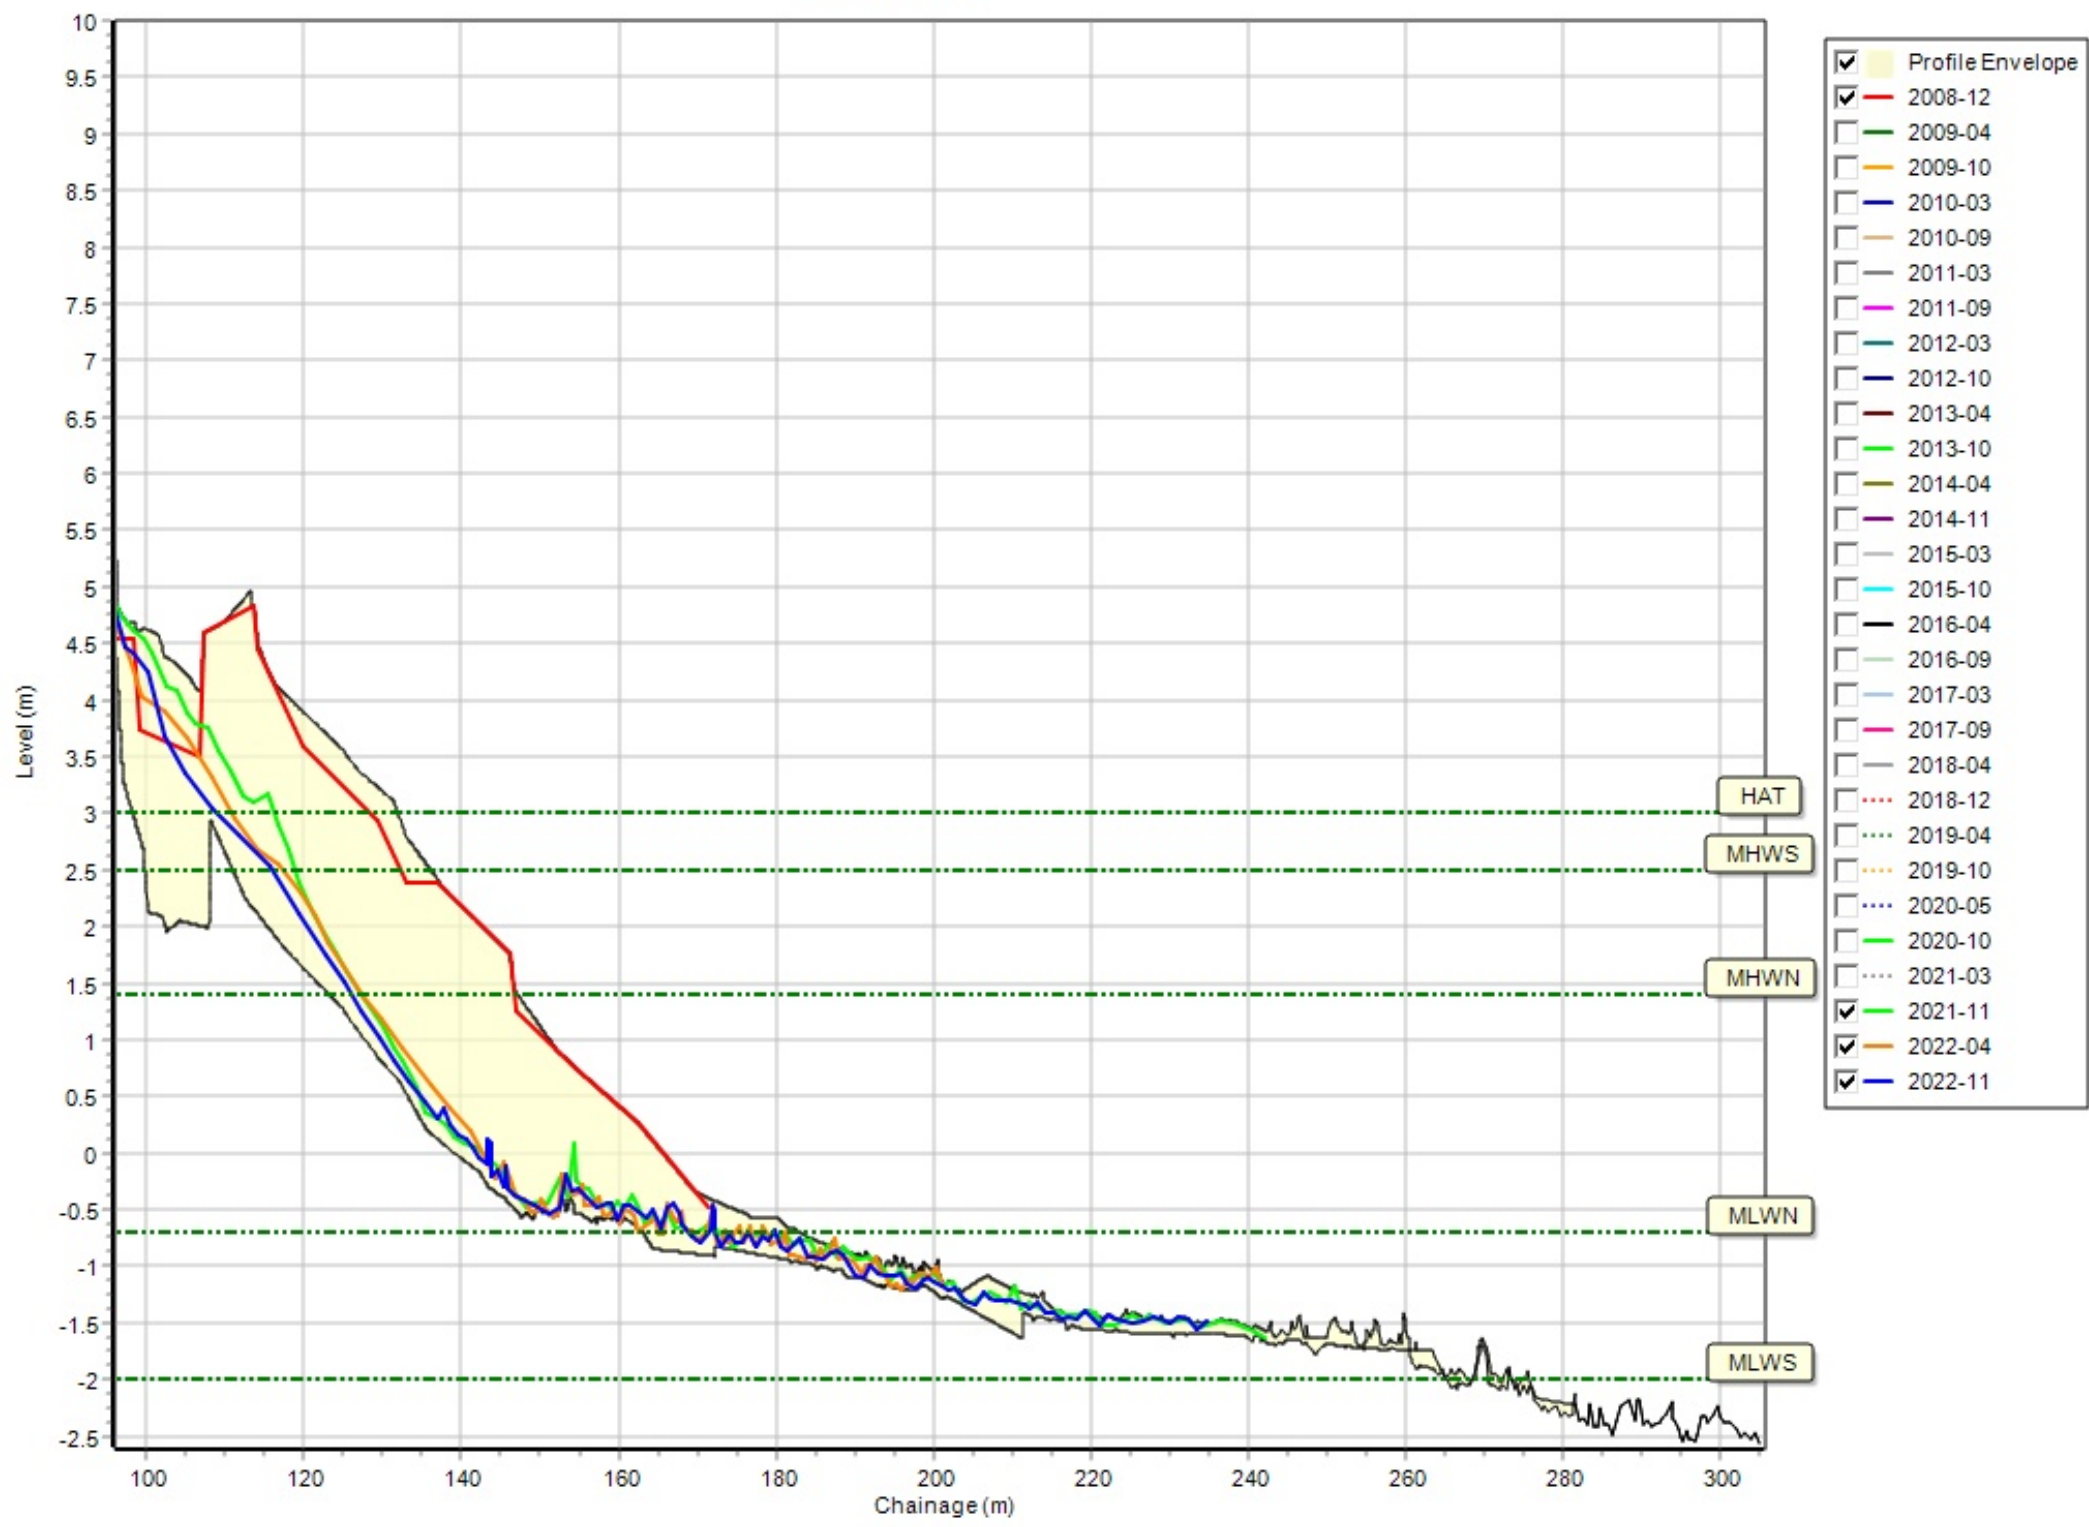
Profiles: 1cEA2

Survey Date	Description of Changes Since Last Survey	Interpretation
<p>24th November 2022</p>	<p>Beach Profiles:</p> <p>Hawthorne Hive is monitored by beach profile 1cEA2 (Appendix A). The survey report notes “<i>unable to measure start of Section EA2 as the vegetation has choked out the section line and route over cliff faces</i>” and therefore all surveys following October 2012 start at 95m chainage.</p> <p>Over the Summer 2022, the profile shows a uniform loss of material across the upper beach (chainage 100m and 143m) at a magnitude of 0.2m. Across the lower beach, seaward of chainage 143m, the rocky foreshore remains exposed. Overall, the profile is at a low level when compared to the range recorded from previous surveys. The course of Hawthorne Burn has not intercepted the profile since April 2013 and remains that way in 2022.</p>	<p>Longer term trends: The upper beach levels were recorded to be notably low in 2014, 2018 and May 2021. On all occasion the beach levels appeared to demonstrate some recovery but not enough to alter the long-term pattern that suggests the beach is undergoing progressive erosion.</p> <p>Limited cliff erosion occurs in this section and therefore sediment supply is limited to erosion of colliery spoil.</p> <p>Storm events which may block the channel and varying flows in Hawthorne Burn are likely to continue to episodically block the channel and change its course across the beach.</p>

At Hawthorne Hive the surveyor was unable to measure the start of Section 1cEA2 as the vegetation has choked out the section line and route over cliff faces.

- At Hawthorne Hive, beach levels have dropped since the previous inspection and remain at a low level compared to the envelope of previous inspections.

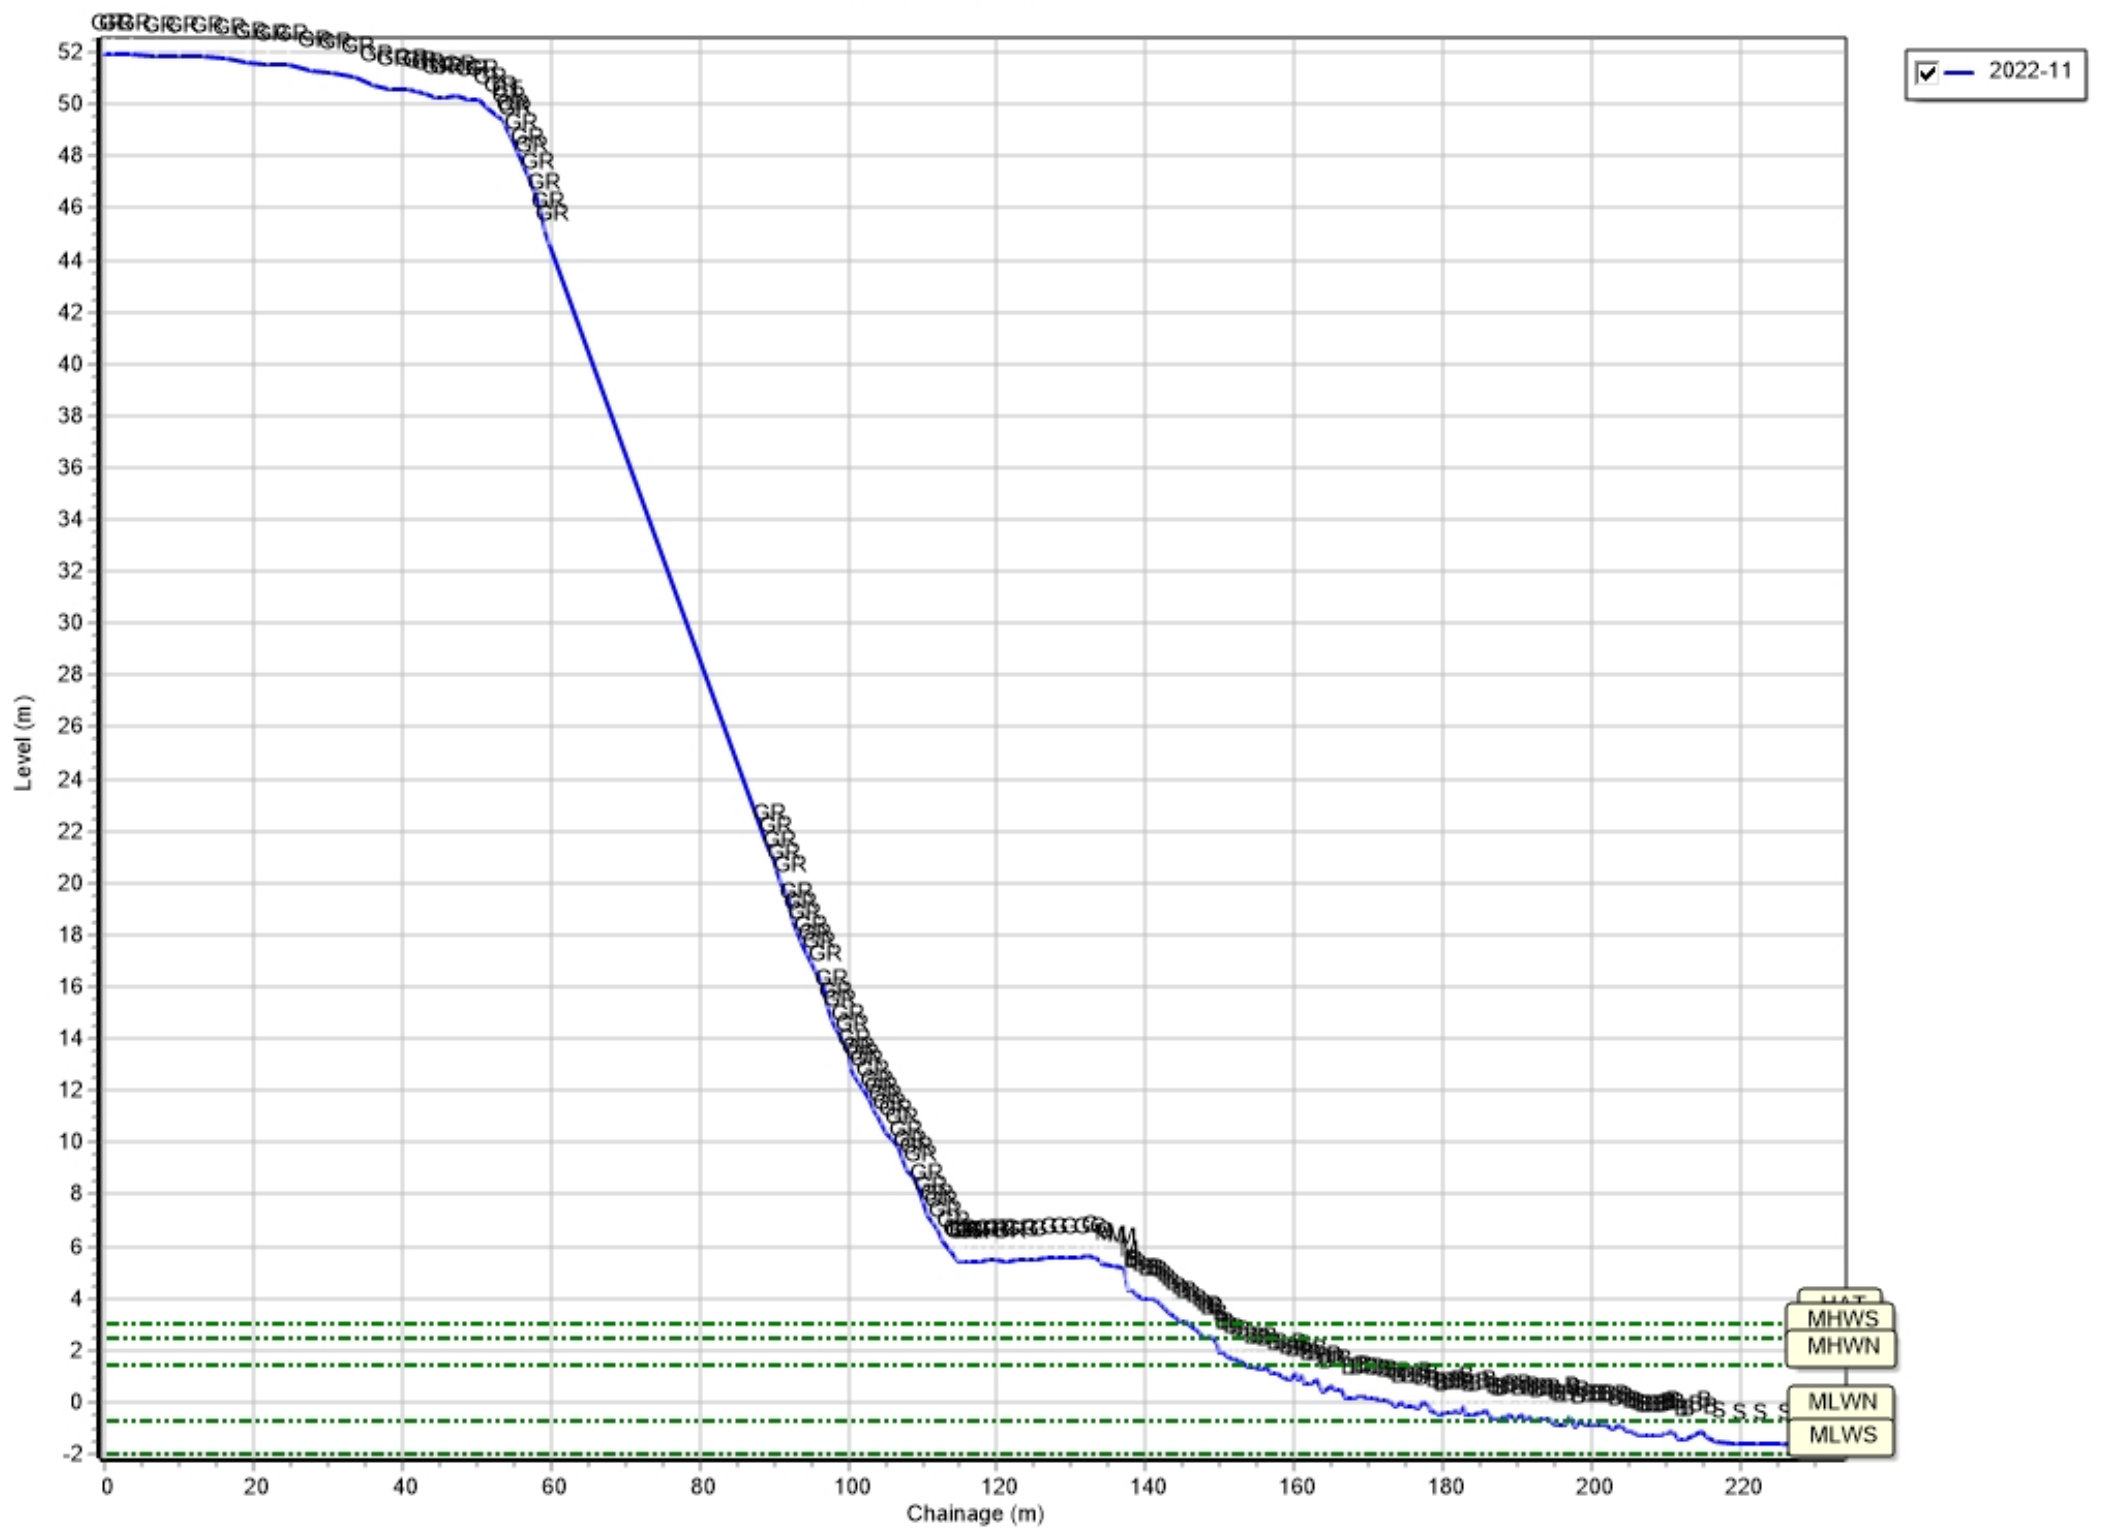
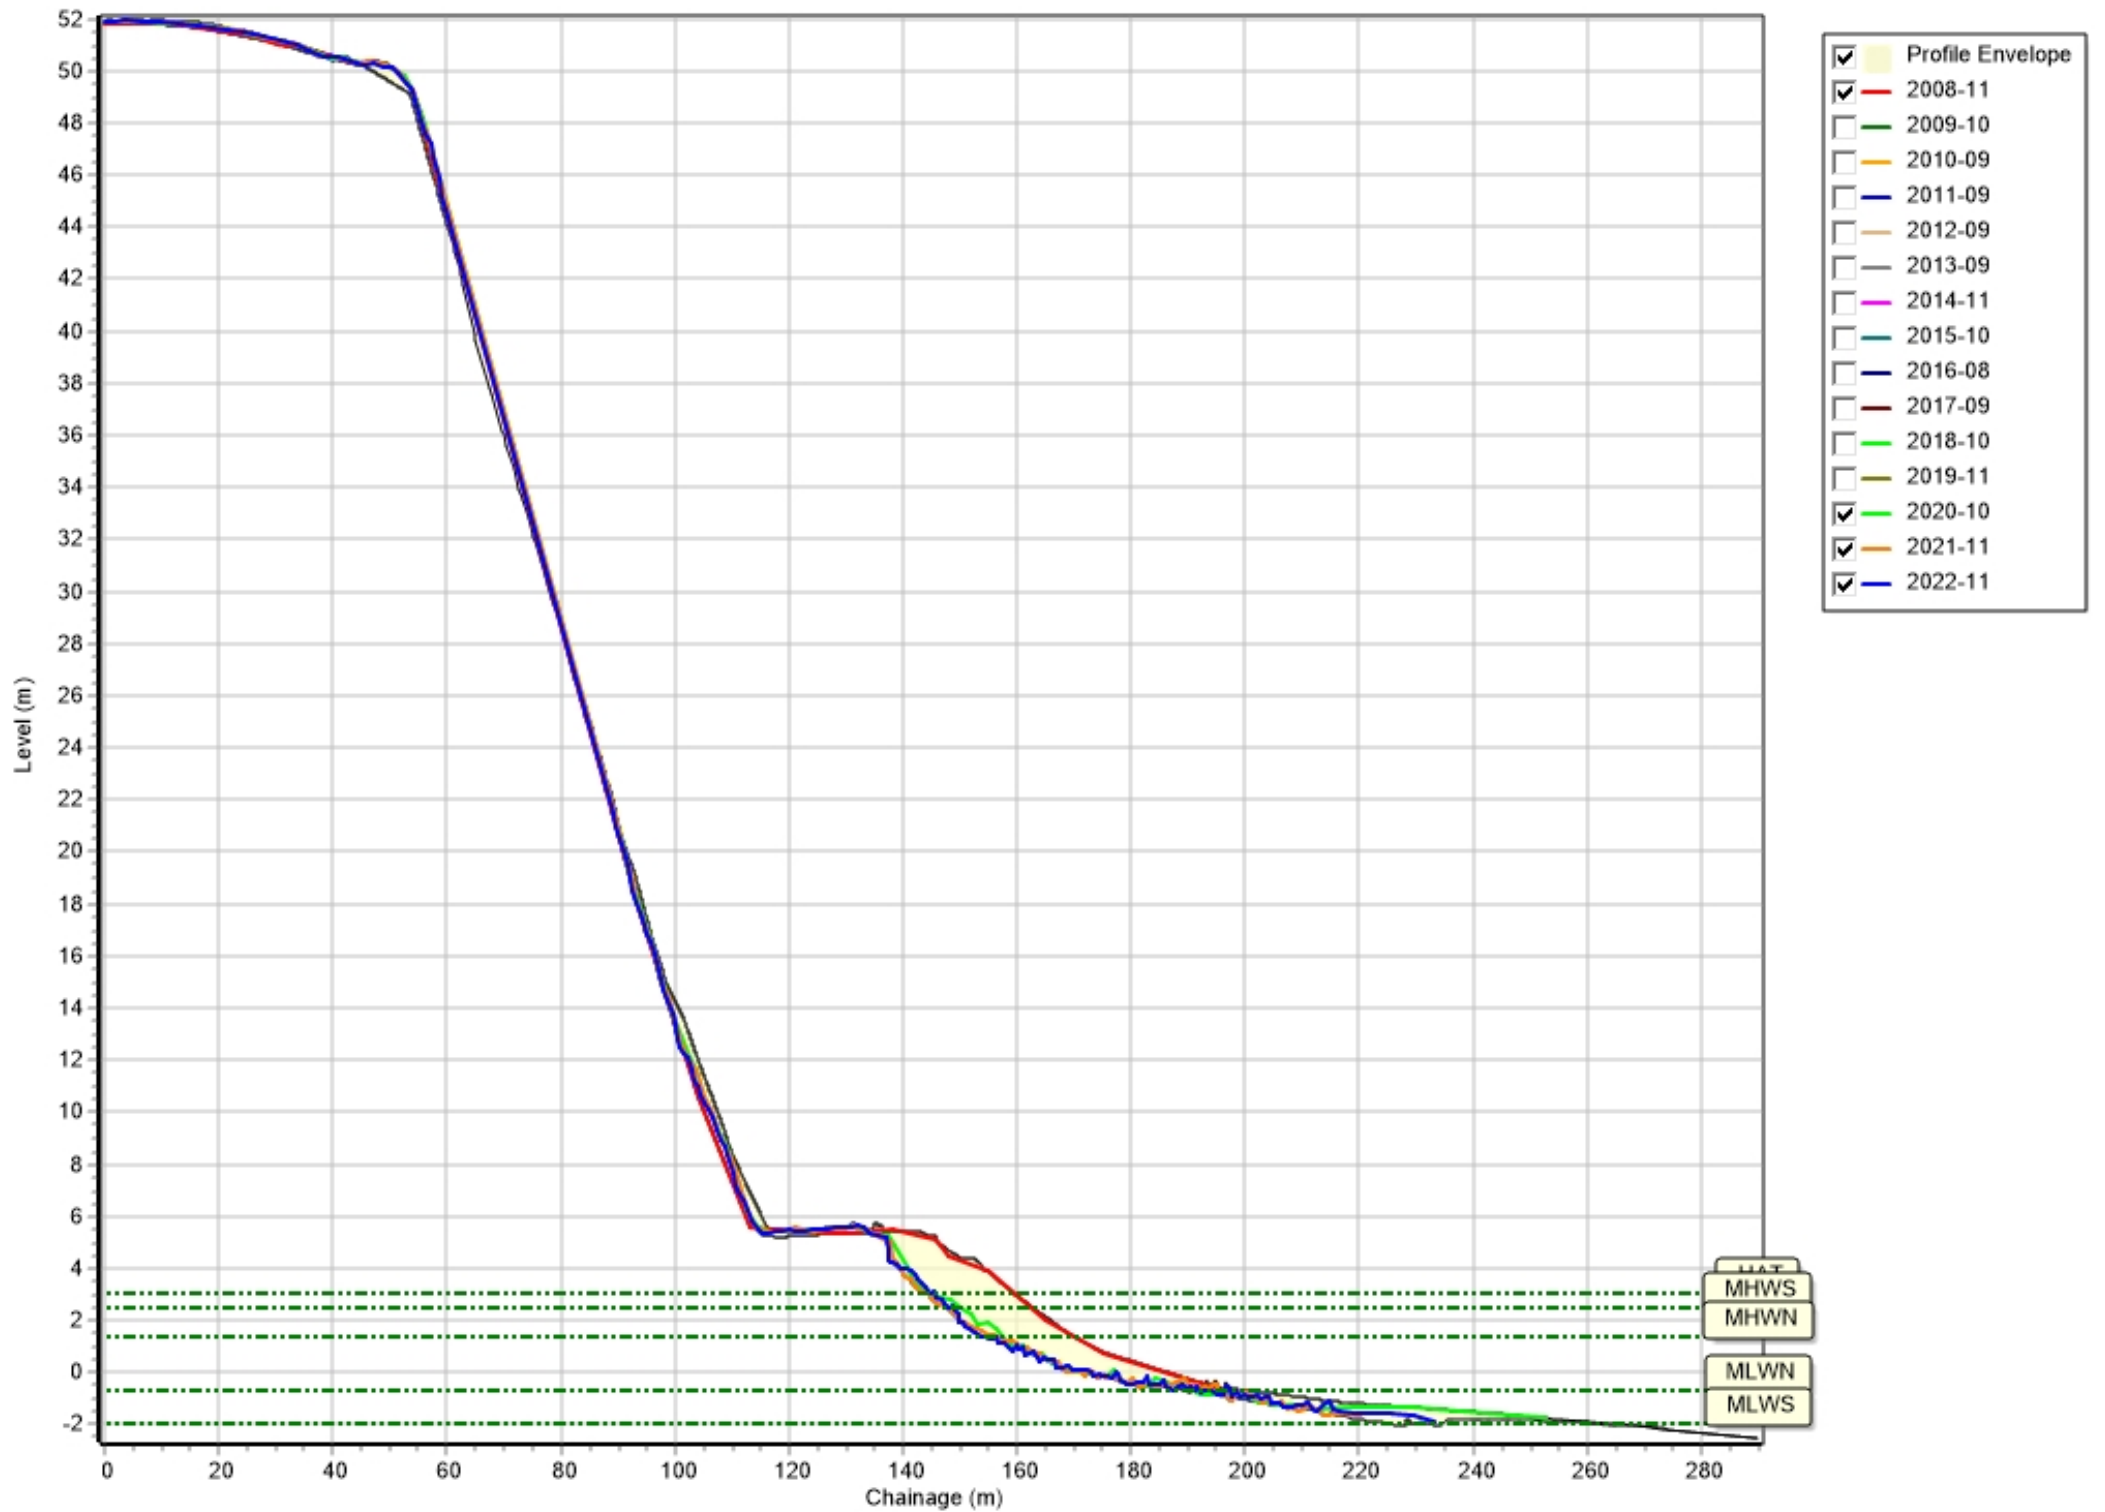
Profiles: 1cBH1

Survey Date	Description of Changes Since Last Survey	Interpretation
<p>23rd November 2022</p>	<p>Beach Profiles:</p> <p>Blackhall Colliery is covered by three beach profile lines (Appendix A) that are monitored annually. As at Blast Beach, profiles are dominated by colliery spoil and exhibit similar forms with a rock cliff, wide spoil beach with a distinct cliff at the eroding face of the colliery spoil, and a gravel and sand foreshore that extends to MLW. The survey report notes that the surveyor was <i>'unable to survey part of section BH1 and BH2 due to dense vegetation'</i>.</p> <p>1cBH1 is located near Horden Point. The Full Measures 2022 survey shows that the profile has again remained stable up to the toe of the cliff at chainage 115m. On the colliery spoil platform, between the toe of the cliff and the face of the colliery spoil, now a chainage 137m, the change is negligible limited to the movement of large cobbles/boulders. The face of the colliery spoil platform has retreated approximately 1m since the previous survey. The cobble beach/foreshore has maintained a very similar profile to the November 2021 profile with change again limited to the movement of large rocks.</p> <p>Profile 1cBH2 has again exhibited negligible change up to the colliery spoil platform face, now at chainage 149m. This means the spoil, has eroded landward a further 6m since November 2021 and total of 11m since November 2020. Seaward of the spoil, the beach profile is split into a steeper upper beach formed of larger sediments (chainage 149m to 192m) and a shallower lower beach (chainage 192m to 270m). At the change in gradient, the beach has lowered by 1.1m in level when compared to the previous survey in November 2021.</p> <p>Profile 1cBH3 shows that since 2008 there has been episodic migration, infilling and scouring of the outflow of Castle Eden Burn, which crosses the profile. The channel has been migrating landward over the years and now is located at the toe of the cliff. Since the previous inspection the channel bed has accreted 0.3m in level and narrowed by up to 4m as a result encroachment from the beach berm on its seaward edge. The berm crest has also experienced a similar level of accretion (0.2m in level). On the seaward aspect of the berm, the beach between chainage 165m to 201m has eroded by 0.6m in level before switching to accretion up to the end of the profile (chainage 255m). Comparing the levels of the beach to the previous year's envelope, it appears the beach is at a low level, particular at the toe of the cliff (due to the burn) and on the upper beach.</p>	<p>As in previous years, the colliery spoil platform continues to erode at Profile 1cBH1 having retreated an additional 1m in 2022. With approximately 30m of spoil remaining, the cliff will remain defended in the short term.</p> <p>The spoil platform at Profile 1cBH2 appears to be eroding at a significantly greater rate, having eroded a further 6m since the previous inspection on top of the 5m in 2021. With ~25m of platform remaining, if the spoil continues to erode at the same rate as the previous 2 years, the cliffs in this section may become exposed within the next 5 years.</p> <p>Longer term trends: The surveys show that the spoil beach along much of the Blackhall Colliery shore is progressively eroding but continues to protect the cliffs in the short term. The colliery spoil face at profile 1cBH1 and profile 1cBH2 has eroded back ~8m and 24m respectively since the first survey in 2011. However, as mentioned above with profile 1cBH2 retreating 11m in the last two years it indicates a change in erosion rate.</p>

At Blackhall the surveyor was unable to access part of sections 1cBH1 and 1cBH2 due to dense vegetation. The surveyor was also unable to survey part of Section BH3 due to deep water at the back of the beach.
