Cell 1 Regional Coastal Monitoring Programme Analytical Report 16: 'Full Measures' Survey 2023

Durham County Council

November 2023

(*) The present report is **Analytical Report 16** and provides an analysis of the 2023 Full Measures survey for County Durham Council's frontage.

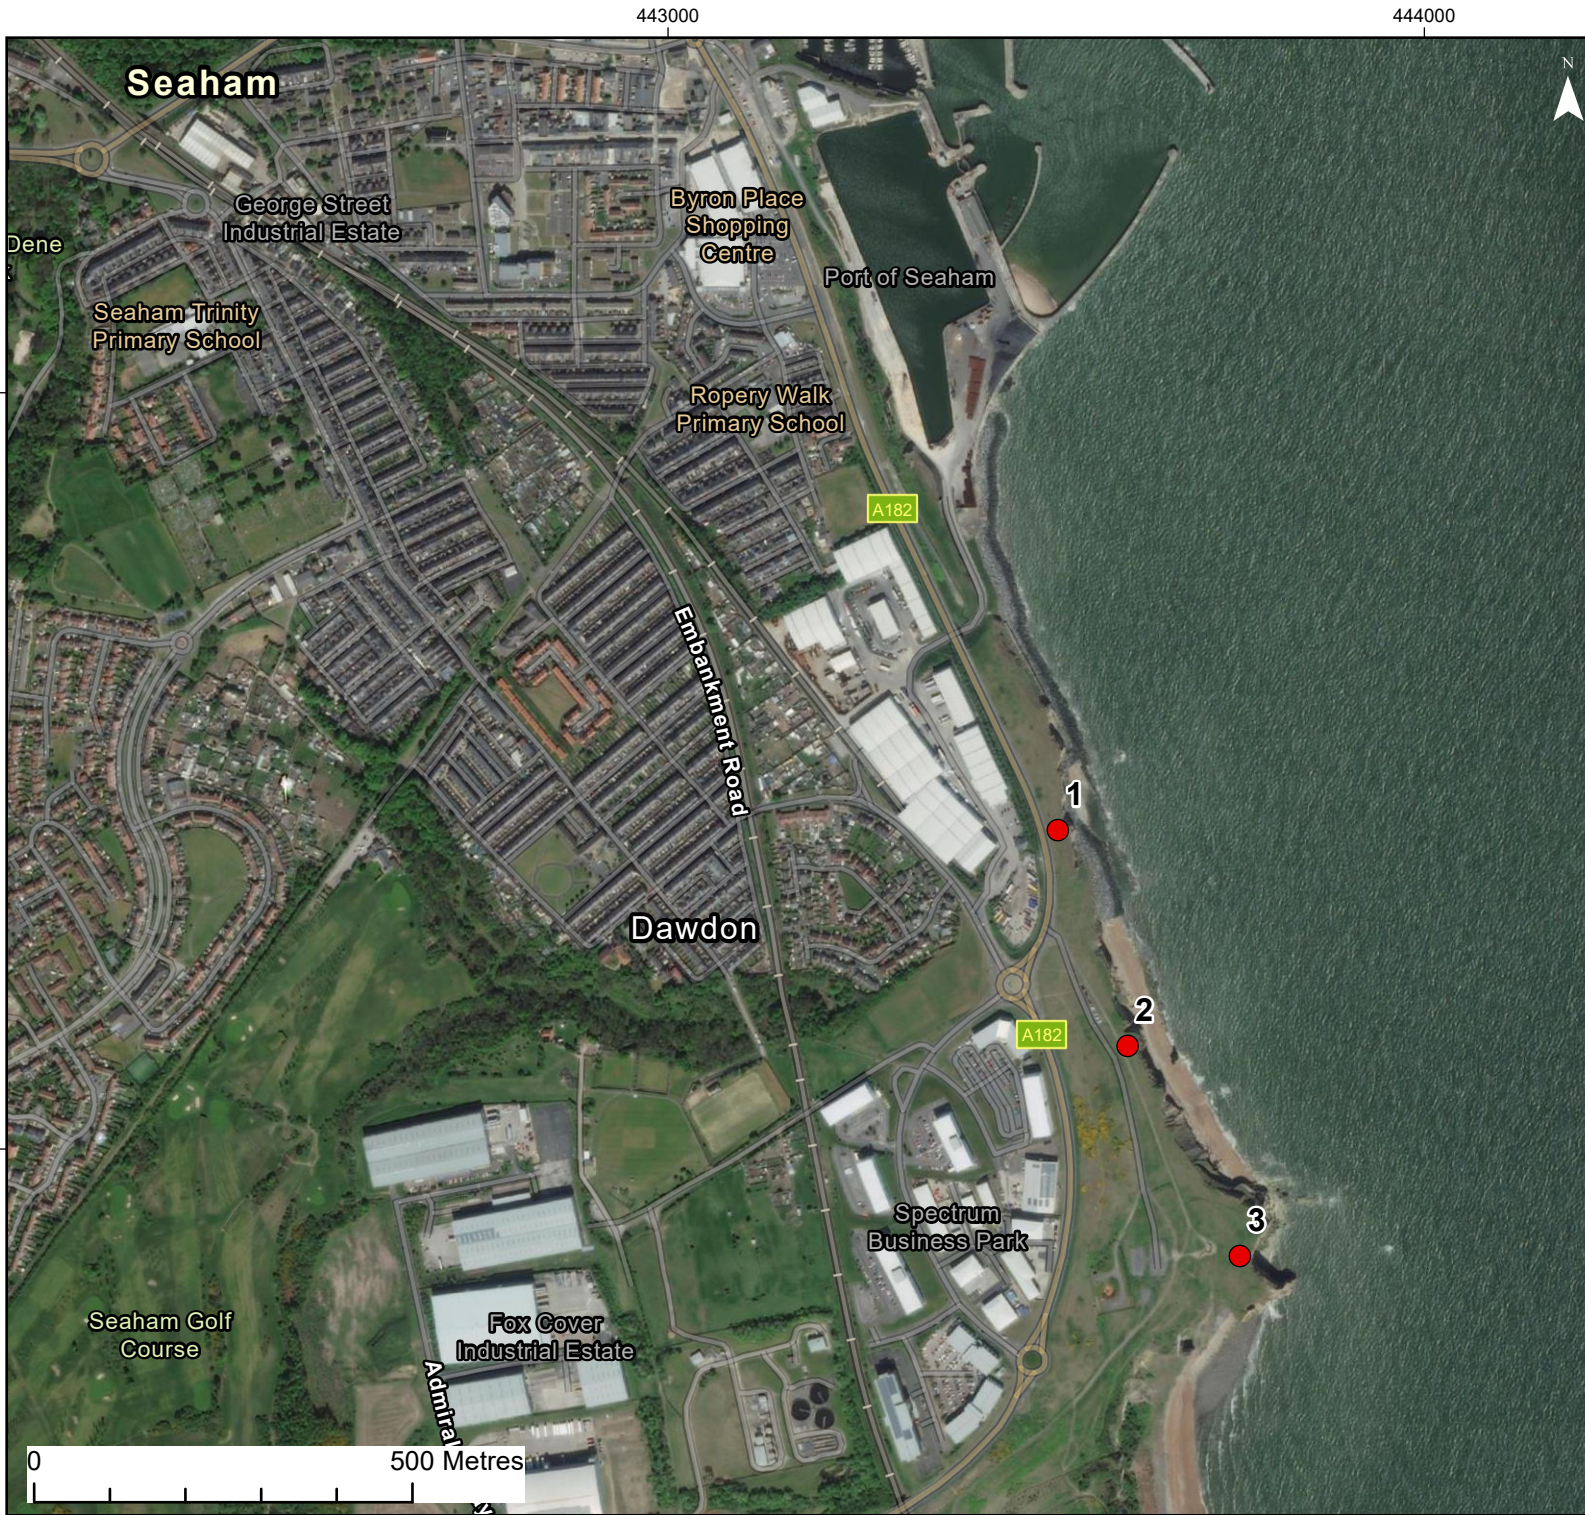
Title:
Figure 3 - Map 1
SEAHAM
Durham County Council Frontage

Three ground control points have been established on the Seaham frontage (Figure B1). The maximum separation between any two points is nominally 300m.

The cliff top surveys at Seaham are undertaken biannually. Measurements are taken from a fixed ground control point along a fixed bearing to the edge of the cliff top.

Survey Date	Description of Changes Since Last Survey	Interpretation
<p>20th September 2023</p>	<p>Cliff-top Survey:</p> <p>Three ground control points have been established along the cliff top at Dawdon (Figure B1). The separation between any two points is nominally 300m. These cliff top surveys are intended to inform on erosion rates of the undefended sea cliffs extending south of the rock armour revetment to the south of Seaham Harbour.</p> <p>The cliff top surveys at Dawdon are undertaken bi-annually. Measurements are taken from a fixed ground control point along a fixed bearing to the edge of the cliff top. Appendix B provides information about the ground control points and results from between the 2008 (baseline) cliff top survey and the current (November 2021) survey.</p> <p>Between March 2023 and September 2023 , none of the three control points have experienced any significant movement landward (>0.1m), recording -0.11m, -0.01m and -0.03m respectively.</p> <p>Appendix B provides results from the September 2023 survey, showing the distance from the ground control point to the edge of the cliff top along the defined bearing and changes in position since the November 2008 baseline survey.</p>	<p>All three control points have recorded a retreat less than 0.1m indicating a period of stability. The fact that all three points show an apparent advancement, may highlight the difficulties associated with identifying the cliff top (possibly due to vegetation) but also generally highlights the margin of error with the survey technique.</p> <p>Longer term trends: Long-term recession rates calculated from the data collected since November 2008 show retreat at 0.07m/yr. for Point 1, 0.02m/yr. for point 2 and 0.09m/yr. at Point 3.</p>

- At Seaham cliffs, all three of the control points showed an apparent advancement since the previous survey, albeit at a low magnitude. This highlights the difficulty in identifying the cliff edge potentially due to vegetation growth.

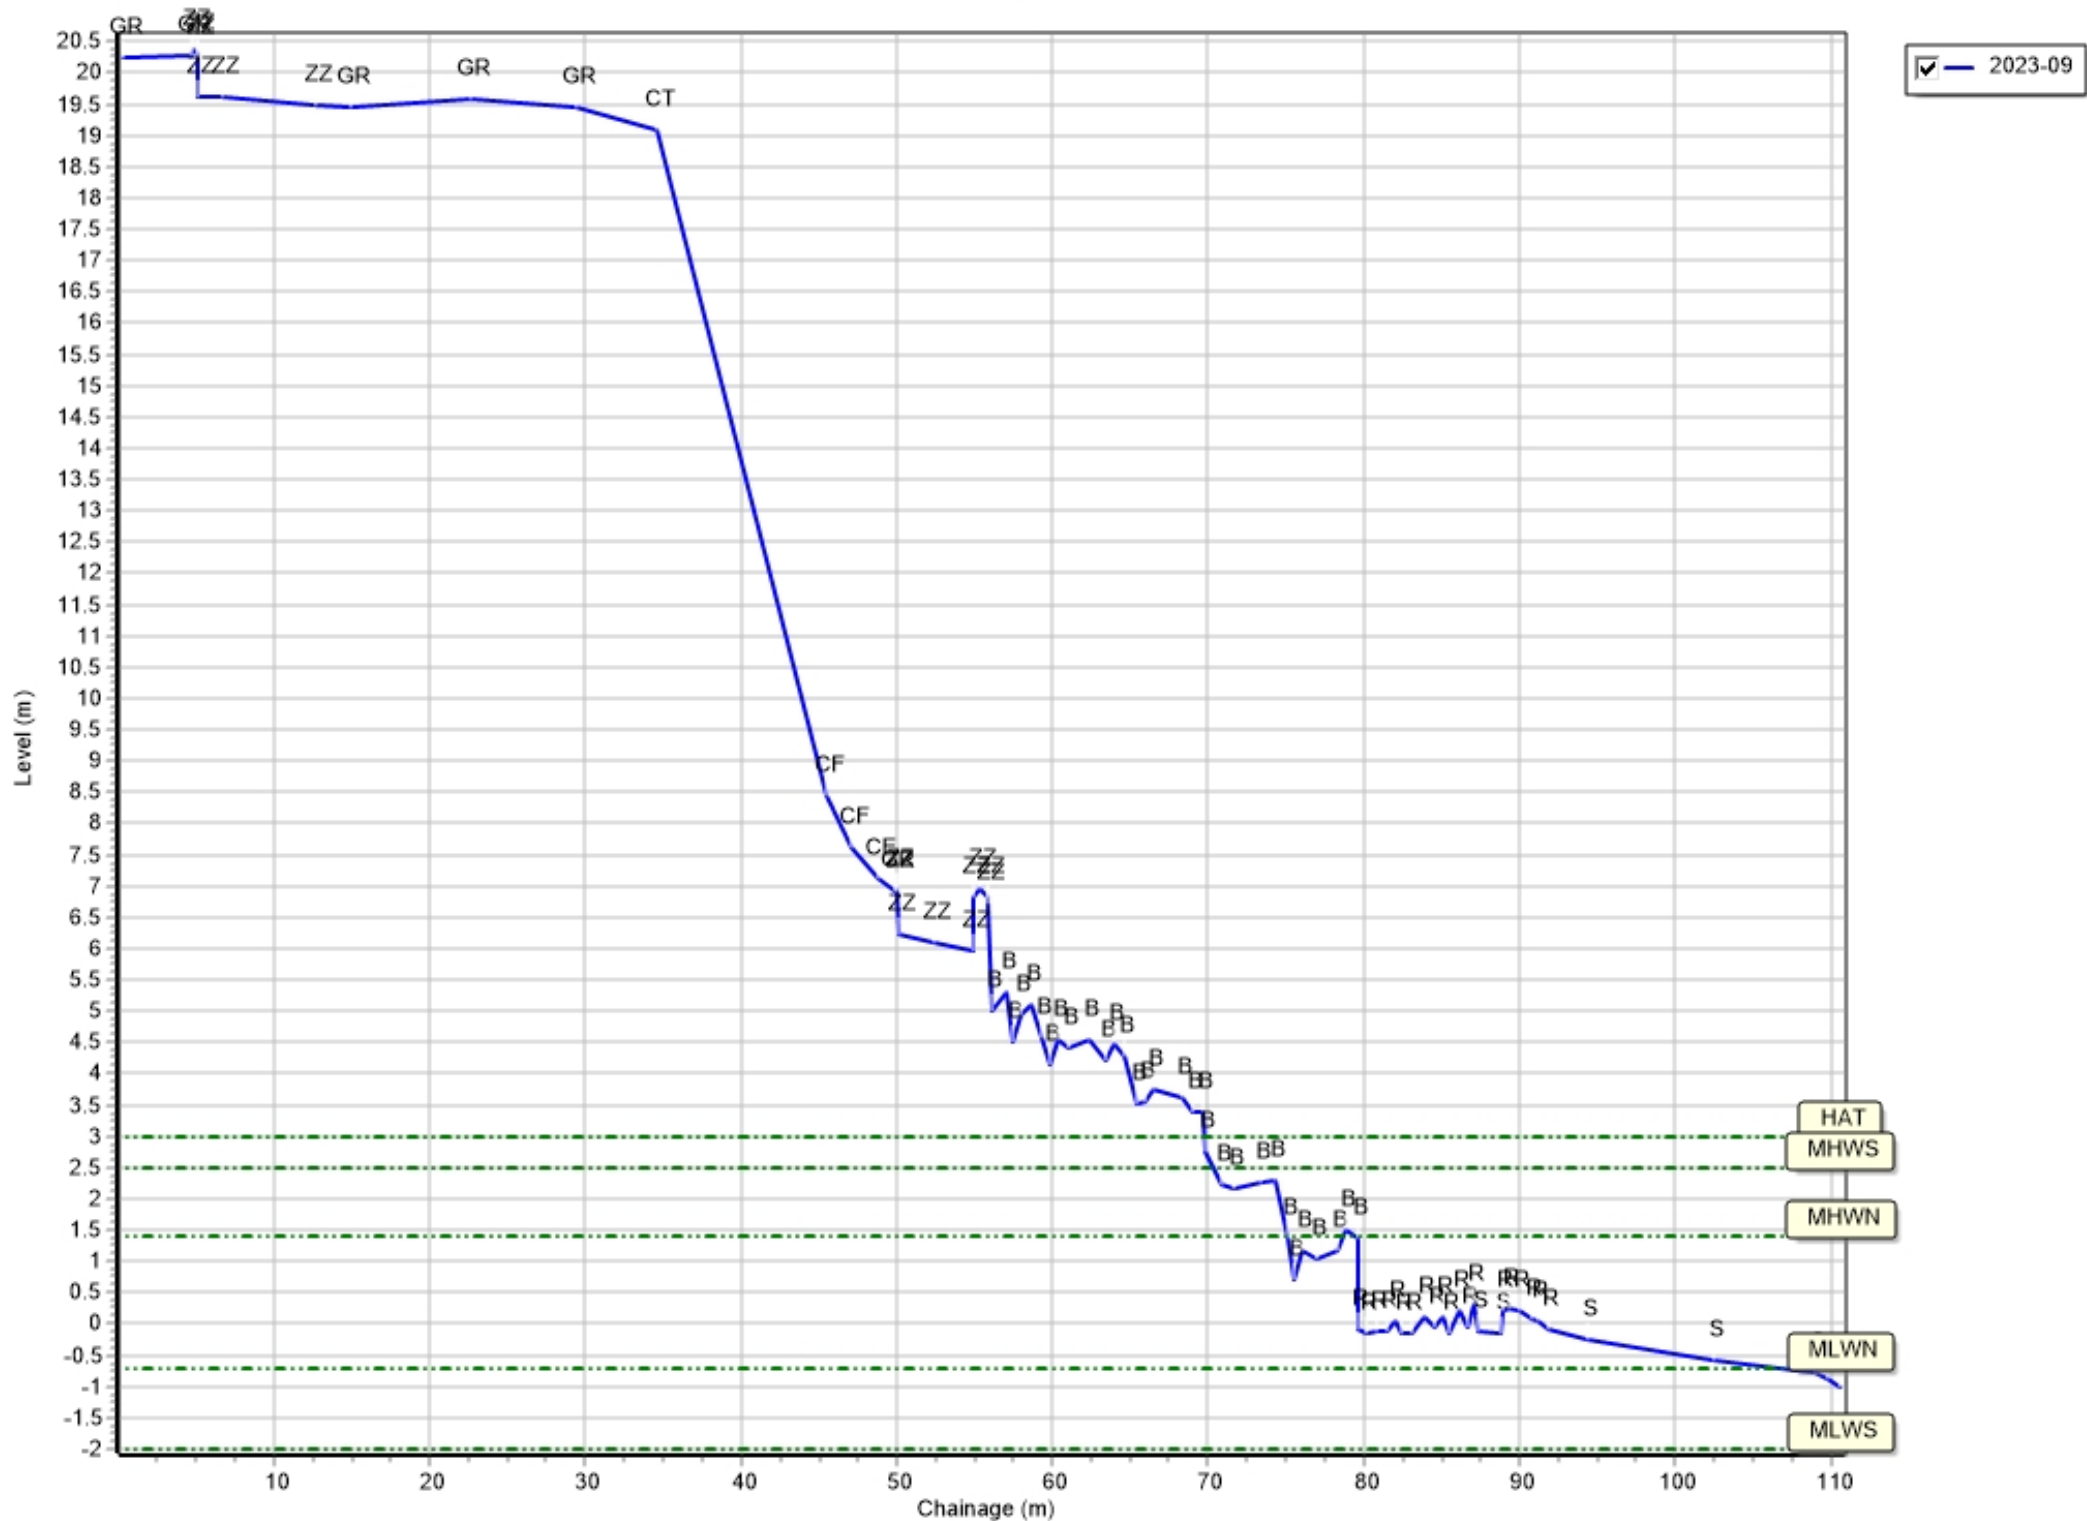
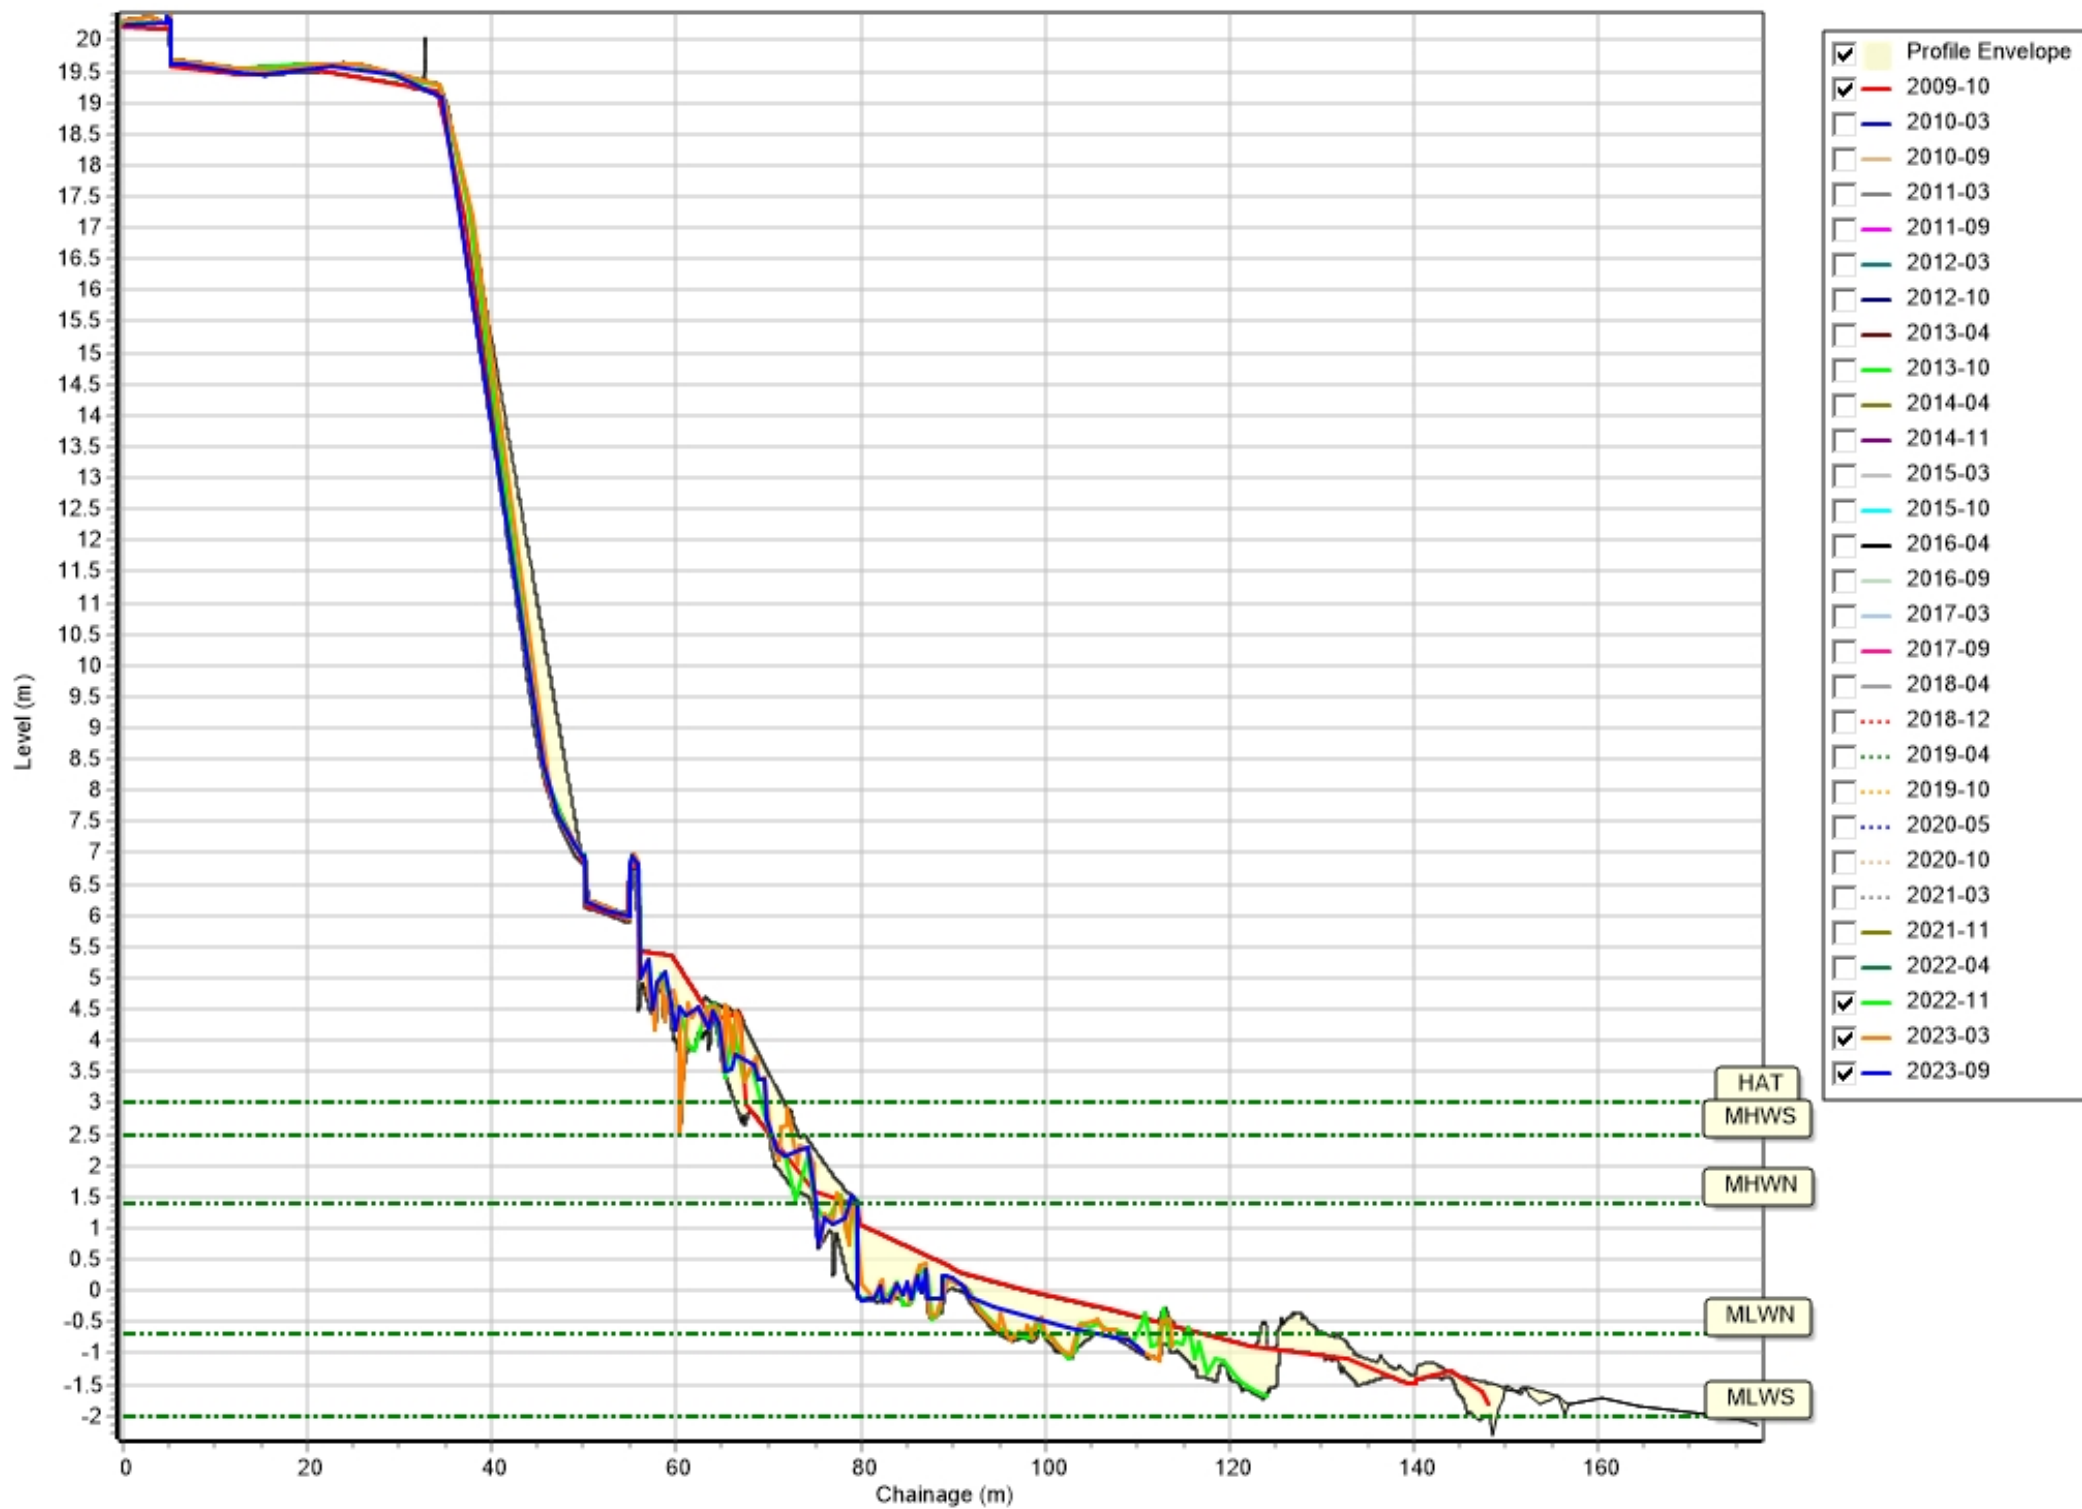
Profiles: 1bEA1

Survey Date	Description of Changes Since Last Survey	Interpretation
3 rd September 2023	<p>Beach Profiles:</p> <p>Beach profile line 1bEA1, located at Featherbed Rocks (Appendix A), has been monitored since April 2009. The profile extends across the cliff top and cliff face then extends across the promenade (chainage 55m), rock armour sea defence (chainage 55m to 80m) and beach. Seaward of the rock armour at chainage 80m, there has again been very little change over the summer of 2023. The beach profile reflects the rocky nature of the foreshore with any minor change reflecting the movement of pockets of sediment between the rock outcrops. Previous surveys have shown accumulations of material at the base of the revetment, but this has not been present since the 2012 Full Measures survey.</p>	<p>Longer term trends: The cliff top and cliff face in this location appear stable and are unlikely to activate whilst the coastal defences remain present.</p> <p>The rocky nature of this foreshore means it is unlikely to undergo significant changes in morphology unless sediment is deposited upon it. A veneer beach was reportedly present between 2010 and 2012 but has not been recorded since.</p>

- There has been little change at Featherbed Rocks. The rocky shore platform remains exposed with the veneer beach that was present in earlier surveys still absent since autumn 2012.

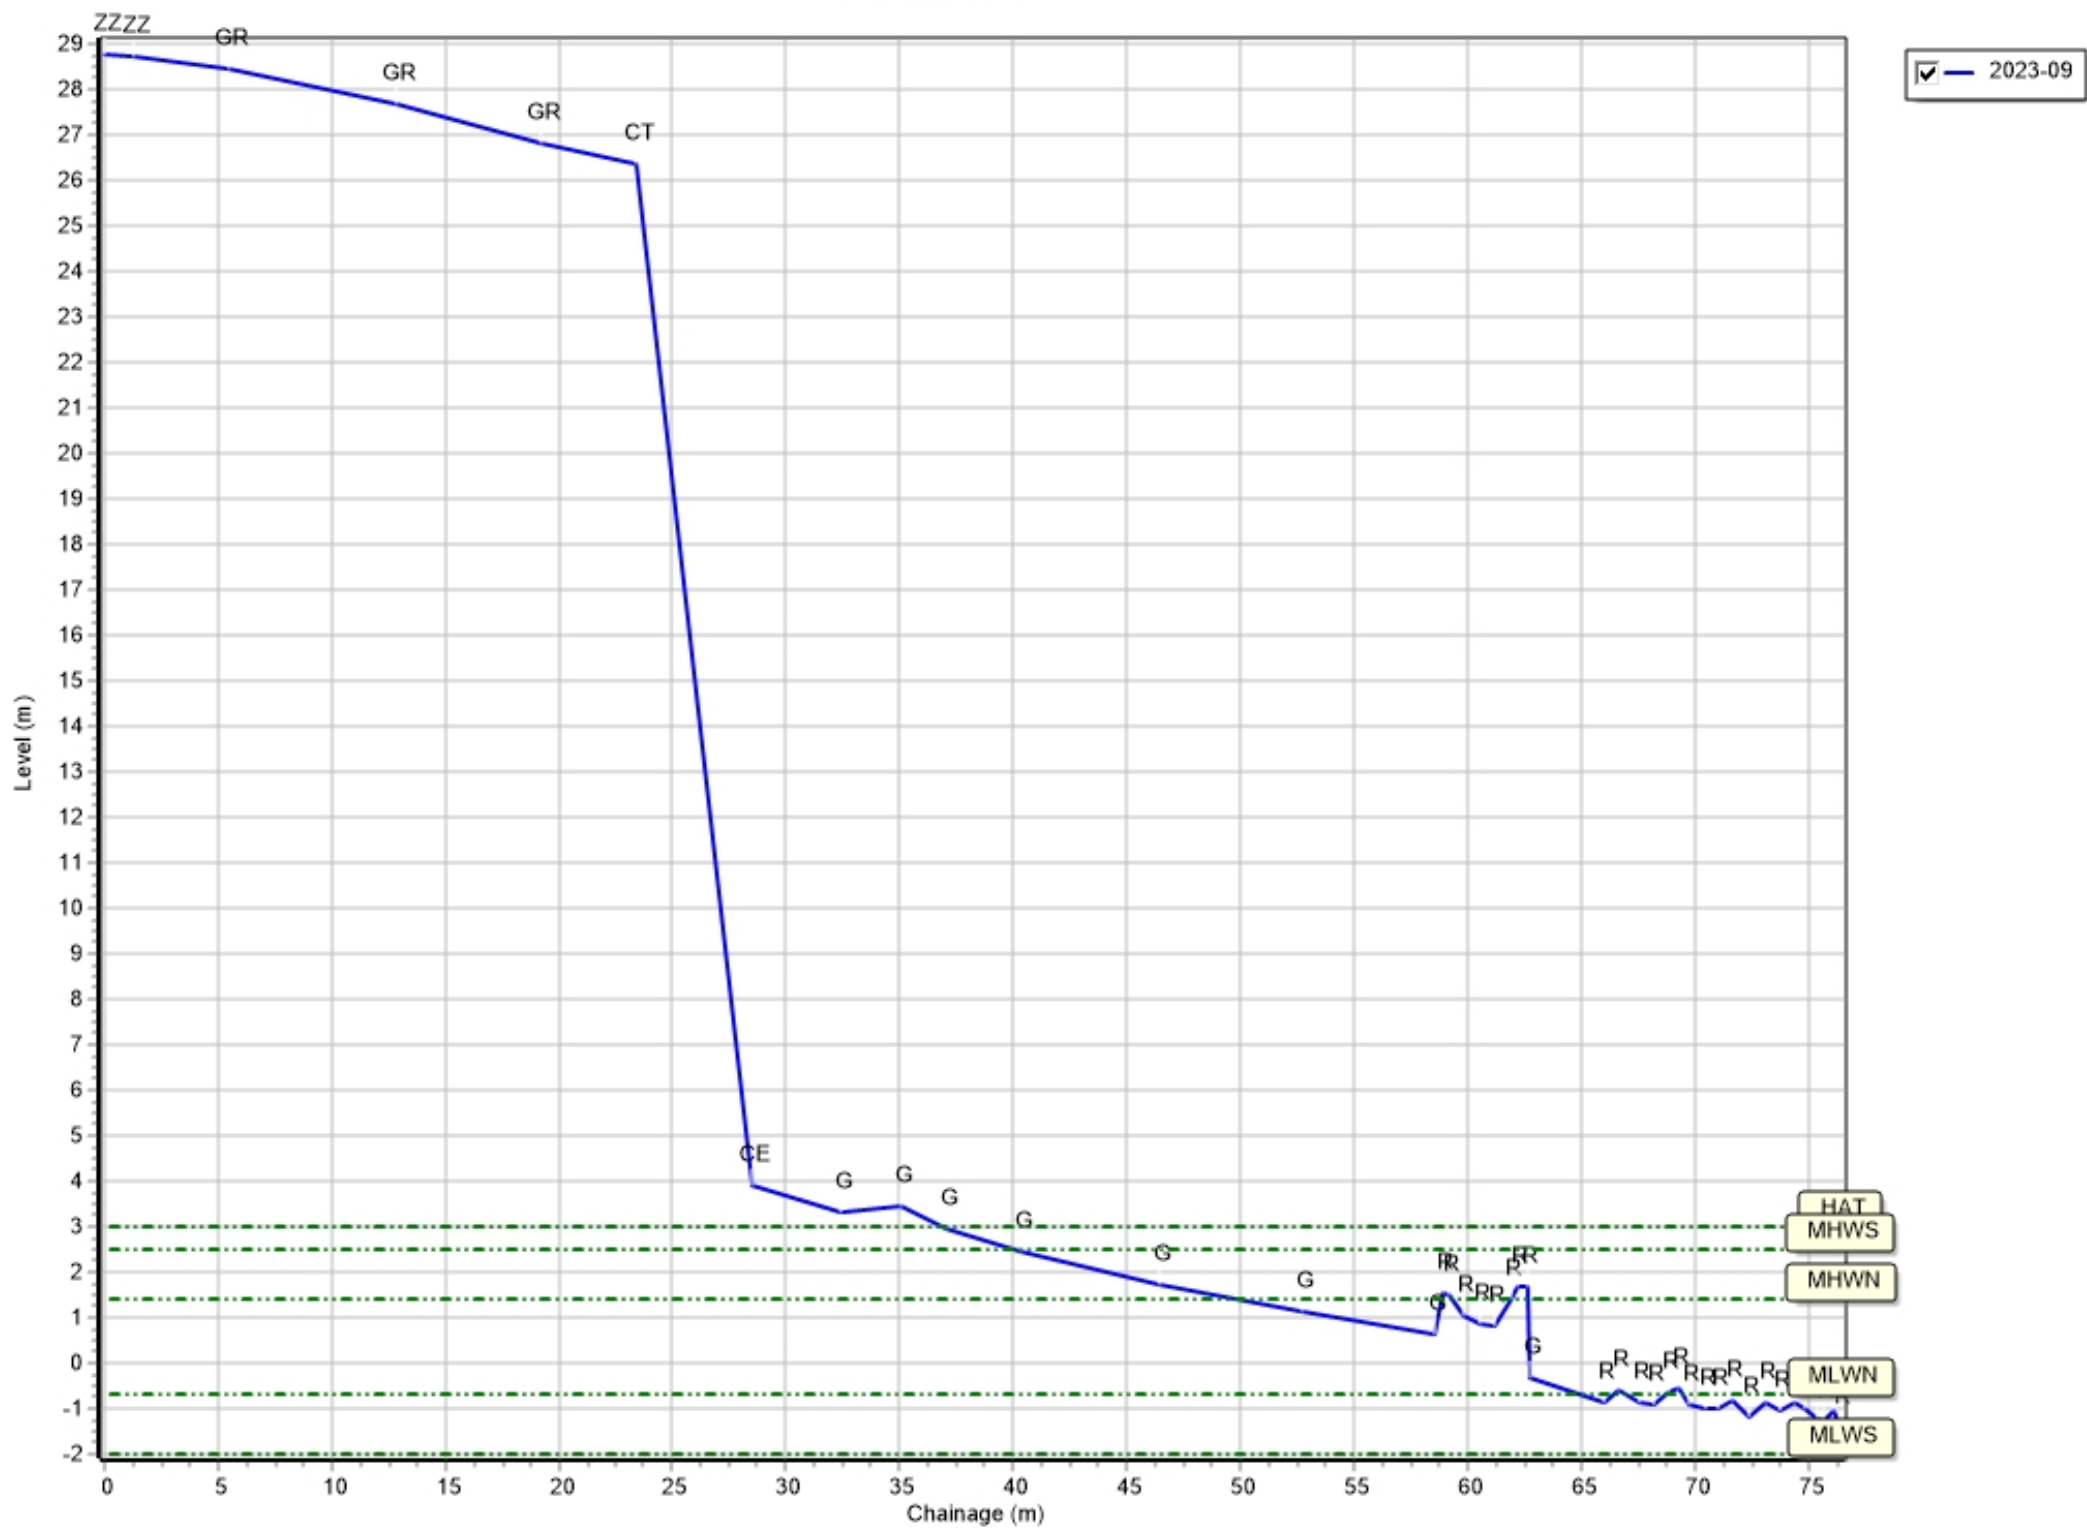
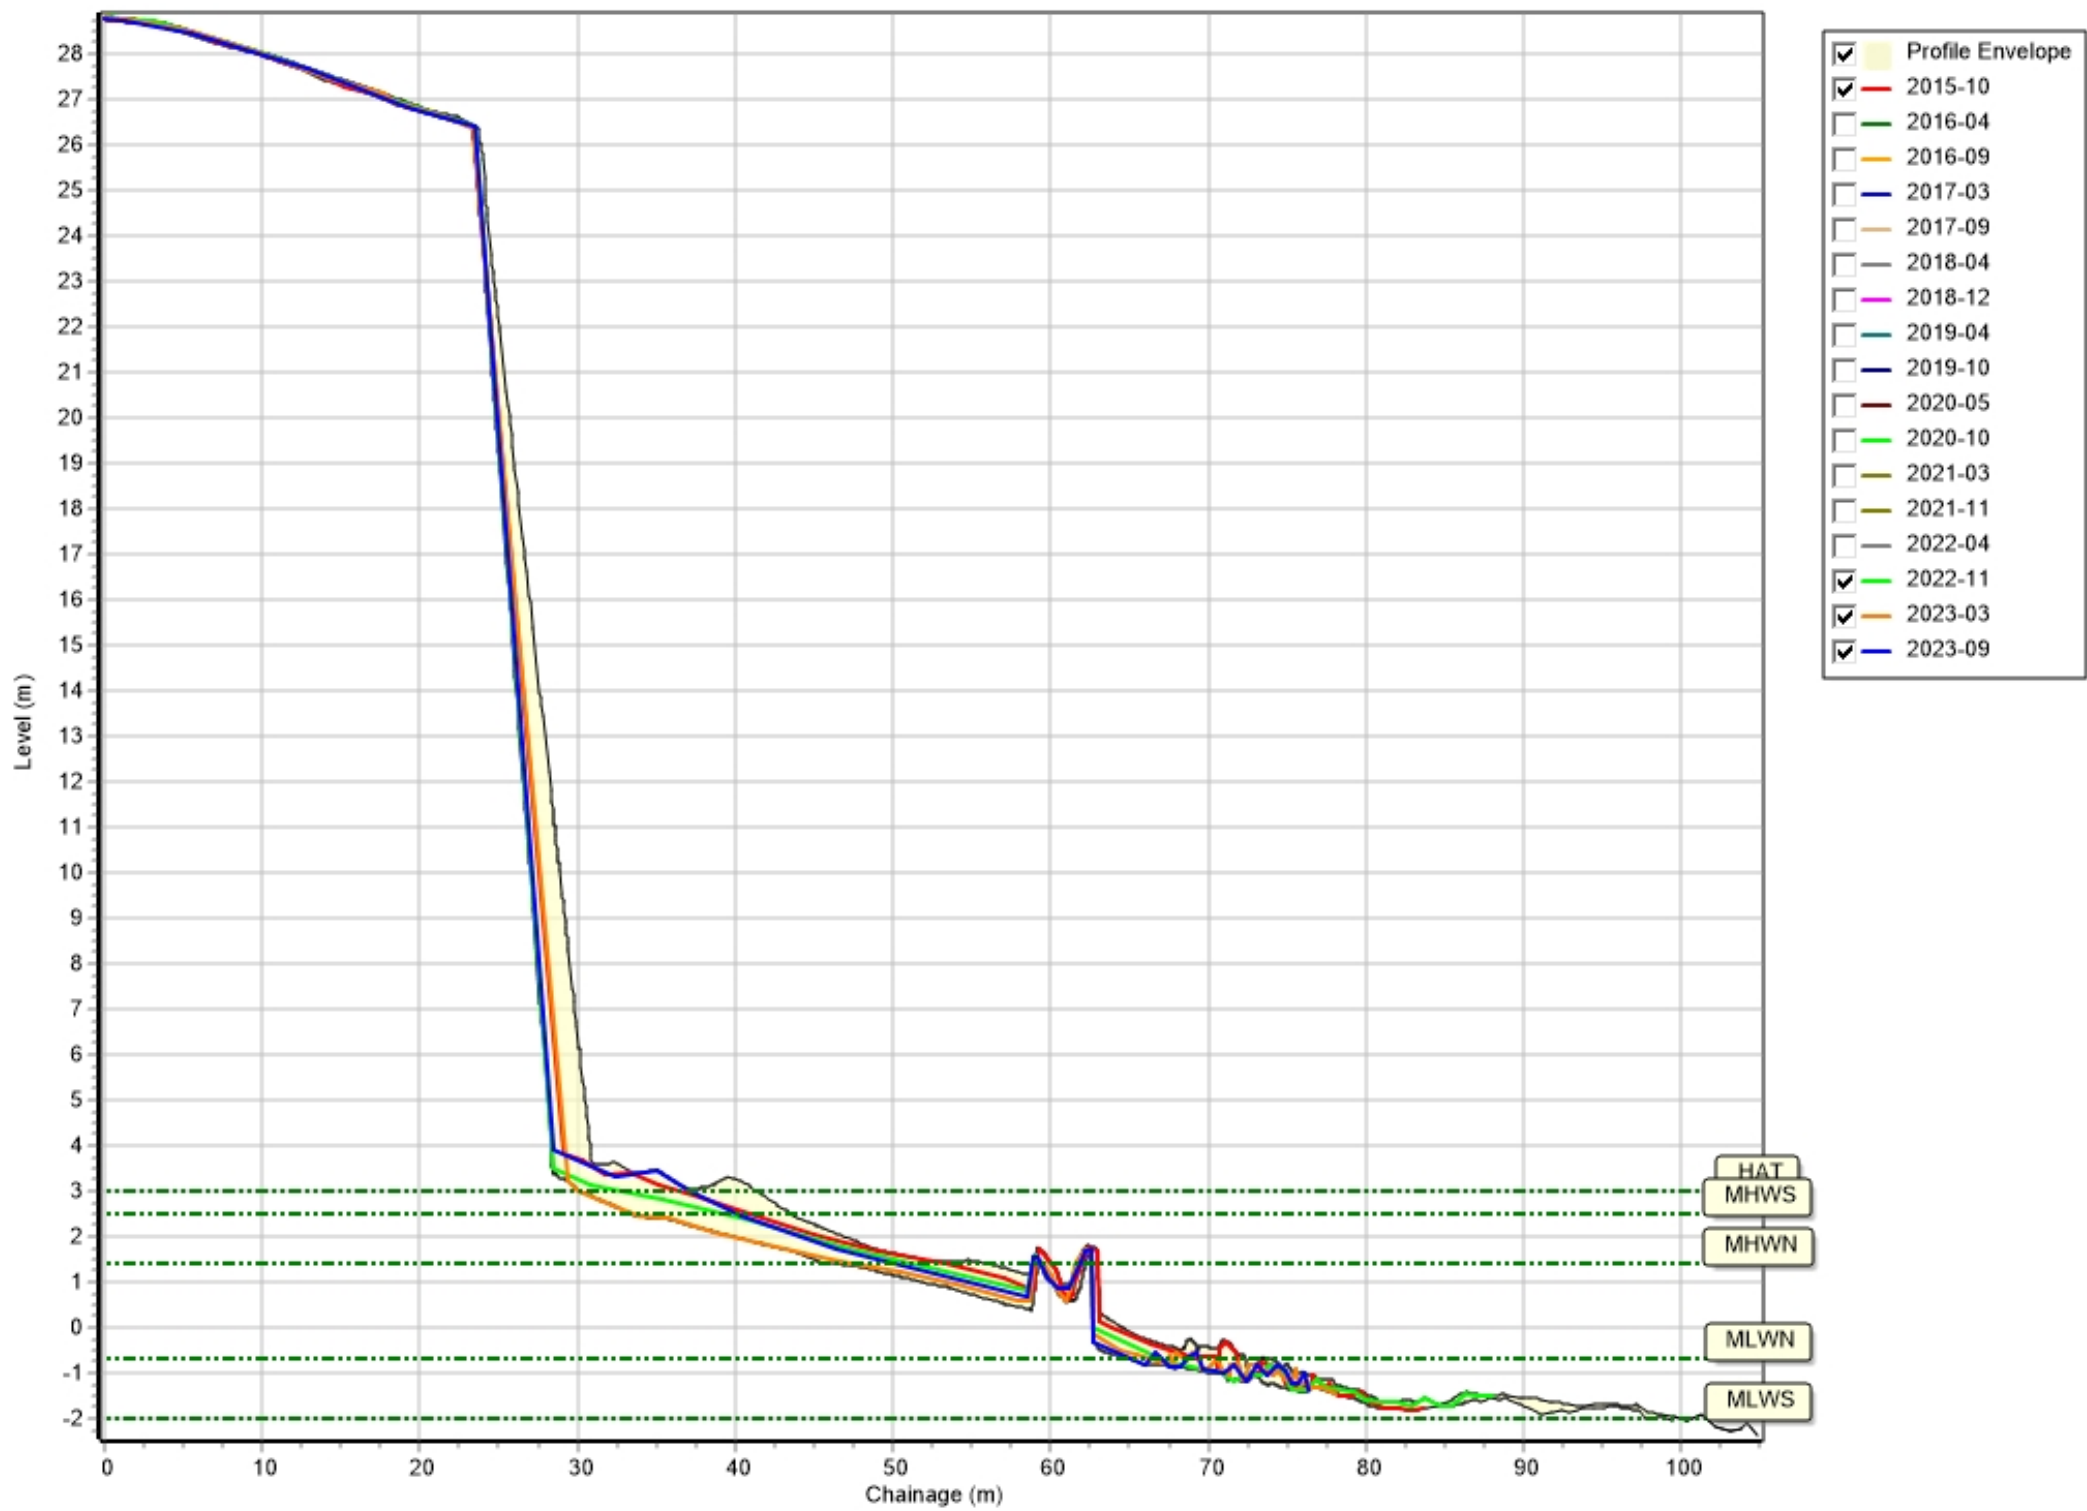
Profiles: 1bSH1B

Survey Date	Description of Changes Since Last Survey	Interpretation
10 th September 2023	<p>Beach Profiles:</p> <p>Blast Beach and Chemical Beach are covered by four beach profile lines (Appendix A). All the profiles exhibit similar forms, with a rock cliff, wide colliery spoil beach with a distinct low cliff at its eroding seaward edge, and a mixed gravel and sand foreshore extending to MLW. The survey report notes that; <i>'Dense vegetation restricts access to the cliff tops of sections SH1, SH2 & SH1A and the cliff base of SH1A.'</i></p> <p>Profile 1bSH1b was added to the programme during the Full Measures survey in October 2015. The profile is located on Chemical Beach, adjacent to the sewage works south of Seaham. The profile consists of cliff to chainage 30m, fronted by a gravel beach. The beach is bisected by a large concrete block between chainage 59m and 63m. Over the summer 2023, the upper section of the beach has accreted by up to 1m at chainage 35m, reducing to accretion of 0.1m at the landward side of the concrete block. Seaward of the concrete blocks, the beach has initially eroded by up to 0.15m over a 3m length, at which point the rocky foreshore is exposed. When compared to the range of the previous surveys, the beach is at a high level at the toe of cliff gradually reducing to a low on the lower beach.</p> <p>Profile 1bSH1a was added to the programme during the Full Measures survey in September 2009. It is located to the north of the previously established 1bSH1. The cliff top, face and landward extents of the colliery spoil platform have all remained unchanged since the previous survey. The eroding face of the spoil also remained unchanged, located at chainage 135m. Seaward of the spoil face, the upper beach has dropped in level significantly with the apparent draw down of material offshore. The drop in beach level peaks at chainage 147m, dropping by 1.7m. From chainage 166m onwards, the rocky foreshore remains exposed.</p> <p>At 1bSH1, the profile has remained unchanged across the cliff top and cliff face up to chainage 40m. At the toe of the cliff, on the colliery spoil platform, an incised channel holds water. The beach profile shows that the channel has accreted by 0.3m over summer 2023, however it is unclear whether this true change or in fact a reflection of varying water levels altering where the surveyors could take readings. The face of the retreating colliery spoil platform has shifted landward 0.4m since the previous survey, a relatively small retreat compared to previous years. Between the spoil and the exposed rocky</p>	<p>The colliery spoil platform on all profiles across Blast Beach appears to have remained stable over the summer 2023 indicating a period of calmer weather.</p> <p>This said, the significant draw down of material in front of the colliery spoil at profile 1bSH1a is thought to likely leave the spoil vulnerable for the subsequent winter months.</p> <p>Longer term trends: The cliffs behind Blast Beach are currently inactive because they are fronted by colliery spoil. The sea cliffs will eventually reactivate as on-going erosion of the colliery spoil removes the protection it affords to the cliffs. This is most likely to occur at the southern end of the bay where the spoil is most rapidly eroding. The accumulating sediment seaward of the colliery spoil in the northern part of the bay will offer the cliffs more protection. However, the trend reversed in the the winter of 2014 with erosion in the north of the bay and accretion in the south. Since 2022, the colliery spoil has undergone a period of stability.</p>
