Cell 1 Regional Coastal Monitoring Programme Analytical Report 16: 'Full Measures' Survey 2023

Durham County Council

November 2023

(*) The present report is **Analytical Report 16** and provides an analysis of the 2023 Full Measures survey for County Durham Council's frontage.

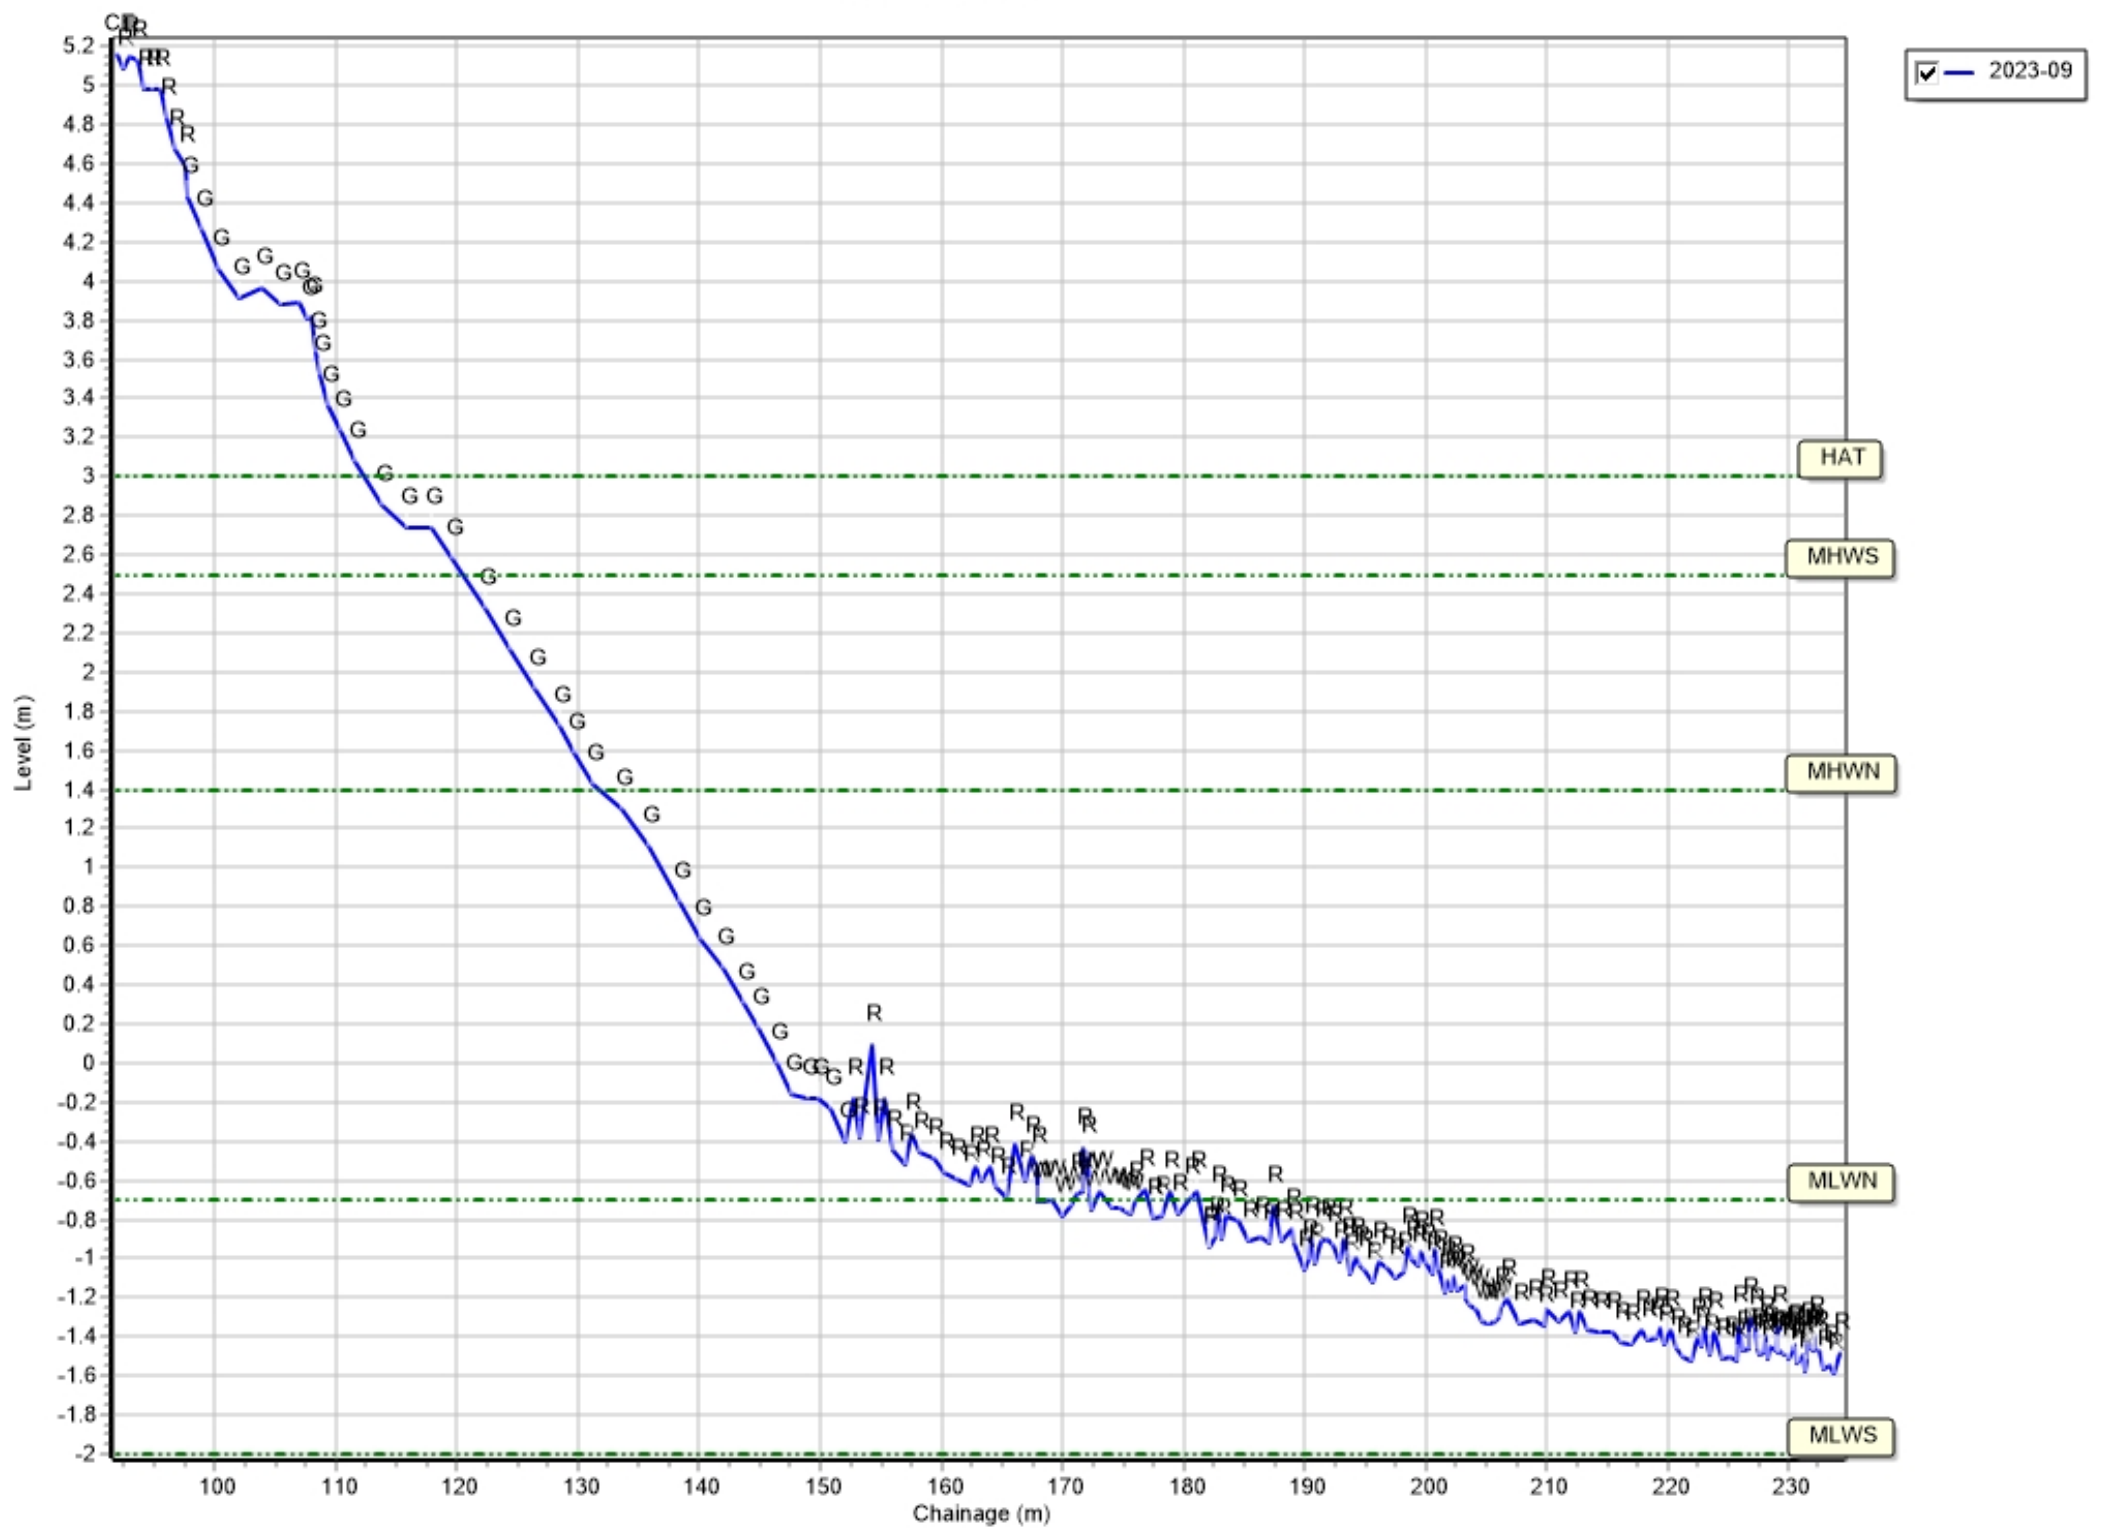
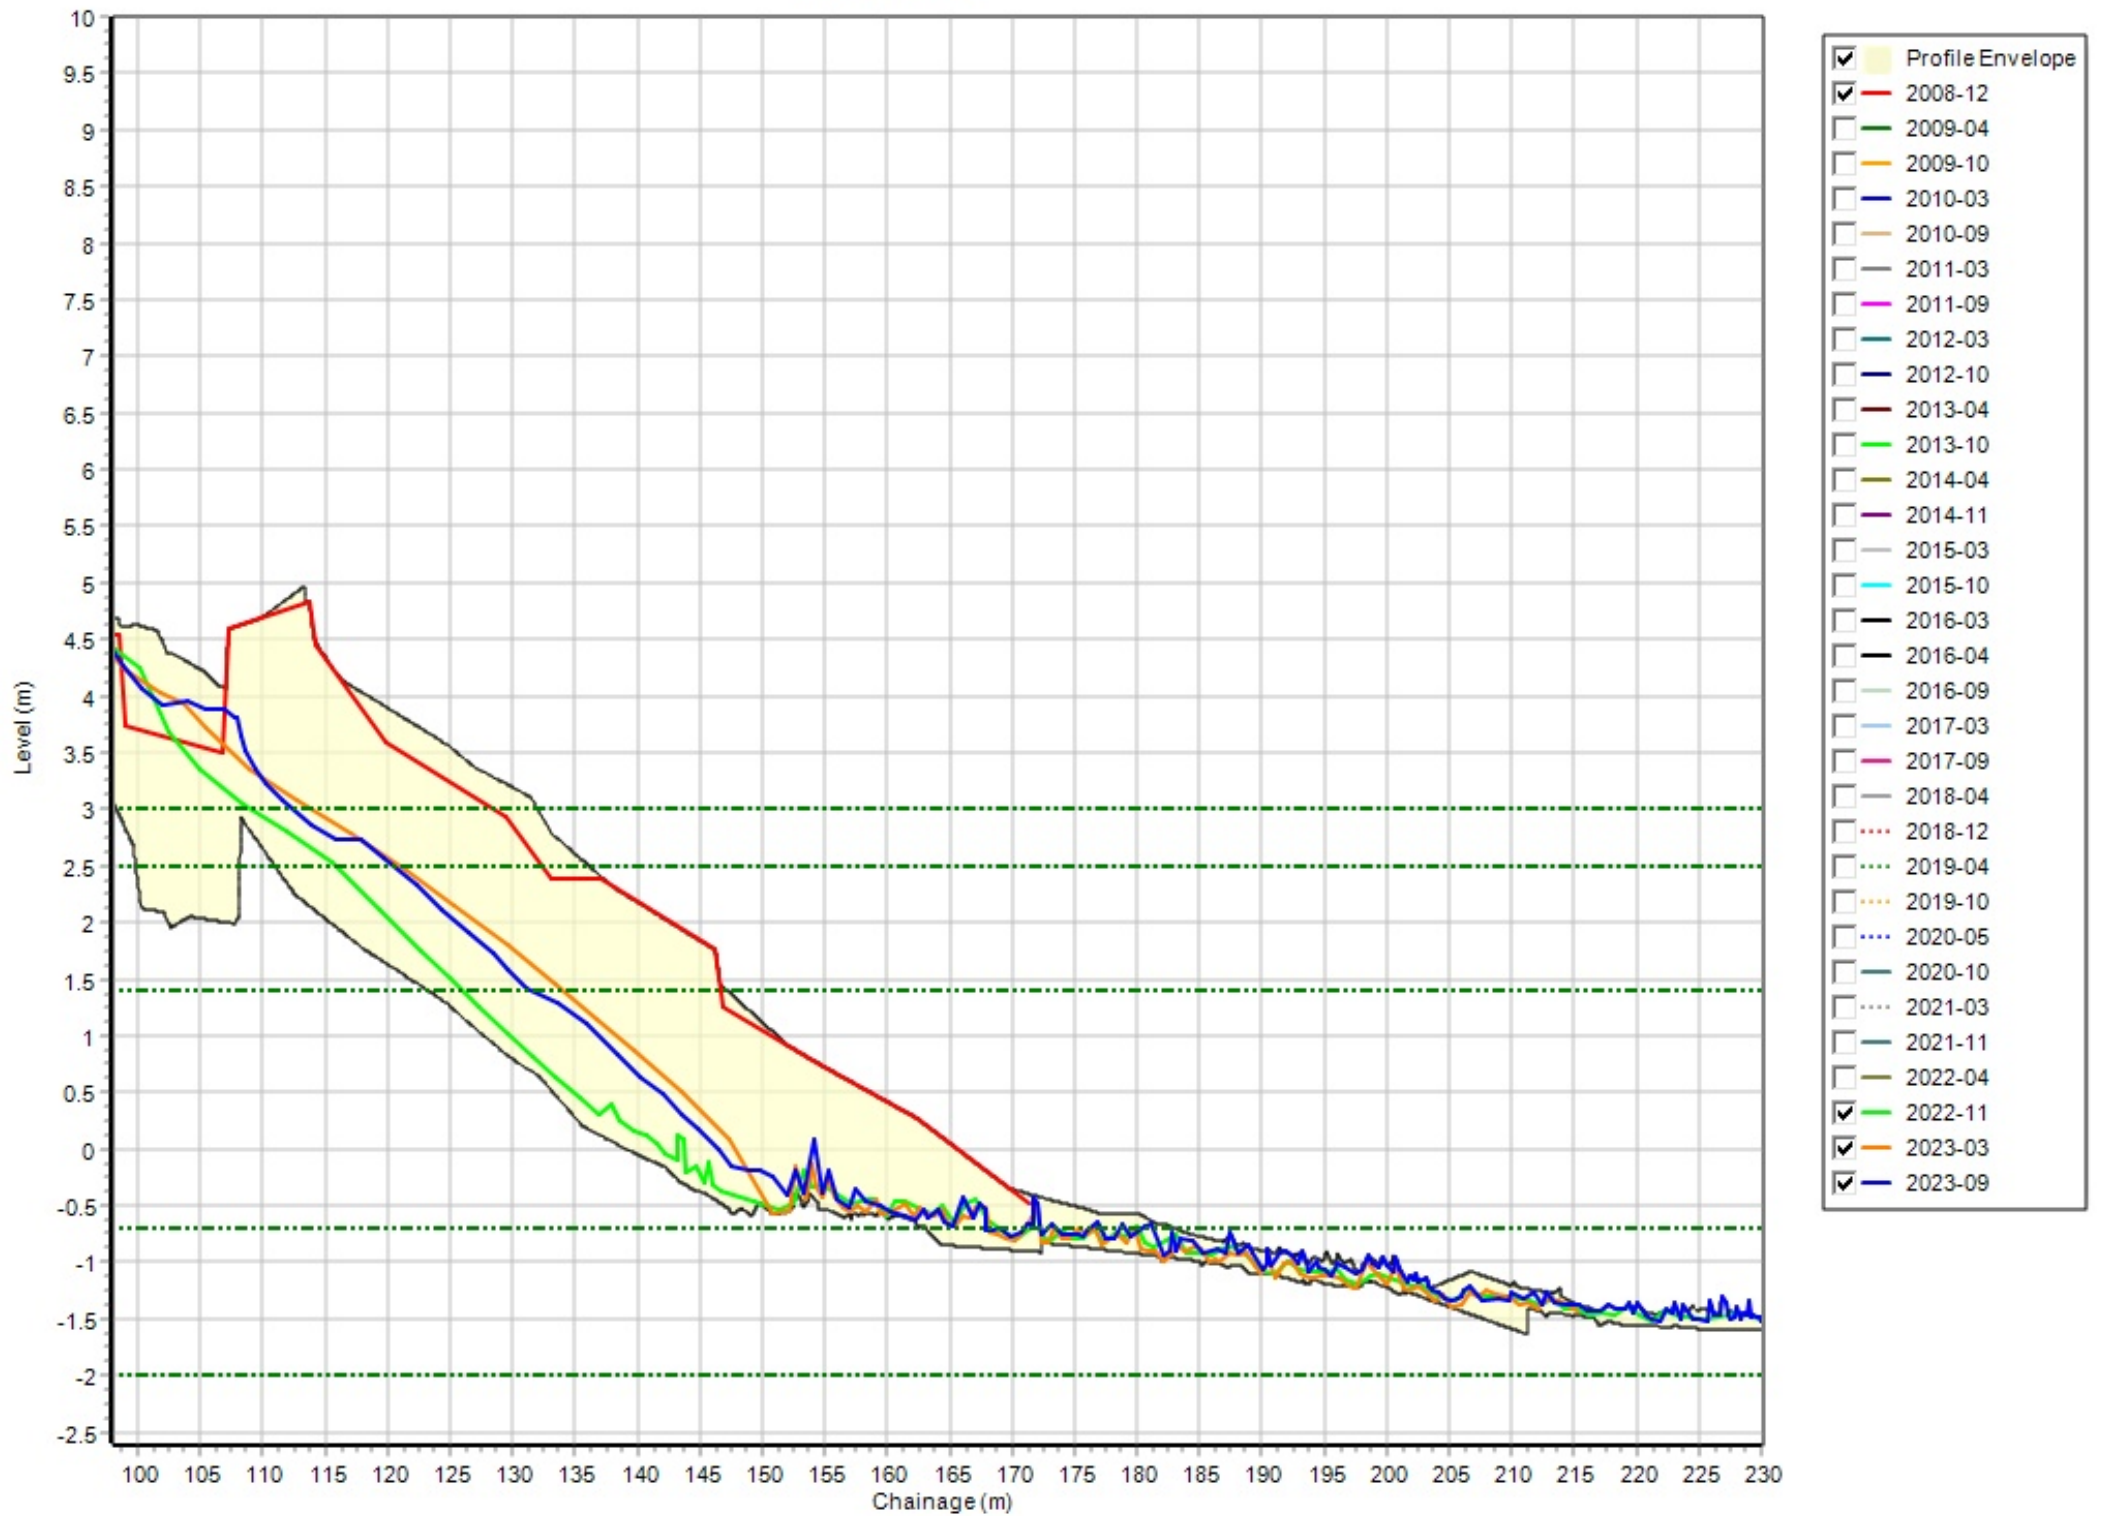
Profiles: 1cEA2

Survey Date	Description of Changes Since Last Survey	Interpretation
20 th September 2023	<p>Beach Profiles:</p> <p>Hawthorne Hive is monitored by beach profile 1cEA2 (Appendix A). The survey report notes “<i>unable to measure start of Section EA2 as the vegetation has choked out the section line and route over cliff faces</i>” and therefore all surveys following October 2012 start at 95m chainage. The steeper upper beach, from chainage 95m to 148m, has remained largely stable. Low levels of accretion (+0.4m) has formed a shallow berm at chainage 108m, with erosion less than 0.2m observed until chainage 148m. Seaward of chainage 148m, the rocky foreshore remains exposed. The upper beach remains at medium level when compared to the range of previous surveys, with the exposed foreshore naturally at the lowest level.</p>	<p>Longer term trends: The upper beach levels were recorded to be notably low in 2014, 2018 and May 2021. On all occasion the beach levels appeared to demonstrate some recovery but not enough to alter the long-term pattern that suggests the beach is undergoing progressive erosion.</p> <p>Limited cliff erosion occurs in this section and therefore sediment supply is limited to erosion of colliery spoil.</p> <p>Storm events and varying flows in Hawthorne Burn are likely to continue to episodically block the channel and change its course across the beach.</p>

At Hawthorne Hive the surveyor was unable to measure the start of Section 1cEA2 as the vegetation has choked out the section line and route over cliff faces.

- At Hawthorne Hive, there has been little change since the previous survey with the upper beach remaining stable. The rocky foreshore remains exposed on the lower beach.

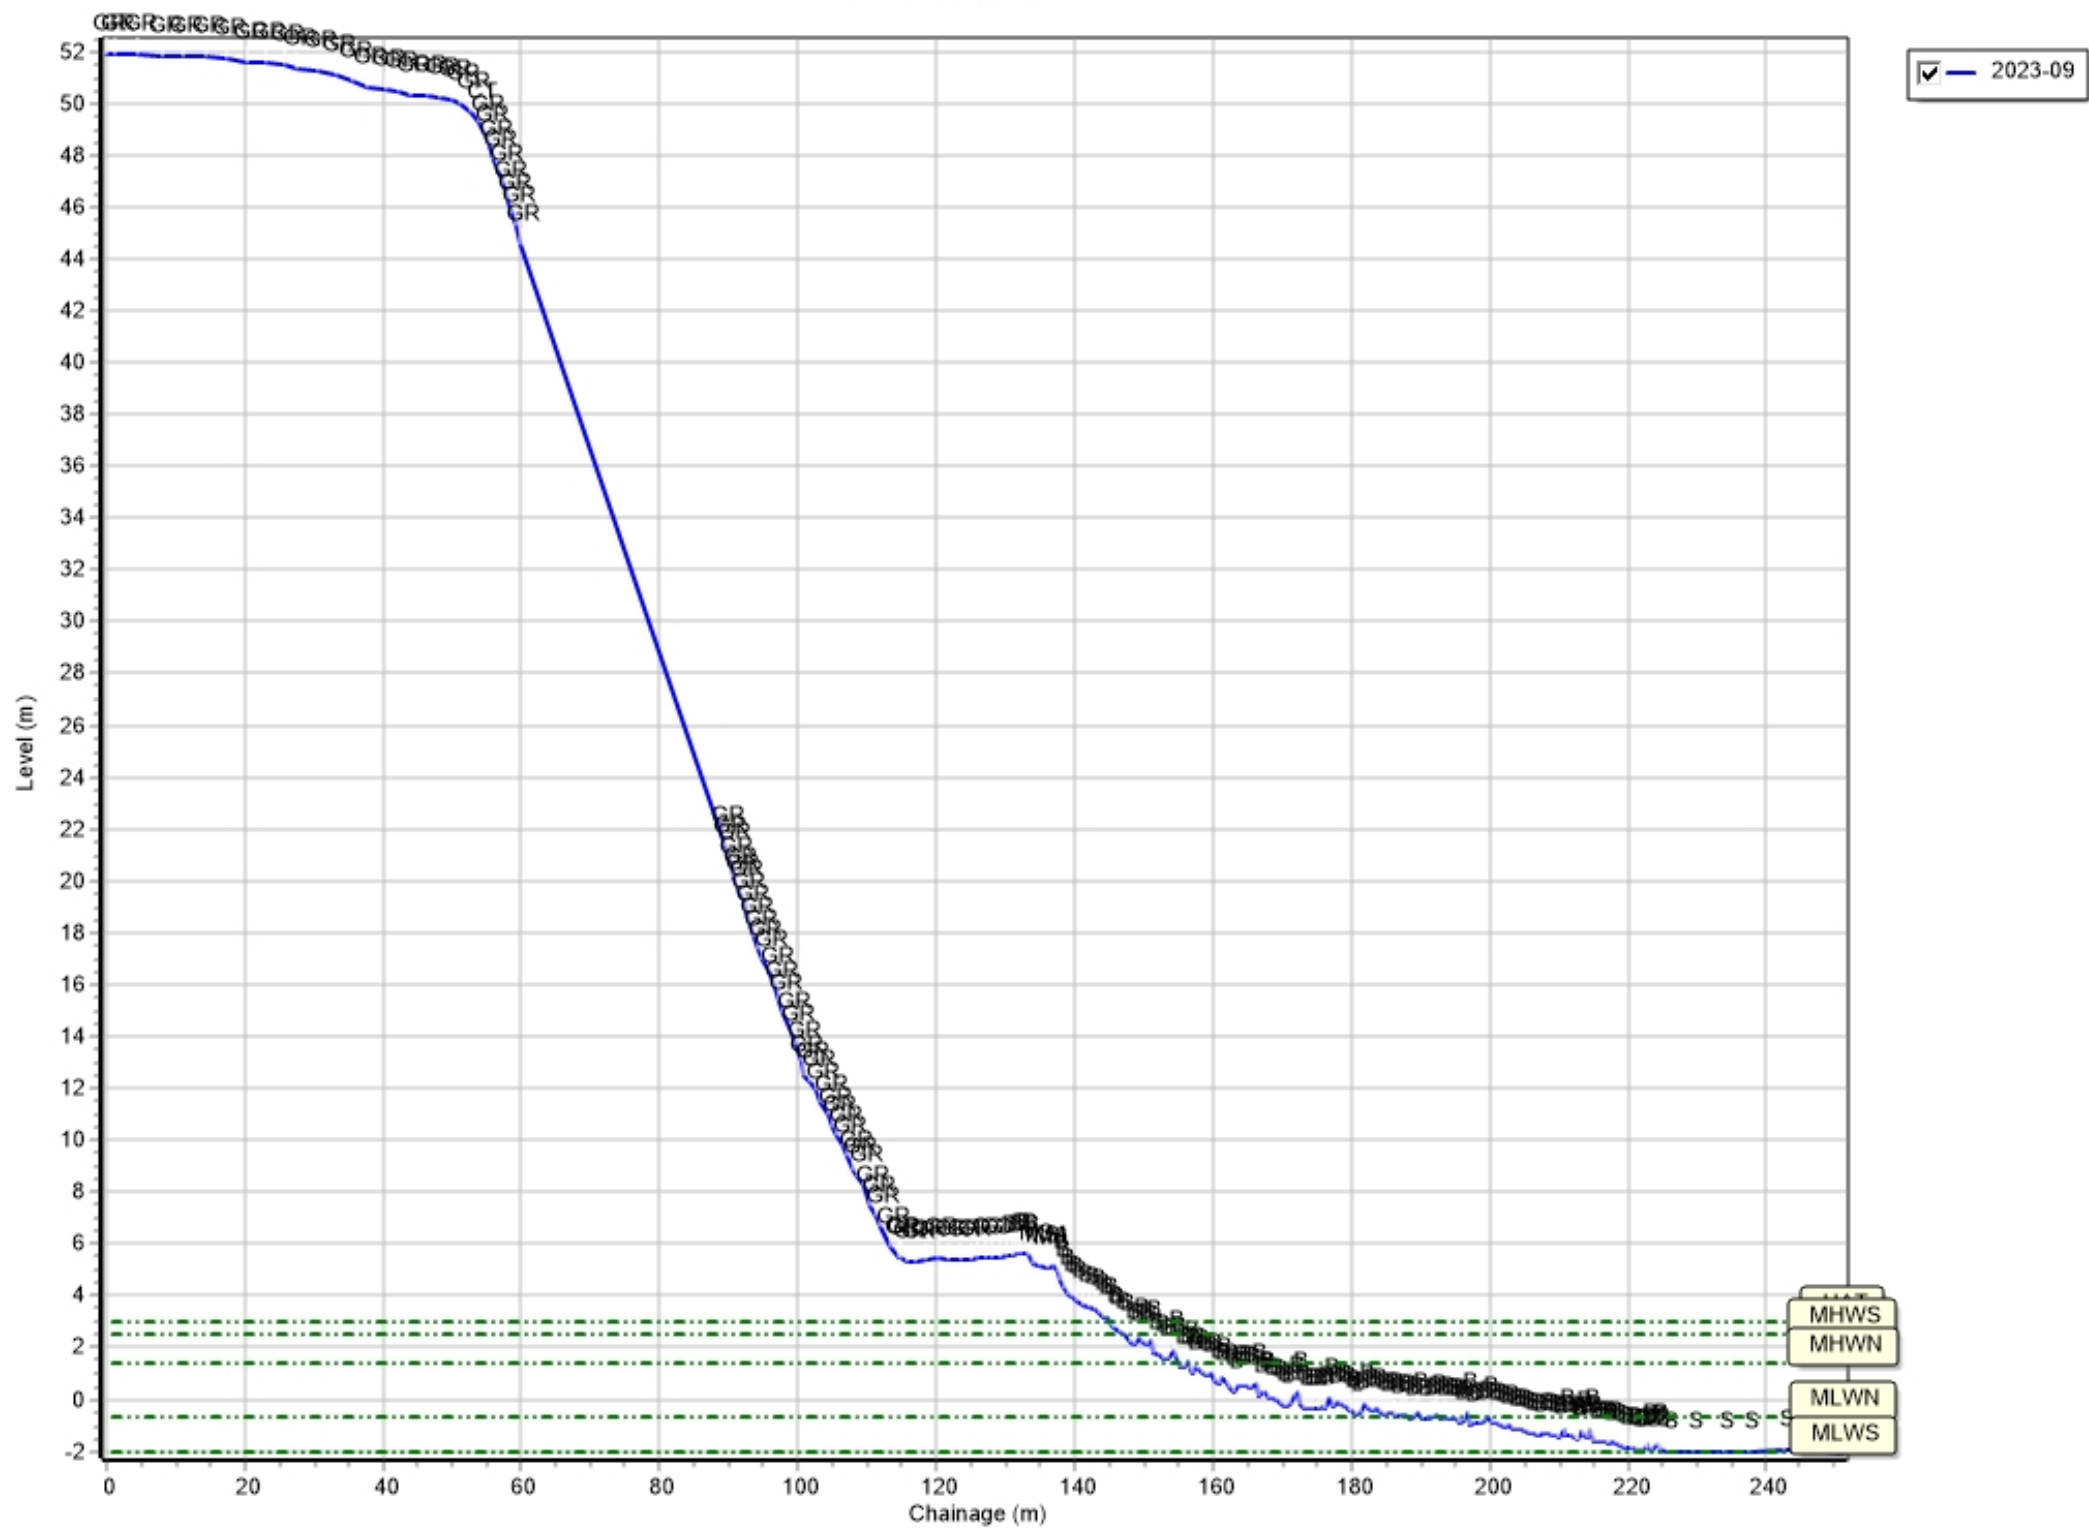
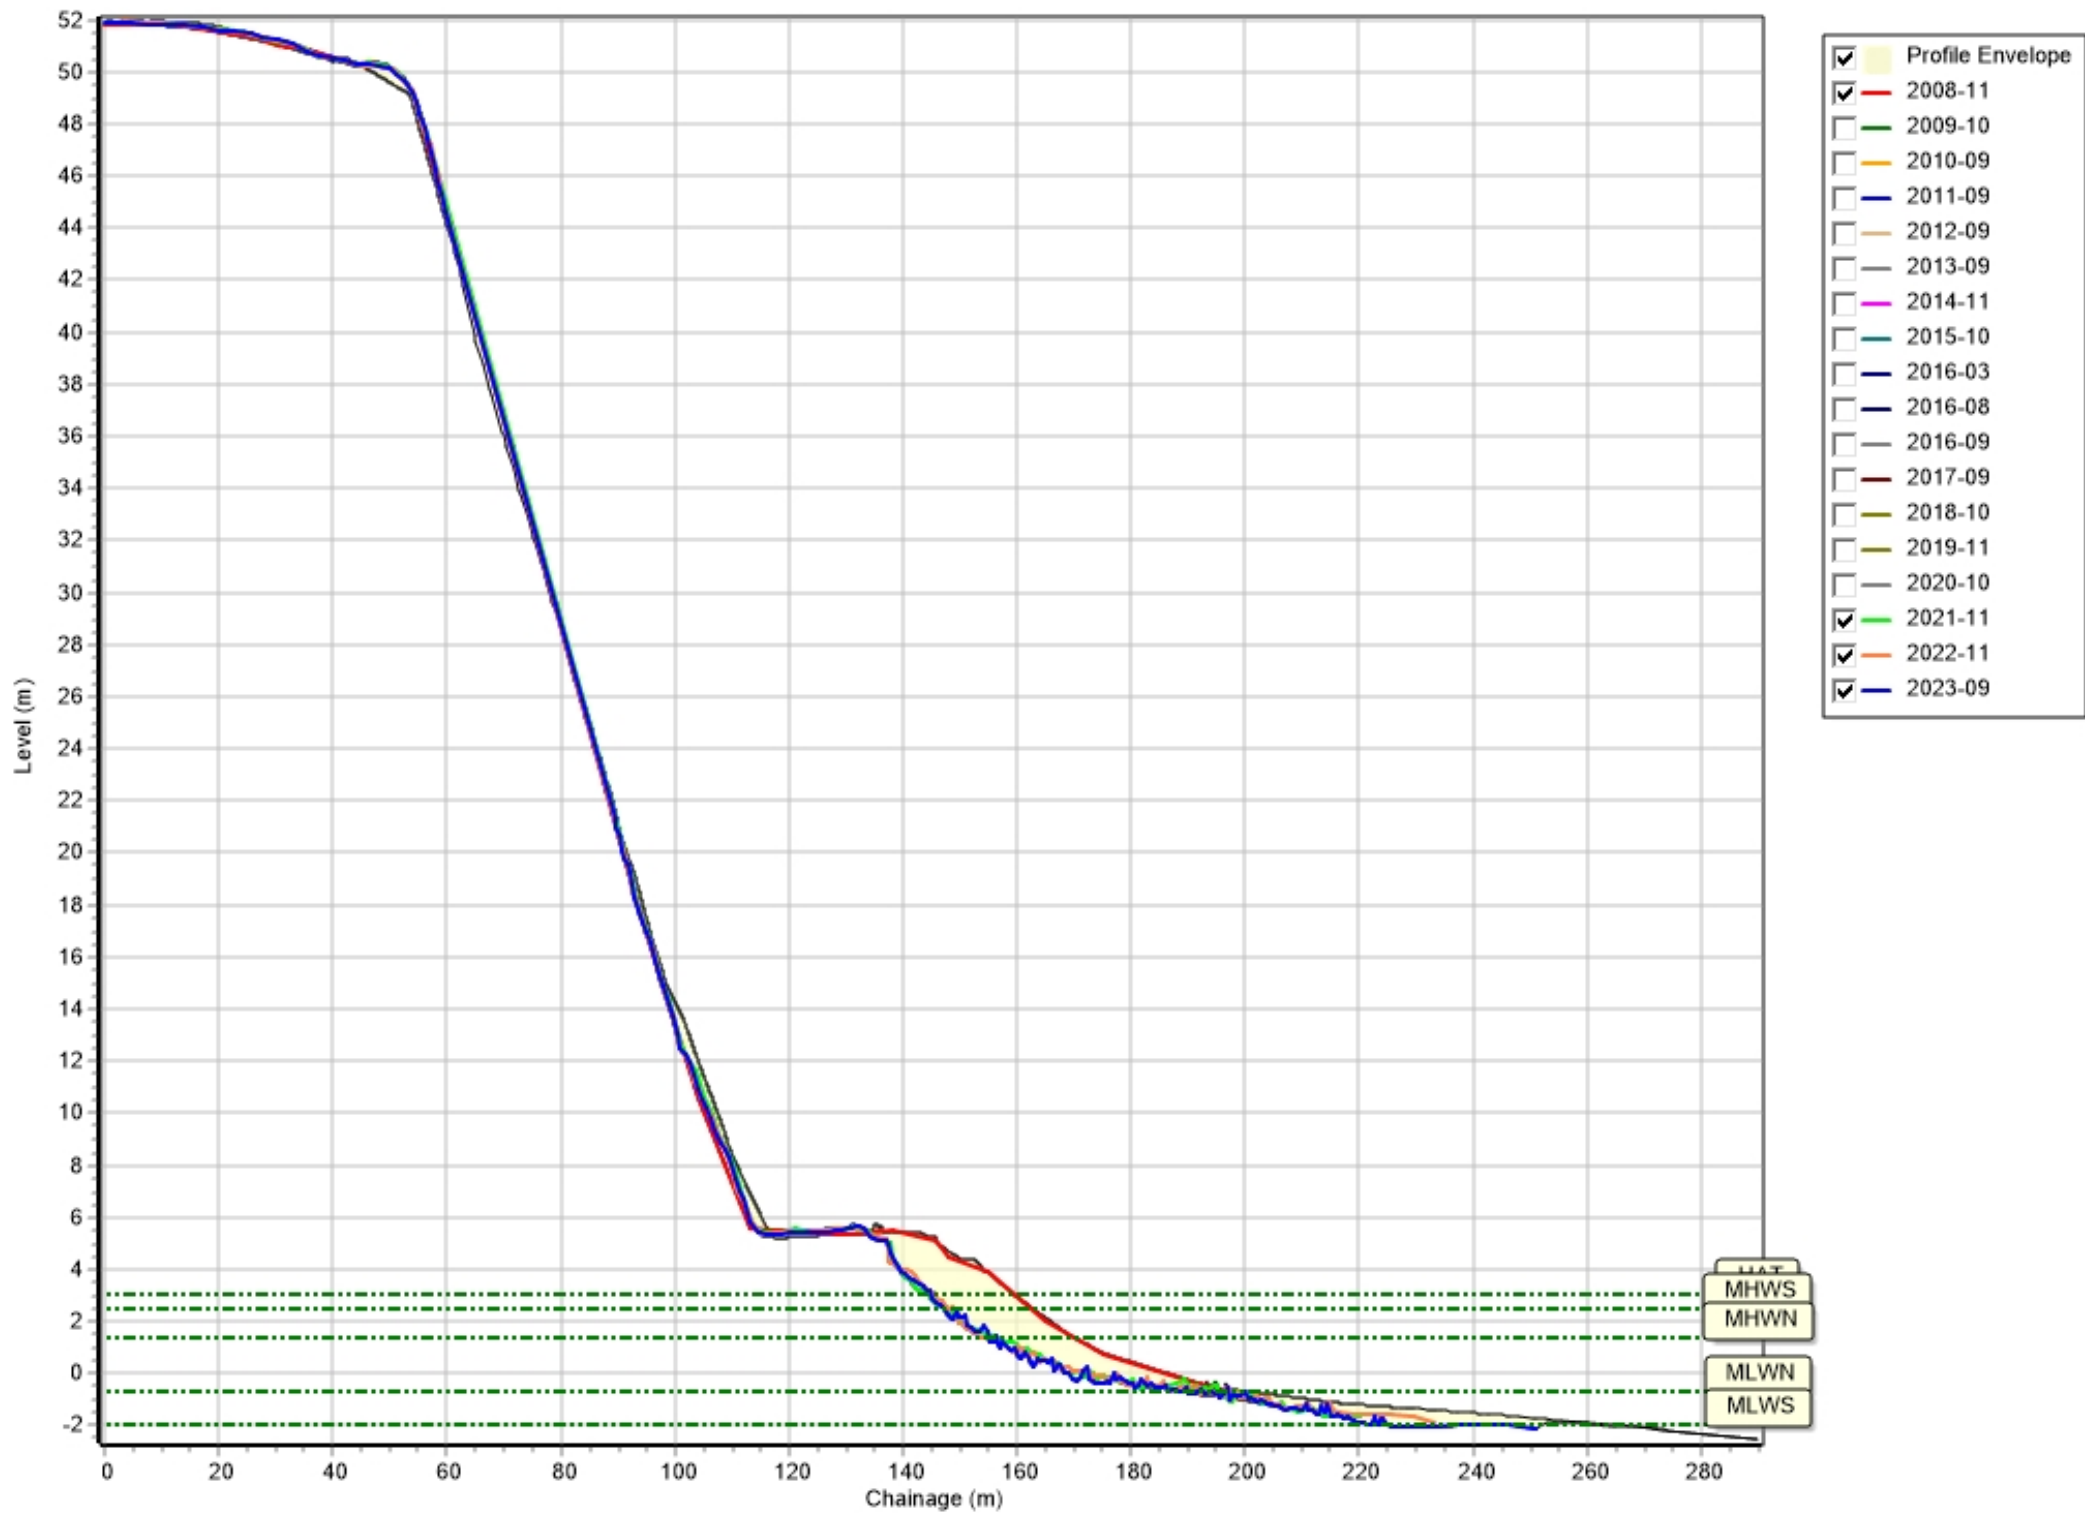
Profiles: 1cBH1

Survey Date	Description of Changes Since Last Survey	Interpretation
4 th September 2023	<p>Beach Profiles:</p> <p>Blackhall Colliery is covered by three beach profile lines (Appendix A) that are monitored annually. As at Blast Beach, profiles are dominated by colliery spoil and exhibit similar forms with a rock cliff, wide spoil beach with a distinct cliff at the eroding face of the colliery spoil, and a gravel and sand foreshore that extends to MLW. The survey report notes that the surveyor was <i>'unable to survey part of section BH1 and BH2 due to dense vegetation'</i>.</p> <p>1cBH1 is located near Horden Point. The Full Measures 2023 survey shows that the profile has remained stable up to the face of the retreating colliery spoil at chainage 137m. Apparent accretion of material at the face of the spoil has resulted in the cliffed face becoming more gradual in topography. The cobble beach/foreshore has maintained a very similar profile to the November 2022 profile with change again limited to the movement of large rocks. The profile remains at the bottom of the range envelope due to the retreating colliery spoil platform over time.</p> <p>At Profile 1cBH2, the backing till cliff appears to have been recently active, with slumping evident in the survey photos. From the toe of the cliff to the face of the retreating colliery spoil, the platform has remained unchanged. Compared to previous years the rate of retreat of the colliery spoil itself is significantly less, retreating landward less than 0.5m since the previous survey, The lower beach, seaward of chainage 190m, has accreted by up to 0.5m in level. Overall, the profile remains at the bottom of the range envelope due to the retreating colliery spoil platform over time, with the exception of the lower beach due to the recent accretion.</p> <p>Profile 1cBH3 shows that since 2008 there has been episodic migration, infilling and scouring of the outflow of Castle Eden Burn, which crosses the profile. The channel has been migrating landward over the years and now is located at the toe of the cliff. Since the previous inspection the channel bed has accreted marginally by 0.2m level but has not changed in width.. The berm crest, seaward of the channel, remains unchanged. On the beach itself the profile appears to show the movement of material up the profile, with accretion of up to 0.8m occurring between 164m and 196m and erosion of a similar magnitude between 196m and 246m. Compared to the range of previous surveys the profile remains largely at its most landward position.</p>	<p>The frontage appears to have experienced a period of stability with the colliery platforms at profile 1cBH1 and 1cBH2 both retreating less than 0.5m since the previous surveys. As a result, there is approximately 30m and 25m of spoil remaining fronting the cliffs at 1cBH1 and 1cBH2 respectively.</p> <p>Longer term trends: The surveys show that the spoil beach along much of the Blackhall Colliery shore is progressively eroding but continues to protect the cliffs in the short term. The colliery spoil face at profile 1cBH1 and profile 1cBH2 has eroded back ~8m and 24m respectively since the first survey in 2011. In recent years profile 1cBH2 has experienced an inflated rate of erosion. This was not observed in the latest survey but should still be monitored closely.</p>

At Blackhall the surveyor was unable to access part of sections 1cBH1 and 1cBH2 due to dense vegetation.

- The frontage appears to have experienced a period of stability with the colliery platforms at profile **1cBH1** and **1cBH2** both retreating less than 0.5m since the previous surveys. As a result, there is approximately 30m and 25m of spoil remaining fronting the cliffs at **1cBH1** and **1cBH2** respectively.
