**Cell 1 Regional Coastal Monitoring Programme
Update Report 1: 'Partial Measures' Survey 2009**

**Durham County Council
Final Report**

June 2009

Update Report 1
'Partial Measures' Survey 2009

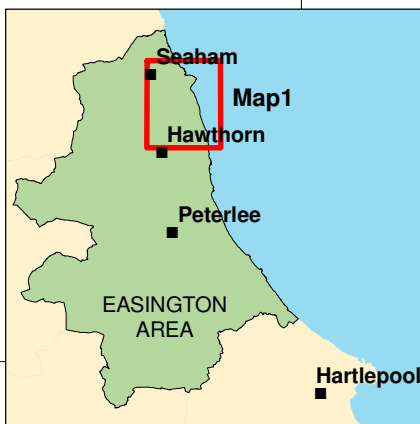
**Figure 2 - Map 1
Durham County
Council Frontage**

TOPOGRAPHIC SURVEY LOCATIONS

- Annual Profile
 - Bi-Annual Profile
 - Cliff Top Survey @ 50 centres
 - Cliff Top Survey @ 100 centres
 - Cliff Top Survey @ 300 centres
- (Indicative Survey Extents shown)*

The location of these surveys is shown in Figure 1. Also enclosed on the accompanying CD-rom is a file which can be opened in Google Earth showing the locations of the surveys.

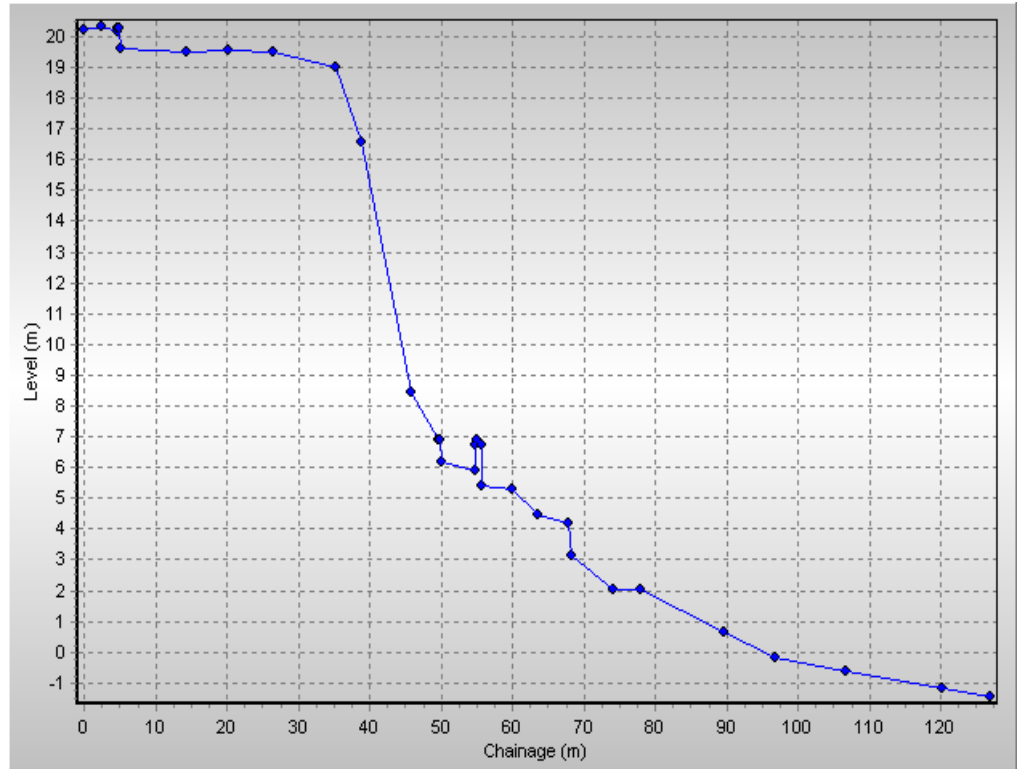
1bEA1

Date 22/04/2009 **Inspector** RH
Wind Light **Sea State**
Summary NEW Re-Located Profile

Easting 442859.813 **Northing** 549874.882 **Bearing** 47

Survey Date	Description of Changes Since Last Survey	Interpretation
03-2009	<p>Beach Profiles:</p> <p>Featherbed Rocks is covered by one beach profile line (EA1) during the Partial Measures survey (Appendix A).</p> <p>Following a recommendation made in Analytical Report 1, the profile line was relocated to its present position in this survey. EA1 now starts on the cliff top immediately adjacent (seaward side) to the B1287 North Road at an elevation of around 20.3mODN and drops to grassland level, of just over 19.5mODN, after a chainage of 5m. For the next 35m chainage the profile extends across the cliff top, dipping slightly at the cliff edge to around 19mODN. The profile then drops 13m down the cliff face to the toe of the cliff and then extends seawards some 4.75m across the promenade. The fronting sea wall is then crossed, with a crest level of 6.9mODN, before the survey drops 1.5m to beach level. There is then a substantial width of upper beach comprising some 22m of accumulated sediment before the profile exhibits a classic curve down to low water.</p>	<p>This profile will be important to monitor for signs of beach accumulation at the toe of the sea wall and any changes in the form of the backing sea cliff. Further south of this profile, the beach sediment accumulates further, almost reaching the crest of the wall.</p>

- Profile EA1 will be useful for monitoring beach accumulation at the toe of the sea wall and any changes in the form of the backing sea cliff.
- There has been substantial cliff top recession at both the northern and southern ground control points along Dawdon cliff. If these rates continue it will give rise for concern, but it may be that two separate but relatively large events have occurred and there may then be a period of relative quiescence until the next such event.
- There has been no erosion of the colliery spoil along Blast Beach, with changes confined to natural variability along the fronting foreshore.
- The outlet channel of Hawthorne Hive remained in a relatively constant position but widened slightly on its seaward margin.

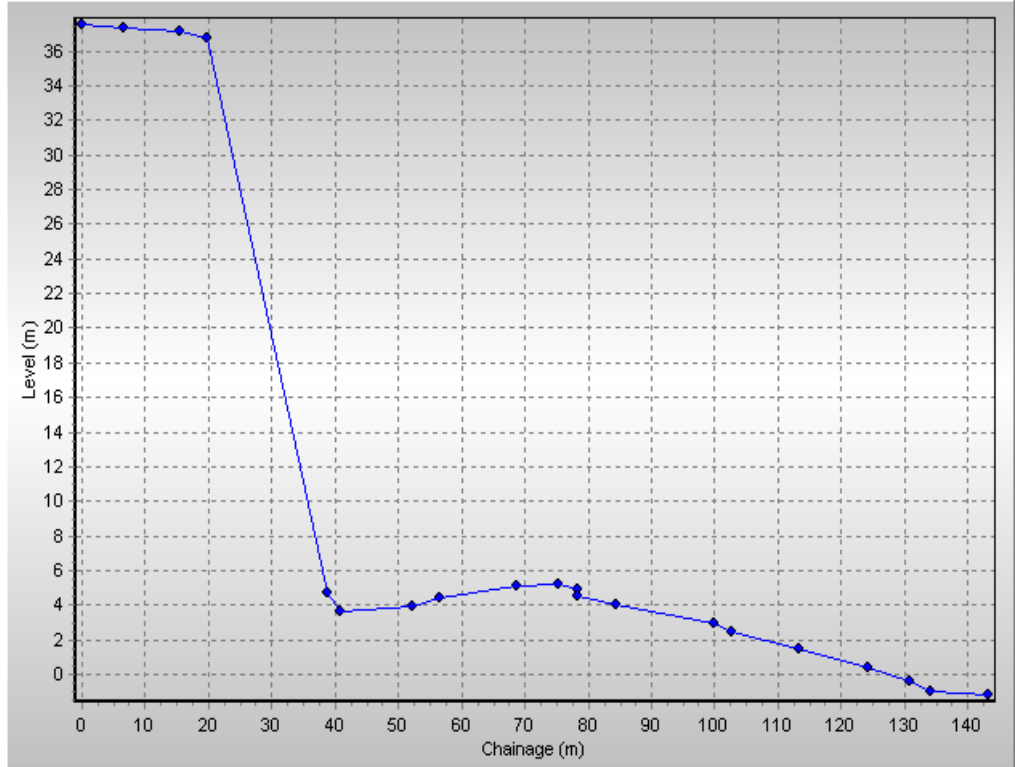
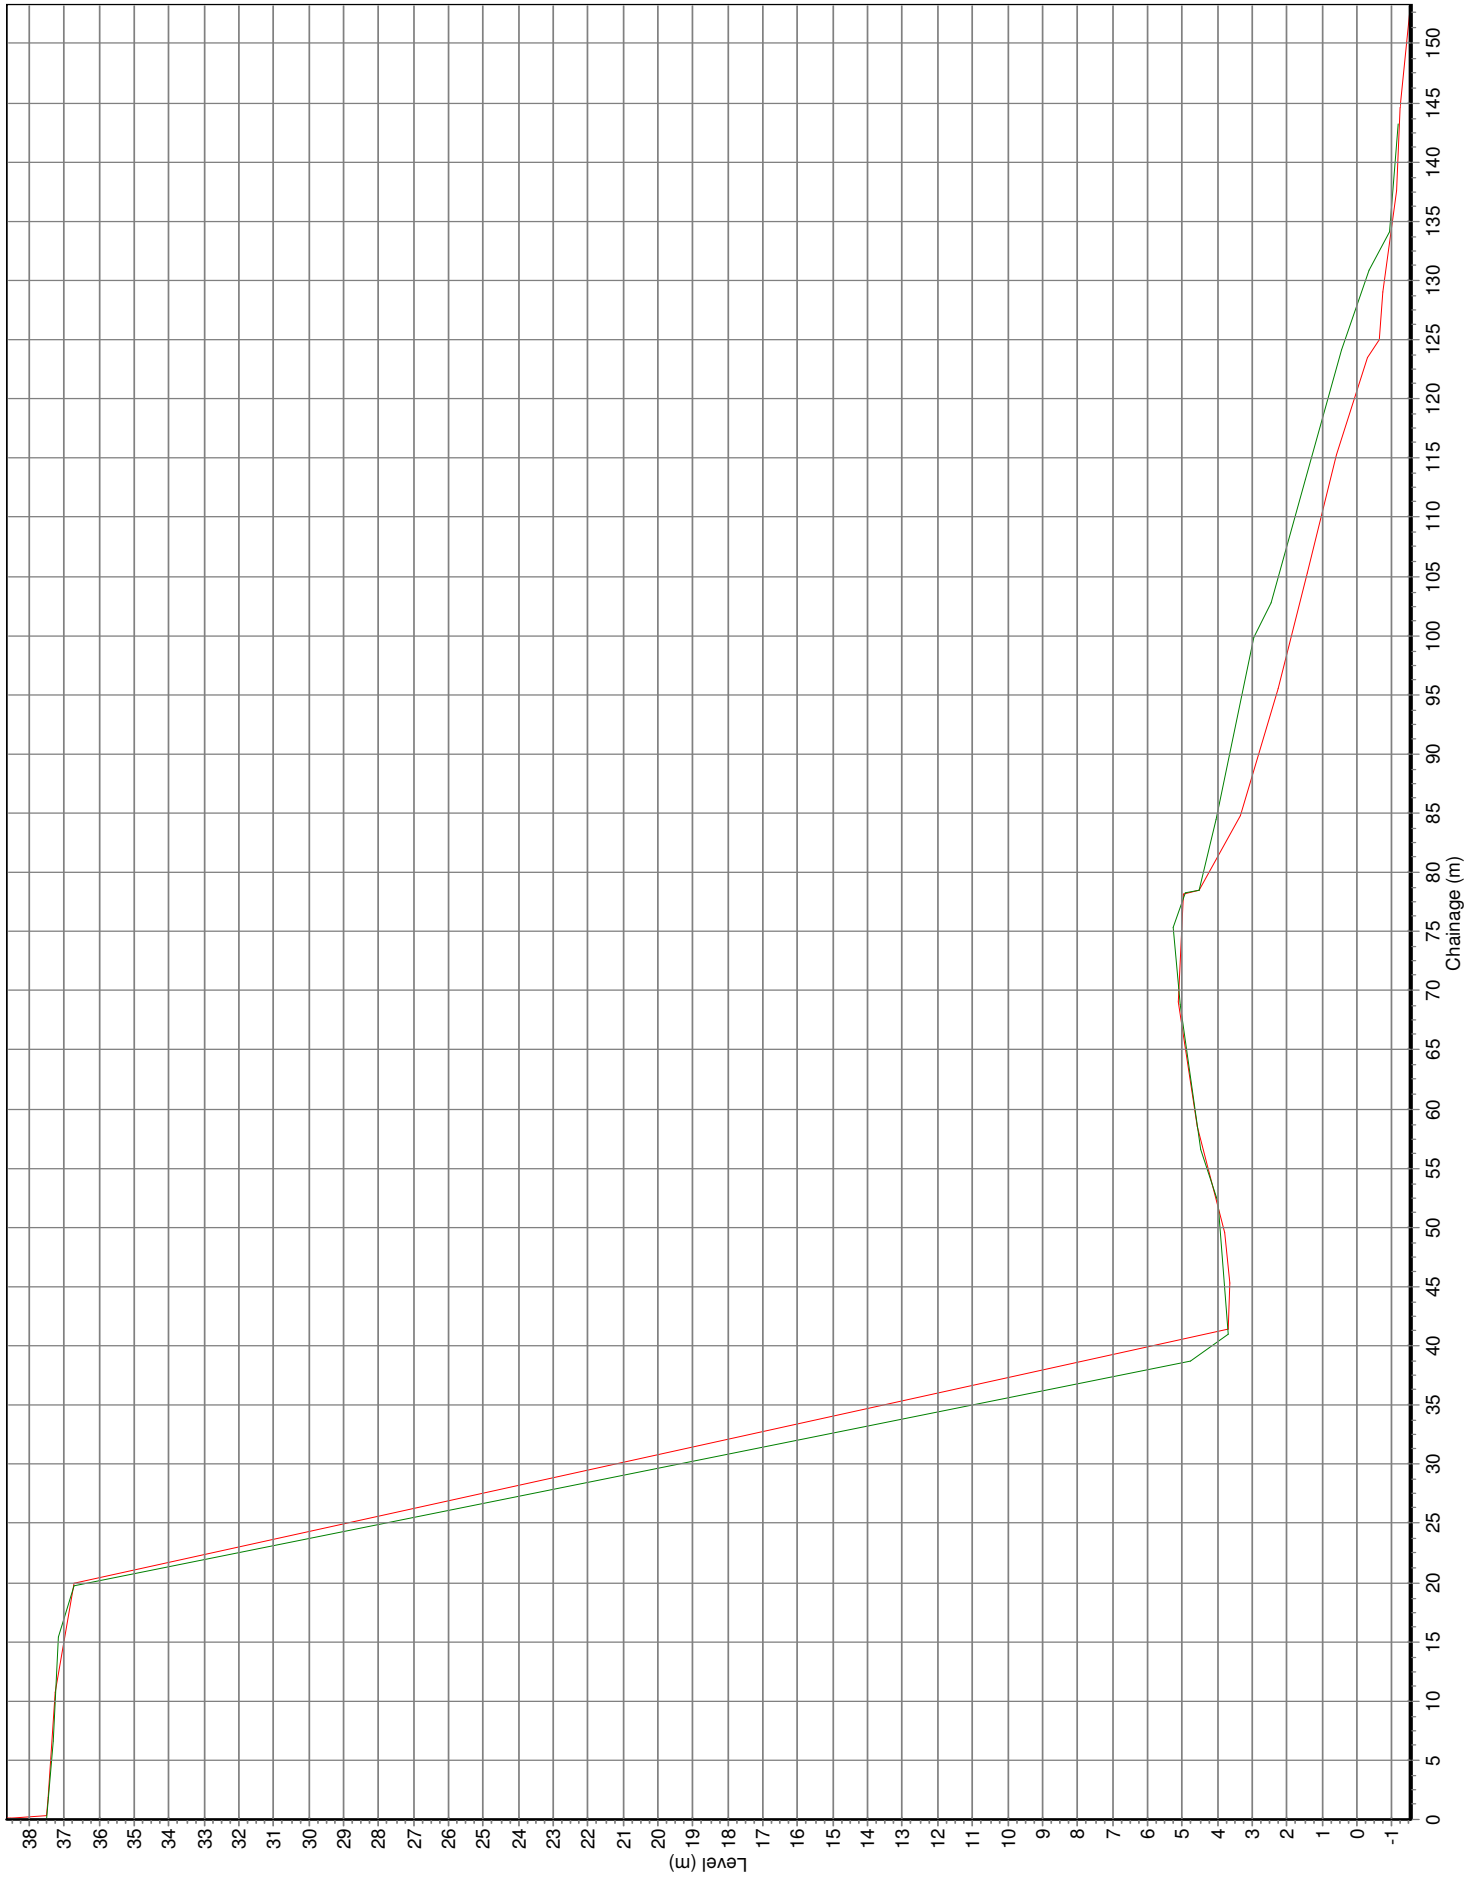
Beach Profiles: 1bSH1

25/1/2008
22/04/2009

Survey Date	Description of Changes Since Last Survey	Interpretation
03-2009	<p>Beach Profiles:</p> <p>Blast Beach is covered by two beach profile lines during the Partial Measures survey (Appendix A).</p> <p>SH1 shows accretion of sediment on the foreshore fronting the beach comprised of colliery spoil. This has raised beach levels here by up to 1m. The colliery spoil has not eroded since the previous survey. Whilst there is 'apparent' change in cliff face, this is simply due to the more recent survey picking up an additional survey point at the base of the cliff and does not represent a true change.</p> <p>SH2 shows a very minor amount of lowering of the foreshore in front of the colliery spoil, but no change in the spoil beach itself. The greatest difference between the two surveys is in the cliff face and top, where the most recent survey has picked up additional survey resolution compared with the first, showing 'apparent' changes in the cliff.</p>	<p>There seems to have been a small amount of redistribution of beach sediment from the southern foreshore to the northern foreshore, but there has been no erosion of the colliery spoil beach.</p>

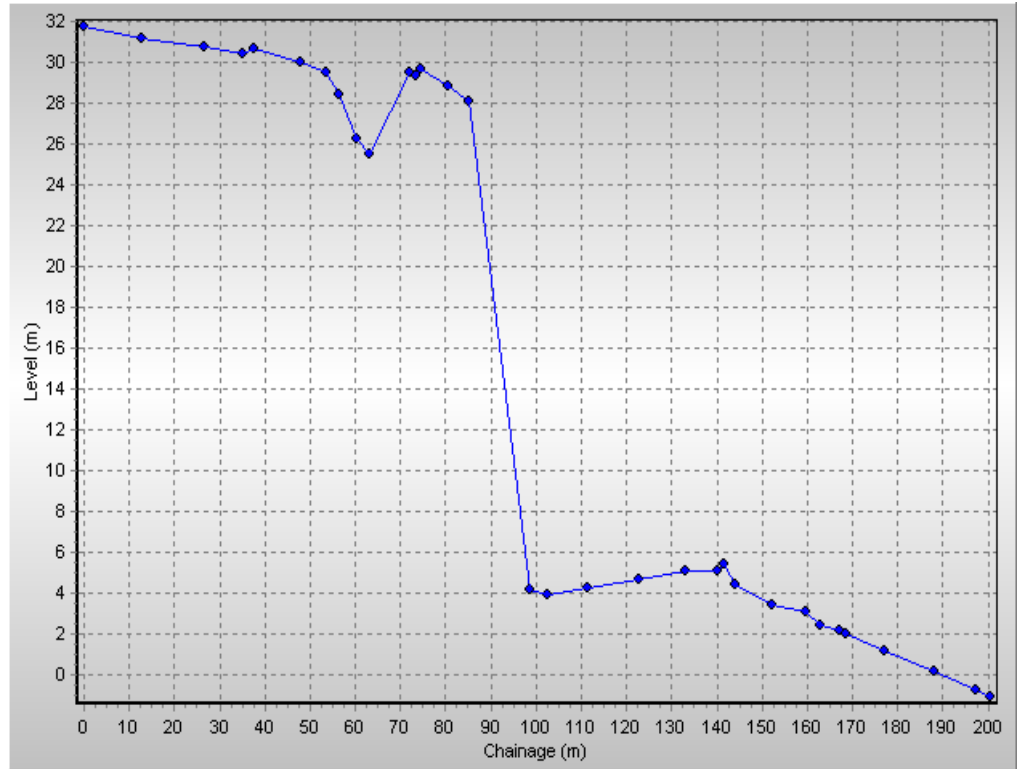
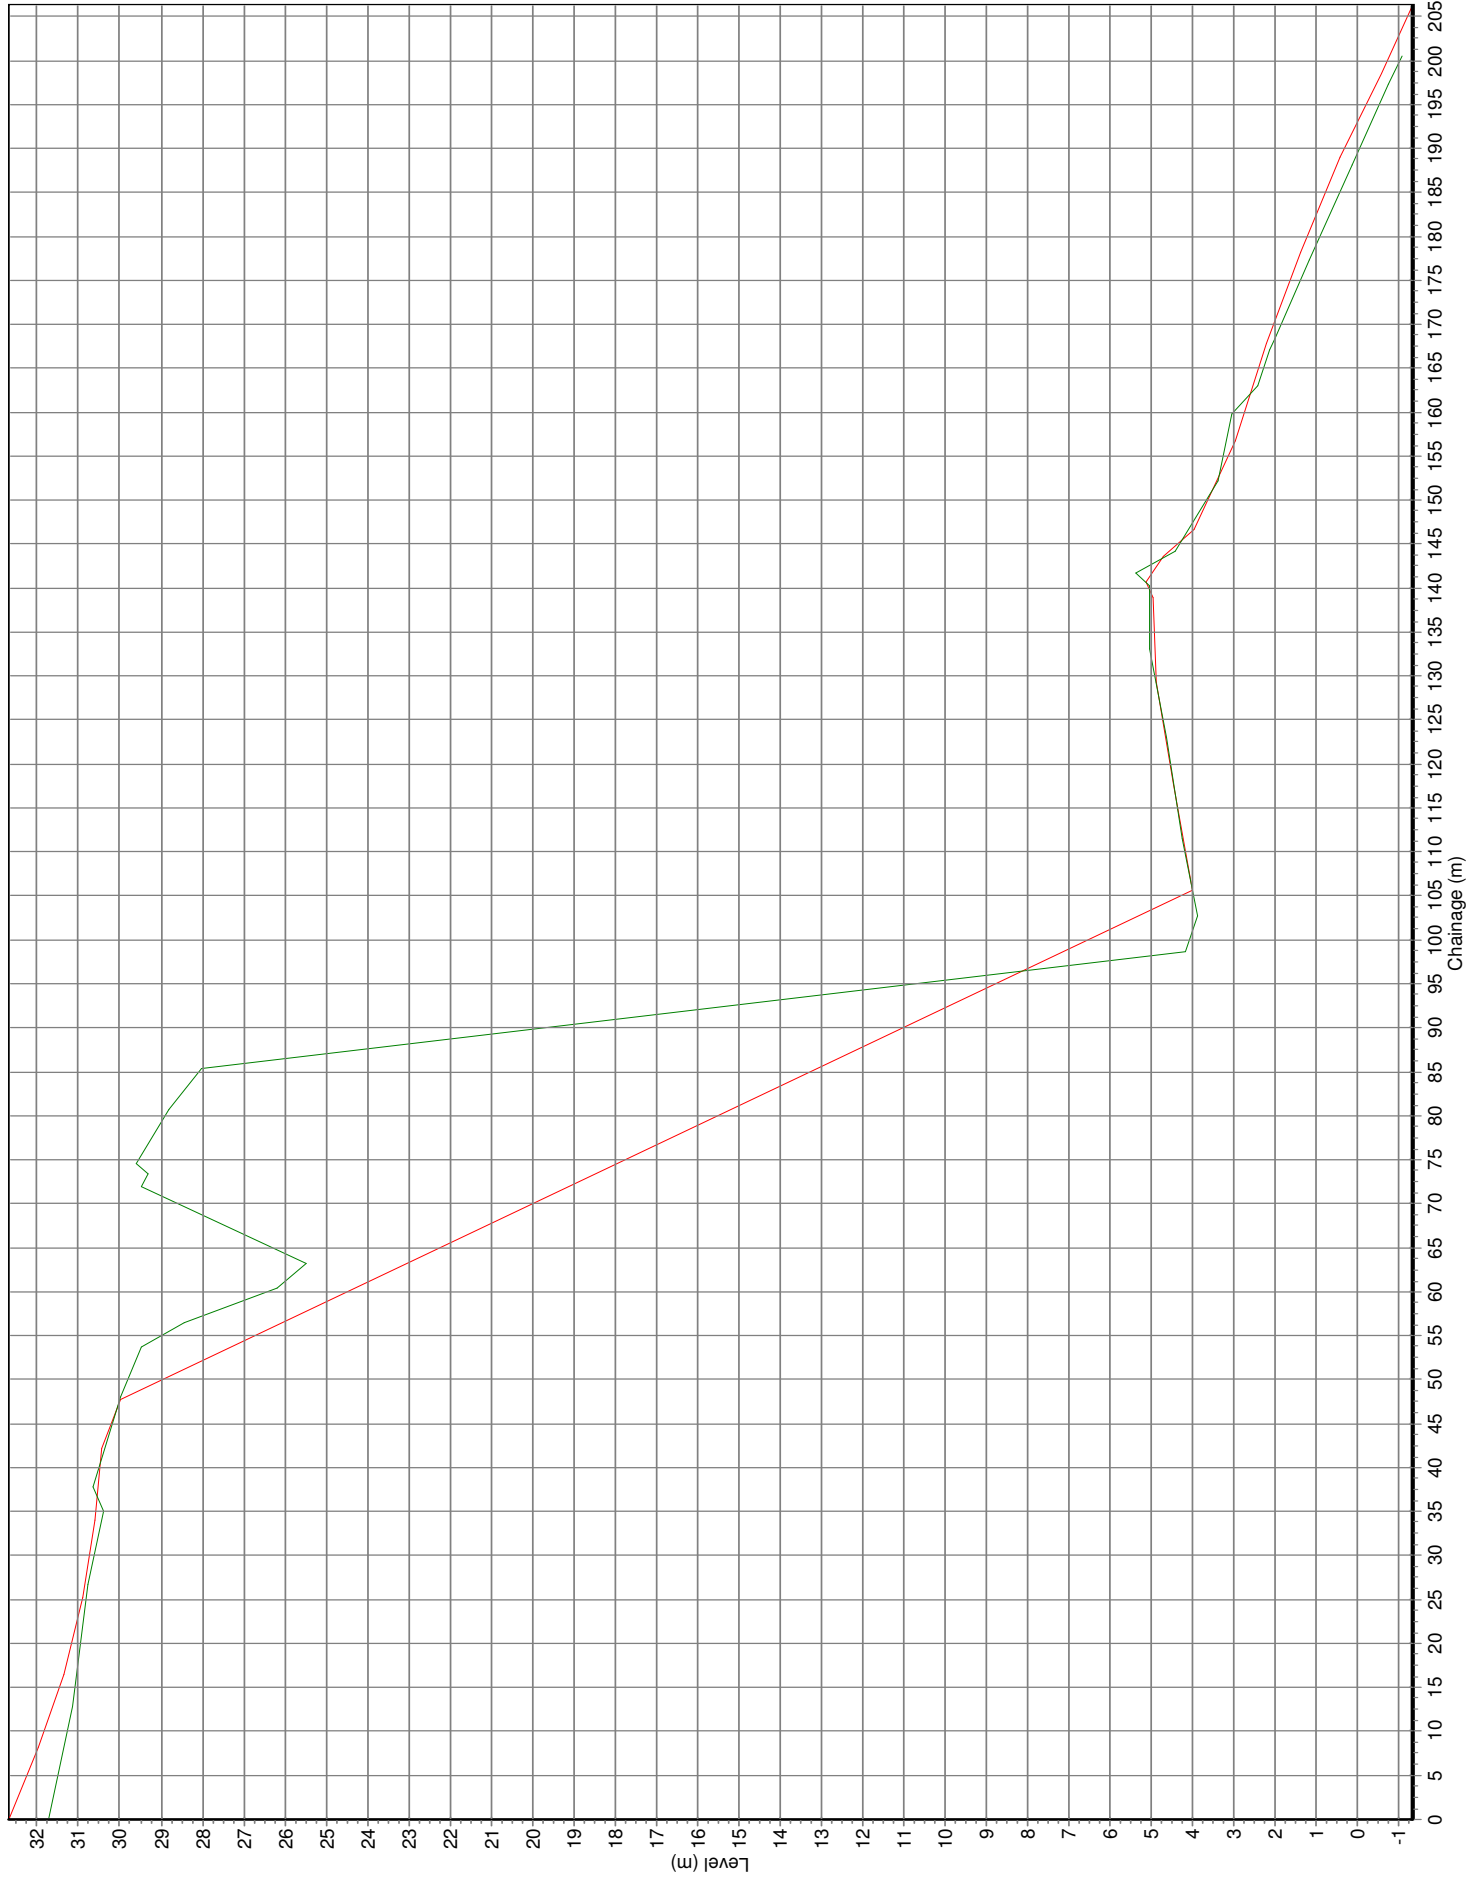
Beach Profiles: 1bSH2

<input checked="" type="checkbox"/>	25/1/2008
<input checked="" type="checkbox"/>	22/04/2009

Beach profiles SH1, SH2 and EA2 extend across cliff tops, each with difficult access to the cliff edge. This has led to notably (SH2) or slightly (SH1 and EA2) different levels of detail being picked up in these difficult areas between successive surveys. This gives rise to 'apparent' changes in the cliff face or cliff top which are not true. However, once crossing the foreshore there are no such problems and the survey accuracy is restored.

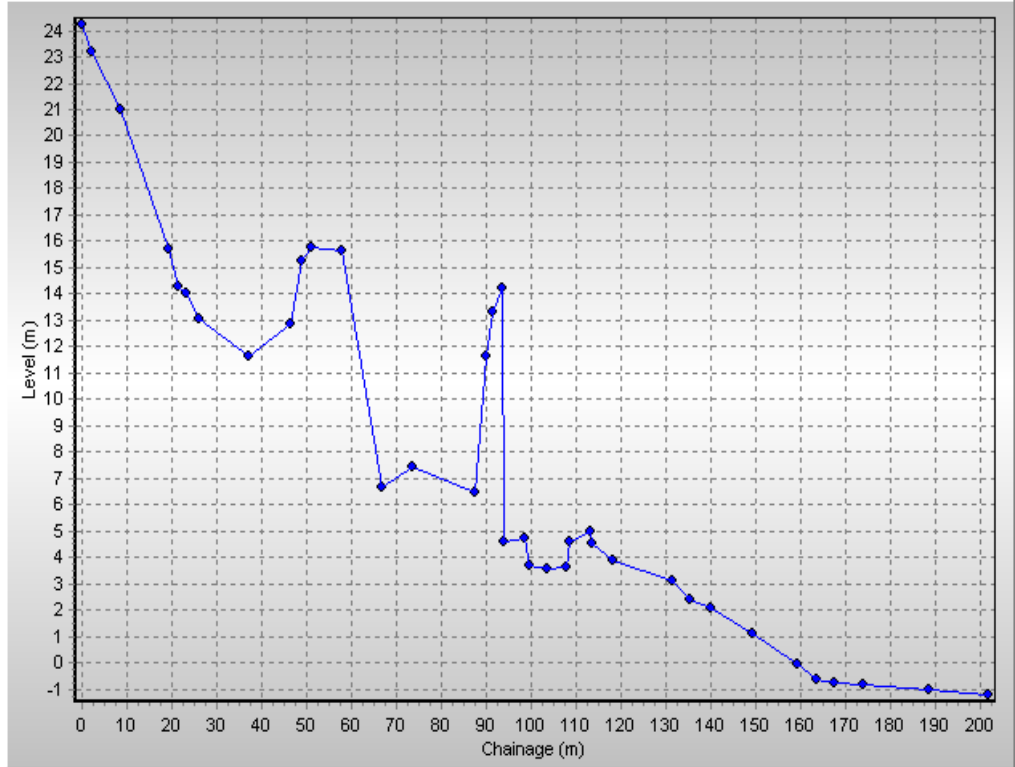
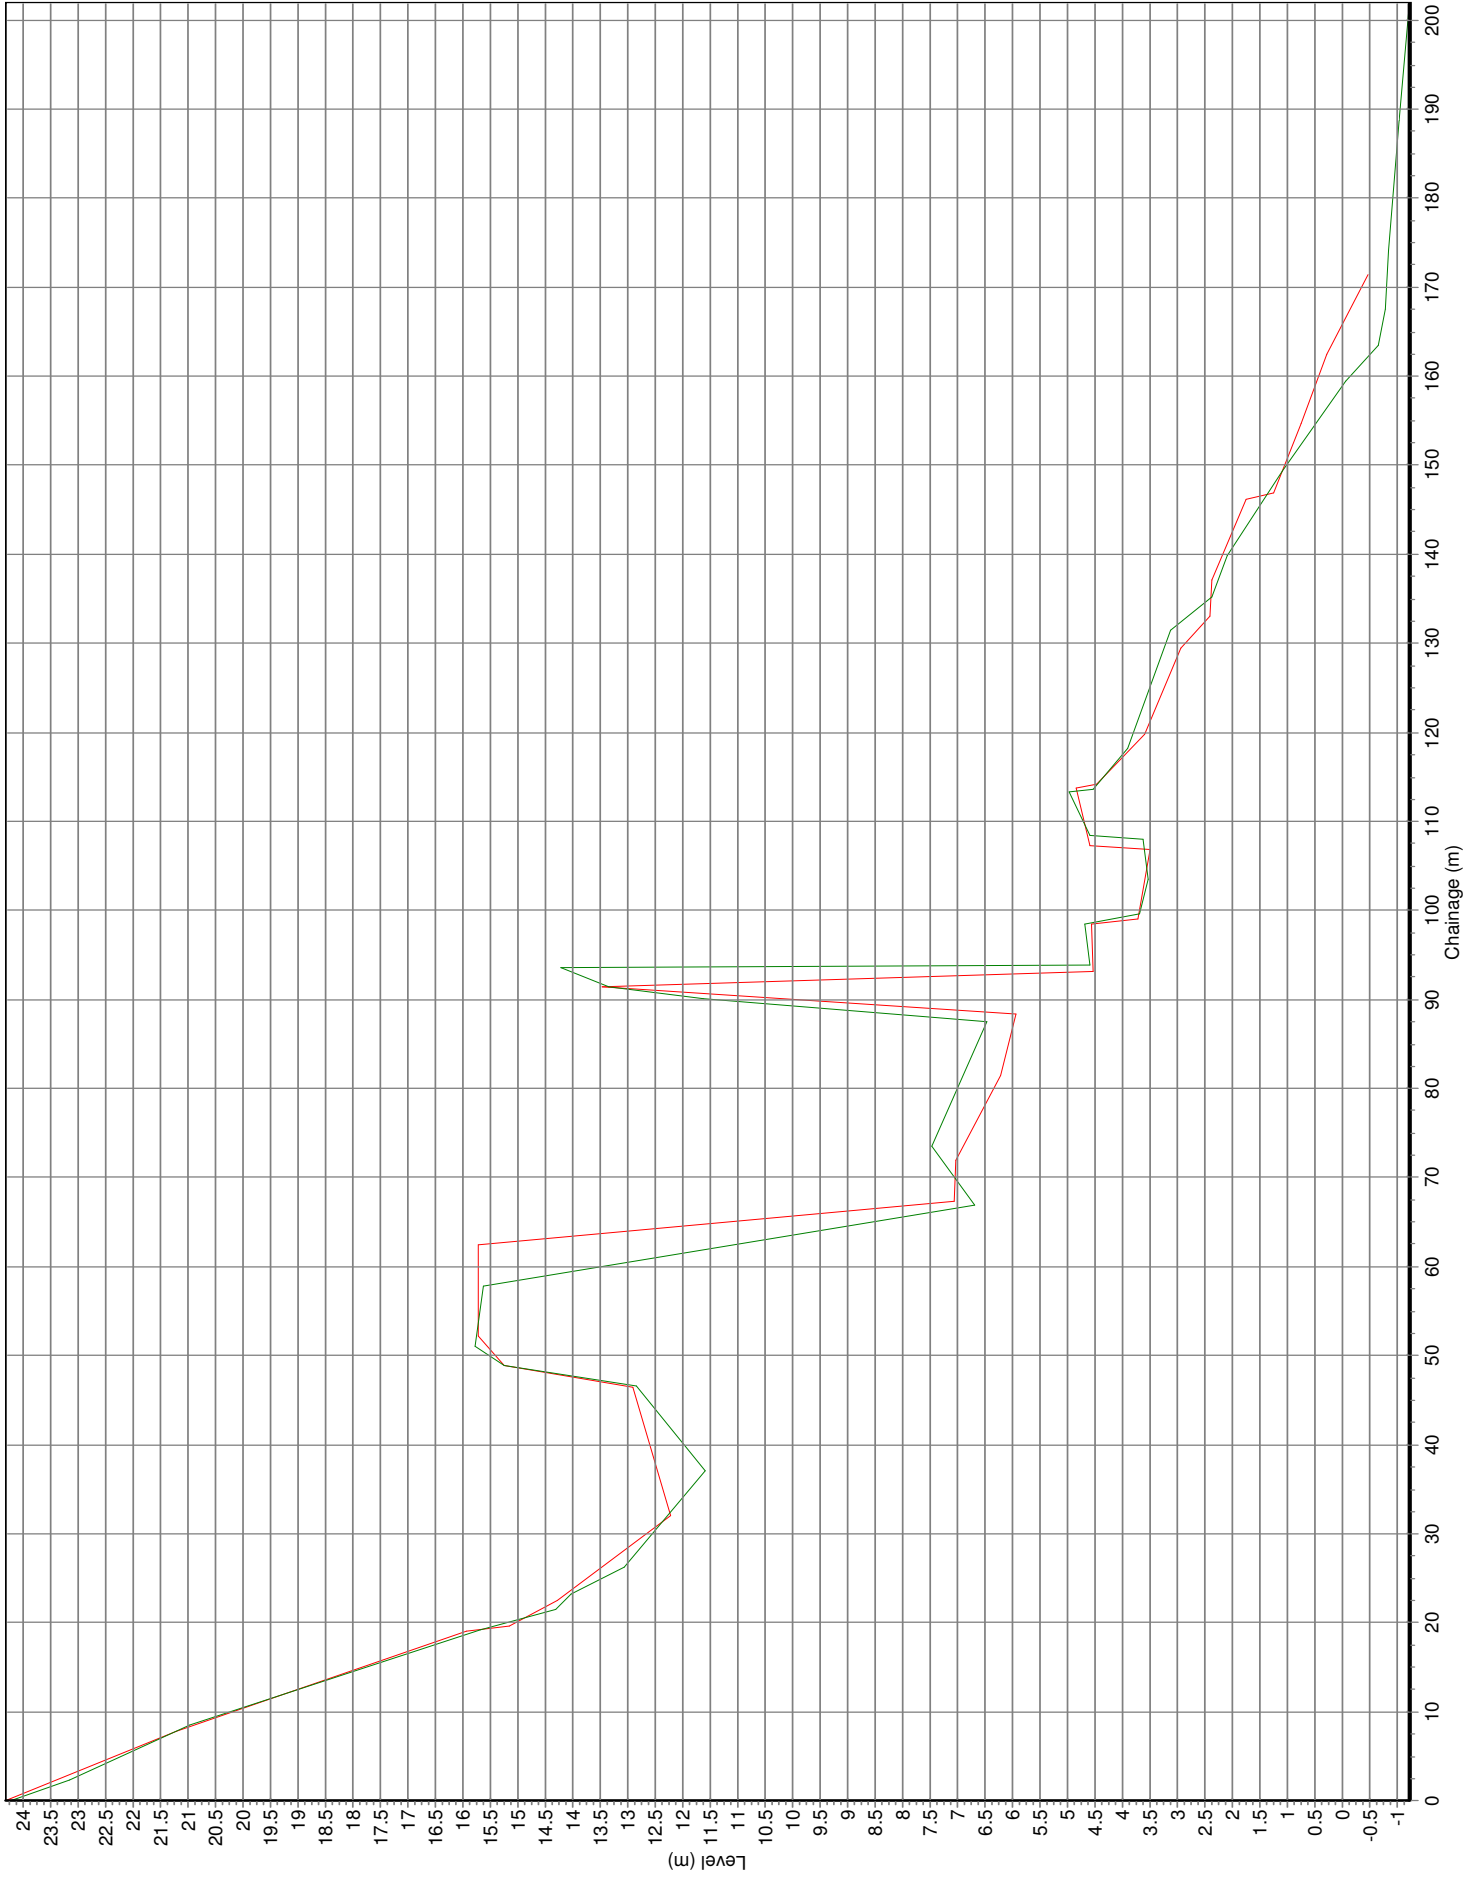
Beach Profiles: 1cEA2

03/12/2008
22/04/2009

Survey Date	Description of Changes Since Last Survey	Interpretation
03-2009	<p>Beach Profiles:</p> <p>Hawthorne Hive is covered by one beach profile line (EA2) during the Partial Measures survey (Appendix A).</p> <p>The foreshore has shown some change, with lowering below around MHWS and accretion above. The outlet channel of Hawthorne Hive remained in a relatively constant position (at this profile line) but widened slightly on its seaward margin.</p>	<p>There was a slight redistribution of sediment from the lower profile to the upper, but this was well within the expected bounds of natural variability.</p>

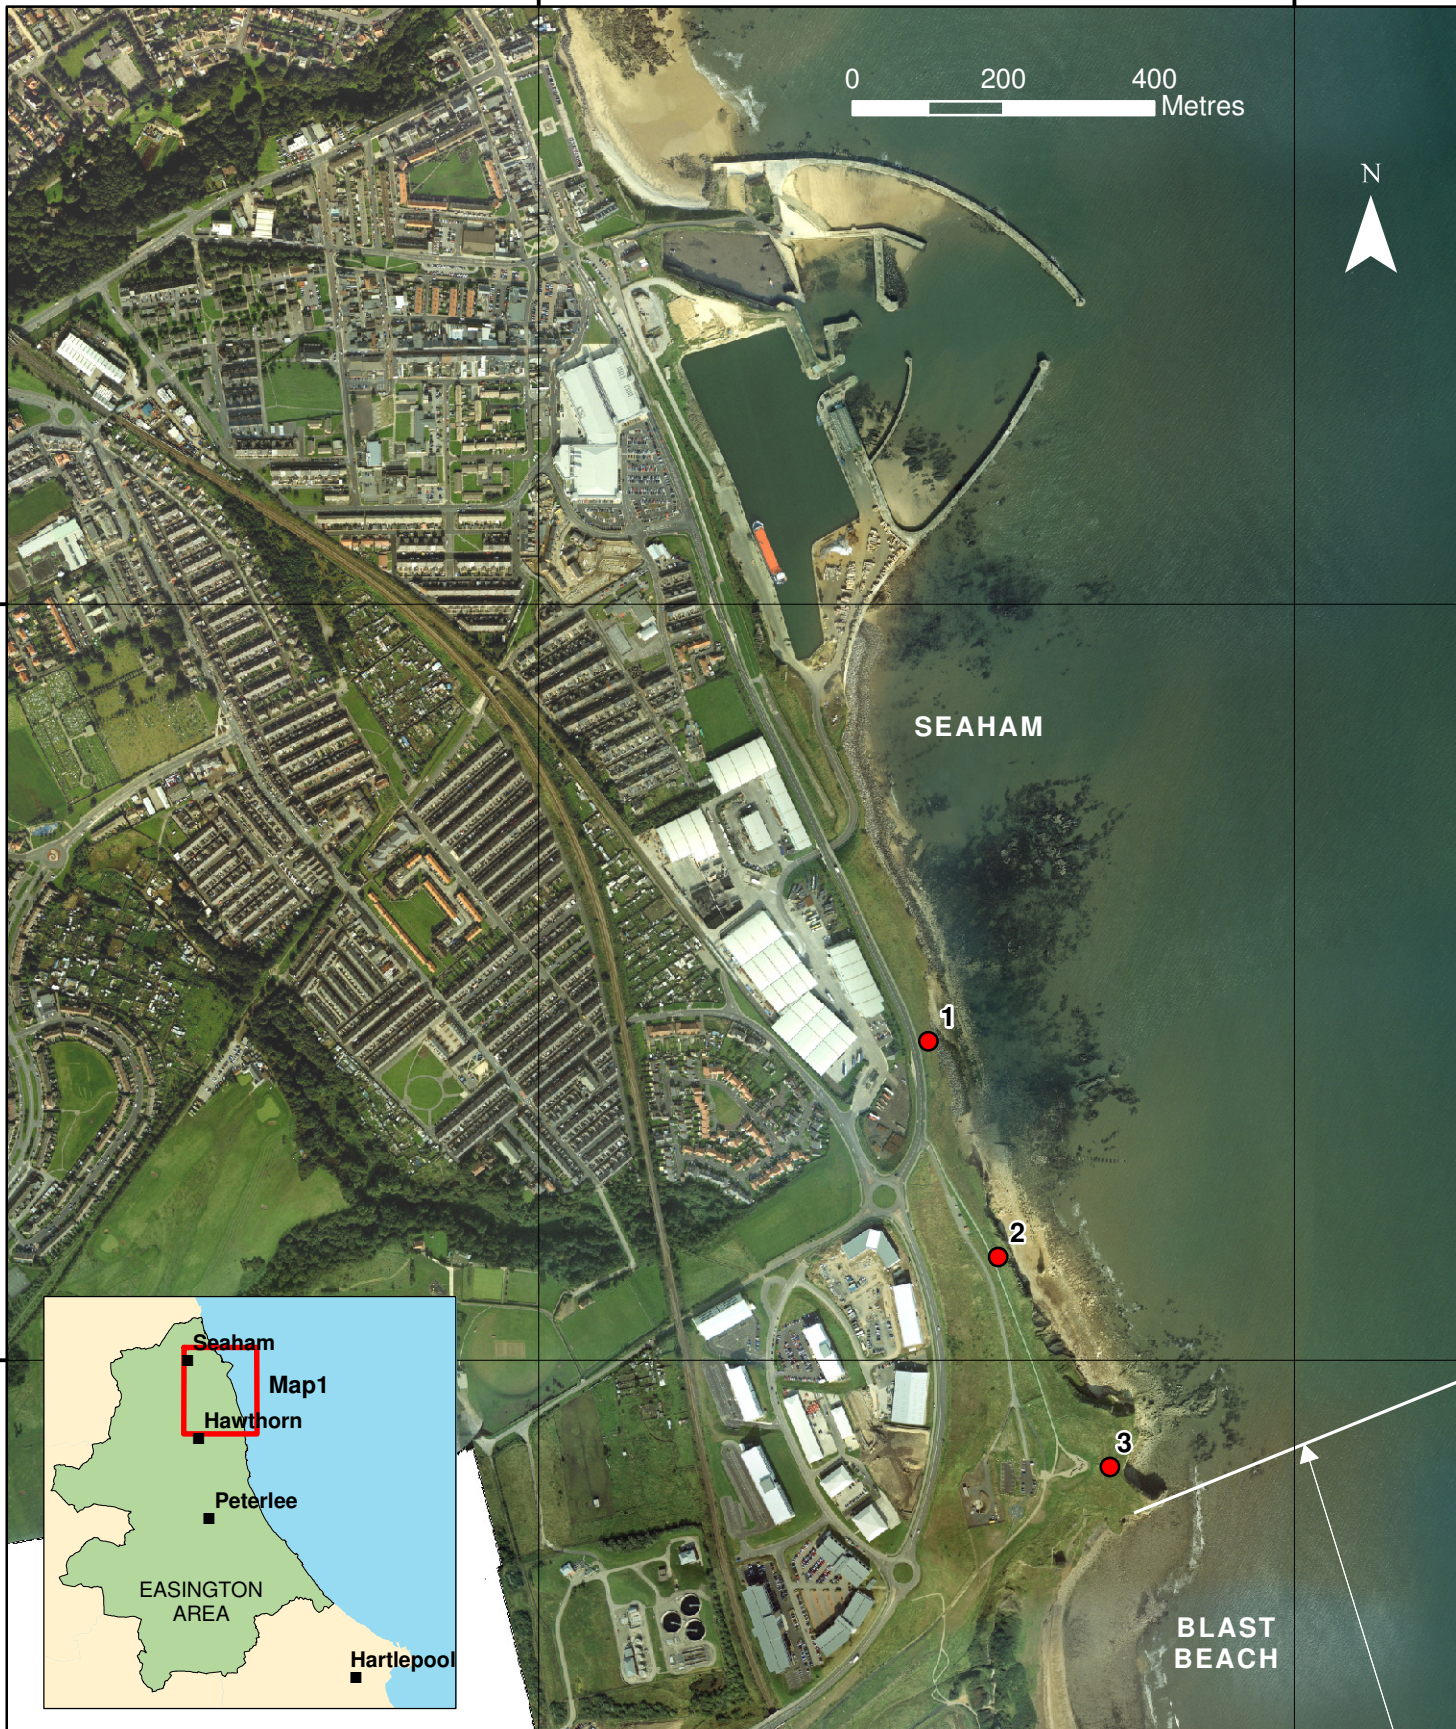
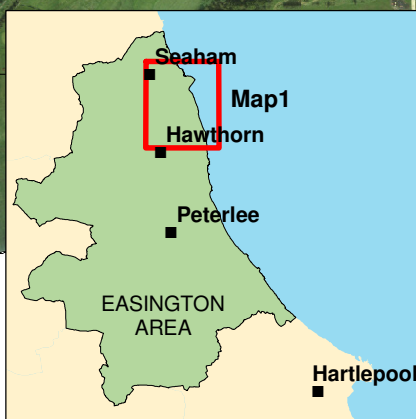
Appendix B - Map 1 Durham County Council Frontage

Three ground control points have been established along the cliff top at Dawdon (Figure B1). The separation between any two points is nominally 300m. These cliff top surveys are intended to inform on erosion rates of the undefended sea cliffs extending south of the rock armour revetment to the south of Seaham Harbour.

The cliff top surveys at Dawdon are undertaken bi-annually. Measurements are taken from a fixed ground control point along a fixed bearing to the edge of the cliff top.

Cliff Top Monitoring Points

Survey Date	Description of Changes Since Last Survey	Interpretation
03-2009 (Baseline)	<p>Cliff Top Survey:</p> <p>Three ground control points have been established along the cliff top at Dawdon (Figure B1).</p> <p>The separation between any two points is nominally 300m. These cliff top surveys are intended to inform on erosion rates of the undefended sea cliffs extending south of the rock armour revetment to the south of Seaham Harbour. The cliff top surveys at Dawdon are undertaken bi-annually. Measurements are taken from a fixed ground control point along a fixed bearing to the edge of the cliff top.</p> <p>Appendix B provides results from the March 2009 survey showing the position from the ground control point to the edge of the cliff top along the defined bearing and changes since the November 2008 baseline survey.</p>	<p>The ground control points at the northern and southern locations have recorded substantial erosion, with values of 0.6m and 1.1m observed respectively. The central ground control point remained relatively stable.</p>

The cliff top position surveys at Dawdon are assumed to have a limit of accuracy of $\pm 0.1\text{m}$ due to the techniques used. Whilst an annual erosion rate has been calculated from these cliff top survey data, it is really too early in the monitoring for this to be a meaningful rate at present. This will improve with longevity of the data record, however, to yield a more meaningful longer-term mean rate.
