**Cell 1 Regional Coastal Monitoring Programme
Update Report 5: 'Partial Measures' Survey 2013**

**Durham Council
Final Report**

June 2013

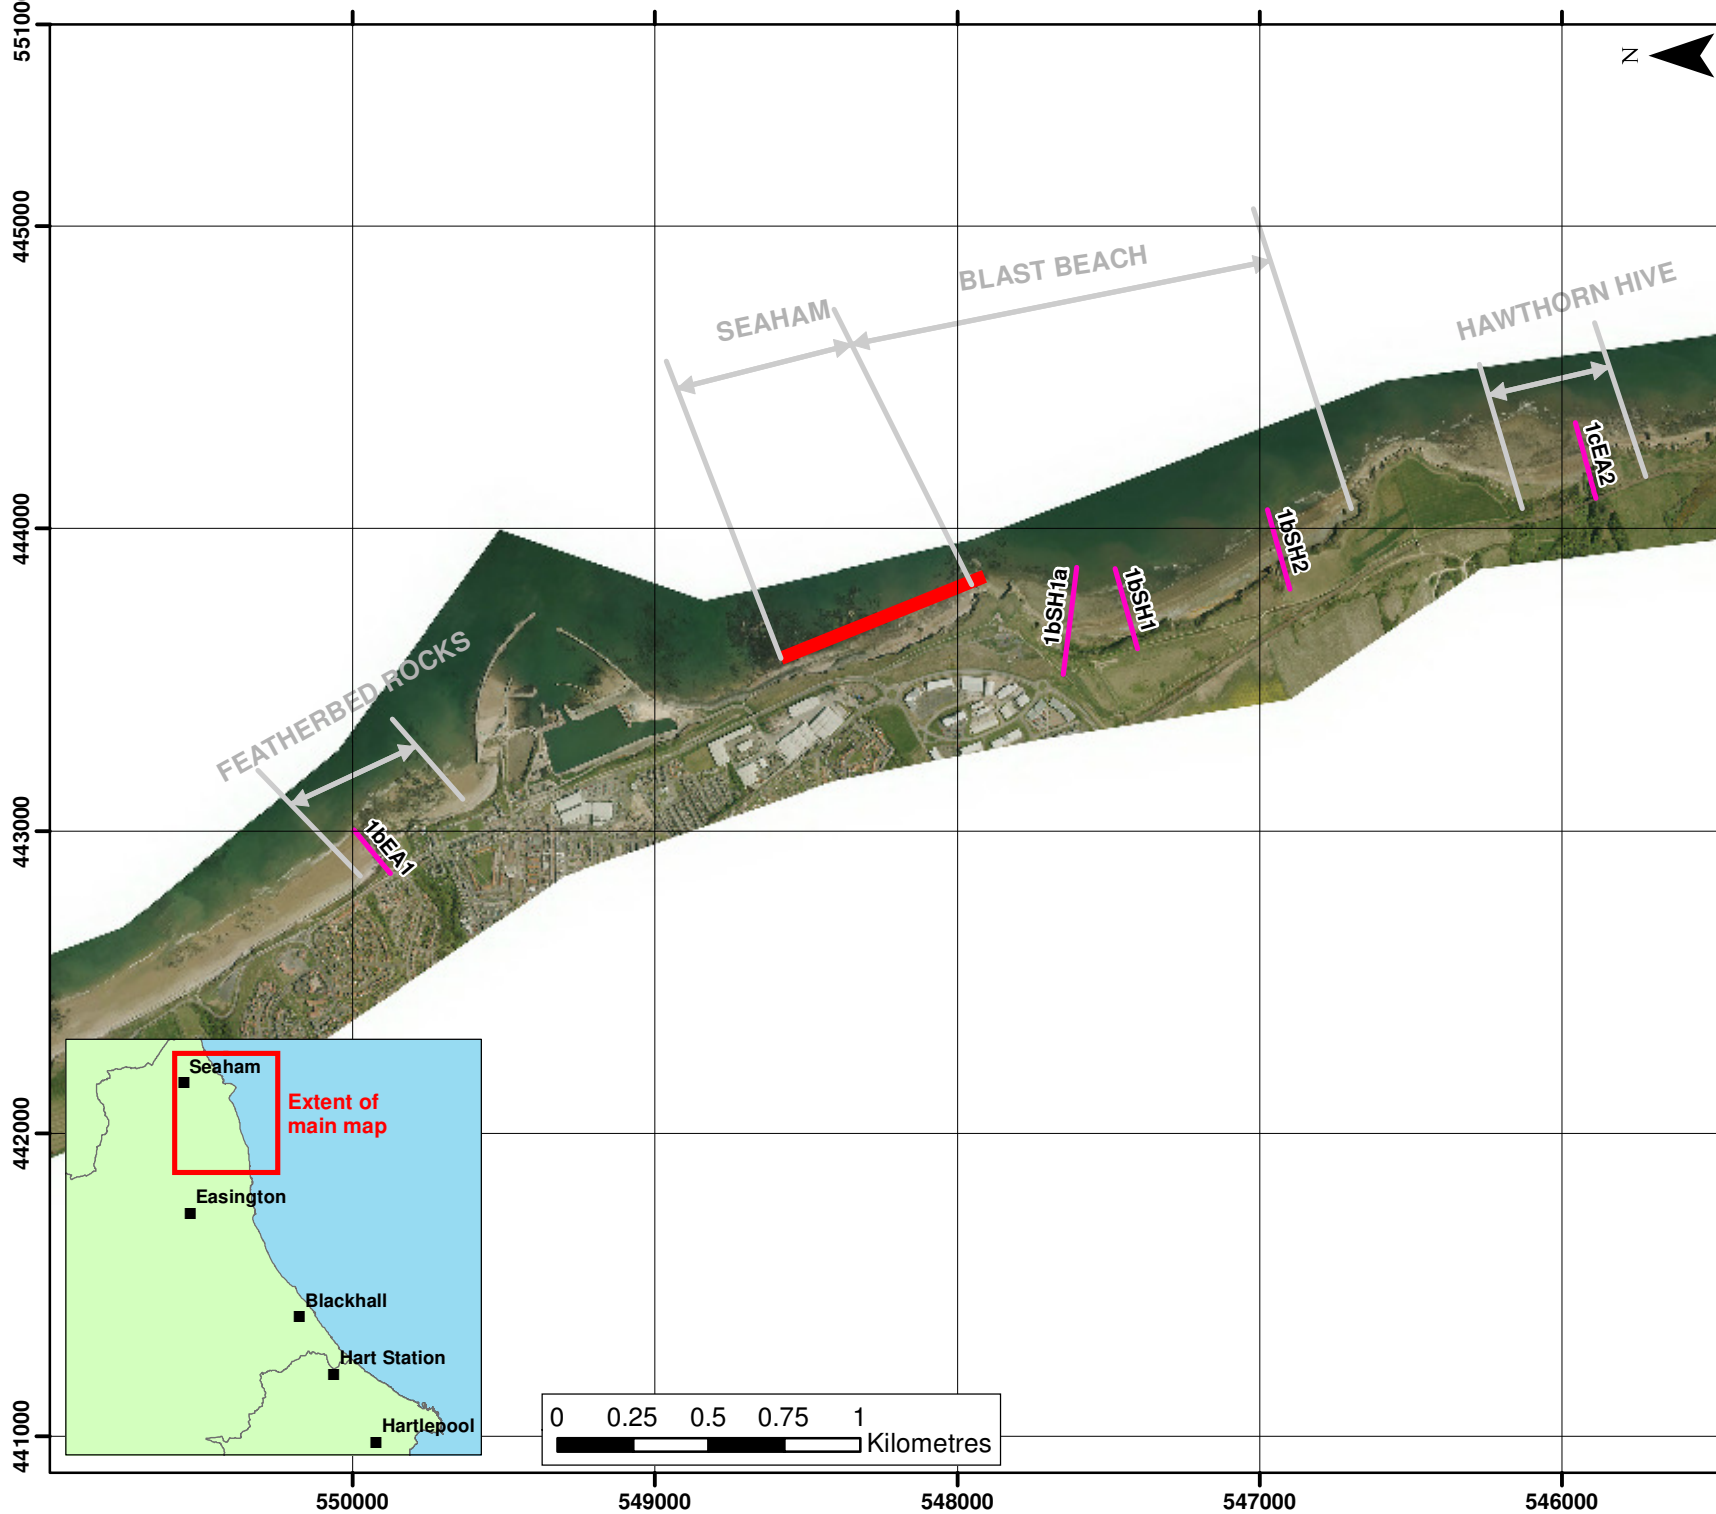
**Figure 2 - Map 1
Survey Locations
Featherbed Rocks to
Hawthorne Hive
Durham County Council**

The location of these surveys is shown in Figure 2. The Partial Measures survey was undertaken along this frontage on 3rd March 2013. During the survey the weather was sunny and dry, the wind was force 3 from the west and the sea state was calm..

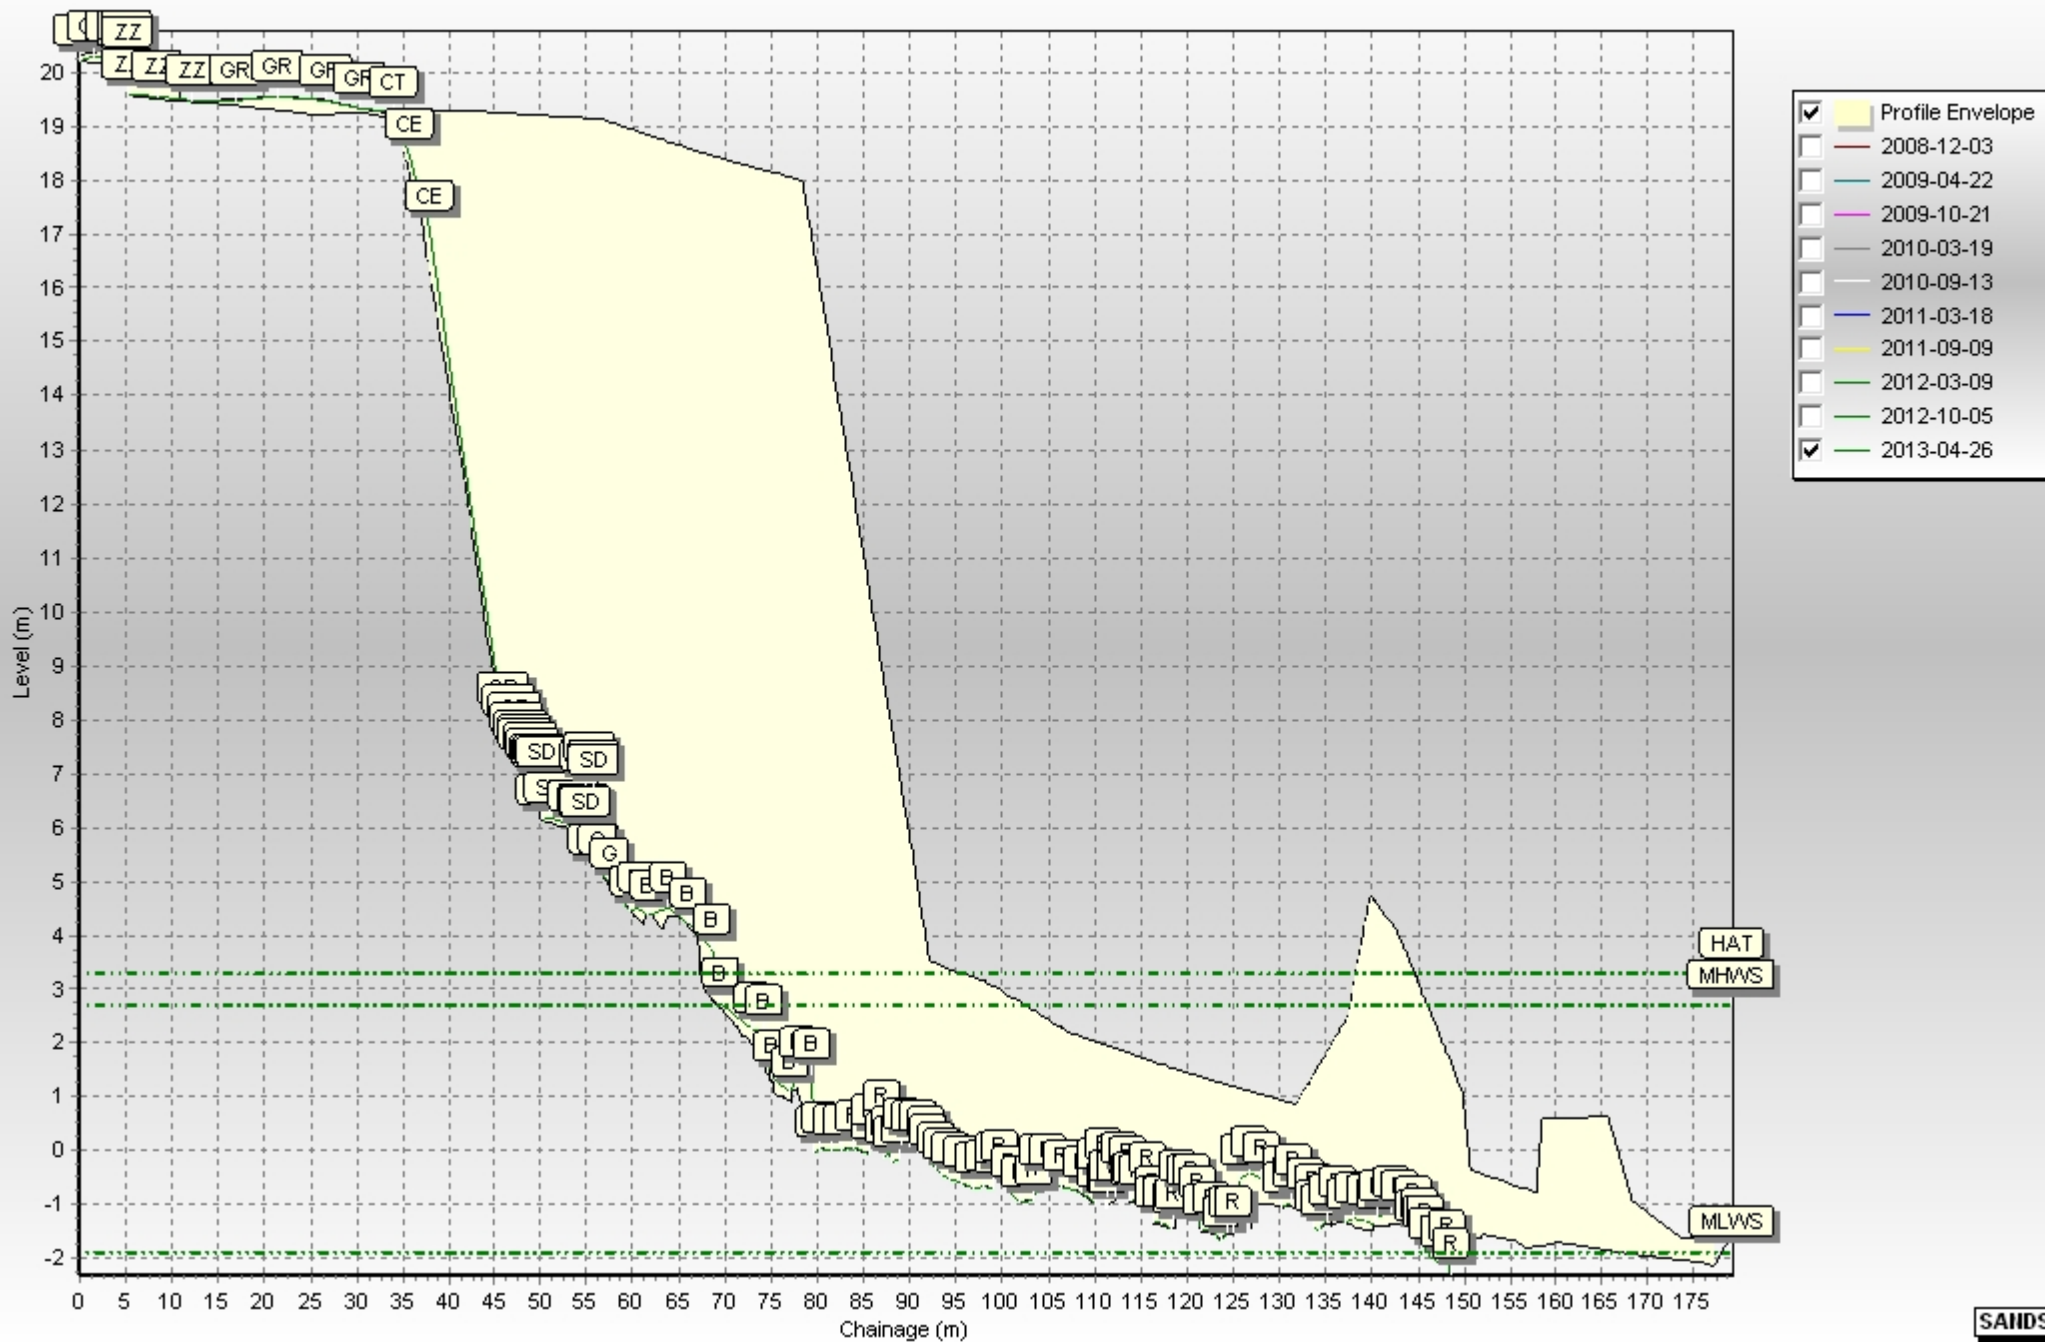
Profiles: 1bEA1

Survey Date	Description of Changes Since Last Survey	Interpretation
26 th April 2013	<p>Beach Profiles:</p> <p>Featherbed Rocks is monitored by one beach profile line (EA1) during the Partial Measures survey (Appendix A). The previous survey was September 2011.</p> <p>Profile EA1 has changed very little to 55m chainage. Between 55m chainage and 80m chainage the sea wall is more exposed than in the October 2012 profile, there has been around 0.2m of erosion. From 80m chainage to 150m chainage the rocks on the foreshore are exposed because the beach level has dropped by up to 0.5m. The profile is among the lowest recorded profiles and is comparable with March 2010.</p> <p>The surveyor noted that section EA1 has no sand on it. Previously unseen groynes can be view to the north of the section line.</p>	<p>The sand veneer had been eroded from the beach over the winter of 2012/13.</p> <p>Longer term trends:</p> <p>The level of the beach in April 2013 was low. The most recent survey is comparable with the lowest beach levels, recorded in March 2010. However, this is considered to be due to seasonal fluctuations.</p>

- At Featherbed Rocks the level of the beach in April 2013 was low. The most recent survey is comparable with the lowest beach levels, recorded in March 2010. The lowering of the beach could be the precursor to a trend of erosion affecting the cliff. As a result, the beach level should be watched closely over the next few surveys to see if this is an erosive trend, or natural variation.

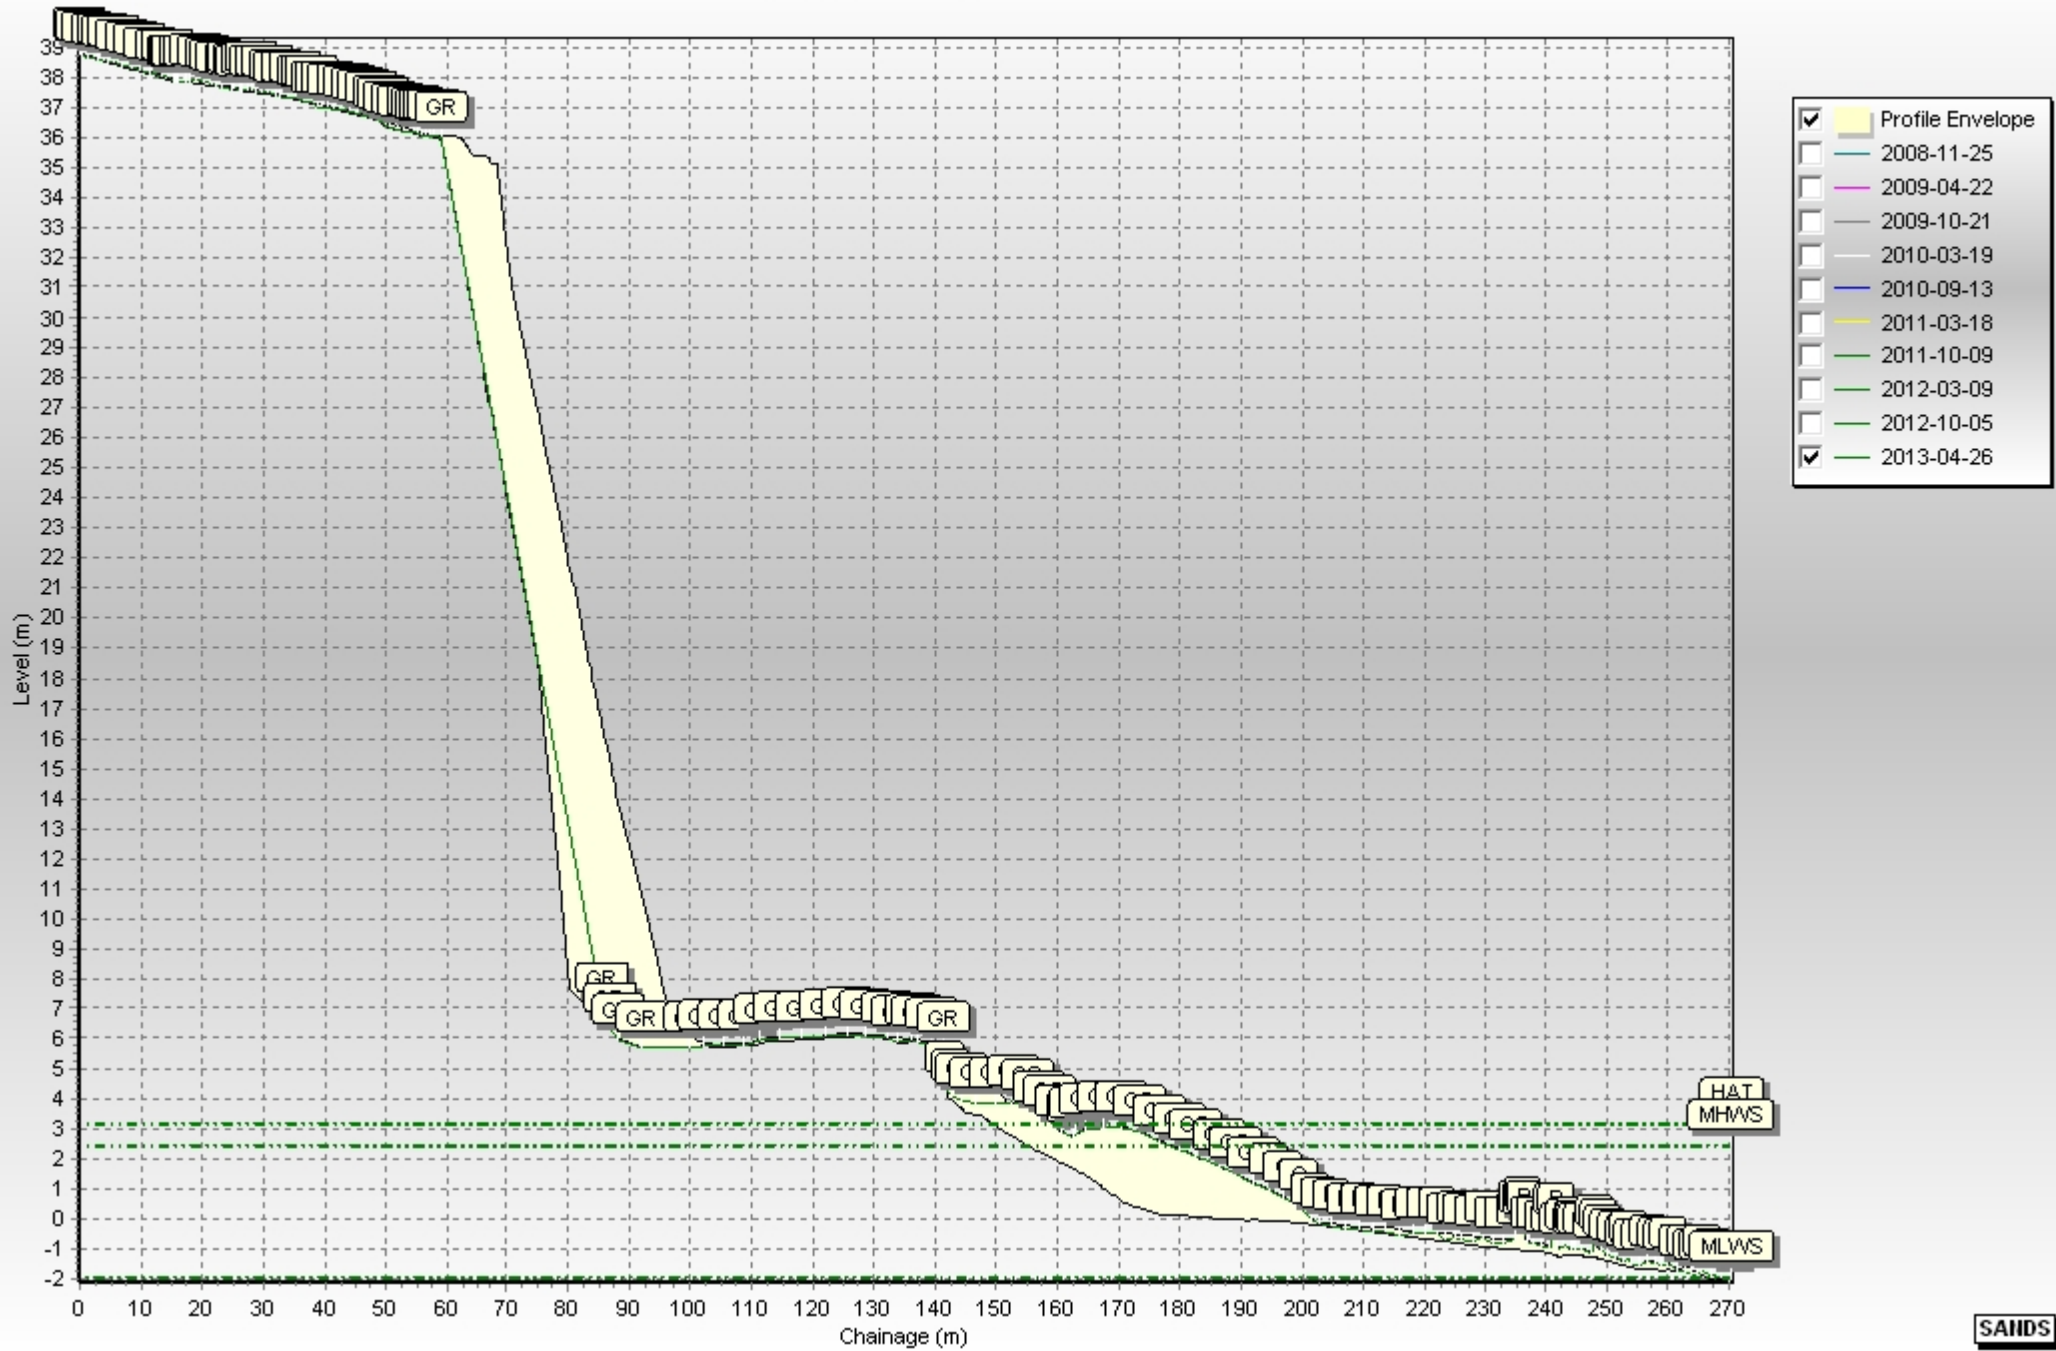
Profiles: 1bSH1A

Survey Date	Description of Changes Since Last Survey	Interpretation
26 th April 2013	<p>Beach Profiles:</p> <p>Blast Beach is covered by three beach profile lines during the Partial Measures survey (Appendix A). Two of these commenced in November 2008, with SH1a being added in October 2009.</p> <p>At SH1a the crest of the eroding face of spoil was at 140m chainage in October 2012 and April 2013. Between 140m and 205m chainage the beach has accreted by up to 2m. From 205m to the end of the survey at 270m chainage, where the rocks are exposed, the beach has not changed over the winter of 2012/13. The surveyor was unable to measure the bottom and top of section 1a due to vegetation</p> <p>SH1 the crest on the upper beach is at 75m chainage in October 2012 and April 2013. From 75m to 100m chainage the beach level has dropped by around 0.5m. Below 100m chainage for the rest of the survey the beach has accreted by 1.5m.</p> <p>SH2 the beach below the berm's crest has eroded by up to 1.5m at around 130m chainage. A mound of material which was on the beach in the October 2012 survey has been eroded resulting in a 1.5m drop in beach level.</p>	<p>There has been a variable pattern of accretion and erosion along this frontage over the winter of 2012/13. The observed localised accretion of the beaches at SH1 and SH1a.</p> <p>There was erosion of beach material at SH2, but no obvious failures on the cliff, although the surveyor noted "a number of recent rock falls". As a result the material which fed the beaches is from the cliffs or other parts of the beach. The accretion is not likely to be from alongshore sediment transport and does not suggest that new material from offshore has entered the beach.</p> <p>Longer term trends:</p> <p>Profile SH2 shows obvious progressive recession with the beach moving landward each year. Conversely both, SH1a and SH1 show fluctuations in the height and width of the beach with no obvious trend through time. The April 2013 beach profiles for SH1a and SH1 have a large mound on each, which is higher than any previous profile and has not been observed before.</p>

At the Blast Beach profile, SH1a, the surveyor was unable to measure the bottom and top of section 1a due to vegetation

- At Blast Beach there has been accretion and erosion along this frontage over the winter months. The observed accretion on the beach is likely to be the accumulation of sediment from the spoil or from alongshore. There is no immediate cause for concern along this frontage. In the future the sea cliffs are likely to reactivate and erode back once the spoil has eroded from the beach.

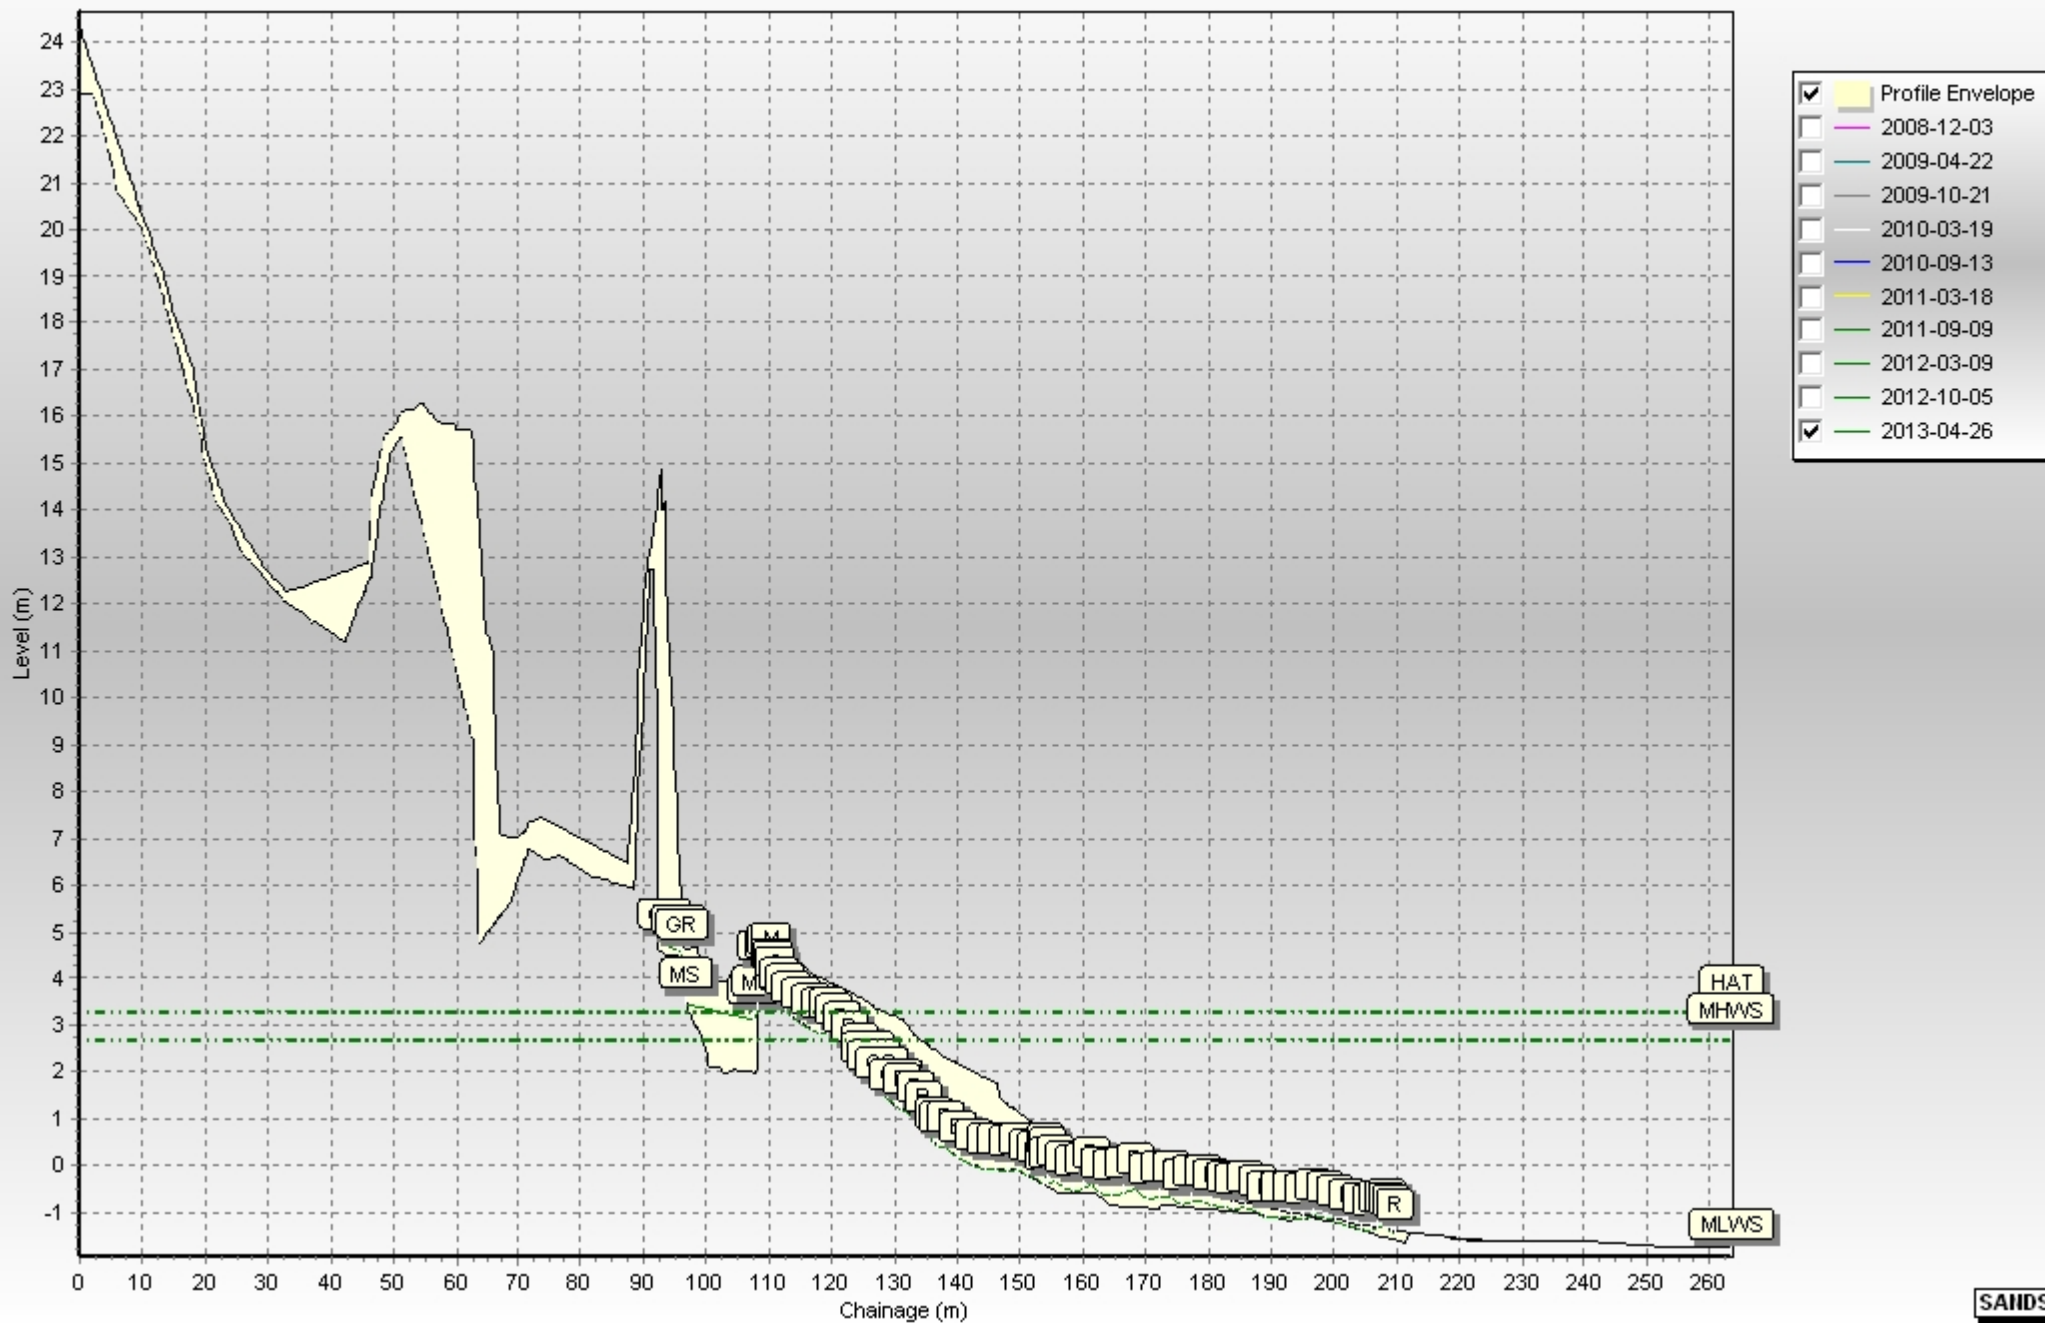
Profiles: 1cEA2

Survey Date	Description of Changes Since Last Survey	Interpretation
26 th April 2013	<p>Beach Profiles:</p> <p>Hawthorne Hive is covered by one beach profile line (EA2) during the Partial Measures survey (Appendix A). The surveyor was “unable to measure start of Section EA2 as the vegetation has choked out the section line and route over cliff faces”. The beginning of the April 2013 survey is at 95m chainage, which is comparable with the October 2012 survey. The channel has in filled and the beach level at 105m chainage is 1.5m higher than in October 2012. Next to the channel the crest of the beach is at 110m chainage and this has remained relatively stable since October 2012. From the crest of the beach at 110m to the end of the survey at 200m chainage the beach level has dropped by 0.5m over the winter of 2012/13 although the gradient is similar.</p>	<p>The beach profile is at a historically low level, with the profile being the lowest since 2008.</p> <p>Longer term trends:</p> <p>The profiles show that the beach is undergoing progressive erosion. There is a clear trend of the profiles moving back through time. The beach levels may still recover over the summer of 2013.</p>

At Hawthorne Hive the surveyor was “unable to measure start of Section EA2 as the vegetation has choked out the section line and route over cliff faces”.

- At Hawthorn Hive the beach profile was at its lowest recorded level and the profiles show that the beach is undergoing progressive erosion. The low beach levels may recover over the summer of 2013.

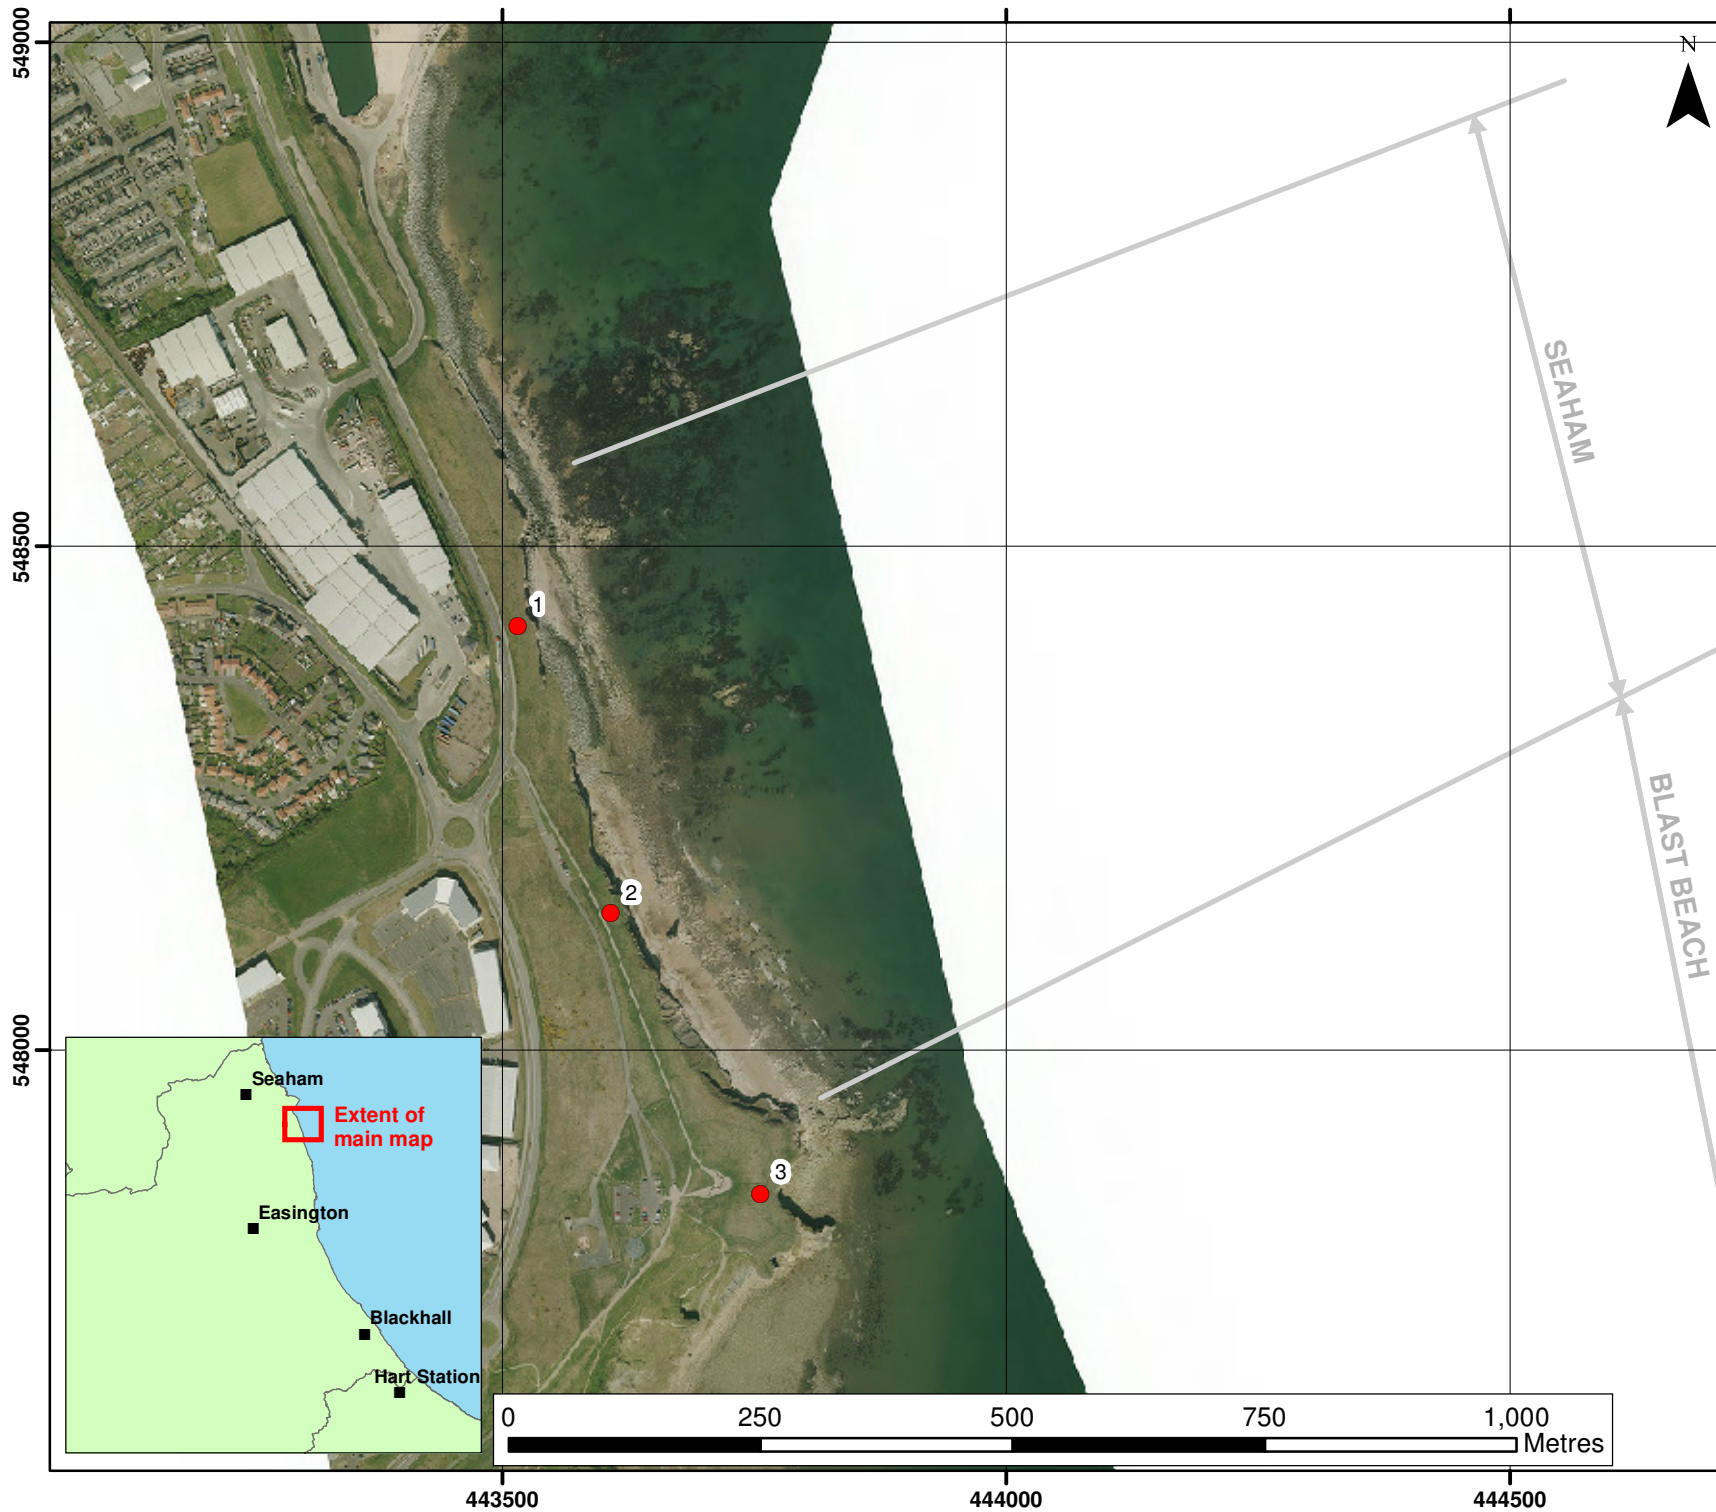
**Appendix B - Map 1
 Ground Control Points
 Seaham
 Durham County Council**

Survey Date	Description of Changes Since Last Survey	Interpretation
26 th April 2013	<p>Cliff-top Survey:</p> <p>Three ground control points have been established along the cliff top at Dawdon (Figure B1). The separation between any two points is nominally 300m. These cliff top surveys are intended to inform on erosion rates of the undefended sea cliffs extending south of the rock armour revetment to the south of Seaham Harbour. The cliff top surveys at Dawdon are undertaken bi-annually.</p> <p>Measurements are taken from a fixed ground control point along a fixed bearing to the edge of the cliff top. Appendix B provides results from the April 2013 survey showing the position from the ground control point to the edge of the cliff top along the defined bearing and changes since the November 2008 baseline survey.</p> <p>The cliff monitoring data are inconclusive, and show no change larger than the 0.1m margin of error in the last 6 months. This result is an artefact of errors in the survey data masking any short term change in cliff position.</p>	<p>All of the ground control points showed a small cliff advance since the previous survey in October 2012. As a result there is low confidence in the cliff recession data.</p> <p>Longer term trends:</p> <p>Ground Control Points 1 and 3 has shown an average recession rate of 0.2m/year since monitoring began in 2008. Point 2 has shown no erosion.</p> <p>There is more confidence in the long-term pattern of change, where the cumulative measured erosion is greater than the error inherent in the technique.</p>

Three ground control points have been established at Dawdon (Figure B1). The maximum separation between any two points varies along the coast, reflecting the degree of risk from the erosion.

The cliff top surveys at Dawdon are undertaken bi-annually. Measurements are taken from a fixed ground control point along a fixed bearing to the edge of the cliff top.

- The Dawdon Cliff survey data shows that the average recession rate since monitoring began in 2008 is around 0.2m/yr although there is some uncertainty over the accuracy of the data.
